## ***Macksville Hospital Development***

### Structural Report

**Project No.:** 10459  
**Date:** 04<sup>th</sup> May 2018

**Issued For:** State Significant Development

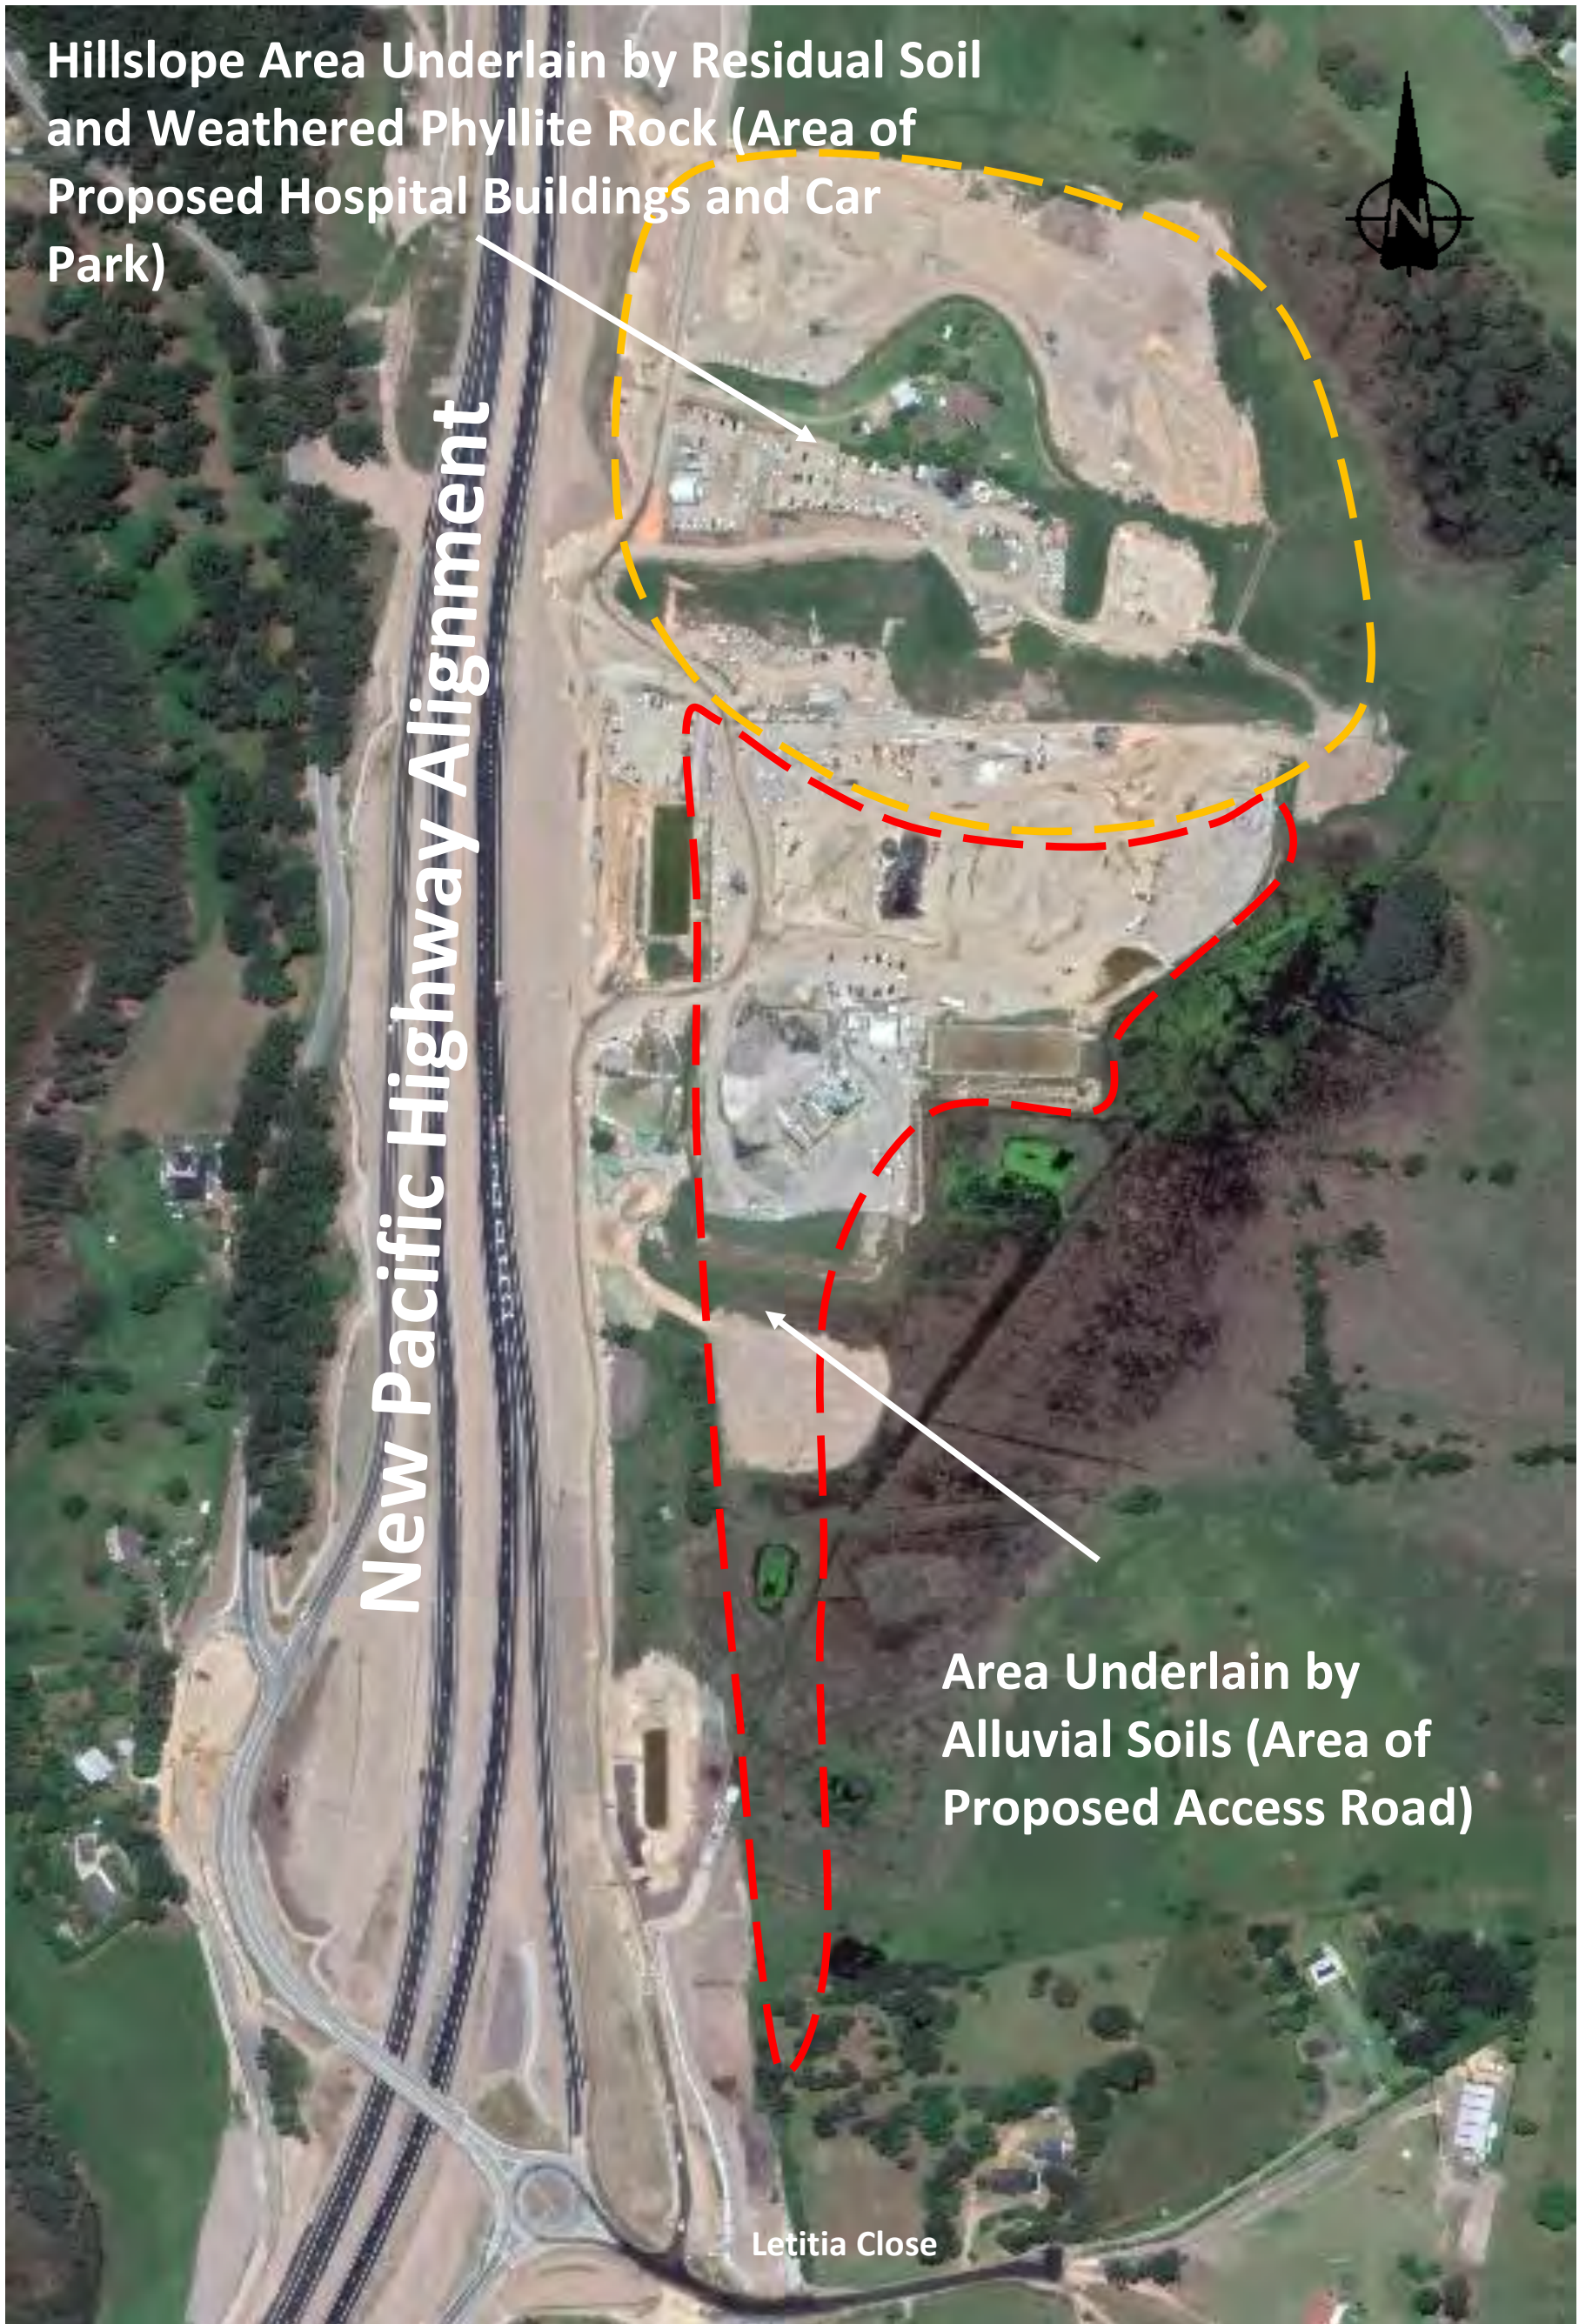
| Title: | Site Location Plan Indicating Geology | Drawing No. | Figure 1 |

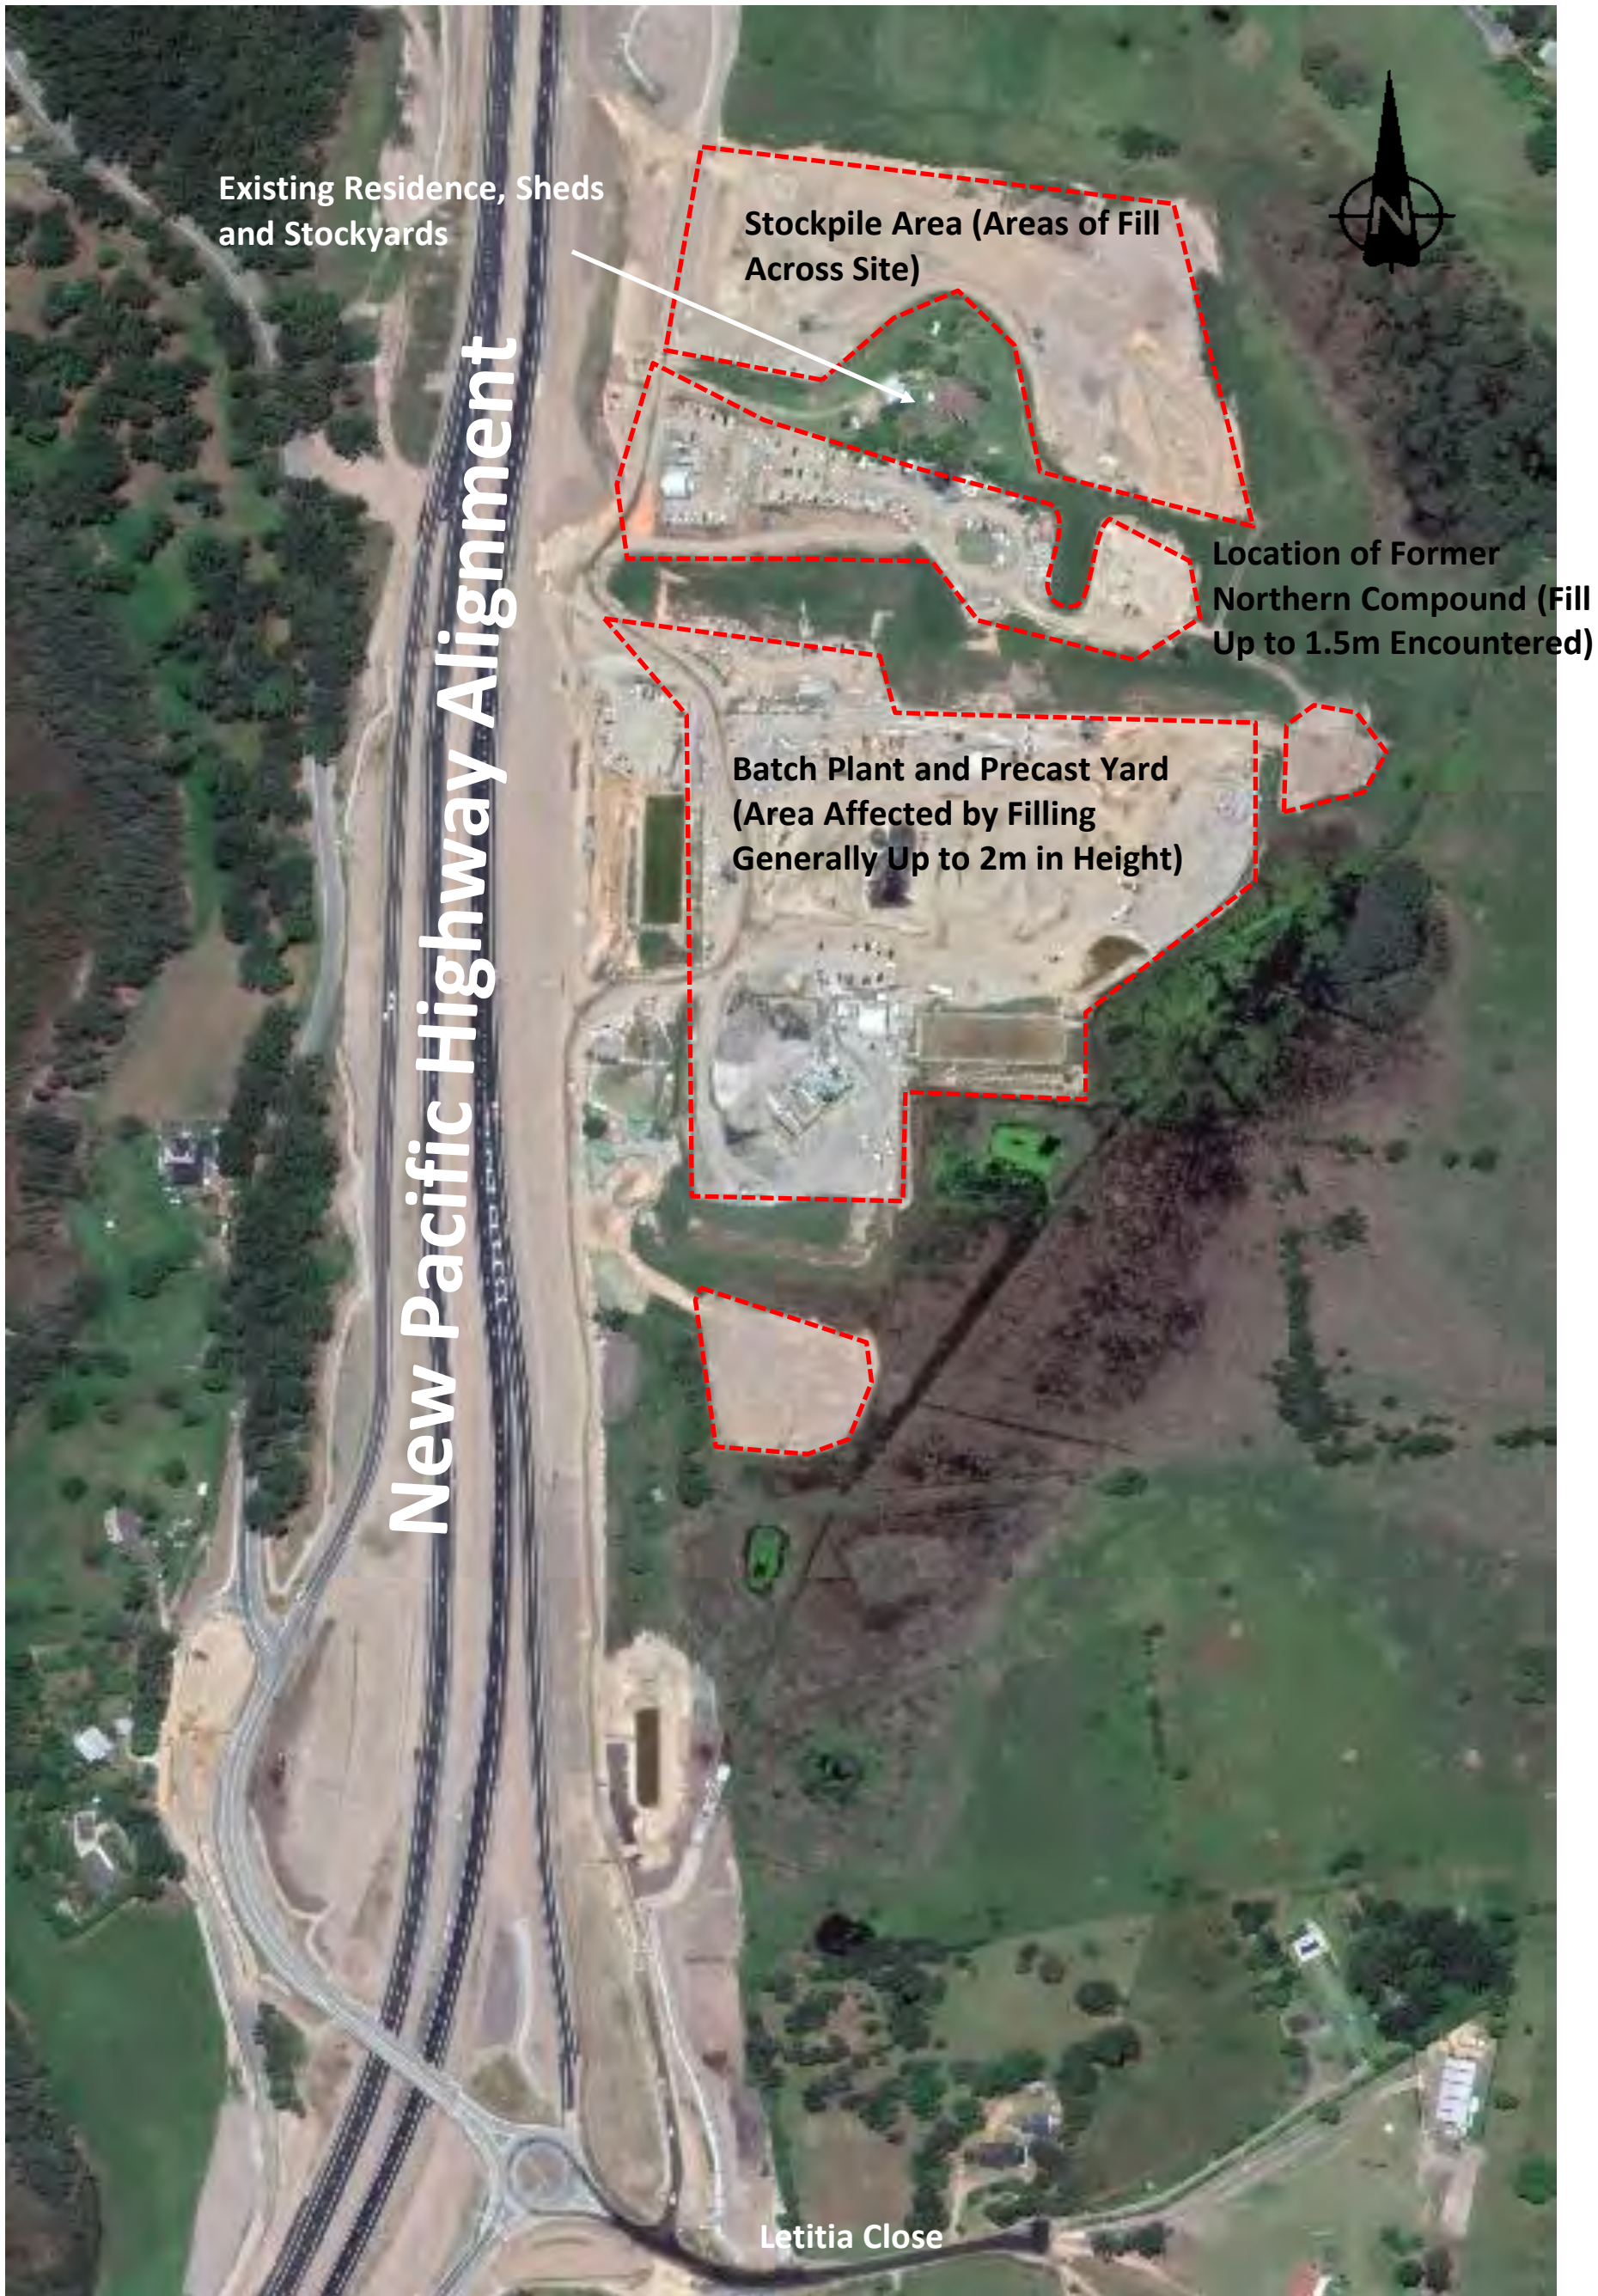
| Title: | Site Plan Indicating Areas Affected by Filling | Drawing No. | Figure 2 |

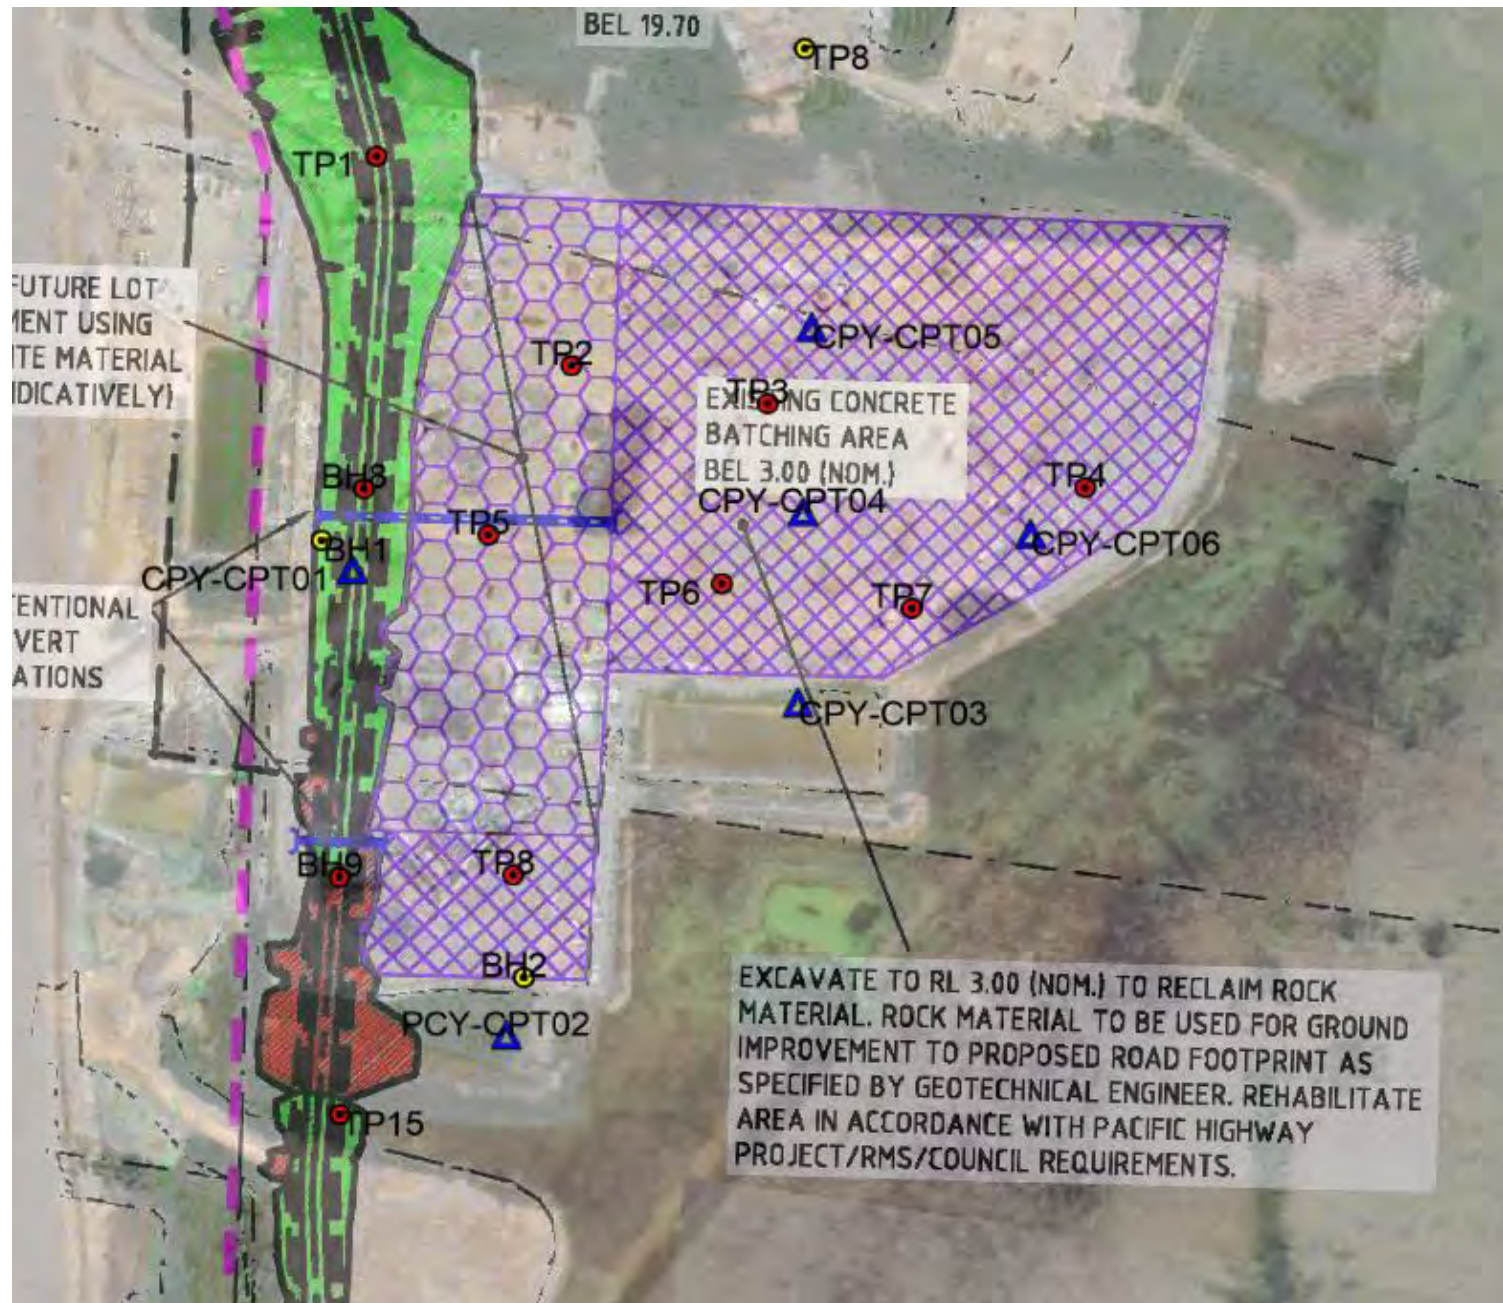
| | Title: | Test Pit and Borehole Location Plan | Drawing No. | Figure 4b |

Fieldwork was conducted by a Geotechnical Engineer from RGS who, logged the materials observed, took samples and recorded results of in-situ testing. Figures 4a to 4c show the investigation locations. Engineering Logs are presented in Appendix A, with explanation sheets defining the terms and symbols used in their preparation.
