Report on  
Preliminary Geotechnical Investigation

Randwick Campus Redevelopment  
Hospital Road and High, Magill and Botany Streets,  
Randwick

Prepared for  
Health Infrastructure

Project 72505.11  
February 2018

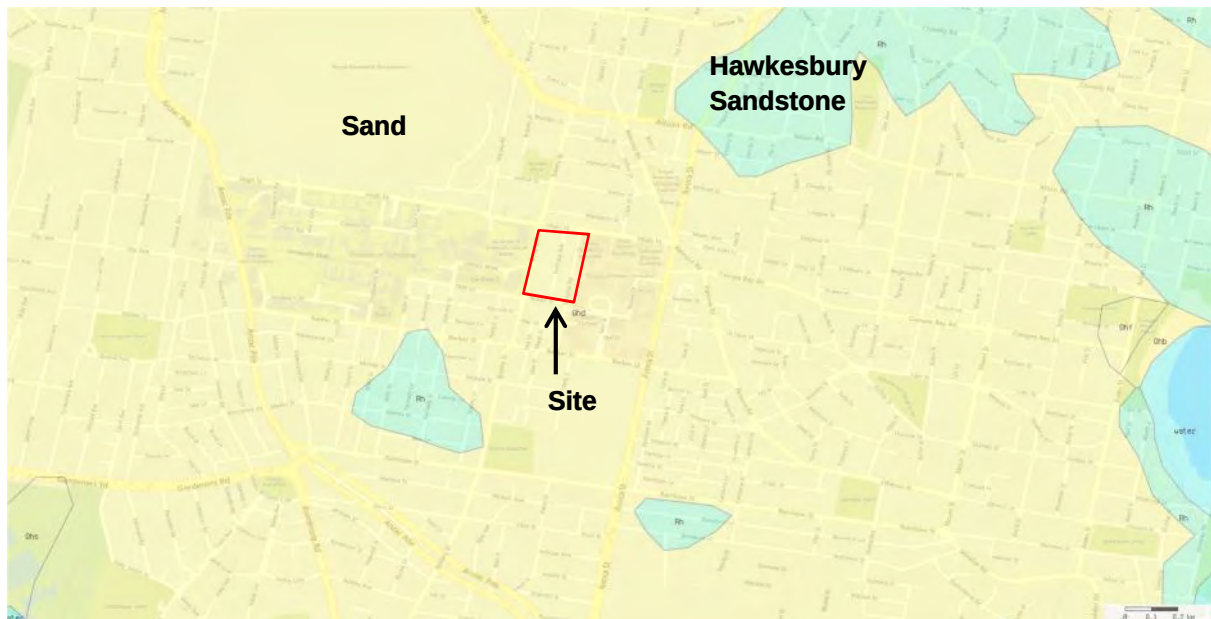
Reference to the Sydney 1:100 000 Series Geological Sheet indicates that the site is underlain by fine to medium grained sand (shown in yellow in Figure 2). Hawkesbury Sandstone comprising medium to coarse grained quartz sandstone with minor shale and laminite bands (shown in blue in Figure 2) is present in areas to the north-east, south-east and south-west of the site. The current investigation confirmed the presence of sand and Hawkesbury Sandstone.

**Figure 2: Regional Geology (Source: Sydney 1:100 000 Series Geological Sheet)**

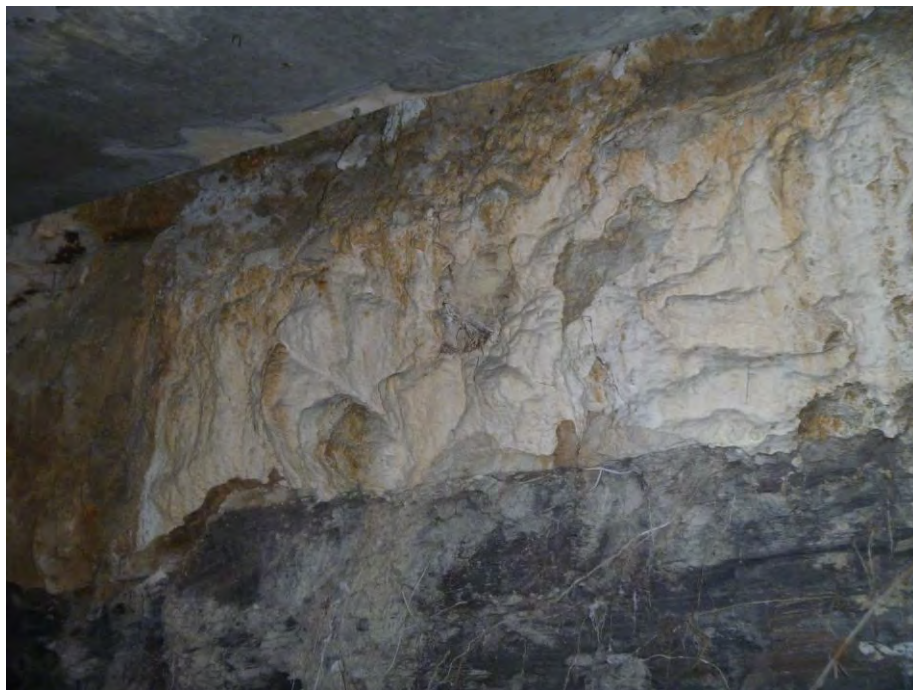
The multi-level car park has a localised rock fall along steeply inclined rock joints, directly above a 0.3 m to 0.9 m thick layer of weathered siltstone. Along the east side of Hospital Road, medium strength sandstone was exposed in significant calcite staining, which is a sign of groundwater seepage, was also evident along part of a rock face at Level B4 (refer to photographs 1 and 2). It is likely that groundwater seepage along adverse rock defects has contributed to the rock fall.

Photo 2 – Calcite staining (i.e. sign of groundwater seepage) on sandstone cutting in Car Park Level B4. Circled area in Photo 1.

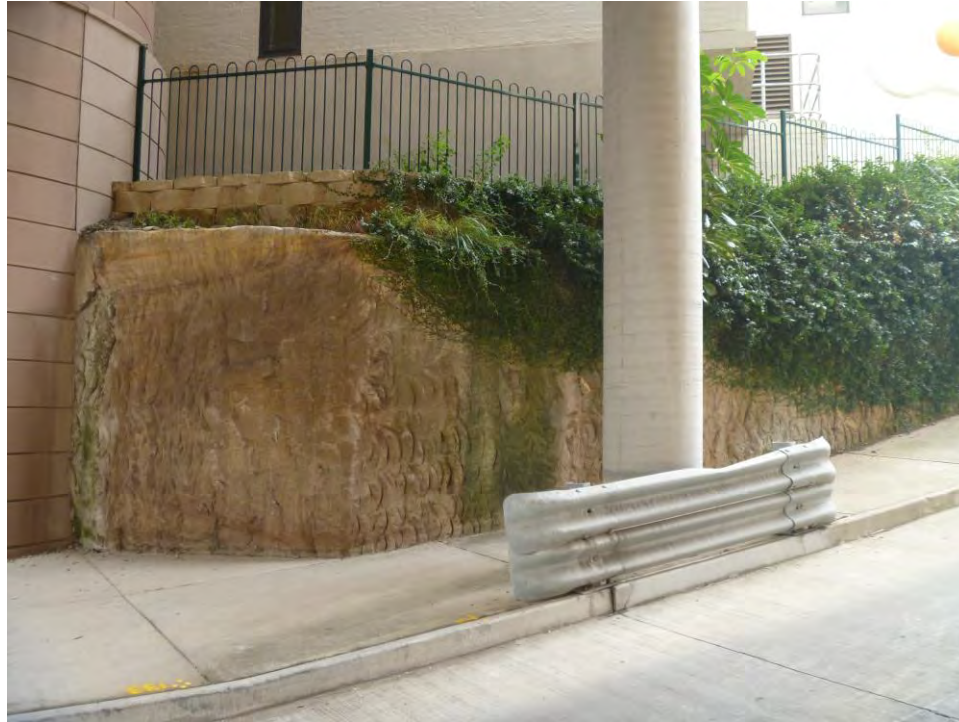
Within the driveway access to a delivery dock, there is a vertical cutting up to about 2 m high exposed medium to high strength sandstone (refer to photographs 3 and 4). It is noted that these rock outcrops are located relatively close to the eastern end of the proposed tunnel and lift shaft, linking the proposed ASB to the Sydney Children's Hospital.

Photo 3 – Medium to high strength sandstone cutting, up to 2 m high.

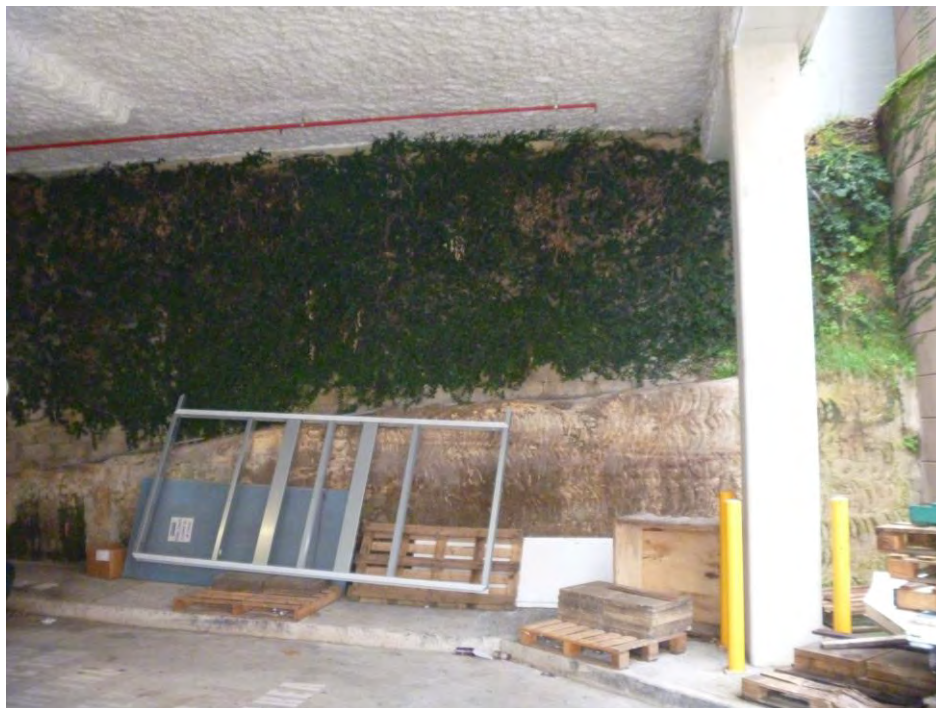
Photo 4 – Medium to high strength sandstone cutting, up to 2 m high.

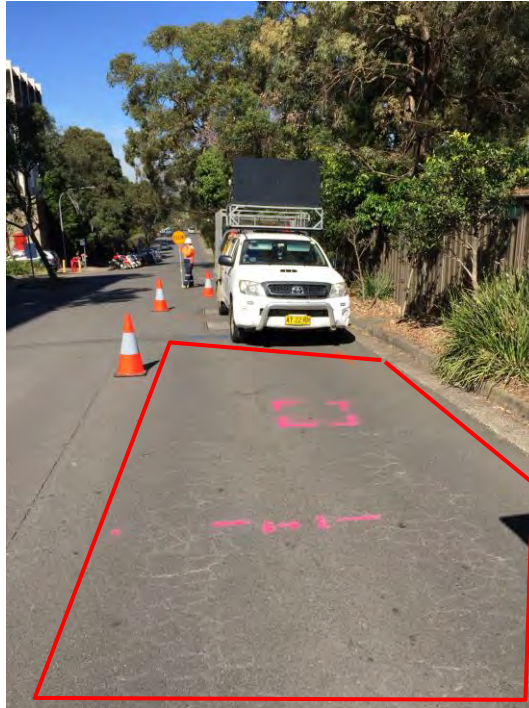
The existing asphaltic concrete (AC) pavement surfaces around the site perimeter appear to be in relatively good condition, except near the current borehole BH2 on Hospital Road, where crocodile cracking of the AC wearing surface was observed along the wheel paths (refer to photograph 5). Medium strength sandstone was also exposed about 1 m below the High Street pavement within a cutting for the Light Rail Project (refer to photograph 6).

Photo 5 – Crocodile cracking along wheel paths in Hospital Road north-bound (near borehole BH2).
