# **TGO RSF 2 Stage 1**

## **Detailed Design Report**

Tomingley Gold Operations Pty Ltd

19 January 2022

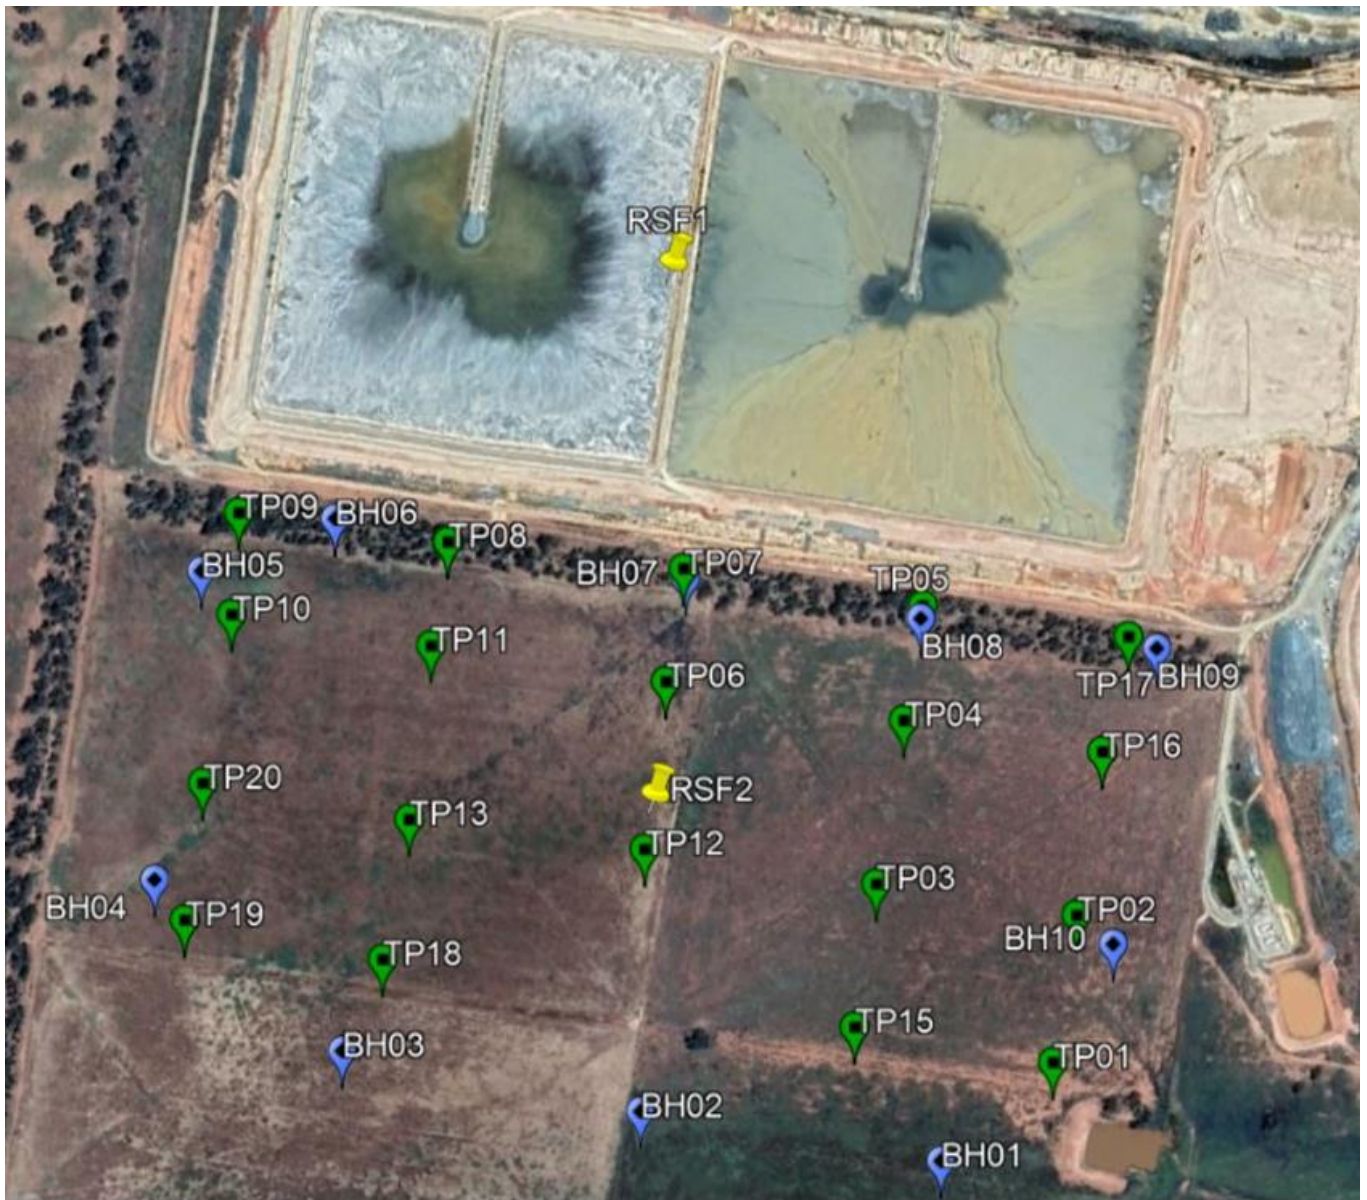
Figure 4.1 Test Pits and Boreholes Location

The location of these test pits and boreholes are shown in Figure 4.1.

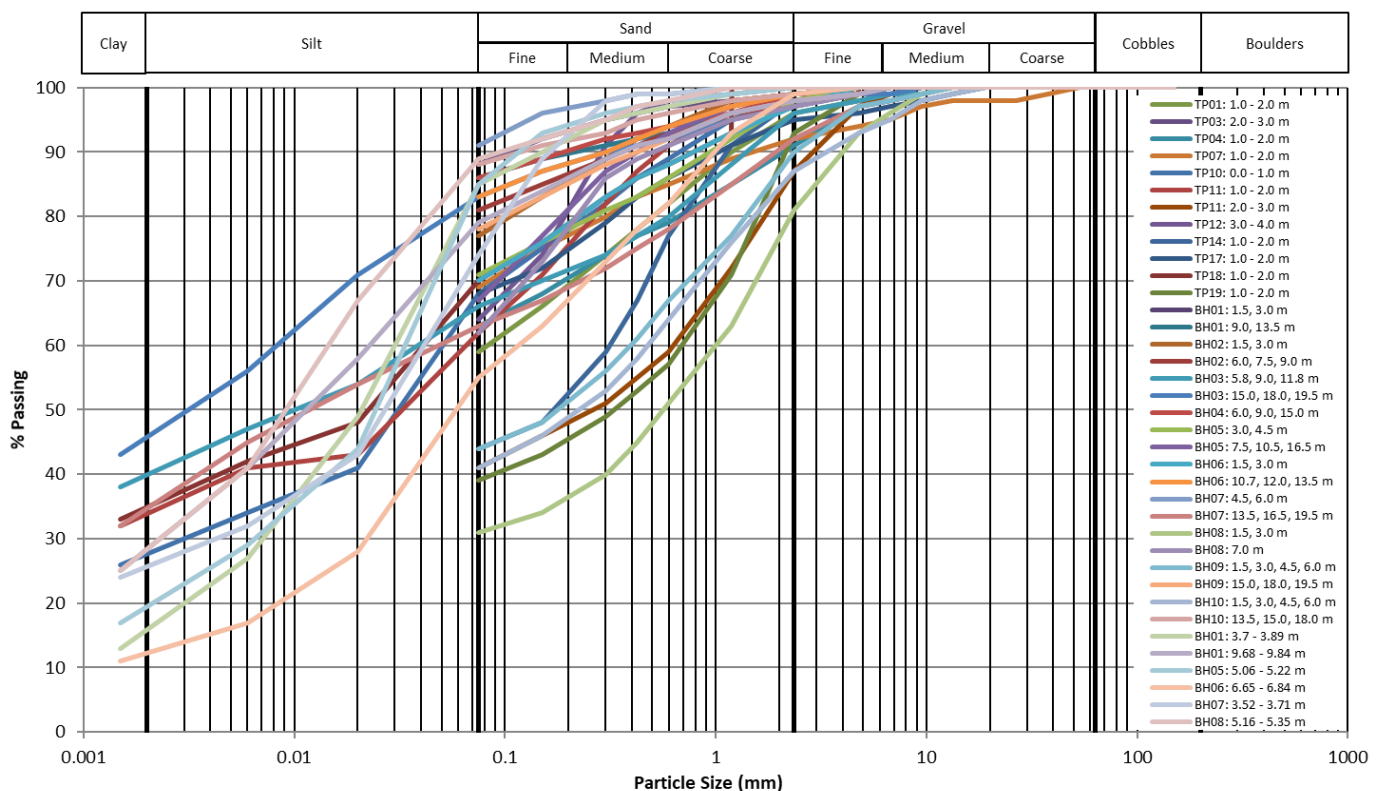
Figure 4.2 Particle Size Distribution Plot

The in-situ unit weight for the materials in the upper 10 m is approximately 1.40 t/m<sup>3</sup> to 1.85 t/m<sup>3</sup>. The specific gravity of the material is approximately 2.6. Oedometer tests conducted on samples collected from boreholes at depths greater than 3 m show Compression Index (C<sub>c</sub>) in the range of 0.09 to 0.12.

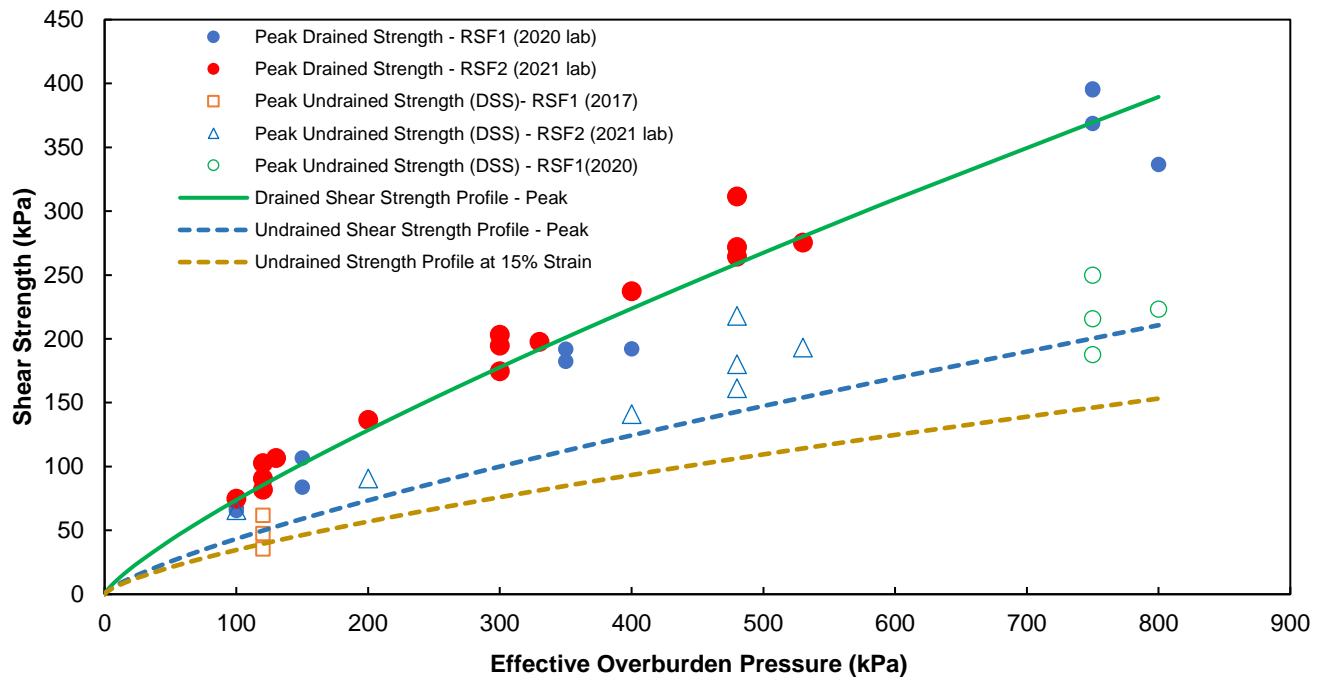
Figure 4.4 Peak Undrained Shear Strength.

Figure 4.4 and Figure 4.5 show the undrained shear strength functions for both peak and the residual conditions for both the RSF2 and RSF1 data. The ultimate residual strength of the foundation was generally not attained even at 15% axial strain. As such, the response at 15% was adopted in the analysis (this strain well exceeds RSF serviceability criteria). The resulting  $S_u/\sigma'_{vo}$  functions were adjusted using a polynomial function considering the minimum values between drained and undrained shear strength.

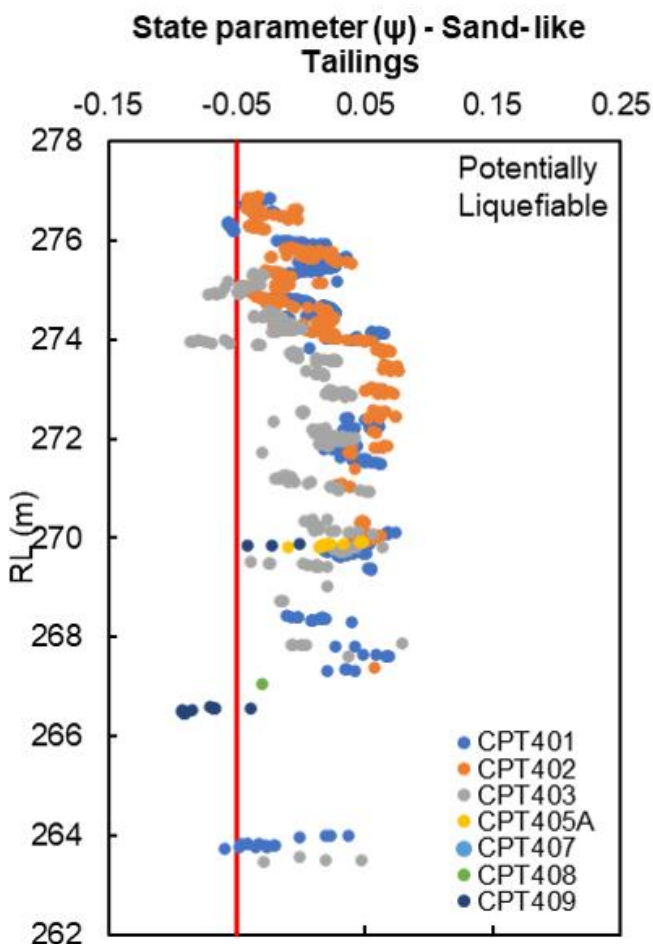
Figure 4.7 State Parameter for Tailings

A  $S_{u,peak}/\sigma'_{vo} \approx 0.20$  for tailings was inferred from the CPTu tests adopting the first quartile for  $S_u$  values as a reasonable criterion for LE analysis. Similarly, the residual shear strength ratios ( $S_{u,r}/\sigma'_{vo}$ ) were obtained using the Critical State Line (CSL) and the state parameter  $\psi$  (defined as the difference in void ratios between the in-situ state and the Critical State under the same effective confining stress) for the ‘sand-like’ tailings. The in-situ state parameters ( $\psi_0$ ) were obtained from 2020 CPTu tests and the expression proposed by Jefferies and Been (2016) which relates  $\psi$  and normalised CPTu tip resistance as shown in Figure 4.7. The ‘sand-like’ tailings shown in Figure 4.7, show that the upper quartile of the data points is  $\psi_{0.3} \geq -0.05$ , and thus slightly dilative. Based on this, a residual undrained shear strength ratio of 0.2 is adopted for the tailings in the RSF1.

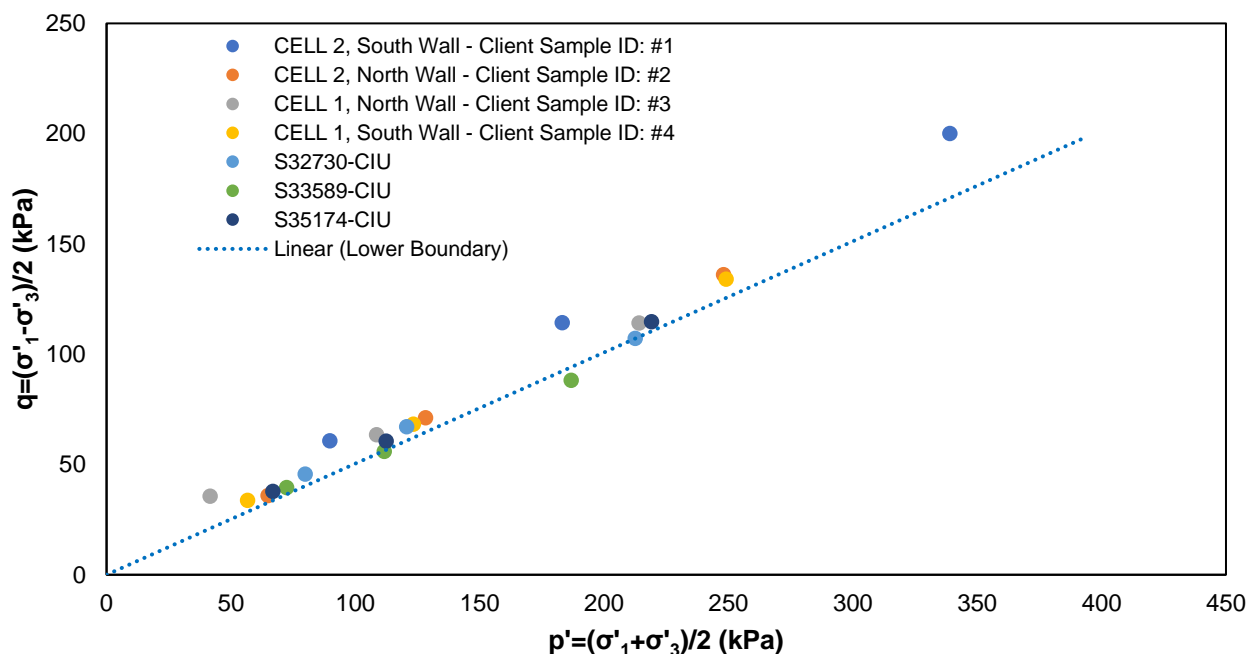
Figure 4.8 Drained Shear Strength – Embankment Clay

For long-term loading conditions, the drained shear strength parameters have been obtained from the effective stress paths ( $p'$ - $q$ ) as described in GHD (2021) and shown in Figure 4.8. Considering the lower bound envelope, an effective friction angle of  $30^\circ$  and zero cohesion is found for the embankment material.

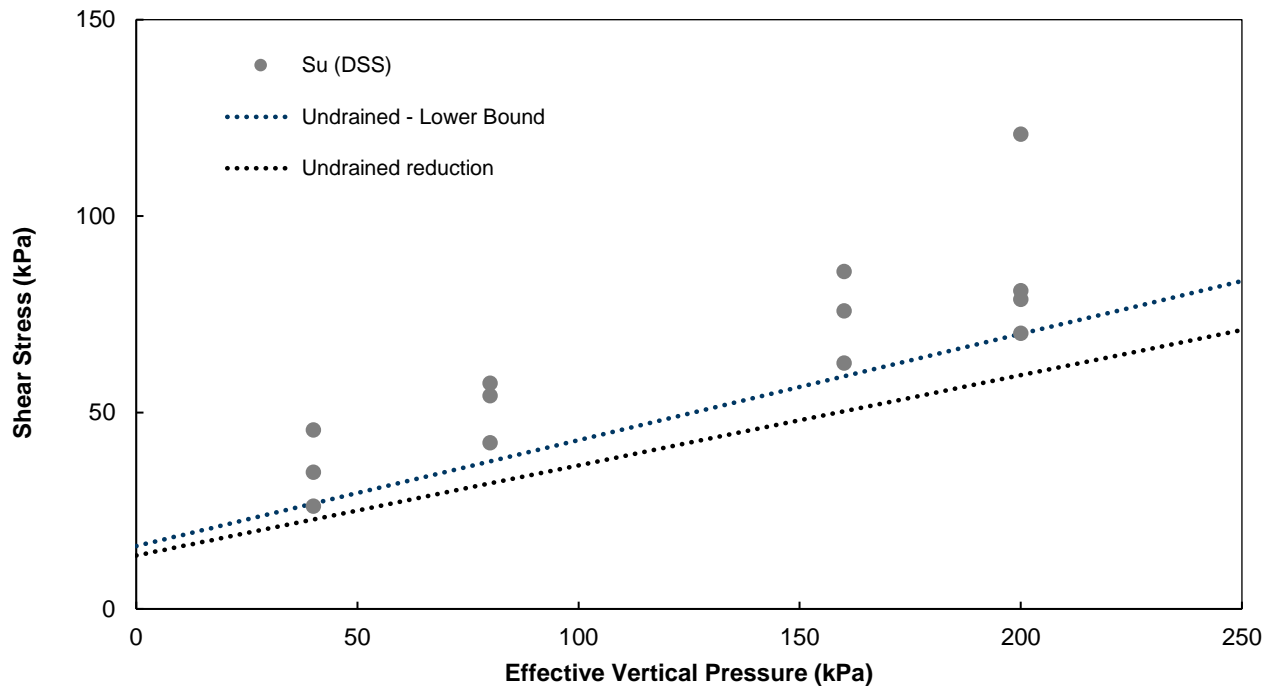
Figure 4.9 Undrained Shear Strength – Embankment clay

Similarly, the undrained shear strength ratio was obtained from CU tests. The resistance has been reduced by a factor of 0.57 to represent in situ direct simple shear (DSS) conditions. Figure 4.9 below shows the lower bound envelope (in the  $\tau$ - $\sigma'_{vo}$  plane) for the equivalent DSS shear strength, which yields  $S_u/\sigma'_{vo} \approx 0.23$  for the material.

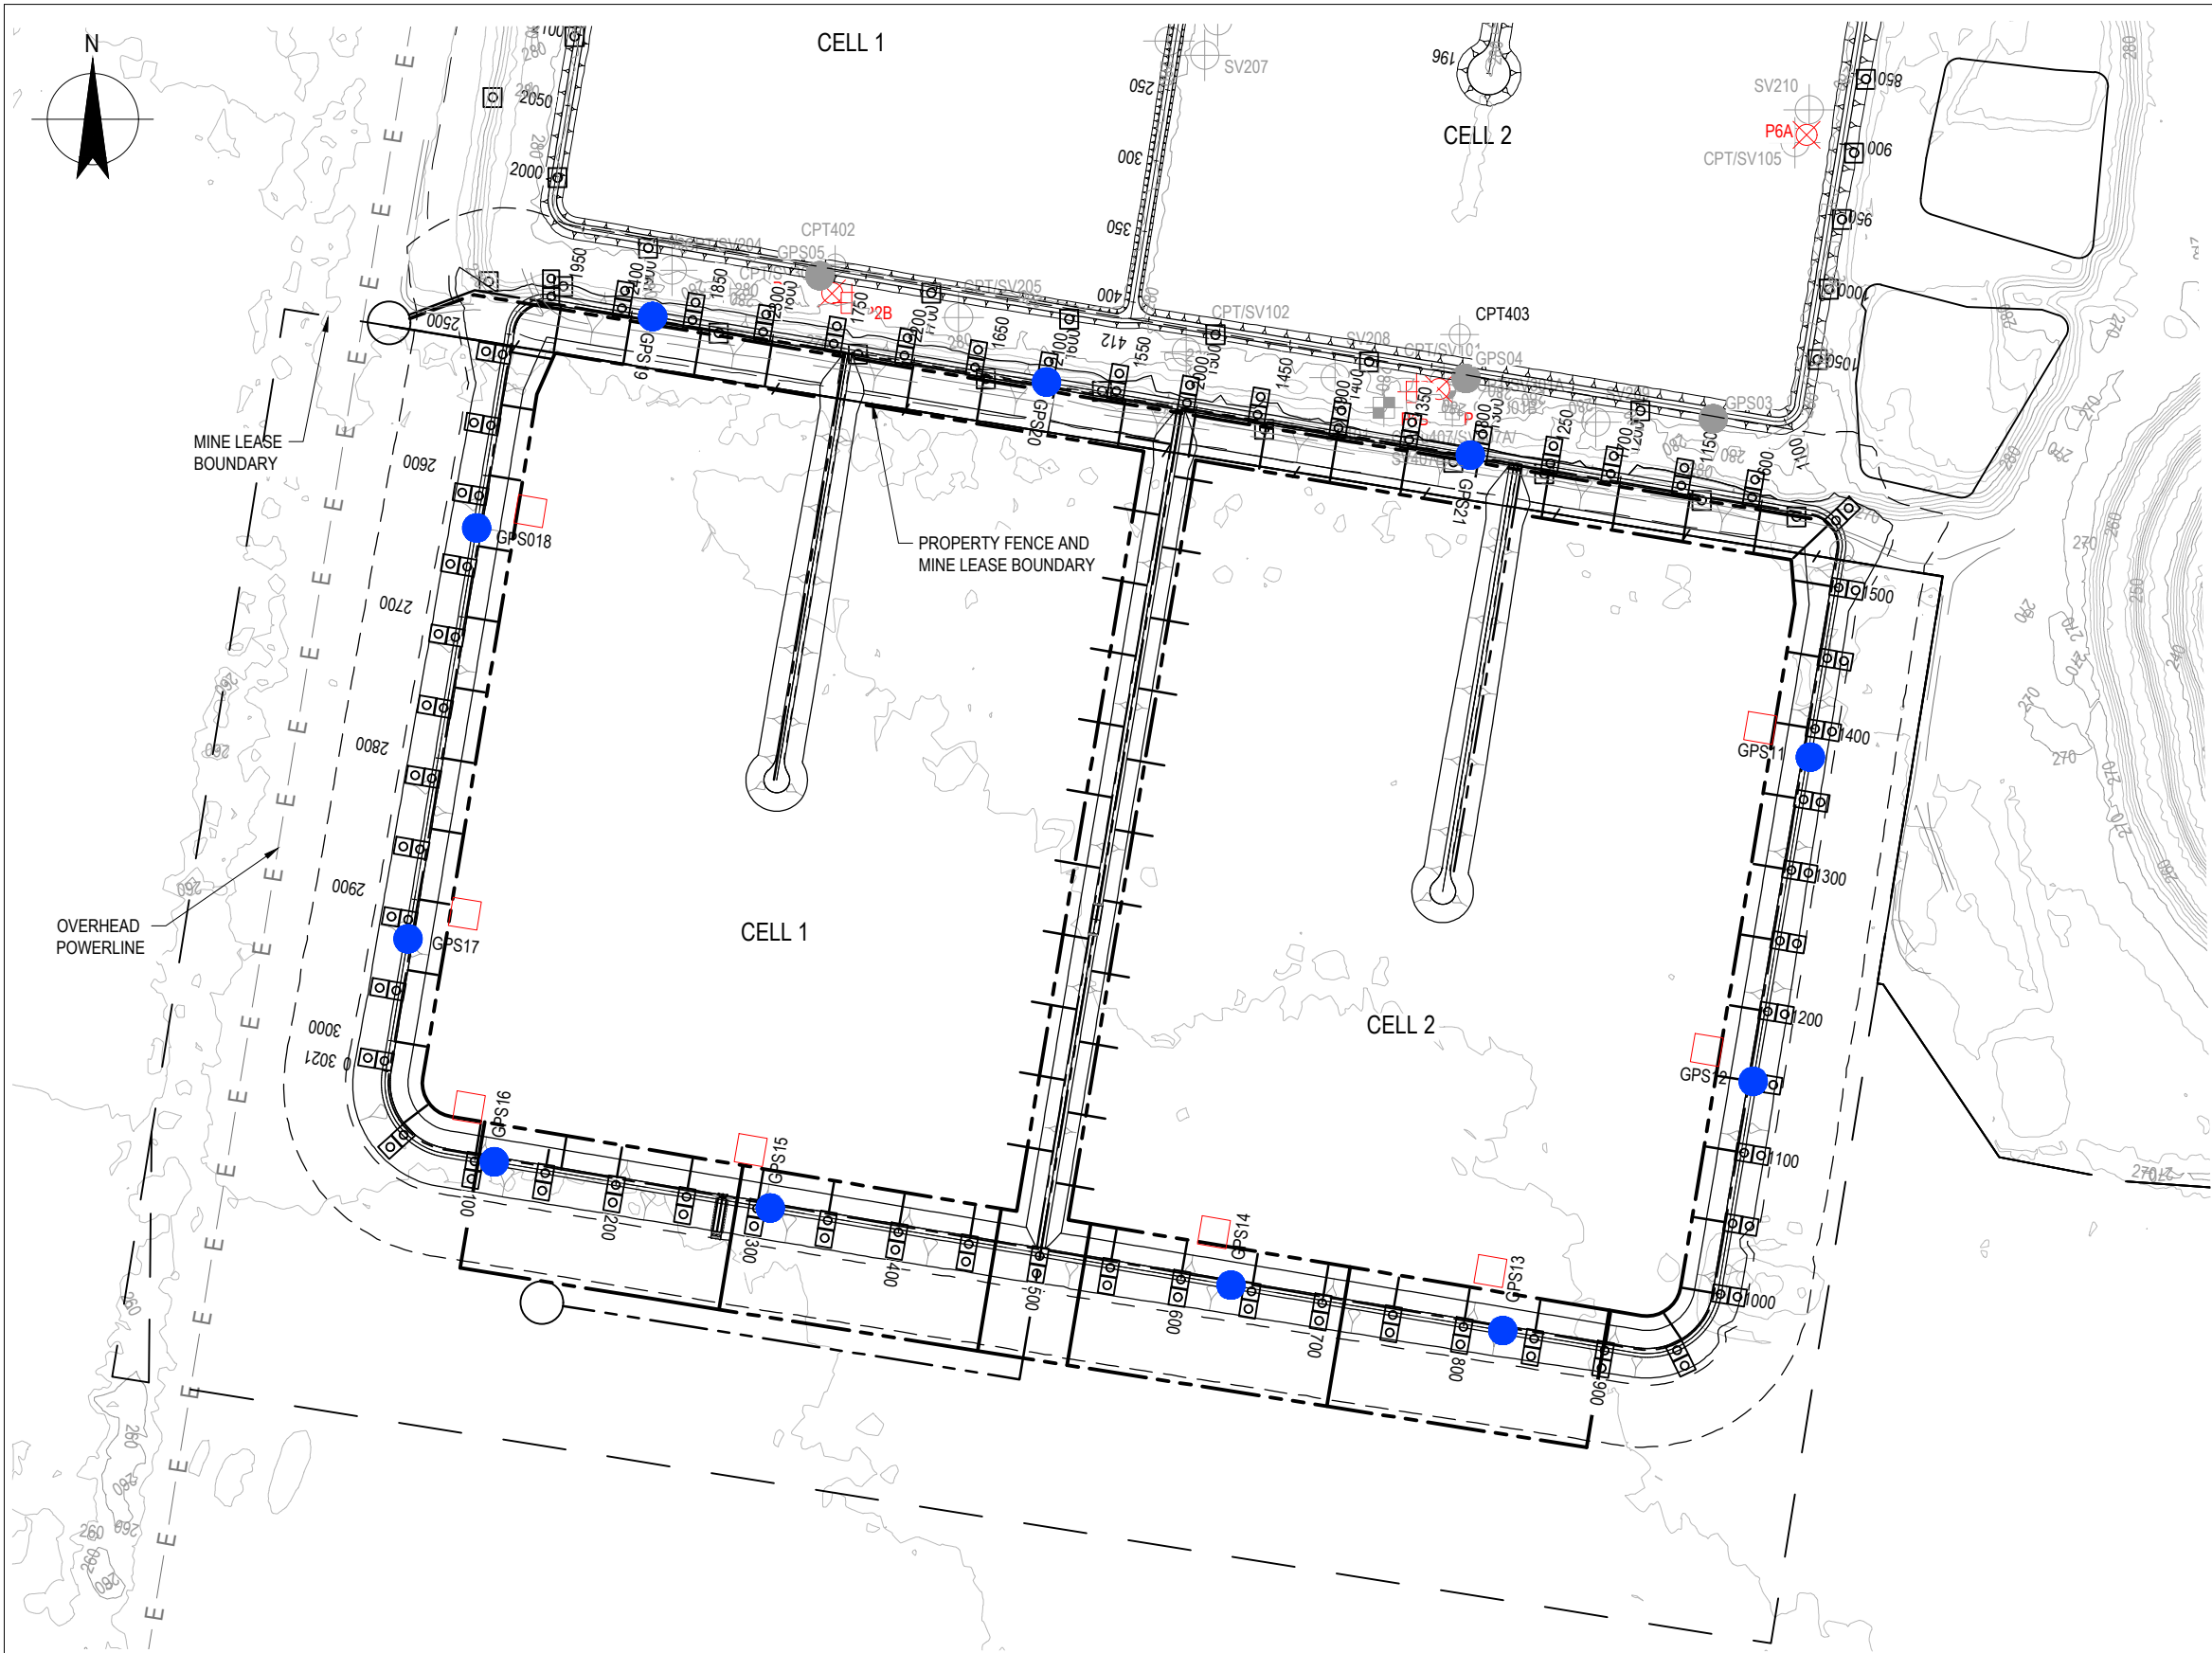
PROPOSED GPS SURVEY LOCATIONS		
POINT	EASTING	NORTHING
GPS11	613772.756	6393495.126
GPS12	613733.223	6393268.255
GPS13	613558.114	6393094.898
GPS14	613368.352	6393126.634
GPS15	613046.595	6393180.445
GPS16	612853.942	6393212.664
GPS17	612793.650	6393368.276
GPS018	612841.610	6393655.048
GPS19	612964.450	6393802.685
GPS20	613239.498	6393756.948
GPS21	613535.455	6393705.913

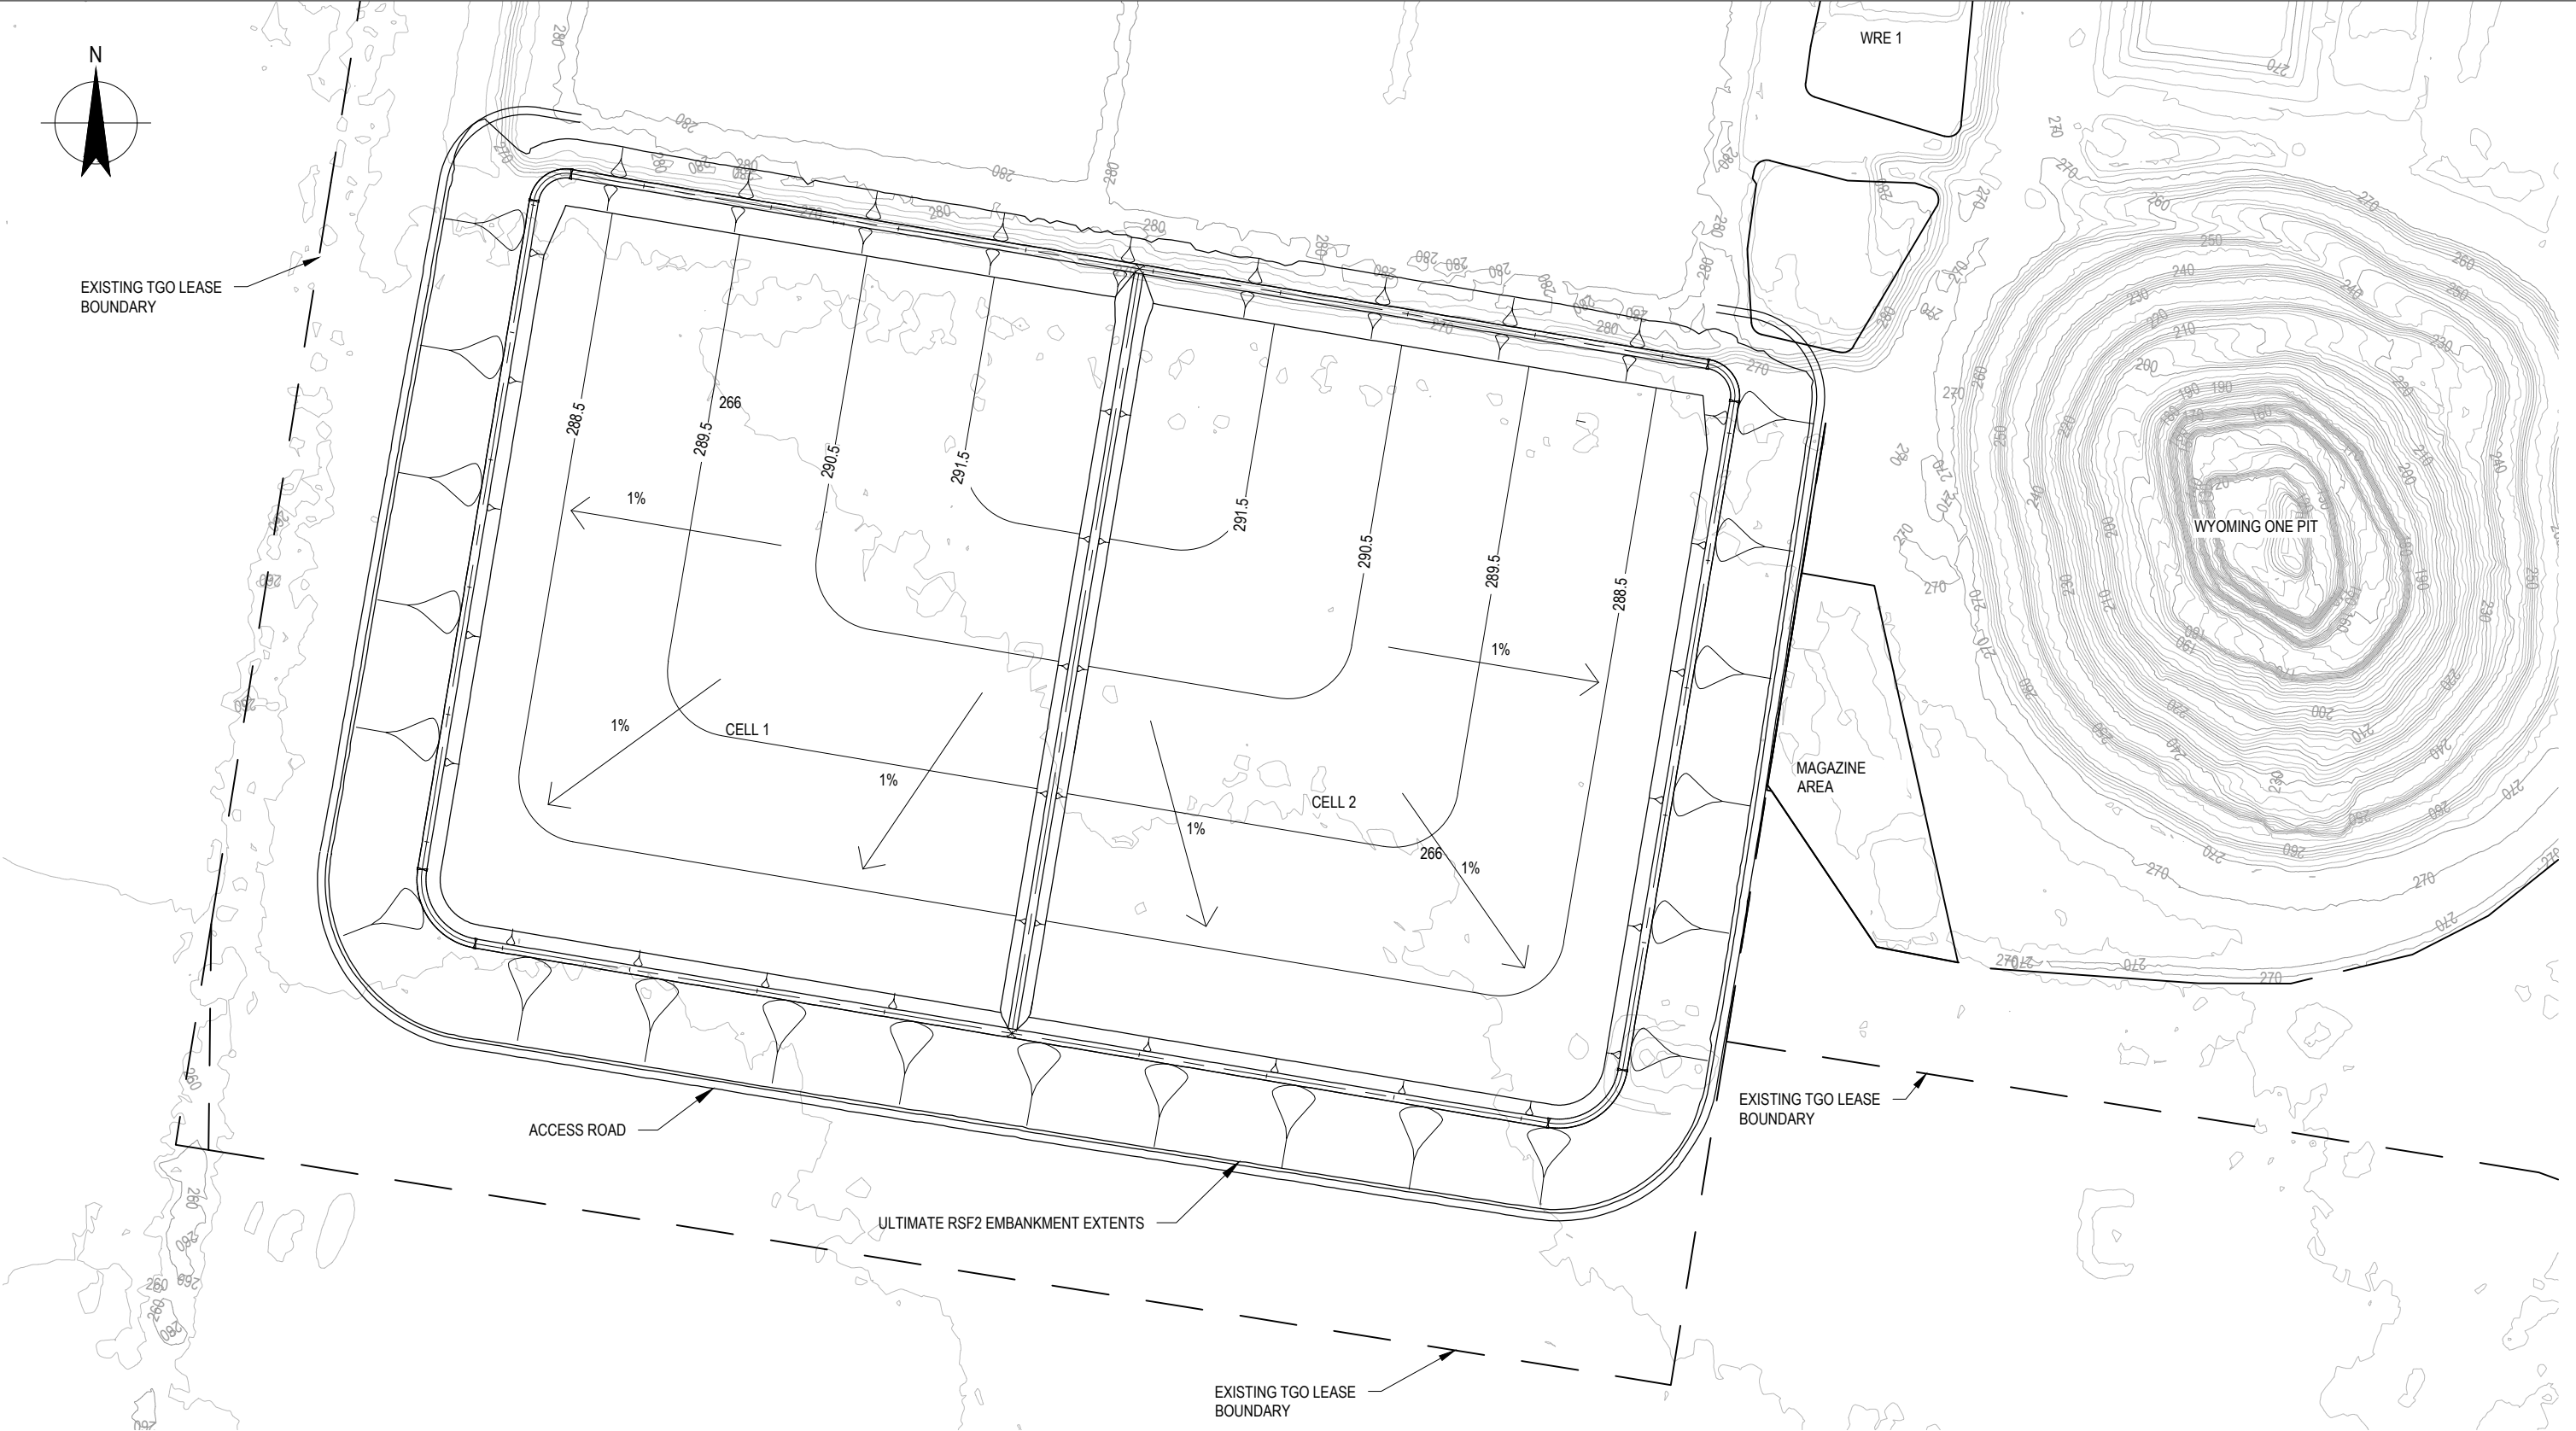
CLOSURE PLAN  
SCALE 1:5000

BASE SURVEY SUPPLIED BY: AAM HATCH  
SURVEYED ON: OCT.2020  
HORIZONTAL DATUM: GDA94, MGA, ZONE 55  
VERTICAL DATUM: AHD

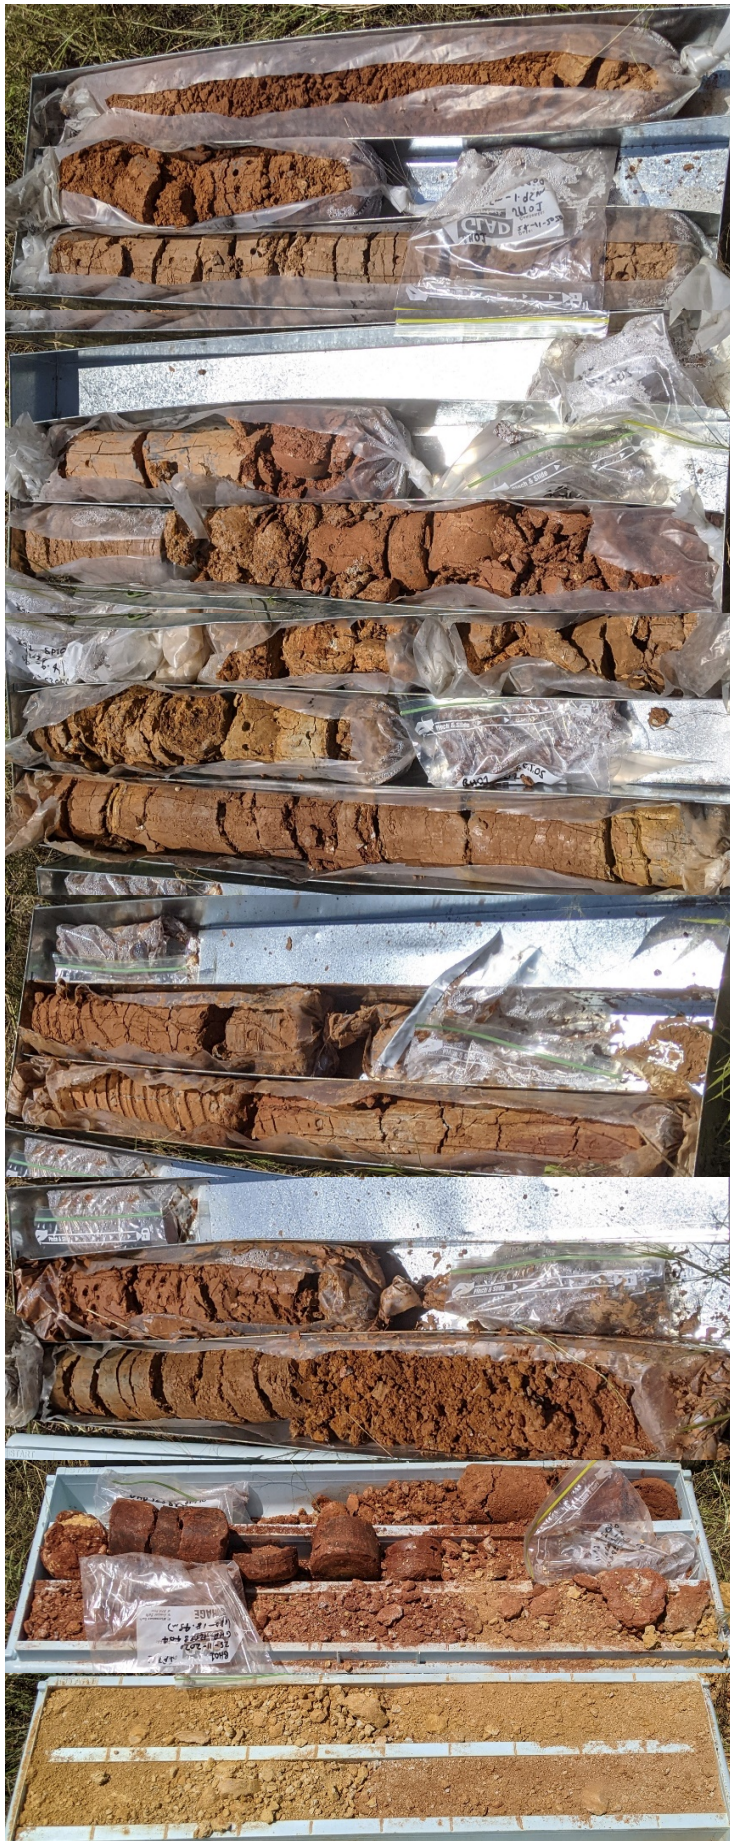
Drawn	Date	Job Number	A4	Title	Core Photo Geotechnical Investigation BH01	Client
TS	18/01/2021	12538404				Tomingley Gold Operations (TGO)
This drawing should be read in conjunction with report number 12538404						Project
						TGO RSF 2 Geotechnical Investigation

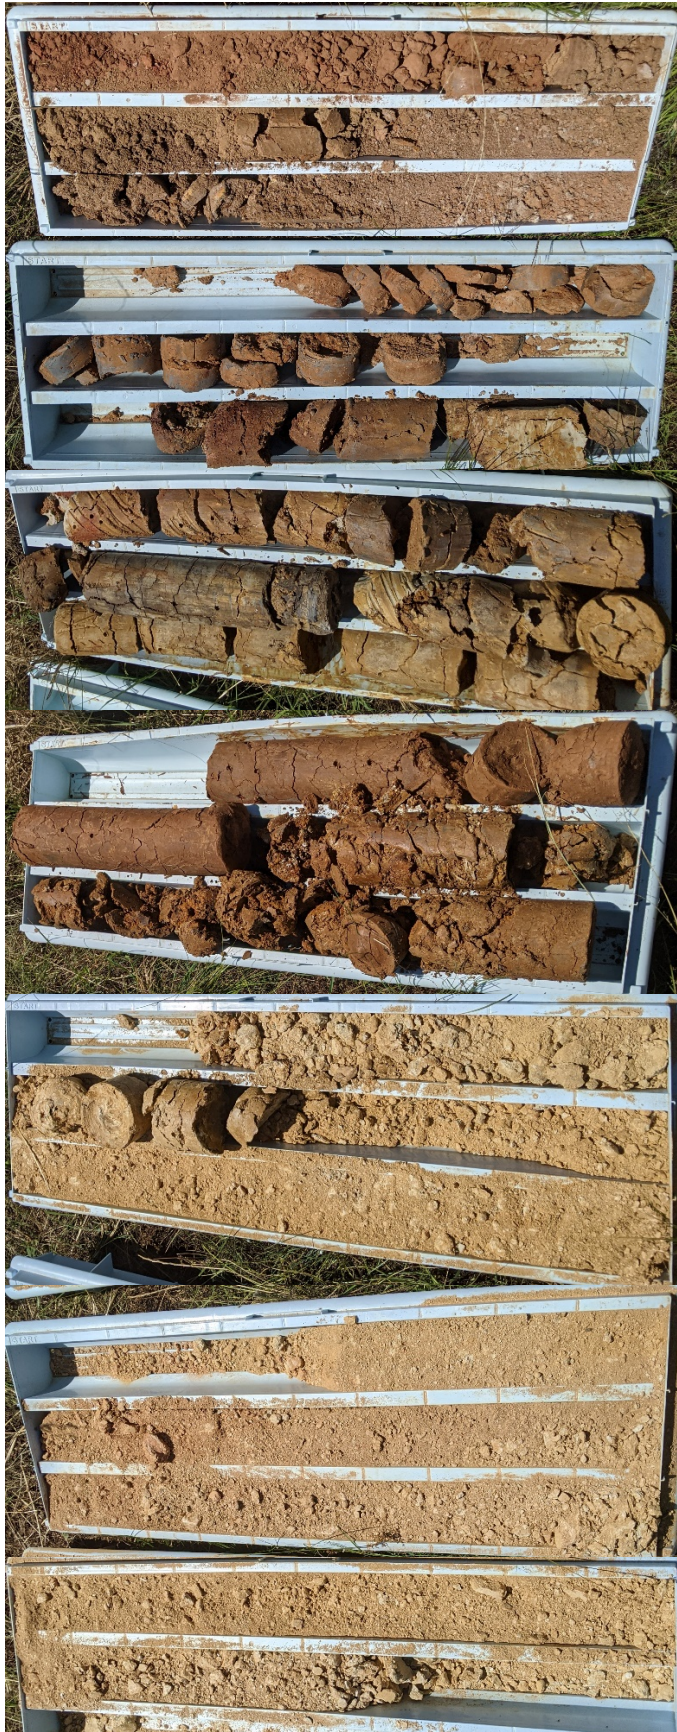
Drawn	Date	Job Number	A4	Title  Core Photo Geotechnical Investigation  BH02	Client	
TS	18/01/2021	12538404			Tomingley Gold Operations (TGO)	
This drawing should be read in conjunction with report number 12538404					Project	
					TGO RSF 2	
					Geotechnical Investigation

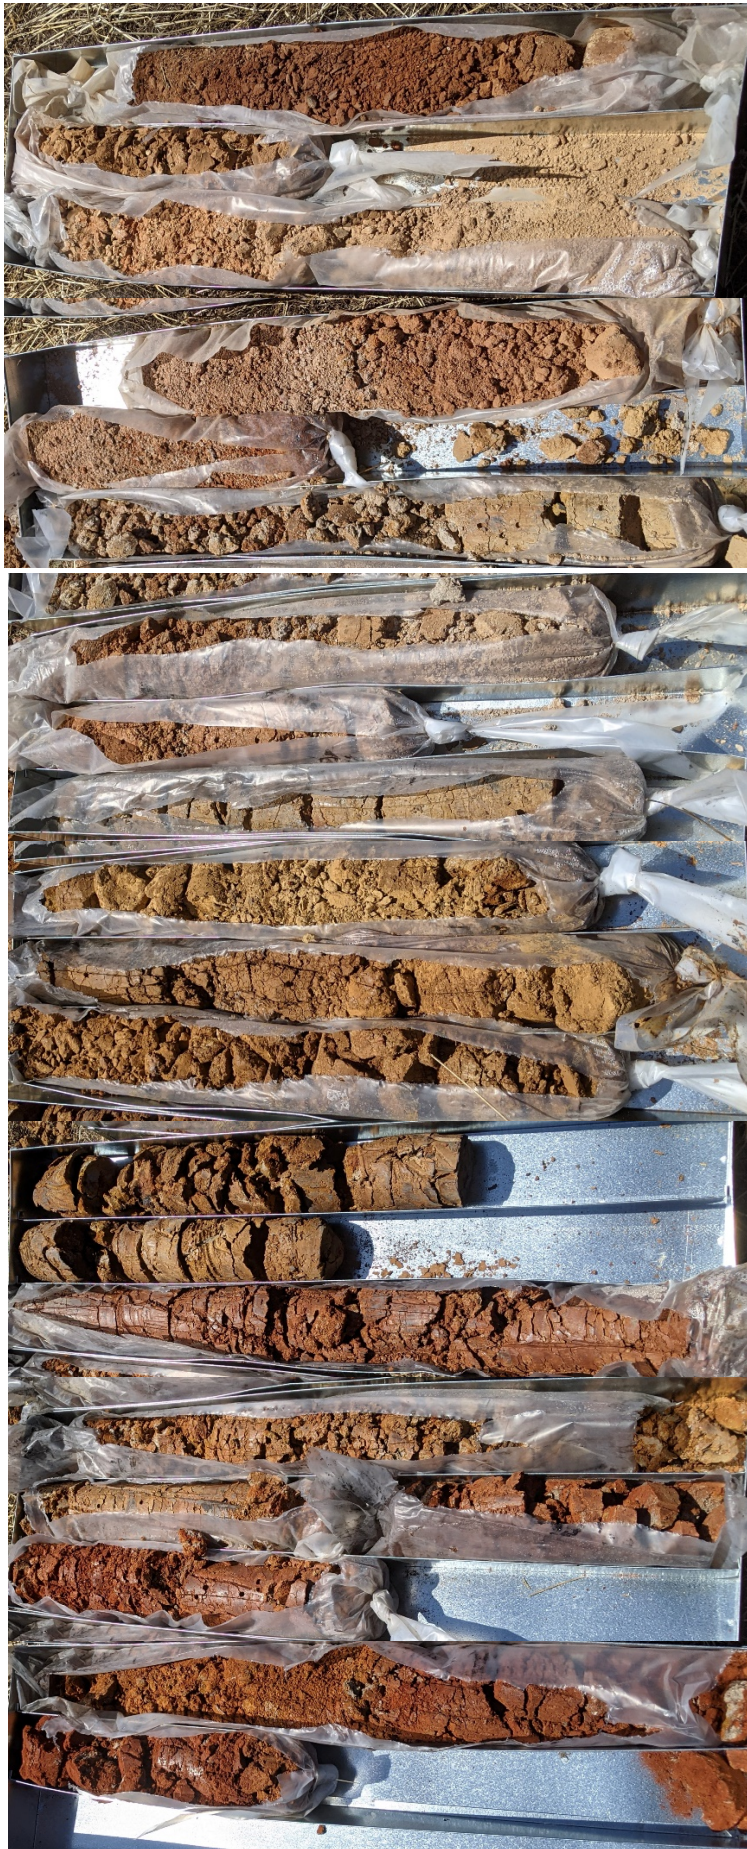
Drawn	Date	Job Number	A4	Title  Core Photo Geotechnical Investigation  BH03	Client
TS	18/01/2021	12538404			Tomingley Gold Operations (TGO)
This drawing should be read in conjunction with report number 12538404					Project
					TGO RSF 2
					Geotechnical Investigation

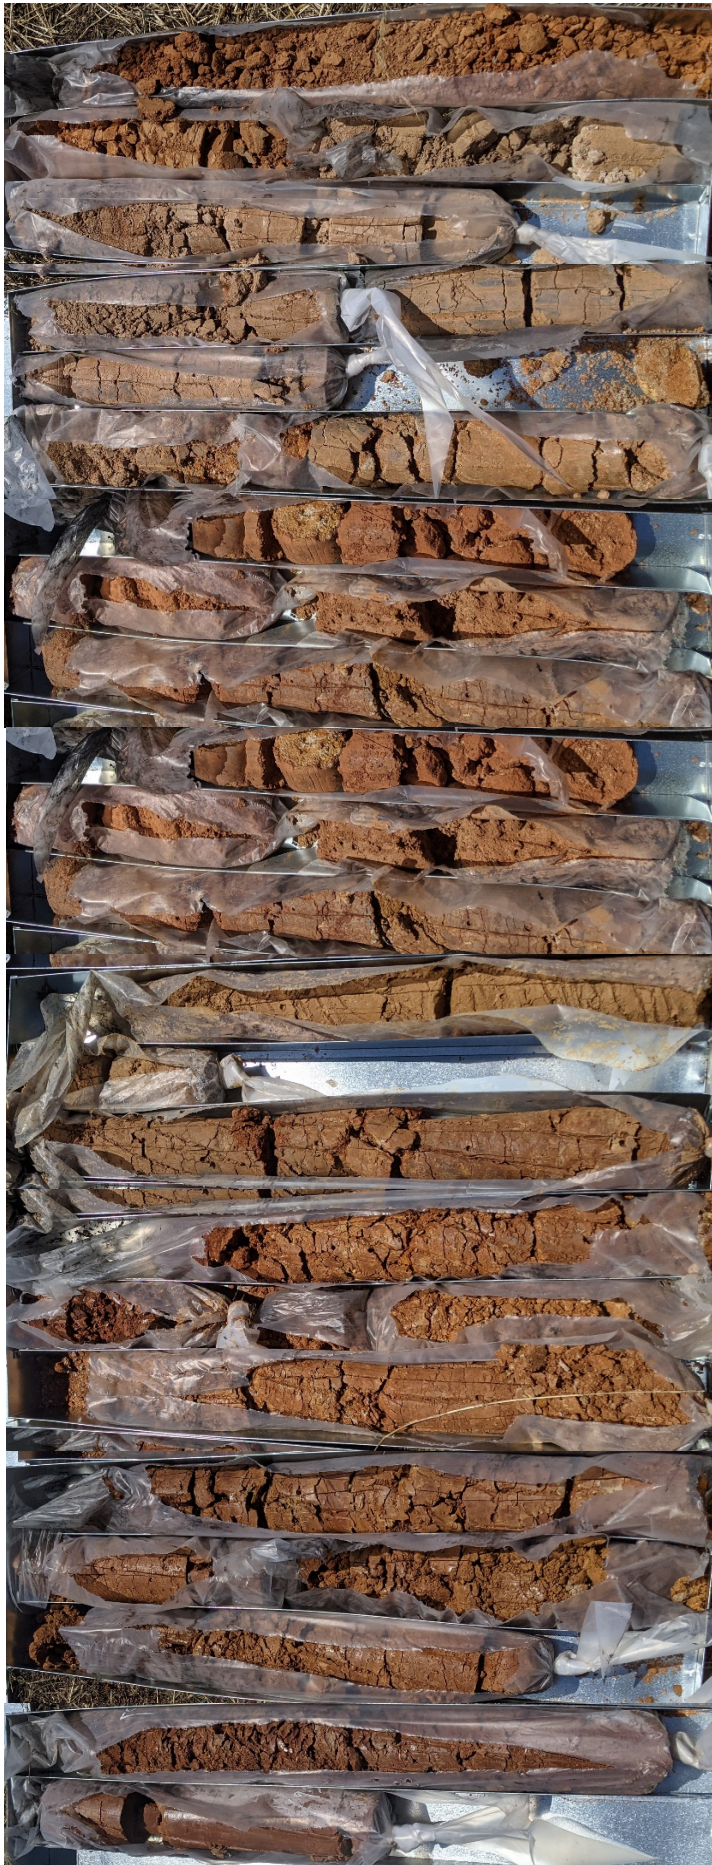
Drawn	Date	Job Number	A4	Title  Core Photo Geotechnical Investigation  BH04	Client
TS	18/01/2021	12538404			Tomingley Gold Operations (TGO)
This drawing should be read in conjunction with report number 12538404					Project
					TGO RSF 2
					Geotechnical Investigation

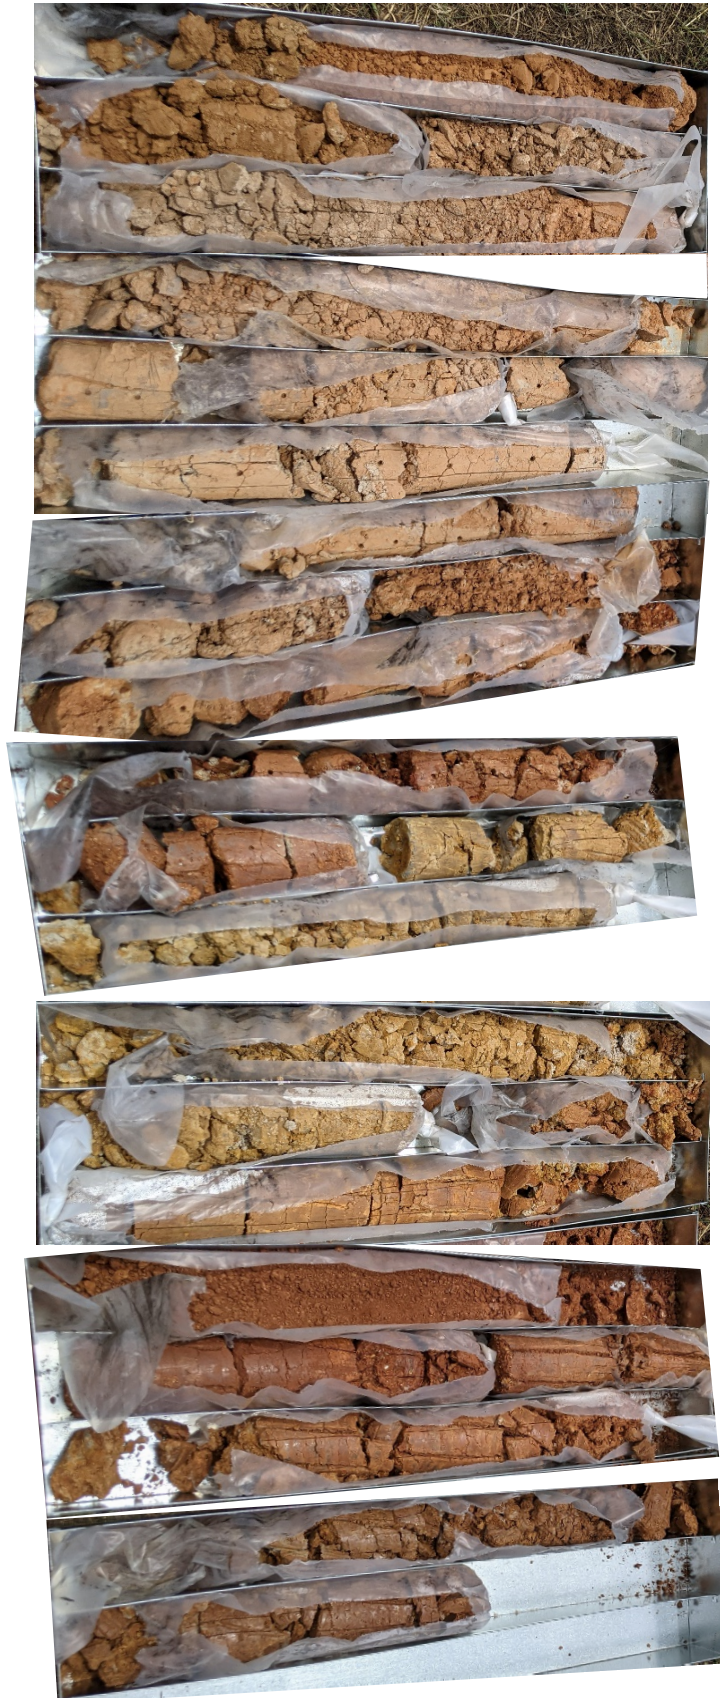
Drawn	Date	Job Number	A4	Title  Core Photo Geotechnical Investigation  BH05	Client
TS	18/01/2021	12538404			Tomingley Gold Operations (TGO)
This drawing should be read in conjunction with report number 12538404					Project
					TGO RSF 2  Geotechnical Investigation

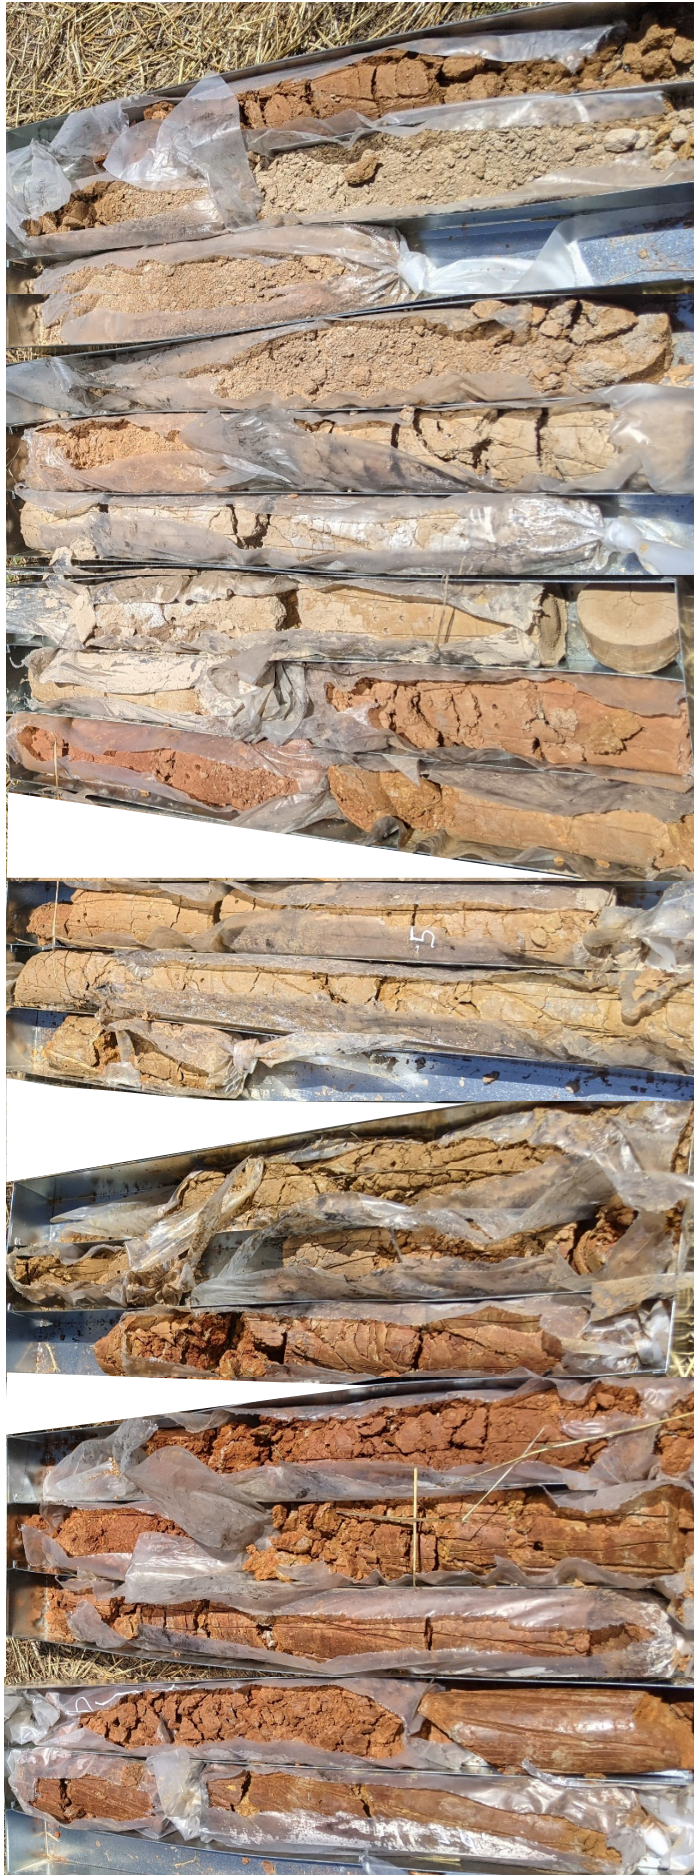
Drawn	Date	Job Number	A4	Title  Core Photo Geotechnical Investigation  BH06	Client
TS	18/01/2021	12538404			Tomingley Gold Operations (TGO)
This drawing should be read in conjunction with report number 12538404					Project
					TGO RSF 2 Geotechnical Investigation
