# **TGO RSF 2 Stage 1**

## **Detailed Design Report**

Tomingley Gold Operations Pty Ltd

19 January 2022

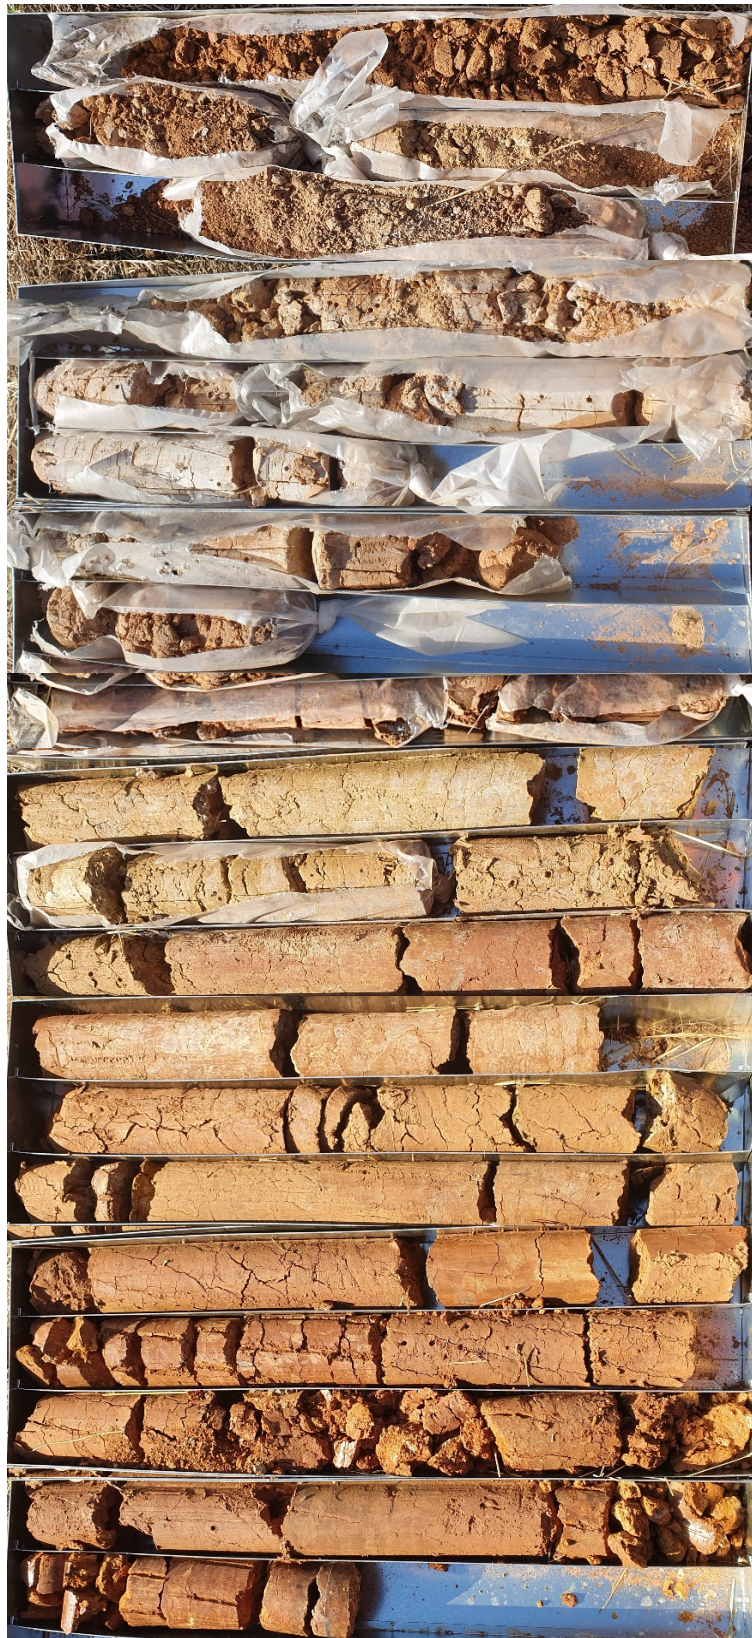
Drawn	Date	Job Number	A4	Title  Core Photo Geotechnical Investigation  BH07	Client	
TS	18/01/2021	12538404			Tomingley Gold Operations (TGO)	
This drawing should be read in conjunction with report number 12538404					Project	
					TGO RSF 2 Geotechnical Investigation

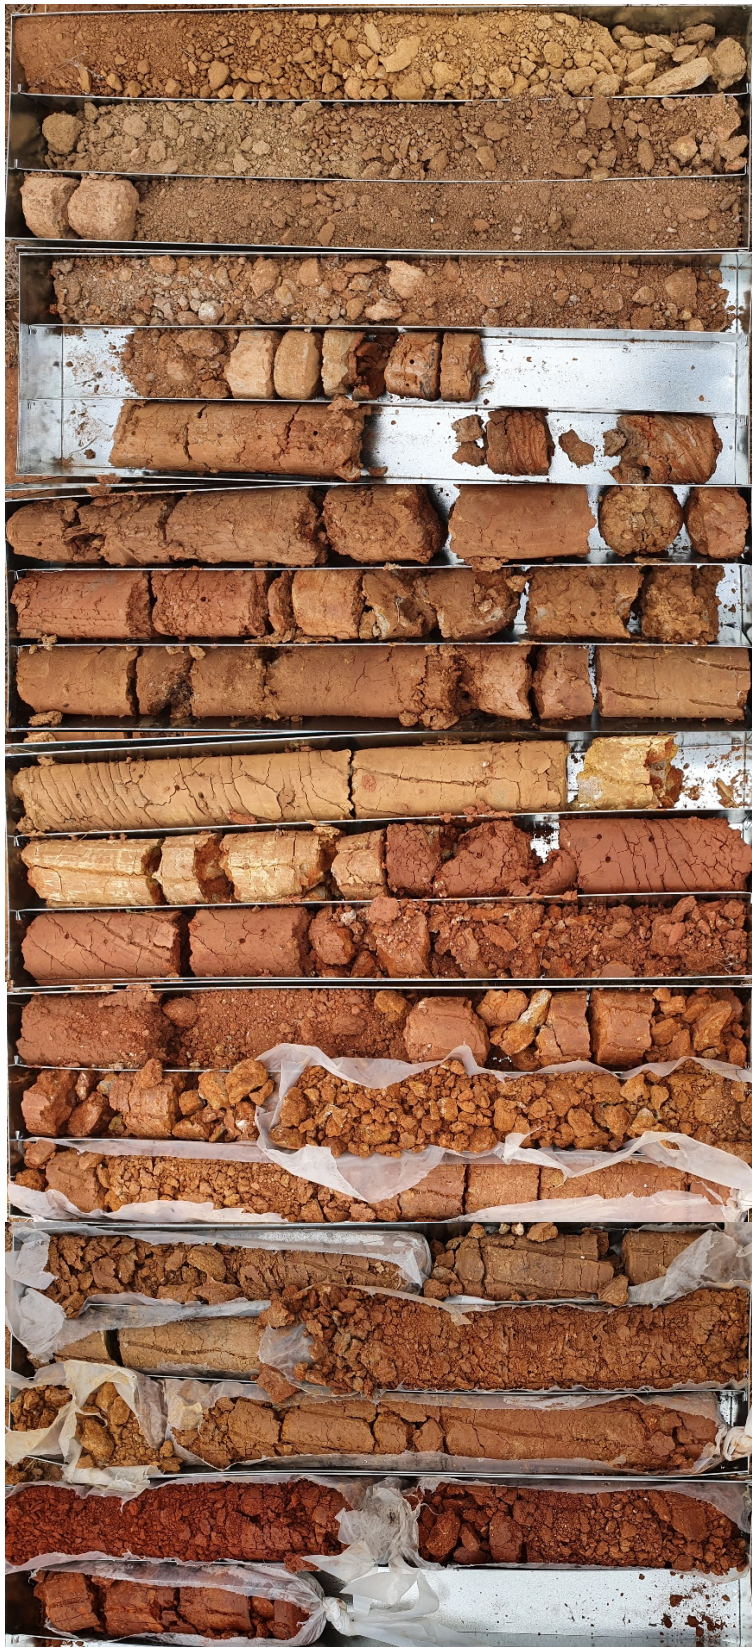
Drawn	Date	Job Number	A4	Title  Core Photo Geotechnical Investigation  BH08	Client	
TS	18/01/2021	12538404			Tomingley Gold Operations (TGO)	
This drawing should be read in conjunction with report number 12538404					Project	
					TGO RSF 2	
				Geotechnical Investigation

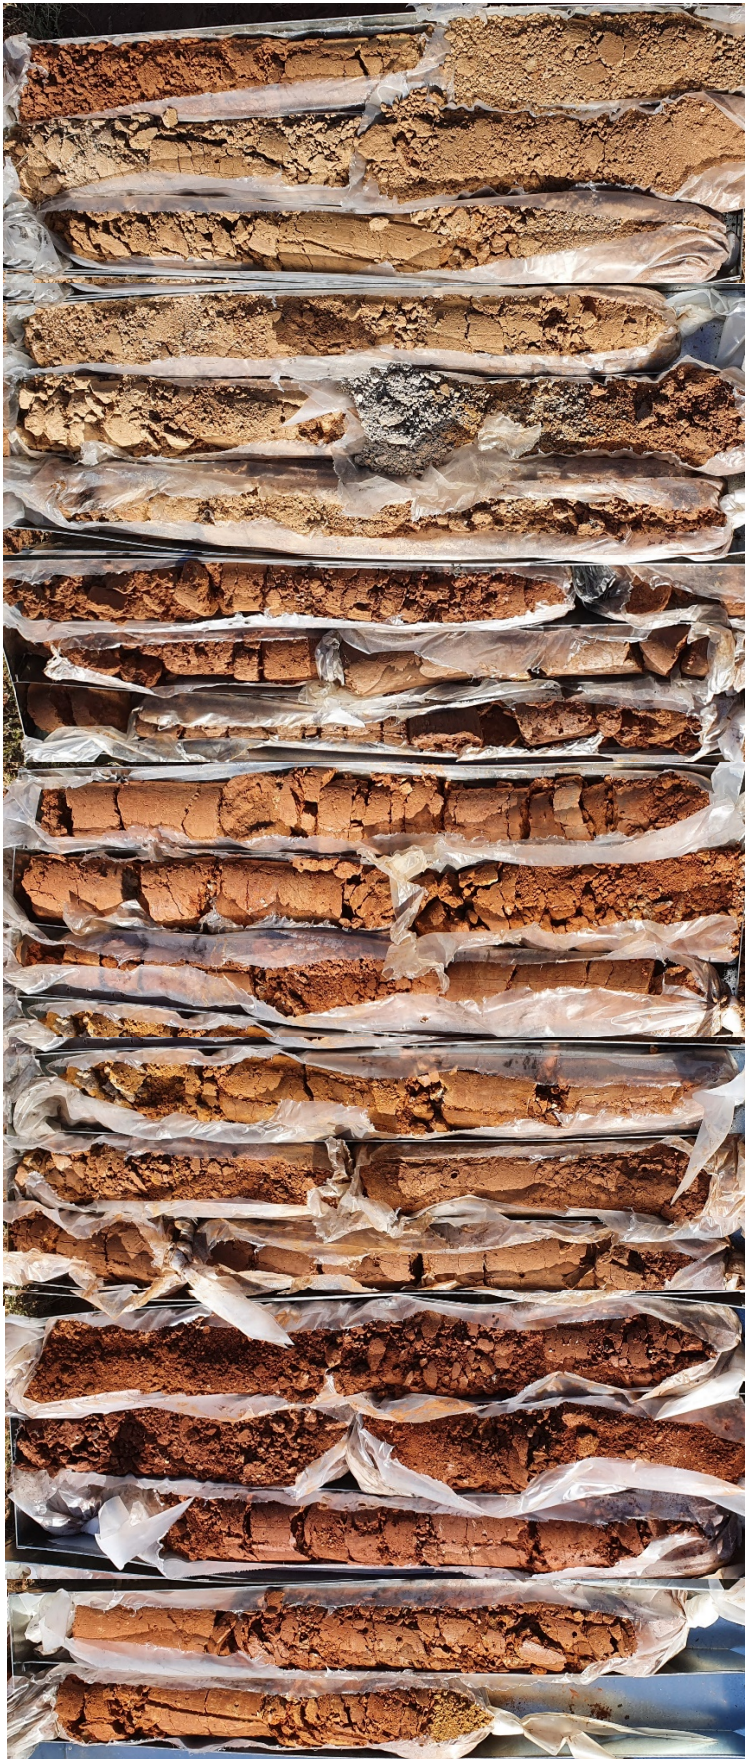
Drawn	Date	Job Number	A4	Title  Core Photo Geotechnical Investigation  BH09	Client
TS	18/01/2021	12538404			Tomingley Gold Operations (TGO)
This drawing should be read in conjunction with report number 12538404					Project
					TGO RSF 2  Geotechnical Investigation

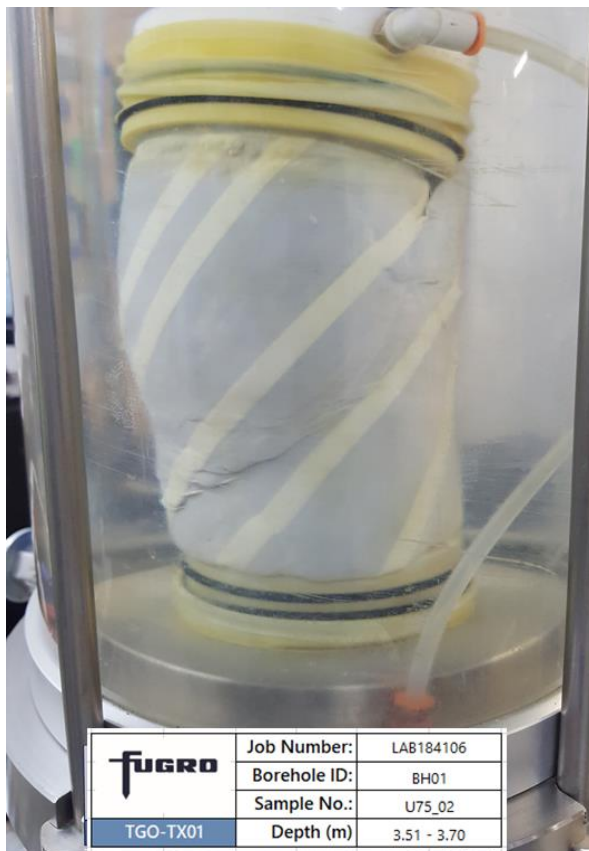
<b>TEST CERTIFICATE</b> <b>MONOTONIC TRIAXIAL</b> <b>Test Method:</b> AGLab Test Procedure FAM-17864 <b>Undrained Triaxial Compression</b>		<b>Fugro Australia Marine Pty Ltd</b> Advanced Geotechnical Laboratory Unit 2, 10 Carbon Court Osborne Park, WA, 6017 Australia	
<b>Client:</b>	GHD Pty Ltd	<b>Job No.:</b>	LAB184106
<b>Client Address:</b>	2 Salamanca Square, Hobart, Tasmania, 7000	<b>IPO No.:</b>	2021-001
<b>Project Name:</b>	TGO RSF 2 Geotechnical Investigation	<b>Lab Sample ID:</b>	2021-001-010
<b>Project Location:</b>	Tomingley, NSW	<b>Borehole ID:</b>	BH01
<b>Sample Description:</b>	Brownish yellow/grey CLAY	<b>Sample No.:</b>	U75_02
		<b>Depth:</b>	3.51 m to 3.70 m
<b>Sample Photographs:</b>

Sample at the end of shearing

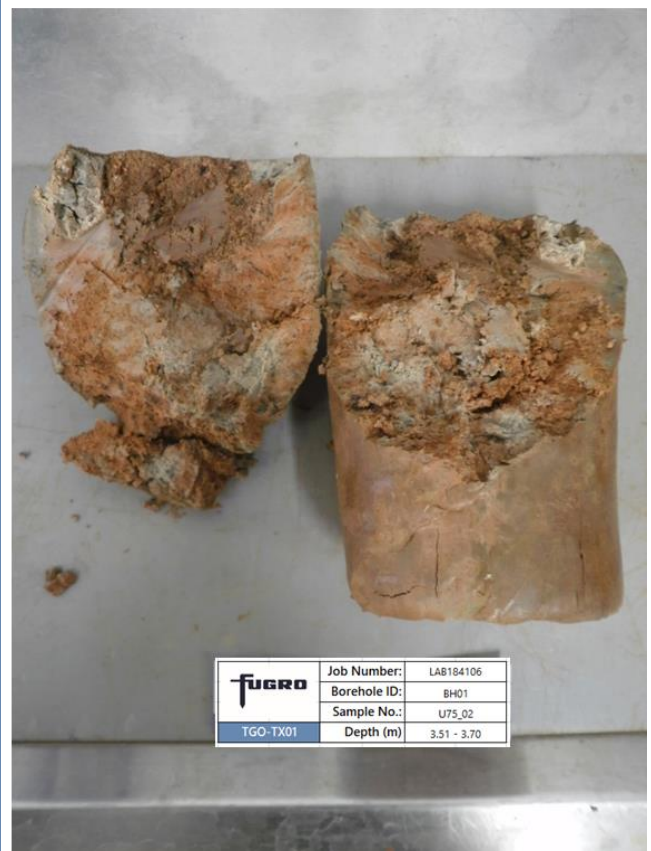
Sample after the test

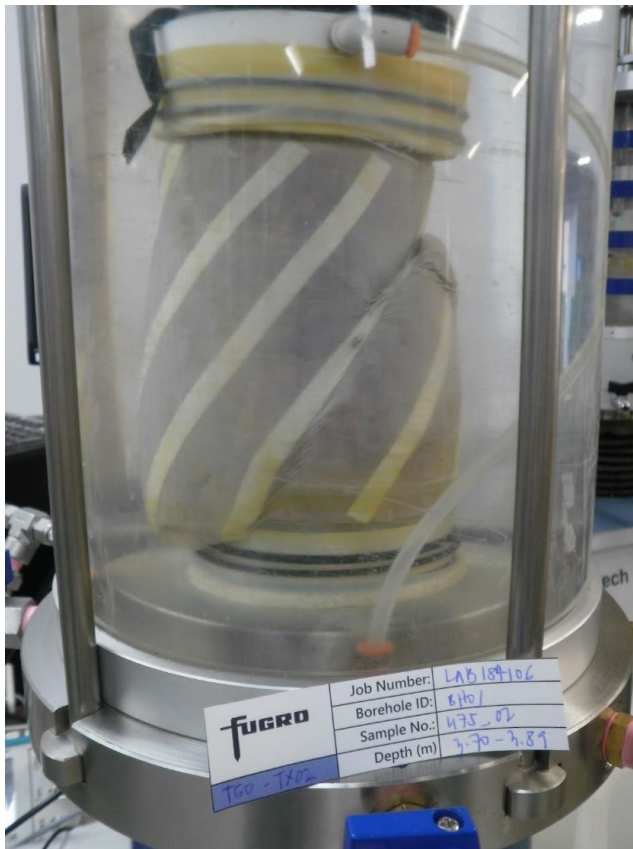
<b>TEST CERTIFICATE</b> <b>MONOTONIC TRIAXIAL</b> <b>Test Method:</b> AGLab Test Procedure FAM-17864 <b>Undrained Triaxial Compression</b>		<b>Fugro Australia Marine Pty Ltd</b> Advanced Geotechnical Laboratory Unit 2, 10 Carbon Court Osborne Park, WA, 6017 Australia	
<b>Client:</b>	GHD Pty Ltd	<b>Job No.:</b>	LAB184106
<b>Client Address:</b>	2 Salamanca Square, Hobart, Tasmania, 7000	<b>IPO No.:</b>	2021-001
<b>Project Name:</b>	TGO RSF 2 Geotechnical Investigation	<b>Lab Sample ID:</b>	2021-001-014
<b>Project Location:</b>	Tomingley, NSW	<b>Borehole ID:</b>	BH01
<b>Sample Description:</b>	Brownish yellow/grey CLAY with sand	<b>Sample No.:</b>	U75_02
<b>Sample Photographs:</b>		<b>Depth:</b>	3.70 m to 3.89 m

Sample at the end of shearing

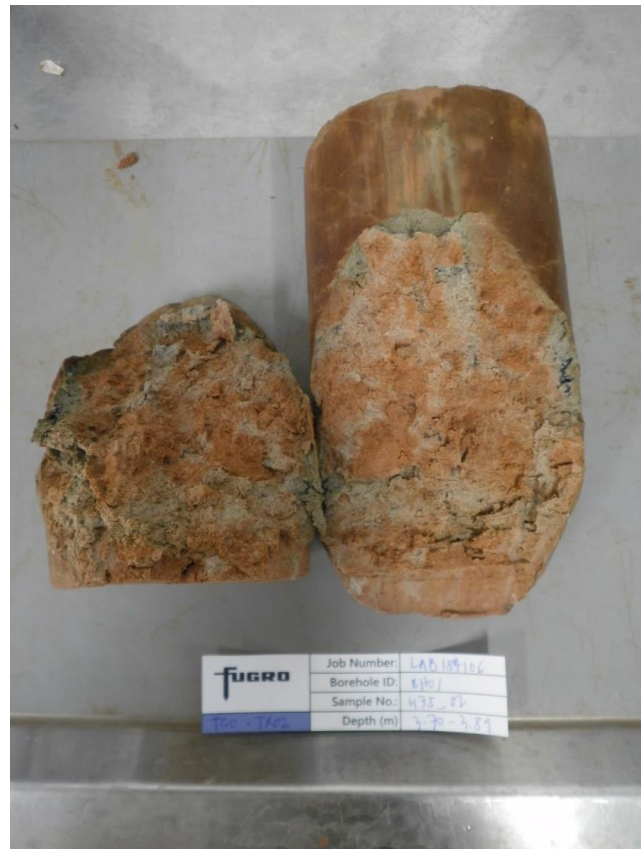
Sample after the test

Comments: Initial axial strain result during consolidation is not available due to data loss.

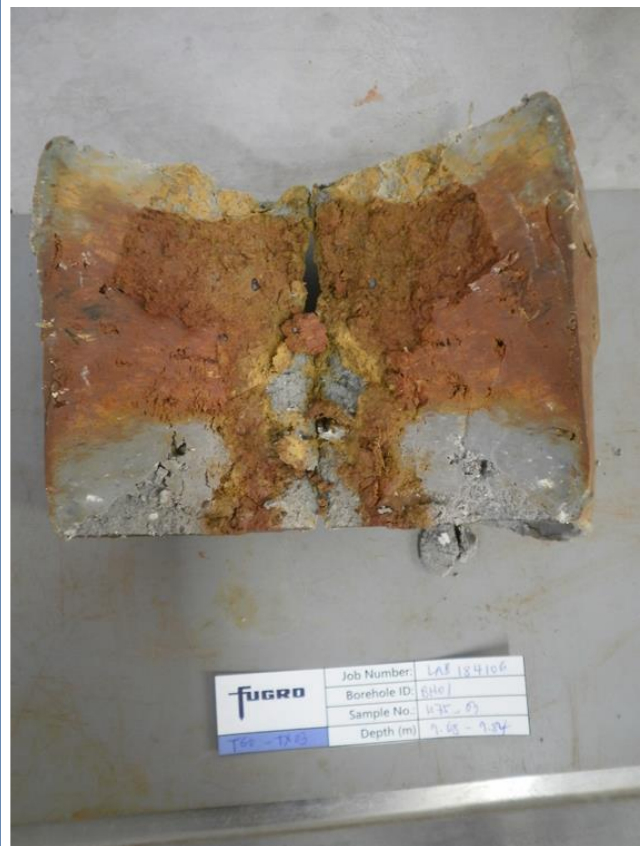
Sample after test

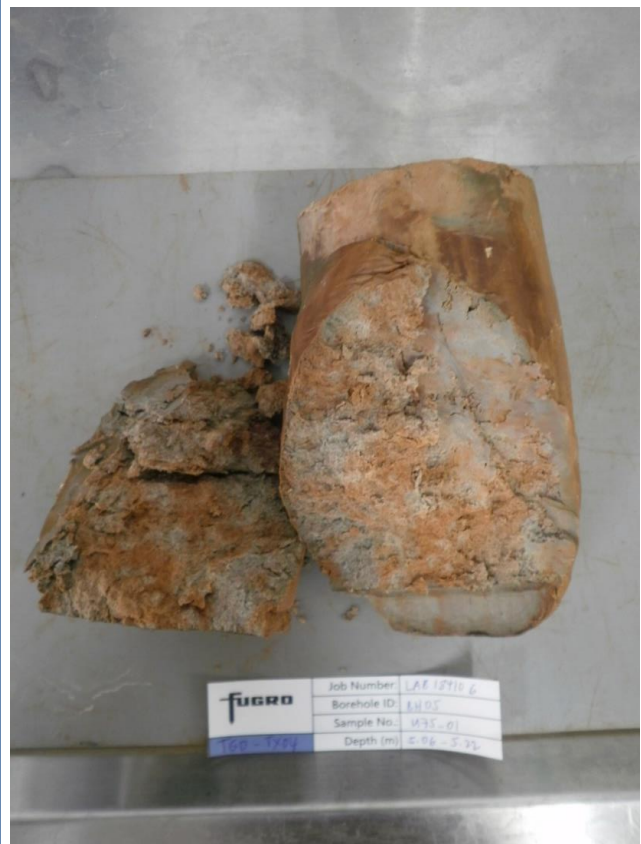
Sample after test

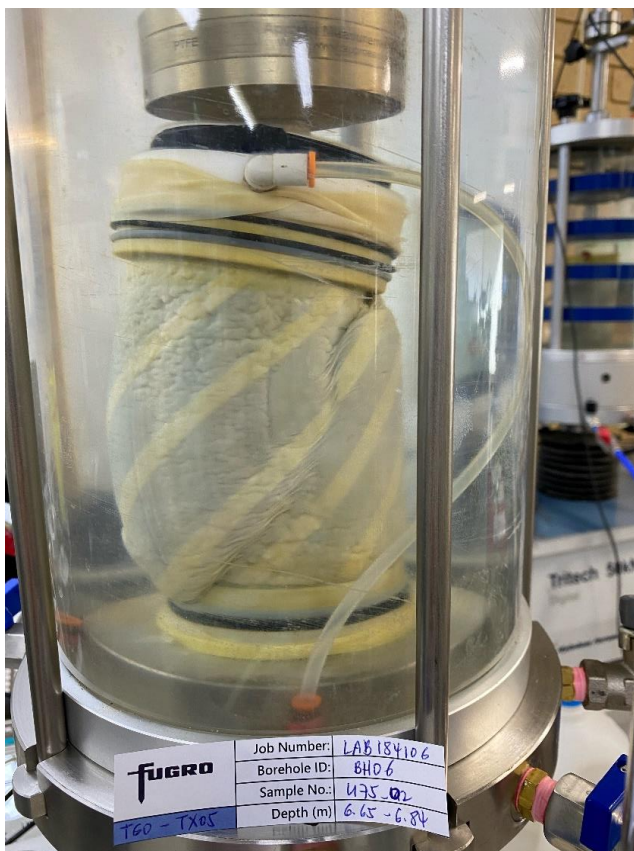
<b>TEST CERTIFICATE</b> <b>MULTISTAGE TRIAXIAL</b> <b>Test Method: AGLab Test Procedure FAM-17864</b> <b>Multistage Undrained Triaxial Compression</b>		<b>Fugro Australia Marine Pty Ltd</b> Advanced Geotechnical Laboratory Unit 2, 10 Carbon Court Osborne Park, WA, 6017 Australia	
<b>Client:</b> GHD Pty Ltd <b>Client Address:</b> 2 Salamanca Square, Hobart, Tasmania, 7000	<b>Job No.:</b> LAB184106 <b>IPO No.:</b> 2021-001	<b>Lab Sample ID:</b> 2021-001-028 <b>Borehole ID:</b> BH06 <b>Sample No.:</b> U75_02 <b>Depth:</b> 6.65 m to 6.84 m	
<b>Project Name:</b> TGO RSF 2 Geotechnical Investigation <b>Project Location:</b> Tomingley, NSW <b>Sample Description:</b> Brownish yellow sandy CLAY			
<b>Sample Photographs:</b>

Sample at the end of shearing

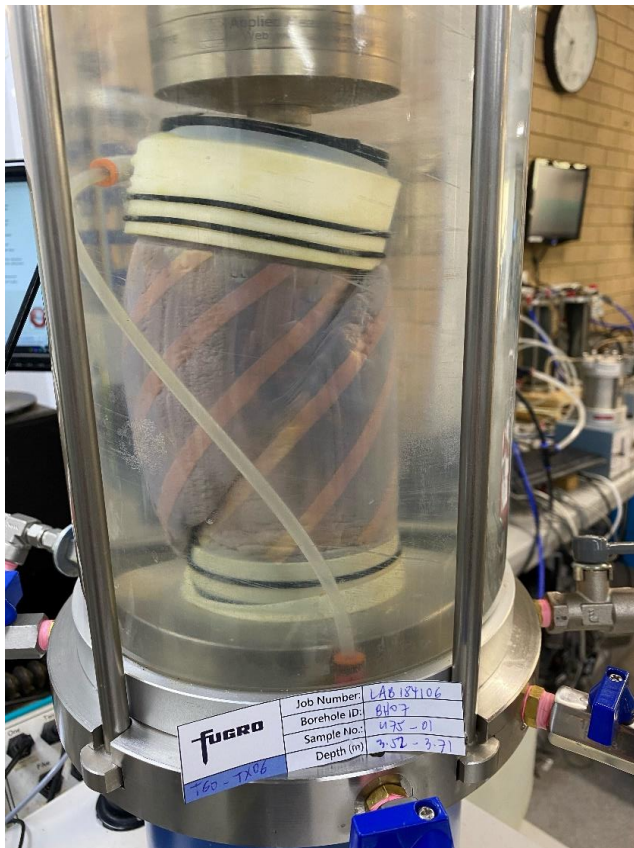
<b>TEST CERTIFICATE</b> <b>MONOTONIC TRIAXIAL</b> <b>Test Method:</b> AGLab Test Procedure FAM-17864 <b>Undrained Triaxial Compression</b>		<b>Fugro Australia Marine Pty Ltd</b> Advanced Geotechnical Laboratory Unit 2, 10 Carbon Court Osborne Park, WA, 6017 Australia	
<b>Client:</b>	GHD Pty Ltd	<b>Job No.:</b>	LAB184106
<b>Client Address:</b>	2 Salamanca Square, Hobart, Tasmania, 7000	<b>IPO No.:</b>	2021-001
<b>Project Name:</b>	TGO RSF 2 Geotechnical Investigation	<b>Lab Sample ID:</b>	2021-001-032
<b>Project Location:</b>	Tomingley, NSW	<b>Borehole ID:</b>	BH07
<b>Sample Description:</b>	Brownish yellow/grey CLAY with sand	<b>Sample No.:</b>	U75_01
<b>Sample Photographs:</b>		<b>Depth:</b>	3.52 m to 3.71 m

Sample at the end of shearing

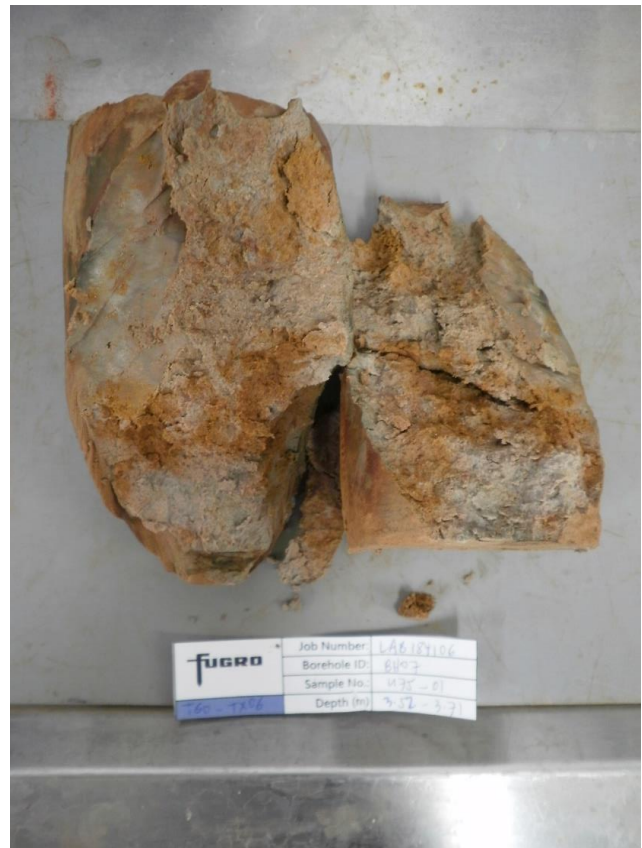
Sample after the test

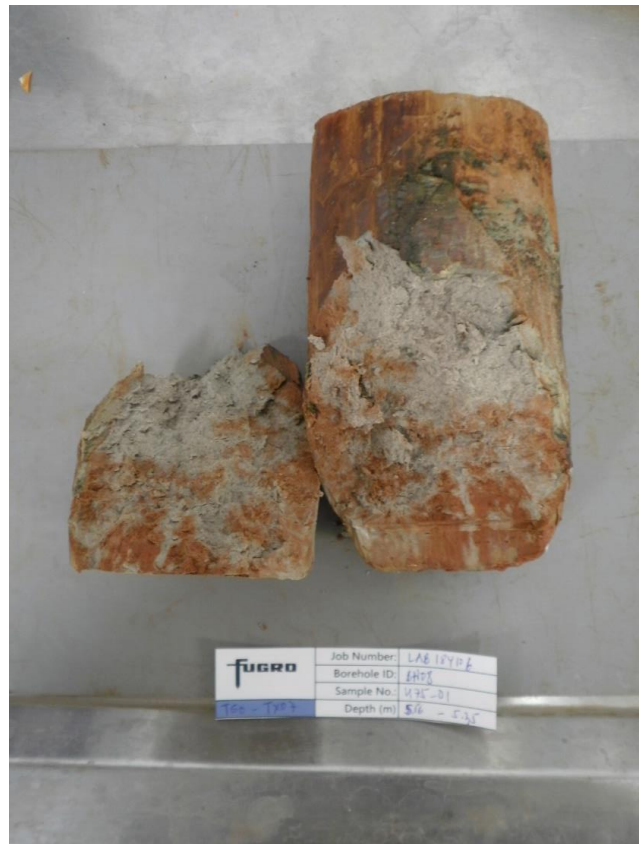
Sample after test

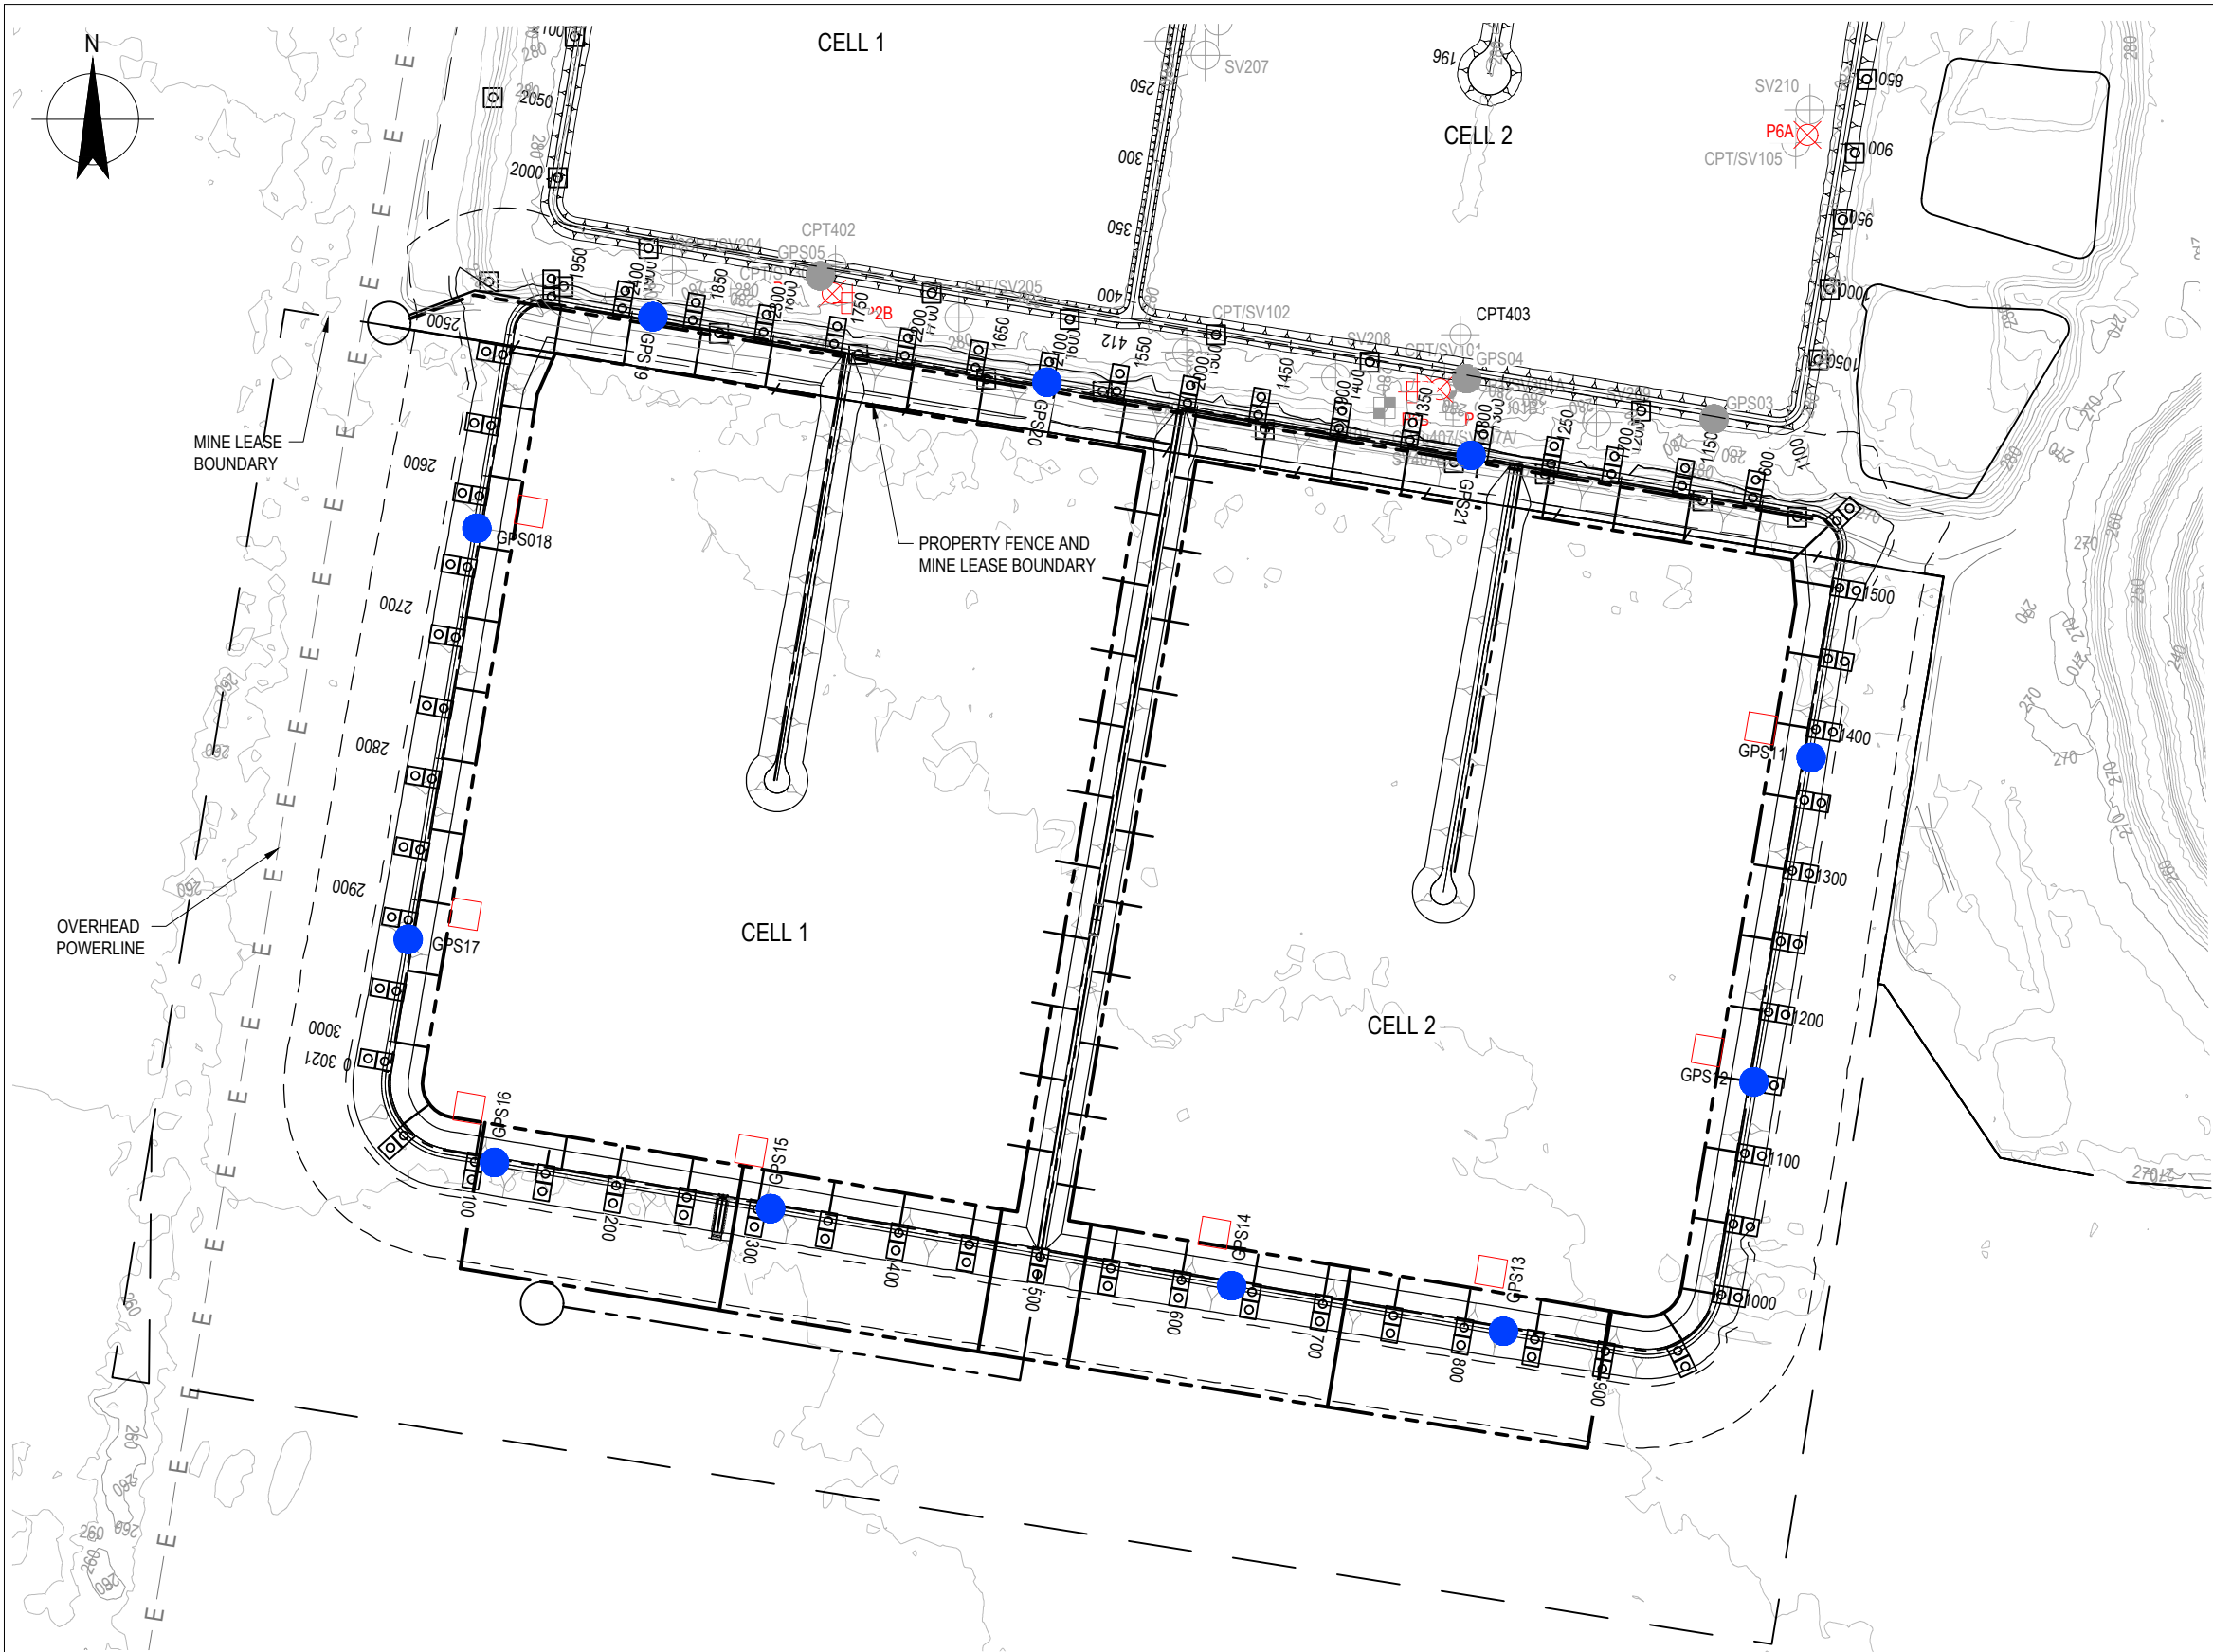
PROPOSED GPS SURVEY LOCATIONS		
POINT	EASTING	NORTHING
GPS11	613772.756	6393495.126
GPS12	613733.223	6393268.255
GPS13	613558.114	6393094.898
GPS14	613368.352	6393126.634
GPS15	613046.595	6393180.445
GPS16	612853.942	6393212.664
GPS17	612793.650	6393368.276
GPS018	612841.610	6393655.048
GPS19	612964.450	6393802.685
GPS20	613239.498	6393756.948
GPS21	613535.455	6393705.913

- LEGEND:**
- VIBRATING WIRE PIEZOMETER CABLE
  - SET A PIEZOMETERS - PUSH IN FROM STAGE 4 CREST
  - SET B PIEZOMETERS - PUSH IN FROM BUTTRESS
  - APRILTAG LOCATION
  - GPSXX GPS SURVEY MONUMENT - NEW
  - GPSXX GPS SURVEY MONUMENT - EXISTING
  - VIBRATING WIRE PIEZOMETER
