## Remedial Action Plan:

Lots 2320 and 2321 DP 1223137,  
17 and 19 Kosovich Place,  
Cecil Park, NSW

P1705798JR06V03  
August 2018

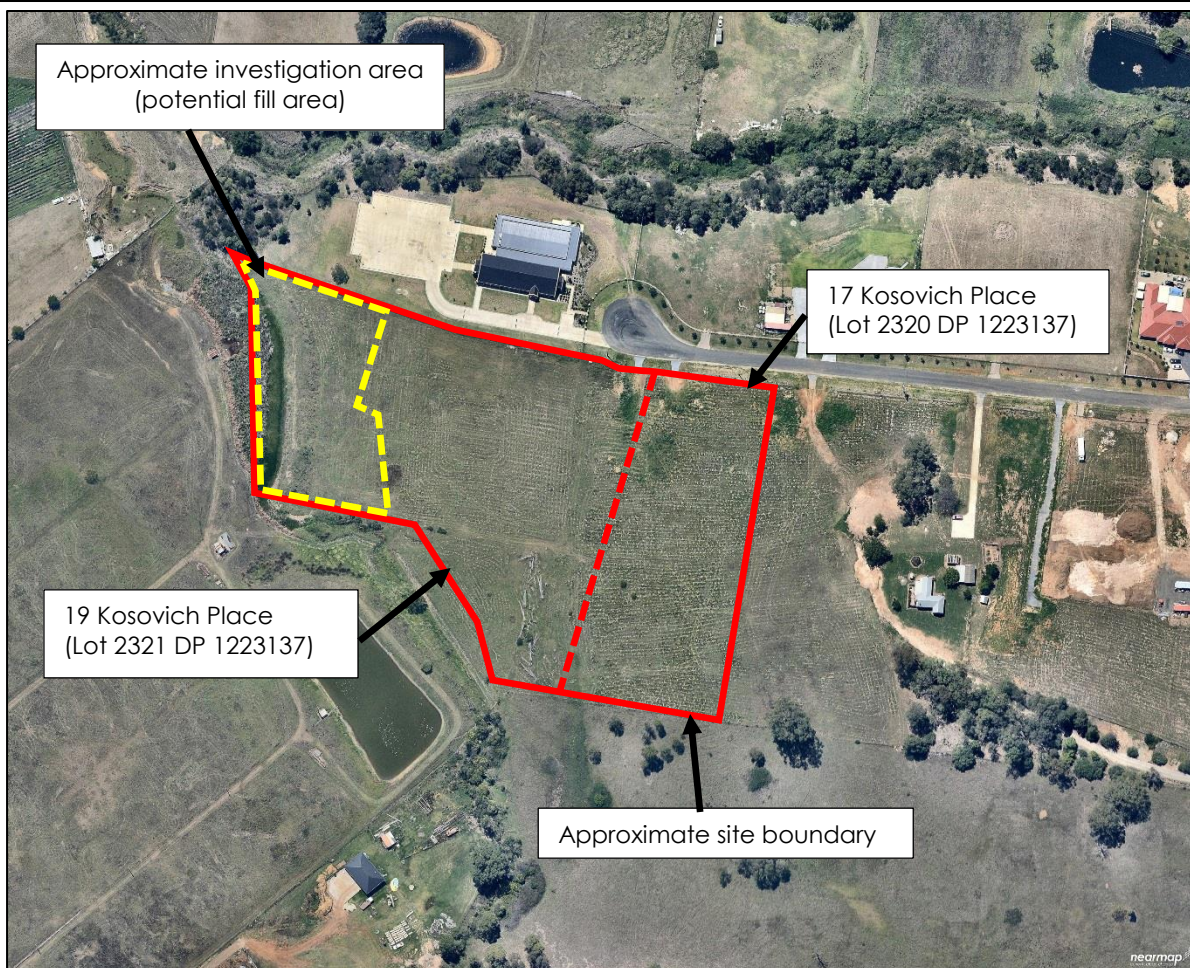
Drawing No:
<b>FIGURE 1</b>
Job No: P1705798

Site information is summarised in Table 1. Site location and general surrounds are provided in Figure 1, Attachment A.

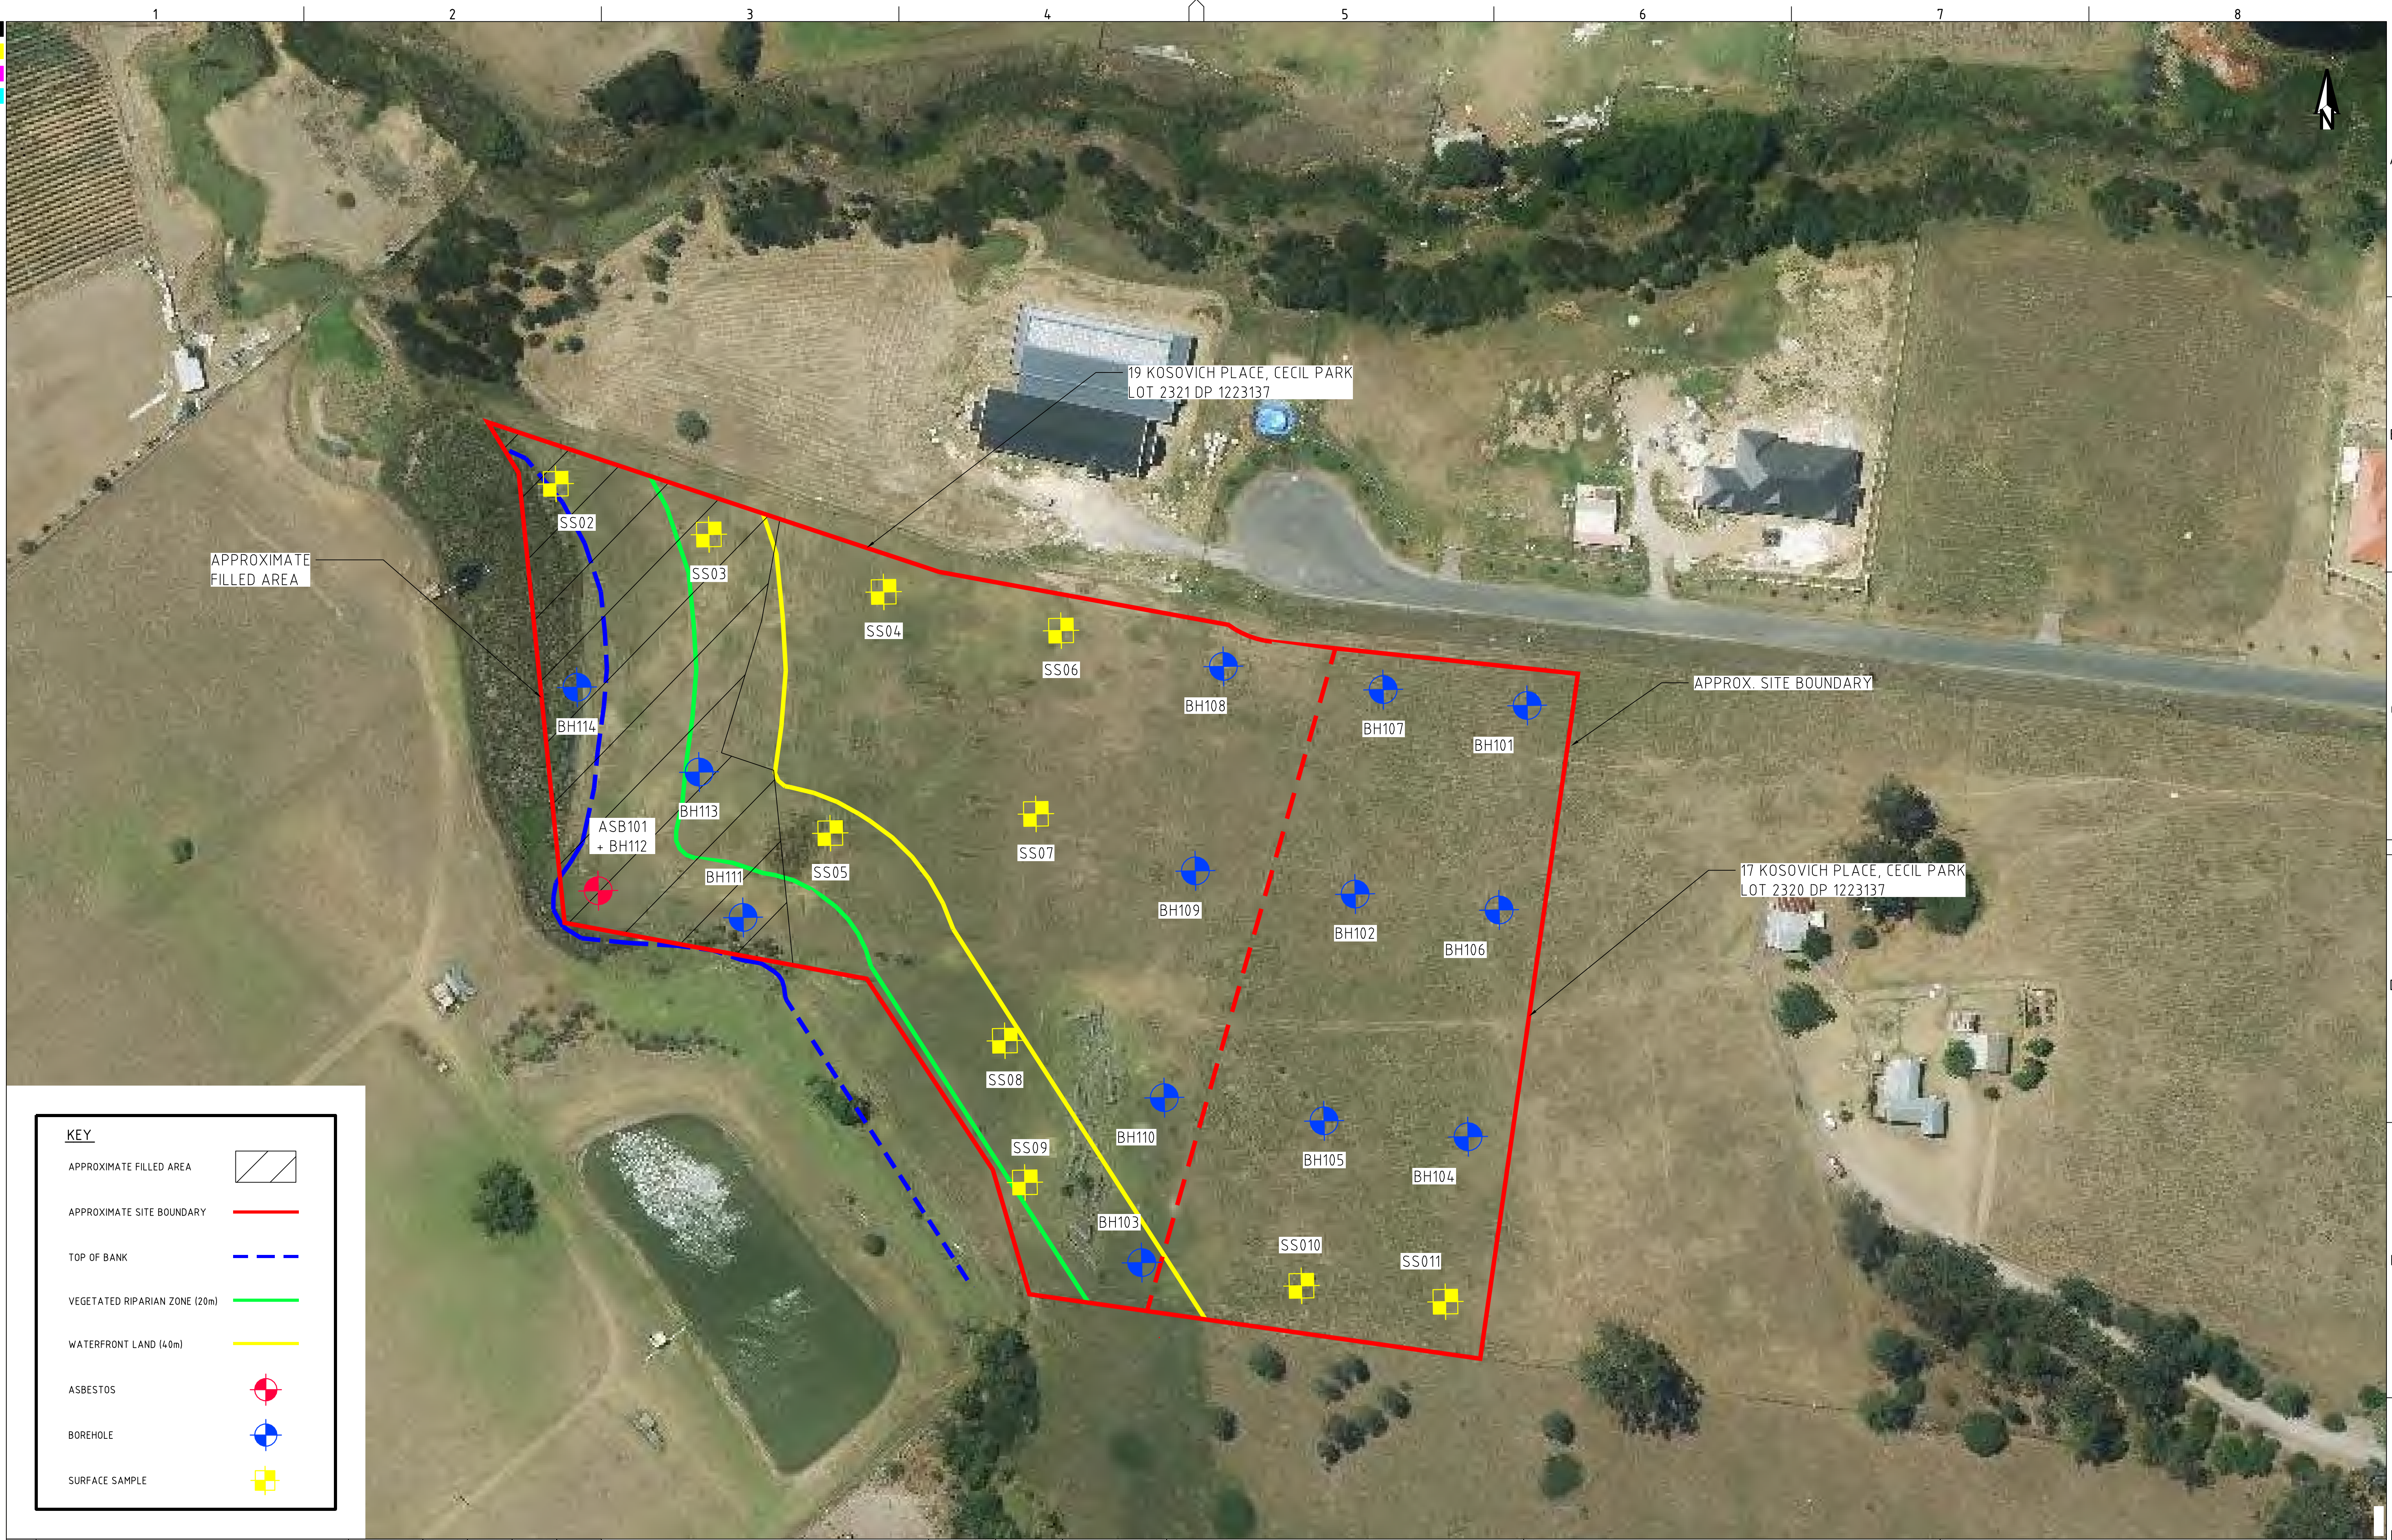
## **13      Attachment B – Areas Requiring Further Investigation, Remediation, and Previous Sampling Points**

Refer to plan PS02-AZ09 (Attachment B) for locations of previous testing and test areas that exceeded guideline levels.

The potential fill area in the western portion of the site (refer to PS02-AZ09, Attachment B) requires further investigation as part of the RAP, to:

- Test pitting across the potential fill area as identified on PS02-AZ09 (Attachment B) to confirm the lateral and vertical extent of fill material; and
- Where further intrusive investigations clearly identify inclusion impacted fill areas, or PACM fragments are observed within surface soils, testing of impacted soils to determine if soils exceed the NEPM weight for weight (w/w) criteria for asbestos.

Site soils shall be assessed against ASC NEPM (1999, amended 2013) health screening levels for asbestos in soil (see Section 6.6.2). If soil samples are found to be contaminated, or bonded PACM fragments have been confirmed through laboratory testing, additional deeper testing within selected areas may be required to determine extent of asbestos contamination, including hotspots. The results of the data closure investigation shall be added as an addendum to the MA DSI (2017a) and any additional remediation requirements shall be addressed in an updated version of this document. Refer to Attachment B for data gap locations (i.e. approximate filled areas).

A Controlled Activity Approval (CAA), to be assessed by Department of Industries - Water (formerly NSW DPI Water), will be required for any works within 40 m of the highest bank of the watercourse, including remedial contamination works (refer to PS02-AZ09, Attachment B).
