Report on  
Geotechnical Investigation

Mudgee Hospital Redevelopment  
Lewis Street  
Mudgee

Prepared for  
Health Infrastructure

Project 86091.00  
April 2018

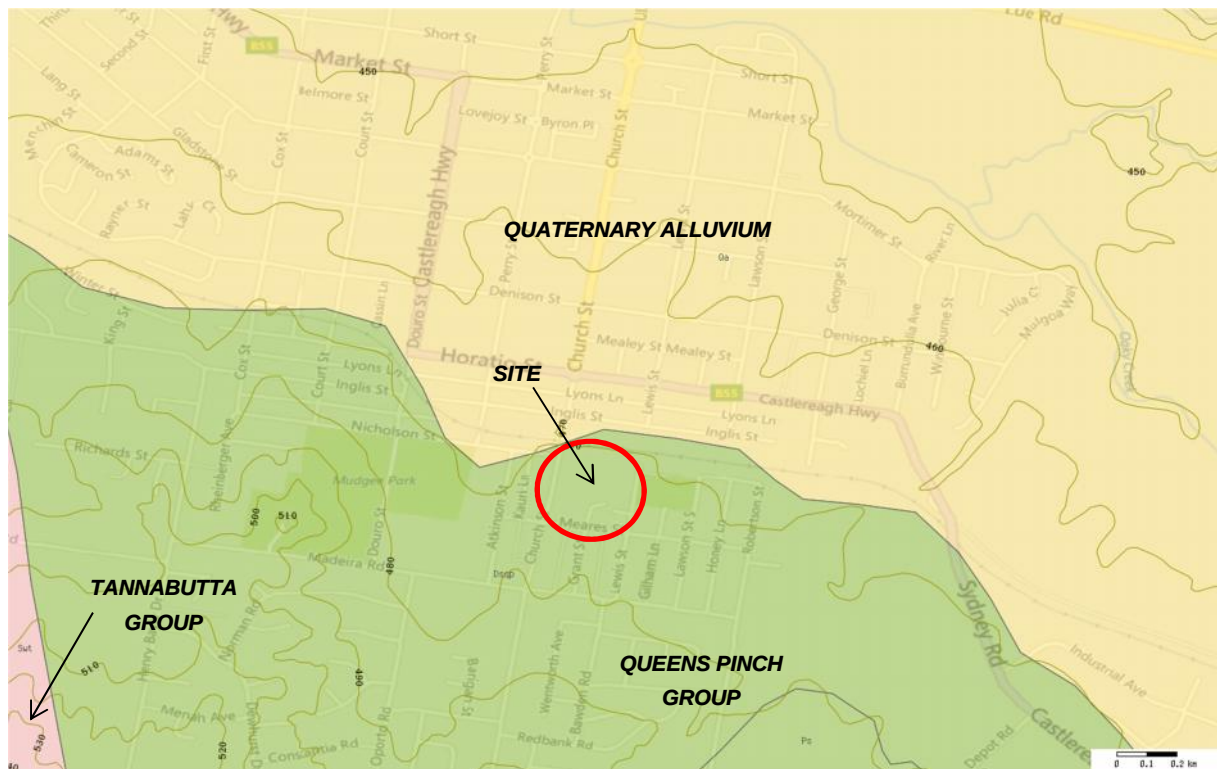
Figure 1: Extract from geological map

Geological mapping indicates that the site is close to a boundary between Quaternary alluvium (gravel, sand, silt and clay) and the Queens Pinch Group (sandstone, mudstone, conglomerate and limestone). The Tannabutta Group (rhyolite and sandstone) is shown to the west of the site. An extract from the geological map is shown in Figure 1.
