Report on  
Preliminary Site Investigation (Contamination)

Mudgee Hospital Redevelopment  
Lewis Street  
Mudgee

Prepared for  
Health Infrastructure

Project 86091.00  
April 2018

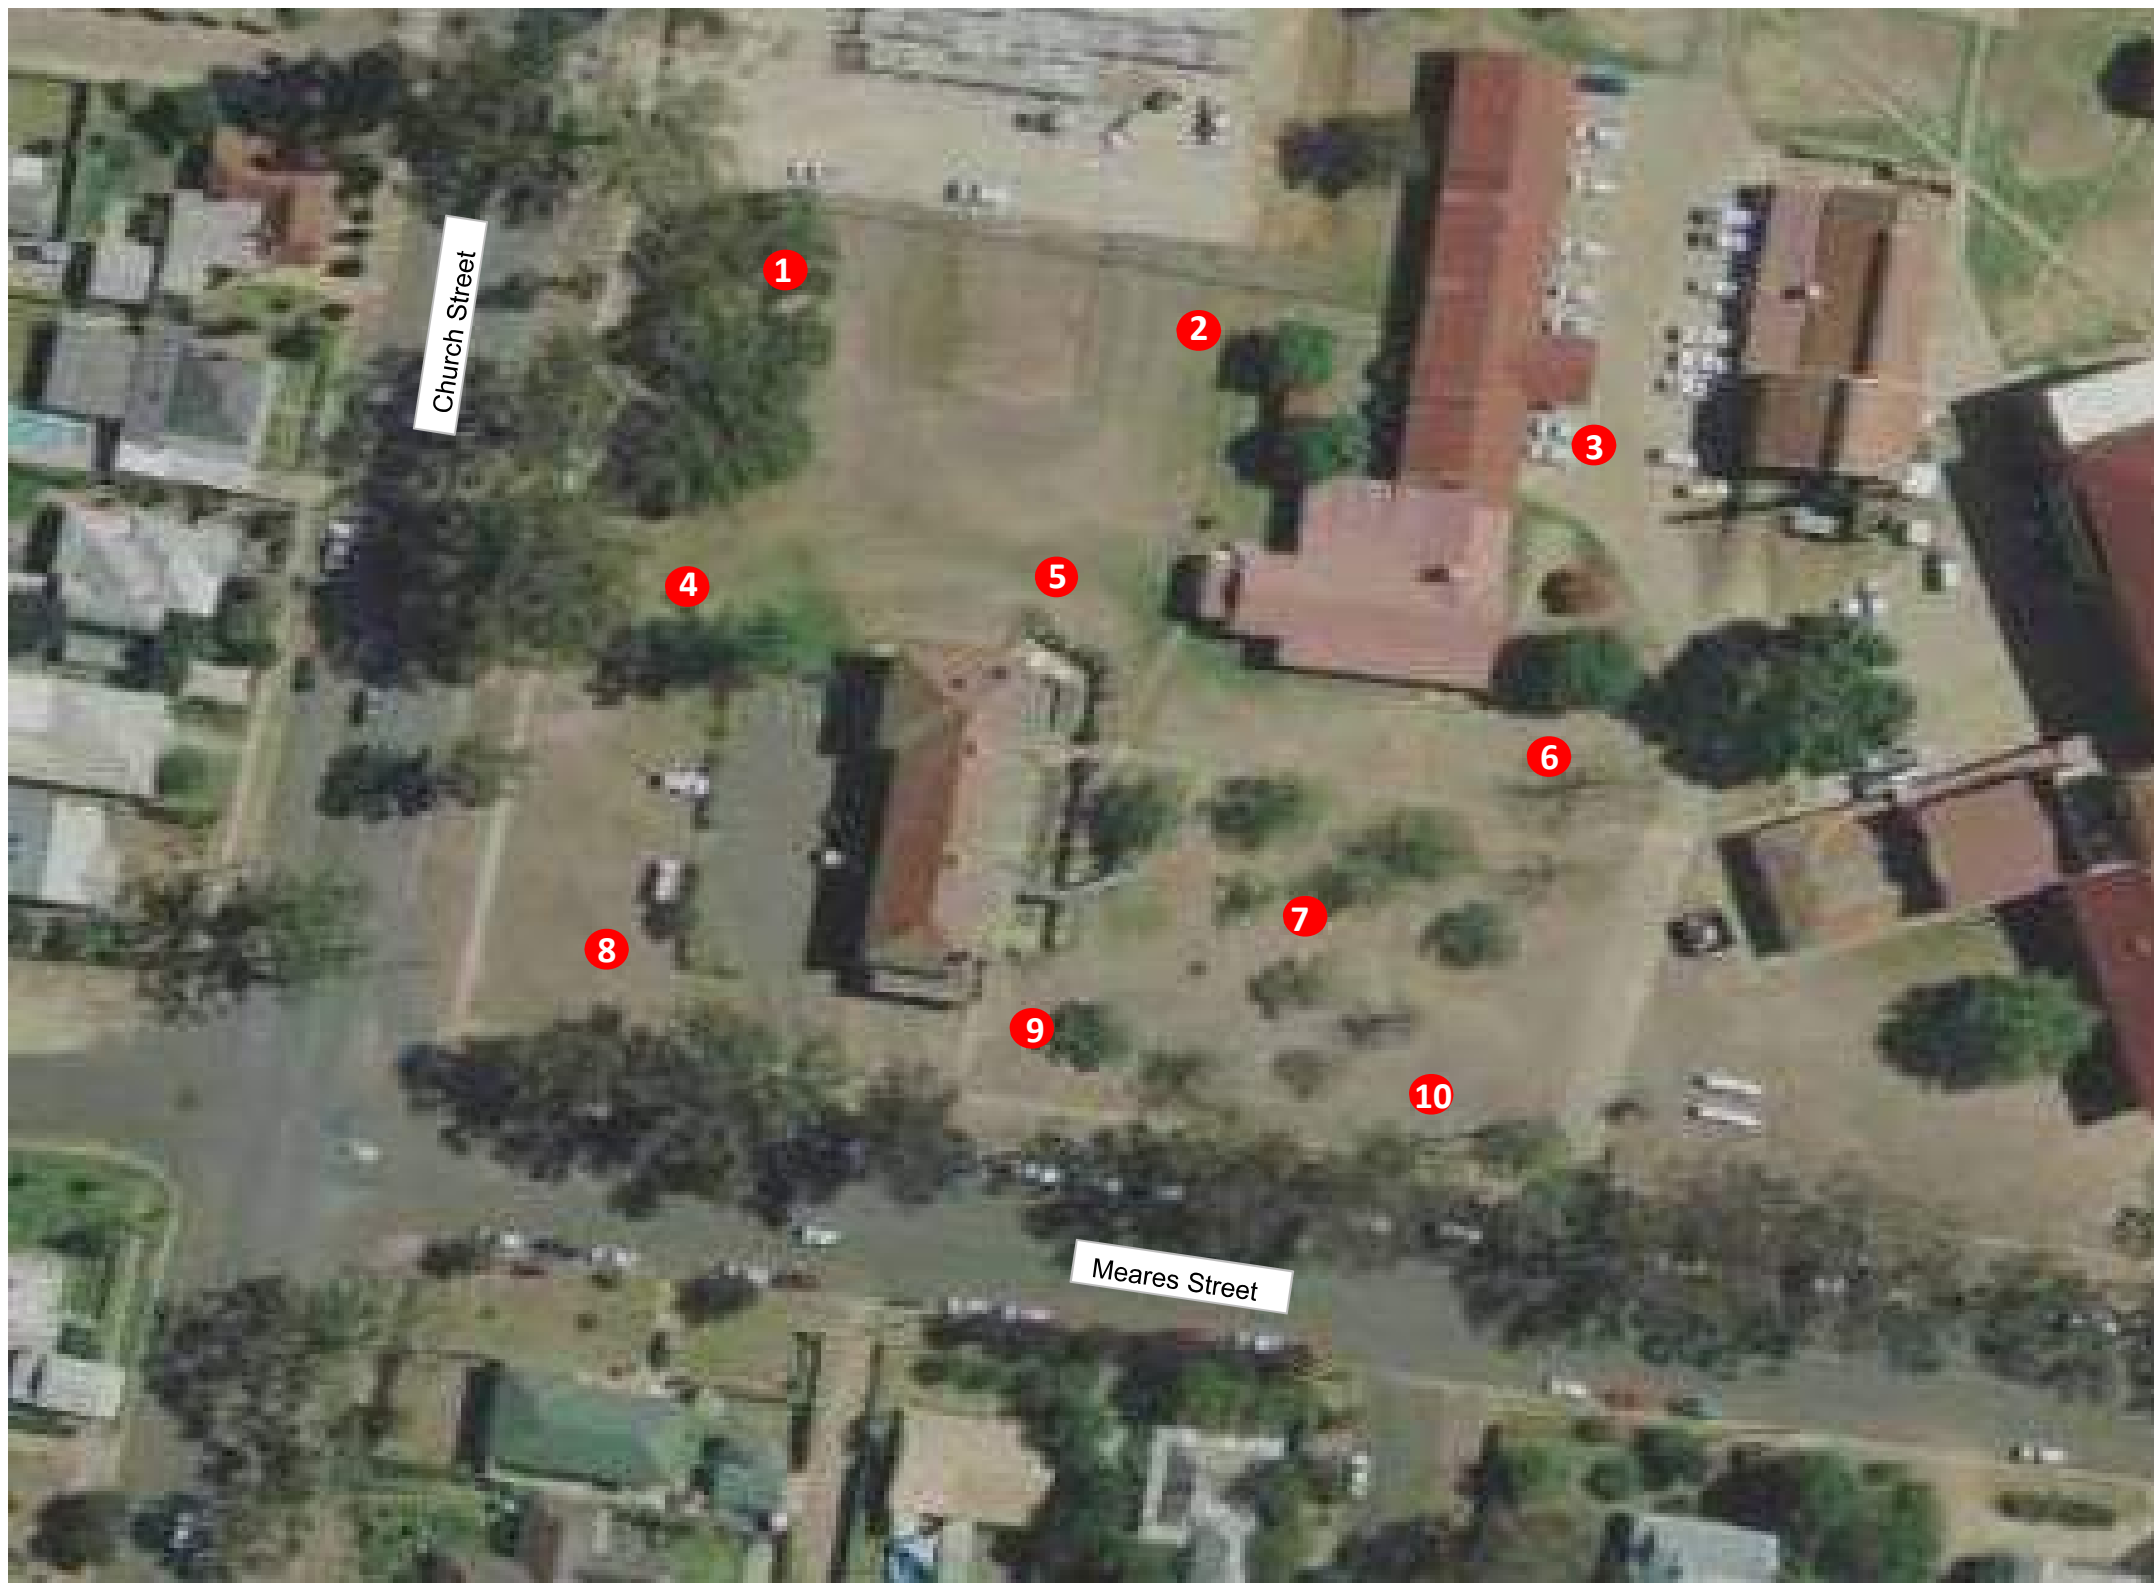
Borehole location

The subsurface conditions encountered in the boreholes are presented in the borehole logs in Appendix E. Notes defining descriptive terms and classification methods are included in Appendix A.

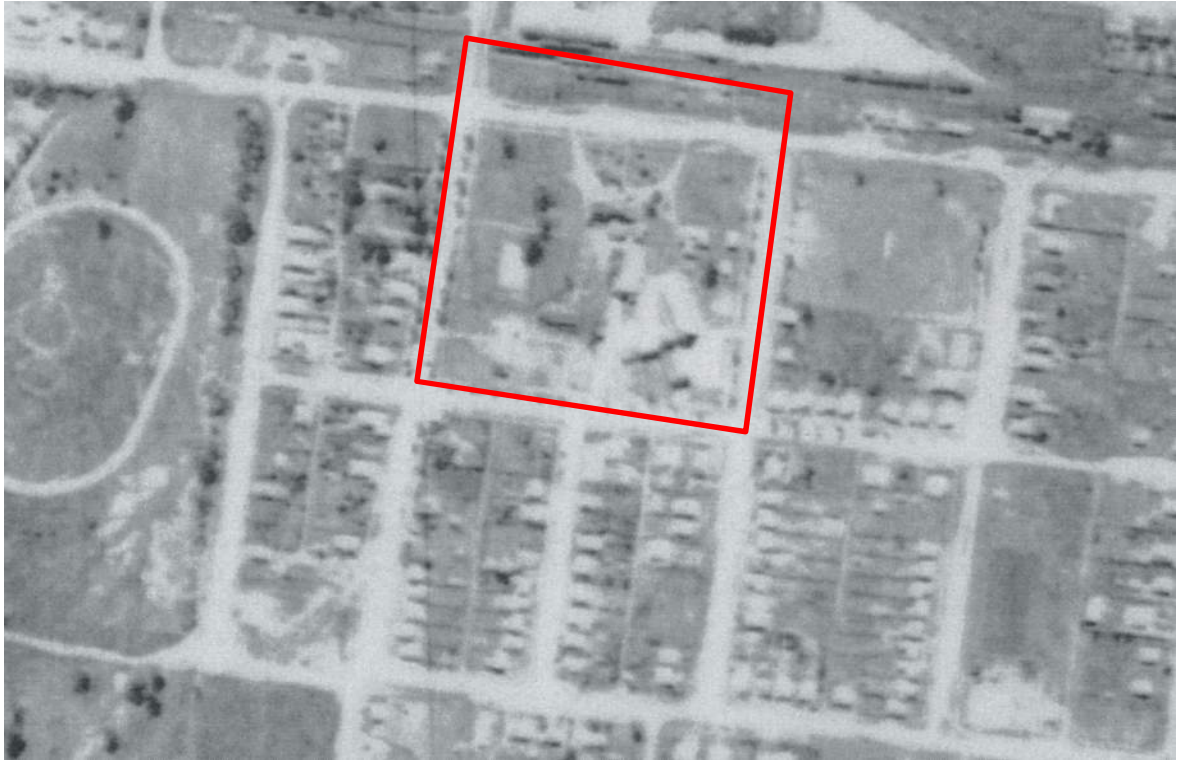
Aerial photograph from 1956

Aerial photographs from 1959, 1967, 1979, 1990, 1994 and 1996 were used to assess historical land-use patterns on the site. The 1956 photograph shows the main hospital building, boiler house, southern portion of the Wellness Centre, the Community Health centre and the disused building off Lewis Street are present. A significant building is also located to the north of the boiler house, as well as smaller structures off Lewis Street. A road is located to the north of the site adjacent to the railway.

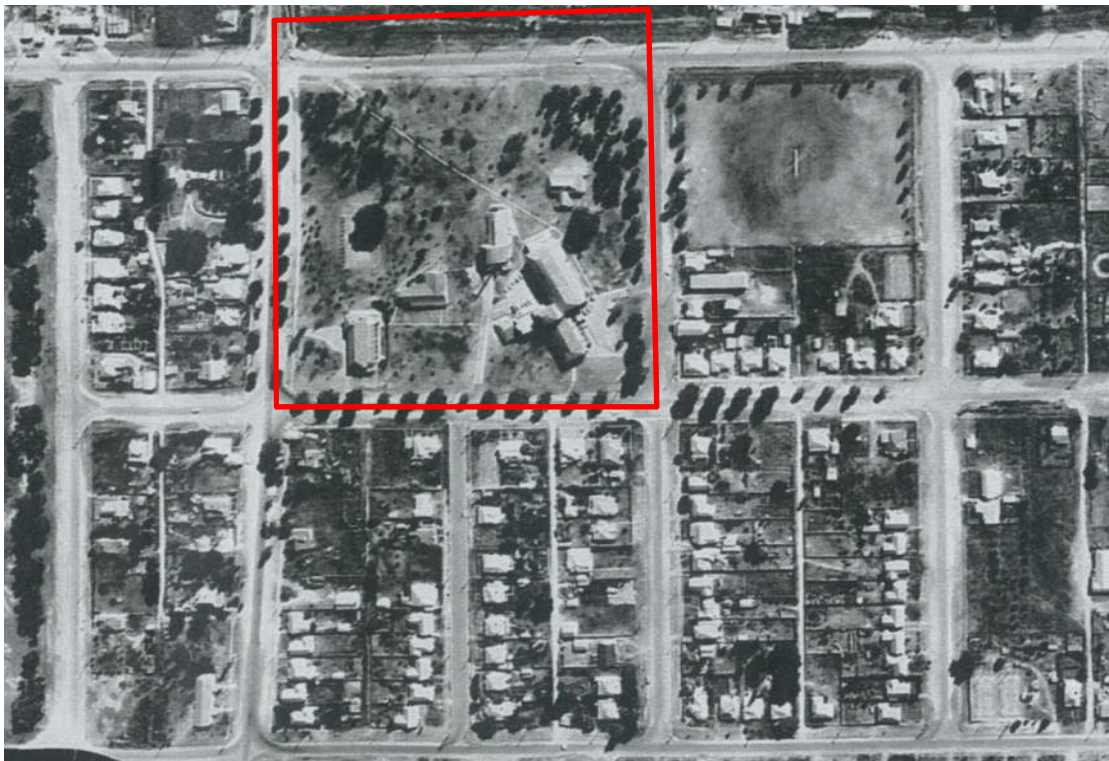
Aerial photograph from 1967

The 1967 photograph shows similar conditions to 1956, except that the building to the north of the boiler house and the smaller structures off Lewis Street have been demolished. Much more vegetation is evident.

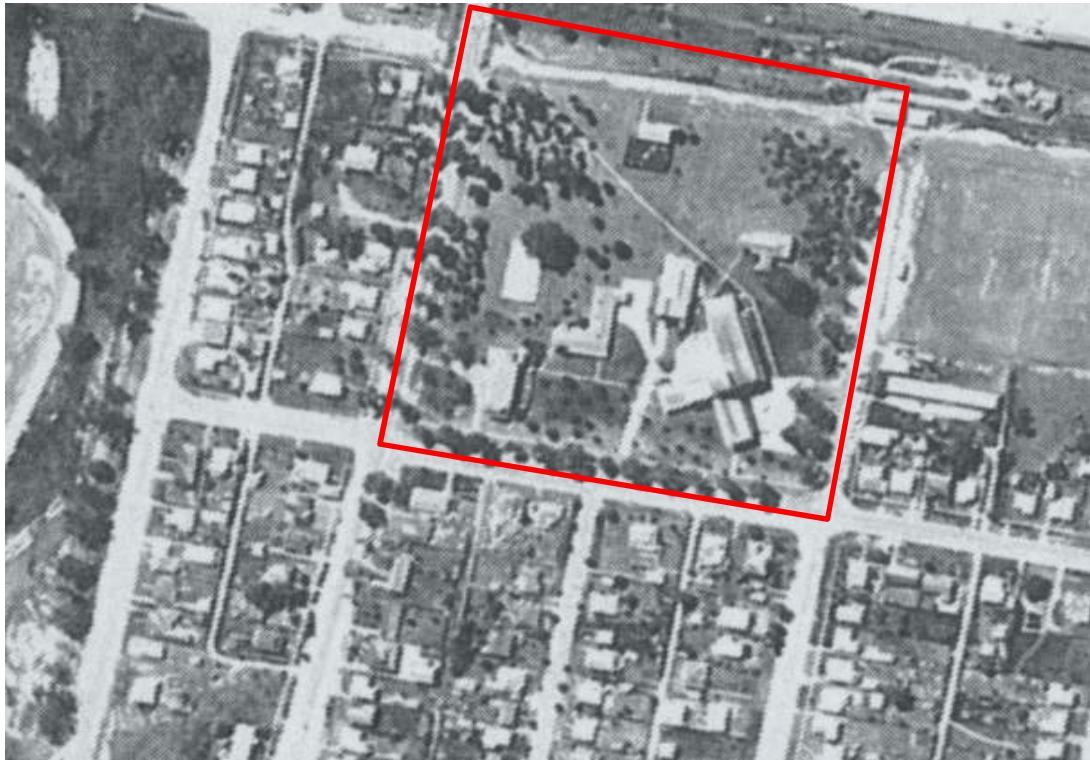
Aerial photograph from 1979

The dwelling in the northern portion of the site appears in the 1979 photograph. The Wellness Centre has been extended to the north and a structure appears in the central-western portion of the site. The 1990 photograph shows similar conditions except that the road to the north has been closed.

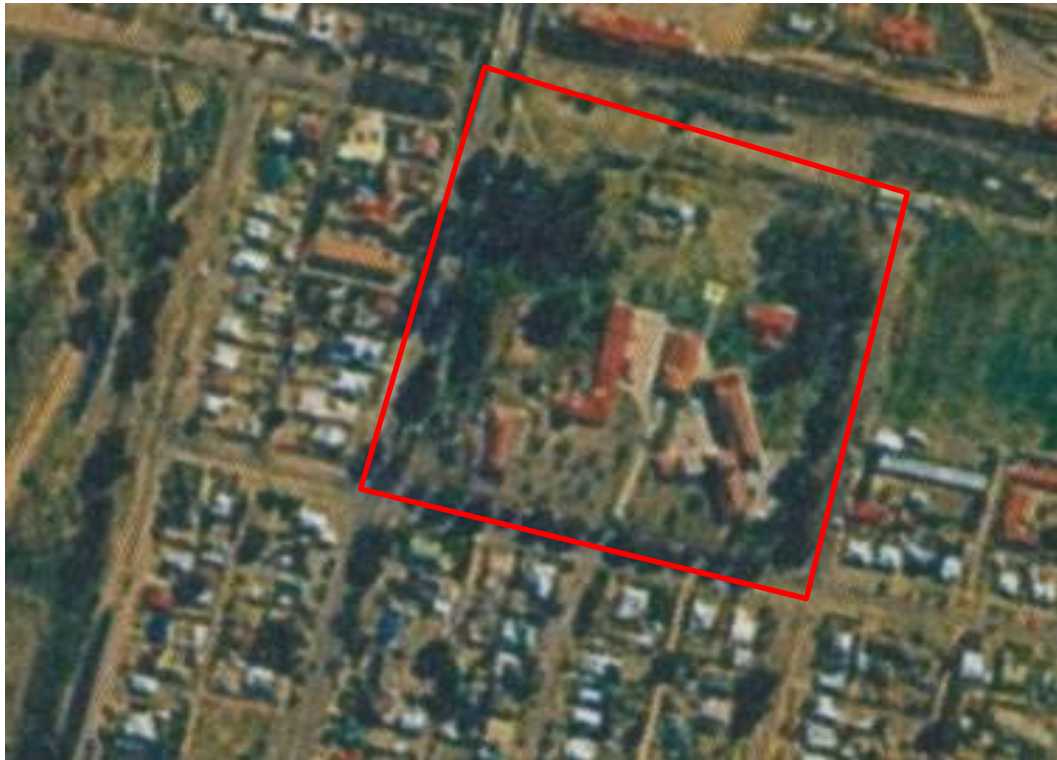
Aerial photograph from 1994

The 1994 and 1996 photographs show similar conditions to 2017 except that the Mudgee Medical Centre in the central-western portion of the site is yet to be constructed.

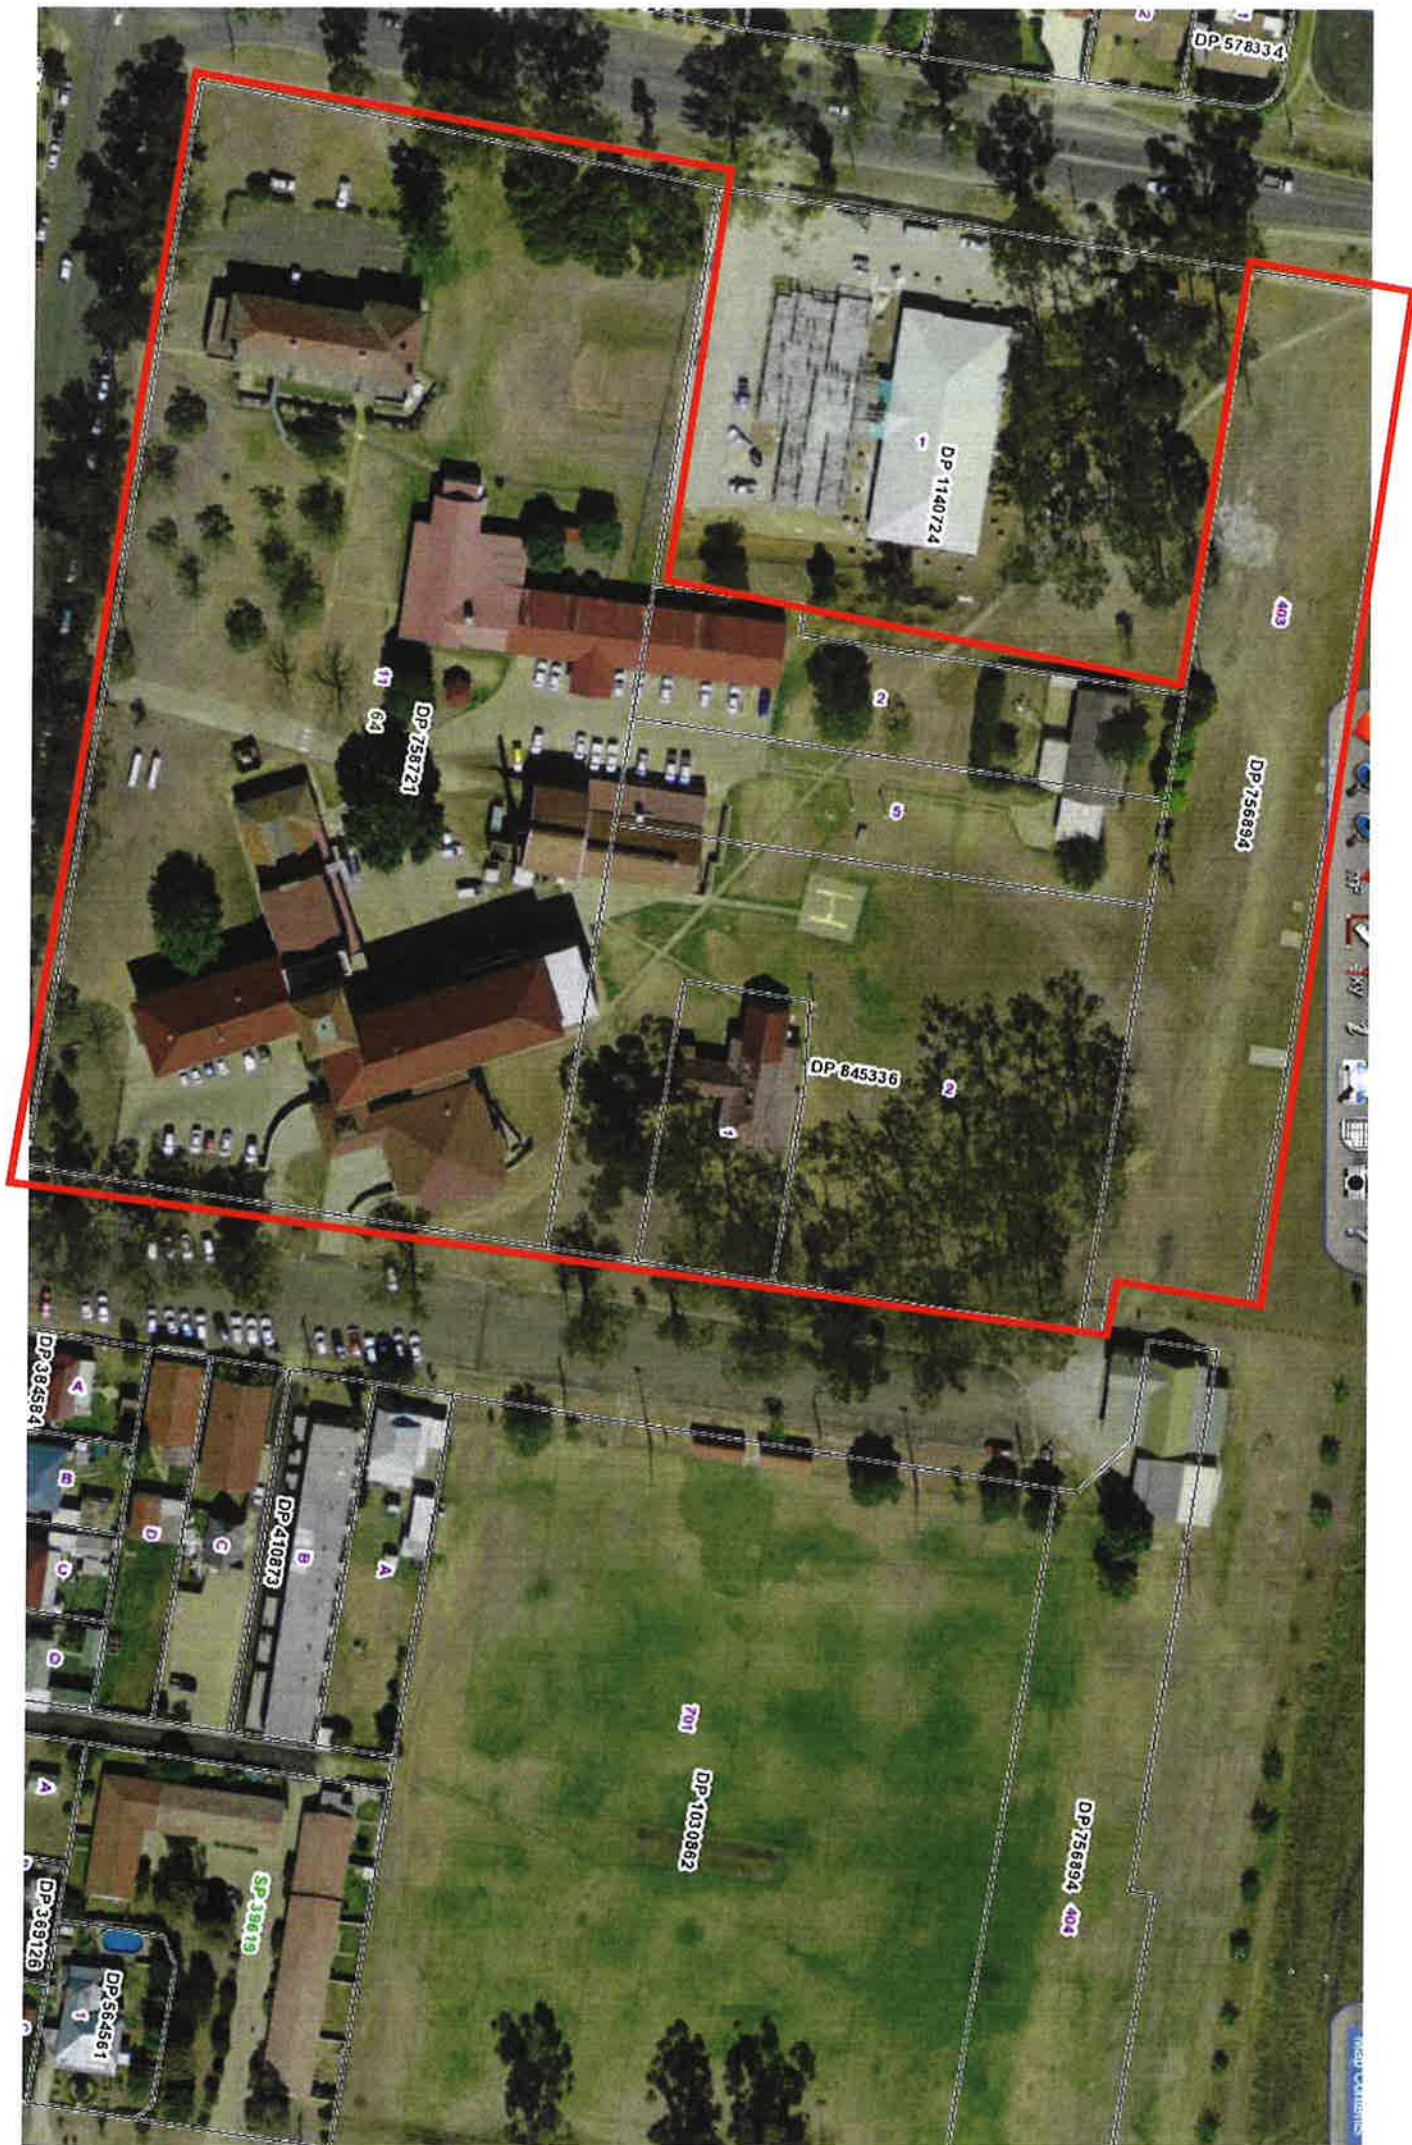
PLAN OF PORTIONS 403 & 404

PARISH MUDGEE COUNTY WELLINGTON  
 LAND DISTRICT MUDGEE SHIRE MUDGEE  
 (TOWN OF MUDGEE)
