**Stage 1 and 2 Contamination Assessment  
Proposed New Amity College Campus  
Lot 1 DP 525996 No 85 Byron Road and  
Lot 2 DP 525996 No 63 Ingleburn Road  
Leppington NSW**

**Ref: JC18322A-r1(rev2)**  
**May 2019**

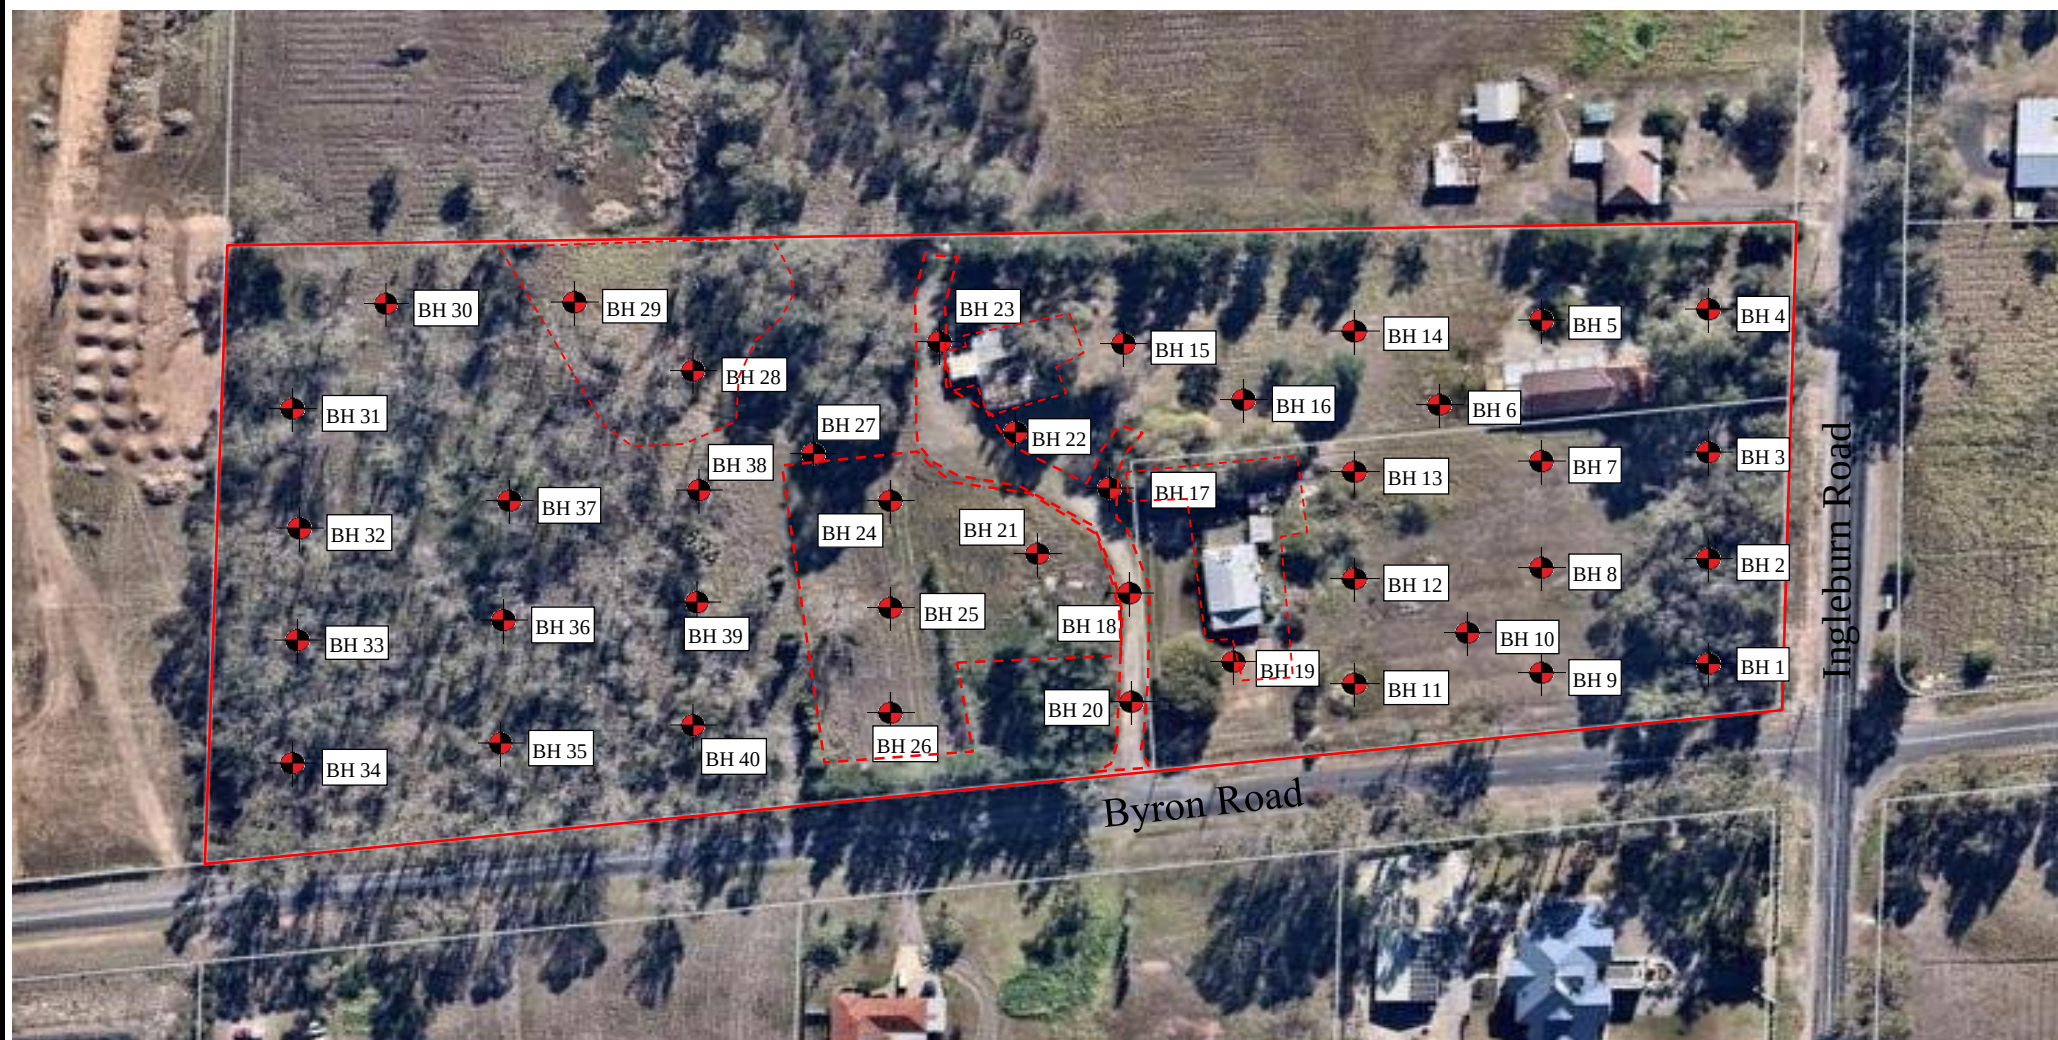
| <b>Project No: JC18322A</b> | <b>Drawing No: 9</b> |

| <b>Gran Associates Pty Ltd</b><br><b>85 Byron Road and 63 Ingleburn Road Leppington</b><br><b>Initial Investigation - Borehole Location Plan</b> | |

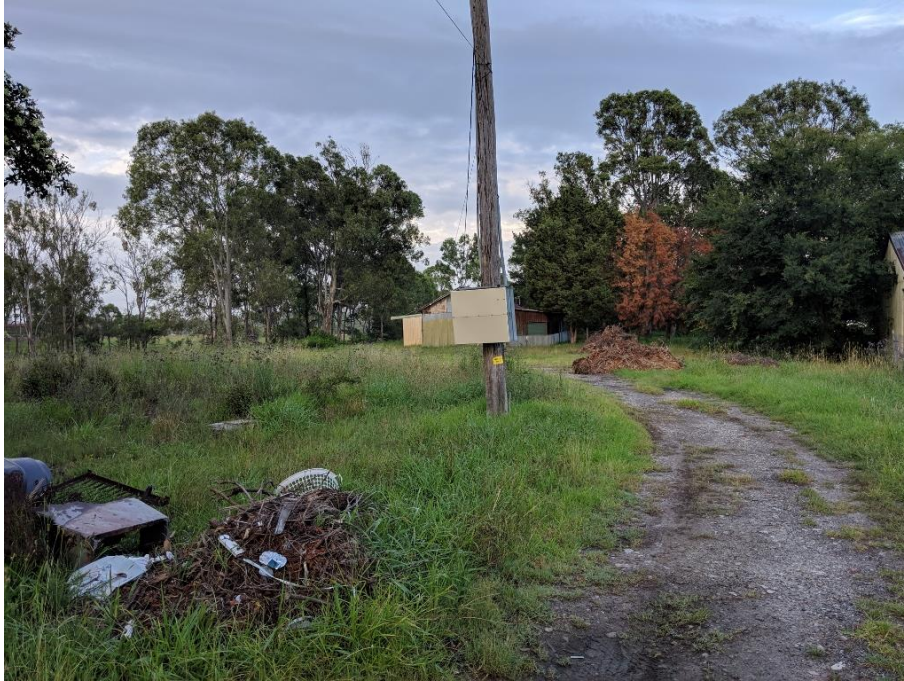
Photo No 1 – Middle of the site facing north-west towards the shed (Site Feature C) in the background and the driveway (Site Feature D) with crushed rock, sandstone and some building debris on the surface in the foreground.

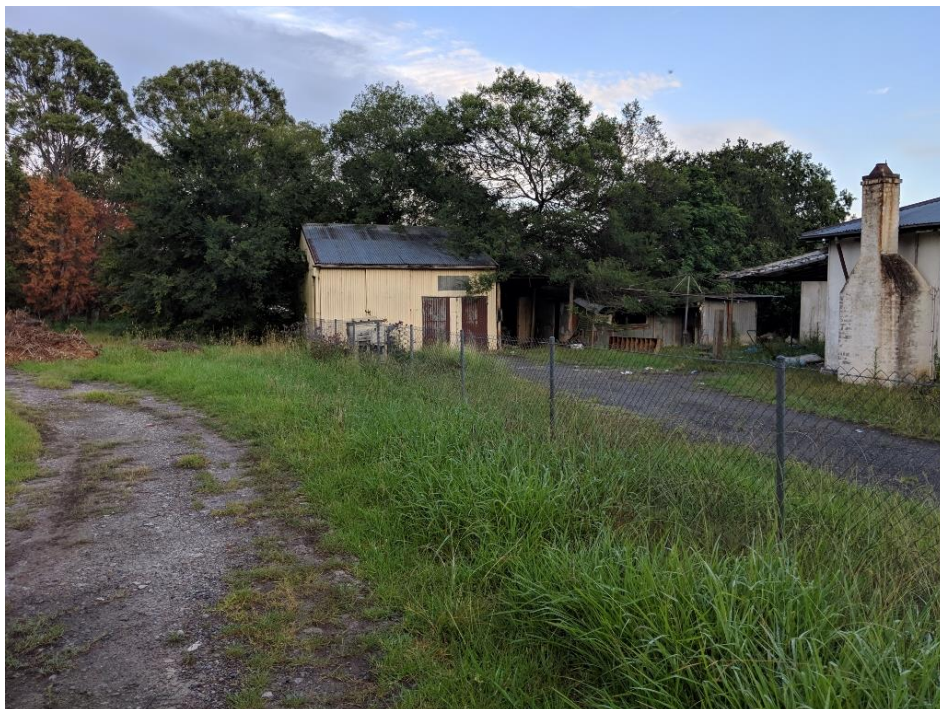
Photo No 2 – Middle of the site facing the fibro dwelling (Site Feature C)

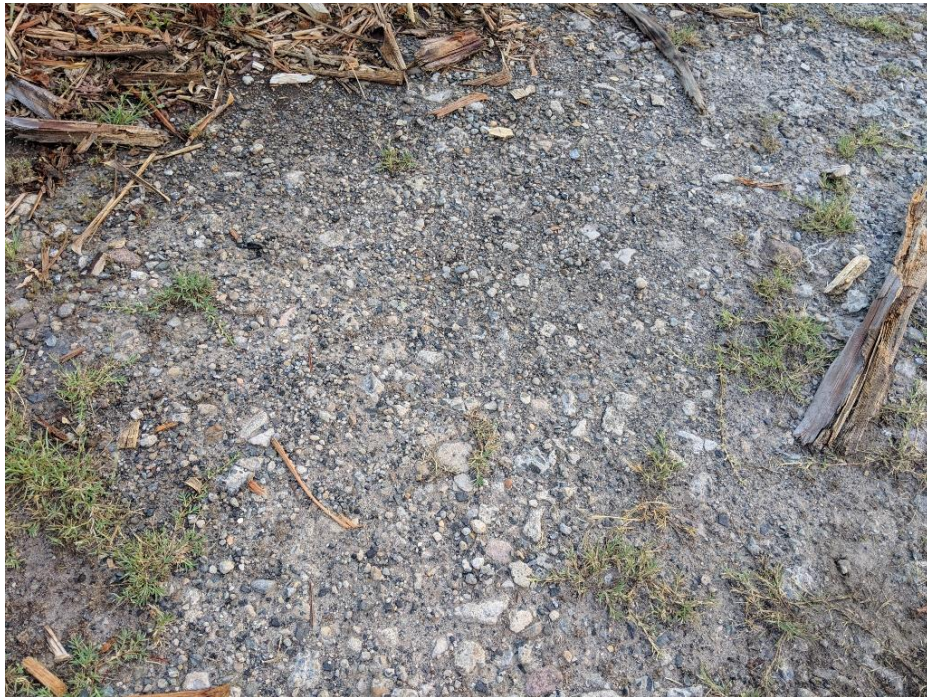
Photo No 3 – Gravel driveway (Site Feature D) with traces of building debris (eg concrete, bricks and asphalt)

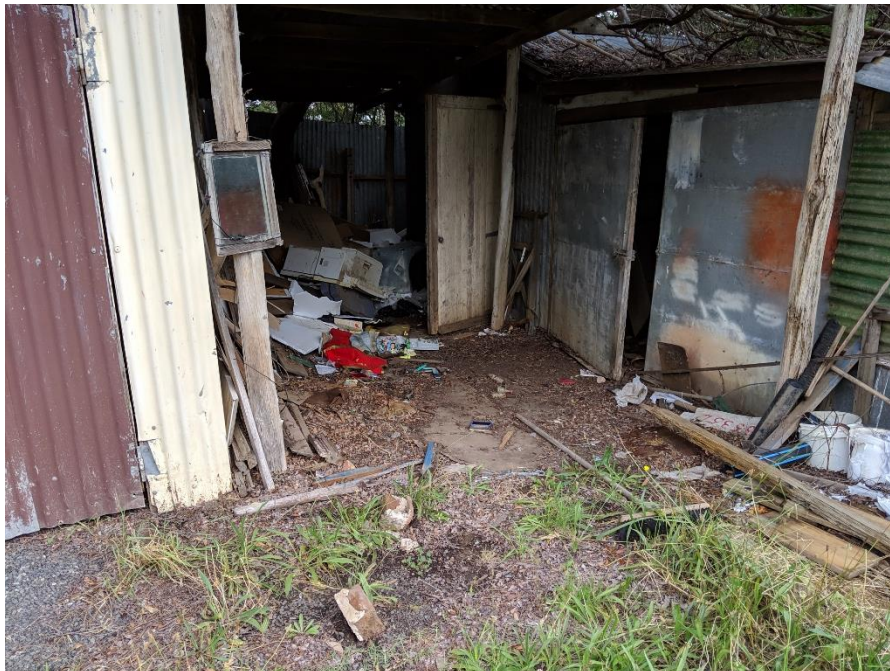
On this basis, there is a risk for these areas to have some contamination associated with leakage of chemicals/fuel or accidental spillage of chemicals/fuel from maintenance of machinery. If contamination exists, it is likely to be confined to the immediate vicinity of the sheds and buildings and within the upper subsurface profiles.

Photo No 4 – Metal and timber sheds to the west of fibro house (Site Feature C) with some minor oil staining on surface.

For the proposed school development, site remediation is required to clean up Area 4. We recommend a remediation action plan (RAP) be prepared outlining a remediation strategy to clean up the site to a suitable level for the proposed school development. In addition the areas of hydrocarbon stained soil encountered between the dwelling and sheds (Area 1 - Site Feature C) should be remediated.

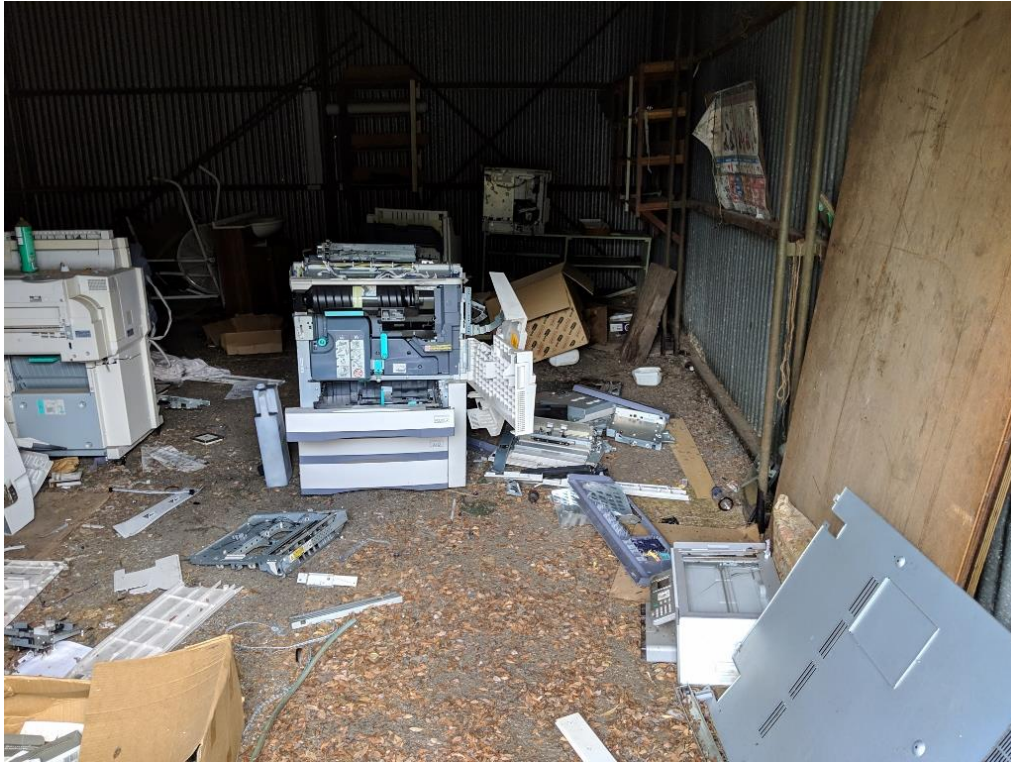
Photo No 5 – Metal shed (Site Feature C) used for general storage of miscellaneous items

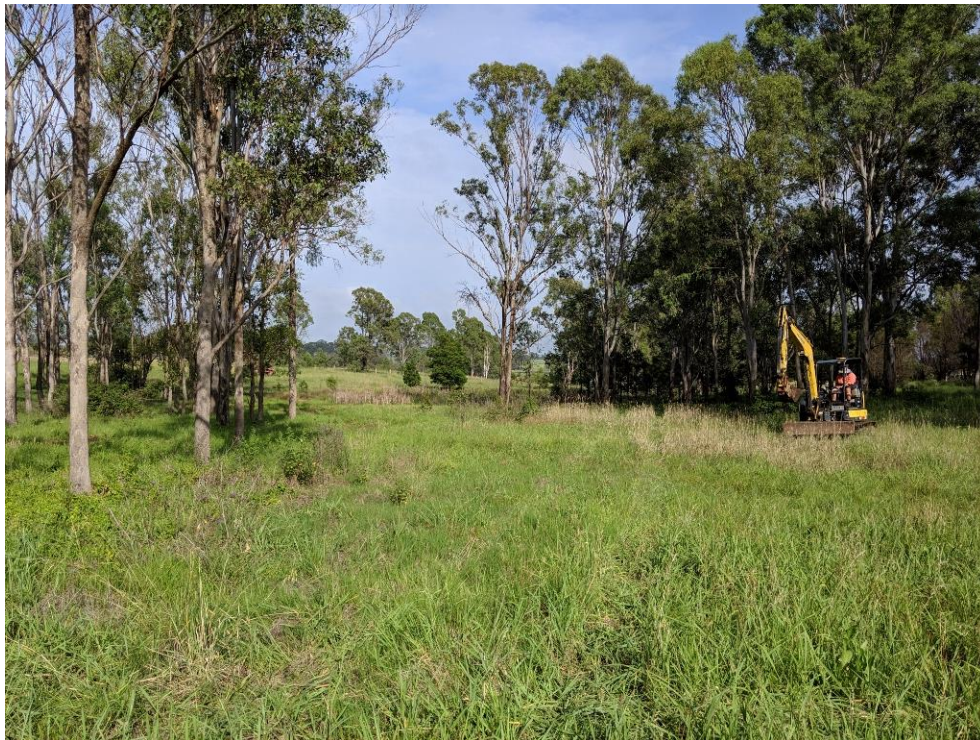
Based on historical aerial photographs and the site topography, the rear portion of the site near the western boundary appeared to be originally part of a depression (ie Site Feature G) which has been backfilled. Some fill consisting of clayey silt and silty clay with some rubbish and asbestos was encountered in BH 28, TP 4 to 8 and 10 and the thickness of fill was found to range from 0.3m to greater than 2.3m.

Photo No 6 – Central western portion of the site facing north-west to the backfilled depression area (Site Feature G).

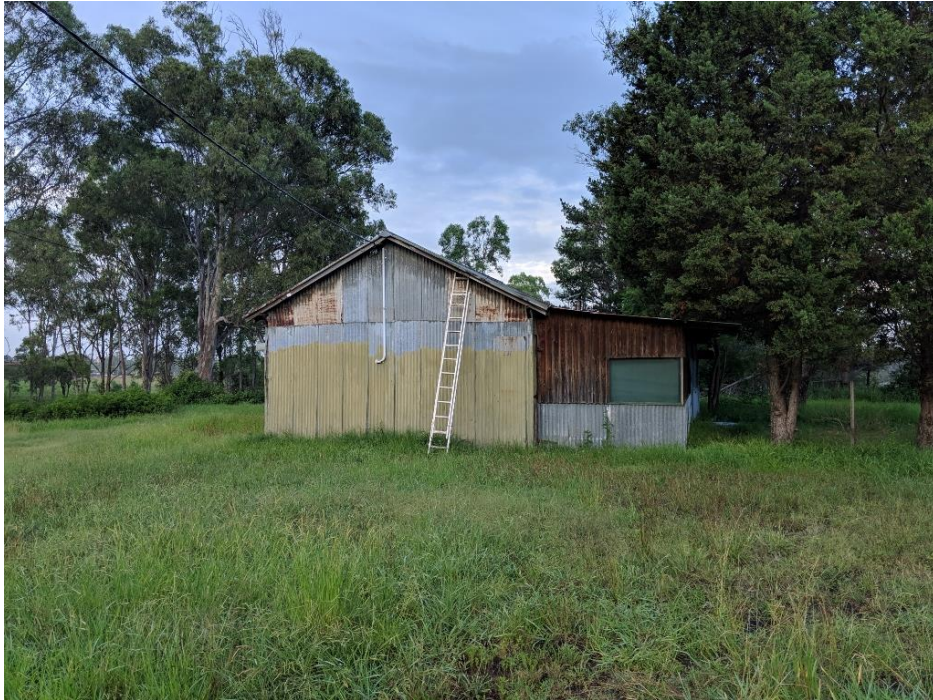
Low concentrations of TRH ( $C_{10}-C_{36} = 120\text{mg/kg}$  and  $C_{16}-C_{34} = 130\text{mg/kg}$ ) were encountered in TP 25 adjacent to the shed (Site Feature E) with the lighter hydrocarbon chain ( $C_6-C_{10}$  and  $>C_{10}-C_{16}$ ) found to be below laboratory detection limits. All other samples analysed were found to have concentrations of TRH below laboratory detection limits.

Photo No 7 – Metal, timber and fibro shed (Site Feature E) facing east

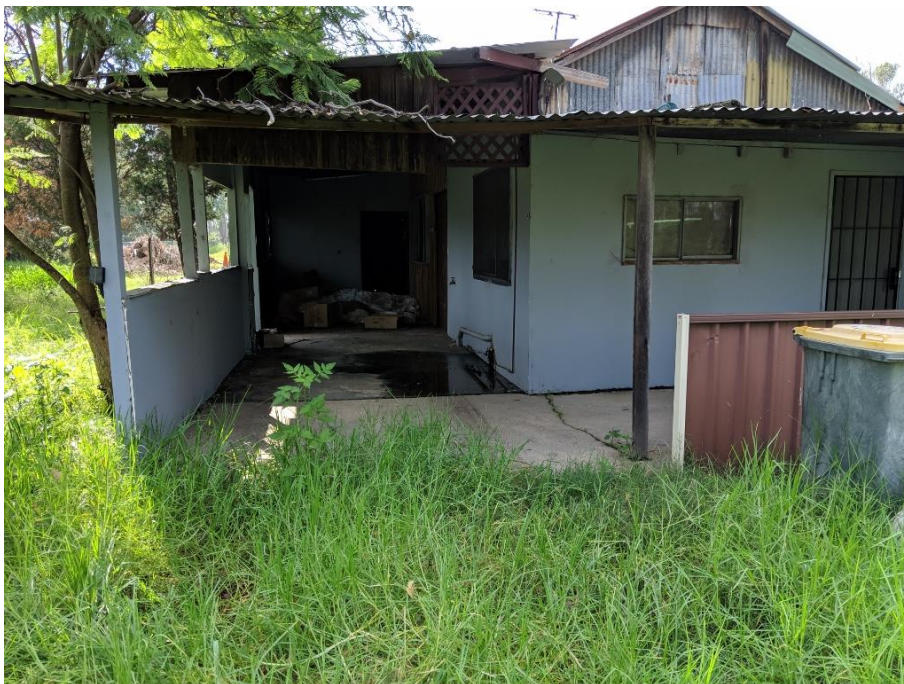
Photo No 8 – Metal, timber and fibro shed (Site Feature E)

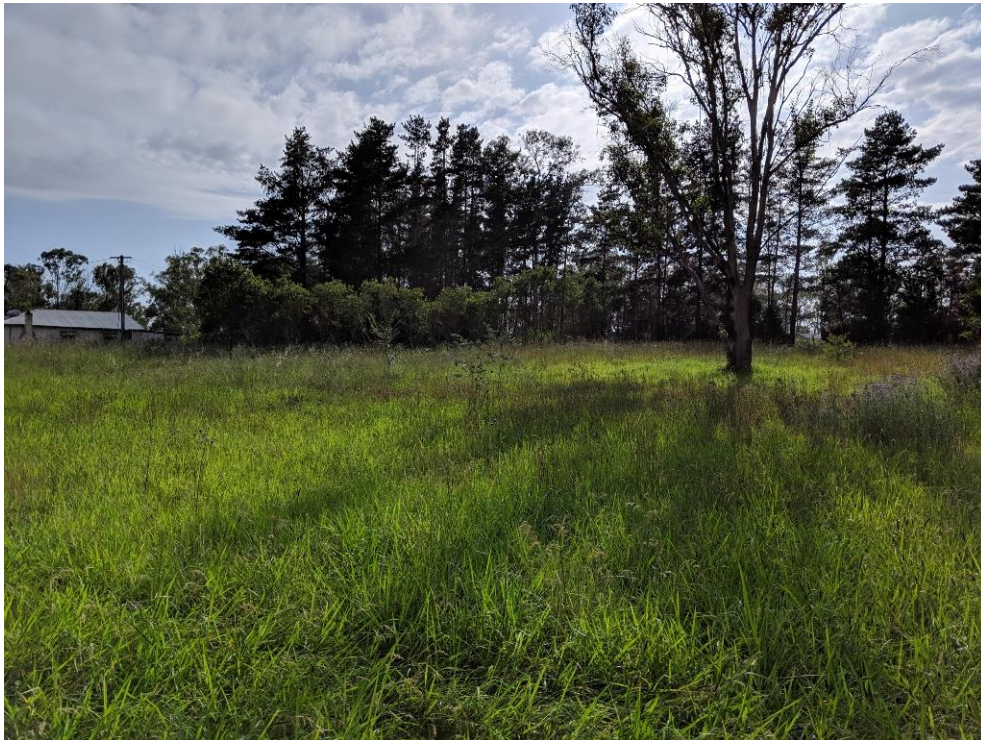
Photo No 9 – Central western portion of the site facing east towards the area of previous small buildings and market garden area (Site Feature F) with the dwelling (Site Feature C) towards the left background.

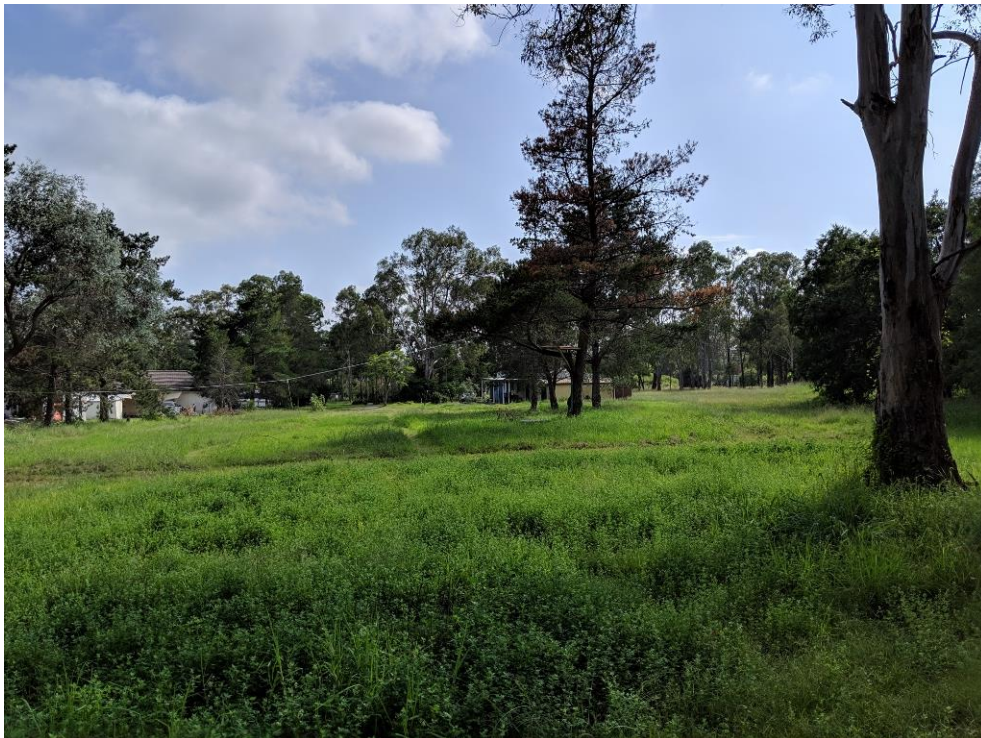
Photo No 10 – Central north-eastern portion of the site facing east towards the previous market garden/agricultural area (Site Feature I) and dwelling (Site Feature B) in the background. Adjacent dwelling to the left background.

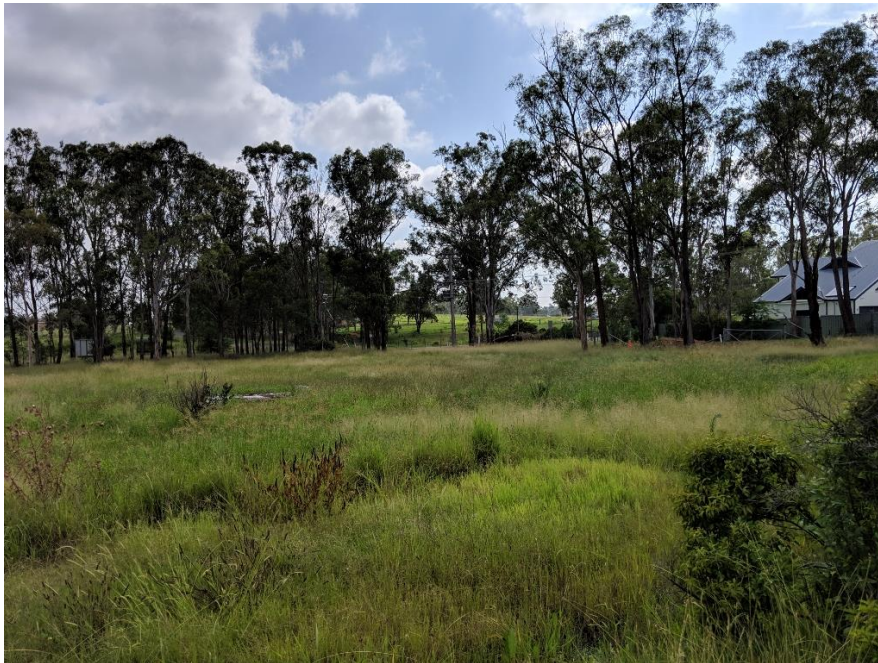
Photo No 11 – Central eastern portion of the site facing east towards the Byron Road and Ingleburn Road intersection with the previous market garden/agricultural area (Site Feature I) in the foreground.

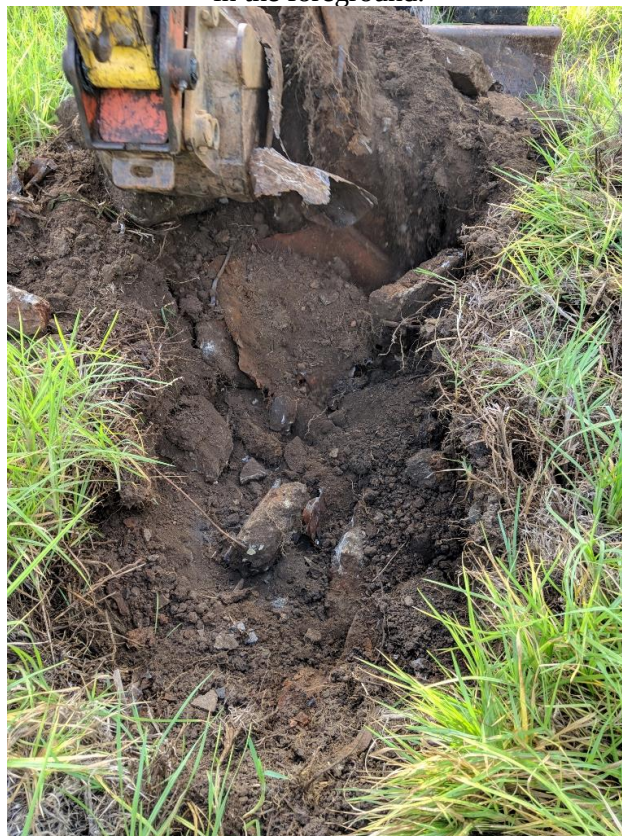
Rubbish including concrete, brick, plastic metal and glass was encountered within the fill in BH 28, TP 4, 6 to 8 and 10 and this fill appeared to have been placed in the previous depression area (ie Site Feature G). Some (>5%) asbestos fragments were encountered in the fill in BH 28, TP 6 to 8 and 10. The fill was generally found to have thickness ranging from 0.3m to greater than 2.3m.

Slightly elevated Zinc concentrations of 550mg/kg and 800mg/kg were encountered in the fill in BH 28 and TP 4 respectively and in TP 8, the concentration of Zinc was found to be 2000mg/kg above the EIL Criteria of 432mg/kg, noting that these samples were taken from the rubbish and asbestos impacted fill in the backfilled depression (Site Feature G).

Photo No 12 – Test Pit No 4 ; Rubbish fill including metal, concrete and bricks encountered in the backfilled depression area (Site Feature G)
