# HYDROLOGY & FLOOD MODELLING

Ref: 610.17428-R03-v3.0  
August 2018

# YARRABEE SOLAR PROJECT

## Environmental Impact Statement - Appendix H Hydrology & Flood Modelling

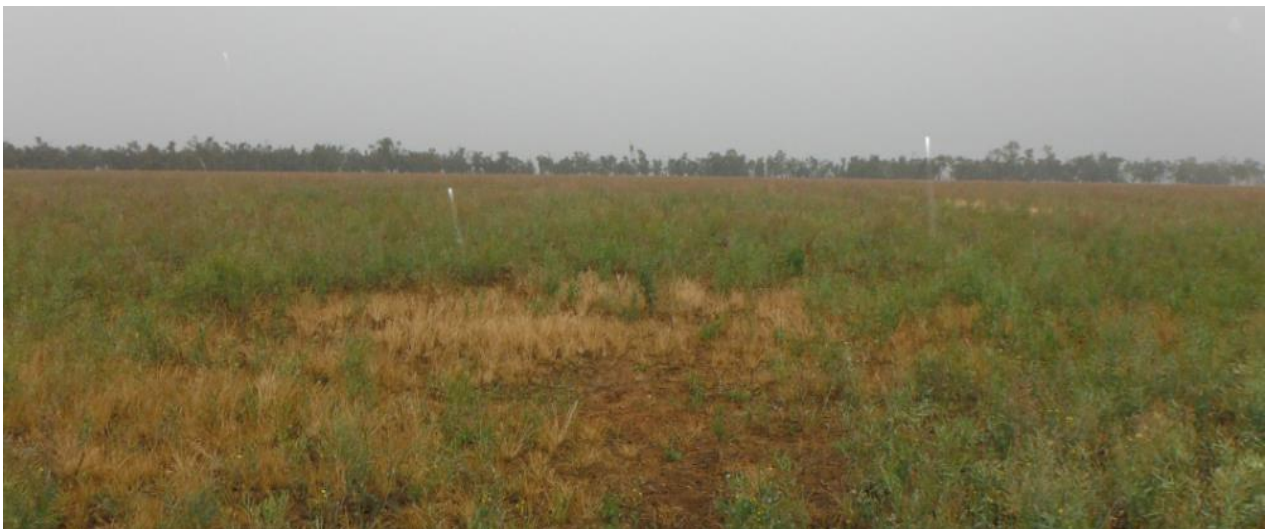
**Photo 1** Typical Site Conditions Looking East towards Washpen Creek

The project site is located immediately west of Washpen Creek, and the topography falls generally westwards away from the western bank of Washpen Creek at very flat grades. Elevations across the project site vary from approximately 133 m to 134 m AHD along the top of the banks of Washpen Creek, to 131 m to 132 m AHD on the western boundary, indicating a fall of around 3 m over a distance of 9 km. Typical site conditions looking east towards Washpen Creek are shown on **Photo 1**.

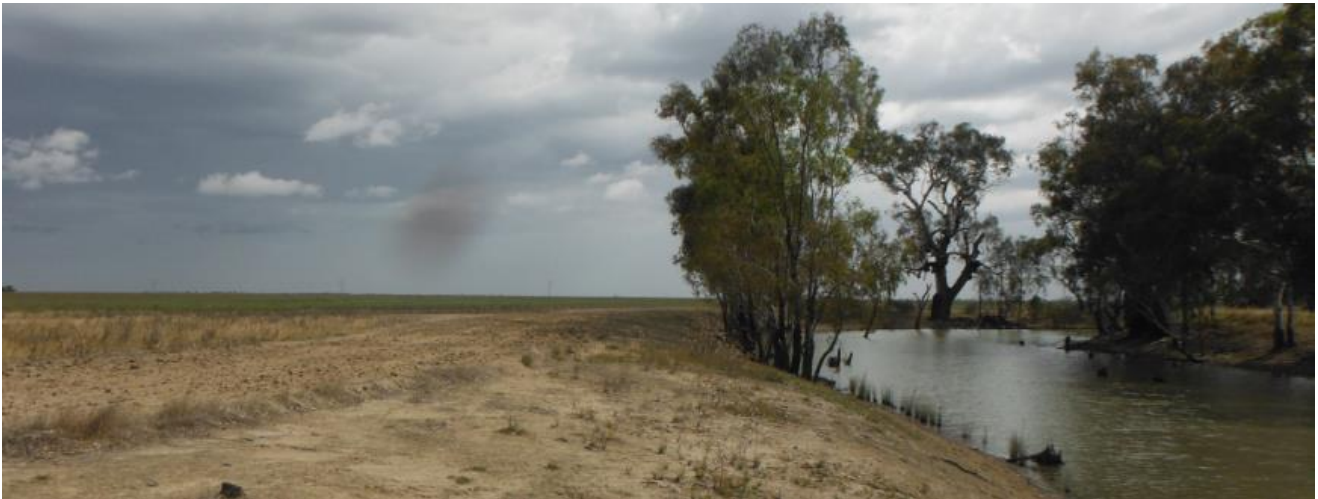
**Photo 2** Washpen Creek looking north

The Project site is located immediately west of Washpen Creek – refer **Photo 2**.

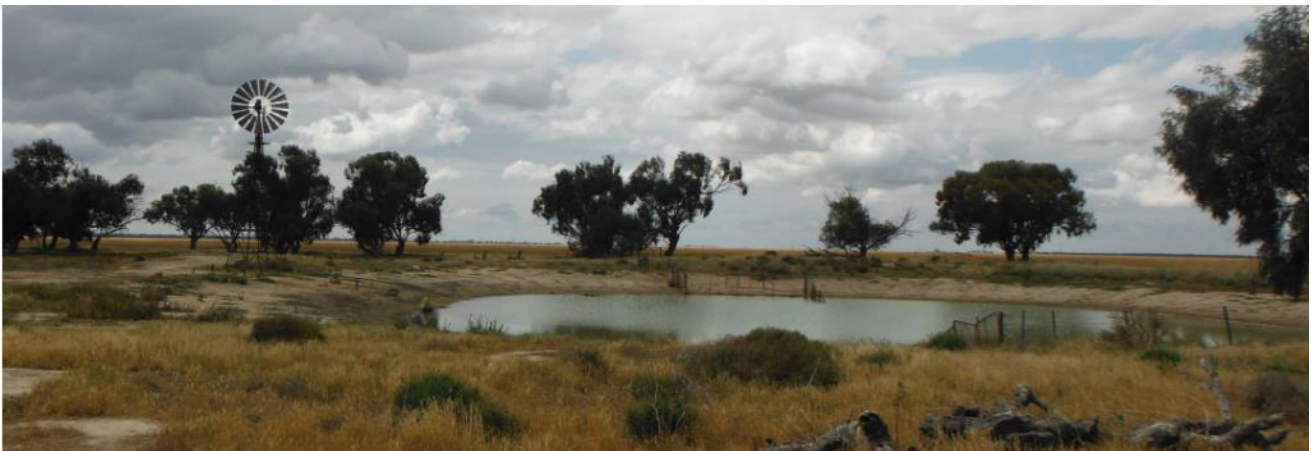
**Photo 3 Existing Site Dam**

Hydraulic modelling indicates that a large portion of the Project site drains to an existing farm dam. This dam currently has a capacity of 25 ML – refer **Photo 3**.

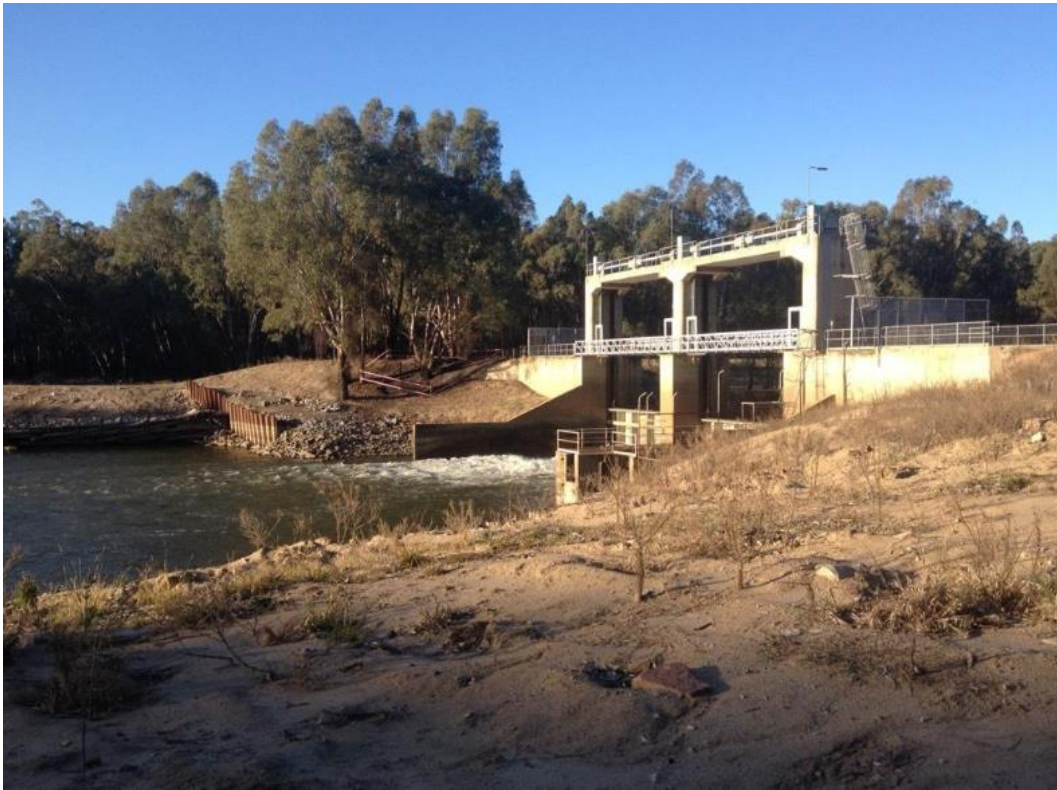
**Figure 20 The Gate-Regulated Yanco Weir on the Northern Anabranch of the Murrumbidgee River**

The regulated Yanco Weir consists of two rectangular sluice gates within concrete channels. Environmental flows pass under the sluice while flood flows overtop the gates - refer **Figure 20**.

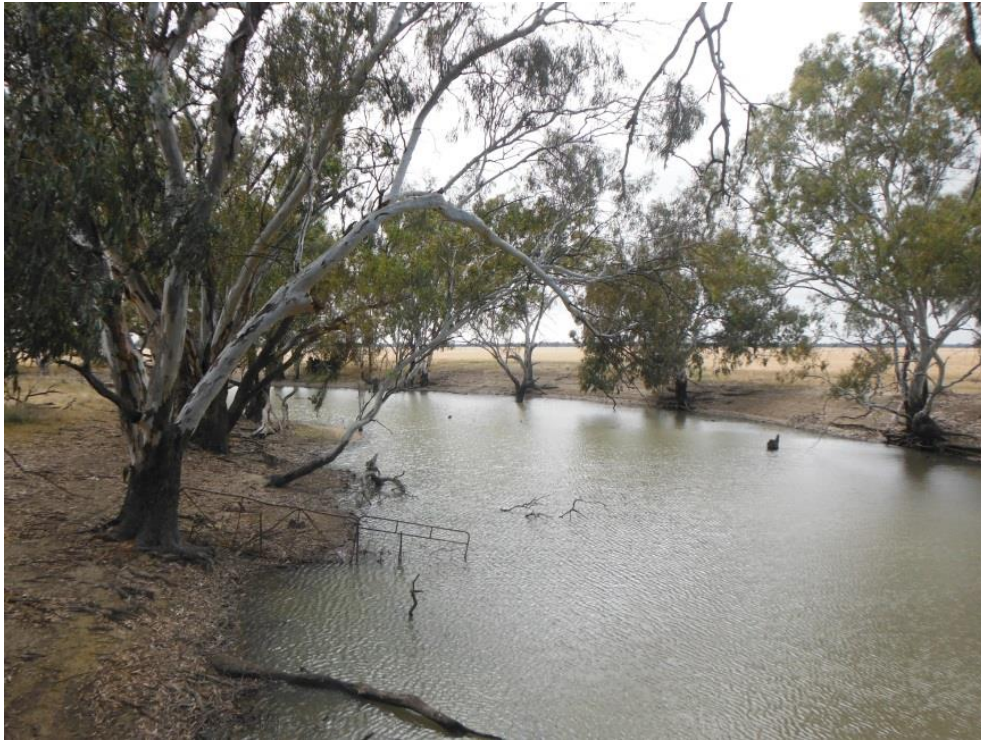
**Figure A.3** Natural Channel, Somewhat Irregular Side Slopes, Clean and Regular Bottom  $n=0.035$ ;  
Overbank Regions  $n=0.04$

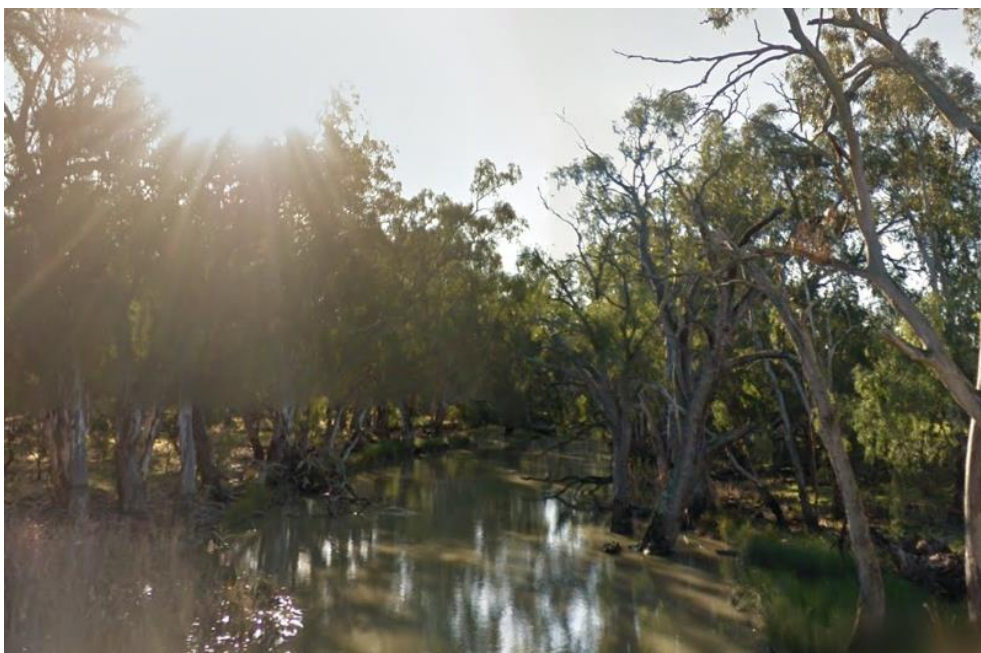
**Figure A.4** Straight, few trees in channel  $n = 0.048$ ;  
Overbank regions heavy timber on overbank, flood stage below branches  $n = 0.10$

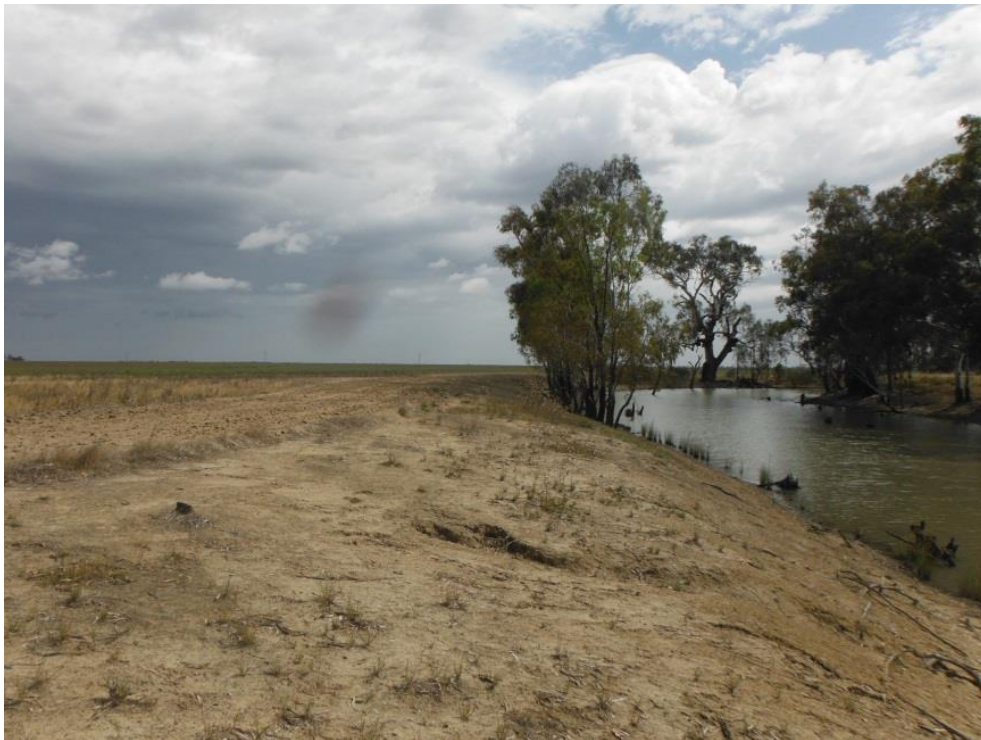
**Figure A.5 Overbank regions with no trees, short or no grass, eroded furrows n = 0.03**

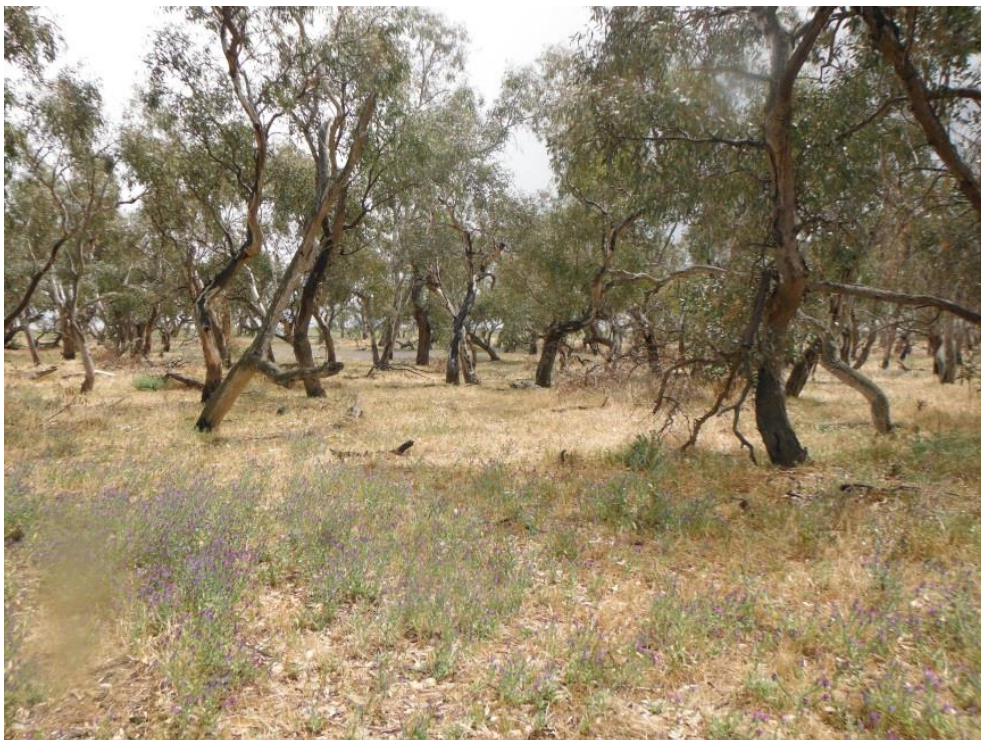
**Figure A.6 Grass, weeds, scattered trees and brush n=0.06**

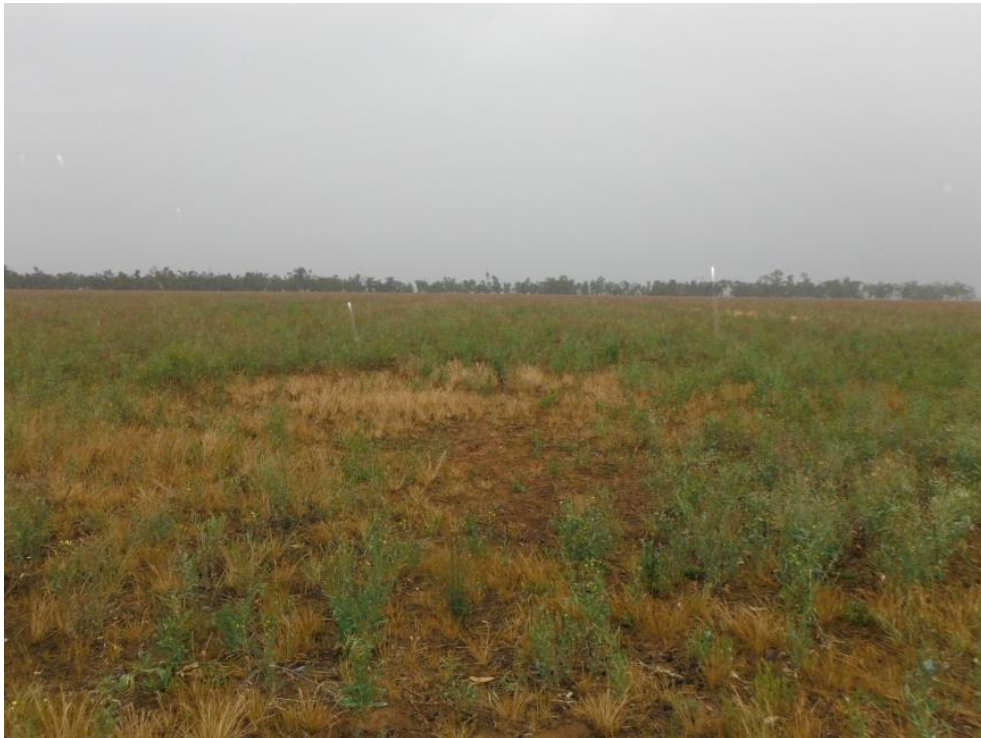
**Figure A.7** Mature field crops  $n=0.04$

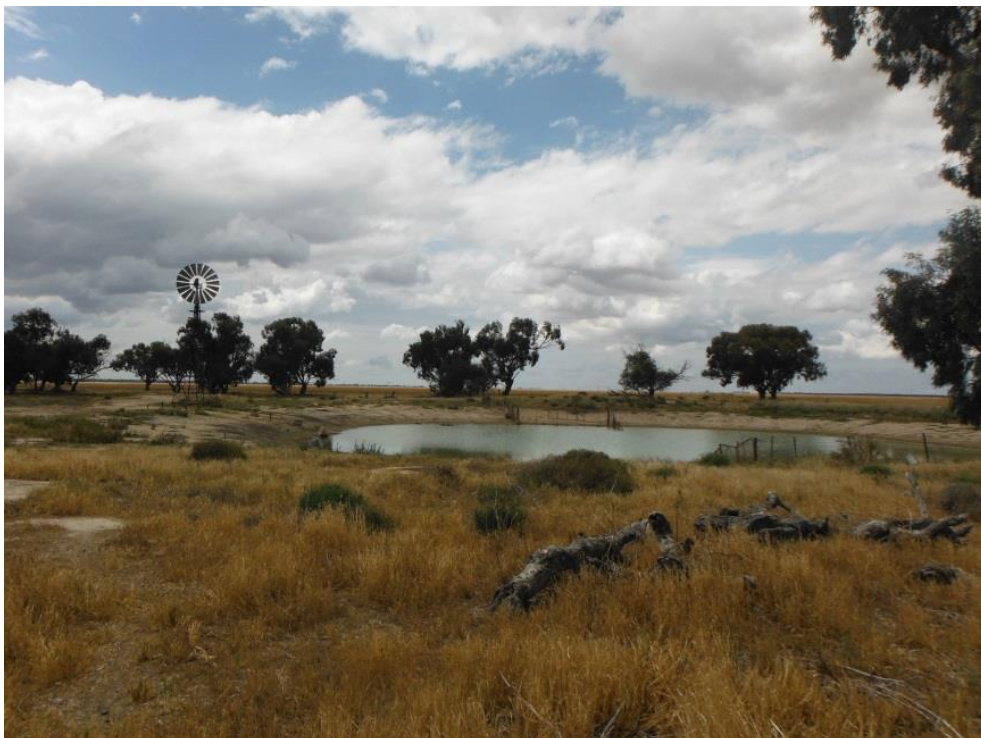
**Figure A.8** Long grass, scattered and downed trees patchy areas  $n = 0.045$

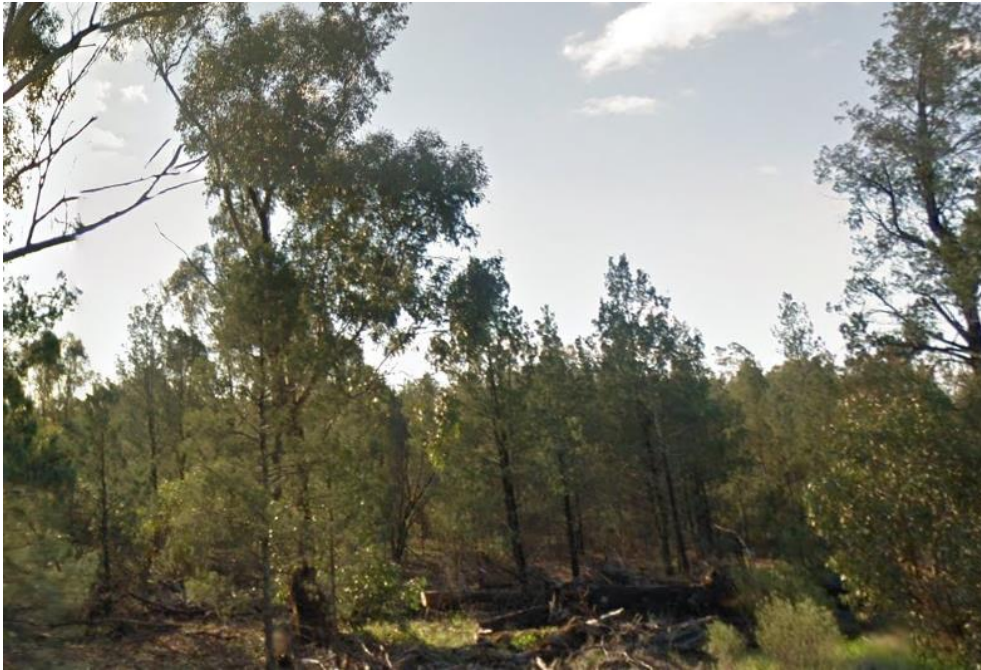
**Figure A.9 Heavy stand of timber, few downed trees, flood stage reaching branches n=0.12**

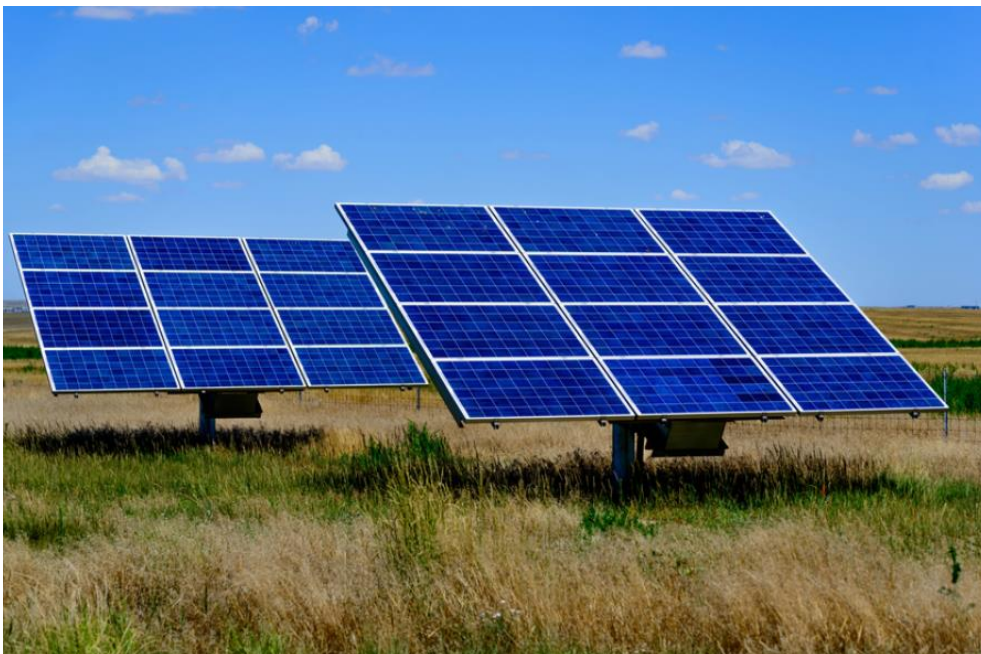
**Figure A.10 Long grass, solar panels above flood level, sparse support posts n=0.05**
