Report on
Geotechnical Investigation

Epping West Public School Upgrade
96 Carlingford Road, Epping

Prepared for
School Infrastructure NSW
c/- Johnstaff Pty Ltd

Project 99674.00
April 2021

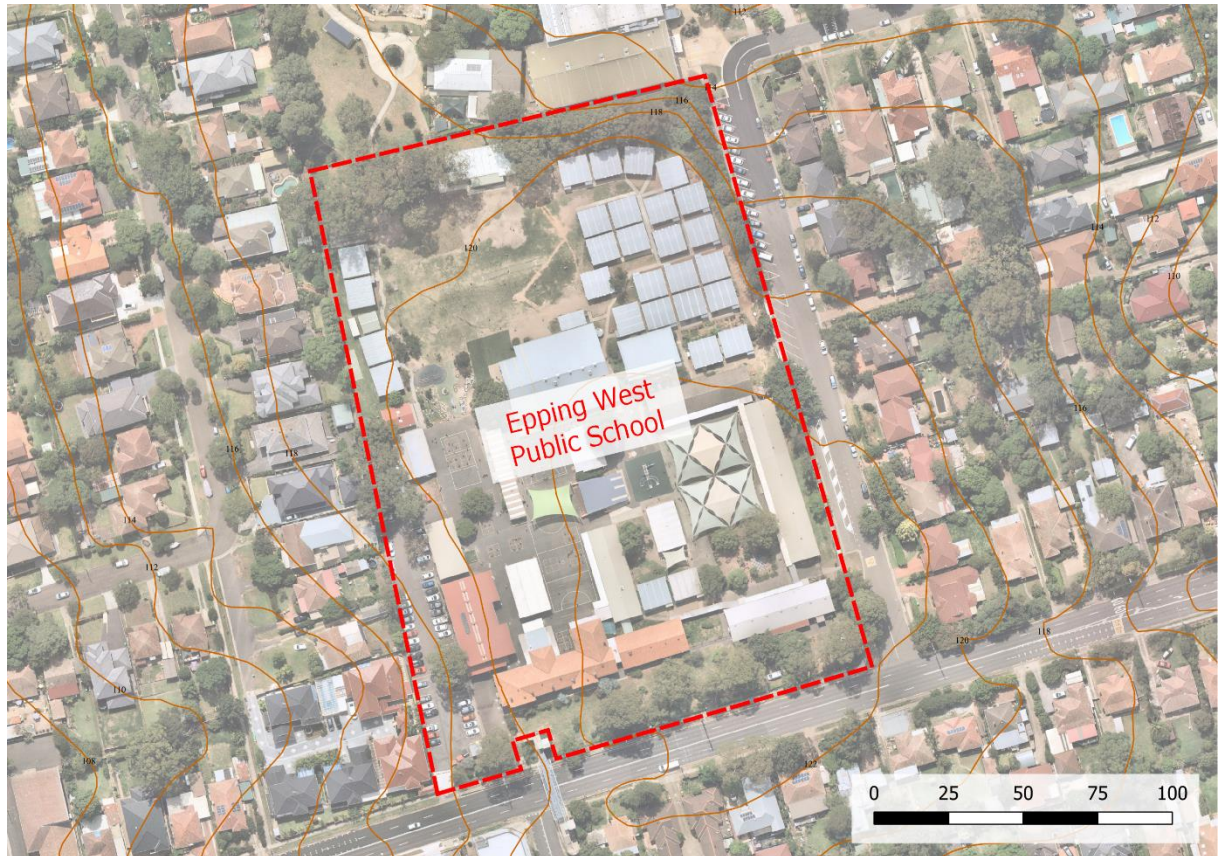
Figure 2: Aerial image of site overlain by 2 m surface contours to AHD

Most of the site is located on a locally elevated area (top of a ridge) and is relatively flat, as shown in Figure 2; the western side of the site slopes gently to the west and the northern side gently to the north.

The surface levels across the school grounds range between about RL 118 m and RL 122 m relative to Australian Height Datum (AHD).

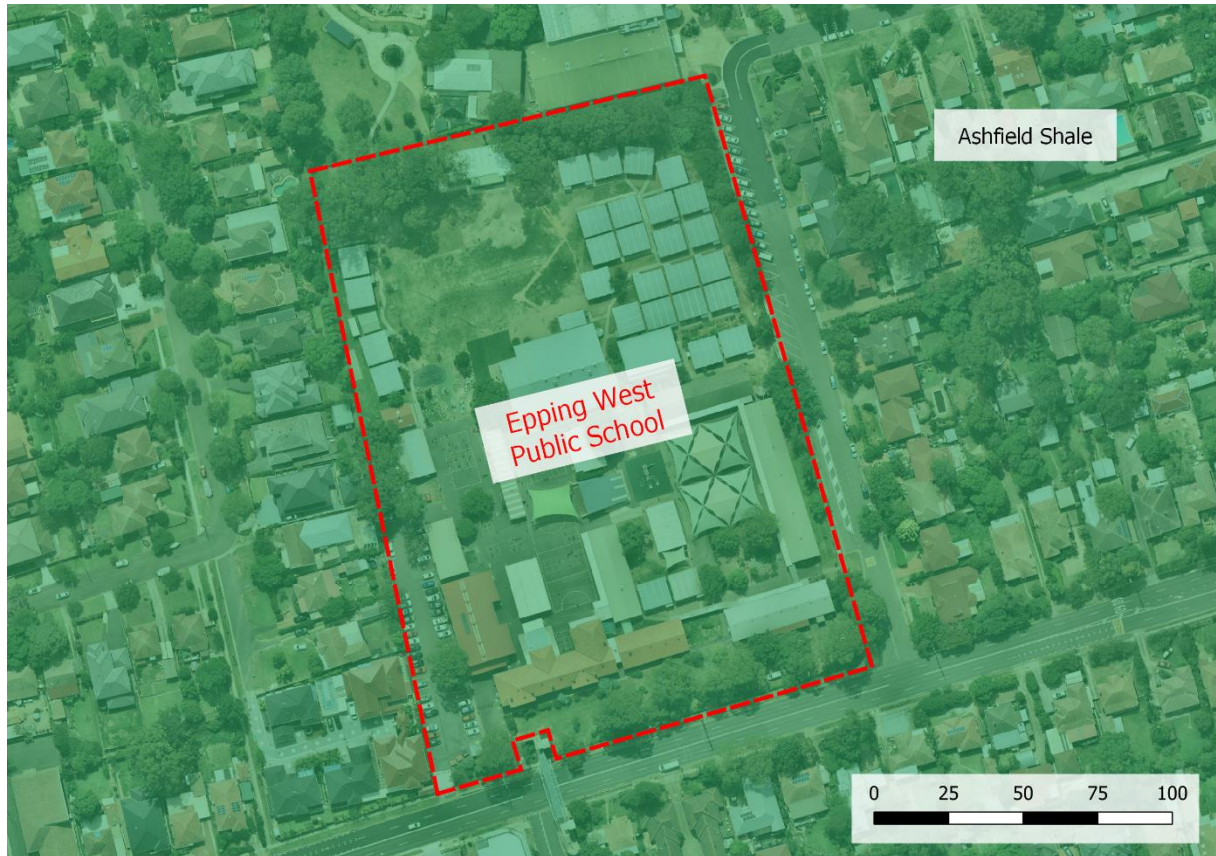
Figure 3: Extract from Sydney 1:100 000 Geological Series Map

The Mittagong Formation, which is often present in the Western Sydney area, is a transitional geological unit between the overlying Ashfield Shale and the underlying Hawkesbury Sandstone. The Mittagong Formation is a relatively thin formation that varies in thickness, typically between 3 m and 8 m thick. It typically comprises interbedded shale, laminite and fine-grained sandstone.

The Hawkesbury Sandstone comprises medium to coarse-grained quartz sandstone, very minor shale and laminite lenses.

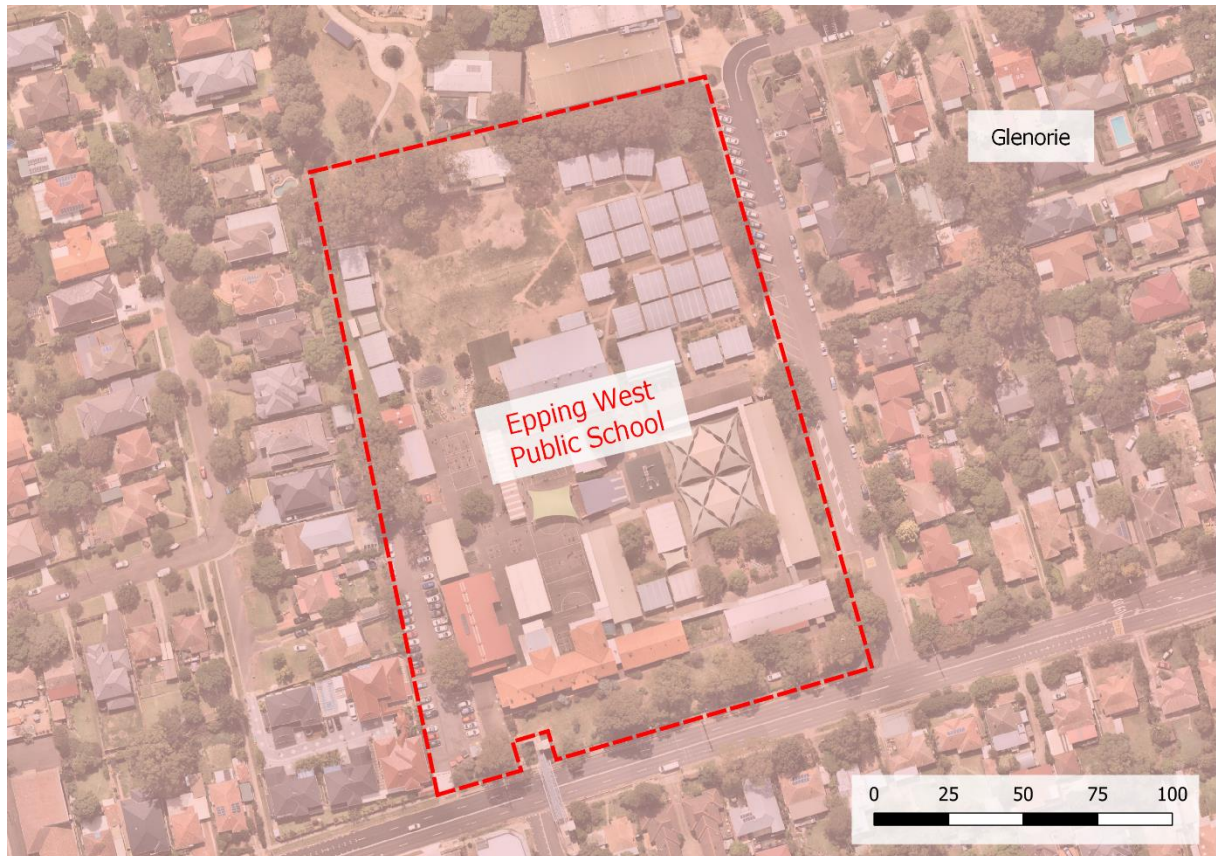
Figure 4: Extract from Sydney 1:100 000 Soil Landscape Map

The Glenorie soil landscape is an erosional soil landscape and is characterised by topography of undulating to rolling hills on Wianamatta Group shales, with local relief of 50 m to 80 m and slope gradients of 5% to 20%. The soil landscape is typically represented by narrow ridges, hillcrests and valleys.

Soils in the Glenorie soil landscape are typically deep on lower slopes and along drainage lines and shallow to moderately deep on crests and upper slopes. These soils typically have a high soil erosion hazard, exhibit localised areas of impermeable highly plastic subsoil and are moderately reactive.

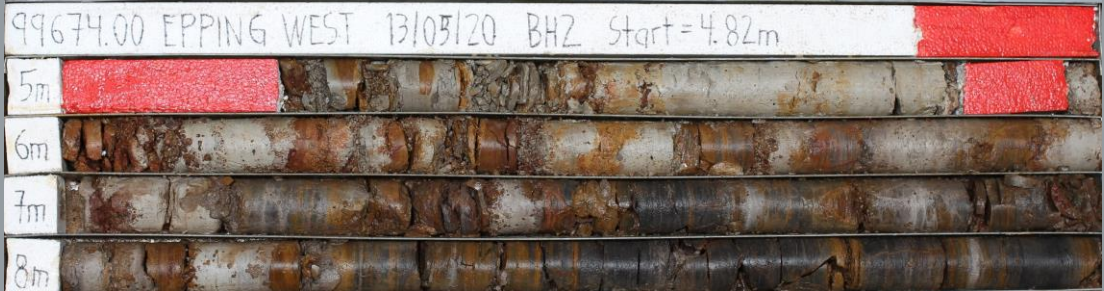
Project No: 99674.00
BH ID: BH2
Depth: 4.82 - 9.00 m
Core Box No.: 1

4.82 - 9.00 m

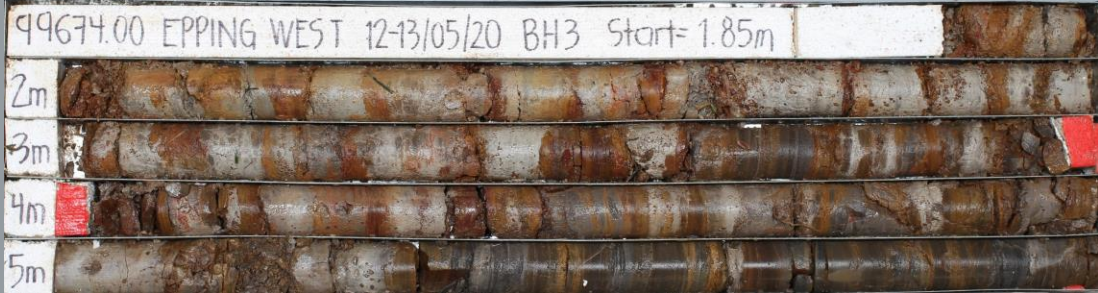
Project No: 99674.00
BH ID: BH3
Depth: 1.85 - 6.00 m
Core Box No.: 1

1.85 - 6.00 m

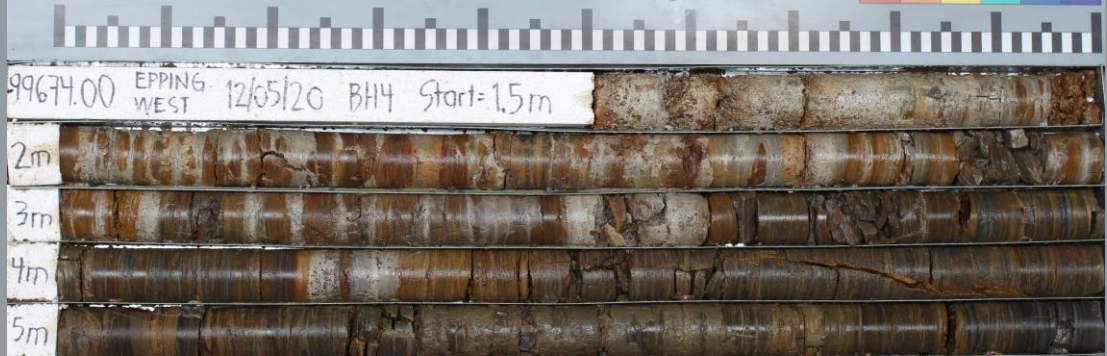
Project No: 99674.00
BH ID: BH4
Depth: 1.56 - 6.00
Core Box No.: 1

1.50 - 6.00 m
