Sampling and Analysis Quality Plan

Proposed Epping West Public School Alterations and
Additions
96 Carlingford Road, Epping

Prepared for
School Infrastructure New South Wales (SINSW)

Project 99674.03
April 2021

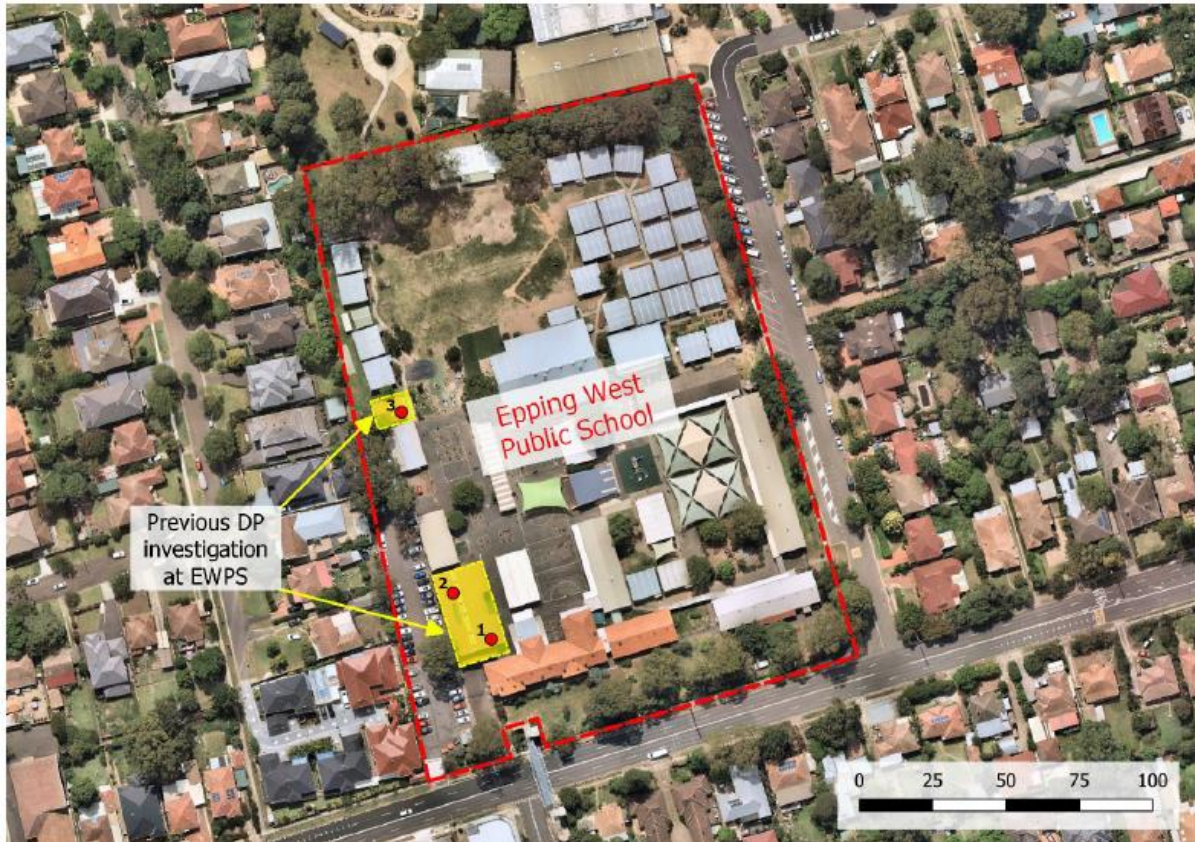
Figure 2: Previous Investigation by DP at Epping West Public School

DP (2009) included targeted intrusive soil sampling which was conducted in the proposed building footprint area (boreholes BH1 to BH3, as shown on Figure 2, above). All recorded laboratory results were within the site assessment criteria (SAC) applicable to the assessment with the exception of the SAC for Total Petroleum Hydrocarbons (TPH) in one sample. The TPH SAC was exceeded by Total Recoverable Hydrocarbons (TRH) recorded at 330 mg/kg of C15-C28 and 680 mg/kg of C29-C36 in Sample 2/0.1-0.2 from BH2. This recorded TRH concentration, in the absence of additional data to characterise the site, and based on the then applicable (now superseded) guidelines triggered a requirement for remediation.

DP (2010) provided a scope of works for the recommended remediation works. DP was not involved in any subsequent remediation works at the site, and has not been provided with any documentation prepared by others in this regard. Both buildings have been constructed as shown on Figure 2.

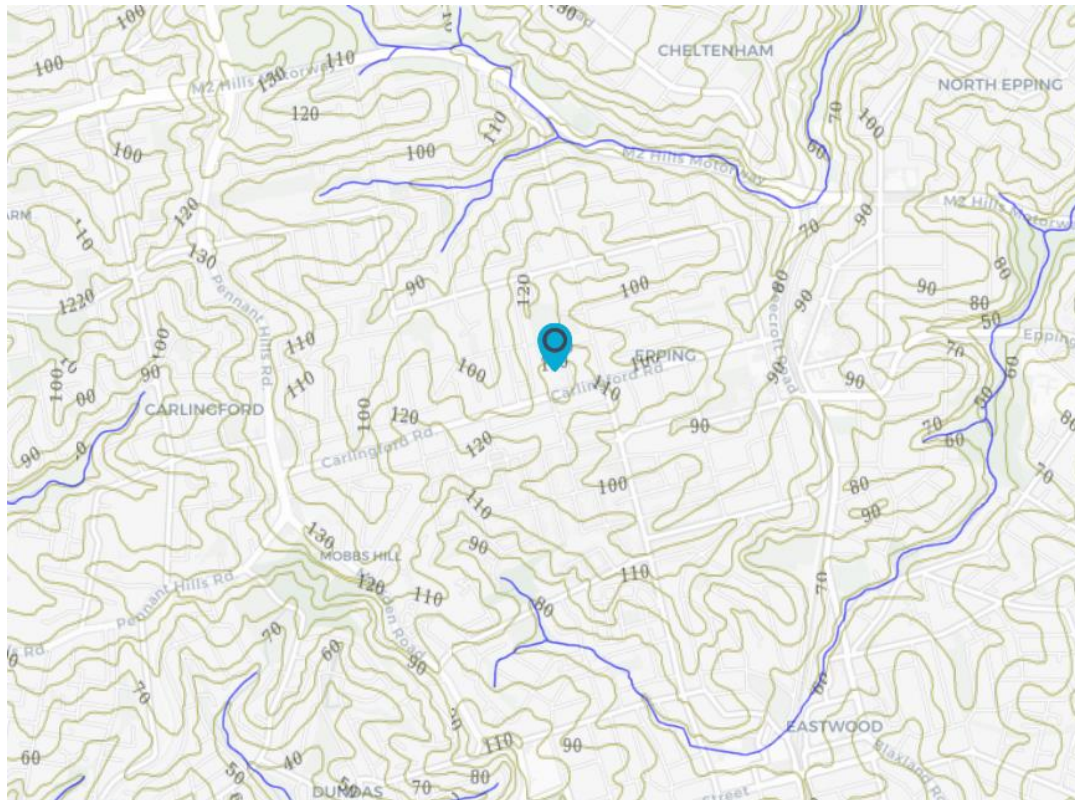
Figure 4: Local Topography and Water Courses (10 m AHD surface contours)

The site is located on a ridgeline as shown on Figure 4. The majority of the site is relatively level, whilst the western side of the site slopes downwards gently to the west and the northern side to the north. The surface levels across the school grounds range between about RL 118 m and RL 122 m relative to Australian Height Datum (AHD).

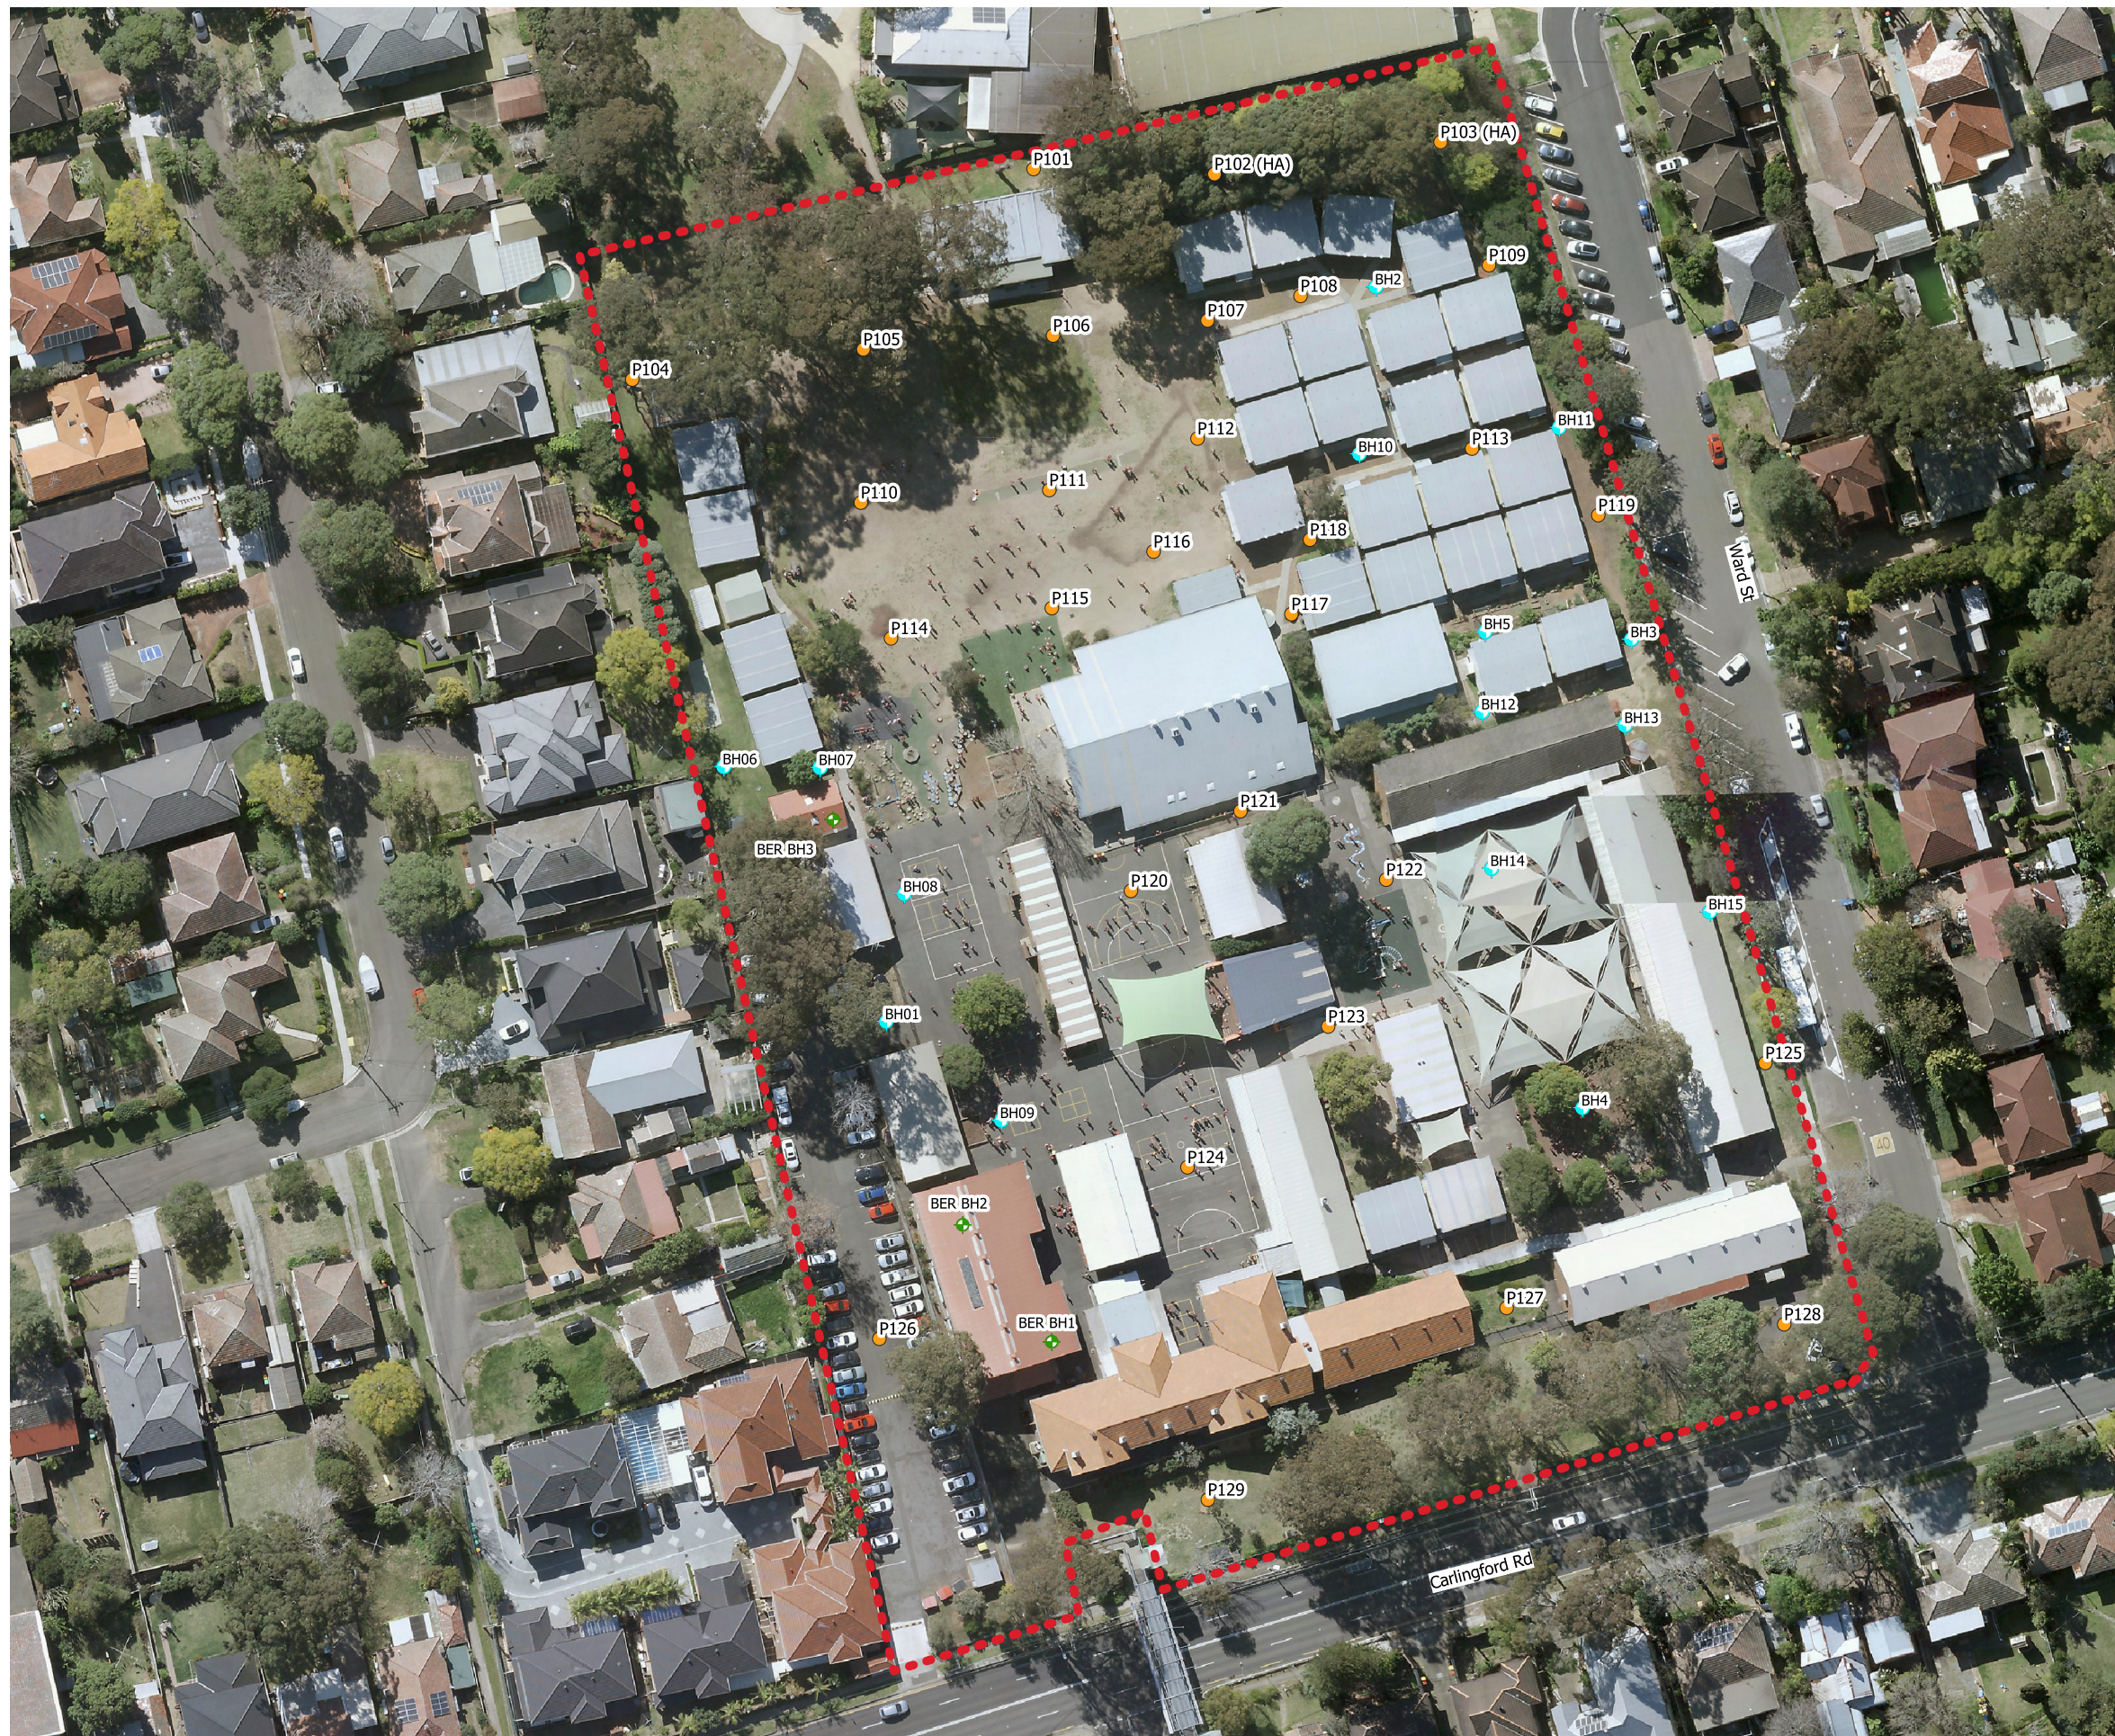
- Site Boundary
- Proposed Borehole (HA indicates hand auger)
- ◆ Previous Borehole (DP, 2020c)
- ◆ Previous Borehole (DP, 2009)

The borehole locations referenced in this section are shown on Drawing R.001.D.02, Appendix A.

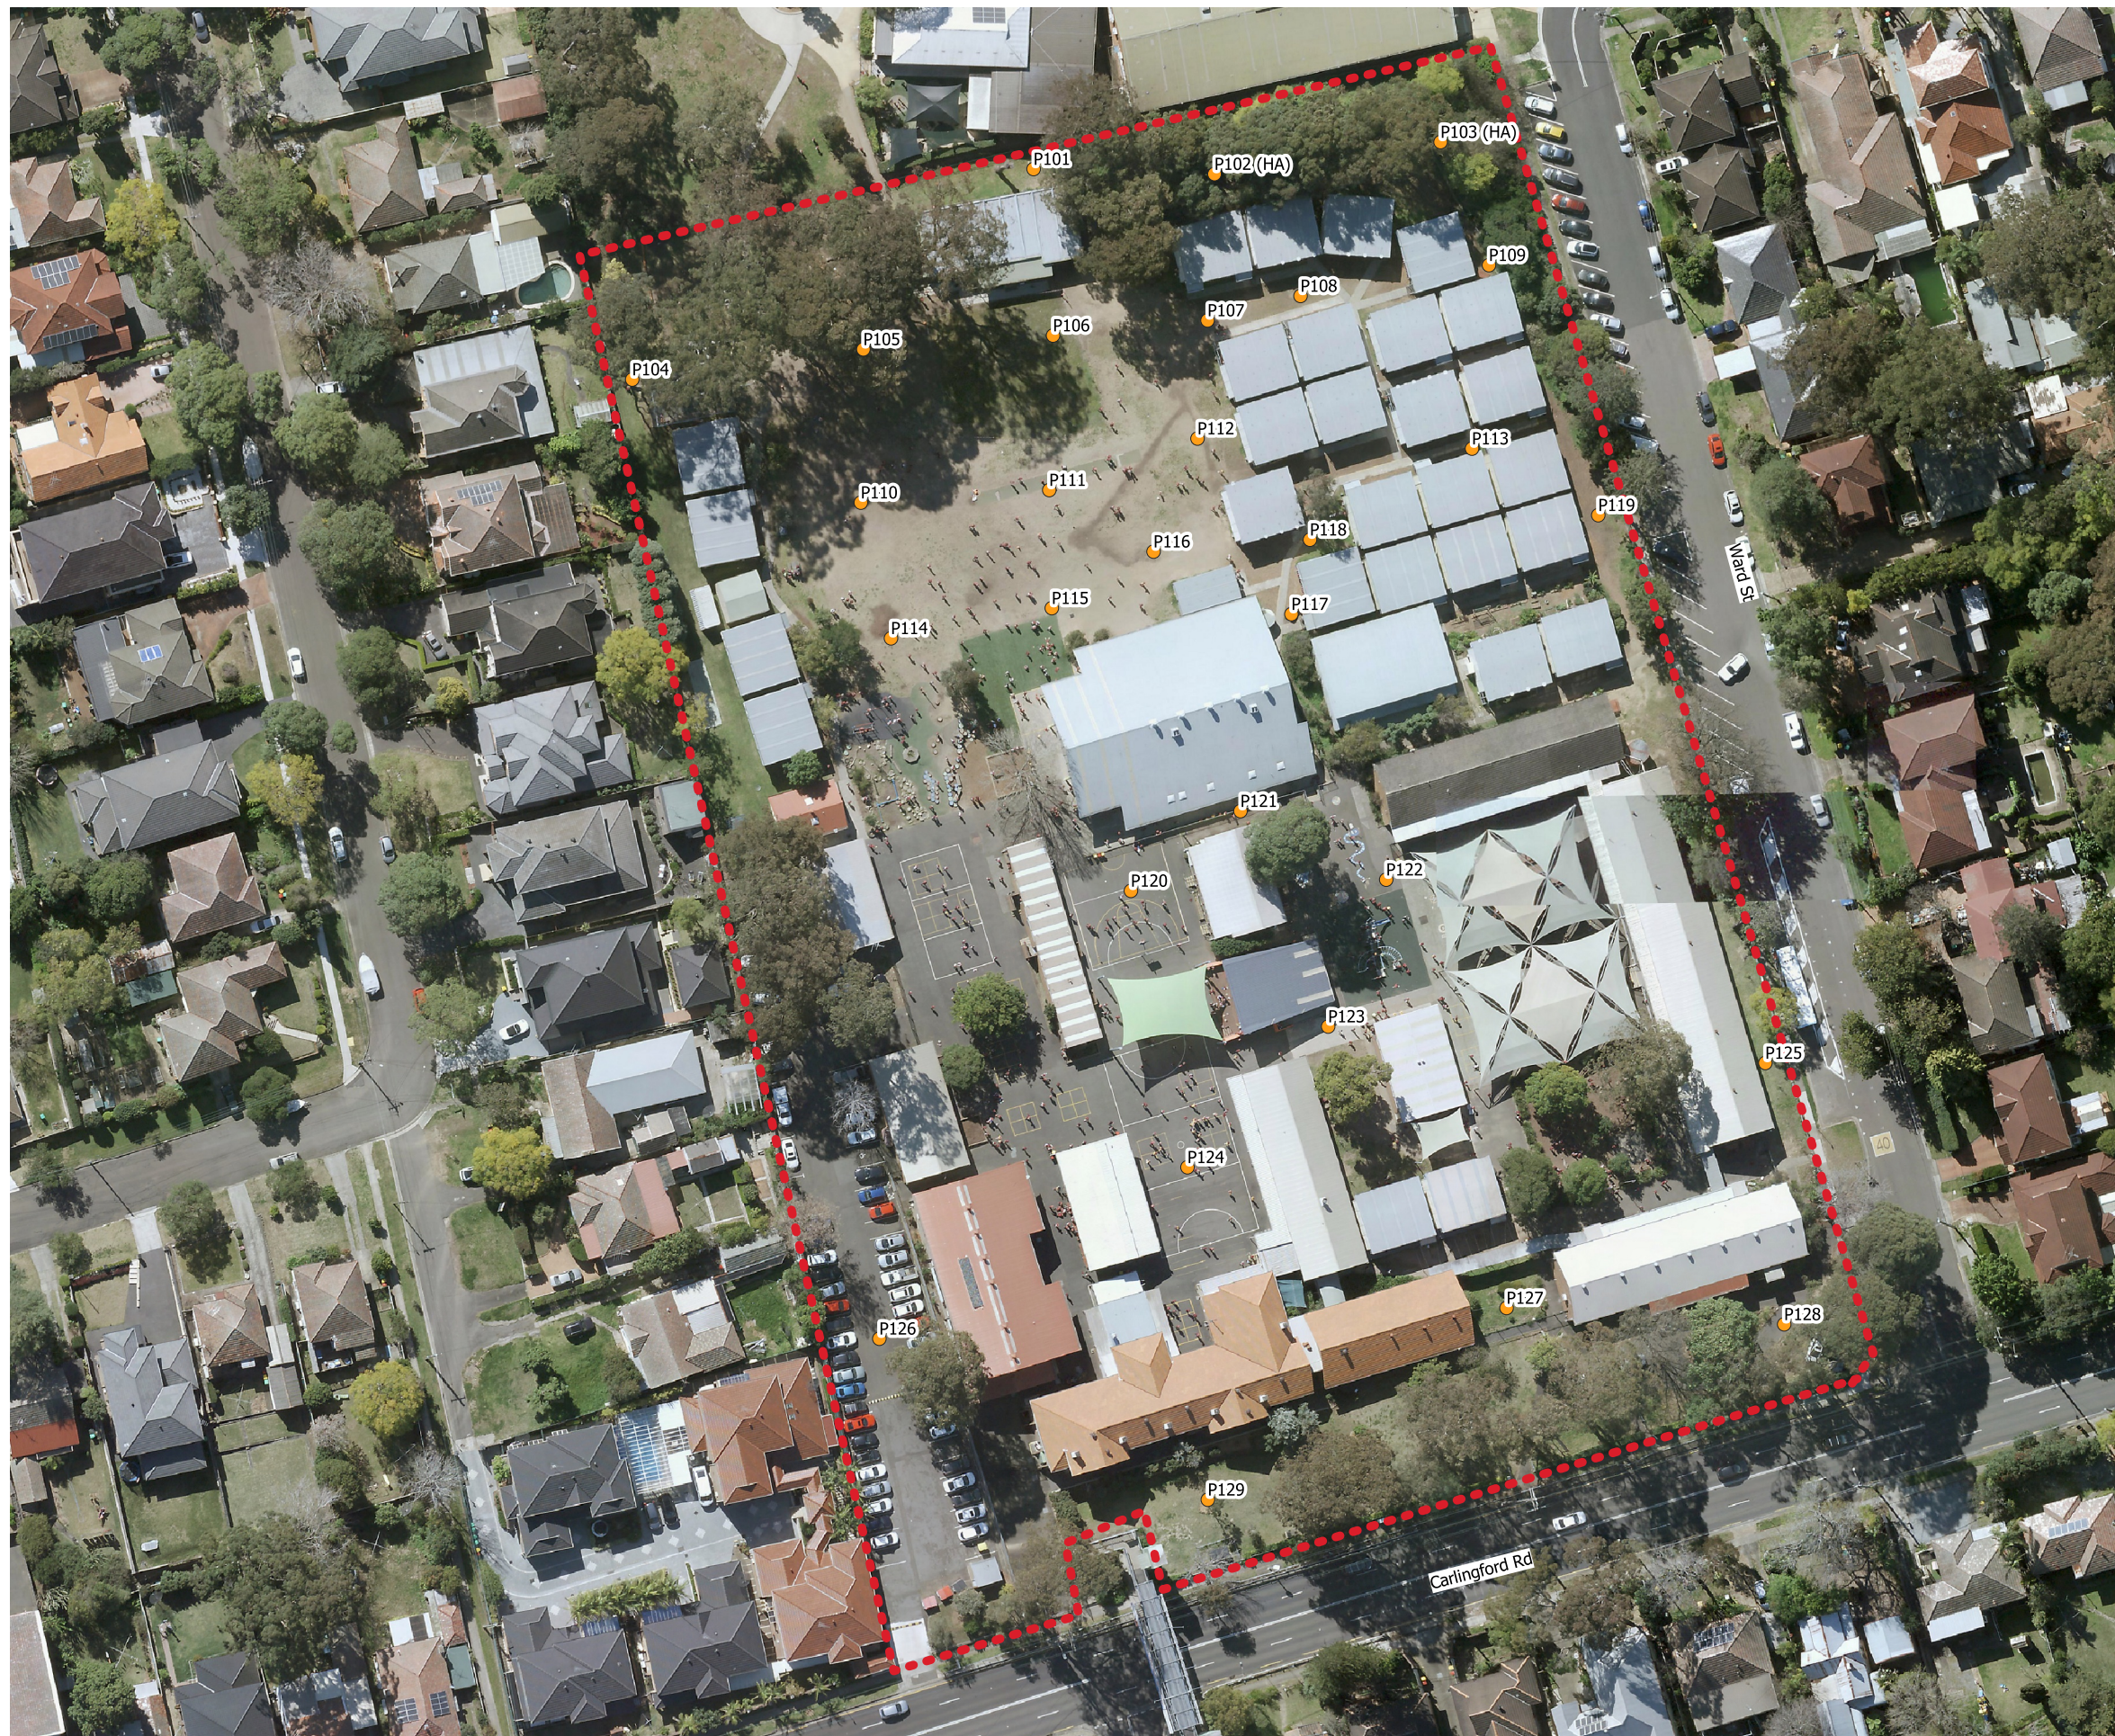
- Site Boundary
- Proposed Borehole
(HA indicates hand auger)

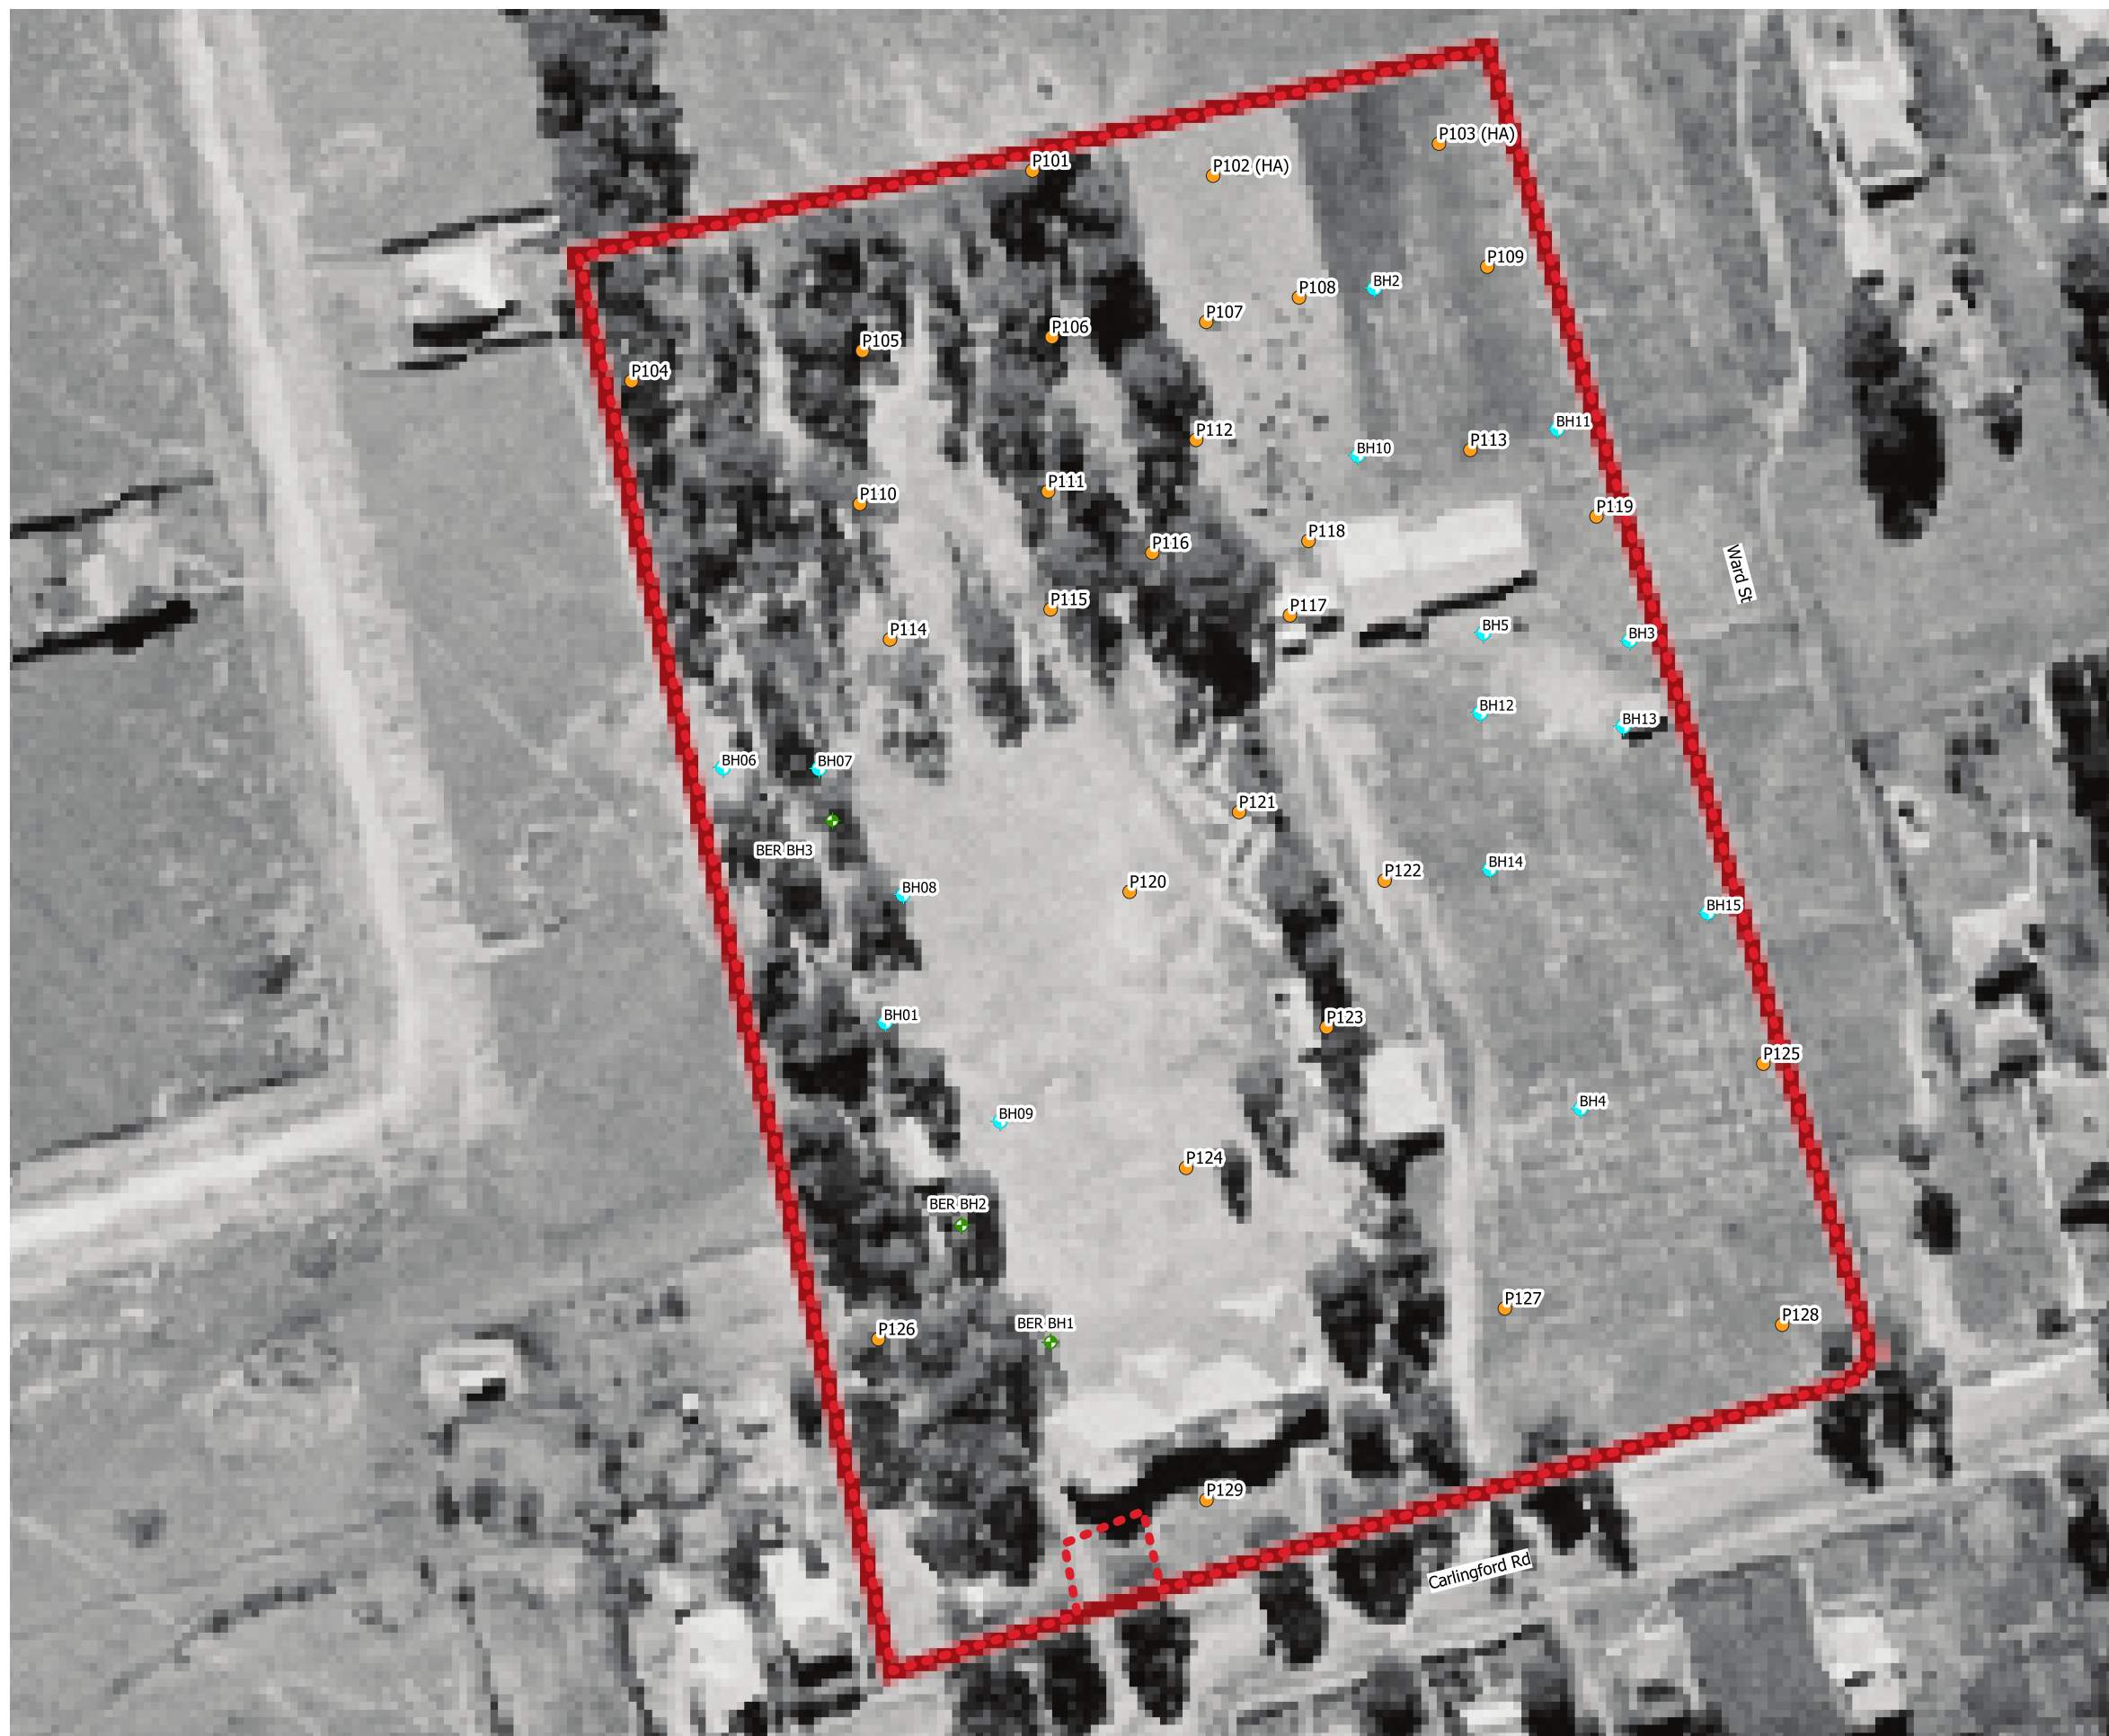
- Site Boundary
- Proposed Borehole (HA indicates hand auger)
- ◆ Previous Borehole (DP, 2020c)
- ◆ Previous Borehole (DP, 2009)
