**Re: Interim Advice 7 (IA7) – Confirmation of satisfactory completion of remediation for the 'Western Stage 1 Development Area', Wentworthville Public School, 70-100 Fullagar Road, Wentworthville NSW**

**WSP AUSTRALIA PTY LTD**  
**PLAN SHOWING EXTENT OF**  
**REMEDATION WORKS ON**  
**LOT 1 IN DP1245593**  
**70 FULLAGAR ROAD, WENTWORTHVILLE**  
**LGA: CUMBERLAND**  
**SCALE 1:800 (A3)**

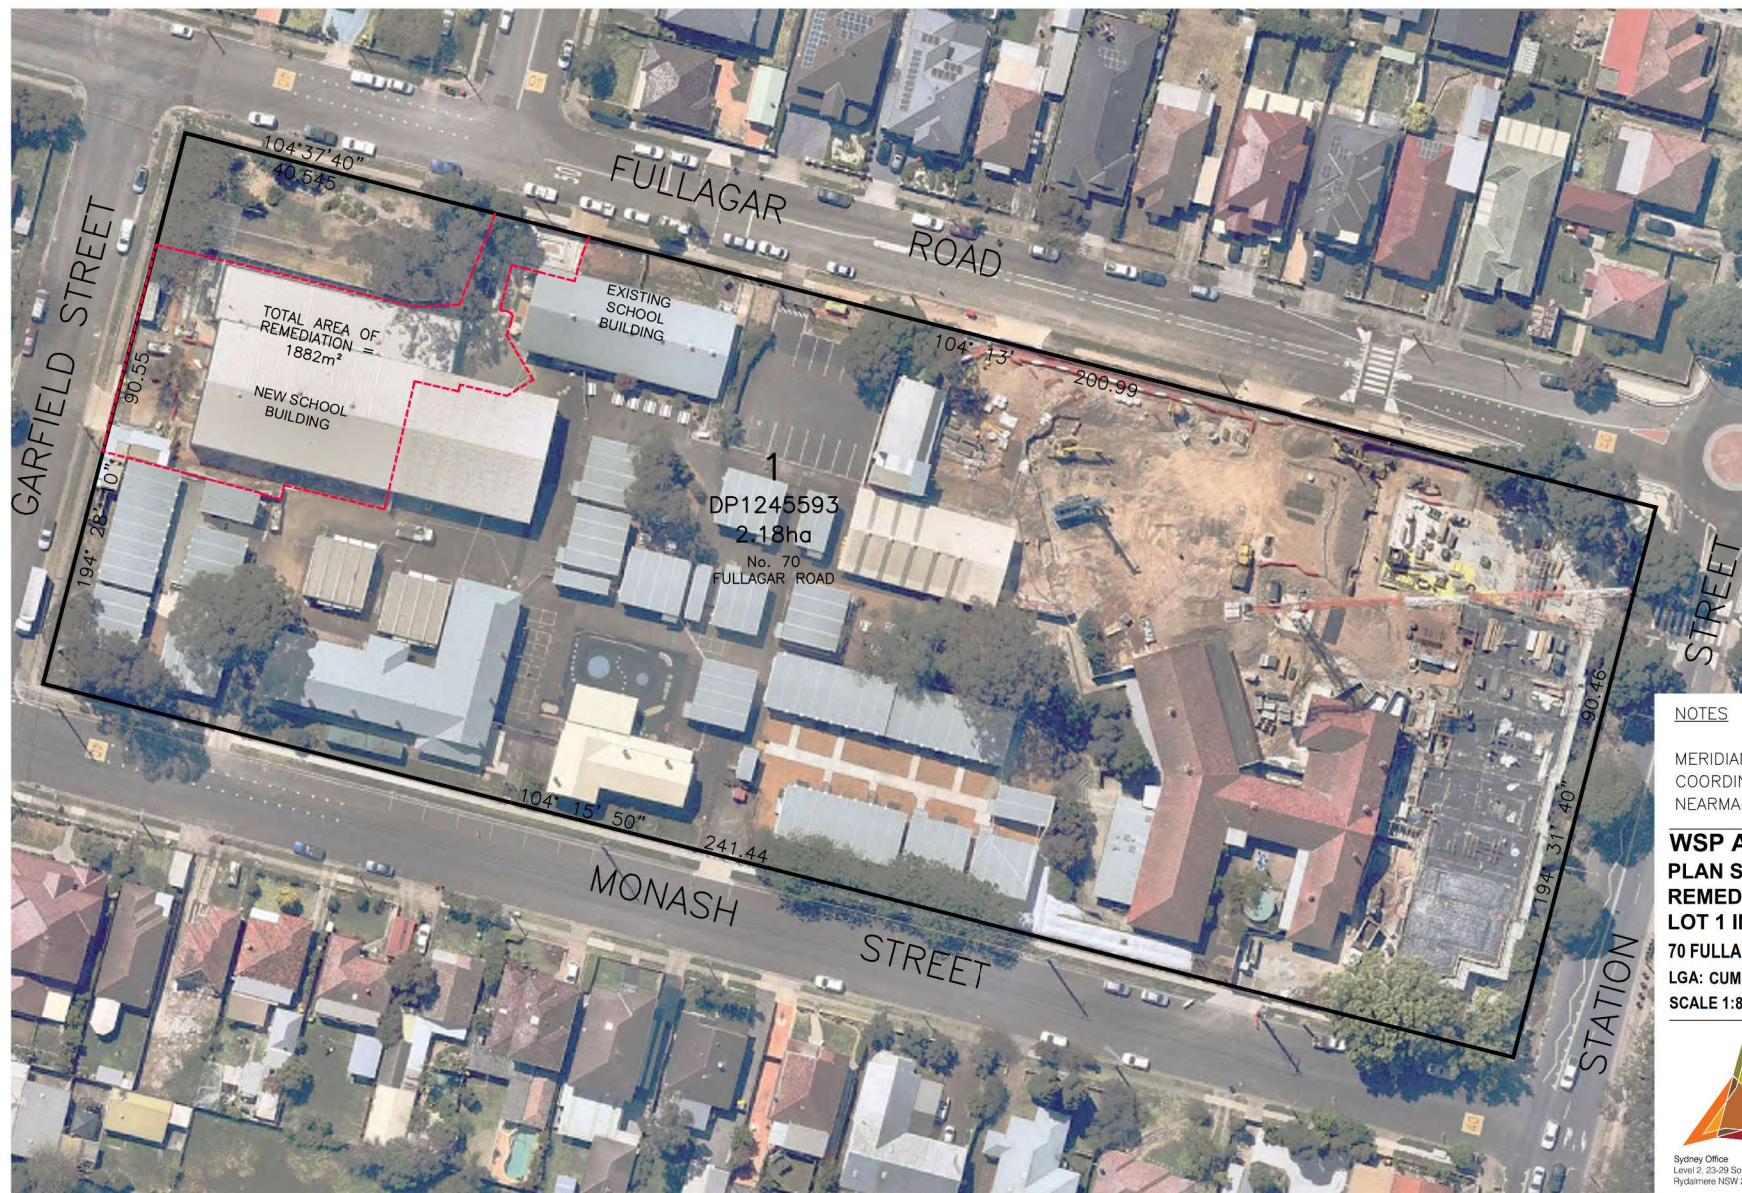
Dwg. No.  
**SY074981.000.7.1**

The area to which IA7 applies is 1,882 m<sup>2</sup> and is referred to by WSP as the Western Stage 1 Development Area. The Western Stage 1 Development Area includes a newly constructed hall, canteen, outside school hours care (OOSH), and the 'ramp 9' area. The boundary of the remediation area covered by this advice is shown in the attached survey plan (Land Partners drawing no.SY074981.000.7.1, 8Oct2020).

Attachment: Land Partners (8 October 2020) Drawing no.SY074981.000.7.1, extent of remediation works considered in this IA.

----- DENOTES EXTENT OF REMEDIATION WORKS
