**Mamre Road Data Centre Campus (SSD-92743706)**

# Aquatic & Riparian Impact Assessment

Final Report

Prepared for Plan Project Management

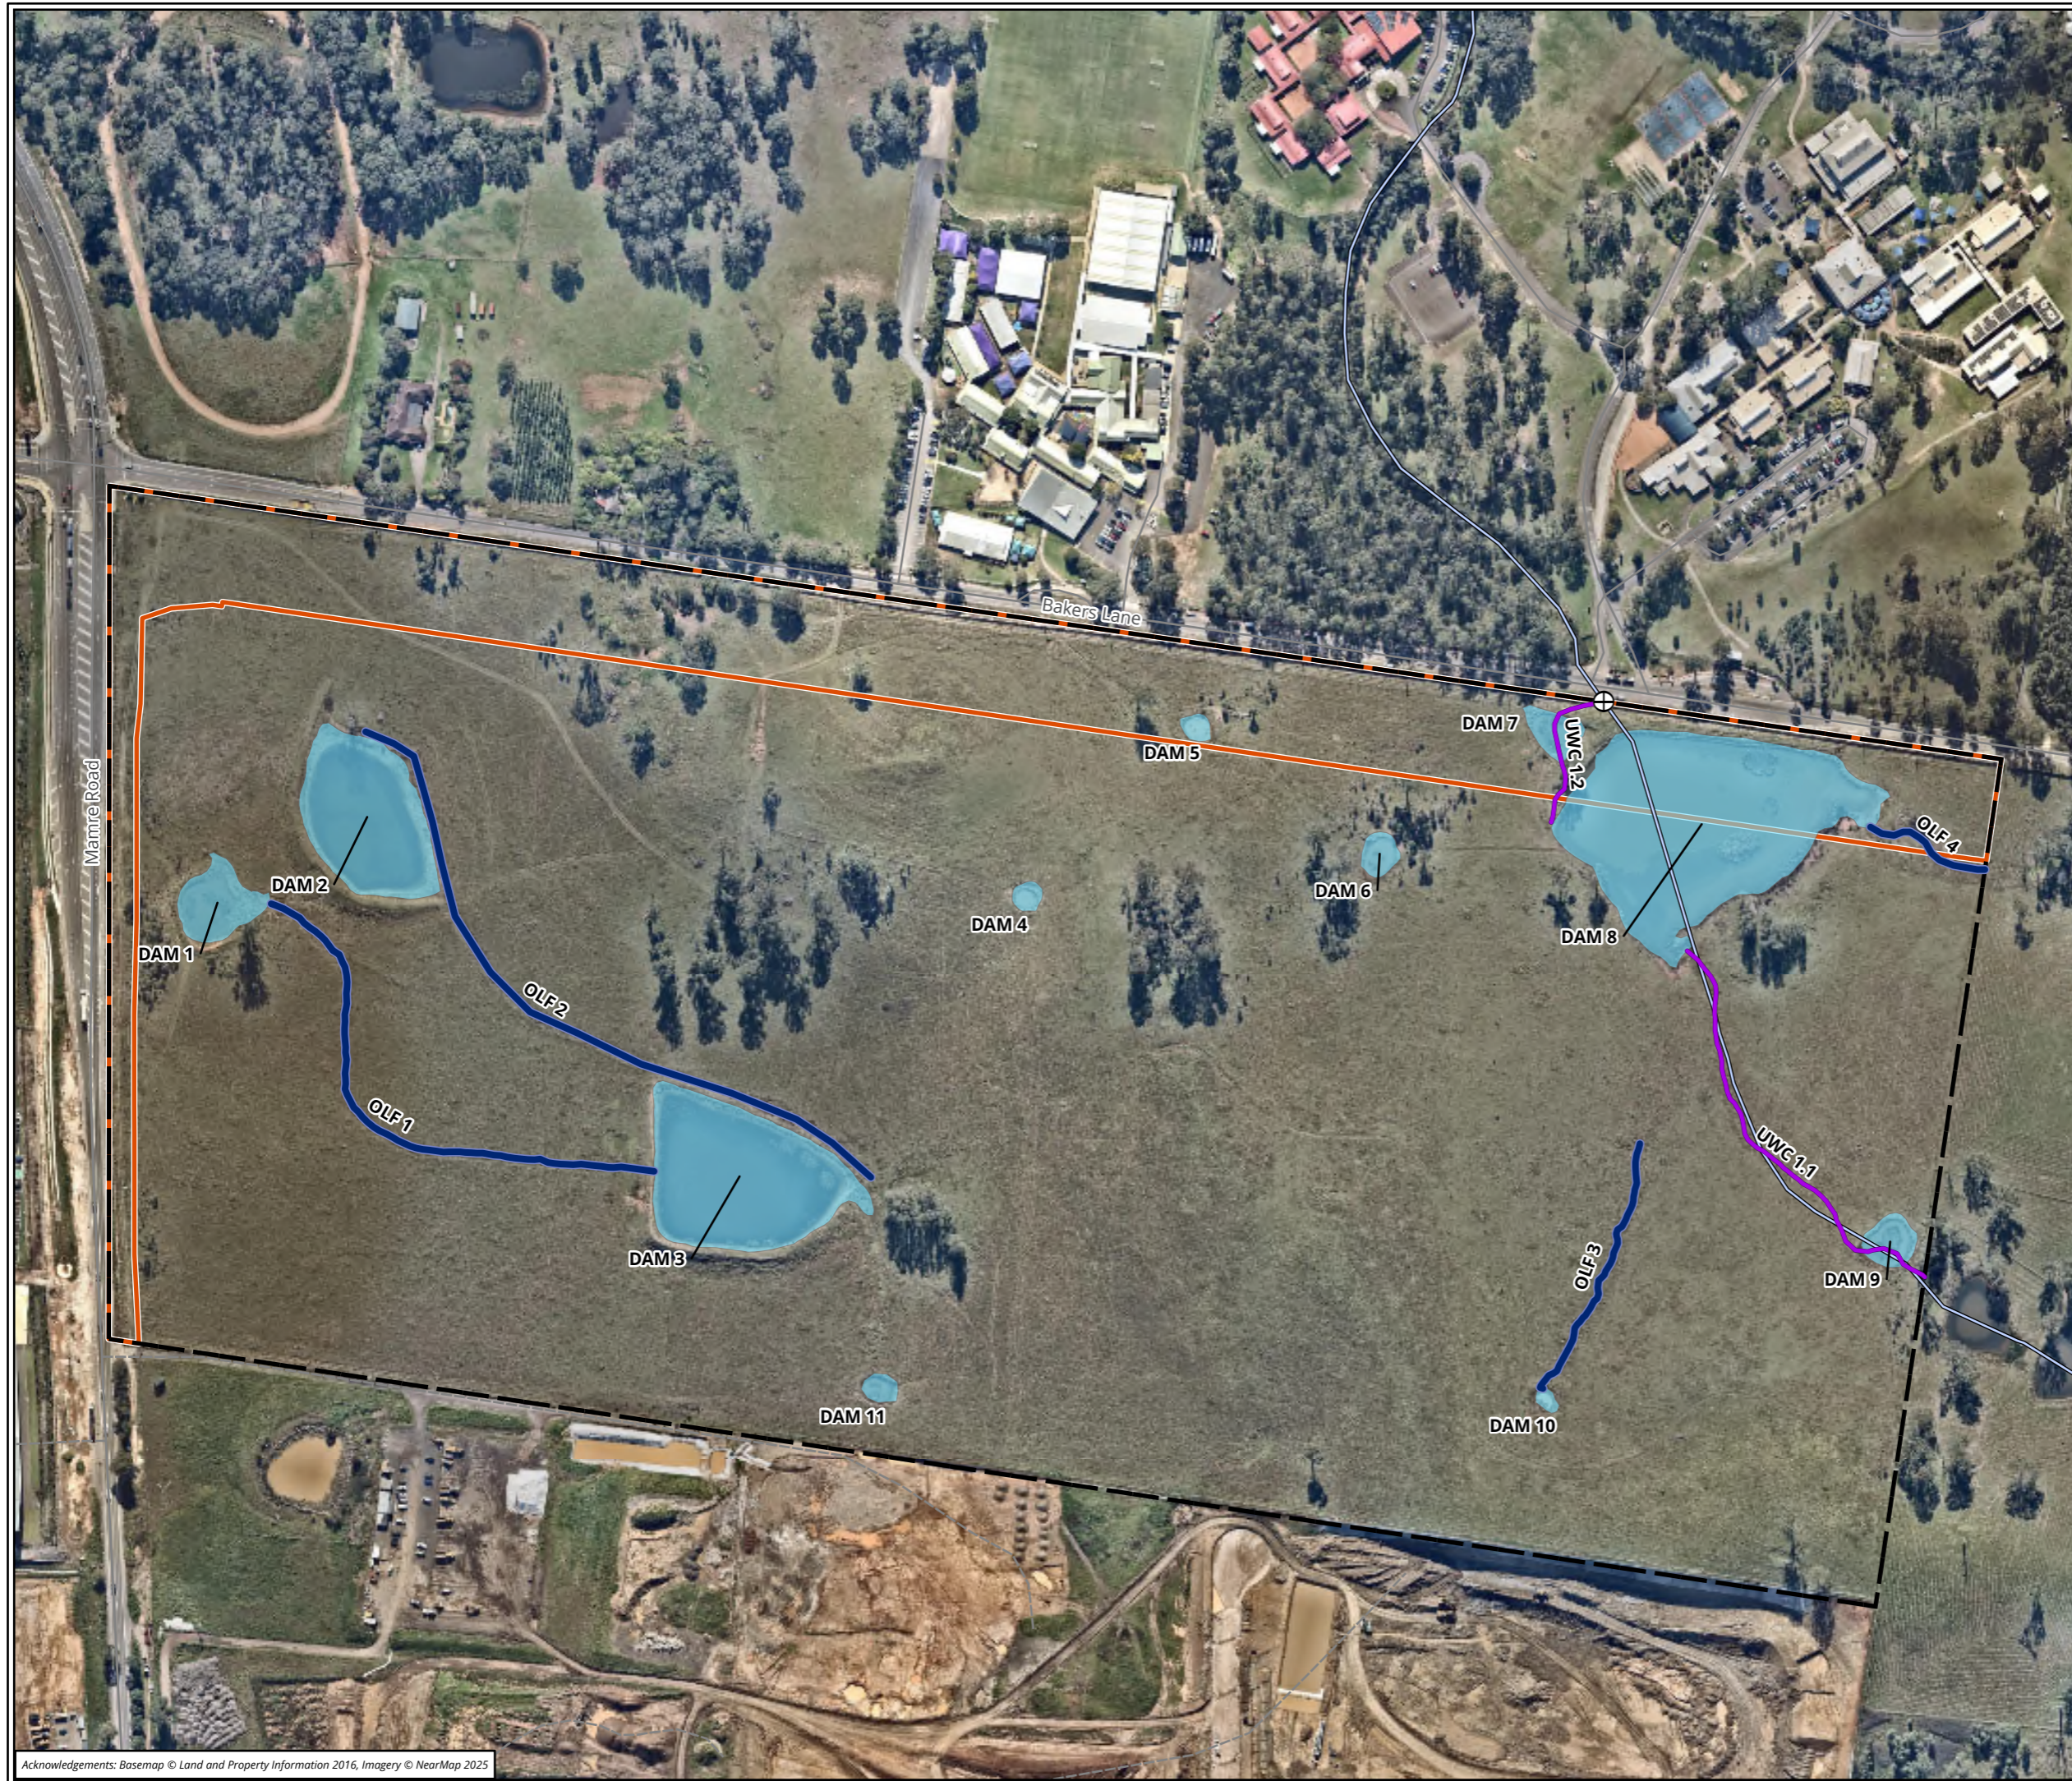
**Figure 2 Riparian ecological features**

Field investigation confirmed the presence of one unnamed non-perennial watercourse (identified as unnamed watercourse 1) within the study area. As seen on the historical imagery, the watercourse has been altered over the years due to changes in agriculture and landscape and is now predominantly absent. The mapped hydroline layer was ground-truthed and accurately mapped by Biosis with a handheld DGPS to reflect the current watercourse pathway (Figure 2). This watercourse has been separated into two distinct reaches due to definable changes in watercourse, as shown on Figure 2. The reaches are defined as:

Field investigations confirmed the presence of four overland flow paths within the study area, as mapped in Figure 2. The length and key characteristics of each overland flow path are summarised in Table 3 below

The study area encompassed a total of eleven farm dams, which were distributed across the landscape and likely served as key water resources within the agricultural setting. These dams varied in size, depth, and usage, reflecting a range of management practices and environmental conditions. The location and extent of each dam is shown on Figure 2 and the size and description in Table 4 below.

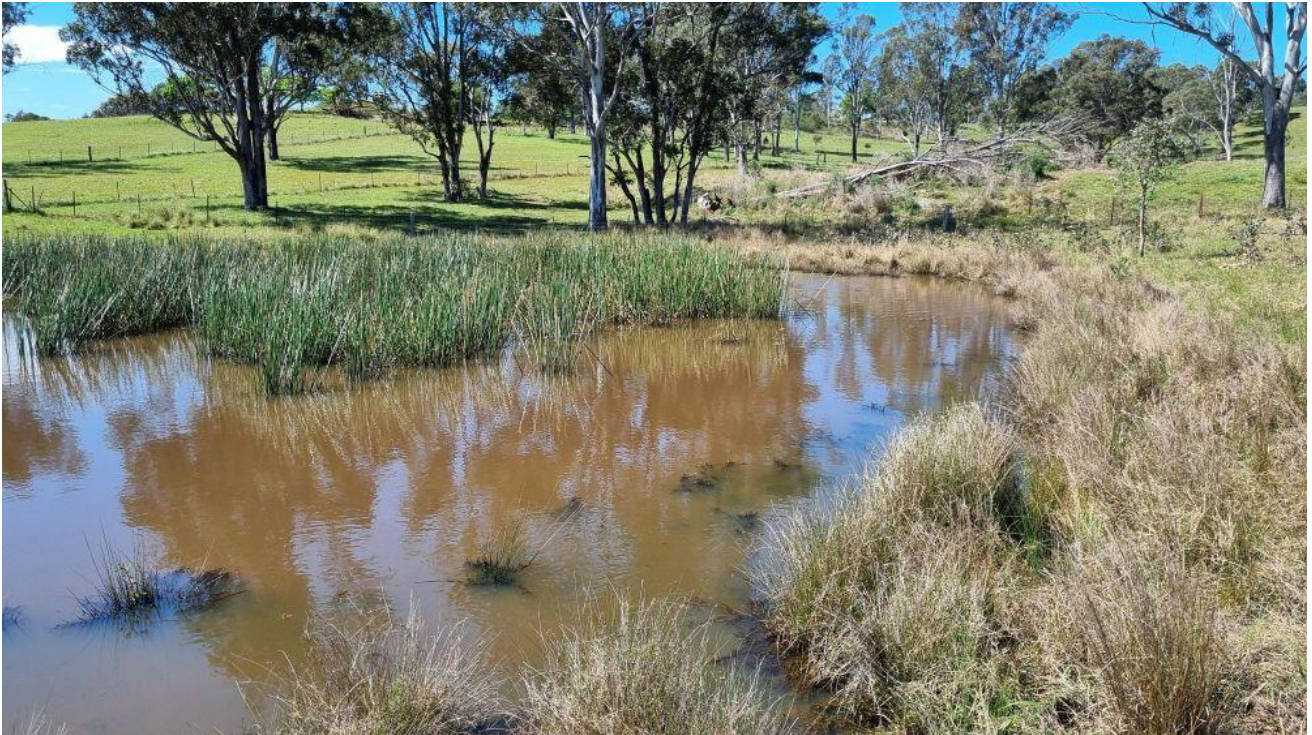
The reach of UWC 1.1 originates offsite to the east of Dam 9 (Photo 1), flows into the study area near Dam 9 and continues in a north-westerly direction for approximately 207 metres into Dam 8 (Photo 2). No active flow was observed during the site assessment. Additionally, the reach lacked definable features such as a bed or banks, and there were no visible changes in vegetation type or presence of aquatic vegetation (Photo 3). No aquatic or semi-aquatic fauna species were recorded during the survey. A small pooling area was observed approximately 20 metres upstream of Dam 8, however this is likely attributable to overflow from the dam rather than natural flow (Photo 4). Based on site evidence, it is likely that UWC 1.1 was historically an active watercourse, but the construction and operation of upstream dams have likely altered the local hydrology, resulting in a reduction or loss of definable stream features along this reach.

**Photo 1** Start of Unnamed Watercourse reach 1.1 to the east of Dam 9 on the eastern boarder of the study area

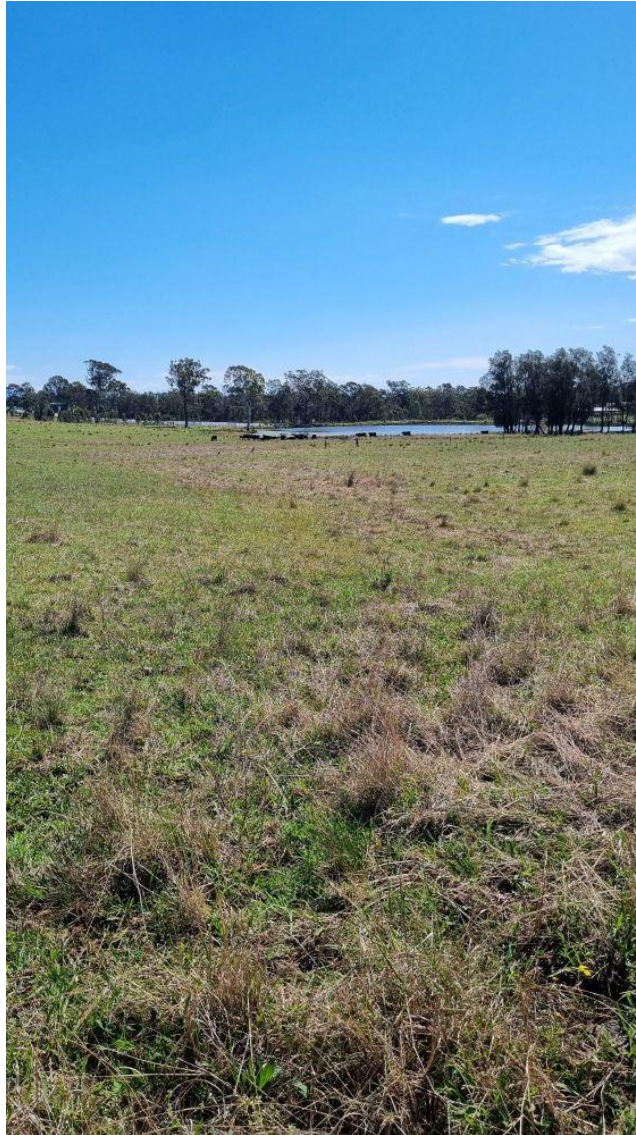
**Photo 2** Unnamed Watercourse reach 1.1 hydroline to Dam 8

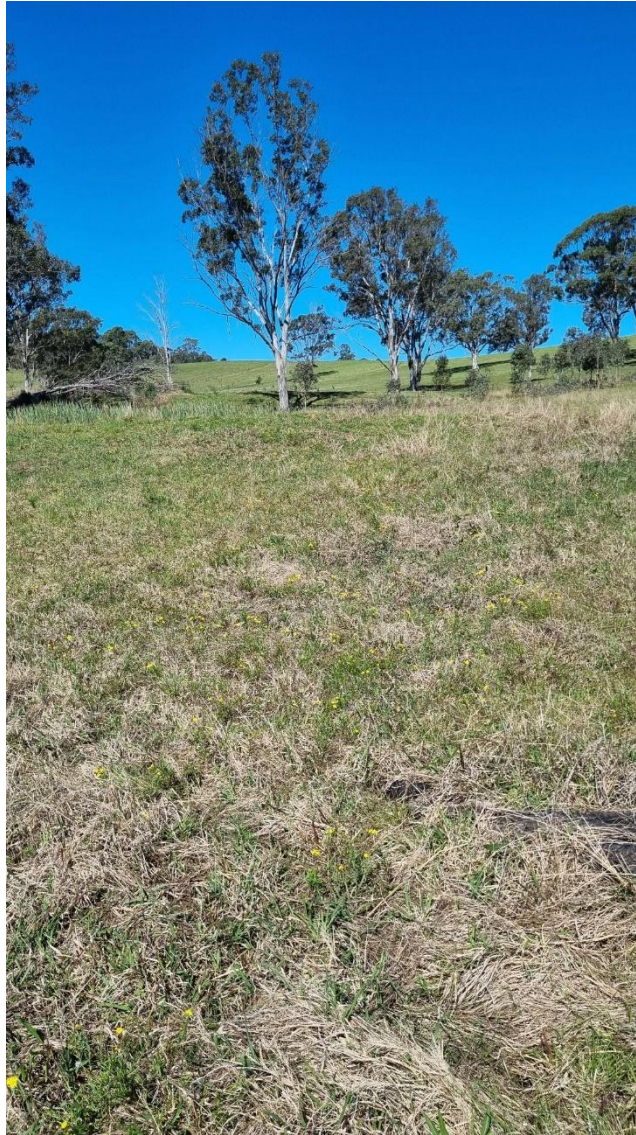
**Photo 3** Unnamed Watercourse reach 1.1 with no bed or bank or visible vegetation changes.

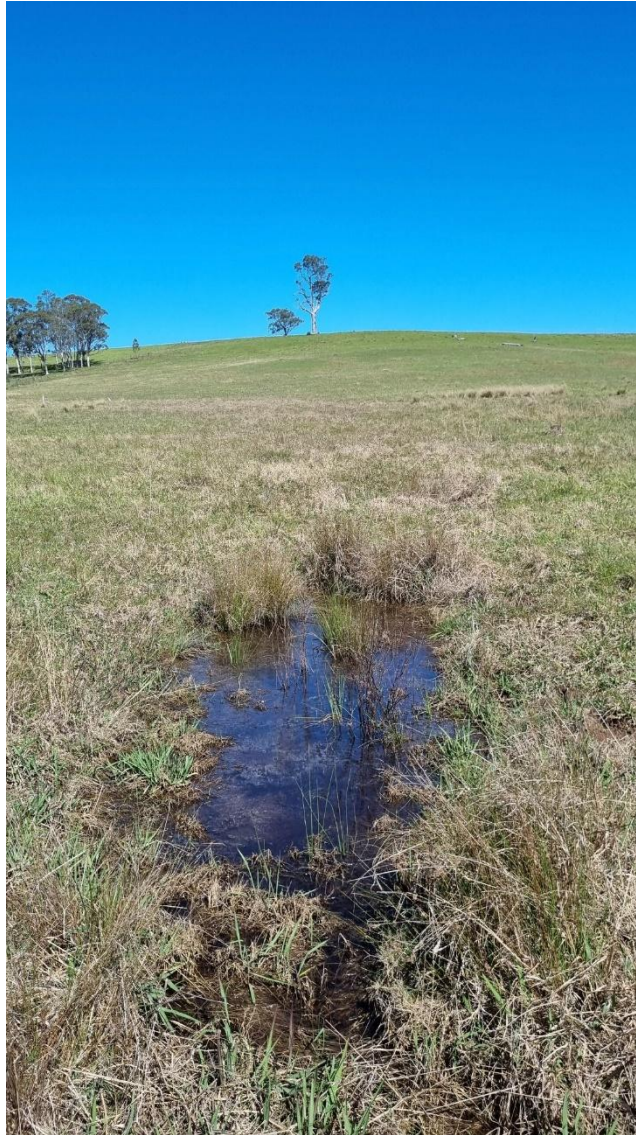
**Photo 4** Small area of pooling on Unnamed Watercourse reach 1.1

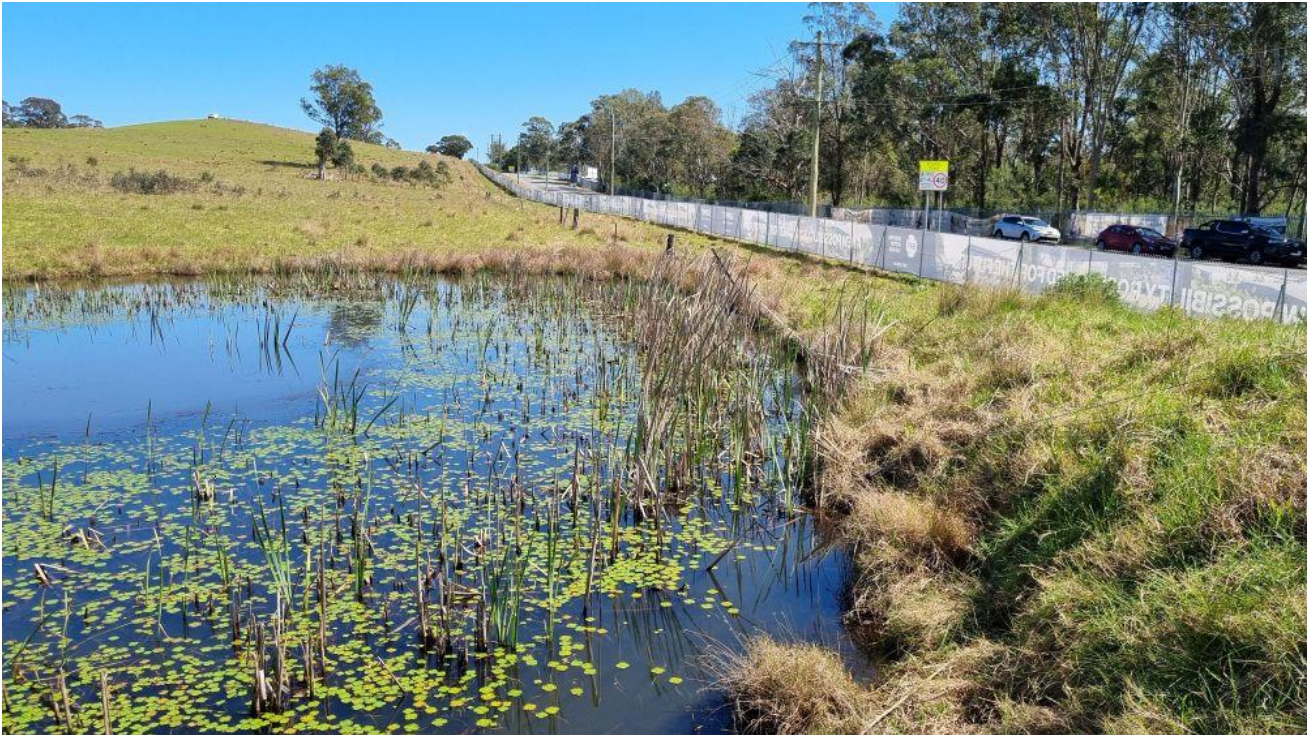
The section of the watercourse reach flowing from the western wall of Dam 8 northwards into Dam 7 and continuing offsite via a culvert under Bakers Lane is referred to as Unnamed Watercourse 1.2 (Photo 5). This reach extends approximately 110 metres from the outlet of Dam 8 to the culvert. At the time of the survey, active surface water flow was observed between Dam 8 and Dam 7. An eroded edge along the back wall of Dam 8 had formed a defined bank, indicating hydrological activity (Photo 6). While no aquatic vegetation was

**Photo 5** Unnamed Watercourse reach 1.2 flowing over Dam 7 and into the culvert on the northern border of the study area

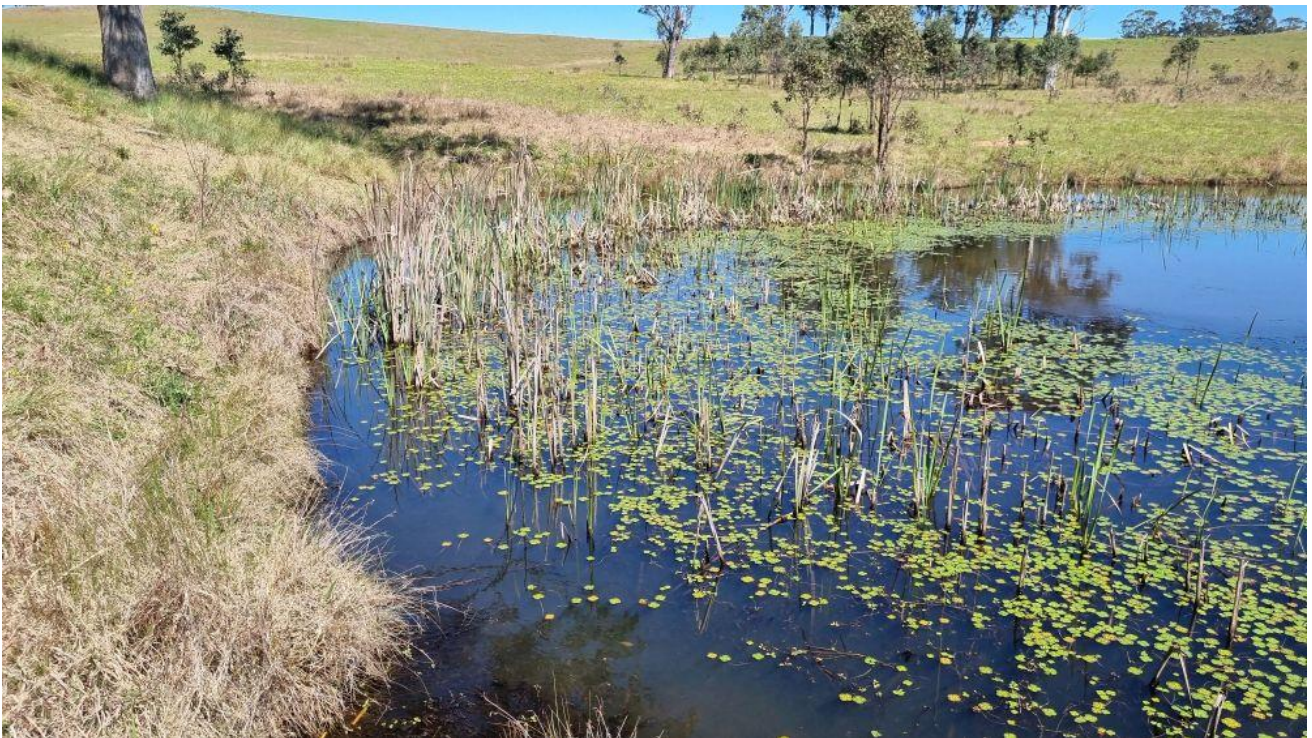
**Photo 6** Water flowing from Dam 8 into Dam 7 with an eroded back edge of Dam 8 creating a bank

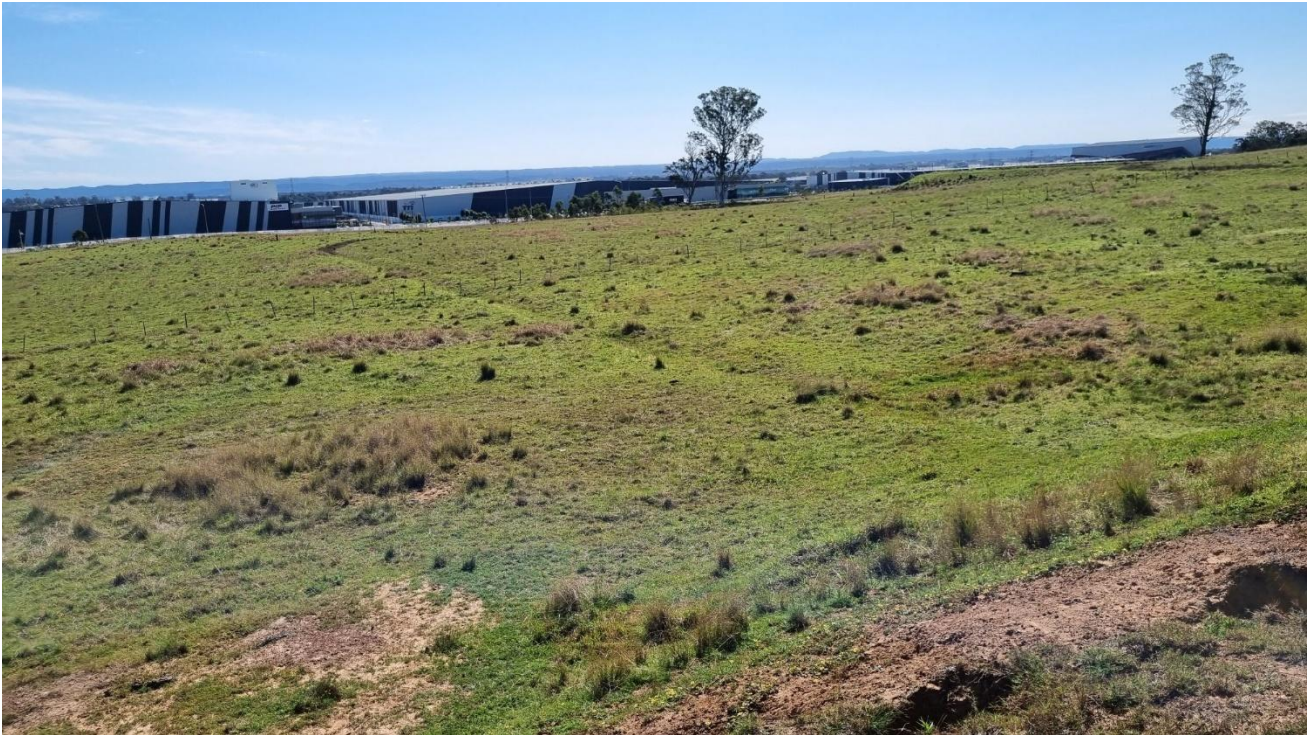
Overland Flows	Length of stream (m)	Comments
<b>Overland flow 1 (OLF 1)</b>	321	OLF 1 originates from both Dam 3 and Dam 1, following a constructed earthworks channel designed to direct surface runoff downslope (Photo 7). Pooling of water was observed in the lower sections of the channel, suggesting that during periods of excessive rainfall, water likely dissipates into the surrounding grassland vegetation rather than continuing as a defined flow path. The water within this channel does not directly flow offsite and remains contained within the study area.
<b>Overland flow 2 (OLF 2)</b>	418	OLF 2 extends from Dam 2 to Dam 3, following a constructed earthworks channel that appears to have been designed to manage surface runoff and minimise erosion within the landscape (Photo 8). During the field investigation, no flowing water was observed within the channel, however, significant pooling was recorded at Dam 3, which was observed to be at full capacity (Photo 9). Historical overflow from Dam 2 has likely contributed to the pooling observed on the upstream side of Dam 3. The water within the channel does not directly flow offsite, and the overland flow is contained within the study area.

**Photo 7** Overland Flow 1 originating from Dam 3 and Dam 1

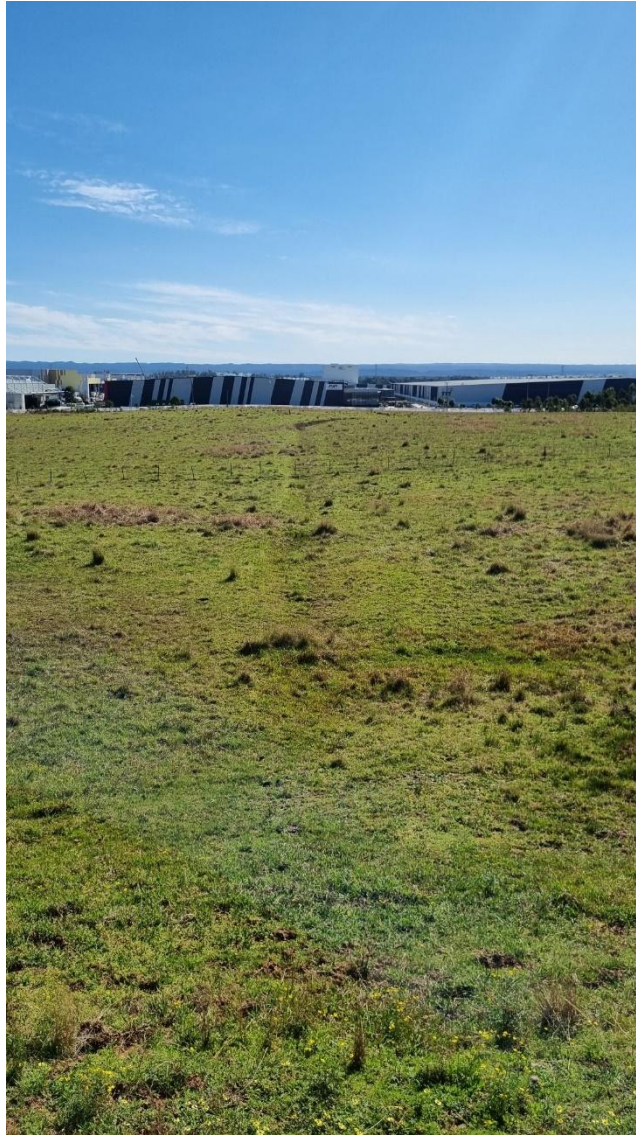
**Photo 8** Overland flow 2 originating from Dam 2 to Dam 3

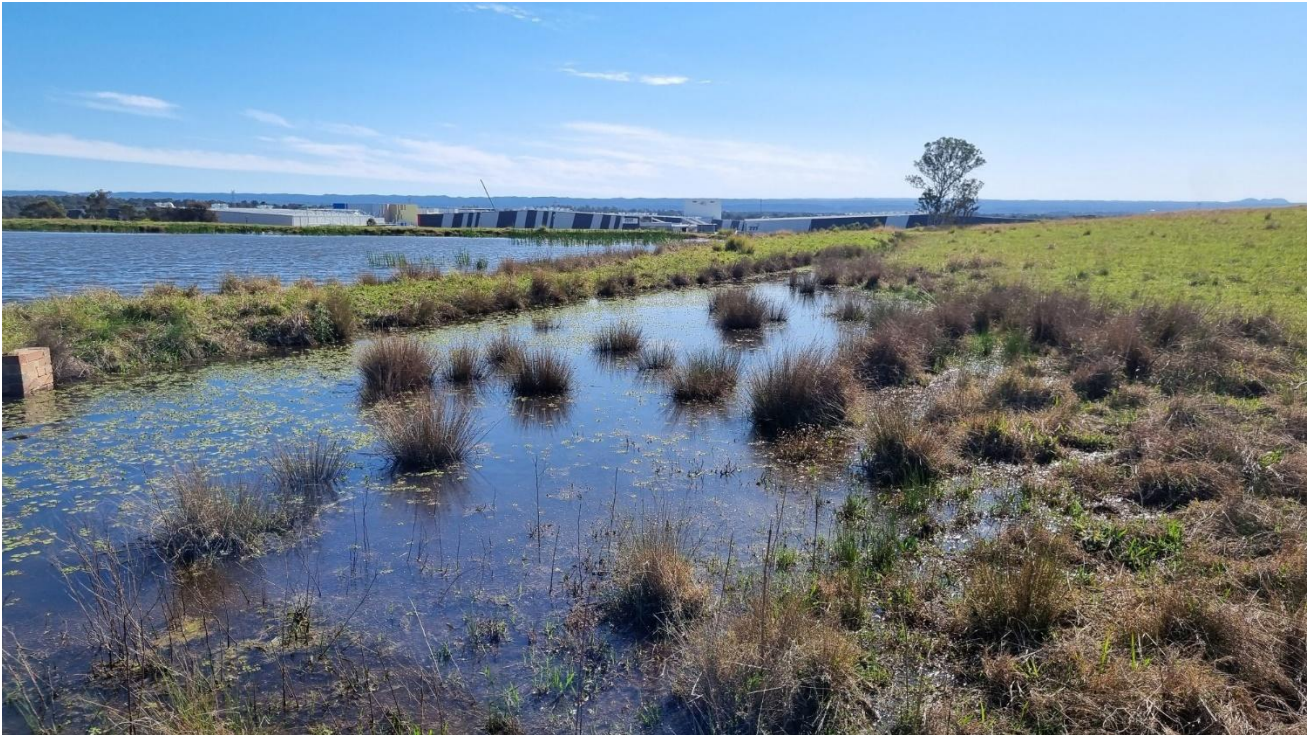
**Photo 9** Significant pooling at Dam 3 from Overland flow 2

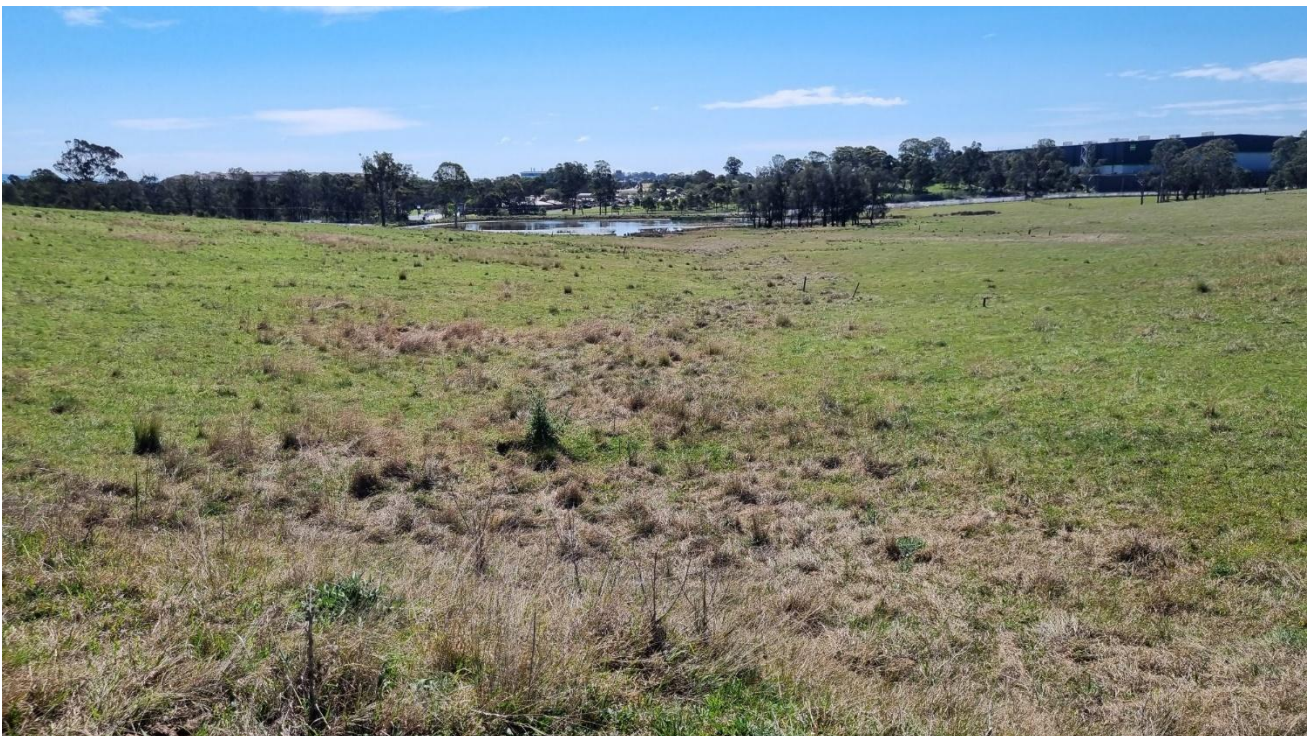
<b>Overland flow 3 (OLF 3)</b>	160	OLF 3 originates from Dam 10 and flows northward until a discernible change in vegetation is no longer visible (Photo 10), indicating the likely extent of surface water movement. Historical flow patterns suggest that this overland flow path may have once connected to either Dam 8 or the mapped first-order watercourse within the study area. However, the construction and presence of Dam 10 have altered the local hydrology, effectively capturing surface runoff during rainfall events and preventing any downstream connectivity to Dam 8 or adjacent drainage features.
<b>Overland flow 4 (OLF 4)</b>	75	OLF 4 occurs in the northeastern corner of the study area, entering from offsite and flowing towards Dam 8 (Photo 11). During the field investigation, pooling water was observed within the flow path as a result of recent rainfall. Aquatic vegetation, including exotic Sharp Rush <i>Juncus acutus</i> subsp. <i>acutus</i> , was recorded near the entry point to Dam 8, likely associated with overflow pooling (Photo 12). No defined watercourse was identified to the east of this area, which may be attributed to historical changes in surface hydrology caused by the construction of upstream farm dams. The water within this overland flow path does not flow offsite but rather contributes to the inflow of Dam 8.

**Photo 10** Overland flow 3 originating from Dam 10

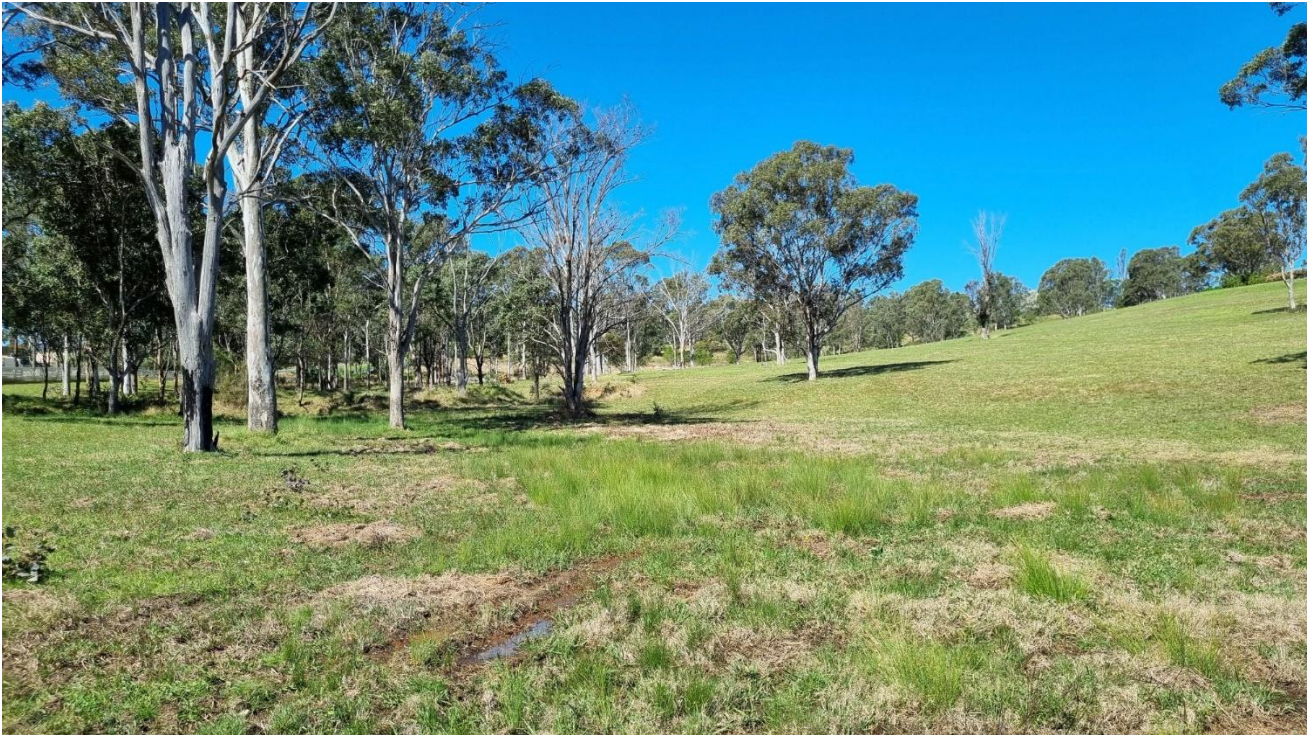
**Photo 11** Overland flow 4 originating from offsite to the northeast of the study area

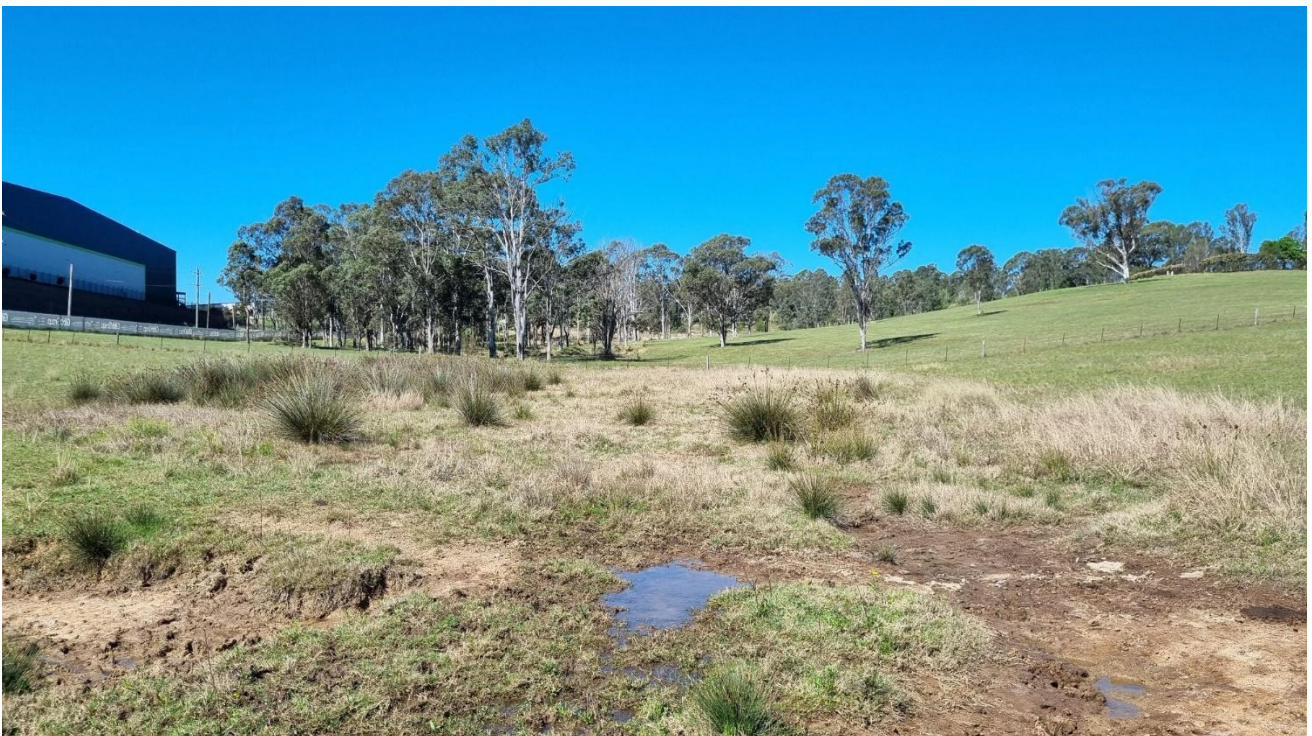
**Photo 12** Pooling near Dam 8 along Overland flow 4

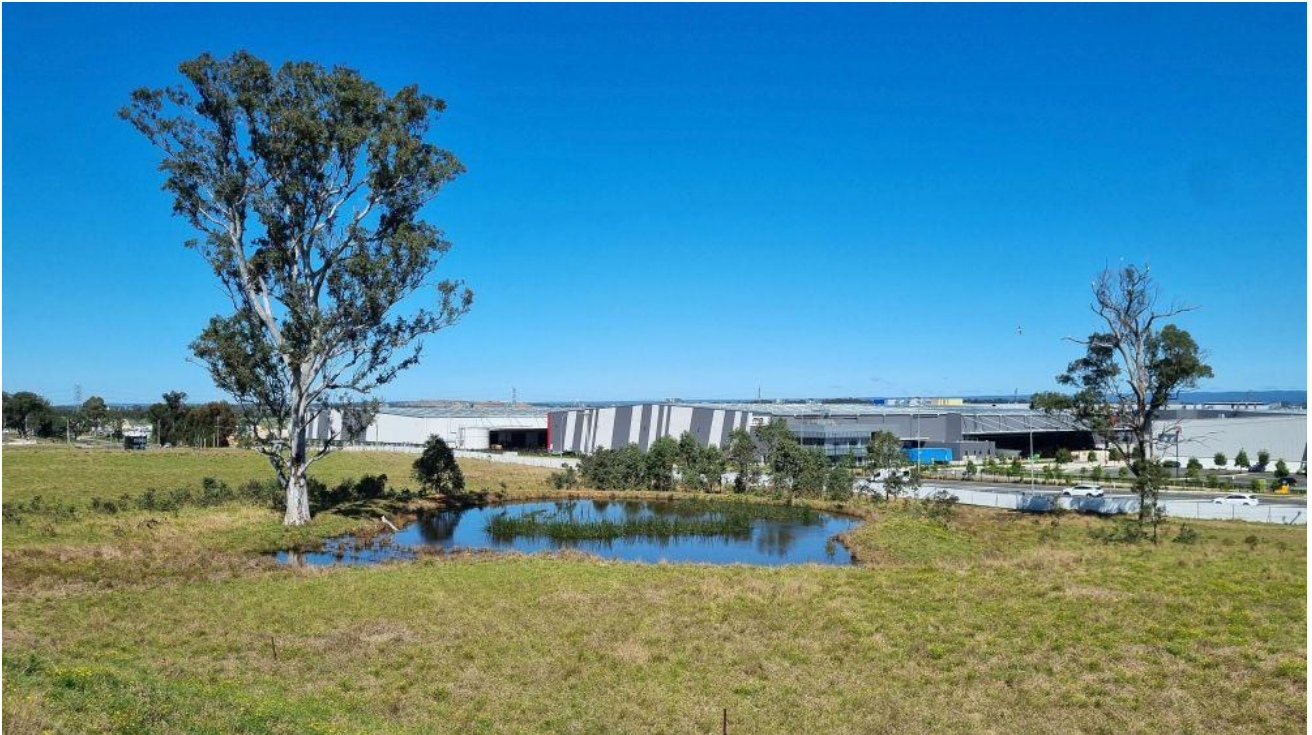
**Photo 13 Farm Dam 1**

Dams	Size (Hectares)	Habitat description
<b>Dam 1</b>	0.17	Dam 1 is slightly turbid with a large patch of <i>Eleocharis sphacelata</i> in the centre and small sparse patches of Water Ribbons <i>Cyanogeton procerum</i> (Photo 13). The water contained aquatic vegetation such as Ribbonweed <i>Vallisneria australis</i> . The border of

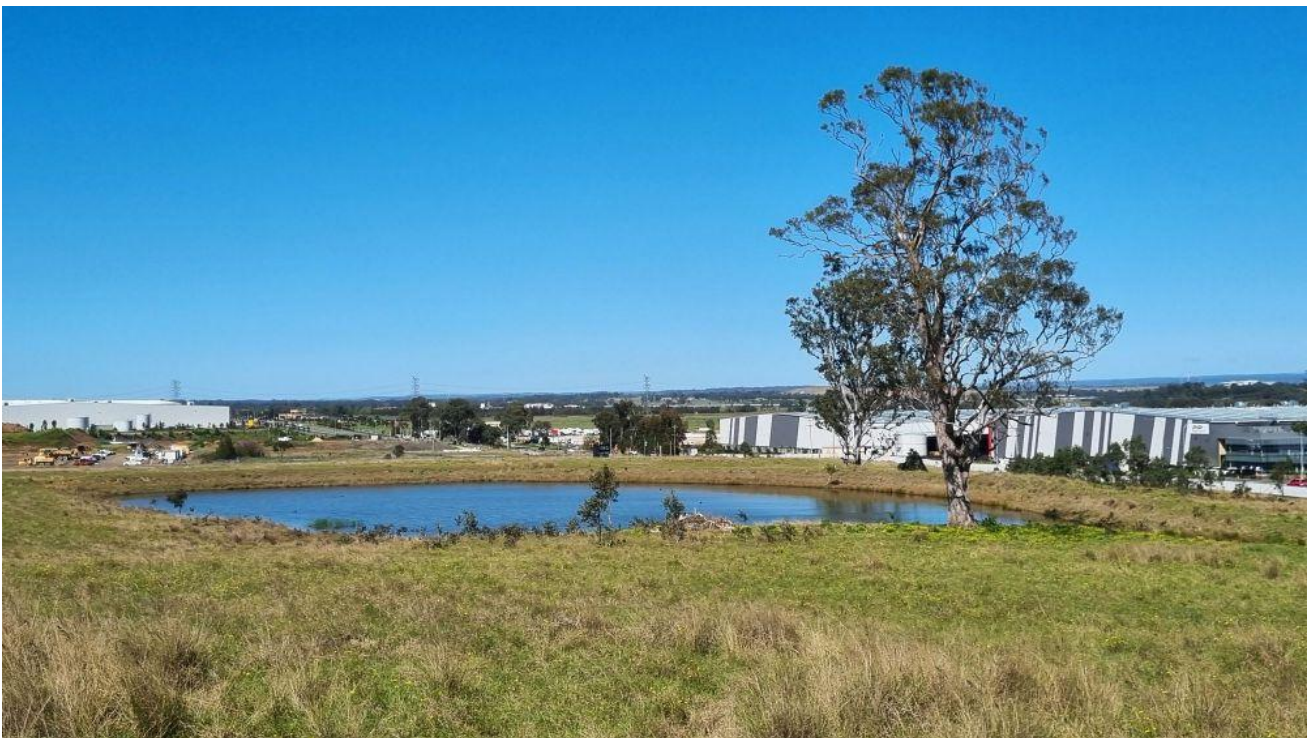
Dams	Size (Hectares)	Habitat description
		<p>the dam was lined with <i>Juncus usitatus</i>, with the southeastern section showing signs of livestock impacts. A Forest Red Gum <i>Eucalyptus tereticornis</i> was present providing minimal shade on the southern section of the dam.</p> <p>The water contained Mosquito Fish <i>Gambusia affinis</i>, and sparse clouds of algae. Fauna species such as Purple Swamp Hen <i>Porphyrio porphyrio</i> and Common Eastern Froglet <i>Crinia signifera</i> were observed utilising the dam.</p>
<b>Dam 2</b>	0.58	<p>Dam 2 is slightly turbid with small patches of <i>Juncus usitatus</i> scattered along the banks and a small patch of <i>Eleocharis sphacelata</i> in the northern section (Photo 14). The water contained aquatic vegetation such as Ribbonweed.</p> <p>The water contained Mosquito Fish, and large clouds of algae. Fauna species such as Australian Wood Duck <i>Chenonetta jubata</i>, Eurasian Coot <i>Fulica atra</i> and Common eastern froglets were observed with the dam.</p>

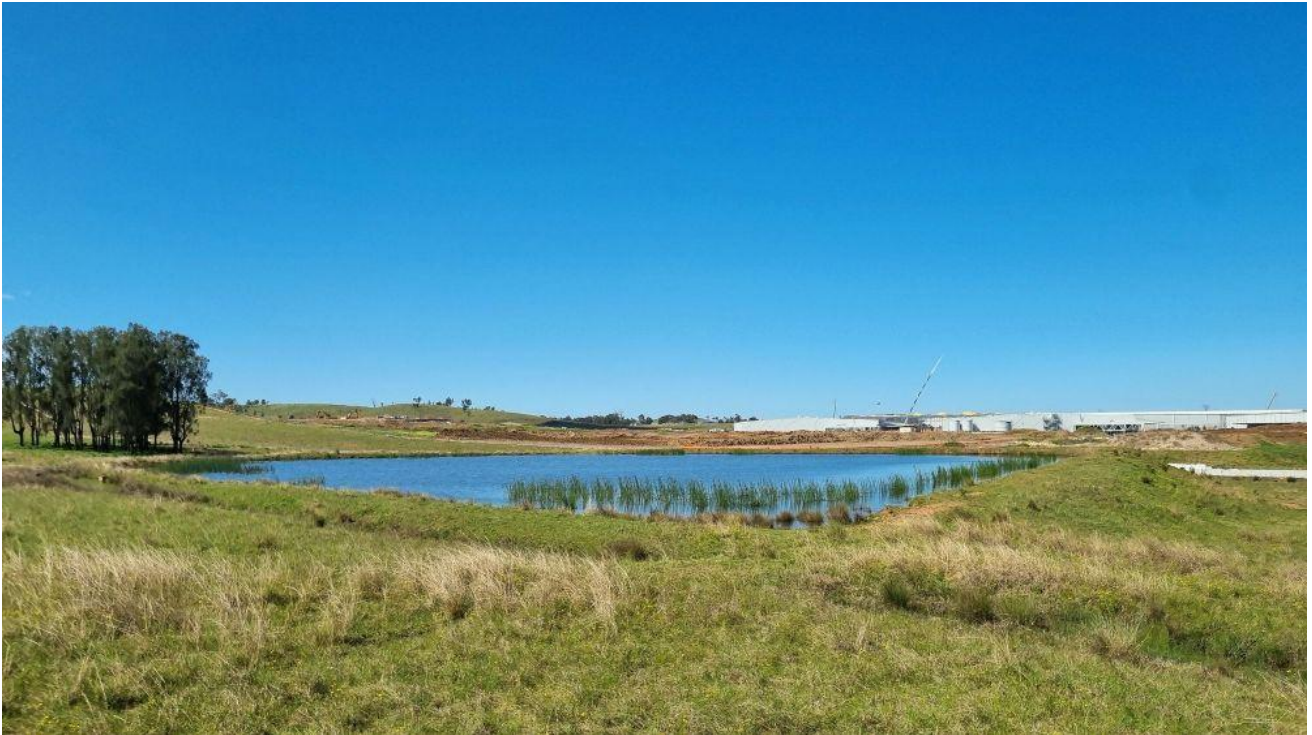
**Photo 15 Farm Dam 3**

<b>Dam 3</b>	0.84	<p>Dam 3 is slightly turbid with emergent vegetation including <i>Eleocharis sphacelata</i> and Water Ribbons, with sparse sections of <i>Juncus usitatus</i> along the banks (Photo 15). The dam had a small surface covering of Nardoo <i>Marsilea mutica</i> and aquatic vegetation of Ribbonweed. The northern side of dam contained an overflow of water due to the dams capacity, labelled as OFL 2.</p> <p>The water contained Mosquito Fish, and large clouds of algae. Fauna species such as Short-finned Eel <i>Anguilla australis</i> Australian Wood Duck, and Eurasian coot were observed with the dam.</p>
<b>Dam 4</b>	0.02	<p>Dam 4 is small and turbid with the banks consists of <i>Juncus usitatus</i> with a small surface covering of Nardoo and <i>Azolla pinnata</i> (Photo 16). The southern section of the dam wall is built from a loose brick pile.</p> <p>Due to the turbidity, no submerged vegetation could be observed, however Mosquito Fish were observed near the banks. No fauna species were observed in the dam.</p>

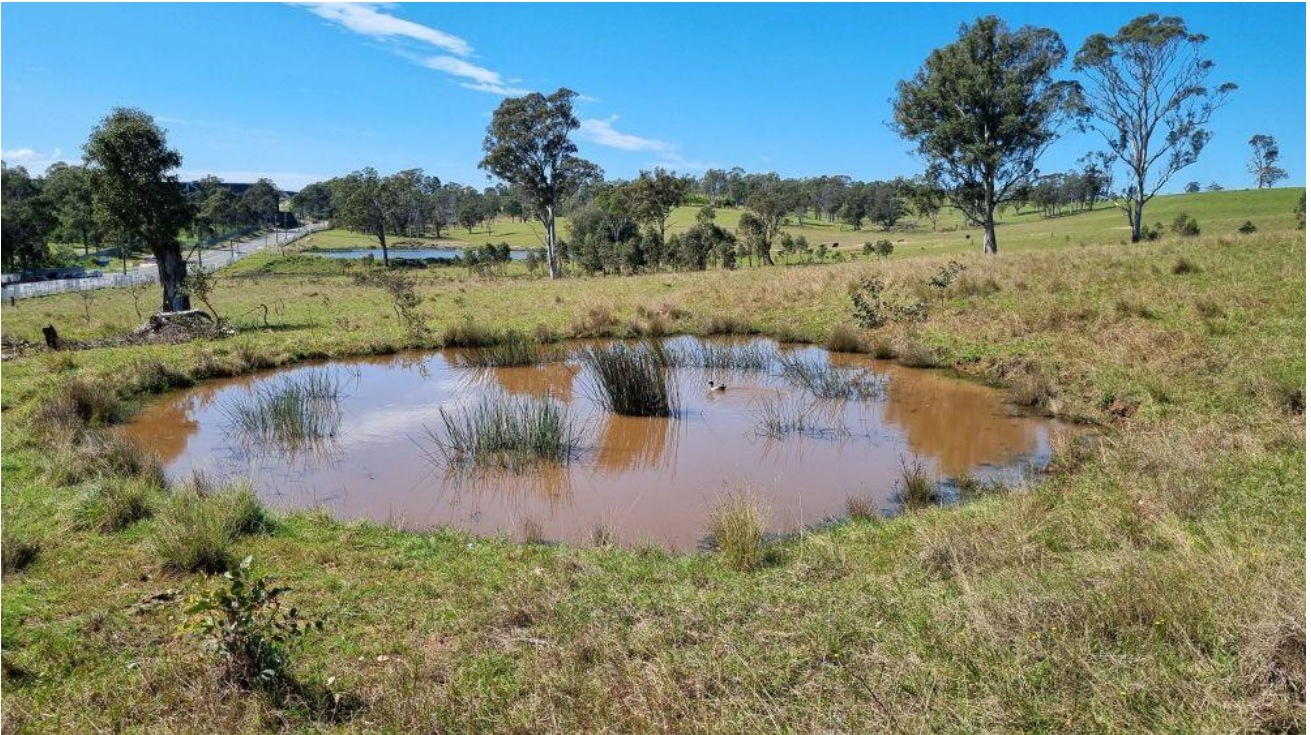
**Photo 17 Farm Dam 5**

<b>Dam 5</b>	0.02	<p>Dam 5 is small and turbid with <i>Eleocharis sphacelata</i> and sparse sections of <i>Juncus usitatus</i> along the banks (Photo 17).</p> <p>Due to the turbidity, no submerged vegetation or aquatic fauna could be observed. Fauna species such as Australian Wood Duck, and Common Eastern Froglet were observed within the dam.</p>
<b>Dam 6</b>	0.05	<p>Dam 6 is turbid with emergent <i>Eleocharis sphacelata</i>, sparse sections of <i>Juncus usitatus</i> along the banks and a small surface covering of Nardoo (Photo 18). The banks show signs of erosion from livestock access.</p> <p>Due to the turbidity, no submerged vegetation could be observed, however Mosquito Fish were observed near the banks. No fauna species were observed in the dam.</p>
<b>Dam 7</b>	0.07	<p>Dam 7 is turbid with an active overflow occurring from Dam 8 (Photo 19). Emergent vegetation of Bulrush <i>Typha orientalis</i> and <i>Eleocharis sphacelata</i>, sparse sections of <i>Juncus usitatus</i> along the banks and a small surface covering of Nardoo. The water contained aquatic vegetation such as Ribbonweed.</p> <p>The water contained Mosquito Fish, and large clouds of algae. Fauna species such as Australian Wood Duck, Eurasian coot and Common Eastern Froglet were observed with the dam.</p>

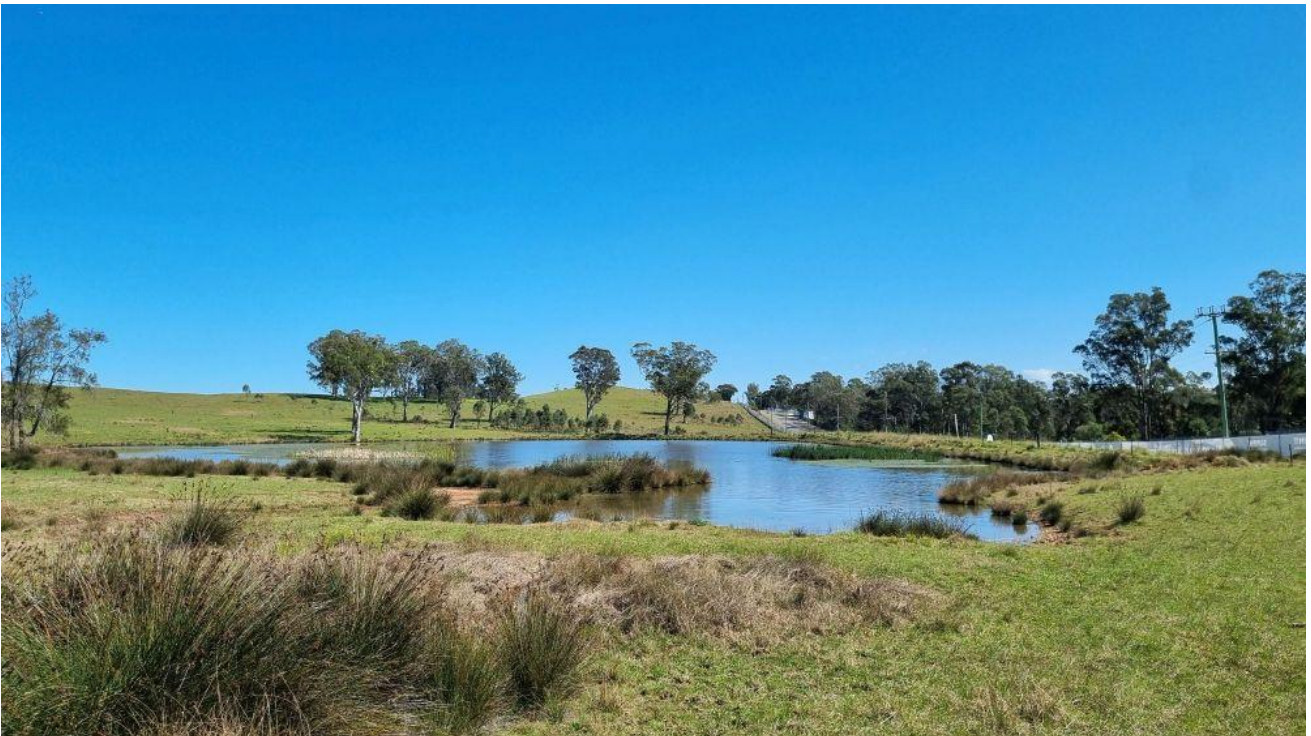
**Photo 20 Farm Dam 8**

<b>Dam 8</b>	1.49	<p>Dam 8 is large, clear, and contains a variety of habitats and vegetation (Photo 20). Emergent and aquatic vegetation such as Bulrush, <i>Eleocharis sphacelata</i>, <i>Bacopa monnieri</i>, <i>Juncus usitatus</i>, Sharp Rush <i>Juncus acutus</i> subsp. <i>acutus</i>, Hyssop Loosestrife <i>Lythrum hyssopifolia</i>, Ribbonweed and Nardoo are observed throughout the dam. The northern side contains a large patch of <i>Eleocharis sphacelata</i>, with the centre containing a Bulrush patch. The southern and eastern banks have dense patches of <i>Juncus usitatus</i> and Sharp rush offering good breeding habitat for frogs. The eastern</p>
