**Mamre Road Data Centre Campus (SSD-92743706)**

# Aquatic & Riparian Impact Assessment

Final Report

Prepared for Plan Project Management

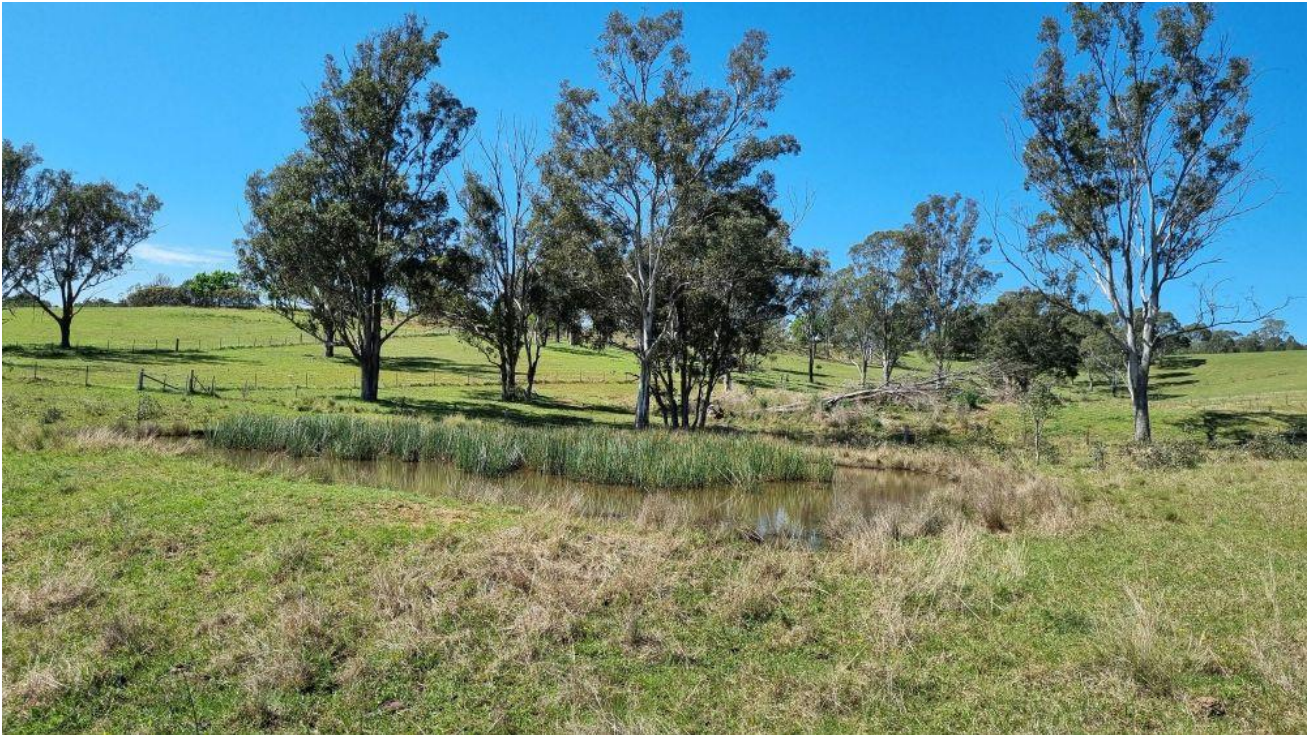
**Photo 20 Farm Dam 8**

<b>Dam 8</b>	1.49	<p>Dam 8 is large, clear, and contains a variety of habitats and vegetation (Photo 20). Emergent and aquatic vegetation such as Bulrush, <i>Eleocharis sphacelata</i>, <i>Bacopa monnieri</i>, <i>Juncus usitatus</i>, Sharp Rush <i>Juncus acutus</i> subsp. <i>acutus</i>, Hyssop Loosestrife <i>Lythrum hyssopifolia</i>, Ribbonweed and Nardoo are observed throughout the dam. The northern side contains a large patch of <i>Eleocharis sphacelata</i>, with the centre containing a Bulrush patch. The southern and eastern banks have dense patches of <i>Juncus usitatus</i> and Sharp rush offering good breeding habitat for frogs. The eastern</p>

Dams	Size (Hectares)	Habitat description
		<p>corner of the dam offers moderate shorebird habitat with two species; Black-fronted Dotterel <i>Charadrius melanops</i> and an unidentified sandpiper (observed flying from the dam on approach), observed using the habitat during the field investigation.</p> <p>The water contained Mosquito Fish, and sparse clouds of algae. Fauna species such as Short-finned Eel, Australian Wood Duck, Eurasian coot, Australasian Grebe <i>Tachybaptus novaehollandiae</i>, and Common Eastern Froglet were observed with the dam.</p>
<b>Dam 9</b>	0.07	<p>Dam 9 is turbid with emergent <i>Eleocharis sphacelata</i> and sparse sections of <i>Juncus usitatus</i> (Photo 21). Active overflow is occurring from the dams offsite to the east.</p> <p>Due to the turbidity, no submerged vegetation could be observed, however Mosquito Fish were observed near the banks. No fauna species were observed in the dam.</p>

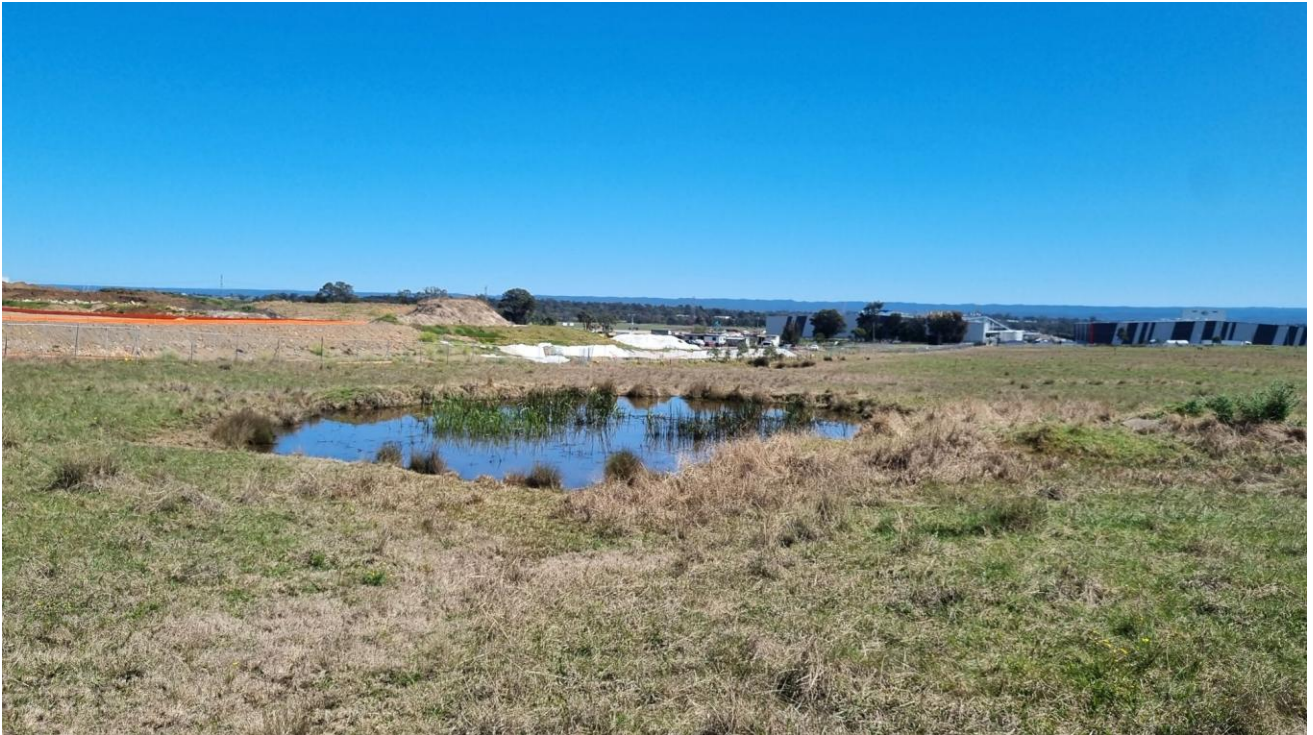
**Photo 22 Farm Dam 10**

<b>Dam 10</b>	0.01	<p>Dam 10 is small and turbid with emergent <i>Eleocharis sphacelata</i>, sparse sections of <i>Juncus usitatus</i> along the banks and a small surface covering of Nardoo (Photo 22). The banks show signs of erosion from livestock access.</p> <p>Due to the turbidity, no submerged vegetation could be observed, however Mosquito Fish were observed near the banks. No fauna species were observed in the dam.</p>
<b>Dam 11</b>	0.01	<p>Dam 11 is small and turbid with emergent <i>Eleocharis sphacelata</i>, sparse sections of <i>Juncus usitatus</i> along the banks and a small surface covering of Nardoo (Photo 23). The banks show signs of erosion from livestock access.</p> <p>The water contained Mosquito Fish, and large clouds of algae. No fauna species were observed in the dam.</p>
