# Mamre Road Data Centre Campus 706-752 Mamre Rd Kemp's Creek, NSW

Remedial Action Plan

70548 | 170,775 (Revision 0)

1 December 2025

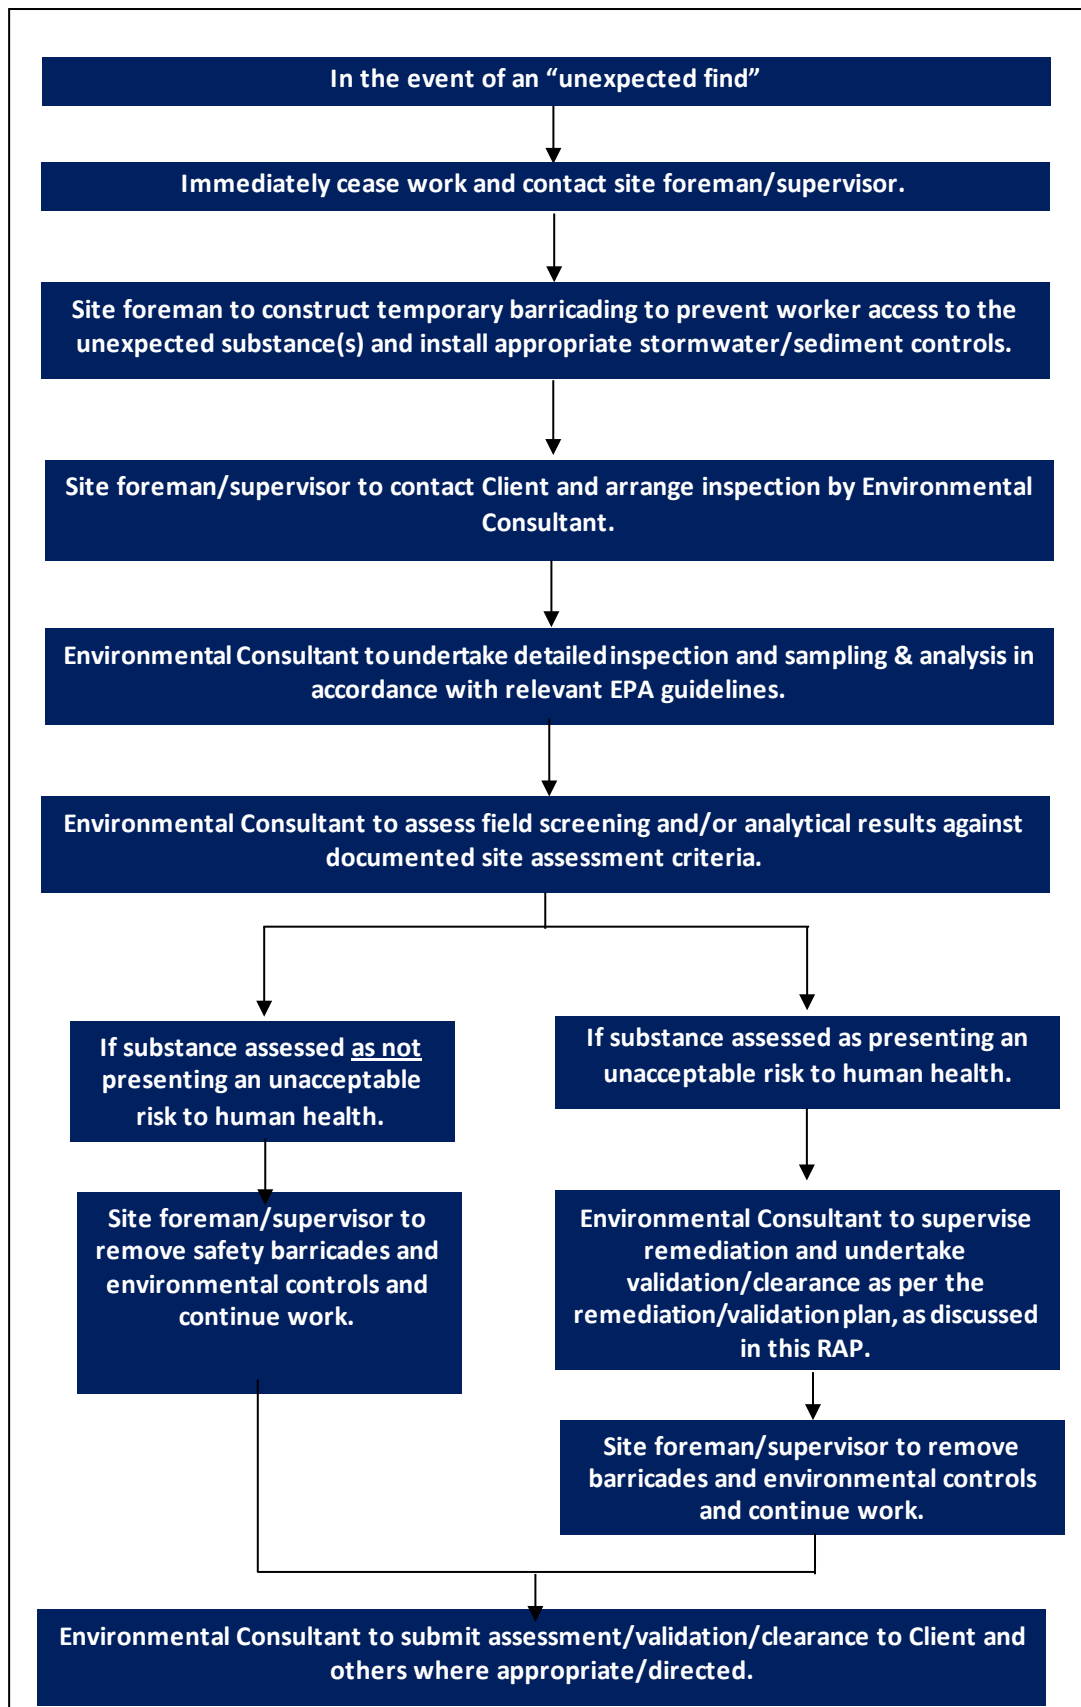
Figure 8.1 – Unexpected Finds Protocol

As a precautionary measure to ensure the protection of the workforce and surrounding community, should any of the abovementioned substances (or any other unexpected potentially hazardous substance) be identified, the procedure summarised in **Flow Chart 8.1** is to be followed.

The sampling strategy for each “unexpected find” shall be designed by the environmental consultant. The strategy will, however, be aimed at determining the nature of the substance – that is, is it hazardous and, if so, is it at concentrations which pose an unacceptable risk to human health or the environment.

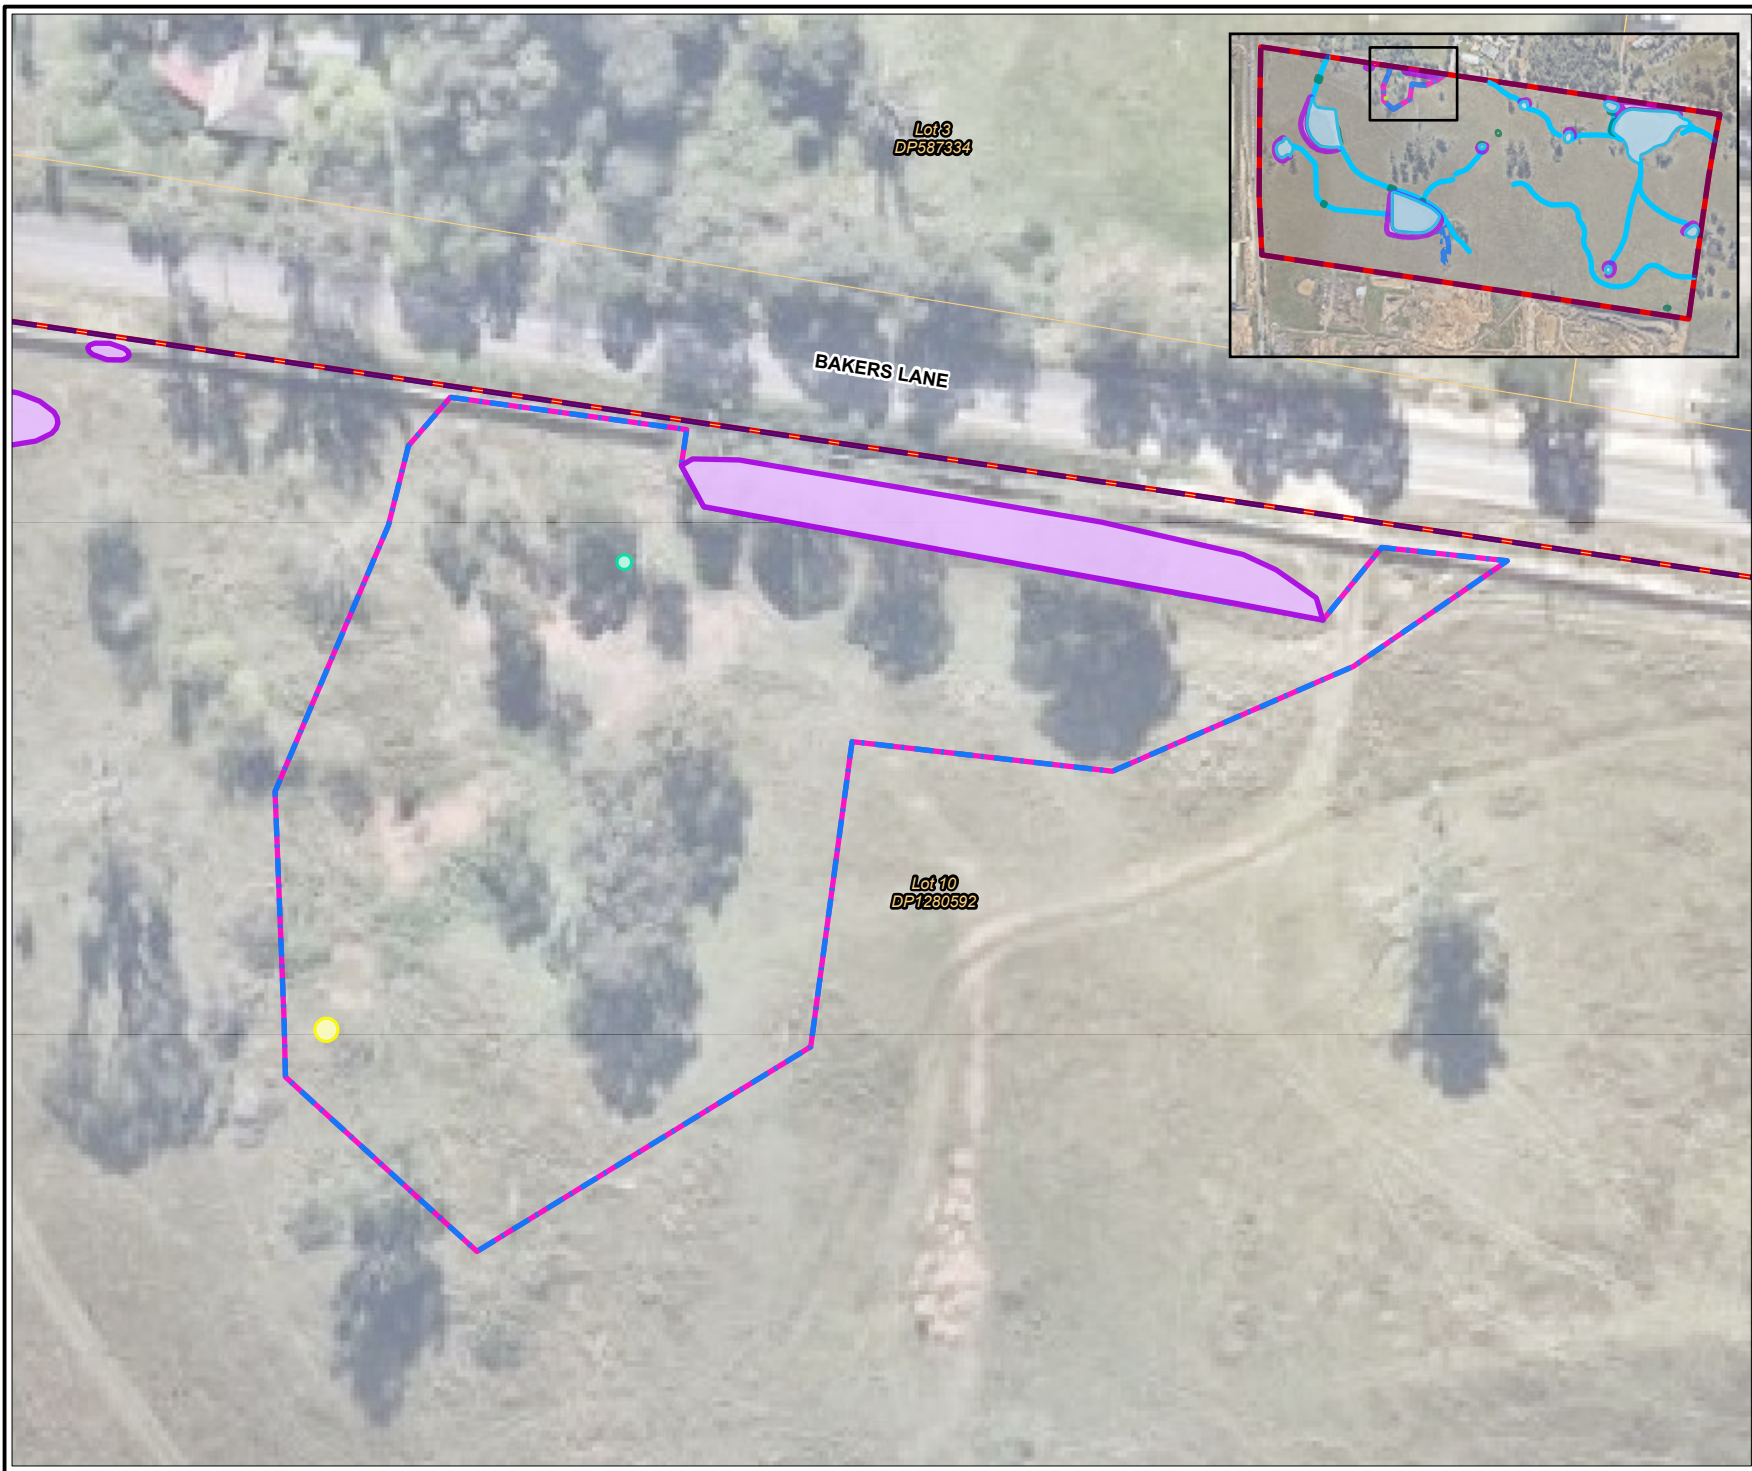
**FIGURE 3B**

**SITE FEATURES AND AREAS OF ENVIRONMENTAL CONCERN**

The site has been the subject of previous environmental investigations (PSM 2010<sup>1</sup>, JBS&G 2020<sup>2</sup> and JBS&G 2025a<sup>3</sup>) which reported localised areas of fill/soil impacted with bonded (non-friable) and friable asbestos, considered to pose a potential health risk requiring remediation and/or management. Household refuse and anthropogenic waste were noted co-mingled with asbestos impacted soil and impacting the site surface (in localised portions of the site), and stained/odorous soils at one location underlying a disused petroleum drum, were considered to pose a potential aesthetic issue requiring management. The investigations also identified the potential for localised contamination to soil in proximity to some infrastructure (septic tank/man-made bore as shown on **Figure 3b**) which will require inspection/validation.
