# Mamre Road Data Centre Campus (706- 752 Mamre Road Kemps Creek)

Results of Geotechnical Investigation

PSM5872-005R REV2    24 November 2025

Aurecon Australasia Pty Ltd

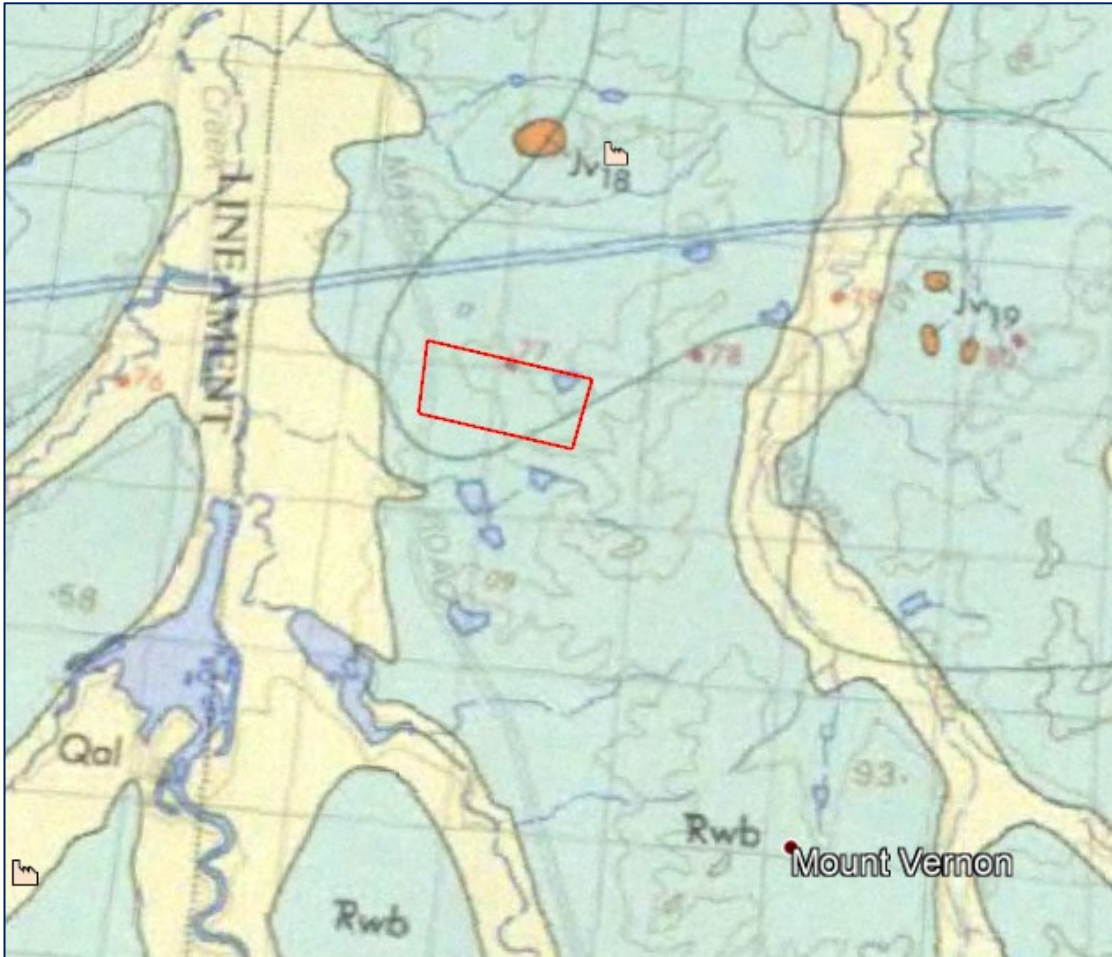
The 1:100,00 Sydney Geological Map indicates that the site is underlain by Bringelly Shale of the Wianamatta group (*Rwb*) which consists of shale, carbonaceous claystone, claystone, laminate, fine to medium grained lithic sandstone, rare coal and tuff.

**Inset 2: 1:100,000 Sydney Geological Map indicating approximate site location in red**

Inset 2 presents the geological map of the site.

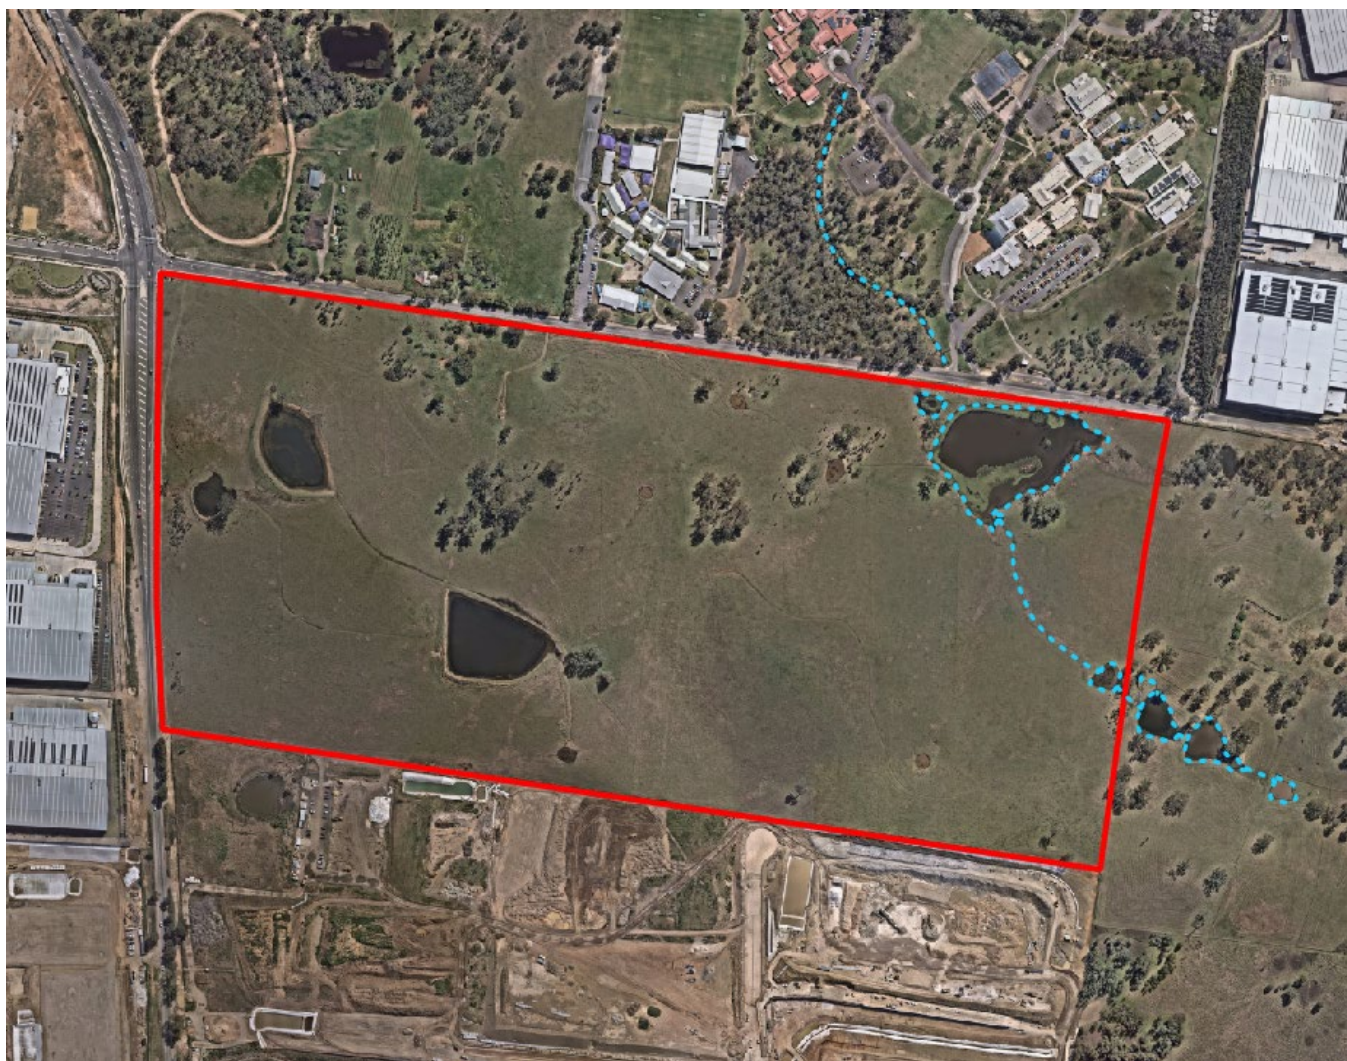
- The Site primarily comprises thickly vegetated areas and landscape areas, with wired fences dividing the site
- Two (2) hill sides are located in the northern-central and southern-central parts of the land at RL 83 m and RL 81.5 m, respectively
- Three (3) water dams are located at the low point areas
- A creek runs across the southern part of the Site, see Inset 4
- At the time of the fieldwork, the surfaces were dry and accessible by foot or vehicles
- Parts of the site have undergone construction work, with a dirt haul road being paved to allow for accessibility of heavy load vehicles (i.e. trucks, plant etc).

**Inset 4:** Aerial site photo (Nearmap, 2025) with the extent of the existing creek running across the Site

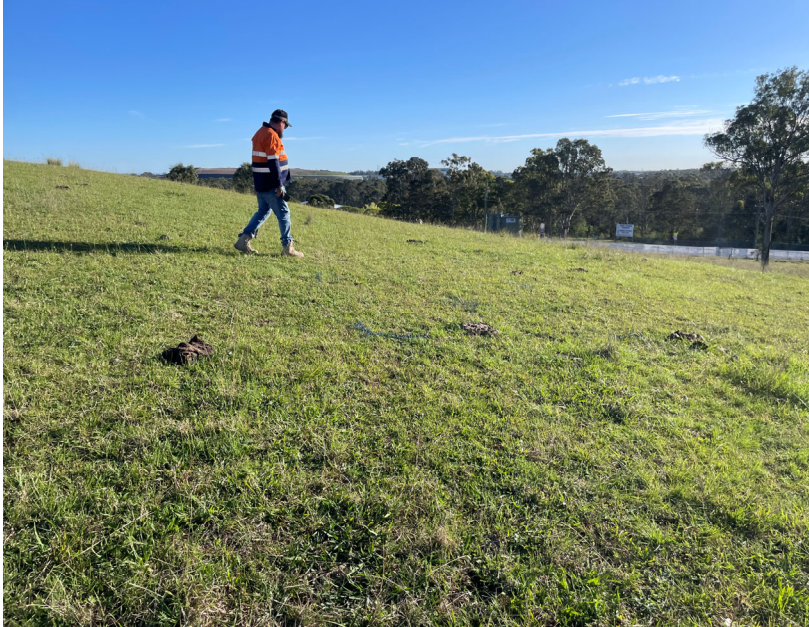
Photo 1 - General site conditions near BH101 facing north

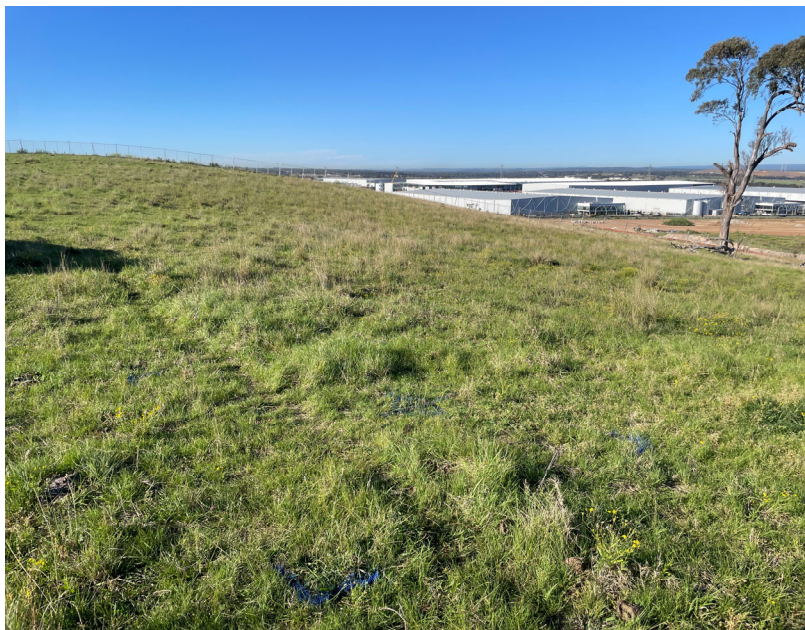
Photo 2 - General site conditions near BH102 facing south-west

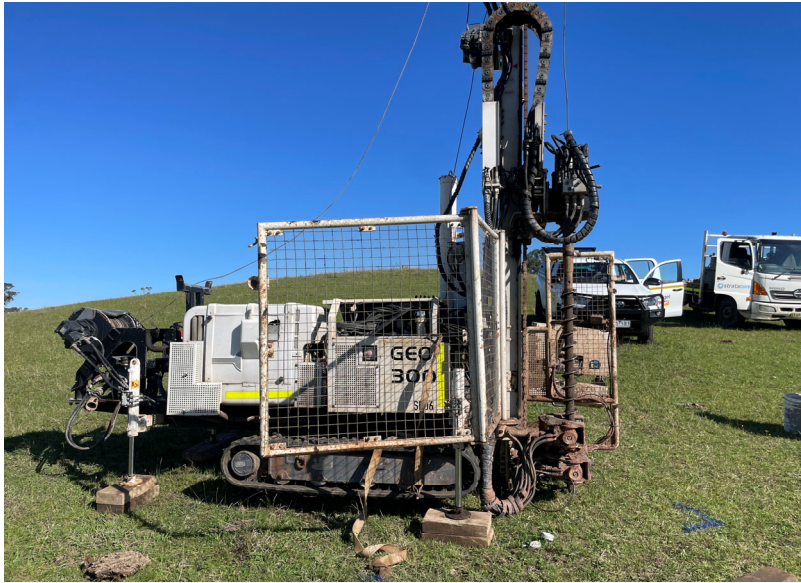
Photo 3 - Track mount drill rig (Comacchio Geo 300)

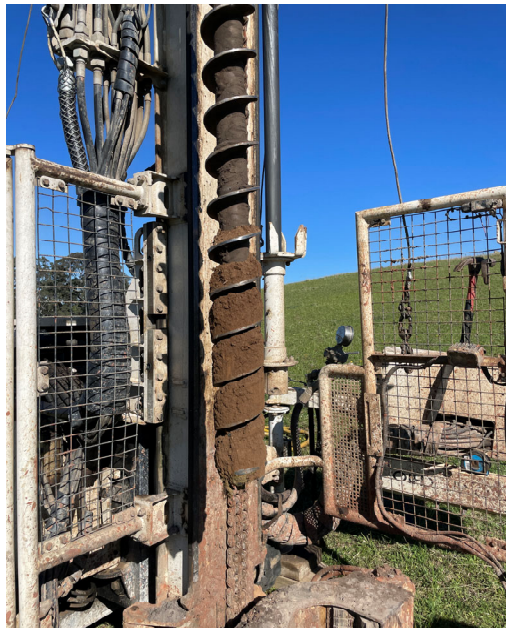
Photo 4 - Soil material from auger drilling

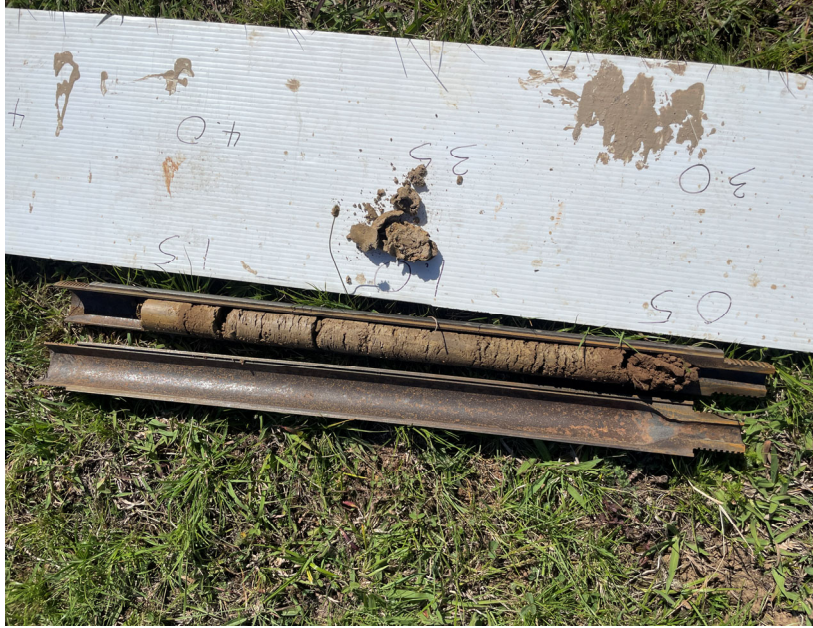
Photo 5 - Typical cutting from Standard Penetration Test

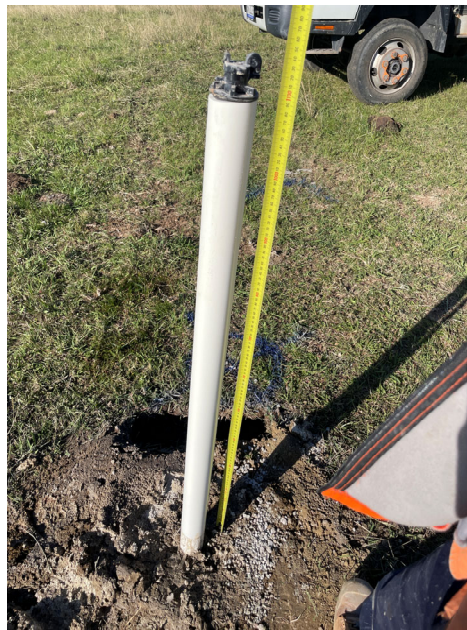
Photo 6 - Ground monitoring well stick-up

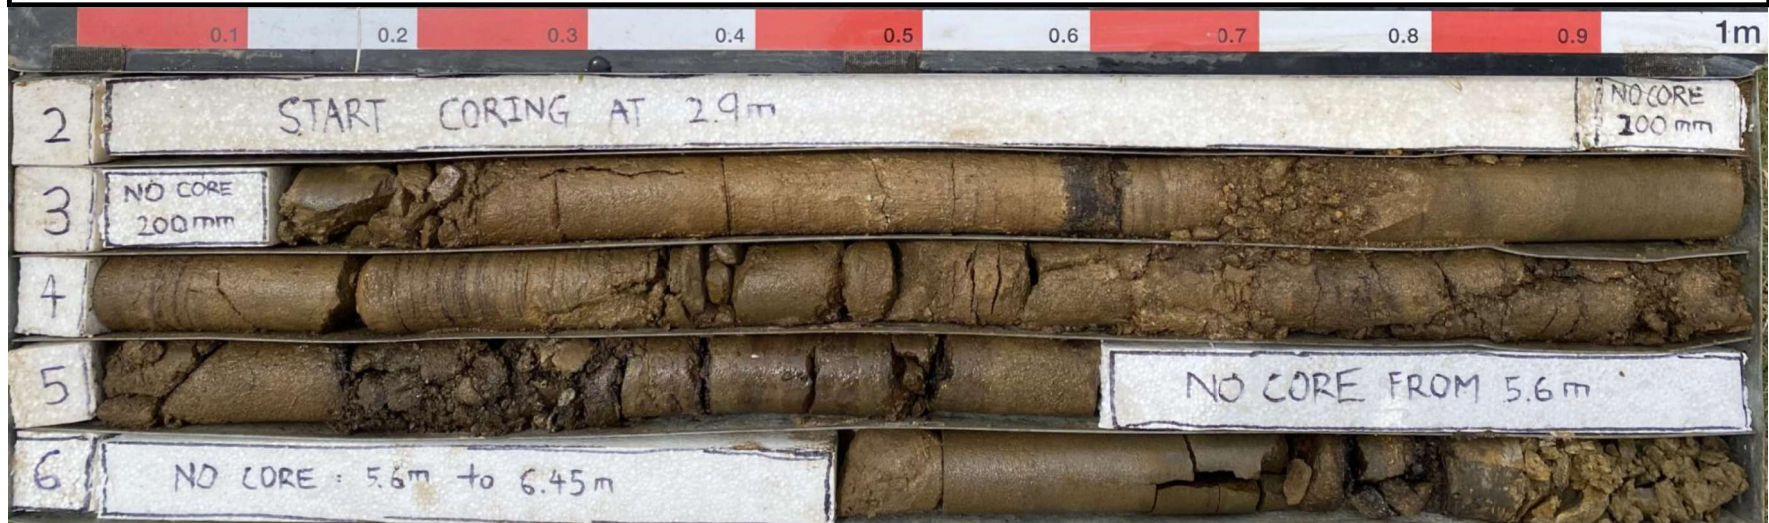
Aliro Group  
Mamre Road  
Kemps Creek  
CORE PHOTOS CH01  
(Core Photo 1 of 2)

BH ID: CH01  
FROM: 2.9 m  
TO: 7.0 m

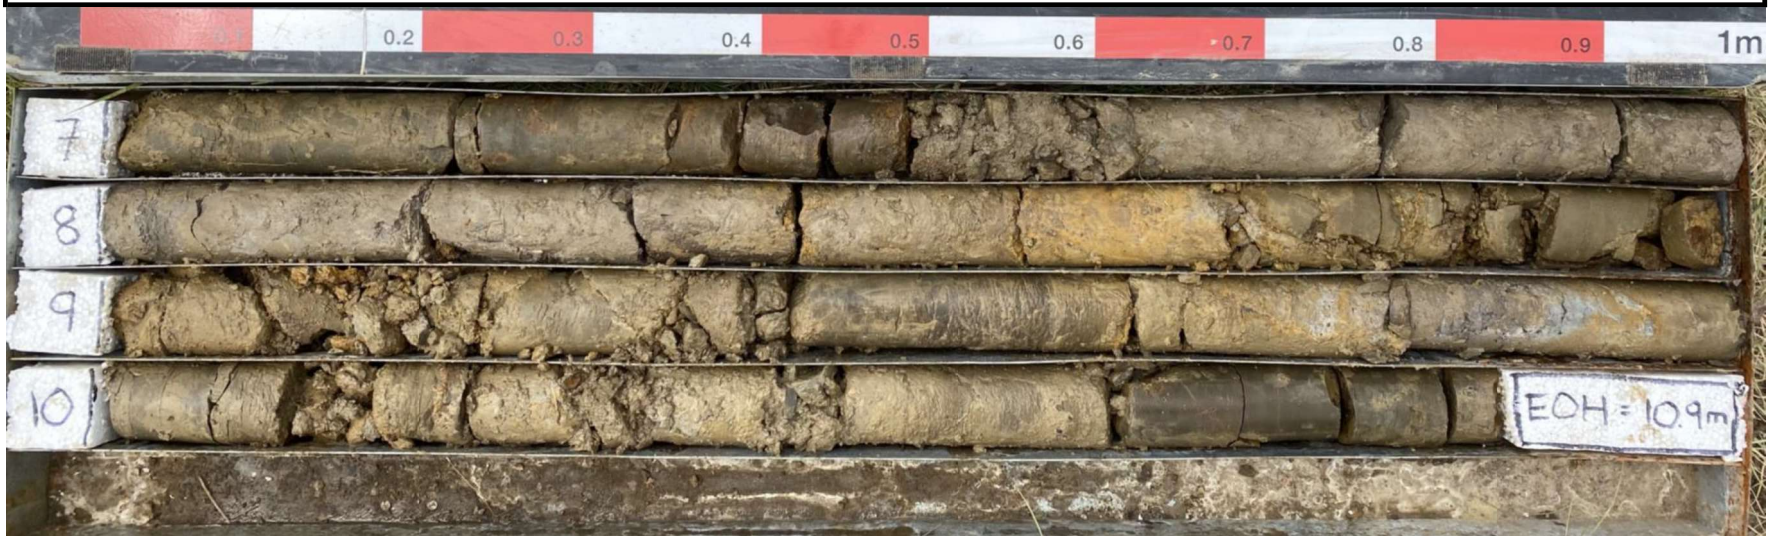
Aliro Group  
Mamre Road  
Kemps Creek  
CORE PHOTOS CH01  
(Core Photo 2 of 2)

BH ID: CH01  
FROM: 7.0 m  
TO: 10.9 m

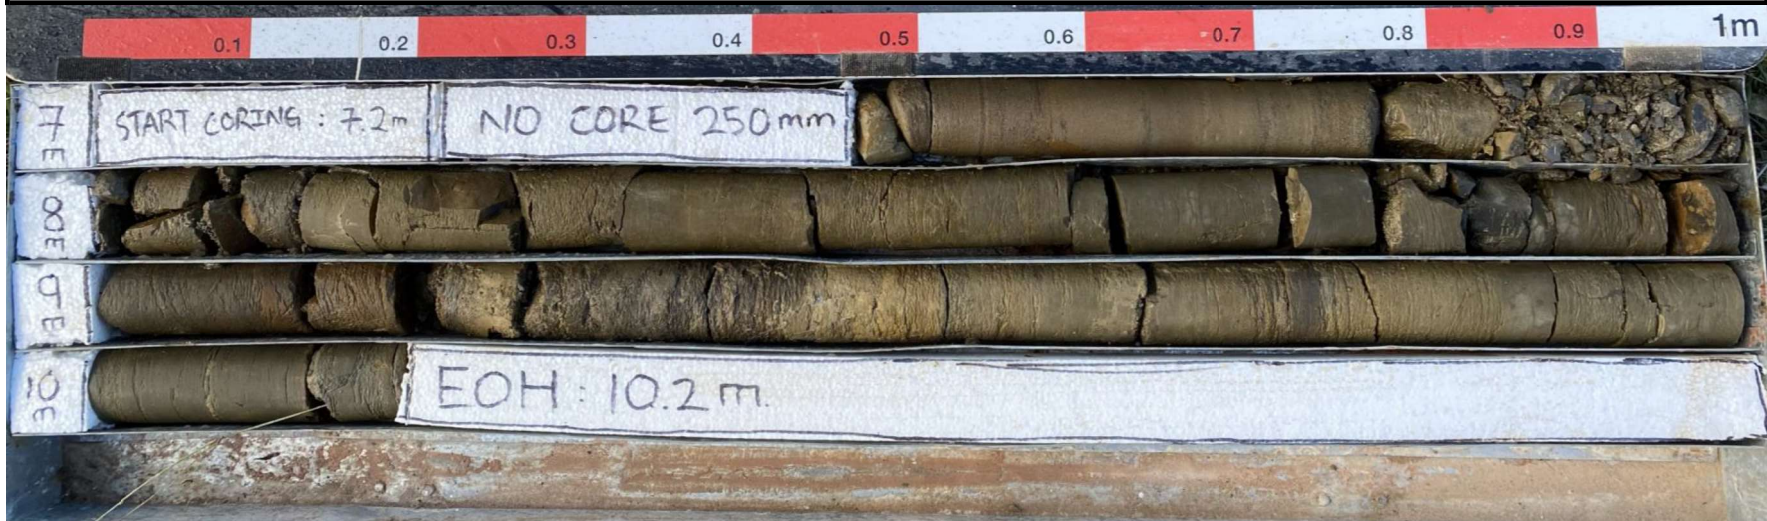
Aliro Group  
Mamre Road  
Kemps Creek  
CORE PHOTOS CH02  
(Core Photo 1 of 1)

BH ID: CH02  
FROM: 7.2 m  
TO: 10.2 m

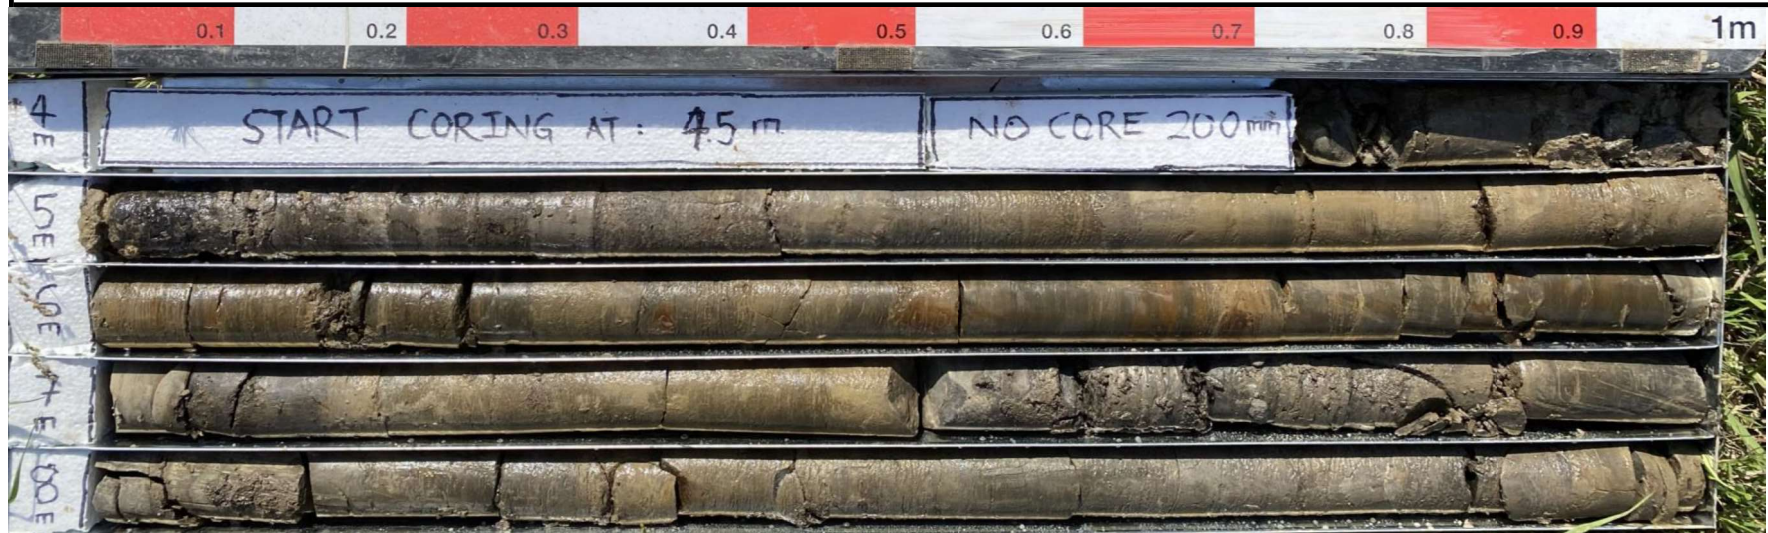
Aliro Group  
Mamre Road  
Kemps Creek  
CORE PHOTOS CH03  
(Core Photo 1 of 2)

BH ID: CH03  
FROM: 4.5 m  
TO: 9.0 m

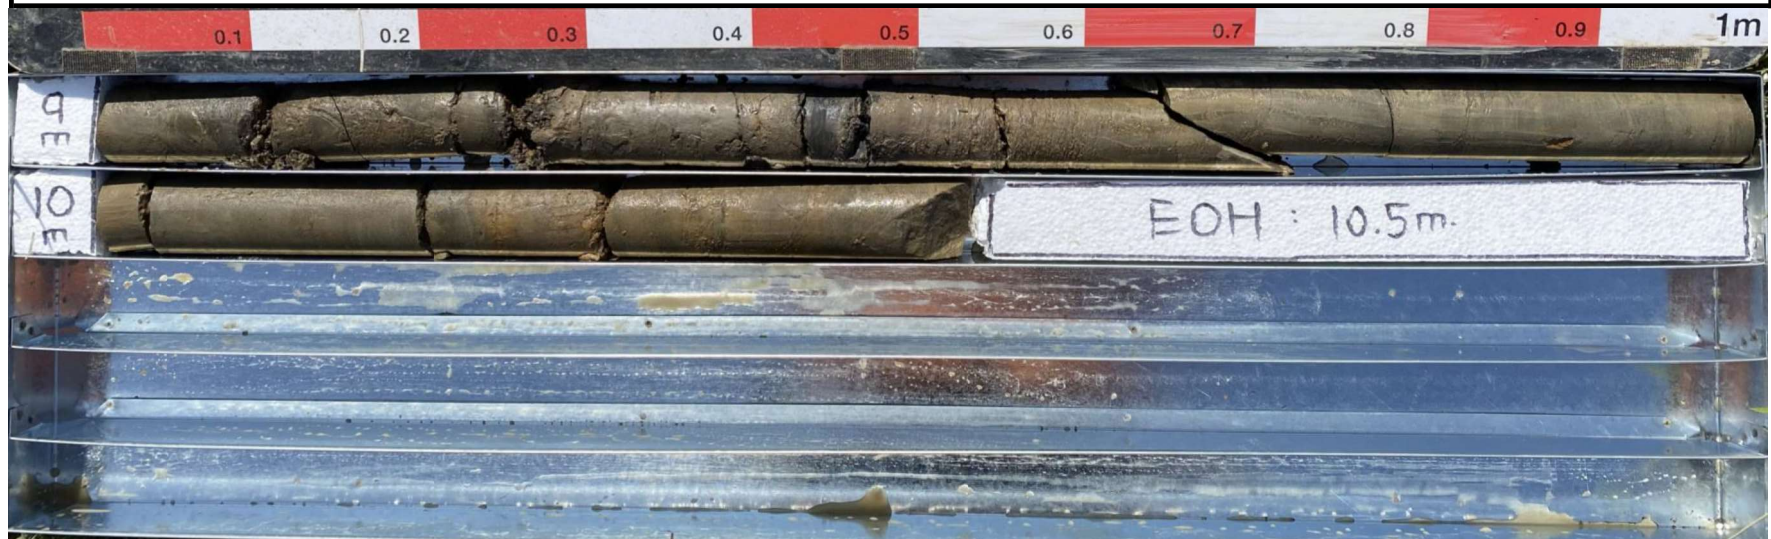
Aliro Group  
Mamre Road  
Kemps Creek  
CORE PHOTOS CH03  
(Core Photo 2 of 2)

BH ID: CH03  
FROM: 9.0 m  
TO: 10.5 m

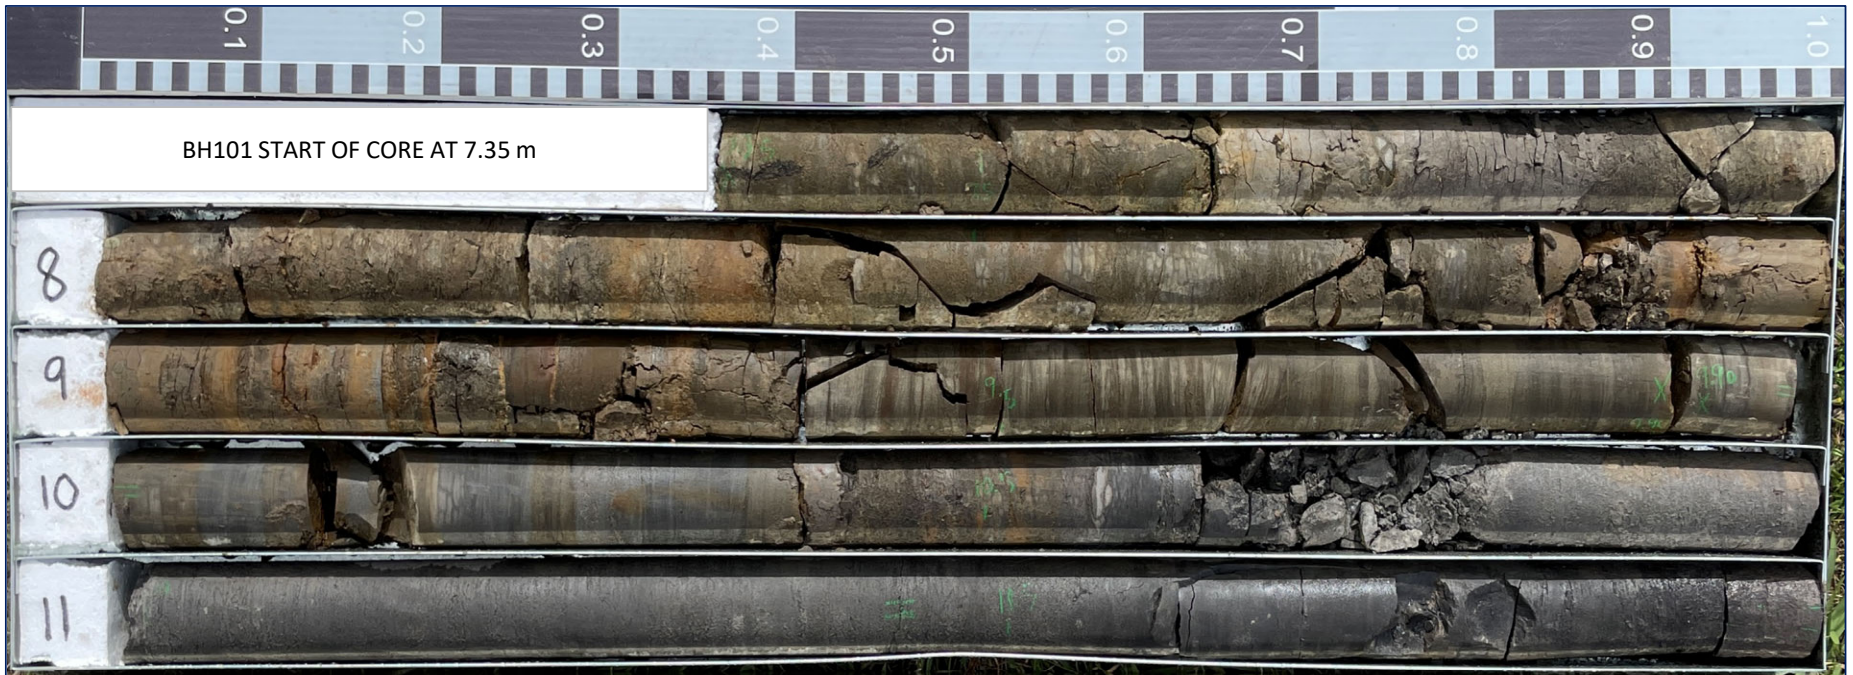
Aurecon  
706-752 Mamre Rd, Kemps Creek NSW  
Geotechnical Site Investigation  
CORE PHOTOS BH101: 7.35 m to 12.00 m  
(CORE PHOTO 1 OF 2)

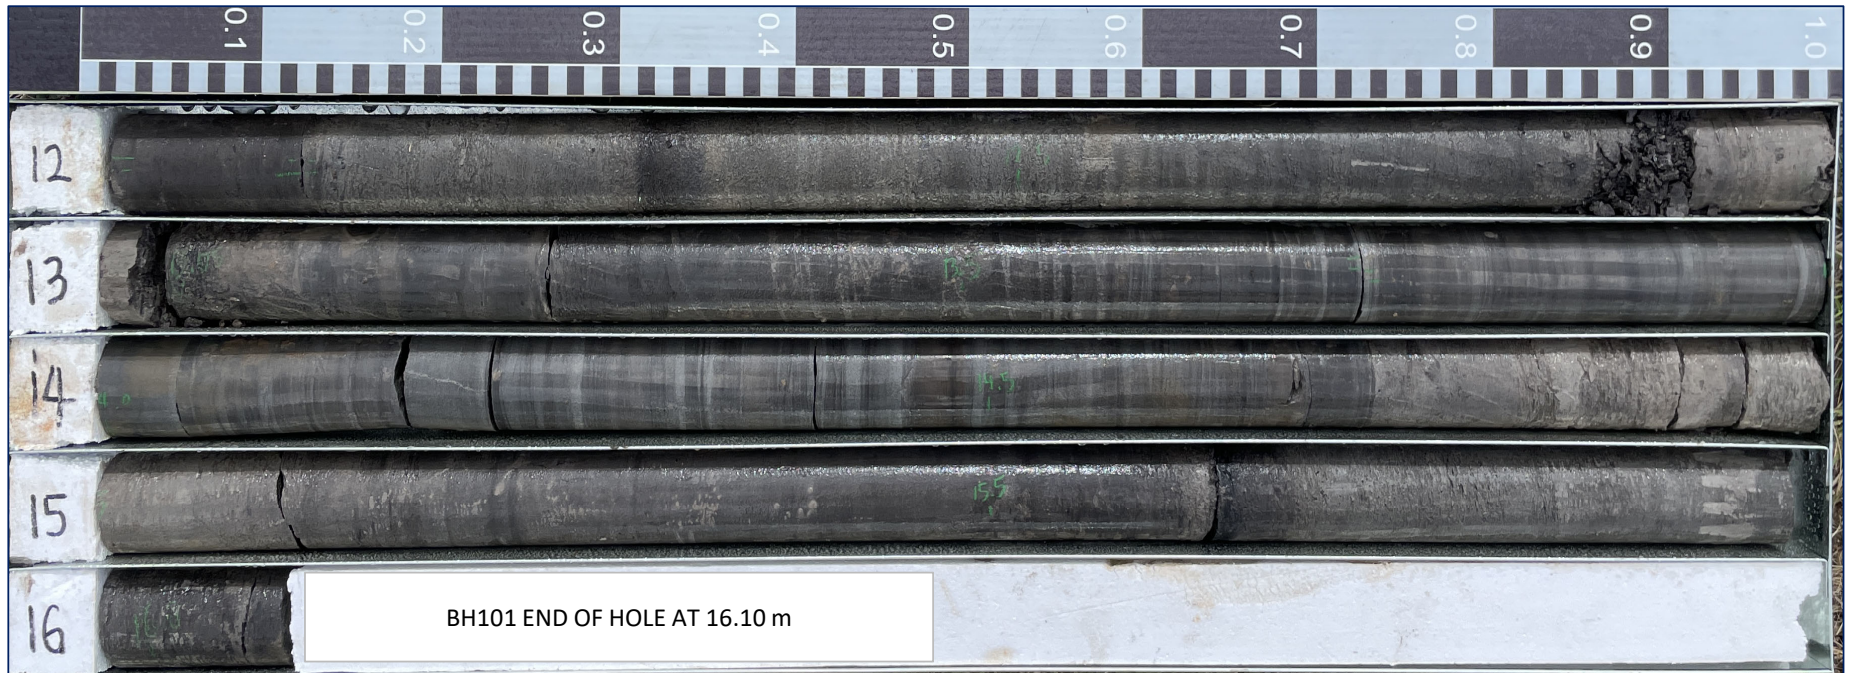
Aurecon  
706-752 Mamre Rd, Kemps Creek NSW  
Geotechnical Site Investigation  
CORE PHOTOSBH101: 12.00 m to 16.10 m  
(CORE PHOTO 2 OF 2)

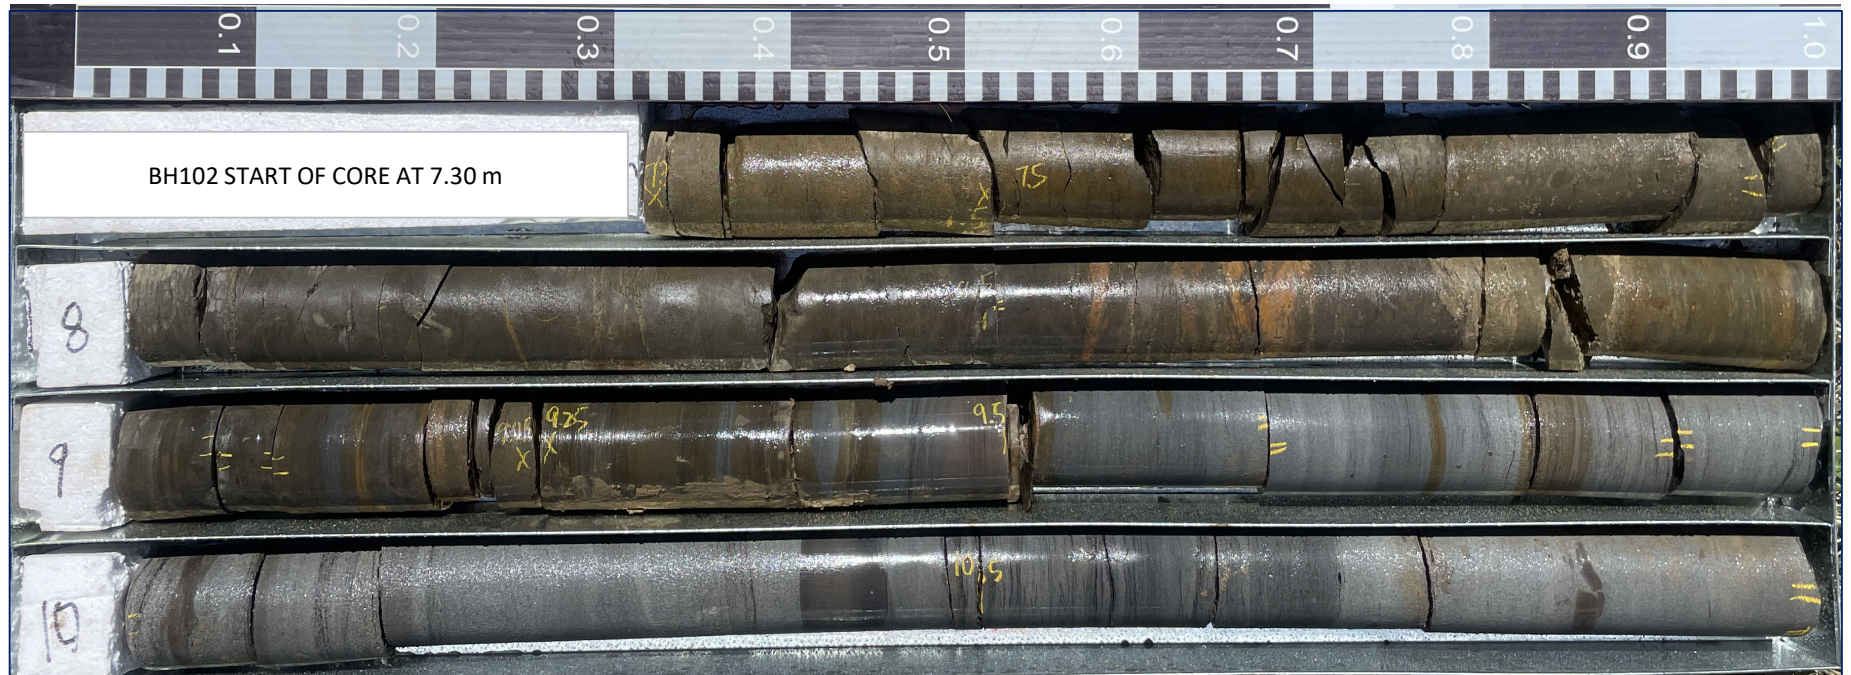
Aurecon  
706-752 Mamre Rd, Kemps Creek NSW  
Geotechnical Site Investigation  
CORE PHOTOS BH102: 7.30 m to 11.00 m  
(CORE PHOTO 1 OF 2)

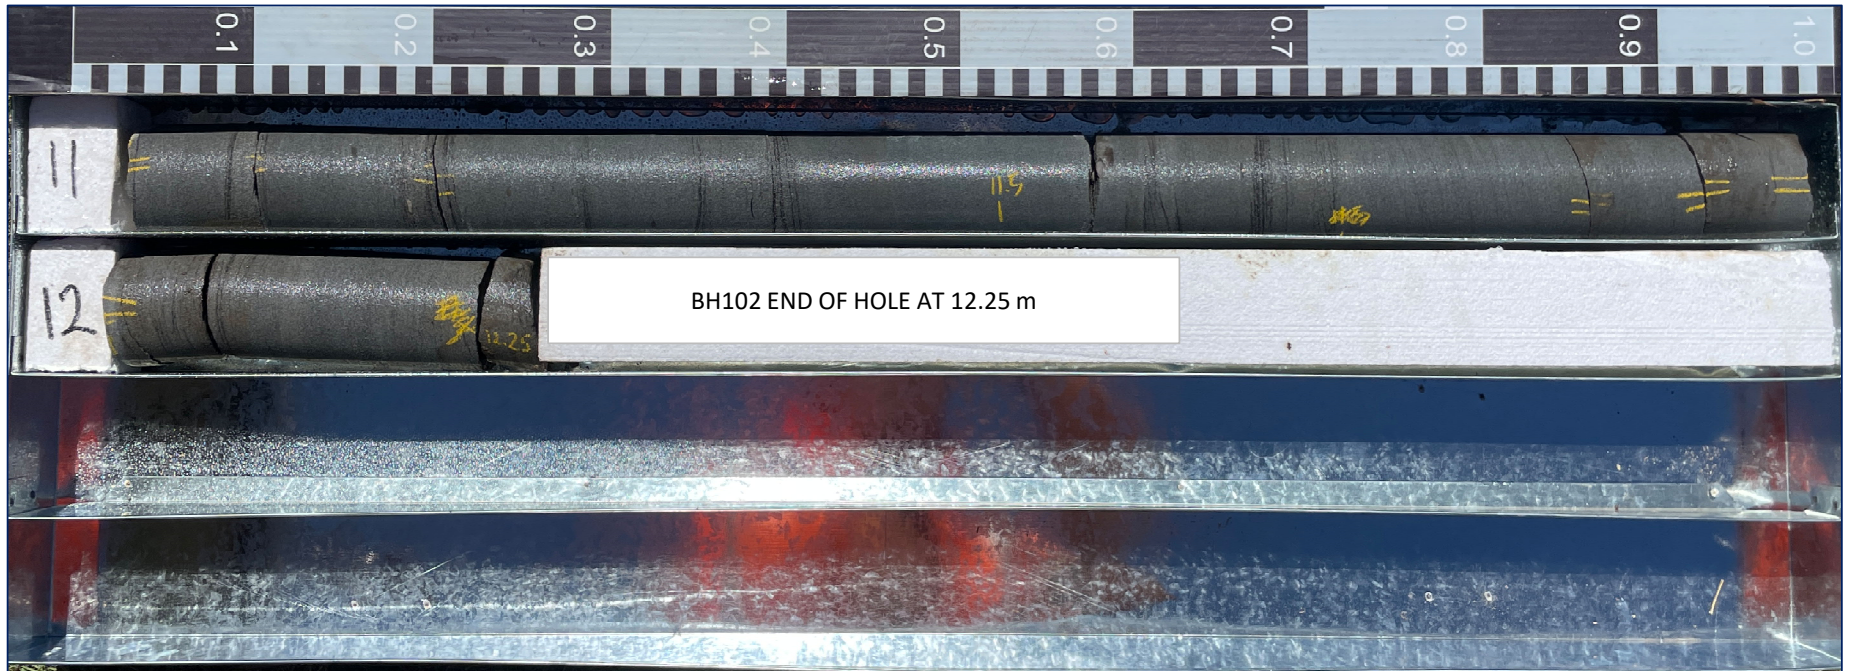
Aurecon  
706-752 Mamre Rd, Kemps Creek NSW  
Geotechnical Site Investigation  
CORE PHOTOS BH102: 11.00 m to 12.25 m  
(CORE PHOTO 2 OF 2)

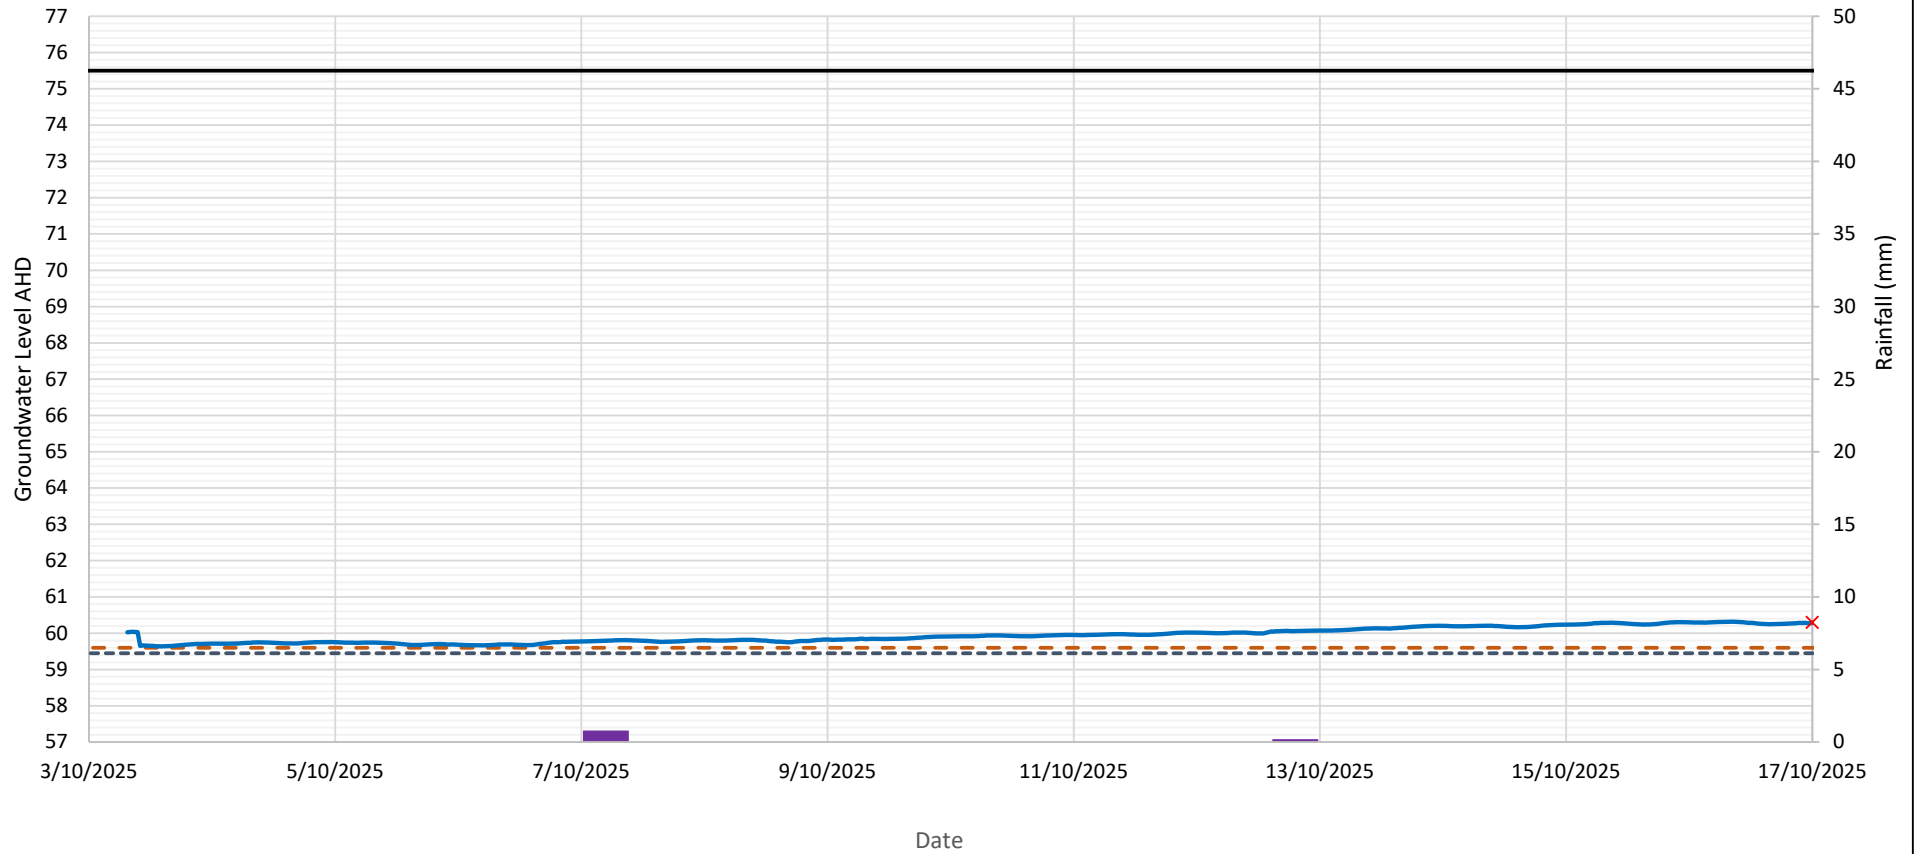
### Groundwater Level in BH101

1. Ground Surface Elevation (m AHD) 75.5
2. Instrument Elevation (m AHD) 59.6
3. Data Logger Instrument Installed on 3/10/2025
4. Bottom of Seal (m AHD) 63.0
5. Bottom of Screen (m AHD) 59.5
6. Rainfall data from BOM station 67108, downloaded 17/10/2025

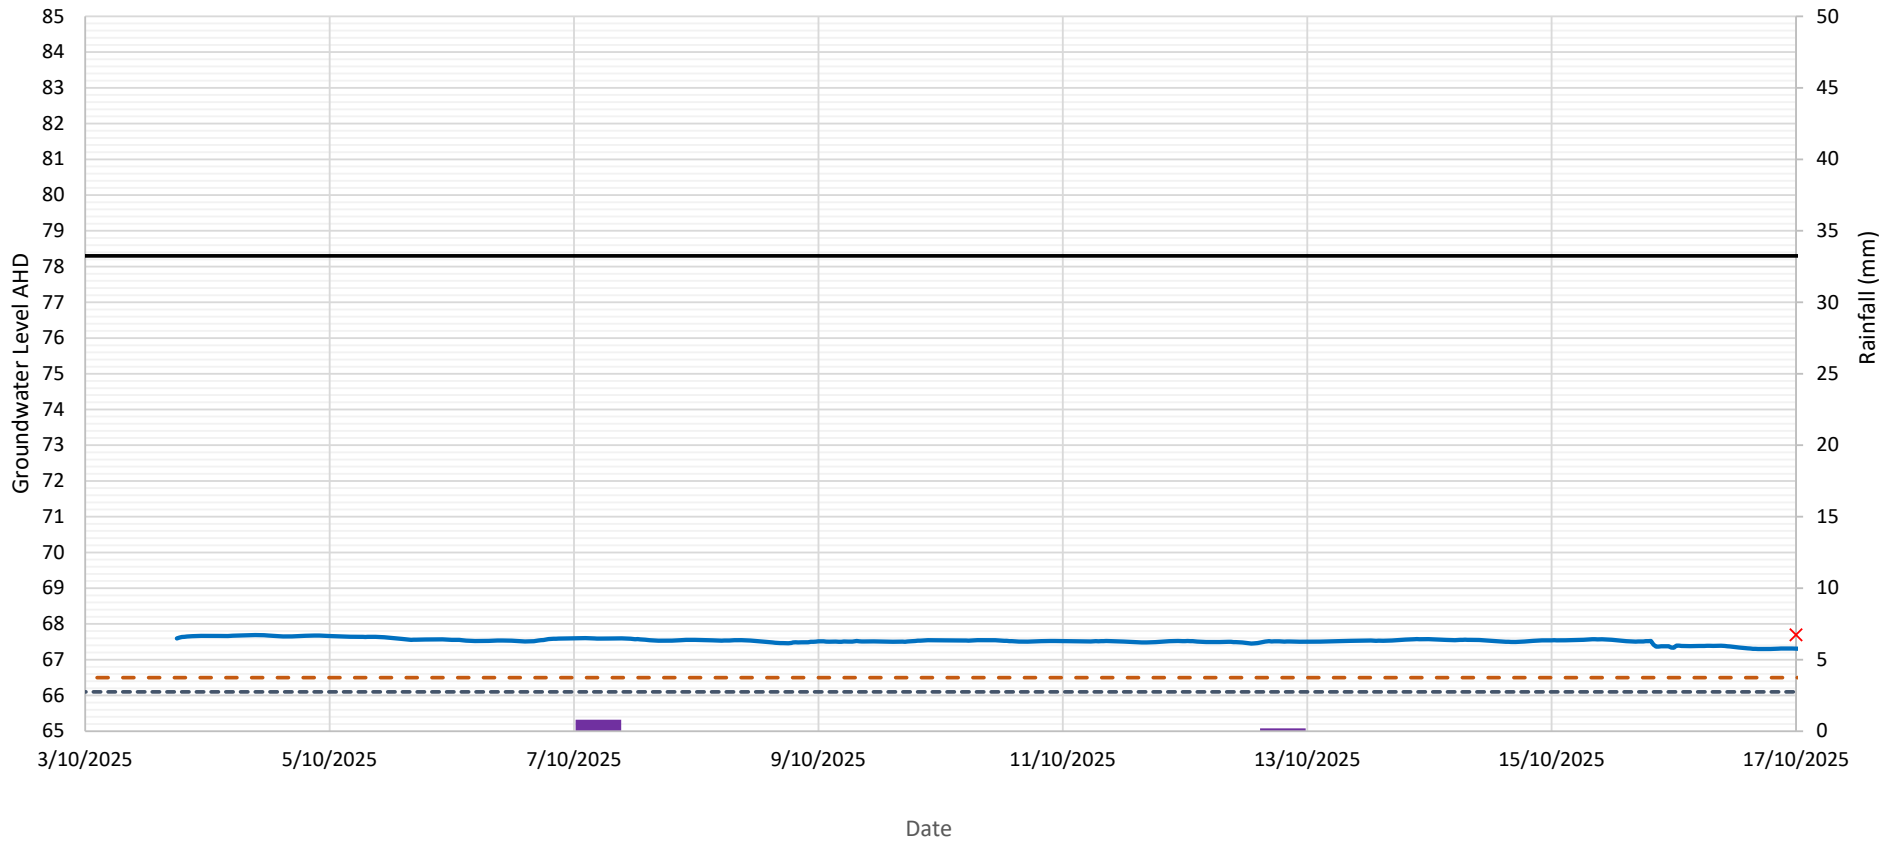
### Groundwater Level in BH102

1. Ground Surface Elevation (m AHD) **78.3**
2. Instrument Elevation (m AHD) **66.5** +0.2 m adjustment
3. Data Logger Instrument Installed on 3/10/2025
4. Bottom of Seal (m AHD) **69.6**
5. Bottom of Screen (m AHD) **66.1**
6. Rainfall data from BOM station 67108, downloaded 17/10/2025

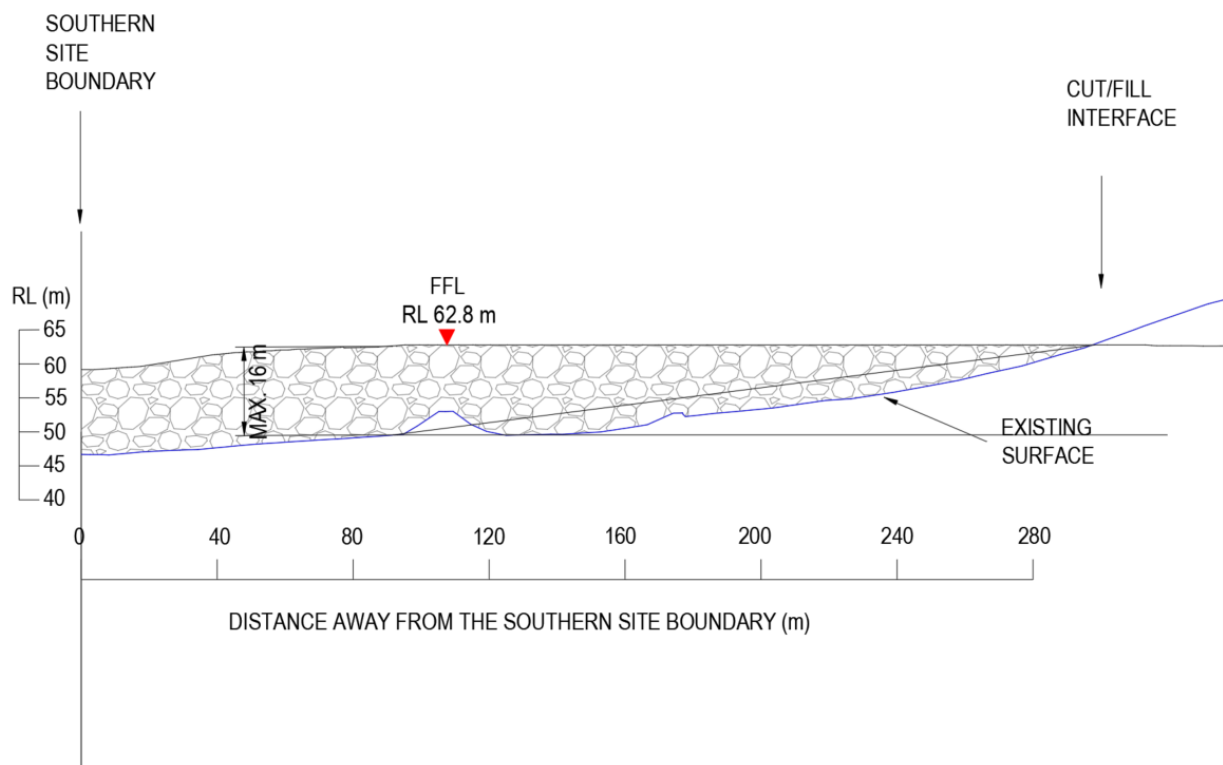
Inset 1 presents the sketch of cross section outlining the variation in ENGINEERED FILL thickness in relation to the Site. The section location is presented in Figure 1.

**Inset 1: Typical north-south section across the deep fill area of the Site showing the maximum thickness of ENGINEERED FILL to be placed during the proposed earthworks**
