# Mamre Road Data Centre Campus

## Dam Decommissioning Plan

AT&L & Associates Pty Ltd

## Report No. 21281RP7

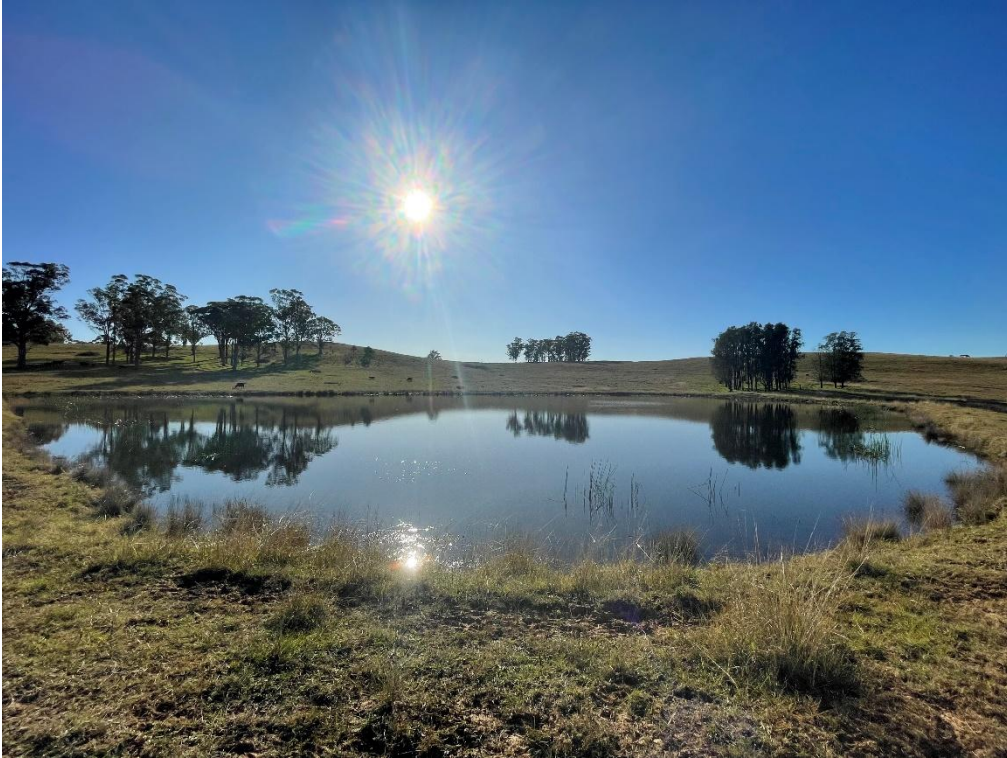
**Photograph 1 Dam 1 (large) within the Project Area**

This dam is large in size with a high-water level at the time of survey although the exact depth could not be measured. The water is of low turbidity, with no oil slicks or foam present on the surface. The walls surrounding the southern and western edges of the dam are steep, with the best access points observed on the northern and eastern sides of the dam which has a much gentler slope and solid ground.

Emergent vegetation such as *Juncus usitatus* is present along the banks of the dam, with *Eleocharis* spp. (Spikerushes) present in patches along the southern and western edges of the dam. Exotic grasses are also present along the banks of the dam, including *Ehrharta erecta* (Panic Veldtgrass), and *Cenchrus clandestinus* (Kikuyu Grass), which trail into the water in some instances.

No amphibians were sighted or heard during the survey; however, a number of native wetland birds were observed, including the Purple Swamphen (*Porphyrio porphyrio*), Little Pied Cormorant (*Microcarbo melanoleucos*), and Australian Wood Duck (*Chenonetta jubata*). No aquatic fauna were observed within the dam during surveys; however, native eels and turtles are likely to occur in the dam. The exotic European Carp (*Cyprinus carpio*) may also be present.

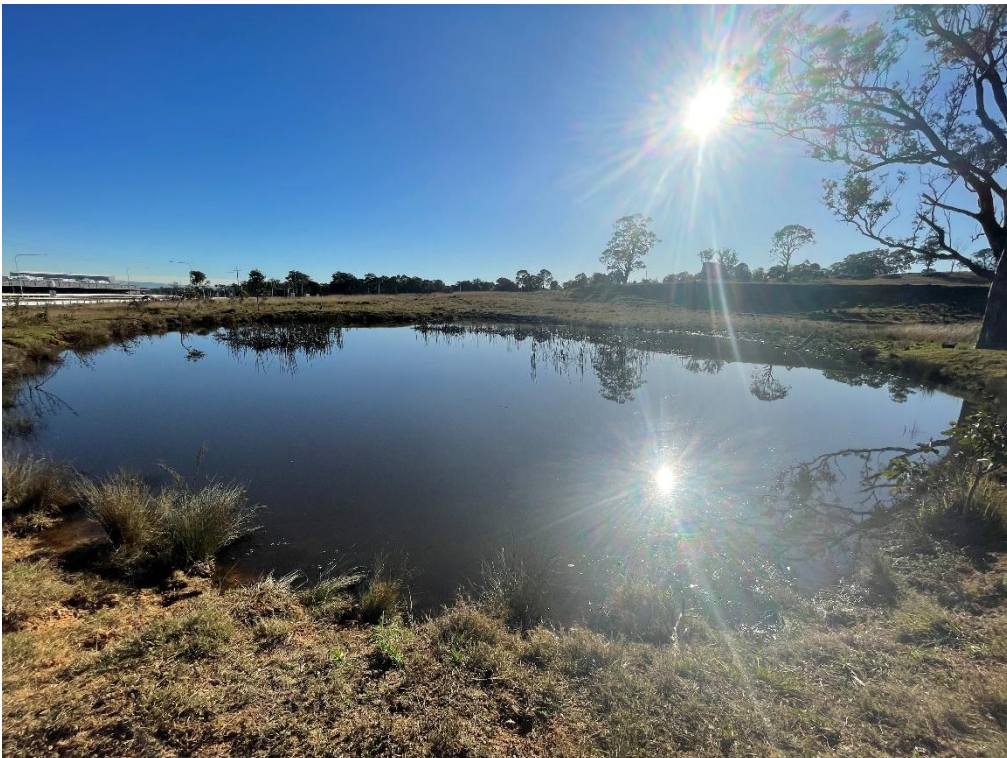
**Photograph 2 Dam 2 (small) within the Project Area**

This dam is small in size with a high-water level at the time of survey although exact depth could not be measured. The water is of low turbidity, with minor oil slicks present on the surface along the southern edge. All but the northern side of the dam is of a gentle slope and have solid ground, with the northern side having a steep wall.

Emergent vegetation such as *Juncus usitatus* is present along the banks of the dam, with patches of *Eleocharis* spp. (Spikerushes) present in the centre of the dam. Exotic grasses are also present along the banks of the dam, including *Ehrharta erecta* (Panic Veldtgrass), and *Cenchrus clandestinus* (Kikuyu Grass), which trail into the water in some instances.

No amphibians were sighted or heard during the survey; however, a number of native wetland birds were observed, including the Eurasian Coot (*Fulica atra*), Australian Wood Duck (*Chenonetta jubata*), and Grey Teal (*Anas gracilis*). No aquatic fauna were observed within the dam during surveys; however, native eels and turtles are likely to occur in the dam. The exotic European Carp (*Cyprinus carpio*) may also be present.

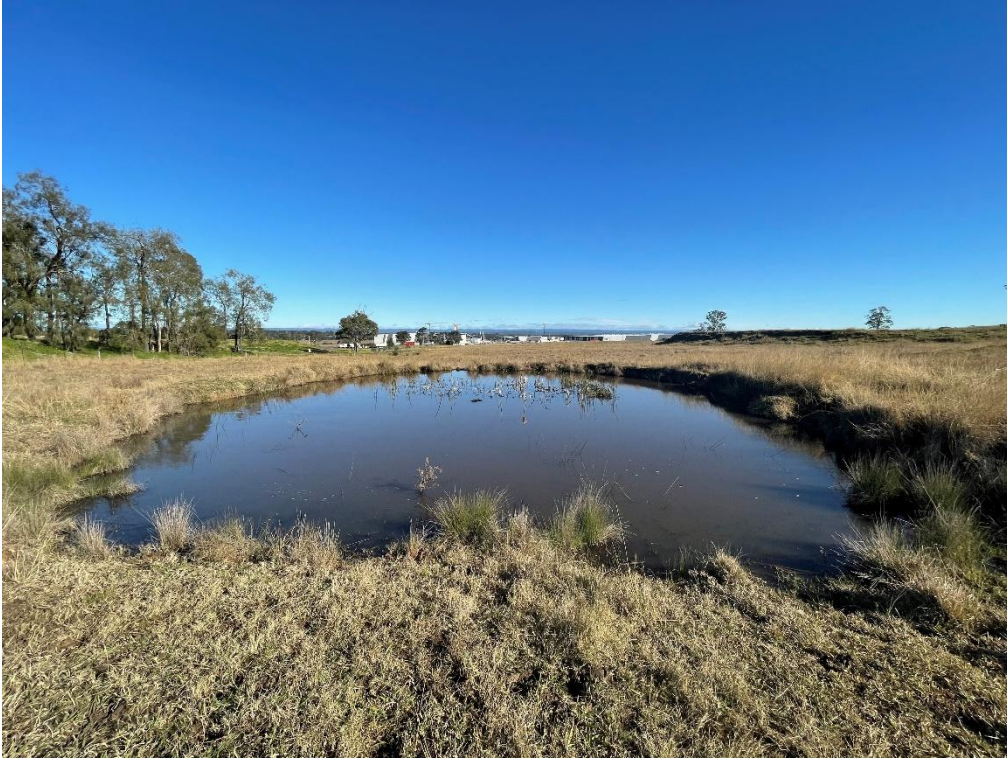
**Photograph 3 Dam 3 (small) within the Project Area**

This dam is small in size with a high-water level at the time of survey although exact depth could not be measured. The water is of moderate turbidity, with no oil slicks or foam present on the surface. All but the northern side of the dam is of a gentle slope and have solid ground, with the northern side having a steep wall.

Emergent vegetation such as *Juncus usitatus* is present along the banks of the dam, with patches of *Eleocharis* spp. (Spikerushes) present in the centre of the dam and along the eastern edge, and *Typha orientalis* (Broadleaf Cumbungi) also present in the centre of the dam. Exotic grasses are also present along the banks of the dam, including *Ehrharta erecta* (Panic Veldtgrass), and *Cenchrus clandestinus* (Kikuyu Grass), which trail into the water in some instances. Minor occurrences of *Senecio madagascariensis* (Fireweed) also occur.

The Common Eastern Froglet (*Crinia signifera*) was heard calling during the survey; however, no wetland bird species were recorded. No aquatic fauna were observed within the dam during surveys; however, native eels and turtles are likely to occur in the dam. The exotic European Carp (*Cyprinus carpio*) may also be present.

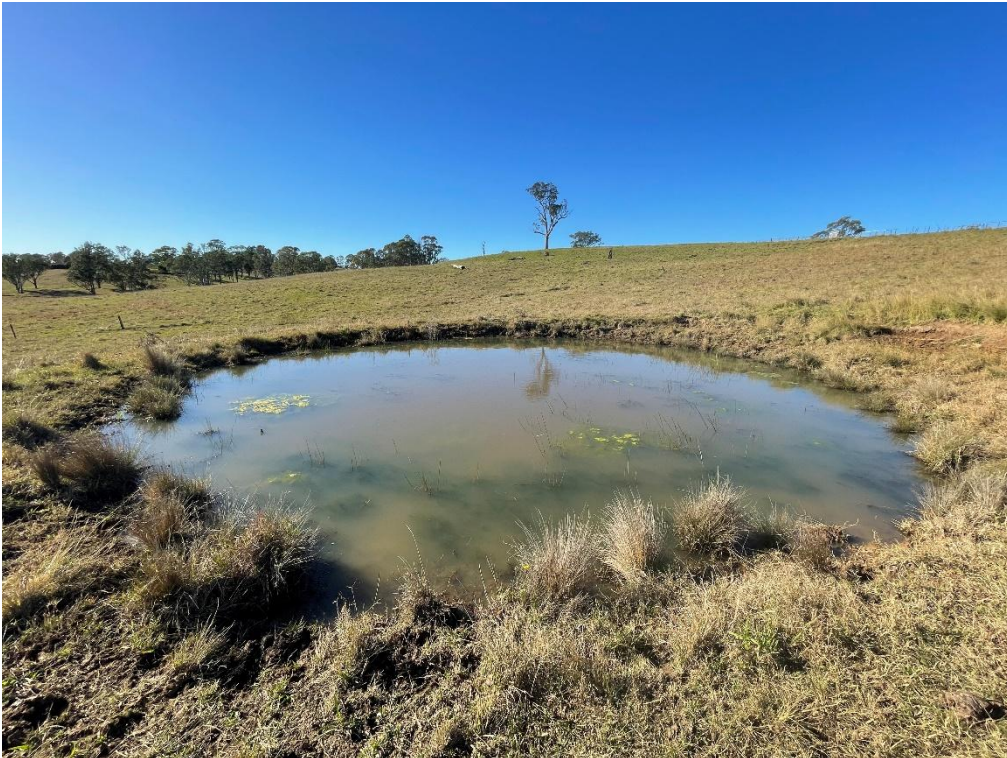
**Photograph 4 Dam 4 (small) within the Project Area**

This dam is small in size with a high-water level at the time of survey although exact depth could not be measured. The water is of moderate turbidity, with no oil slicks or foam present on the surface; however, a large algal bloom is present in this dam. All sides of the dam are of a gentle slope and have solid ground.

Emergent vegetation such as *Juncus usitatus* is present along the banks of the dam, with patches of *Eleocharis* spp. (Spikerushes) present in the centre of the dam. Exotic grasses are also present along the banks of the dam, including *Ehrharta erecta* (Panic Veldtgrass), and *Cenchrus clandestinus* (Kikuyu Grass), which trail into the water in some instances.

No amphibians or wetland birds were sighted or heard, and no aquatic fauna were observed within the dam during surveys. Based on the presence of an algal bloom, aquatic fauna such as eels and turtles, or the European Carp (*Cyprinus carpio*), are unlikely to be present in the dam.

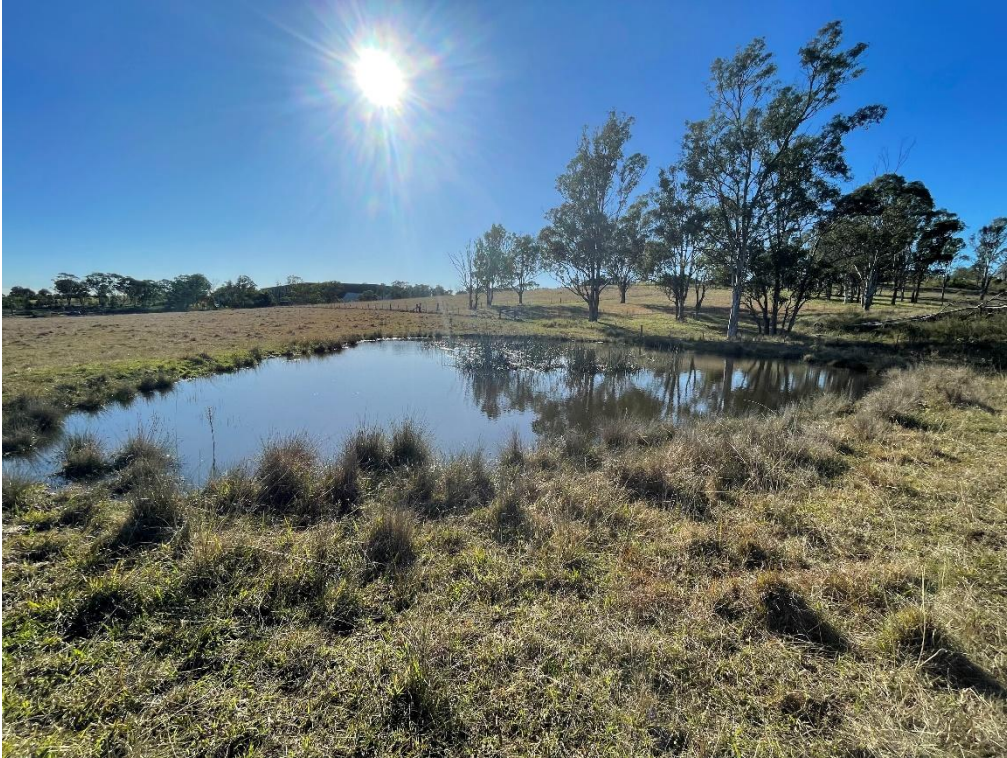
**Photograph 5 Dam 5 (small) within the Project Area**

This dam is small in size with a high-water level at the time of survey although exact depth could not be measured. The water is of low turbidity, with no oil slicks or foam present on the surface. All sides of the dam are of a gentle slope and have solid ground.

Emergent vegetation such as *Juncus usitatus* is present along the banks of the dam, with a large patch of *Eleocharis* spp. (Spikerushes) present in the centre of the dam. Exotic grasses are also present along the banks of the dam, including *Ehrharta erecta* (Panic Veldtgrass), and *Cenchrus clandestinus* (Kikuyu Grass), which trail into the water in some instances.

The Common Eastern Froglet (*Crinia signifera*) was heard calling during the survey; however, no wetland bird species were recorded. No aquatic fauna were observed within the dam during surveys; however, native eels and turtles are likely to occur in the dam. The exotic European Carp (*Cyprinus carpio*) may also be present.

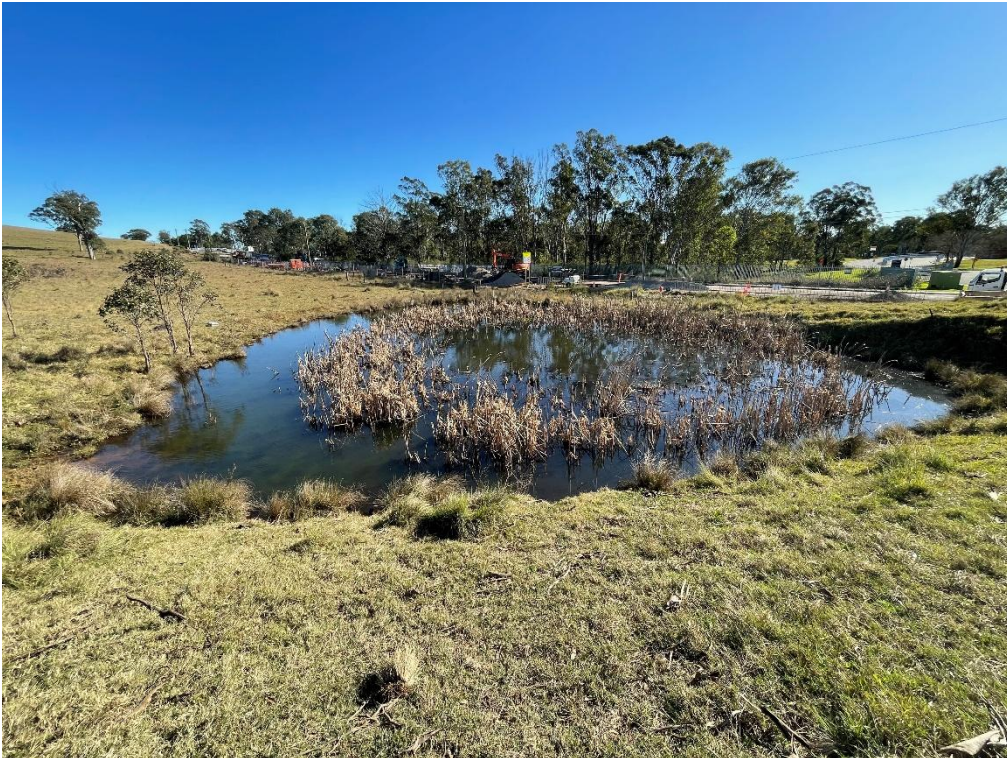
**Photograph 6 Dam 6 (small) within the Project Area**

This dam is small in size with a high-water level at the time of survey although exact depth could not be measured. The water is of low turbidity, with oil slicks present on the surface along the eastern edge of the dam, and a large algal bloom also present. All sides of the dam are of a gentle slope and have solid ground.

Emergent vegetation such as *Juncus usitatus* is present along the banks of the dam, with a large patch of *Typha orientalis* (Broadleaf Cumbungi) present in a circle around the centre of the dam. Exotic grasses are also present along the banks of the dam, including *Ehrharta erecta* (Panic Veldtgrass), and *Cenchrus clandestinus* (Kikuyu Grass), which trail into the water in some instances.

No amphibians or wetland birds were sighted or heard, and no aquatic fauna were observed within the dam during surveys. Based on the presence of an algal bloom, aquatic fauna such as eels and turtles, or the European Carp (*Cyprinus carpio*), are unlikely to be present in the dam.

Additionally, a hollow-bearing tree is located in close proximity to this dam, which is currently occupied by a pair of Red-rumped Parrots (*Psephotus haematonotus*).

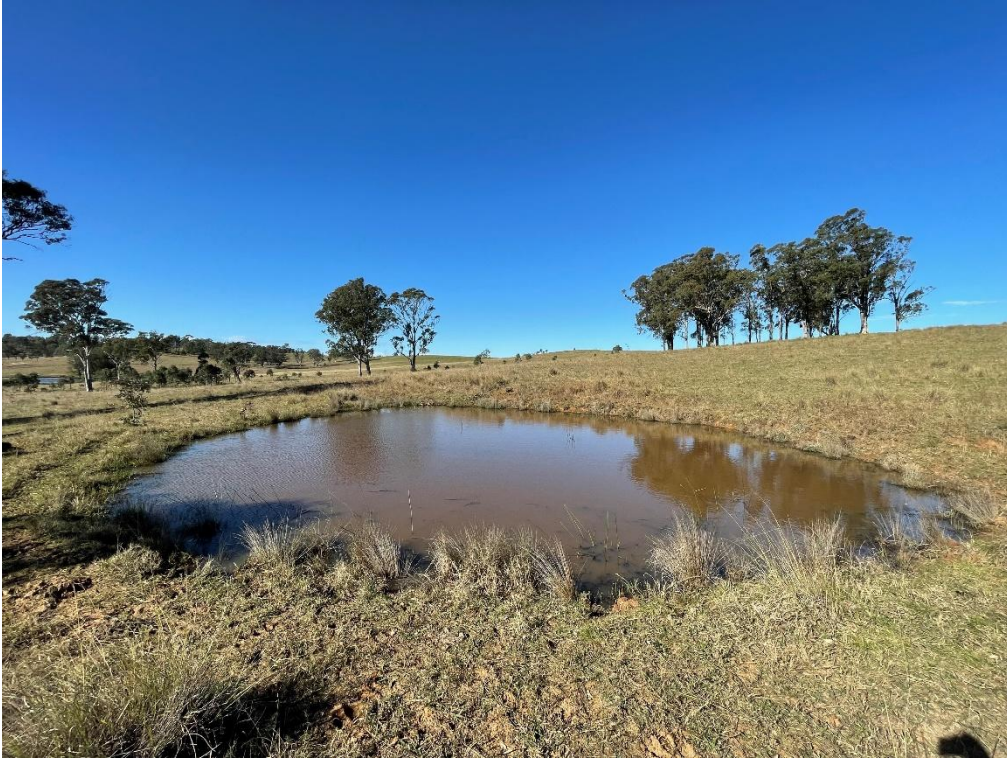
**Photograph 7 Dam 7 (small) within the Project Area**

This dam is small in size with a high-water level at the time of survey although exact depth could not be measured. The water is of high turbidity, with no oil slicks or foam present on the surface. All sides of the dam are of a gentle slope and have solid ground.

Emergent vegetation such as *Juncus usitatus* is present along the banks of the dam, with small patches of *Eleocharis* spp. (Spikerushes) present within the dam. Exotic grasses are also present along the banks of the dam, including *Ehrharta erecta* (Panic Veldtgrass), and *Cenchrus clandestinus* (Kikuyu Grass), which trail into the water in some instances.

The Common Eastern Froglet (*Crinia signifera*) was heard calling during the survey; however, no wetland bird species were recorded. No aquatic fauna were observed within the dam during surveys; however, native eels and turtles are likely to occur in the dam. The exotic European Carp (*Cyprinus carpio*) may also be present.

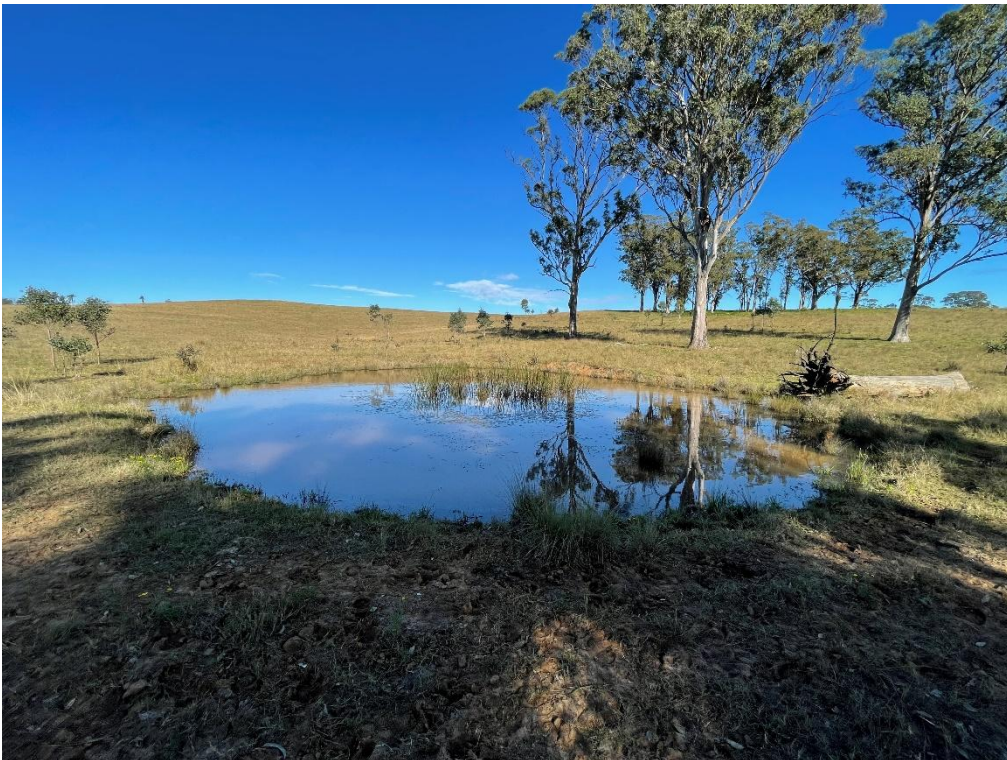
**Photograph 8 Dam 8 (small) within the Project Area**

This dam is small in size with a high-water level at the time of survey although exact depth could not be measured. The water is of high turbidity, with no oil slicks or foam present on the surface. All sides of the dam are of a gentle slope and have solid ground.

Emergent vegetation such as *Juncus usitatus* is present along the banks of the dam, with patches of *Eleocharis* spp. (Spikerushes) present within the dam. Exotic grasses are also present along the banks of the dam, including *Ehrharta erecta* (Panic Veldtgrass), and *Cenchrus clandestinus* (Kikuyu Grass), which trail into the water in some instances.

The Common Eastern Froglet (*Crinia signifera*) was heard calling during the survey; however, no wetland bird species were recorded. No aquatic fauna were observed within the dam during surveys; however, native eels and turtles are likely to occur in the dam. The exotic European Carp (*Cyprinus carpio*) may also be present.

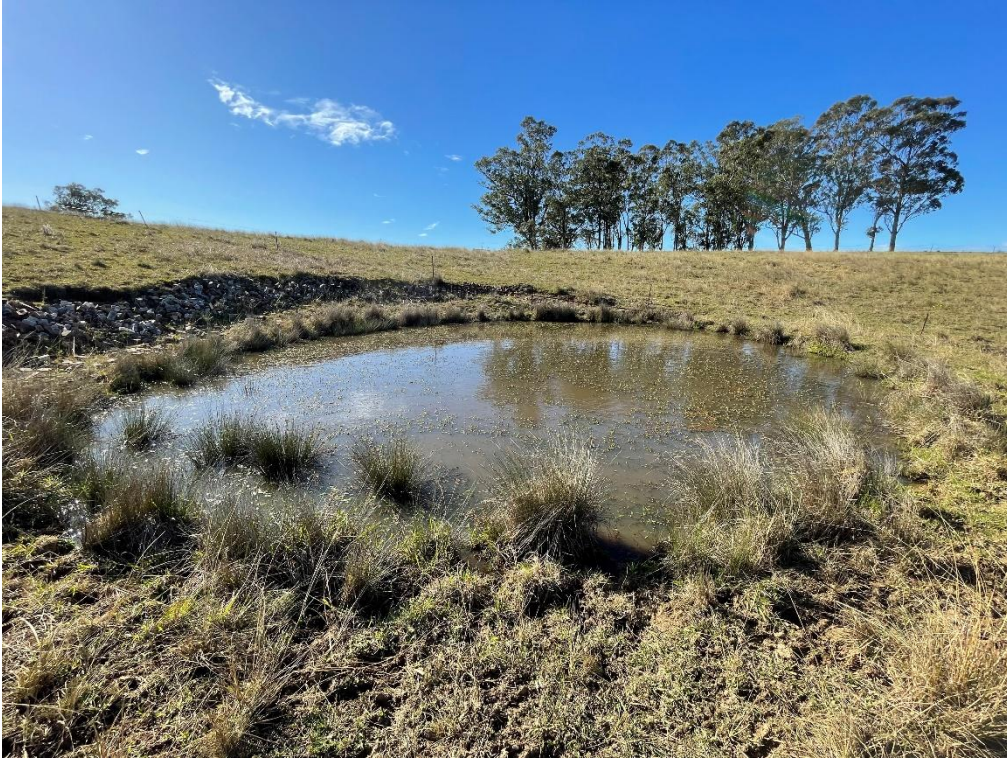
**Photograph 9 Dam 9 (small) within the Project Area**

No amphibians or wetland birds were seen or heard calling, and no aquatic fauna were observed within the dam during the survey; however, native eels and turtles are likely to occur in the dam. The exotic European Carp (*Cyprinus carpio*) may also be present.

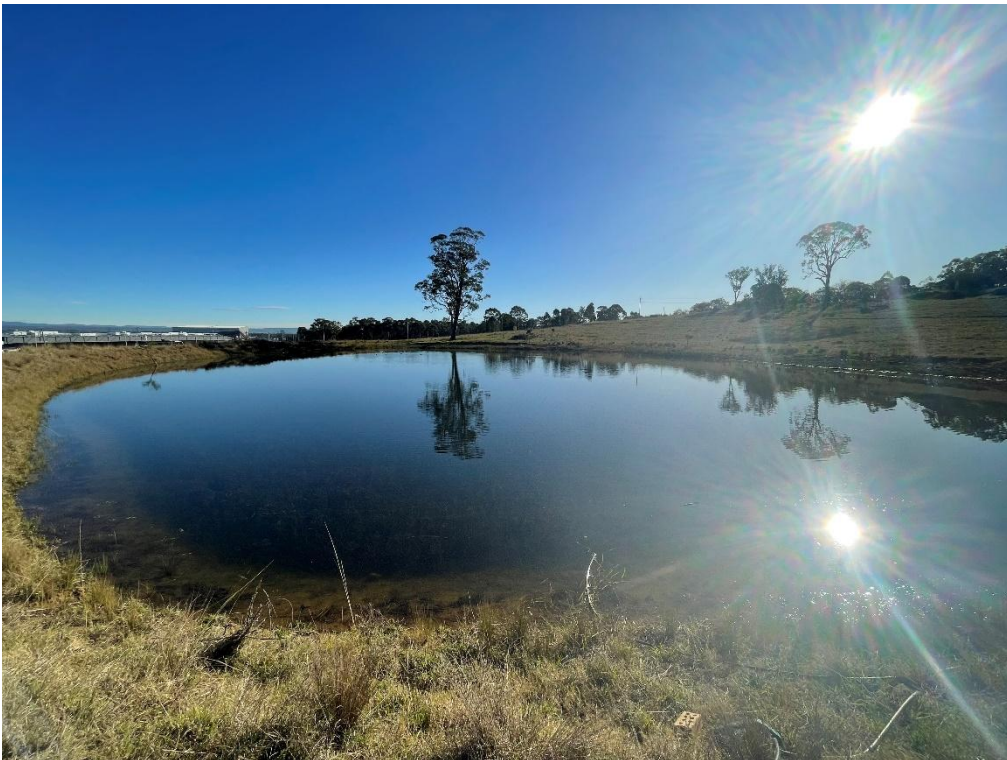
**Photograph 10 Dam 10 (large) within the Project Area**

This dam is large in size with a high-water level at the time of survey although the exact depth could not be measured. The water is of very low turbidity, with no oil slicks or foam present on the surface. The walls surrounding the southern and western edges of the dam are steep, with the best access points observed on the northern and eastern sides of the dam which has a much gentler slope and solid ground.

No amphibians were sighted or heard during the survey; however, a number of native wetland birds were observed, including the Eurasian Coot (*Fulica atra*), and Australian Wood Duck (*Chenonetta jubata*). No aquatic fauna were observed within the dam during surveys; however, native eels and turtles are likely to occur in the dam. The exotic European Carp (*Cyprinus carpio*) may also be present.

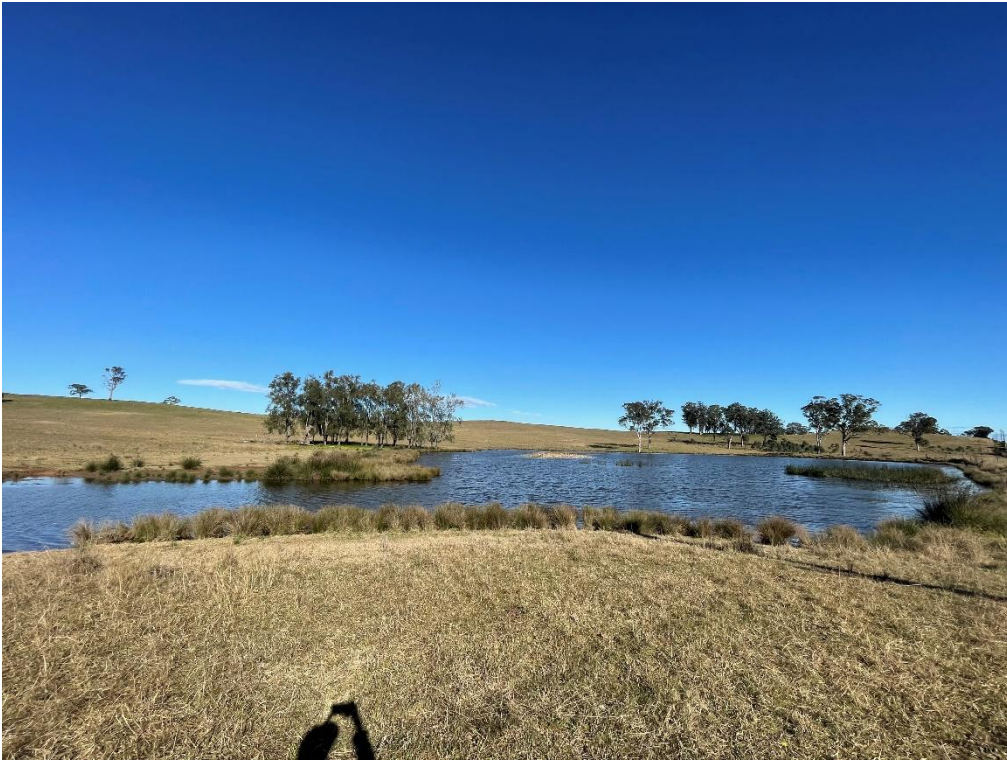
**Photograph 11 Dam 11 (large) within the Project Area**

This dam is the largest on the site, with a high-water level at the time of survey although the exact depth could not be measured. The water is of low turbidity, with no oil slicks or foam present on the surface. The walls surrounding the southern and western edges of the dam are steep, with the best access points observed on the northern and eastern sides of the dam which has a much gentler slope and solid ground.

No amphibians were sighted or heard during the survey; however, a number of native wetland birds were observed, including the Eurasian Coot (*Fulica atra*), Australasian Grebe (*Tachybaptus novaehollandiae*), Australian Wood Duck (*Chenonetta jubata*), and Little Pied Cormorant (*Microcarbo melanoleucos*). No aquatic fauna were observed within the dam during surveys; however, native eels and turtles are likely to occur in the dam. The exotic European Carp (*Cyprinus carpio*) may also be present.
