MOSMAN LAND NO.1 PTY LTD

Geotechnical Investigation

40-48 Redan Street, Mosman NSW

E26955.G03
28 January 2026

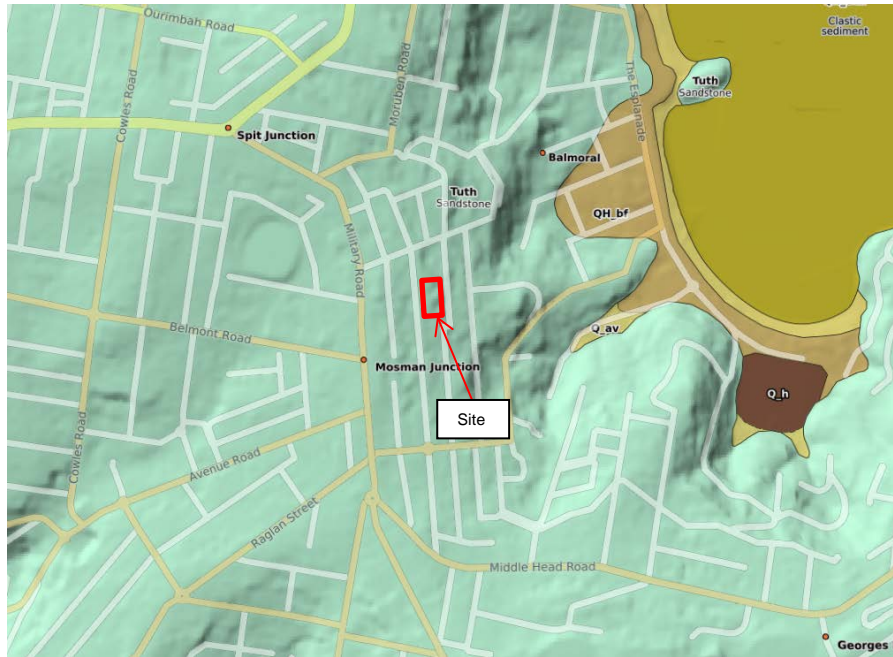
Plate 2 Regional Geological Setting (Source: MinView).

Attribute	Description
Topography	The topography of the area and the site generally slopes down to the east at 7° to 9°. The site itself is located toward the middle of an east facing hillside and ground surface levels range between approximately RL 64m AHD to RL 55m AHD.
Geology (Source: MinView)	Plate 2 below presents an extract of the MinView 'NSW Seamless Geology' version 2.4 map showing the site location within the local geology and indicates that the site is located on Hawkesbury Sandstone. Hawkesbury Sandstone typically comprises medium to coarse-grained quartz sandstone displaying small to large scale, high-angle cross-bedding with minor shale and laminate lenses.

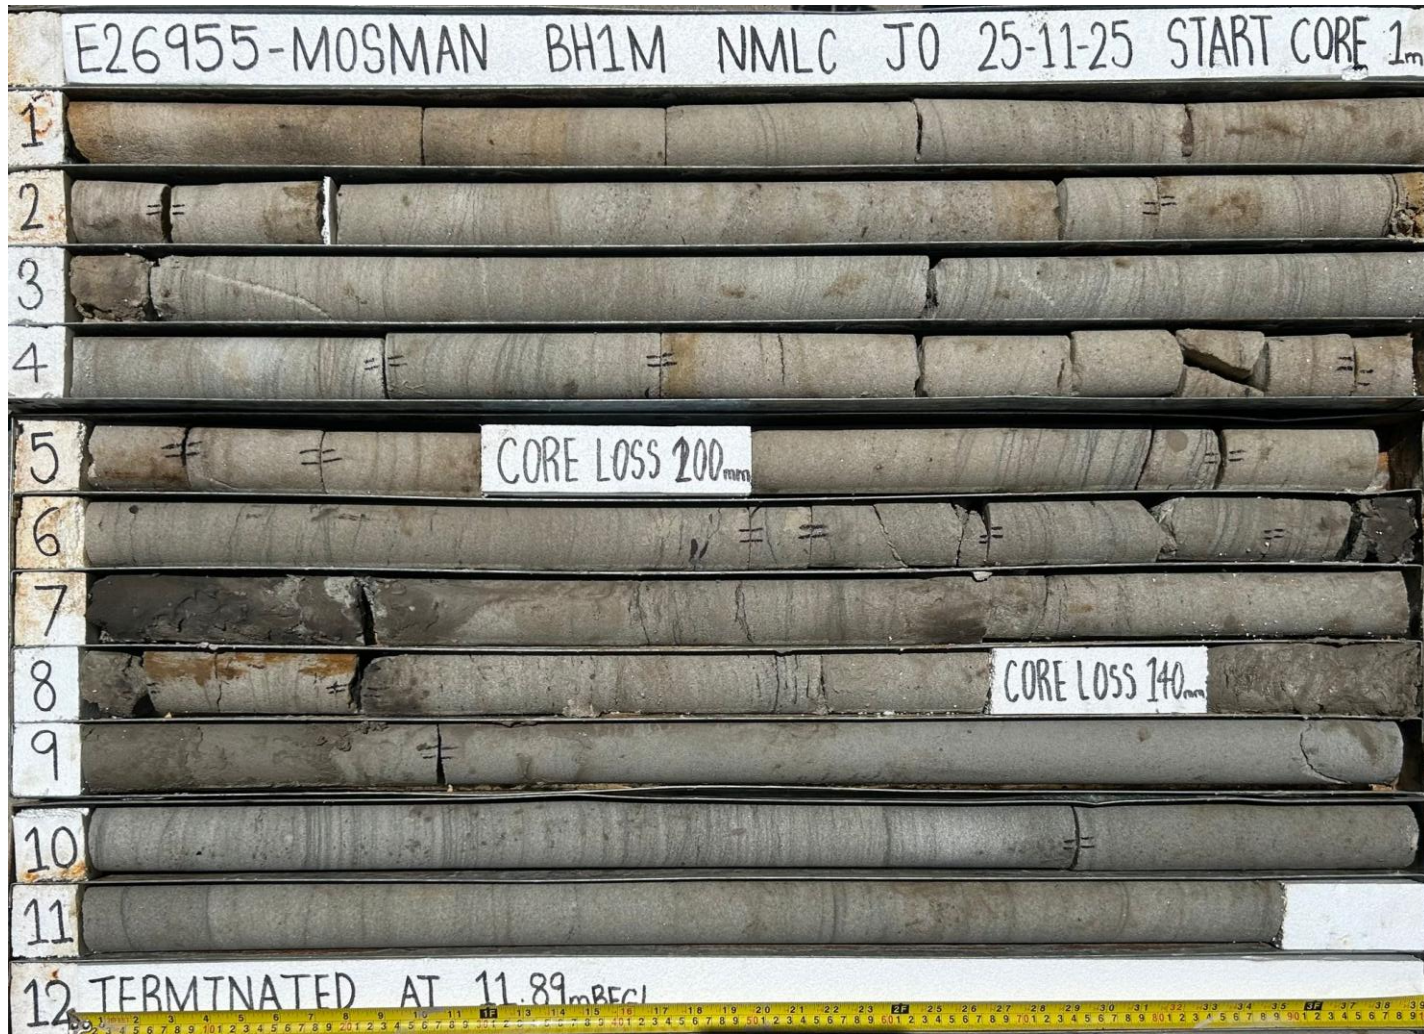
CORE PHOTOGRAPH OF BOREHOLE: BH1M

Project	Proposed Residential Development	East	337730.4	Depth Range	1.00m to 11.89m
Location	40-48 Redan Street, Mosman	North	6255582.0	Contractor	Hard Access Drilling
Position	See Figure 2	Surface RL	~59.1m	Drill Rig	Tight-Access Drilling Frame
Job No.	E26955.G03	Inclination	90°	Logged	JO Date 25/11/25
Client	Mosman Land No.1 Pty Ltd	Box	1 to 2 of 2	Checked	SK Date 28/01/26

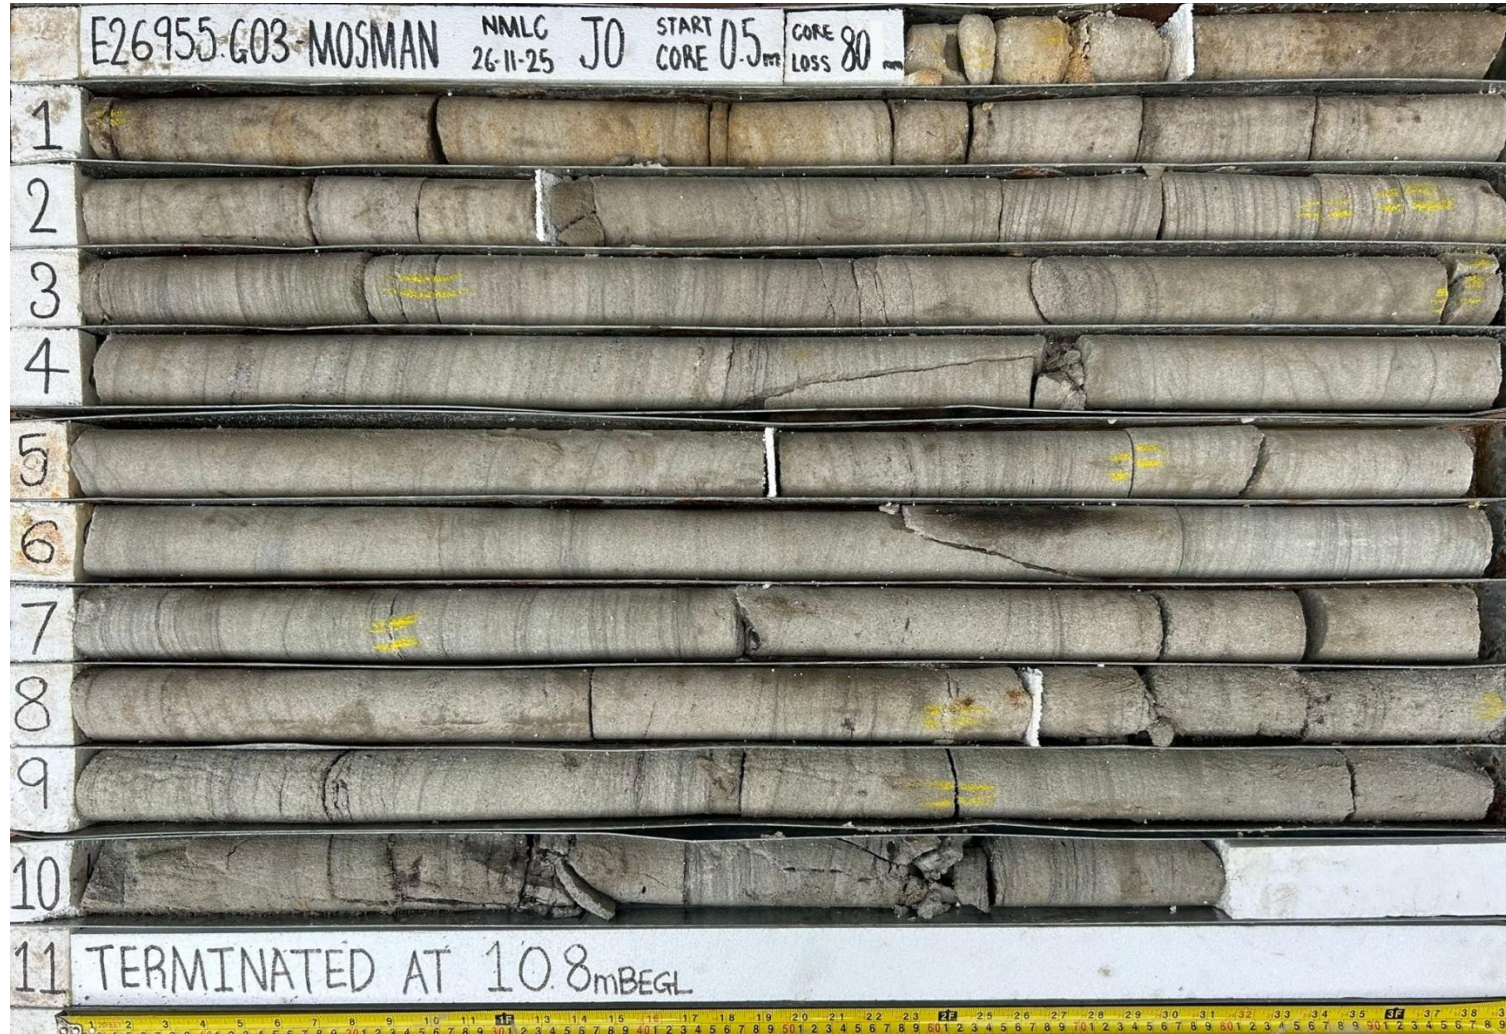
East 337735.4
North 6255571.6
Surface RL ~60.4m
Inclination 90°
Box 1 to 2 of 2

Depth Range 0.50m to 10.80m
Contractor Hard Access Drilling
Drill Rig Tight-Access Drilling Frame
Logged JO **Date** 26/11/25
Checked SK **Date** 28/01/26

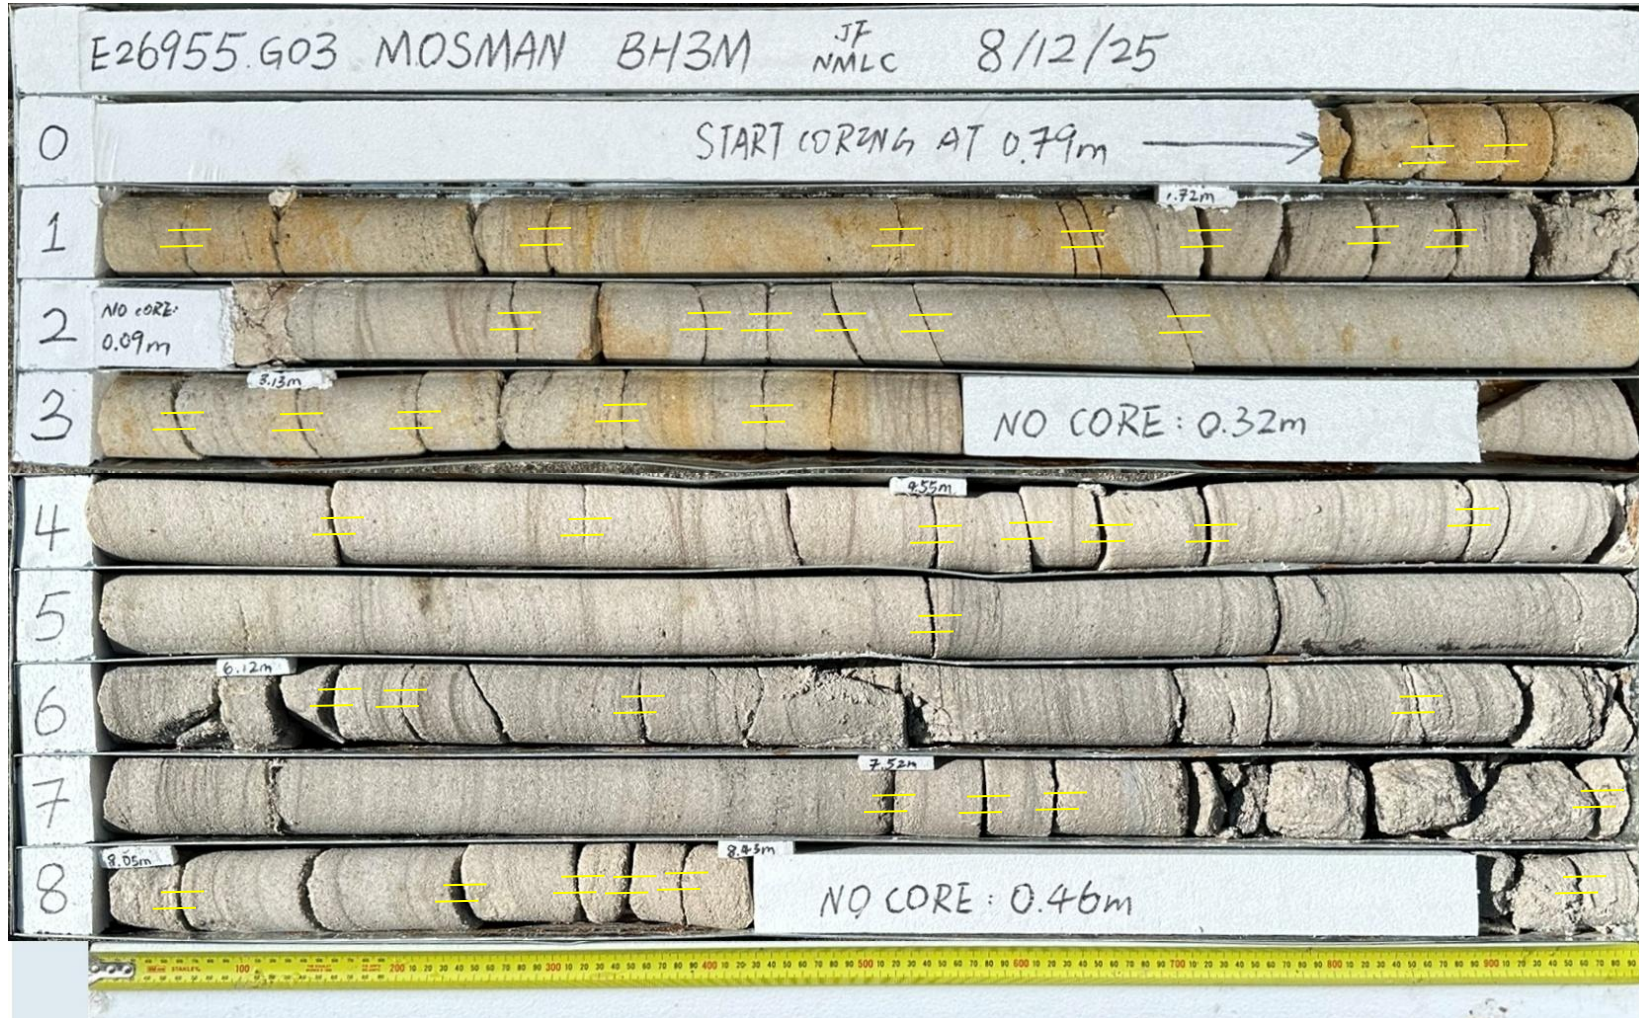
CORE PHOTOGRAPH OF BOREHOLE: BH3M

Project	Proposed Residential Development	East	337706.8	Depth Range	9.00m to 15.22m
Location	40-48 Redan Street, Mosman	North	6255529.4	Contractor	STS
Position	See Figure 2	Surface RL	~61.6m	Drill Rig	Tight-Access Drilling Frame
Job No.	E26955.G03	Inclination	90°	Logged	JF Date 8/12/25
Client	Mosman Land No.1 Pty Ltd	Box	3 to 4 of 4	Checked	SK Date 28/01/26

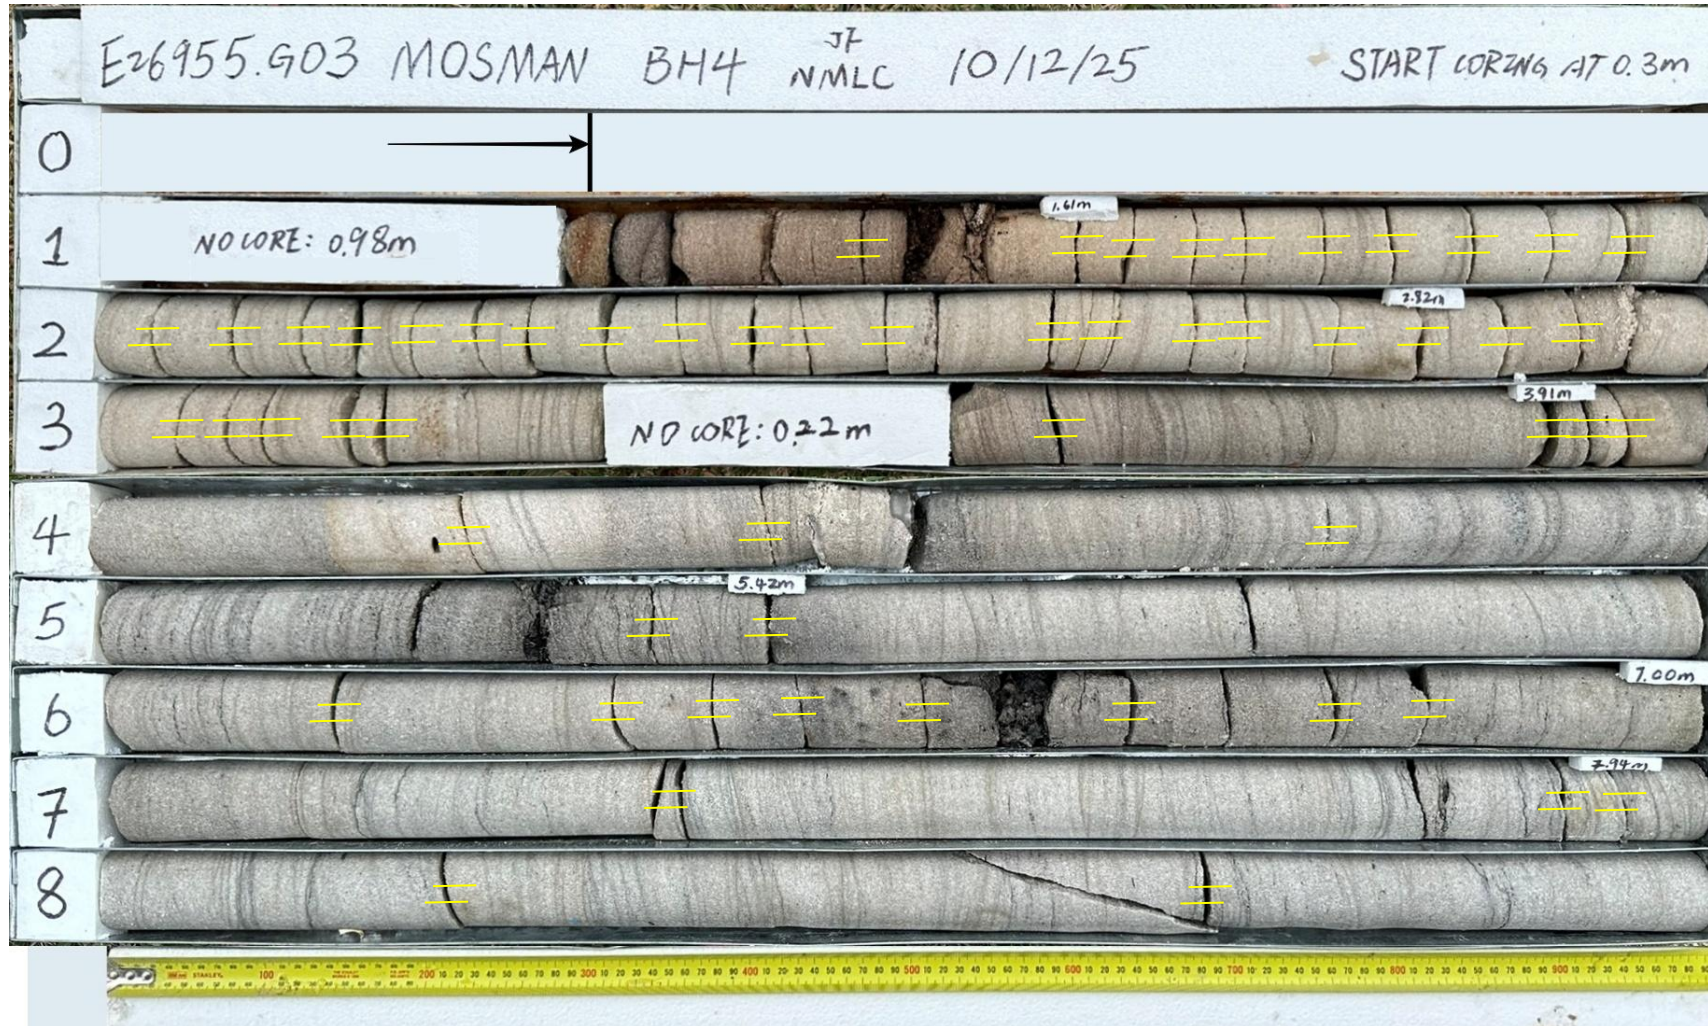
East 337732.8
North 6255522.6
Surface RL ~58.8m
Inclination 90°
Box 1 to 2 of 3

Depth Range 0.30m to 9.00m
Contractor STS
Drill Rig Tight-Access Drilling Frame
Logged JF **Date** 10/12/25
Checked SK **Date** 28/01/26
