**UNEXPECTED FINDS PROTOCOL  
PREPARED FOR  
COBRA WASTE SOLUTIONS PTY LTD  
30 LOFTUS ROAD, YENNORA NSW 2161**

**Report No:** 201156-06\_CEMP\_UFP\_Rev2  
April 2024  
(Released: 8 April 2024 )

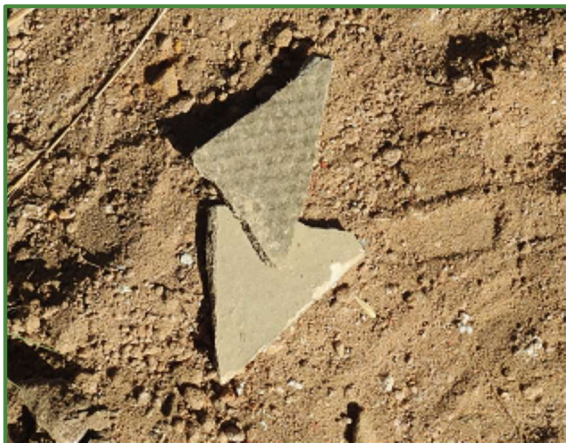
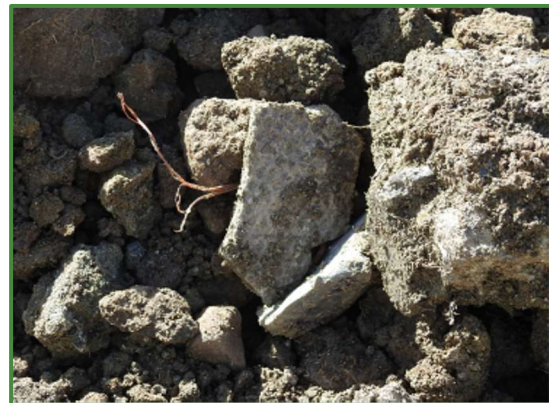
Figure 2-1: Asbestos examples.

Example photographs of unexpected finds of asbestos fragments are shown in Figure 2-1.

#### Asbestos fragments found in excavated material

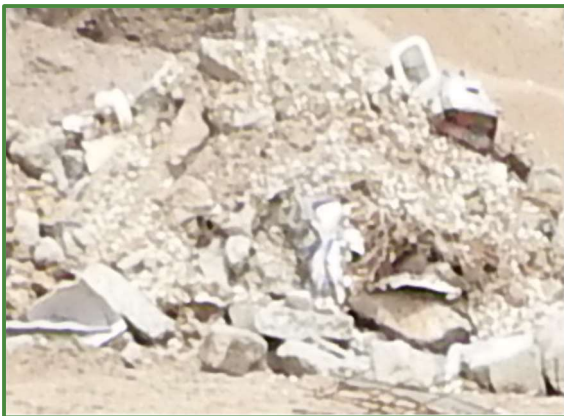
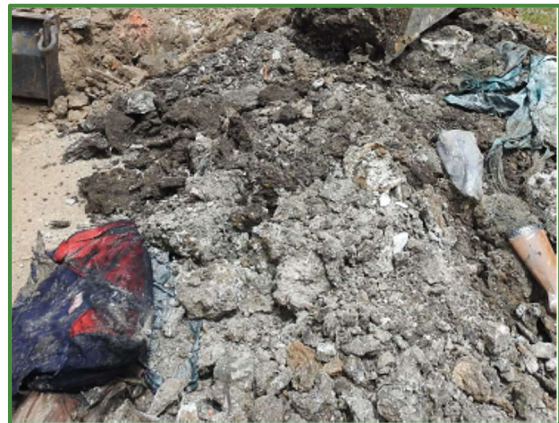
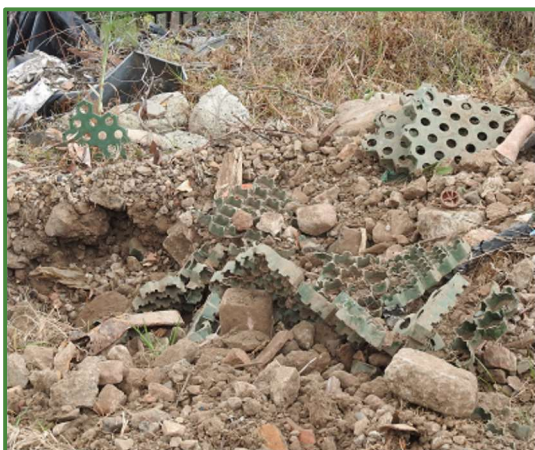
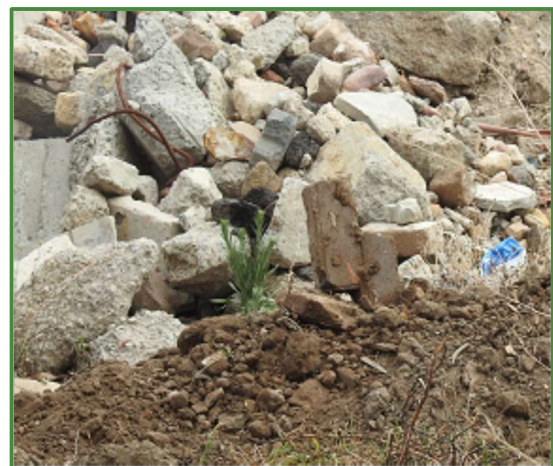
Figure 2-2: Buried waste examples.

This section provides a visual guide to enable identification of buried wastes in the unlikely event that these are encountered. Example pictures of buried wastes are shown in Figure 2-2. Buried wastes can include:

- Contaminated material identified by discolouration, staining or odour;
- Buried demolition wastes such as concrete, rubble, asphalt, bricks, tiles, timber, glass, piping and plastics;
- Buried industrial wastes including chemical containers or drums, ash, scrap metal and paint; and
- Buried domestic wastes such as plastic bags, cans, cardboard, paper, fabrics and food wastes.

#### Buried Wastes

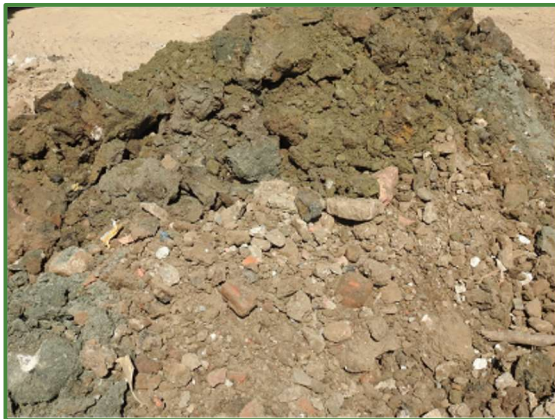
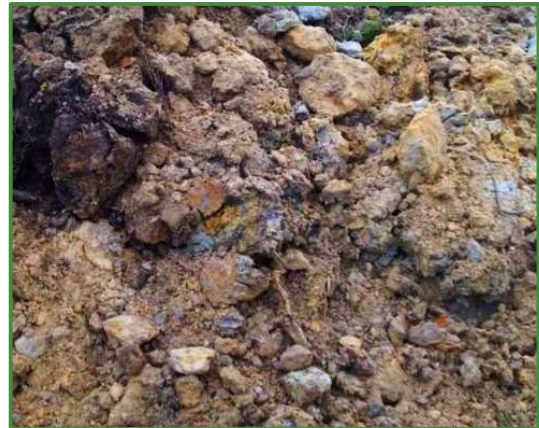
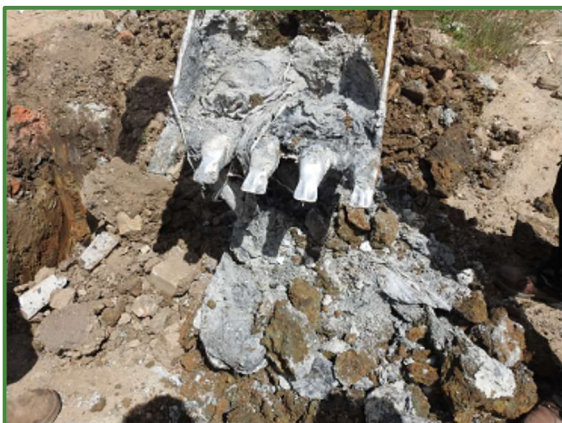
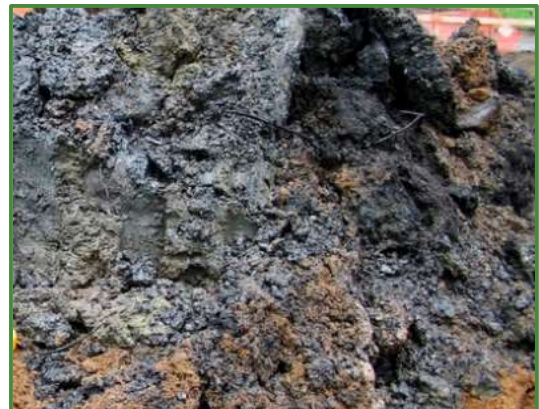
Figure 2-3: Potentially contaminated soil examples.

Contaminated soil can be identified by discolouration, staining and/or unpleasant or unusual odour. Examples of potentially contaminated soils are provided in Figure 2-3.

- Fibre cement or other asbestos containing materials
- Discolouration of the soil including staining
- Odorous soil or groundwater (including seepage)
- Buried chemical drums or containers or brightly or unusually coloured material
- Tar-like or ashy material

**Potentially contaminated soil – is discoloured and often has an unpleasant or unusual odour**

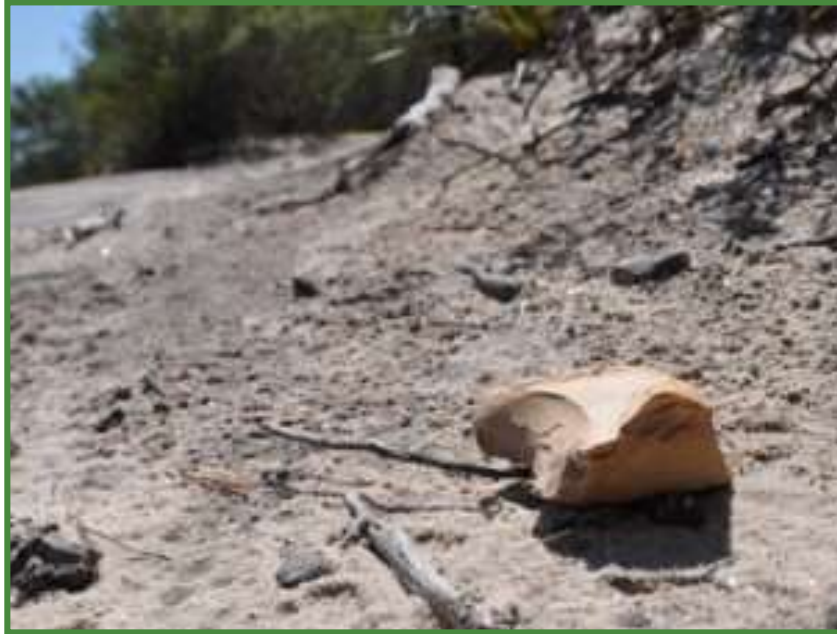
Figure 2-7: Aboriginal isolated artefact

Figure 2-7 provides a photographic example of an isolated artefact. The Aboriginal heritage office describes a single artefact as an isolated find:

*“These can be verified by identifying the stone and sourcing its origin, or verifying the manufacturing scars on the artefact. The isolated find can be a flaked stone, core or any finished implement. Raw materials most commonly used are chert, silcrete, and mudstones, while larger axe heads are usually made from river rocks or iron stone materials. Although*

*isolated finds are generally artefacts found on their own, they often imply other artefacts will be present in associated deposit nearby.”*
