Site Audit Statement

Site audit statement no. SAS164-2

Address 2 Rhodes Street, Meadowbank NSW

10834-ER-5-1_Rev02

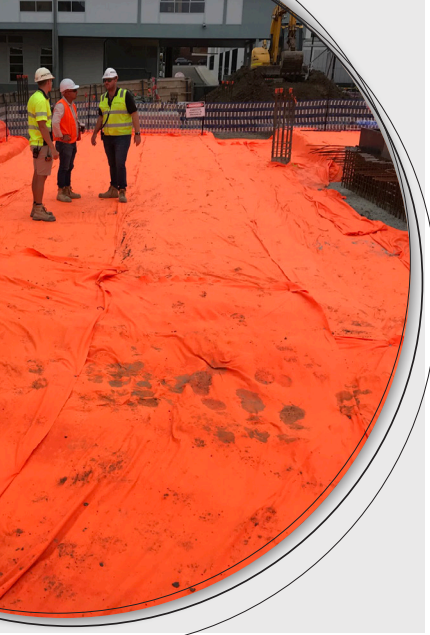
PROFAB® GEOTEXTILE INDICATOR MARKER LAYER

FOR DELINEATION OF POTENTIALLY HAZARDOUS MATERIAL LAYERS

Capping layer defects should be monitored and repaired, particularly as the capping layer ages, to ensure that the capping layer remains serviceable. Where significant surface wear, deformation, cracking, or damage to the surface of the capping layer is observed, an immediate and thorough investigation should be completed to identify the defect mechanism. In relation rectification to of capping layer and the minimum requirements based on current capping conditions, please refer to **Sections 5.2 and 5.4**, respectively. A copy of the specification for the geotextile marker is included in **Appendix F**.
