Yorks Creek Diversion Constraints Analysis

Geomorphological Assessment

Glendell Continued Operations Project

Geomorphological Assessment for Yorks Creek Diversion Constraints Analysis

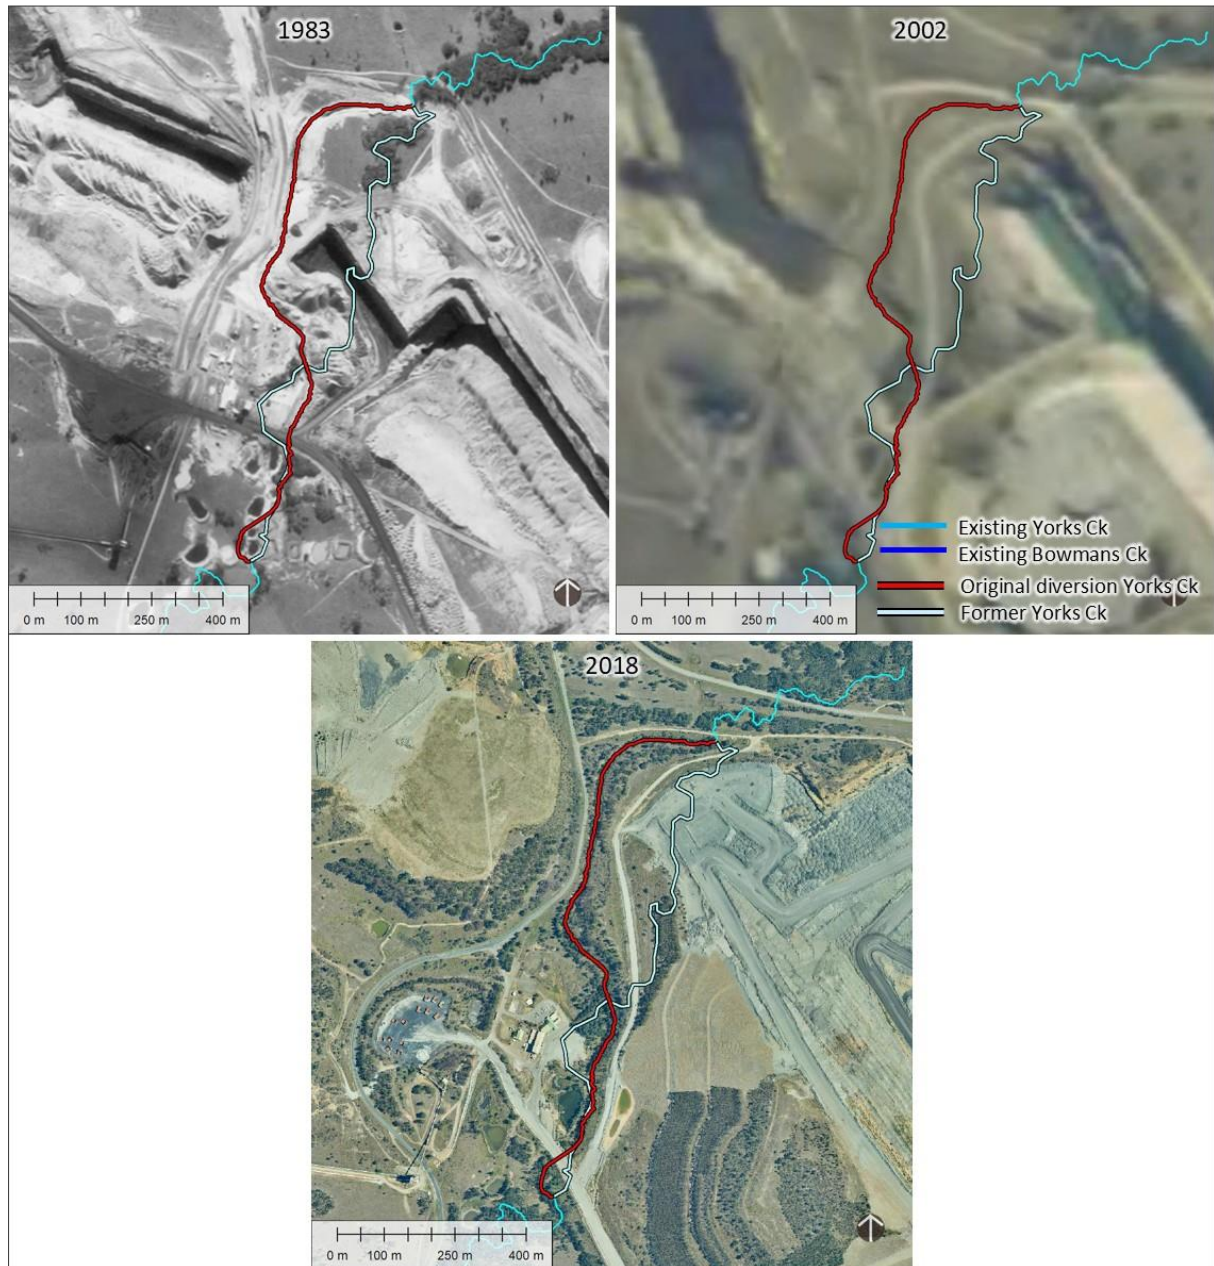
Figure 5. Historical aerial photography showing detail of original diversion of Yorks Creek.

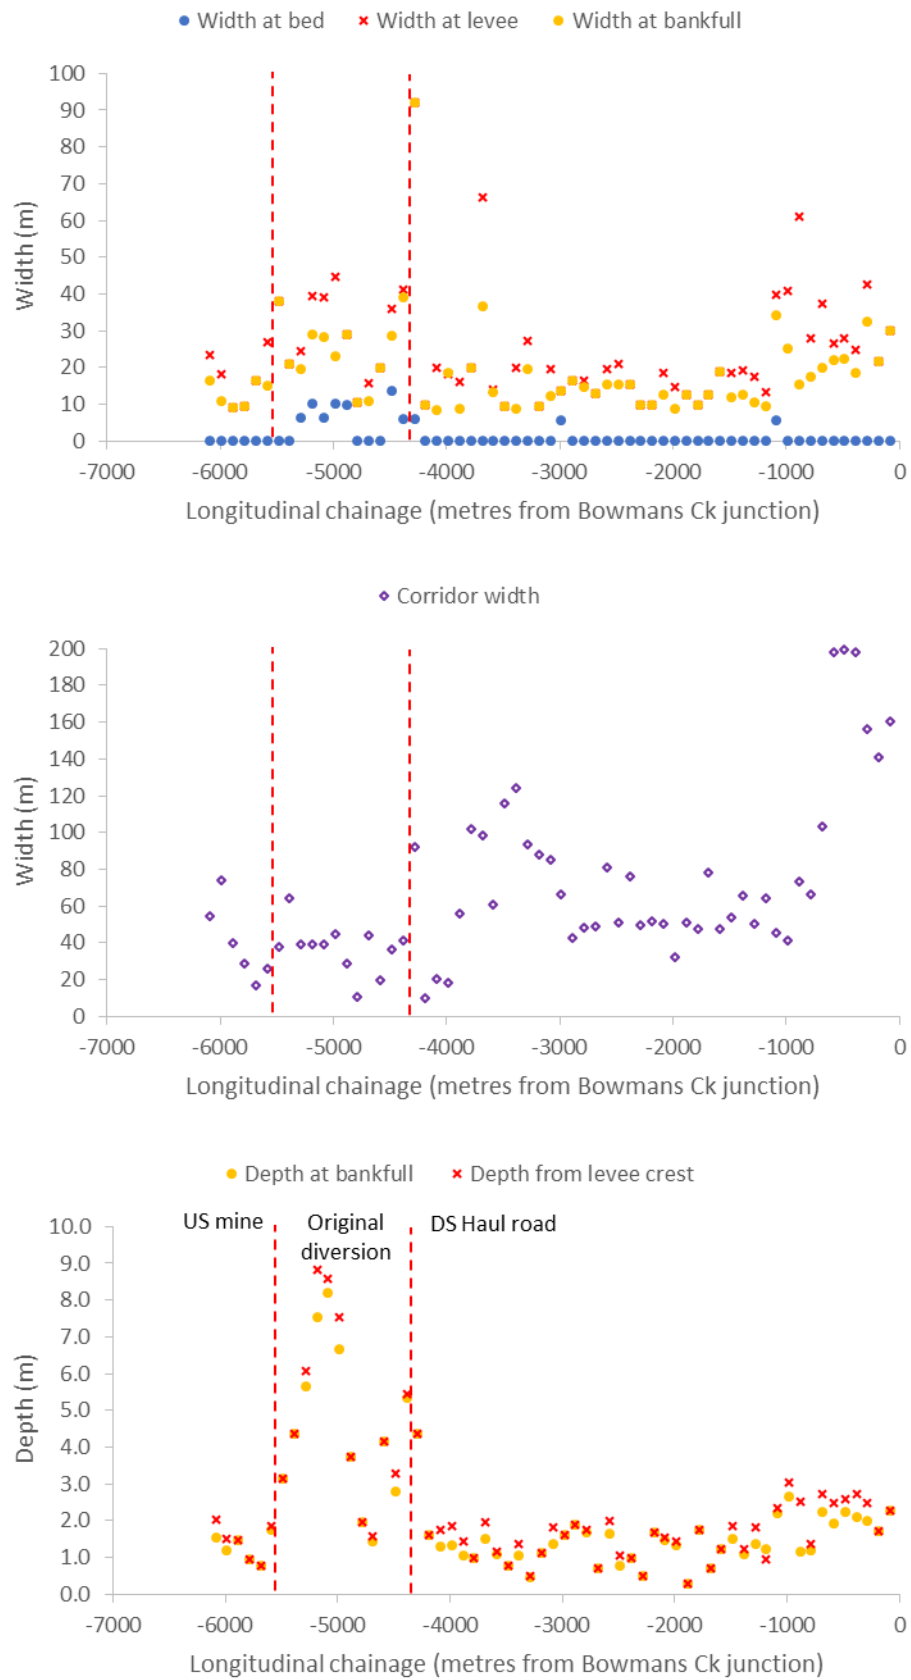
Figure 7. Yorks Creek downstream widths and depths at 100 m point spacing, from LiDAR-based DEM.

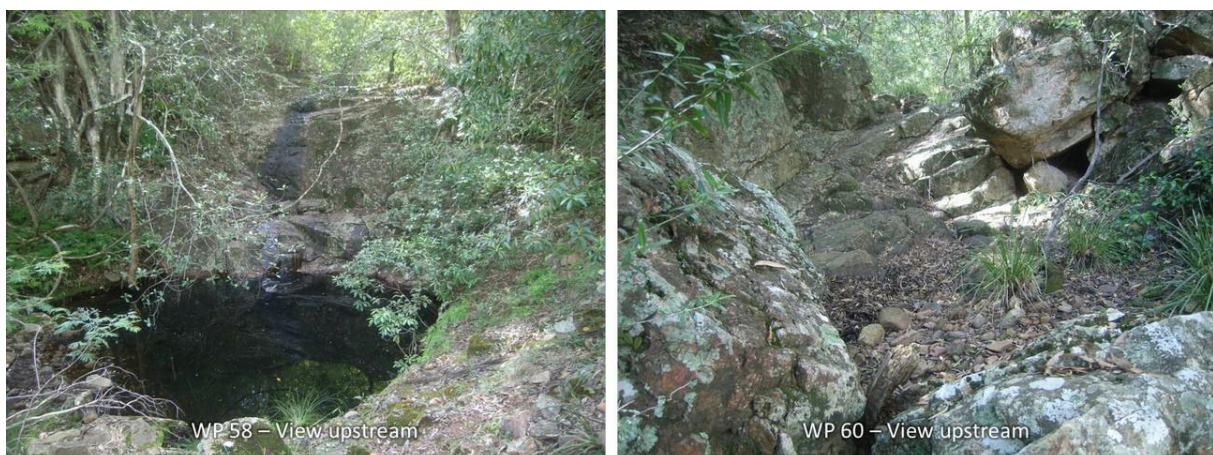
Figure 11. Waterfall 4.5 m high in Yorks Creek at WP 58, and cascade with 6 m fall at WP 60.

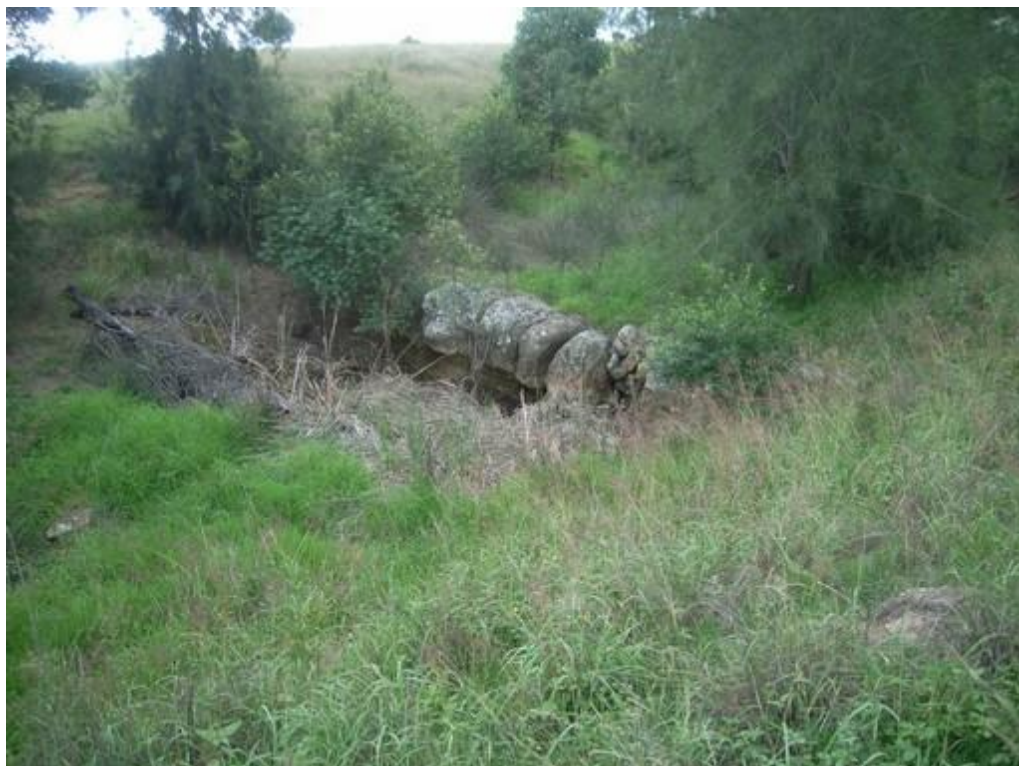
Figure 13. Rock knickpoint in Yorks Creek at fault line, WP 72.

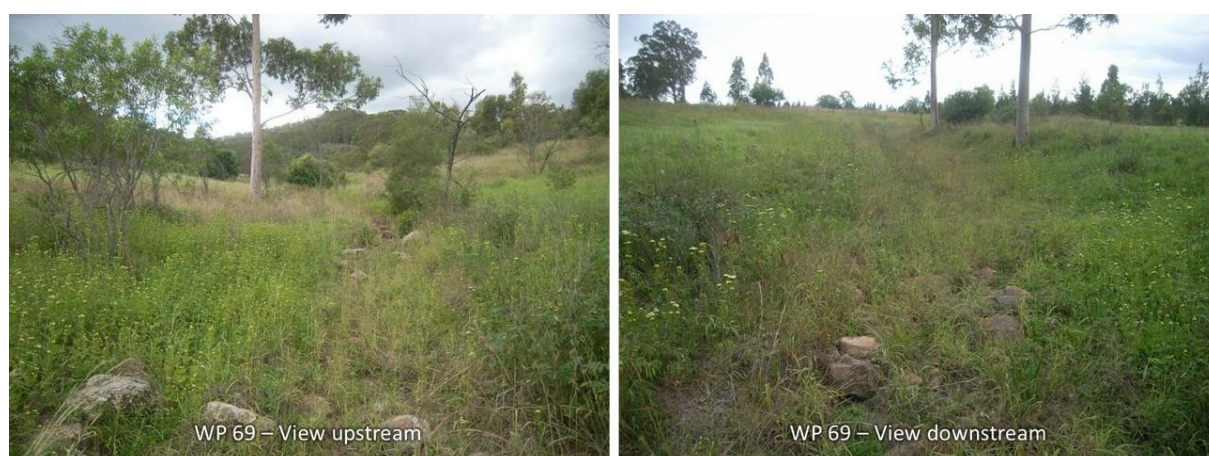
**Figure 16. Yorks Creek at the transition from Foy Pinnacle to Isis Soil and Land Resources unit.**

The distributions of the Soil and Land Resources units was strongly related to topography and also geology (Figure 15). Streambank erosion hazard was not observed across the entire Study Area, but sheet erosion hazard was ubiquitous (Table 11). Localised gully erosion hazard was present in Ravensworth, Gundy Gundy and Waverly units, but widespread in Isis unit (Table 11). The start of the Isis unit is mapped about 500 m upstream of the fault at WP 72, at WP 69 (Figure 9). Here the channel gradient starts to decline, and flows within sloping valley sides with occasional exposed cobble-sized weathered colluvial material in the banks (Figure 16).

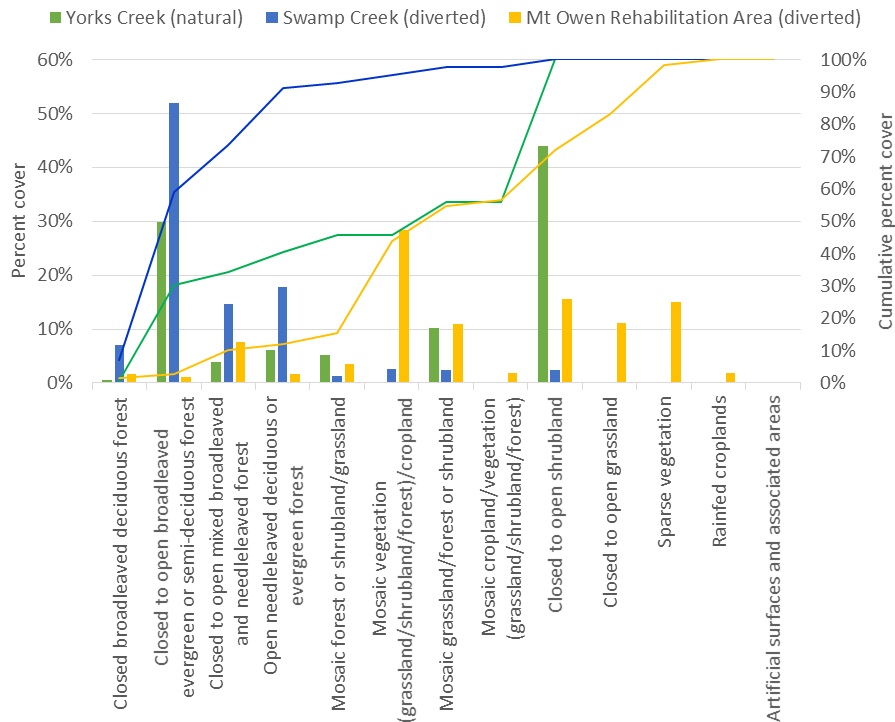
Figure 17. Percent and cumulative catchment area cover of the thirteen GlobCover land cover categories for the three Yorks Creek catchments. Categories arranged left to right in order from lowest to highest risk of surface erosion. Note that drainage from Mount Owen Rehabilitation Area would not be released to the catchment until good ground vegetative cover is achieved.

The GlobCover land cover categories were arranged in order from lowest risk of surface erosion (closed forest, open to closed forest, open forest, mosaic vegetation) to highest risk (shrubland, grassland, sparse vegetation, rainfed croplands and artificial surface). Land cover area was calculated for each category for the Yorks Creek catchments (Figure 17). With respect to land cover, Swamp Creek, with a high percentage of forest cover, had the lowest risk of surface erosion. Mount Owen Rehabilitation Area had the highest risk of surface erosion, and Yorks Creek natural catchment was in-between. Drainage from the Mount Owen Rehabilitation Area would not be released to the catchment until good ground vegetative cover is achieved, which would change its risk of surface erosion to low. The inclusion of this area, particularly the sparse/unvegetated area (approx. 40% or rehab area), in the erosion risk assessment likely overstates the sediment load. Considering these three catchments combined, the land cover distribution was similar to that of the entire Bowmans Creek catchment, within which Yorks Creek is situated (Figure 18).

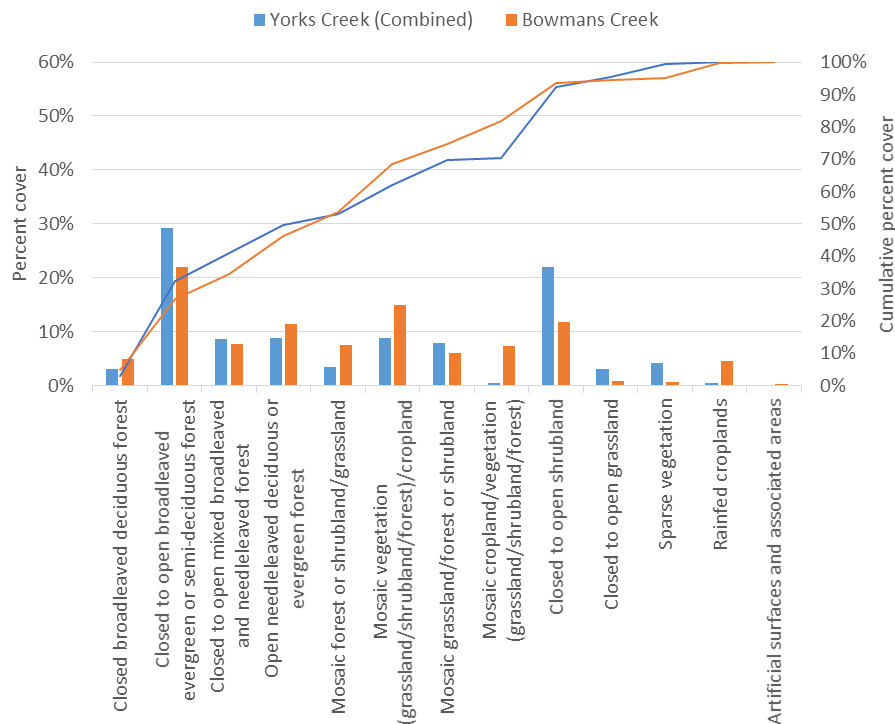
Figure 18. Percent catchment area cover of the 13 GlobCover land cover categories for the combined three Yorks Creek catchments compared with the entire Bowmans Creek catchment. Categories arranged left to right in order from lowest to highest risk of surface erosion.

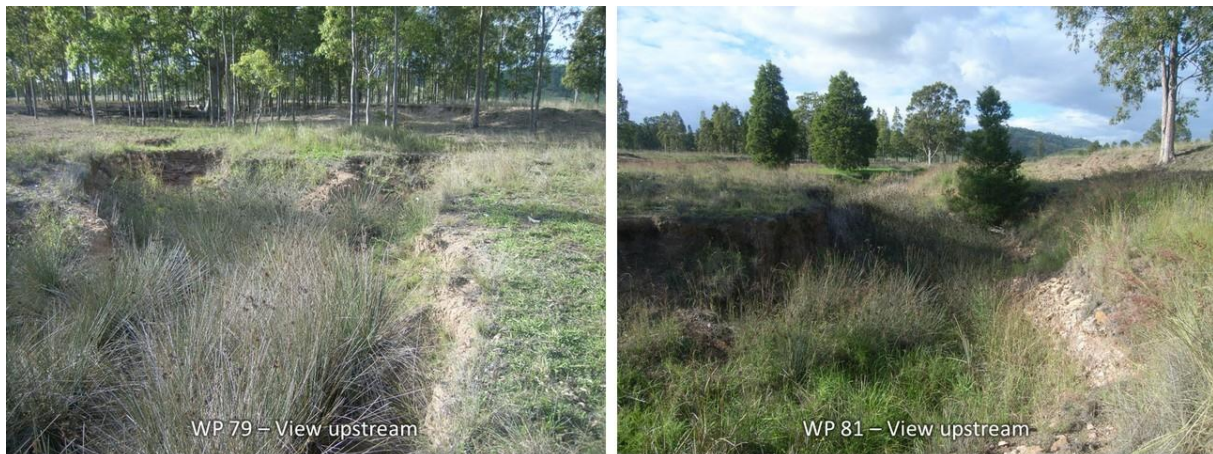
Figure 19. Upstream boundary of incised gully system in Yorks Creek.

Incised main channel and tributary gullies were observed in the field from WP 79, located 35 m upstream of the junction of a tributary of Yorks Creek. Here the channel had a 1.1 m knickpoint in uncohesive material, marking the upstream extent of a major gully system in lower Yorks Creek (Figure 19). A distance of 65 m downstream from the tributary knickpoint, at WP 81, in the main channel of Yorks Creek, another knickpoint 0.9 m high set in silt/clay bed material was observed (Figure 19). In this area, the channel was wide, with a flat bed filled with a deep deposit silt/clay material almost completely covered with stands of emergent macrophytes and grass (Figure 20). The banks at the outside edge of the incised channel were near vertical and showed evidence of erosion from local direct raindrop impact and floodplain runoff draining to the channel (Figure 20). Further downstream the incision showed evidence of older age, with less steep banks and more vegetation cover on the banks (Figure 21). At a distance downstream of about 1.1 km from the upstream boundary of the gully system, the incision was significantly infilled, had moderately sloping banks, and dense riparian, bank and channel vegetation (Figure 22), enhanced by revegetation efforts by Glencore.

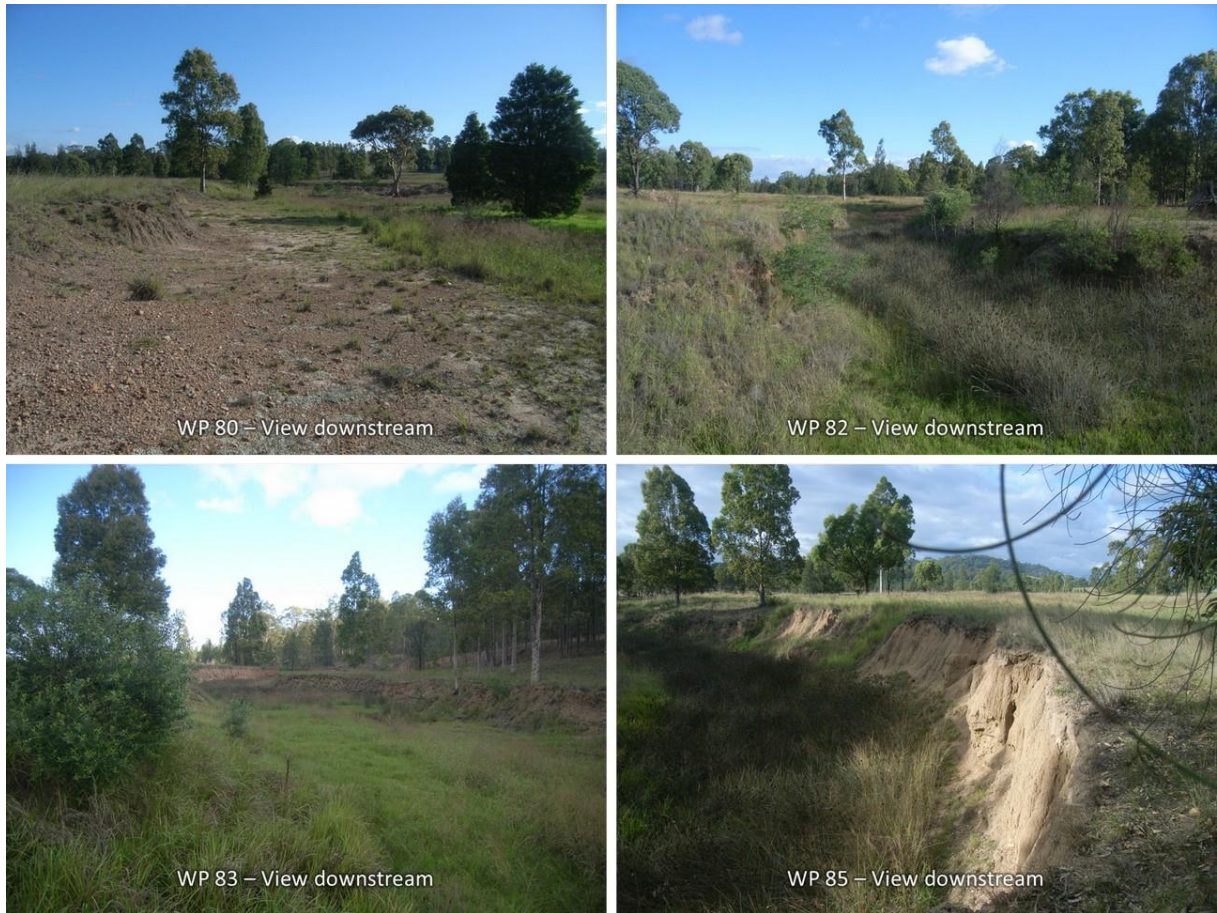
Figure 20. Upper reach of incised gully system in Yorks Creek.

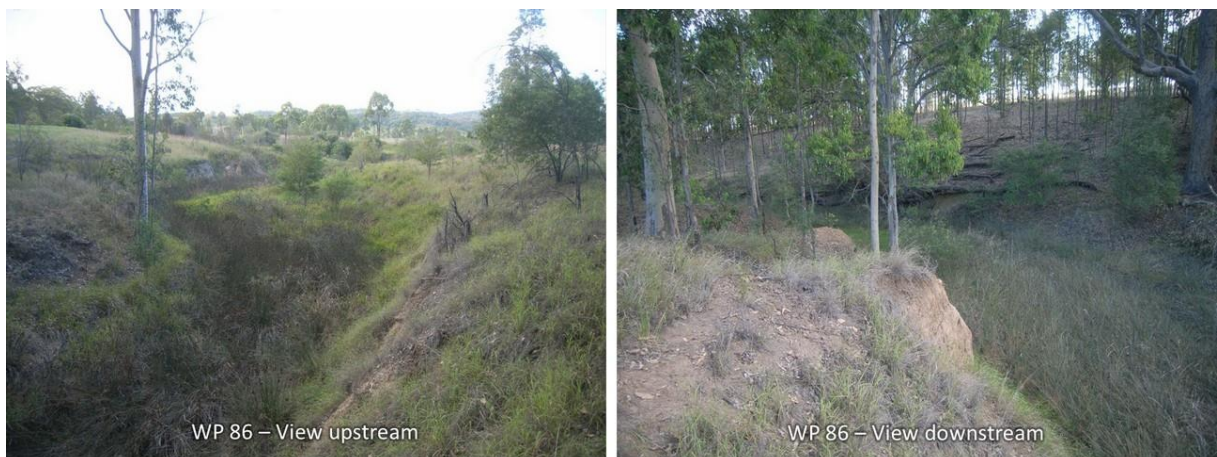
Figure 21. Mid-reach of incised gully system in Yorks Creek.

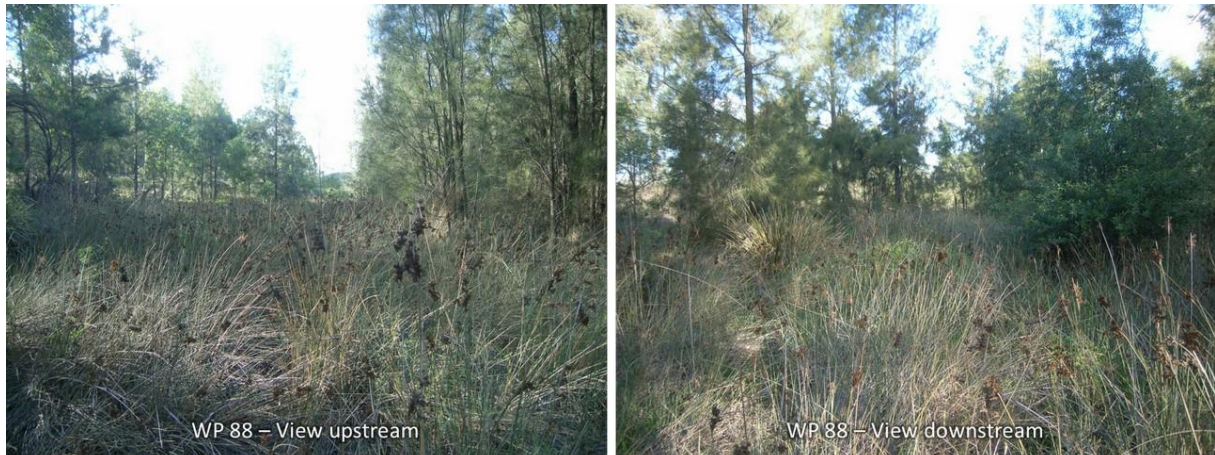
Figure 22. Lower-reach of incised gully system in Yorks Creek.

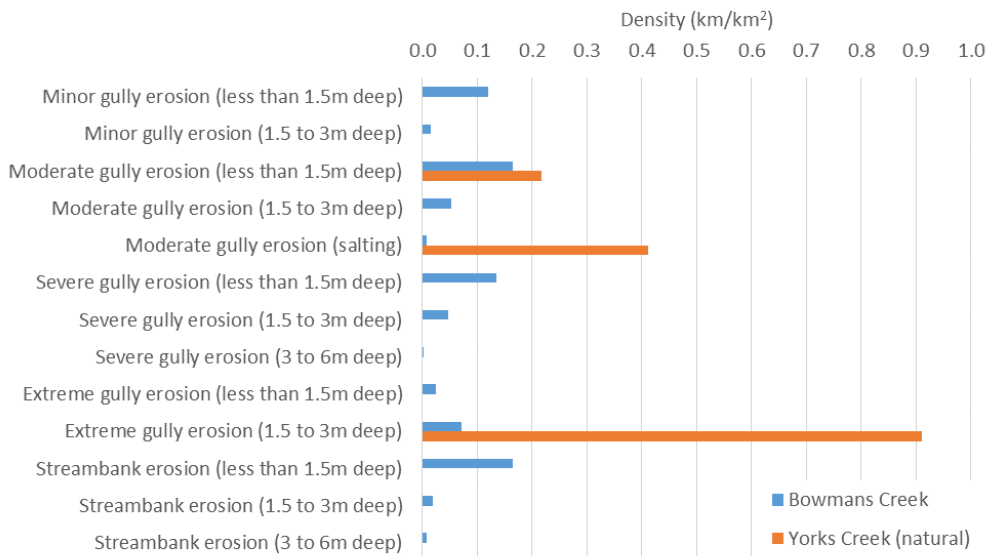
Figure 25. Distribution of all 13 categories of the Gully and Streambank – Landform and Condition Dataset (OEH), mapped in 1991 – 1993, for Bowmans and Yorks creek catchments. Erosion categories listed top to bottom in order of severity.

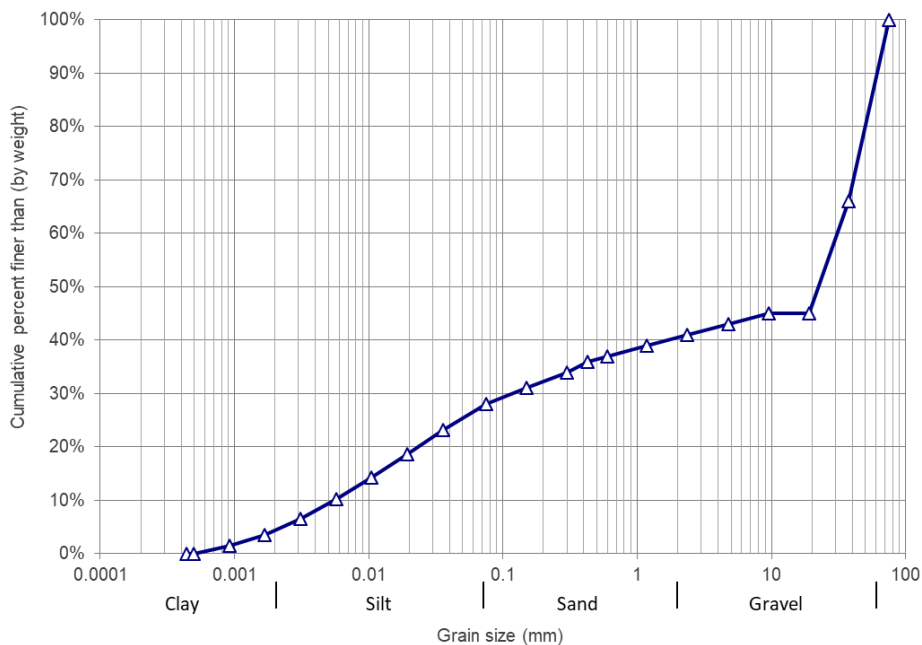
Figure 28. Particle size distribution of surface bed material at WP 93 on Yorks Creek.

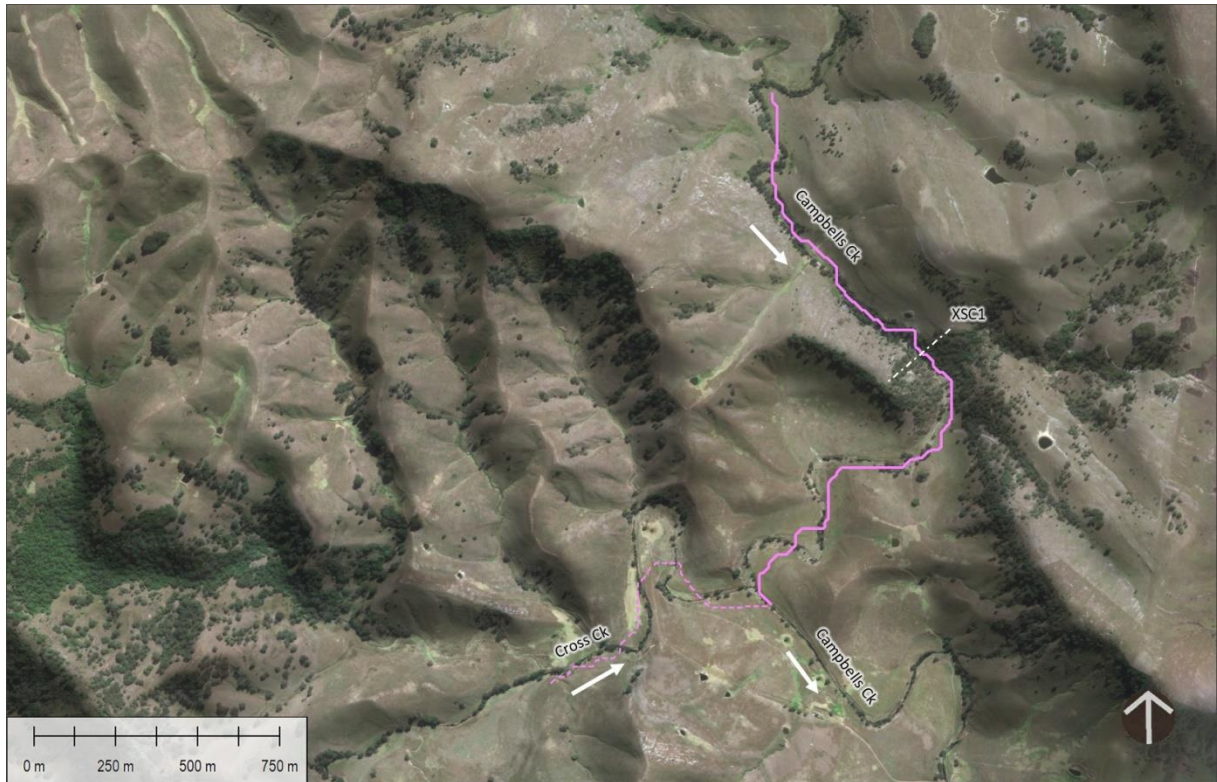
Figure 32. Gorge on Campbells Creek with steep stream link (pink).
