APPENDIX 23

Heritage
Assessment

Appendix 23 – Heritage Assessment

This appendix contains the following Heritage Assessment documentation in relation to Ravensworth Estate and the Ravensworth Homestead Complex:

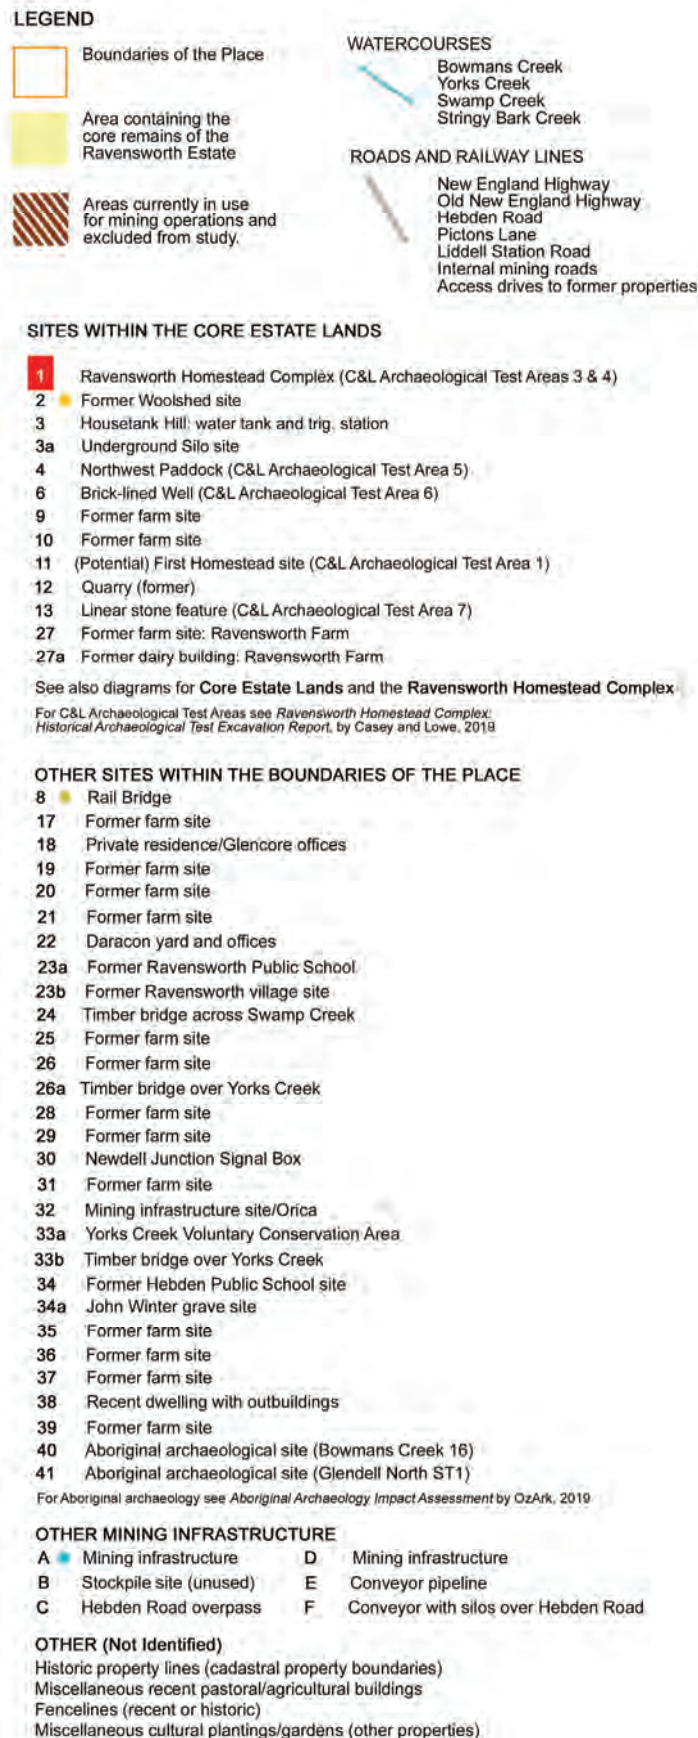
Figure 1. 3: Aerial view of the Place identifying the location of the principal components of the place, the Ravensworth Estate core remains and other sites within the boundaries of the place. See overleaf for legend.
Source: Base aerial and mapping information courtesy of Glencore/Umwelt, 2018

Refer to Figures 1.3 and 1.5 for location of Site numbers.

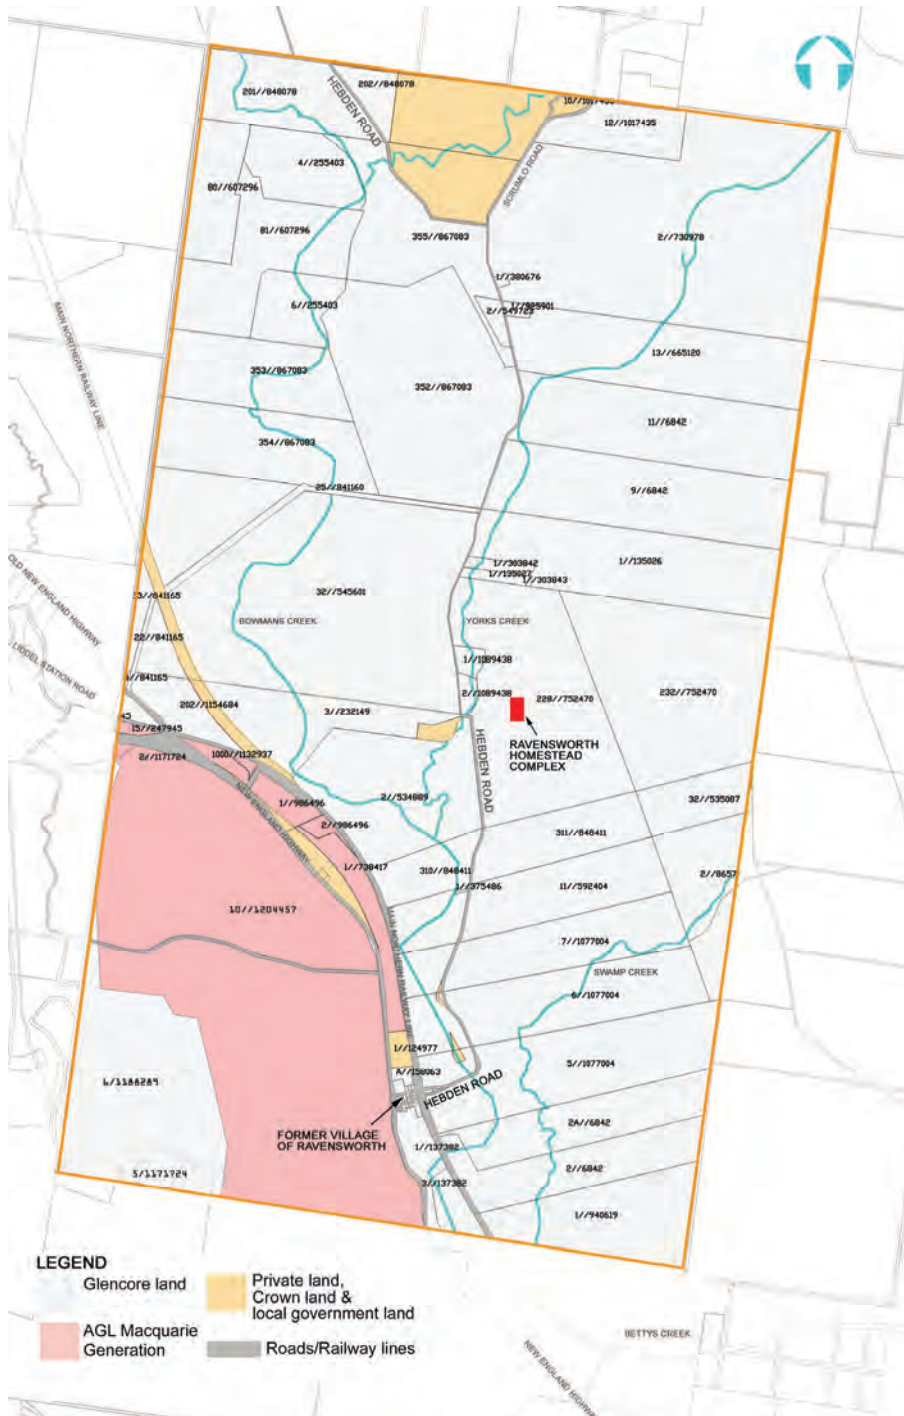
Figure 1. 7: Current cadastral plan showing the individual allotments that comprise the place and current ownership of these allotments. Source: Base mapping information courtesy of Glencore/Umwelt

Within the boundaries of the place, the majority of land is owned and managed by Glencore (or their subsidiaries), including the land containing the Ravensworth Homestead Complex (shaded light grey in Figure 1.7) as part of the Mount Owen Complex, comprising mining operations at the Mount Owen Mine (North Pit), the Ravensworth East Mine (Bayswater North Pit), and the Glendell Mine (see also Figure 1.8 below).

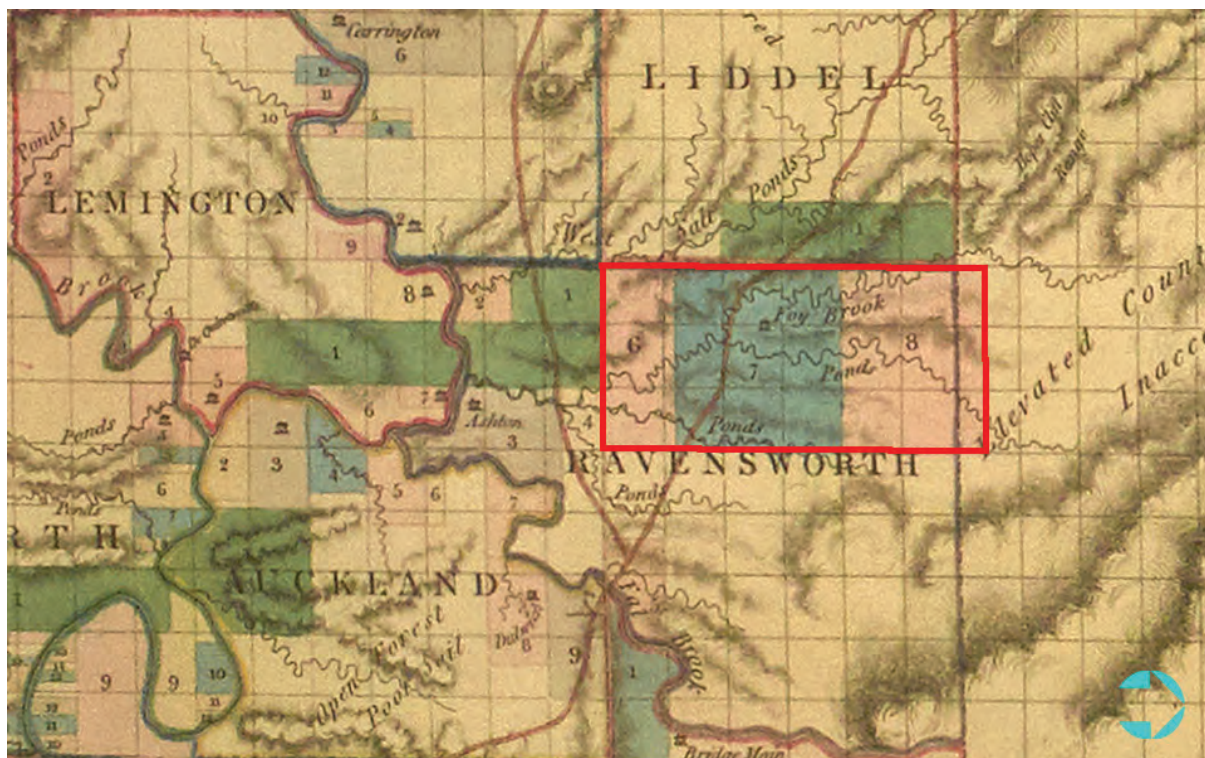
Figure 2. 1: Detail from Dangar's map to which the descriptions in his Index related. Numbers 6, 7 and 8 in the (then) Parish of Ravensworth are outlined in red. Source: Dangar, Henry, *Map of the River Hunter and its branches ...*, 1 Aug 1828, NLA Map NK 646

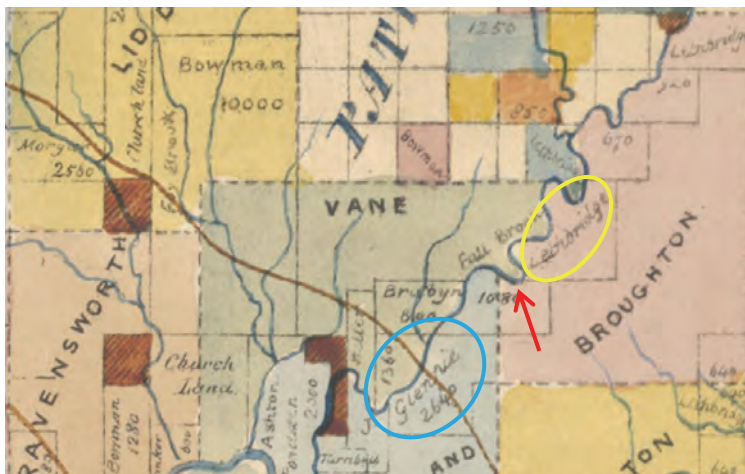
Figure 2. 3: Detail of County of Durham plan c1843, showing the locations of Bowman's Ravensworth estate, Glennie's property on Fal Brook (circled in blue) and Lethbridge's farm further along Fal brook (circled in yellow). The red arrow shows the bend in Fal brook where the huts of Chilcott and Alcorn were located. Source: 1843 Map of the County of Durham by W. Baker, NLA MAP RaA 8 Plate 3

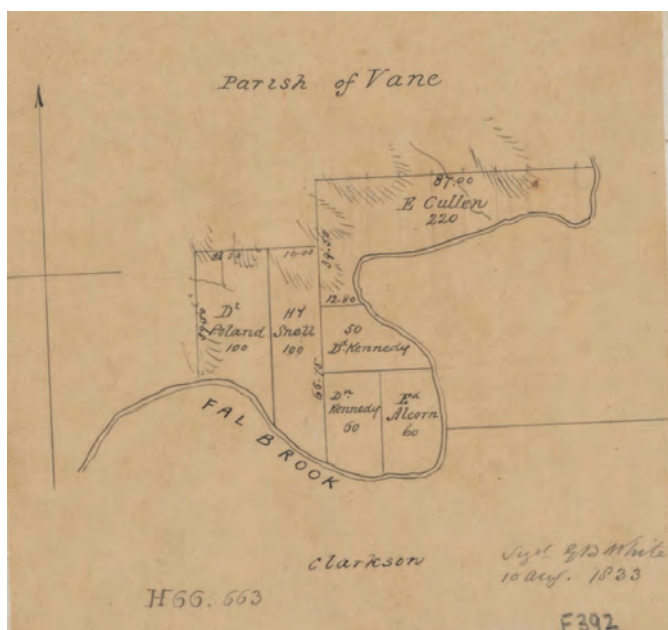
Figure 2. 4: Copy of plan for Crown Plan 66-663 showing the position of Chilcott's and Alcorn's farms on a bend in Fal Brook surveyed by G.B. White dated 1833. Source: NLA, MAP F 392

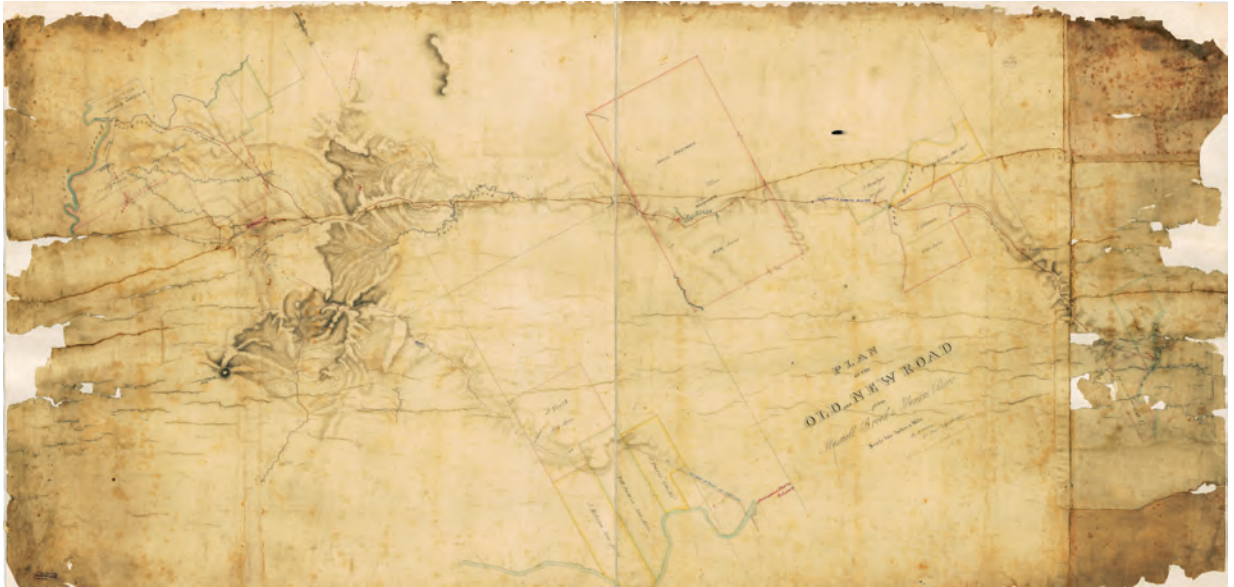
Figure 2. 10: Dixon's road plan of April 1833. Source: R.5.830, Crown Plan

A plan of the old and new Road from Muswellbrook to the Hunter River dated April 1833 by Assistant Surveyor Robert Dixon showed James Bowman's land near Foy Brook at Ravensworth with the house, barn and the new house shown. A paddock next to Foy Brook was marked as well as the line of fence. His area was shown as 10,439 acres, which tallies with the area of the three portions shown on the Crown Plan H.35.663.⁹⁸ The new road between Muswellbrook and the Hunter River crossed Ravensworth.

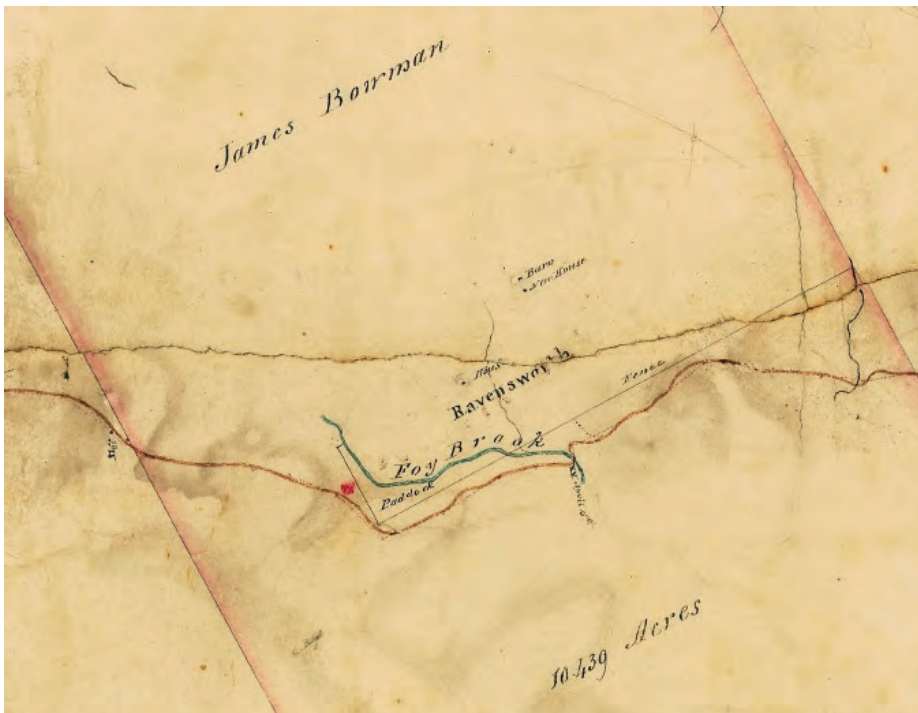
Figure 2. 11: Part of Dixon's road plan showing buildings on Ravensworth including 'House', 'New house' and 'Barns' Source: R.5.830, Crown Plan

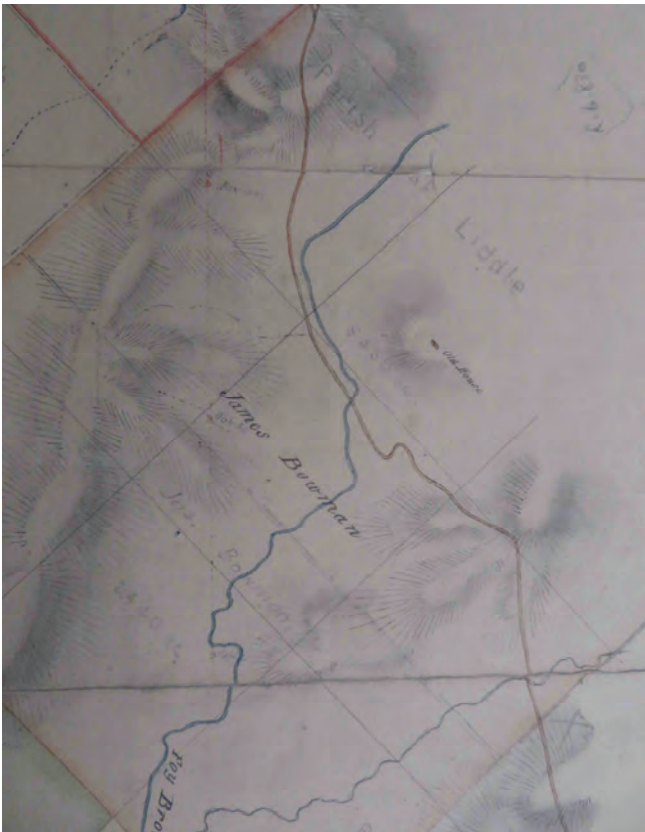
Figure 2. 12: Detail from G.B. White's road survey showing "Old House" on James Bowman's land. Source: SA Map 5095 originally R.6.830

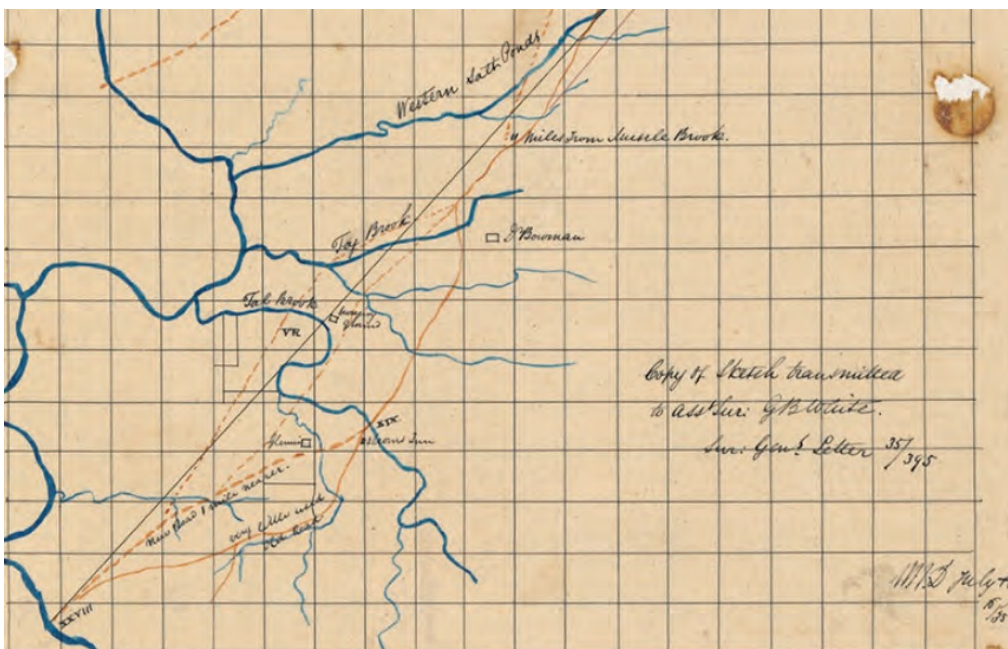
Figure 2. 13: Detail from G B White's sketch also showing a house owned by J Bowman. Source: Surveyor General, Sketch Book 3 f 16, SANSW

A sketch by G.B. White dated July 1835, showing roads in the vicinity sent to the Surveyor General showed Bowman's house plus the "burying ground" near the Fal Brook.¹¹³ It was almost certainly associated with the road survey above.

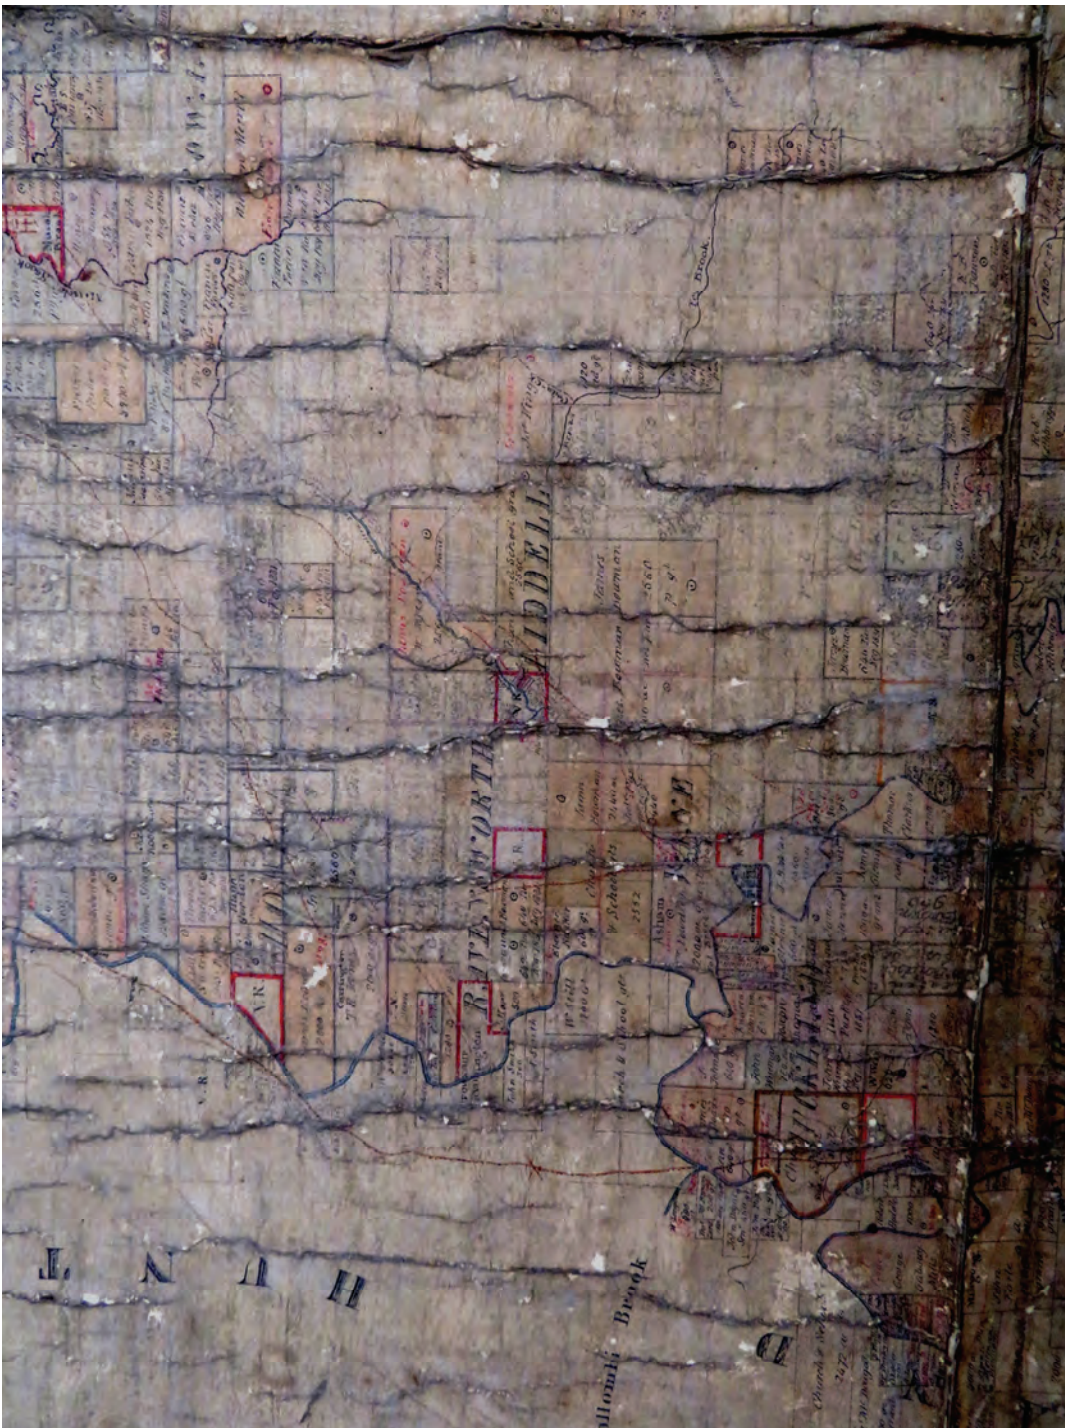
Figure 2. 19: Fernyhough's 1839 map depicted the status of land held by various individuals. It is difficult to read and may have later information added to it. Source: County Durham, 1839, SA Map 2520

A map of the County of Durham compiled in 1839 by draftsman William Henry Fernyhough showed the grants of James Bowman (see Figure 2.19 below). It was used as a charting map by the Surveyor General for some years so further information was added. This possibly includes some of the grants charted on the map. It appears to have not being used after 1846 since no grants to William Russell were shown. The map is rather dark and heavily used so some of the detail is unclear. It does depict a number of the grants that Bowman received after those that made up the core of his holding plus land to the south-east around Camberwell village.¹⁶⁶

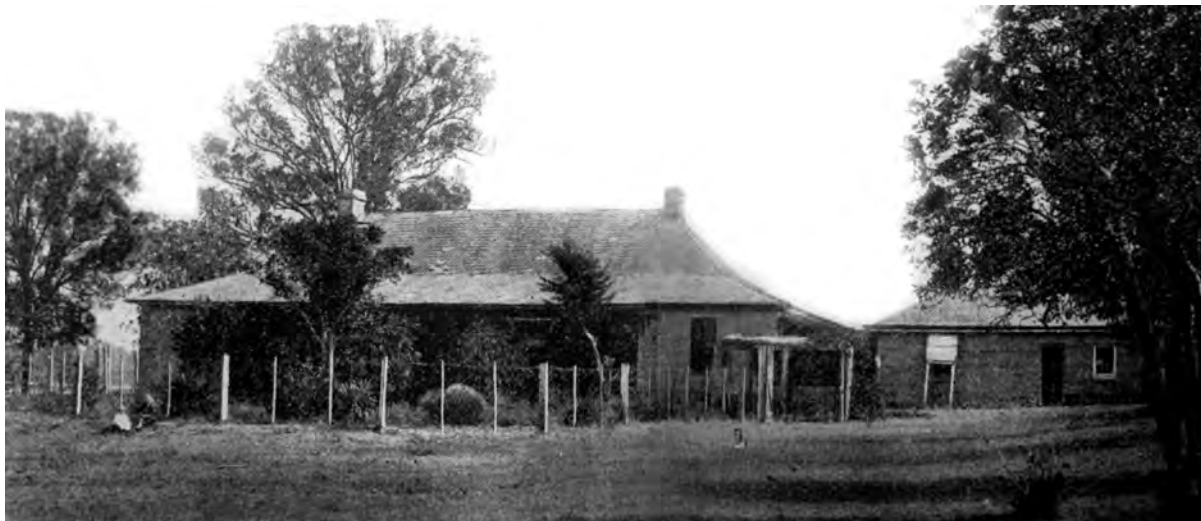
Figure 2. 36: Ravensworth House in 1902 as seen from the south with kitchen wing on the right. Source: *Sydney Mail*, 15 Feb 1902, pp 416-7 (original negative provided by Fairfax Newspapers)

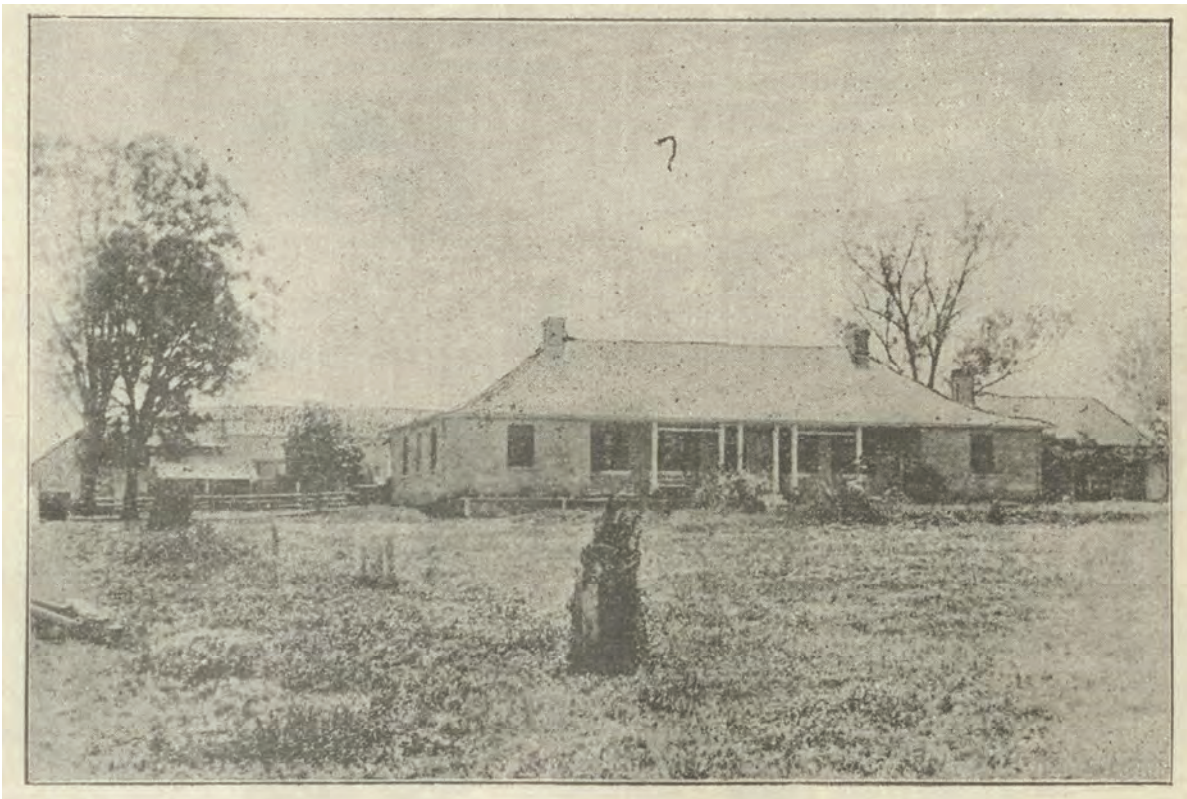
Figure 2. 39: The earliest known photograph of the Ravensworth homestead showing the front (south) elevation of the main house with the kitchen wing to the right and the stables to the left. Another building forming the northern boundary of the complex is just visible to the right of the stables. This photograph appeared in *The Bulletin* as part of an article entitled “The Future of New South Wales: Mixed Farming”. Source: *The Bulletin*, Vol. 11 No. 579 (21 Mar 1891), p. 19

A photographer visited the family in the 1890s and again (assumed) in the early 20th century and a series of photographs of the homestead survive from the Hill family period. (See Figures 2.39 to 2.42 below).

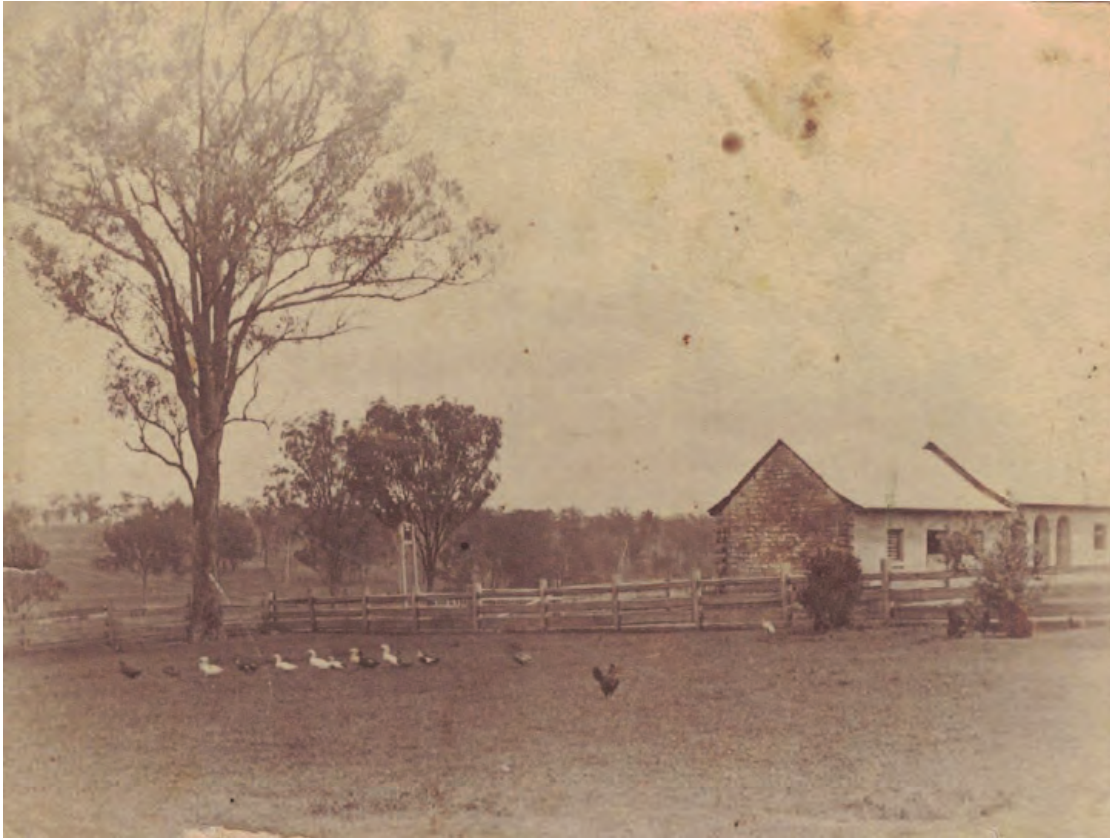
Figure 2. 41: Ravensworth stables as seen from the northern side of the main house. Note the bell post with bell in centre frame. Source: Marshall family photographs

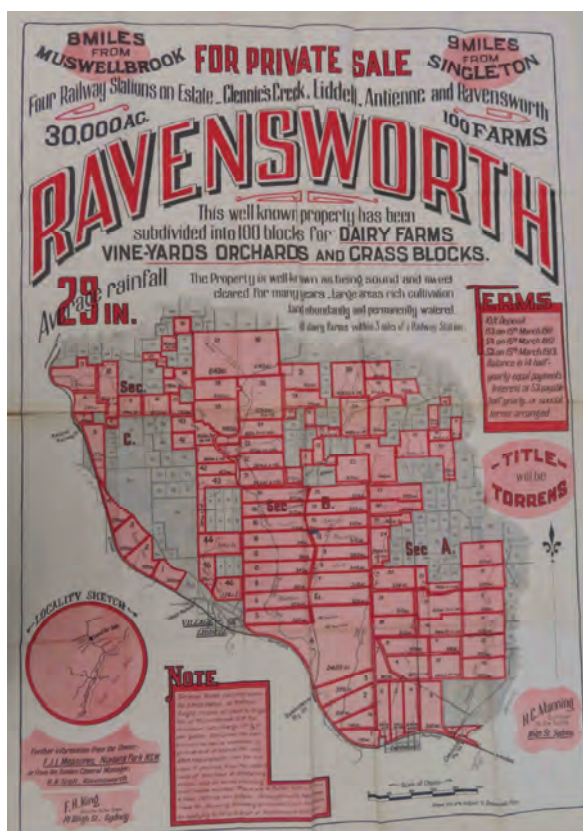
Figure 2.46: The original version of the Ravensworth subdivision plan. Source: NRS 3829, School file, Hebden, SANSW 5/16256.4

On 6 January 1912, a sale notice for the Ravensworth Estate by its owner F.J.L. Measures, Niagara Park was issued (see Figure 2.45).²⁵⁹ Various versions of the subdivision plan of Measures' Ravensworth Estate are held in the Mitchell Library and in files held at State Archives of NSW. One of them dated about 1911 showed the lots with some details of purchasers but only showed buildings on Lots 4 and 5. Some of the land was shown as sold (see Figures 2.46 to 2.49).

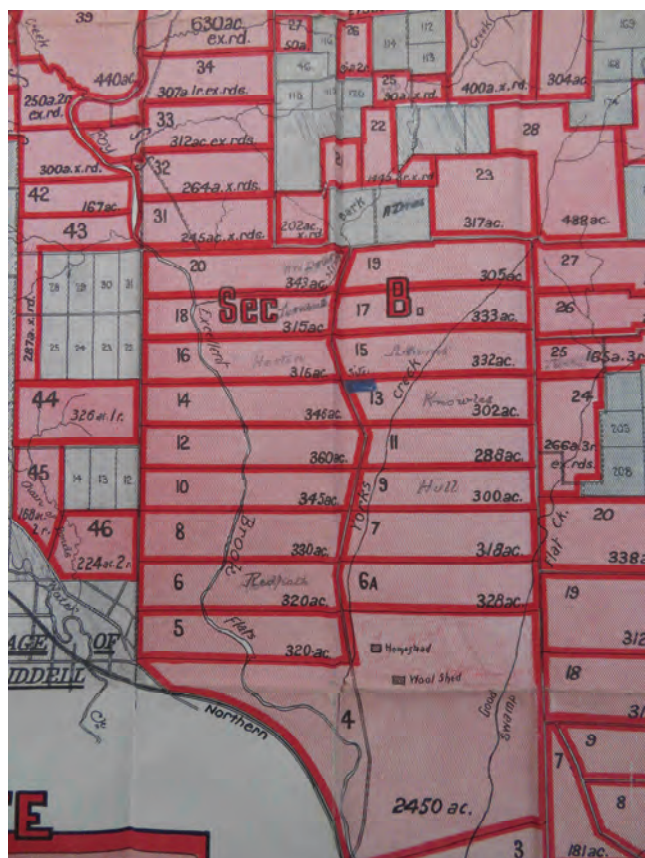
Figure 2. 47: Enlargement of the original version of the Ravensworth subdivision plan. Note the wool shed and homestead are shown on Lot 4 with three creeklines traversing the property and Hebden Road cutting through the centre of the allotment. Source: NRS 3829, School file, Hebden, SANSW 5/16256.4

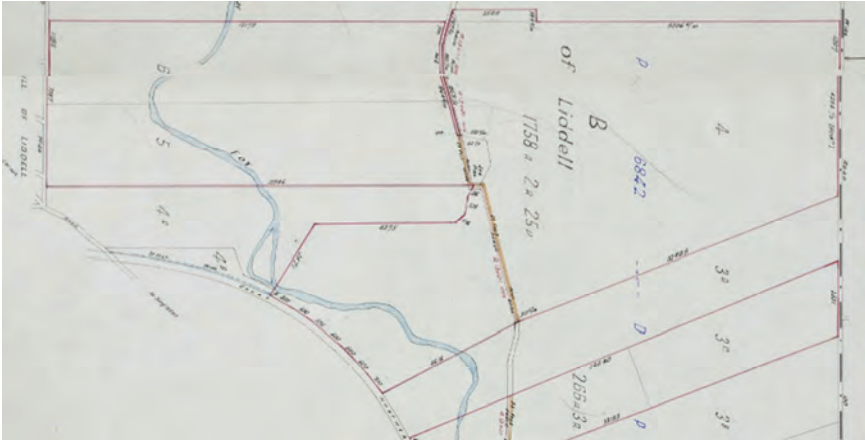
Figure 2.54: Detail from Certificate of Title of A.C. Reid's land showing the extent of Allotment 4 Section B DP 6842. Source: Vol. 3144 Fol. 148

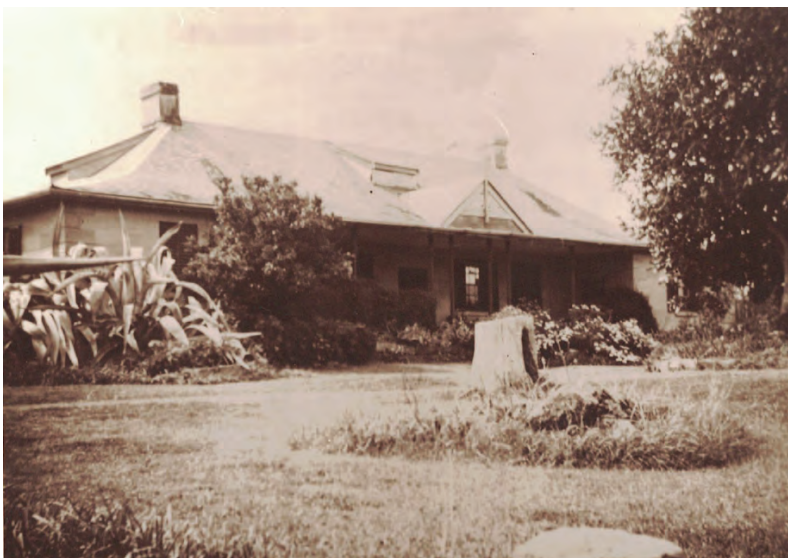
Figure 2. 62: Ravensworth homestead post renovation in c1906. Source: Courtesy of G & J Marshall

An undated report on his consolidation application that was stamped 15 February 1929 was compiled by an unnamed official. He stated he had been visiting the property and was familiar from earlier visits. It was an old improved property acquired by Marshall with an old stone homestead that he had renovated and “made into an excellent dwelling”. The stone stables and large stone shed were also renovated. A shed had been converted into a shelter for dairy cattle by adding stalls. A small mill and piping worth £30 had been added to the garden. The total of 27 chains of new 7 wire fencing had been added on the eastern boundary costing £30. No other improvements had been made since the acquisition.

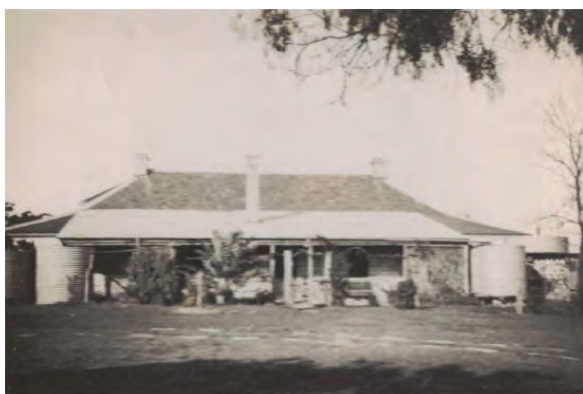
Figure 2. 64: Early 20th century photograph of the north (rear) elevation of the main house with various water tanks. Note the roof is slate by this time. Source: Courtesy of G & J Marshall.

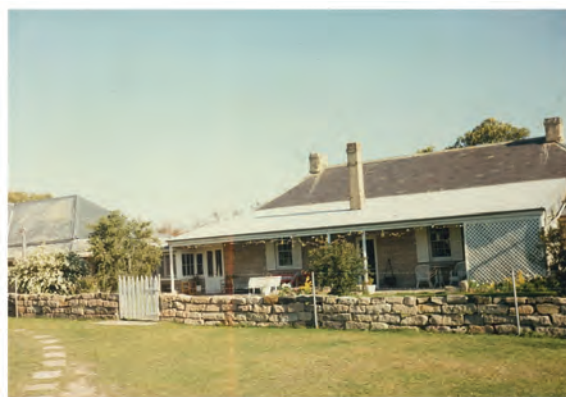
Figure 2. 65: Late 20th century (1970s?) photograph of the north (rear) elevation of the main house. Source: Courtesy of G & J Marshall.

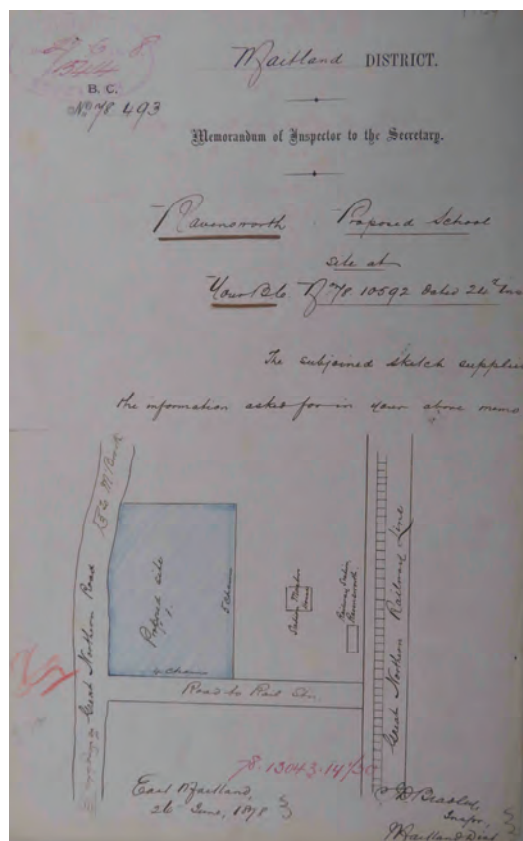
Figure 2.76: The site of Ravensworth school. Source: NRS 3829, School file, Ravensworth, Part A, SANSW 5/17442.1

In 1912, when the school buildings were being repaired a site plan showed the position of the buildings and the configuration of the combined schoolhouse and residence (see Figure 2.76).³⁴⁴

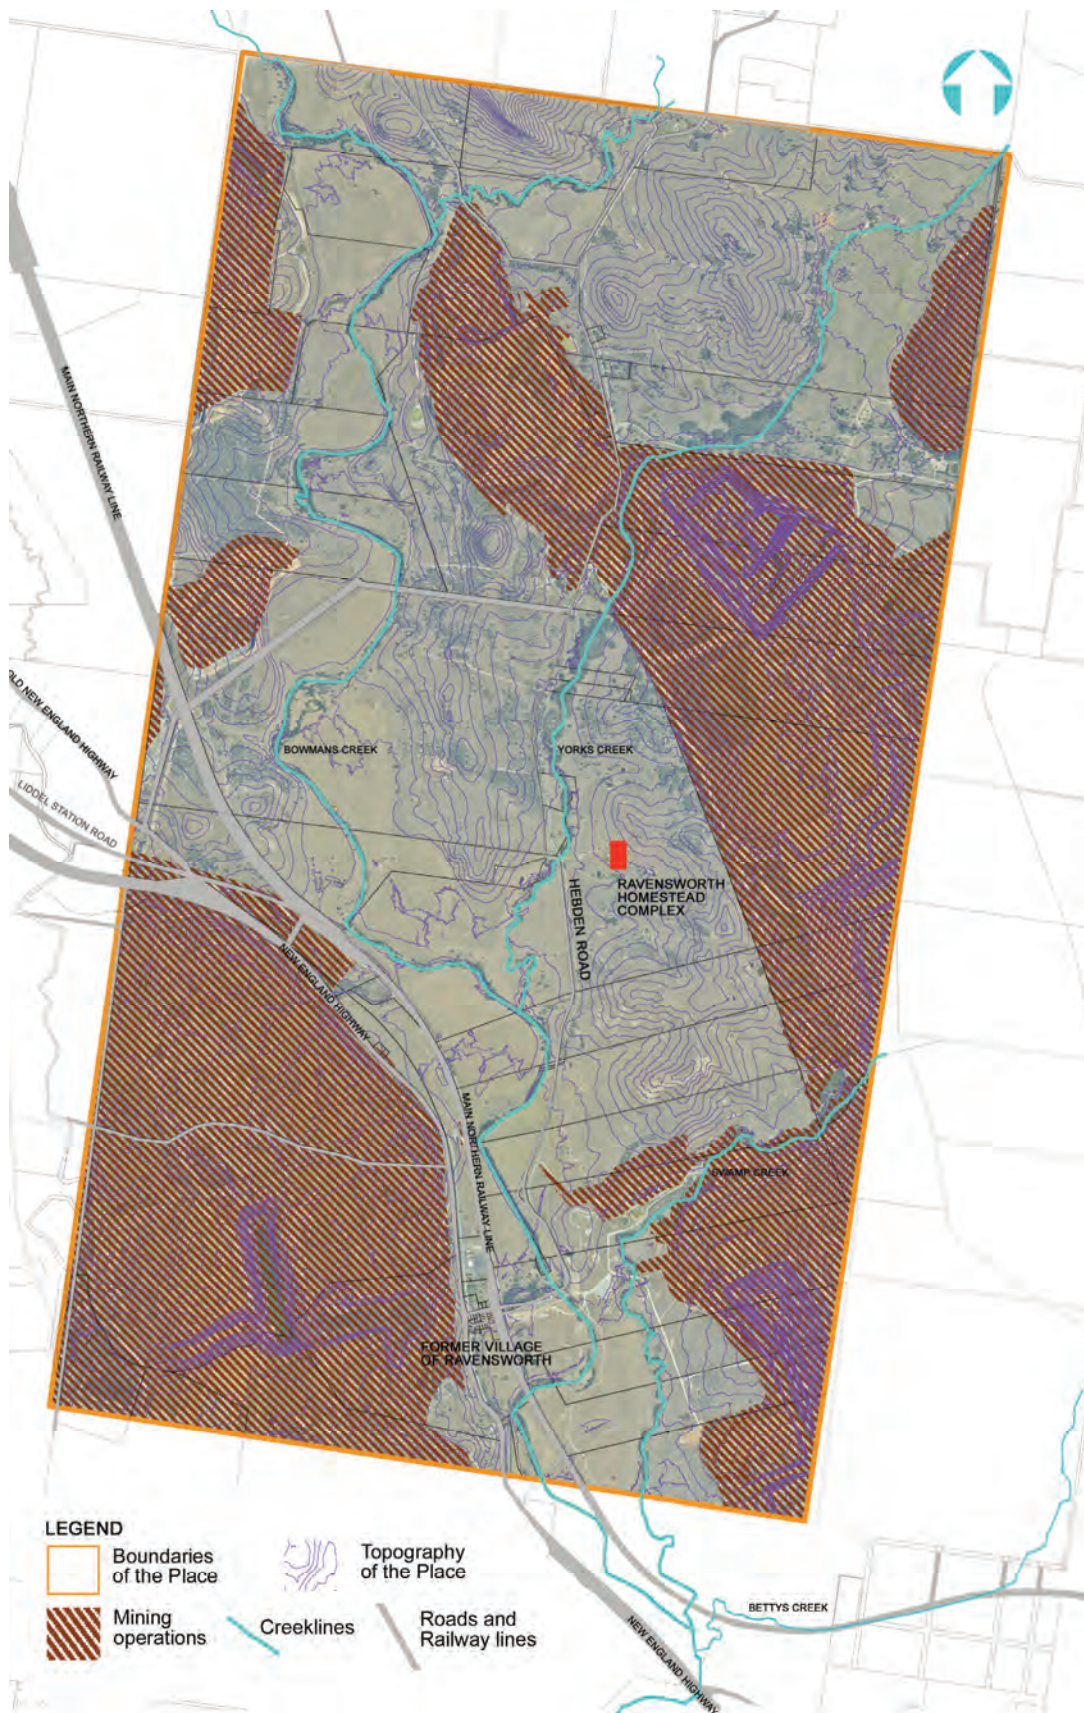
Figure 3. 4: Aerial view and cadastral plan overlaid with topographic mapping showing the rolling hills, alluvial flats and open cut mining areas within the boundaries of the place. Source: Base information courtesy of Glencore/Umwelt

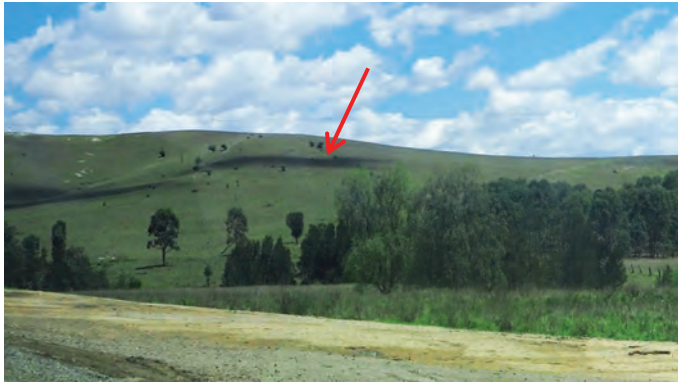
Figure 3. 11: Fenceline (indicated with an arrow) visible crossing a rise as seen looking northwest from Pictons Lane. This fenceline follows the 1824 northern boundary alignment of Portion 149 of the parish of Liddell.

However, some important early fence lines remain that define the entire northern edge and sections of the western and eastern sides of Portion 149 of the Ravensworth estate that James Bowman was permitted to use from 1824 (see Figure 3.11). This is not to suggest that the existing fences are

necessarily old, but that the alignments preserved by the current fences denote parts of the boundaries of this early portion of the former estate.

The length of the northern fence line (4.898 km), consistent with the length of the eventual Ravensworth grant Portions 149 (Liddell), 150 (Liddell) and 1 (Vane), is close to 3 imperial miles across and may coincide with some of the mile grid survey lines originally proposed by Henry Dangar in his 1820s survey of Hunter Valley lands for the purpose of grant allocation and administration by the colonial government.

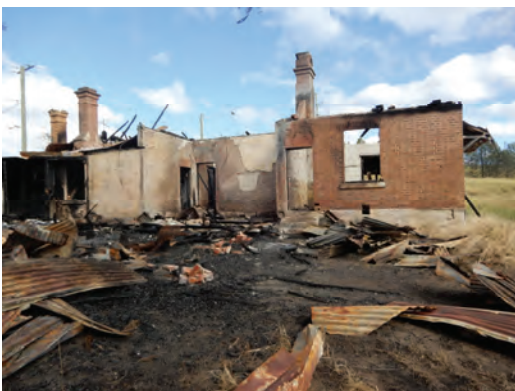
Figure 3. 16: Rear (east) and south wing of the Ravensworth Public School building following the recent fire.

In May 2019, the school building was the victim of an arson attack and it is currently in very poor condition.

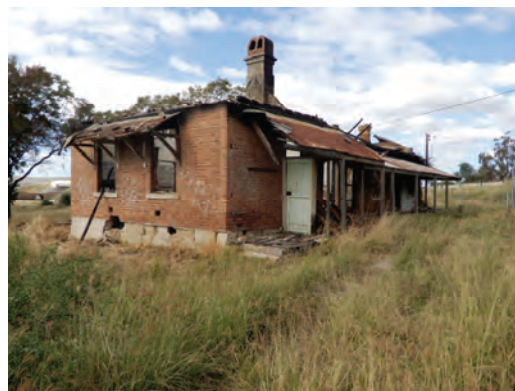
Figure 3. 17: Front (west) elevation of the school building.

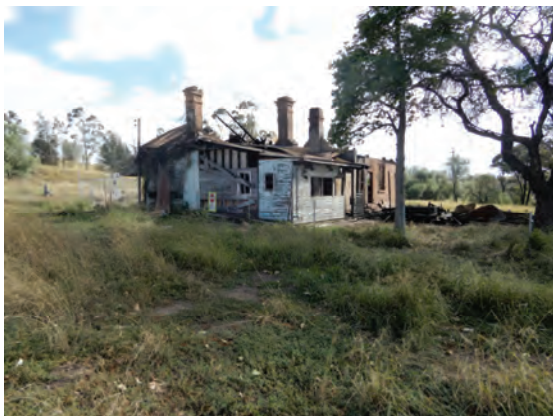
Figure 3. 18: North and east elevations of the school building.

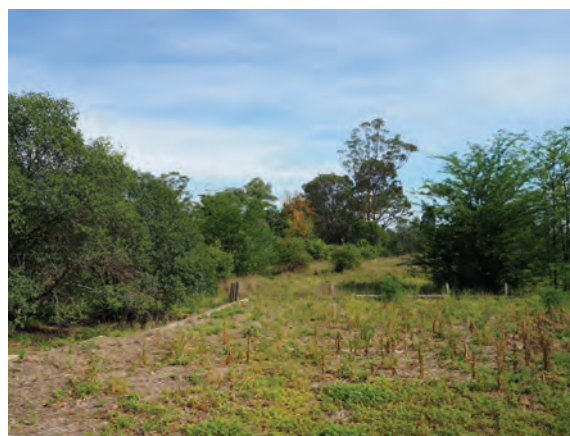
Figure 3. 21: Evidence of the location of the former school master's residence with orange orchard in background.

The former school master's residence was located adjoining the playgrounds to the northeast, however reportedly it was burnt to the ground in recent years. Evidence remains of its location by way of a concrete slab.

To the north of the school allotment is an orange orchard, formerly associated with the school master's residence, which continues to survive.

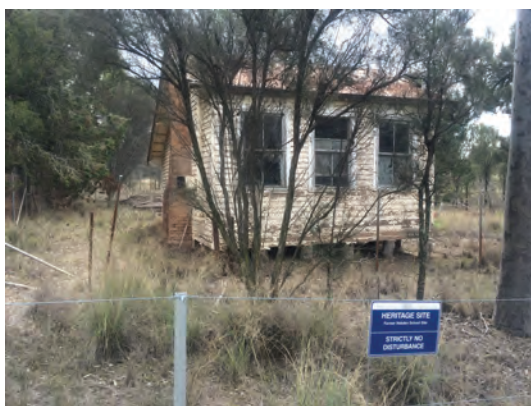
Figure 3. 25: Frontage (west) of Hebden Public School.

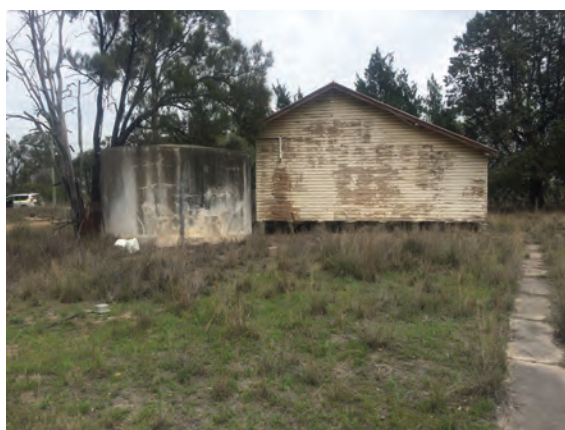
Figure 3. 27: Northern elevation of the school building with concrete path

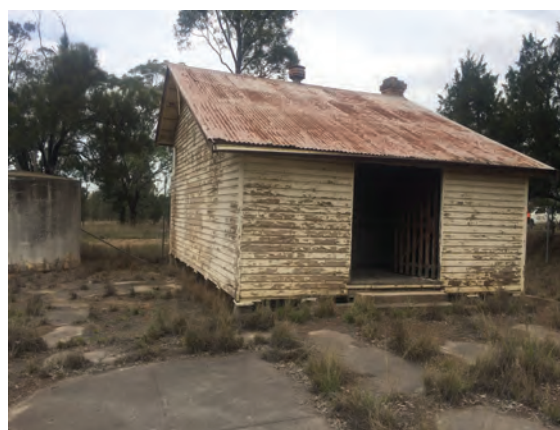
Figure 3. 28: Rear (east) elevation of the school building with entry.

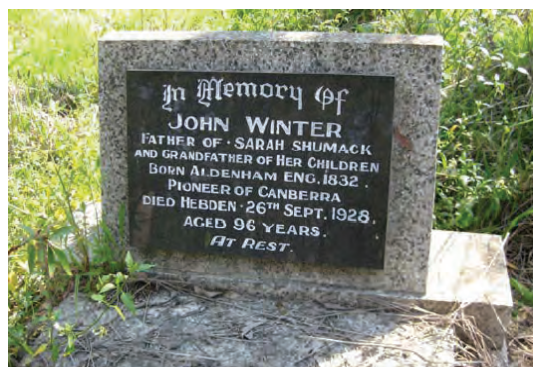
Figure 3. 29: John Winter's head stone. Source: Umwelt, 2014, p. 4.11

Located on the northern boundary of the Hebden Public School is a single grave comprising a granite slab and headstone with engraved terrazzo monument.

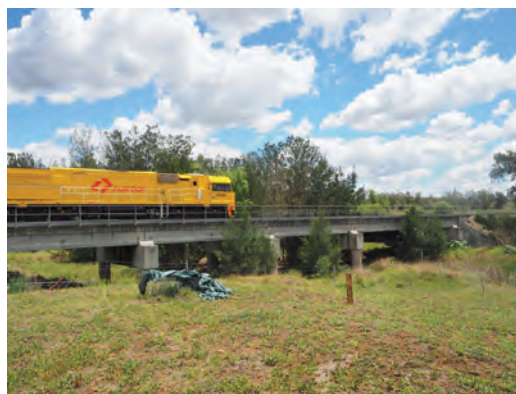
*“Bowmans Creek No. 2
259.076 km
Year 2006”*

Figure 3. 30: Coal train crossing over Bowmans Creek No. 2 bridge

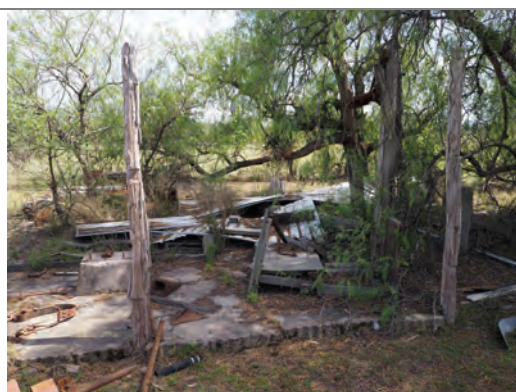
Archaeological remains of former early to mid 20th century farm house with associated farm structures including cattle ramp and yards, storage shed, tanks, fencing and timber footings. Cultural plantings located around building ruins and adjacent to Bowmans Creek including peppercorn.

Figure 3. 32: Ruins of former farmhouse with peppercorn tree adjacent.

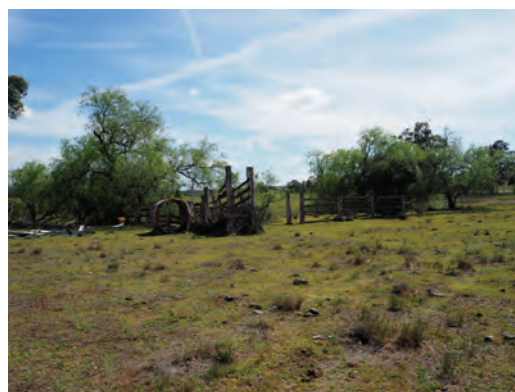
Figure 3. 33: Ruins of sheep ramp with yards with peppercorn trees

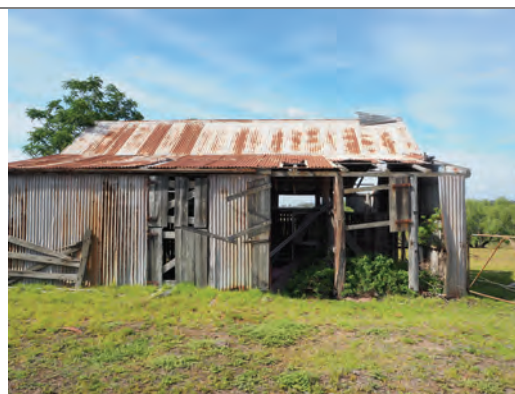
Remnant mid 20th century stables built of bush poles with corrugated iron cladding and adjacent cattle yards. The yards are still in use by Colinta Holdings who use the Ravensworth lands for cattle grazing.

Adjacent are archaeological remains of the former farmhouse and other farm structures including a cattle

Figure 3. 36: Ruins of former stables/cattle stalls and shed.

ramp, cistern, two dams and footings of other buildings.

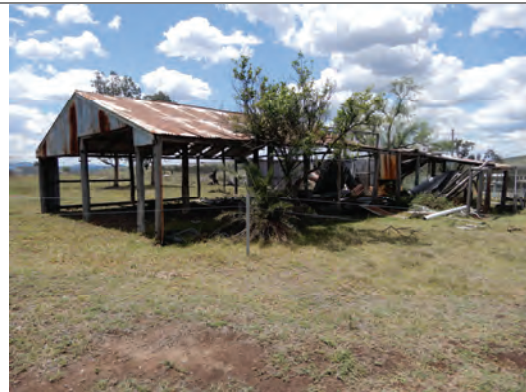
Footings and scattered remains of former house with cultural plantings including bougainvillea with adjacent sheep shed of bush pole and corrugated iron cladding. Other cultural plantings including orange, carob, willow and agave.

Figure 3. 38: Sheep shed with cultural plantings.

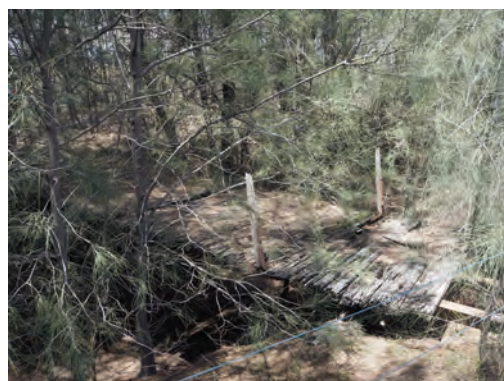
Timber bridge on steel rails over creek, probably used for moving stock. Located near to former farm (see Site 25). Currently fenced with steel star picket and wire and identified as: "Heritage Site No. 1".

Figure 3. 40: Timber bridge over Swamp Creek.

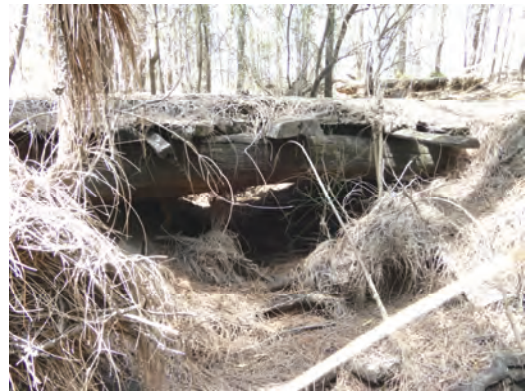
Timber and bitumen covered bridge supported on timber posts. Possibly early 20th century. The bridge provides access over Yorks Creek to the west from Hebden Road and leads to Site 26 (see above).

Figure 3. 43: Timber and bitumen bridge.

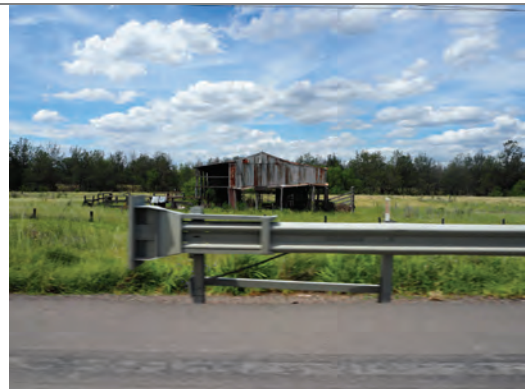
Former hayshed of bush poles and corrugated iron cladding with timber cattle yards located between the New England Highway and the Great Northern Railway. Evidence of other associated former farm buildings in close proximity.

Figure 3. 44: Former hay barn with cattle yards.

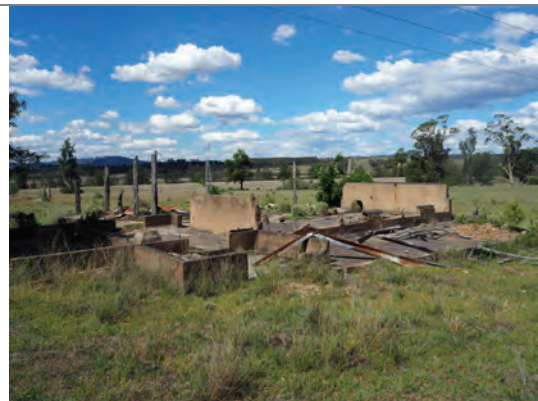
Located adjacent to the Great Northern Railway, remnants of former dairy including concrete foundations and parts of walls of dairy building with sluices, timber posts remain standing from other farm outbuilding, fence lines, scattered building materials and machinery and a hollowed-out log water trough.

Figure 3. 45: Remains of former dairy building.

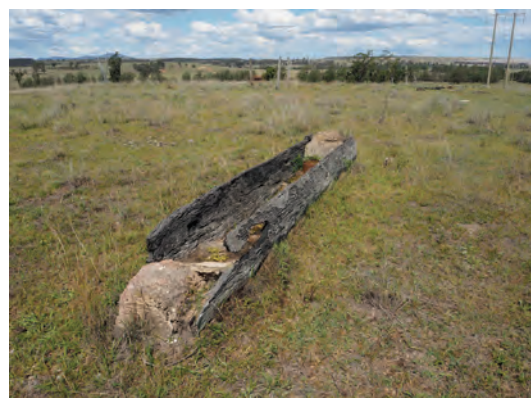
Figure 3. 46: Timber log water trough.
