APPENDIX 23

Heritage
Assessment

Appendix 23 – Heritage Assessment

This appendix contains the following Heritage Assessment documentation in relation to Ravensworth Estate and the Ravensworth Homestead Complex:

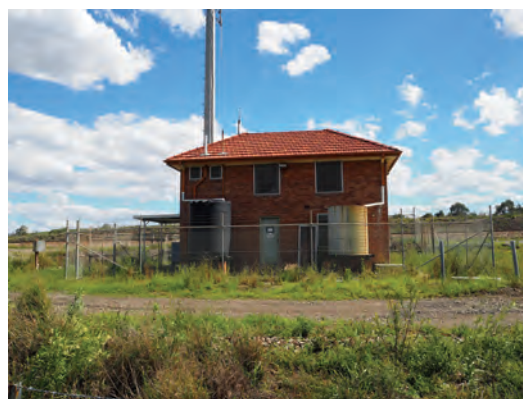
1960s red brick and tile elevated signal box with associated infrastructure and fenced in wire mesh and steel post fencing. Still in operation remotely.

Figure 3. 47: Newdell Junction signal box

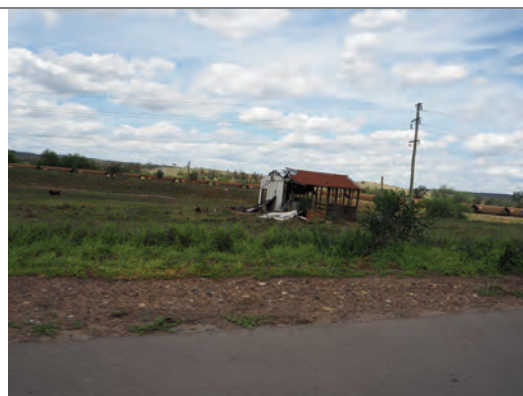
Former farm building in poor condition adjacent to the New England Highway. Timber structure with corrugated metal roofing and fibrous cement wall cladding. Evidence of brick incinerator and concrete tank stand. Some cultural plantings including peppercorn and scattered machinery.

Figure 3. 48: Dilapidated farm building adjacent to the New England Highway.

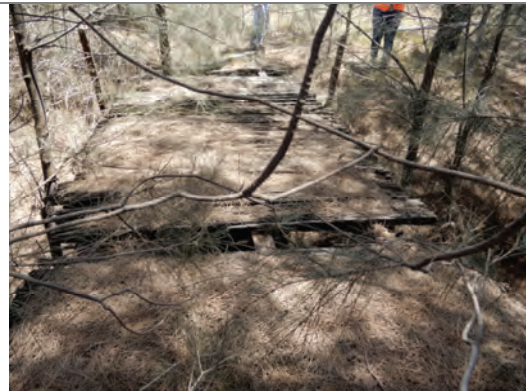
Located at the eastern end of the allotment adjacent to the Yorks Creek Voluntary Conservation Area and accessed via a dirt track leading eastwards from Hebden Road. An early 20th century timber bridge which it is assumed was used for moving stock. The creek is overgrown with regenerating she-oaks.

Figure 3. 51: Timber bridge over Yorks Creek.

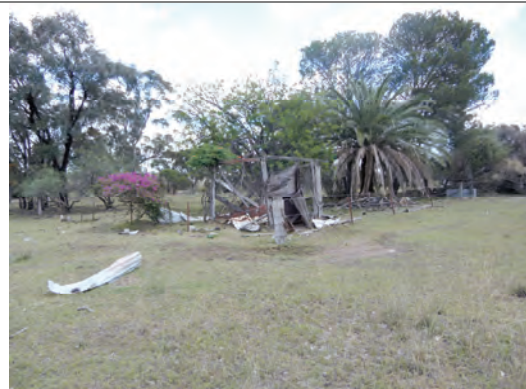
Located on the eastern side of Hebden Road to the north of the Hebden School site (Site 34a), a remnant residential allotment with evidence of former dwelling and outbuildings including timber and wire shed (ruined), rubbish heap, dam, entry driveway gate and scatter building materials and footings. The site is fenced with timber post, star picket and barb wire. Cultural plantings throughout the allotment including bougainvillea, begonia, agave sp. silky oak and date palm.

Figure 3. 52: Ruins of a shed at southeast corner of allotment with cultural plantings.

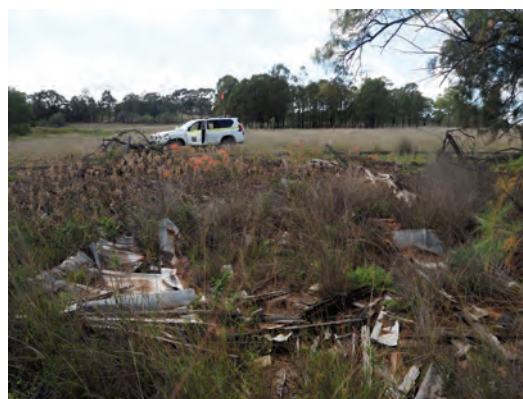
The site contains the ruins of farmhouse with footings and building materials including stone piers and brick base for a laundry copper or chimney and adjacent evidence of farm buildings including timber posts and a series of small dams. Cultural plantings include oleander, passionfruit, aloe and Kurrajong.

Figure 3. 53: Former farmhouse site with scattered building materials and cultural plantings.

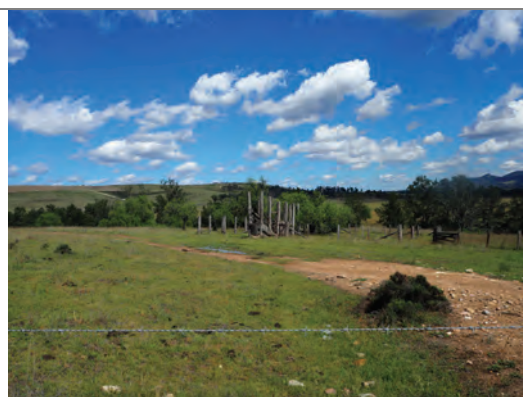
Former cattle yards with loading ramp adjacent to internal road on the western side of the Ravensworth East (northern) emplacement area. The confluence of Bowmans Creek and Stringy Bark Creek is directly to the north. The cattle yards appear to relate to a former farm located on the western side of Bowmans Creek which has since been demolished.

Figure 3. 54: Former cattle yards with ramp.

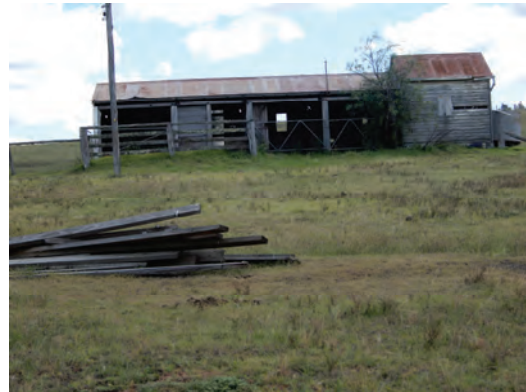
Remains of the farm buildings include early 20th century timber dairy with attached men’s quarters, large corrugated iron clad shed with attached cattle yards, timber machinery shed, timber and corrugated iron clad barn. The paddocks on the alluvial flats to the north of the farm buildings leading to Bowmans Creek remain marked out with timber and wire fencing.

Figure 3. 57: Timber dairy with yards and adjoining men’s quarters

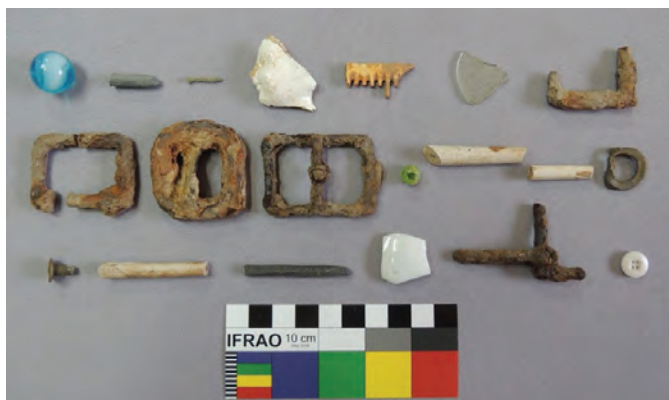
Figure 3.150: Selection of miscellaneous artefacts from the site, TAs 3, 4, 5, & 6. Top row from TA3 (l-r): TT6a glass marble and slate pencil; TT6A copper shoe tack; TT6B glazed ceramic doll head and celluloid comb; TTE spectacle lens; TT2 iron buckle. Middle row from TA4: iron buckles; glass bead; kaolin pipe stems; copper alloy button frame. Bottom row TA5: copper alloy stud, kaolin pipe stem, slate pencil, porcelain doll shoulder fragment; TA6: iron buckle, porcelain button. Source: Casey & Lowe, 2019, Figure 4.27, p. 105

- Scattered within and around the various structures in TA3-6 were numerous fragments of ceramics and glassware used by the occupants over time. The table and tea wares were mostly imported from the UK. The glass represented a range of beverages and food. Consumption of food by the residents at the site were represented by small numbers of animal bone, mostly from sheep. Several of the examples had butchery marks and one was burnt (Figure 4.35). In the future these may assist in our understanding of slaughtering practices at Ravensworth Estate and what cuts of meat were preferred.

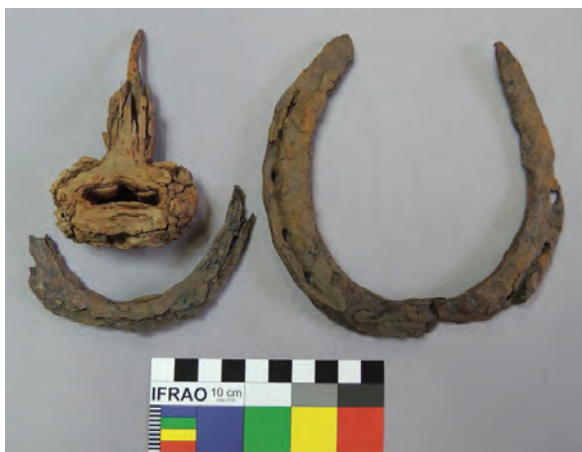
Figure 3. 152: Iron objects from TA5/TT2 relating to horse transport and leatherworking. L-r: borer for punching holes in leather, above toe of broken horseshoe; broken horseshoe with large nail holes in fullering groove. Source: Casey & Lowe, 2019, Figure 4.31, p. 108

- Blacksmithing and horse farriering activities are strongly indicated by artefacts found associated with structures to the north of the homestead complex TA5 TTs 2-4. These include large pieces of unworked and worked iron for structures, vehicles, various horse and possibly oxen shoes and equipage. A leather hole punch presumably for straps and belts was found in TA5 TT2 (context 76).

- Blacksmithing and horse farriering activities are strongly indicated by artefacts found associated with structures to the north of the homestead complex TA5 TTs 2-4. These include large pieces of unworked and worked iron for structures, vehicles, various horse and possibly oxen shoes and equipage (Figure 4.31). A leather hole punch presumably for straps and belts was found in TA5 TT2 (context 76).

Figure 4.31: Iron objects from TA5/TT2 relating to horse transport and leatherworking. L-r: borer 76/#212 for punching holes in leather, above toe of broken horseshoe 78/#217; broken horseshoe 78/#216 with large nail holes in fullering groove. 100mm scale. Photo: DSCN9898.

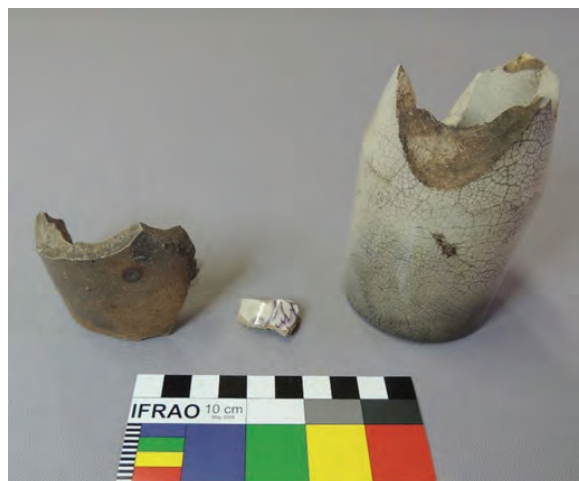
Figure 3. 153: Ceramic fragments from TA3/TT9 context 11. L-r: salt glazed stoneware bottle; purple top plate. Source: Casey & Lowe, 2019, Figure 4.34, p. 109

Five archaeological test trenches were opened in TA3 during the project as well as a number of test pits for the relocation of the buildings. Some 154 (MIC) artefacts were retrieved from eight trenches/ test pits (Table 4.3, Table 4.4). The trenches/ test pits were located beside the walls of the main wing, kitchen wing and adjacent outbuildings (stables and barn) and the northeast cottage (men's quarters), as well as in the north courtyard, south garden, and just outside the house complex fence in the western and southern paddocks (see Figure 3.9). Most of the trenches/ test pits were small and the artefacts found in them relate to a long period of occupation of the property. Only the more diagnostic items were retained and catalogued, others were recorded and photographed on site. In addition, 12 animal bone fragments, mostly identified as sheep, were found in TT2 (10), 6 (1) and D (1). These probably represent meals of mutton and lamb (Figure 4.34).

Figure 4.34: Ceramic fragments from TA3 TT9 context 11. L-r: salt glazed stoneware bottle #17; purple top plate #19 and white glazed bottle #20. Scale: 100mm. Photos: DSCN9911, 9913.

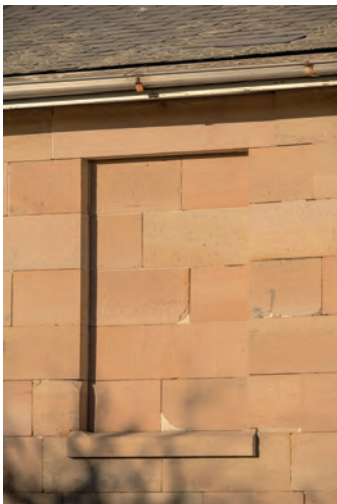
Another notable feature is that the west side of the house and the west side of the Barn contain blank window recesses consciously designed to enhance the appearance of the buildings as they were approached from the west.

Figure 3. 156: Blank recess located in the west elevation of the Main House.

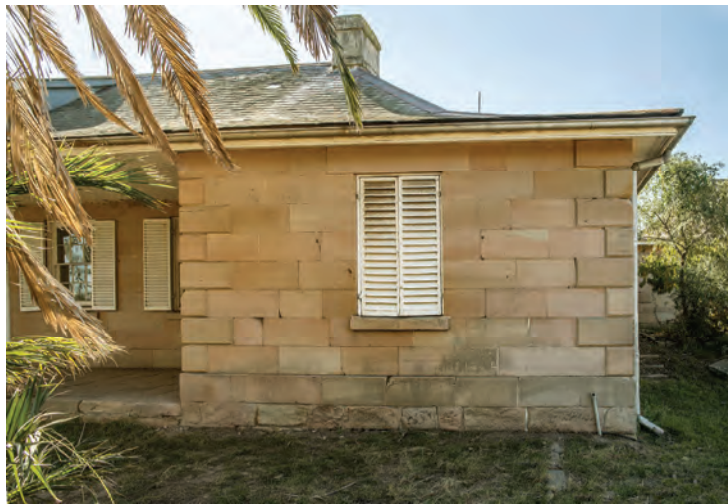
Figure 3. 157: The eastern portion of the south (front) elevation of the Main House showing the quoins.

At each corner of the house and each external wall of all buildings, the stonemasons have originally provided very fine, dressed, projecting chamfered quoin stones in 12" courses. The quality of the face work generally diminishes towards the rear of each building. Usually 300mm courses, it breaks into 150mm courses on less important sides.

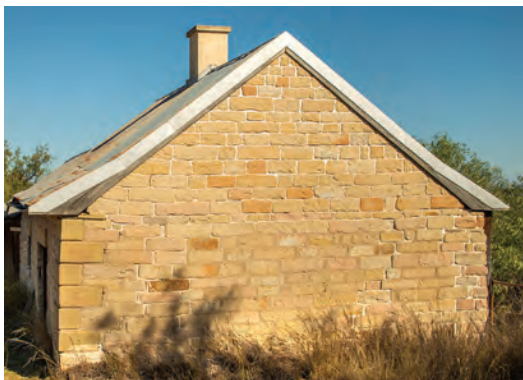
The Kitchen Wing and the Barn and Stable buildings have well-constructed hardwood framed bell-cast eaves, probably originally intended for lath and plaster linings. The House and Kitchen wings have timber framed roofs utilising regularly spaced, larger, king rafters (strengthened by collar ties) that support purlins that support the common rafters.

Figure 3. 158: North elevation of the Barn showing the bellcast eaves

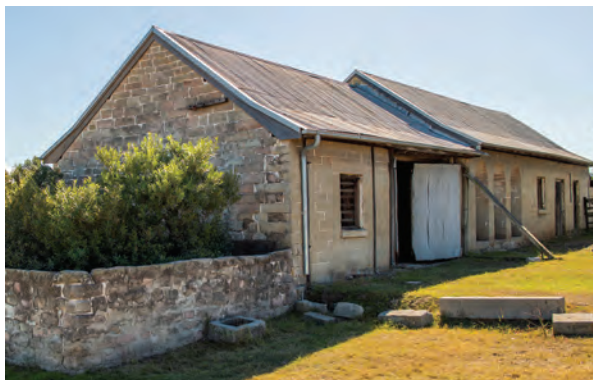
Figure 3. 159: South and east elevations of the Stables with bellcast eaves and attached rubble stone water tank.

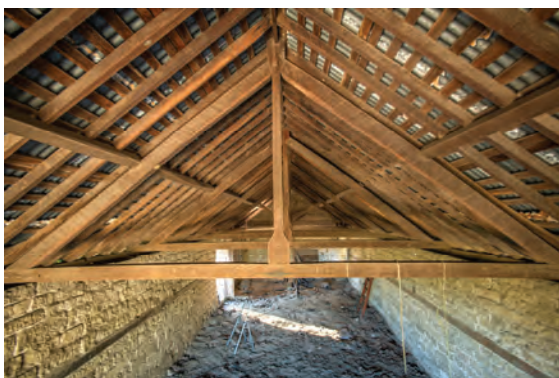
The Barn and Stable buildings have well-built king post trust roof framing supporting purlins supporting common rafters. The workmanship is of high quality for both the wall and roof construction.

Figure 3. 160: Roof structure of the Barn. Photo: D. Liddle, 2018

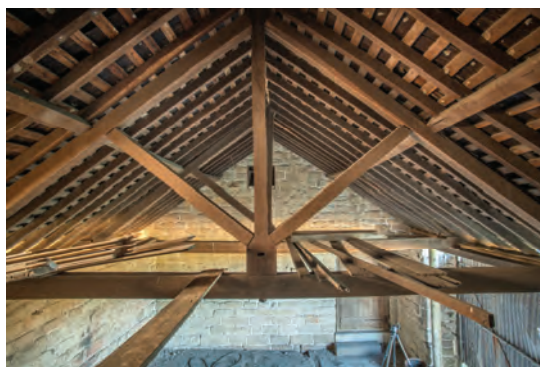
Figure 3. 161: Roof structure of the Stables. Photo: D. Liddle, 2018

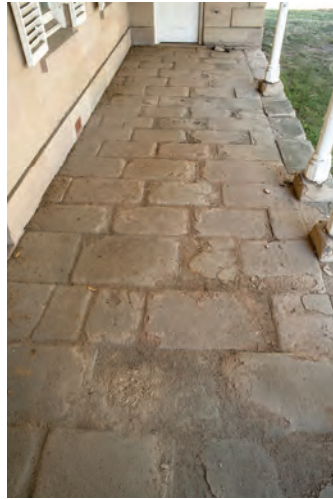
Figure 3. 168: Stone flagging on south (front) verandah. Photo: David Liddle 2018

The roof has 400mm wide eaves possibly originally lined in lath and plaster but now fibre cement. The front verandah has a ceiling of pressed metal and Late 19th century cast iron columns that replaced the original tapered posts. The northern addition included a shallow, timber framed verandah with roof integral to the adjacent rooms and stone flagged floor, probably reusing in flagging from the original north verandah.

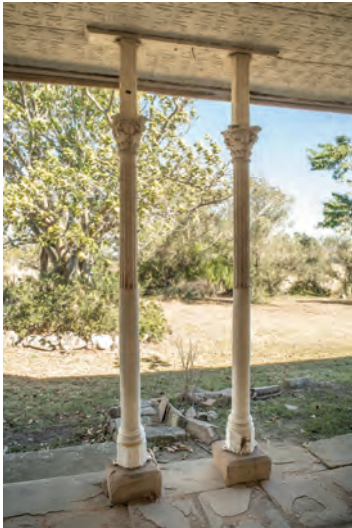
Figure 3. 170: Double columns to front (south) verandah. Photo: David Liddle 2018

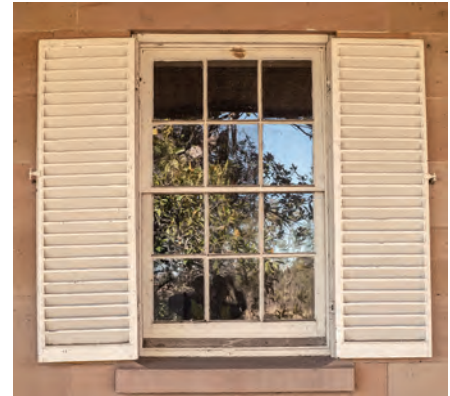
Figure 3. 172: Typical timber framed six pane double sash window with timber shutters. Photo: David Liddle 2018

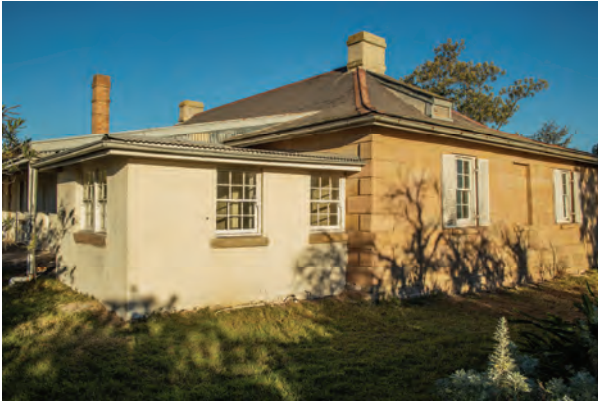
Figure 3. 175: Later bathroom addition to northwest corner of Main House. Photo: David Liddle 2018

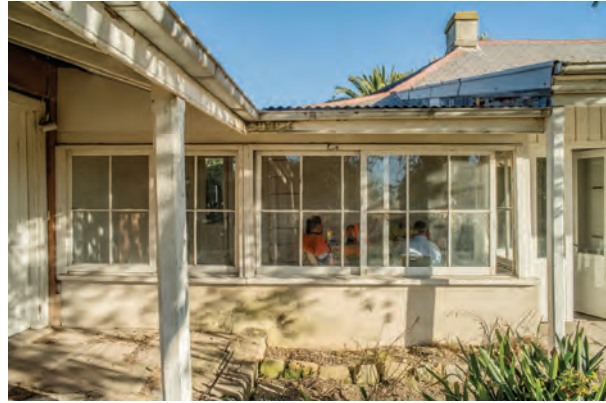
Figure 3. 176: Later infill link between Main House and Kitchen Wing. Photo: David Liddle 2018

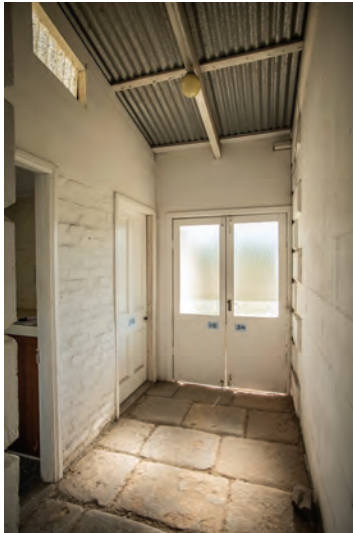
Figure 3. 182: Connection between bathroom addition and outer wall of the northwest room. Photo: David Liddle 2018

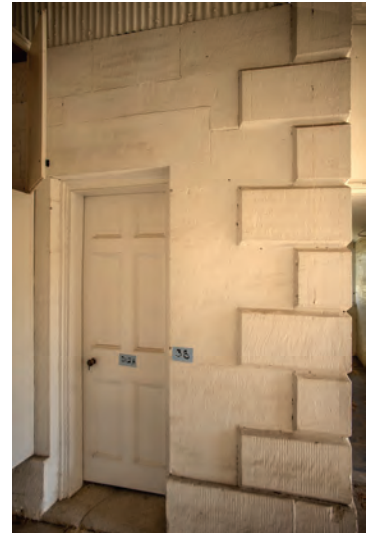
Figure 3. 184: Entry into northwest room with quoins. Photo: David Liddle 2018

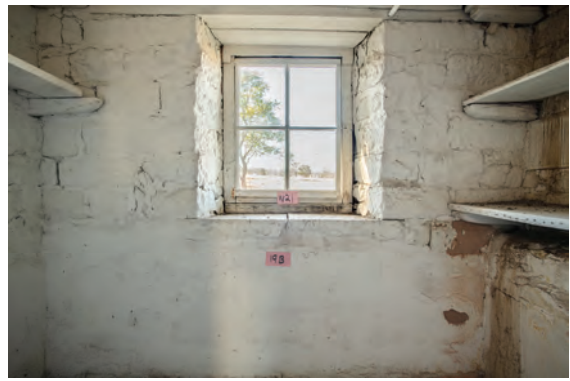
Figure 3. 201: Window in pantry. Photo: David Liddle 2018

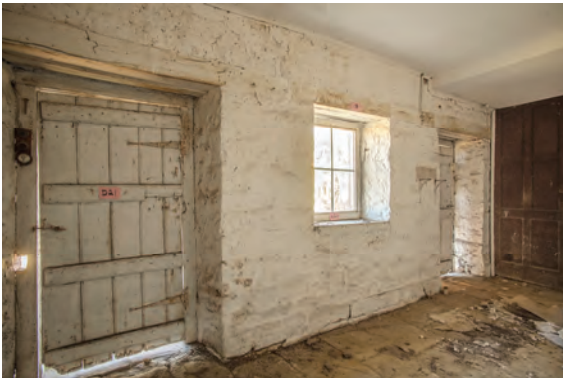
Figure 3. 202: Southeast room accessed from south garden (Space H18). Photo: David Liddle 2018

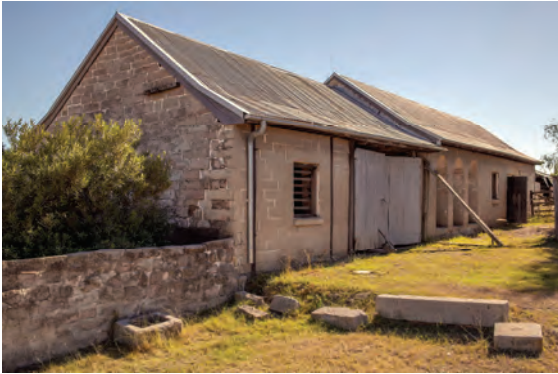
Figure 3. 205: Eastern elevation. Photo: David Liddle 2018

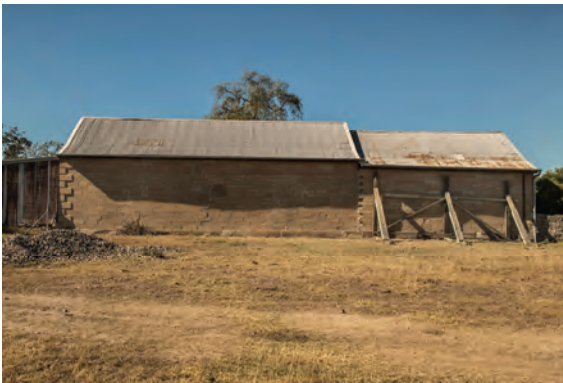
Figure 3. 207: West elevation with propping. Photo: David Liddle 2018

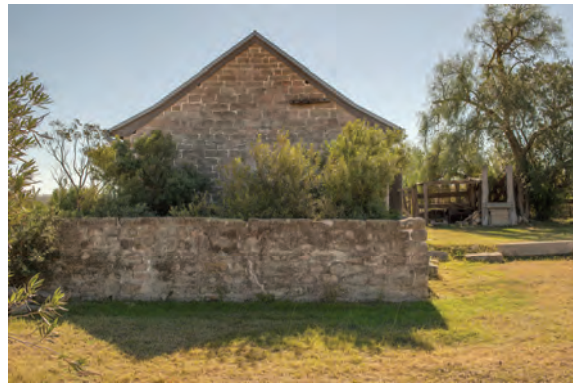
Figure 3. 208: South elevation with rubble stone water tank. Photo: David Liddle 2018

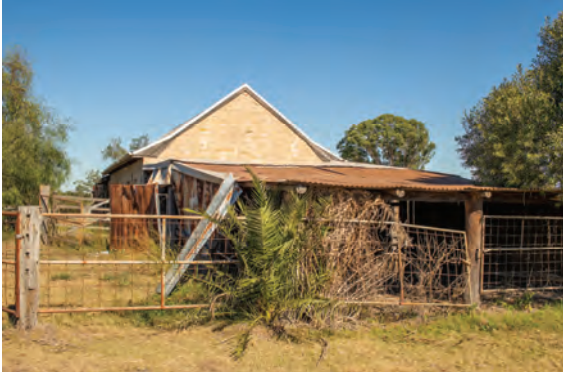
Figure 3. 209: North elevation with skillion addition and yards. Photo: David Liddle 2018

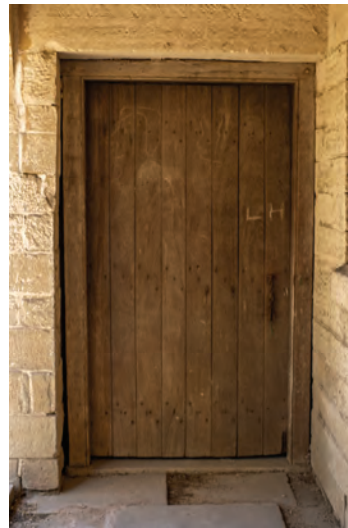
Figure 3. 212: Typical stable door. Photo: D. Liddle, 2018

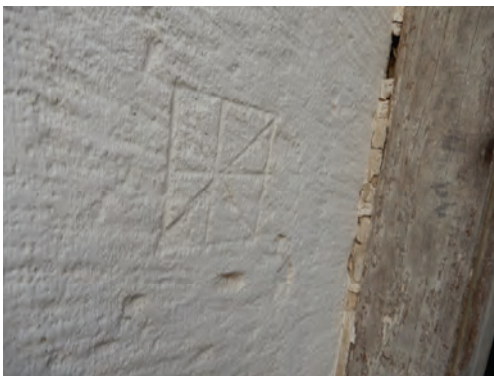
Figure 3. 213: Makers mark scratched into soffit of door in Stables.

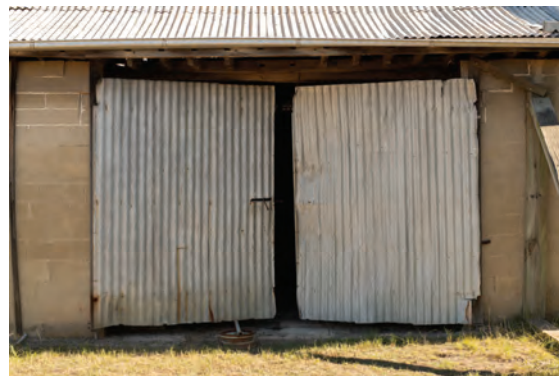
Figure 3. 214: Later garage doors inserted in southern portion of Stables.

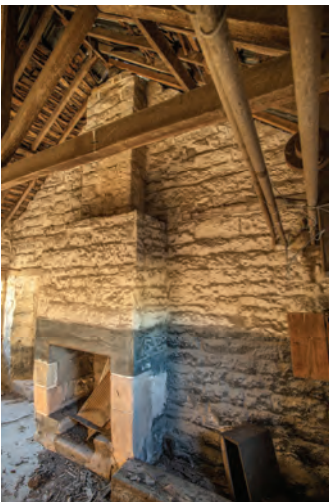
Figure 3. 229: Fireplace in northern space (Space B3). Photo: D. Liddle, 2018

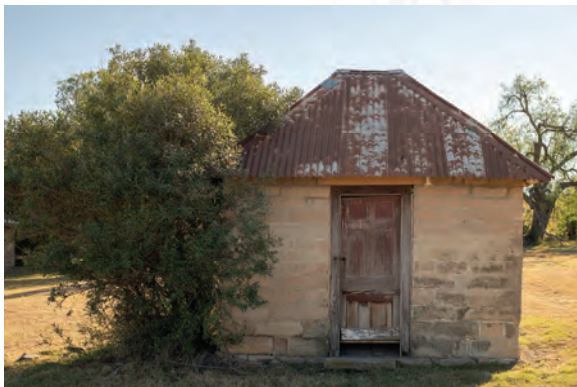
Figure 3. 235: South elevation and entry door. Photo: D. Liddle, 2018

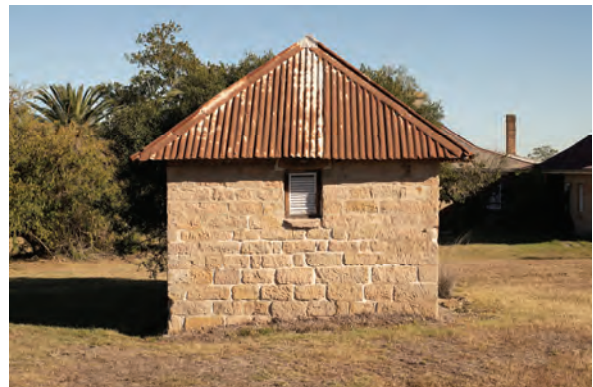
Figure 3. 236: East elevation with window. Photo: D. Liddle, 2018

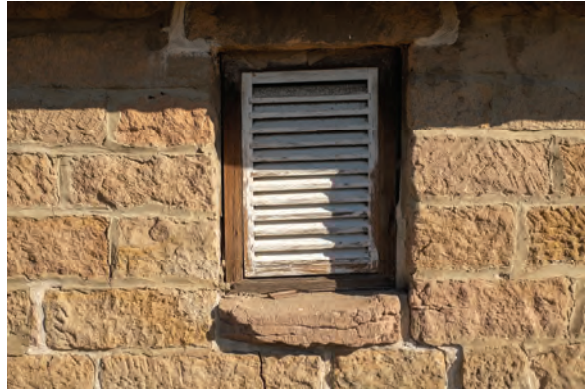
Figure 3. 238: Timber louvred window. Photo: D. Liddle, 2018

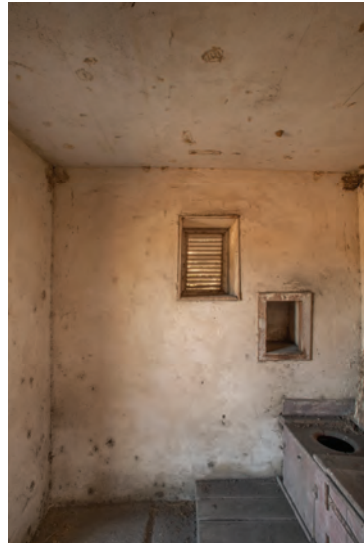
Figure 3. 240: Interior of western wall with window and niche.

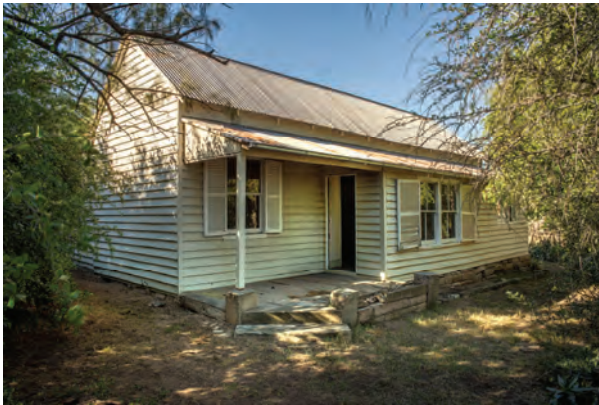
Figure 3. 242: North-west corner
Source: David Liddell

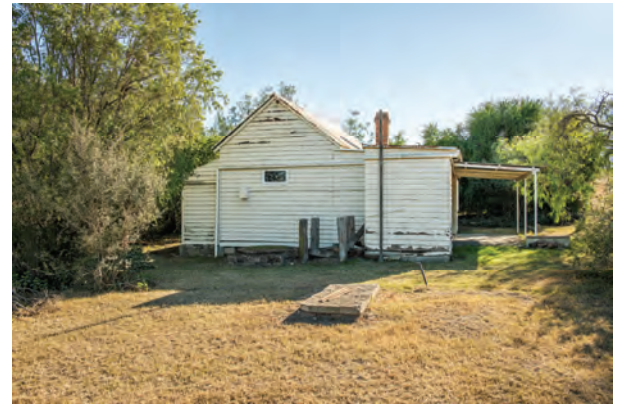
Figure 3. 243: South elevation
Source: David Liddell

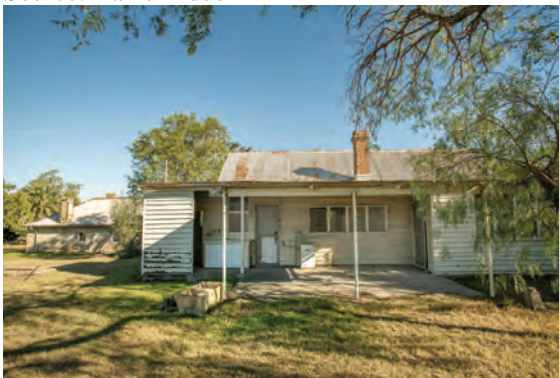
Figure 3. 244: East elevation Source: David Liddell

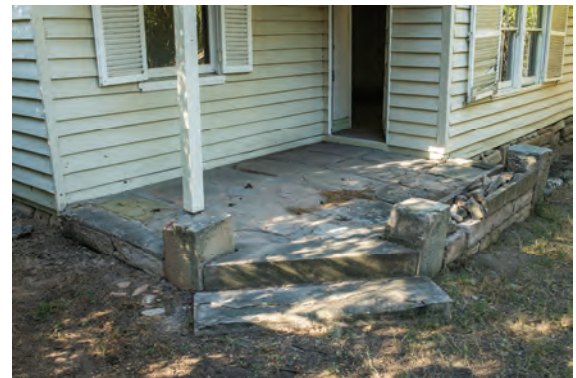
Figure 3. 245: Detail of front verandah (Space Q2A).
Source: David Liddell

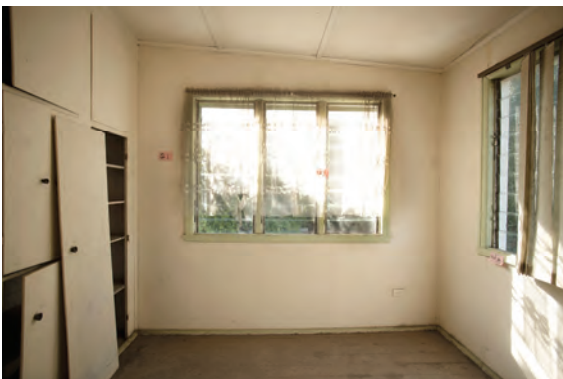
Figure 3. 250: Bedroom (Space Q1). Source: David Liddell

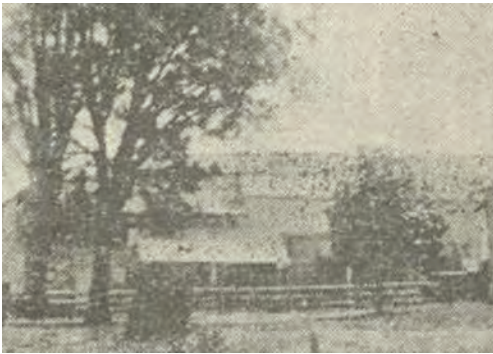
<p>Figure 3. 259: Detail from 1891 photo of Ravensworth showing the rear buildings including the stables and north wing. Source: <i>The Bulletin</i>, Vol. 11 No. 579 (21 Mar 1891), p. 19</p>

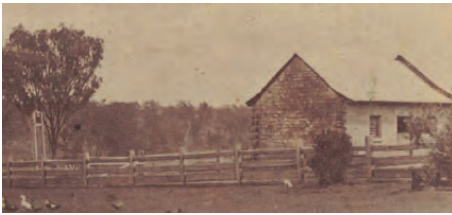
Date	Type of Evidence	Comment
1890-1911	Photographic	<p>Hill period photo shows tooting on the southern corners of the Stables where an addition has been removed. There was no stone water tank to south of Stables at this time. The photo also shows a bell on bell post and timber yards.</p>

<p>Figure 3. 260: Detail from photograph showing the stables as seen from the northern side of the main house. Source: Marshall family photographs</p>
1890-1911	Photographic	<p>Hill period photos shows original front verandah posts large tapered timber posts on the (surviving) stone bases.</p>

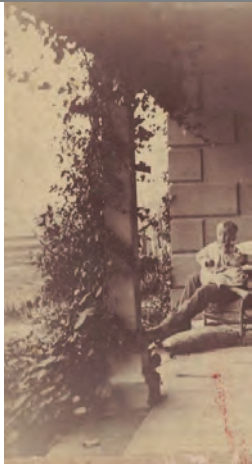
<p>Figure 3. 261 (right): Detail from photograph showing the front (south) verandah column. Source: Marshall family photographs</p>
15 February 1902	Documentary/ Photographic	<p>The <i>Sydney Mail</i> published an article on Ravensworth. Describing the homestead with the walls of the house were of stone 3 feet thick with windows built to use as firing ports for rifles to defend the house (no physical evidence exists). D F Mackay had carried out much ringbarking, built dams and 10 miles of fencing plus a large woolshed.⁵⁹</p> <p>The photograph accompanying the article shows the southern elevations of the main house and kitchen wing- both with slate roofing. A skillion link is seen between the house and the kitchen wing. Lattice awning with support posts over western window on south elevation of Kitchen wing.</p>

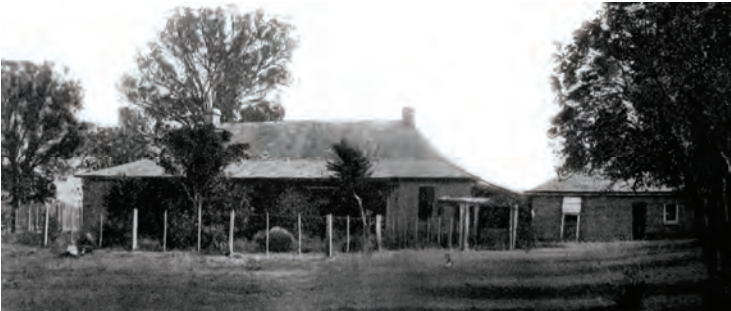
<p>Figure 3. 262: Ravensworth House in 1902 as seen from the south with kitchen wing on the right. Source: <i>Sydney Mail</i>, 15 Feb 1902, pp 416-7</p>

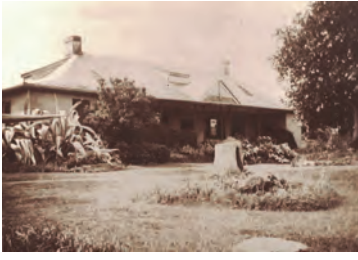
Date	Type of Evidence	Comment
7 Dec 1905	Documentary	Advertisement calling of tenders for “Renovations to Ravensworth House”, by architect J. Warren Scobie. The scope of works is not known at this time, although it is assumed based on physical evidence that this work included the addition of the pediment and dormer vents to the roof of the main house, replacement of the ceilings in the main house and the kitchen wing, possibly the replacement of the timber columns to the front (south) verandah with cast iron posts and the construction of the Men’s Quarters.
c1905	Photographic	<p>Undated photograph shows skillion dormer vents inserted in the east, west and north slopes of the main roof and the slated gable roof and pediment formed over the front verandah. At this time additional struts were probably installed in the roof to support the load of the slate. At this time also, the present cast iron columns were probably installed on the front verandah replacing the original tapered timber posts of which the stone bases were retained. Assumed the work of architect J. W. Scobie (see above).</p>

<p>Figure 3. 263: Undated (early 20th century) photograph of the main house following renovations. Source: <i>G & J Marshall</i></p>

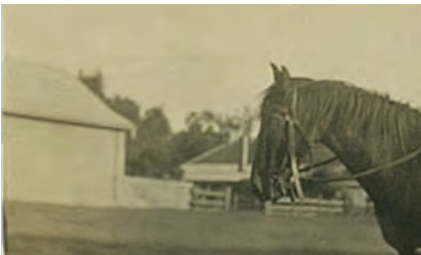
Date	Type of Evidence	Comment
		<p>A brickwork copper structure was installed at the north-east corner of Space S18 indicating a laundry use and possibly an original timber partition dividing the southern door, D20, was removed.</p> <p>The window to S20 was installed or at least enlarged using a fireplace lintel and window sill salvaged from an original construction.</p> <p>A fly proof screen was installed at the east end of Space S19 in the Kitchen Wing to form Space 19B.</p>
1928	Photographic	<p>The rubble stone water tank at south end of stables is shown. This work is noted as occurring in January 1928 (see above). Western boundary fence is shown as timber post and rail.</p>

<p>Figure 3. 266: Undated (Late 1920s) photograph showing the western entry to farm yard with kitchen and main house in background. Source: G & J Marshall</p>
15 February 1929	Documentary	<p>An undated report by an unnamed official stated he had been visiting the property and was familiar from earlier visits. It was an old improved property acquired by Marshall with an old stone homestead that he had renovated and “made into an excellent dwelling”.</p> <p>The stone stables and large stone shed were also renovated.</p> <p>A shed had been converted into a shelter for dairy cattle by adding stalls.</p> <p>A small mill and piping worth £30 had been added to the garden.</p> <p>The total of 27 chains of new 7 wire fencing had been added on the eastern boundary costing £30.</p> <p>No other improvements had been made since the acquisition.</p>

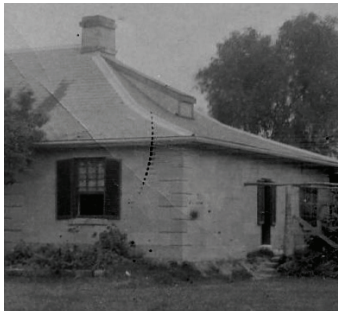
1930s	Photographic	<p>At some stage, the southern window on the east elevation of the main house was converted into a door. Photographic evidence shows the door opening with shutters attached.</p>

<p>Figure 3. 267: 1930s photograph looking northwest to the front of the Main House showing a later addition door opening on the east elevation, still with window shutters. Source: Courtesy of T. Cameron</p>

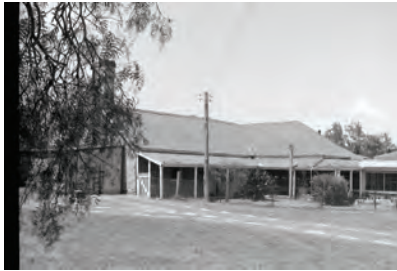
1977	Photographic	<p>At northern end of Kitchen wing is an attached skillion, corrugated iron garage with stone flagging wheel tracks.</p>

<p>Figure 3. 269: 1977 photograph showing the kitchen wing. Source: C. Lucas, LSJ archives</p>

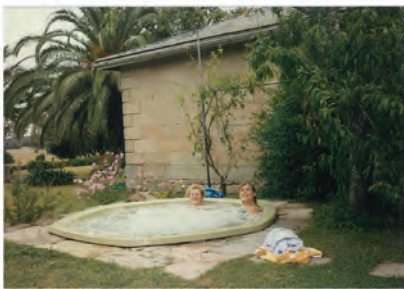
Date	Type of Evidence	Comment
1977	Photographic	Shows an addition to northern end of west wing of Main house (replaced later with stone addition containing a bathroom) was a skillion with weatherboard cladding. Figure 3. 270: 1977 photograph showing the west elevation of the main house with rear skillion addition. Source: C. Lucas, LSJ archives
Circa 1980	Physical	The ceiling of Space S16 in the Kitchen Wing was replaced with plasterboard and the space fitted out as a modern kitchen.
Circa 1980	Physical	The present Bathrooms S5 and S6 were constructed at the north-west corner of Main Wing incorporating two original stone window sills on the west side.
Circa 1980	Photographic	Inground spa with stone flagging surround located on east of Main House, south of Kitchen Wing. This may be the location of the original house cistern (unconfirmed).

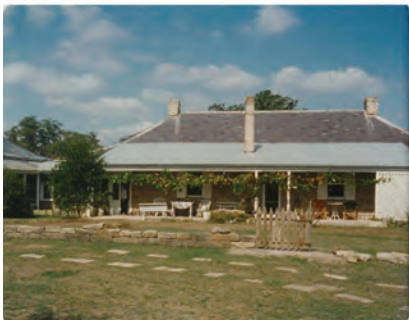
1980s	Photographic	Garden stone wall to rear of house under construction with timber picket gate. Lattice enclosure to west end of rear verandah with watertank on stand behind (as seen in 1920s photo) Stone flagging wheel tracks Rear elevation of Main House (containing the two room addition) in stone, un-rendered and unpainted. Timber French doors to link (H15B).

Figure 3. 272: 1980s (?) photo of the rear of the main house with rubble stone wall under construction. Source: G & J Marshall

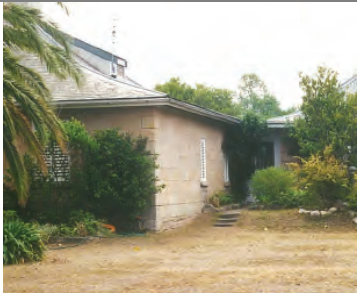
By 1998	Photographic	<p>The later door opening on the east elevation of the main house was restored as a window.</p>

<p>Figure 3. 276: 1998 photo of the east elevation of the main house showing the southern window opening restored with shutters. Source: G & J Marshall</p>

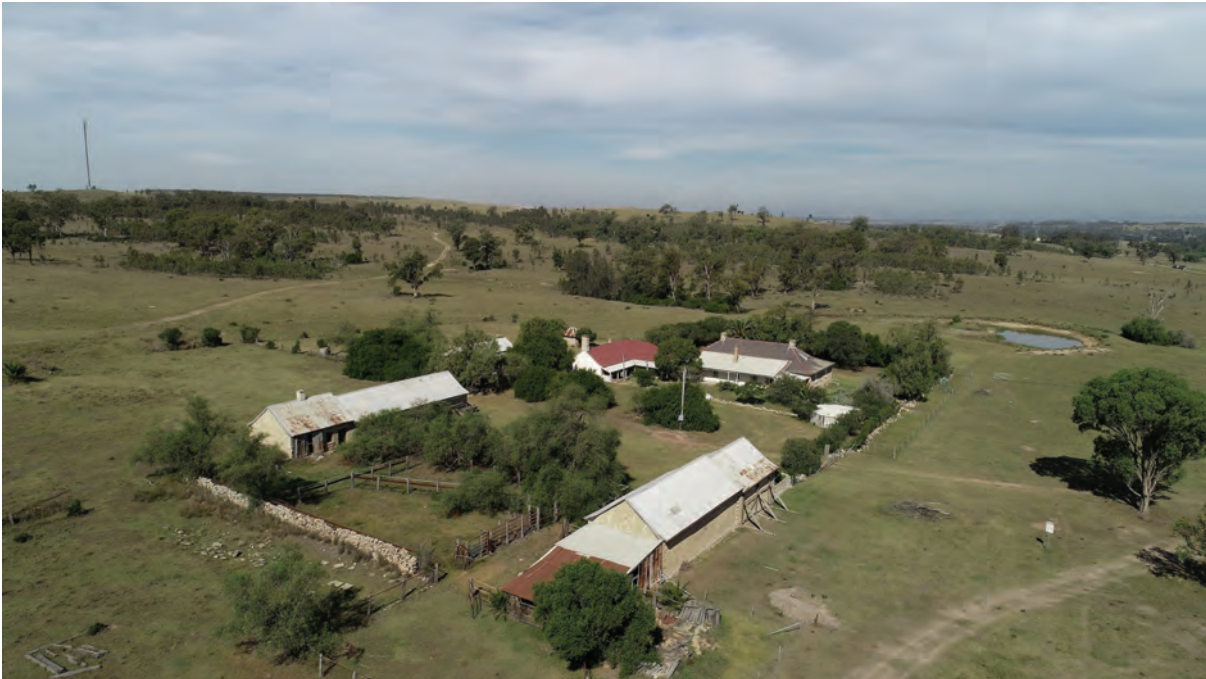
Figure 3. 277: Aerial view of the Ravensworth Homestead Complex showing the planned landscaped setting within the broader agricultural/pastoral landscape. Source: Glencore, 2018

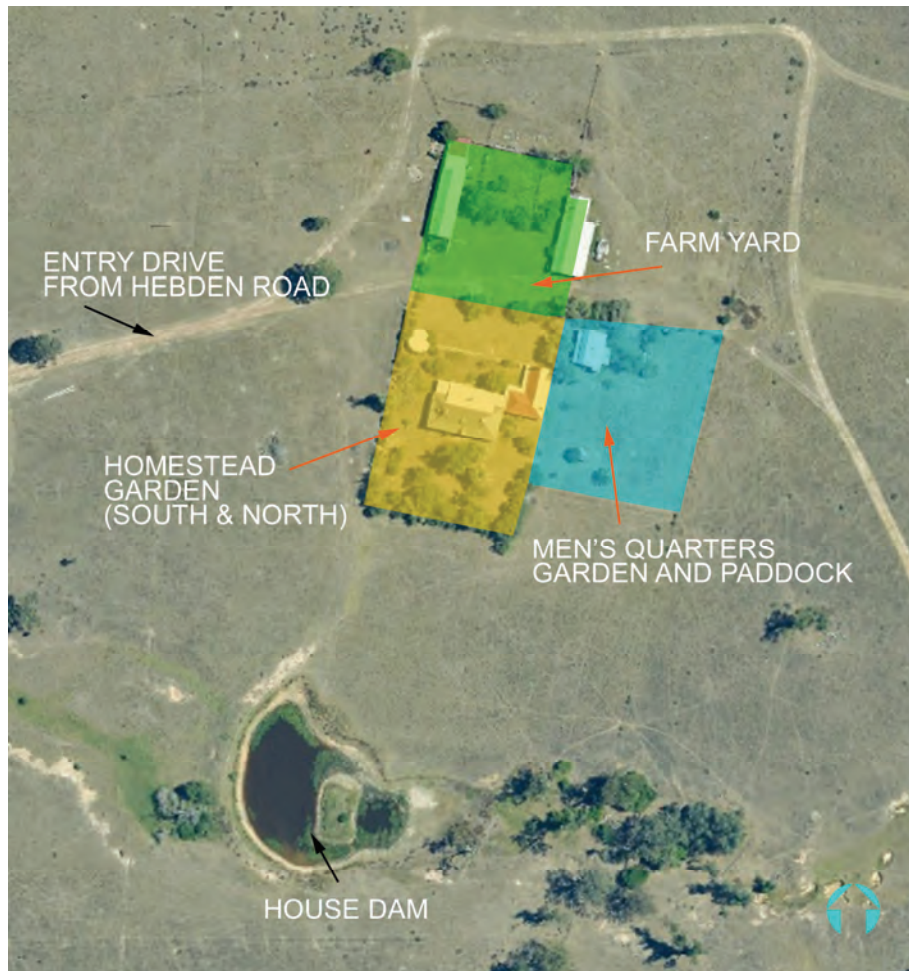
Figure 3. 278: Diagram showing the different landscaped areas of the Ravensworth Homestead Complex

The homestead group forms an orthogonal farm layout with the homestead and kitchen wing to the south and the stables and barn to the north. (The privy and men's quarters cottage are positioned outside this geometric layout.) (Refer to Figure 3.278.) Accordingly, the associated plantings range from those associated with the remnant pleasure grounds in the immediate vicinity of the homestead to gardens around the cottage to lines of Kei Apple (*Dovyalis caffra*) and Peppercorn trees towards the functional farm buildings to the north.

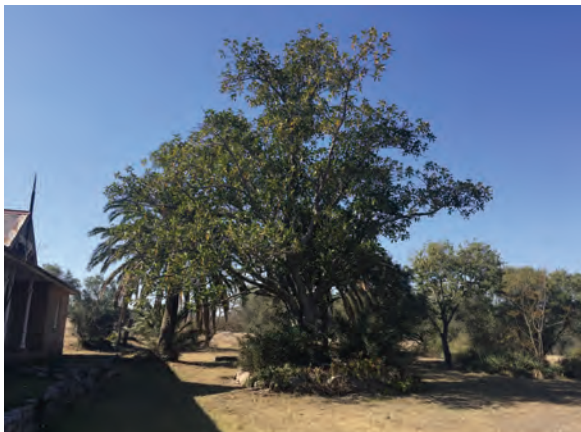
Figure 3. 279: The Moreton Bay fig tree within a raised bed in front of, and on axis with, the homestead. Photo: G. Britton, 2018

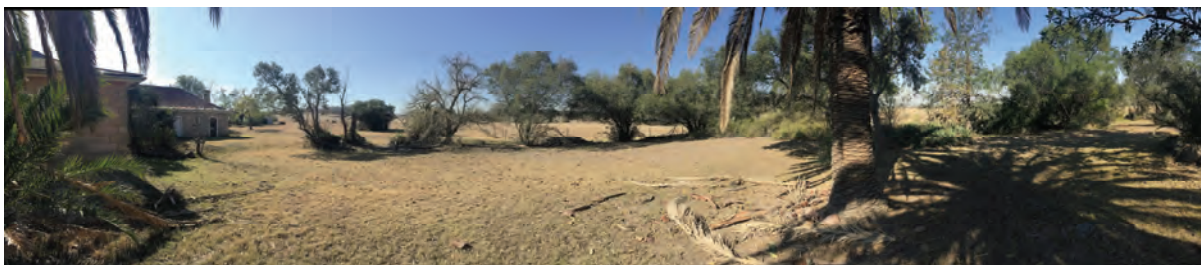
Figure 3. 281: A view between two mature date palms of the lawn space for the tennis court or croquet lawn. Note the row of African olives along the eastern boundary. Photo: G. Britton, 2018

The division between the eastern paddock (which holds the privy) and the southern homestead garden is defined by a row of African olives, which also defines the eastern edge of the tennis court area.

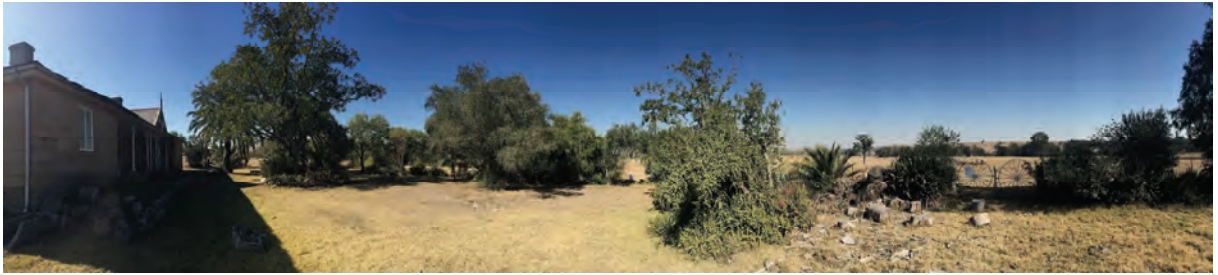
Figure 3. 282: Panorama of the homestead front grounds showing stone structures in the foreground (left) and the existing gateway (with cart wheels) at the western homestead grounds boundary (right). Also, in front of this gateway are logs from a fallen former eucalypt within the grounds, the stump of which remains. Photo: G. Britton, 2018

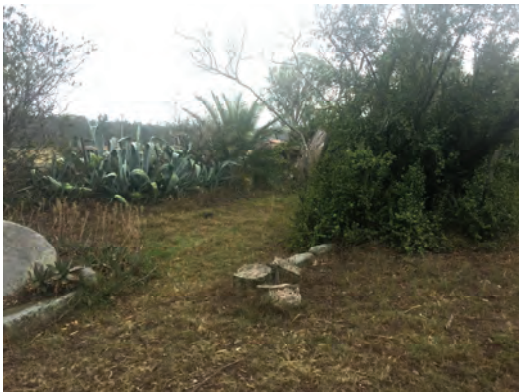
Figure 3. 283: The sunken garden in the southwest corner of the front garden.

Later additions to this southern area include a small tennis (or possibly croquet) lawn to the south-eastern side and a small sunken garden to the southwestern corner. A broken sandstone structure is located near the small tennis lawn and is presumed to be a former trig marker from the nearby Ravensworth Trigonometrical Station.

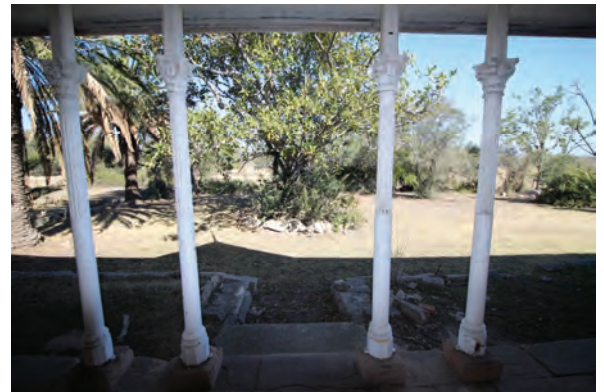
Figure 3. 284: The central circular garden bed with fig on axis with the front door of the homestead

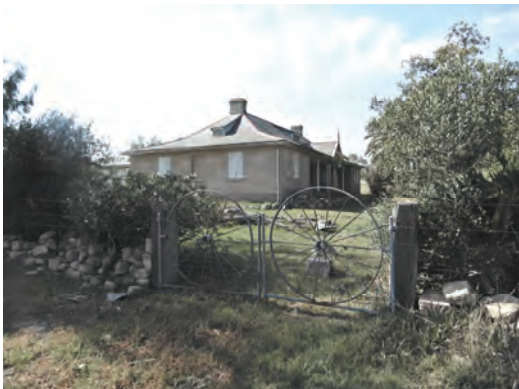
Figure 3. 285: The entry gate leading into the southern homestead garden, possibly indicating an earlier carriage drive.

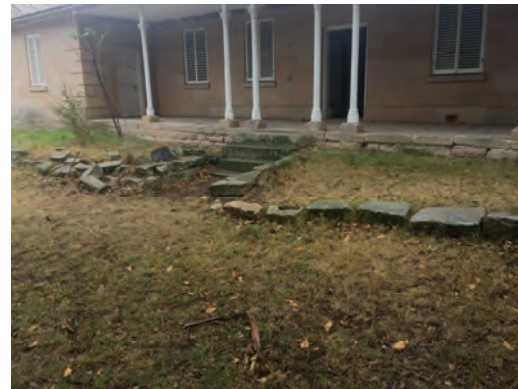
Figure 3. 286: The raised garden beds along the frontage of the main wing of the homestead

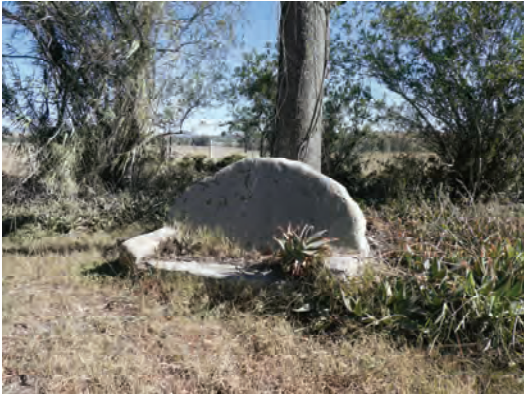
Figure 3. 287: The stone seat in the sunken garden.

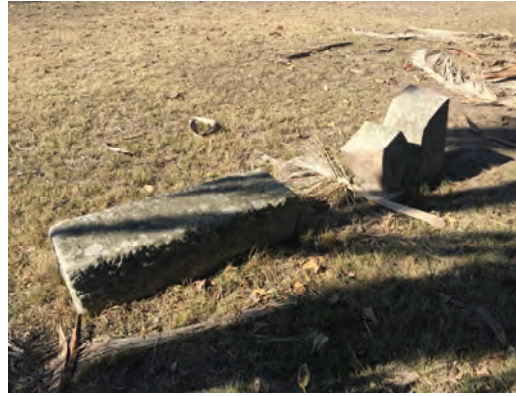
Figure 3. 288: The remnant stone pieces, possibly from the trigonometry station, now located in the southern garden area.

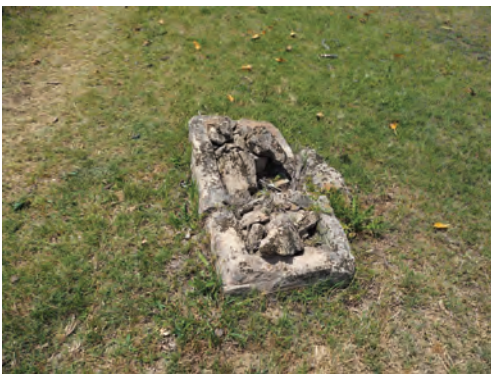
Figure 3. 289: Stone water trough located in the southern garden area.

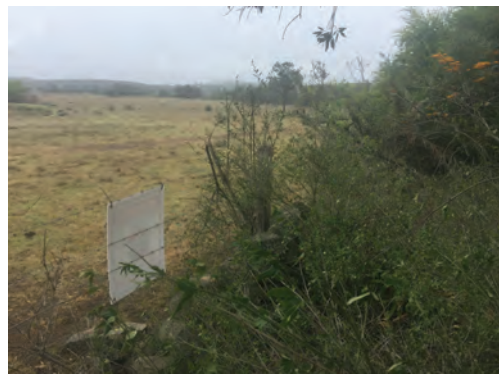
Figure 3. 290: Barbed wire and timber post fencing along the southern boundary of the garden.

Both western and southern house garden boundaries are fenced and reinforced by low, coursed rubble walls as well as wire and timber post or star picket fence lines.

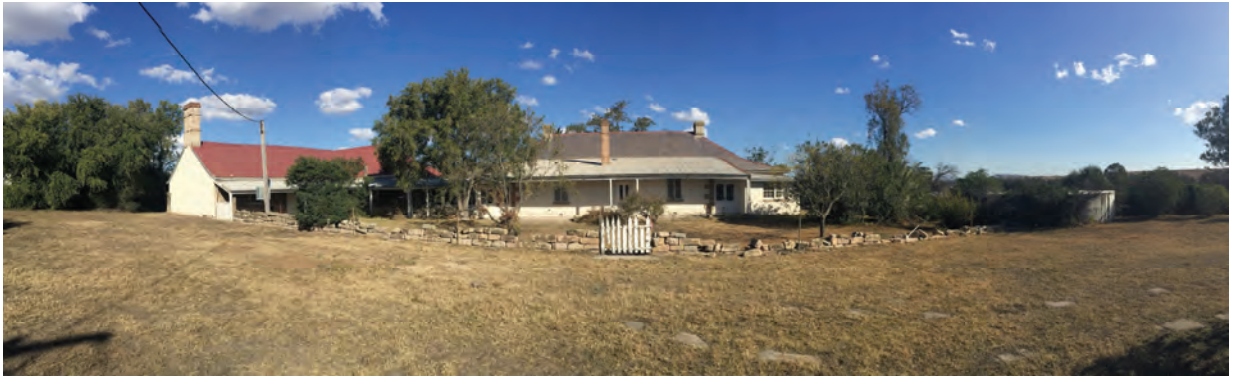
Figure 3. 291: A panoramic view of the rear ground of the homestead, centred on the house axis (the picket gate in line with the back door) The tallest plant on the left is a *Callistemon* sp. with the rose behind the picket gate. On the right is a young Jacaranda with a line of oleanders behind. The Japonica is to the left of the water tank while common honeysuckle covers part of the tank. Photo: G. Britton, 2018

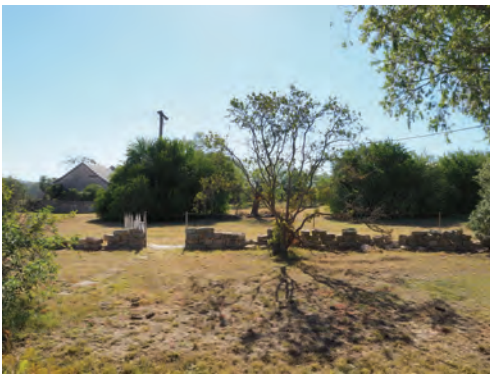
Figure 3. 292: Stone rubble wall defining the northern garden of the Homestead.

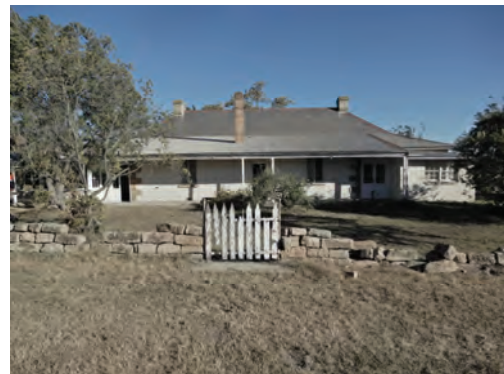
Figure 3. 293: Stone rubble wall with timber picket gate along the northern boundary of the northern garden with the Main House in the background.

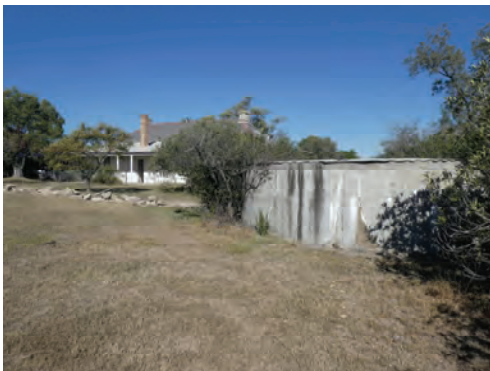
Figure 3. 294: Concrete watertank located in north-western corner of the rear garden.

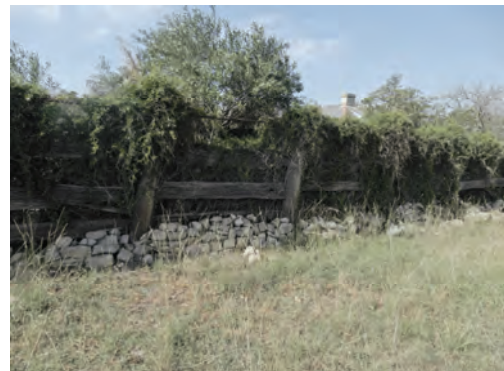
Figure 3. 295: Timber post and rail fence with stone rubble and steel post supports for plantings defining the western boundary of the rear garden.

The western boundary of the rear house garden from the service area also consists of a timber post and rail fence above the rubble stone wall.

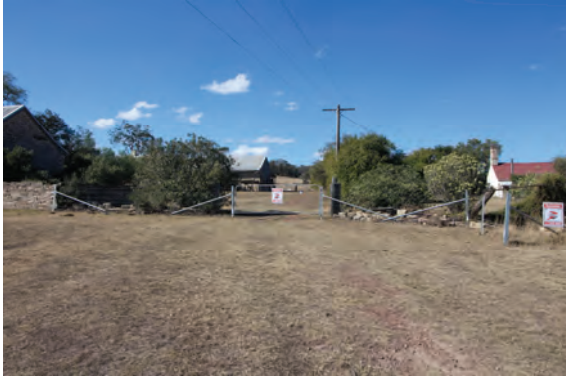
Figure 3. 298: View of the entry gate with steel posts into the service compound from the main driveway access to the west.

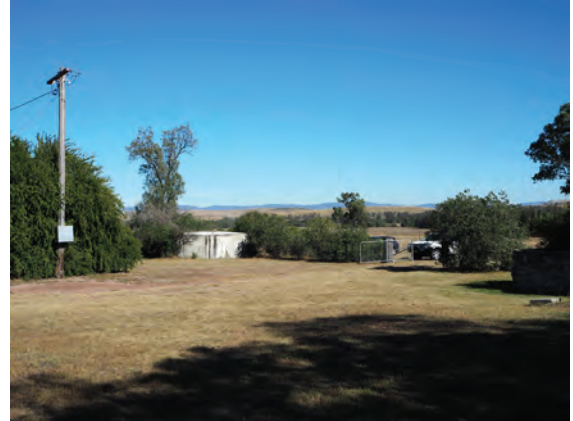
Figure 3. 299: Western entry gate with adjacent water tank and electricity pole as seen from within the Service Compound

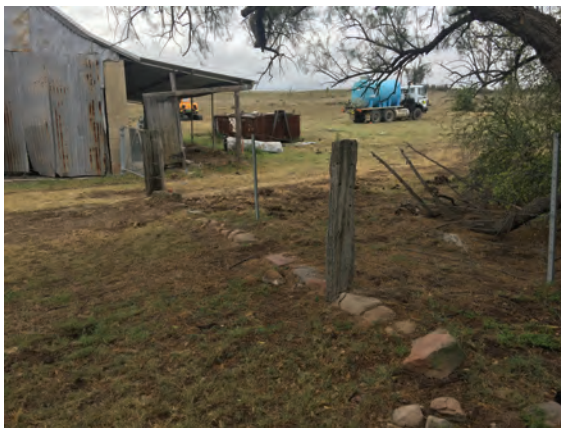
Figure 3. 300: Eastern gateway and fencing between the Barn and the Men's Quarters cottage area.
