APPENDIX 23

Heritage
Assessment

Appendix 23 – Heritage Assessment

This appendix contains the following Heritage Assessment documentation in relation to Ravensworth Estate and the Ravensworth Homestead Complex:

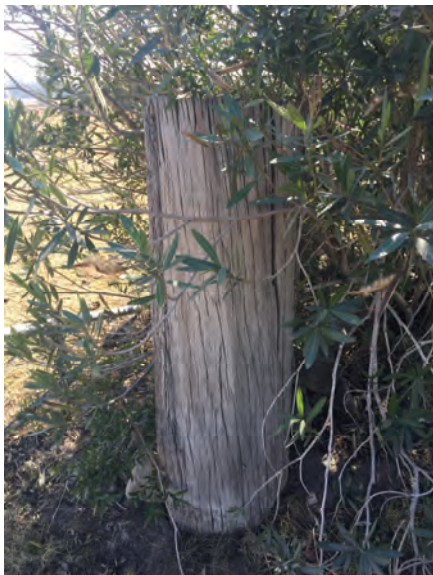
Figure 3. 302: Entry gate post to the Homestead Complex. G. Britton, 2018

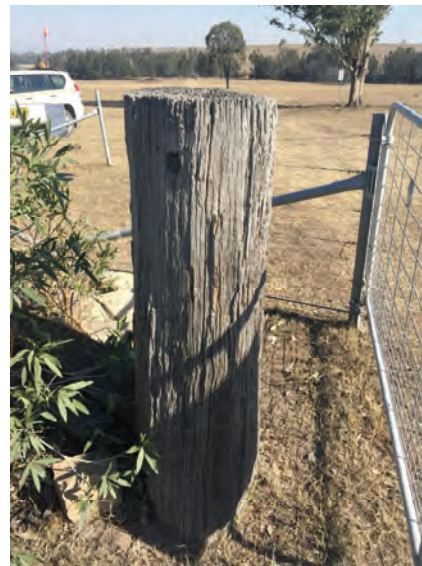
Figure 3. 303: The southern-most of the two entry gate posts to the Homestead Complex. G. Britton, 2018

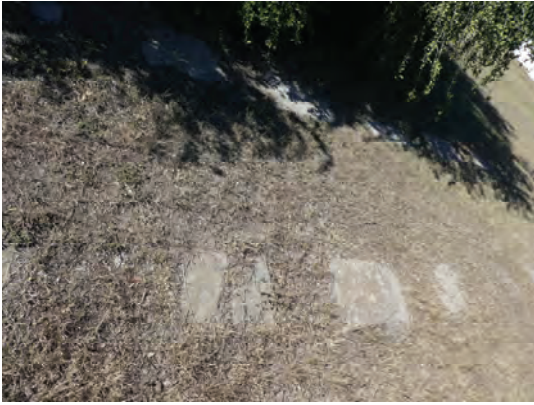
Figure 3. 304: Stone wheel lines located in the service compound

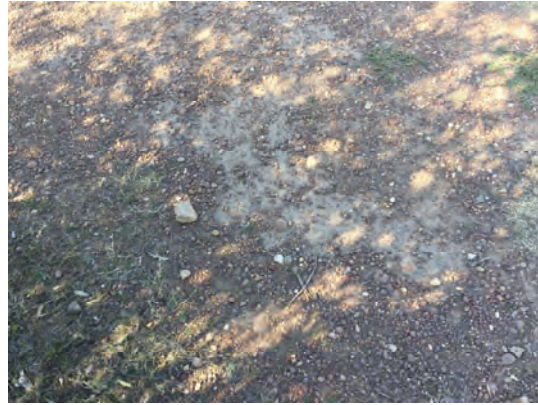
Figure 3. 305: Remnant gravel within the Homestead Complex yard indicating a former access track. G. Britton, 2018

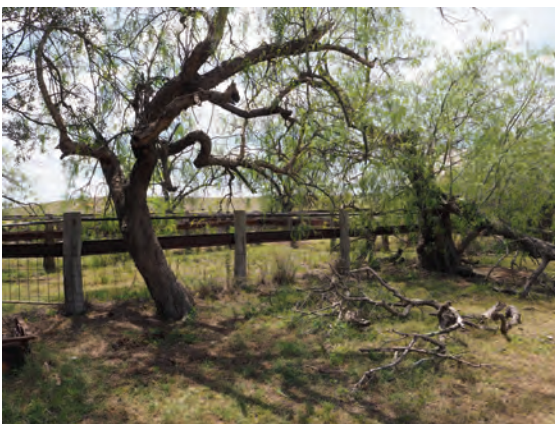
Figure 3. 306: Timber post, wire and iron girder fencing with a row of peppercorns defining the yards from the open service areas.

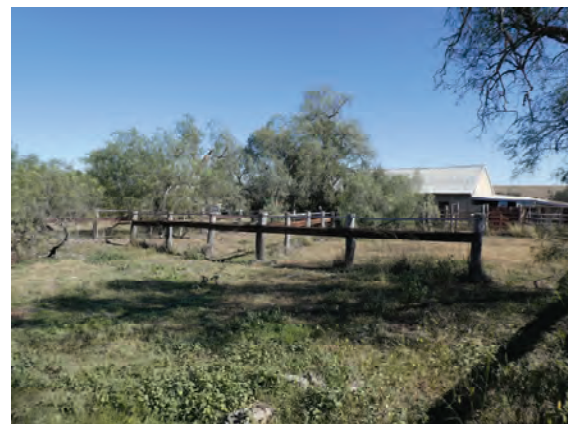
Figure 3. 307: Timber post and rail fencing at the northern end of the service compound. The Stables is in the background.

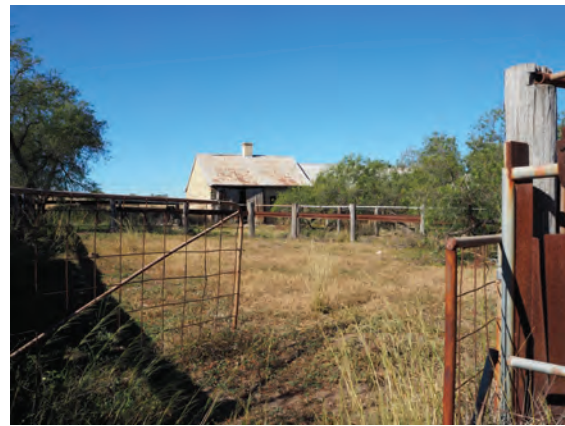
Figure 3. 309: Mixed timber and steel fencing with gates forming sheep yards at the northern end of the service compound. The Barn is in the background.

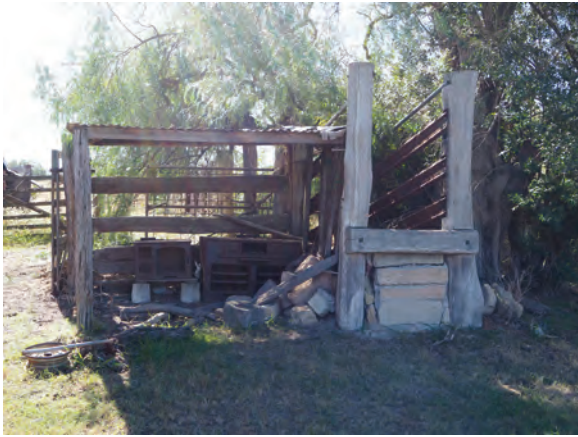
Figure 3. 310: Sheep ramp with adjacent shelter and old stoves.

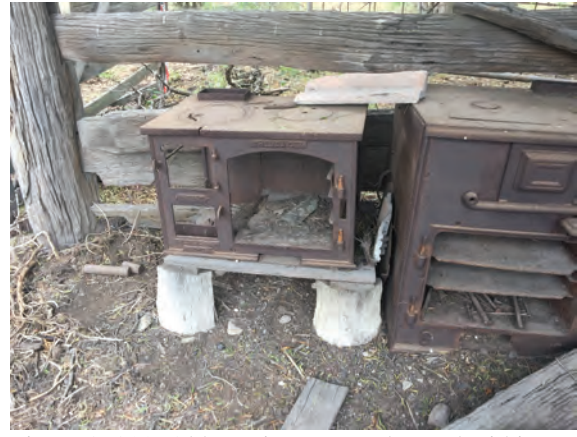
Figure 3. 311: Old cast iron stoves located within shelter in yard area.

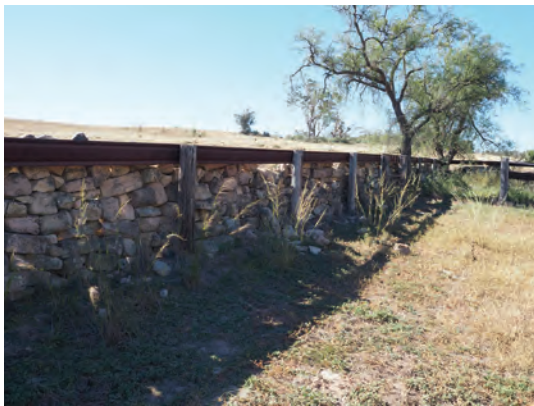
Figure 3. 312: Northern wall of the Homestead Complex of rubble stone, timber posts, iron girders and steel mesh.

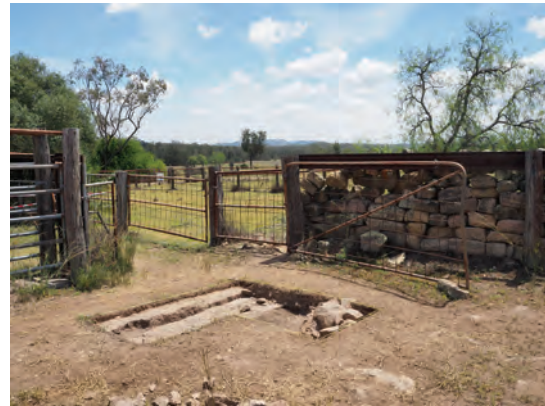
Figure 3. 313: Gates at north-western corner of yard area with adjacent north wall. Note archaeological site in foreground.

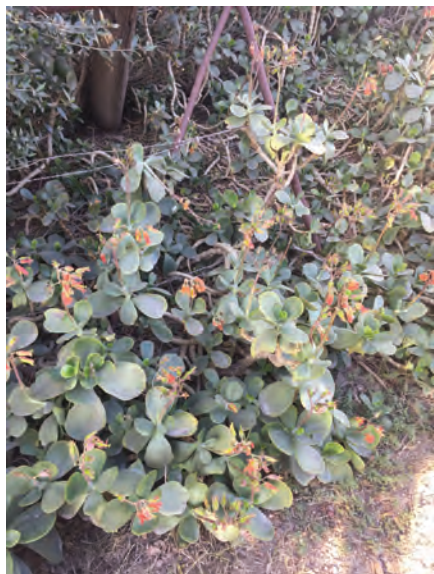
Figure 3. 314: Bed of massed *Crassula* sp. to the southwest of the Men's Quarters. Photo: G. Britton, 2018

The Men's Quarters has various remnant plantings around it. These include stone-edged beds of *Aloe* sp., *Crassula* sp., *Crassula ovata*, *Eucomis* sp.? along with an Oleander, Peppercorn trees, a *Callistemon* sp., *Clivia miniata* and a *Bignonia* sp.? Kei Apple forms hedging – intended or otherwise - along fence lines around the cottage. A *Casuarina* sp. also remains though it is unclear if this was planted.

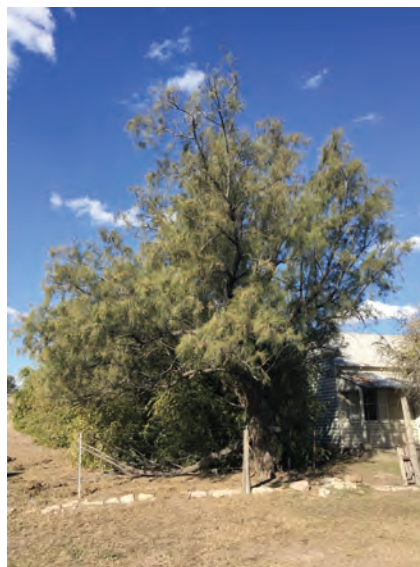
Figure 3. 315: *Casuarina* sp. next to a gate to the Men's Quarters. Photo: G. Britton, 2018

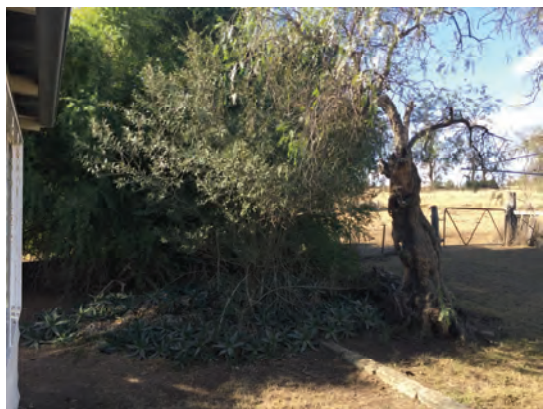
Figure 3. 316: A bed of *Aloe* sp. to the northeast of the Men's Quarters with a peppercorn tree to the right and an African Olive and Kei Apple to the left. Photo: G. Britton, 2018

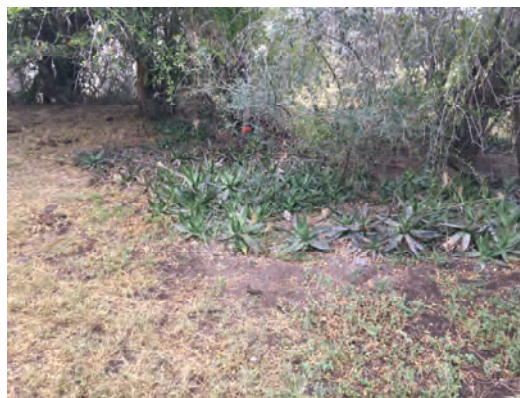
Figure 3. 317: Typical plantings in the front garden area of cottage consisting of *Aloe* sp. with a row of Oleander and Kei Apple defining the western boundary of the cottage garden.

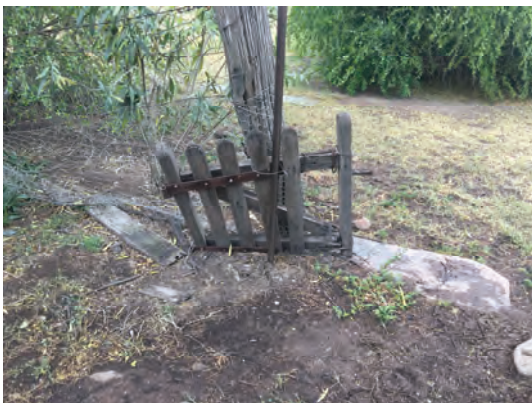
Figure 3. 320: Timber picket entry gate with wire mesh and timber post fencing.

The front (west) garden of the cottage is also fence with timber post and wire mesh fencing with a timber picket gate providing access from the Service Compound and a metal pole and wire mesh gate leading from the northern side of the Kitchen Wing.

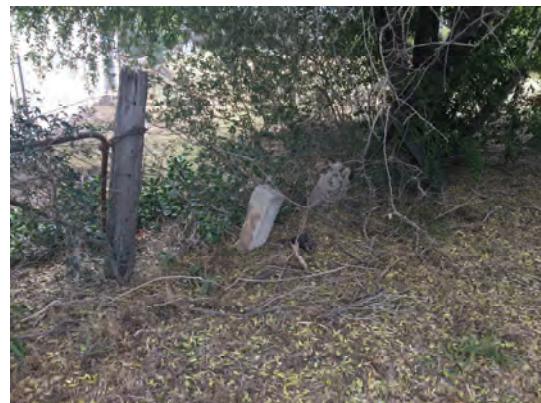
Figure 3. 321: Timber post and wire mesh fencing with old steel pole and mesh gate.

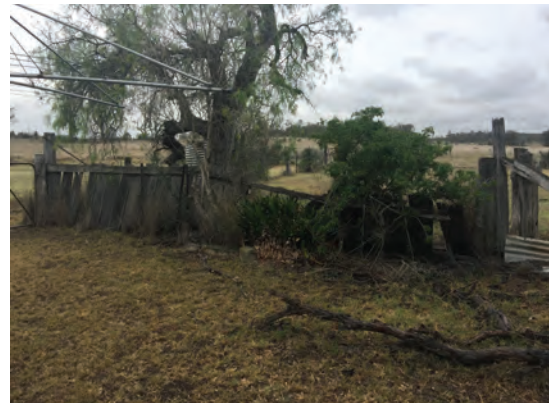
Figure 3. 323: Remnant timber slab faced fencing with peppercorn tree.

The cottage is still defined by fencing to the north (now reinforced by a weedy Kei Apple hedge) and to the west (also reinforced by remnant plantings and weeds) that separates it from the service area beyond. Beyond the washing line to the east are panels of a timber slab-faced fence with various remnant plantings.

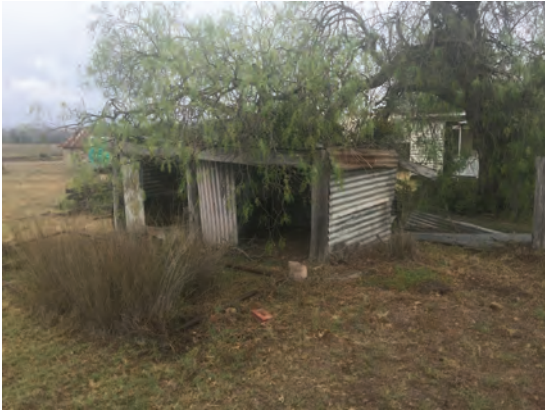
Figure 3. 324: Old chicken shed to rear of cottage.

There are also the remains of a timber tank stand, a stone and concrete tank stand, a corrugated iron water tank on stone base and a chicken shed.

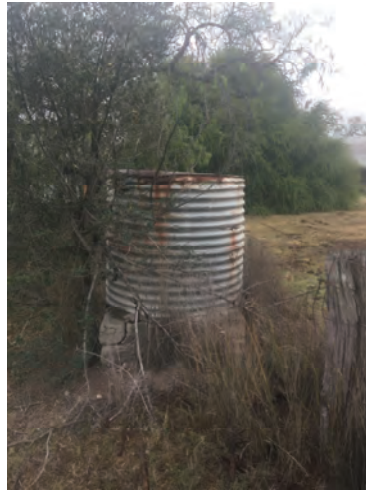
Figure 3. 325: Corrugate metal water tank on stone base.

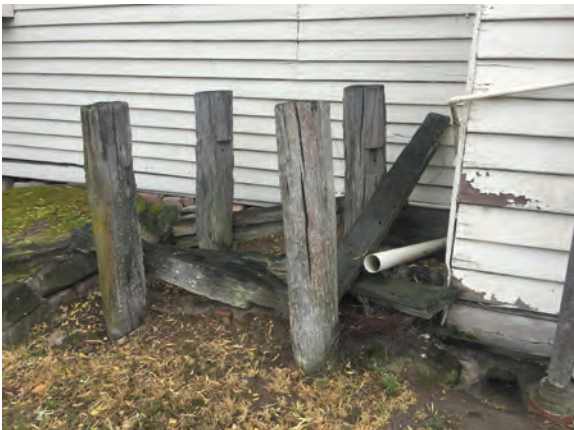
Figure 3. 326: Timber tank stand on southern side of the cottage.

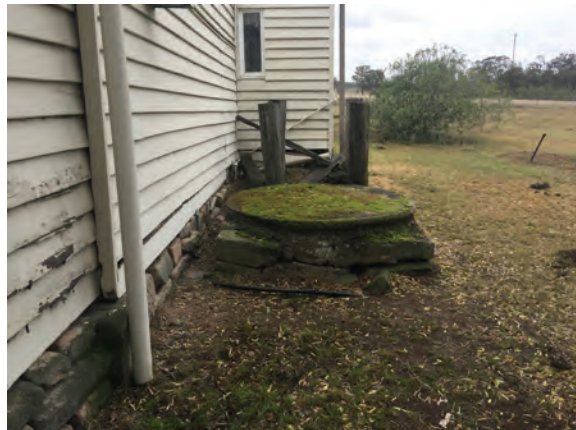
Figure 3. 327: Concrete and stone tank stand on southern side of the cottage.

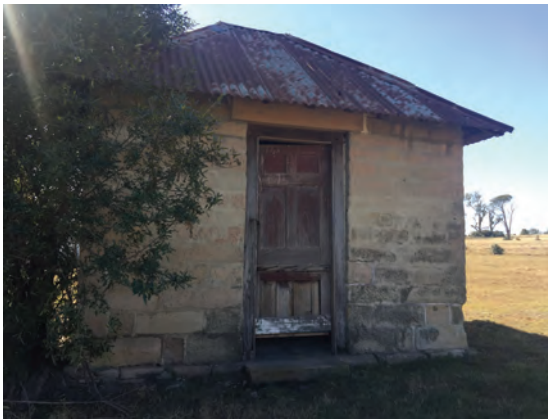
Figure 3. 330: A more recent opportunistic olive has seeded next to the privy. Photo: G. Britton, 2018

Within the paddock is located the Privy and the unmarked grave site (assumed to be a member of the White family) that is distinguished by the simple, unadorned sandstone slab to the east of, and on axis with, the homestead. A relatively recent African Olive volunteer has self-propagated at the western wall of the privy and, if not removed, potentially poses a threat to the fabric and stability of the structure (see Figure 3.330).

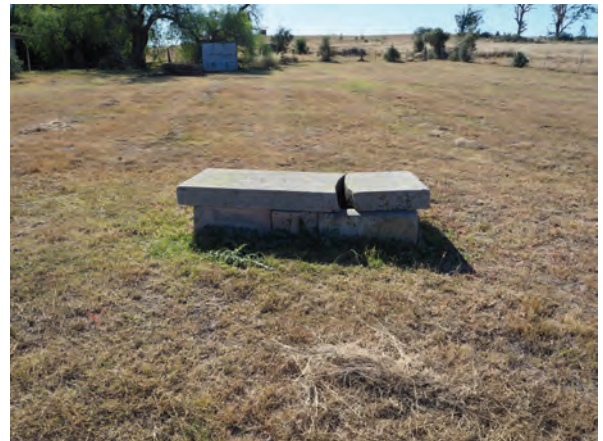
Figure 3. 331: The stone grave located in the paddock.

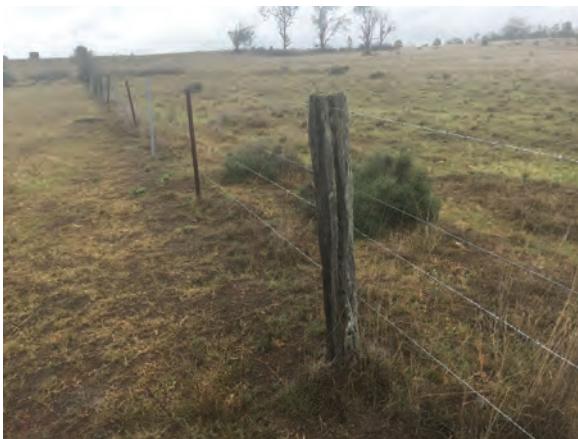
Figure 3. 332: Typical fencing found along the eastern, southern and northern boundaries of the paddock.

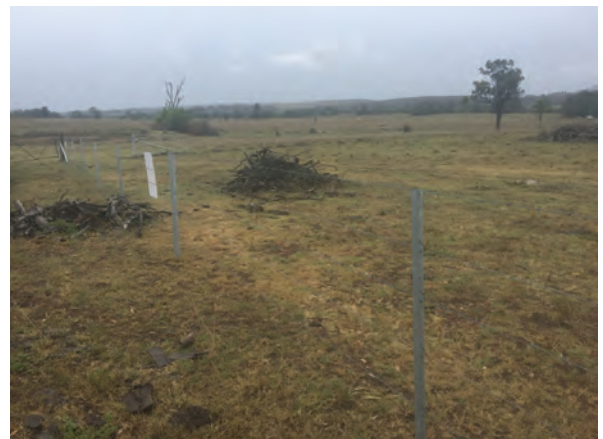
Figure 3. 333: Typical fencing found along the eastern, southern and northern boundaries of the paddock.

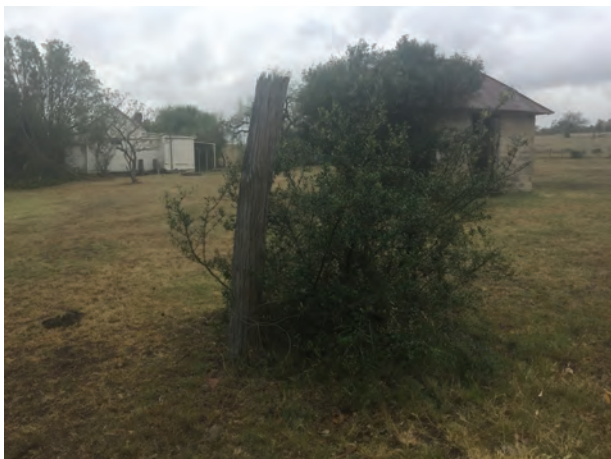
Figure 3. 334: Remains of a fence line with timber post and African boxthorn.

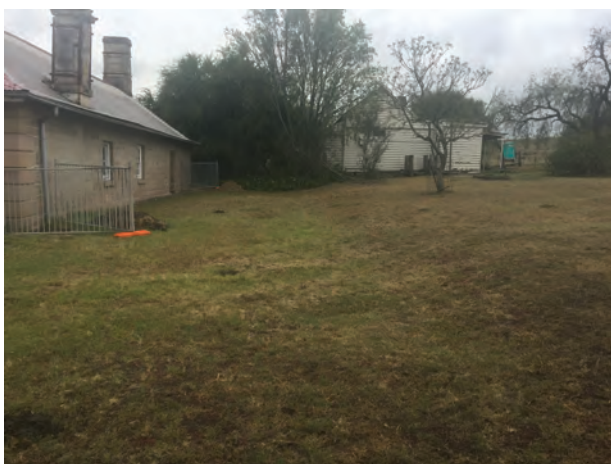
Figure 3. 336: Ground level change between the Homestead south garden (on the left) and the Men's Quarters paddock (on the right)

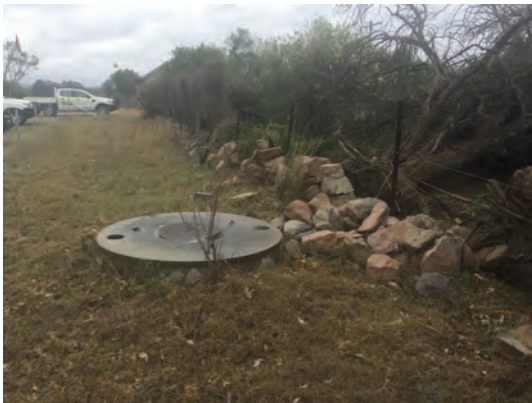
Figure 3. 339: Cistern located on the western side of the southern homestead garden with collapsed stone wall and star picket and wire fencing.

Smaller features include a cistern on the western side of the homestead garden, a dog/pet burial site to the south of the homestead garden and indicated by a loose rectangle of sandstone pieces and a long stretch of scattered sandstone, the remains of a former building on the northern side of the Farm Yard.

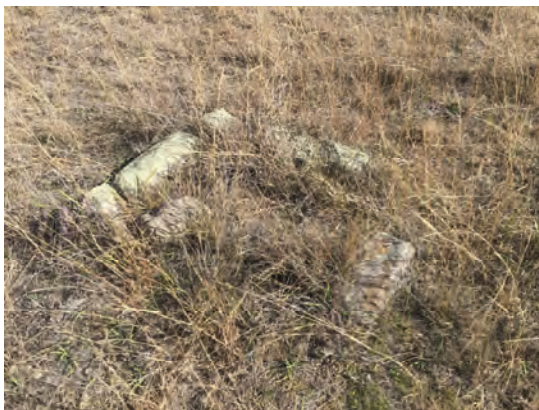
Figure 3. 341: Sandstone marking the former pet grave

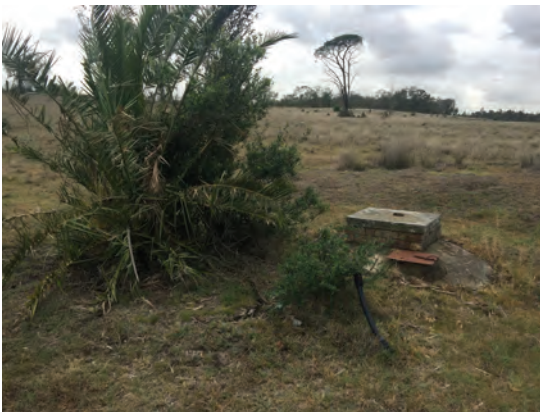
Figure 3. 347: The underground well with palm with Aleppo pine in the background.

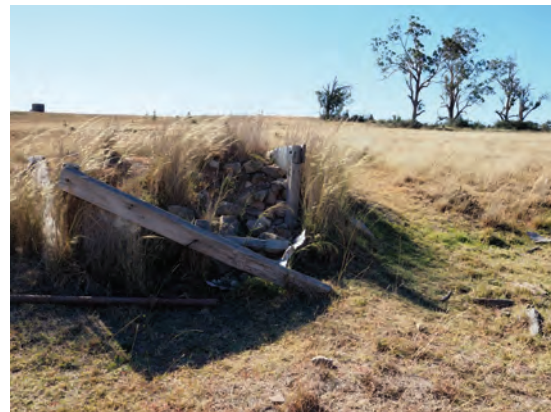
Figure 3. 348: Remnant cattle/sheep ramp.

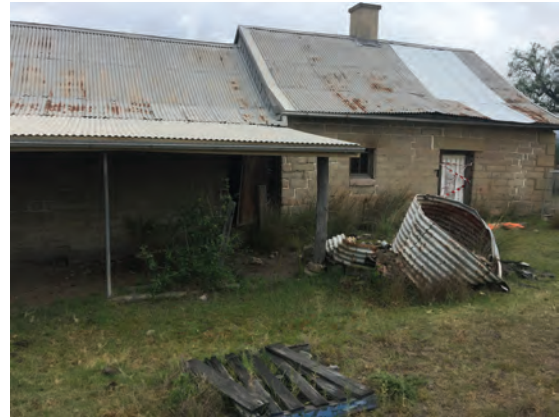
Figure 3. 350: Collapsed water tank and building materials on the eastern side of the Barn.

There are also scattered remains of other farm features including a collapsed windmill (Landscape Feature No. 63) and on the eastern side of the Barn is a collapsed corrugated metal water tank and a skip bin.

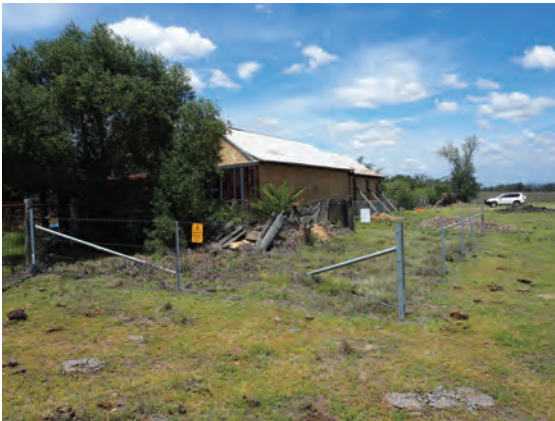
Figure 3. 351: Fenced area on the western side of the Stables with ruins of former timber slab building.

On the western side of the Stables is a fenced off area which contains the collapsed remains of a former timber slab structure and sheep dip (Landscape Feature No. 55), with scattered stone and Oleander.

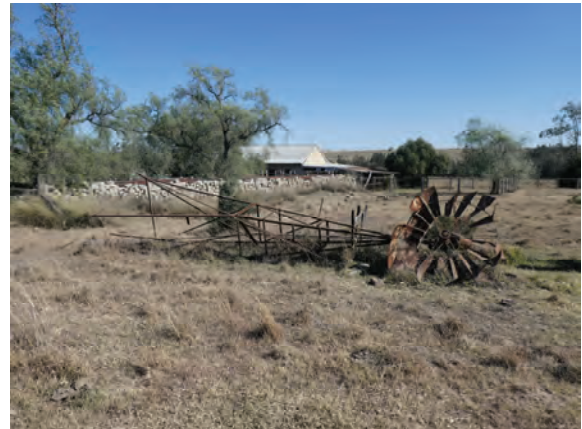
Figure 3. 352: Collapsed windmill to the northeast of the complex, with rubble stone wall and Stables in the background.

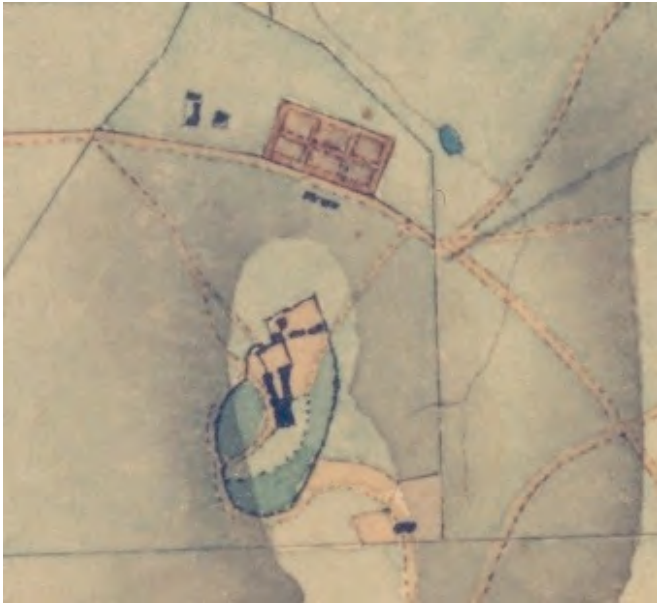
Figure 4. 2: Detail from 1847 plan indicating the rectangular Lower Garden at Camden Park (in red) located some distance from the mansion in its landscaped setting. The Camden Park garden, substantially completed by 1824 was close to a creek and was 8 acres and 30perches, providing James Bowman with a perfect example to follow. Source: *Plan of the Camden Estate in the county of Camden, the property of James & William Macarthur, Esq. showing the extent of agriculture*, SLNSW, M M Ser 4 000/1 A 3004/Map 4

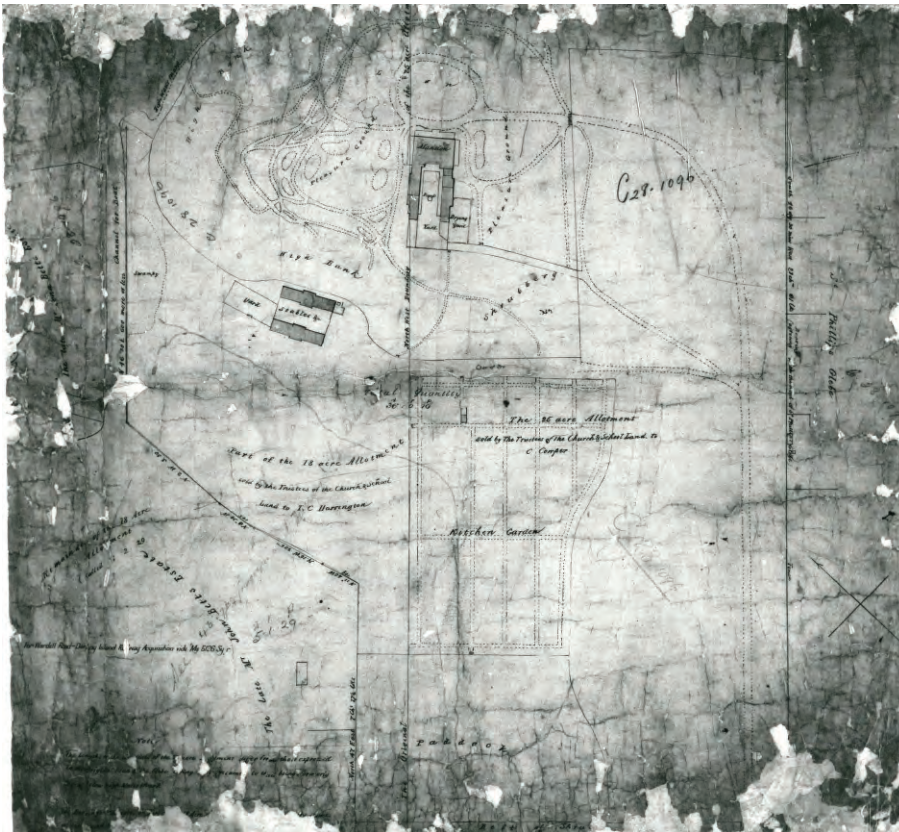
Figure 4. 5: Tracing from survey of Lyndhurst for deed for Bank of Australasia. Note the large kitchen garden behind the house. The offices at the back of the house were enclosed by a high wall. Source: J. Armstrong 1849 Church Lands Petersham State Archives NSW AO Map 2247/ courtesy of Sydney Living Museums, Caroline Simpson Library and Research Collection

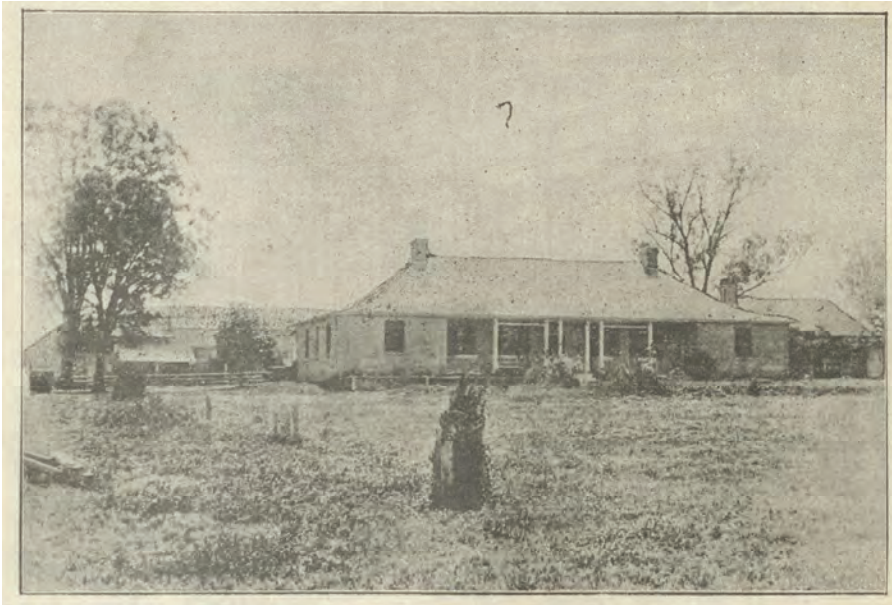
Figure 4. 8: Earliest known photograph of the Ravensworth Homestead showing the configuration of the buildings, front garden and other landscape features. Source: The Bulletin, Vol. 11, No. 579, 1891

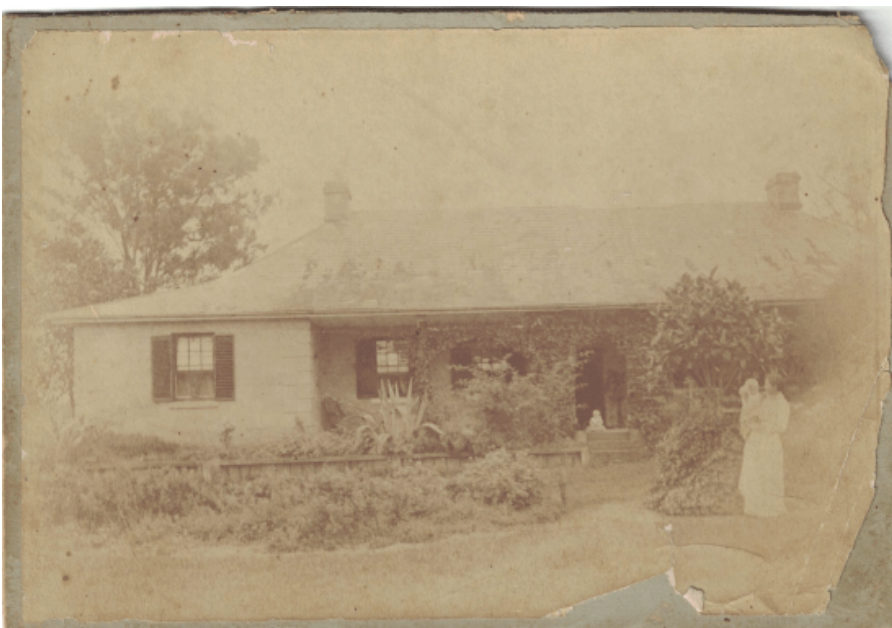
Figure 4. 9: Undated but possibly late 19th century photo of the Hill family at Ravensworth Homestead. Source: Hill family photograph courtesy of the Marshall family.

A photograph (undated but assumed early 20th century) of the front of the Main House (see Figure 4. 9) shows that climbers had been grown up the frame on the verandah. The raised garden bed was made of wooden palings topped with a beam. Several succulent *Agave americana* and shrubs had been established in the raised bed. In the circular area in front of the house the Moreton Bay fig (*Ficus macrophylla*) had been planted on axis with the front door in a small circular bed which also sported a built-up section which may have been a rockery that is partially obscured by the woman and child. An oval garden bed with mounds of billowing shrubs or perennials was to the west of the central circular bed.

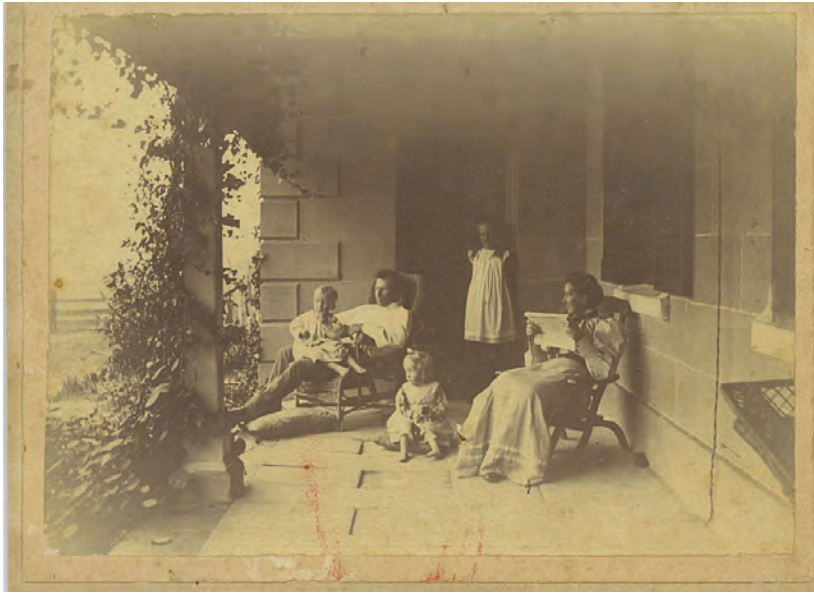
Figure 4. 10: Photograph of the front (south) verandah of the main house. Source: Hill family photograph courtesy of the Marshall family.

Another photograph of the Hill family group on the front (south) verandah in the late 19th century or early 20th century (prior to the replacement of the original timber verandah posts with cast iron columns in c1905) shows a post and 3-rail fence to the west of the house and garden (see Figure 4.10).

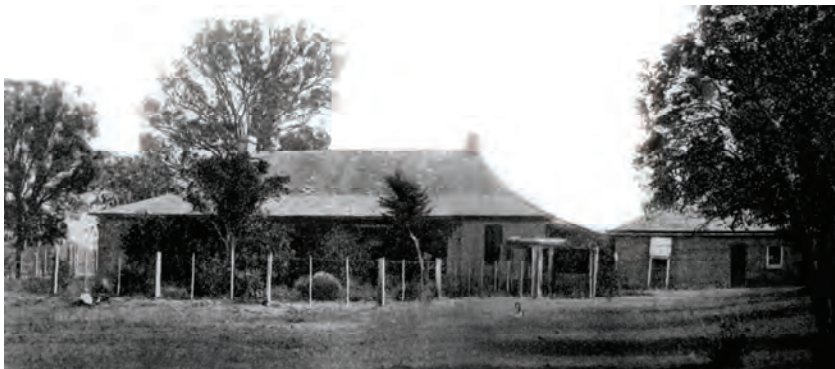
Figure 4. 11: Early photograph of Ravensworth published in the *Sydney Mail*, Saturday 15th February 1902, p. 416-417

The 1902 photograph (Figure 4.11) that appeared in the *Sydney Mail* shows that the Moreton Bay fig had grown considerably and another tree, which was possibly an araucaria had been planted. A log pergola or gateway structure supported a climber at the south-eastern end of the house and a number of shrubs in the garden were well grown. The kitchen wing was excluded from the fenced garden area. One feature of these photos is the remnant eucalypts to the back of the house and the tree to the west of the house in the location of where a large *Casuarina* is today (refer to Section 3.10 for further details).

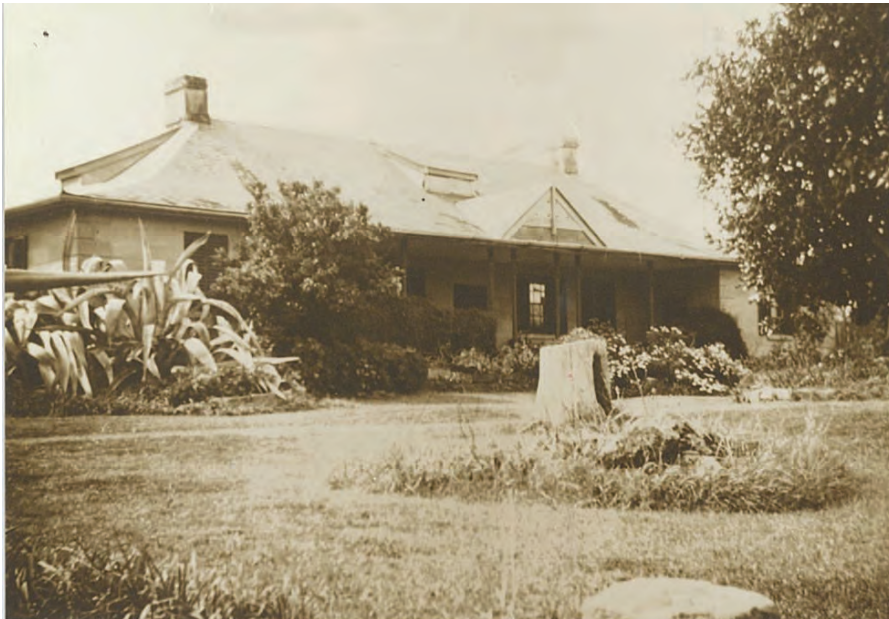
Figure 4. 12: A photo assumed from the later Hill period, which terminated in 1911, post-dates the alteration to the house believed to date from c1905. Source: Hill family photograph courtesy of the Marshall family.

A later photograph also believed to date from the Hill period and taken after the introduction of the roof vents and front gablet and the replacement of the verandah posts (c1905) shows that the *Ficus macrophylla* (Moreton Bay fig) had grown large (Figure 4.12). The *Agave americana* at the south west corner of the house were large and had expanded to form a huge clump. The location of a spike in the foreground of the photo indicates that there were additional plants of *Agave americana* on the western side of the garden and there are still plants of this species in that area. A path ran from the west to the central circular loop. The flowering plants at the front of the verandah give the impression of daisies. A large shrub in front of the house could be *Viburnum tinus* or a *Raphiolepis* (Indian hawthorn). The circular garden bed was edged with stone, which is the current edging for that bed (refer to Section 3.10). In the foreground a tree stump may relate to one of the eucalypts cut down

some years earlier (as seen in the 1891 photograph above) and a circular “bed” had been formed around it.

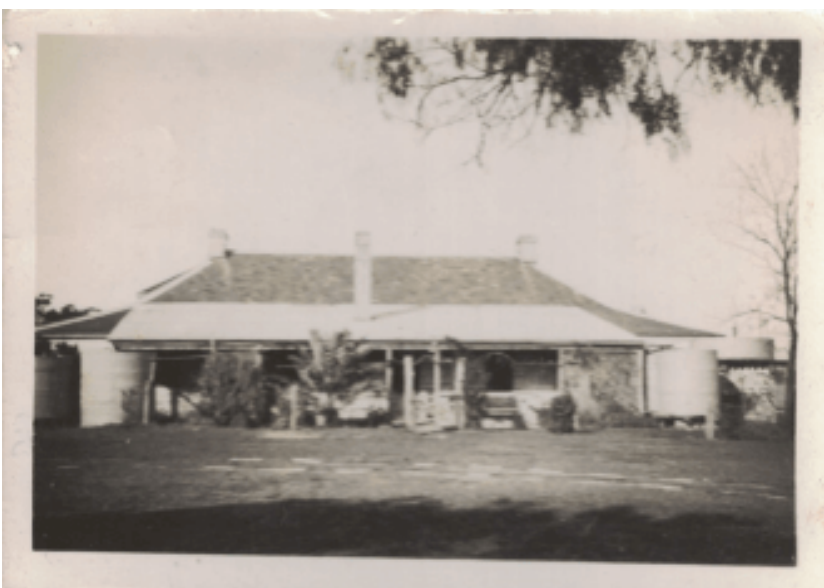
Figure 4. 13: Photograph of the rear (north) façade of the homestead in the 1930s. At the back of the house there was a wooden frame possibly to support the China rose. The rose survives in the same location. Source: Courtesy of the Marshall family

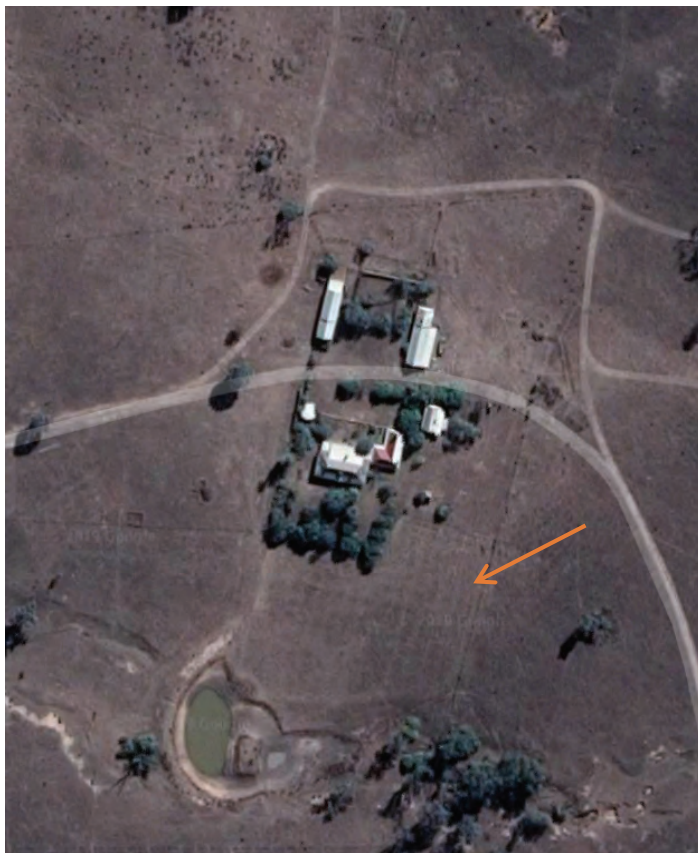
Figure 4. 14: Recent aerial view of the Ravensworth homestead complex showing evidence of former orchards between the southern garden and the homestead dam (indicated with an arrow). Source: GoogleMaps, imagery CNES, 2019

Lidar images and current aerial photographs of the property indicate a regular pattern relating to planting between the southern garden fence and the House Dam (Figure 414, VG 12 and 13). These may relate to an earlier era of cultivation but they may also indicate an additional area of the orchard planting from 1923, although Geoffrey Marshall did not recall any planting in that location during conversation in 2018. However, given that Geoffrey Marshall was born a considerable time after 1923, it is possible some of the 150 trees failed or were removed.

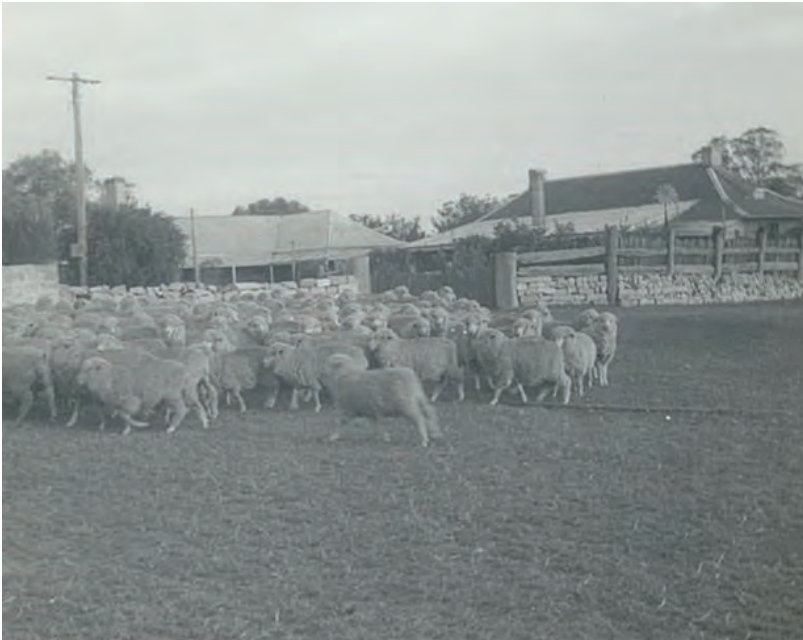
Figure 4. 15: This 1930s photograph shows how stone was used to infill the lower part of the post and rail fence along the western boundary of the homestead. Source: Courtesy of the Marshall family

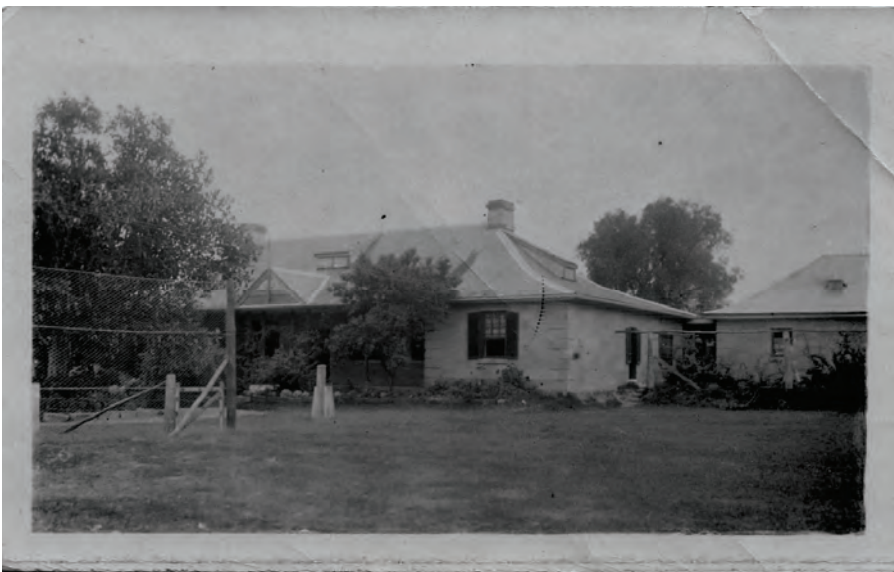
Figure 4. 16: 1930s photograph looking northwest to the front of the Main House with the Kitchen Wing on the right. In the foreground, to the east of the front garden was the ‘tennis’ court. This photograph is taken at a direction as the 1902 photograph above (see Figure 4.11). Source: Courtesy of T. Cameron

Other features introduced by the Marshalls include a “tennis’ court” to the east of the front garden, which was partially surrounded by a tall wire fence. A rustic frame marked the change in level and a garden between the bench upon which the kitchen wing sits and the tennis area. The 1930s photo of the south garden pre-dates the planting of the Canary Island palms in the front garden (see Figure 4.16). The roughly rectangular stone prism in the photograph is from the trig. station.

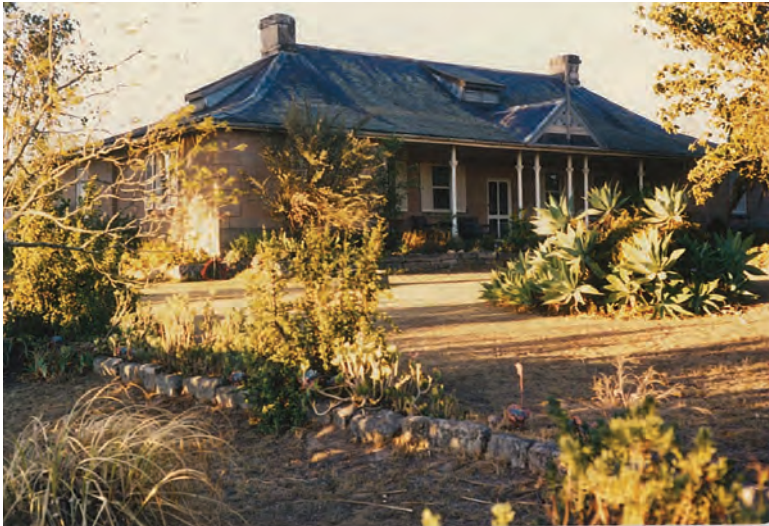
Figure 4. 17: 1970s photograph indicating that the *Agave attenuata* had been planted in the circular bed around and on an old tree stump. In the foreground is the 'sunken' or 'fairy' garden, which Geoff Marshall recalls helping his parents to build (1940s-50s). The sunken garden includes a stone seat with a semi-circular back that Geoff Marshall stated came from the old blacksmith's shop on the property. It is located to the west and south of enormous jade plants. Source: Courtesy of the Marshall family

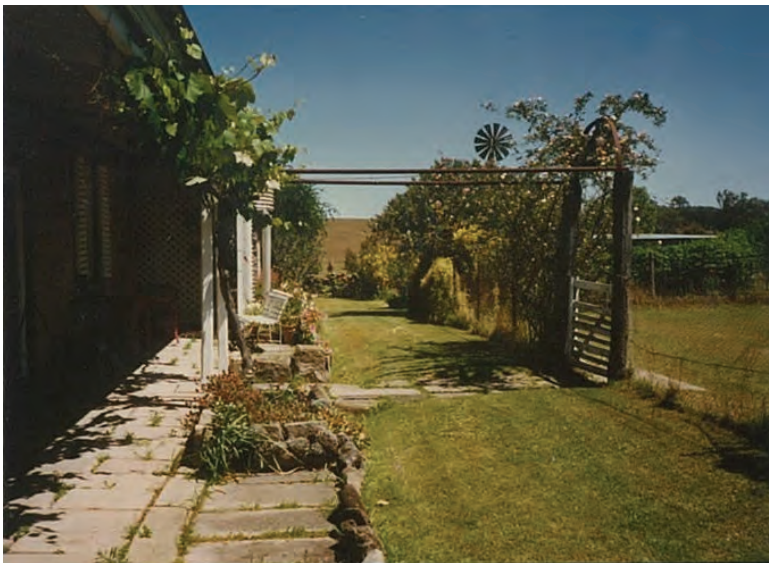
Figure 4. 19: The fence at the back dividing the house from the service yard was closer to the back of the house during the A.C. Marshall era. The large 'Splendens' oleander was beyond the fence and a frame supported a grape vine on the verandah edge and a rose at the back gate. The fence line was shifted further north and a wall constructed from recycled stone after Geoff and Jenny Marshall took over the main house. Source: Courtesy of T. Cameron

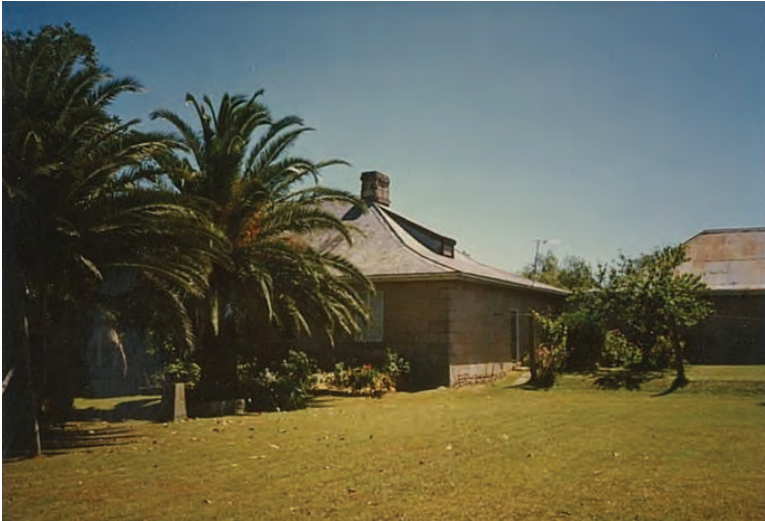
Figure 4. 20: Two Canary Island palms (*Phoenix canariensis*) were planted on the eastern side of the 'carriageloop' by the Marshalls and possibly date from the 1940s. A 1958 aerial photograph indicates that the palms were there and sufficiently grown to be visible. The plantings on the southern boundary and to either side of the homestead garden were not as numerous as they are now. The now massive jade plants on the western side of the garden appear as small dots on this photograph. Source: Courtesy of T. Cameron

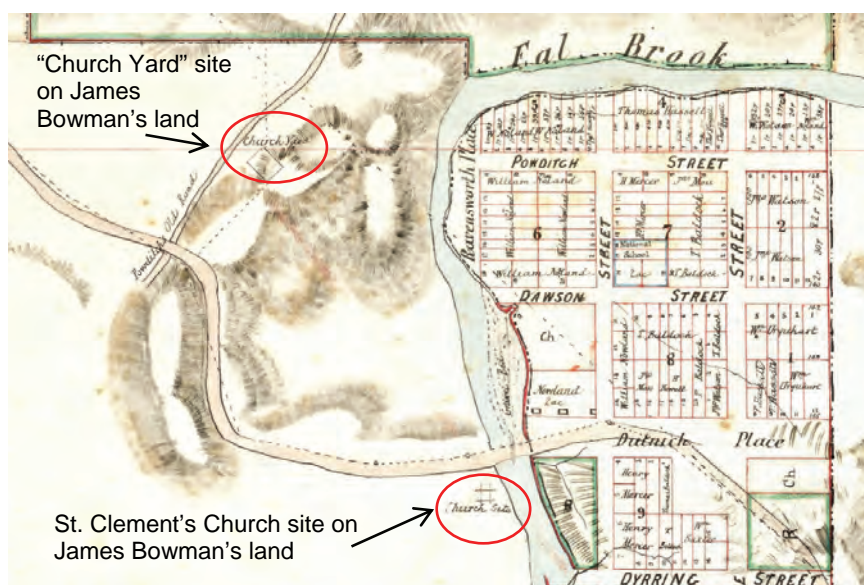
Figure 4.24: Detail from 1892 Plan of the Village of Camberwell showing location of the church site and church yard. Source: NSW LPI- Historical Land Records Viewer

In 1840, the town of Camberwell was established and a portion of land, outside of the village boundaries, on the western bank of Glennies Creek was nominated as a church site. It is unclear whether or not Bowman donated the land or provided any funds towards the building of the church. Another church yard was also marked out further to the north, adjacent to Glennies Creek Road (formerly Powditch's Old Road), however, this church yard appears not to have been developed. (See Figure 4.24.)

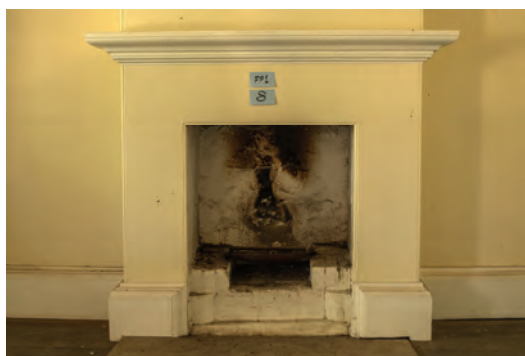
Figure 4. 40: Carved stone mantel piece. Photo: D. Liddle, 2018

- Shuttered, multi-paned, timber framed windows - good examples of their type;
- Solid framed, 6-panel timber doors - good examples of their type (the 2 no. doors facing the front verandah are particularly good examples);
- Carved stone mantel pieces - relatively rare and good examples of their type;
- Stone flagged verandahs and halls – good examples of their type;
- Timber framed roofs – good, possible rare, example of their type.

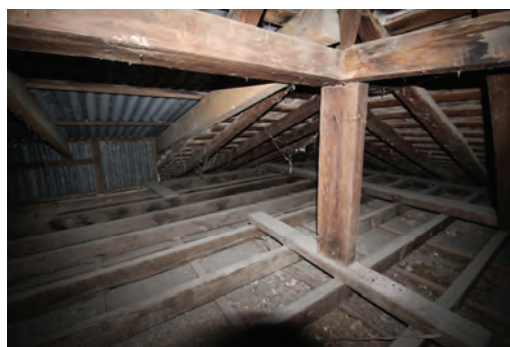
Figure 4. 41: Roof framing.

The House and Kitchen wing are composed of a system of King rafters (almost trusses) supporting purlins that support the common rafters in an arrangement of exceptional quality (although now sometimes damaged by termite attack).

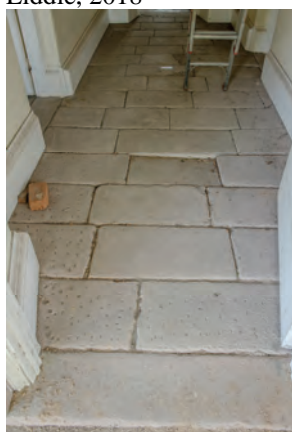
Figure 4. 42: Stone flagging to rear hall. Photo: D. Liddle, 2018

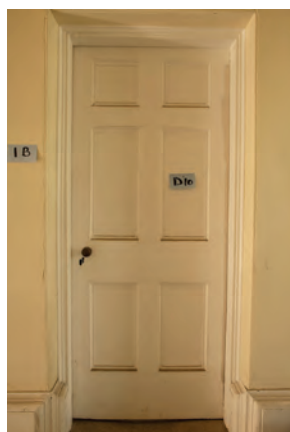
Figure 4. 43: Six panelled internal door. Photo: D. Liddle, 2018

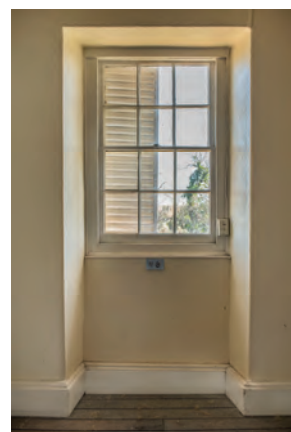
Figure 4. 44: Shuttered, multi-paned, timber framed windows. Photo: D. Liddle, 2018

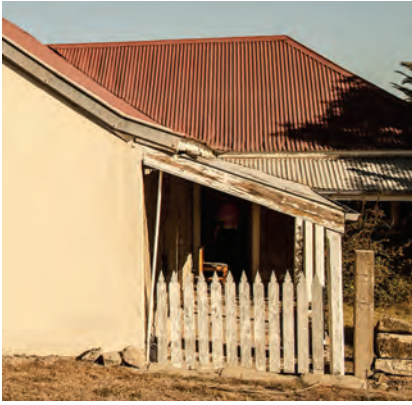
Figure 4. 45: Bell-cast eave. Photo: D. Liddle, 2018

- Large stone kitchen fireplace;
- Tent-form kitchen ceiling;
- Timber framed, boarded doors – good examples of their type;
- Multi-pane sliding sash windows - albeit some altered – good examples of their type;
- Solid floors (possibly stone flagged or composite);
- Colonial style verandahs - good examples of their type;
- Good, possibly rare, roof framing system; and
- Bell-cast eaves detailing – good example of its type.

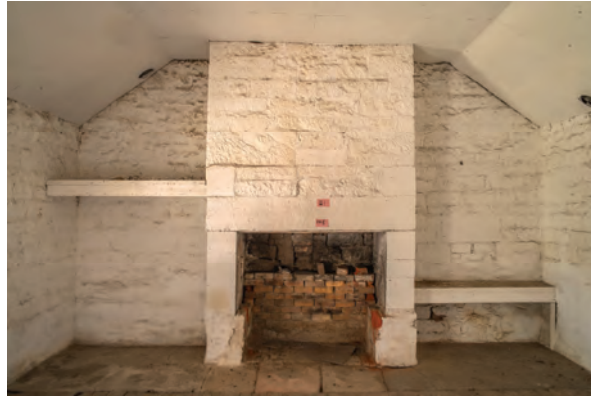
Figure 4. 46: Large stone kitchen fireplace and tent form kitchen ceiling. Photo: D. Liddle, 2018

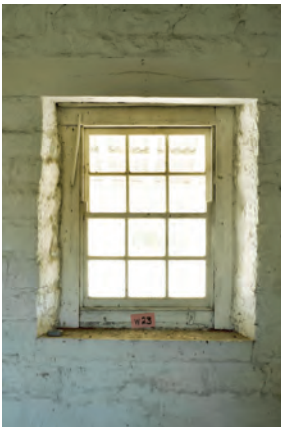
Figure 4. 47: Multi-pane sliding sash window. Photo: D. Liddle, 2018

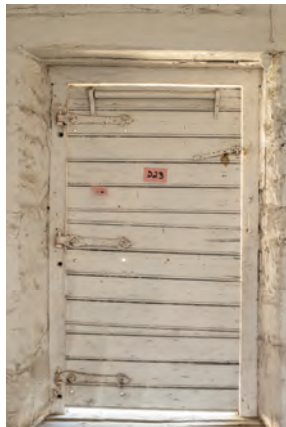
Figure 4. 48: Timber framed boarded doors. Photo: D. Liddle, 2018

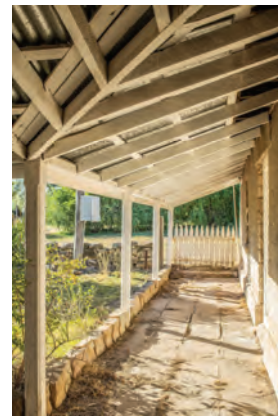
Figure 4. 49: Colonial style verandah. Photo: D. Liddle, 2018

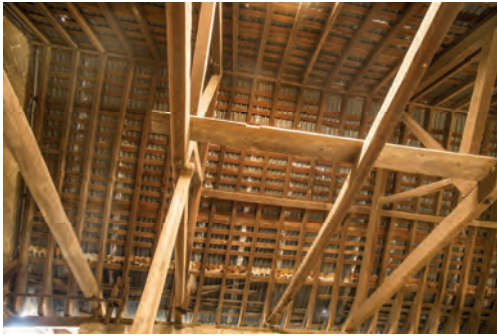
Figure 4. 50: Barn roof framing. Photo: D. Liddle, 2018

- Well-constructed truss roof – good example of its type;
- Blank window recesses on west wall (that contribute to the overall architectural character of the farm yard, see below); and
- Bell-cast eaves detailing- good example of its type.

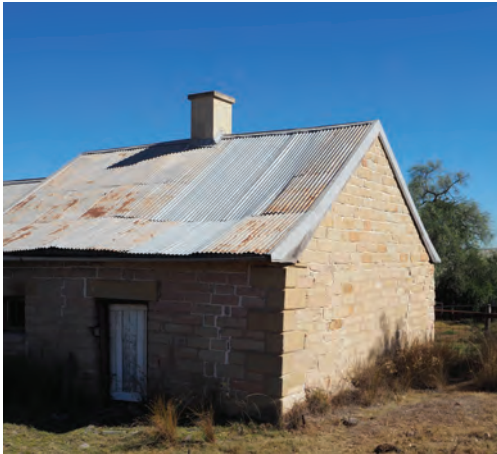
Figure 4. 51: Bell-cast eave.

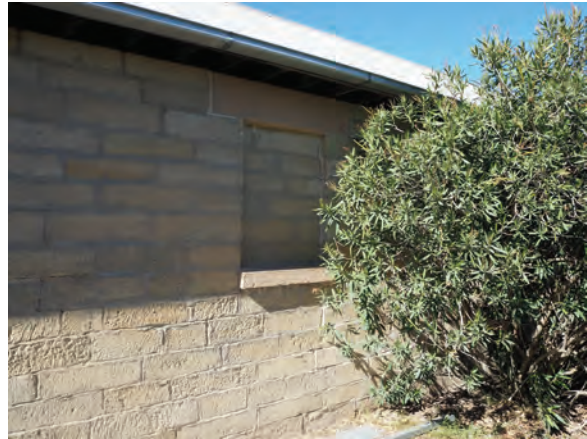
Figure 4. 52: Blank window recess.

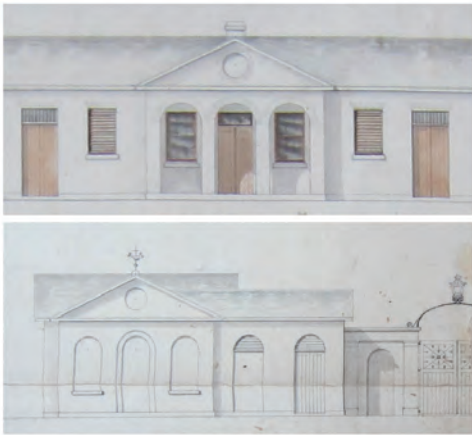
Figure 4. 53: Details from Verge's designs for stables for Camden Park (not built). Source: *'Paper Houses': John Macarthur and the 30 year design process of Camden Park*; S. E. Hill, 2016, unpublished report, University of Sydney, Figure 9.43, p. 291

The east elevation treatment of the building has led to the suggestion that John Verge, the noted early colonial Sydney architect, may have been the designer, as it is similar to an unbuilt design by Verge for Camden Park and to the existing stables complex at Wivenhoe.
