APPENDIX 23

Heritage
Assessment

Appendix 23 – Heritage Assessment

This appendix contains the following Heritage Assessment documentation in relation to Ravensworth Estate and the Ravensworth Homestead Complex:

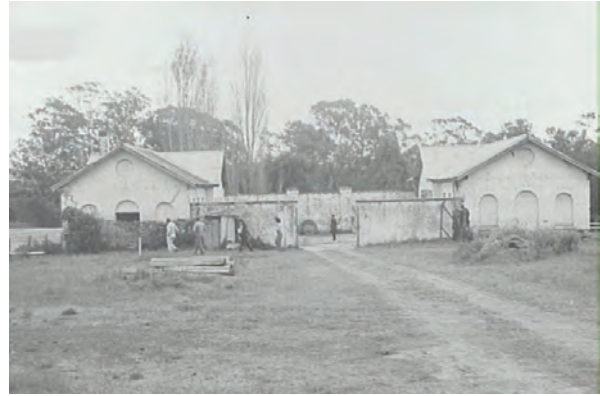
Figure 4. 54: c1984 photograph by Daphne Kingston of the stables and coach house complex at Wivenhoe, Cobbitty, completed in c1838 and attributed to John Verge. Source: Camden Council library, CHS1528

The east elevation treatment of the building has led to the suggestion that John Verge, the noted early colonial Sydney architect, may have been the designer, as it is similar to an unbuilt design by Verge for Camden Park and to the existing stables complex at Wivenhoe.

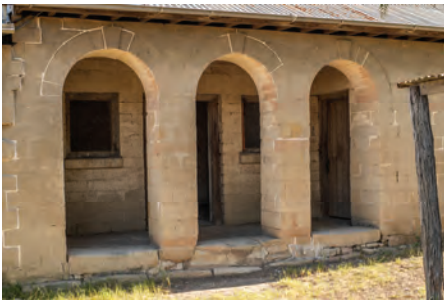
Figure 4. 55: 3 arch arcade. Photo: D. Liddle, 2018

- Symmetrical composition about an east-west axis;
- Central architectural feature – in this case a 3-arch arcade;
- Stone flagged stable spaces – good examples of their type albeit without any surviving stalls or loose boxes;

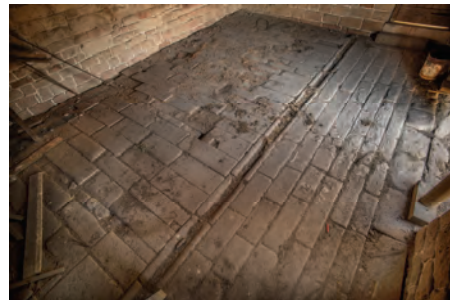
Figure 4. 56: Stone flagging. Photo: D. Liddle, 2018

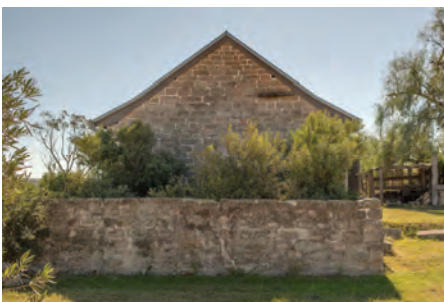
Figure 4. 57: Bell-cast eave Photo: D. Liddle, 2018

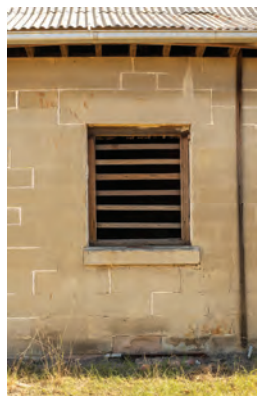
Figure 4. 58: Timber framed louvered window. Photo: D. Liddle, 2018

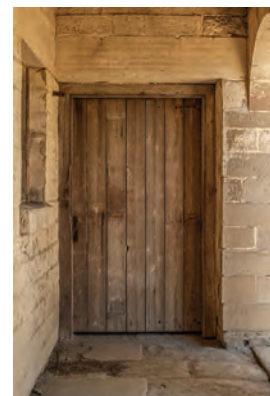
Figure 4. 59: Heavy timber frame door. Photo: D. Liddle, 2018

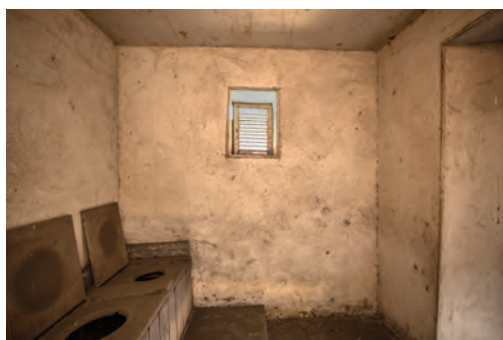
Figure 4. 60: Timber joinery thunder box with timber framed louvered window. Photo: D. Liddle, 2018

- Masonry construction and pitched roof – good example of its type;
- Original door and window joinery – good examples of their type;
- Timber joinery thunder box – relatively intact and very good example of its type; and
- Stone flagged floor – good example of its type.

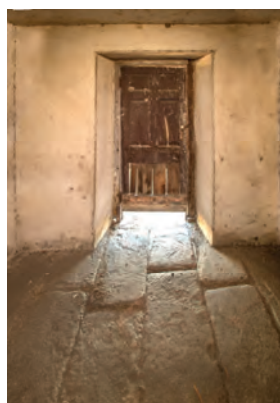
Figure 4. 61: Six panelled door with stone flagged floor. Photo: D. Liddle, 2018

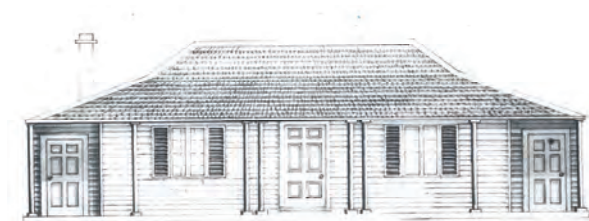
Figure 4. 66: Plate 12.12 in *The Australian Colonial House* (1997) of the elevation of Glendon by Robert or Helenus Scott, n.d. Source: Broadbent, J., 1997; *The Australian Colonial House*, Hordern House, p. 273

Other similarities of note: the end rooms of the Glendon addition (c1837) are broader than the front and back verandahs, a feature which also occurs at Ravensworth. Also, at Glendon and Thornthwaite, Scone, NSW, the Scotts used paired posts on the front verandahs which again, occurs at Ravensworth.

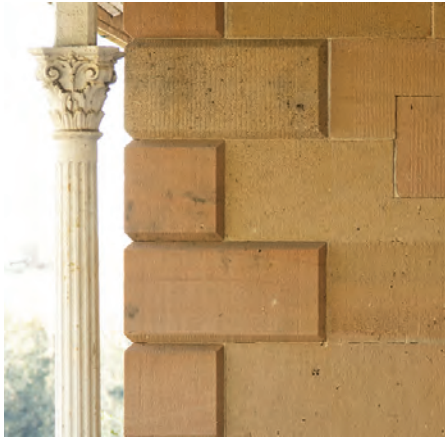
Figure 4. 68: Quoins to front verandah of Main House. Photo: D. Liddle, 2018

The adjacent Kitchen Wing has been set up with walls of 9 no. courses with similar quoins. The upper side of the top courses in both wings line up making the Kitchen floor level 300mm higher than the Main wing.

Exceptional care has been applied to the finishing and jointing of the stone work.

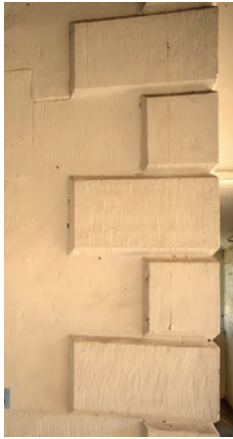
Figure 4. 69: Quoins to rear verandah of Main House. Photo: D. Liddle, 2018

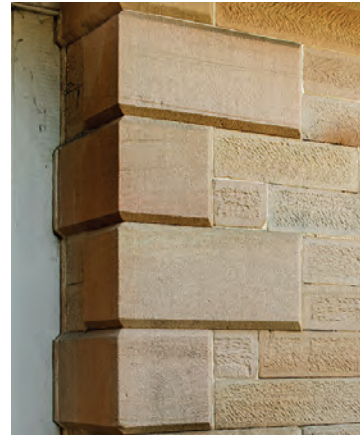
Figure 4. 70: Quoins to Kitchen Wing. Photo: D. Liddle, 2018

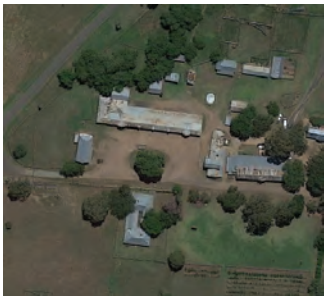
<p>Figure 4. 76: Aerial view of Belgenny Farm showing the enclosed farmyard to the rear of the main house. Source: GoogleEarth, 2019</p>

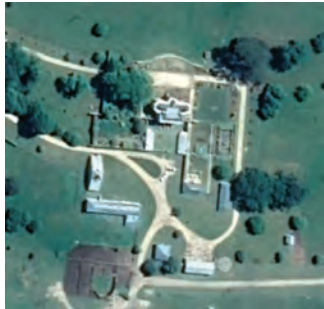
<p>Figure 4. 88: Aerial view of Killymoon with large partially enclosed farmyard to the south of the main homestead. Source: GoogleEarth, 2019</p>	  <p>Figure 4. 89: c1960 photograph of the Killymoon coach house with granary and stables. Source: National Trust of Australia (Tas), TSO00017900</p>
<p><i>Dundullimal, Dubbo, 1840s</i></p> <p>Built around 1840 as the head station of a 6,500-hectare (16,000-acre) squatting run, the Dundullimal homestead is believed to be the oldest surviving slab hut house in Australia. The first recorded occupants were brothers Charles Campbell and Dalmahoy Campbell in the late 1830s.</p> <p>The homestead is built on the same axis as its stone stables and coach house. The homestead group of outbuildings comprise stone stables, a coach house / outbuilding, located south-west of the homestead and stables, the site of the former kitchen, located east of homestead, and the site of the former privy.</p>

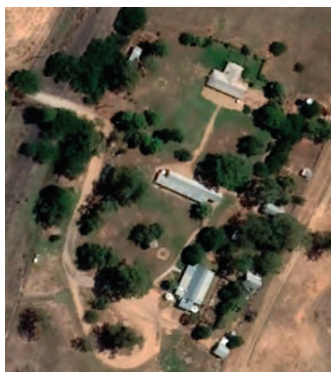
<p>Figure 4. 90: Aerial view of Dundullimal with house and stables and coach house on axis. Source: GoogleEarth, 2019</p>

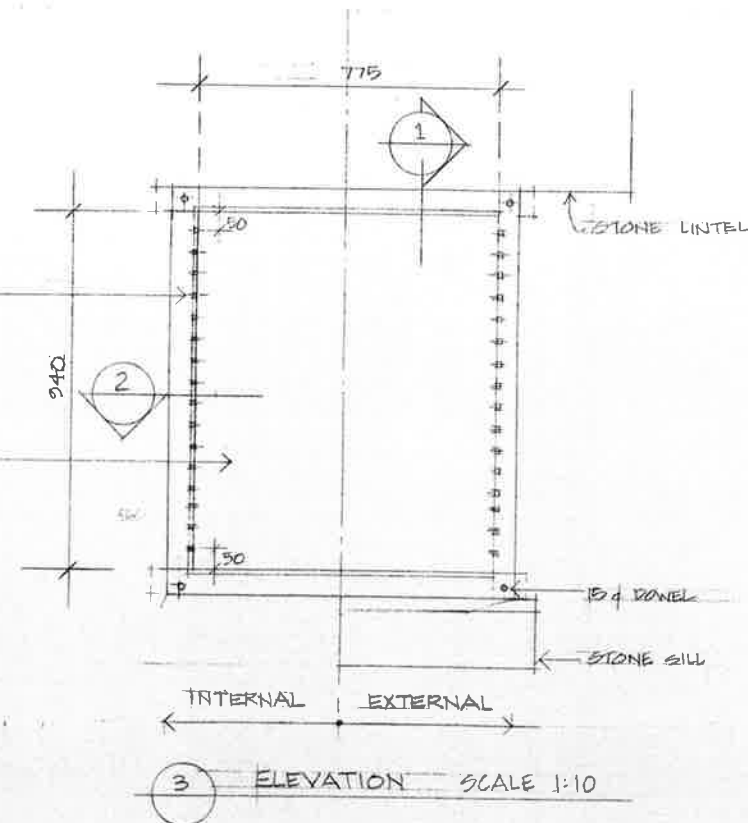
Date	No.	Amendment
Job		
RAVENSWORTH HOMESTEAD		
HEBBER ROAD		
RAVENSWORTH NSW		
for:		
MT OWEN PTY LTD		
Dwg.		
AS BUILT		
WINDOW 51		
(SPACE 51) LOUVRED		
LUCAS STAPLETON JOHNSON		
LSJ Heritage Planning & Architecture		
ACN 002 584 189 ABN 60 763 960 154		
Nominated Architect: Ian Stapleton (reg. 4032)		
Lucas Stapleton Johnson & Partners Pty Ltd		
Suite 101, Level 1, 191 Clarence Street		
Sydney, NSW, 2000 Telephone: (02) 9357 4811		
Email: mailbox@lsjarchitects.com		
Date	Drawn	Checked
28-08-2018	DP	
Scale (at A1)	Check all dimensions	
1:1	Figured dimensions to be taken in preference to scale	
1:10	© COPYRIGHT Lucas Stapleton Johnson & Partners Pty. Ltd.	
1:2		
Dwg. No.		
123 800	/ 110 /

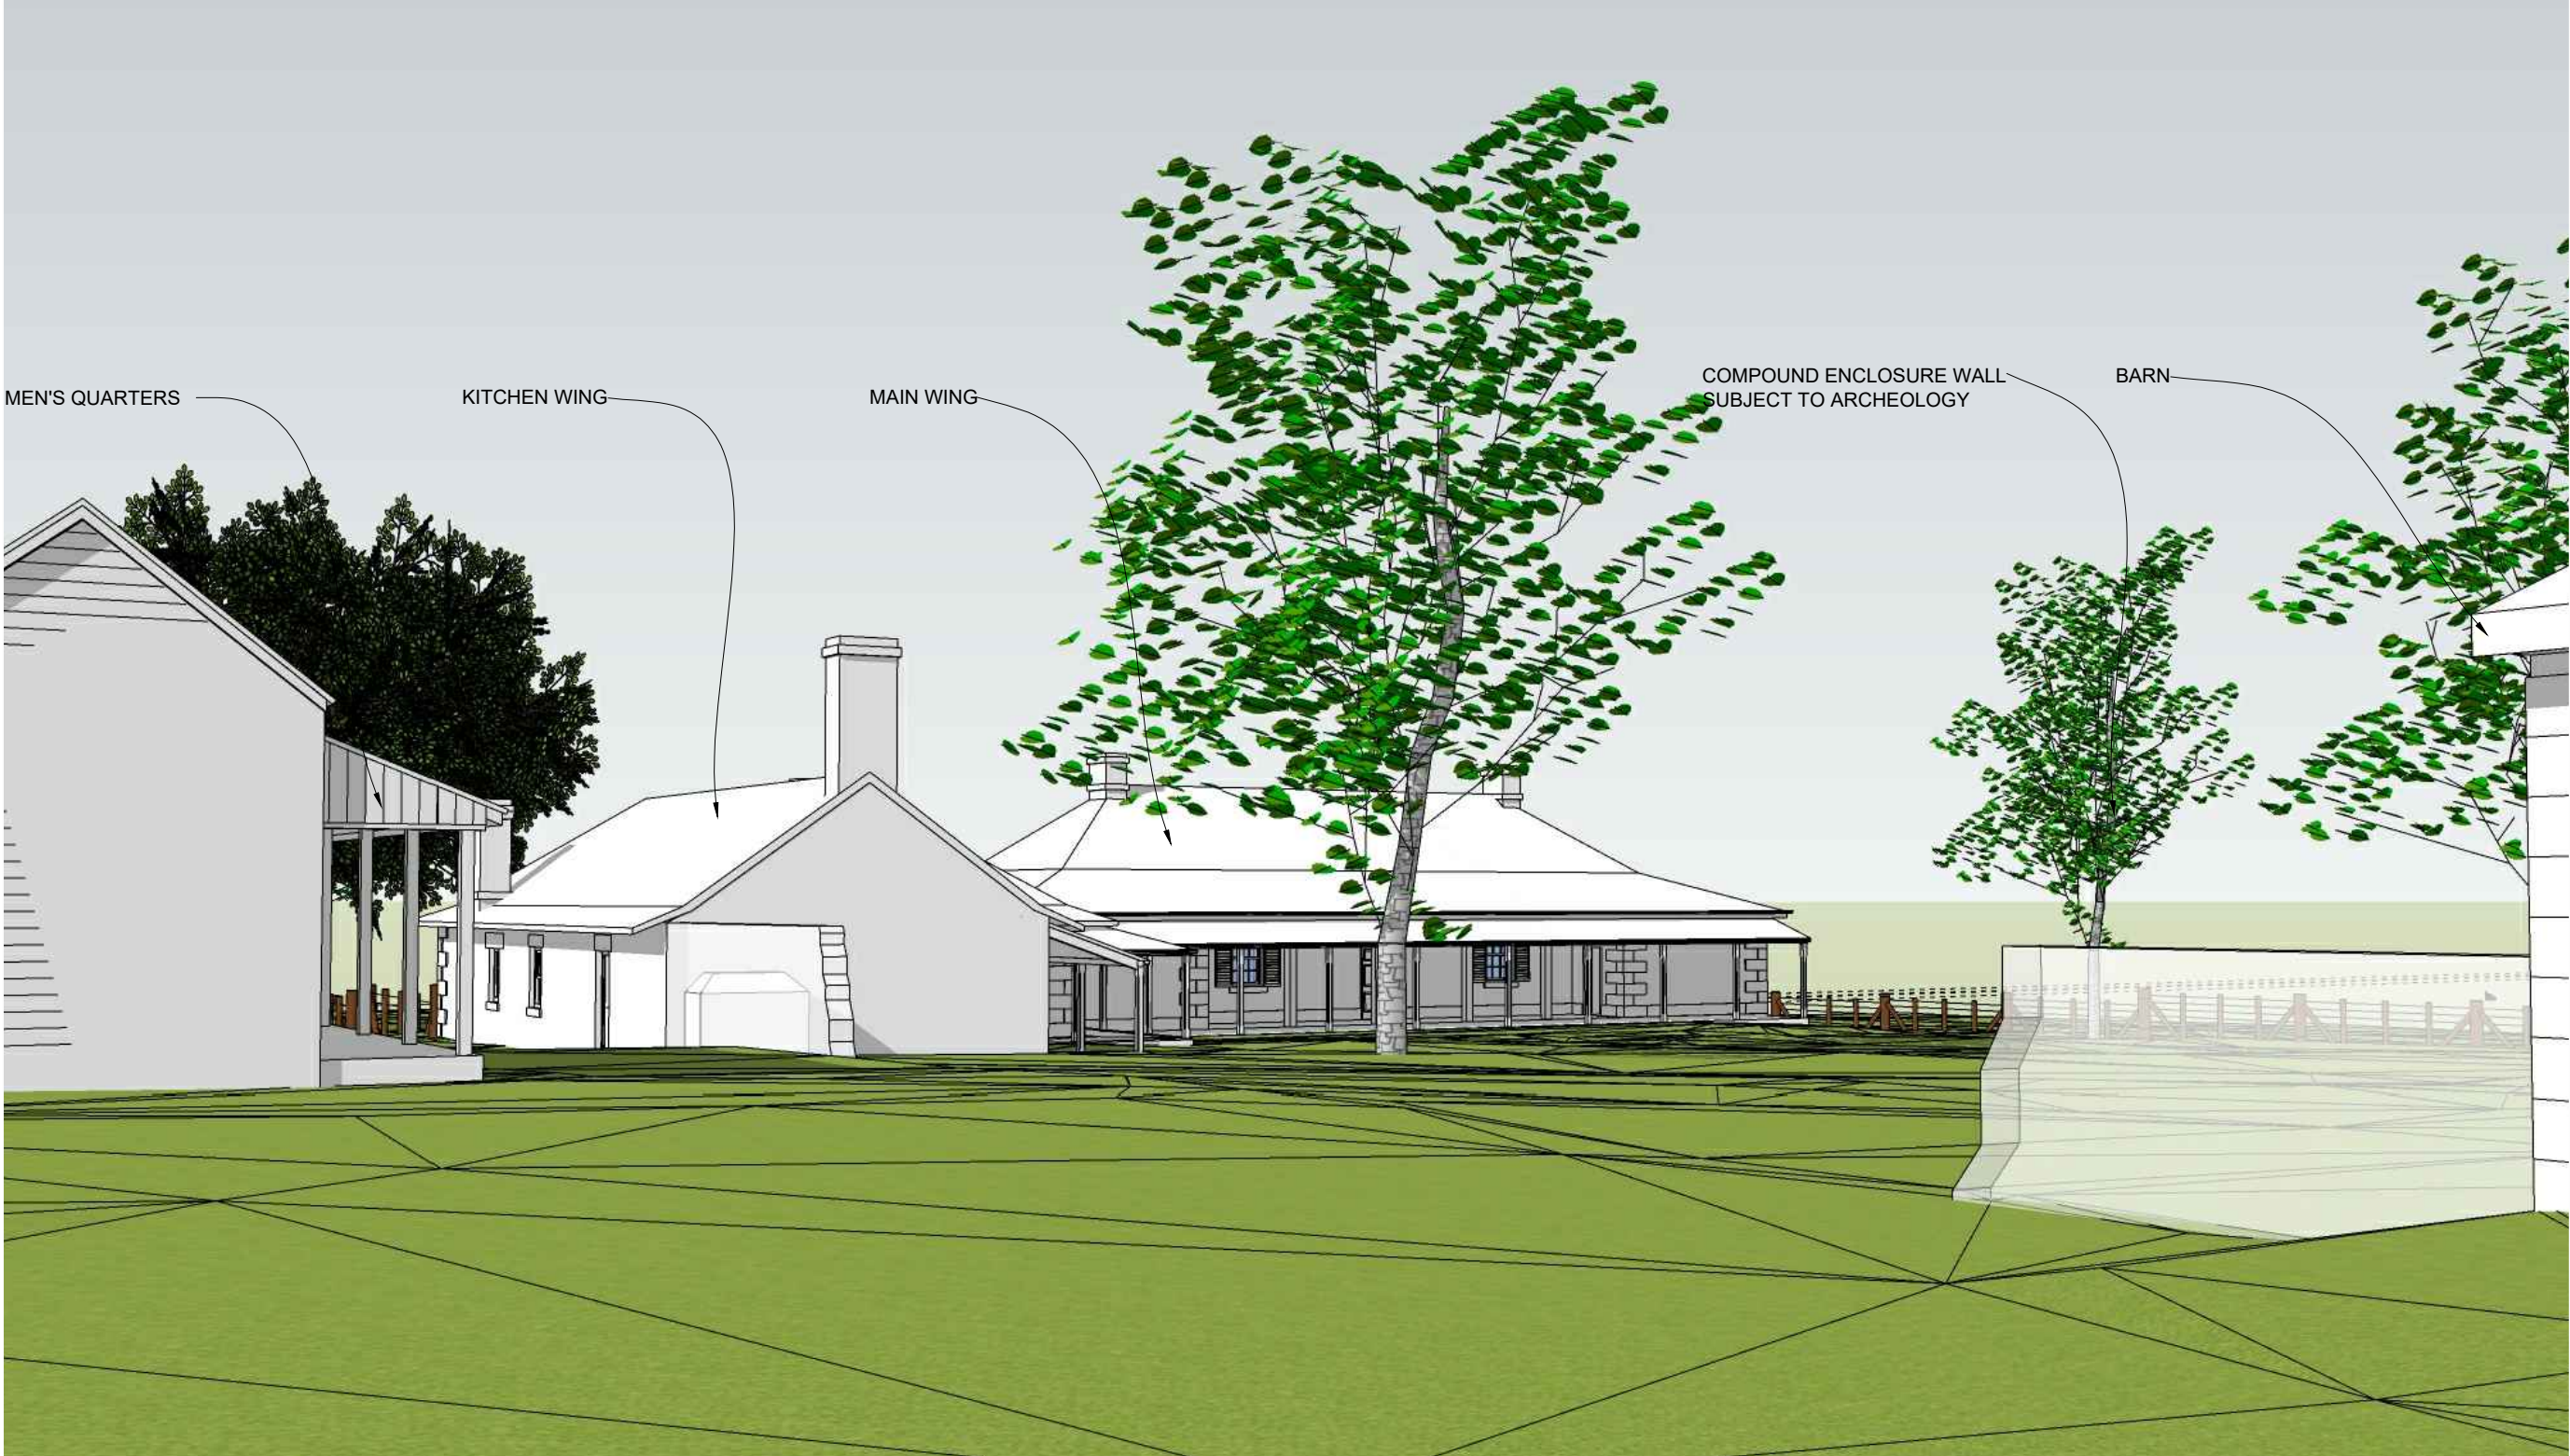
VIEW FROM NORTH-EAST TO KITCHEN WING AND MAIN WING
123800_SP.SK

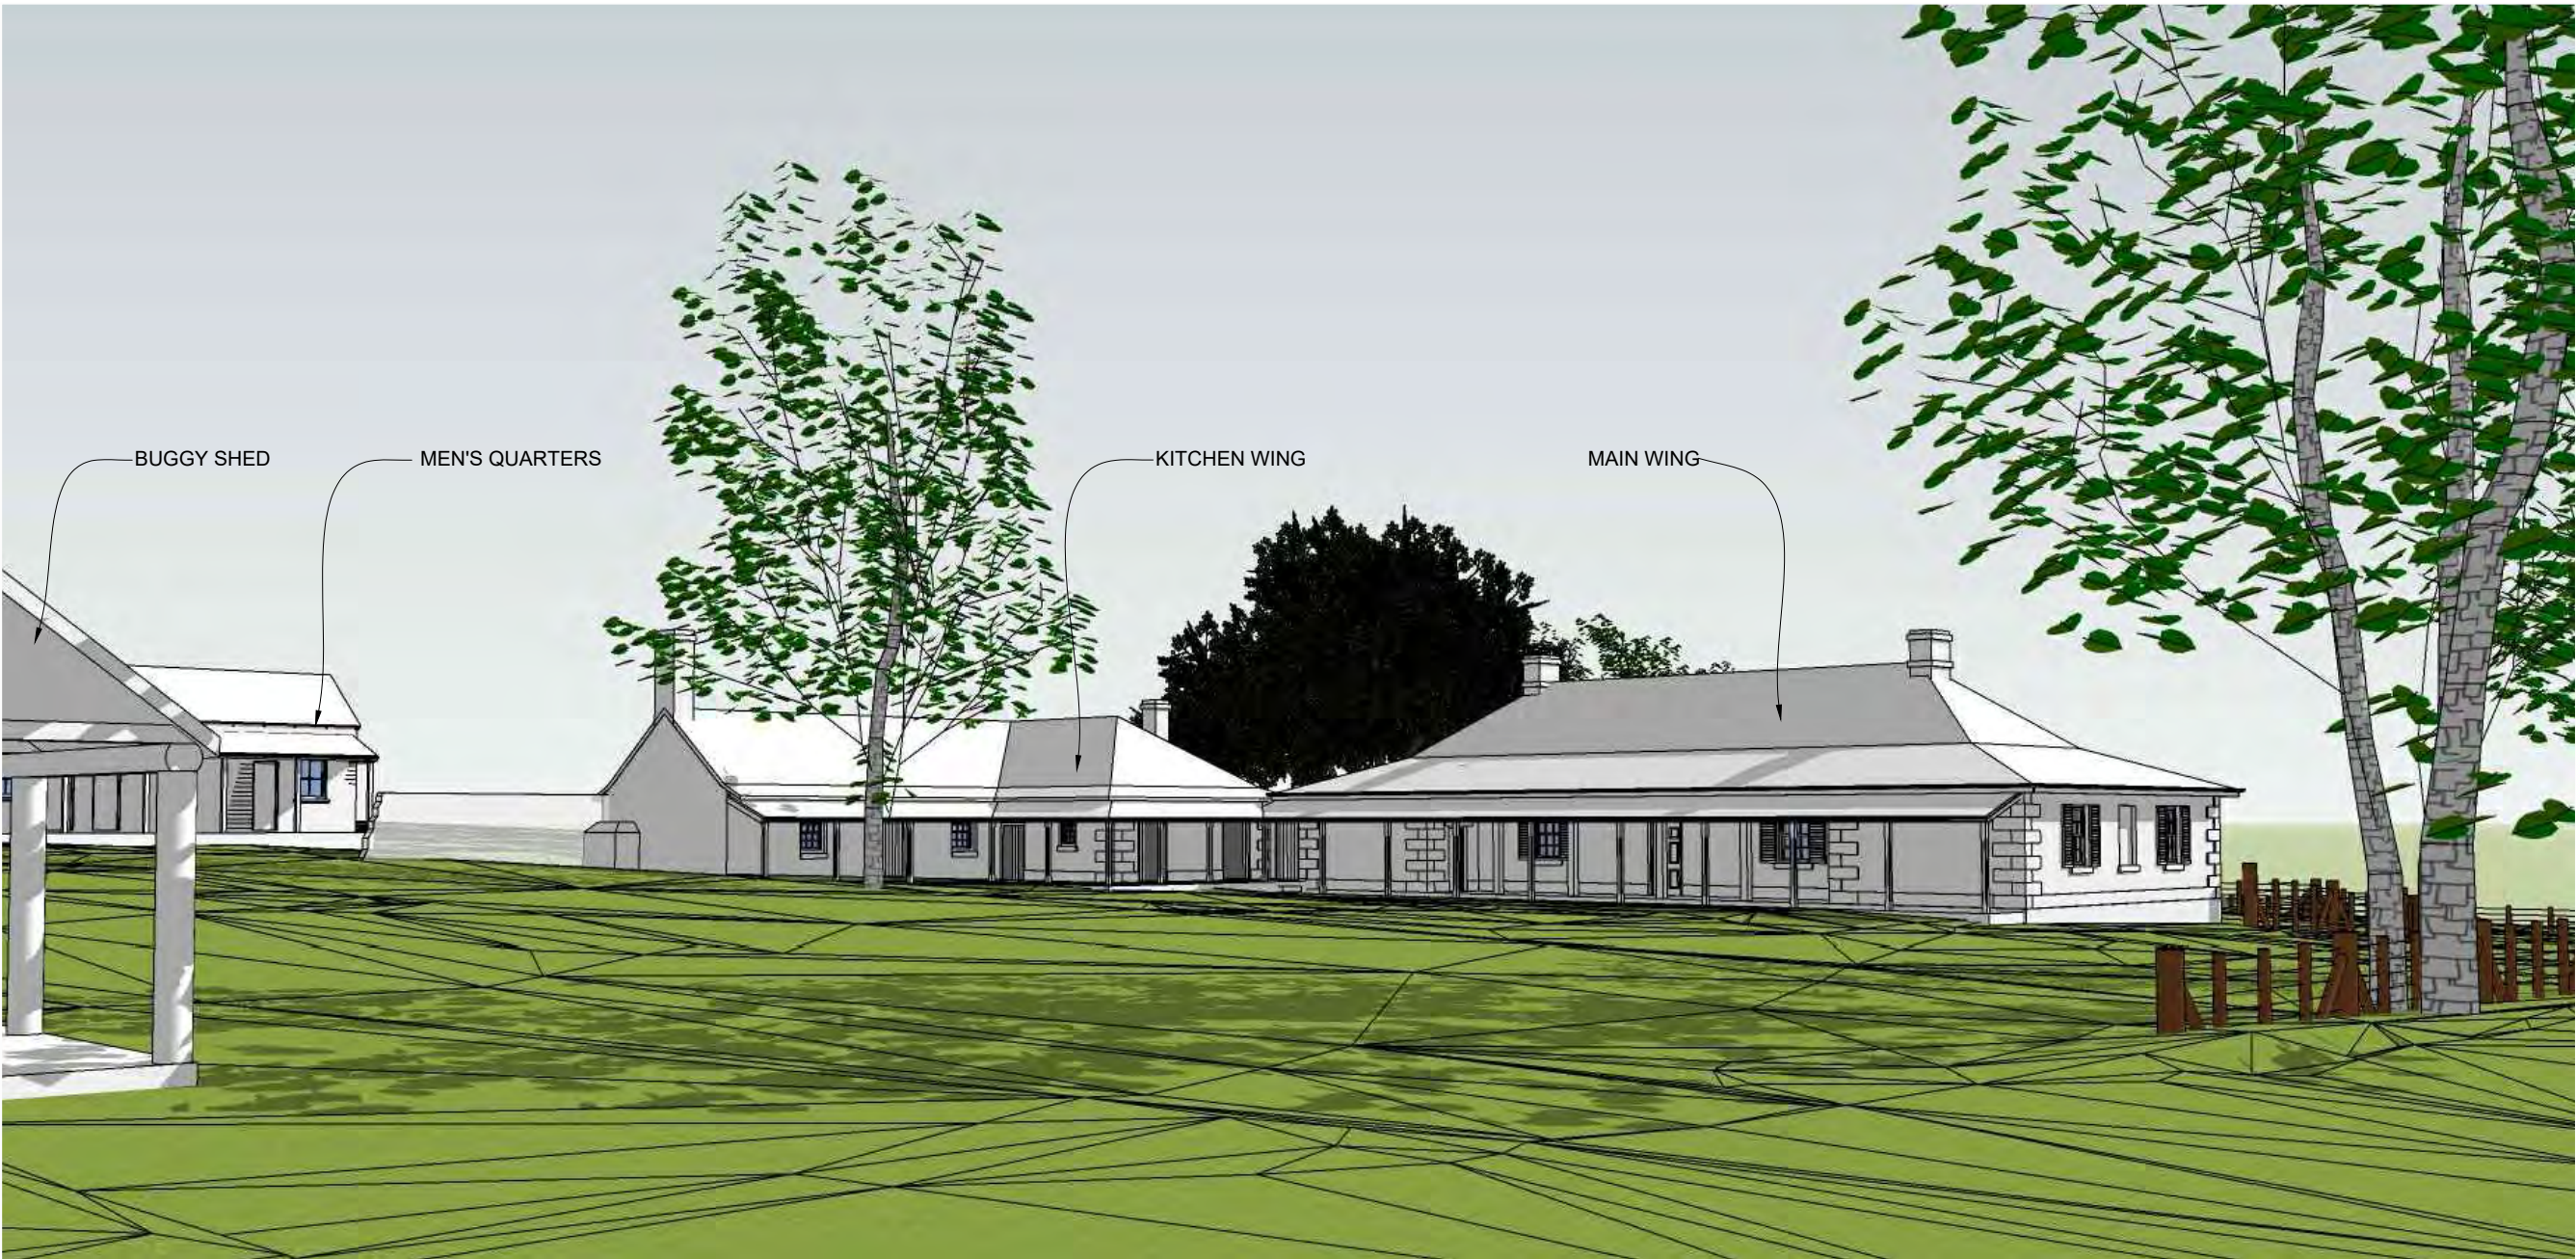
VIEW FROM NORTH-WEST TO HOMESTEAD
123800_SP.SK

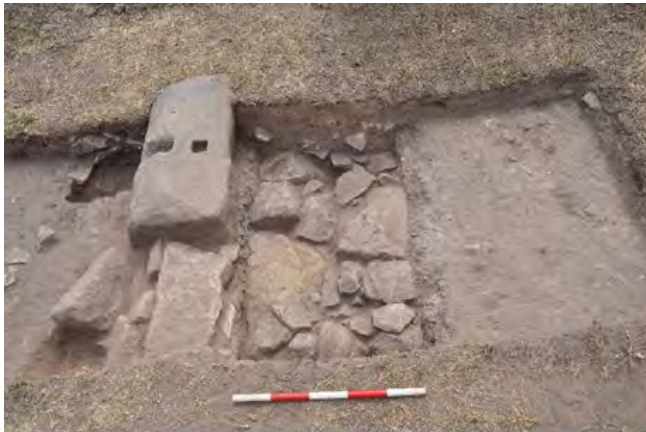
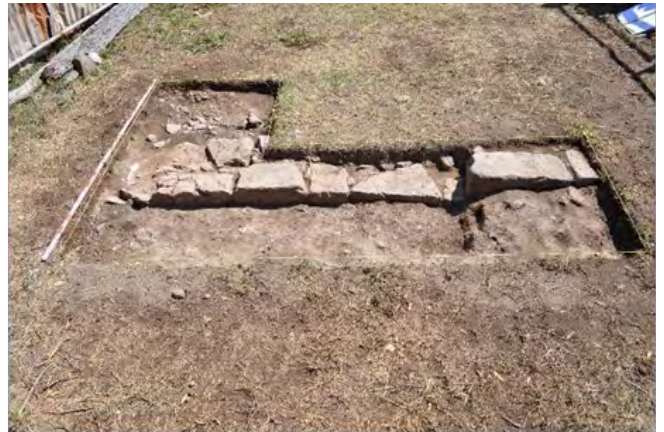
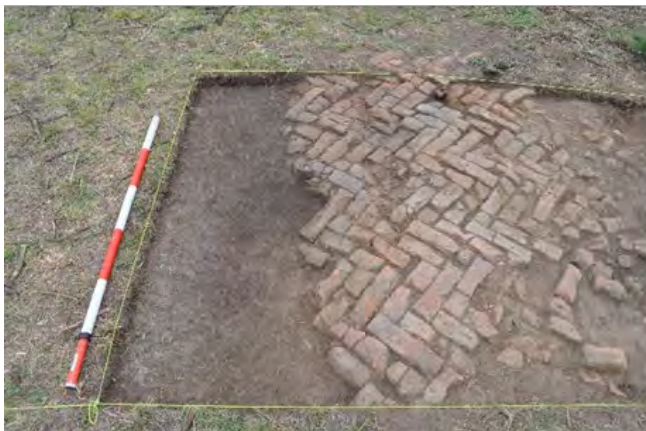
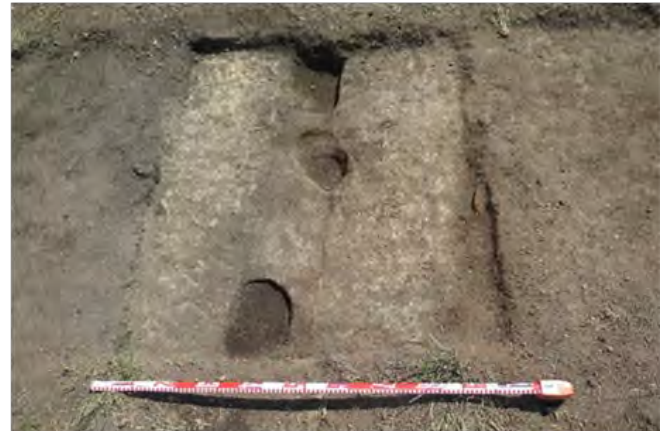
Top Left and Right: Remains of foundation walls relating to the 1830s building identified as potential convict accommodation (TA4, TT4 and TT6). *Bottom Left:* Herringbone Paving (TA6, TT7). *Bottom Right:* Linear feature and postholes, part of larger unexcavated structure (TA5, TT2).

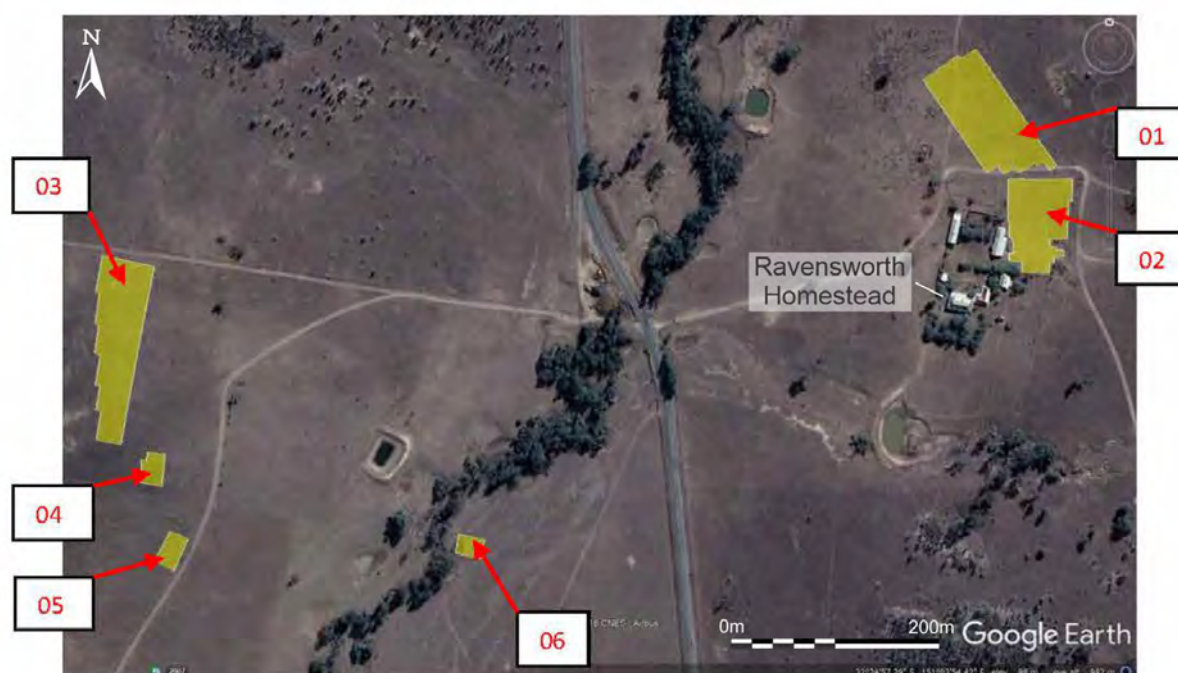
Figure 3.2: Locations of GPR coverage (in yellow). Source: MALA 2018.

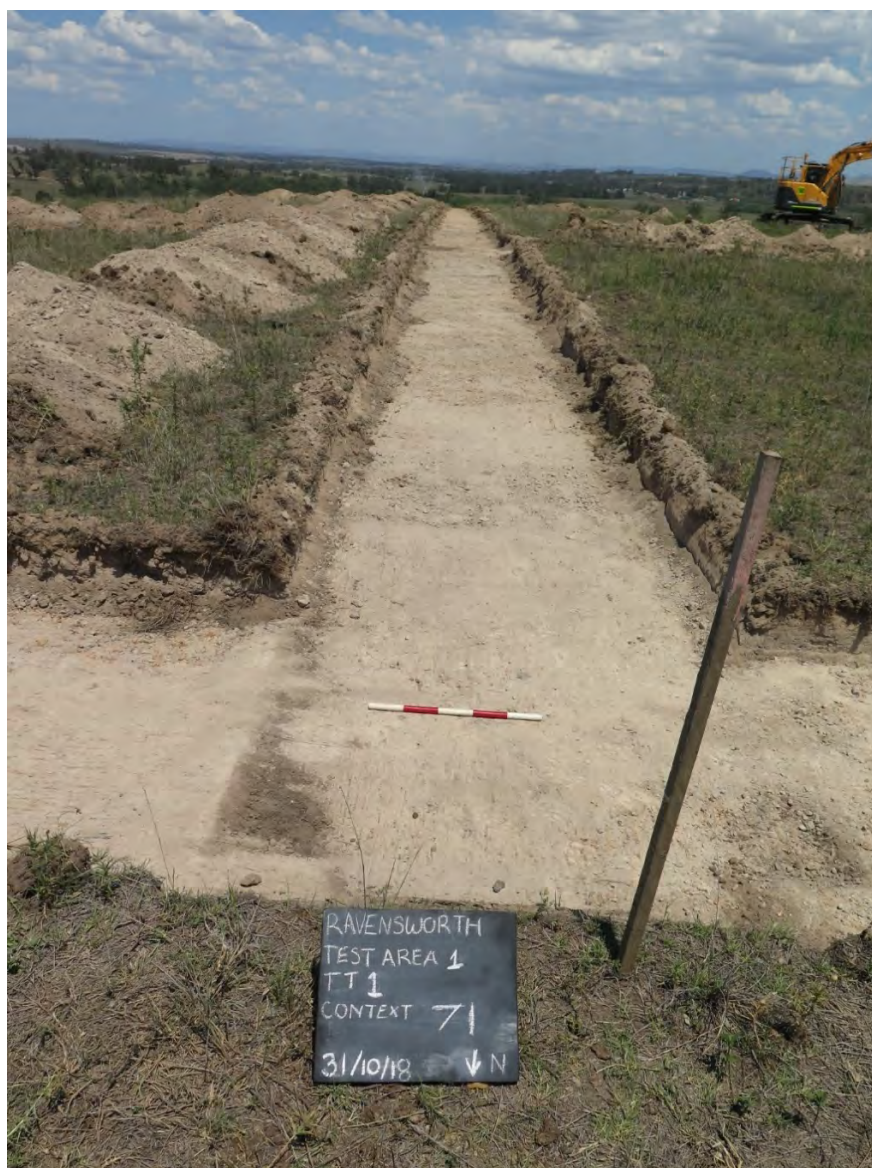
Figure 3.4: TA1/TT1 facing south showing the consistency in the natural deposit across the area. TT2 runs east-west in the foreground and TT3 is in the background marked by the east-west spoil piles. Looking south, scale 500mm.

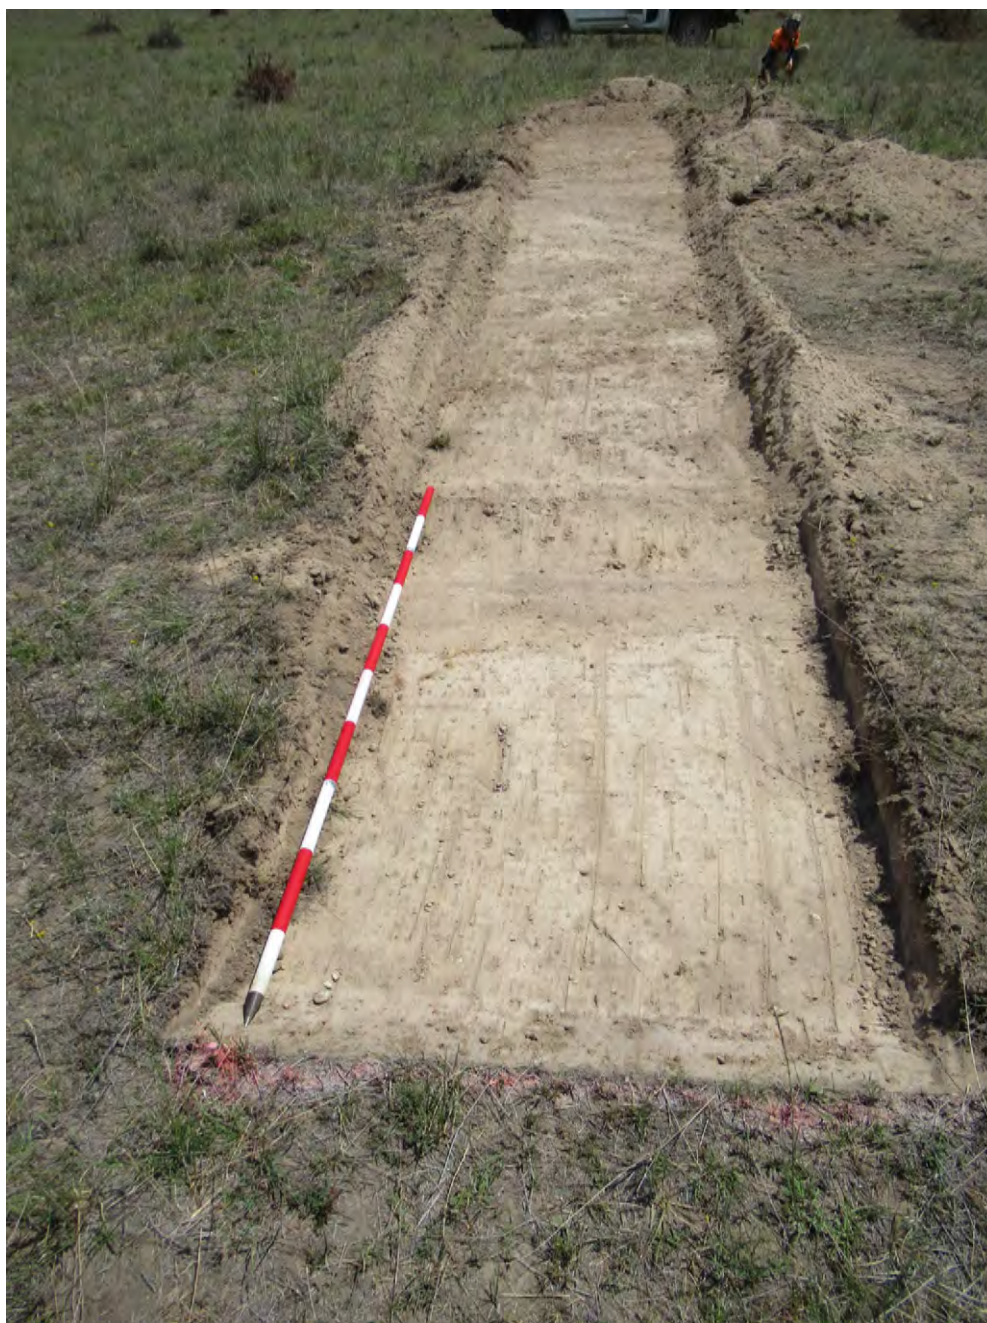
Figure 3.5: TA1/TT8 facing north showing the consistency in the natural deposit across the area. Looking north, scale 2m.

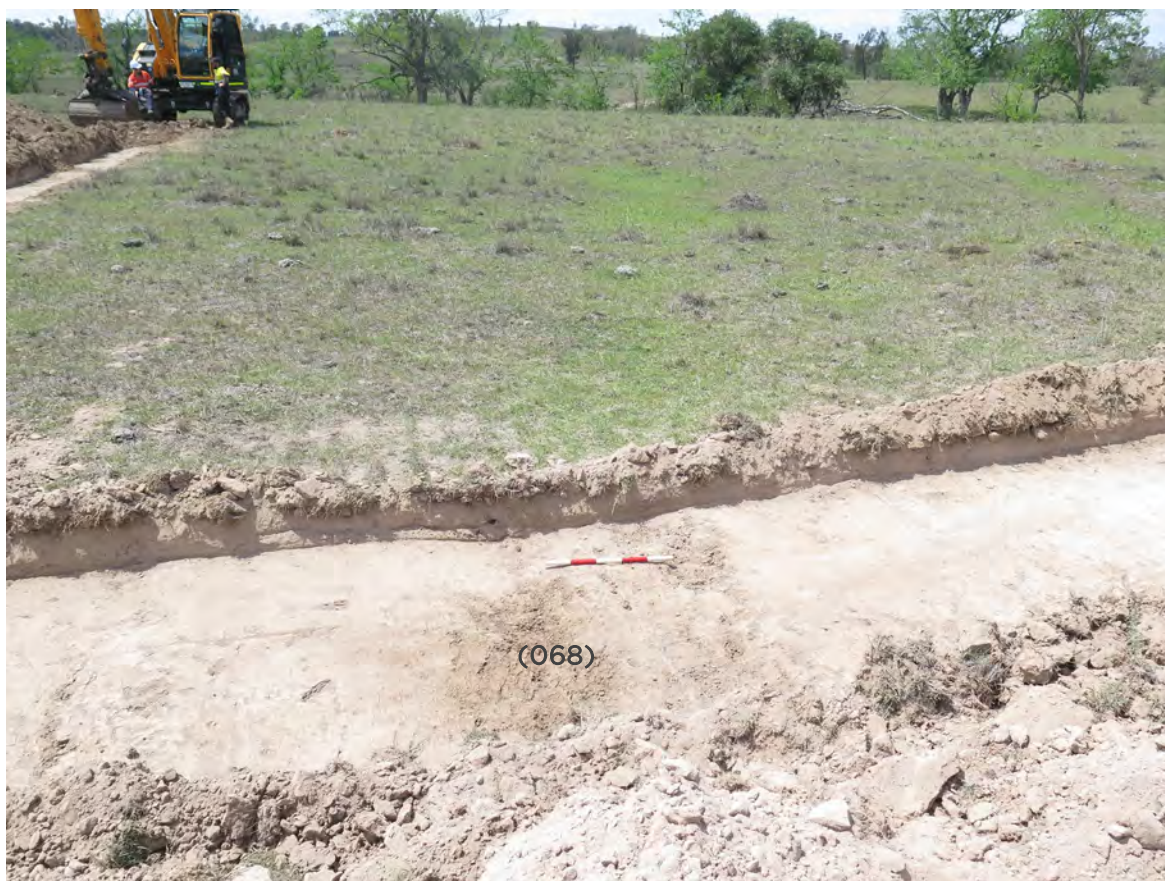
Figure 3.7: TA2/TT2 facing north showing the light brown silt (O68) interpreted as being a field drain. TT2, visible on the left, runs north-south in the background. Looking north, scale 500mm

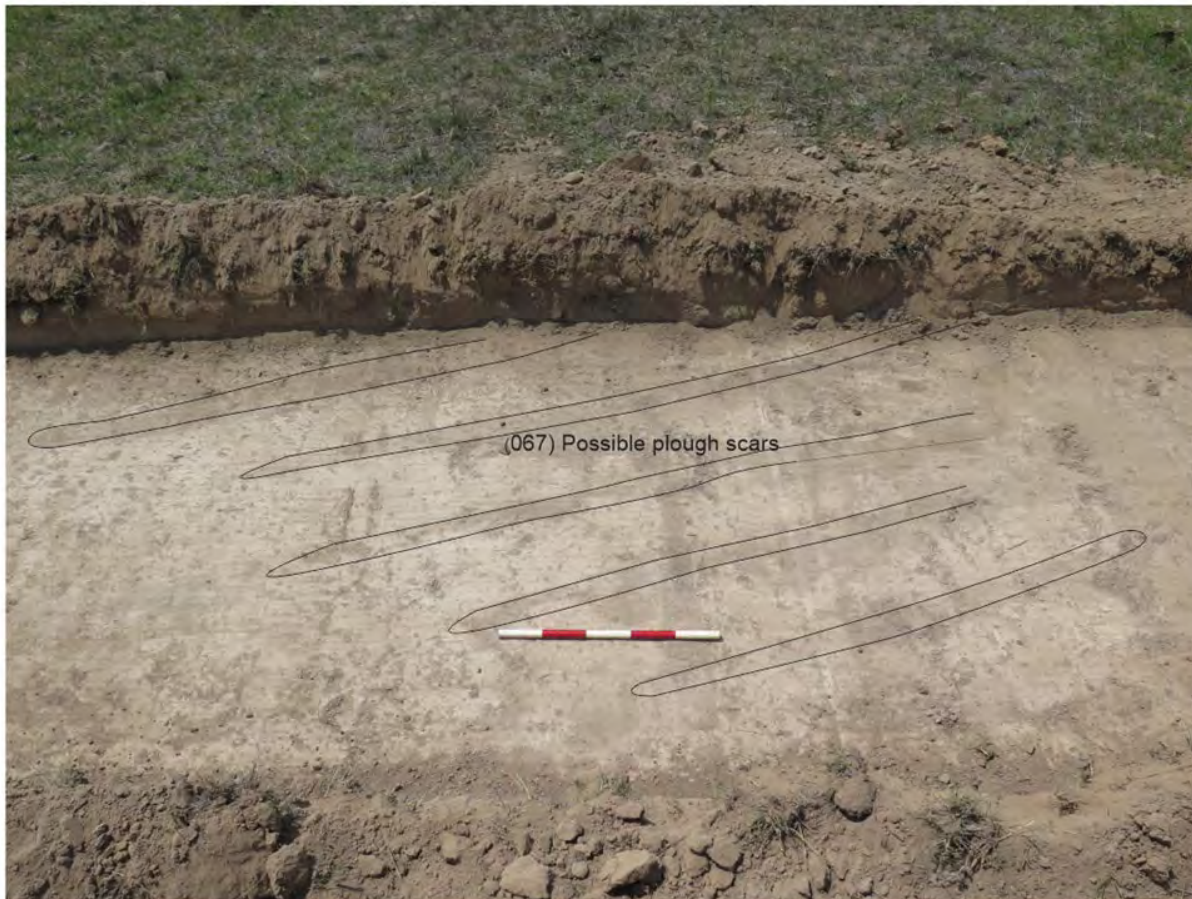
Figure 3.8: TA2/TT2 facing north showing possible plough scars highlighted in black running NNW-SSE. Scale 500mm.

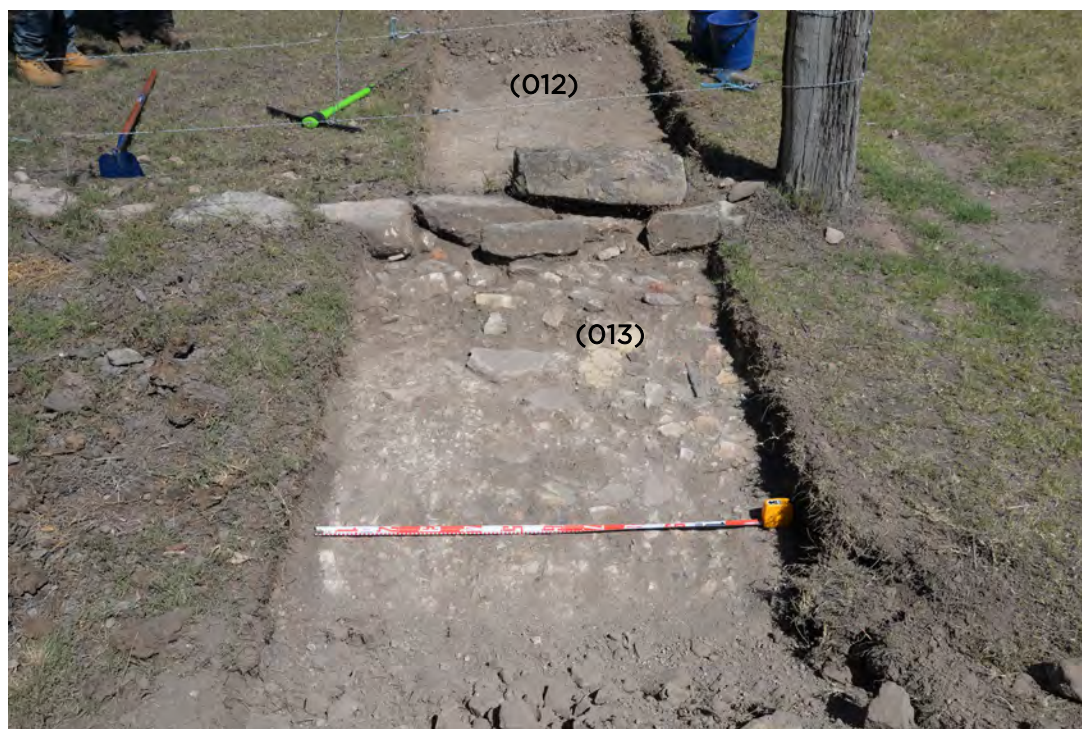
Figure 3.10: TA3/ TT2 crosses the Homestead complex eastern boundary fence. Looking west.
Scale 1100mm

Table 3.7: Archaeological contexts in TA3/TT2.

Context	Description	Thickness
O12	Modern grey clay topsoil.	200mm
O13	Compact rubbly greyish brown silty clay.	110mm
O14	Natural pebble stratum.	80mm

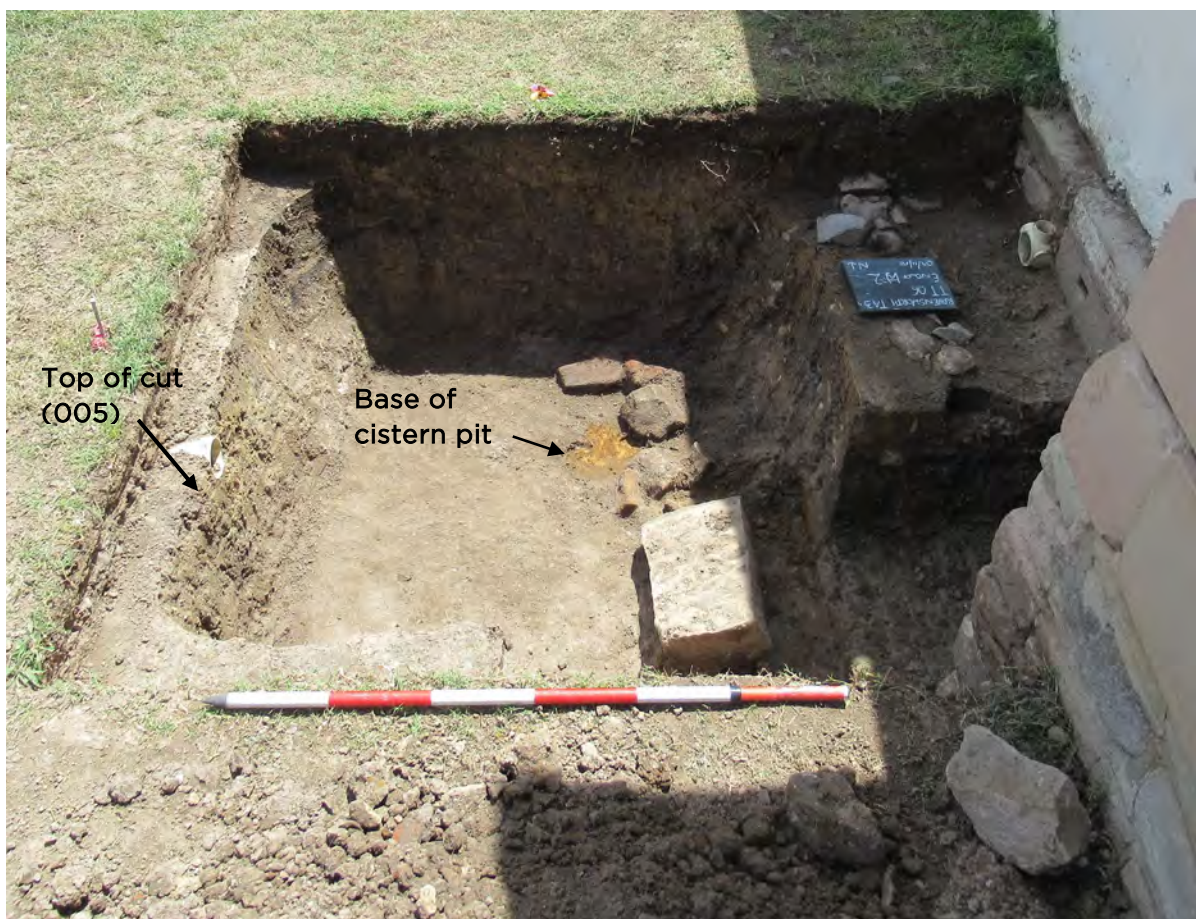
Figure 3.11: Post-excitation photo of TA3/TT6a showing the maximum exposed extent of the cistern pit and rubble contained within. Looking north. Scale 1200mm.

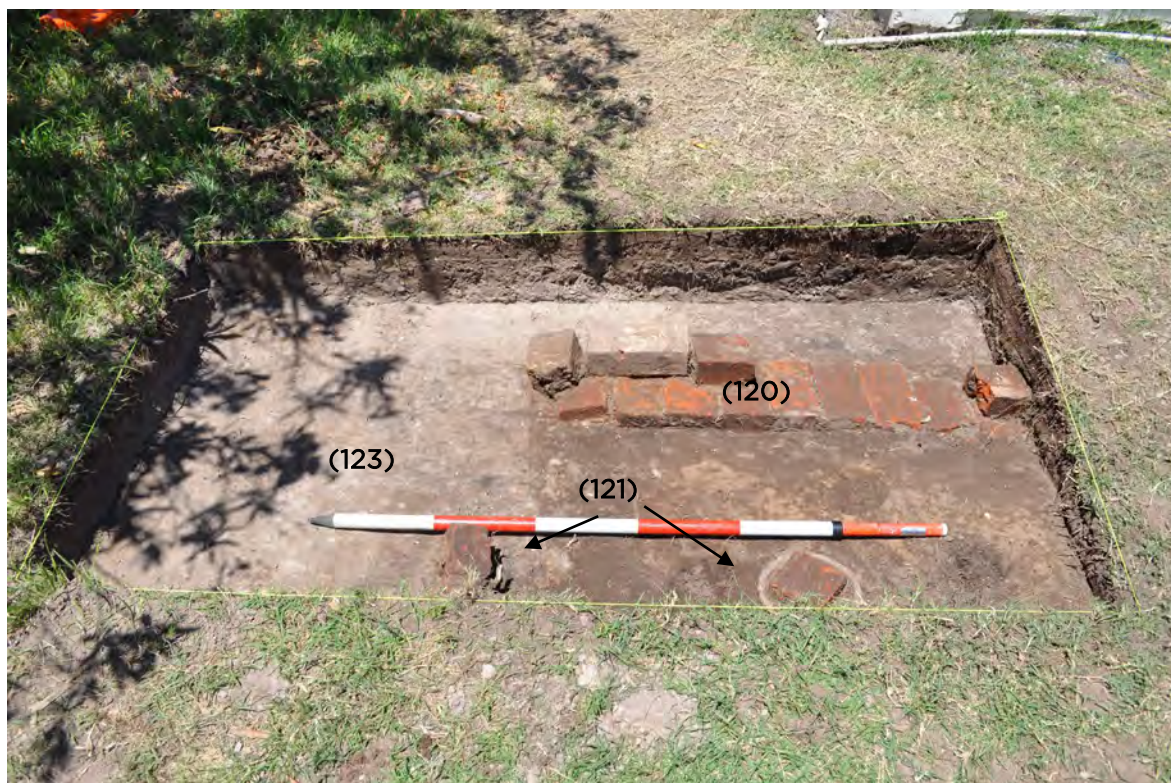
Figure 3.12: Facing east of TA3/TT6b showing the brick wall foundation (120) and multiple salt-glazed pipes (121). Looking east. Scale 1200mm.

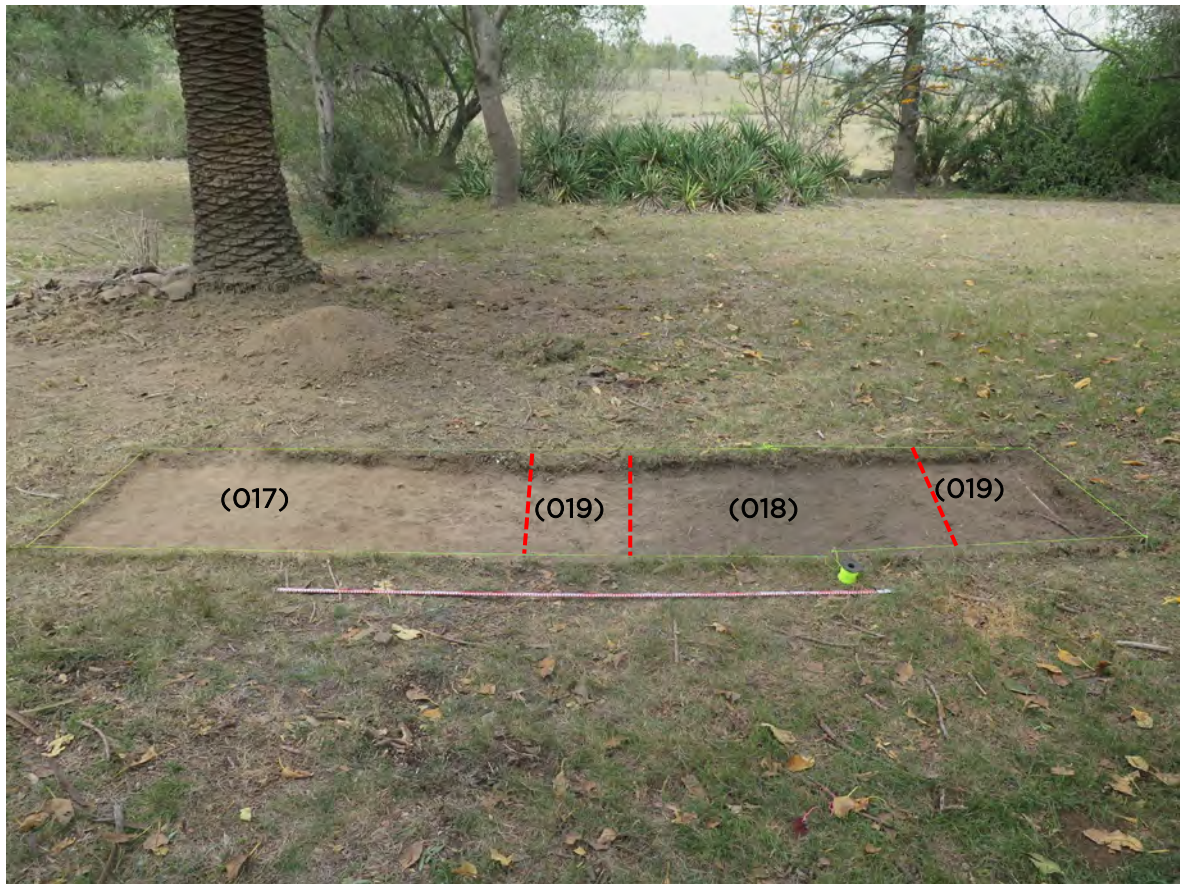
Figure 3.13: South-facing view of TA3/TT8. The possible garden path (018) is arrowed in the right half of the trench with the two bands of light grey brown silty sandy clay (019) on either side. Looking south. Scale 2m.

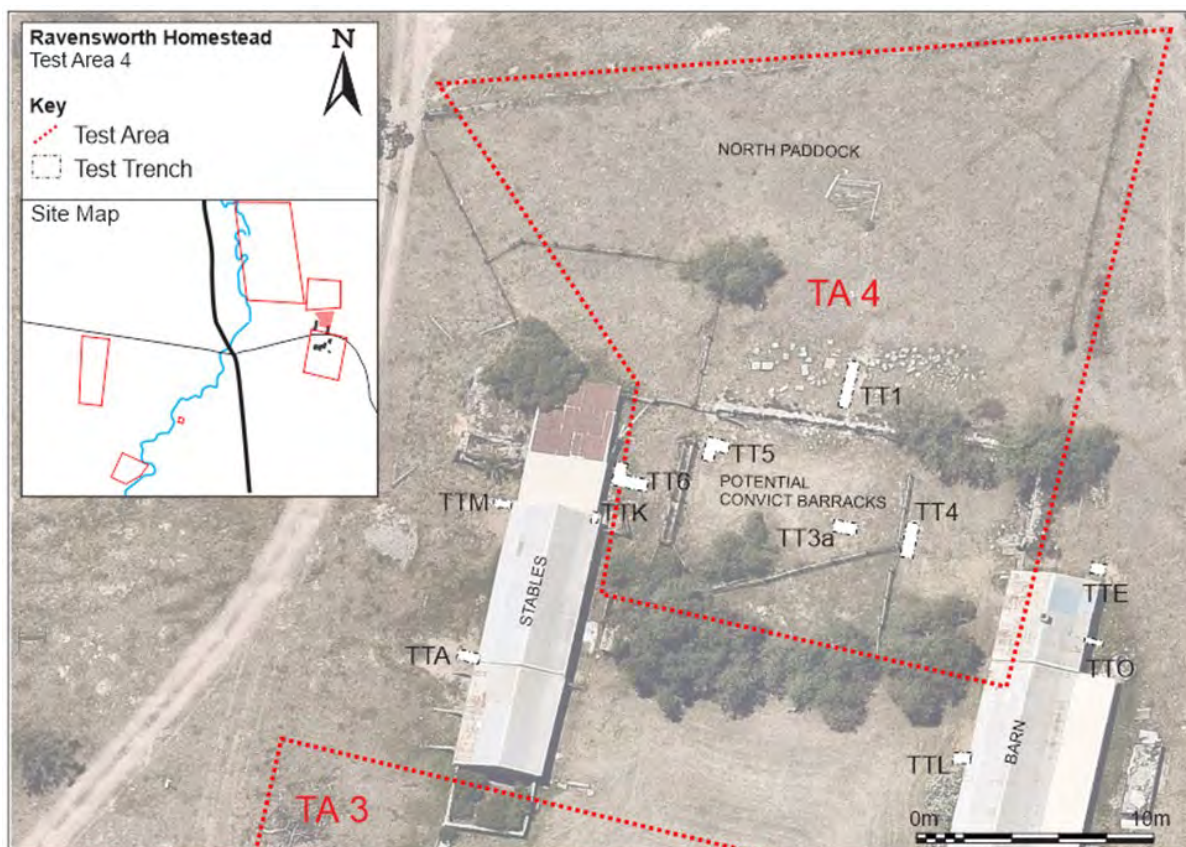
Figure 3.15: Location of test trenches in Test Area 4, shown with outbuildings and farm walls.
