APPENDIX 23

Heritage
Assessment

Appendix 23 – Heritage Assessment

This appendix contains the following Heritage Assessment documentation in relation to Ravensworth Estate and the Ravensworth Homestead Complex:

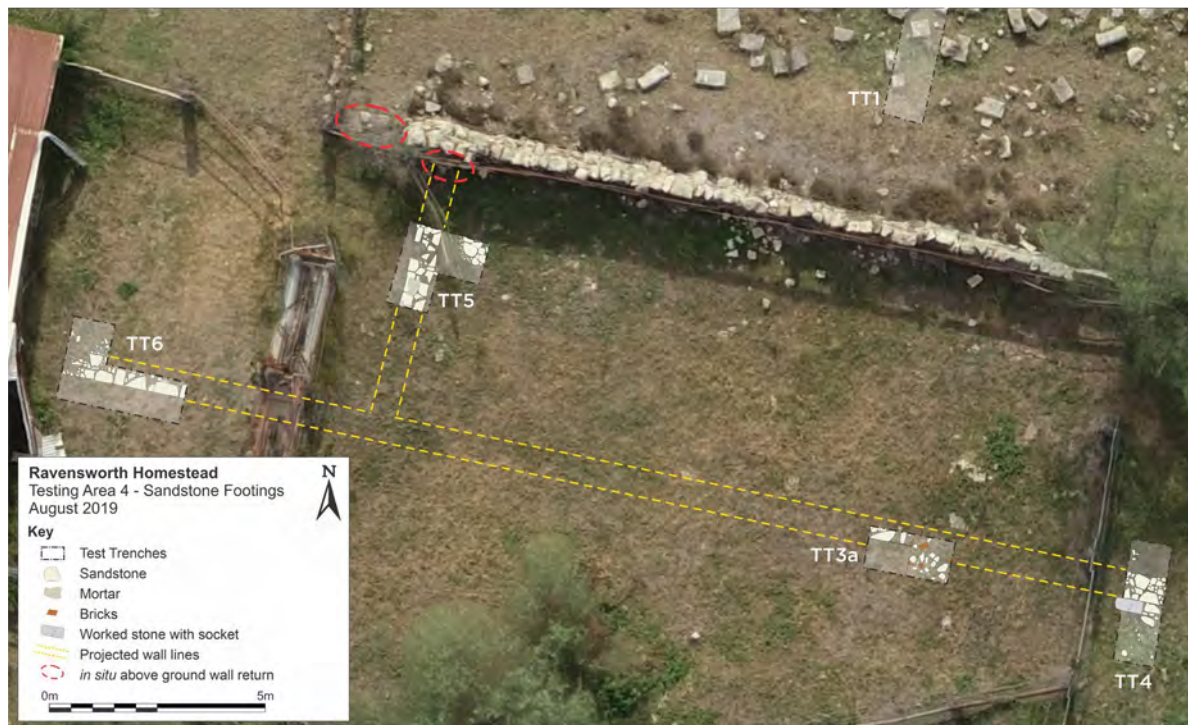
Figure 3.16: TA 4 showing foundations/ cuts uncovered in TT 6, 5,3a and 4 with projected wall lines and area where *in situ* above ground wall returns was identified (red hashed line).

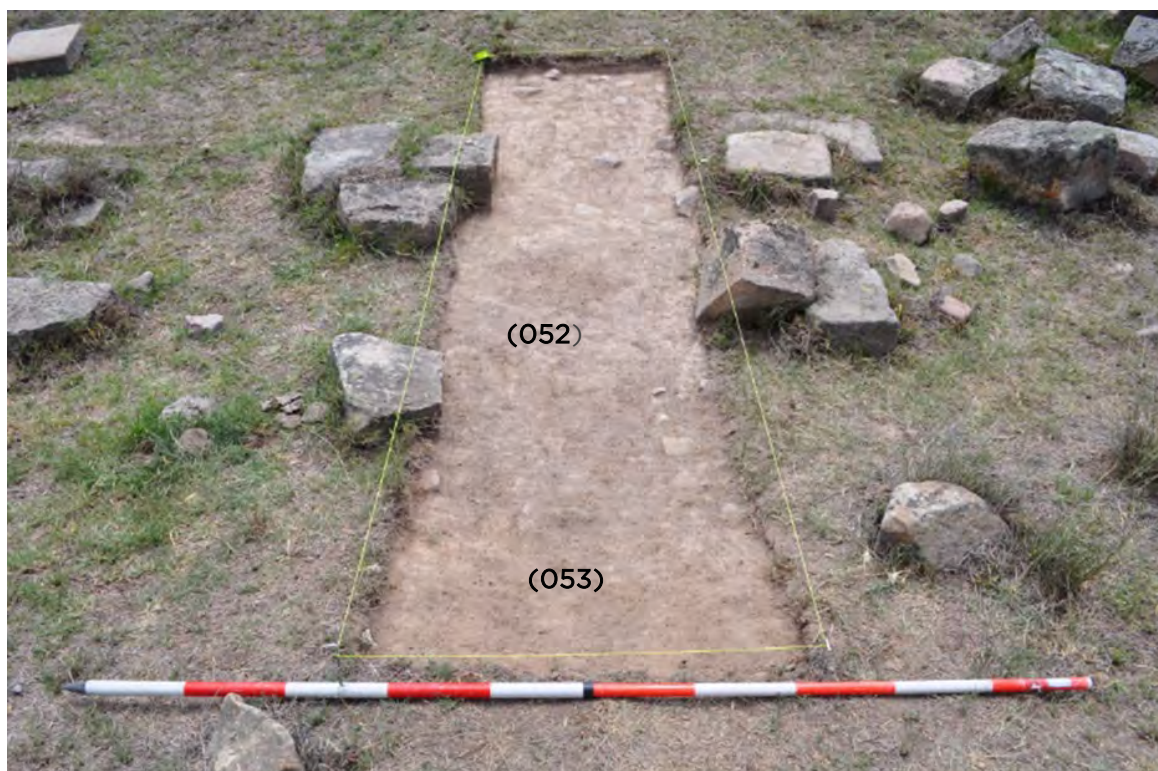
Figure 3.17: Excavation in TA4/TT1 of very loose mid to dark brown silty sand (052), down to loose light brown silty clay (053), showing that stones across this area sat on the surface with some embedded 30-40mm into the silty sand layer. View to north. Scale: 2m.

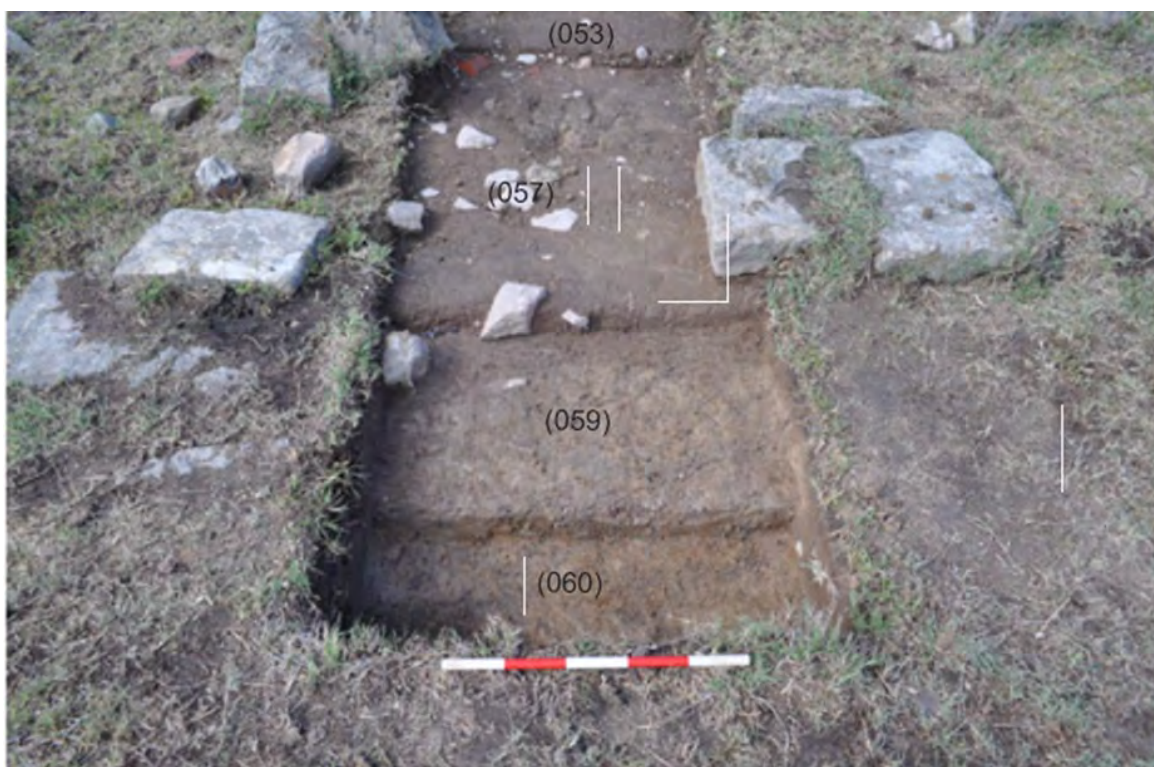
Figure 3.18: Sondage in TA4/TT1 through loose light brown silty clay (053) through compact light brown silty clay (057), compact reddish-brown clayey silt (059) and indurated yellow clay (060). View to south. Scale: 500mm.

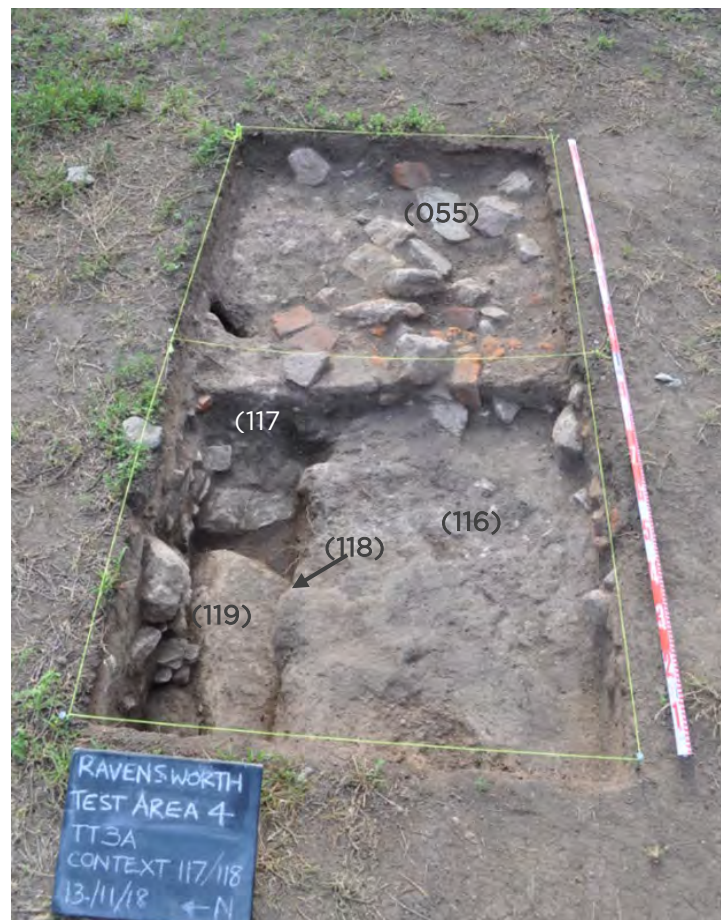
Figure 3.19: TA4/TT3a, foundation trench (118) for sandstone wall footing (119) in bottom left corner of trench running east-west. View to east. Scale: 2000 mm.

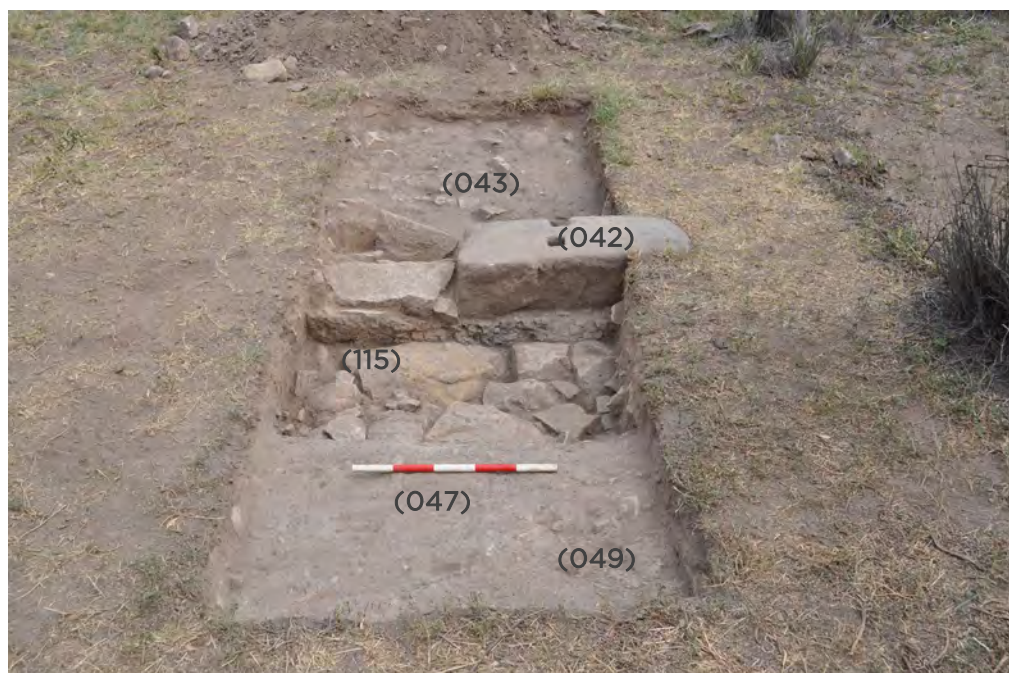
Figure 3.20: TA4/TT4, foundation trench (047) running east-west, with finely dressed sandstone block with two cut sockets (042). View to south. Scale: 500mm

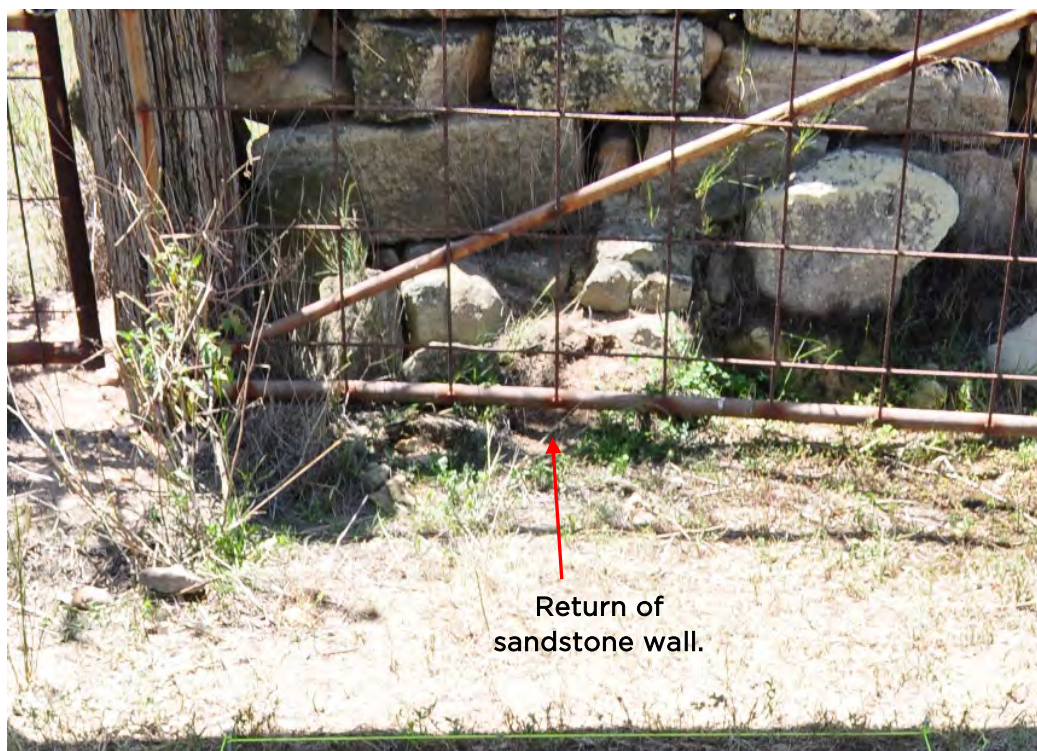
Figure 3.21: Surviving portion of sandstone wall (running north-south) at the base of the north wall (running east-west) in the north yard. TT4/TT5 was aligned to test the reading that the sandstone blocks were *in situ*. Looking north. No scale.

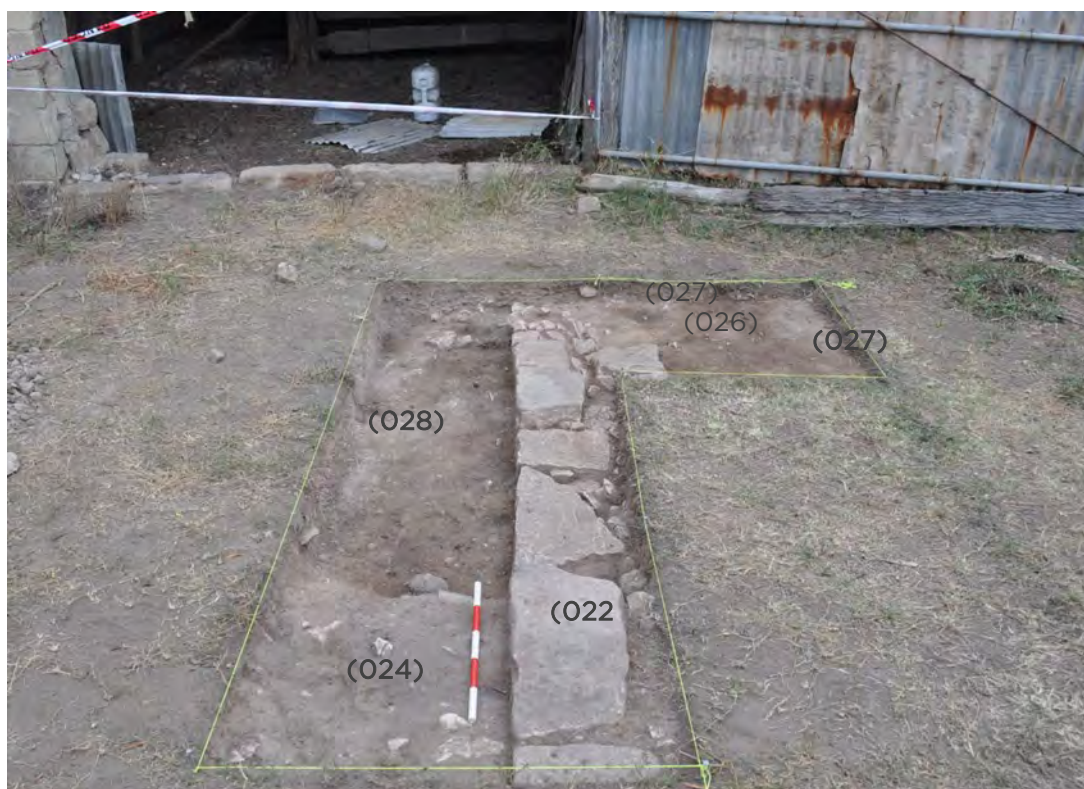
Figure 3.23: TA4/TT6, dressed sandstone footing (O22) running east-west. View to west. Scale: 500mm.

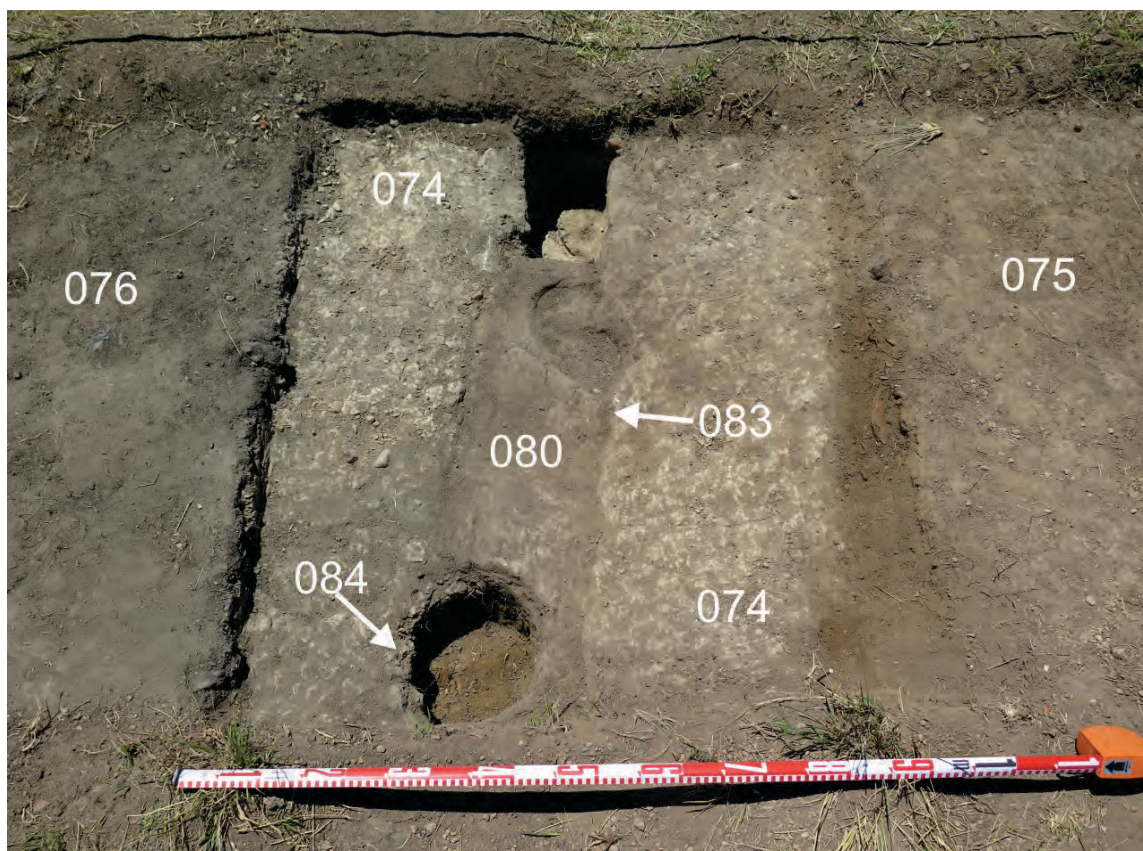
Figure 3.26: TA5/TT2, wall slot (083) and postholes. View to south. Scale: 1.1m.

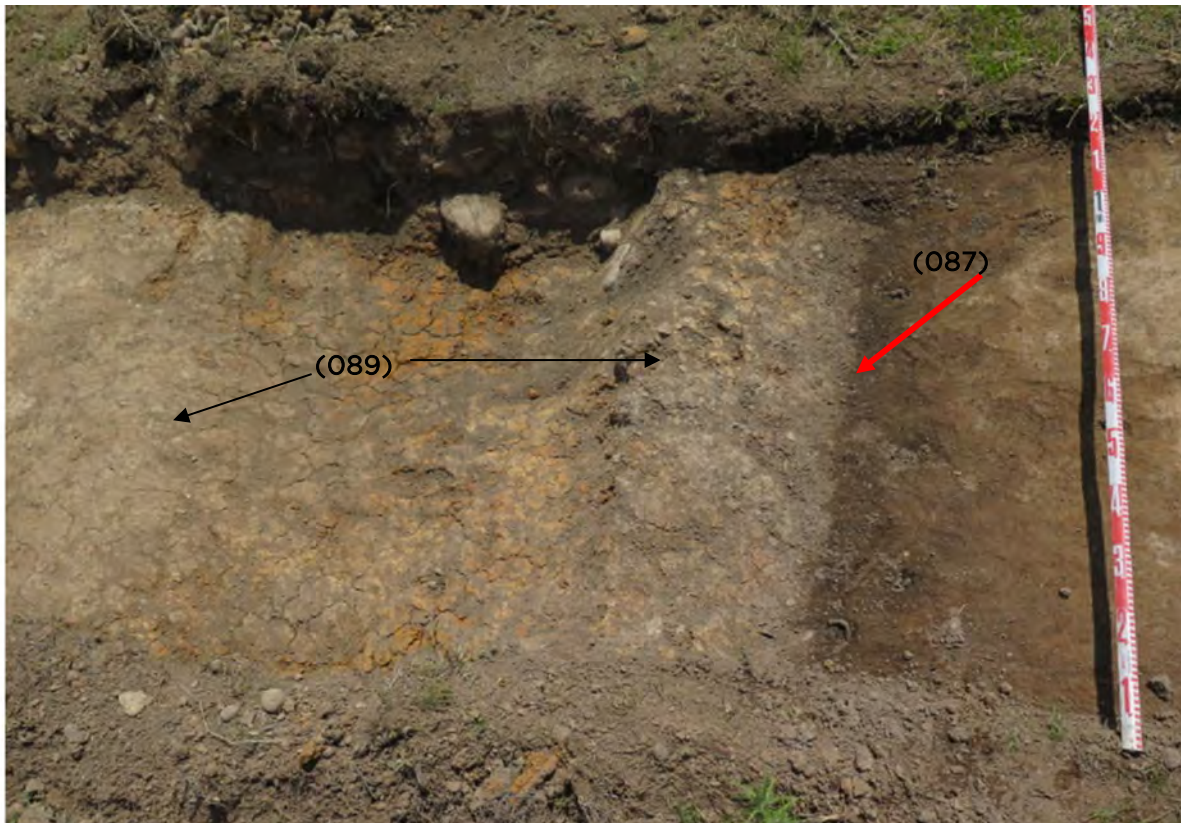
Figure 3.27: TTA5/TT3, line of decaying timber to east (red arrow) with shallow north-south trench (089). View to north. Scale 1.5m.

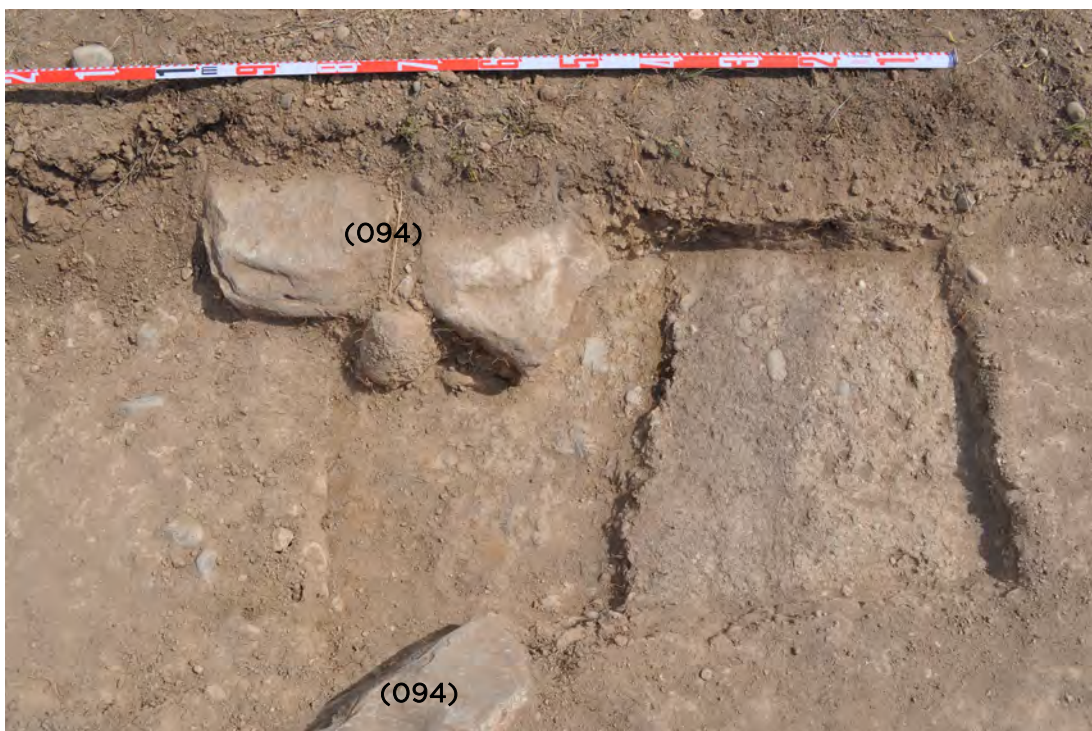
Figure 3.28: Concentration of sandstone pieces (094), potentially remains of a collapsed building, at the point the ground levels out. Scale 1.2m.

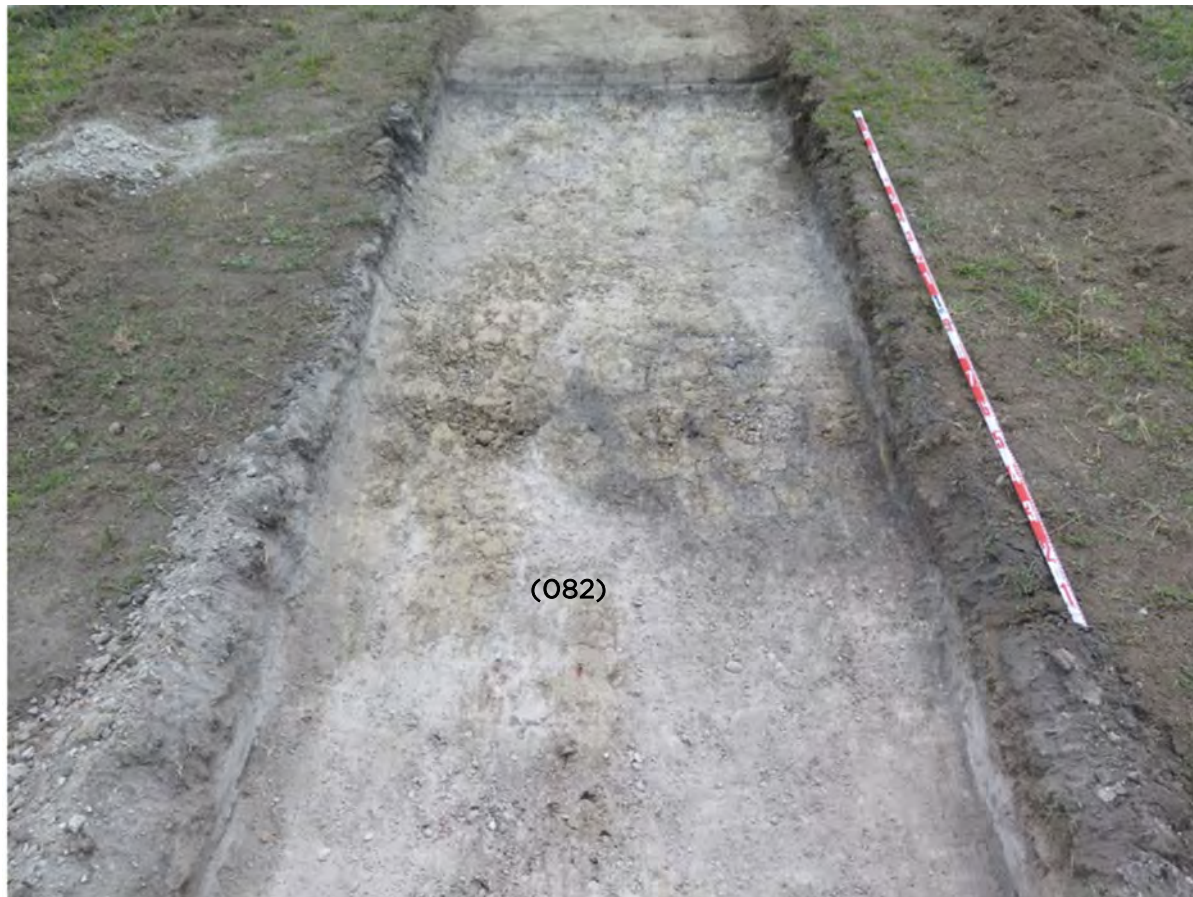
Figure 3.29: TA5/TT4 showing loose dark grey silty sand (082). View to south. Scale 2m.

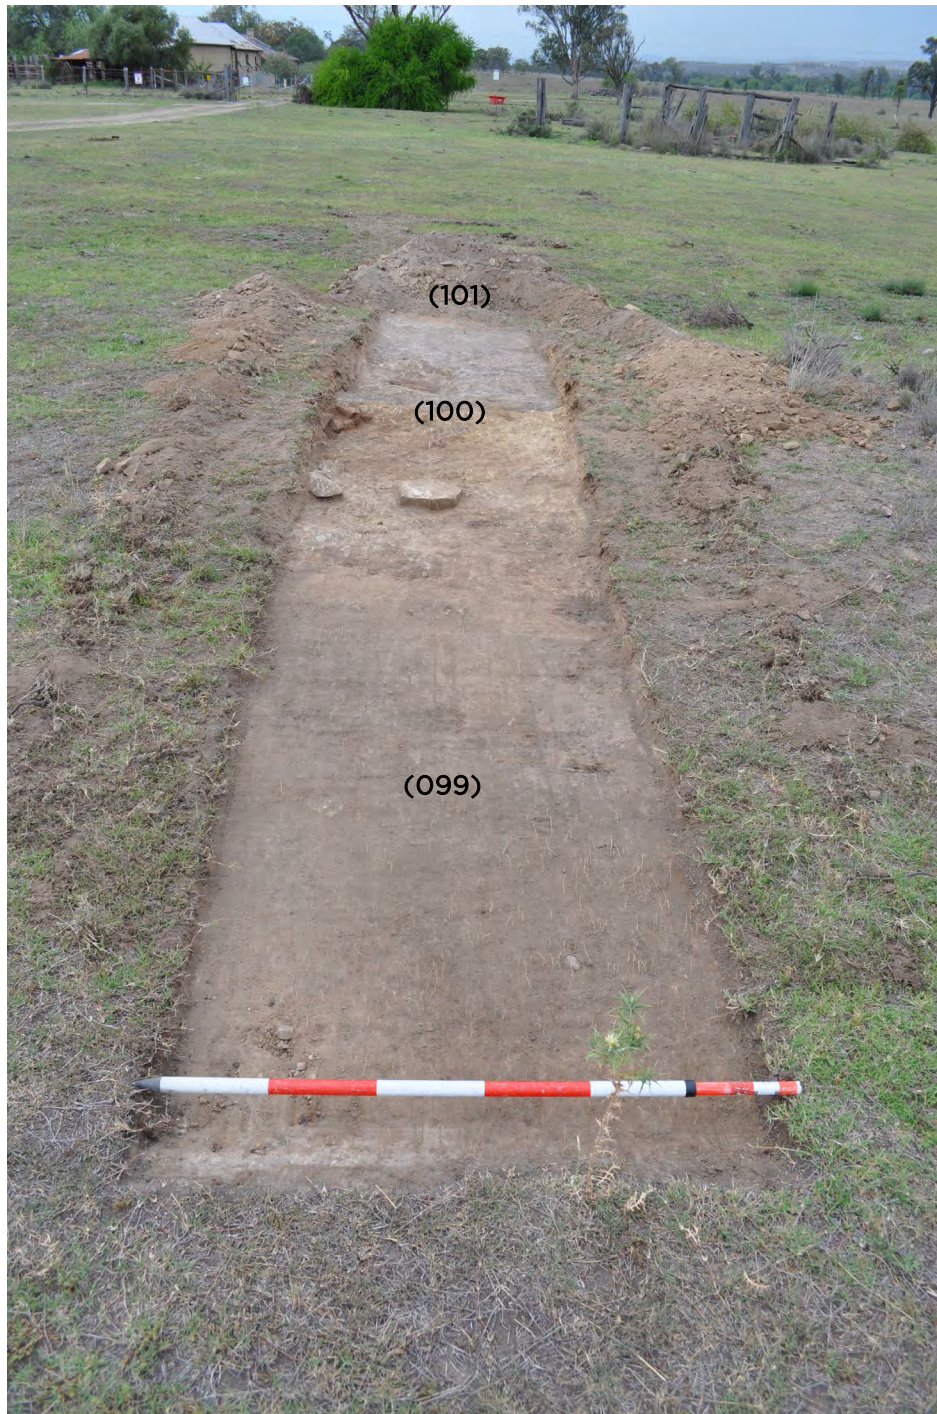
Figure 3.30: TA5/TT5 (looking south) showing loose light brown silty fine sand (099) at the southern of the trench, friable light yellow to light brown sandy silt with mixed sandstone fragments (100) in the centre and friable pale whiteish grey silty sandy clay (101) to the south of the trench. Scale: 1200mm.

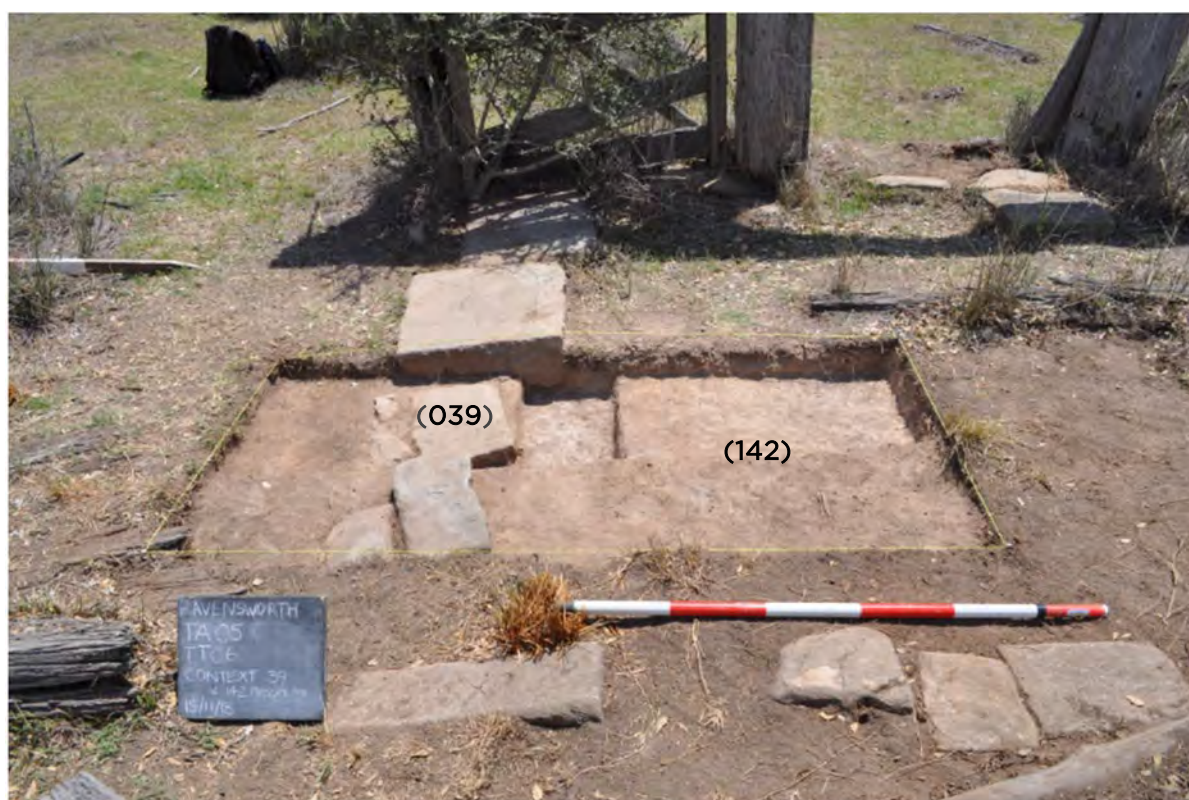
Figure 3.31: TA5/ TT6 showing a single course of reused sandstone blocks consistent with other areas across the site. Scale 1.2m.

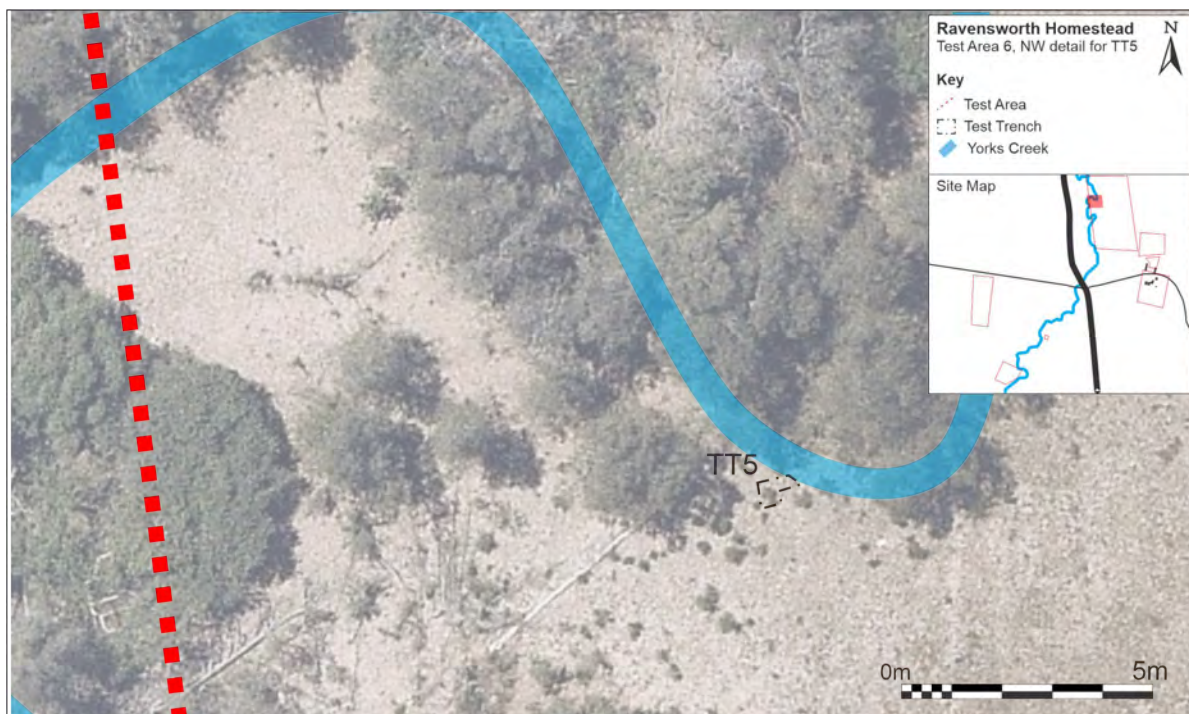
Figure 3.34: Test Area 6 showing TT5 adjacent to the banks of Yorks Creek.

During survey work undertaken in this test area, several pieces of cut sandstone, appearing to form part of a structure, were observed protruding from the eastern bank of Yorks Creek (Figure 3.34, Figure 3.35).

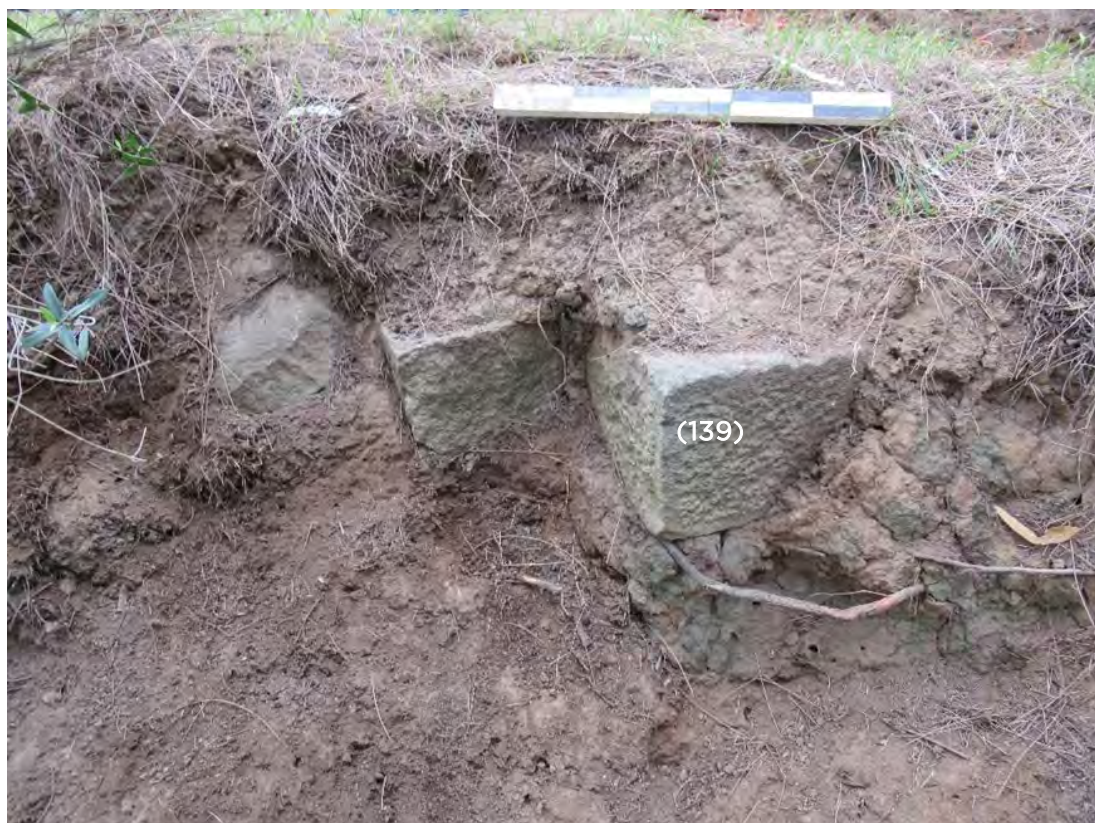
Figure 3.35: TA5/TT5, cut sandstone blocks protruding from the east bank of Yorks Creek, close to a bend in the creek. View to south. Scale: 300mm

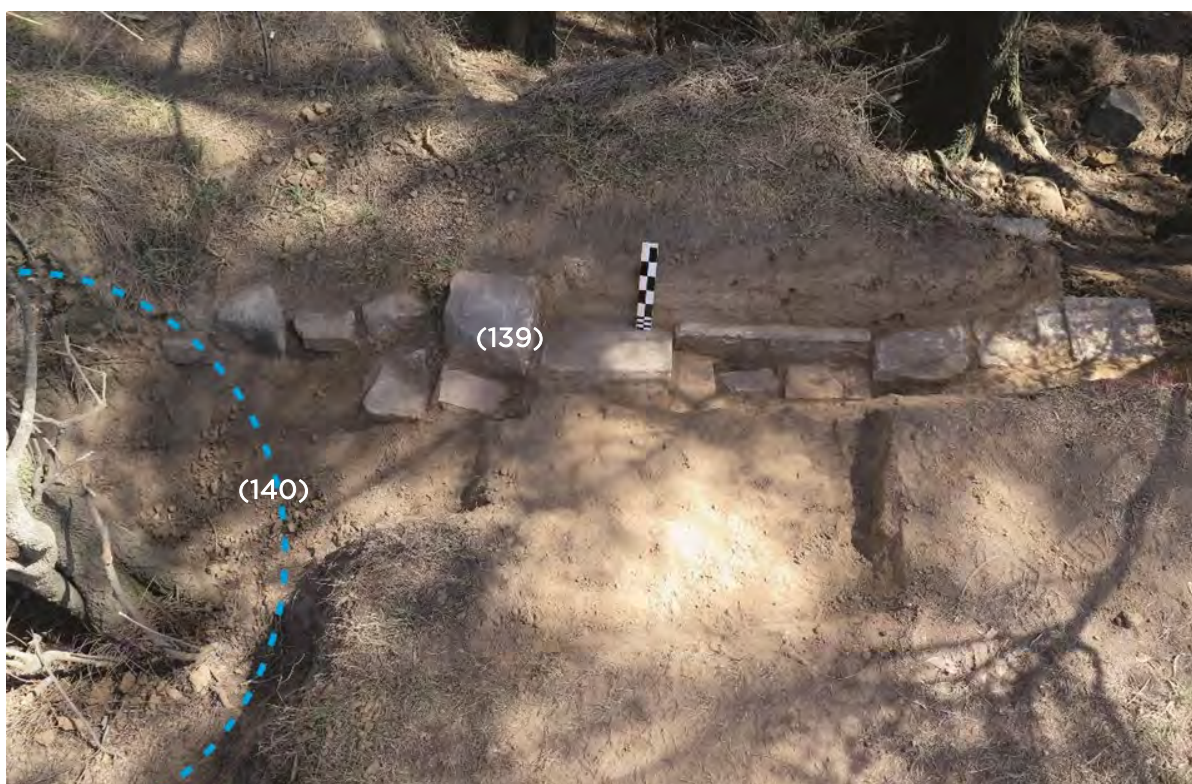
Figure 3.36: TA6/TT5, sandstone feature (139) and circular cut (140, containing tree) to the left of the photograph, outlined in blue. View to north. Scale: 300mm.

TT5 was excavated at the surface level of the bank along the alignment of the sandstone blocks, in the direction of an overgrown, open circular cut (Figure 3.36). Up to 40mm of topsoil and grass roots (137) were removed revealing a pale orange/grey sandy silt with frequent charcoal flecking (138). Context 138 is believed to have been deposited by flooding events which had occurred since the construction of the sandstone block feature (139). The sandstone blocks are roughly rectangular in shape and ranged in size from 170mm x 80mm x 80mm (length x width x height) to 270mm x 250mm x 140mm. The overall feature measured 2.7m from east-west and consisted of up to two courses. Some of the stone showed evidence of re-use of stone from an older structure, though differences in the finish of the stone and the attachment of lime mortar was found only on isolated blocks. The structure also included five rectangular narrow sandstock bricks on its south side. The circular cut (140) at the west end of the stone feature had a diameter of 1.5m with a depth of up to 0.75m. A small tree was growing in the centre of the cut and grass was growing along the internal sides.

The overall impression was of water being channelled from the creek into the circular cut via the sandstone feature. Possible uses for this may have been as a laundry area or as a dry well used to syphon floodwater away from a garden or agricultural area. Blocks which had likely been removed / fallen from the feature through erosion were visible in the creek bed. This may have acted as a channel that directed water into a storage reservoir.

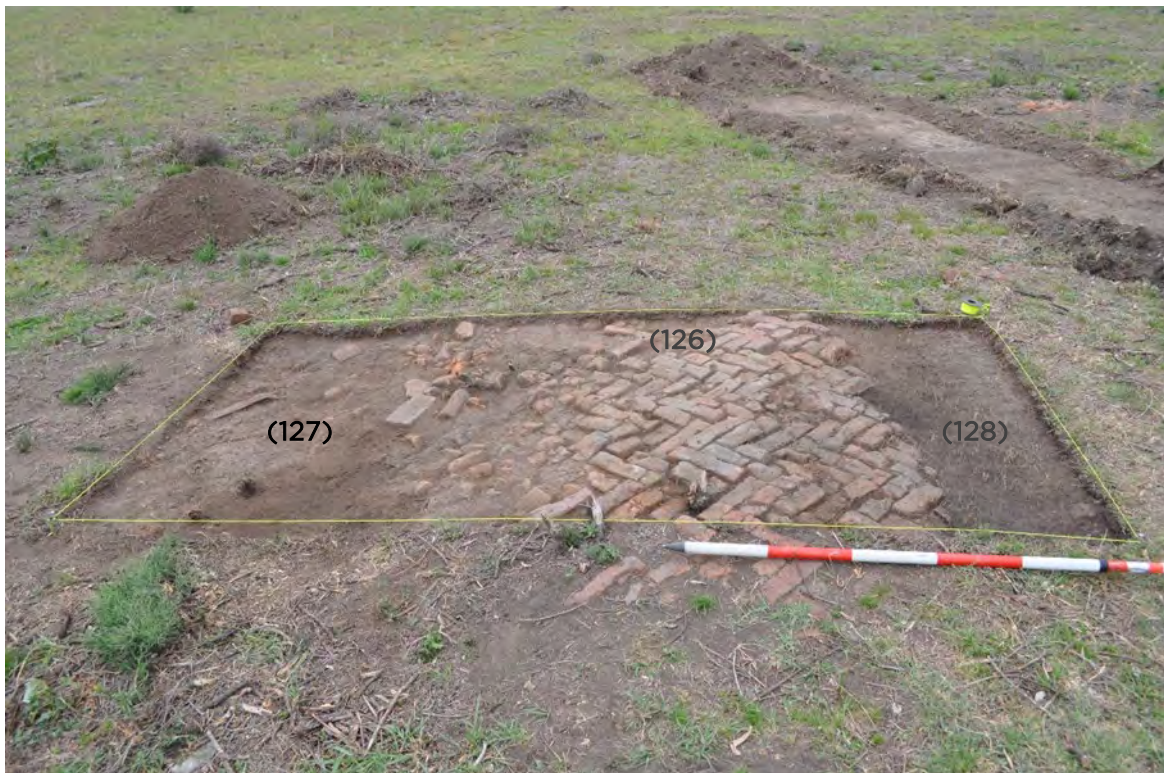
Figure 3.37: TA6/TT7 with herringbone paving (126) clearly visible. View to north. Scale: 1.1m.

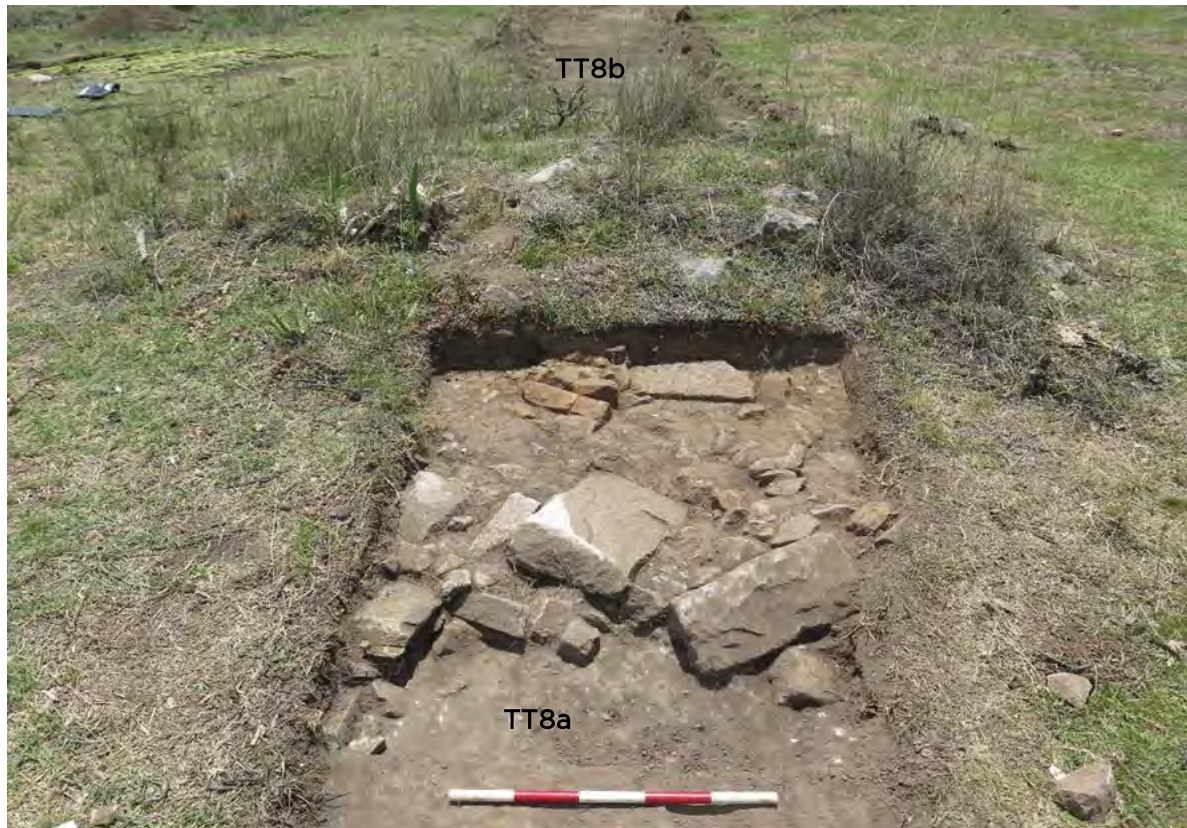
Figure 3.38: TA6, rubble at north end of TT8a with TT8b extending northwards from the other side of the mound. View to north. Scale: 500mm.

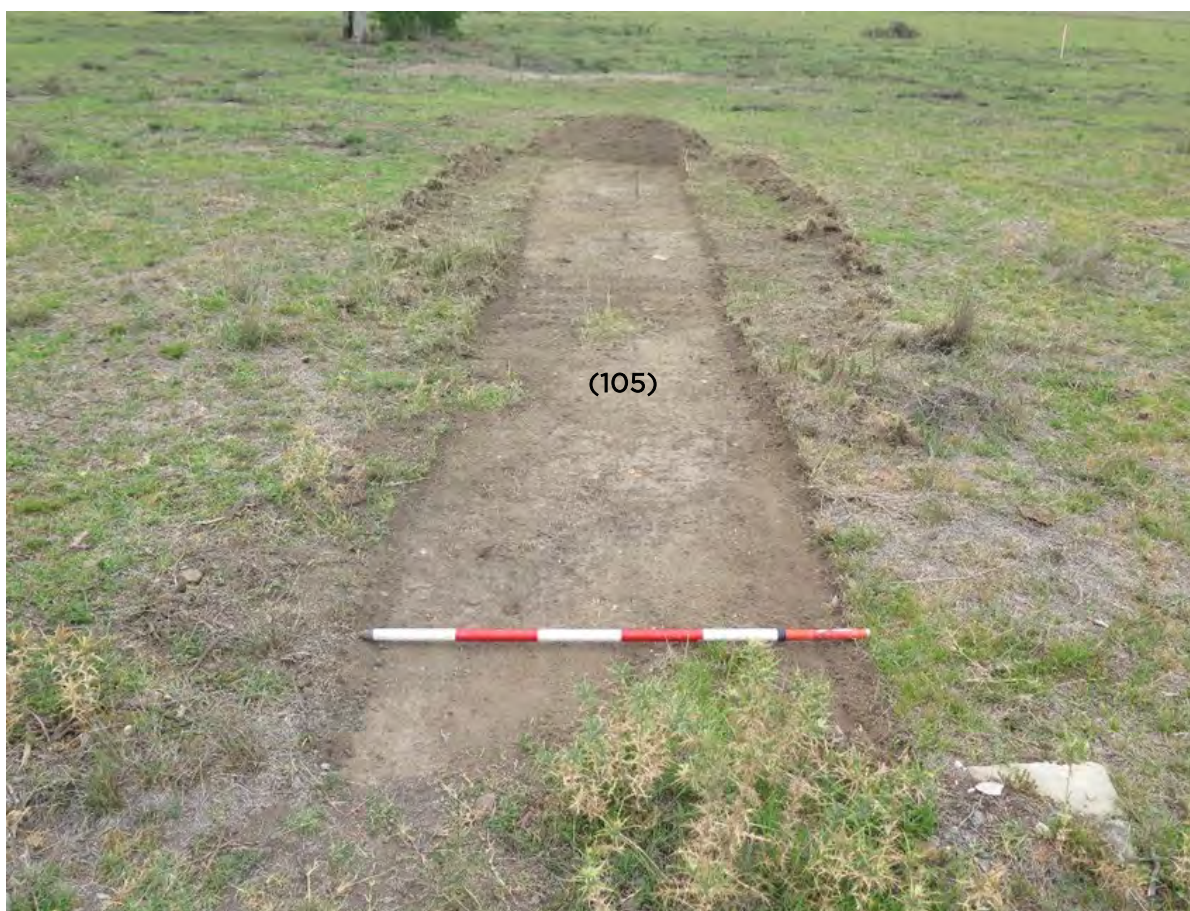
Figure 3.39: TT9 in TA6. View to the south. Scale: Scale: 1200mm.

TT9 was excavated to investigate potential agricultural or structural features in the south part of Test Area 6 (Figure 3.33, Figure 3.39). The trench measured 7.5m north-south and 1m wide. The topsoil (105) in this area was removed by machine to a depth of 50mm. No archaeological features or deposits were encountered although artefacts including broken glass, ceramics and metal objects (mostly nails) were recovered from the topsoil. This is not surprising given the proximity of TT9 to the structural remains found in TT8a, 8b and 7.

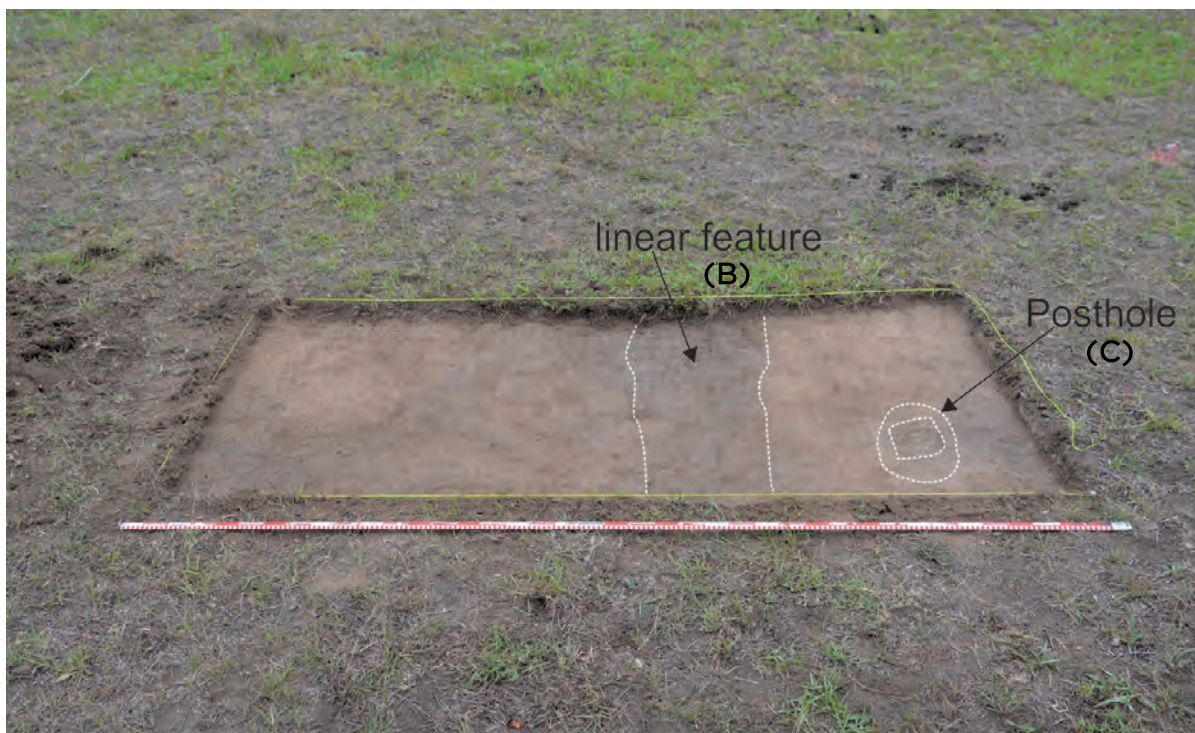
Figure 3.43: TA7/TT2 showing possible linear feature (B) running north-south and a potential post hole (C). View to south. Scale: 2m.

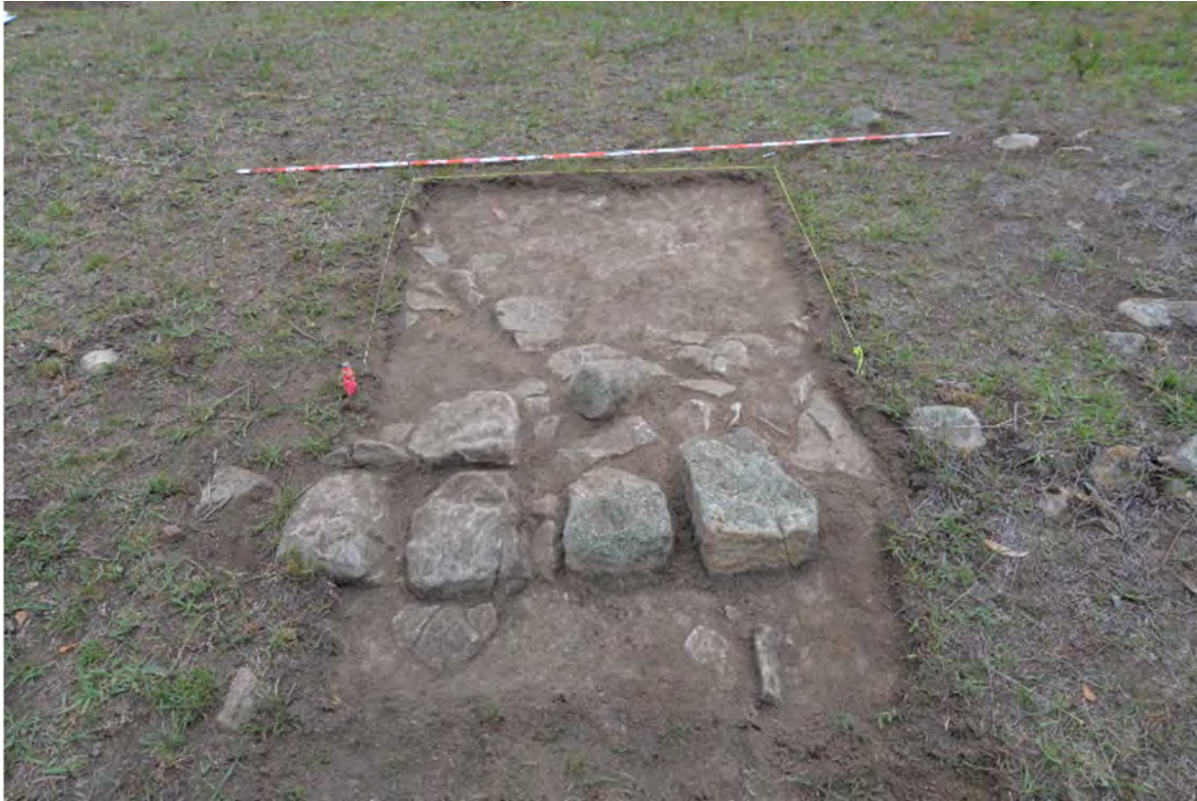
Figure 3.44: TA7/TT3 looking northeast. Scale 2m.

TA7/TT3 was located across the line of sandstone pieces embedded in the ground that respect the east bank of Yorks Creek (Figure 3.40, Figure 3.44). It measured 1 x 1.75m on an east-west alignment incorporating a section of the sandstone feature and was excavated to a maximum depth of 50mm. Following the removal of the modern topsoil a clear edge to the stonework facing the creek became visible with a second row of stones, more indiscriminately laid than the first, immediately to the east. The width of the two rows of laid stones was 500mm. The feature continued to both the north and south and formed a definitive edge to the creek bank especially compared to adjacent areas where the bank was more gently sloping, hence its interpretation as remnants of a retaining wall.

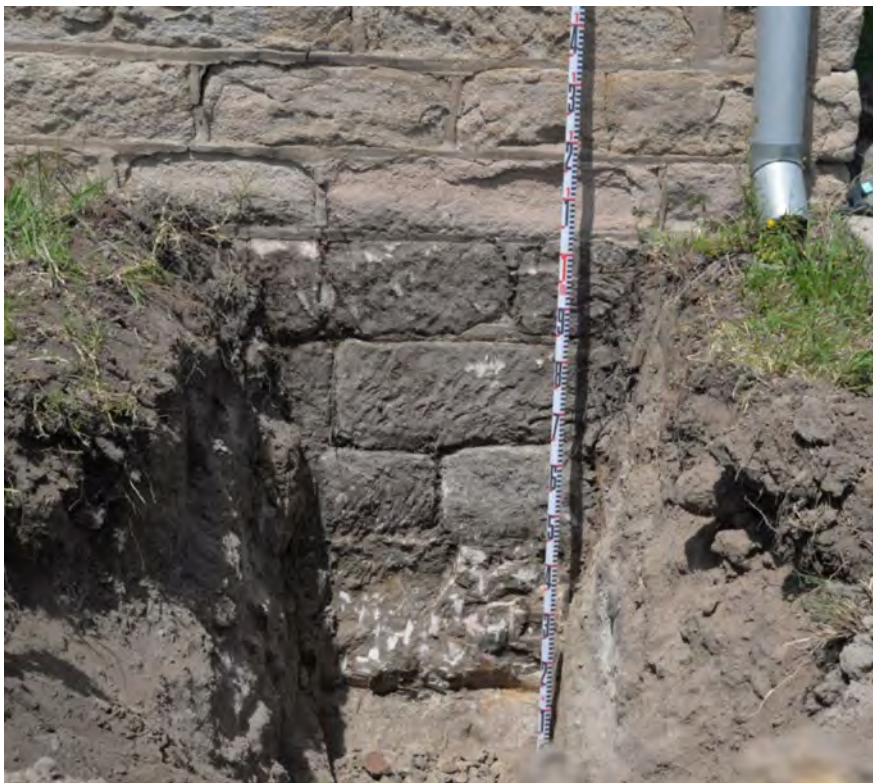
Figure 3.45: Footings for main wing showing four courses of footings. Architectural Test Pit 1, west-facing wall. Scale: 1.4m

The test pits showed that the main wing and kitchen wing had significant sturdy footings of up to four courses in depth (Figure 3.45). The footings for the stables, while only two to three courses in depth, were of similar sturdy construction (Figure 3.47). The footings for the barn varied and in many places were more rubble-like than the shaped stones of the stables or the main wing (Figure 3.48).
