APPENDIX 23

Heritage
Assessment

Appendix 23 – Heritage Assessment

This appendix contains the following Heritage Assessment documentation in relation to Ravensworth Estate and the Ravensworth Homestead Complex:

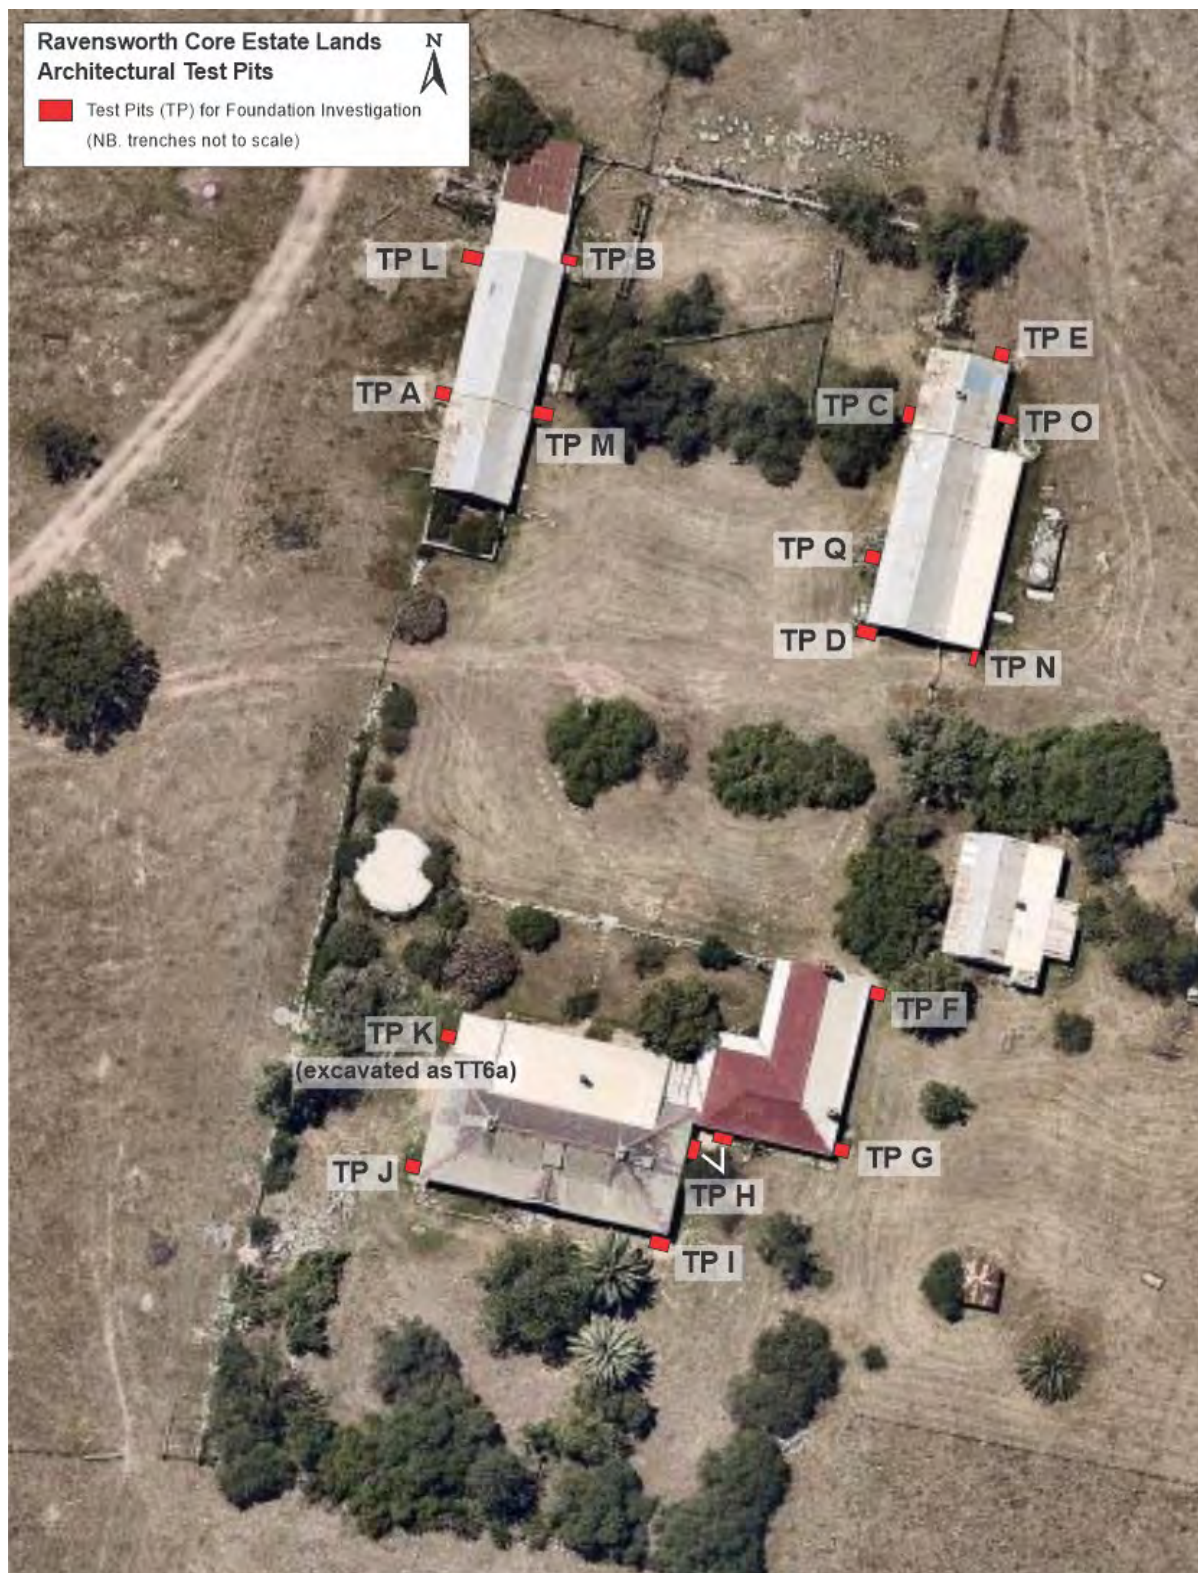
Figure 3.46: Location of architectural test pits.

During the archaeological program sixteen test pits were excavated to inform building conservation works and the relocation methodology for the Ravensworth Homestead Complex. Four auger boreholes were also proposed (but not undertaken during the archaeological program). The location of the test pits and auger boreholes are shown in Figure 3.46.

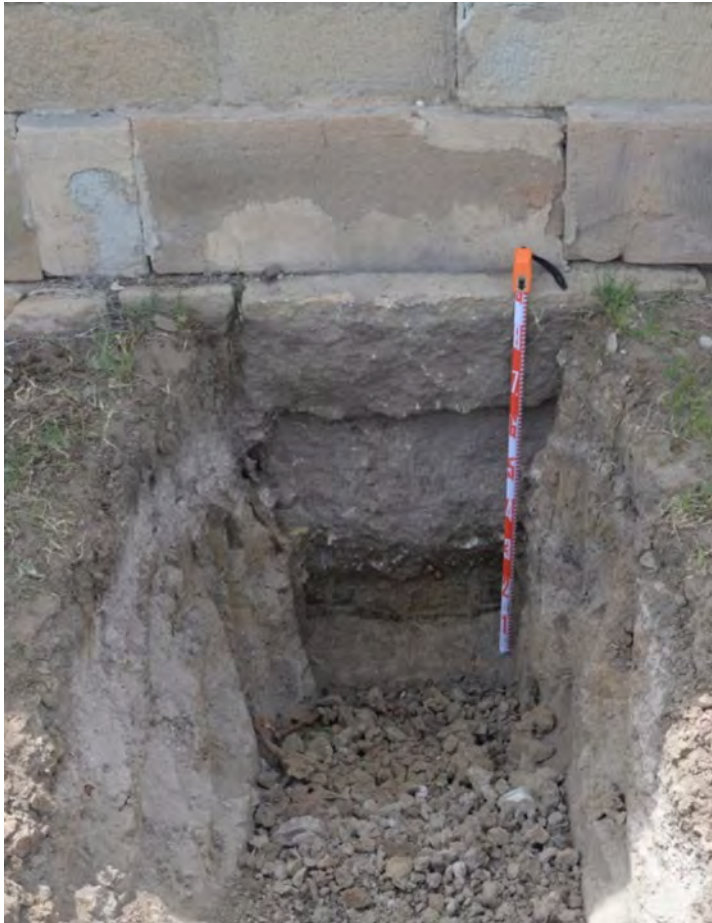
Figure 3.47: Footings for stable building, three courses deep. Test Pit A, west-facing wall. Scale: 900mm.

The test pits showed that the main wing and kitchen wing had significant sturdy footings of up to four courses in depth (Figure 3.45). The footings for the stables, while only two to three courses in depth, were of similar sturdy construction (Figure 3.47). The footings for the barn varied and in many places were more rubble-like than the shaped stones of the stables or the main wing (Figure 3.48).

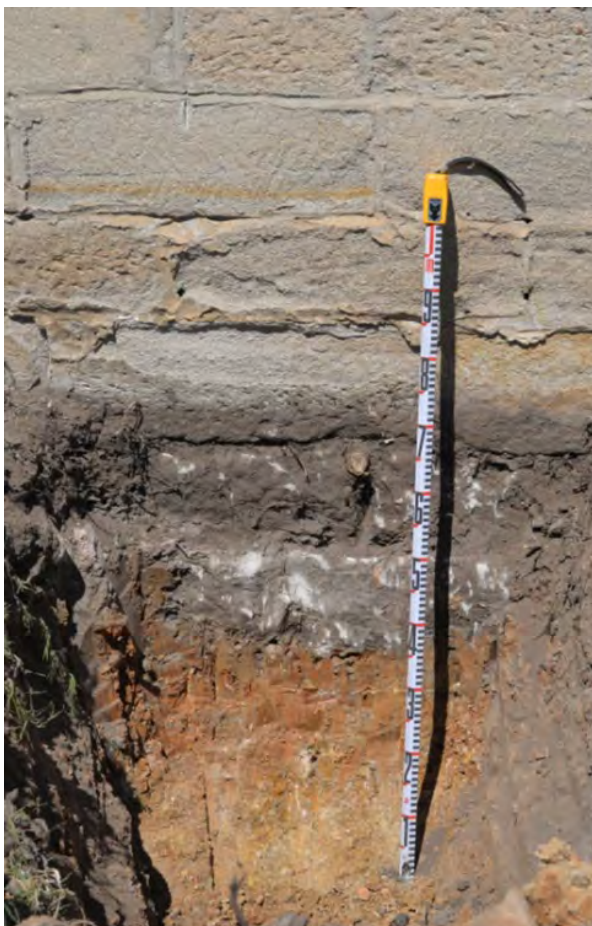
Figure 3.48: Footings for barn building. Test Pit Q, west-facing wall. Scale: 1m.

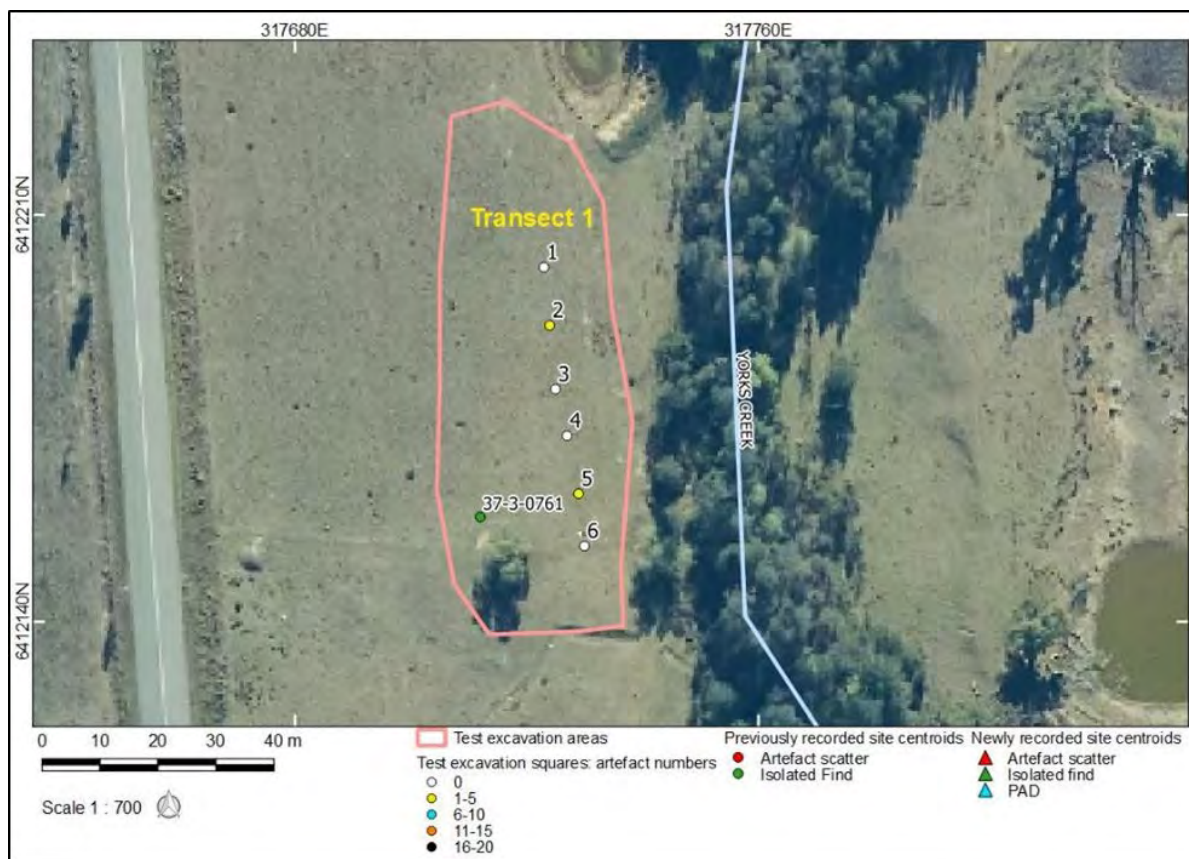
Figure 3.51: Location of Aboriginal Test Pits: Area 12. Source: OzArk 2019.

One transect with six excavation squares were excavated in Area 12 (Figure 3.51). A small number of Aboriginal artefacts were recovered. Some historic items, ceramic and glass were present (retained and passed on to Casey & Lowe) and evidence of general European disturbance in the area (small sandstone footings, a lot of general rubbish and some iron fragments in a 'cut' within one of the excavation squares). Soil depths ranged from 150-250mm.

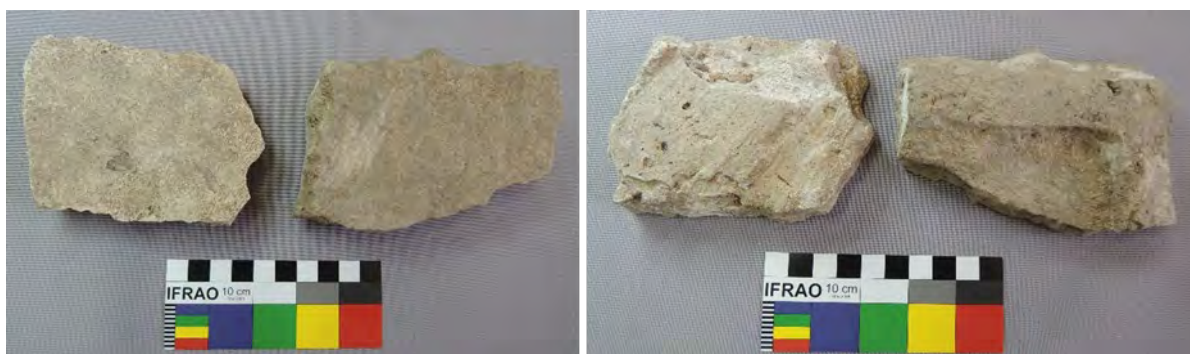
Figure 4.2: White to light grey render fragments from modified topsoil in TA3 TT2. Left: surface of two-coat lime plaster ceiling render #301 with slightly rough surface and two-coat wall render of harder smooth concrete set coat above lime plaster scratch/float coat. Right: underside of same fragments showing impressions of timber laths and wide joints of sandstone or brick masonry. Scale: 100mm. Photos: DSCN9855 and 9857.

While there were some small fragments of sandstock brick in the rubble (not sampled), the most notable items were the ceiling and wall renders (Figure 4.2). Several were from a white-painted lath and plaster ceiling, and others from sandstone or brick walling.³² Although the mortars and renders of the original structures at the property have not yet been fully investigated, these items provide some evidence for changing finishes of the main wing and kitchen wing or nearby outbuildings (stables and barn) (see also Section 4.3.2).³³ The plaster for both was made of rock lime, generally dated from c.1840, with the walling examples having a thick set coat of lime cement that was probably applied slightly later, perhaps from the 1880s. If the ceiling plaster came from the original construction of the house in the late 1820s then it is likely that the lime was shipped from Newcastle or overland from Sydney.

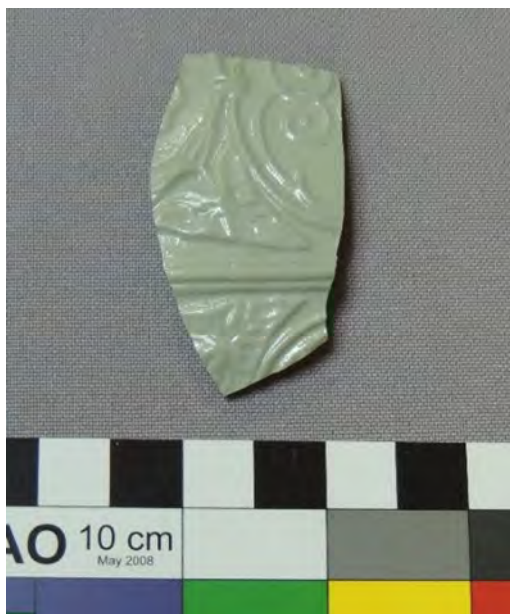
Figure 4.3: Grey-green moulded stoneware vessel (jug?) body fragment with moulded vine scroll from TA3 TT8 18/#12. Scale: 100mm. Photo: DSCN9919.

Scattered ceramic and glass fragments in the topsoil and cinders spread over a path at the front (south side) of the main wing included part of an unusual grey-green moulded stoneware jug or vase embossed with vine scrolls made in the UK from c.1835-c.1870 (Figure 4.3).⁴⁰

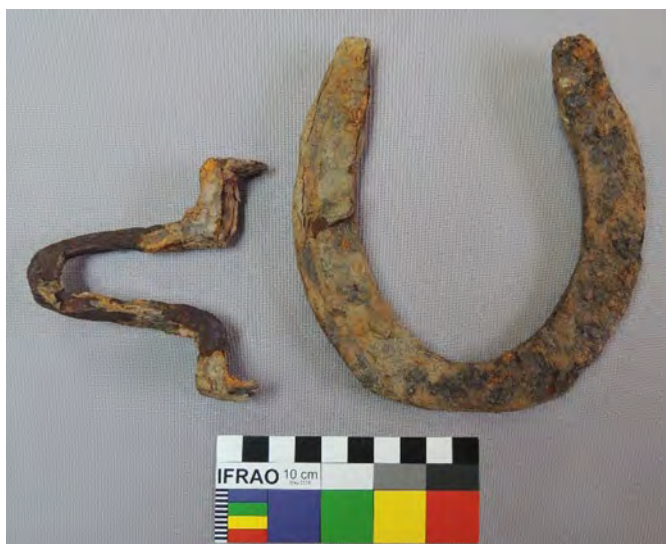
Figure 4.4: Hand-forged iron objects from modified topsoil in TA3 TTD and TTE. *Left:* door catch 155/#272. *Right:* horseshoe with worn toe and bent nail remaining in fullering 156/#273. Scale: 100mm. Photo: DSCN9884.

The trenches often revealed iron objects typically used on a farm. These included hand-forged hardware from farm buildings and agricultural machinery and horseshoes and equipage (Figure 4.4).⁴¹

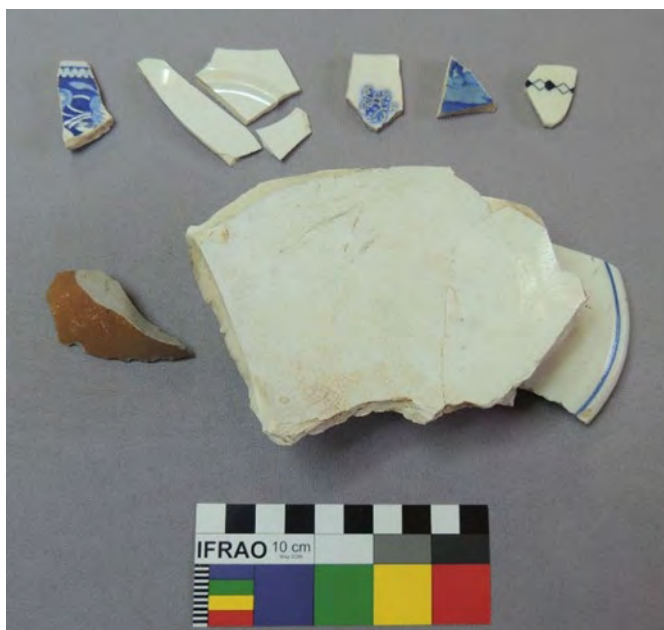
Figure 4.5: Selection of ceramics from TA3. *Top row* tea and table wares (l-r): from TT6A context 1, blue tp plate #001, gilded saucer #002 (3) and 'sprig' #003; from TT6B, blue tp 1/#004; TT6A geometric black (2/#005). *Bottom row*: from TT6A, salt-glazed stoneware bottle 9/#006; large footed soup tureen with banded decoration 109/#007. Scale: 100mm. Photo: DSCN9906.

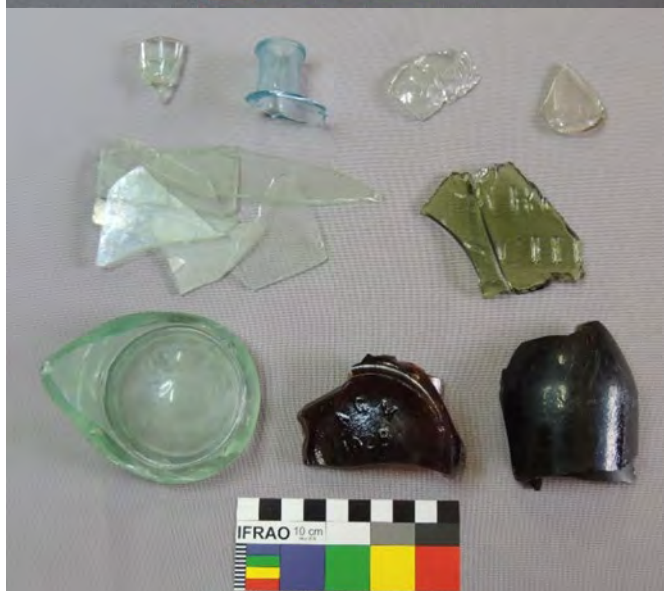
Figure 4.6: Selection of glass bottles and window pane fragments from TA3. *Top row bottles (l-r)*: Lamont aerated water TT6A 2/#505; blue pharmaceutical TT6 10/#515; embossed ammonia and milk TT8 18/#531-#532. *Middle row from TT6A*: window glass 9/#513 and schnapps bottle 109/#519. *Bottom row bottles*: TT6A beverage 9/#514; TT8 beer 1928 manufacture 18/#530; TT6A beer-wine 2/#503. Scale: 100mm. Photo: DSCN9939.

Among the 81 artefacts found in various late fill contexts (Table 4.4) were an array of ceramics and glass used by different families at the homestead from the mid-19th century until recent times. As yet no glass tableware has been found.⁴² The 81 artefacts included table and tea wares that were mostly imported from Britain (Figure 4.5) although due to the small sample no matching sets were able to be discerned.⁴³ In general, the shapes and decorative patterns were typical of middle-income households seen at other historic sites in Sydney and Newcastle. Perhaps notable is the broken base of a footed soup tureen with modest blue banded decoration that would have been suitable to serve a series of economical and nourishing meals for a large family. The fragments from glass containers (Figure 4.6) show that a wide range of beverages, including milk, beer, wine and gin or schnapps consumed by the residents.⁴⁴ Other containers held a variety of pharmaceutical, grooming and household-cleaning products.⁴⁵

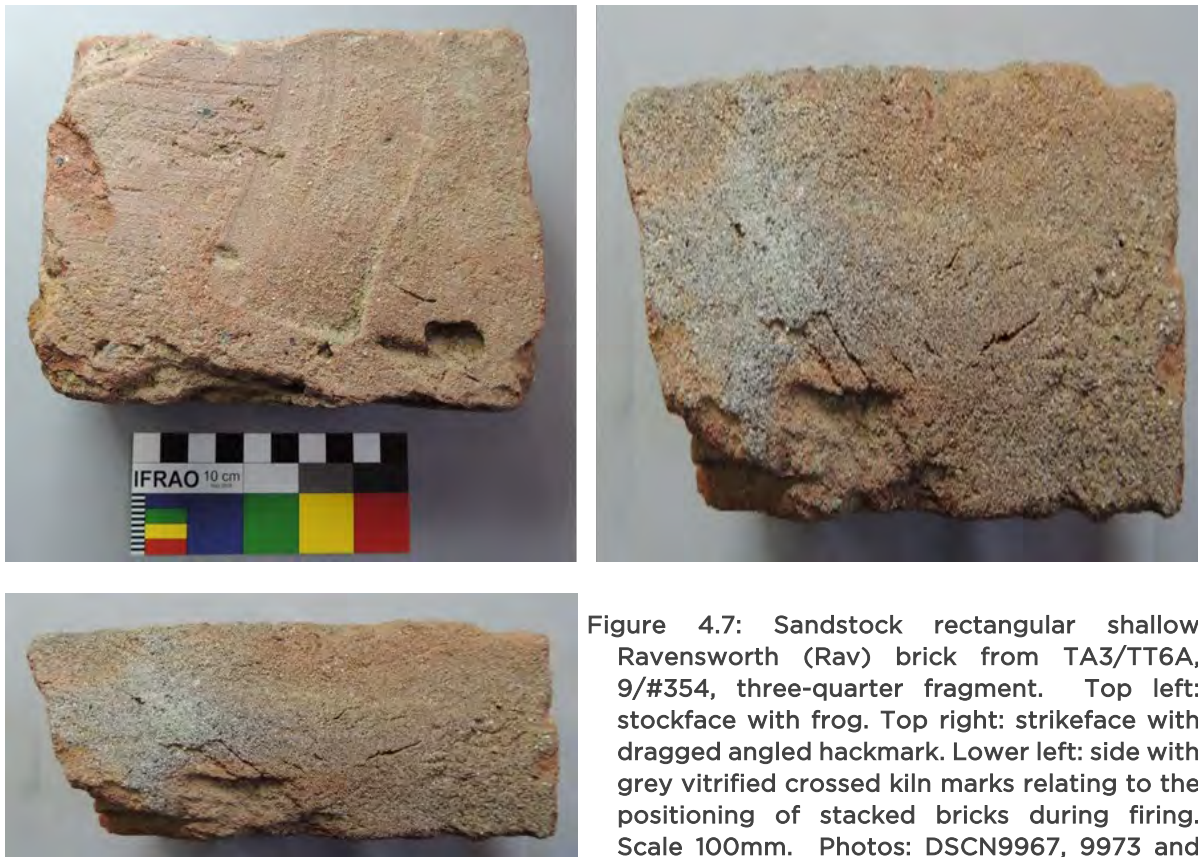
Figure 4.7: Sandstock rectangular shallow Ravensworth (Rav) brick from TA3/TT6A, 9/#354, three-quarter fragment. Top left: stockface with frog. Top right: strikeface with dragged angled hackmark. Lower left: side with grey vitrified crossed kiln marks relating to the positioning of stacked bricks during firing. Scale 100mm. Photos: DSCN9967, 9973 and 9983.

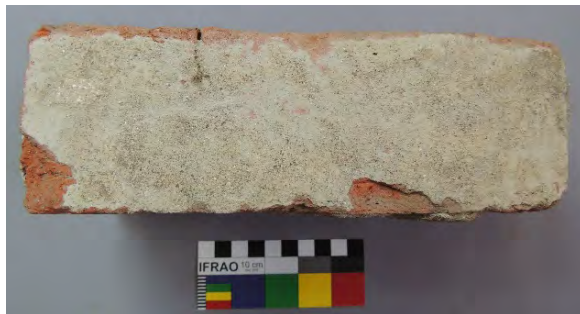
Figure 4.8: Sandstock rectangular narrow Rav brick from TA3 TT6A, 2/#311, three-quarter fragment. Top left: stockface with expanded clay beside large ironstone causing warping below frog. Top right: fairly smooth strikeface with red-brown ironstones and cream quartz. Lower left: one side with light grey-brown sandy lime mortar. Scale: 100mm. Photos: DSCN9814, 9785 and 9783.

Another type of sandstock brick (Sandstock rectangular narrow Rav) found in TA3 (Figure 4.8) was used to build a narrow toilet block wall and occasionally for other purposes. Having a deeper narrower rectangular frog, it was hand-moulded in a similar manner to the wider frogged bricks although they were generally better-made with the surfaces being flatter and less sandy. However, the clays show that they came from a similar source, with the ironstones and rarer white quartz pebble inclusions usually being better crushed and mixed. Inconsistent removal of the larger stones during puddling resulted in some bricks becoming distorted and cracked during firing. Other examples of this type of brick were found in a narrow wall or channel beside the creek in TA6 TT1 (Section O).

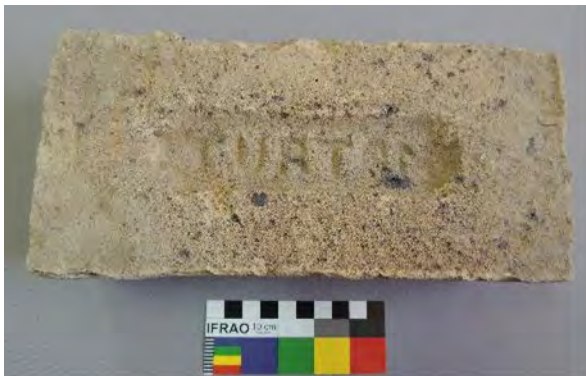
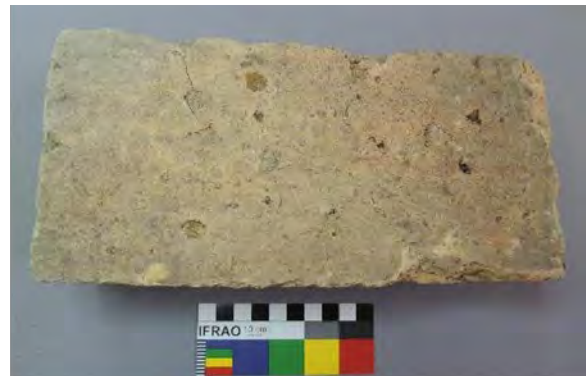
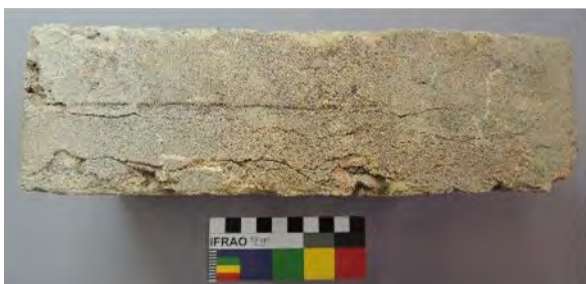
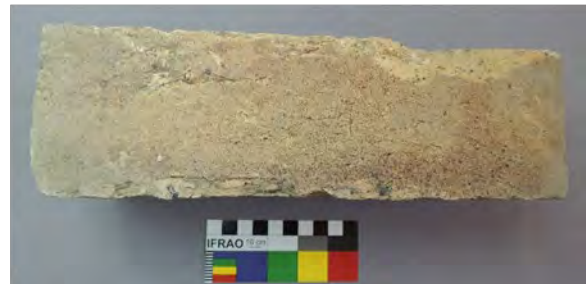
Figure 4.9: Sandstock rectangular Turton brick from TA3 TT6A, 2/#313 with stockface with 'TURTON' mark in rectangular frog, strikeface higher fired at right end, side with horizontal hackmark impressed during drying prior to firing. Scale: 100mm. Photos: DSCN9817, 9797, 9795 and 9802.

Another brick type was found in TT3A (Figure 4.9) that can be attributed to the brickmaker Frank Turton who operated from his yard in Maitland from 1882-c.1914.⁵² He was a son of Robert Turton who with his family made bricks in Newcastle from 1851-1976.⁵³ The yard at Maitland only produced hand-moulded bricks. This type of brick was well-made using different clays to the other two varieties of sandstock bricks found at Ravensworth Estate, although the kiln firing was also uneven in temperature and oxygen distribution causing distortion and discolouration. Interestingly, the narrow hackmark impression along one side is very similar to those occasionally seen on the bricks with narrow rectangular frogs. Only one other possible fragmentary example of a Turton brick was found at the site at TA4/TT4 (59/#322).

- The most recent sandstock brick from the same TT6A was made by Frank Turton from 1882-c.1900 (Figure 4.9). Turton and his family operated a brick yard in East Maitland from 1882 until 1969.

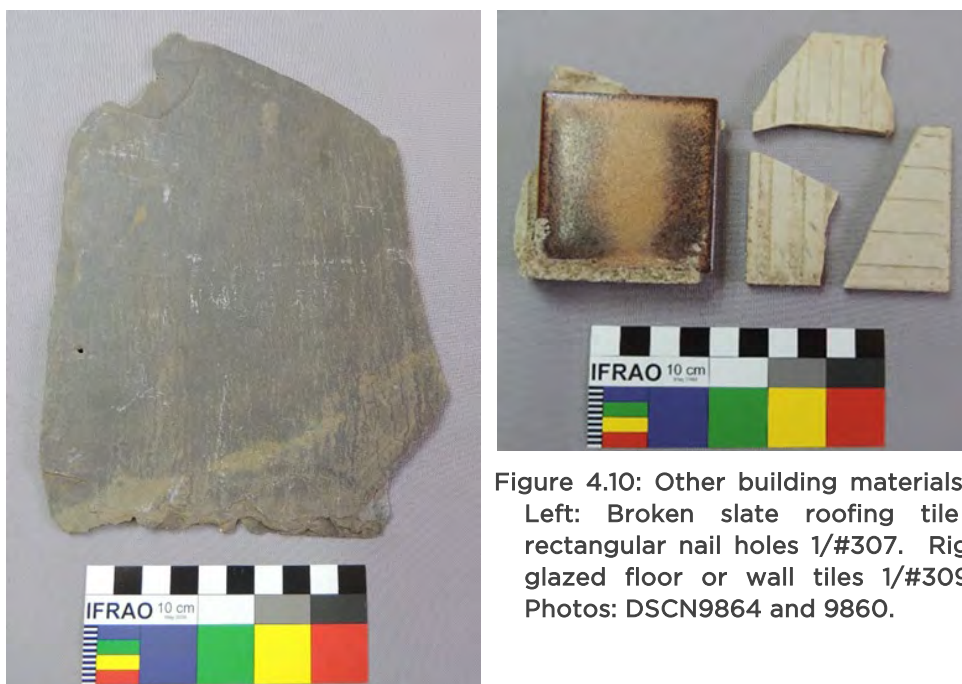
Figure 4.10: Other building materials from TA3 TT06A. Left: Broken slate roofing tile with two small rectangular nail holes 1/#307. Right: modern brown glazed floor or wall tiles 1/#309. Scale: 100mm. Photos: DSCN9864 and 9860.

At one time the roof of at least one building, probably the main wing, was roofed in slate, and other thicker pieces were used in damp-proofing of footings. Slate was fashionable from c.1840 and the example from TT3A had holes for fixing slate tiles to battens using small cut nails with shanks that were rectangular in section (Figure 4.10).⁵⁴ In contrast the modern brown-glazed floor or wall tiles in TT3A relate more to recent modernisation of the bathroom or laundry. They could have been used in the toilet block where the test trench was located that was serviced by salt-glazed pipes made after c.1865.⁵⁵

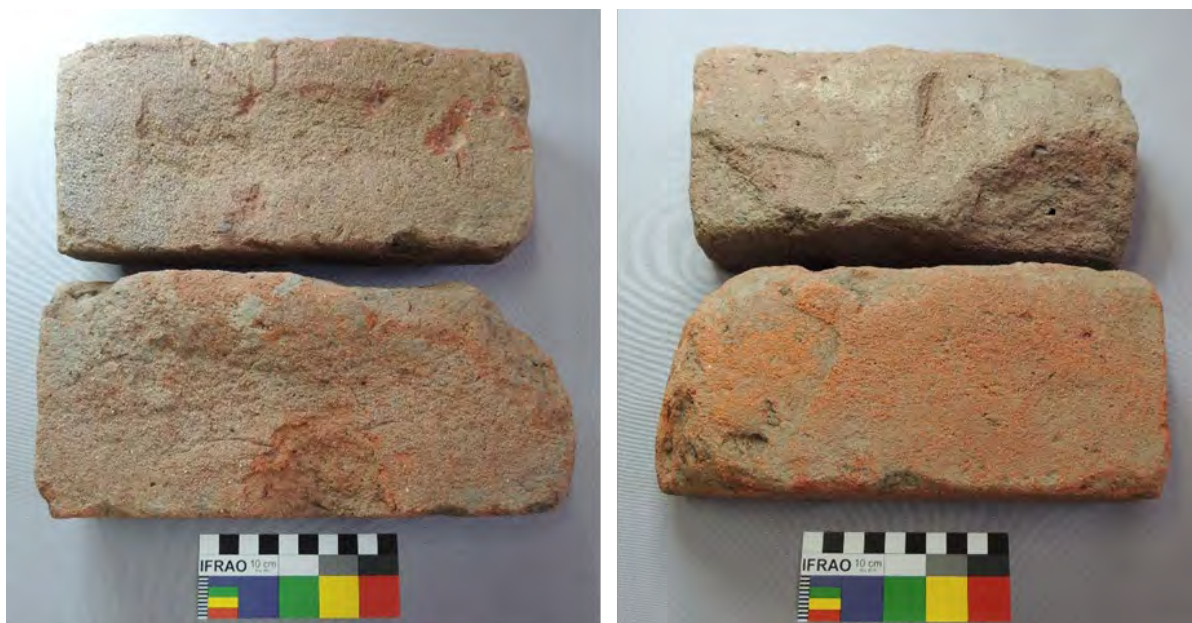
Figure 4.11: Worn sandstock rect shallow Rav bricks with fairly homogenous clay from TA4 TT03A, 55/#332 above 117/#335. Top left: stockface with frog. Top right: Strikeface with angled hackmarks to left. Lower left: side with lower 117/#335 having a slightly raised horizontal hackmark. Scale: 100mm. Photos: DSCN9754, 9759 and 9755.

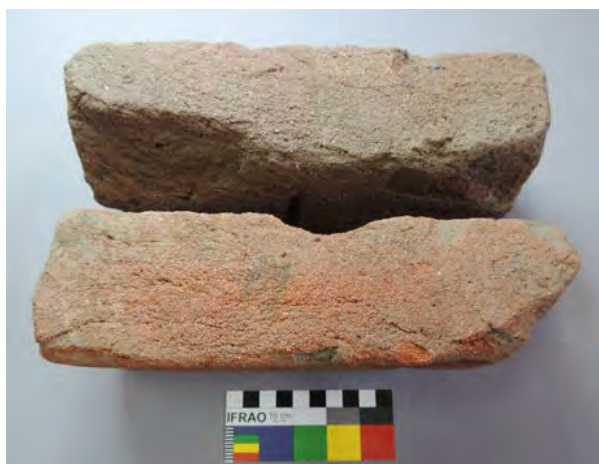
Figure 4.12: Sandstock rect shallow Rav brick with slightly warped shape, from TA4 TT03A, 55/#330 stockface with frog and with sandy light grey-brown lime mortar. Scale: 100mm. Photo: DSCN9764

made during the first years of occupation of the homestead and outbuildings. They were identical to ones used as paving in TA5 TT7 (126) and the well structure in TA6. The variances in clamp firing are evident in the colours, sizes, shapes of bricks. Some had surface features from stacking in the drying (hacking) yard (Figure 4.11). One brick (55/#330) had remnant sandy light grey-brown lime mortar attached (Figure 4.12).

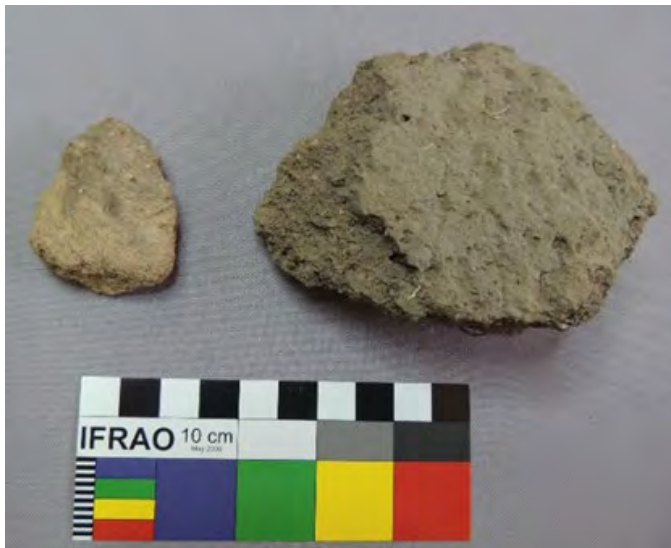
Figure 4.13: Dark grey-brown mud mortar samples from sandstone footings of potential convict barracks in Area 4. Left: TT3A 117/#339 (BM Sample 8). Right: TT5 35/#341 (BM Sample 5). Scale: 100mm. Photo: DSCN9849.

The sandstone footings of the potential convict barracks in TA4 appear to have been bonded in dark brown mud mortar (Figure 4.13), presumably redeposited topsoil. This remained *in situ* in TT5 below the robber trench and in fill above the footings in TT3A. Walling below ground-level can be stable without the use of lime in mortar due to the inherent stability of the surrounding soil or bedrock. There was limited evidence for lime mortar or plaster finishes for the superstructure with some bricks in mixed demolition and topsoil fill TT3A having a light grey-brown sandy lime mortar (Figure 4.12). The lime was derived from crushed and burned limestone that would have been brought to the homestead. However, the thick demolition rubble in TT5 appeared to be resting on a thin crumbly horizontal deposit that continued to the east and may be degraded mortar or plaster, or part of a worn rammed mortar surface.

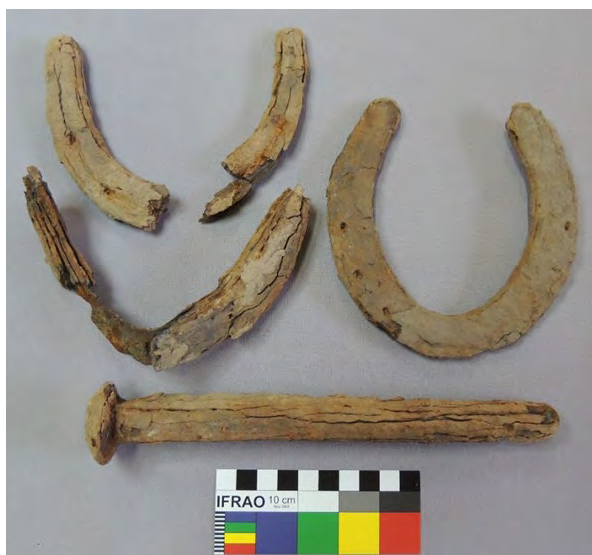
Figure 4.20: Iron objects from modified topsoil 73 in TA5 TT4 associated with horse transport and equipment. Top rows (l-r): damaged and used horseshoes, #232 above #231 and #23. Bottom: bolt #229. Scale: 100 mm. Photo: DSCN9892.

In TA5 the most varied assemblages came from TT2 and TT4 with a small range of ceramic and glass vessels comparable to those found closer to the main wing. The tableware was manufactured in the UK over a long period of time, with some decorative types made from 1780, while others from 1865.⁶³ Although there were also a few small items dating to the 19th century (Figure 4.27), such as a porcelain button and copper alloy stud,⁶⁴ clay tobacco pipe⁶⁵ and a doll,⁶⁶ many objects show a clear association with blacksmithing and leatherworking (Figure 4.31). These activities are part of the continual maintenance of farm structures, equipment for haulage animals, vehicles and agricultural machinery. Just below the surface of TT4 was a large oxen yoke (97/#233, Figure 4.19).⁶⁷ Several damaged horse shoes and other large metal items (Figure 4.20) were found scattered within disturbed topsoil in and around the structures.⁶⁸

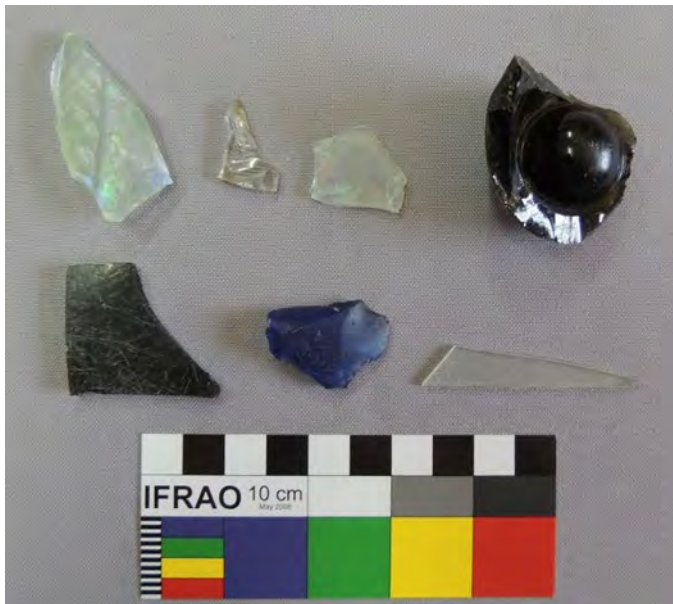
Figure 4.22: Selection of glass bottles & window pane fragments. Top row (l-r): TT8A Whybrow oil-vinegar 134/#604-#605 and window #608; TT7 wine-champagne 125/#609. Bottom row from TT9: gin-schnapps, condiment-medicine 105/#610-#611 and window #613. Scale: 100mm. Photo: DSCN9950.

The artefacts used to construct the ruined building in this part of TA6 were found in every test trench (TT7, 8A, 8B and 9) and generally in good condition. They included chiselled sandstone blocks and sandstock bricks, the latter of which were mainly laid in a herringbone design to form a path or paved space (Figure 3.37). The bricks were the same type (sandstock rect shallow Rav) as found in other areas of the property (Figure 4.28). In the paving, the side facing upward was worn over time, perhaps mainly by the trampling of sheep or cattle rather than humans (Figure 4.23). Numerous hand-forged and cut varieties of iron tacks, nails and hooks (Figure 4.25) were scattered in the topsoil and demolition fills, as well as in gaps in the brick paving. The sampled fragments show that part of the building was finished in a white-painted lime plaster render and set (Figure 4.24), and the windows glazed in Crown glass made until c.1850 (Figure 4.22).

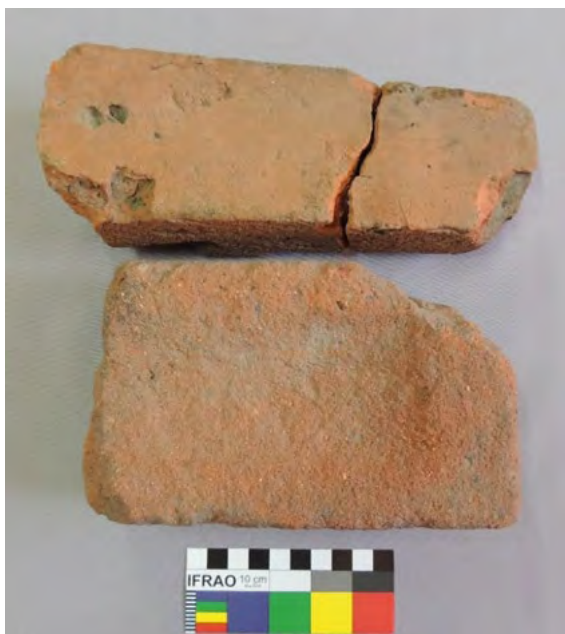
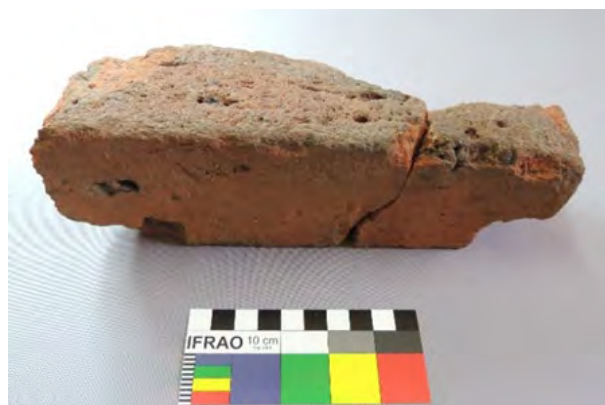
Figure 4.23: Sandstock rect shallow Rav bricks from TA6 TT7. Left: 126/#346 strikeface above 125/#345 stockface with the top sides worn from being laid on-edge in herringbone paving. Right: footworn side 126/#346. Scale: 100mm. Photos: DSCN9803 and 9809.

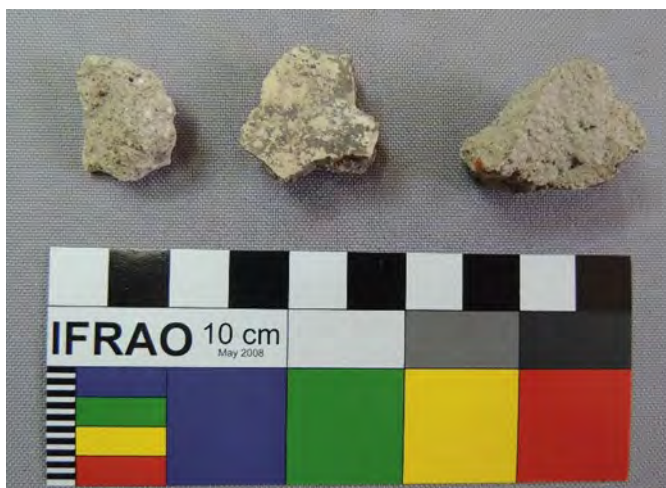
Figure 4.24: White-painted grey lime plaster render and set fragments from demolition rubble 133/#348 in TT8B in TA6. Scale: 100mm. Photo: DSCN9852.

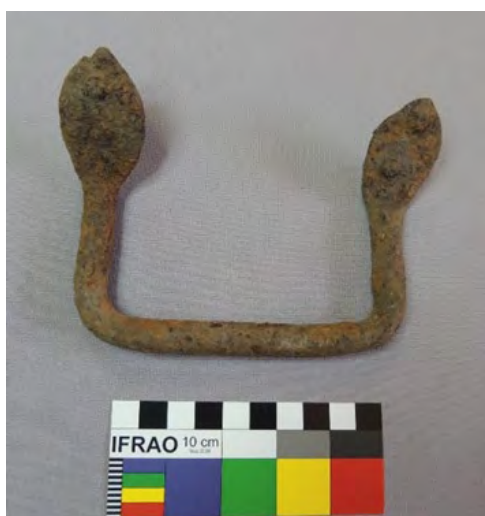
Figure 4.25: Forged large iron handle 105/#268 from modified topsoil in TA6 TT9. Scale: 100mm. Photo: DSCN9882.

Five test trenches were opened in TA6 (see Figure 4.25). A total of 88 (MIC) artefacts were recovered (Table 4.8). While the non-structural objects included a buckle and furniture handle (Figure 4.25), many more related to preparation, serving and consumption of food. These included a variety of ceramic tea and tablewares (Figure 4.21) and glass bottles (Figure 4.22) for alcoholic and non-alcoholic beverages, as well as condiments and other products. The decorative ceramic patterns were slightly different from those found in TA3 and TA4 although they were roughly contemporary. Most were manufactured in the UK from the 1830s, with the Rockingham glazed teapot (130/#60), common in 19th century Australian households (1796-c.1900). There was a helix-cable pattern plate (TT8A) which is the sake patten on the handle of a ladle in TA4 (Figure 4.15). Food or other merchandise was stored in a large stoneware demijohn bottle (105/#70). The three animal bone fragments found in TT8A, including a broken sheep's tooth, may be the remains of meat cuts eaten by the occupants (Figure 4.35).

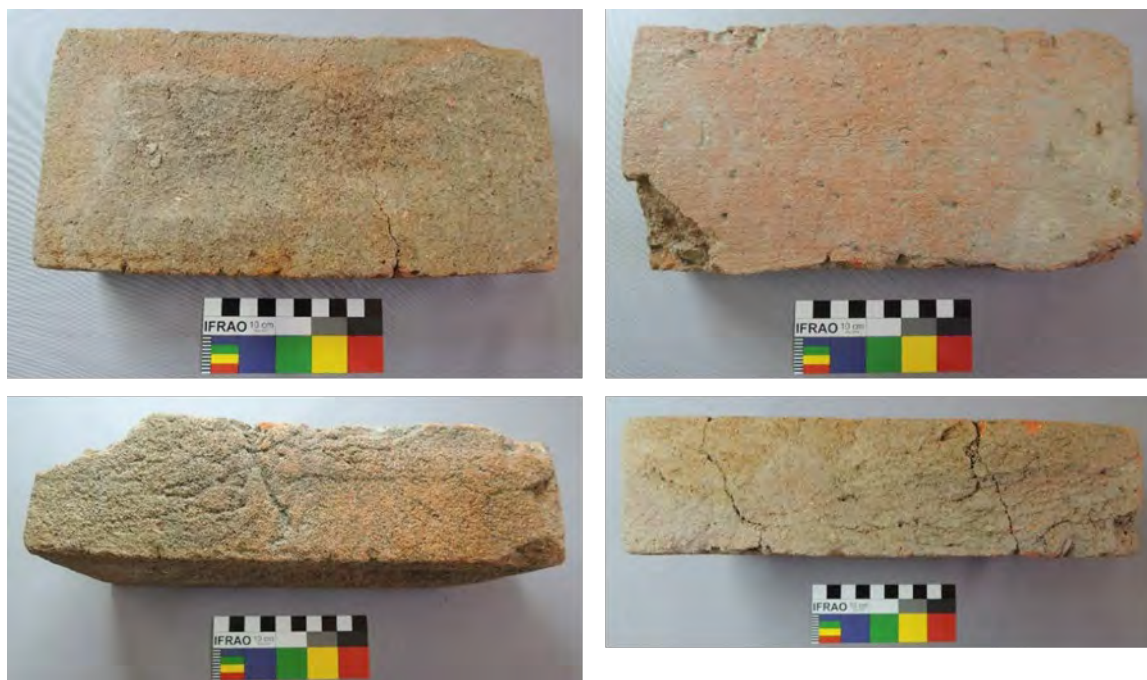
Figure 4.28: Sandstock rect shallow Rav brick from TA6 Well, 158/#349 with crack and remnant grey-brown silt. *Top left*: stockface with frog and fine saw marks on border from stockboard. *Top right*: strikeface with small ironstones. *Lower left*: side with low raised horizontal hackmark. *Lower right*: other side with white quartz pebble on lower right edge. Scale: 100mm. Photos: DSCN9818, 9826, 9828 and 9821.

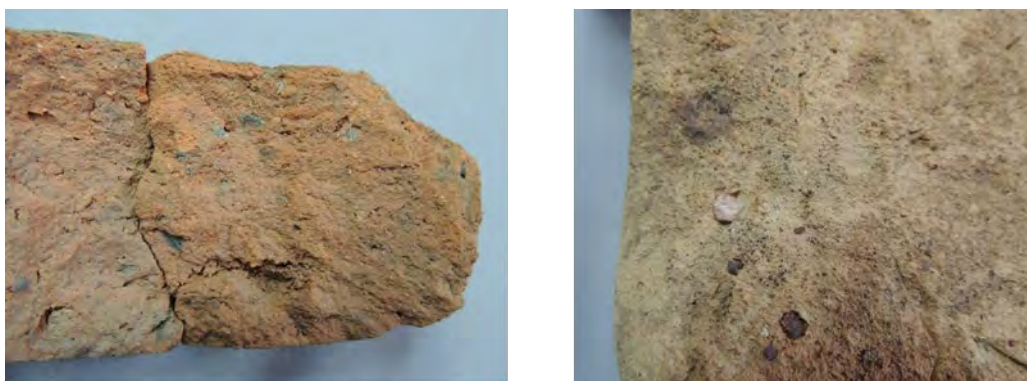
Figure 4.29: Clay fabric detail of sandstock rect shallow Rav bricks from TAs 4 and 6. Left: fired to a fairly homogenous deep red with grey ironstones and rare white quartz pebbles 126/#346. Right: fired to pink and white with red-brown ironstones and cracked white quartz pebbles 55/#328. Scale: 100mm. Photos: DSCN9844 and 9841.

- The architectural items reveal that sandstock bricks used in association with sandstone masonry in some structures, were locally made from the clays and gravels, most probably on the property, somewhere along one of the creek lines (Figure 4.28, Figure 4.29). These hand-made sandstock bricks with wide shallow frog have not been previously recorded. As they were probably made by convict or itinerant brickmakers for the original owner of the Ravensworth Homestead, James Bowman, they provide a significant contribution to our understanding of early construction in the region and this study provides a good comparison for

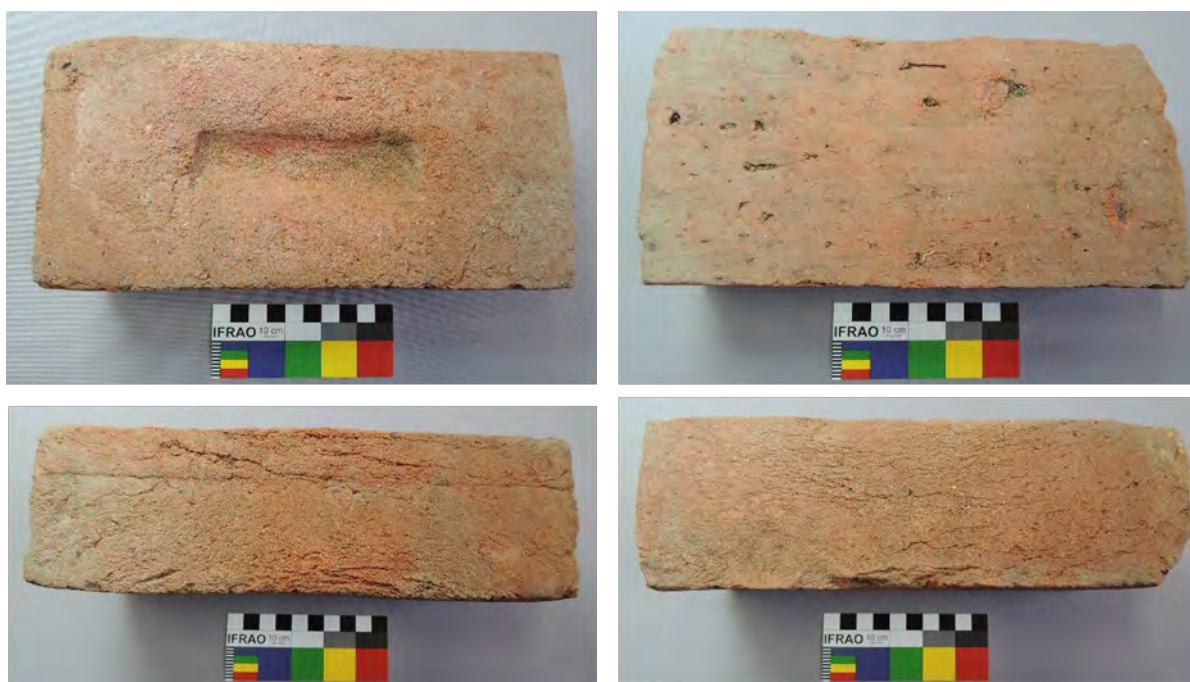
Figure 4.30: Sandstock rect narrow Rav brick from TA3 TT6B, 120/#355 with colour changes and slight warping from firing. Top left: stockface with frog. Top right: strikeface with divots where stones removed. Lower left: side with impressed horizontal hackmark. Lower right: other side with smooth flat surface. Scale: 100mm. Photos: DSCN9977, 9980, 9979 and 9981.

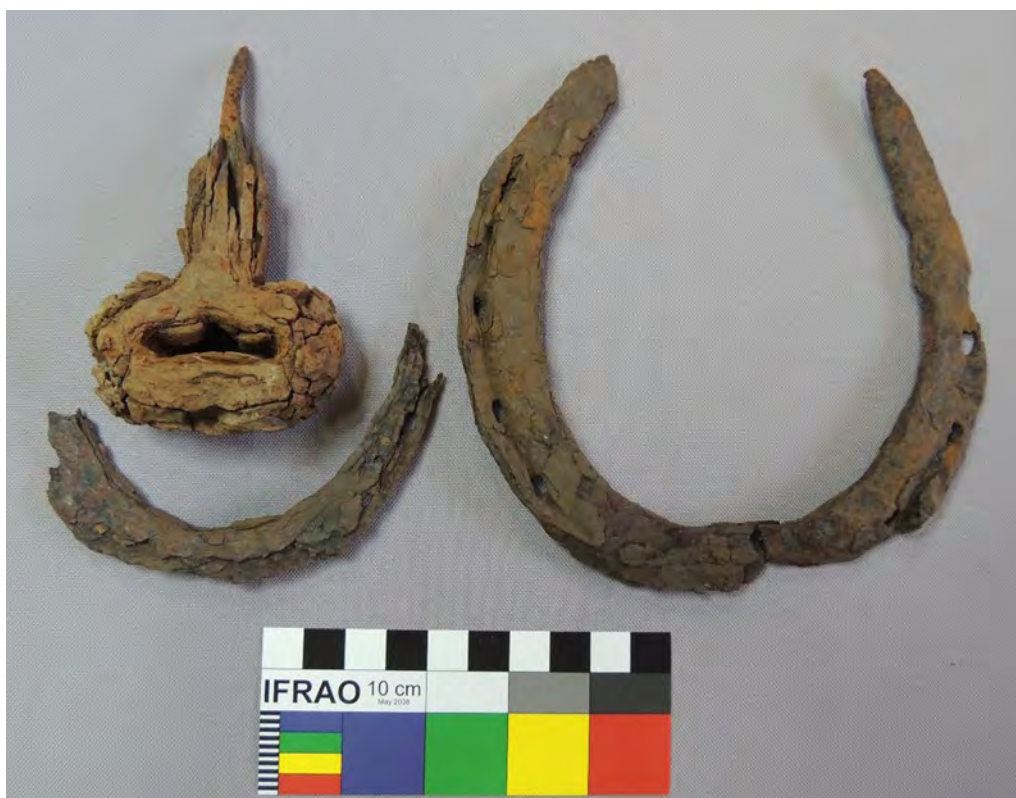
Figure 4.31: Iron objects from TA5/TT2 relating to horse transport and leatherworking. L-r: borer 76/#212 for punching holes in leather, above toe of broken horseshoe 78/#217; broken horseshoe 78/#216 with large nail holes in fullering groove. 100mm scale. Photo: DSCN9898.

- Blacksmithing and horse farriering activities are strongly indicated by artefacts found associated with structures to the north of the homestead complex TA5 TTs 2-4. These include large pieces of unworked and worked iron for structures, vehicles, various horse and possibly oxen shoes and equipage (Figure 4.31). A leather hole punch presumably for straps and belts was found in TA5 TT2 (context 76).

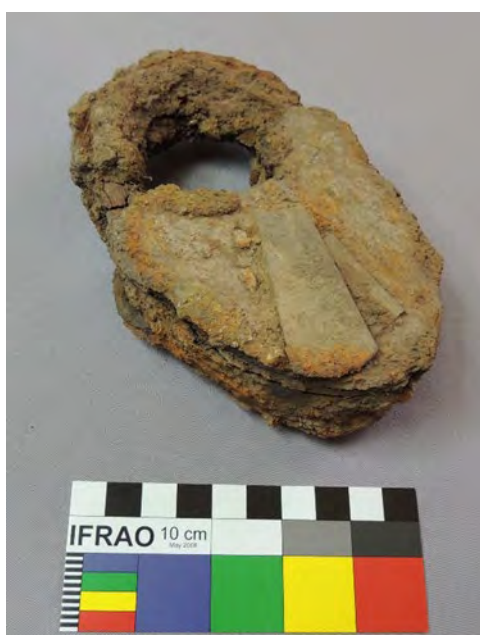
Figure 4.32: Iron padlock with brass keyhole escutcheon and pivoting cover 43/#185 from yard surface/fill on the south side of wall 047 in TA4/TT4. Angled view. Scale: 100mm. Photo: DSCN9870.

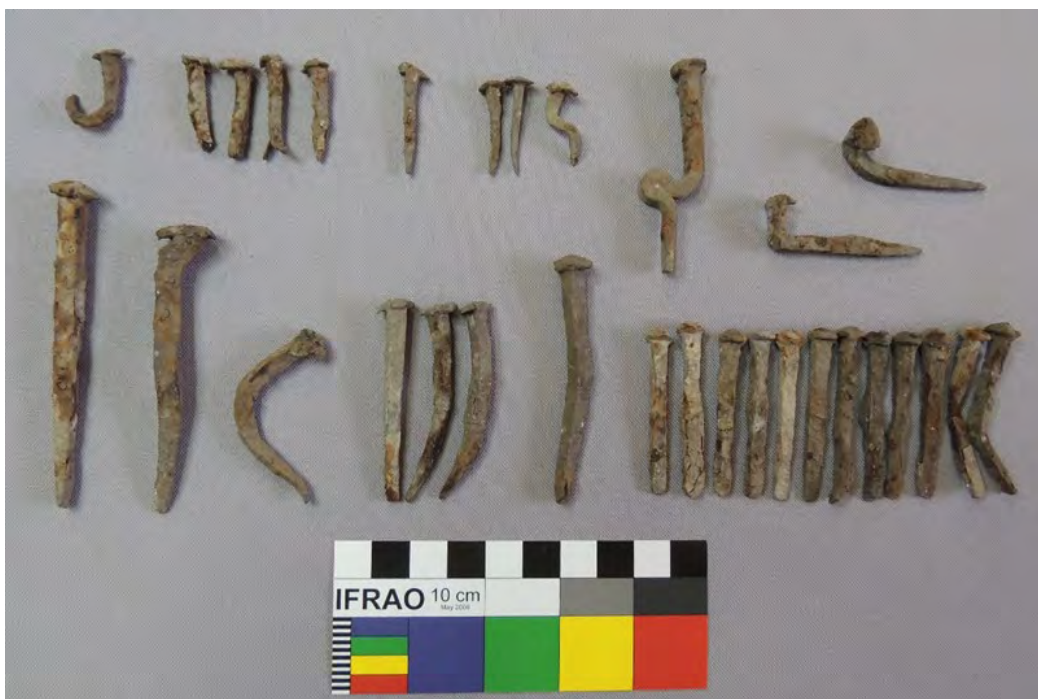
Figure 4.33: Iron tacks, nails and hooks from demolition rubble 133 in TA6 TT8B. *Top row (l-r):* hand-forged tacks #249, #250 (4), #251 and #252 (3); machine-wrought and hand-forged nails bent into hooks #253, #254 and #255. *Bottom row:* hand-forged nails #243, #244, #245, #246 (3) and #247; cut/wrought nails #248 (12). Scale: 100mm. Photo: DSCN9889.

- Hand-forged nails and spikes probably made at the blacksmiths were found in great abundance within the rooms and on the brick paving of the demolished structure in TA6/TT7-9 (Context 133). The demolition debris also included fragments of lime mortar and white painted plaster, as well as window glass.

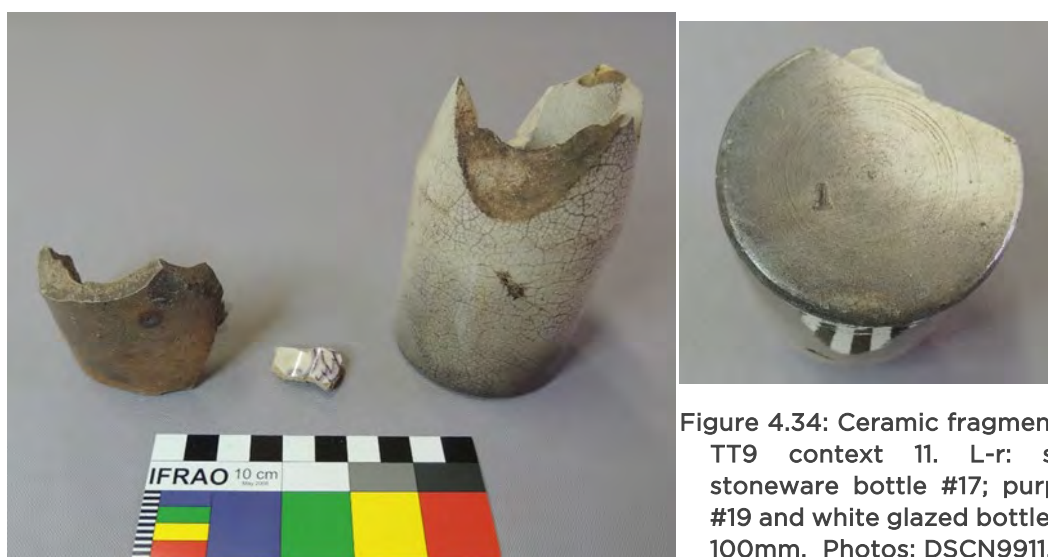
Figure 4.34: Ceramic fragments from TA3 TT9 context 11. L-r: salt glazed stoneware bottle #17; purple top plate #19 and white glazed bottle #20. Scale: 100mm. Photos: DSCN9911, 9913.

- Scattered within and around the various structures in TA3-6 were numerous fragments of ceramics and glassware used by the occupants over time. The table and tea wares were mostly imported from the UK (Figure 4.5, Figure 4.15, Figure 4.17, Figure 4.34). The glass represented a range of beverages and food, various pharmaceuticals and other products (Figure 4.6, Figure 4.16, Figure 4.18).

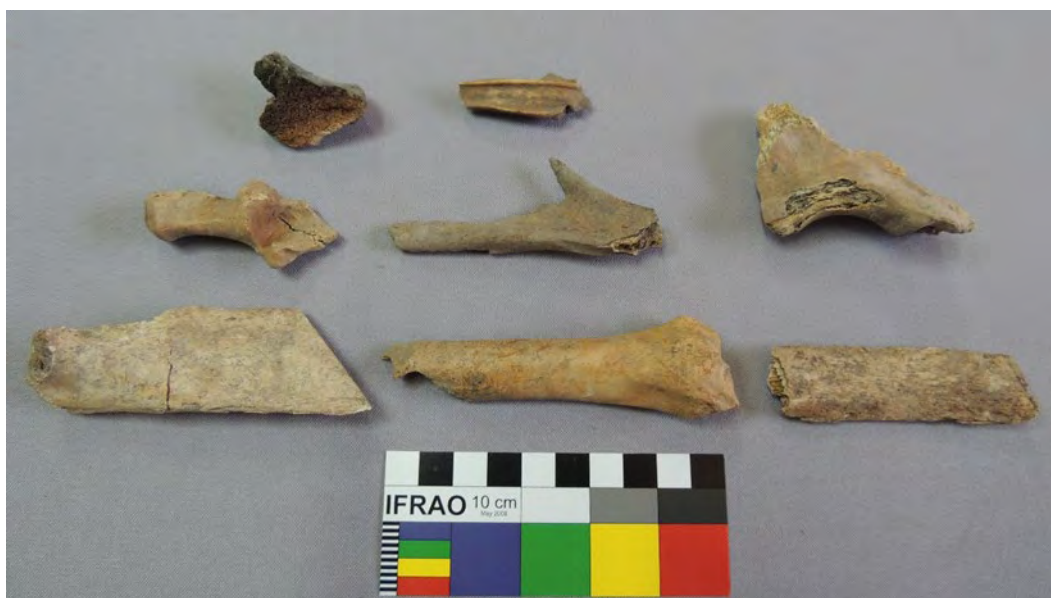
Figure 4.35: Selection of animal bones some with butchery marks from TA3, TA4 and TA6. *Top Row* from TA6 TT8A (l-r): burnt 133/#288; teeth 134/#286. *Middle Row*: TA3 TTD 155/#289, TT2 12/#275; TA4 TT1 58/#283. *Bottom row* from TA3, with butchery marks: TT2 12/#276, 13/#279; TT6 10/#281. Scale: 100mm. Photo: DSCN9960.

- Consumption of food by the residents at the site were represented by small numbers of animal bone, mostly from sheep. Several of the examples had butchery marks and one was burnt (Figure 4.35). In the future these may assist in our understanding of slaughtering practices at Ravensworth Estate and what cuts of meat were preferred.
