APPENDIX 23

Heritage
Assessment

Appendix 23 – Heritage Assessment

This appendix contains the following Heritage Assessment documentation in relation to Ravensworth Estate and the Ravensworth Homestead Complex:

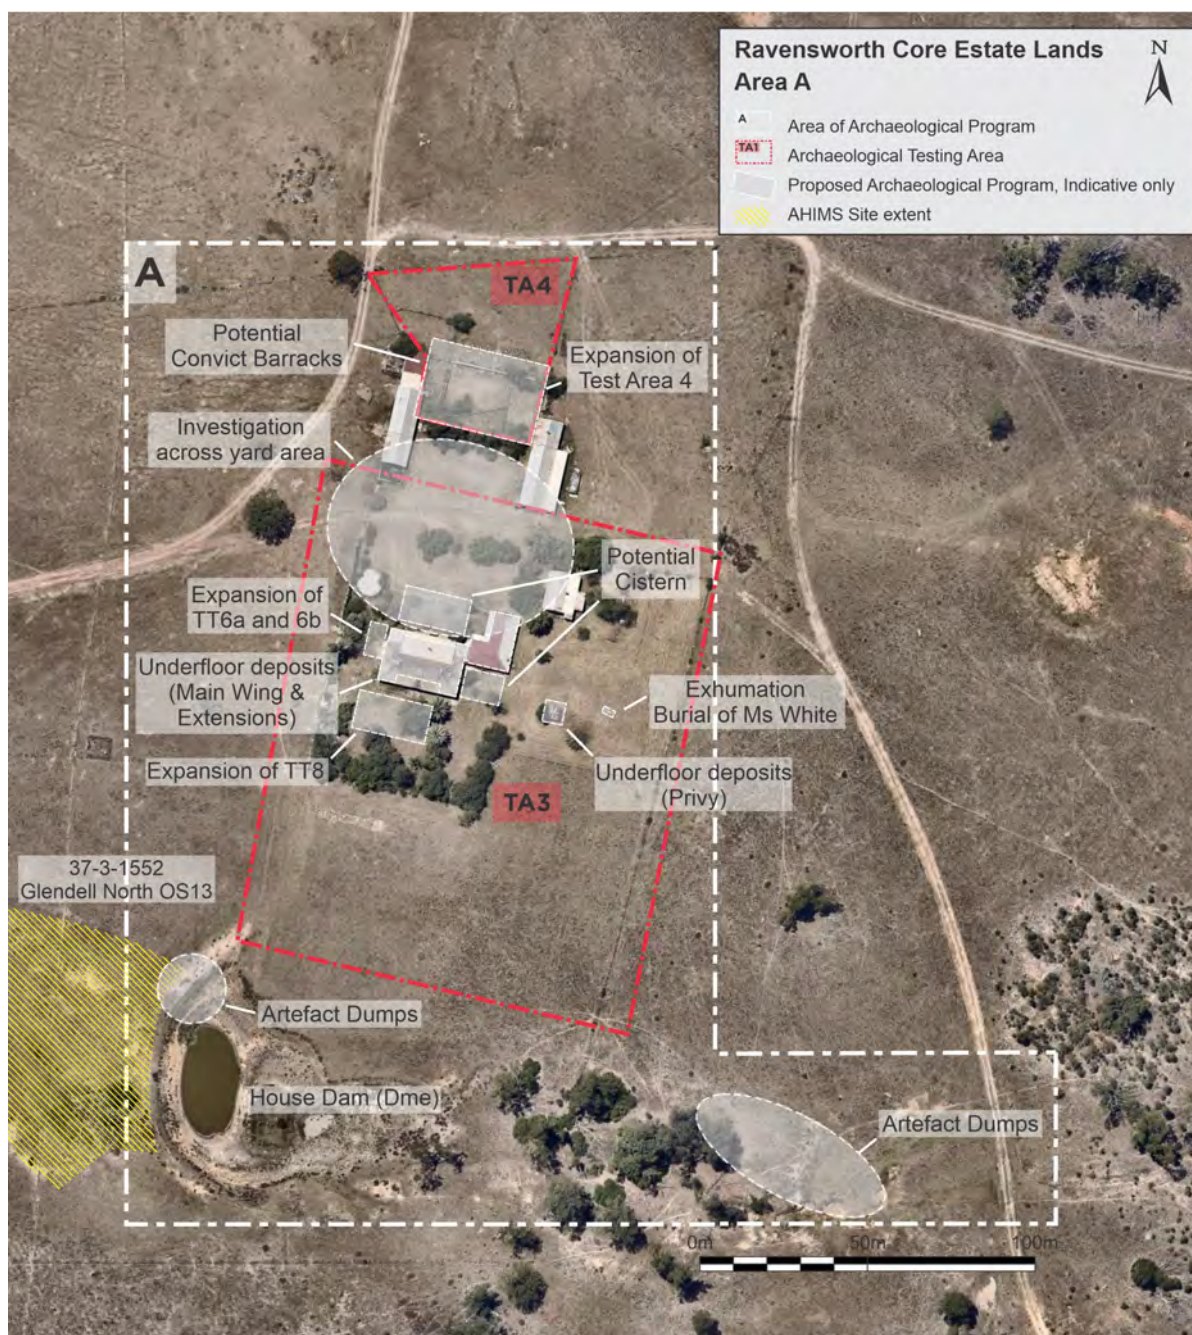
Figure 7.2: Key areas of investigation proposed for the archaeological program in Area A. Also showing the location of Aboriginal site - Glendell North OS13.

In this area the archaeological program (Figure 7.2) includes:

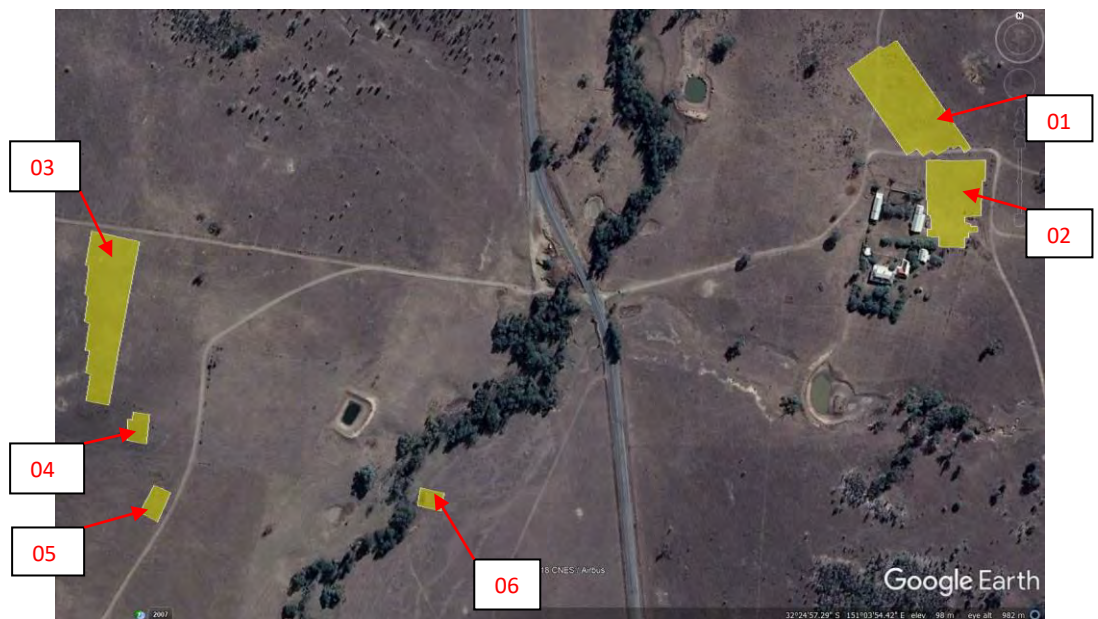
Figure 1: Yellow areas indicate GPR coverage on site. Labels 1-6 Indicate these areas.

The survey area was initially broken down into seven main survey locations, totalling approximately 13 hectares over the property. Upon arrival to site and commencement of the data acquisition, the survey area was reduced by Casey and Lowe to six smaller main areas (labelled 01-06 in figure 1 below), instructed on the day during GPR scanning.

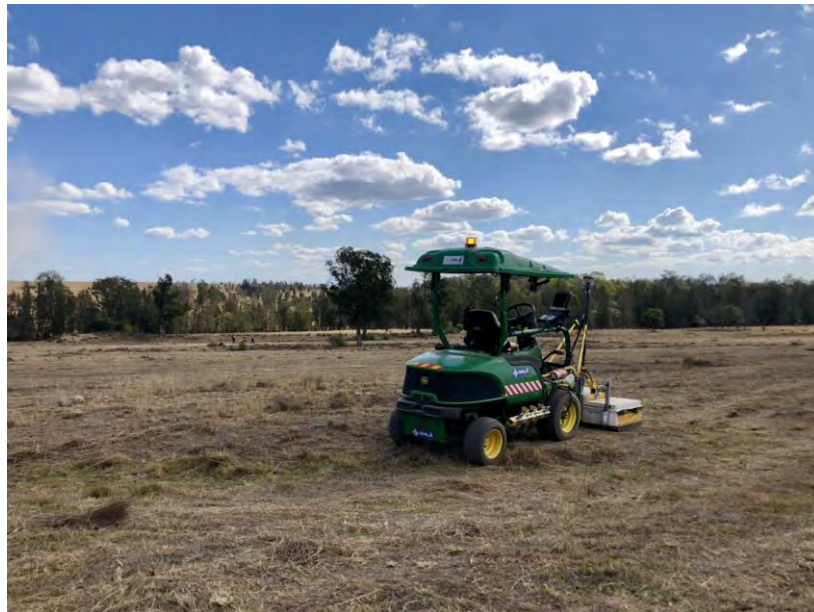
Figure 3: MALA 400MHz 3D MIRA acquiring data on site.

MALA GPR Imaging Radar Array (MIRA) is the most technically advanced GPR system on the market. It is the only system of its kind that integrates acquisition, processing, QA/QC, positioning data, interpretation and export of ground penetrating radar data (figure 3).

The MIRA instrument can quickly and easily gather full 3D data in broad paths, called "swats" using 16 channels. This allows for data collection in one pass (i.e. a swat needs to be covered only once, in singular direction) as opposed to single channel systems which require multiple passes in multiple directions. The MIRA system is an efficient and effective solution for large scale ground penetrating radar mapping and subsurface object identification. Results are processed in 3D depth slices and are displayed and interpreted through a dedicated software package (rSlicer) and then exported into suitable GIS or CAD data formats (.dxf).

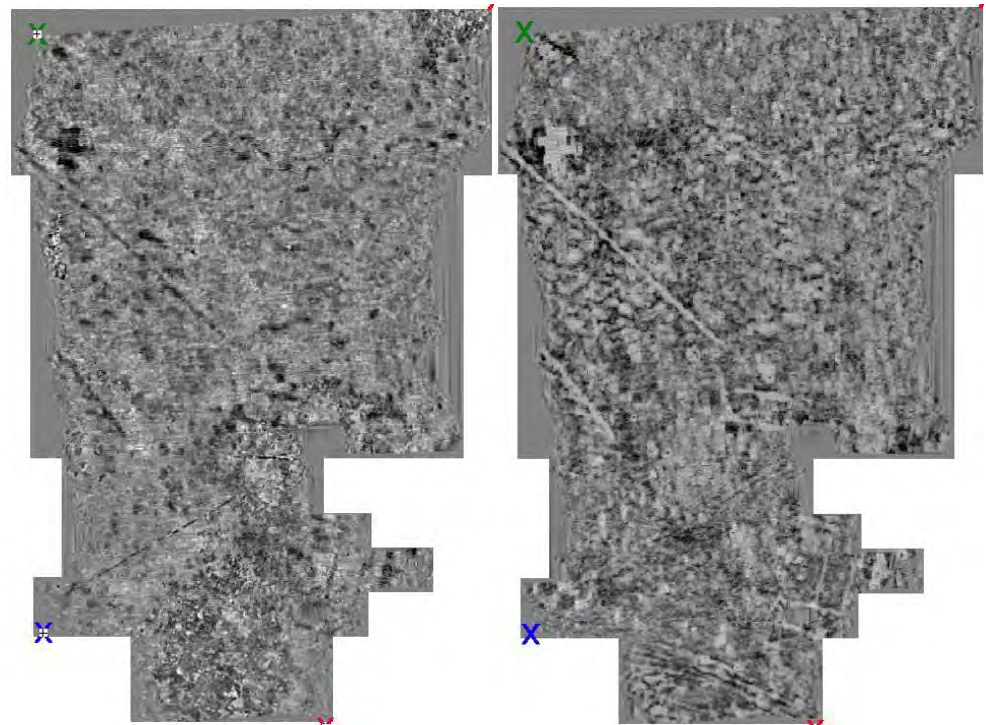
Figure 8 & 8: Figure 8 on the left displays Area 02 subsurface anomalies (400mm depth slice). Figure 9 on the right displays Area 02 surface anomalies (0mm depth slice).

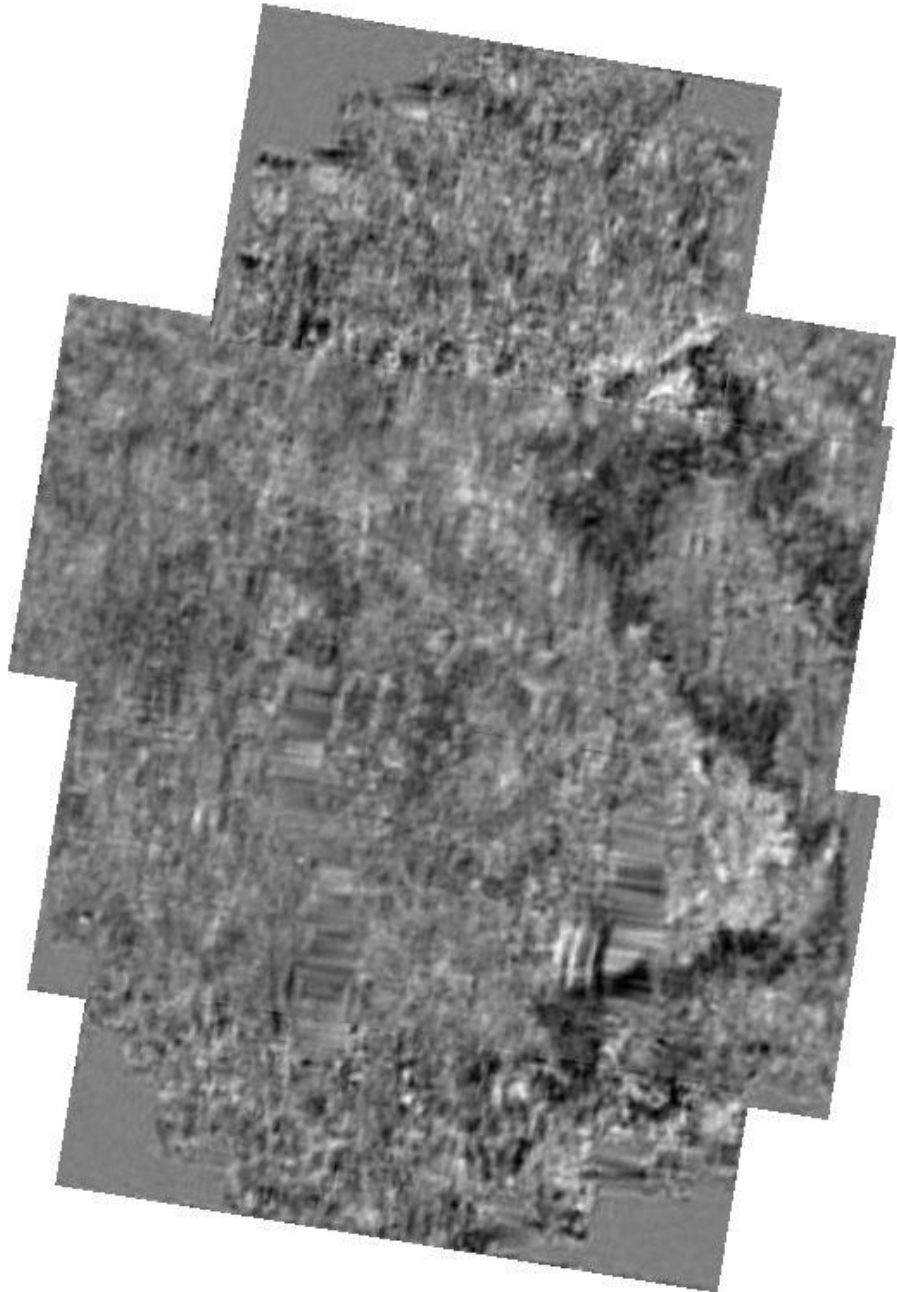
Figure 12: Area 04 subsurface anomaly. Processed depth slice at 220mm depth.

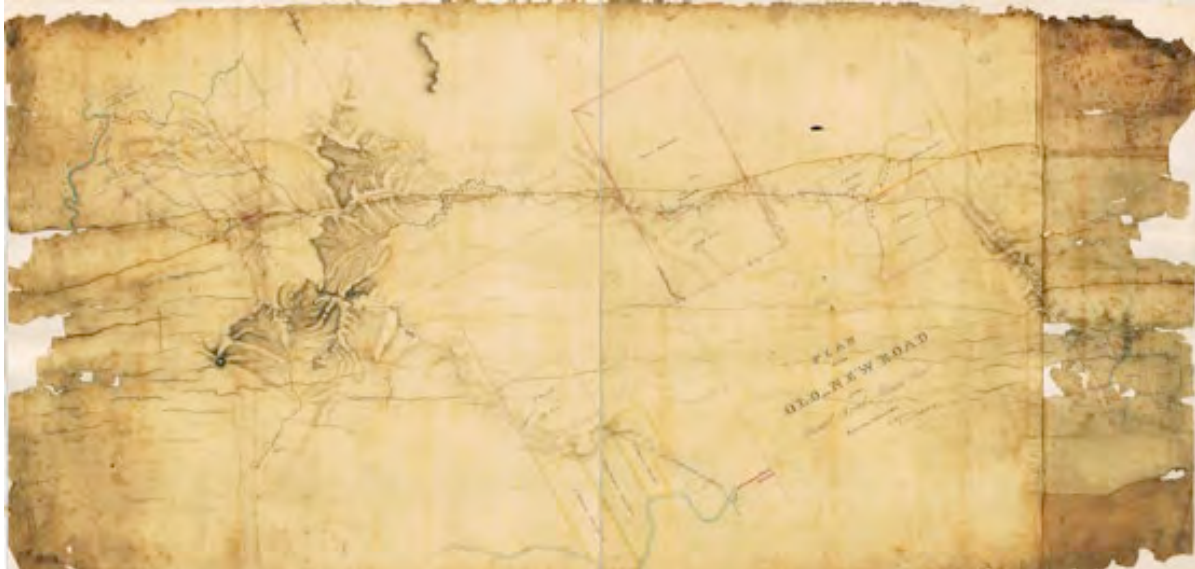
Figure 3.5: Dixon's road plan of April 1833. Source: R.5.830, Crown Plan.

A plan of the old and new Road from Muswellbrook to the Hunter River dated April 1833 by Assistant Surveyor Robert Dixon showed James Bowman's land near Foy Brook at Ravensworth with the house, barn and the new house shown. A paddock next to Foy Brook was marked as well as the line of fence. His area was shown as 10,439 acres, which tallies with the area of the three portions shown on the Crown Plan H.35.663 (Figure 3.5, Figure 3.6).⁶¹

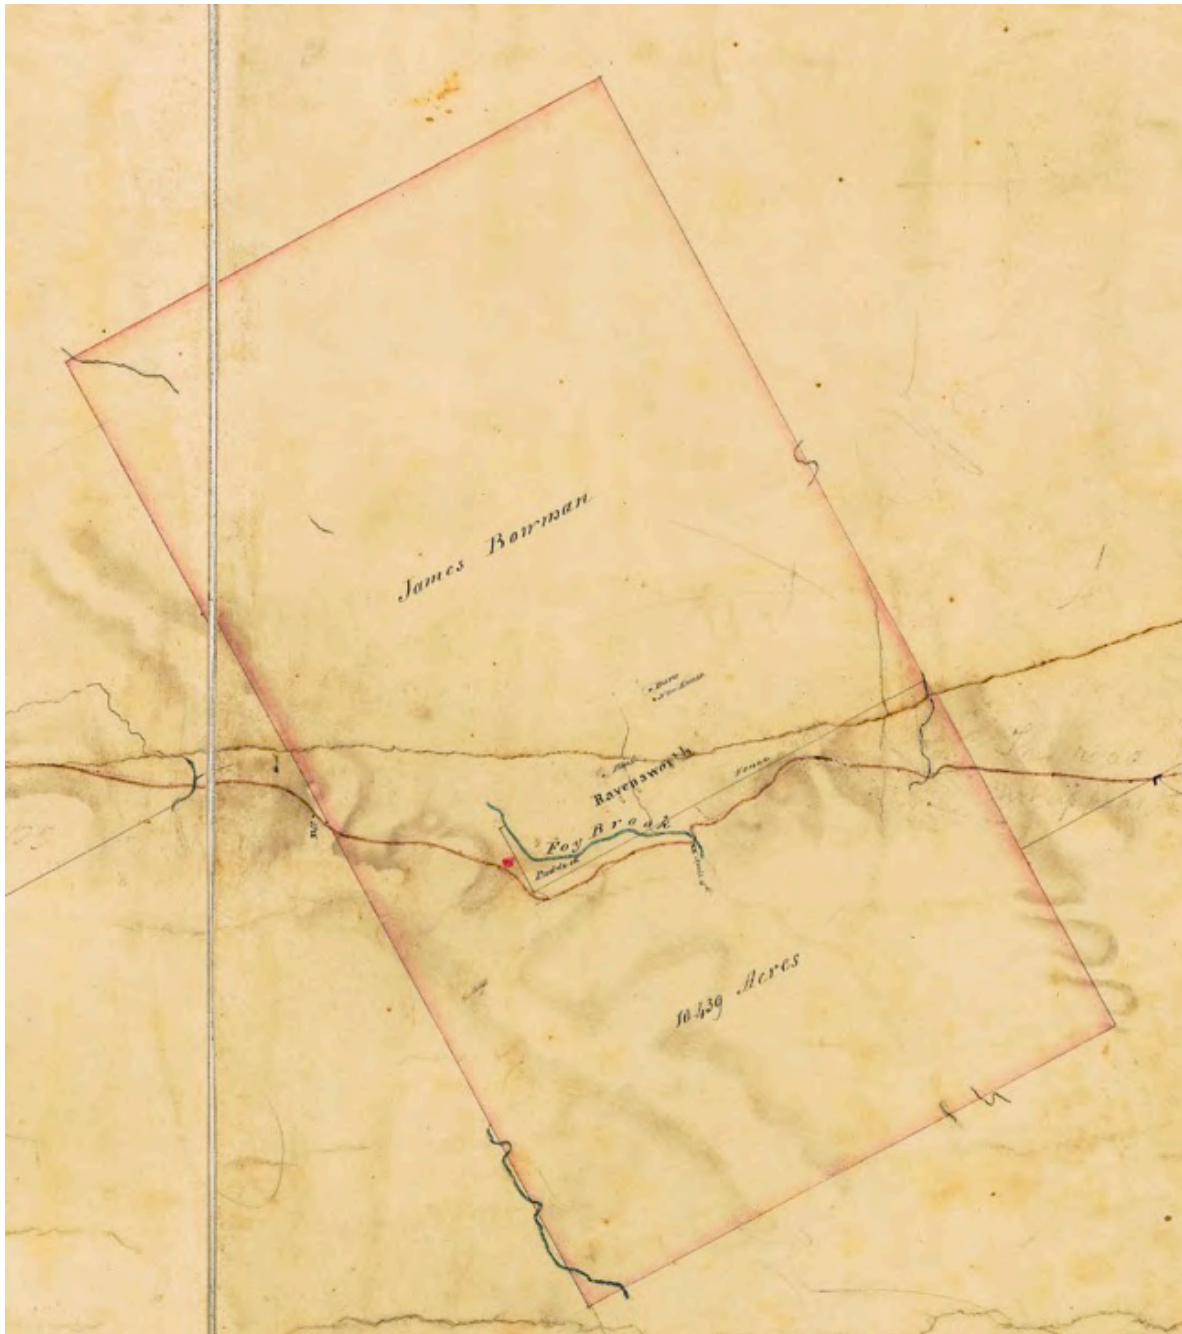
Figure 3.6: Part of Dixon's road plan showing buildings on Ravensworth including 'House', 'New house' and 'Barns'. Source: R.5.830, Crown Plan.

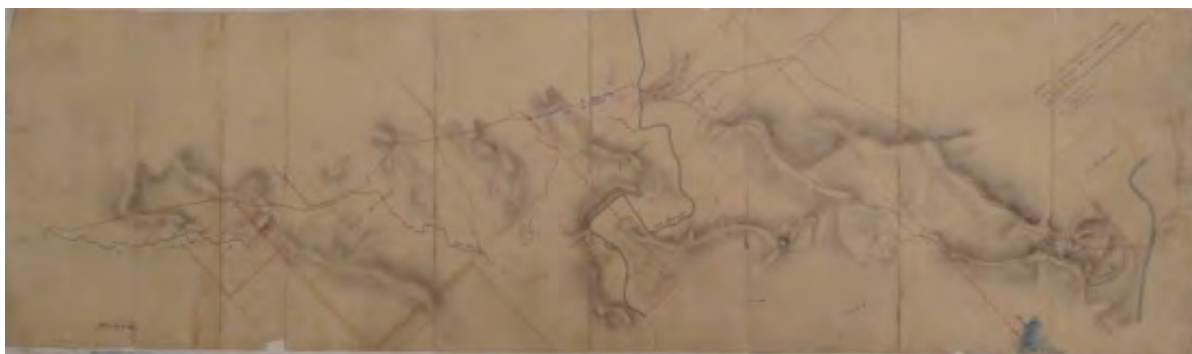
Figure 3.7: G B White's road survey. Source: SA Map 5095 originally R.6.830.

A road survey of 1835 by Assistant Surveyor G B White showed the land held by Bowman, plus an 'Old House' north of the road. A 'Burial Ground' near the VR (Village Reserve = Village of Camberwell?) was also marked on the plan (Figure 3.7, Figure 3.8).⁶⁶

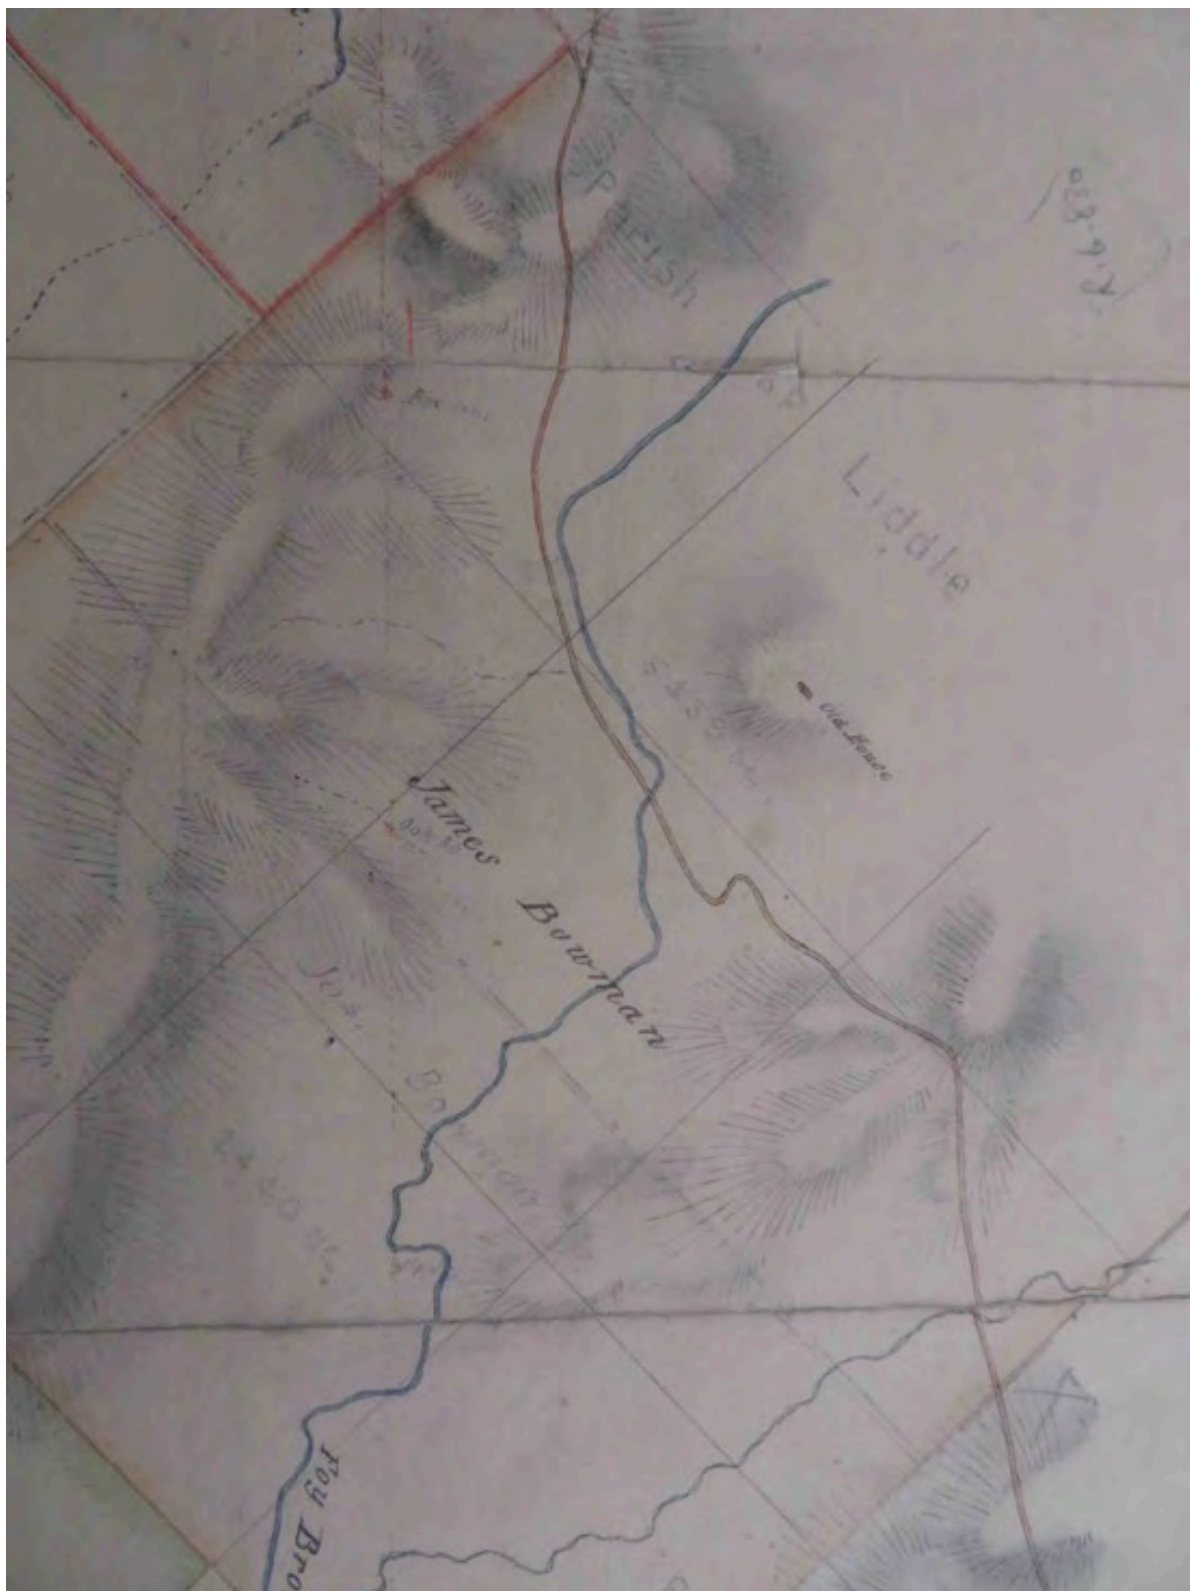
Figure 3.8: Enlargement of G B White's road survey showing 'Old House'. Source: SA Map 5095 originally R.6.830.

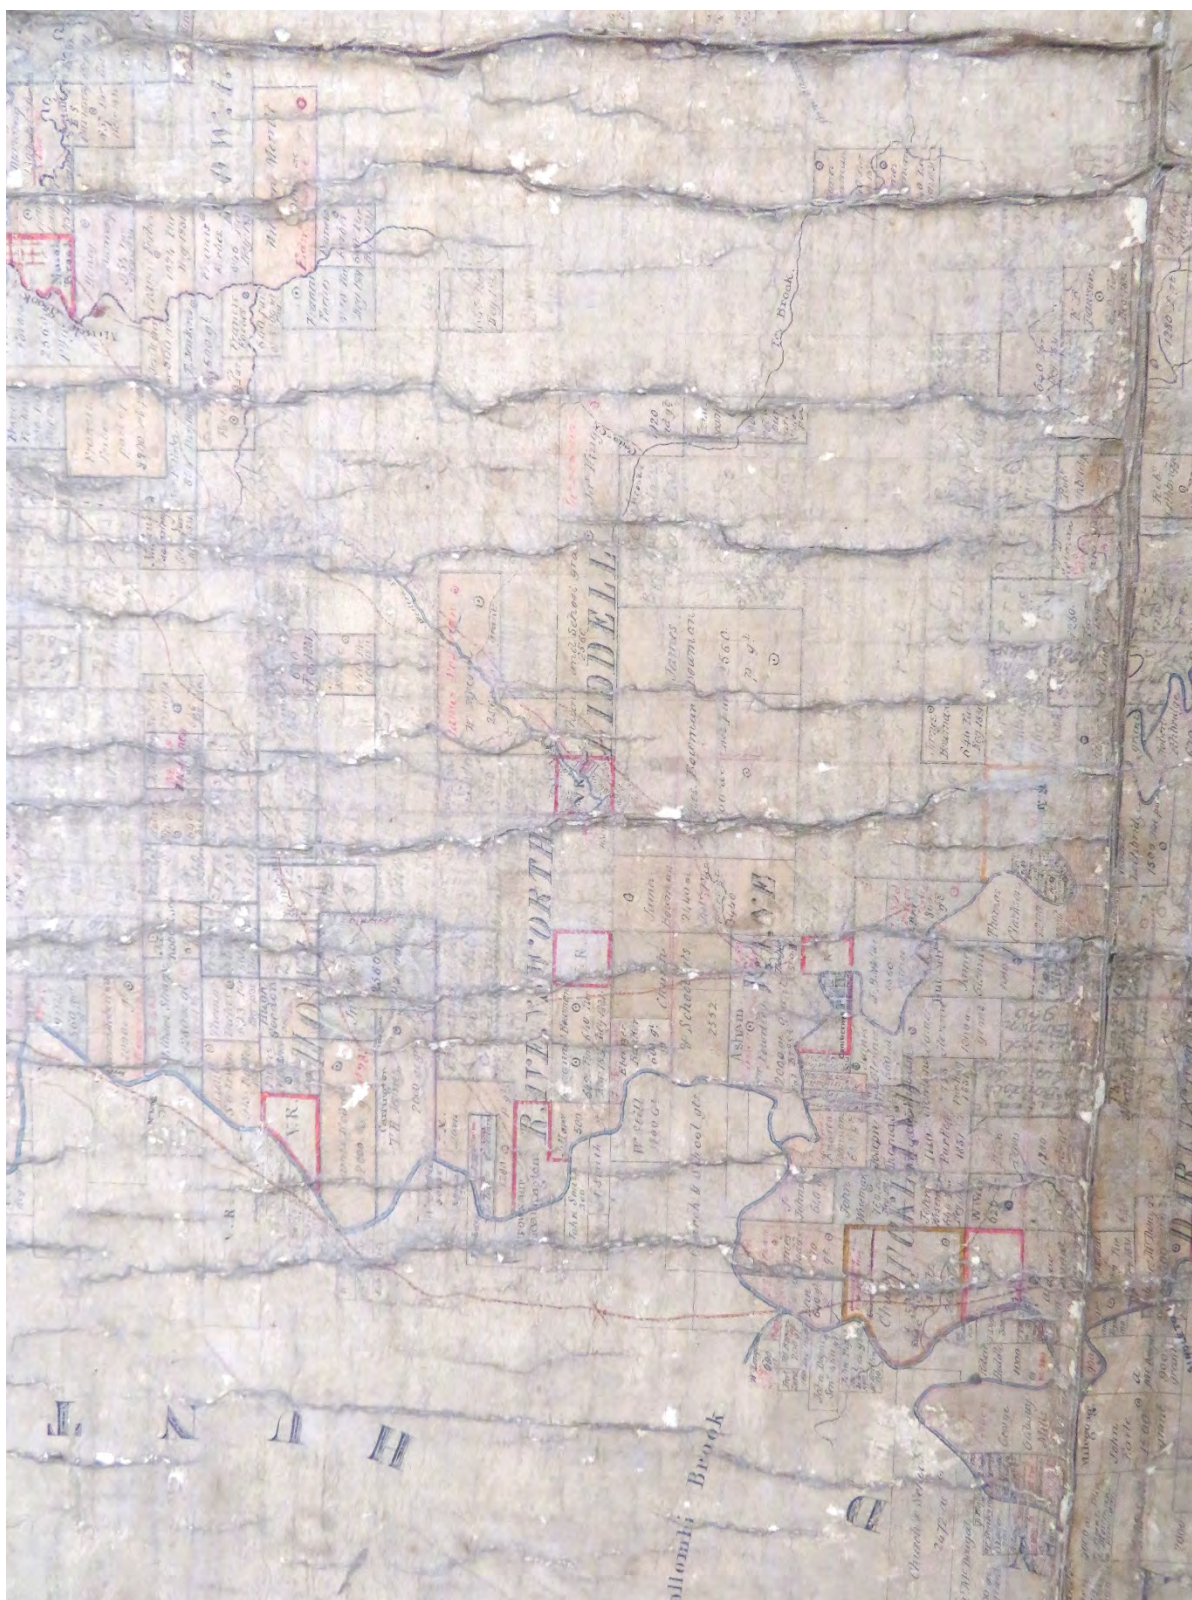
Figure 3.12: Fannyhough's 1839 map depicted the status of land held by various individuals. It is difficult to read and may have later information added to it. Source: County Durham, 1839, SA Map 2520.

Figure 3.12). It was used as a charting map by the Surveyor General for some years so further information was added. This possibly includes some of the grants charted on the map. It appears to have not being used after 1846 since no grants to William Russell were shown. That is rather dark and heavily used so some of the detail is unclear. It does depict a number of the grants that Bowman received after those that made up the core of his holding.¹¹⁰

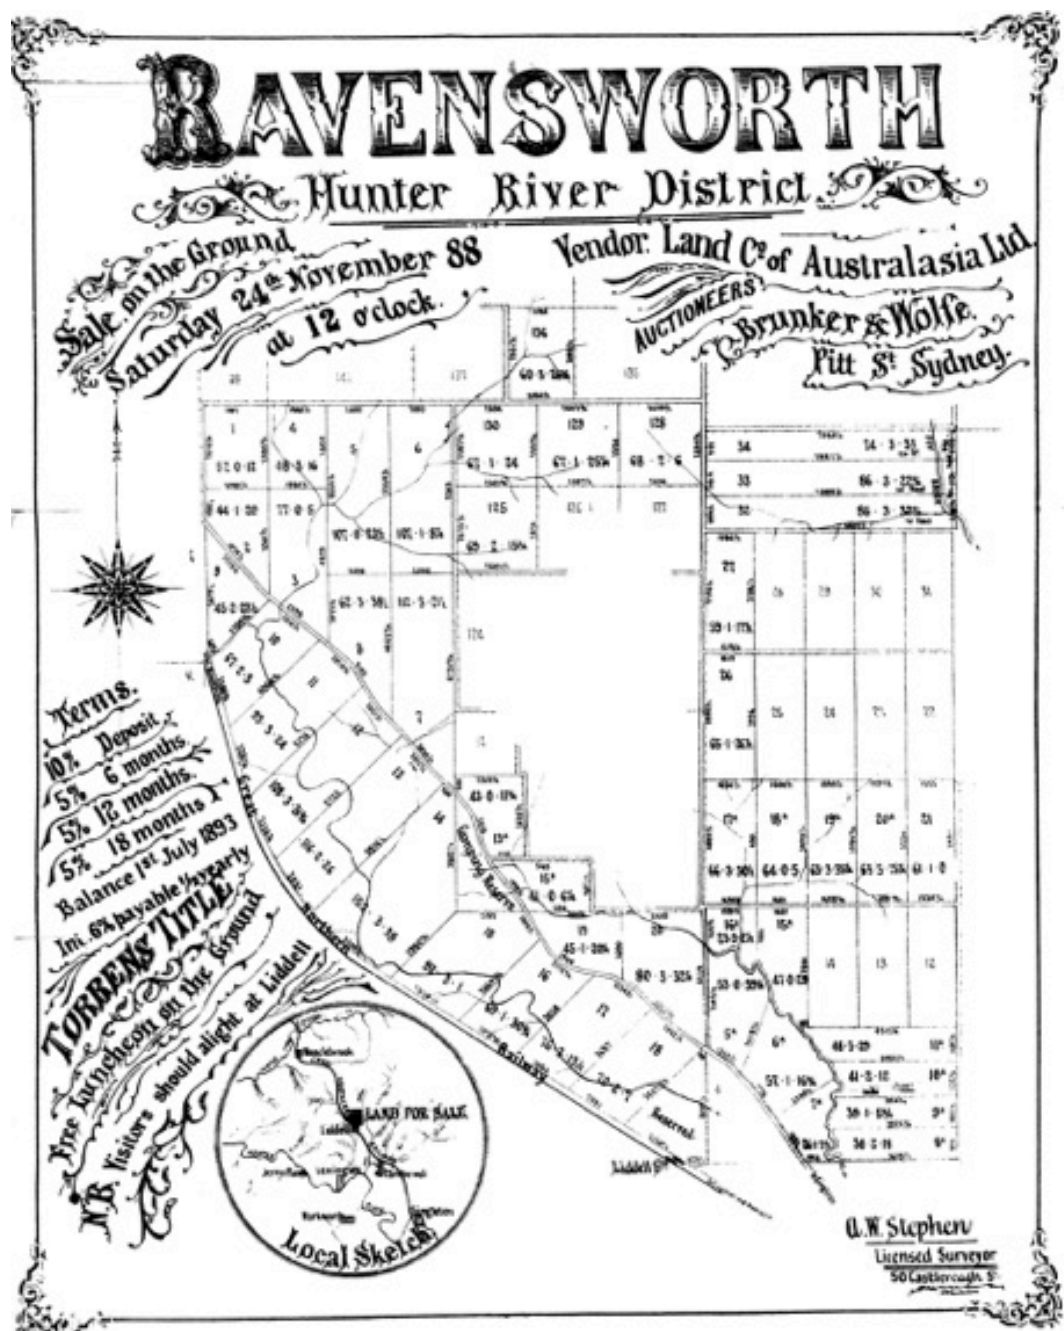
Figure 3.23: The Land Company subdivision of November 1888. Source: County Durham, Subdivision Plans, ML, ZCP/D6/9.

On 24 November 1888, Brunker and Wolfe auctioned lots for the Land Company of Australasia. This was mainly a subdivision of the original Portion 89 and some surrounding land. A notation on a copy of the sale contract showed that the plan was registered at the LTO as 1550 (L).¹⁷⁹ No transfers or conveyances of this land registered at the Titles Office (Figure 3.23).

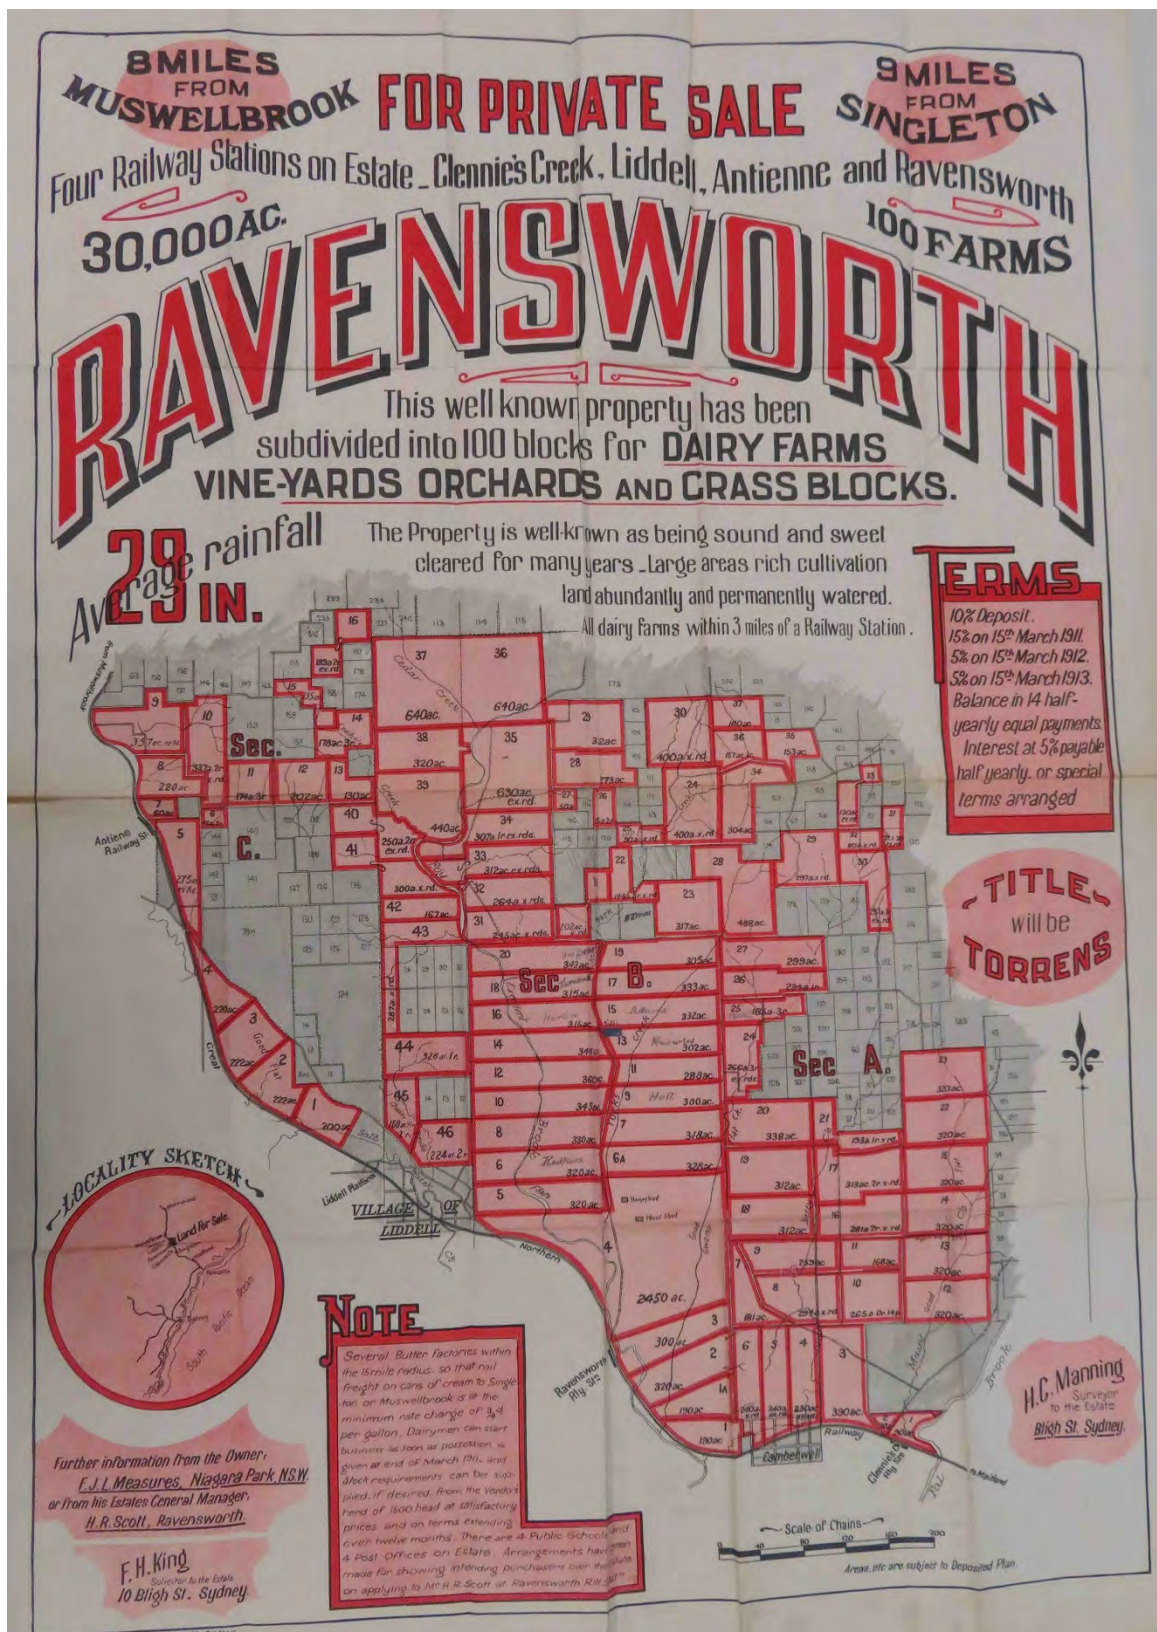
Figure 3.31: The original version of the Ravensworth subdivision plan. Source: NRS 3829, School file, Hebden, SANSW 5/16256.4.

Various different versions of the subdivision plan of Measures' Ravensworth Estate are held in the Mitchell Library and in files held at State Archives of NSW (Figure 3.31 to Figure 3.40). One of them dated about 1911 showed the lots with some details of purchasers but only showed buildings on lots 4 and 5 (Figure 3.33, Figure 3.34). Some of the land was shown as sold.²¹³

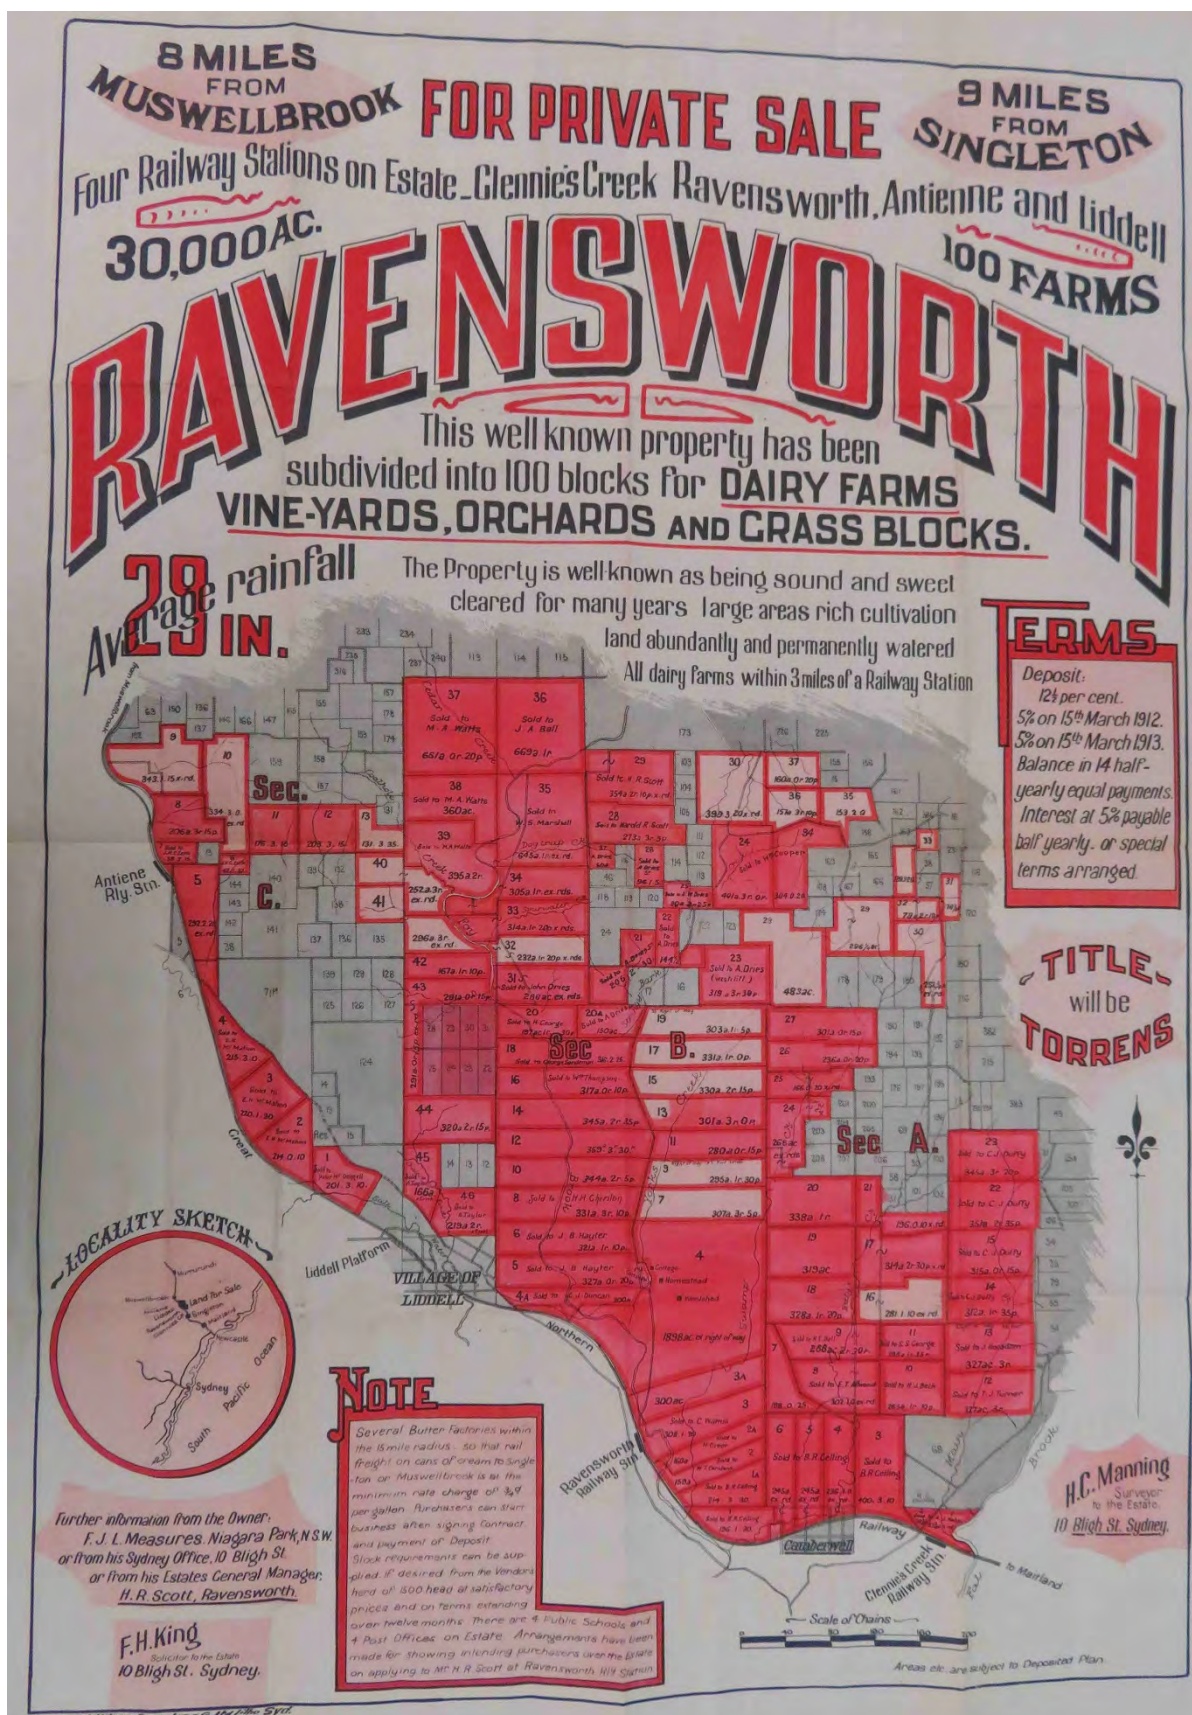
Figure 3.35: Another copy of the later version of the sale plan with an additional building on Lot 4 and with part of lot 4 excised to create lot 4A. Source: NRS 3829, School file, Hebden, SANSW 5/16256.4.

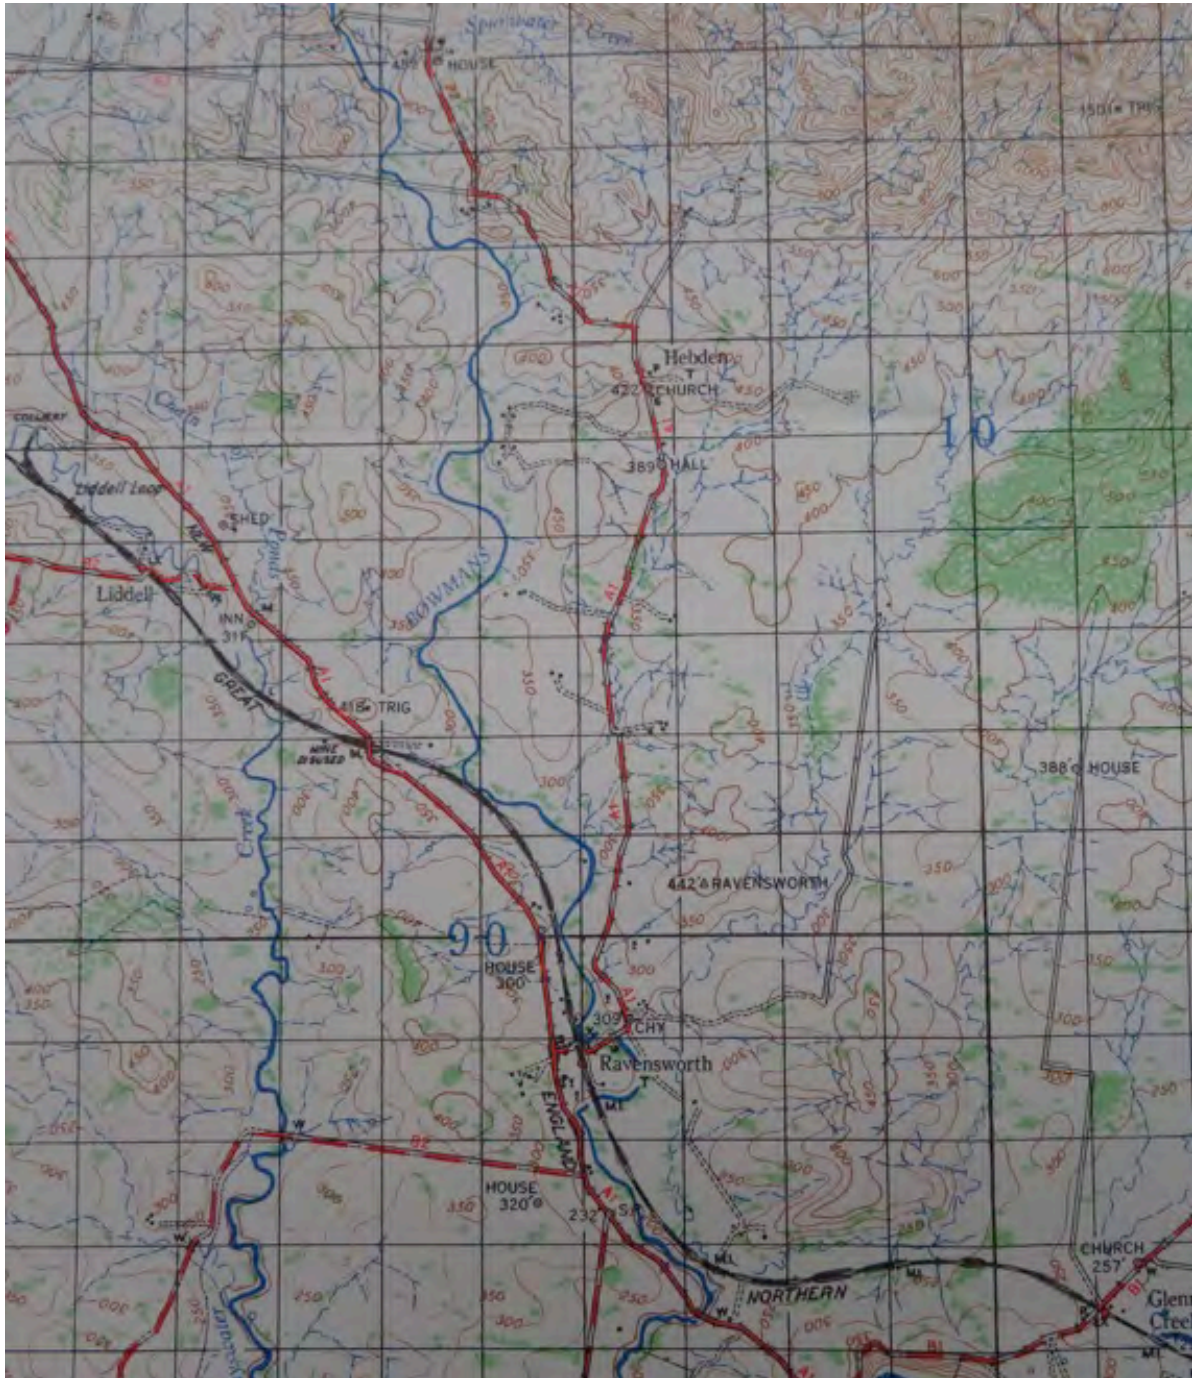
Figure 3.45: The 1942 Army Topographical map of Ravensworth. Source: Australia – Army, Topo Map 1:63360, Camberwell, Zone 8, No 378, 1942.

The valuation of Patrick Plains Shire completed on 1 October 1933 by the Valuer General, described the improvements on the property as a stone homestead, 14 rooms, slate roof, men's hut, cowshed, stone hayshed, stone cart shed, fencing and ringbarking. At an unspecified later date, the men's hut, cow shed, stone hayshed and stone cart shed were altered to 'WB/Gl Ctge - Farm Bldgs' and 'Water Supply' was added.²⁶⁵ When Lands Inspector John Bonar reported on 31 August 1936, he noted that Marshall had recently improved a shed and had erected a 2 stand shearing plant and he was shearing with two men when Bonar visited.²⁶⁶ The 1942 Australian Army Topographical map showed the buildings across the study area including those at Ravensworth (Figure 3.45).²⁶⁷

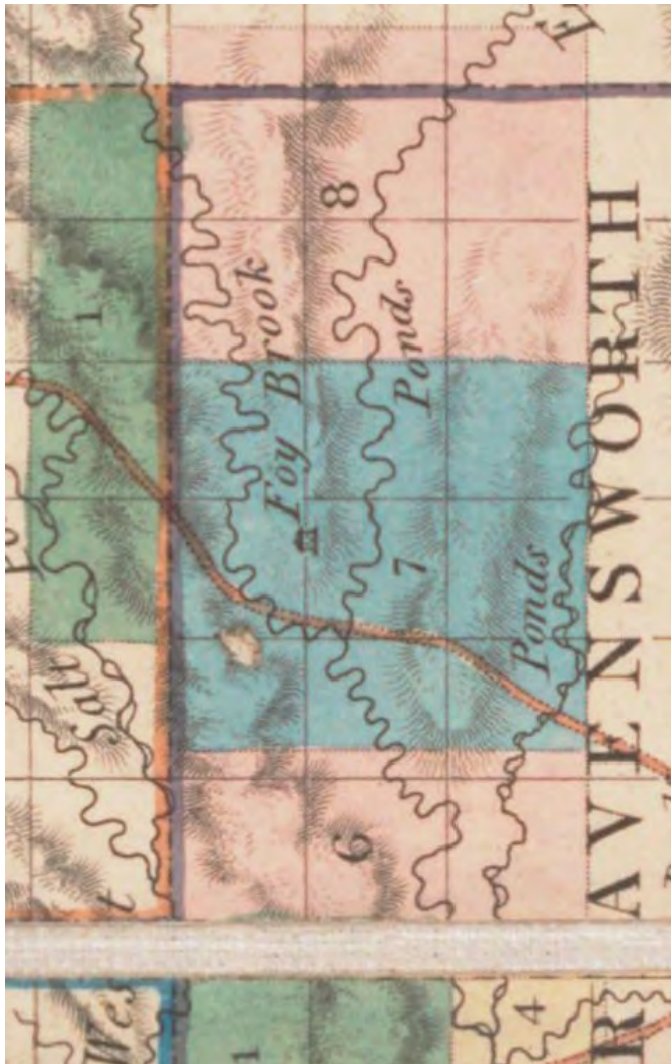
Figure 5.6: Detail from Dangar's 1828 plan of the Hunter Region, showing a house on the ridge line situated between Foy Brook and Yorks Creek.

An earlier building labelled 'House' and 'Old House' (GCO8) is marked on three early historic maps (Figure 5.7).³³⁶ There is no obvious trace of the site on the ground and determining the precise location of the building remains a matter of informed consideration. The maps were georeferenced using common lot boundaries. The lack of a network of easily identifiable features and discrepancies between the two maps mean that they should not be overinterpreted. Georeferencing Dixon's map using lot boundaries situates the house on the southern side of a prominent hill or ridge (Figure 5.7). The later homestead (GCO1) and a barn, which were also marked on the map, provide some degree of rudimentary control. The georeferenced Dixon map (1832) places them about 100m west of their actual locations. The two creek lines reflect their general situation but they deviate variably by up to 100m from their current courses. However, there were no other features within the Bowman grant boundary with which to test the accuracy of the map. The margin for error is therefore at least 100m but it could be more and there is no way of testing the potential margin for error any further without fieldwork including excavation. White's map was also georeferenced using the lot boundaries. That georeferenced map places the old house on the west bank of Yorks Creek, around 300m to the southeast of where it is located on Dixon's map. However, hachuring depicted around the house on that map suggests that the house was actually located on high ground, which suggest that Dixon's map provides a more accurate location.

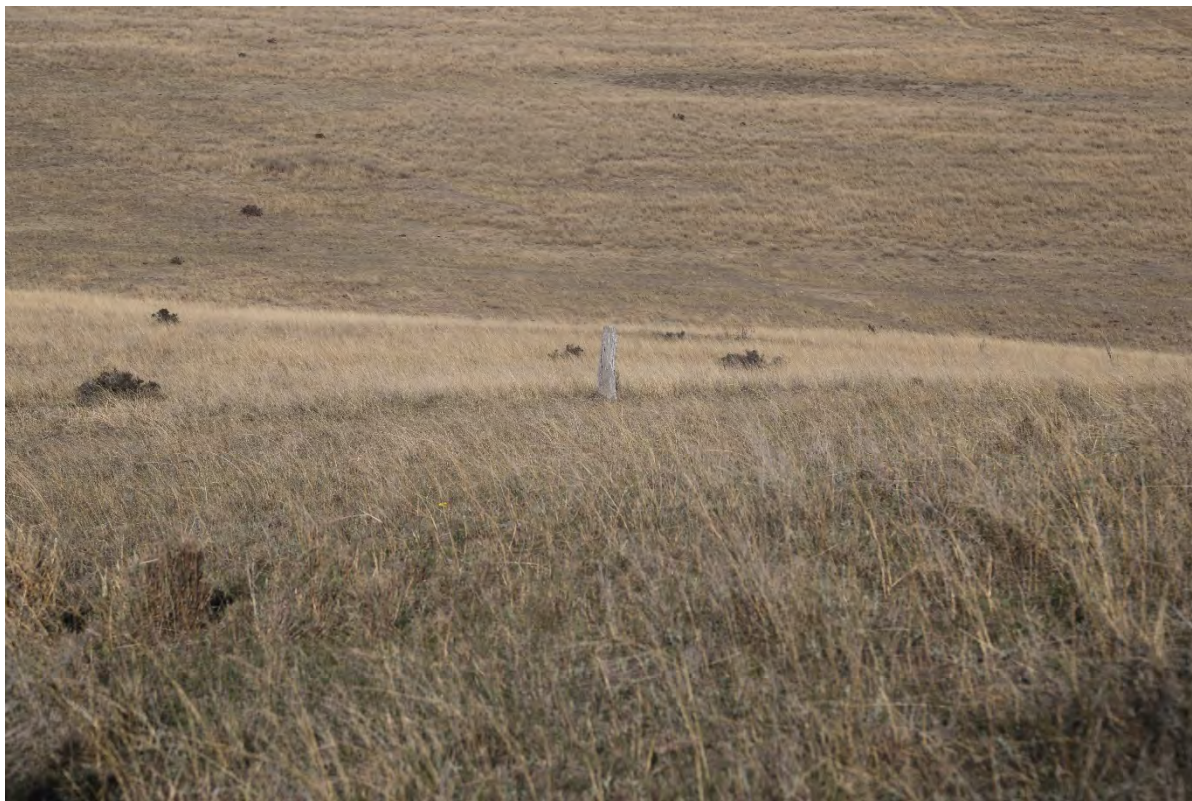
Figure 5.8: Old House (South) (to South). Casey & Lowe 2018.

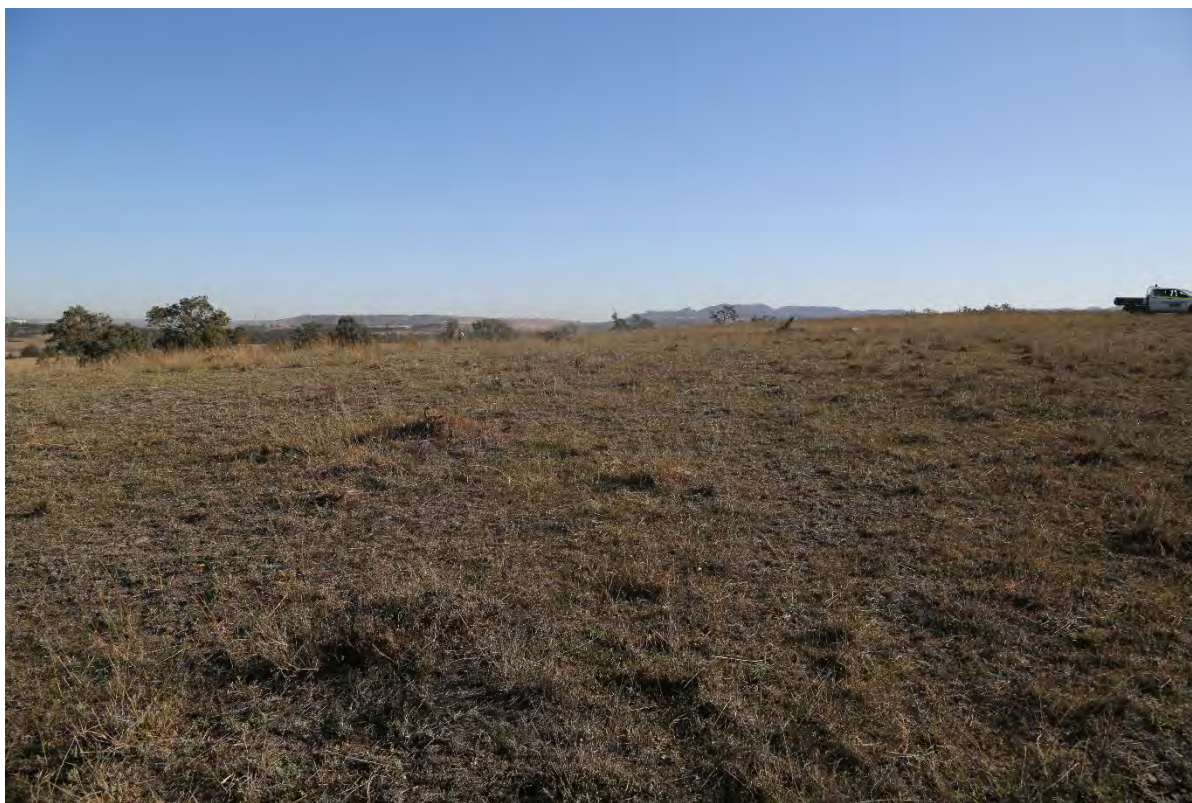
Figure 5.9: Old House (North) (to north). Casey & Lowe 2018.
