APPENDIX 23

Heritage
Assessment

Appendix 23 – Heritage Assessment

This appendix contains the following Heritage Assessment documentation in relation to Ravensworth Estate and the Ravensworth Homestead Complex:

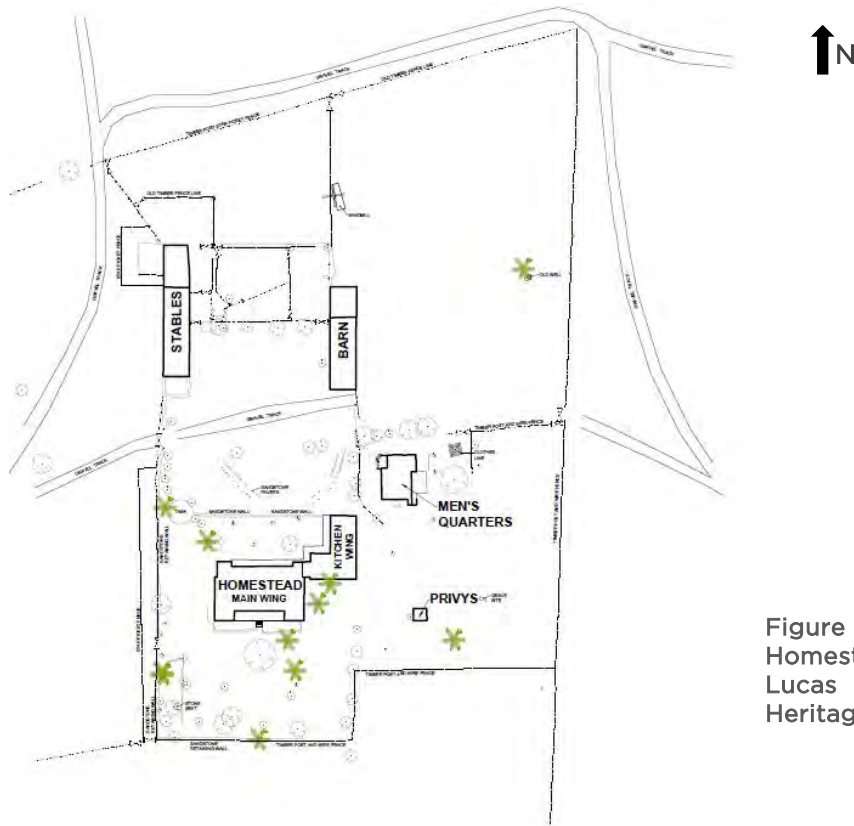
Figure 5.10: Plan of Ravensworth Homestead Complex. Source: Lucas Stapleton Johnson Heritage Planning & Architecture.

Ravensthorpe Homestead Complex comprises five buildings—the main house (residence and kitchen wings), two outbuildings (the stables and barn), an ablutions building and a later cottage, briefly described below (Figure 5.10 to Figure 5.21). The complex is set within an extensive landscaped garden which include a range of archaeological features - underground silos, stone walls, etc.

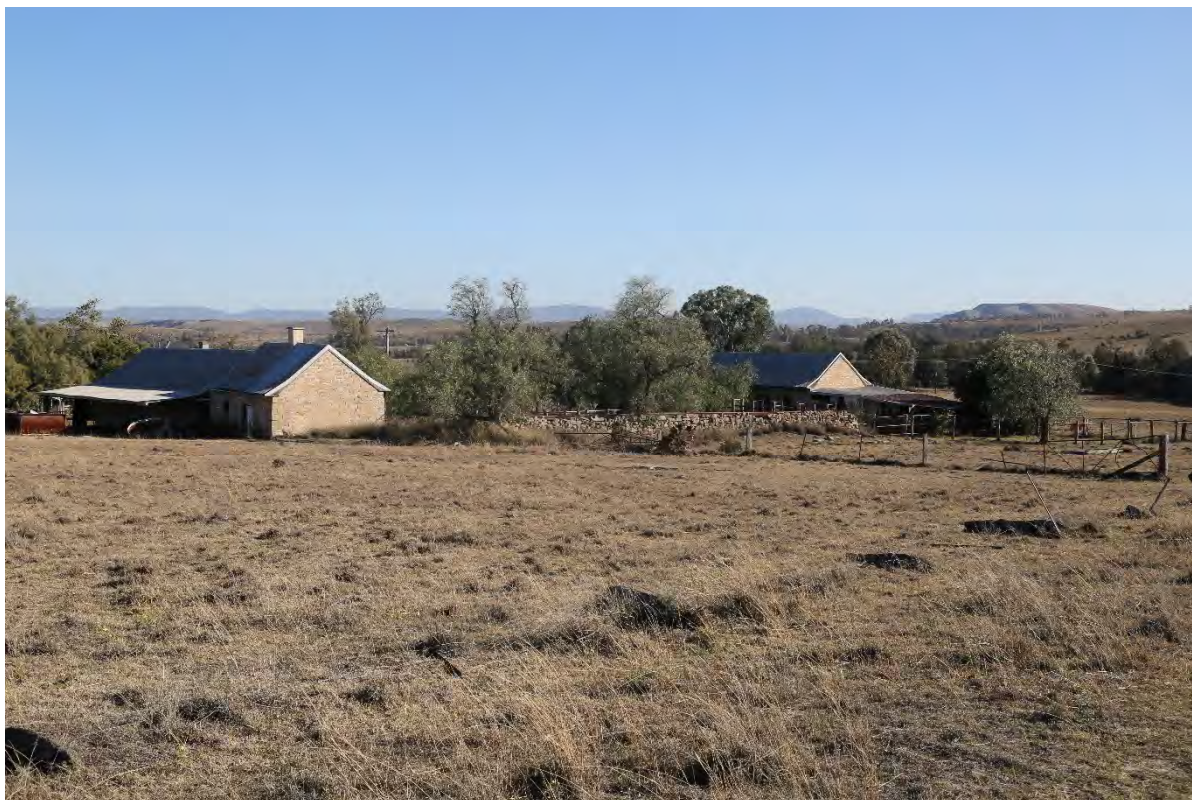
Figure 5.12: Northeast of homestead, barn in the foreground and stables in the background (to the right of the picture) with the area of the potential third building located between the two in the general location of the stone wall (view to SW). Casey & Lowe 2018.

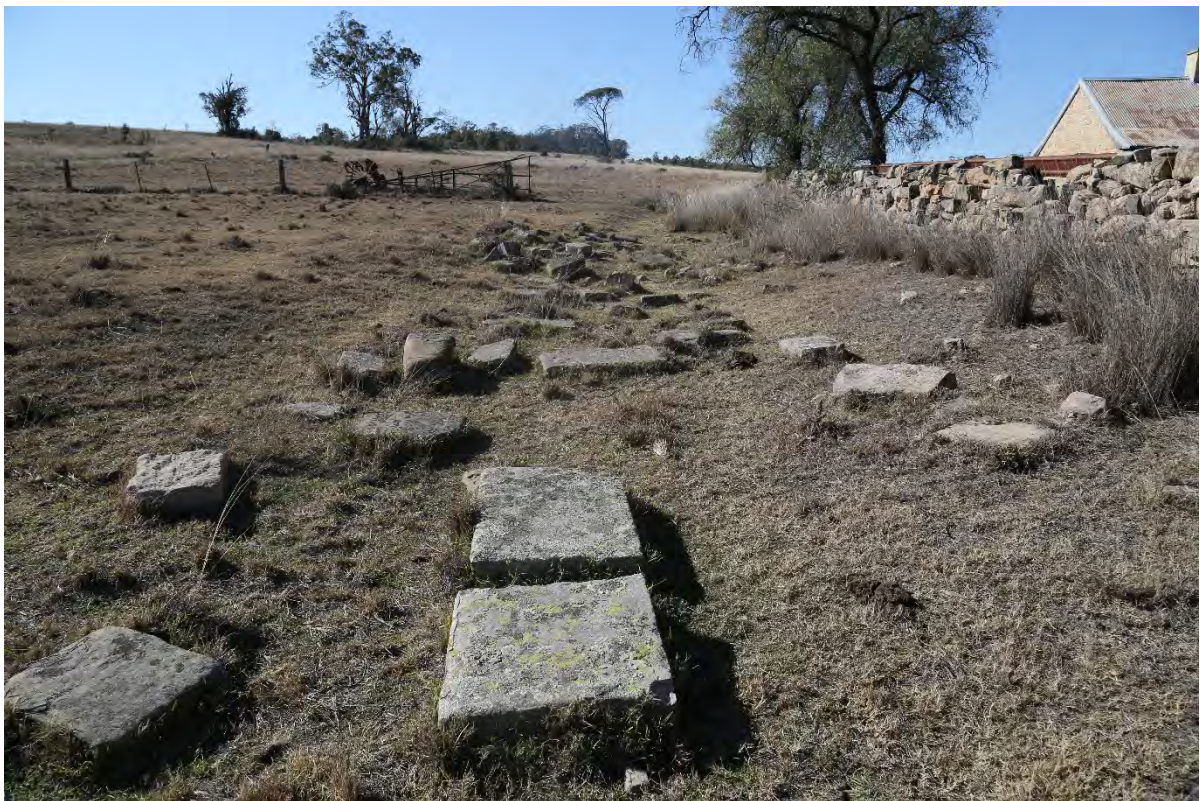
Figure 5.15: Northeast of homestead – area with significant amount of worked building stone - immediately to north of area described by the former owner Geoff Marshall (and others) the convict accommodation (view to East). Casey & Lowe 2018.

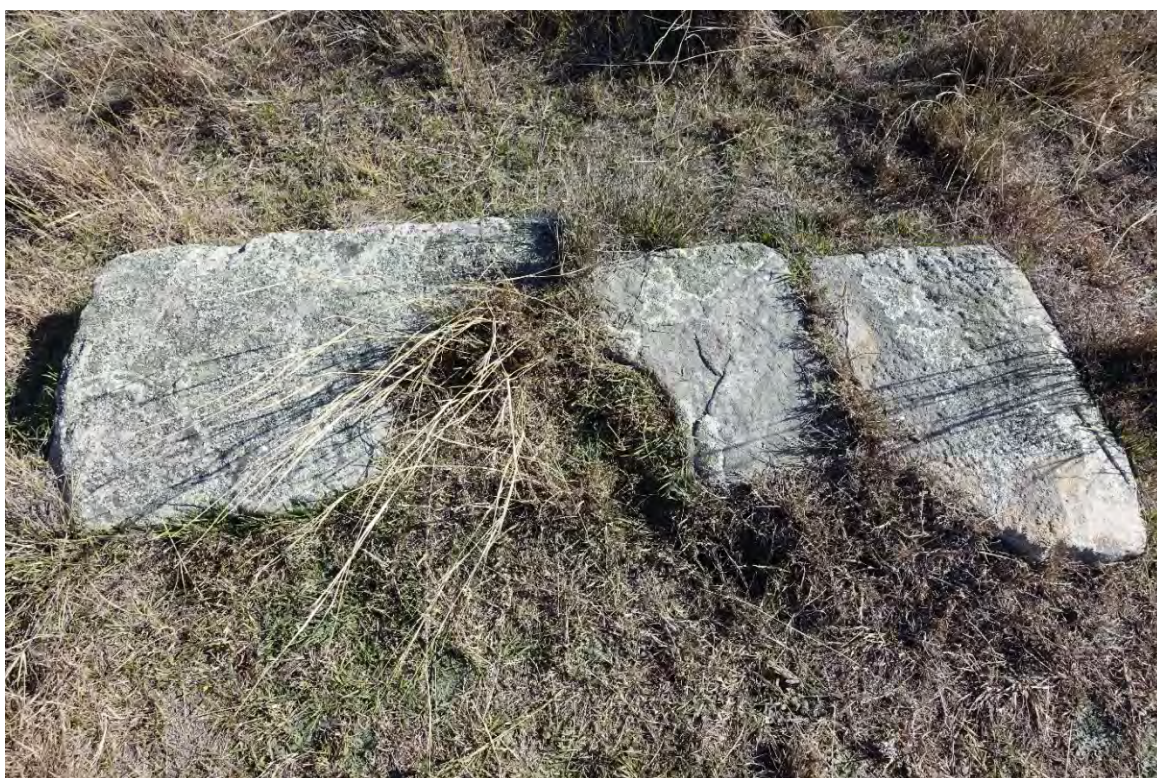
Figure 5.20: Dressed stone block with semi-circular dressed opening, described by the former owner Geoff Marshall as part of the Blacksmiths workshop. Casey & Lowe 2018.

The most significant cluster of features was located at the base of the eastern ridge. It consisted of a series of potential terraces and mounds (GCO3a). Two cut-stone blocks were located here. One block has a semi-circular dressed opening or cavity (Figure 5.20). A line of rectangular stone blocks and an adjacent sub-rectangular mound were located further to the west. These probably indicate a wall or an associated fence-line and a building. Some elements were included on the recent commissioned survey. A sketch plan was compiled in order to provide a preliminary understanding of the topography. The approximate locations of selected features were also logged using a tablet and cellular connection. This provided locations with an approximate positional accuracy of around 2m to 4m, which could be checked in some cases against the georeferenced aerial imagery and DEM.

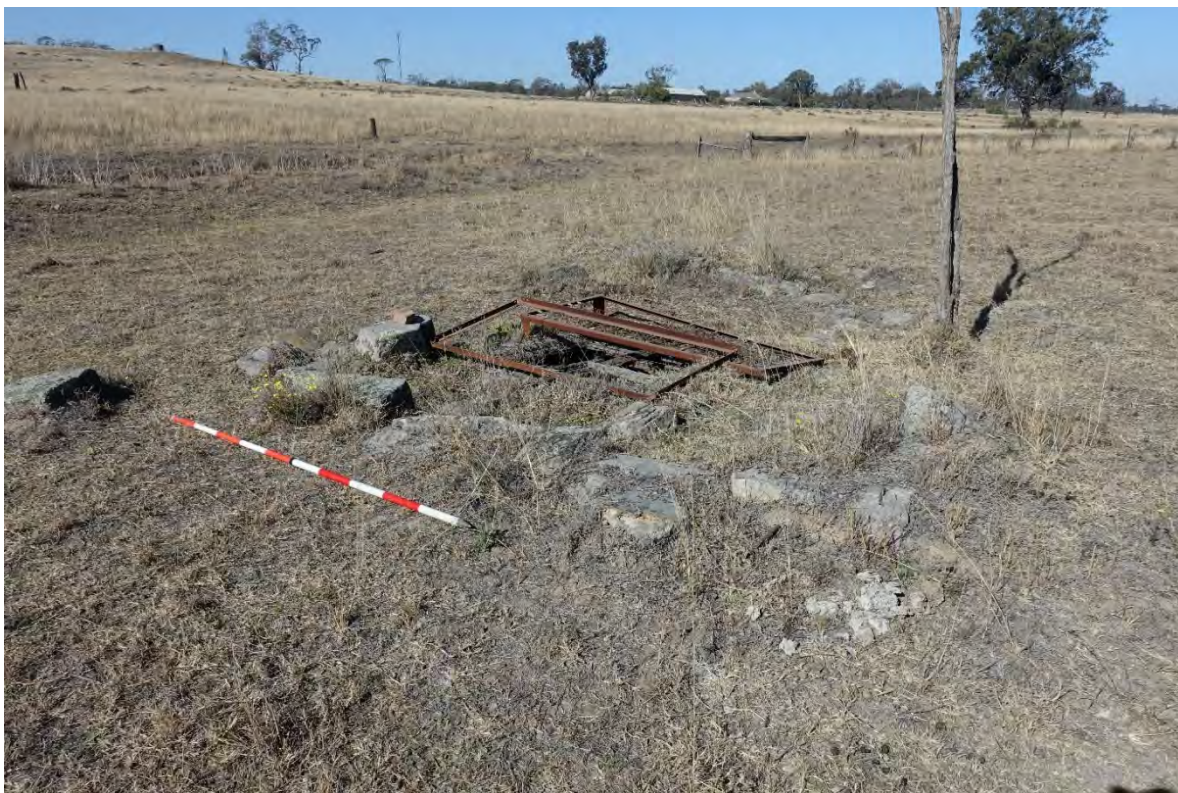
Figure 5.23: Well with stone kerb, looking southeast. Photo: Casey & Lowe.

This area contains the early brick well (GCO4) (Figure 5.23) and the remains of the early dam wall (GCO18). This area is partly fenced into two small and distinct lots. The presence of the well just outside the northern lot could suggest habitation in the immediate vicinity. A (later?) cottage (GCO14) once occupied the south end of the southern lot and it was visible on the DEM.

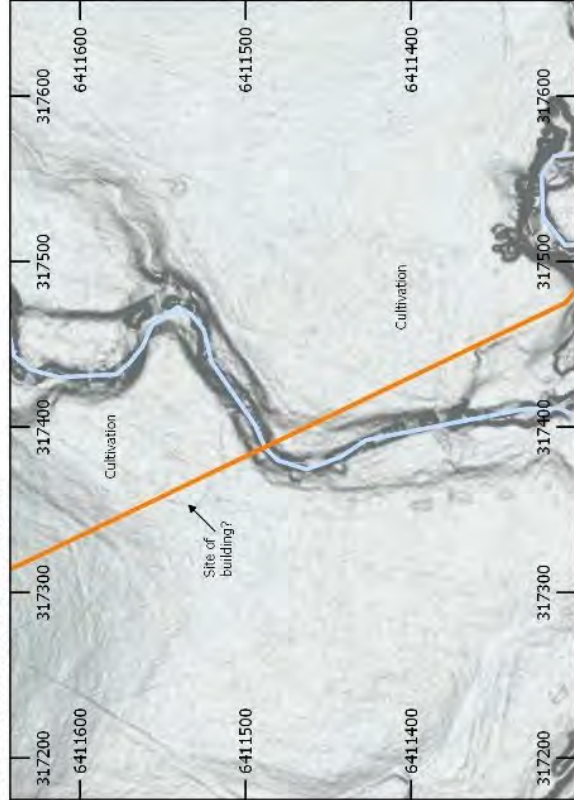
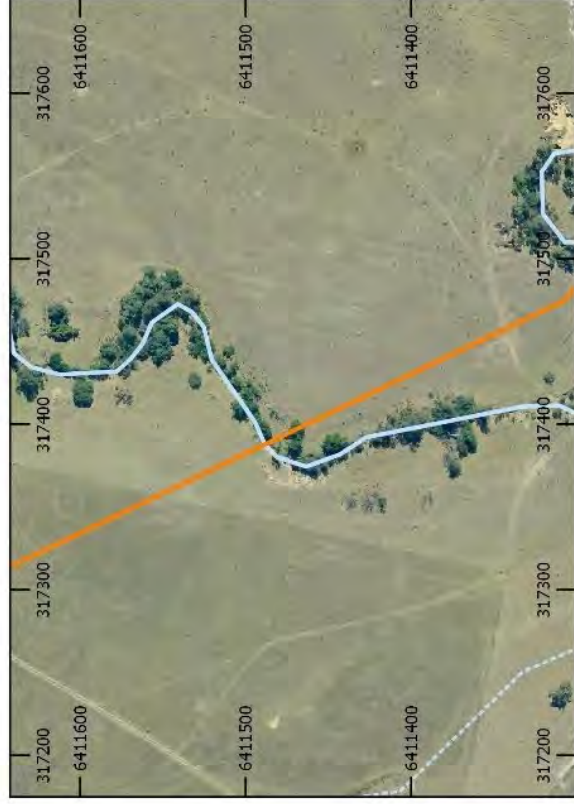
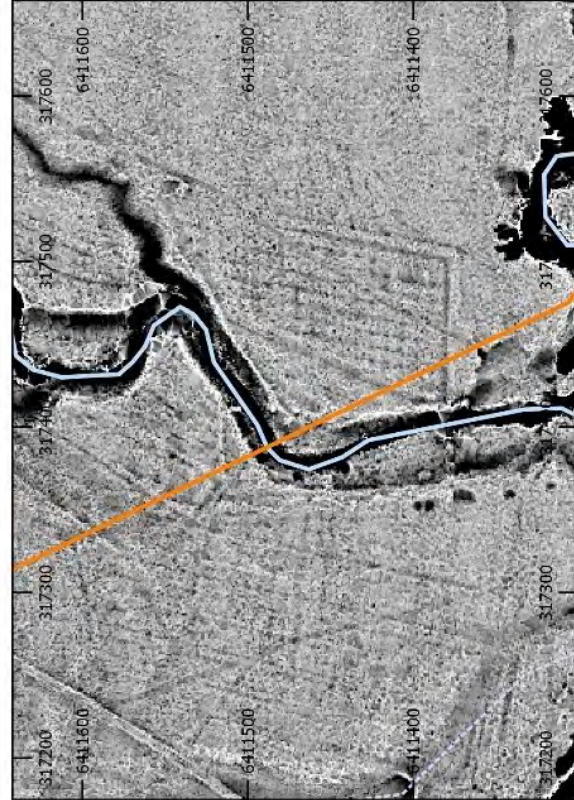
Figure 5.27: Southern cultivation areas on either side of Bowman's Creek. These are visible in the open positive (bottom left).

The most extensive area of cultivation (GCO16) was located on the floodplain lying between Bowmans Creek and Yorks Creek, located about 200m from the potential site of the old house (Figure 5.27). It was situated to the south and to the southwest of the ridge on which the early homestead was located. Groups of aligned linear anomalies are visible in the Lidar-derived DEM and traverse the older palaeo-channels. This relatively level area, of presumably relatively good alluvial soil, was close to the early homestead so it was potentially cultivated at an early date. The current linear anomalies could be later in date. The 1967 and 1983 aerial photographs do not show obvious signs of cultivation, however, some of the linear groups correspond to what appear to have been paddocks at that time.

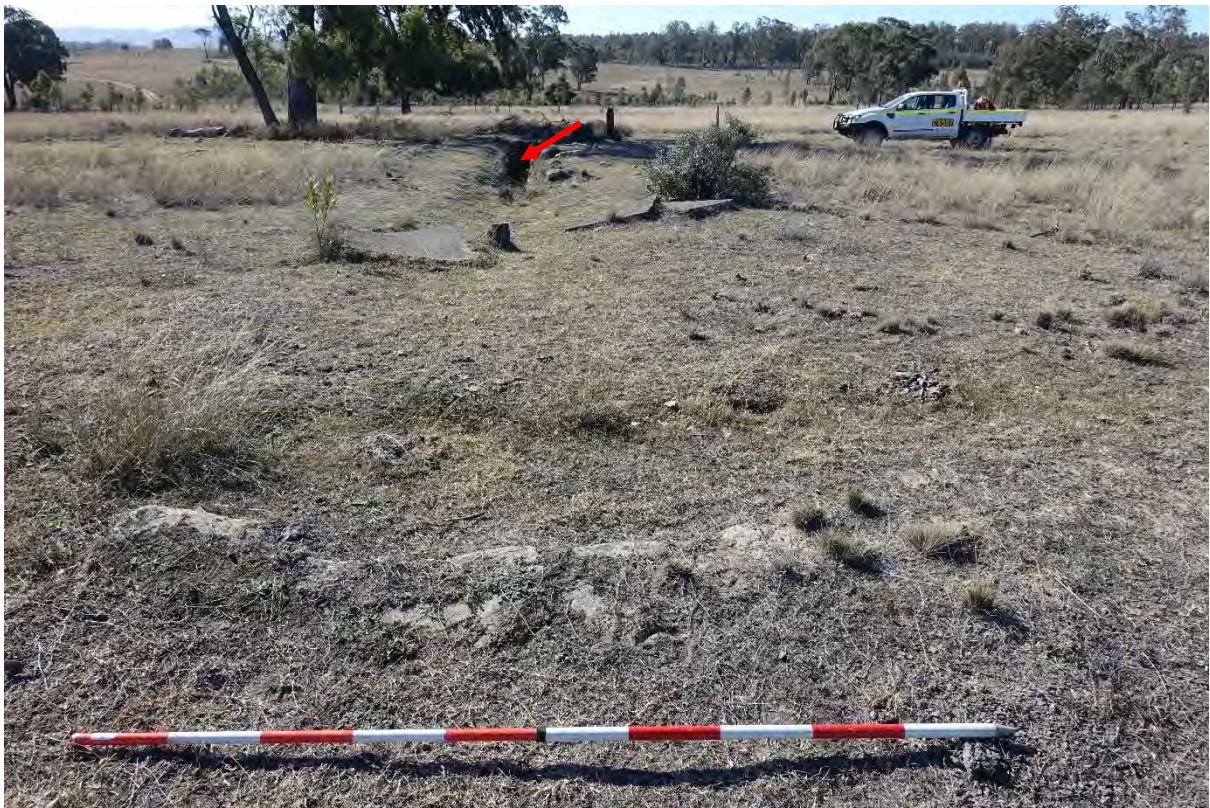
Figure 5.28: Sheep dip (arrowed), wall footing and fenceposts (facing north). Photo: Casey & Lowe.

The shearing sheds site (GCO5) was known from historic maps. The outline of a sheep dip had been surveyed. The GIS analysis of the Lidar-derived DEM revealed a number of clearly-defined anomalies immediately to the west of the sheep dip (Figure 5.29). A roughly rectangular area is defined on the west by a curved depression and on the east by three irregular anomalies. The north was featureless and linear. A rectangular anomaly on the southern side (measuring approximately 18m east-west and 9m north-south) is probably the site of a building. This area is likely to be the site of buildings and associated yards, or possibly even gardens. The site visit confirmed that mounds of stone and brick located at the east end of the site could be the remains of other walls and buildings. Other anomalies to the north and west of the sheep dip could be the remains of other structures. The environs must have been fenced too in order to manage and sort the sheep. Old fenceposts and the site of a gateway were observed around the site and they could be traces of this earlier system (Figure 5.28, Figure 5.30, Figure 5.31).

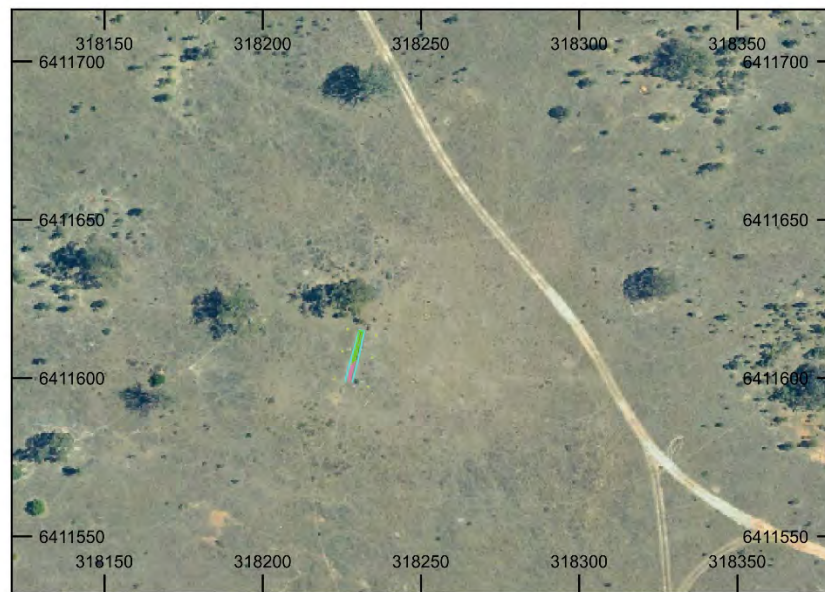
Figure 5.29: Site of sheep dip and woolshed.

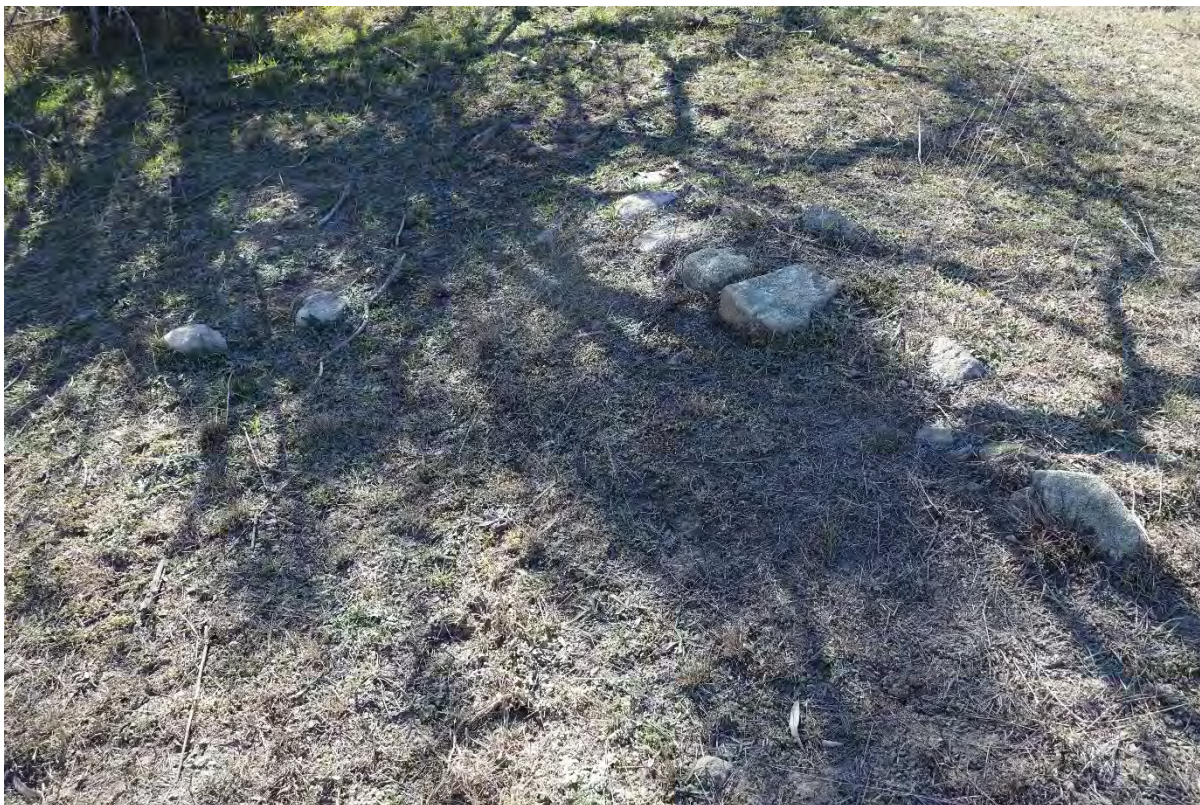
Figure 5.37: View of potential grave site partially outlined by rubble stone. Photo: Casey & Lowe.

A potential burial site (GCO6), considered by local oral tradition to be the possible resting place of John Bowman, was pointed out by Glencore employees. It was beneath a tree canopy and was located on the east bank of Yorks Creek, some 500m southwest of Ravensworth Homestead. There is a line of rectangular stones possibly forming an edge of some sort (Figure 5.37, Figure 5.38) and therefore possibly marking a grave. It is also 200m due east of the potential site of the early house. It is also around 20m south of the potential return of the early (1820s to 1830s) home paddock fence.

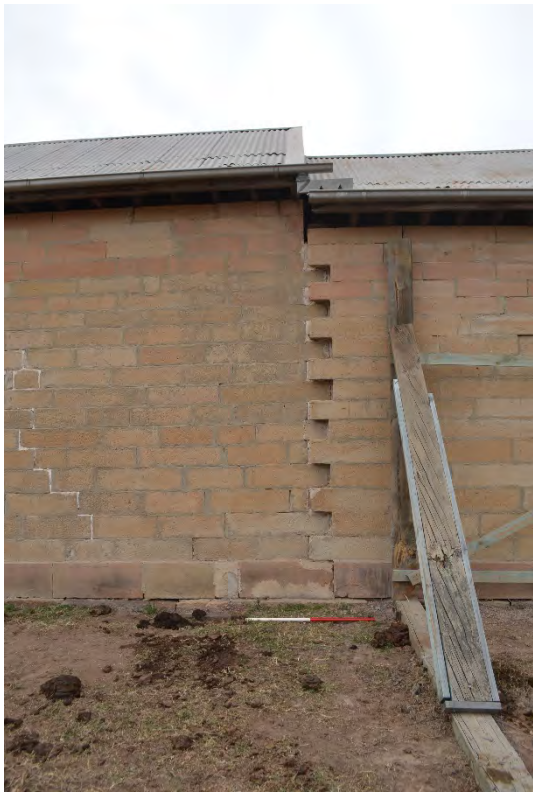
Tr A: General view. Stable, west-facing wall.	Tr A: Detail. Stable, west-facing wall.

Trench	Location	Observation	Orientation/ Trench size
Tr. A	Stable, west-facing wall	Lower foundation course partially visible.	E-W / 600mm by 800mm
Tr. B	Stable, east facing wall		E-W / 600mm by 800mm
Tr. C	Barn, west-facing wall	Lower foundation course partially visible.	E-W / 600mm by 800mm
Tr. D	Barn, south-facing wall/entrance	Area partially disturbed, evidence of modern plastic pipe visible.	E-W / 600mm by 800mm
Tr. E	Barn, east-facing wall, (northern end)	Lower foundation course partially visible.	E-W / 600mm by 800mm
Tr. F	East Wing, east-facing wall	Lower foundation course partially visible.	E-W / 600mm by 800mm
Tr. G	East Wing, east-facing wall	Lower foundation course already visible.	E-W / 600mm by 800mm
Tr. H	Join between Main House and East Wing	External sandstone floor across the whole area. Difficult to do this trench without removing flooring.	E-W / 600mm by 800mm
Tr. I	Main House east-facing wall (southern end)	Downpipe located in this area. Relocate trench immediately to north.	E-W / 600mm by 800mm

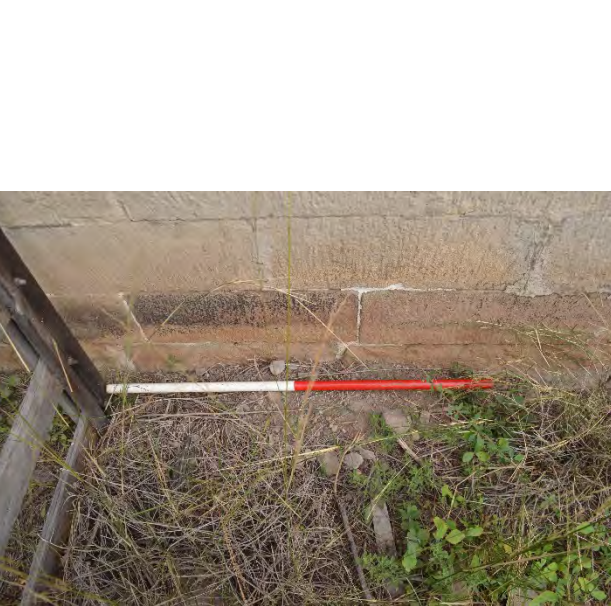
Tr B: General view. Stable, east-facing wall	Tr B: Detail. Stable, east-facing wall

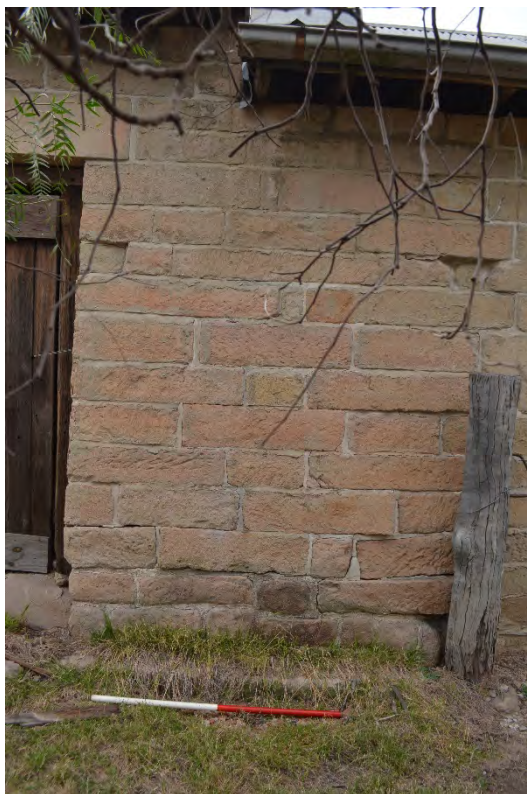
Tr C: General view. Barn, west-facing wall

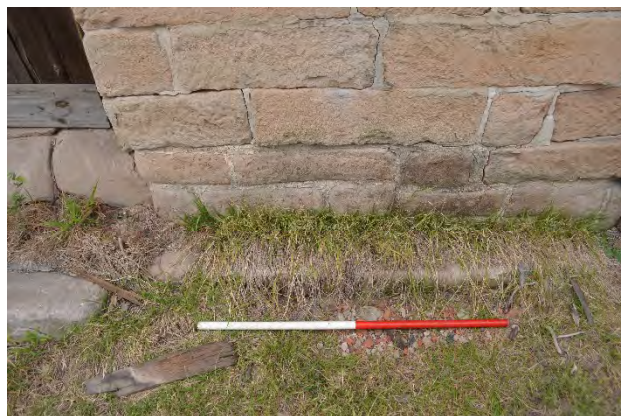
Tr C: Detail. Barn, west-facing wall

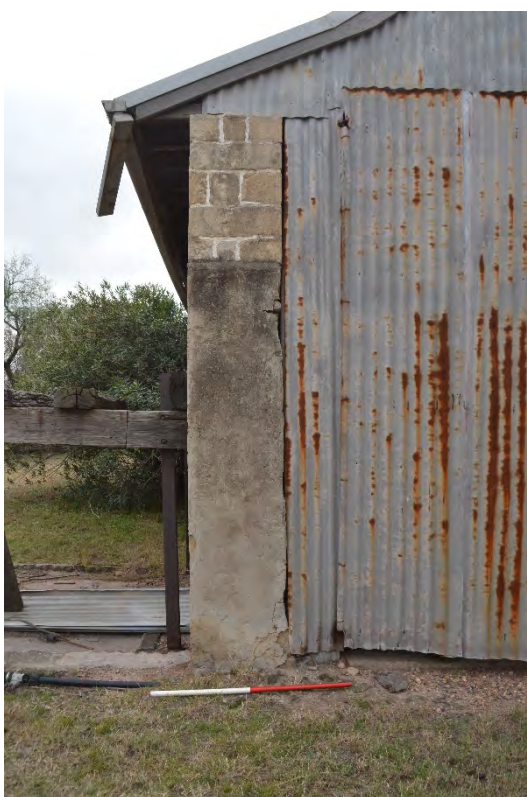
Tr D: General view. Barn, south face wall / entrance

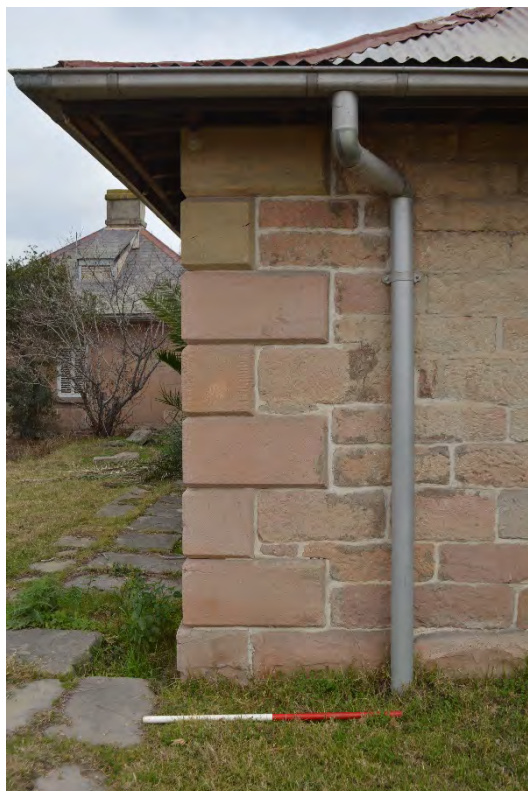
Tr G: General view. East Wing, east-facing wall

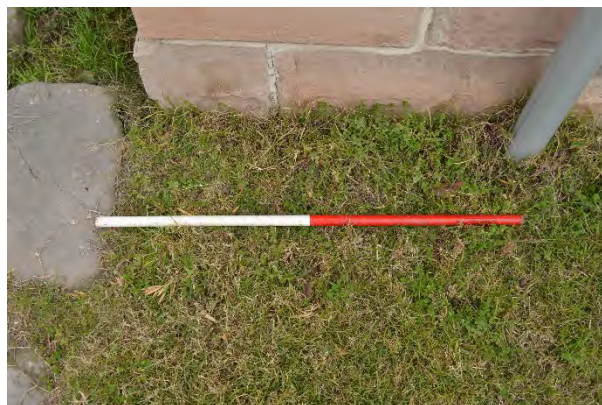
Tr G: Detail. East Wing, east-facing wall

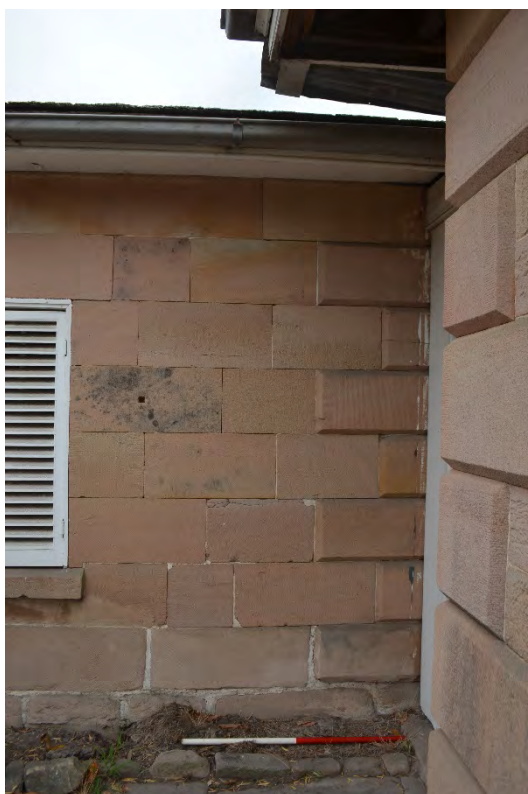
Tr H: General view. Join between Main House and East Wing

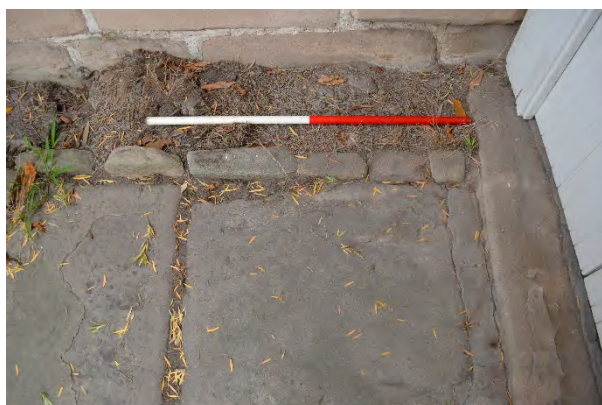
Tr H: Detail. Join between Main House and East Wing

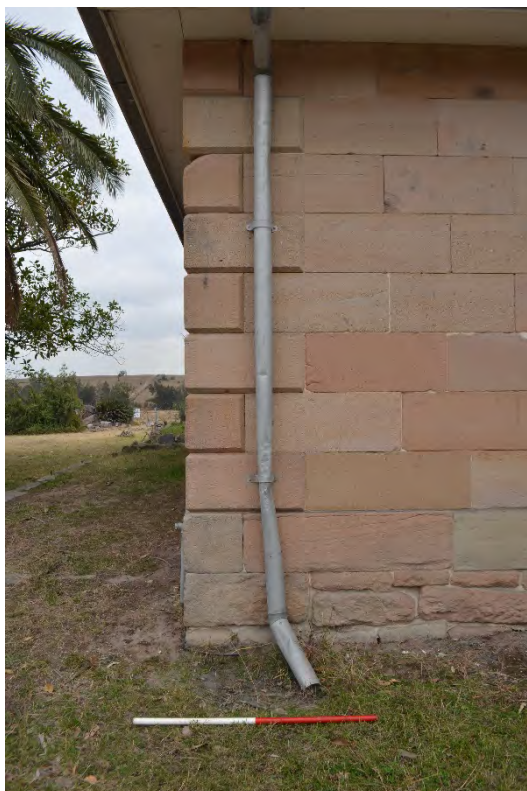
Tr I: General view. Main House east-facing wall (southern end)

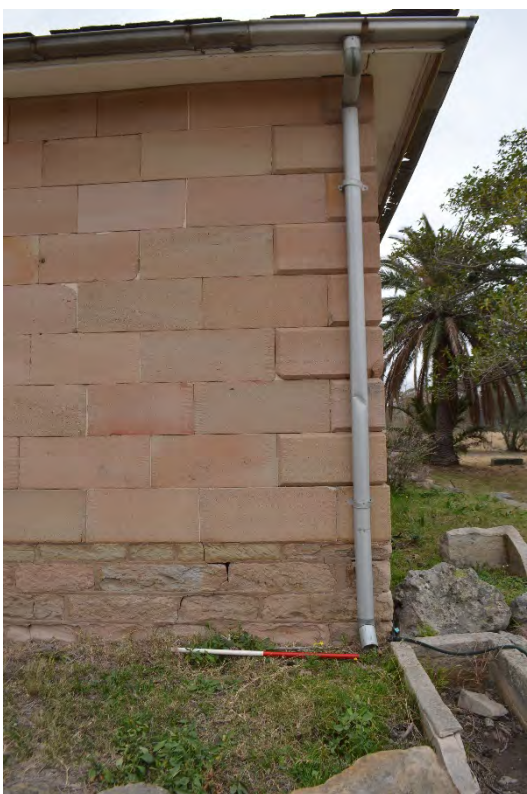
Tr J: General view. Main House west-facing wall (southern end)

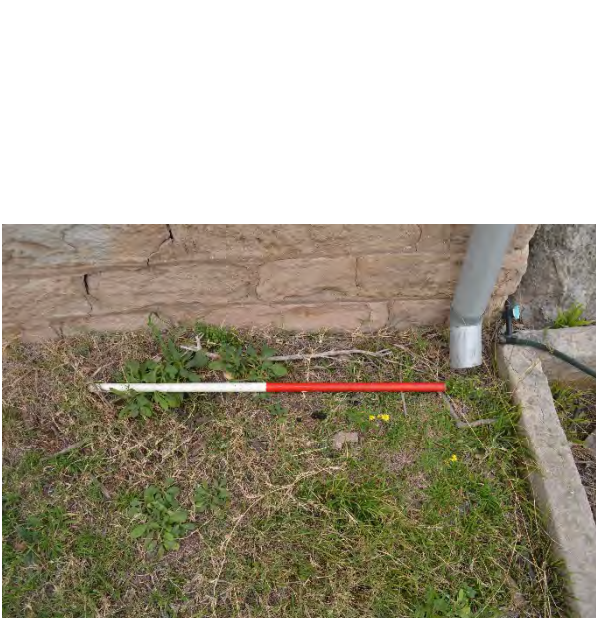
Tr J: Detail. Main House west-facing wall (southern end)

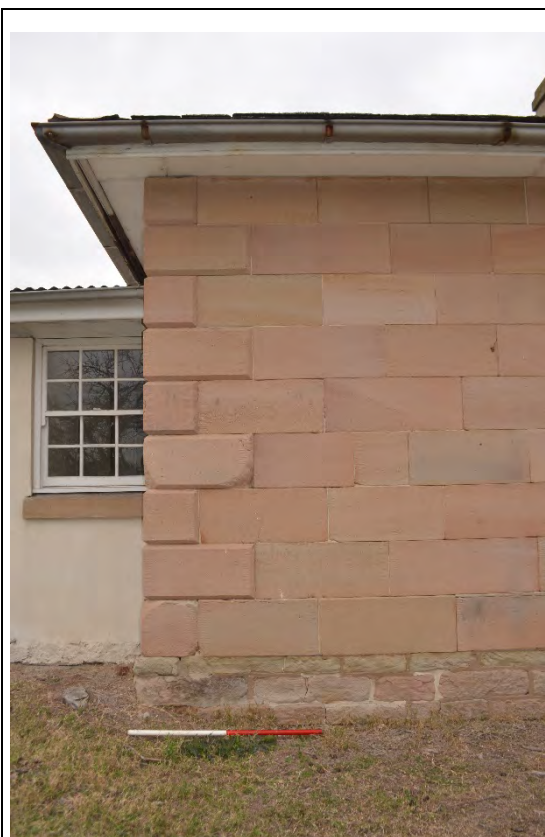
Tr K: General view. Main House west-facing wall (northern end)

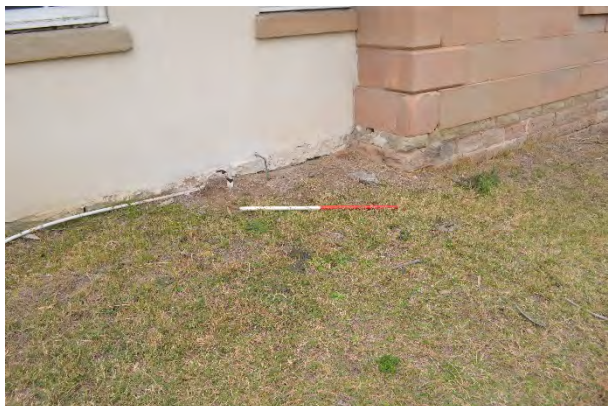
Tr K: Detail. Main House west-facing wall (northern end)

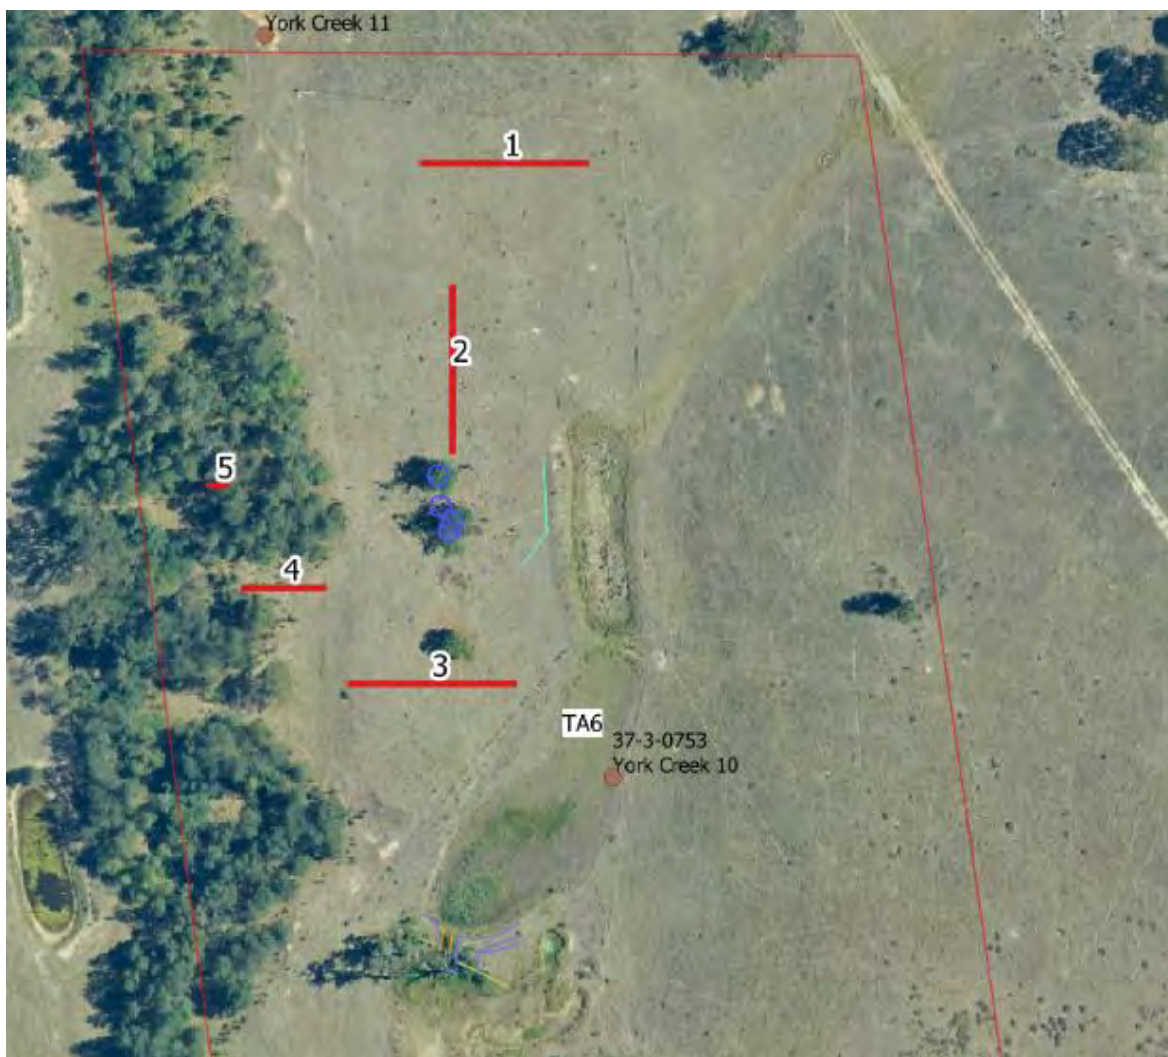
Figure 7.6: Plan showing proposed historical archaeological test trench locations in Test Area 6 (TA6) in relation to the AHIMS site 37-3-0753.

One of Casey and Lowe's proposed test locations includes AHIMS site 37-3-0753. The proposed test area is large and site 37-3-0753 and its vicinity will be avoided during the proposed historical archaeological testing program.
