# Glendell Mine Extension Ravensworth, NSW

## Statement of Heritage Impact

Prepared for:  
**Mt Owen Pty Ltd, Glencore**  
Locked Bay 6015  
Hunter Regional MC NSW 2310

Prepared by:  
**Lucas Stapleton Johnson & Partners Pty. Ltd.**  
Level 1, 191 Clarence Street  
Sydney NSW 2000  
Telephone: (02) 9357 4811  
Email: mailbox@lsjarchitects.com

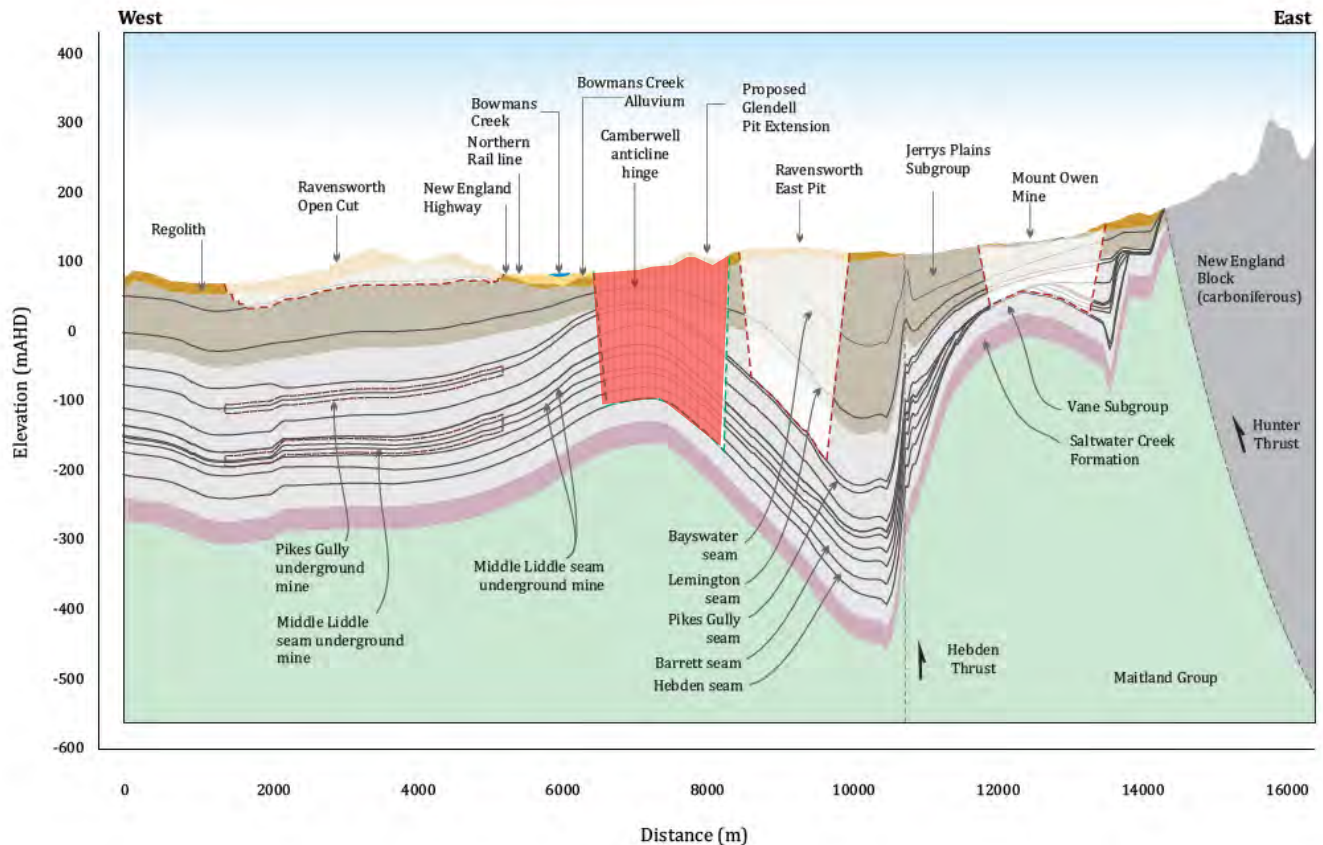
**Figure 3 - Geological Constraints**

Glencore proposes to extend the existing Glendell open cut mine to the north into one of the few remaining economically viable open cut coal resources in the Greater Ravensworth area. **Figure 2** and **Figure 3** illustrate the existing geological and surface infrastructure constraints, including the extent of previous and current coal extraction.

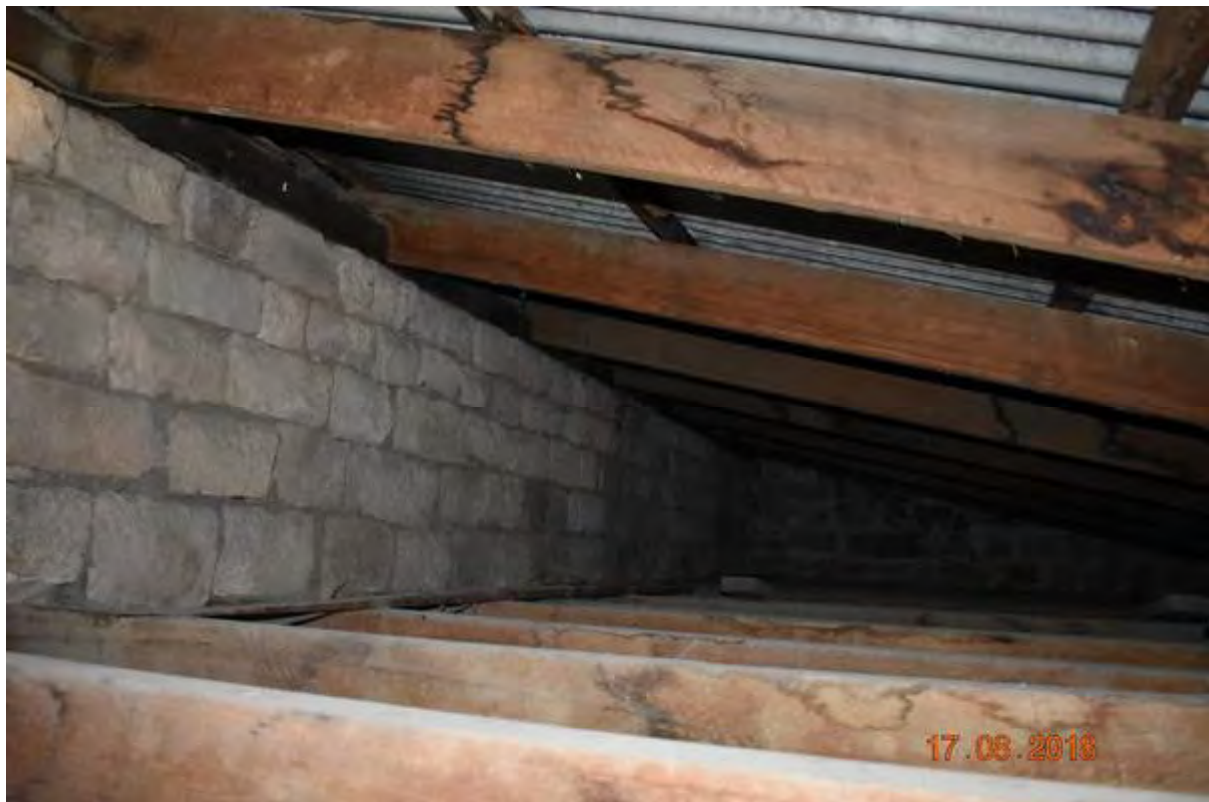
*Figure 6 – Roof arrangement to the rear of the homestead central section – showing the addition roof structure*

Removal of the rear additions reduces the overall clearance requirement to 9060 mm for the central section with significant overhang of the front veranda on one side if retained; and a worst case offset of around 5968 mm from the centre of the track width would result at 5534 mm above grade.

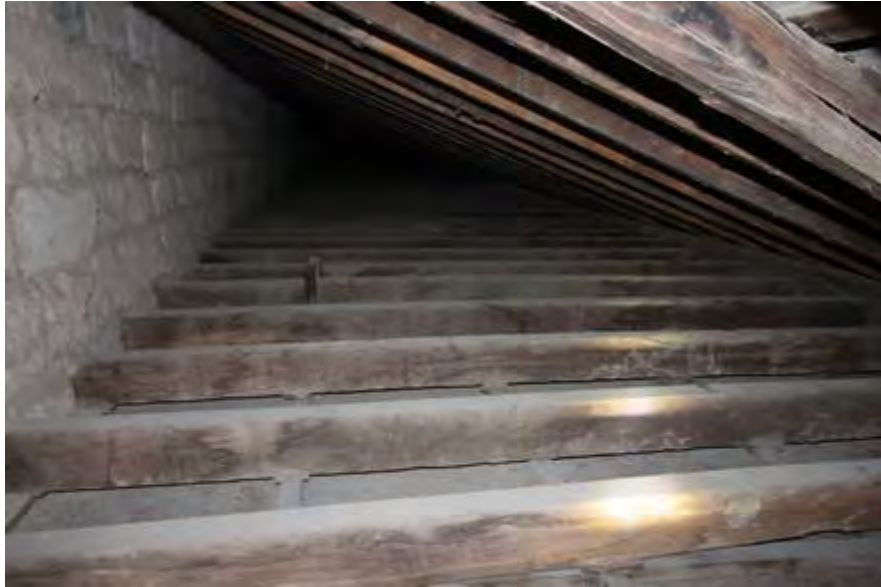
*Figure 7 – The front veranda roof framing showing the ceiling joists recessed into pockets in the front perimeter wall*

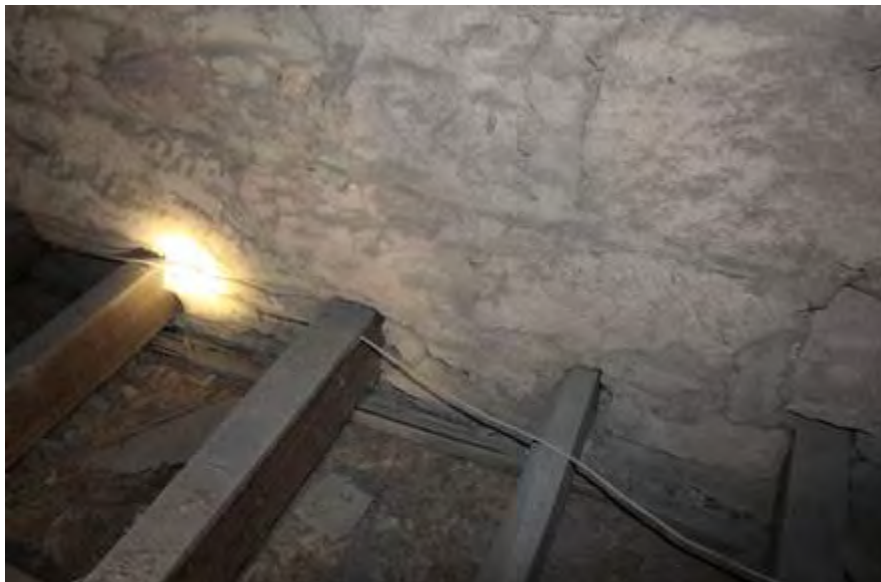
*Figure 8 – A close up of the pocket configuration taken from the western section of the homestead.*

This arrangement is comparable to that found at the veranda ceiling joist/wall interface

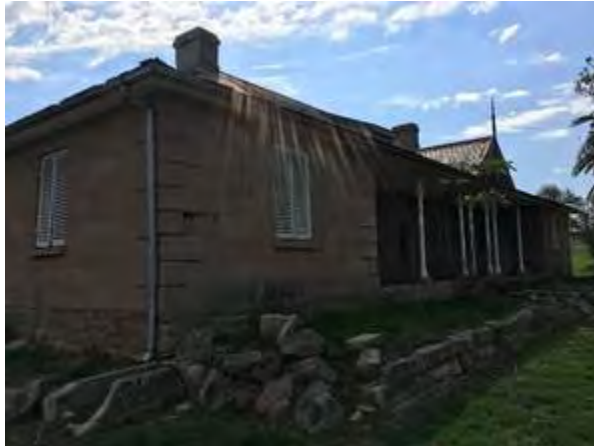
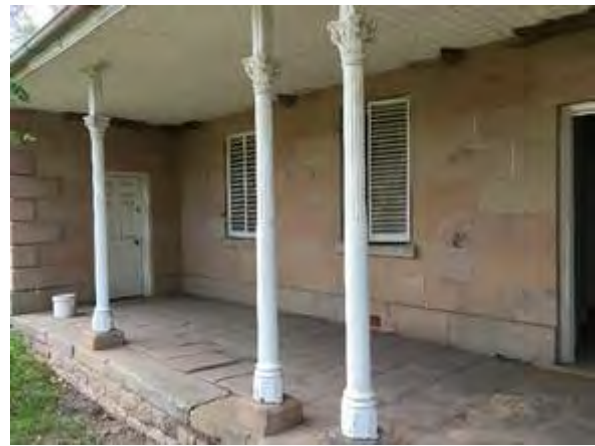
Figure 9 – Front verandah from the outside

The barn and the stable are both wider than the main house (when split in sections) however as they are essentially symmetrical and less in half width than the offset on the Kitchen section or the homestead central section (at the eave height) they are not the worst-case building sections in terms of clearance width.

The Kitchen was used as the basis for the clearance width for the route analysis given that the veranda could be removed from the Main Homestead if need be.

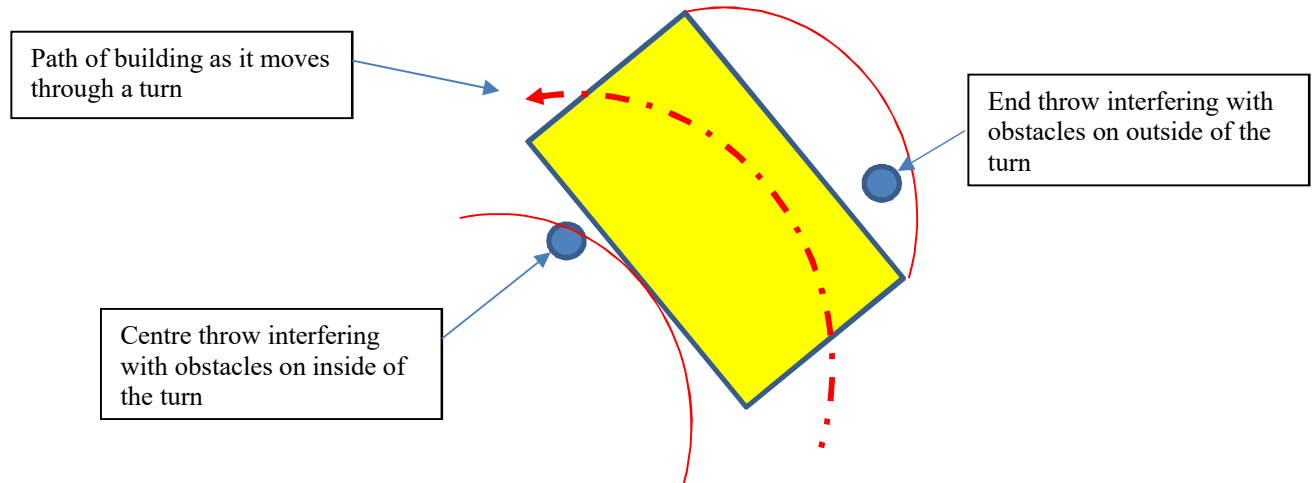
Figure 10 – Example layout where the end or centre throw of the building can conflict with external obstacles. Building moving around a curve

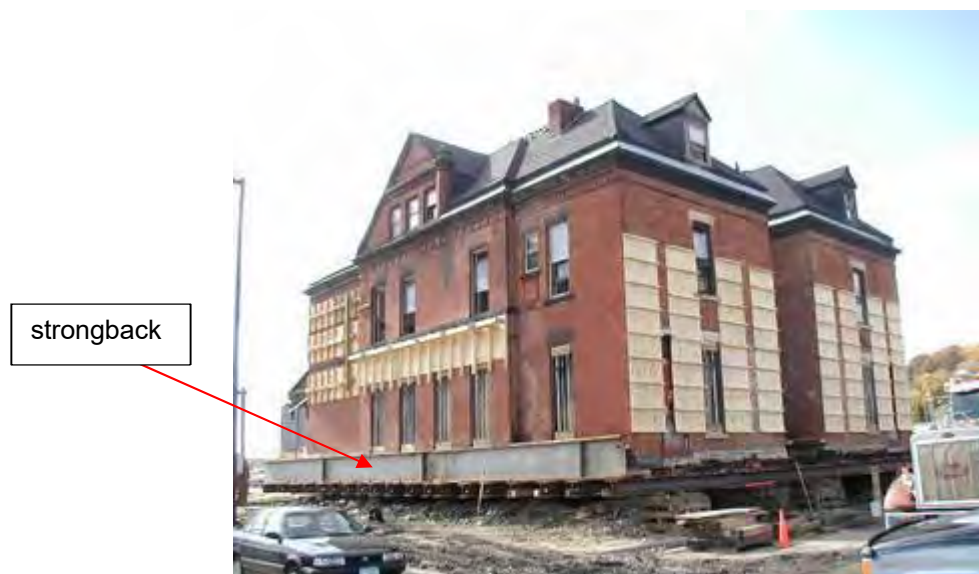
*Figure 14 – Strong back incorporated on a masonry move to stabilize the building platform (and cross steel cantilevers)*

Each technique comes with compromises and the load plane needs to be carefully configured to suit the topography to be traversed.

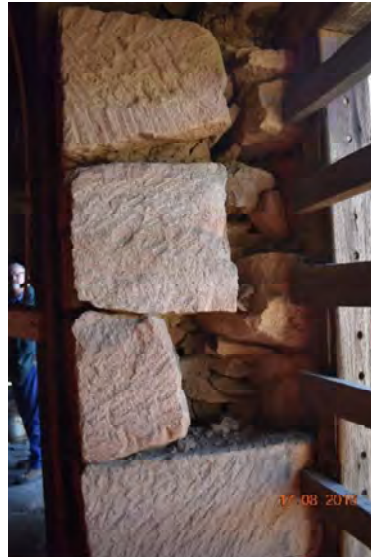
*Figure 17 – The inner leaf and rubble construction evident in a window in the stable. The outside leaf is not visible and is on the other side of the window frame*

The construction of the existing walls for all building in the Ravensworth complex are a three leafed system in approximately 1:1:1 ratio across the width i.e. 1/3 outside stone: 1/3 rubble: 1/3 inside stone. This compares to a monolithic wall construction where the walls are built as one solid leaf.

The walls of all stone buildings on the site vary between 470 and 640 mm thick. However the outer and inner leaves are estimated to be less than 180 mm thick in some places and are not well tied together with the use of tie stones appearing to be limited. In our assessment of the wall stability and resistance to listing, Mammoth has treated each wall as three separate leaves which are not tied together.

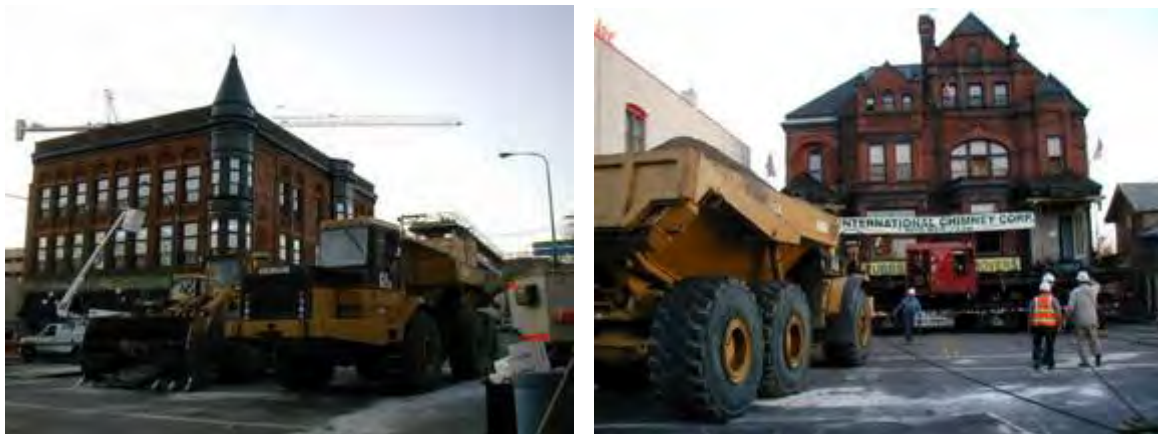
*Figure 24 – Example of tow vehicles used to anchor a building as it goes down a significant slope*

For slopes greater than 5-6% additional vehicles are likely to be required to control the structure on downward grades or to pull the building up the higher slope.

The route review must consider the inclusion of tow or braking vehicles for high slope sections and also for the leap frogging of the vehicles from front to back or vice versa where there is a change in slope from uphill to downhill or downhill to uphill.

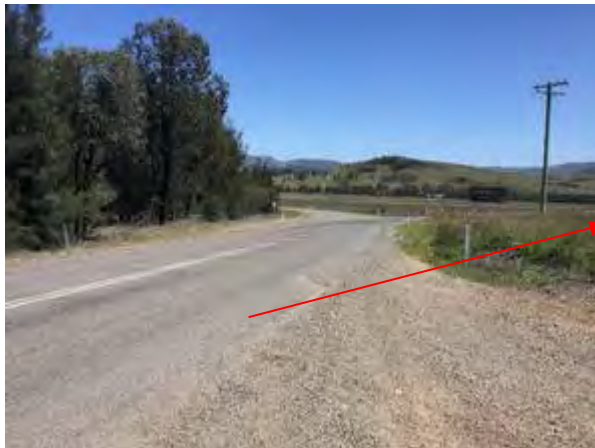
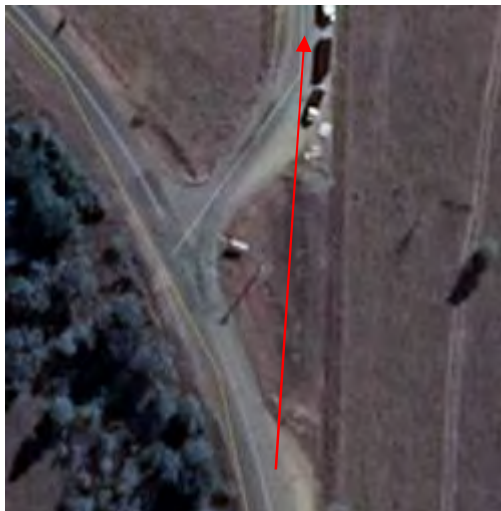
*Figure 29 – Picton's Lane – Hebden Rd intersection at road level and from above showing the powerpole with stay and proposed realignment.*

There is 1 public intersection on the Picton's Lane Route. This is the turn off into the Lane itself. If the buildings are relocated to Picton's Lane, turn off at this location will need re-work. Ideally the corner of the intersection would be cut to avoid a difficult turn with cross fall. However a power pole exists at this point which incorporates a stay which traverses the alignment of the proposed redirection. This pole will therefore need to be removed and or re-stabilised in some way. The powerlines will also need to be crossed at this point and sufficient clearance will need to be maintained

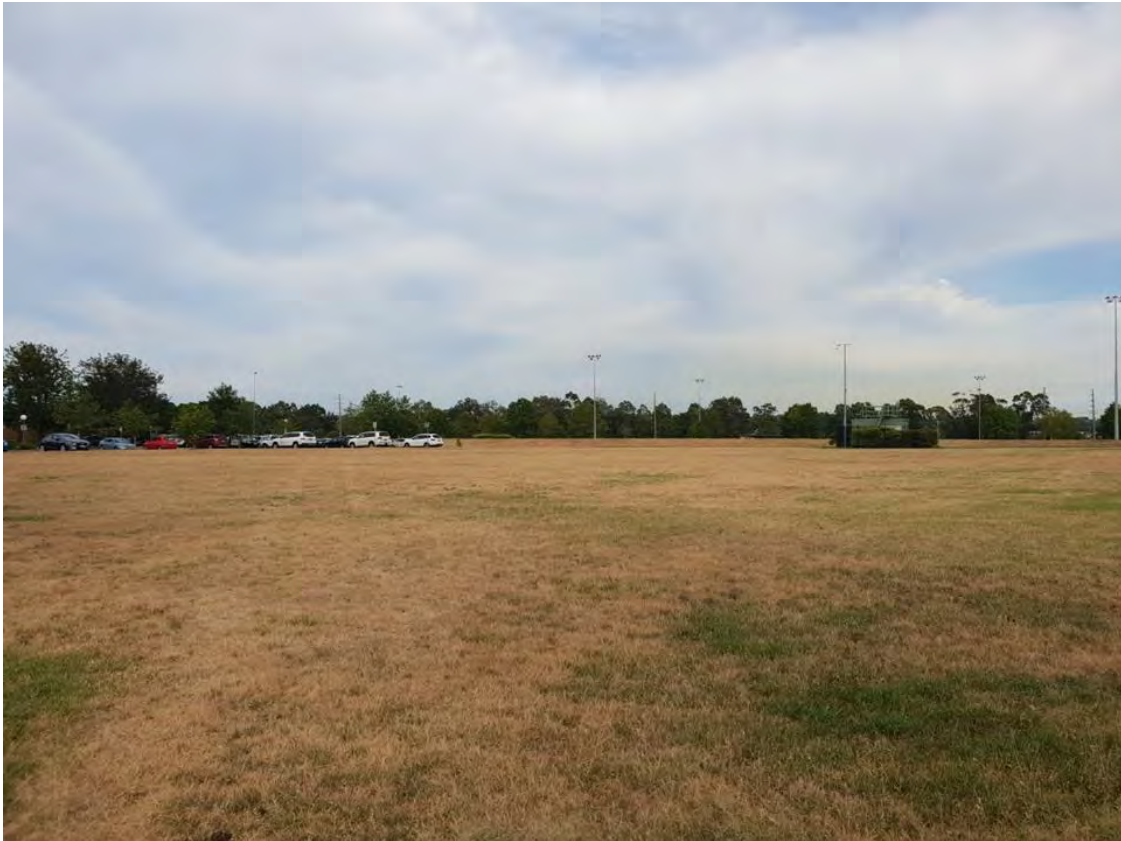
- Air quality monitoring station located at the rear of site. These monitors have restrictions on their proximity to other landuses and may need to be relocated with agreement from EPA/OEH to facilitate the homestead relocation.
- Power supply box located at the front right-hand side of the site
- Site is easily accessible via Civic Avenue
- Site is surrounded by business including childcare, swimming pool, gym, council and motel
- Terrain is flat and the area appears to be just of adequate size to fit the relocated homestead complex in its original layout, however without much space for a recreated circular driveway or other contextual features from the historical homestead layout.

**Plate 1      Option 1 – Singleton Site 1 – Civic Avenue**

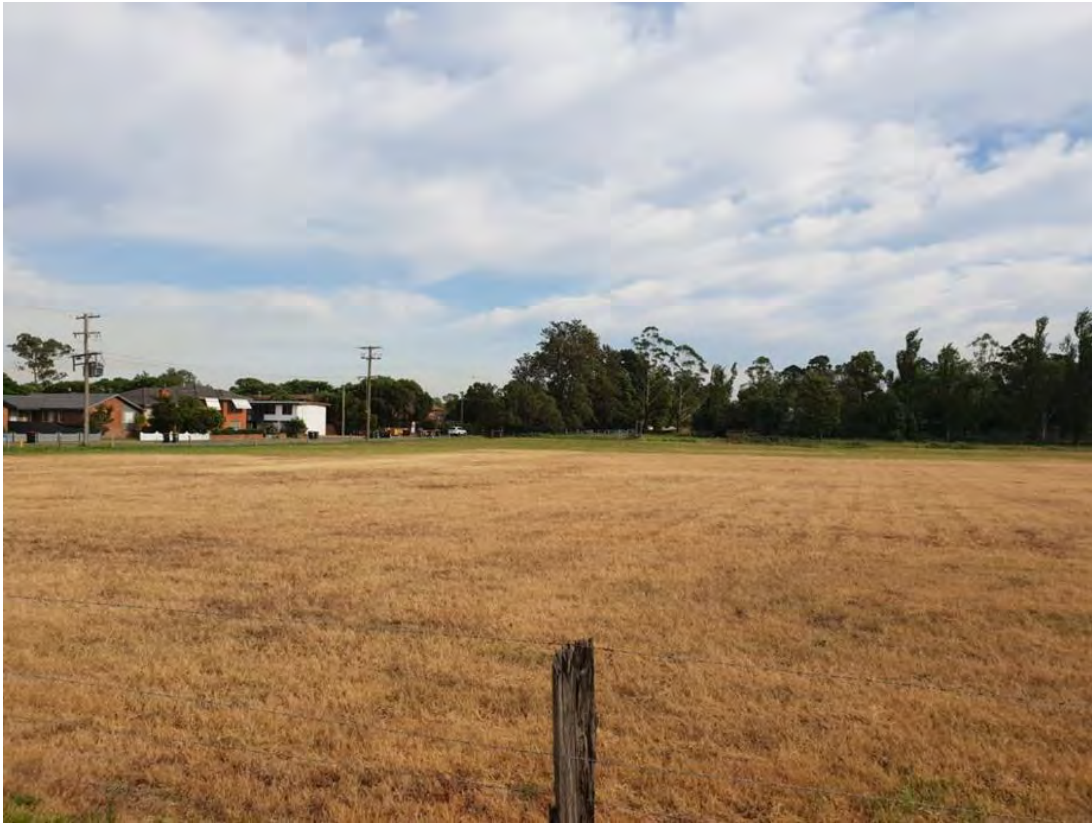
- Cattle yards are located at rear, left-hand side of site
- Powerlines run along Boonal Street (on the left-hand side of the site)
- Site is easily accessible via Boonal Street or Howe Street
- Terrain is flat with a gentle downward slope away from Howe Street towards the rear of the site
- Appears to be adequate space for the relocated homestead complex, although historical contextual features such as the circular drive would not fit if the original building layout was maintained.

**Plate 2      Option 2 – Singleton Site 2 – Howe Street**

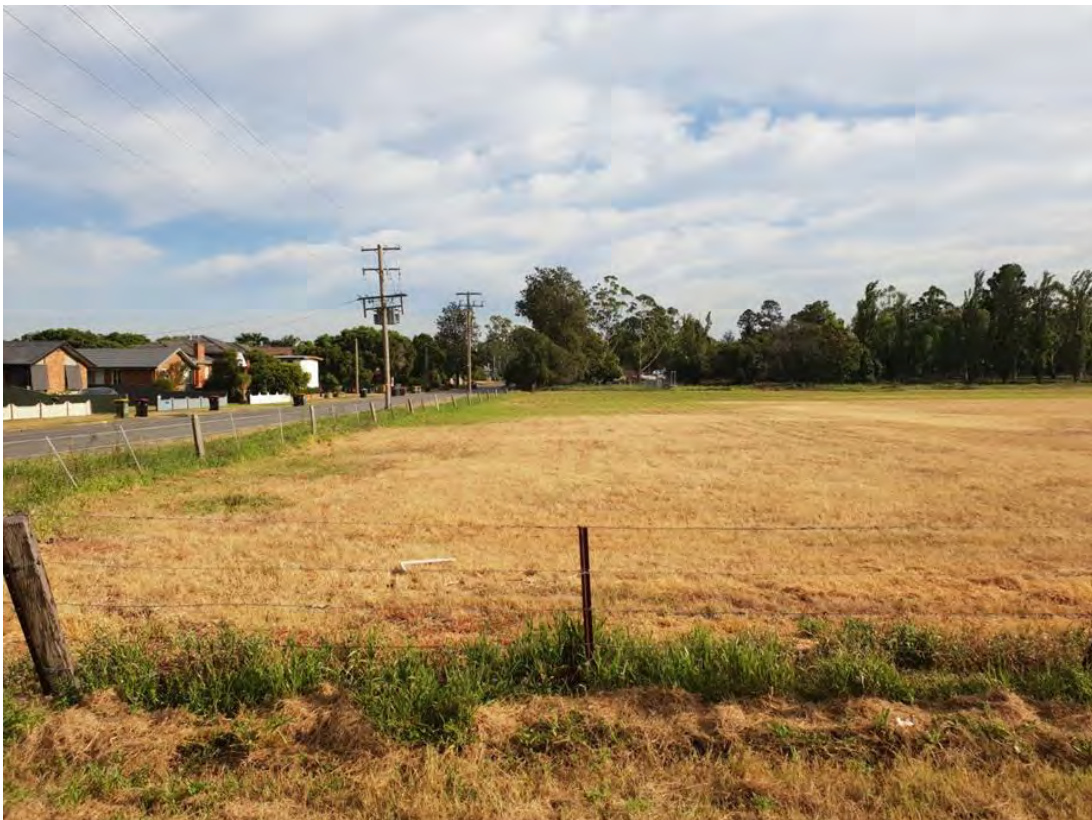
**Plate 3      Option 2 – Singleton Site 2 – Howe Street**

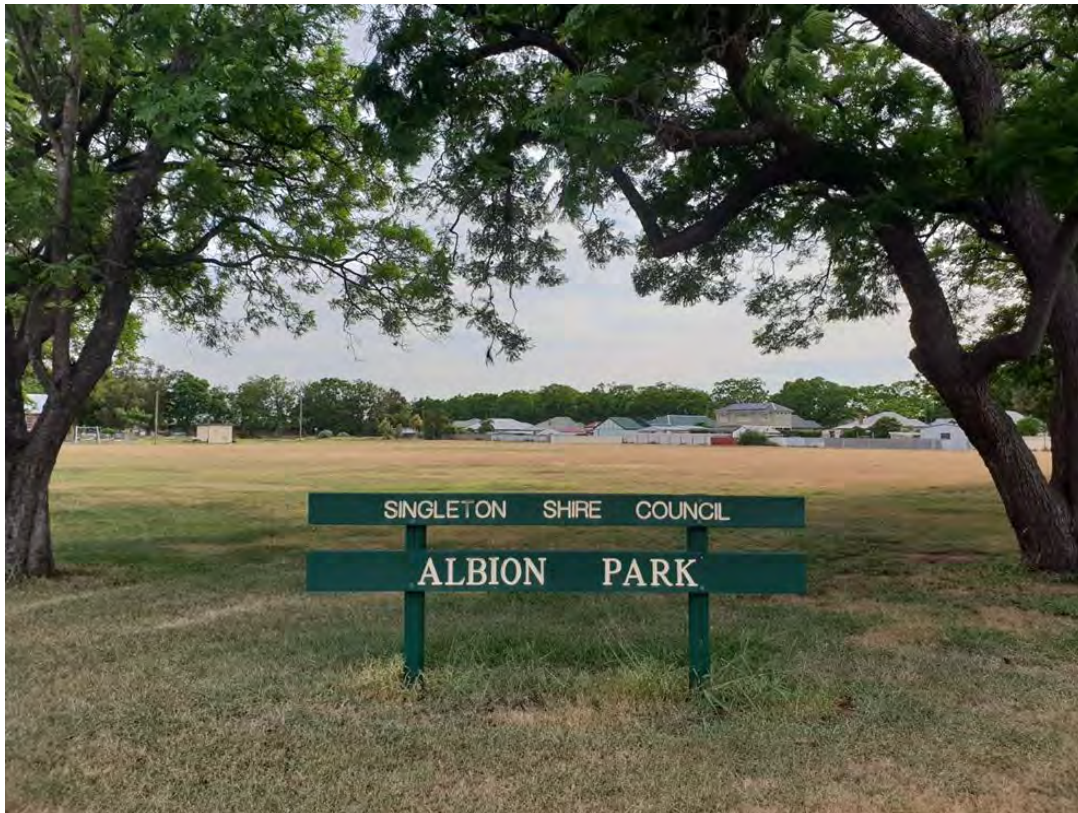
- Cricket pitch in centre of site
- Large trees run along Bathurst Street and Wynyard Street
- Three picnic tables and shelters as well as two taps run along Wynyard Street
- Site is easily accessible via Bathurst or Wynyard Streets
- Terrain is flat, site appears to provide adequate space for the relocated homestead complex.

**Plate 4      Option 3 – Singleton Site 3 – Albion Park from Bathurst Street**

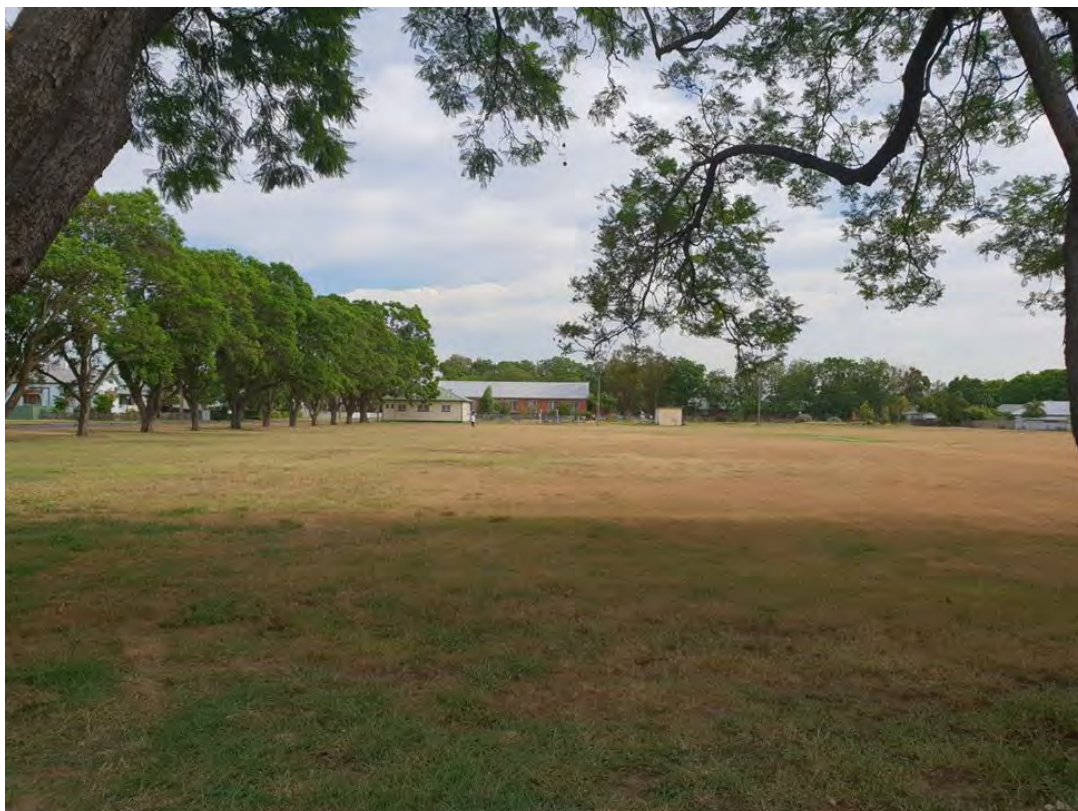
**Plate 5      Option 3 – Singleton Site 3 – Albion Park from Wynyard Street**

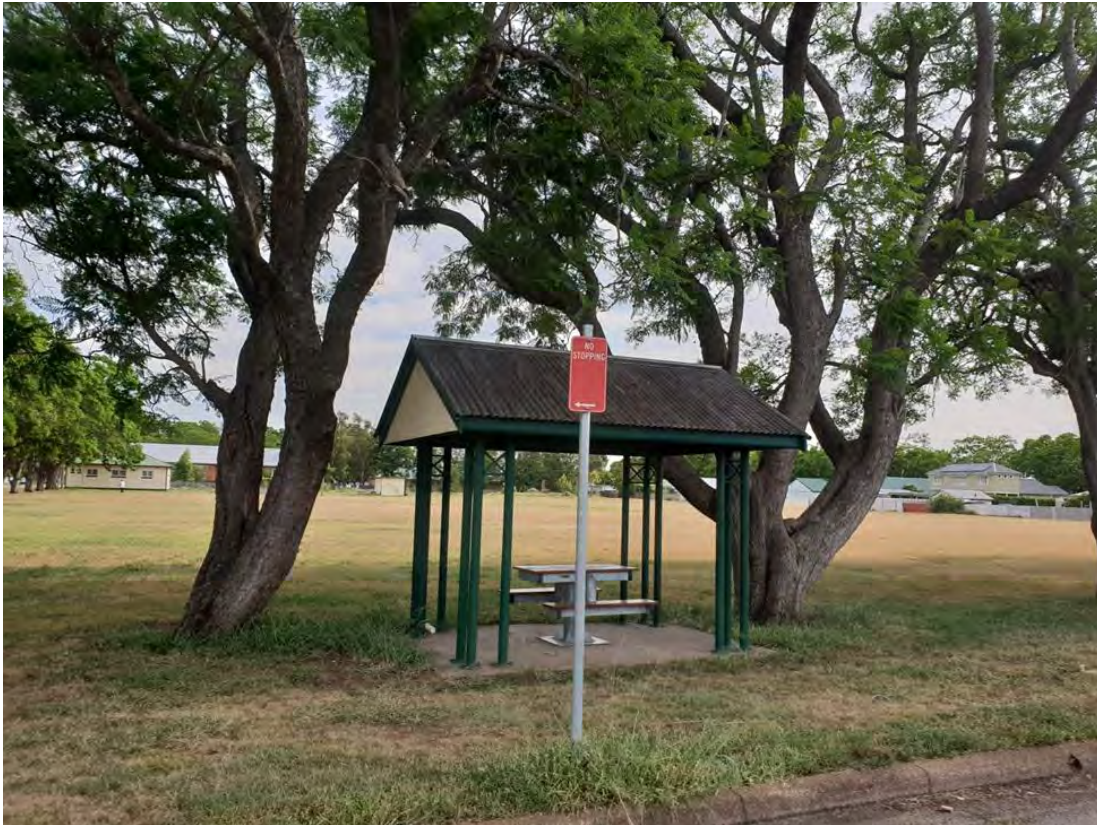
**Plate 6      Option 3 – Singleton Site 3 – Albion Park from Wynyard Street**

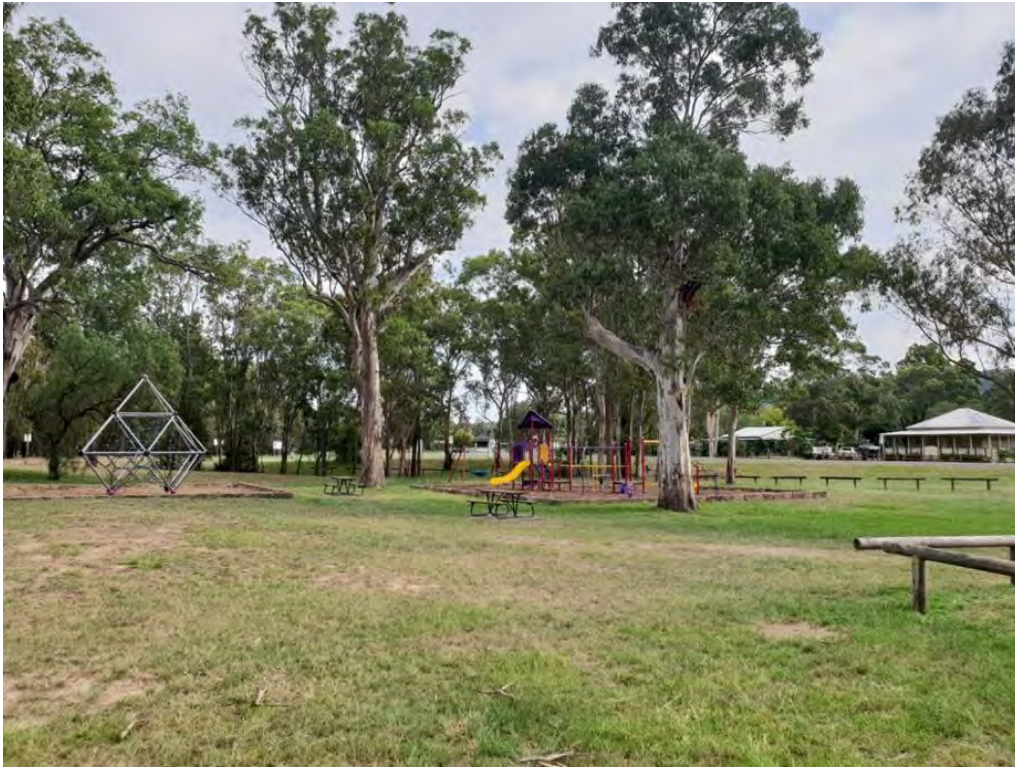
- Playground and picnic tables are located within the site – would need relocating
- Gravel road and carpark are located within the site
- War memorial is located within the site – may need relocation and would be subject to community stakeholder consultation
- Adjacent to NSW Rural Fire Station
- An absorption trench is located within the left-hand side of the site
- Site is easily accessible via Wollombi Street
- It should be possible to re-establish a circular drive to the front of the relocated homestead to enhance heritage aspects if required.
- Terrain undulates by approximately one metre across the site
- Vegetation mapping shown as non-native is not confirmed at inspection. This will require further investigation to determine species present. See **Plates 7** and **Plate 8**.

**Plate 7      Option 4 – Broke Site 1 – Wollombi Street (South)**

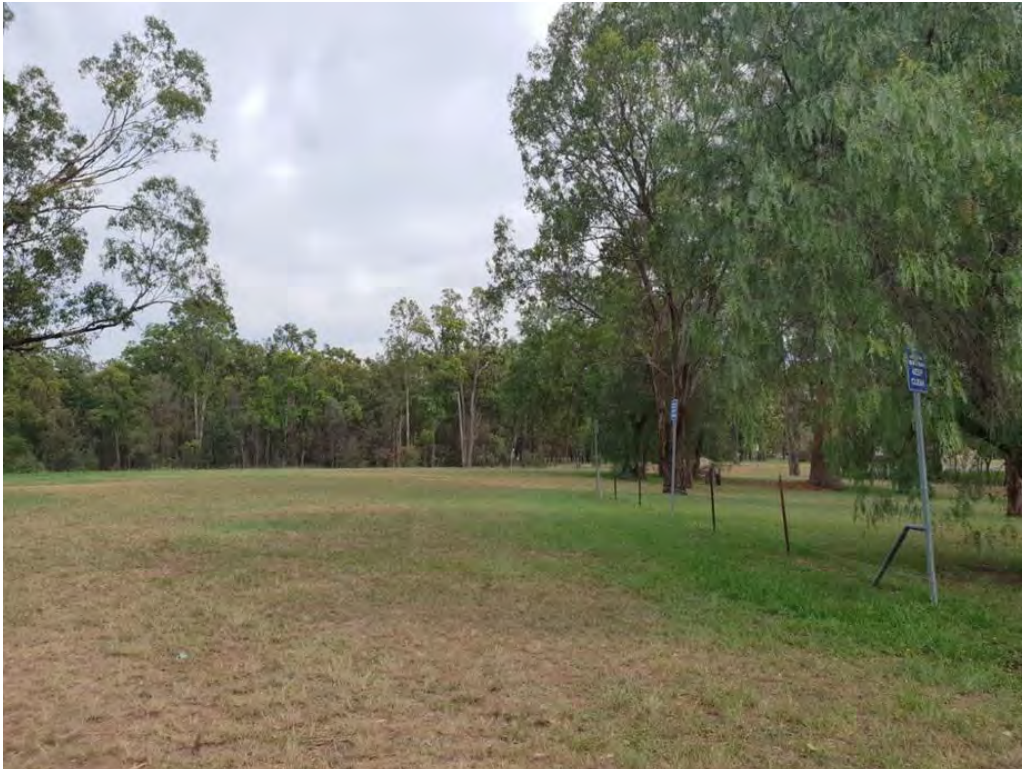
**Plate 8      Option 4 – Broke Site 1 – Wollombi Street (South)**

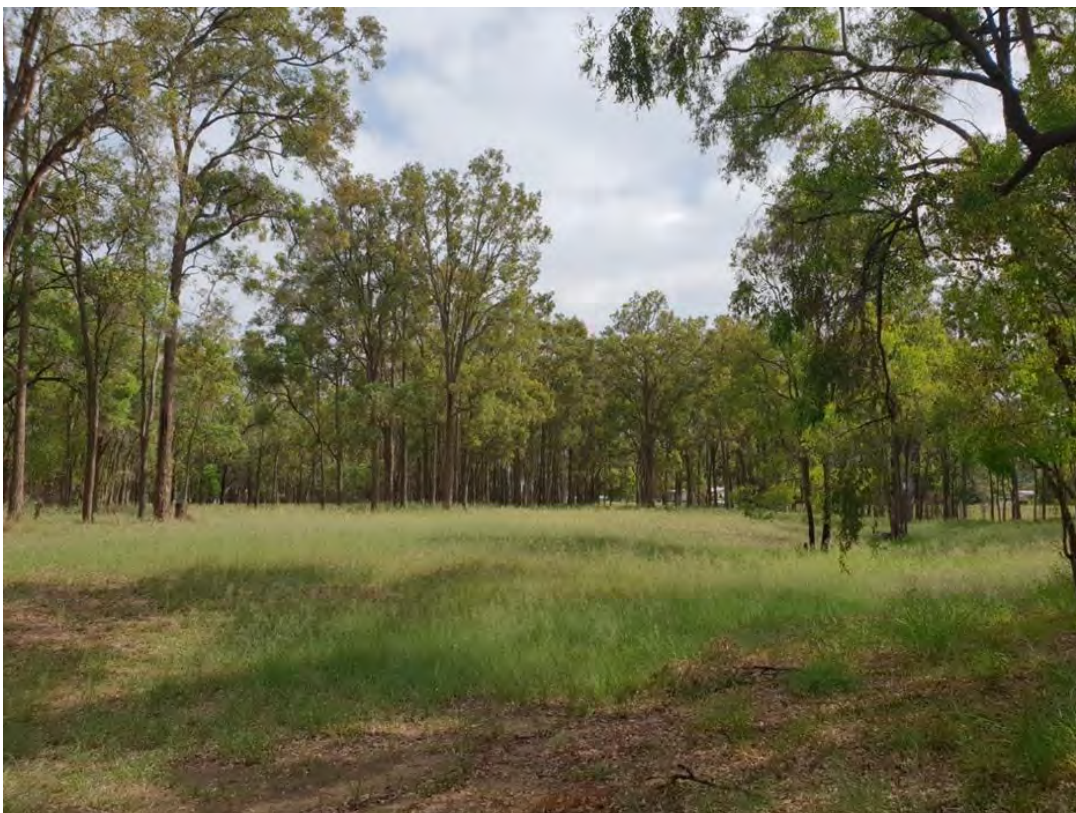
- Site contains established vegetation (trees) but has pockets of open space
- Public toilets and camping areas located to the North of the site
- Site is accessible via Milbrodale Road or Wollombi Street
- Terrain is relatively flat with one main depression through the centre of the site that is likely to require filling to mitigate flood risks.

**Plate 9      Option 5 – Broke Site 2 – Wollombi Street (North)**

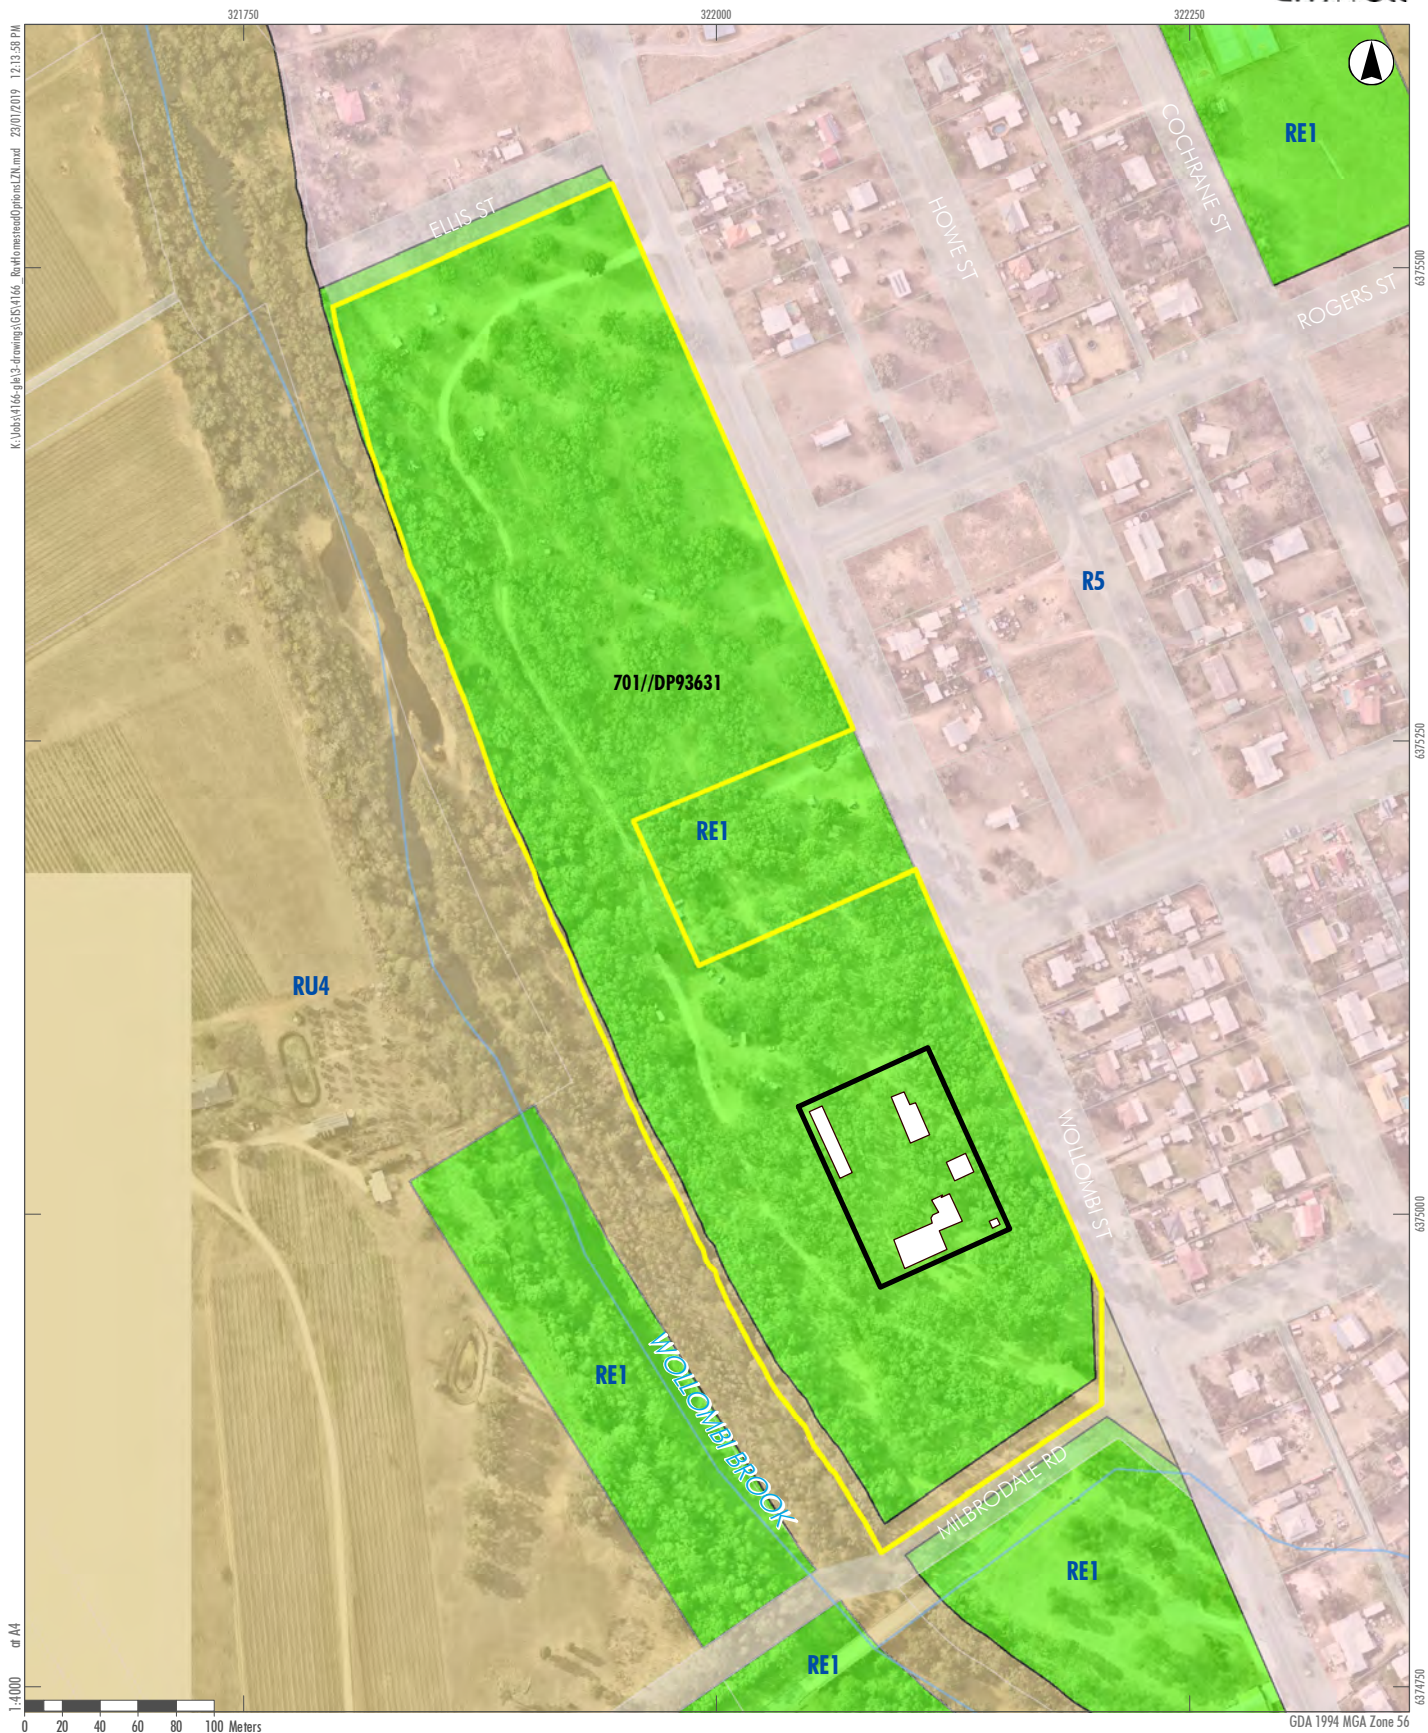
FIGURE 5.1

Option 5 - Broke Site 2 - Wollombi Street (Nth) Overview

The site is not included within the Flood Planning Map in the LEP (**Figure 5.1**), however given the site is located between the watercourse Wollombi Brook and the flood planning area, it can be assumed that the site would be potentially effected during a 1:100 ARI flood event.

Whilst the known Aboriginal heritage site would remain unaffected as it is outside of the proposed site (**Figure 5.1**), given the proximity of the relocation area to permanent water (Wollombi Brook) and the presence of a known Aboriginal site nearby, it is reasonable to assume that further Aboriginal heritage sites are likely to be present and appropriate surveys and investigations and potentially additional permits would be required prior to development.

The proposed site would impact on McNamara Park (**Figure 5.1**). The local community provided feedback during the Our Villages Our Vision 2012 study which states that McNamara Park is well utilized by tourists and brings visitors to the area for low key holidays. The need to protect and expand the area as a gateway to the National Park was also noted by the community.

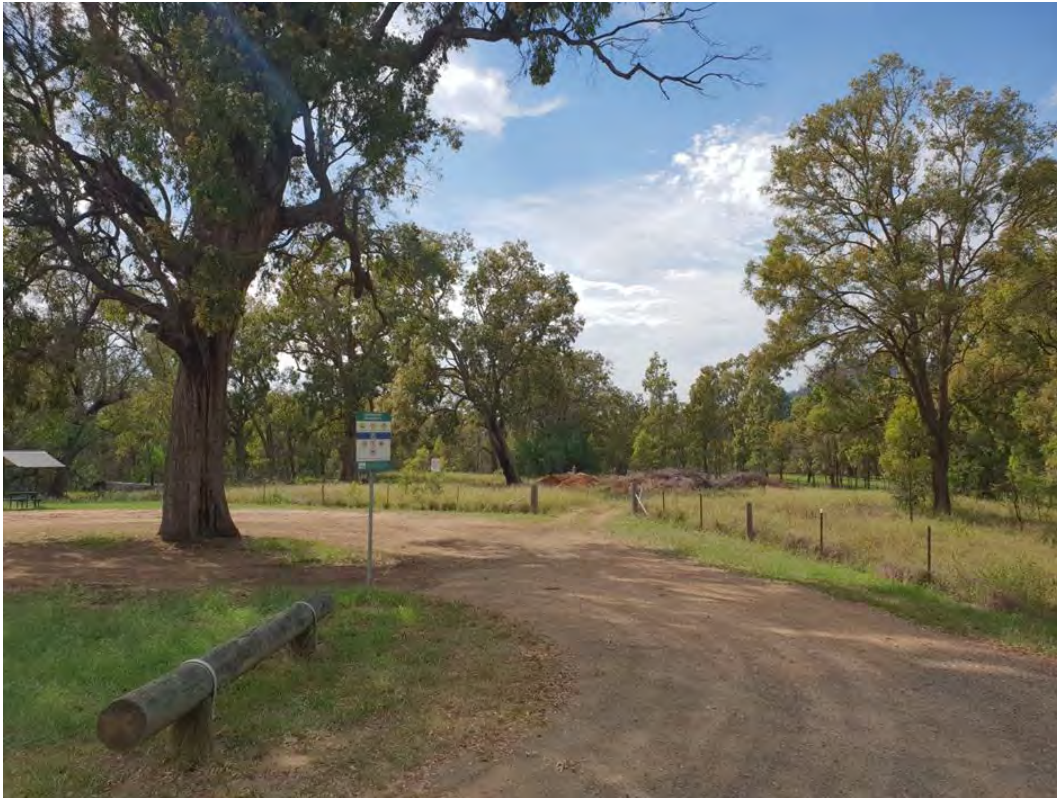
**Plate 11 Option 6 – Broke Site 3 – Milbrodale Road**

- One picnic table located on the site which is accessed via a gravel road/carpark
- Logs and mulch/woodchip currently in a pile located within the site
- Site is easily accessible via Milbrodale Road
- Terrain is mostly flat however on the right-hand side of the current entrance there is a steep depression where water is likely to flow
- Extensive vegetation to be cleared and potentially offset

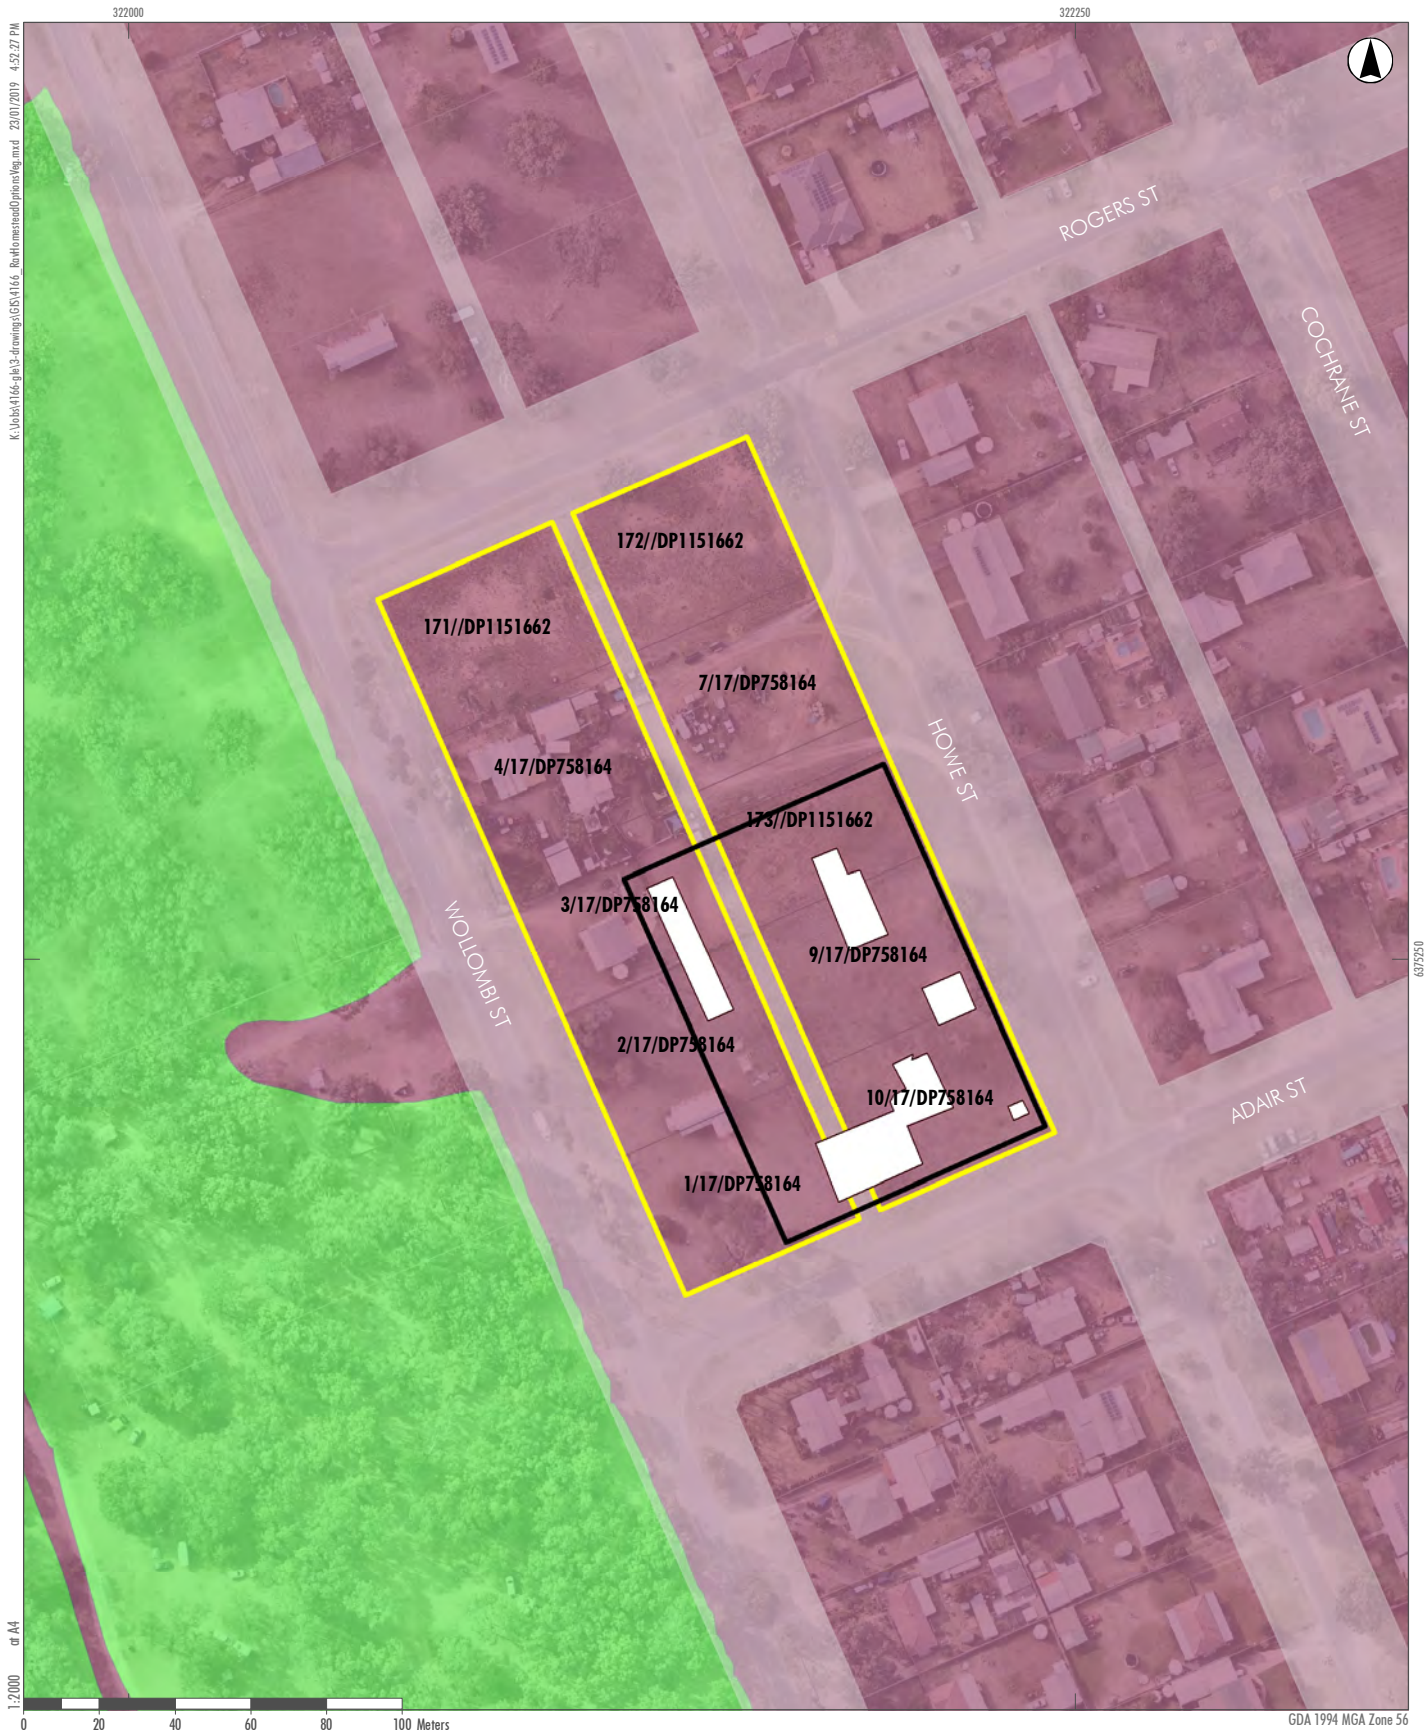
FIGURE 7.2

Option 7 - Broke Site 4 – Adair Street  
Land Zoning (Singleton LEP 2013)

Refer to **Figure 7.2**.
