# Glendell Mine Extension Ravensworth, NSW

## Statement of Heritage Impact

Prepared for:  
**Mt Owen Pty Ltd, Glencore**  
Locked Bay 6015  
Hunter Regional MC NSW 2310

Prepared by:  
**Lucas Stapleton Johnson & Partners Pty. Ltd.**  
Level 1, 191 Clarence Street  
Sydney NSW 2000  
Telephone: (02) 9357 4811  
Email: mailbox@lsjarchitects.com

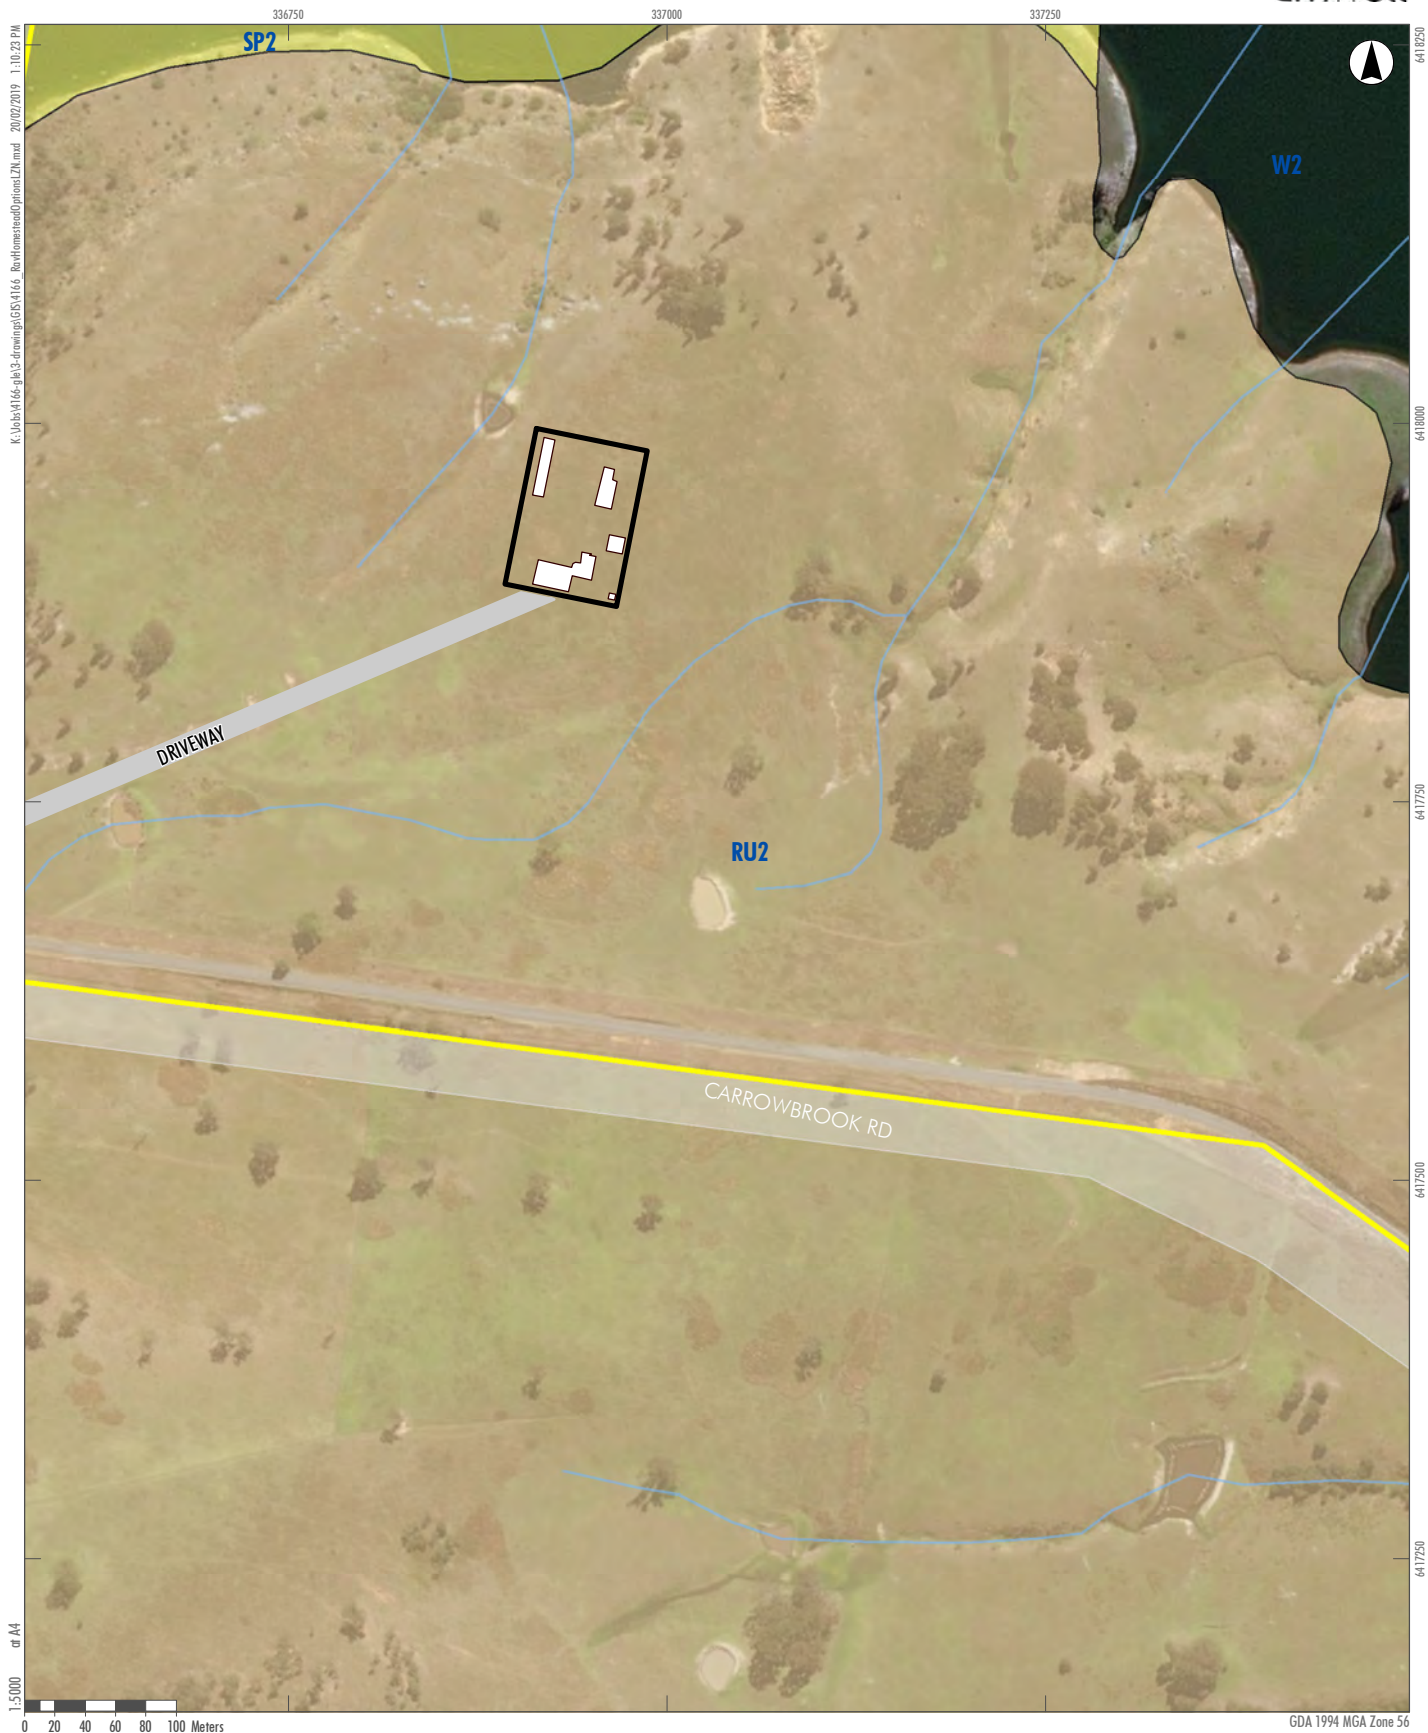
FIGURE 9.1

Option 9 - Lake St Clair Site 2 Overview

The site is not included within the Flood Planning Map in the LEP (**Figure 9.1**). It is assumed that the zoning boundaries for Singleton LEP zones W7 and SP2 shown on **Figure 9.2** were determined using Lake St Claire maximum storage levels which indicates that the proposed site is above the maximum storage level. Lake St Clair maximum storage levels should be checked to confirm this.

The Aboriginal site is would remain unaffected as it is outside of the proposed site (**Figure 9.1**).

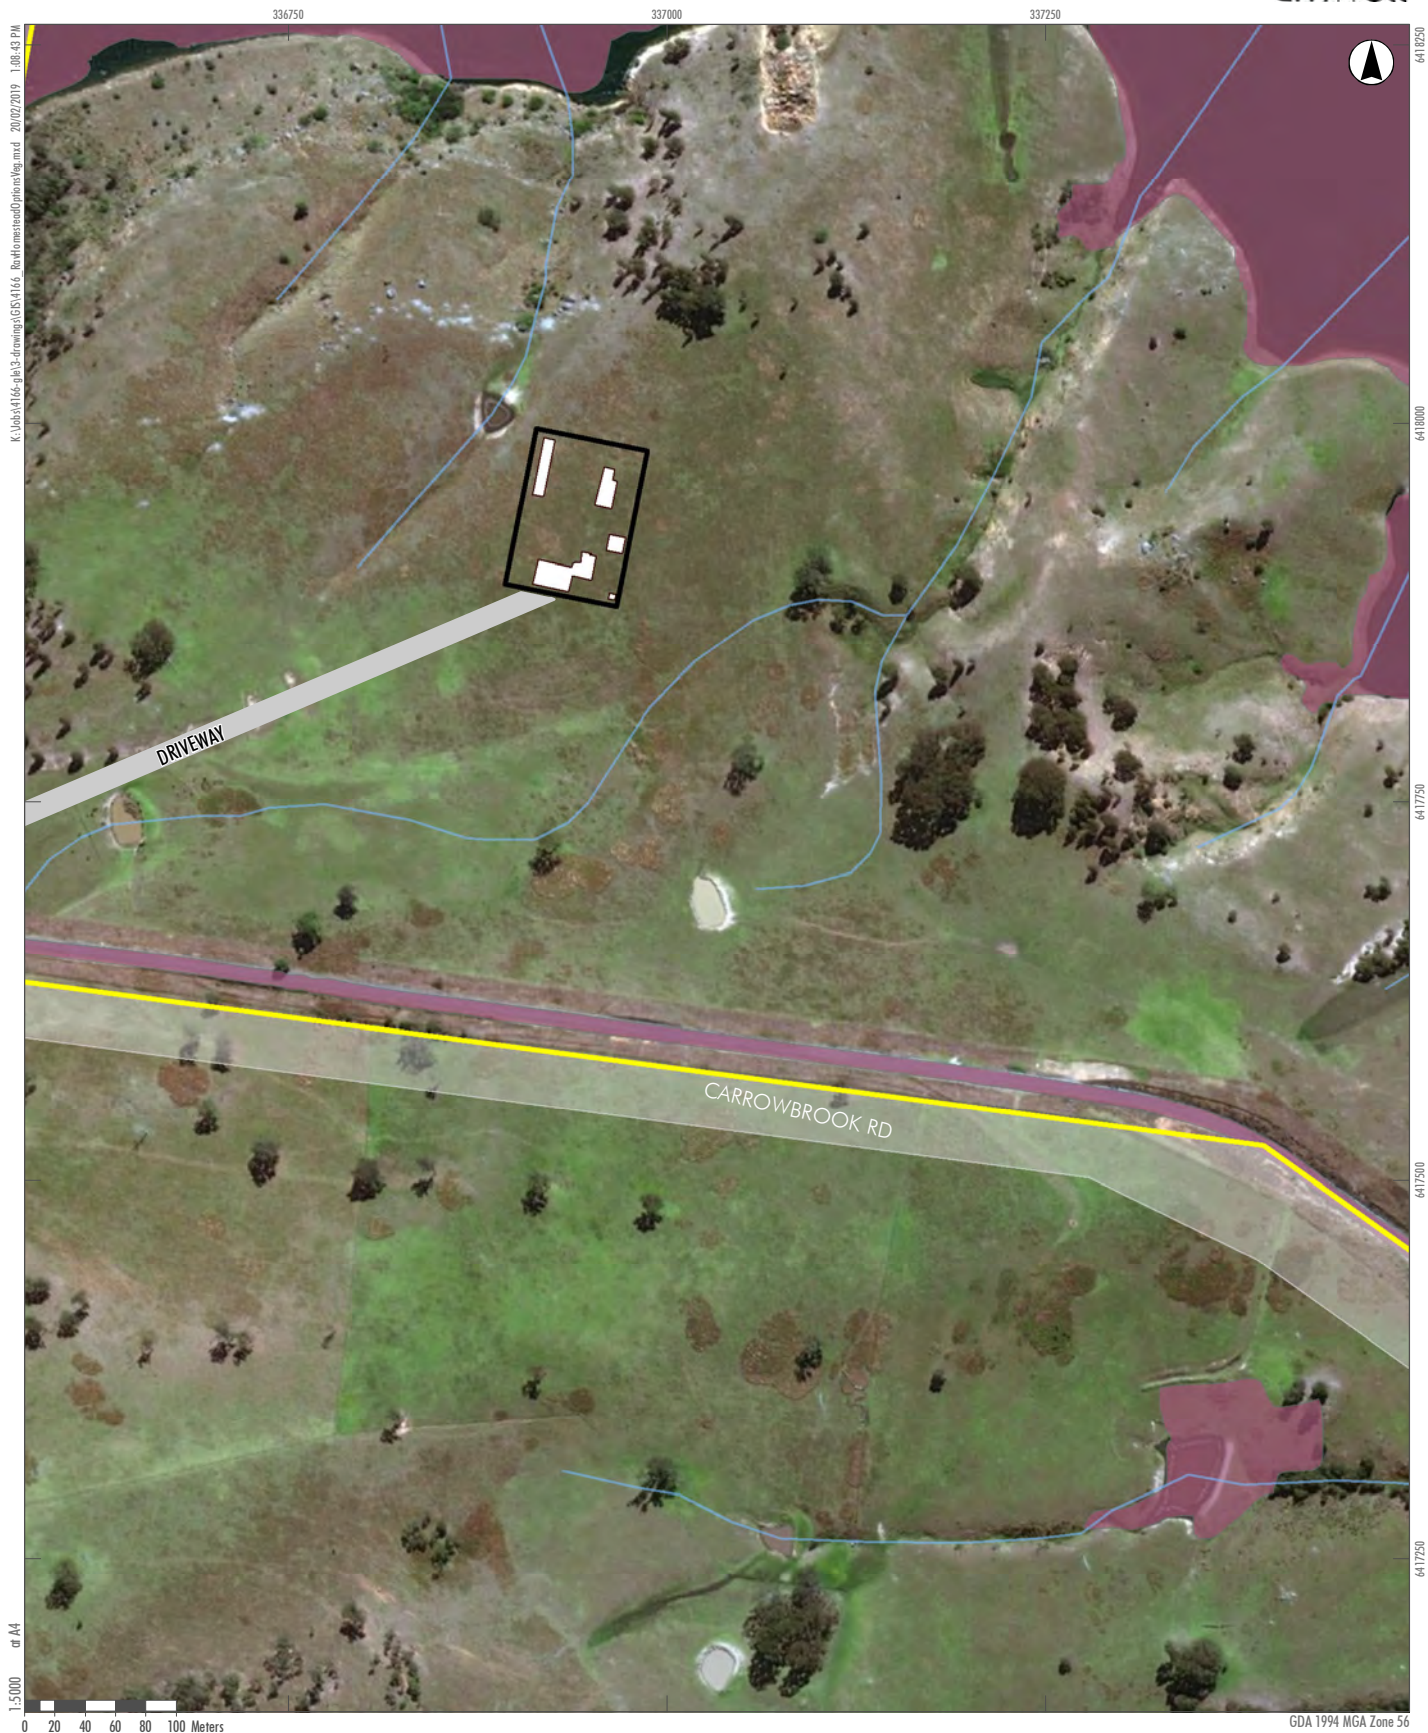
FIGURE 9.2

Option 9 - Lake St Clair Site 2  
Land Zoning (Singleton LEP 2013)

Refer to **Figure 9.2**.

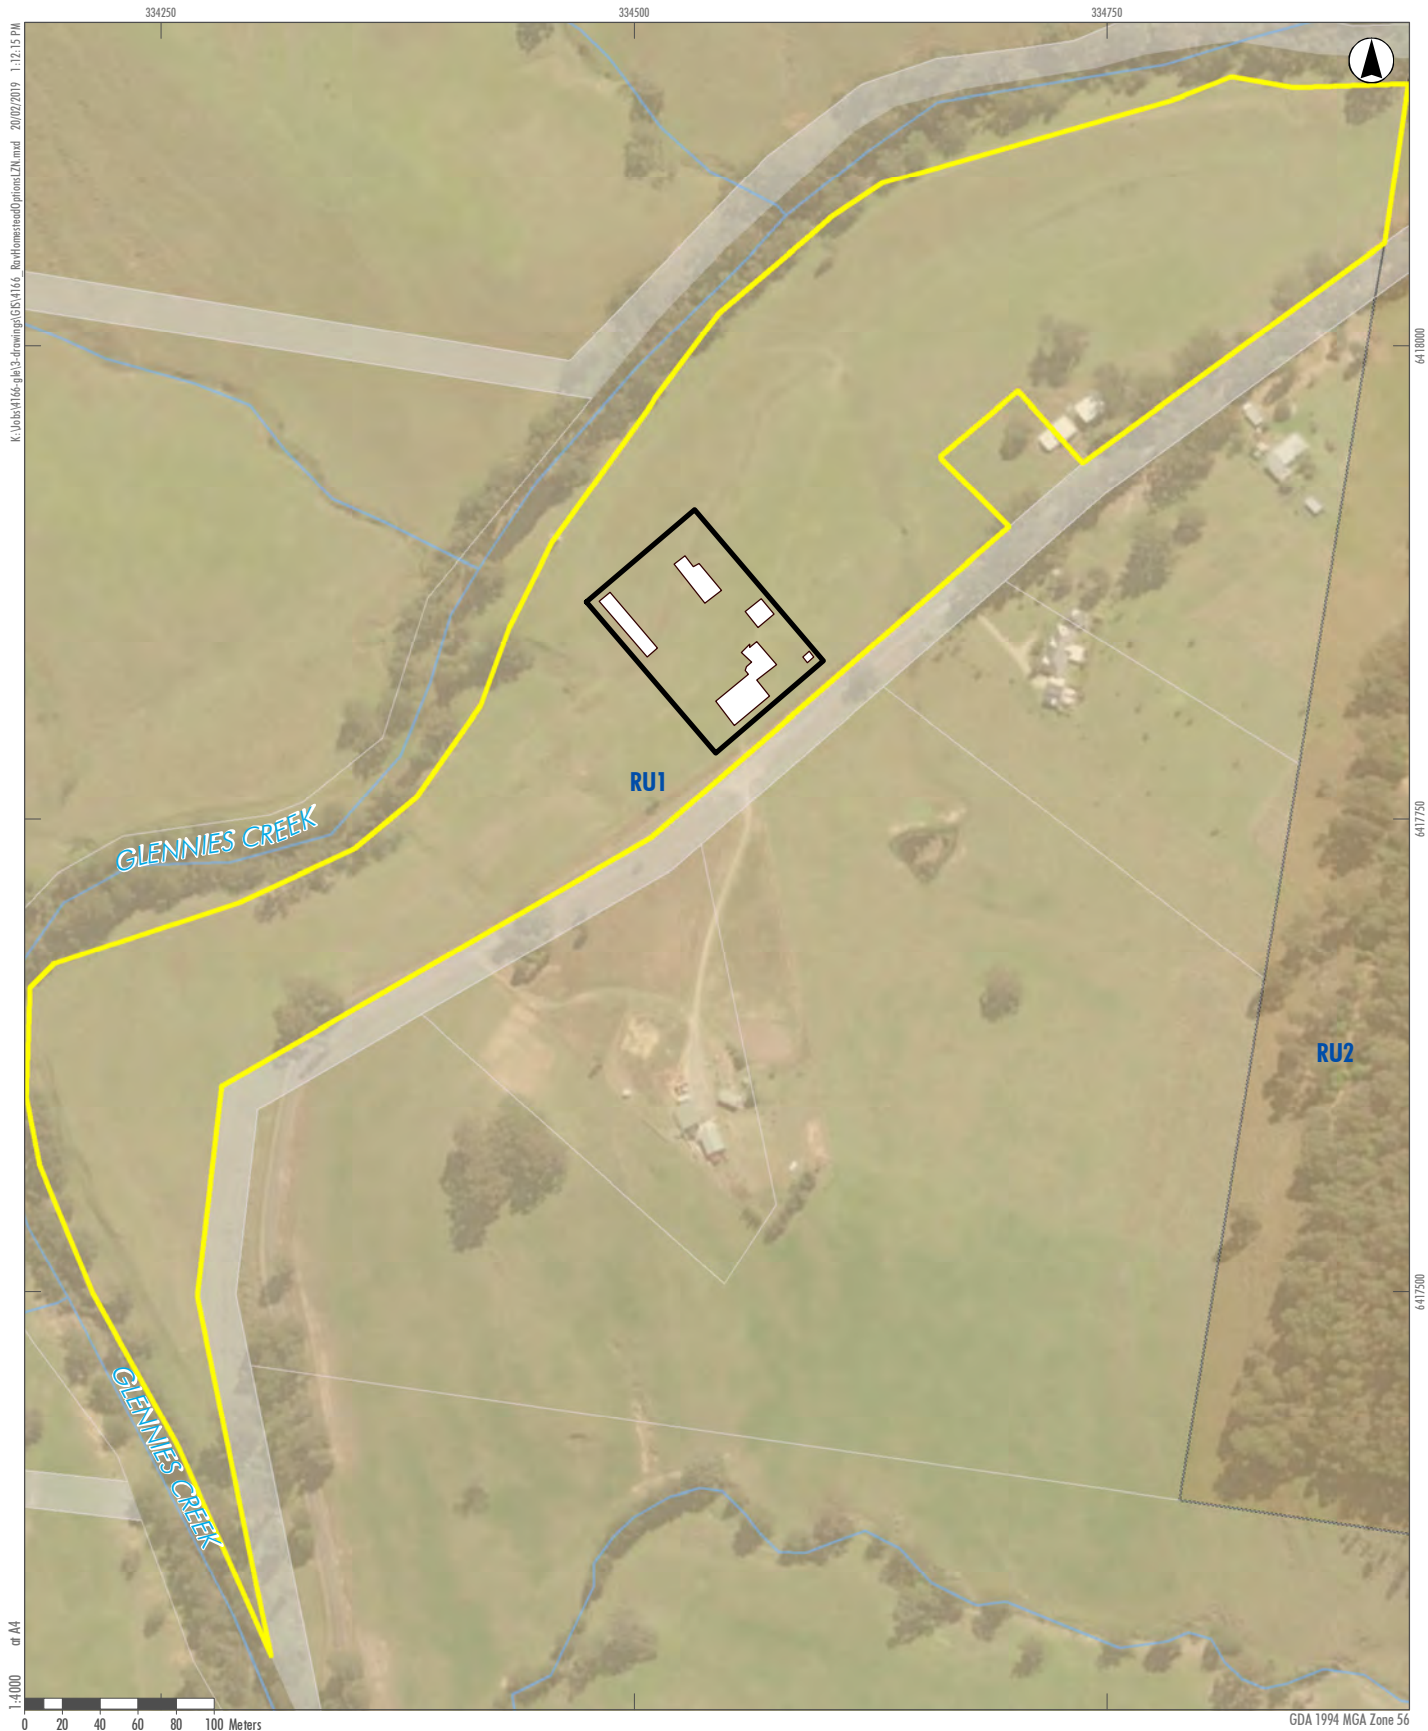
FIGURE 10.1

Option 10 - Lake St Clair Site 1  
Overview

The site is not included within the Flood Planning Map in the LEP (**Figure 10.1**), no information is available on whether the site would be potentially affected by dam level rise during a significant flood event, however whilst this needs further clarification, initial indications are that this is unlikely to be an issue.

The Aboriginal site is would remain unaffected as it is outside of the proposed site (**Figure 10.1**).

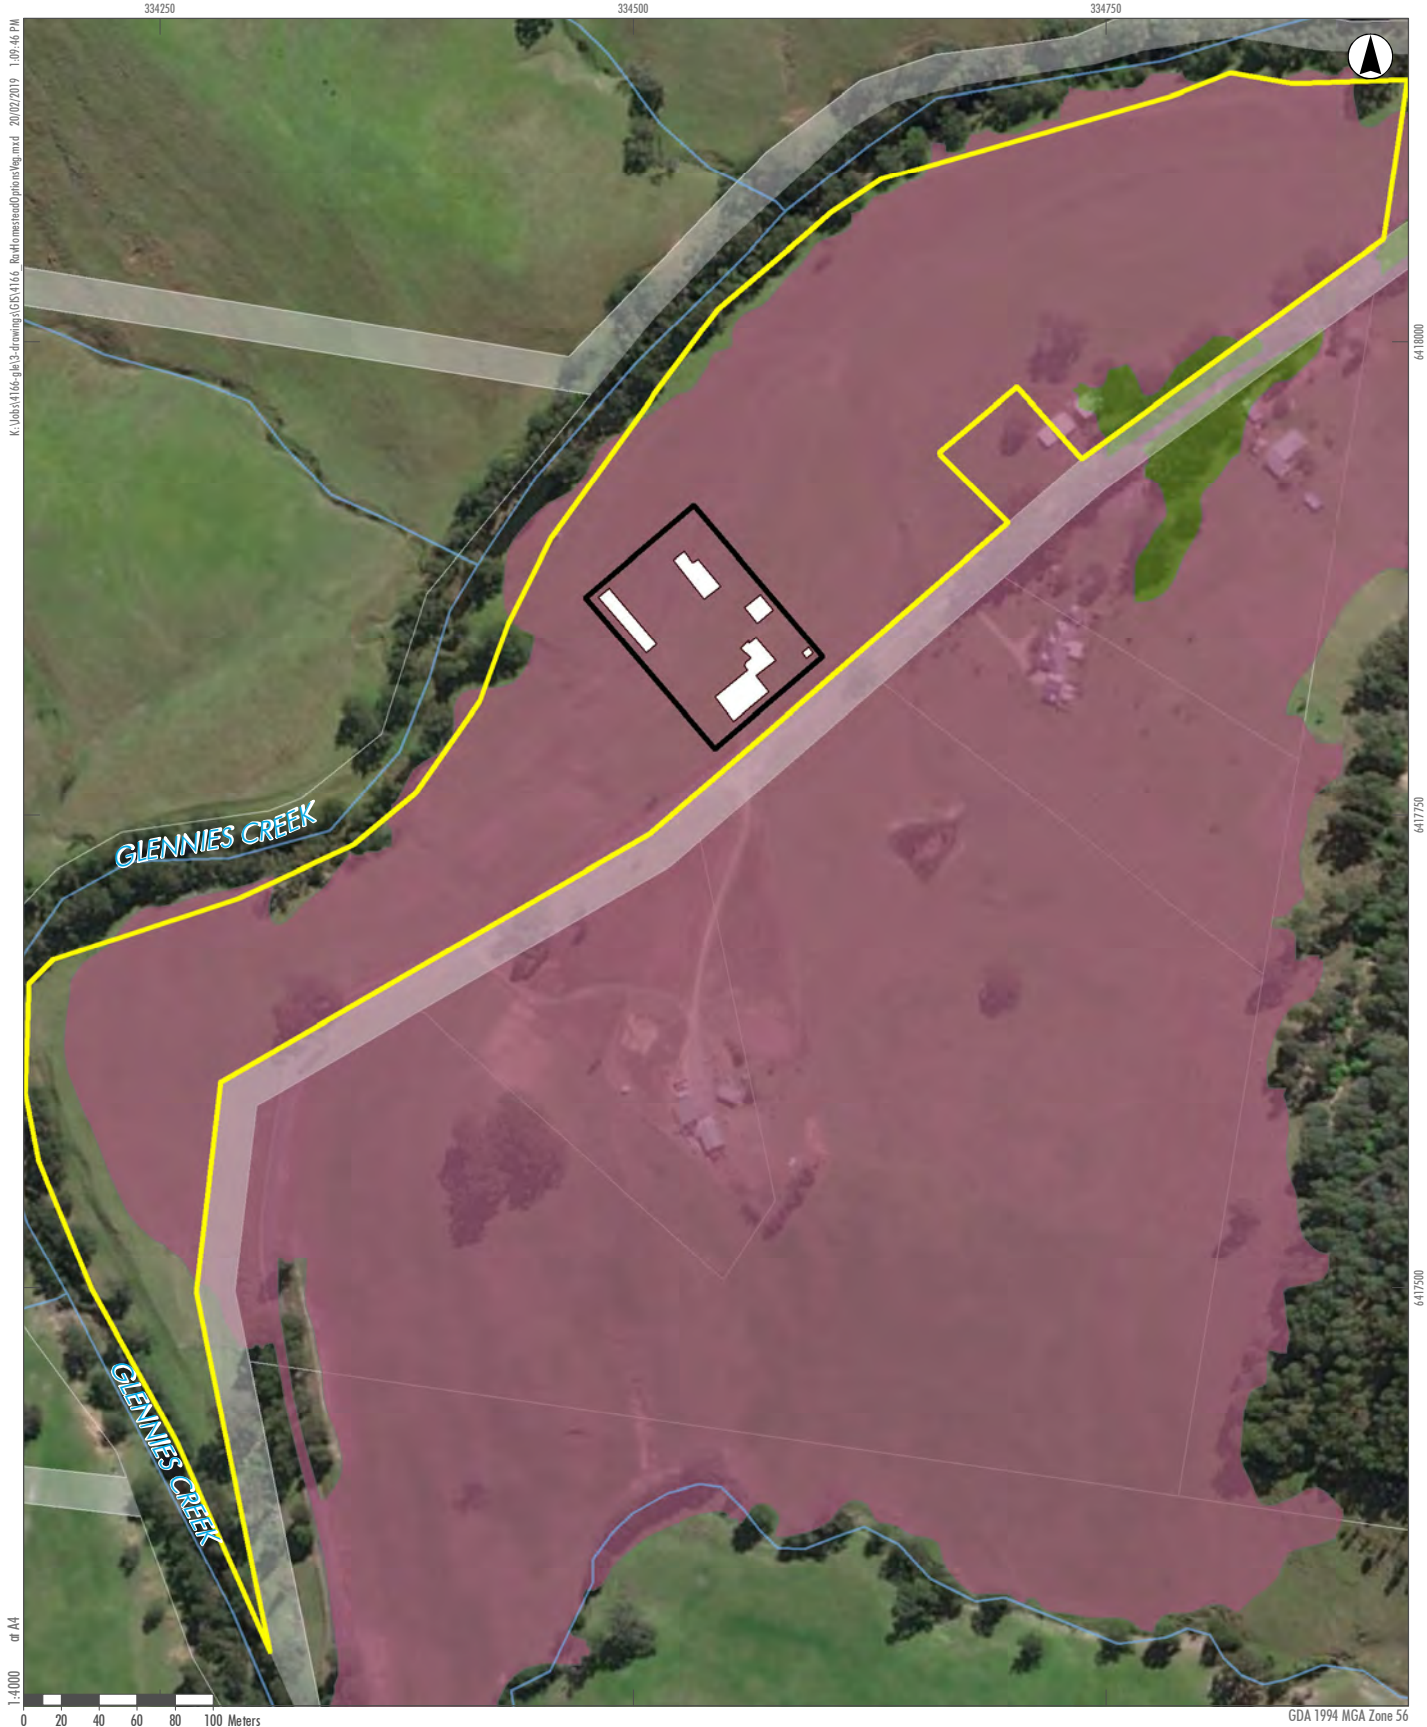
FIGURE 10.2

Option 10 - Lake St Clair Site 1  
Land Zoning (Singleton LEP 2013)

Refer to **Figure 10.2**.

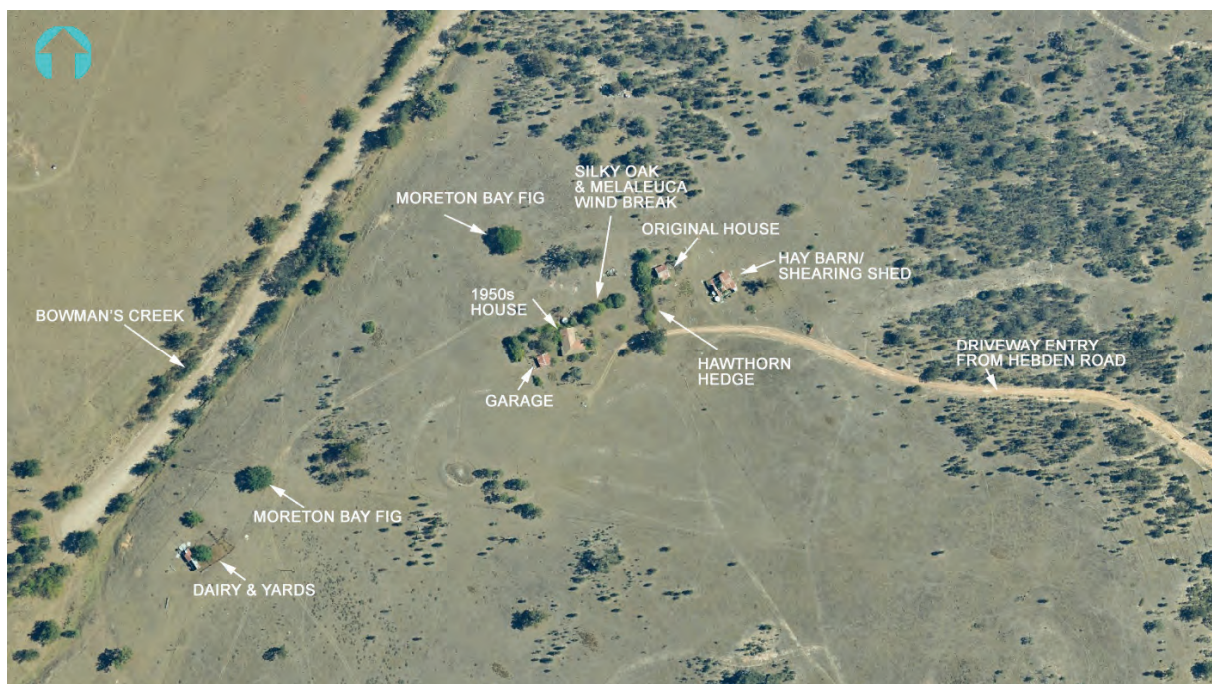
Figure 3. 1: Aerial view of Ravensworth Farm noting the principal features of the place. Source: base aerial courtesy Glencore.

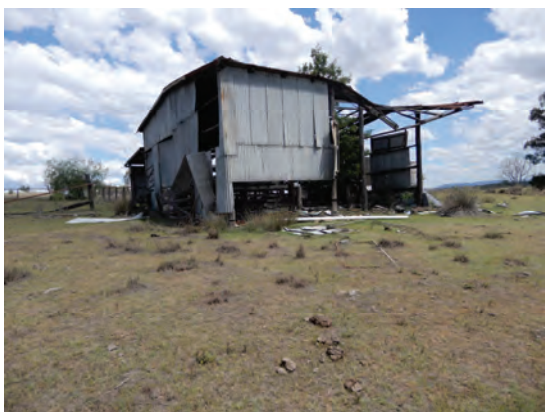
The building is in poor condition, with silky oaks growing within the body of the structure.

Figure 3. 2: West elevation of haybarn/shearing shed.

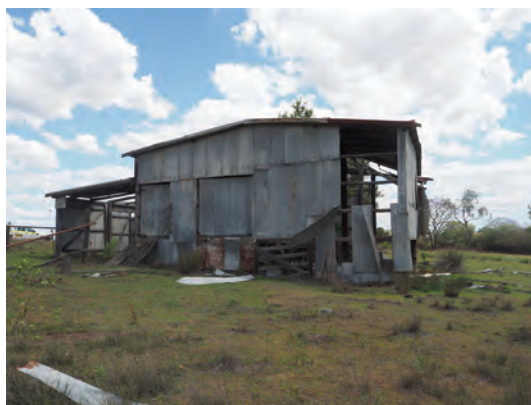
Figure 3. 3: North elevation of haybarn/shearing shed.

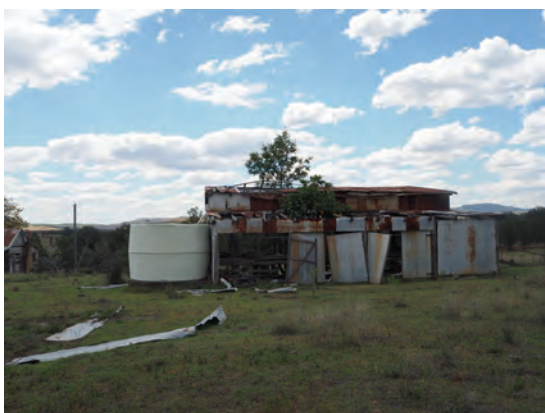
Figure 3. 4: South elevation of haybarn/shearing shed.

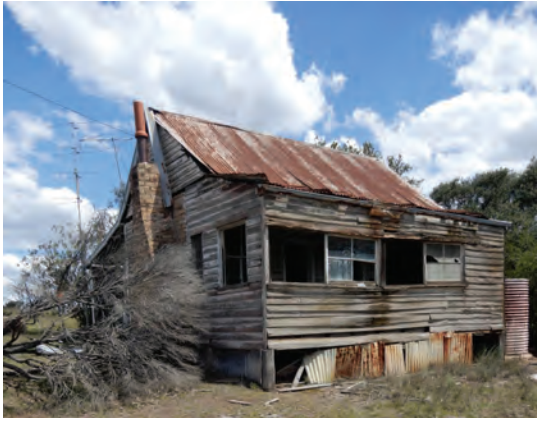
Generally, the building is in poor condition.

Figure 3. 5: West and north elevations of the early 20<sup>th</sup> century weatherboard farm house

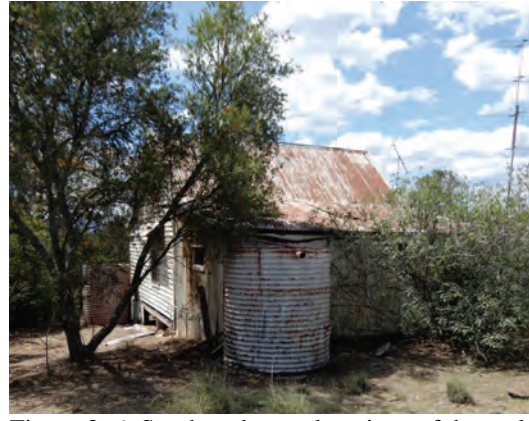
Figure 3. 6: South and east elevations of the early 20<sup>th</sup> century weatherboard farm house with watertank.

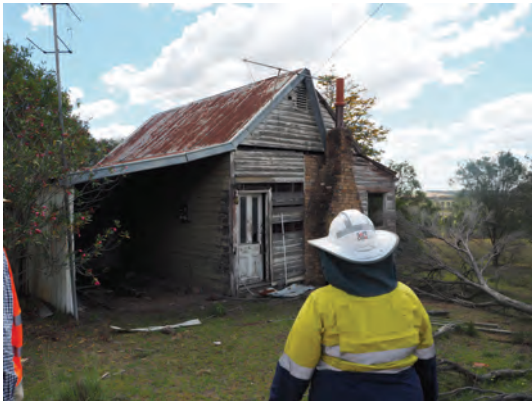
Figure 3. 7: Front (north) elevation with brick chimney and attached car/cart port on east elevation.

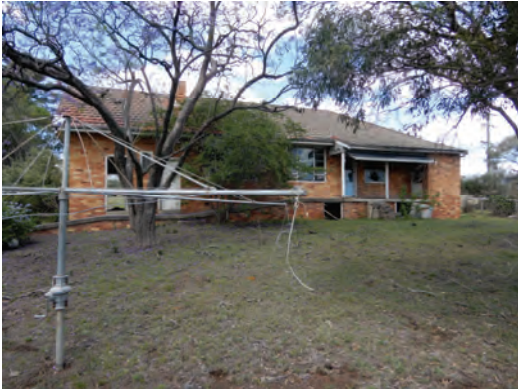
Single storey, face brick with tiled gable roof dwelling with timber framed sliding and steel framed casement windows, timber French doors, timber flush doors and timber single panel glazed doors. Internally, the dwelling retains evidence of its original 1950s fittings and features including carpeting, wall paper, wall tiles, engraved glazing panels and stone clad chimney piece. Generally, the building is in fair condition. The residence is set in a domestic garden with hills hoist, steel post and wire mesh fencing and planned garden beds with cultural plantings including jacaranda, silky oak, roses and bougainvillea.

Figure 3. 12: Southwest elevation of the 1950s farm house with rear garden and hills hoist.

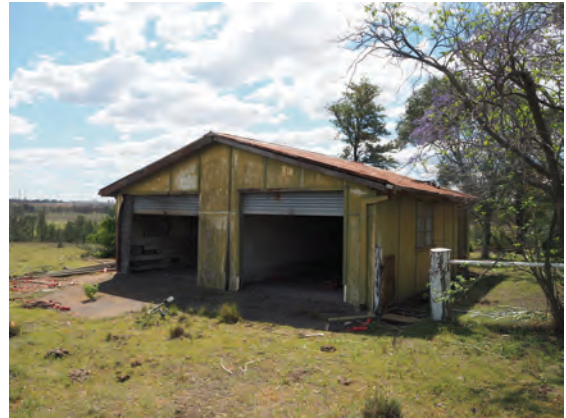
Figure 3. 19: Double garage

Large, fibrous cement sheet clad garage with metal roller doors, painted corrugated metal roofing and cement flooring. Located in the southwestern corner of the domestic garden enclosure of the 1950s residence.

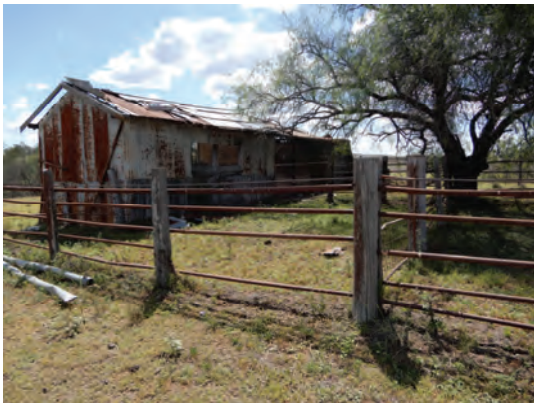
Located to the southwest of the main farm site (Site 27) is the remains of a dairy building of timber with corrugated metal sheeting and weatherboard with attached cattle yards and loading ramp (Site 27a). The building is in very poor condition.

Figure 3. 20: Dairy with cattle yards and peppercorn tree.

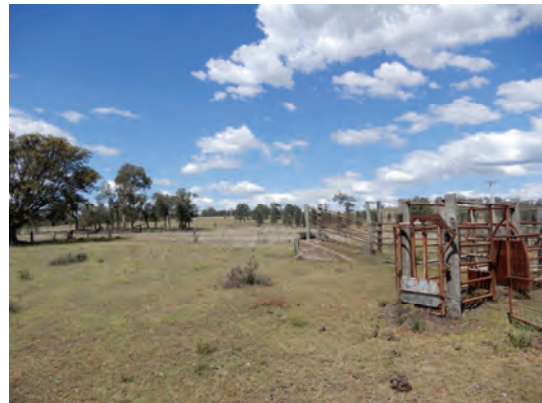
Figure 3. 21: Cattle loading ramp with yards.

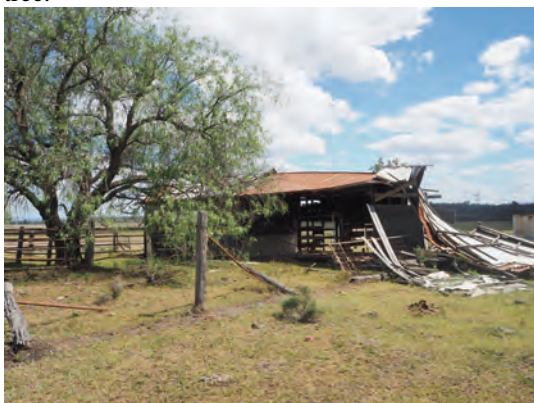
Figure 3. 22: Northeast elevation of Dairy building

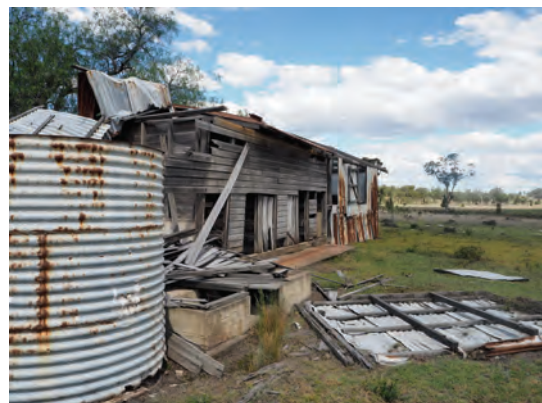
Figure 3. 23: Southwest elevation of Dairy with water tank

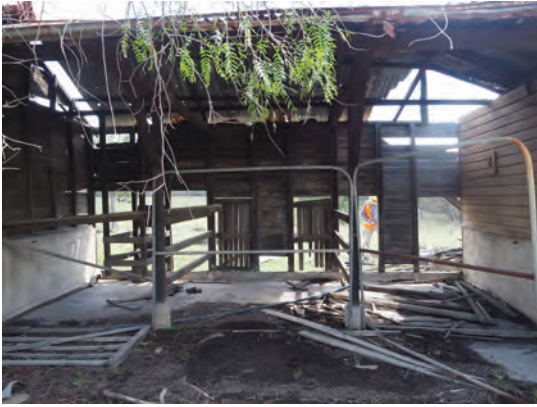
Figure 3. 24: Interior view of cattle stalls

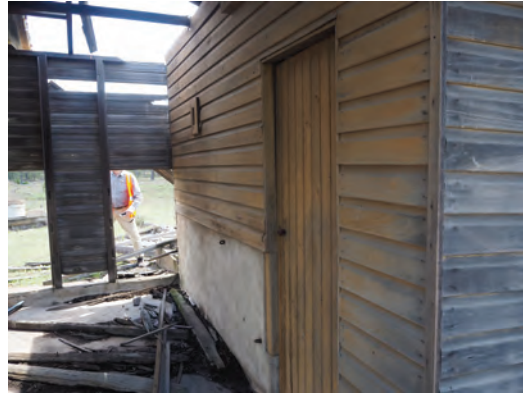
Figure 3. 25: Weatherboard store located within Dairy.

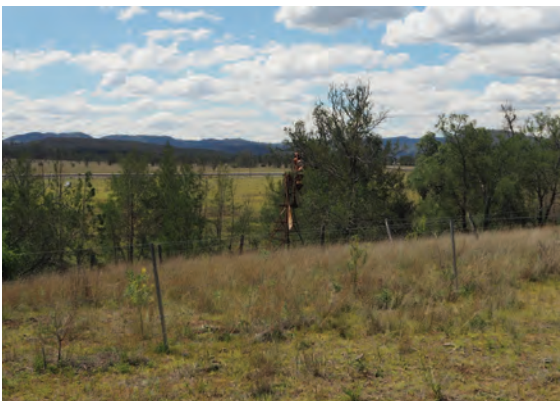
Figure 3. 26: Old windmill to west of the 1950s residence adjacent to Bowmans Creek.

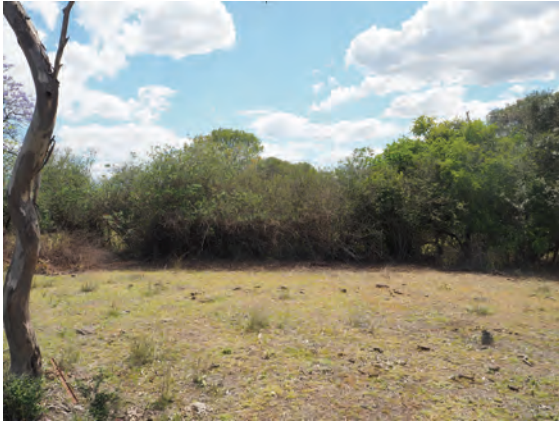
Figure 3. 28: Established hawthorn hedge to the south of the early cottage.

In addition to the above, there also survive a number of landscape features of note that are related to the establishment period of the property in the early 20<sup>th</sup> century. These include Moreton Bay fig trees, windbreaks of silky oak and melaleucas, and a substantial hawthorn hedge separating the early cottage area from the 1950s residence.

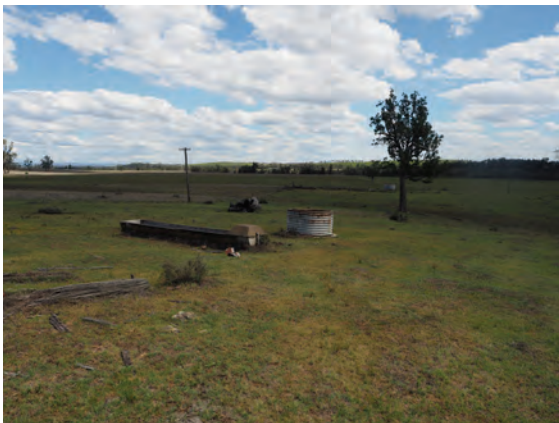
Figure 3. 30: Water trough and tank to the south of the Dairy.

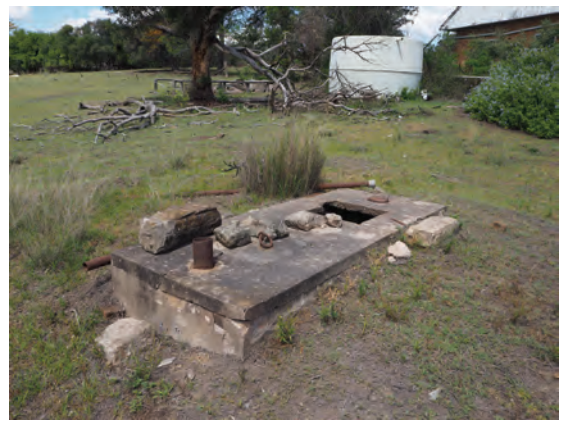
Figure 3. 33: Former septic tank to the west of the 1950s residence.

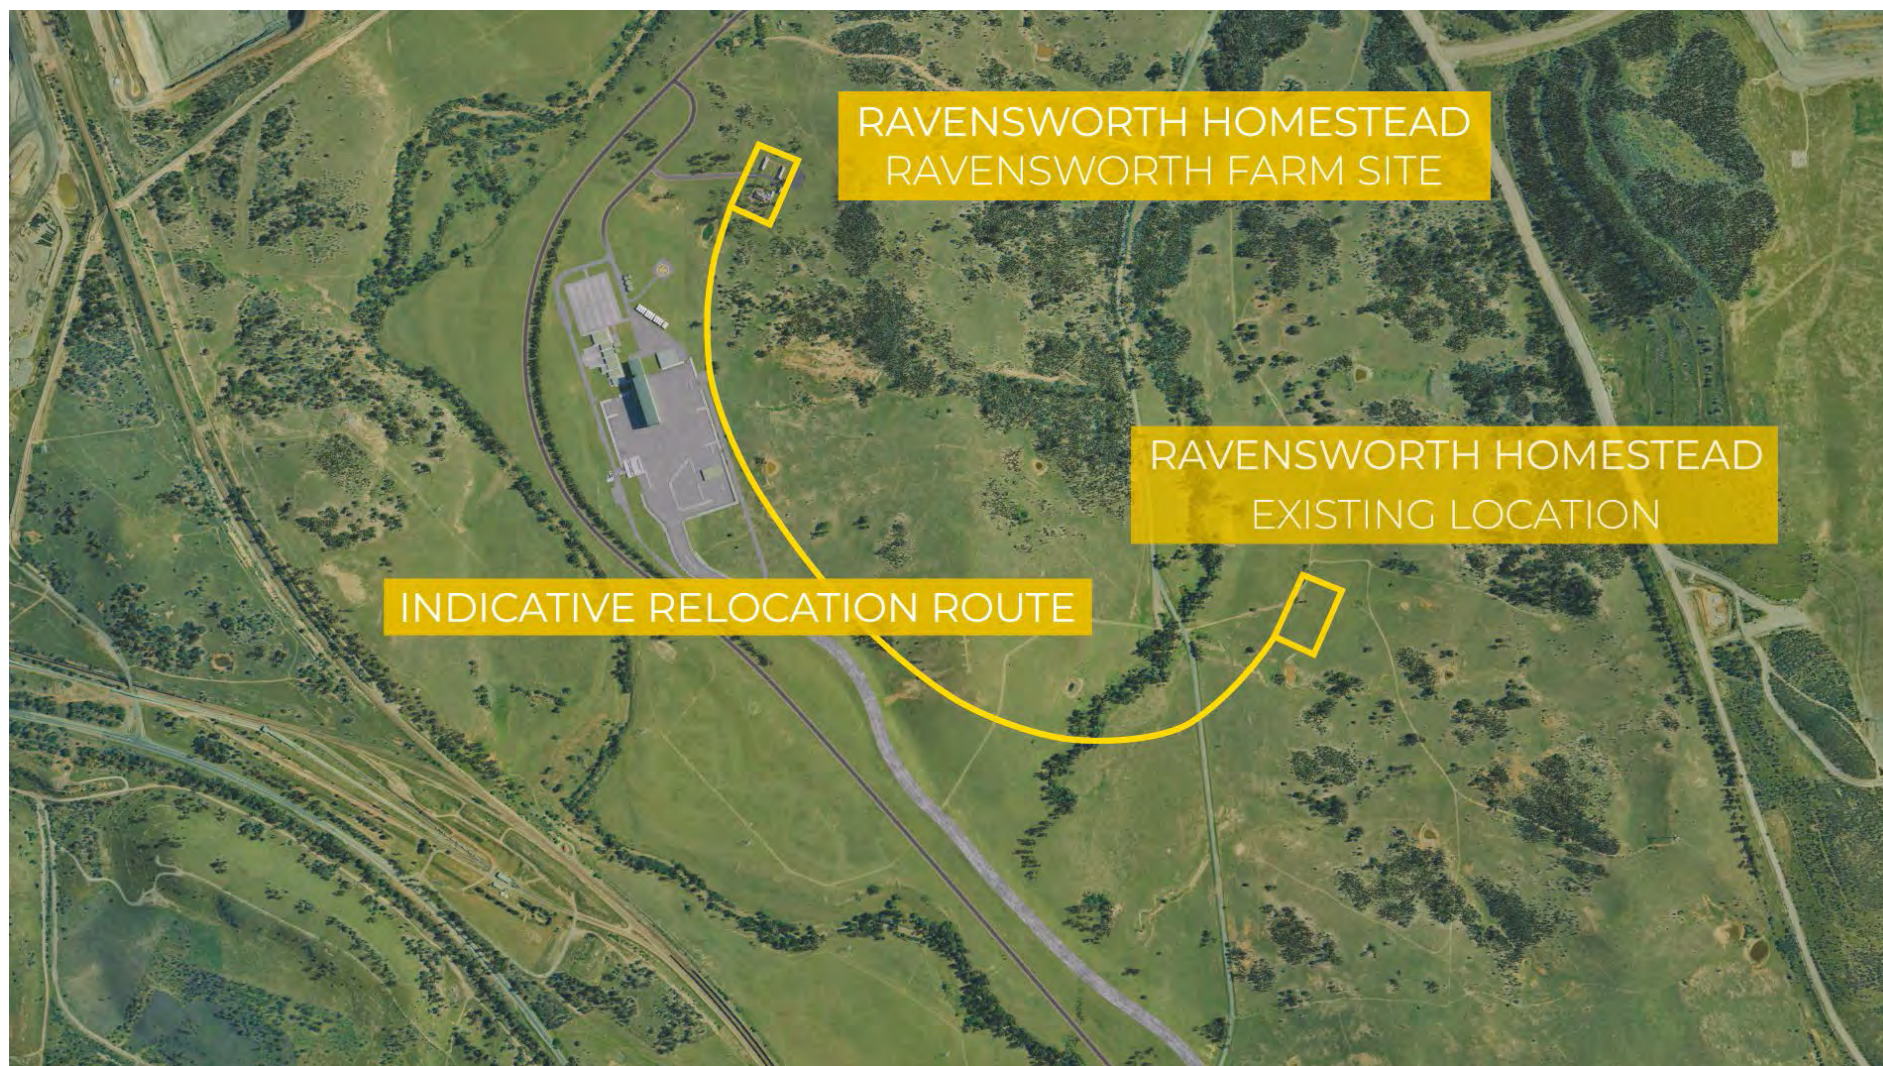
Aerial view, indicative relocation route shown

All images shown are conceptual in nature and are intended to give an indication of the visual qualities of the Ravensworth Farm relocation option with the final arrangement of infrastructure and surrounding terrain subject to future detailed design and detailed mine closure planning.

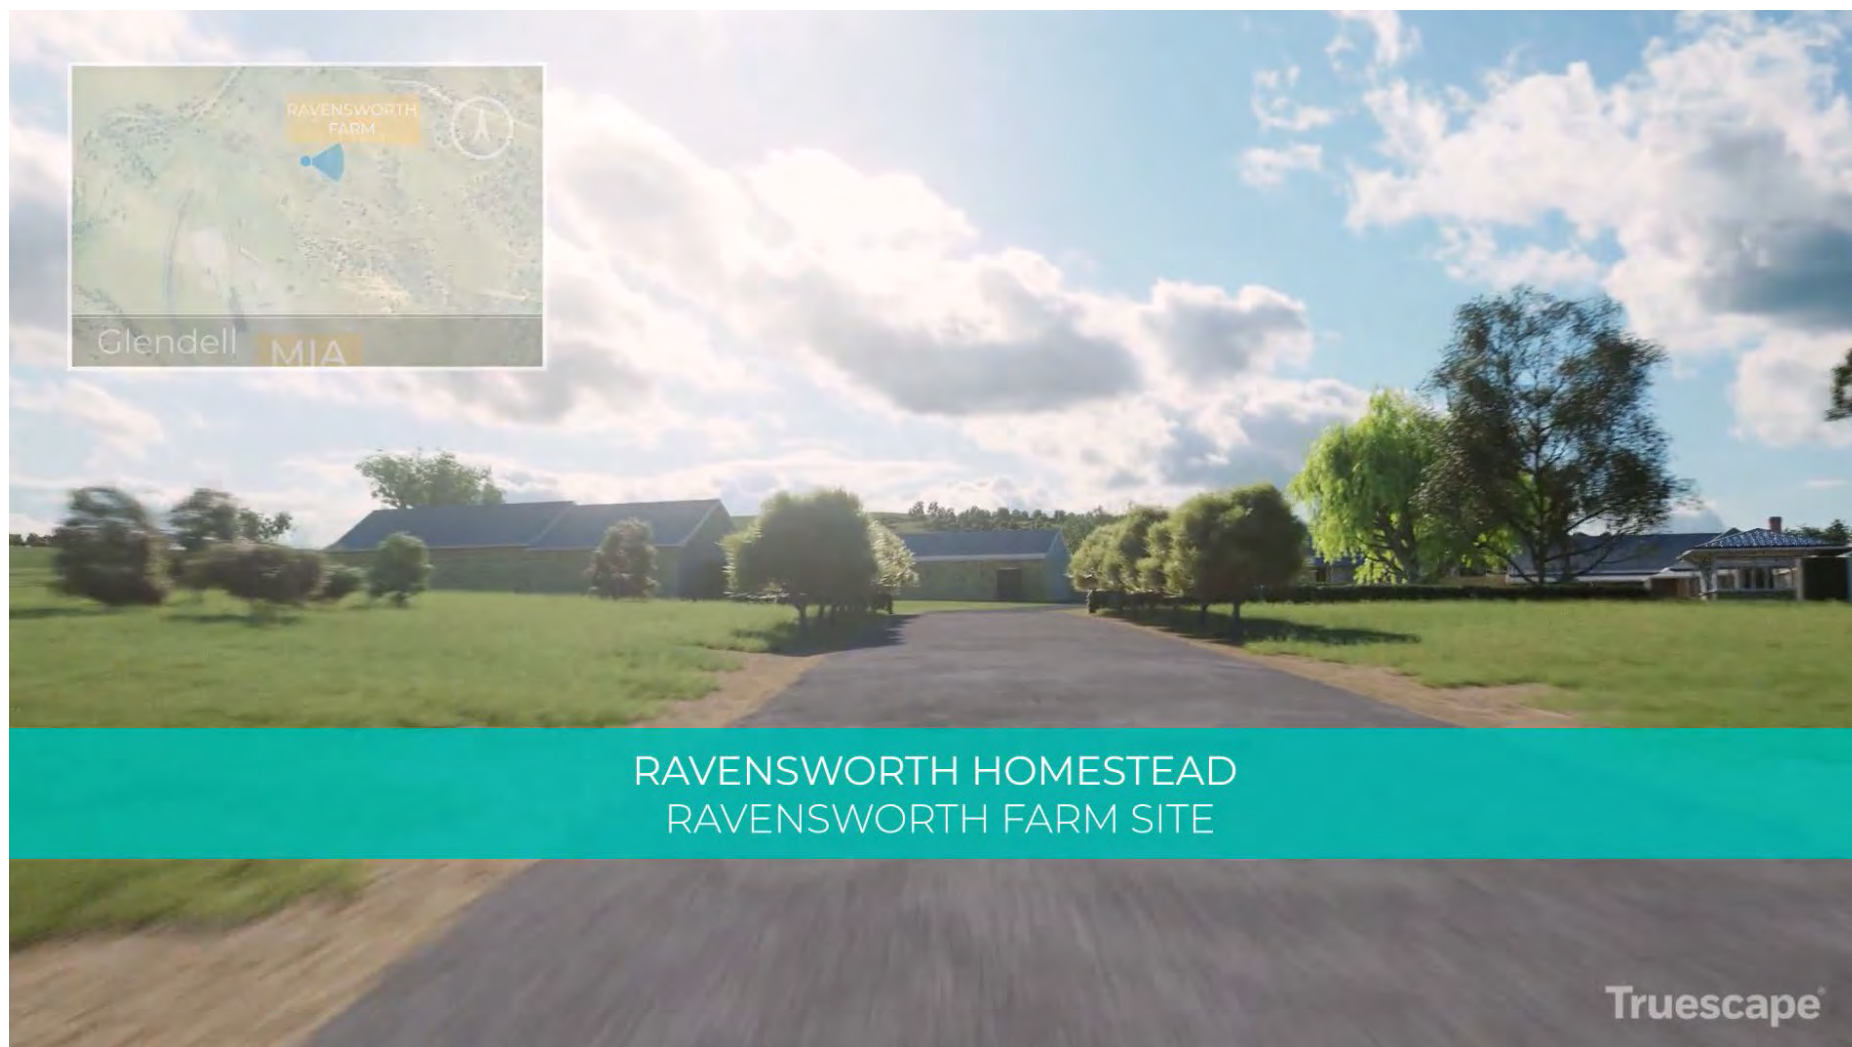
Approach to Ravensworth Homestead from new access road (note same approach angle as existing)
