# Glendell Mine Extension Ravensworth, NSW

## Statement of Heritage Impact

Prepared for:  
**Mt Owen Pty Ltd, Glencore**  
Locked Bay 6015  
Hunter Regional MC NSW 2310

Prepared by:  
**Lucas Stapleton Johnson & Partners Pty. Ltd.**  
Level 1, 191 Clarence Street  
Sydney NSW 2000  
Telephone: (02) 9357 4811  
Email: mailbox@lsjarchitects.com

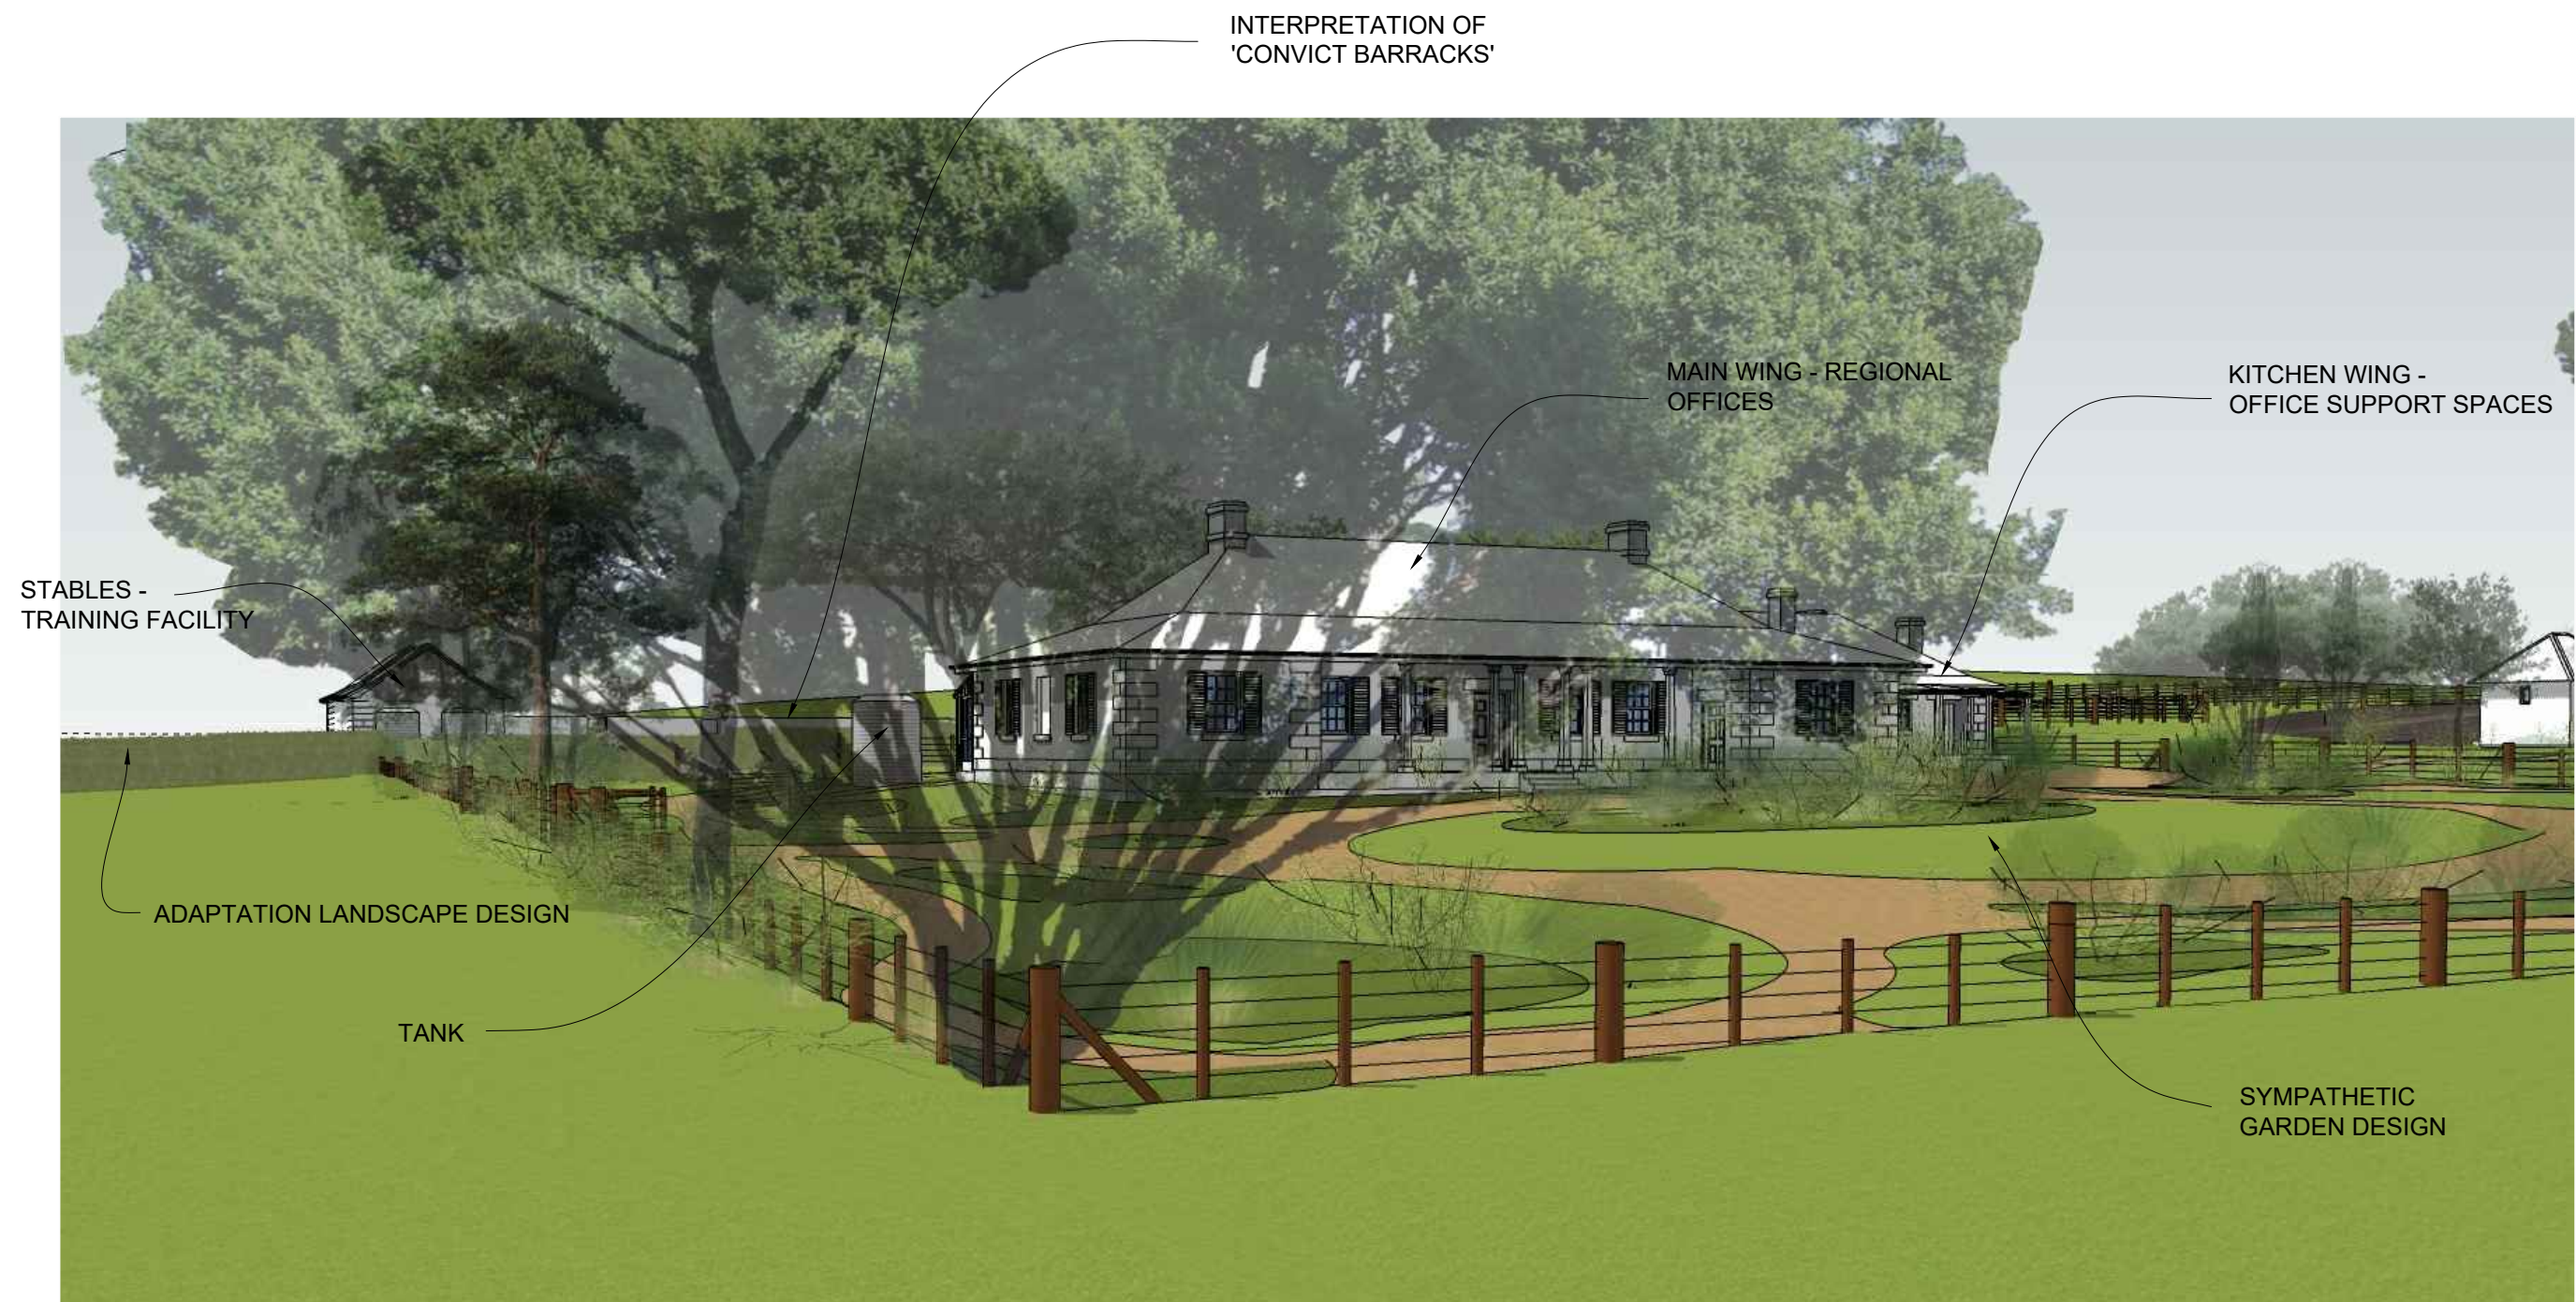
123800\_SP\_A.SK

VIEW FROM SOUTH WEST - APPROXIMATING  
VIEWPOINT OF 1891 PHOTO (THE BULLETIN)

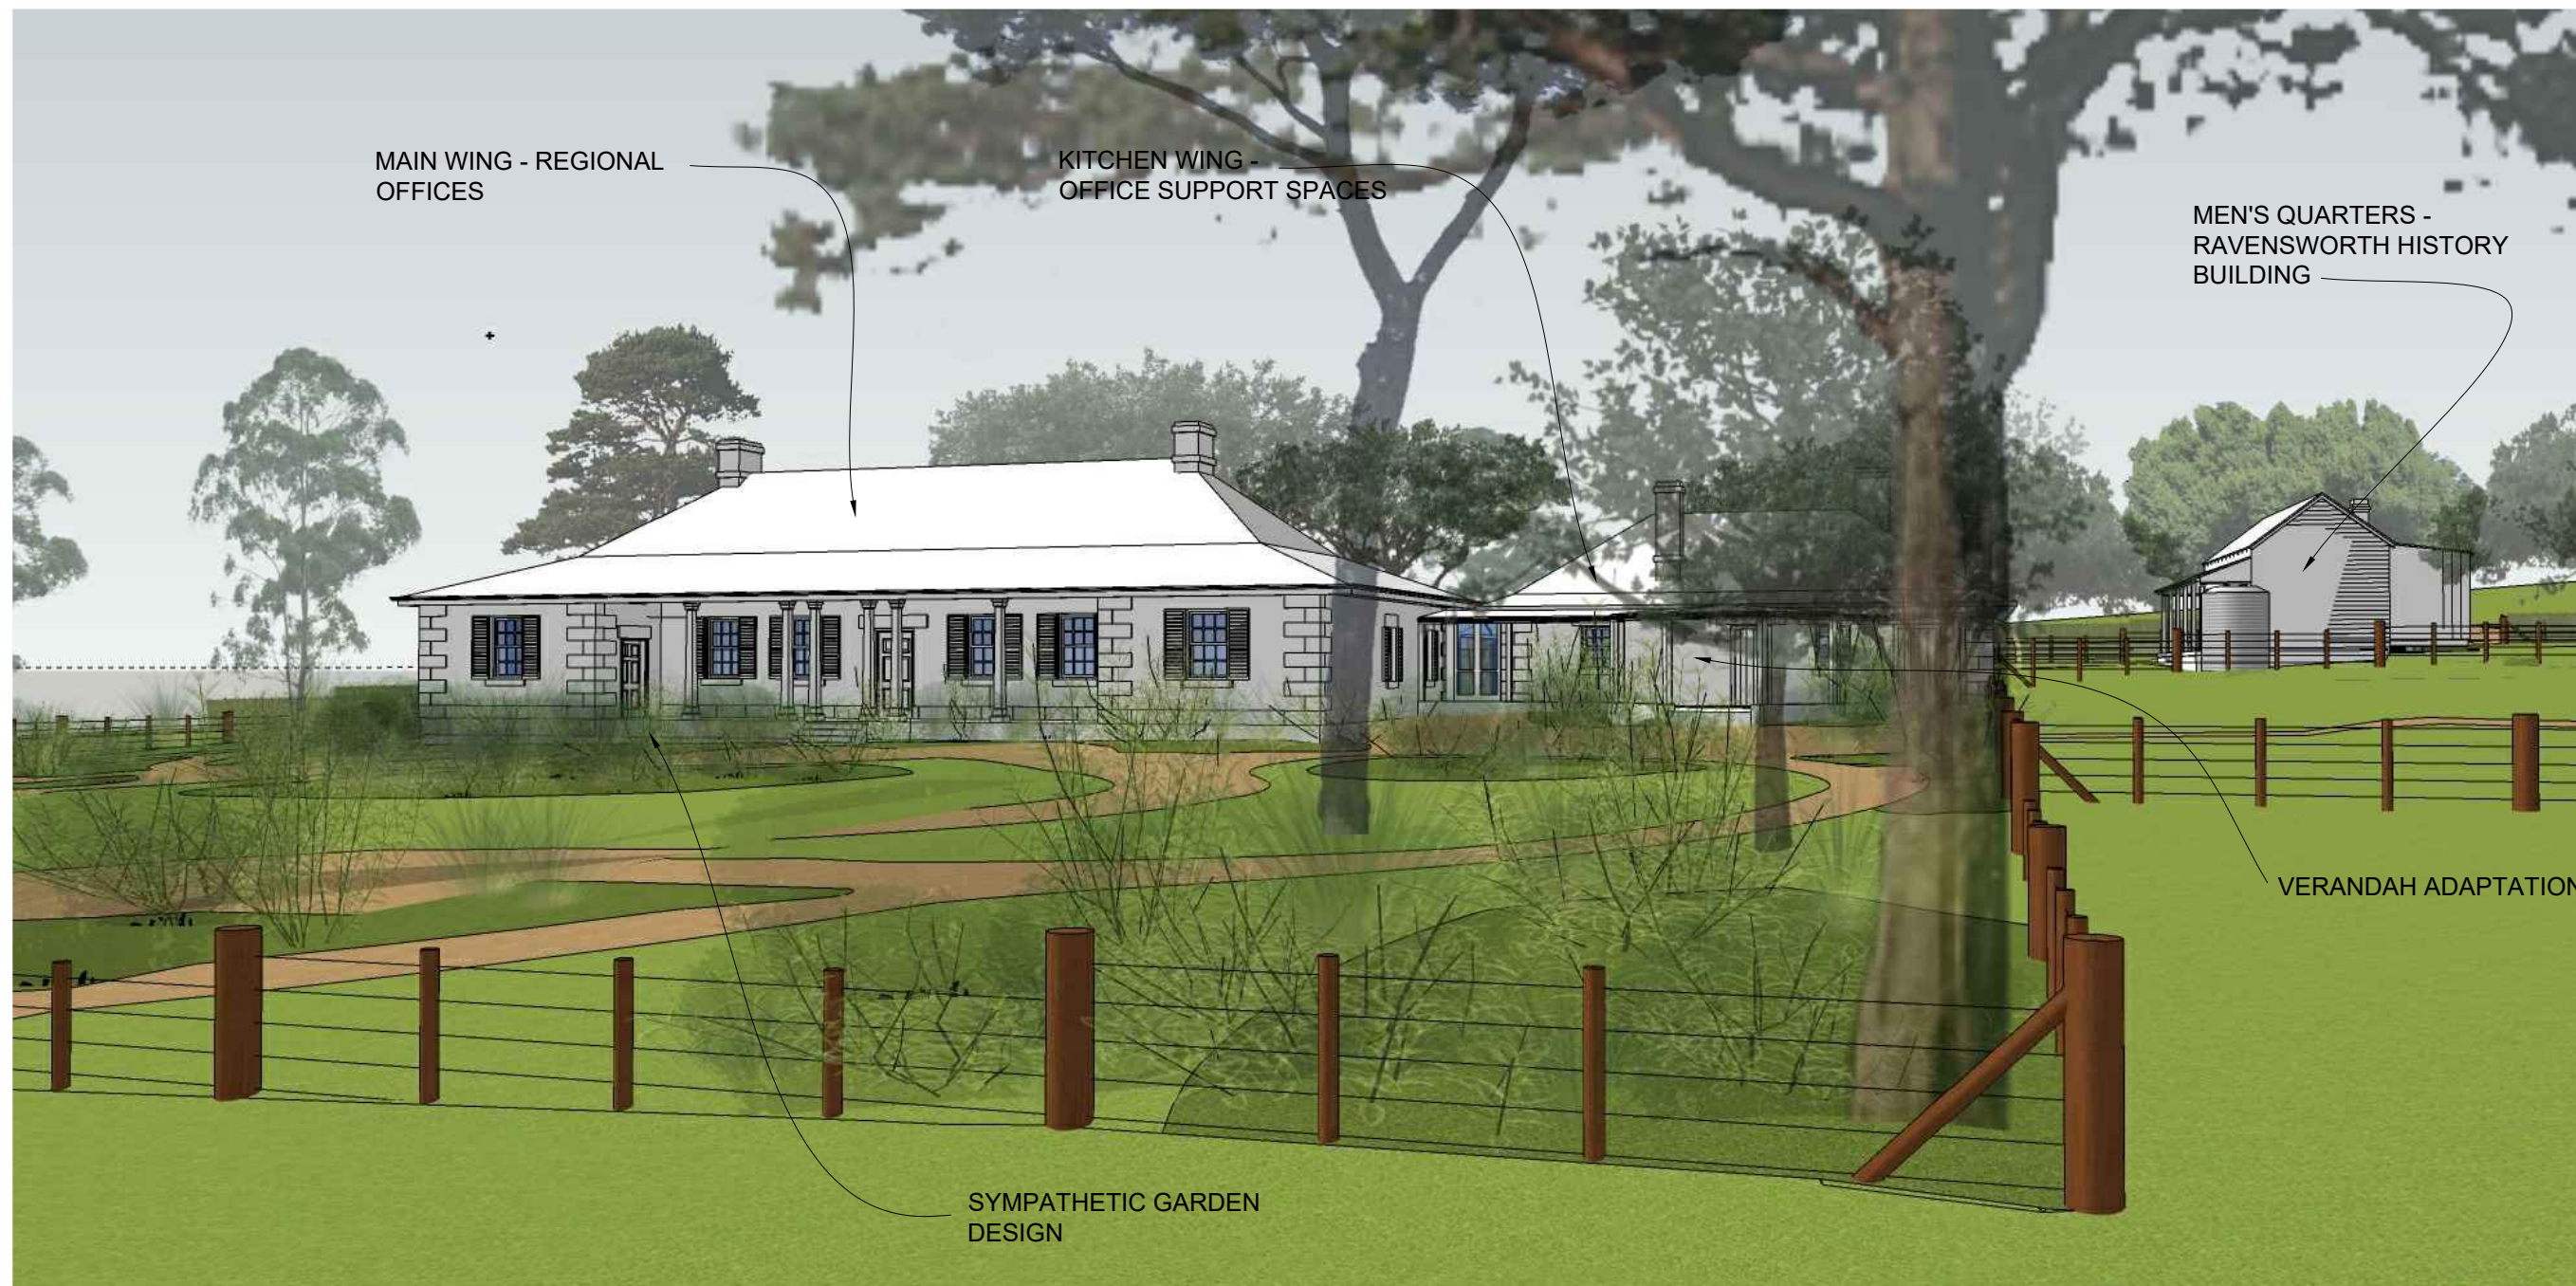
123800\_SP\_A.SK

VIEW FROM SOUTH EAST - APPROXIMATING  
VIEWPOINT OF 1902 PHOTO (SYDNEY MAIL)

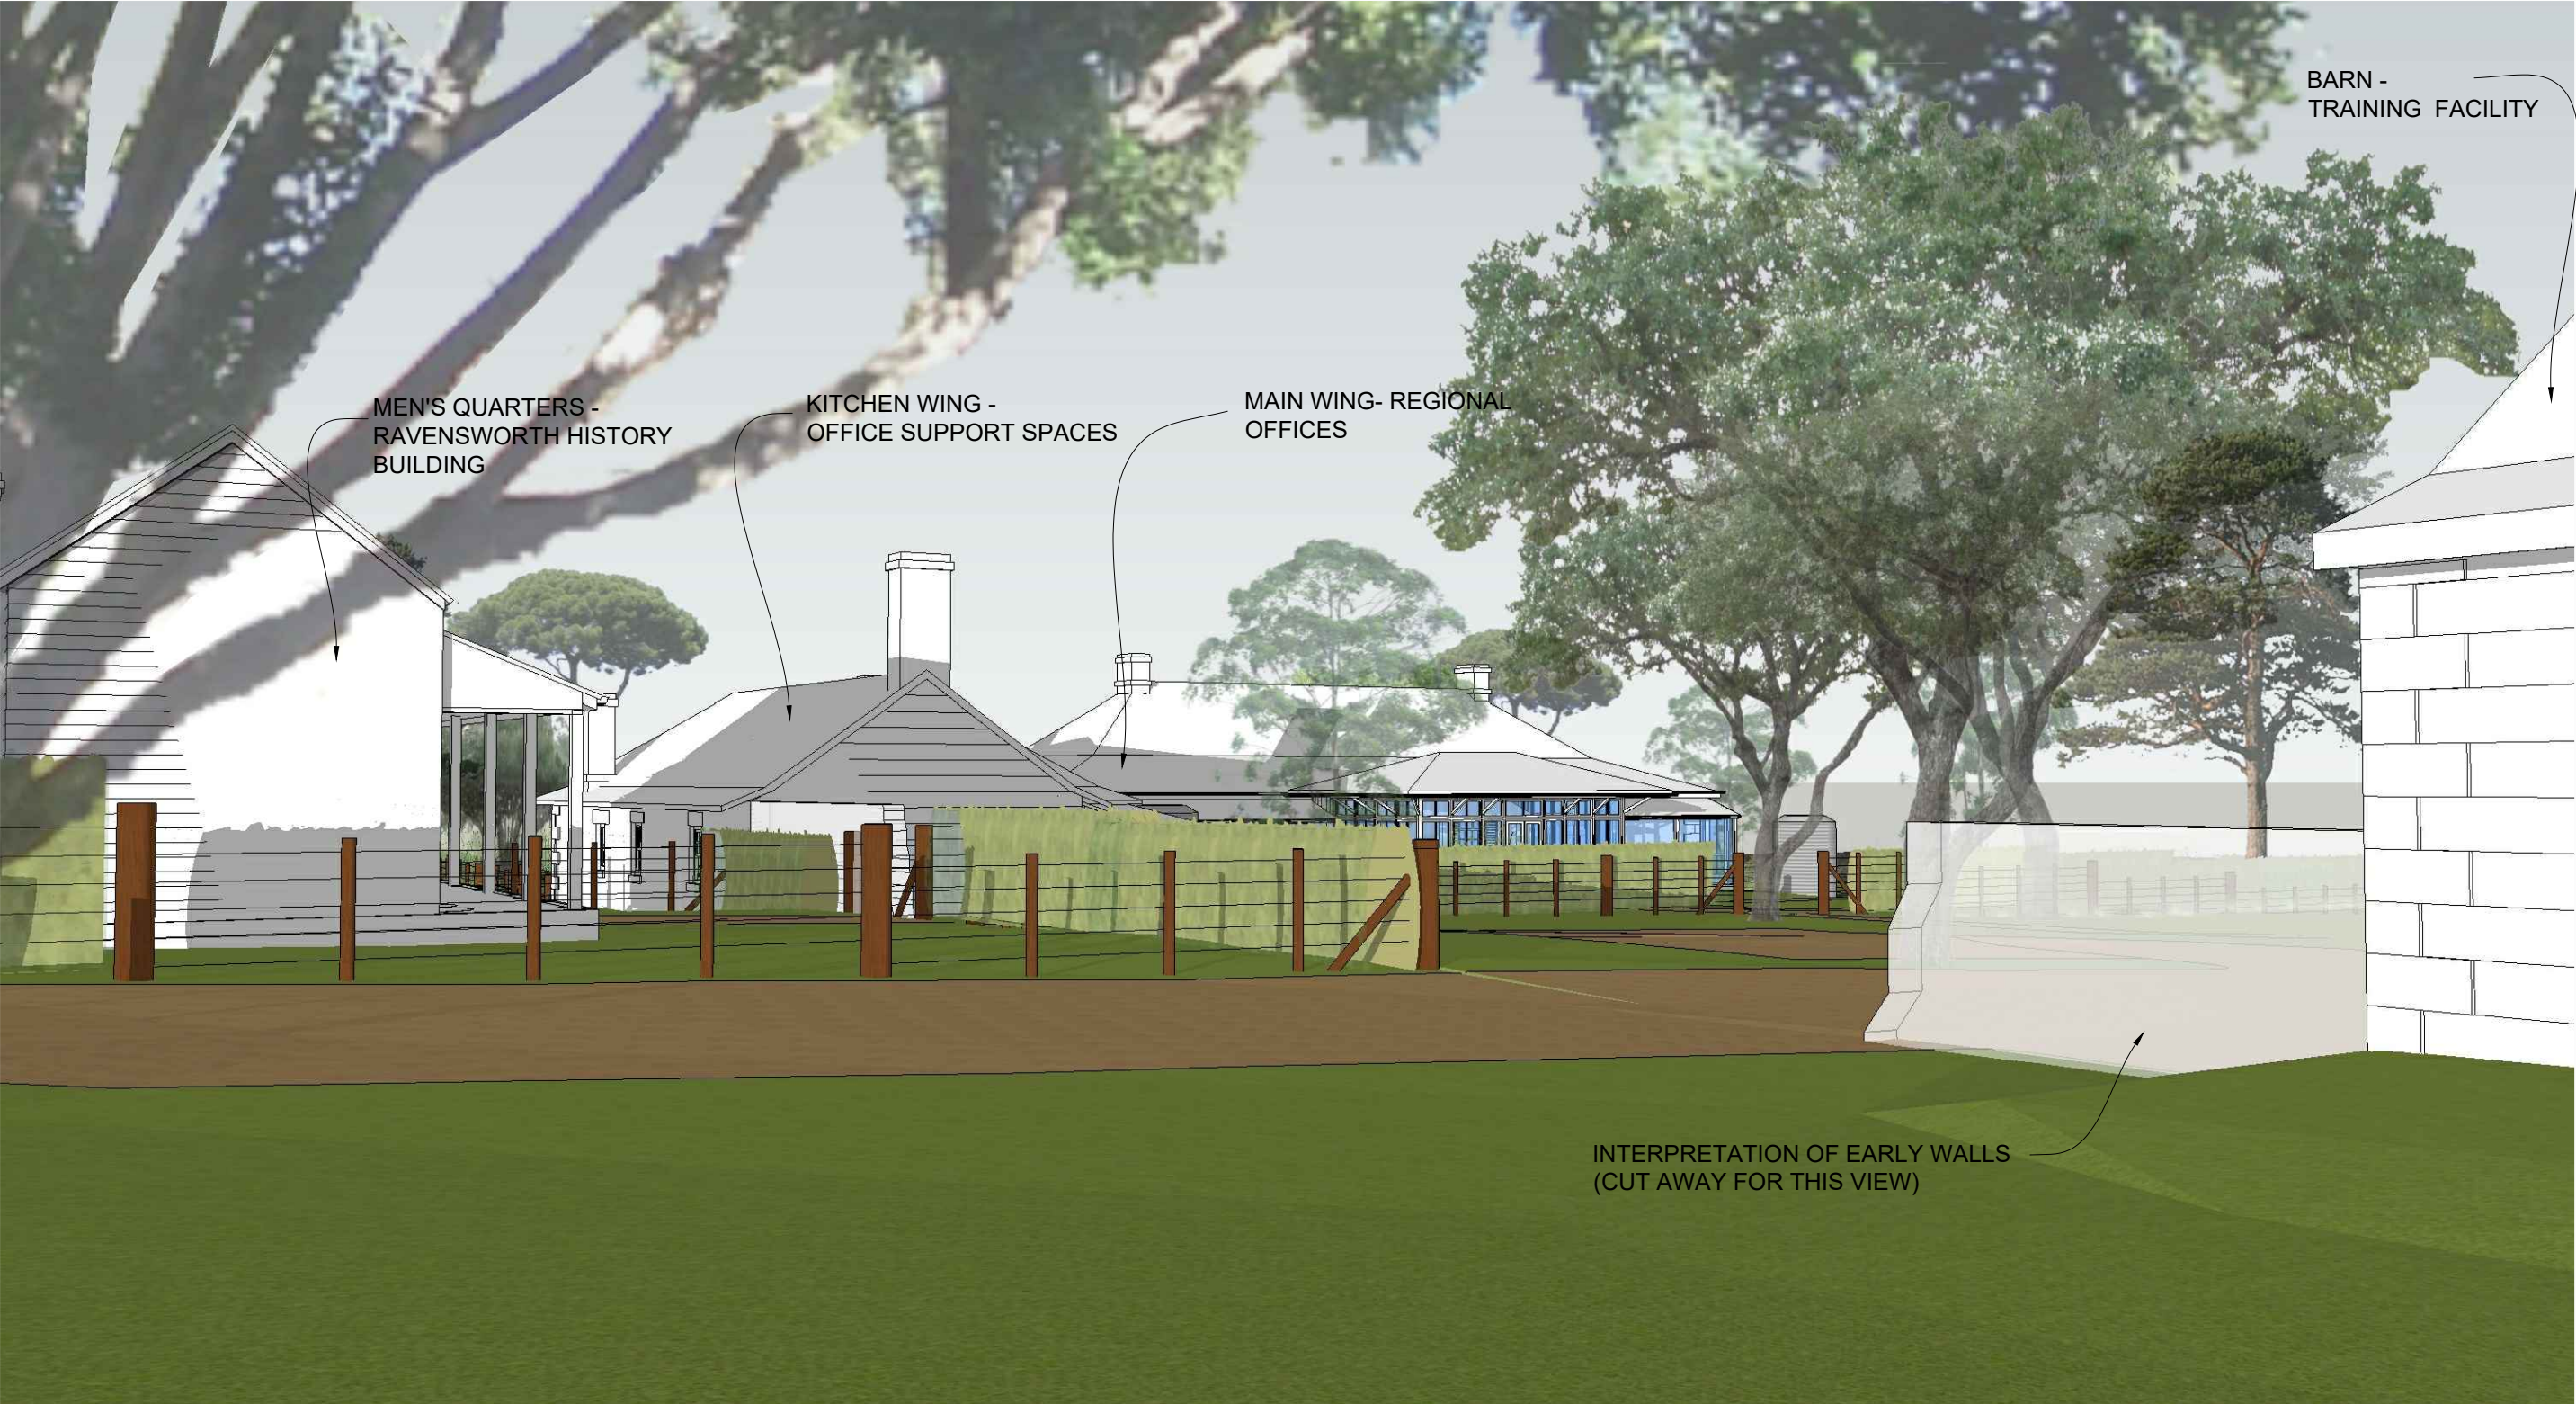
VIEW FROM NORTH-EAST TO KITCHEN WING AND MAIN WING  
123800\_SP\_A.SK

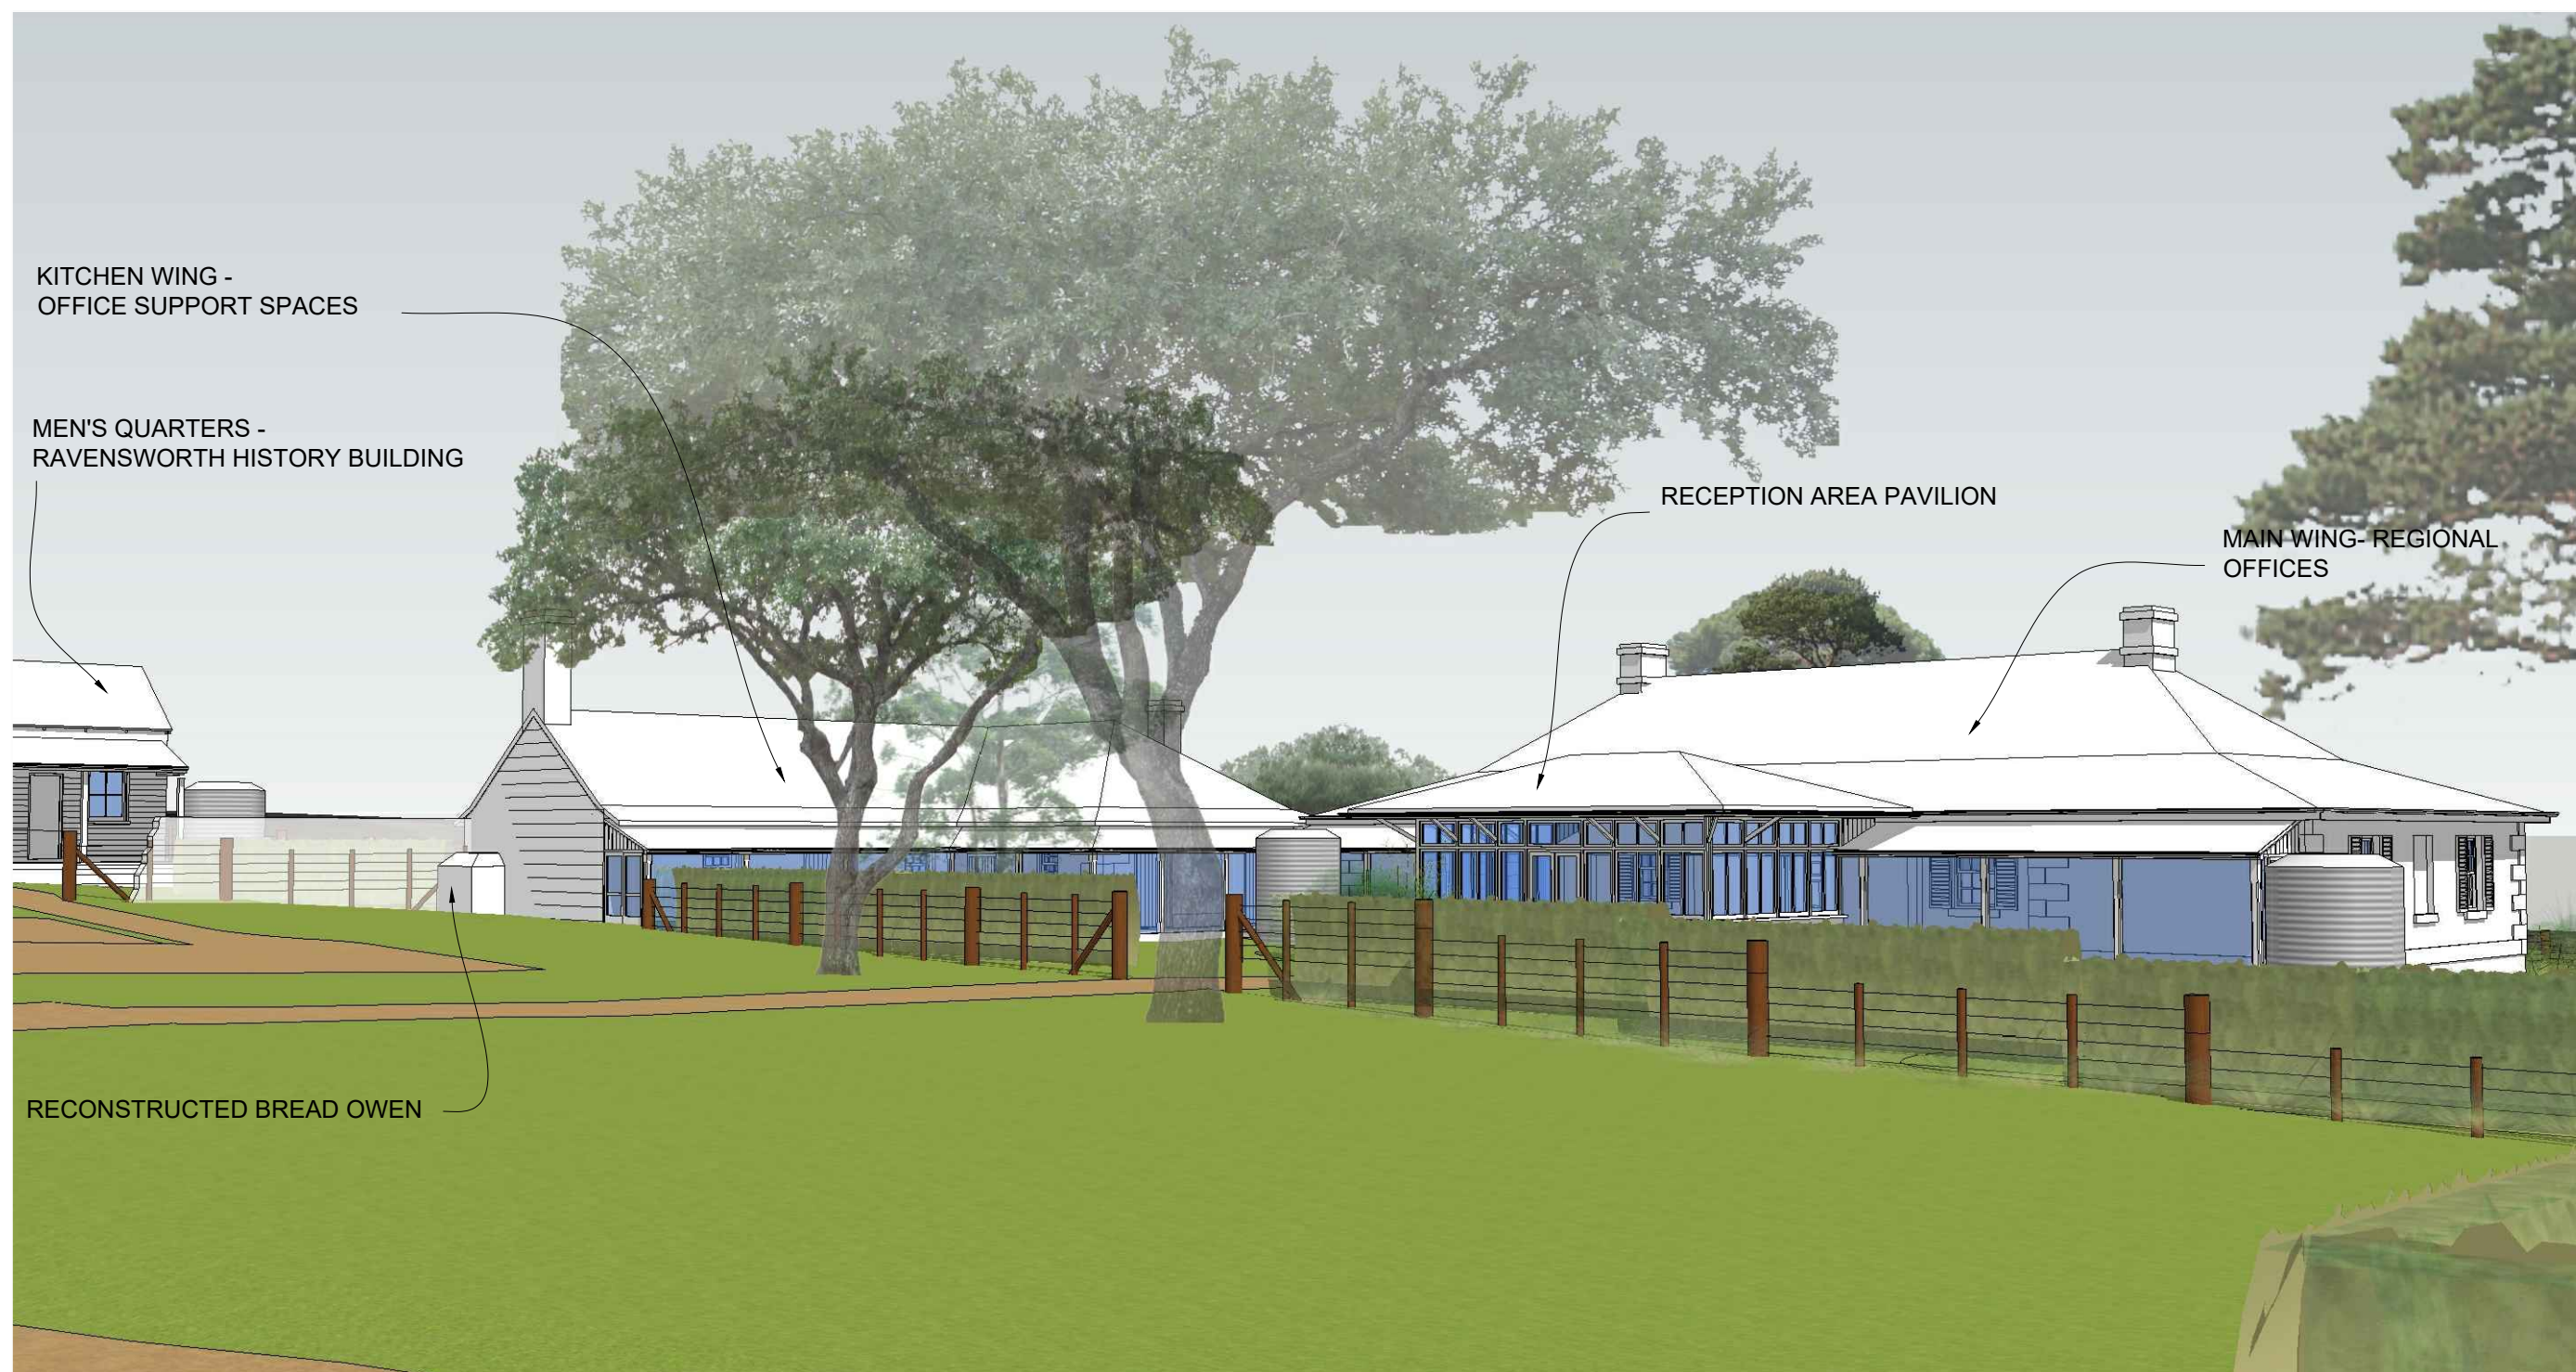
123800\_SP\_A.SK

① VIEW FROM NORTH TO RECEPTION AREA, MAIN WING AND KITCHEN WING

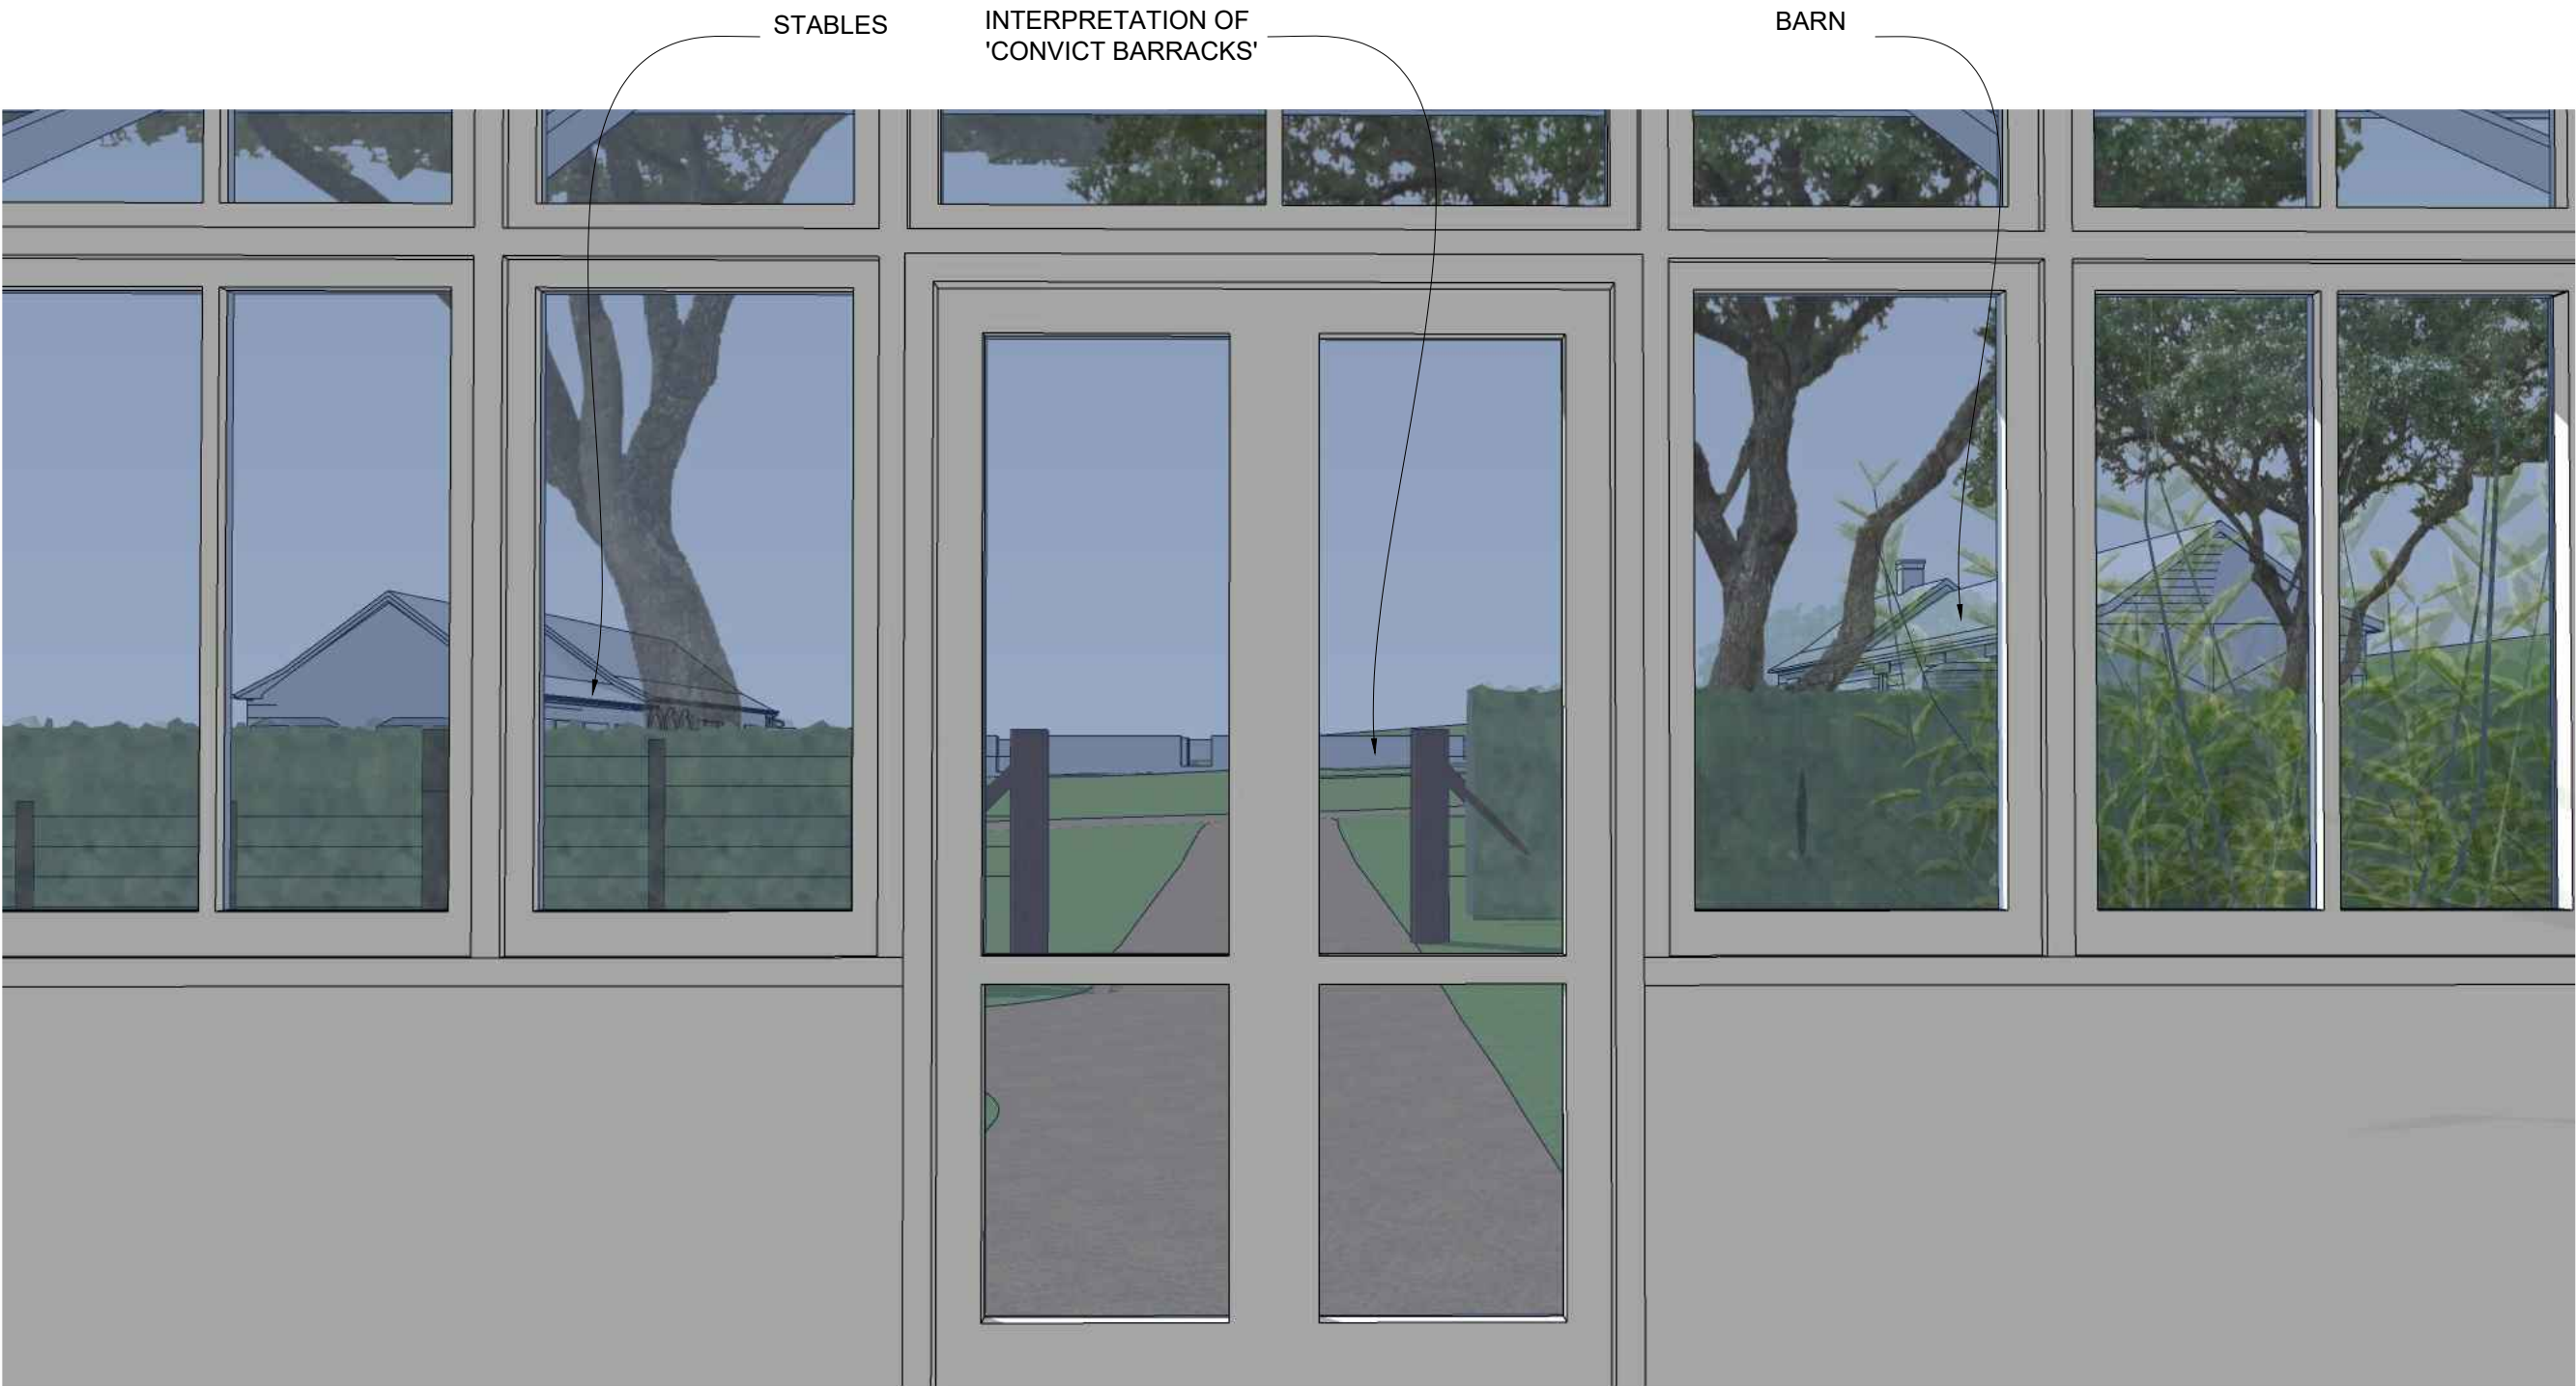
CONCEPTUAL VIEW FROM OFFICE RECEPTION / NORTH GARDEN  
TO SERVICE YARD

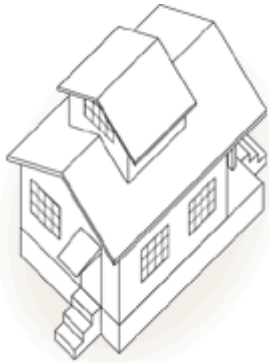
Step 1 – Organise all administration details prior to relocation of structure

Step 2 – The house is dug out and supported on temporary shoring to allow for the installation of beams to carry the structure.

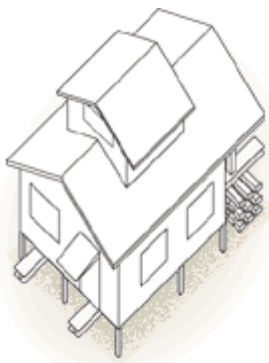
Step 3 – Steel main beams and traverse beams are installed under the house to create a grid like platform that will allow the structure to be moved without being damaged.

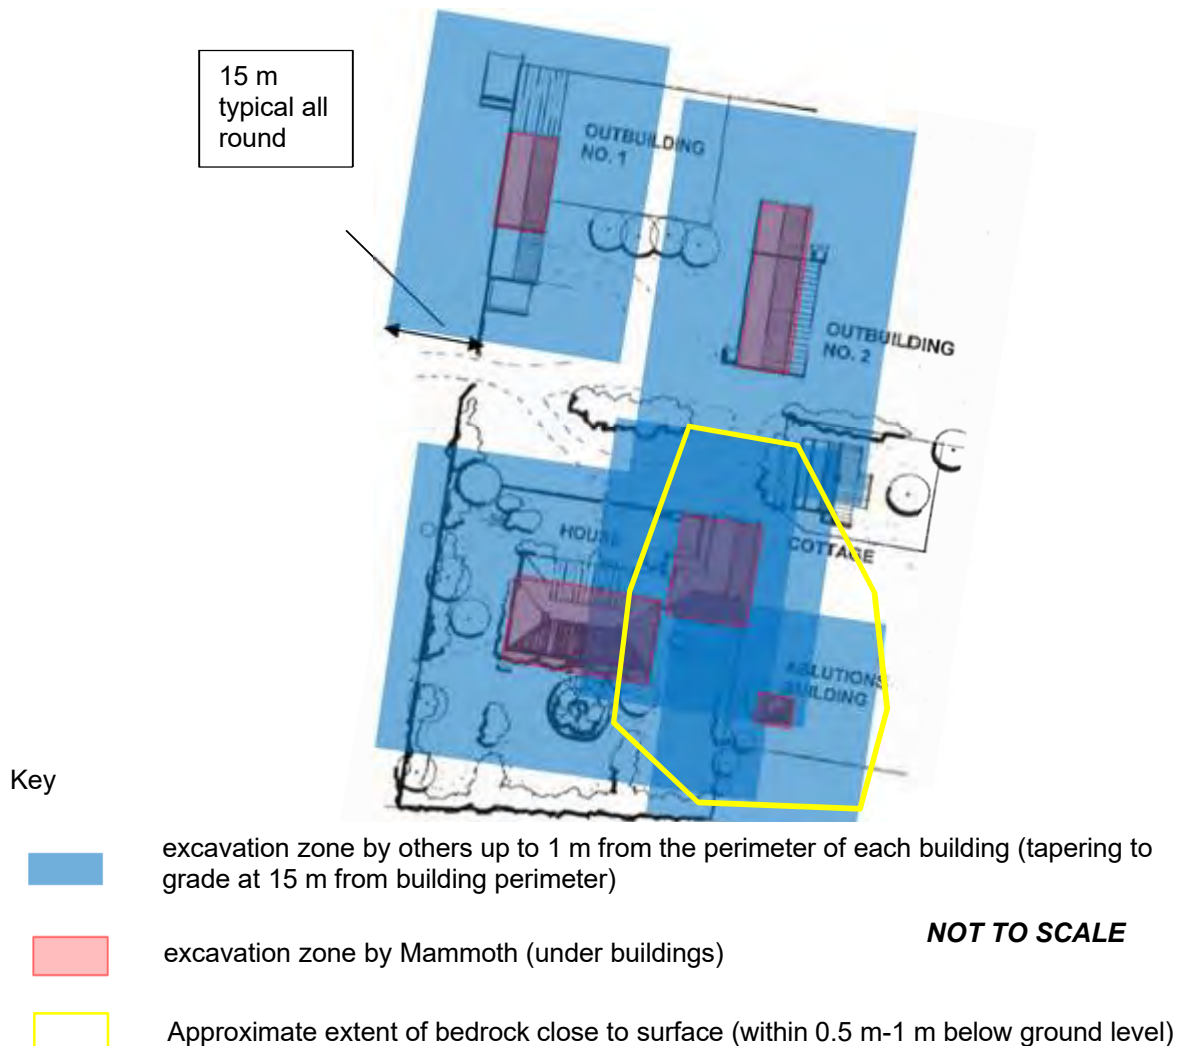
Figure 4 – Required excavation around buildings – plan view

The approximate extent of excavation required around each building is shown in Figure 4.

Excavation around the buildings will be required to an average depth of around 1.2 m below the cutline tapering up to grade. This will provide access to the building's foundations. Excavation within a metre of the building and under the building footprint will be undertaken by Mammoth after the pre-digging is finalised.

Note 1 – Excavation is not required around the Cottage.

Note 2 – If financially equivalent it may be better to excavate the entire region between the buildings to a lower flat level. This has the advantage of providing a flat work area and reduces the pooling of water under the buildings in a rain event – reducing potential project delay.

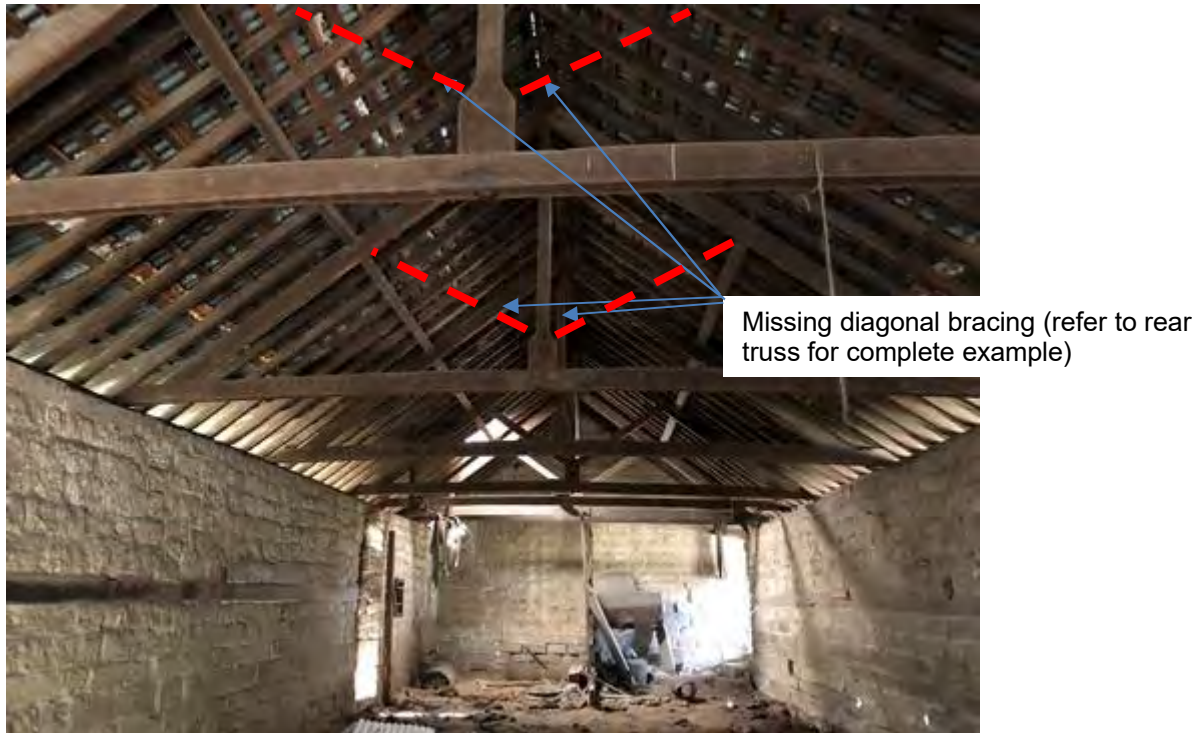
Figure 5 – Missing bracing in the Barn

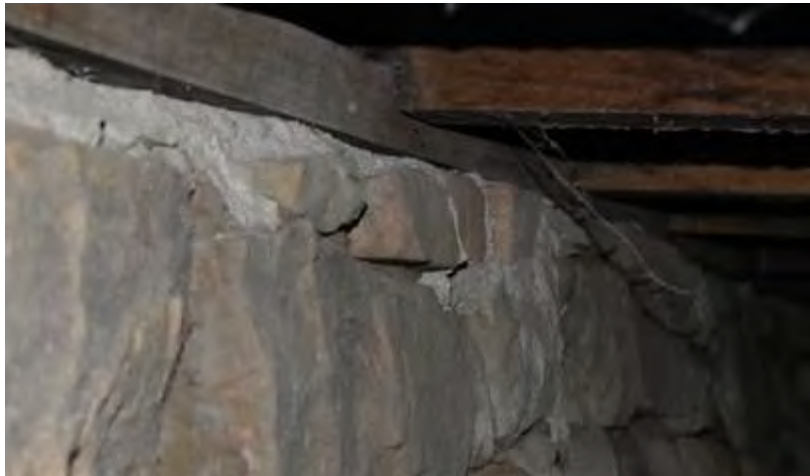
*Figure 7 – Void in the internal leaf wall due to integrated floor joist*

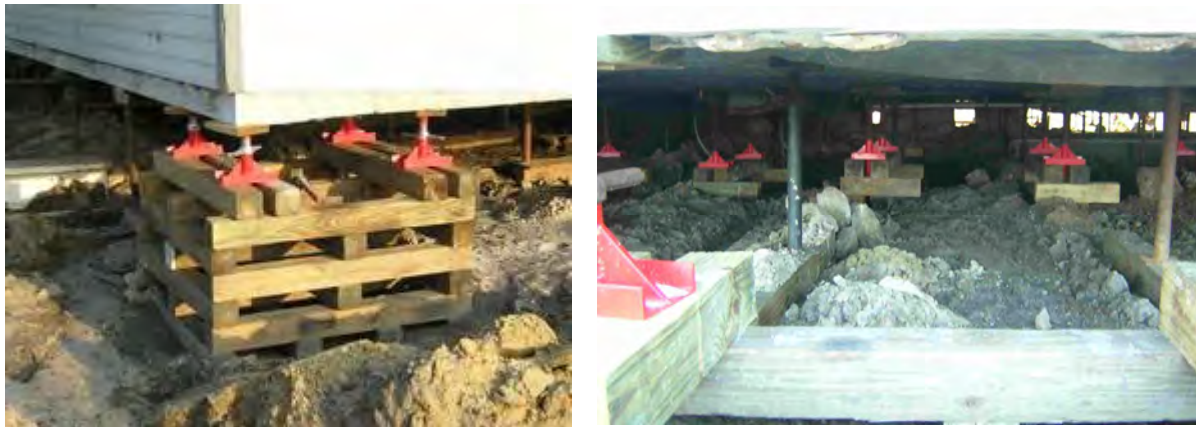
Figure 8 – Jacking posts

a) Heavy duty jacking posts installed under a building perimeter wall with lighter weight posts under the remaining floor structure. b) View through to the building's partially demolished footer supporting the far perimeter wall with the building floor supported above.

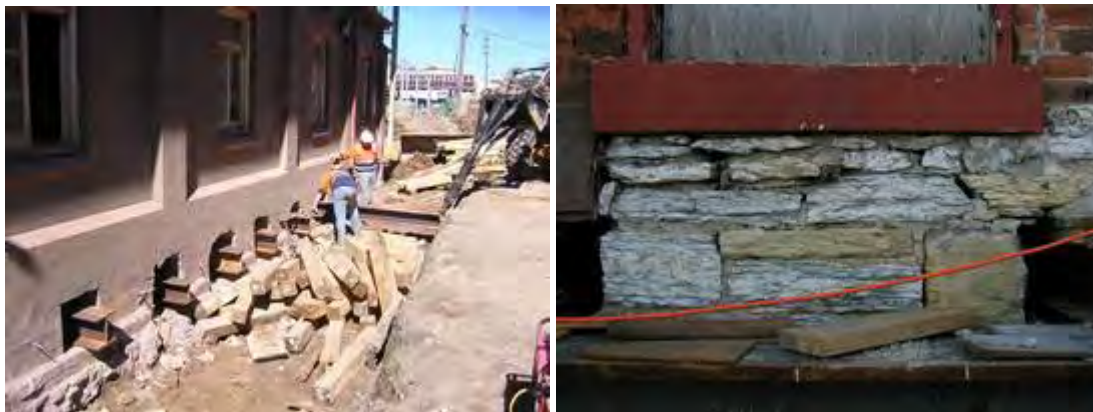
Figure 9 – Examples of footers being retained with support steel inserted through “windows” in the footers

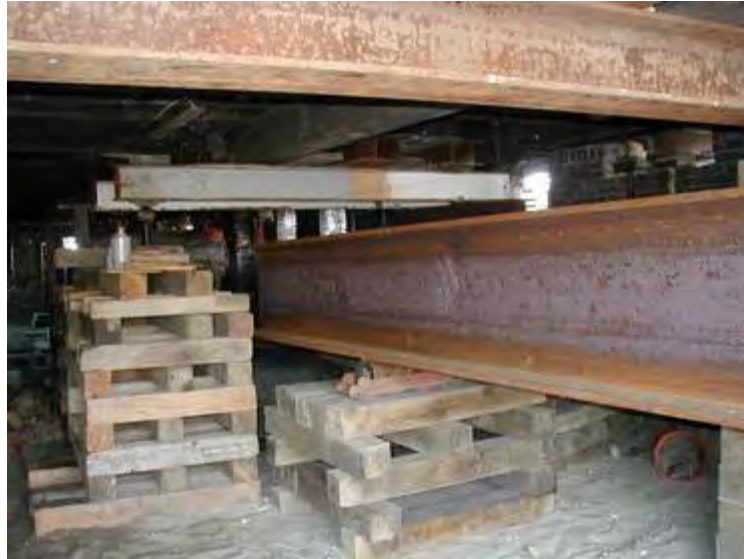
Layers of steel will be installed in a grid arrangement under each building to provide support during the move. Beams are maneuvered under the building using a loader. Rollers or slide plates are employed to enable the beams to slide into position.

*Figure 10 – Main beam being maneuvered into position*

Wooden wedges are used between the beams and the bottom of the building to ensure that the weight of the building is being taken on all beams. These wedges are knocked into position until firm and pre-stress the beams to accommodate elastic deflection in the beams.

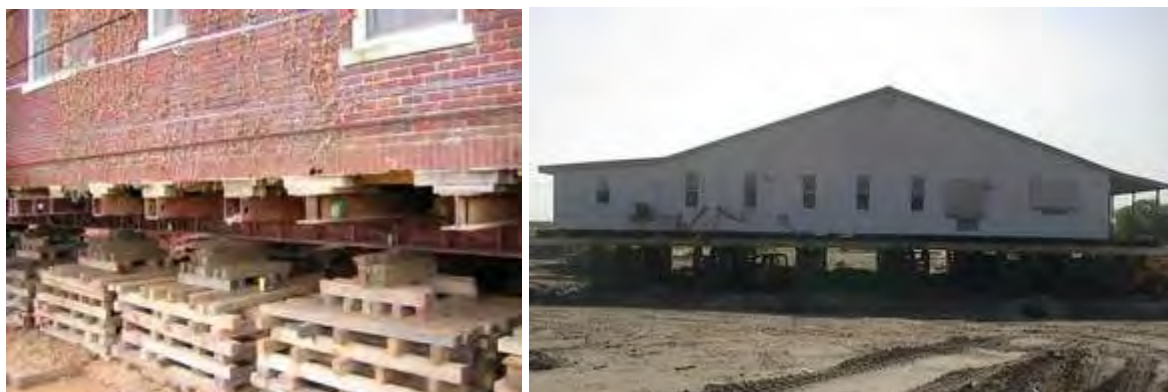
*Figure 11 – Buildings supported on cribbing*

Each building is raised using a unified jacking machine which ensures all parts of the building are raised as one. The unified jacking system enables the pressure on jacks to be monitored – critical to confirming that everything is progressing correctly and to accurately determine the actual weight of the building (plus support steel) and the associated weight distribution across the load plan.
