# Glendell Mine Extension Ravensworth, NSW

## Statement of Heritage Impact

Prepared for:  
**Mt Owen Pty Ltd, Glencore**  
Locked Bay 6015  
Hunter Regional MC NSW 2310

Prepared by:  
**Lucas Stapleton Johnson & Partners Pty. Ltd.**  
Level 1, 191 Clarence Street  
Sydney NSW 2000  
Telephone: (02) 9357 4811  
Email: mailbox@lsjarchitects.com

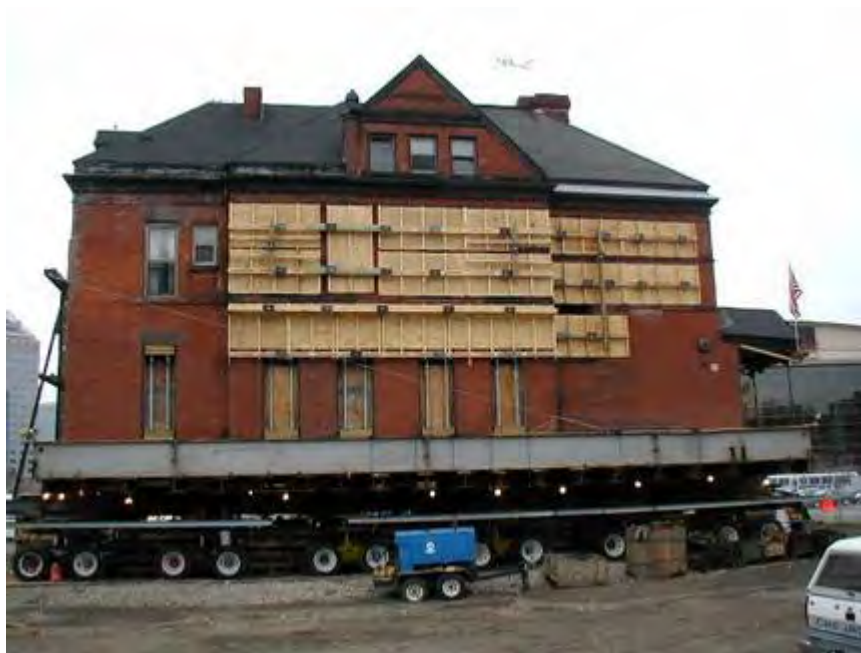
The number of dollies employed is dependent on the weight of the building and its distribution. The limiting factor is usually the wheel load limit for the roads on route – a lesser problem for the Ravensworth Complex relocation as the move will be confined to prepared internal Glencore routes as opposed to the public road network.

*Figure 12 – A loaded building*

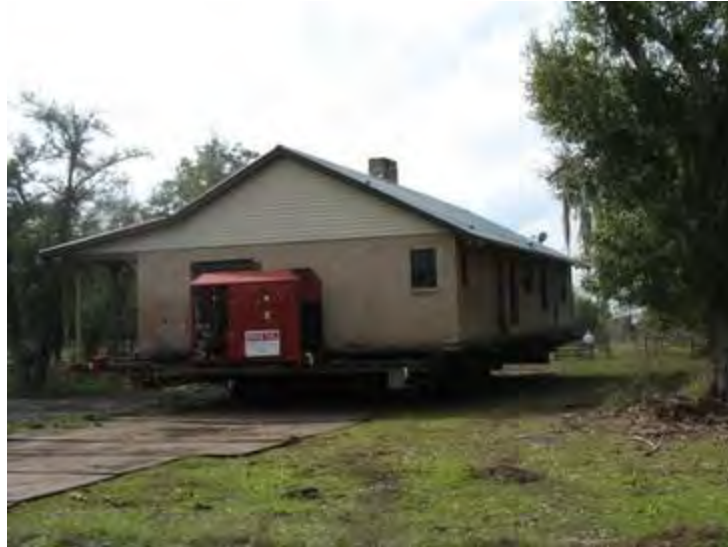
*Figure 13 – Hydraulic power dollies installed under a building enabling it to be self propelled (i.e. no tow vehicle)*

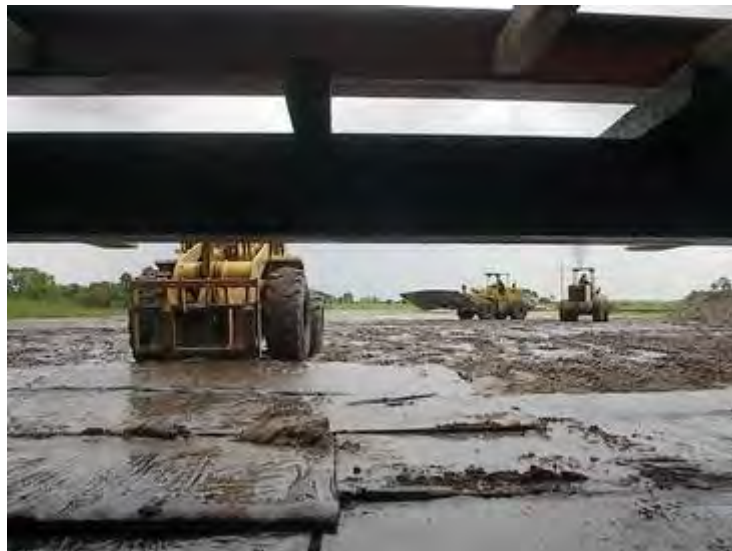
Each move is expected to take less than one day. Steel plate will be utilized where necessary to prevent bogging on the original site and to distribute ground pressures applied by the dollies at the initial and final sites. Plates will also be employed to protect underground cables if required.

*Figure 14 – Laying of steel plate to spread dolly wheel loads over unprepared agricultural land.*

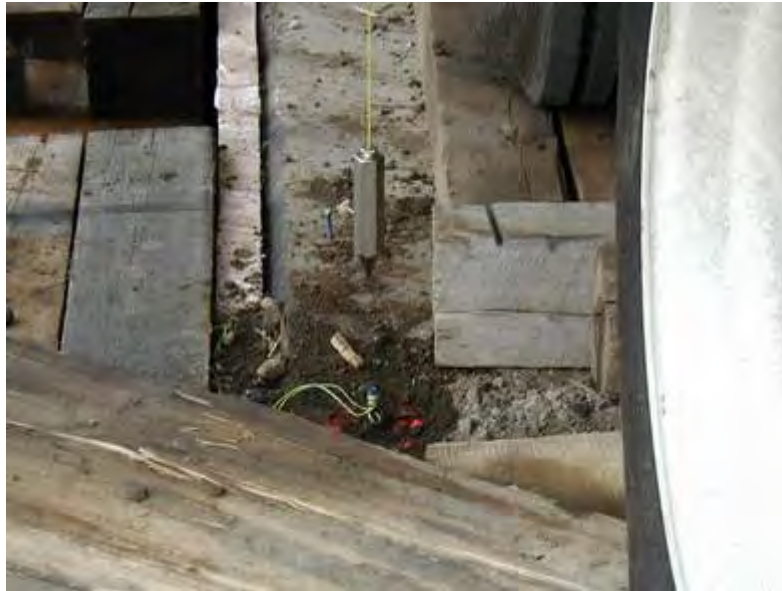
*Figure 15 – Spotting a building using plumb bobs.*

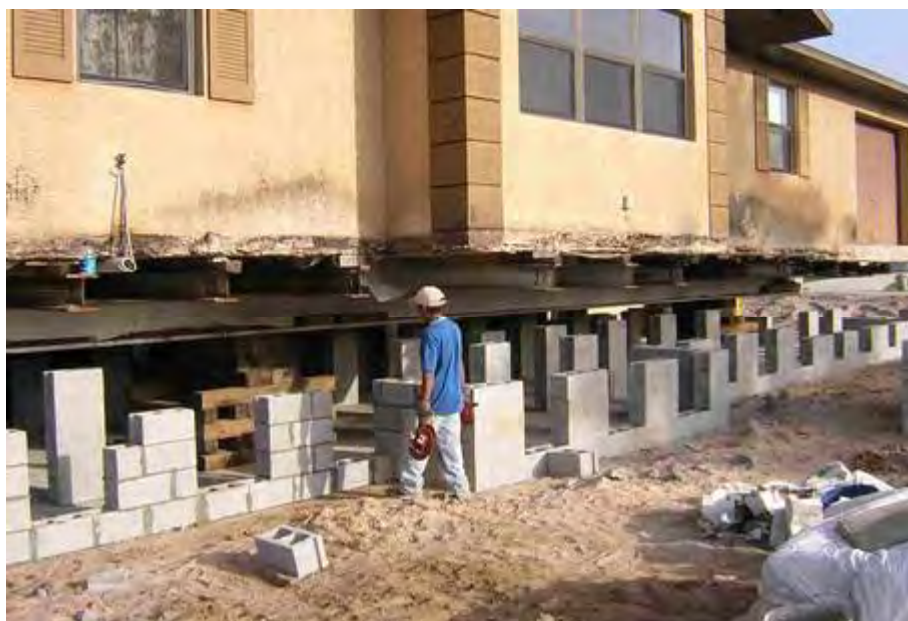
*Figure 16 – Building of block work above new foundation prior to lowering of a masonry building.*

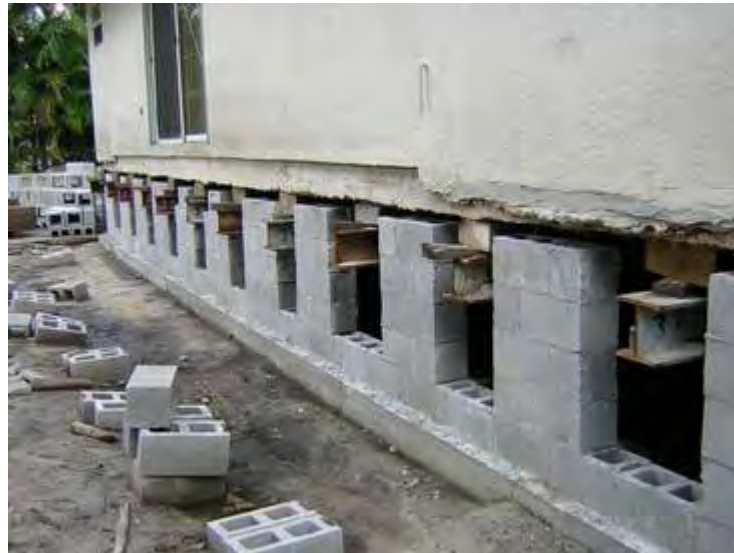
Each building will be retained in the raised position until the block work is ready to accept the building. The design of the support blockwork will allow for the temporary support equipment to be removed once the weight of the building is transferred to the permanent construction. Conventionally this is achieved via the incorporation of “windows” in the blockwork with clearance to release the load from Mammoth’s steel and to extract the beams.

*Figure 17 – Finished blockwork incorporating windows for steel clearance.*

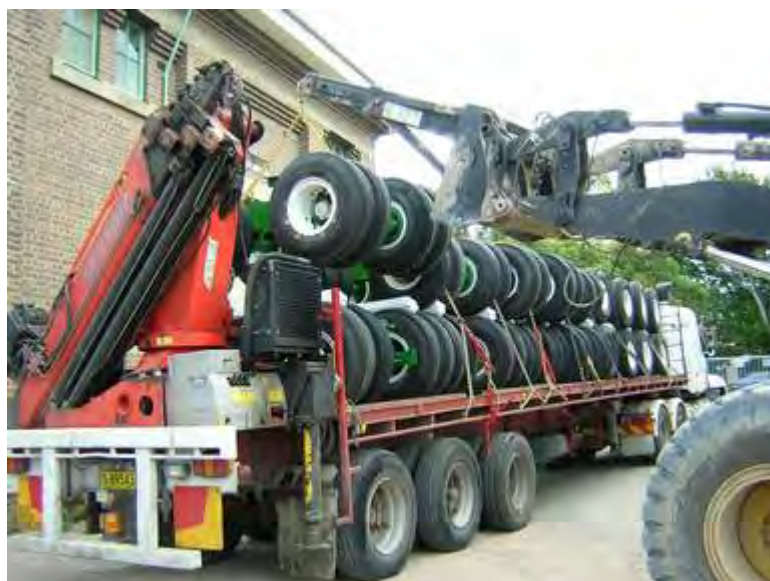
As the equipment is removed it will be transferred to the laydown area where it will be used to move the other buildings or at the completion of the move, loaded on trucks to remove it from the site.

*Figure 18 – Loading dollies*

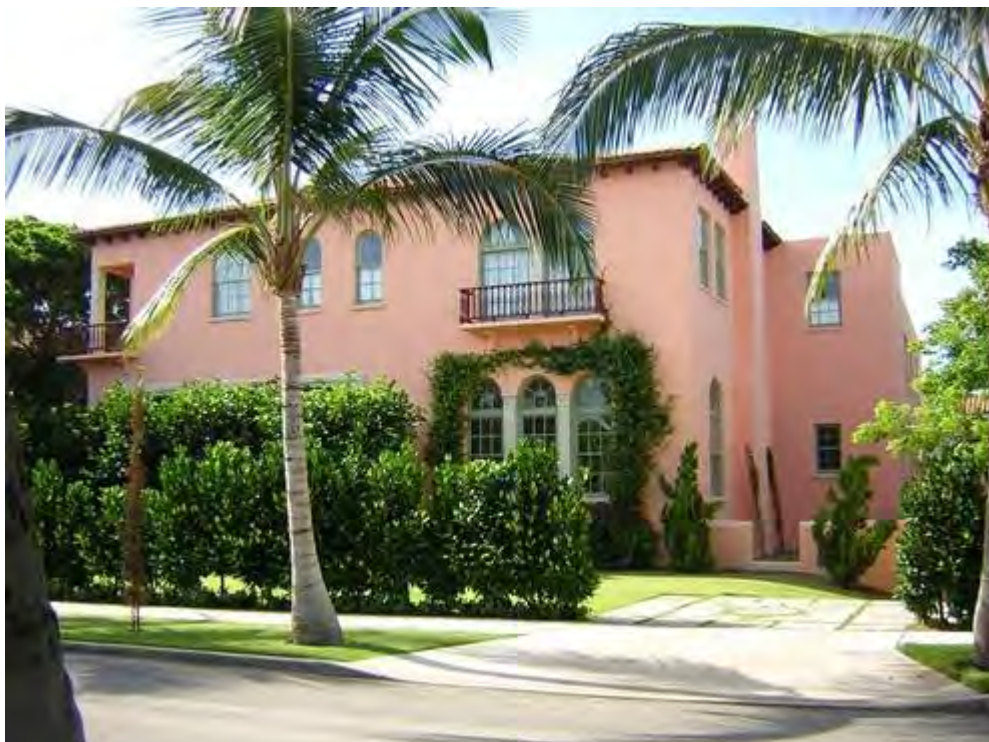
*Figure 19 – A relocated masonry building project complete after backfill, landscaping and restoration*

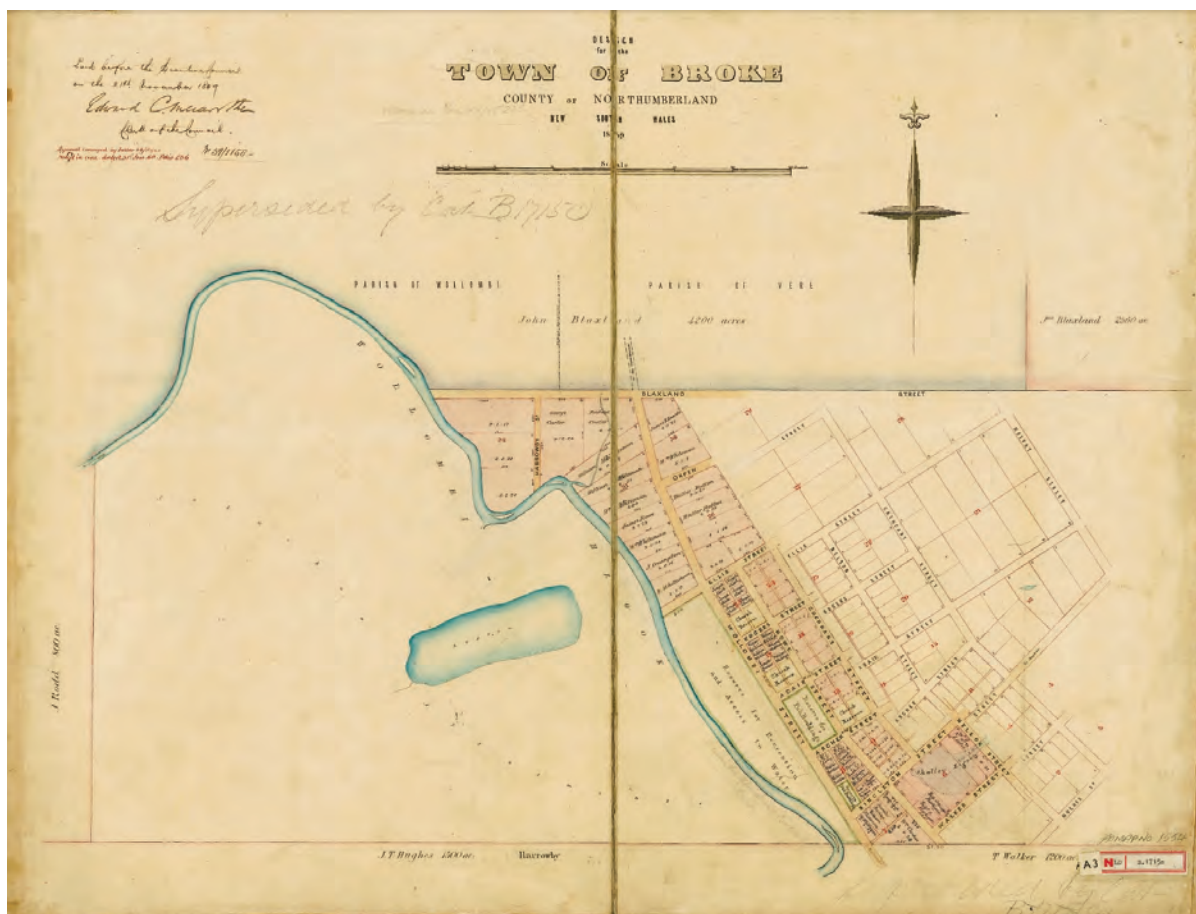
Figure 2. 3: Village Design Plan for Village of Broke, 1859. Source: SA Map 1554

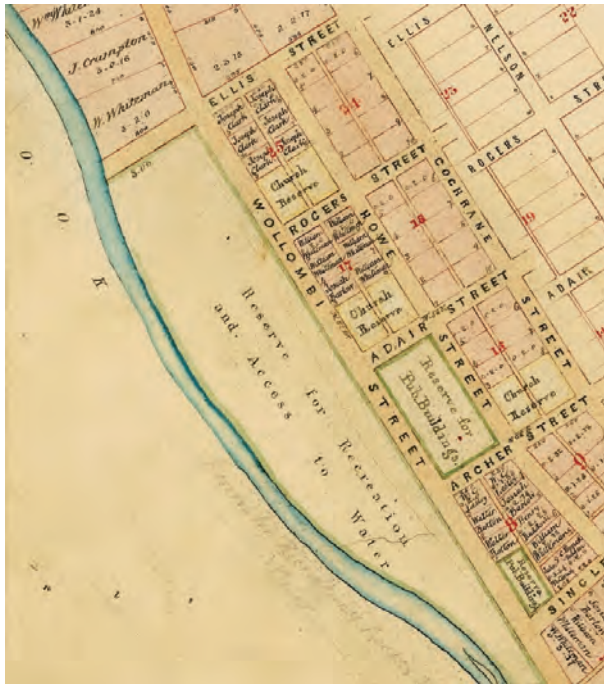
Figure 2. 4: Detail of the 1859 Village Design plan showing the Recreation and Water Reserve. Source: SA Map 1554

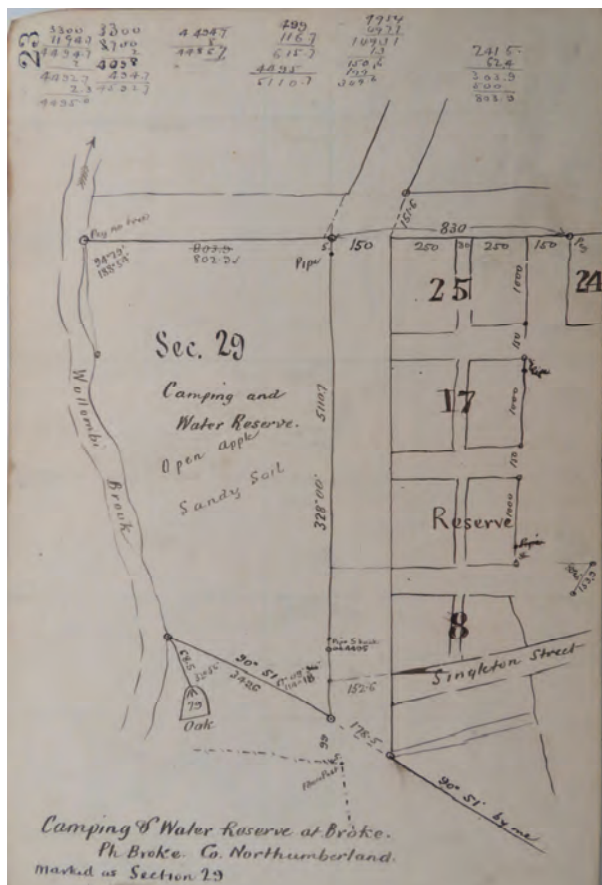
Figure 2. 5: Licensed Surveyor Worters R Pulver's fieldbook sketch of the Reserve boundaries. Source: NRS 13889, Surveyor General, Surveyors Field Book, No 7107, W Pulver, SANSW, p 23

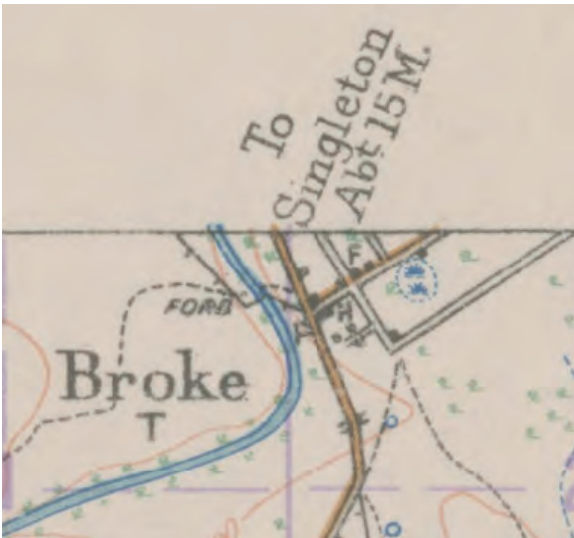
Figure 2. 9: The 1927 Topographical Map showed a ford across Wollombi Brook where a track crossed the Reserve. Source: Australia – Army, Topo Map 1:63360, ML Map M Ser 3 804 3, Cessnock, 1927, Zone 8 Sheet 395

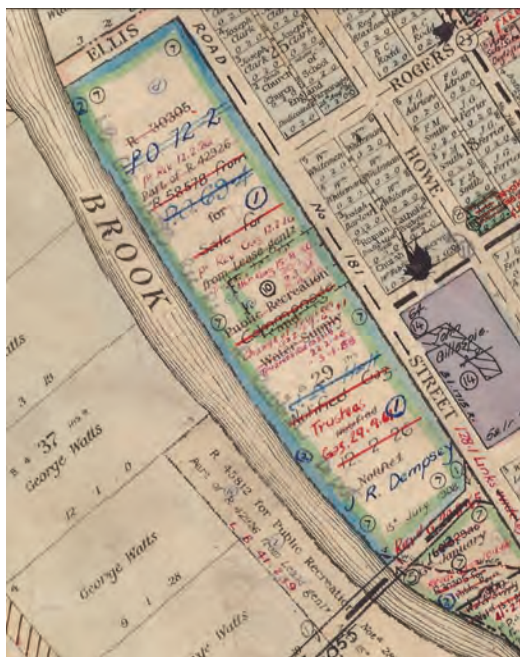
Figure 2. 11: The Lands Department Regional Charting map of the Village of Broke recorded more recent Permissive Occupancies on the Reserve. Source: HLRV, LRS

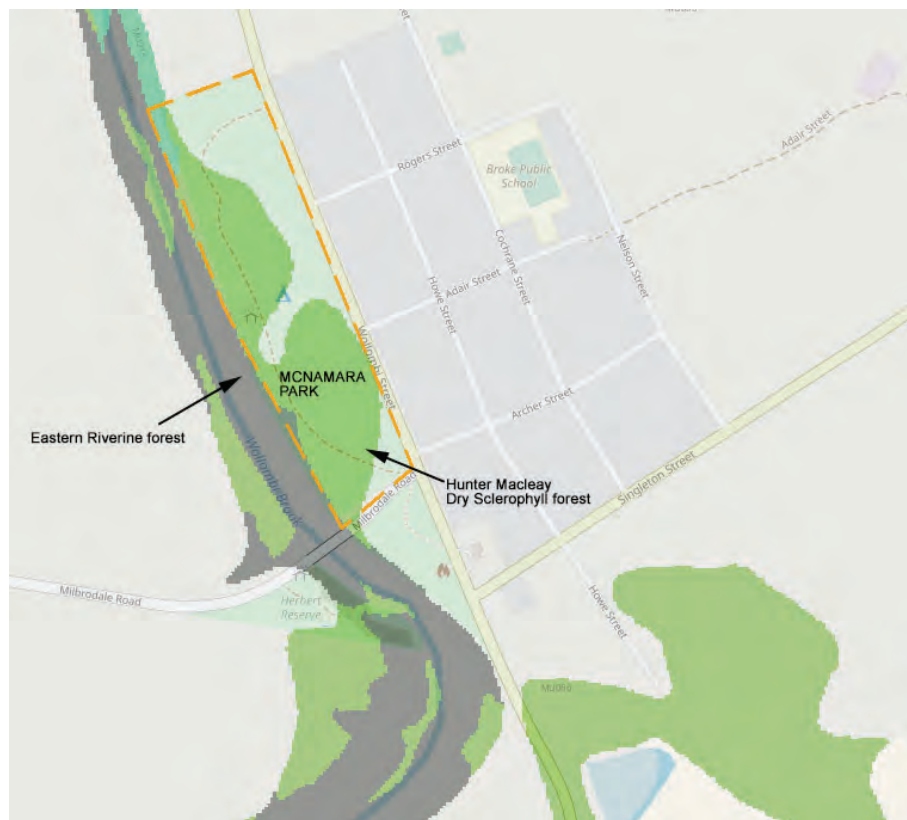
Figure 3. 13: Extract from Greater Hunter Native Vegetation Mapping v4.0 showing vegetation classes identified at McNamara Park, Broke. Source NSW Government SEED web map; <https://geo.seed.nsw.gov.au/>; annotated by LSJ, Oct 2019

The Hunter-Macleay Dry Sclerophyll forest is a dry open eucalypt forest to 30 metres tall with a mixed shrub stratum and semi-continuous grassy ground cover. This forest type is found at foothills and undulating terrain in rain shadow valleys below 400 metres elevation, on well-drained soil and are associated with the major coastal river valleys along the NSW coast.

The Eastern Riverine Forest is an open casuarina forest, 10 to 40 metres tall, dominated by river oak (*Casuarina cunninghamiana*). The forest is found along riparian corridors in open terrain of coastal hinterland and tablelands up to 700 metres elevation.<sup>77</sup>

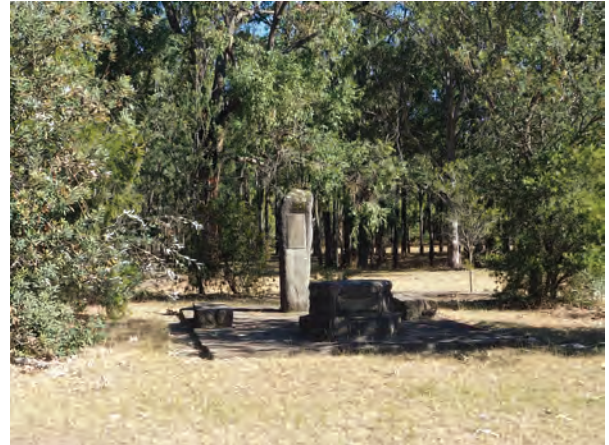
Figure 3. 28: **Site Feature 2** - Bicentennial memorial of sandstone and metal with sundial and stone plinth on sandstone and concrete base with surrounding native and exotic plantings.

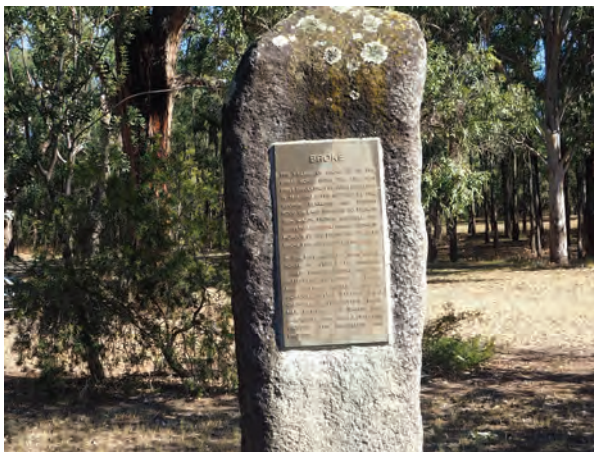
Figure 3. 29: Upright stone plinth (eroded) with plaque.

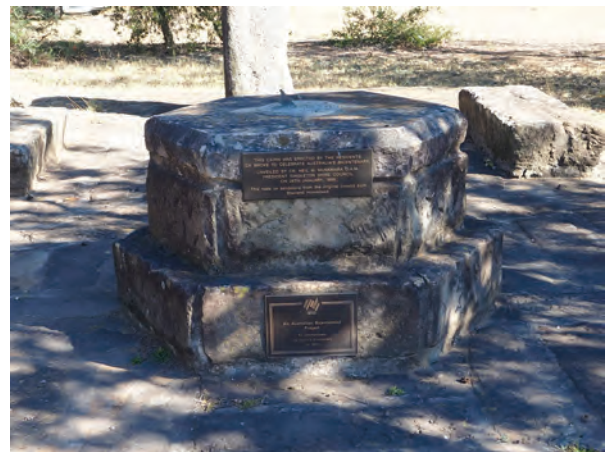
Figure 3. 30: Sandstone and metal sun dial erected as a memorial to the Australian Bicentenary.

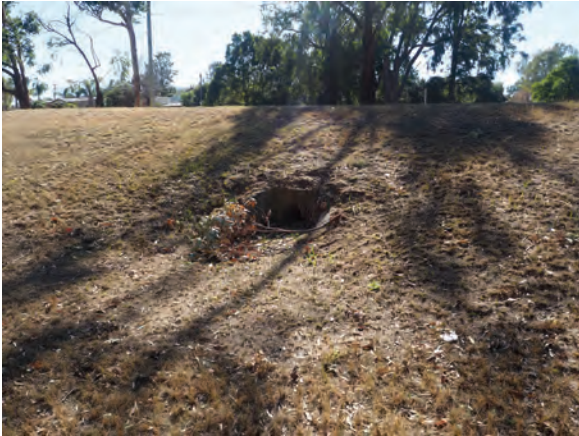
Figure 3.33: Culvert running under Wollombi Street and exiting into McNamara Park.

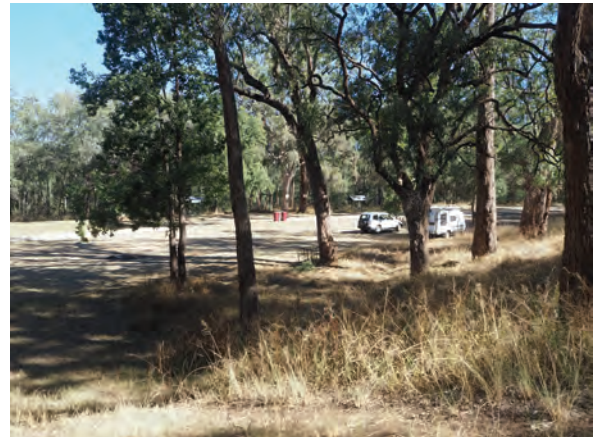
Figure 3.41: Line of painted timber and concrete vehicle barriers on bank leading down to lower camping area and picnic sites.

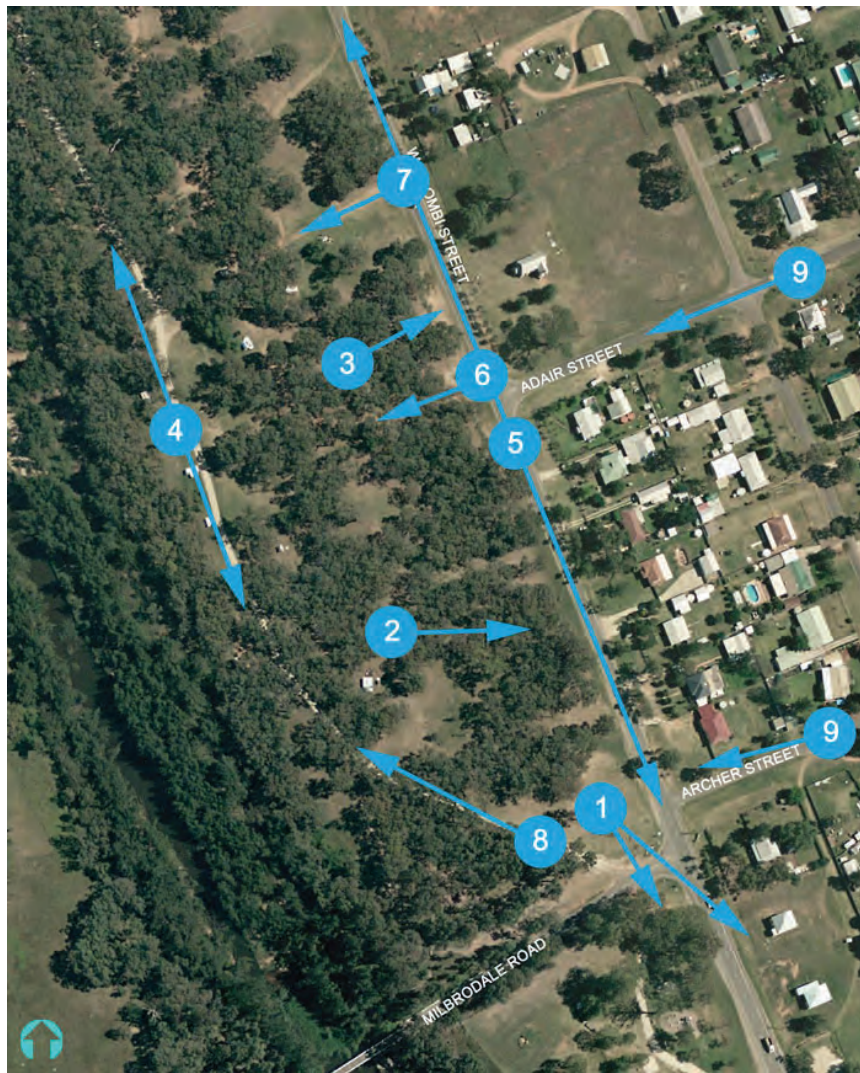
Figure 3. 45: Aerial view of McNamara Park identifying main views to and from the reserve.

Table 3. 1: Views to and from McNamara Park, Broke. Refer to Figure 3.45 below for location of views.

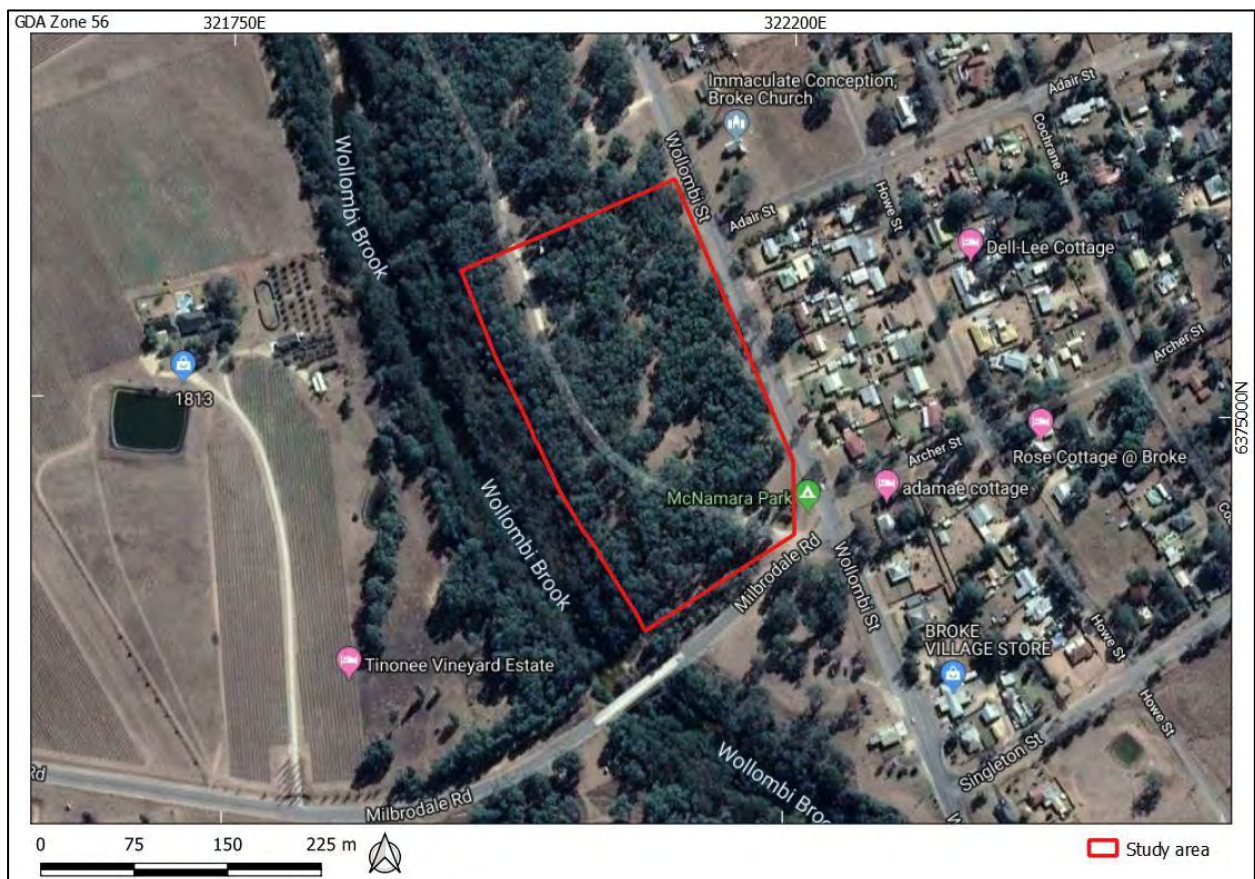
**Figure 1-2: Aerial showing the study area.**

The study area encompasses 5.5 hectares (ha) of land within Lot 701 DP93631 at Broke, NSW (**Figure 1-2**). The study area is part of McNamara Park and is bounded to the east by Wollombi Street; south by Milbrodale Road and west by Wollombi Brook.

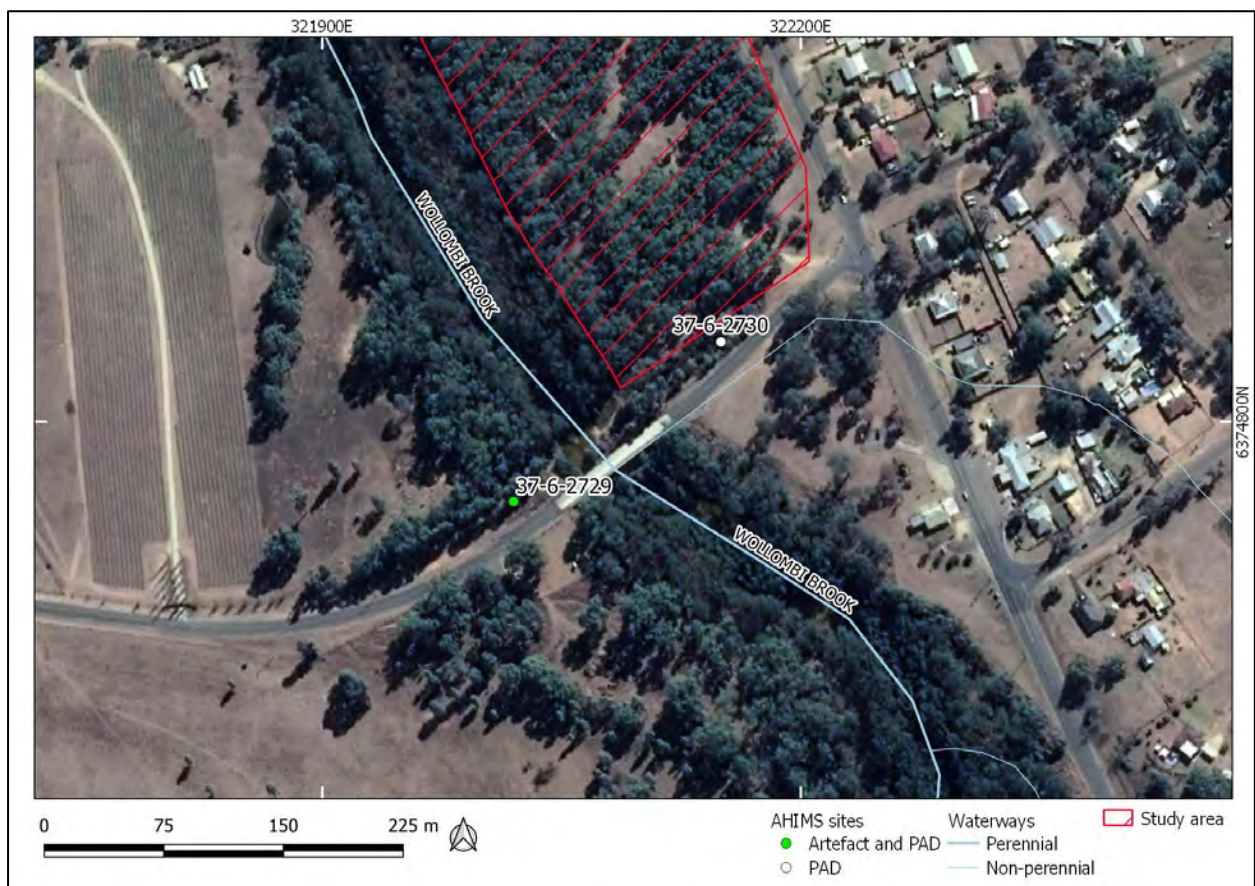
**Figure 2-1: Location of 37-3-2729 and 37-6-2730 in relation to the study area.**

The AHIMS results show two sites near the study area, 37-3-2729 and 37-6-2730 (**Figure 2-1**). 37-3-2729 (Broke Bridge PAD1) is listed as an artefact with potential archaeological deposit (PAD), located 95 metres (m) southwest of the study area. The PAD extent is 70 m in length and varies in width from 1 m where it joins Milbrodale Road in the west and up to 15 m wide adjacent to Wollombi Brook (McCardle Cultural Heritage 2011). Site 37-6-2730 (Broke Bridge PAD2) is listed as a PAD, 12 m south of the study area. This PAD is 50 m in length and varies in width from 1 m where it joins Milbrodale Road in the east up to 15 m adjacent to Wollombi Brook (McCardle Cultural Heritage 2011). Based on the provided extent of 37-6-2730, the site PAD does not extend into the study area, however, the landform (elevated terrace) assessed as having PAD does. Both sites are listed as ‘valid’ on AHIMS, however, the archaeological assessment which records the sites recommended test excavations be completed prior to the construction of the bridge and road approaches. **Section 2.3.3.4** further outlines the archaeological assessment for these PADs, which was completed for bridge upgrade works over Wollombi Brook on Milbrodale Road.

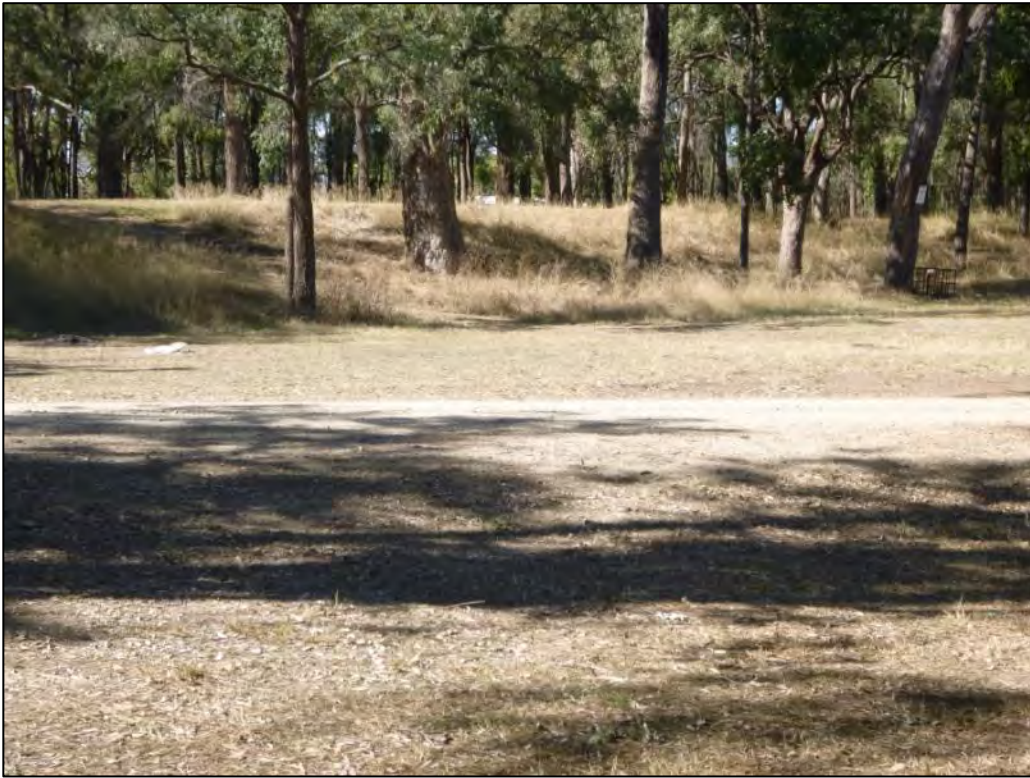
Plate 3: View from the secondary terrace to the tertiary in the north of the study area where the transition is more distinct.

No Aboriginal sites were identified during the visual inspection. Small quartz pebbles and fragments were present mostly across vehicle tracks, however, no pieces of material displayed any flaking characteristics consistent with tool manufacturing. Despite a lack of surface manifestations, the secondary and tertiary terraces which extend across most of the study area were confirmed as being archaeologically sensitive landforms (SAL). These landforms were identified as being a SAL as they comprise flat, elevated, well drained landforms adjacent to Wollombi Brook (**Plate 1 to 4**). The landforms have also been subject to low levels of disturbance and comprise sandy soils which in this context can have a depth greater than 1 m (**Plate 5**). The tertiary terrace has been assessed as having high potential for archaeological subsurface deposits as it is the most elevated landform with less disturbance, while the secondary terrace has been assessed as having moderate to high potential (**Figure 2-7**). Areas of disturbance within these landforms, i.e. the graded access track, building foundations do form part of the SAL. The transition zone between the secondary and tertiary terrace is higher in the north of the study area, approximately 1 to 2 m and gradually becomes lower towards the south (**Plates 3 and 4**). The profile in the transition zone highlights the sandy nature of the soils present.

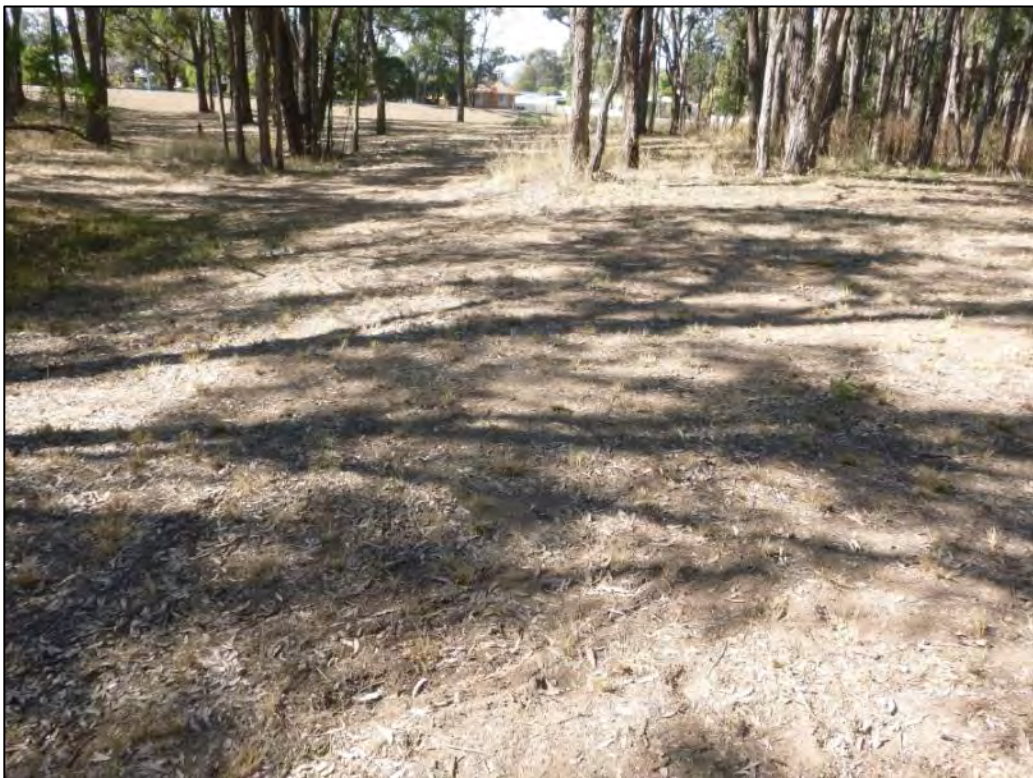
Plate 4: View from the secondary terrace to the tertiary in the south of the study area where the transition is less distinct.

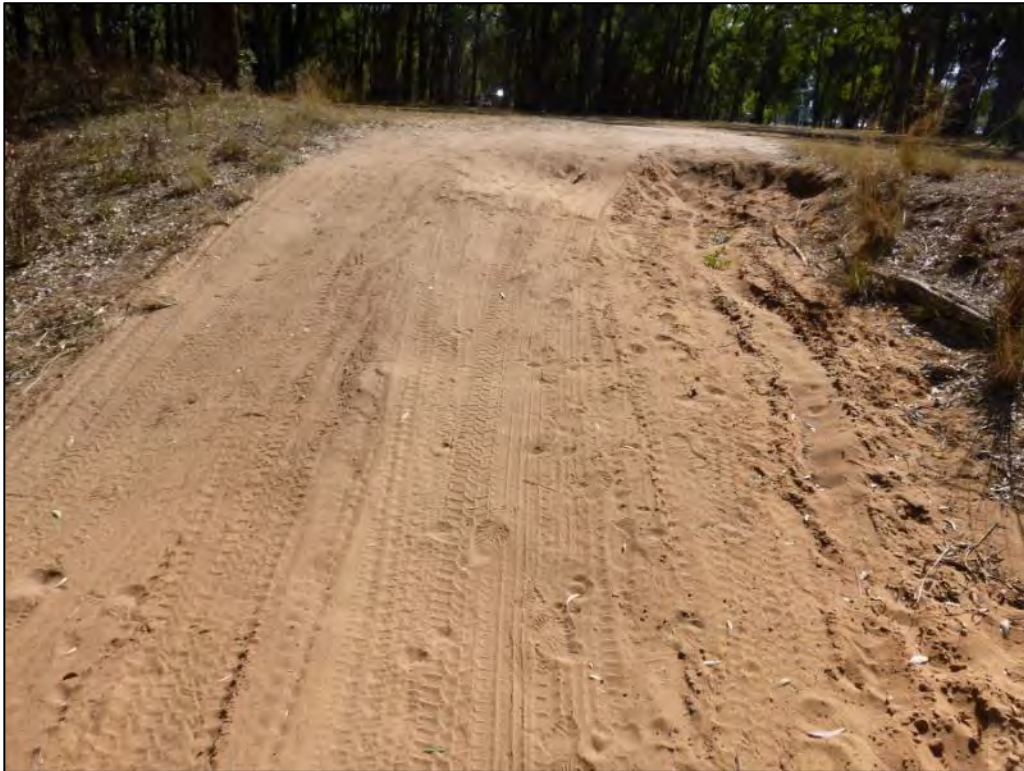
Plate 5: Detail of the sandy deposit at the transition of the tertiary and secondary terrace.

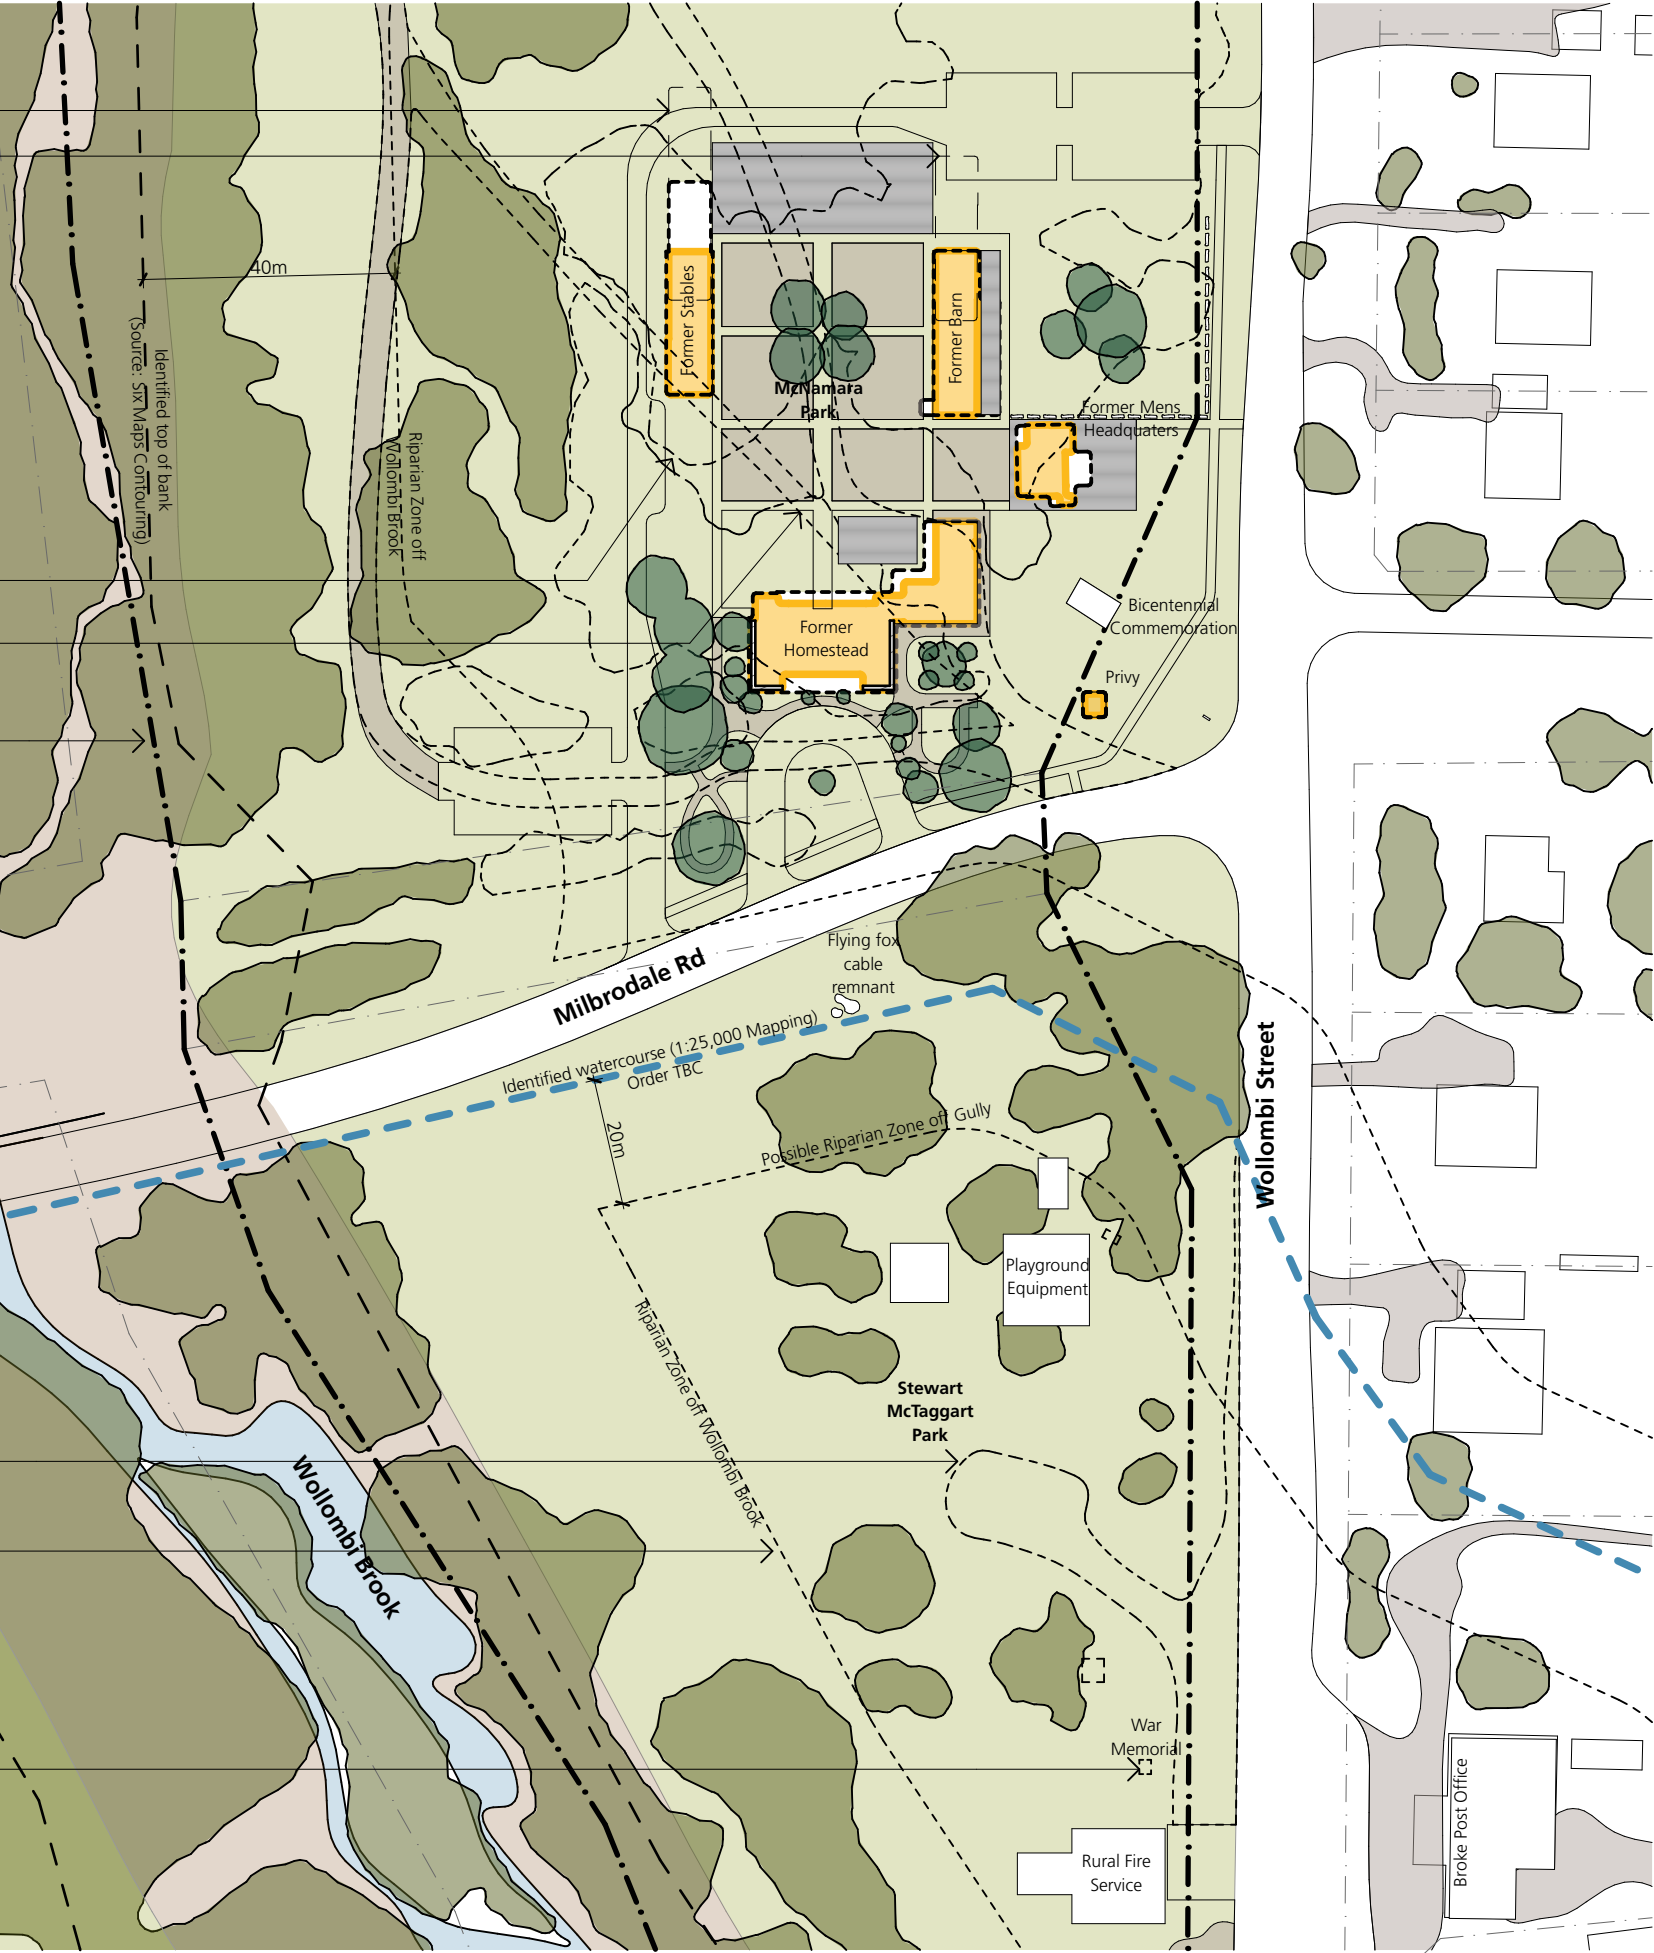
CONCEPT

RIPARIAN ZONES FROM BROOK AND GULLY SHOWN DASHED

EXISTING WAR MEMORIAL
