# Glendell Mine Extension Ravensworth, NSW

## Statement of Heritage Impact

Prepared for:  
**Mt Owen Pty Ltd, Glencore**  
Locked Bay 6015  
Hunter Regional MC NSW 2310

Prepared by:  
**Lucas Stapleton Johnson & Partners Pty. Ltd.**  
Level 1, 191 Clarence Street  
Sydney NSW 2000  
Telephone: (02) 9357 4811  
Email: mailbox@lsjarchitects.com

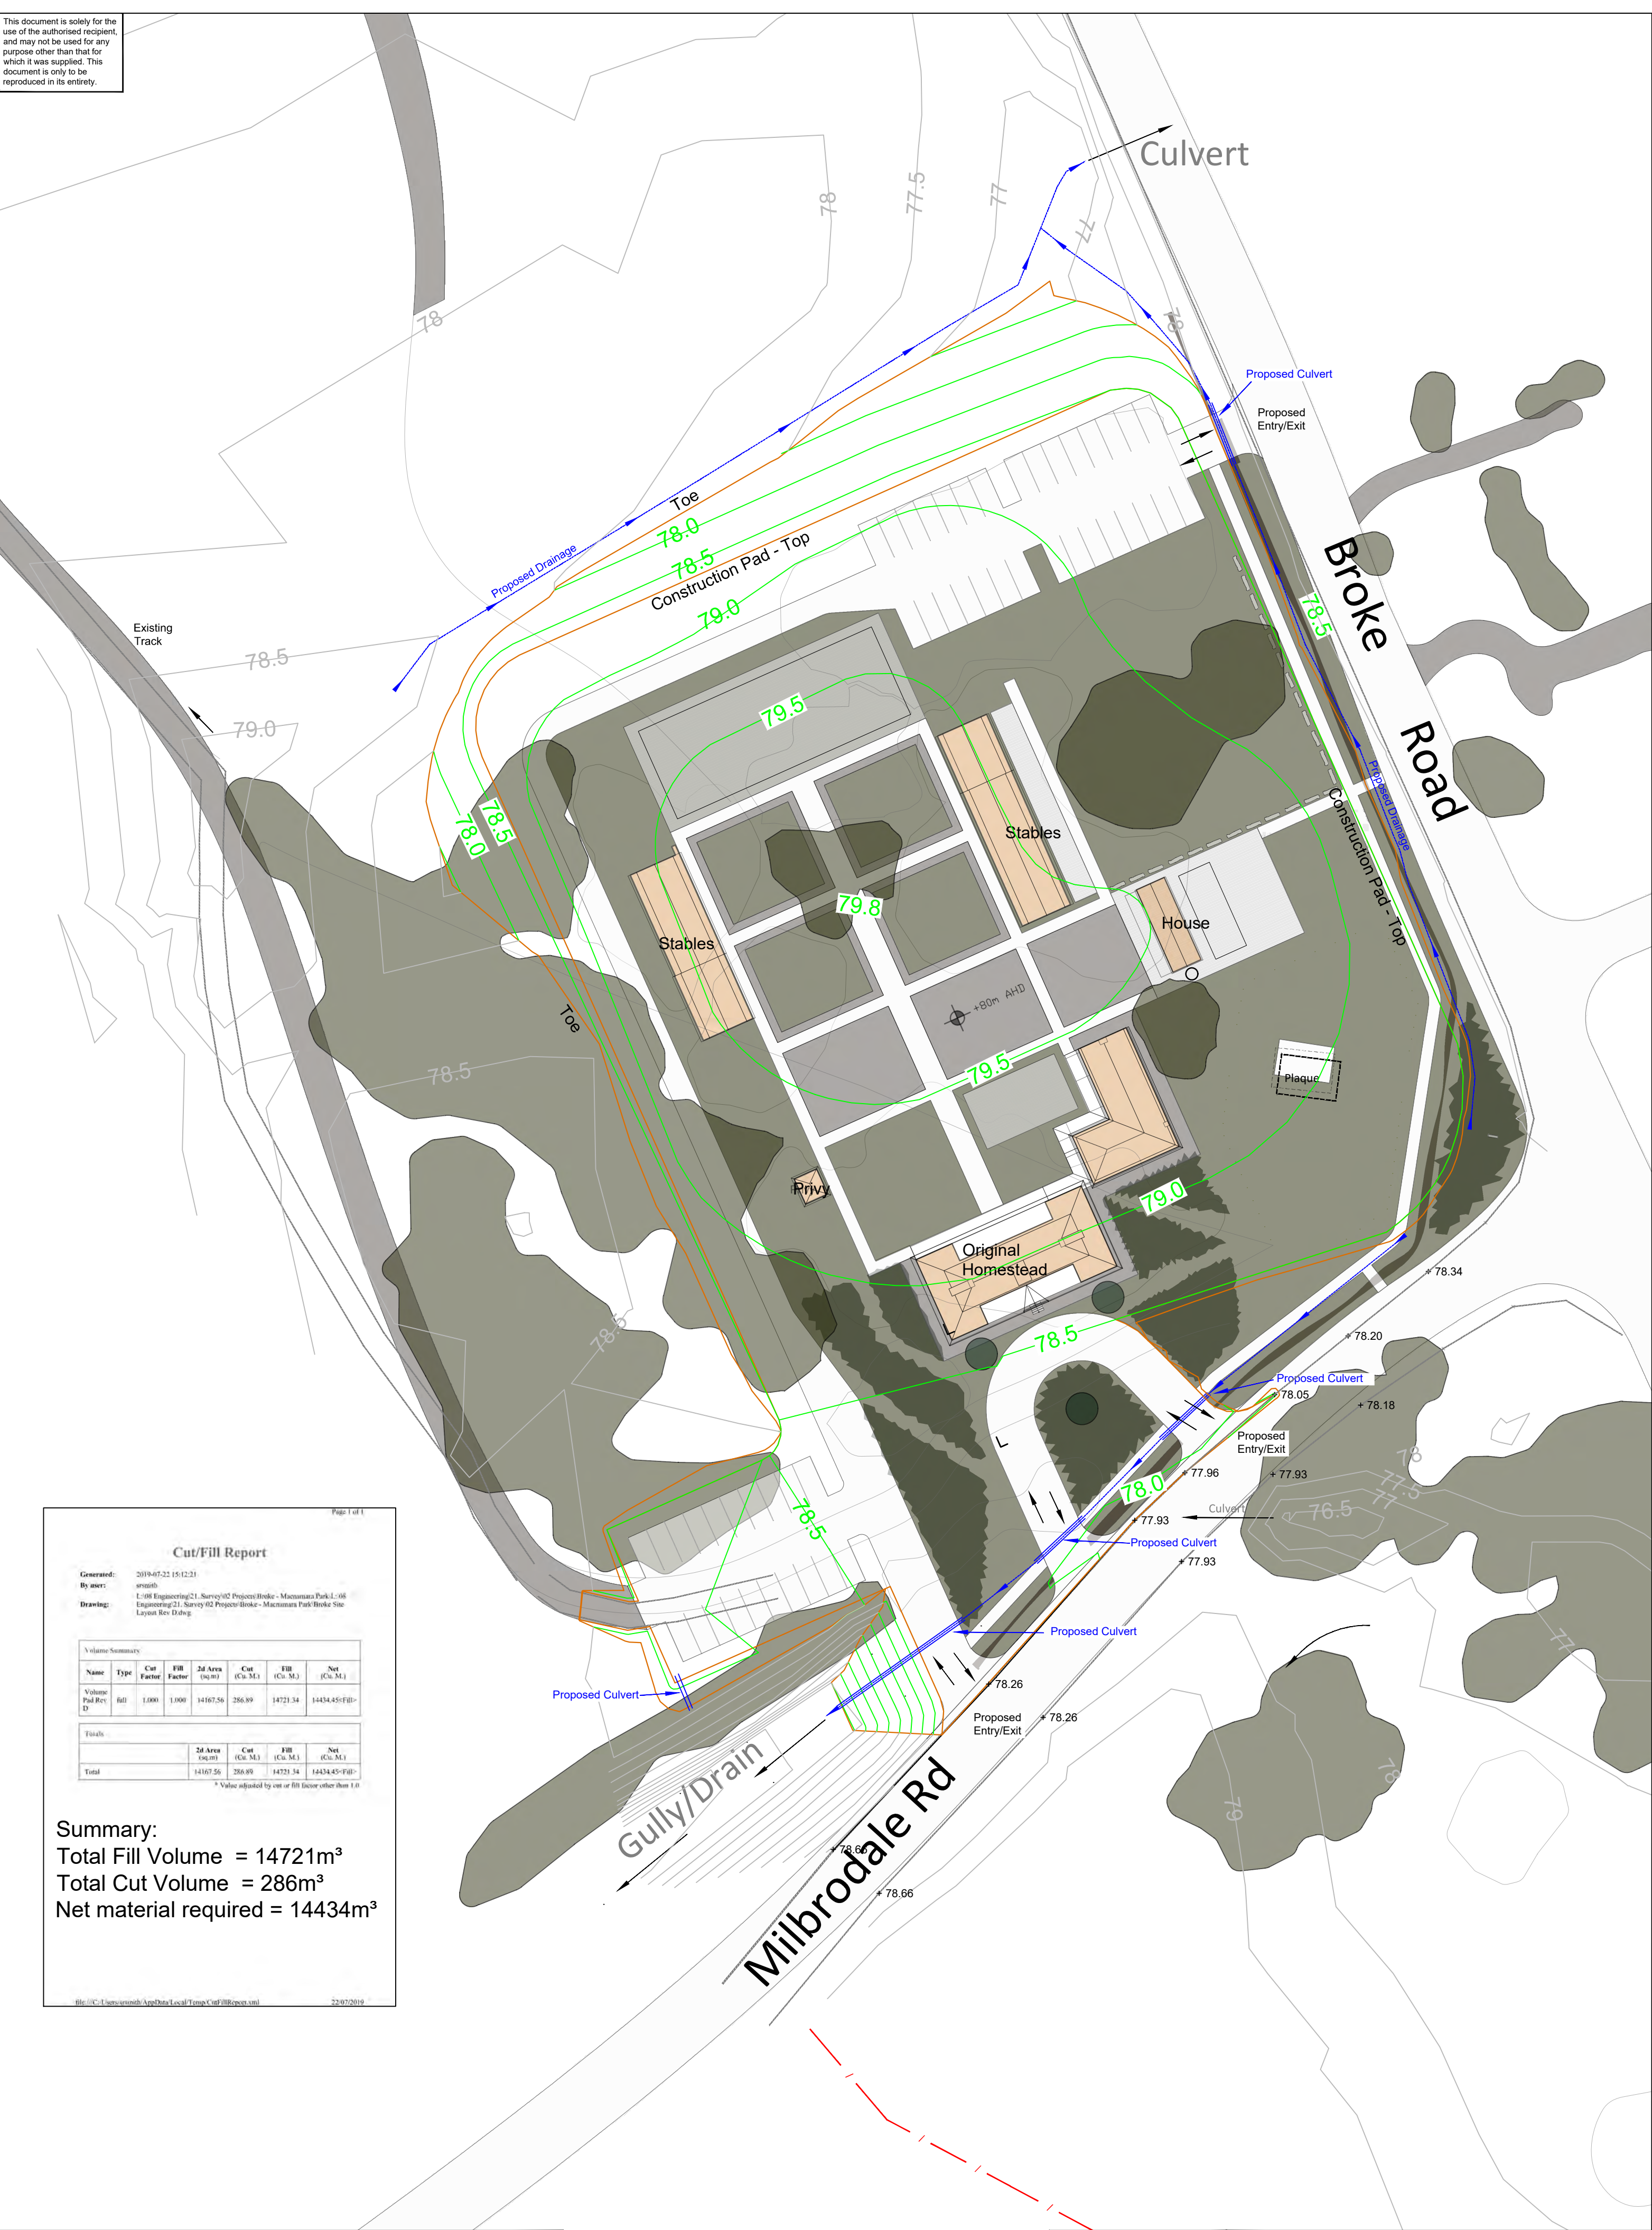
## Preliminary Earthworks Plan

Generated: 2019-07-22 15:12:21  
By user: ssmith  
Drawing: L:\08 Engineering\21\_Survey\02 Projects\Broke - Macnamara Park L-08 Engineering\21\_Survey\02 Projects\Broke - Macnamara Park\Broke Site Layout Rev D.dwg

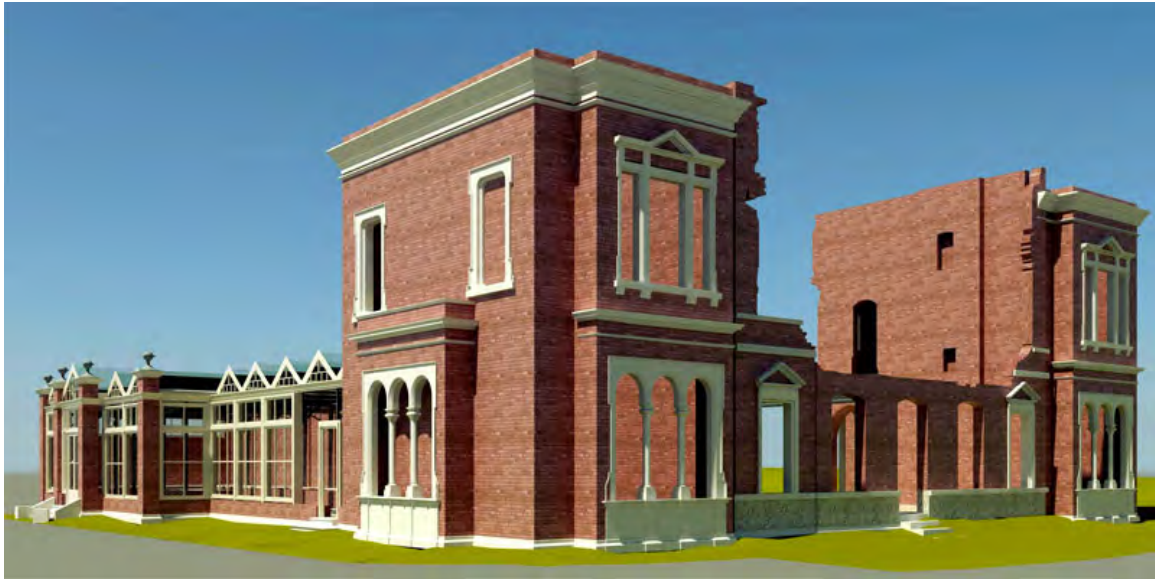
2: Woodseat Hall render output combining Point Cloud data to form the base BIM.

As BIM is capable of incorporating both qualitative and quantitative information about a built asset to represent physical and functional characteristics, it can provide simulations of the appearance, development and performance of an asset. Intangible characteristics, such as heritage values and significance, can be integrated into the 3D model in a structured and consistent way, which allows easy information extraction and the production of deliverables. This will make it an invaluable asset to pass on to the new site owners to assist in monitoring for further conservation works in the future, and in developing interpretive material for public engagement with the site.

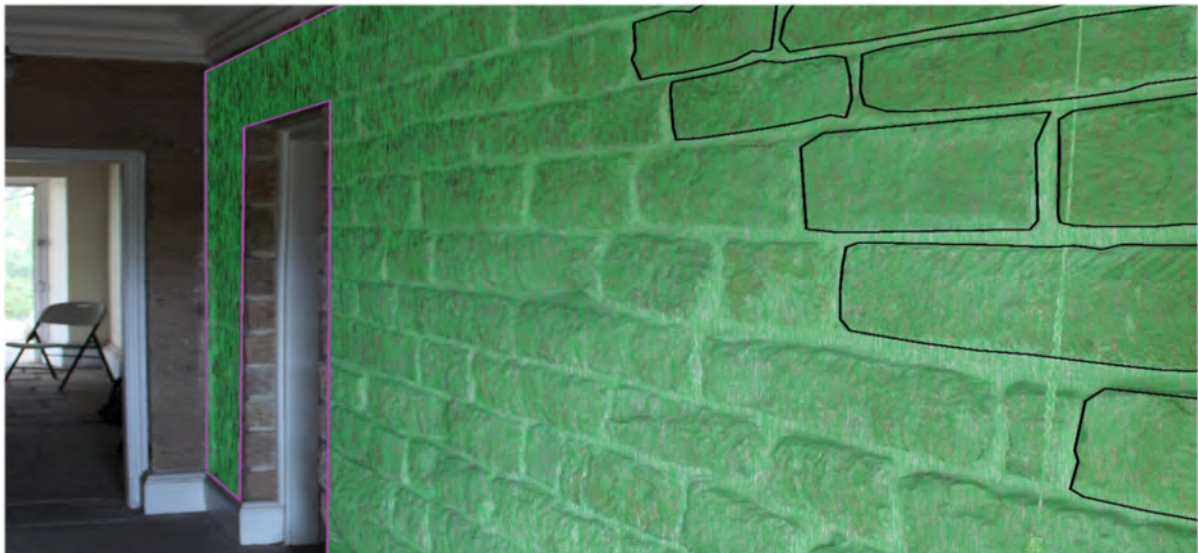
3: Projection of Building Information Model using Photogrammetry and Cataloguing Data sets to map the central hallway in the Main House

The method for developing the BIM for the Ravensworth Homestead Complex is as follows
