## Post Approval – Consultation

## Jordan Springs Public School

### Detailed design road safety audit

RC-PROJ-0001-01 DD RSA JORDAN SPRINGS REV 1

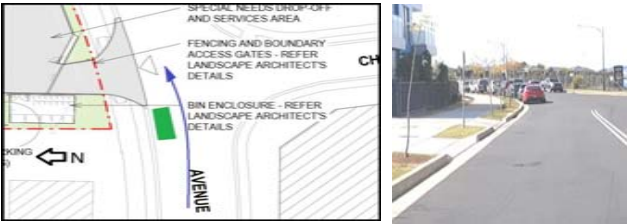
| 3b | Stopping/ parking restrictions on the kerblines – <i>Special needs</i> car park on the northern side of Cullen Avenue. Continued from item 3a... | <p>Continued from item 3a...</p> <p><b><i>Special needs</i> car park on the northern side of Cullen Avenue</b></p> <p>The <i>special needs</i> car park on the northern side of Cullen Avenue will inevitably generate eastbound left-turn movements into the car park. If vehicles are allowed to stop along the northern kerbline of Cullen Road, the left-turning vehicle would be forced to take a more central position in the roadway. This would limit any passing opportunity by trailing eastbound vehicles. Any passing attempt could also generate <i>head-on</i> crash risks with westbound vehicles. By contrast, if a short length of <i>stopping</i> zone is put in place on the western side of the driveway, the left-turning vehicle could shift to the north (green vehicle in left-hand image).</p> <p>This would allow eastbound trailing vehicles to pass around the slowed vehicle without encroaching into the westbound lane.</p> <p>Also, a <i>no stopping</i> zone would also improve sightlines of drivers egressing from the driveway. This is especially since the driveway will be located midway along a horizontal curve, and on the inside of the curve. The combined effect of the horizontal curvature of the road and vehicles stopped along the northern kerbline may reduce the <i>minimum gap sight distance</i> (MGSD) from the driveway. This is the sight line needed by egressing drivers to view approaching traffic streams, judge gaps and then enter those traffic streams. The potentially restricted MGSD sight line may lead to <i>cross traffic</i> crashes.</p> <p><b>Below Left:</b> Extract from the design showing the proposed layout of the <i>special needs</i> car park on the northern side of Cullen Avenue. <b>Below Right:</b> Looking eastbound along Cullen Avenue showing the kerbside parking demands under pre-existing conditions. Note also the impact of the horizontal curve and parked cars, on the sight line between eastbound drivers and the future driveway, and vice versa.</p> | Medium | The recommended no stopping zones have been implemented in conjunction with a number of bus zones - refer to LTC approved drawings for further information |

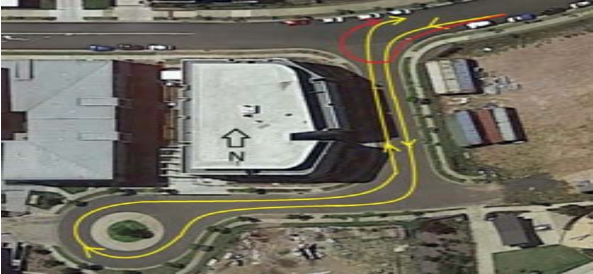
| 4b | Operational impacts of the pick up/ drop off bay on the northern side of Cullen Avenue.<br>Continued from item 4a... | <p>Continued from item 4a...</p> <ul style="list-style-type: none"> <li>As described in item 4a, the pick up/ drop off bay is configured as <i>a left-in only</i> access at its western end, and <i>a left-out only</i> egress at its eastern end. The inhibited right-turn entry movement at its western end may generate "q-turns" at the Cullen Avenue/ Charlotte Street intersection (ie. a westbound left-turn into Charlotte Street, followed by a u-turn, and followed by a right-turn back into Cullen Avenue such that the entire movement resembles a "q"). Typical "q-turn" movements are illustrated below – including a short "q-turn" along the red path and a longer version illustrated by the yellow path. Both of these will generate right-turn movements from Charlotte Street. This would generate crash conflicts with westbound and eastbound vehicular movements on Cullen Avenue. Typically, right-turns from the minor leg of intersections are the most difficult turning manoeuvres since there are gap acceptance (and hence gap-checking) requirements in both major road flows. The short "q-turn" path illustrated by the red arrow also introduces a u-turn in the control area of the intersection which could have its own crash conflicts such as with vehicles turning into or out of Charlotte Street. Consideration may be needed for signposted time- based prohibitions (bans) on right-turns from Charlotte Street during school zone periods.</li> </ul> <p><i>Left: With no other restrictions in place, the audit team envisages that Charlotte Street will be used by westbound drivers to perform "q-turns" to access the pick up/ drop off bay in lieu of the likely prohibited right-turn entry to the bay.</i></p> | Medium | Additional signage and line marking will be installed at the intersection of Cullen Avenue & Charolette Street to ensure that all road users are aware which traffic is has right of way (Cullen Avenue) |

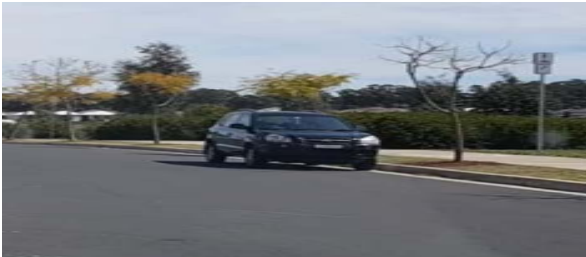
| 5 | Shared path designation on Cullen Avenue and Lakeside Parade. | <p>The pre-existing footpaths surrounding the school site are not well defined with respects to their status as shared paths or common footpaths. On Cullen Avenue, to the east of the school site, the footpath is a designated shared path (see signage in image below). This legally allows usage by pedestrians and cyclists. However, aside from this sign, there are no other signs to confirm or terminate the shared path status. The northern footpath of Cullen Avenue has the appearance and width of a shared path. As such, with no other reassurance signage, this could be a lost opportunity for improving bicycle safety. If cyclists simply believe that the paths are common footpaths, then they would tend ride on the roadways (unless they are eligible to cycle on the footpath under NSW Road Rule 250). By riding on the roadway, this could increase exposure to <i>vehicle-bicycle</i> crashes.</p> <p>The audit team acknowledges that there are 44 bicycle spaces are proposed in the staff car park, and hence there is a predicted demand for bicycle travel to and from Jordan Springs Public School.</p> <p>Similarly, the footpath on Lakeside Parade is not defined as a shared path although it appears wide and flat enough to operate as one. This is also a lost opportunity, especially since this footpath would be directly accessible from the bicycle parking area.</p> <p>Consideration could be given to formalising the status of these footpaths and if appropriate, signposting these as shared paths.</p> <p><b>Left:</b> Pre-existing signs on the northern path of Cullen Avenue indicate that this is a designated shared path. This sign is along the northern footpath to the east of the school site.</p> | | Low | |

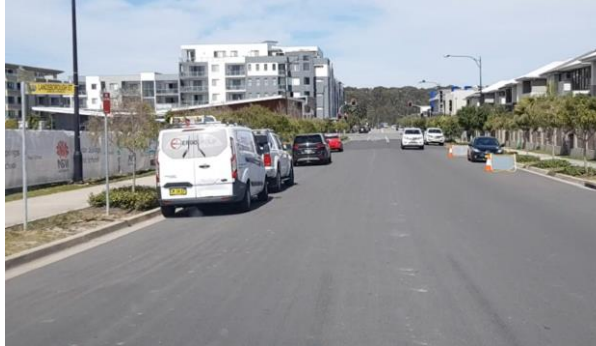
| Ref | Location | Road safety audit finding | Priority |
|---|---|---|---|
| 3a | Stopping/ parking restrictions on the kerblines – Lakeside Parade at the staff car park. | <p>The plans do not indicate whether there will be any <i>no stopping</i> zones along the Lakeside Parade and Cullen Avenue kerblines. Some critical locations were identified including the staff car park on the eastern side of Lakeside Parade, the special needs car park on the northern side of Cullen Avenue, and the pick up/ drop off bay on the northern side of Cullen Avenue. These have been discussed separately in items 3a, 3b and 3c.</p> <p><u>Staff car park on the eastern side of Lakeside Parade</u></p> <p>The staff car park will inevitably generate southbound left-turn movements, and northbound right-turn movements by inbound traffic. Southbound left-turners would tend to slow down when approaching and turning into the car park. If the eastern kerbline allows vehicles to stop or park, then the left-turning vehicle would need to commence the turn from a more central position in the road. This offers little passing opportunity for trailing southbound vehicles. By contrast, if a short <i>no stopping</i> zone is put in place along the eastern kerbline, the left-turning vehicle (red vehicle marked X) could shift to the kerbline and allow trailing vehicles to pass around as indicated by the blue arrow. As such, a <i>no stopping</i> zone should be considered on the eastern kerbline.</p> <p>Similarly, if northbound right-turners (red vehicle marked Y) stop to wait for gaps, any vehicles stopped along the western kerbline would restrict any passing opportunity by other trailing northbound vehicles. If a short <i>no stopping</i> zone is put in place on the western kerbline, trailing southbound vehicles could then use this space to pass around the stopped vehicle (green arrow).</p> <p>The above two scenarios illustrate the value of <i>no stopping</i> zones to improve passing clearance and to reduce <i>rear-end</i> crash potential. Short lengths of <i>no stopping</i> zones either side of the car park driveway would also help to preserve sight lines from the driveway to the north and south. Students and pedestrians moving along the eastern footpath and car park driveway would be less likely to be obscured by parked cars, and hence would be more visible to any drivers turning into the driveway.</p> <div style="display: flex; align-items: center;"> </div> <p><b>Left:</b> Extract from the design showing the criticality of passing opportunities on Lakeside Parade at the staff car park. This could be improved by implementing short lengths of <i>no stopping</i> zones on the eastern and western kerblines. <b>Right:</b> Looking southbound along Lakeside Parade from Crimson Street. Note the kerbside parking demand under pre-existing conditions.</p> | Medium |

| 3a | Stopping/ parking restrictions on the kerblines – Lakeside Parade at the staff car park. | <p>The plans do not indicate whether there will be any <i>stopping</i> zones along the Lakeside Parade and Cullen Avenue kerblines. Some critical locations were identified including the staff car park on the eastern side of Lakeside Parade, the special needs car park on the northern side of Cullen Avenue, and the pick up/ drop off bay on the northern side of Cullen Avenue. These have been discussed separately in items 3a, 3b and 3c.</p> <p><b>Staff car park on the eastern side of Lakeside Parade</b></p> <p>The staff car park will inevitably generate southbound left-turn movements, and northbound right-turn movements by inbound traffic. Southbound left-turners would tend to slow down when approaching and turning into the car park. If the eastern kerbline allows vehicles to stop or park, then the left-turning vehicle would need to commence the turn from a more central position in the road. This offers little passing opportunity for trailing southbound vehicles. By contrast, if a <i>shorto stopping</i> zone is put in place along the eastern kerbline, the left-turning vehicle (red vehicle marked X) could shift to the kerbline and allow trailing vehicles to pass around as indicated by the blue arrow. As such, a <i>no stopping</i> zone should be considered on the eastern kerbline.</p> <p>Similarly, if northbound right-turners (red vehicle marked Y) stop to wait for gaps, any vehicles stopped along the western kerbline would restrict any passing opportunity by other trailing northbound vehicles. If a <i>shorto stopping</i> zone is put in place on the western kerbline, trailing southbound vehicles could then use this space to pass around the stopped vehicle (green arrow).</p> <p>The above two scenarios illustrate the value of <i>stopping</i> zones to improve passing clearance and to reduce <i>rear-end</i> crash potential. Short lengths of <i>no stopping</i> zones either side of the car park driveway would also help to preserve sight lines from the driveway to the north and south. Students and pedestrians moving along the eastern footpath and car park driveway would be less likely to be obscured by parked cars, and hence would be more visible to any drivers turning into the driveway.</p> <p><b>Below:</b> Extract from the design showing the criticality of passing opportunities on Lakeside Parade at the staff car park. This could be improved by implementing short lengths of <i>no stopping</i> zones on the eastern and western kerblines. <b>Right:</b> Looking southbound along Lakeside Parade from Crimson Street. Note the kerbside parking demand under pre-existing conditions.</p> | Medium | The recommended no stopping zones have been implemented in conjunction with a number of bus zones - refer to LTC approved drawings for further information |

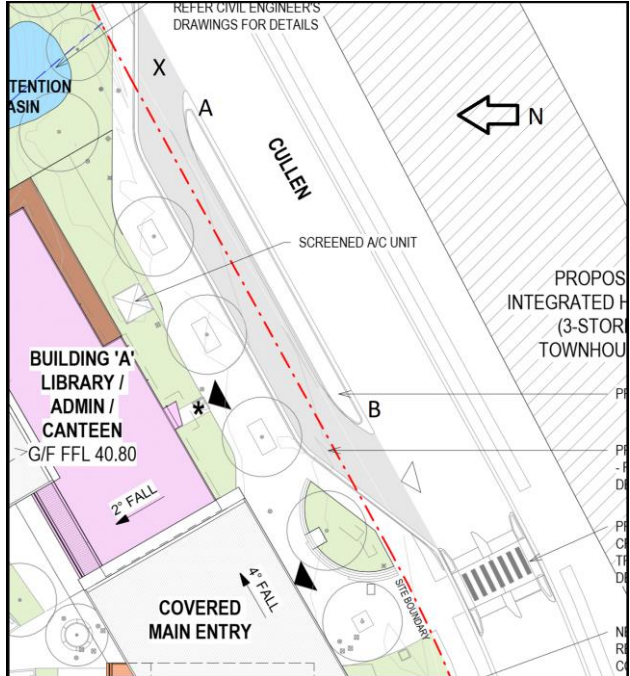
| Ref | Location | Road safety audit finding | Priority |
|---|---|---|---|
| 3c | <p>Stopping/ parking restrictions on the kerblines –Pick up/ drop off bay on the northern side of Cullen Avenue.</p> <p>Continued from item 3b...</p> | <p>Continued from item 3b...</p> <p><u>Pick up/ drop off bay on the northern side of Cullen Avenue</u></p> <p>The kerline adjacent to the pick up/ drop off bay (marked A-B below) would also need to be signposted as a <i>no stopping</i> zone. This is to preserve sight lines from the egress point at X to the west. That is, any vehicles stopped along this kerline could block the <i>minimum gap sight distance</i> (MGSD) sight line from the egress point to the west.</p> <p>Also, if vehicles are allowed to stop along this kerline, it may be mis-used by parents/ carers when picking up children. These drivers may consciously avoid entering the pick up bay and joining its queue. They may resort to waiting on kerline A-B. This is especially undesirable as it would encourage students to cross the pick up bay with risks of impacts by vehicles moving along this facility. Also, the students would be forced to wait and board/ alight the vehicle from the narrow traffic island between the pick up/ drop off bay and Cullen Avenue.</p> <p><i>Left: Extract of the design showing the proposed layout of the pick up/ drop off bay.</i></p> | Medium |

| 3c | <p>Stopping/ parking restrictions on the kerblines</p> <p>–Pick up/ drop off bay on the northern side of Cullen Avenue.</p> <p>Continued from item 3b...</p> | <p>Continued from item 3b...</p> <p><b>Pick up/ drop off bay on the northern side of Cullen Avenue</b></p> <p>The kerblines adjacent to the pick up/ drop off bay (marked A-B below) would also need to be signposted as <b>no stopping zone</b>. This is to preserve sight lines from the egress point at X to the west. That is, any vehicles stopped along this kerblines could block the <b>minimum gap sight distance</b> (MGSD) sight line from the egress point to the west.</p> <p>Also, if vehicles are allowed to stop along this kerblines, it may be mis-used by parents/ carers when picking up children. These drivers may consciously avoid entering the pick up bay and joining its queue. They may resort to waiting on kerblines A-B. This is especially undesirable as it would encourage students to cross the pick up bay with risks of impacts by vehicles moving along this facility. Also, the students would be forced to wait and board/ alight the vehicle from the narrow traffic island between the pick up/ drop off bay and Cullen Avenue.</p> <p><b>Below:</b> Extract of the design showing the proposed layout of the pick up/ drop off bay.</p> | Medium | <p>The recommended no stopping zones have been implemented in conjunction with a number of bus zones - refer to LTC approved drawings for further information</p> |

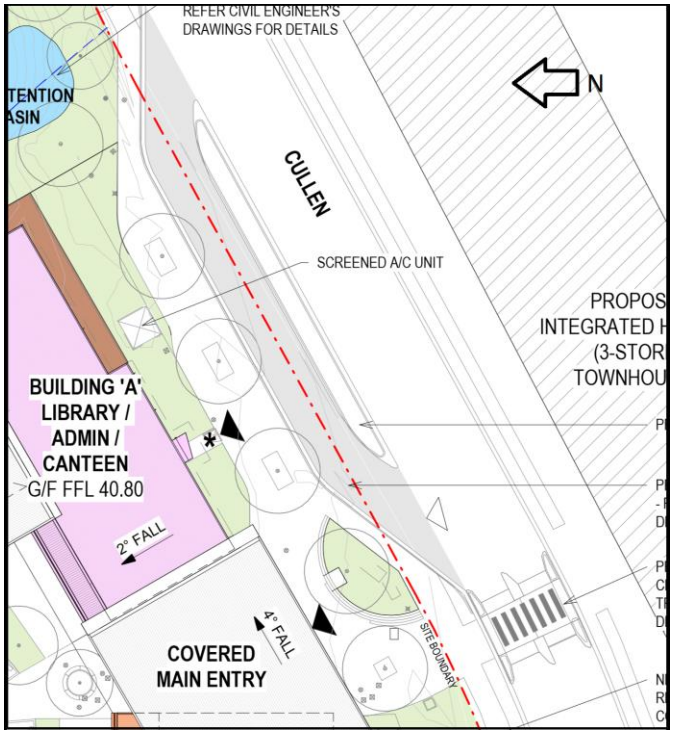
| Ref | Location | Road safety audit finding | Priority |
|---|---|---|---|
| 4a | Operational impacts of the pick up/ drop off bay on the northern side of Cullen Avenue. | <p>There are likely to be significant queuing and queue-related road safety impacts due to the pick up/ drop off bay. This would be especially during afternoon pick up periods following each school day. The audit team notes the following:</p> <ul style="list-style-type: none"> <li>It is assumed that the pick up/ drop off bay will be a one-way <i>eastbound only</i> traffic lane and that all entry would be via the western opening and all egress will be via the eastern opening. Signs and pavement markings should be included, as appropriate, to stipulate this one-way rule and to prohibit entry into the eastern opening.</li> <li>The pick up/ drop off bay is configured as a <i>left-in only</i> access at its western end and a <i>left-out only</i> egress at its eastern opening. This is considered a reasonably safe layout assuming that all drivers comply with these turn restrictions. Signs and pavement arrows (as appropriate) should be considered to prohibit right-turns into or out of the pick up/ drop off bay. The westbound right-turn into the western opening would be a sharp hairpin turn. Some vehicles may not be able to perform this as a single manoeuvre and may need to resort to three-point turns (including a reversing adjustment with associated crash risks). The right-turn entry movement to the western opening could be a tempting movement since any vehicles that approach from the east would have very few other practical methods of turning around (see item 4b). By contrast the prohibited outbound right-turn movement (from the eastern opening) could be replaced by a left-turn out, and a u-turn at the Alinta Promenade roundabout (further east).</li> </ul> <p>Continued in item 4b...</p> <p><b>Left:</b> The proposed layout of the pick up/ drop off bay.</p> | Medium |

| 4a | <p>Operational impacts of the pick up/ drop off bay on the northern side of Cullen Avenue.</p> | <p>There are likely to be significant queuing and queue-related road safety impacts due to the pick up/ drop off bay. This would be especially during afternoon pick up periods following each school day. The audit team notes the following:</p> <ul style="list-style-type: none"> <li>It is assumed that the pick up/ drop off bay will be a one-way <i>eastbound only</i> traffic lane and that all entry would be via the western opening and all egress will be via the eastern opening. Signs and pavement markings should be included, as appropriate, to stipulate this one-way rule and to prohibit entry into the eastern opening.</li> <li>The pick up/ drop off bay is configured as <i>left-in only</i> access at its western end and <i>left-out only</i> egress at its eastern opening. This is considered a reasonably safe layout assuming that all drivers comply with these turn restrictions. Signs and pavement arrows (as appropriate) should be considered to prohibit right-turns into or out of the pick up/ drop off bay. The westbound right-turn into the western opening would be a sharp hairpin turn. Some vehicles may not be able to perform this as a single manoeuvre and may need to resort to three-point turns (including a reversing adjustment with associated crash risks). The right-turn entry movement to the western opening could be a tempting movement since any vehicles that approach from the east would have very few other practical methods of turning around (see item 4b). By contrast the prohibited outbound right-turn movement (from the eastern opening) could be replaced by a left-turn out, and a u-turn at the Alinta Promenade roundabout (further east).</li> </ul> <p>Continued in item 4b...</p> <p><b>Below:</b> The proposed layout of the pick up/ drop off bay.</p> | Medium | <p>Signage &amp; line marking has been incorporated into the kiss &amp; drop as recommended by the auditor to ensure that the bay operates in a single direction only.</p> |

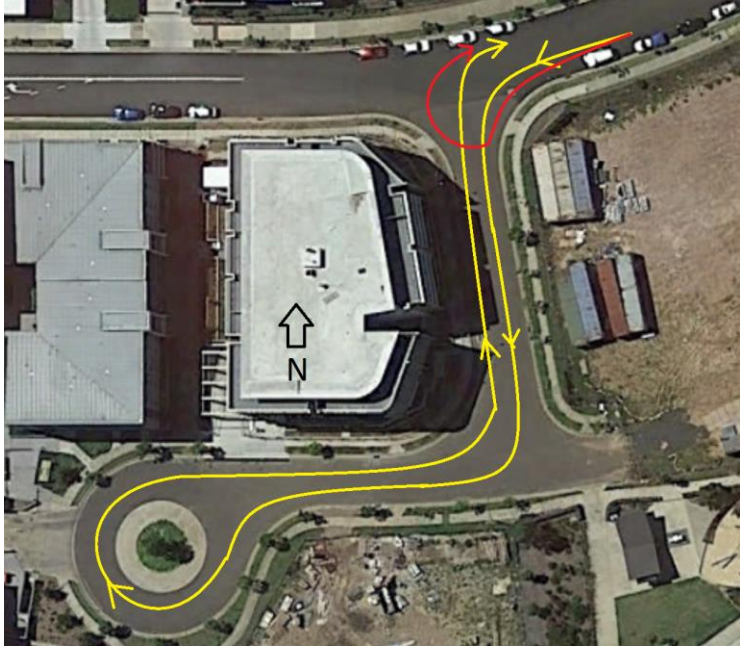
| Ref | Location | Road safety audit finding | Priority |
|---|---|---|---|
| 4b | <p>Operational impacts of the pick up/ drop off bay on the northern side of Cullen Avenue.</p> <p>Continued from item 4a...</p> | <p>Continued from item 4a...</p> <ul style="list-style-type: none"> <li>As described in item 4a, the pick up/ drop off bay is configured as a <i>left-in only</i> access at its western end, and a <i>left-out only</i> egress at its eastern end. The inhibited right-turn entry movement at its western end may generate “q-turns” at the Cullen Avenue/ Charlotte Street intersection (ie. a westbound left-turn into Charlotte Street, followed by a u-turn, and followed by a right-turn back into Cullen Avenue such that the entire movement resembles a “q”). Typical “q-turn” movements are illustrated below – including a short “q-turn along the red path and a longer version illustrated by the yellow path. Both of these will generate right-turn movements from Charlotte Street. This would generate crash conflicts with westbound and eastbound vehicular movements on Cullen Avenue. Typically, right-turns from the minor leg of intersections are the most difficult turning manoeuvres since there are gap acceptance (and hence gap-checking) requirements in both major road flows. The short “q-turn” path illustrated by the red arrow also introduces a u-turn in the control area of the intersection which could have its own crash conflicts such as with vehicles turning into or out of Charlotte Street. Consideration may be needed for signposted time-based prohibitions (bans) on right-turns from Charlotte Street during school zone periods.</li> </ul> <p><b>Left:</b> With no other restrictions in place, the audit team envisages that Charlotte Street will be used by westbound drivers to perform “q-turns” to access the pick up/ drop off bay in lieu of the likely prohibited right-turn entry to the bay.</p> | Medium |

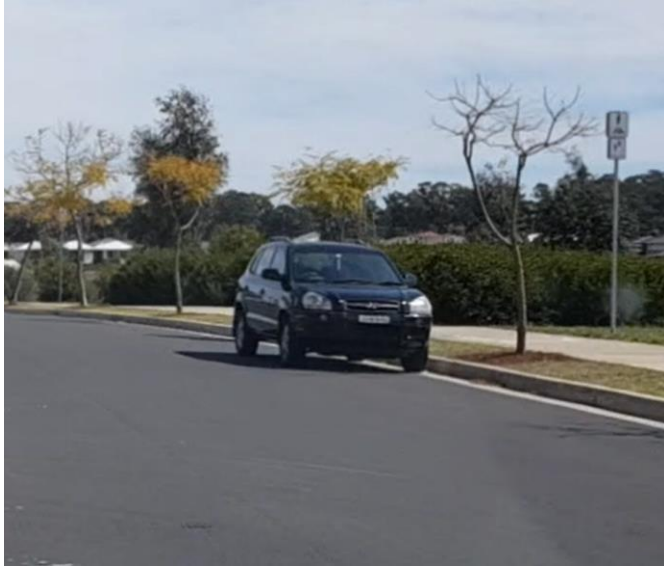
| Ref | Location | Road safety audit finding | Priority |
|---|---|---|---|
| 5 | Shared path designation on Cullen Avenue and Lakeside Parade. | <p>The pre-existing footpaths surrounding the school site are not well defined with respects to their status as shared paths or common footpaths. On Cullen Avenue, to the east of the school site, the footpath is a designated shared path (see signage in image below). This legally allows usage by pedestrians and cyclists. However, aside from this sign, there are no other signs to confirm or terminate the shared path status. The northern footpath of Cullen Avenue has the appearance and width of a shared path. As such, with no other reassurance signage, this could be a lost opportunity for improving bicycle safety. If cyclists simply believe that the paths are common footpaths, then they would tend ride on the roadways (unless they are eligible to cycle on the footpath under NSW Road Rule 250). By riding on the roadway, this could increase exposure to <i>vehicle-bicycle</i> crashes.</p> <p>The audit team acknowledges that there are 44 bicycle spaces are proposed in the staff car park, and hence there is a predicted demand for bicycle travel to and from Jordan Springs Public School.</p> <p>Similarly, the footpath on Lakeside Parade is not defined as a shared path although it appears wide and flat enough to operate as one. This is also a lost opportunity, especially since this footpath would be directly accessible from the bicycle parking area. Consideration could be given to formalising the status of these footpaths and if appropriate, signposting these as shared paths.</p> <p><b>Left:</b> Pre-existing signs on the northern path of Cullen Avenue indicate that this is a designated shared path. This sign is along the northern footpath to the east of the school site.</p> | Low |

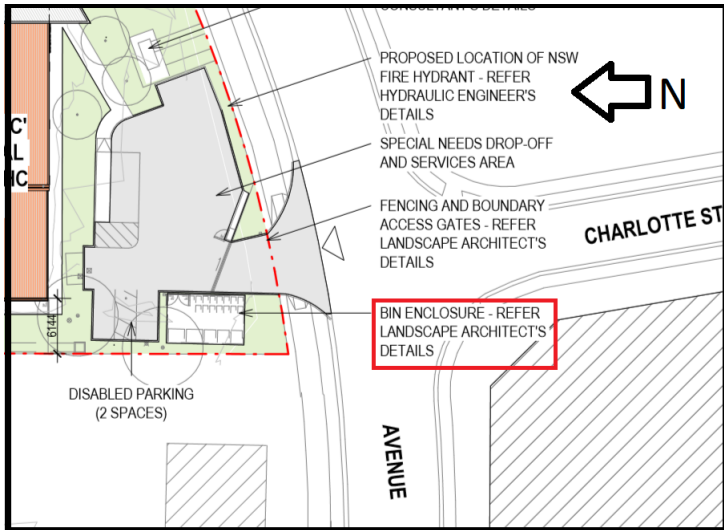
| Ref | Location | Road safety audit finding | Priority |
|---|---|---|---|
| 6 | <i>Special needs</i> car park on the northern side of Cullen Avenue. | <p>The plan indicates that a bin enclosure area will be provided in the <i>special needs</i> car park on the northern side of Cullen Avenue. This implies that garbage collection will take place at this location. If these are duplex bins, then typically the waste collection truck would need to enter the premises, lift and empty the bins and then egress. If so, this car park area does not seem large enough for a truck to perform a u-turn in a single manoeuvre. This would inevitably require a three-point turn including a reversing movement. This could increase the risk of impacts with other parked cars, structures or pedestrians.</p> <p>If these bins are wheeled sulo bins, then consideration could be given to providing a separate paved path for these to be wheeled to the kerbline. Otherwise the bins would need to be wheeled to the street via the driveway.</p> <p>The audit team were also uncertain whether the disabled parking spaces are intended for (i) drivers to drop off and pick up disabled students, or (ii) for use by disabled drivers (staff or visitors), or (iii) both. If intended to be used by disabled drivers, these parking spaces will be difficult to use. If the vehicles are parked <i>front-in</i>, then the driver would inevitably need to perform a difficult reverse weaving movement to egress from the parking space. This would also require sight line checks at various angles to check for other vehicular or pedestrian movements. Drivers with neck mobility limitations may not be able to achieve these visibility checks. The bin enclosure area could also block driver visibility.</p> <p>If drivers park <i>rear-in</i>, they would need to perform an awkward reverse weaving manoeuvre into the spaces. This could also prove difficult for disabled drivers, especially those with neck mobility limitations.</p> <p><b>Left:</b> Extract of the design showing the proposed layout of the special needs parking area, on the northern side of Cullen Avenue.</p> | Low |

| 6 | Special needs car park on the northern side of Cullen Avenue. | <p>The plan indicates that a bin enclosure area will be provided in the special needs car park on the northern side of Cullen Avenue. This implies that garbage collection will take place at this location. If these are duplex bins, then typically the waste collection truck would need to enter the premises, lift and empty the bins and then egress. If so, this car park area does not seem large enough for a truck to perform a u-turn in a single manoeuvre. This would inevitably require a three-point turn including a reversing movement. This could increase the risk of impacts with other parked cars, structures or pedestrians.</p> <p>If these bins are wheeled side bins, then consideration could be given to providing a separate paved path for these to be wheeled to the kerbline. Otherwise the bins would need to be wheeled to the street via the driveway.</p> <p>The audit team were also uncertain whether the disabled parking spaces are intended for (i) drivers to drop off and pick up disabled students, or (ii) for use by disabled drivers (staff or visitors), or (iii) both. If intended to be used by disabled drivers, these parking spaces will be difficult to use. If the vehicles are parked <i>front-in</i>, then the driver would inevitably need to perform a difficult reverse weaving movement to egress from the parking space. This would also require sight line checks at various angles to check for other vehicular or pedestrian movements. Drivers with neck mobility limitations may not be able to achieve these visibility checks. The bin enclosure area could also block driver visibility.</p> <p>If drivers park <i>rear-in</i>, they would need to perform an awkward reverse weaving manoeuvre into the spaces. This could also prove difficult for disabled drivers, especially those with neck mobility limitations.</p> <p><b>Left:</b> Extract of the design showing the proposed layout of the special needs parking area, on the northern side of Cullen Avenue.</p> | | Low | It is anticipated that the waste collection activities will take place outside of the hours that it is anticipated that there will be other school users on site. Therefore it is considered unlikely that conflict between waste collection vehicles and disabled parking bay users will occur. |

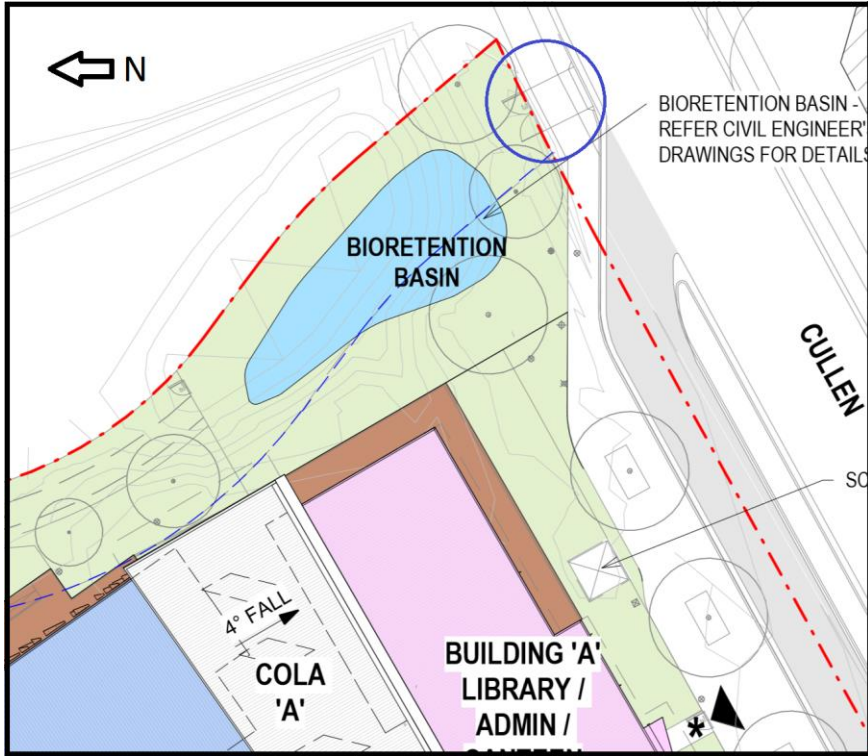
| Ref | Location | Road safety audit finding | Priority |
|---|---|---|---|
| 7 | Maintenance access gate at the eastern end of the property – on the northern side of Cullen Avenue. | <p>The design indicates that a maintenance gate will be provided on the northern side of Cullen Avenue at the eastern end of the property. This is presumably so that vehicles can access the bioretention basin and other landscaped areas on the eastern side of the school buildings. Overall, this gate would have low-volume usage. However, it still creates an unnecessary driveway conflict point into Cullen Avenue. There is an opportunity to relocate this gate to the pick up/ drop off bay and hence rationalise the number of conflict points that would have a direct connection to Cullen Avenue. By relocating the gate accordingly, this may also improve access by maintenance vehicles. By contrast, the currently proposed maintenance gate appears to lead vehicles directly towards a steep embankment and towards the basin.</p> <p><b>Above:</b> Proposed layout of the maintenance gate (circled in blue) and its close proximity to the pick up/ drop off bay.</p> | Low |

| 7 | Maintenance access gate at the eastern end of the property – on the northern side of Cullen Avenue. | <p>The design indicates that a maintenance gate will be provided on the northern side of Cullen Avenue at the eastern end of the property. This is presumably so that vehicles can access the bioretention basin and other landscaped areas on the eastern side of the school buildings. Overall, this gate would have low-volume usage. However, it still creates an unnecessary driveway conflict point into Cullen Avenue. There is an opportunity to relocate this gate to the pick up/ drop off bay and hence rationalise the number of conflict points that would have a direct connection to Cullen Avenue. By relocating the gate accordingly, this may also improve access by maintenance vehicles. By contrast, the currently proposed maintenance gate appears to lead vehicles directly towards a steep embankment and towards the basin.</p> <p><b>Below:</b> Proposed layout of the maintenance gate (circled in blue) and its close proximity to the pick up/ drop off bay.</p> | Low | <p>this access point has only been incorporated into the design to provide access to the bio treatment basin for the maintenance of the filter medium. This activity is likely to only take place on a bi-annual basis. As such, there will be very little opportunity for conflict along Cullen Avenue to occur. Additionally, to relocate the access point to the kiss &amp; drop bay would create conflict between heavy vehicles accessing the basin for maintenance and pedestrians &amp; vehicles attempting to utilise the kiss &amp; drop bay. Given this, the integration of the bio treatment basin access and the kiss &amp; drop day is considered likely to increase the risk of conflict.</p> |
