1&2 Murray Rose Avenue, Olympic Park

Historical Archaeological Assessment

Report to Austino Property Group

October 2018

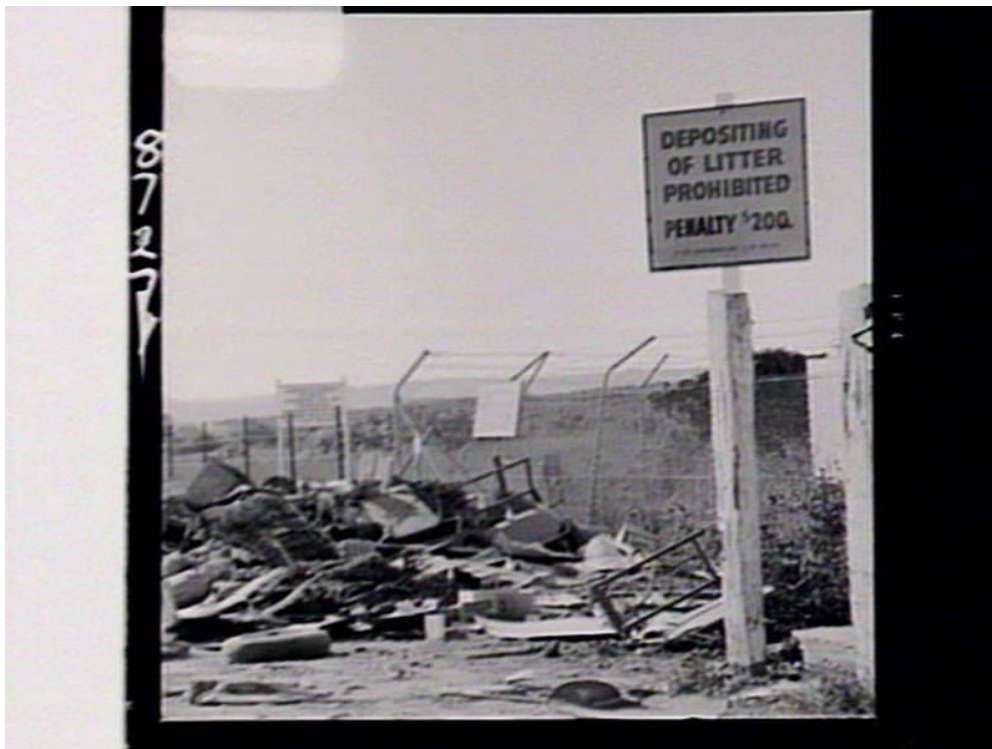
Figure 3.5: View of the waste deposited in Homebush Bay taken in 1972 (Source: State Library of NSW)

As industrial development in Sydney expanded in the mid-twentieth century, locations to discard industrial waste were required. Homebush, at that time relatively undeveloped, was chosen as a dumping location for toxic waste, including waste from factories such as Timbrol and Union Carbide that were located nearby in Rhodes.²⁰ Wentworth Bay was filled in with industrial waste and the natural ecology of the area was severely damaged. The area nearest Homebush Bay became a shipbreaking yard in 1966, with many of the wrecks still visible today. By 1988 there was an estimated 9 million cubic metres of waste and contaminated soils spread over 400 hectares within the 760-hectare site (Figure 3.5).²¹

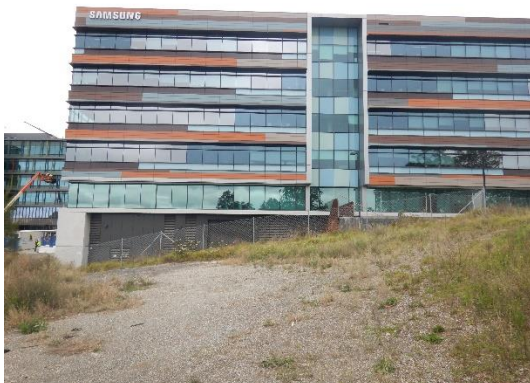
Figure 4.1: View of west of Samsung Electronics Australia (Photographed by R. Taddeucci, 24 September 2018)

The northern portion of the study area is the mapped extent of 1 Murray Rose Avenue. The area is located north of Murray Rose Avenue and is boarded to the east by Bennelong Parkway and Samsung Electronics Australia to the west (Figure 4.1). To the west the area has been cut into and a retaining wall constructed to accommodate a loading dock for Samsung Electronics Australia. A chain-link fence boarded the entire property.

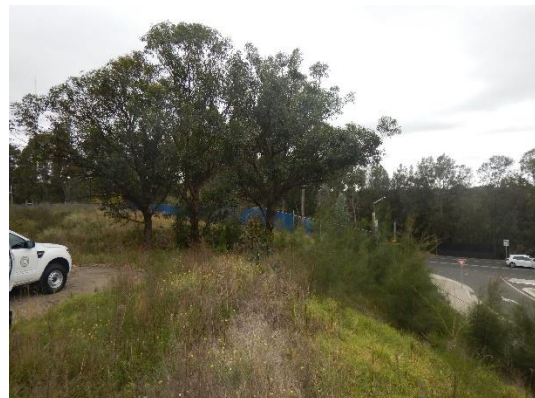
Figure 4.2: View east of the artificial slope of the property down to Murray Rose Avenue (Photographed by R. Taddeucci, 24 September 2018)

From the exterior of the property it was evident that the ground had been artificially elevated from the natural plain located to the east. A retaining wall had been constructed along the east and trees planted to stabilise the elevation of the property.

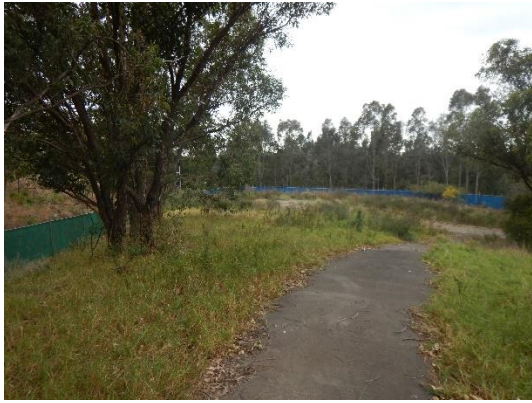
Figure 4.4: Ground exposure (Photographed by R. Taddeucci, 24 September 2018)

The area was densely covered by high grasses which restricted ground surface visibility (Figure 4.2). An east west oriented, bitumen footpath was located across the centre of 1 Murray Rose Avenue (Figure 4.3). A few areas of ground exposure were present across 1 Murray Rose Avenue, these areas did not contain evidence of historical artefacts (Figure 4.4). A concrete garden bed had been established in the centre of the property (Figure 4.6). A fallen telephone pole was also located within the property (Figure 4.5).

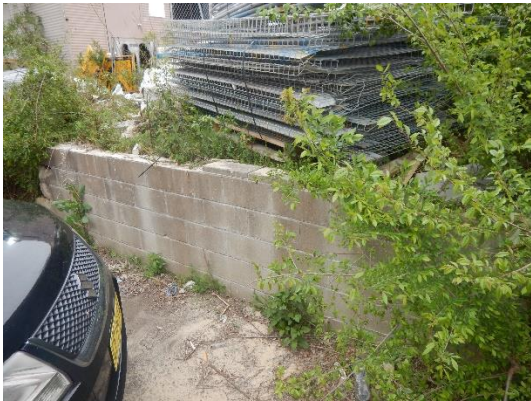
Figure 4.7: Retaining wall located at the south of the property (facing northwest) (Photographed by R. Taddeucci, 24 September 2018)

A retaining wall had been established in the property (Figure 4.7). The east of the property was bordered by a large retaining wall, approximately 2 m high (Figure 4.13). At the southern edge of the property there was an artificial slope (Figure 4.14). The slope illustrated that the property was situated on top of fill above clay overlaying bedrock.

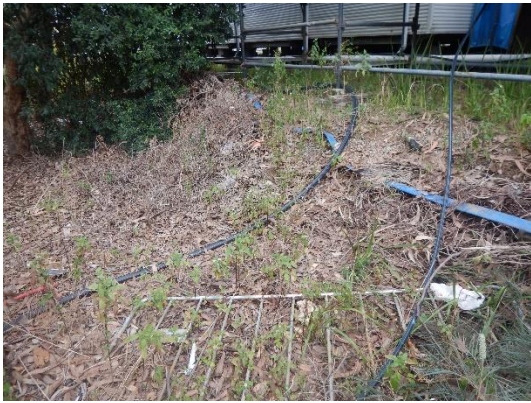
Figure 4.9: Vegetated area at the south of the property (Photographed by R. Taddeucci, 24 September 2018)

A large portion of the property had been covered in concrete. Due to the laying of concrete there were very few areas of exposed ground. In the south of the property, no concrete had been laid; however, dense foliage completely obscured surface visibility. Gravel had also been scattered across the study area, obscuring surface visibility (Figure 4.9).

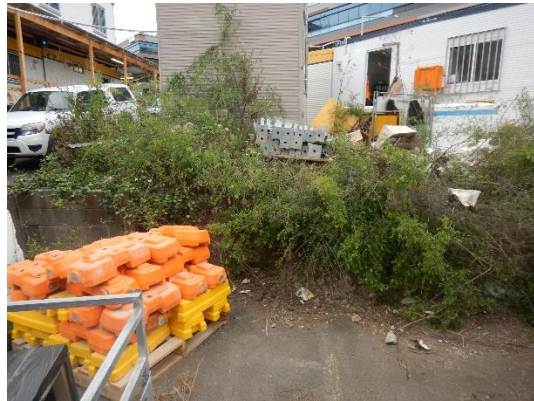
Figure 4.8: Retaining wall located at the south of the property (facing west) (Photographed by R. Taddeucci, 24 September 2018)

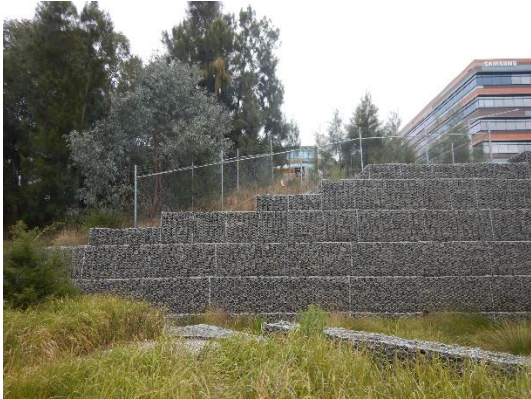
Figure 4.13: View west of retaining from outside the property (Photographed by R. Taddeucci, 24 September 2018)

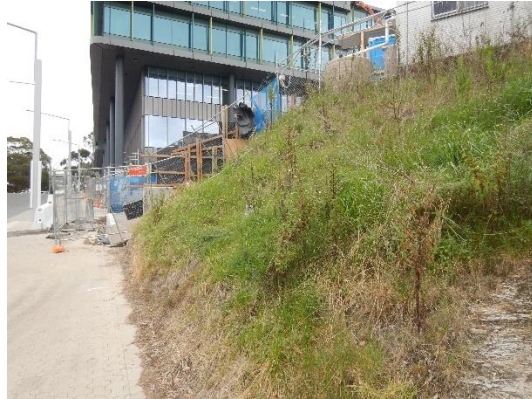
Figure 4.14: View west of artificial slope along the south of the property (Photographed by R. Taddeucci, 24 September 2018)
