**REPORT**  
**TO**  
**AUSTINO PROPERTY GROUP**  
**ON**  
**GEOTECHNICAL INVESTIGATION**  
**FOR**  
**PROPOSED RESIDENTIAL DEVELOPMENT**  
**AT**  
**1 MURRAY ROSE AVENUE,**  
**SYDNEY OLYMPIC PARK, NSW**

**9 October 2017**  
**Ref: 30808YFrpt**

Date: 9 October 2017  
Report No: 30808YFrpt  
Revision No: 0

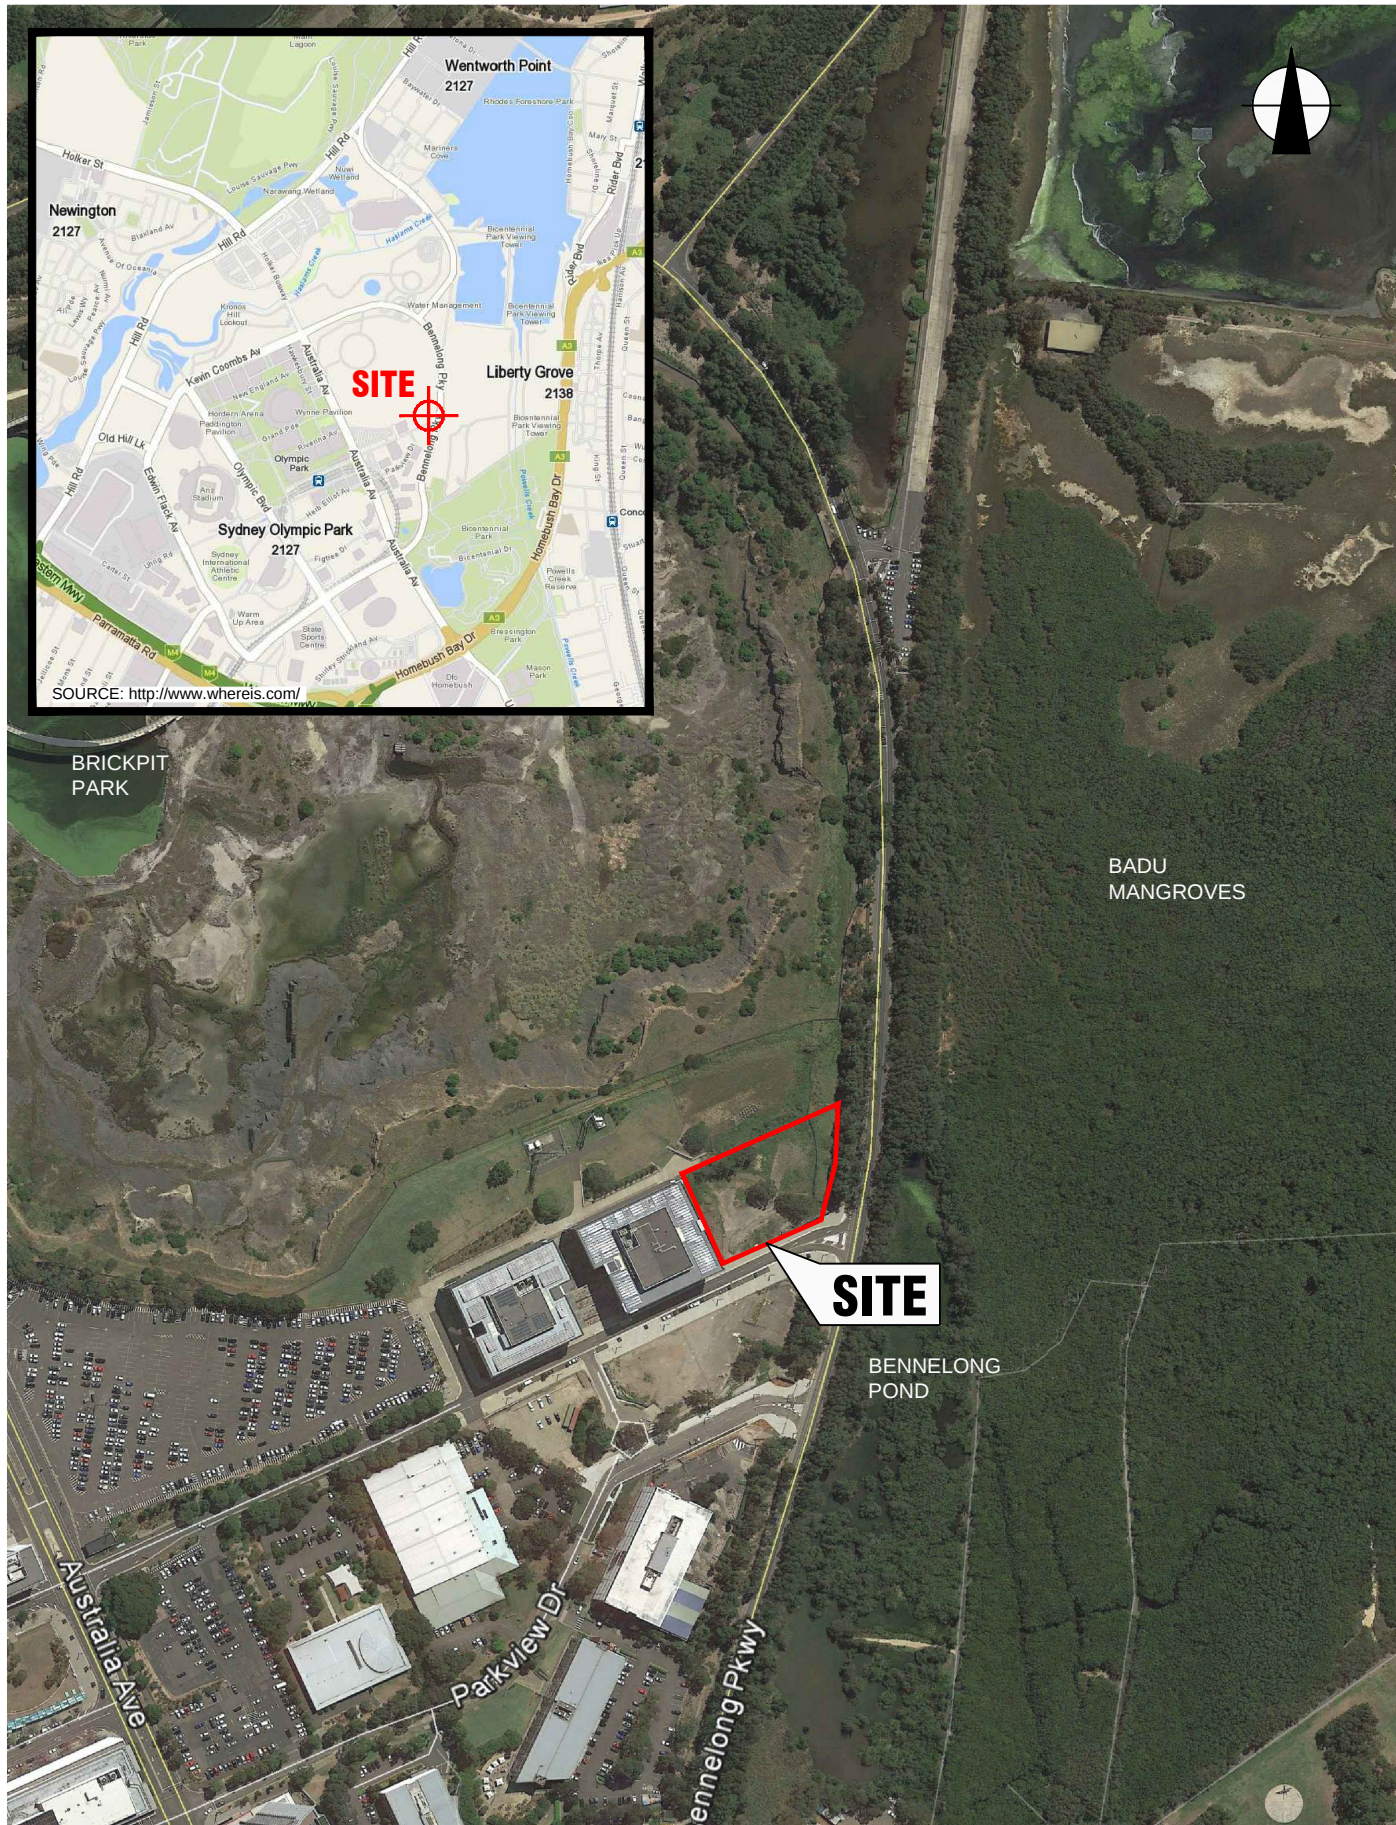
AERIAL IMAGE SOURCE: GOOGLE EARTH PRO 7.1.5.1557  
AERIAL IMAGE ©: 2015 GOOGLE INC.

This plan should be read in conjunction with the JK Geotechnics report.
