## **Upgrades to Chatswood Public School and Chatswood High School**

### **Appendix 13 - Remediation Action Plan**

Chatswood Public School  
Remedial Action Plan

5 Centennial Avenue,  
Chatswood NSW

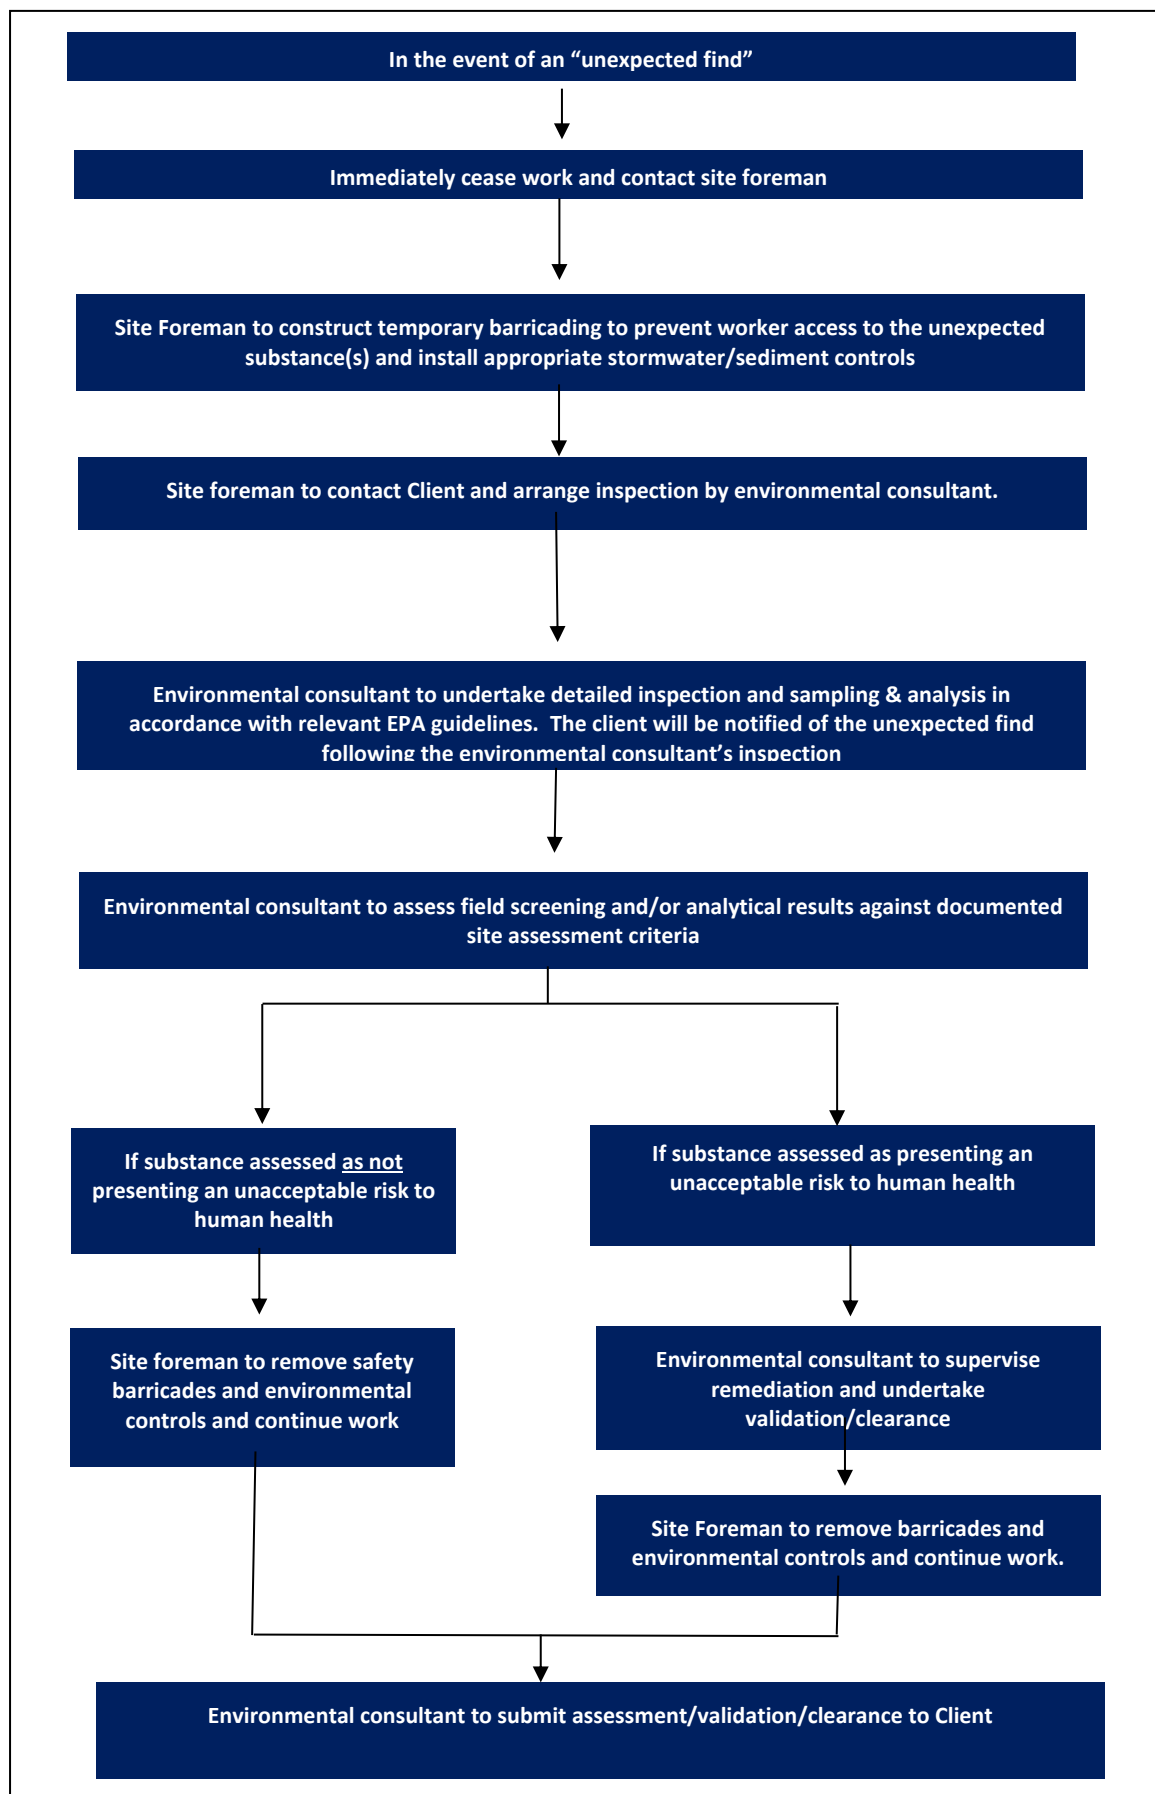
Figure 7.1 - Unexpected Finds Protocol

As a precautionary measure to ensure the protection of the workforce and surrounding community, should any of the abovementioned substances (or any other unexpected potentially hazardous substance) be identified, the procedure summarised in **Figure 7.1** is to be followed.

The sampling strategy for each “unexpected find” shall be designed by a suitably qualified environmental consultant. The strategy will, however, be aimed at determining the nature of the substance – that is, is it hazardous and, if so, is it at concentrations which pose an unacceptable risk to human health or the environment.

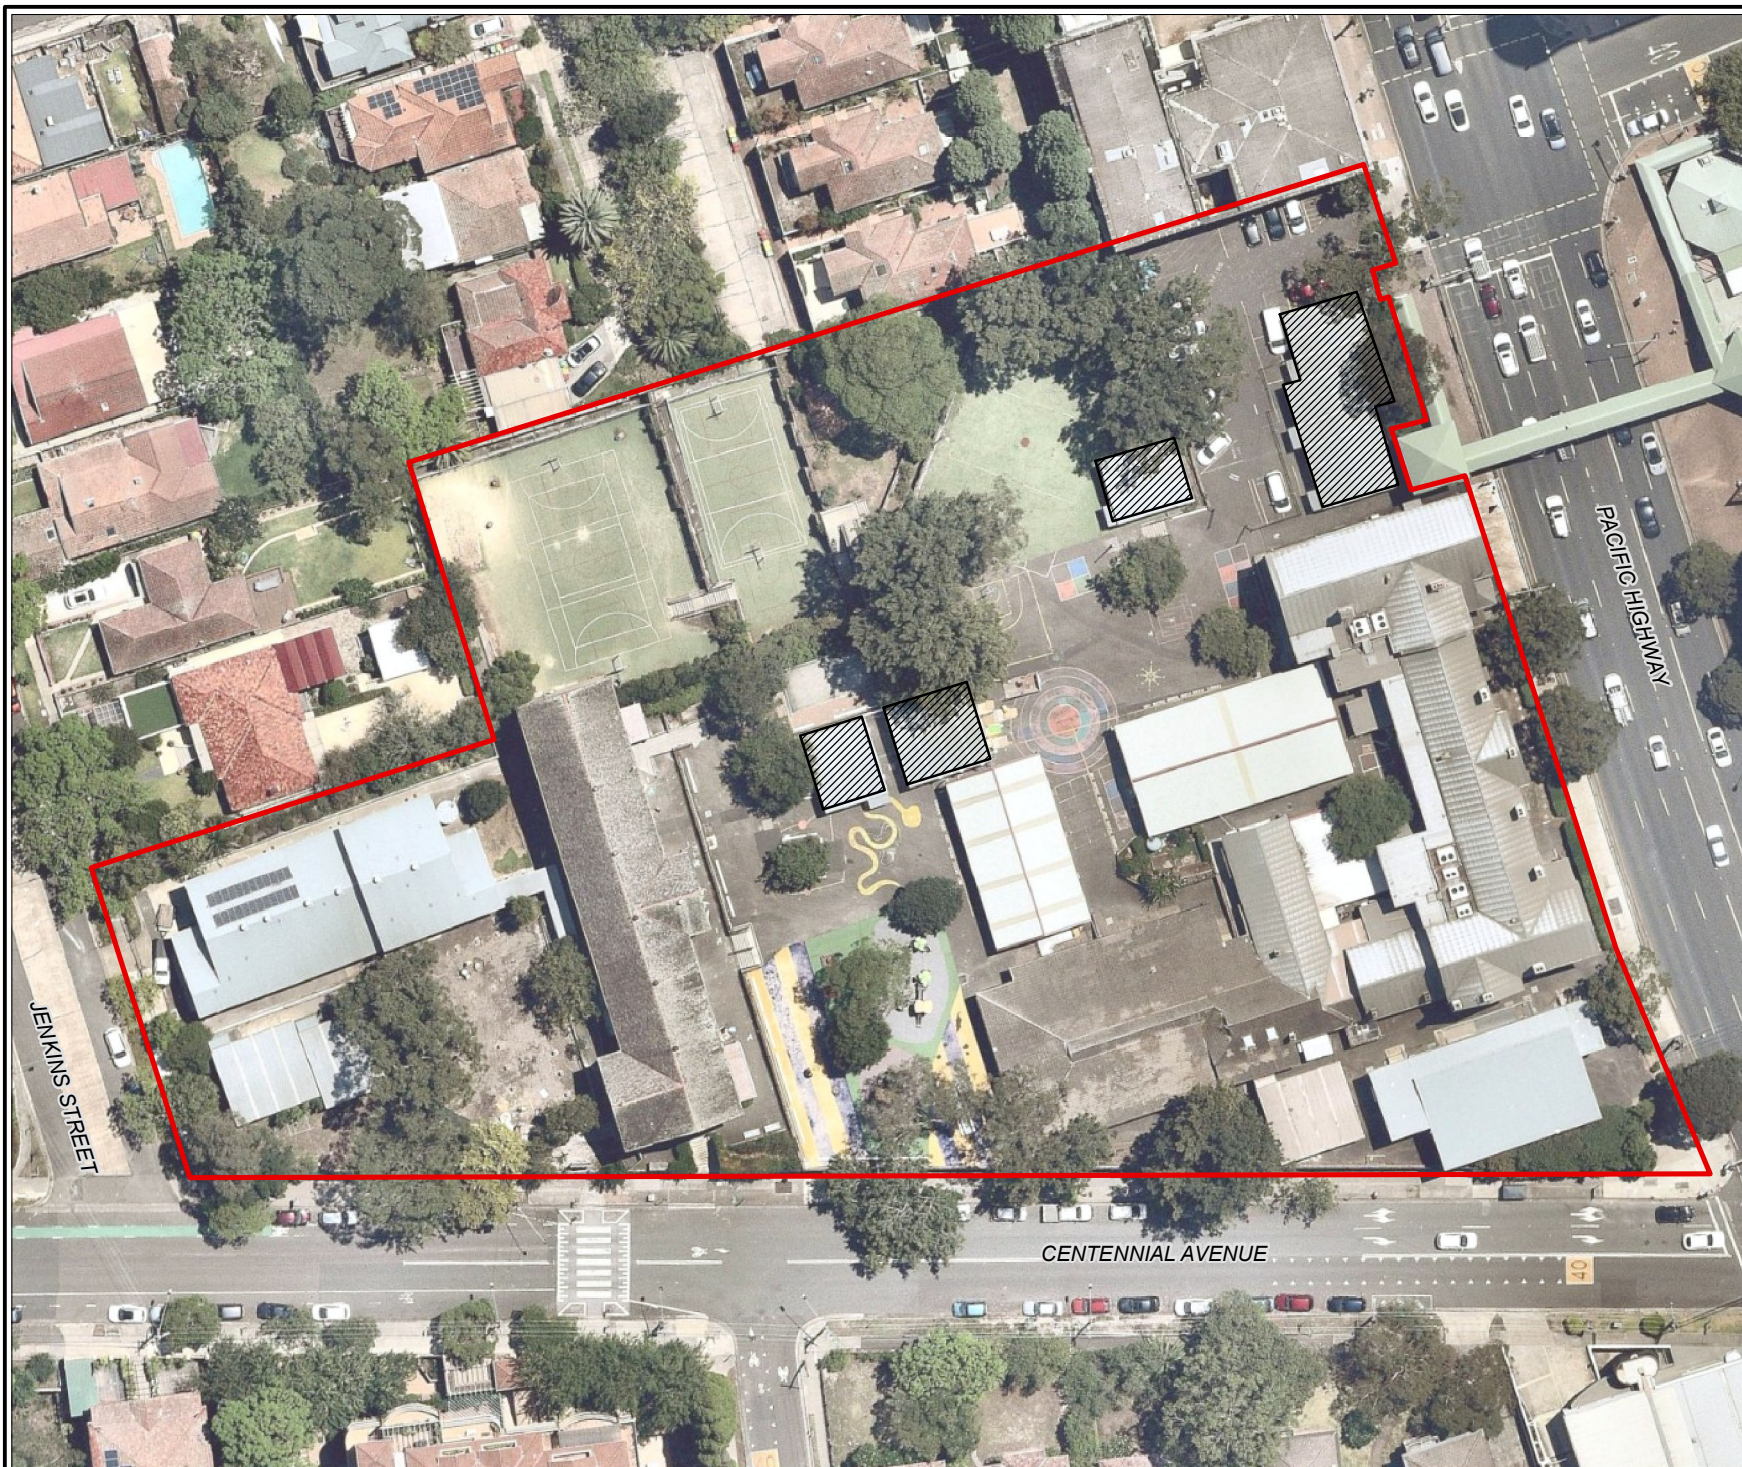
**FIGURE 1**

**SITE LOCATION**

The site details are summarised in **Table 2.1**. A plan showing the location of the site is provided as **Figure 1**, and a plan showing the boundaries of the site is provided as **Figure 2**.

The property is legally identified as Lot 1 in DP 812207 and Lot C in DP 346499 and comprises an area of approximately 1.4 ha. A plan showing the location of the site is provided as **Figure 1**, and a plan showing the boundaries of the site is provided as **Figure 2**.

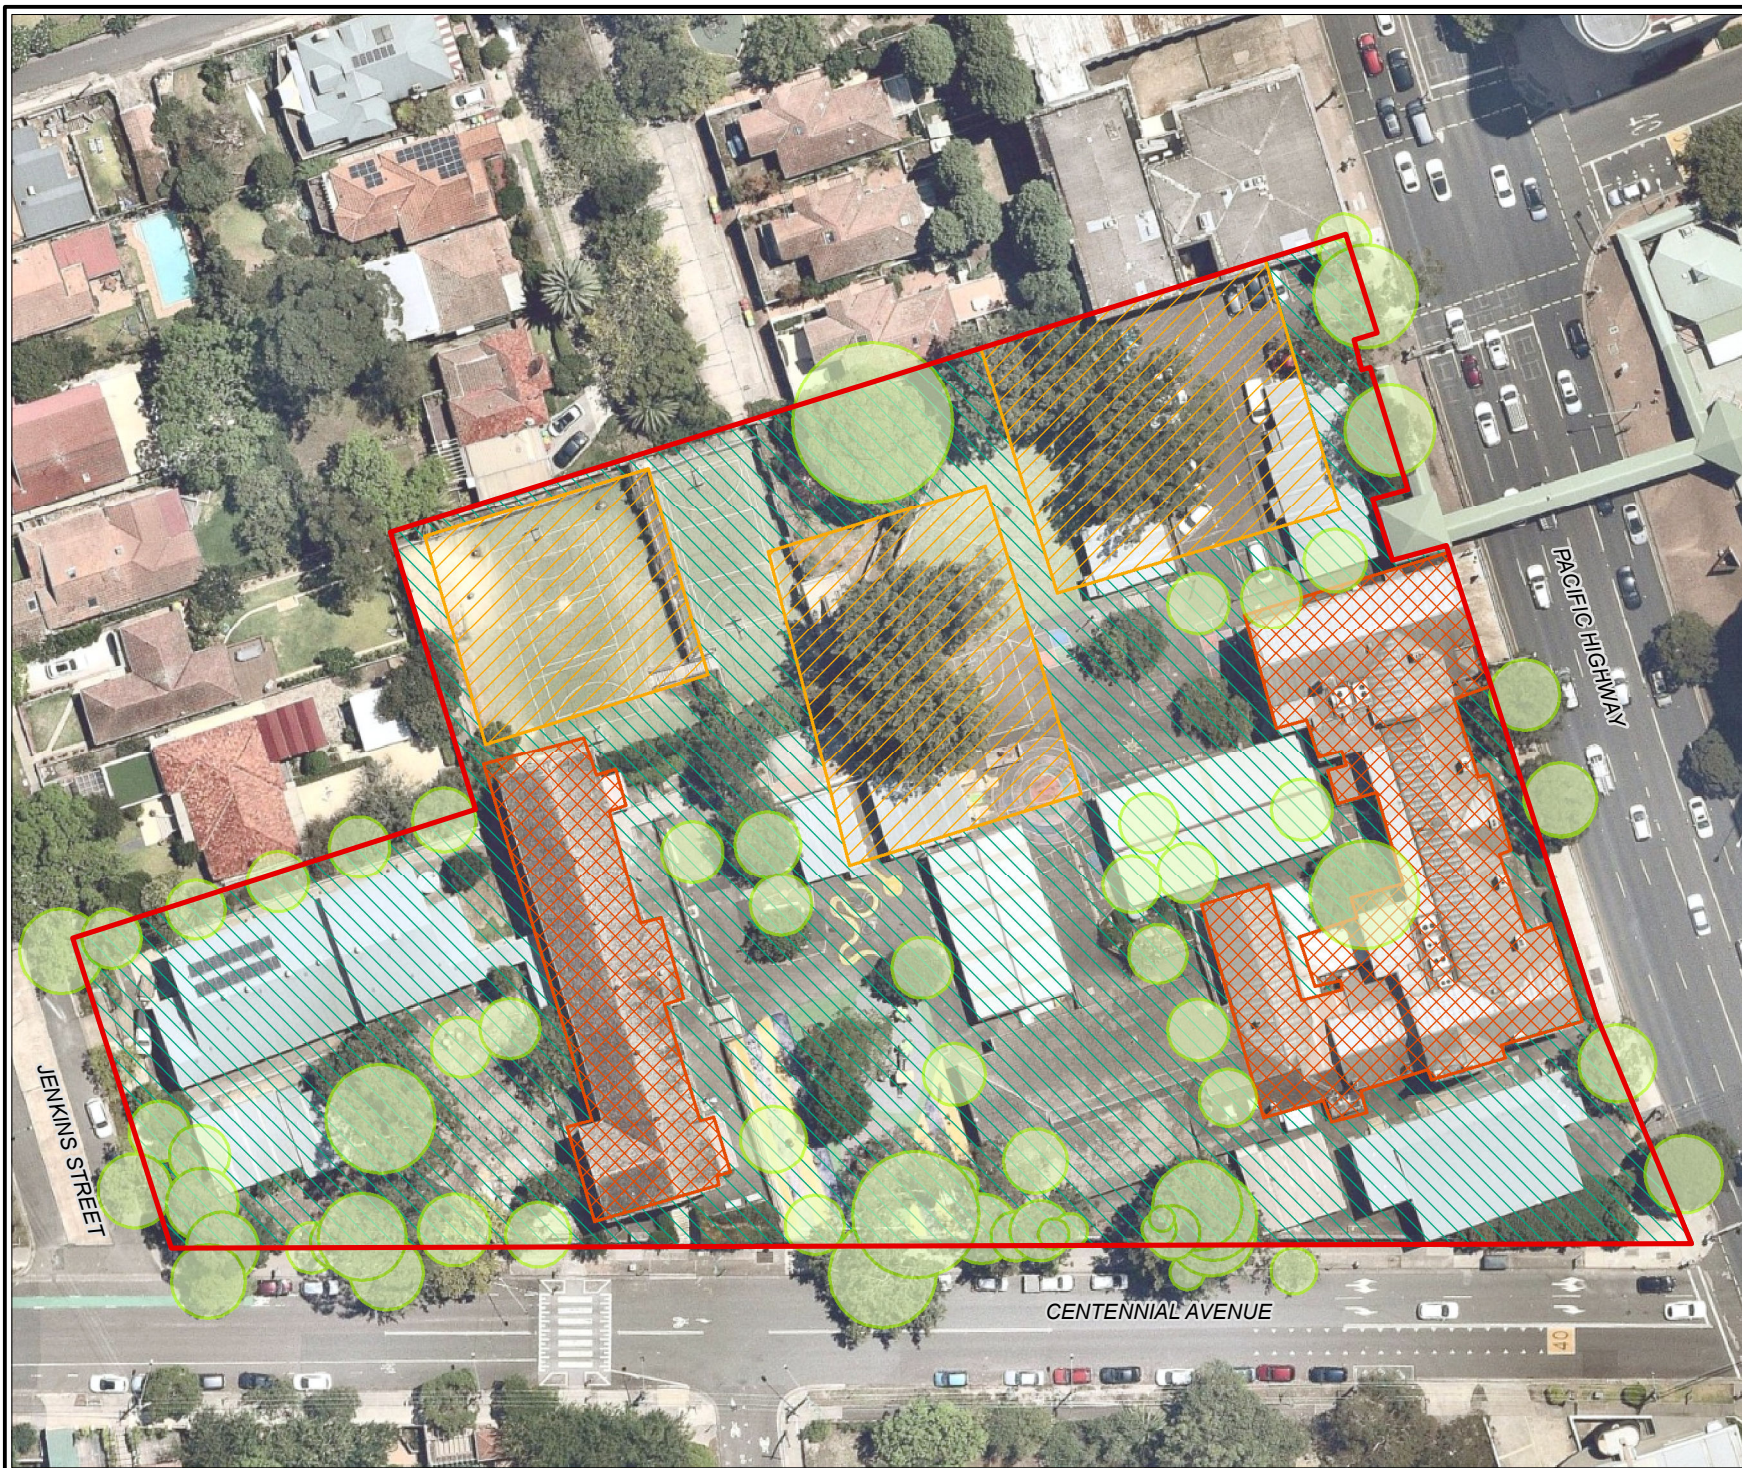
**FIGURE 3**

- Legend:**
- Approximate Site Boundary
  - Proposed Tree Locations
  - Existing Buildings to be retained
  - Proposed Buildings
  - Proposed Circulation Node
  - Proposed Outdoor Space

**PROPOSED  
SITE LAYOUT**

Given the specific development plans, as shown in **Figure 3** (ground floor) (and provided in full in **Appendix B**) and as understood at the time of preparation of this RAP, and the general preference for minor landscaping to include grassed areas and shrubs, the following physical separation arrangements are to be implemented within the extent of the site inclusive of accessible / open space areas (as shown in **Figure 6**):

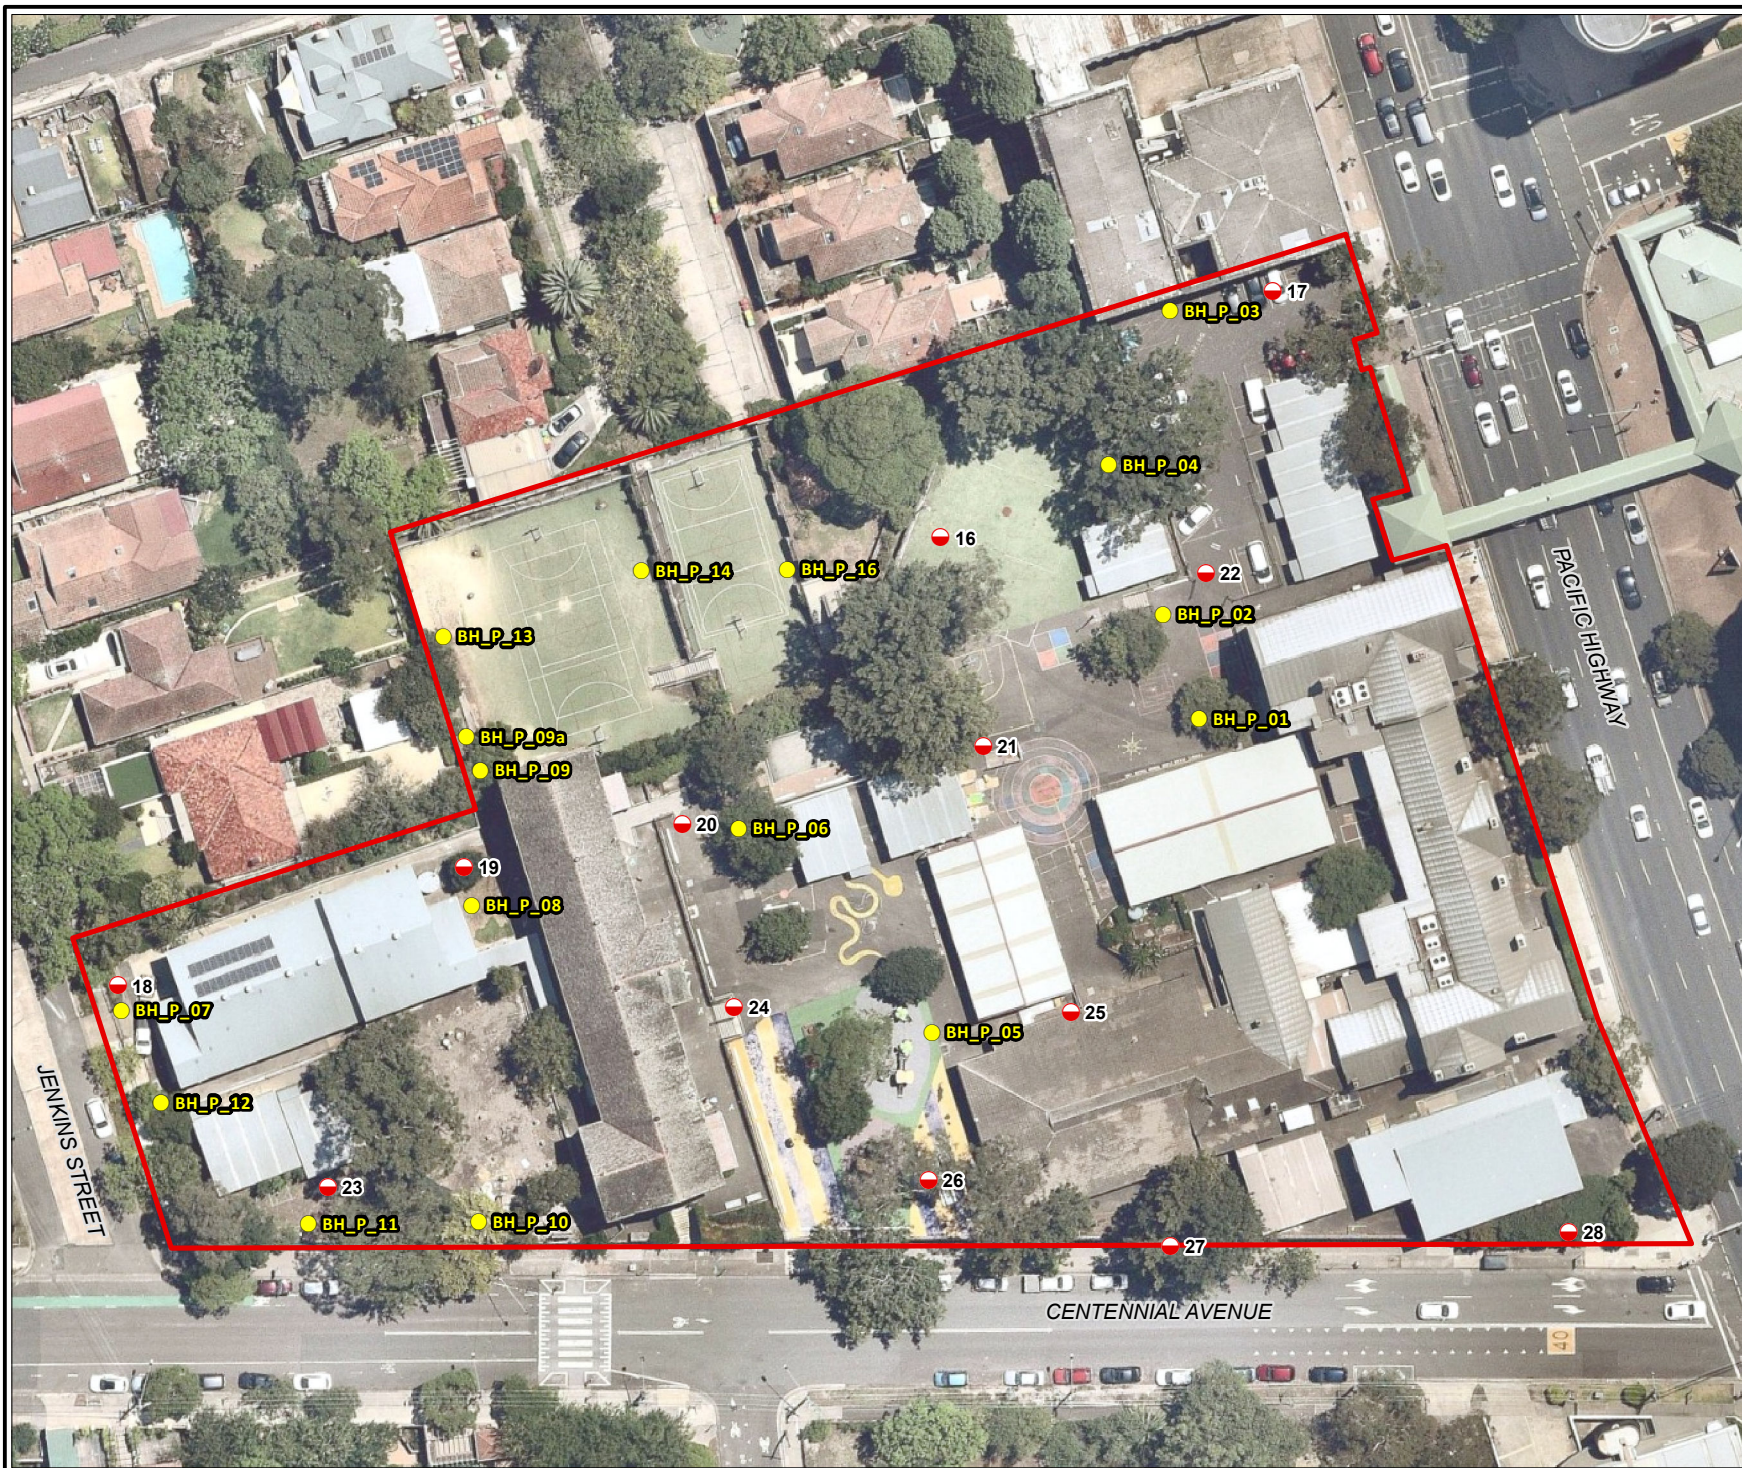
**FIGURE 4A**

**HISTORICAL SOIL SAMPLE  
LOCATIONS**

The results of the analytical data indicated that there are potentially unacceptable risks to human and ecological health at several locations resulting from PAHs, heavy metals and TRH. It was noted that the likely source of these materials can be attributed to ash, bitumen and blue metal gravels identified in the fill profile. JBS&G did not identify any risks relating to the migration of contamination from the site. Soil sampling locations are shown in **Figure 4A** and **4B**, and soil exceedances are shown in **Figure 4C**.

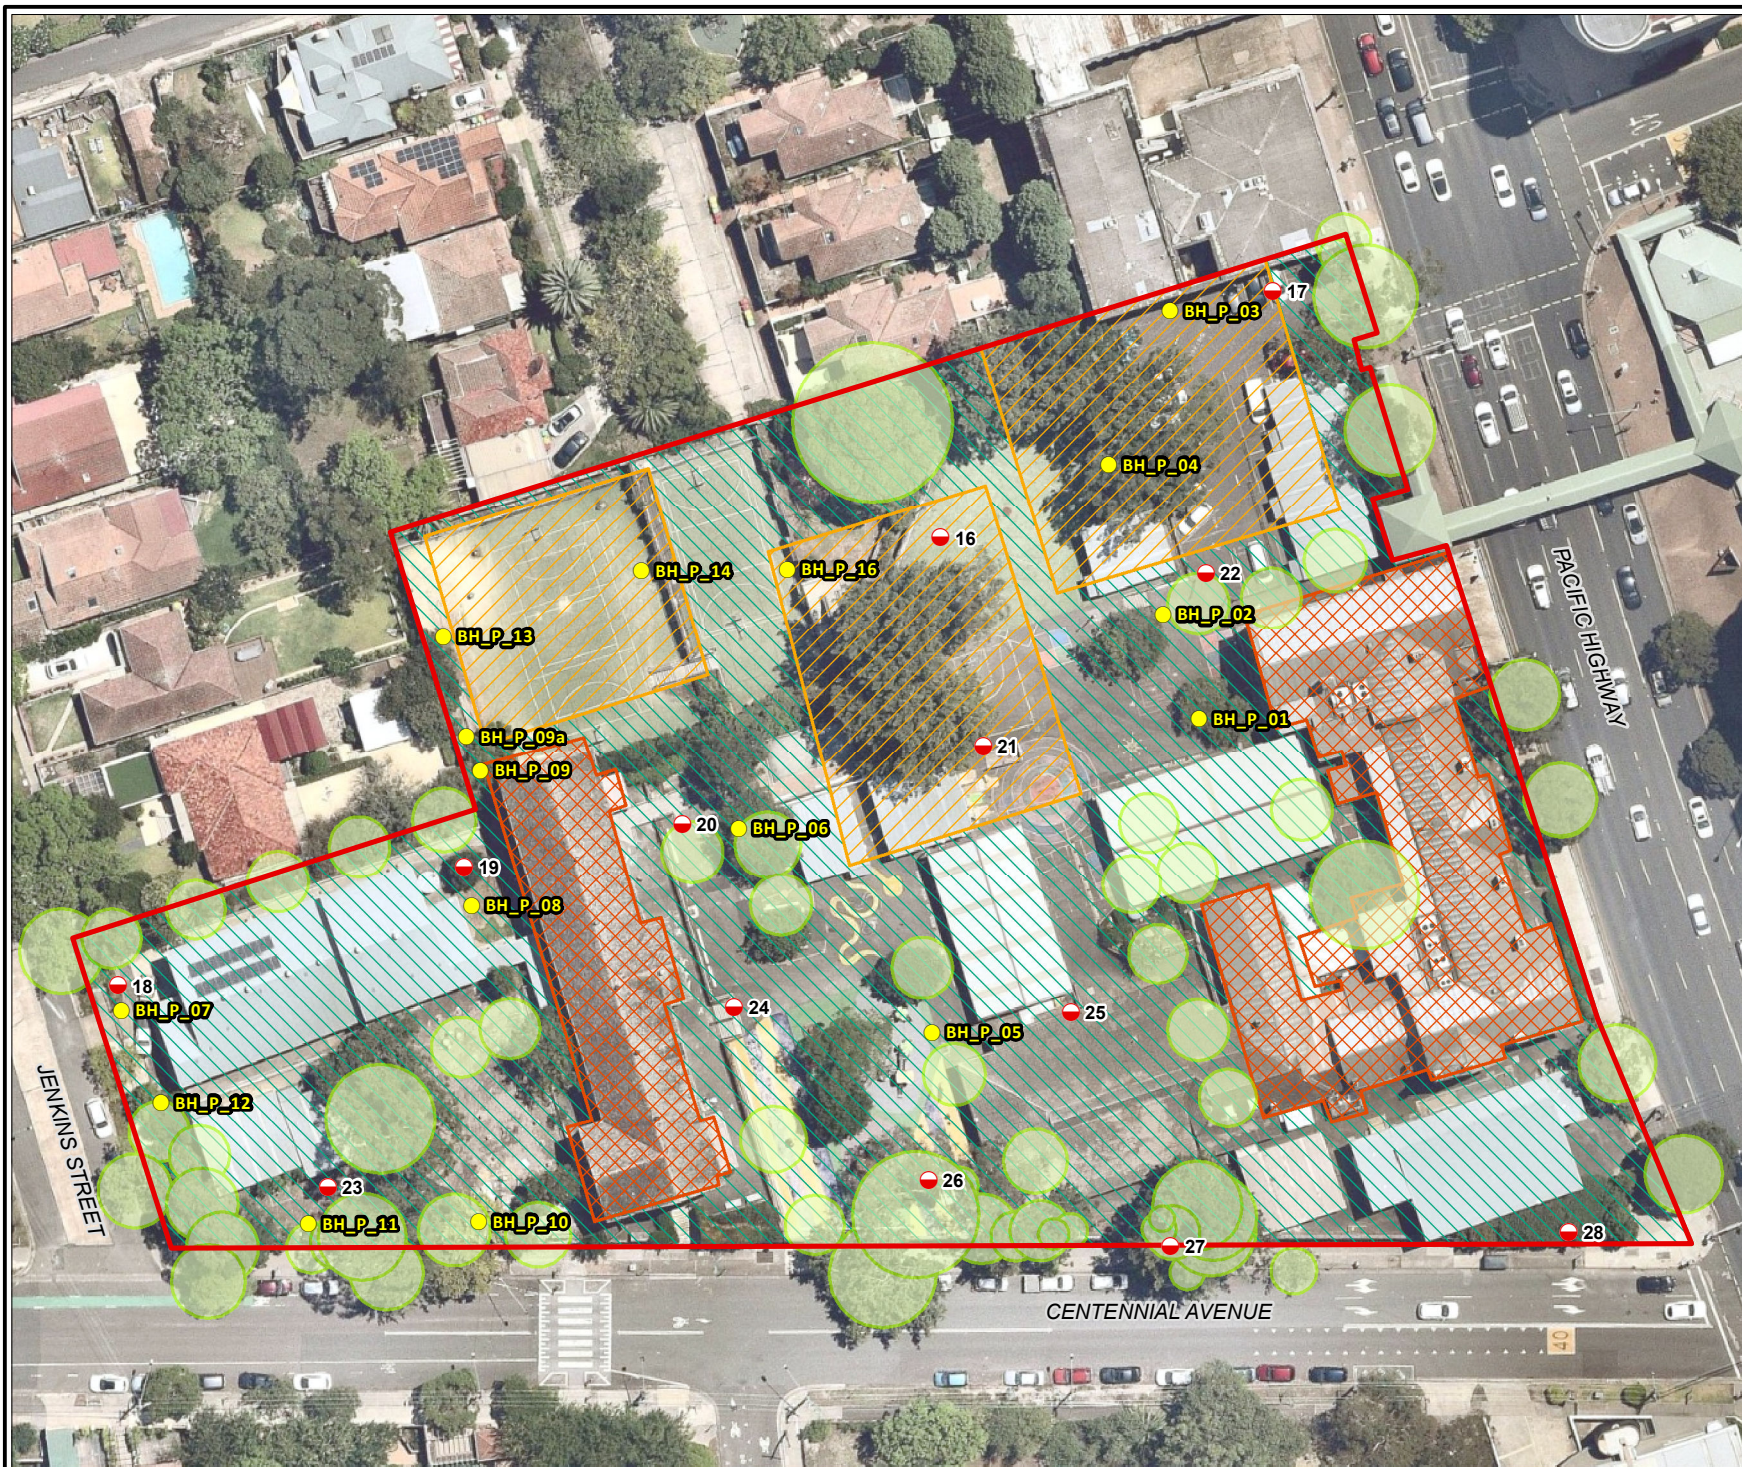
**FIGURE 4B**

**HISTORICAL SOIL SAMPLE  
LOCATIONS (PROPOSED  
SITE LAYOUT)**

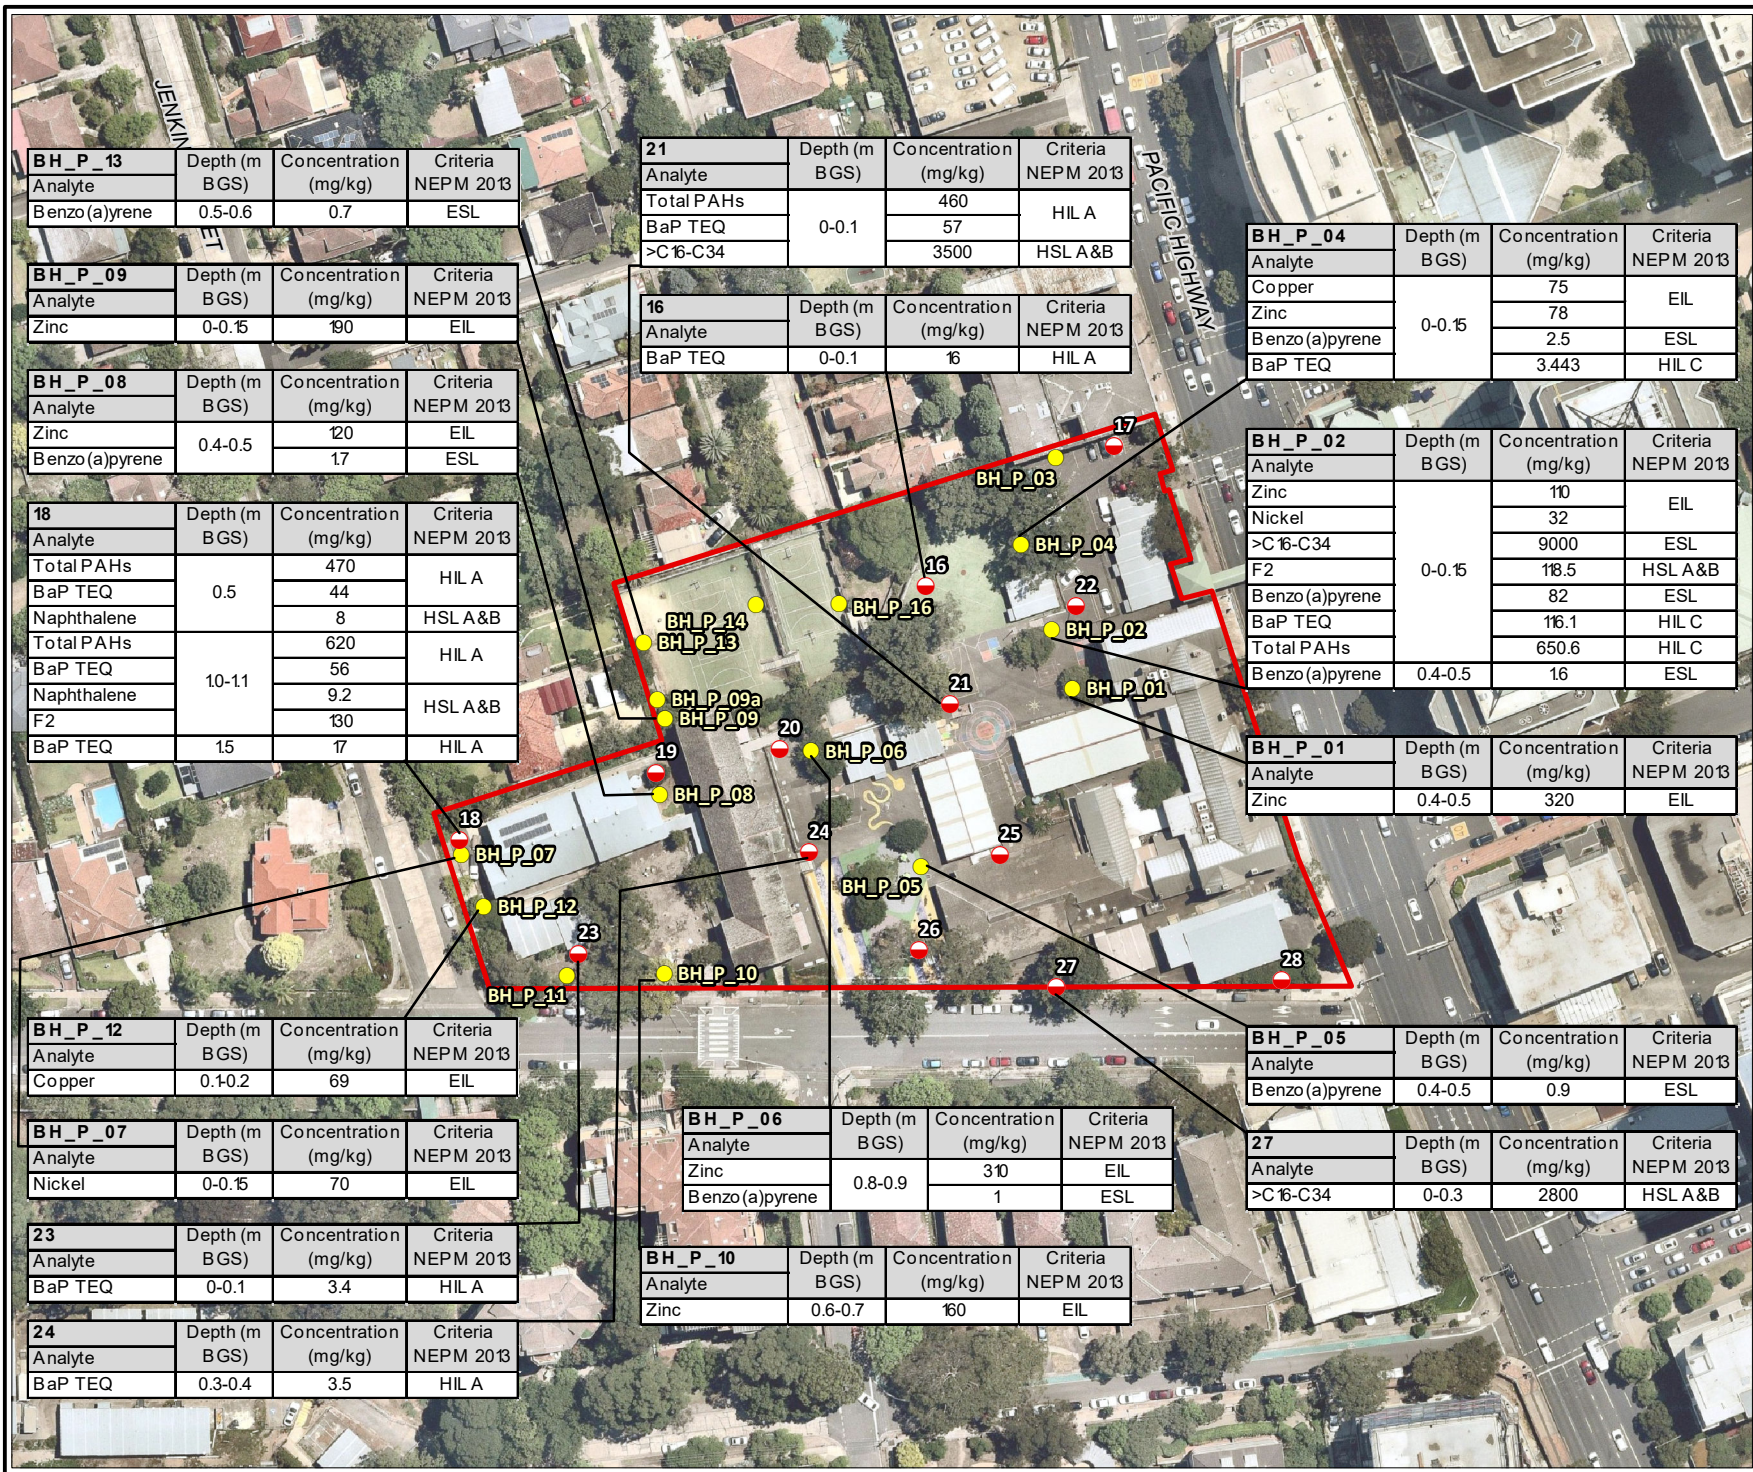
**FIGURE 4C**

Note - F2= >C10-C16 less naphthalene

**SOIL EXCEEDANCES**

Potentially unacceptable health risks from the potential intrusion of vapours to future site structures was noted from TRH (>C10-C16, F2 fraction) concentrations at two locations, BH\_P\_02 0-0.15 and BH18-1.0-1.1 (DP 2018). The former location was advanced in proximity to the school car park, and the latter was located at the westernmost driveway off Jenkins Street. Fill materials from BH18 (off Jenkins Street) were noted to exhibit hydrocarbon odours and ash within fill materials, which were observed between 0.8 m bgs and 1.8 m bgs. The source of these impacts is unknown. JBS&G consider that there are currently no risks posed by the reported hydrocarbon impacts as there are currently no structures overlying the sampling locations and therefore no risk for the accumulation of vapours. Furthermore, the reported concentrations only marginally exceed the adopted Tier 1 criteria and are likely to attenuate over time due to the volatile nature of the compounds.

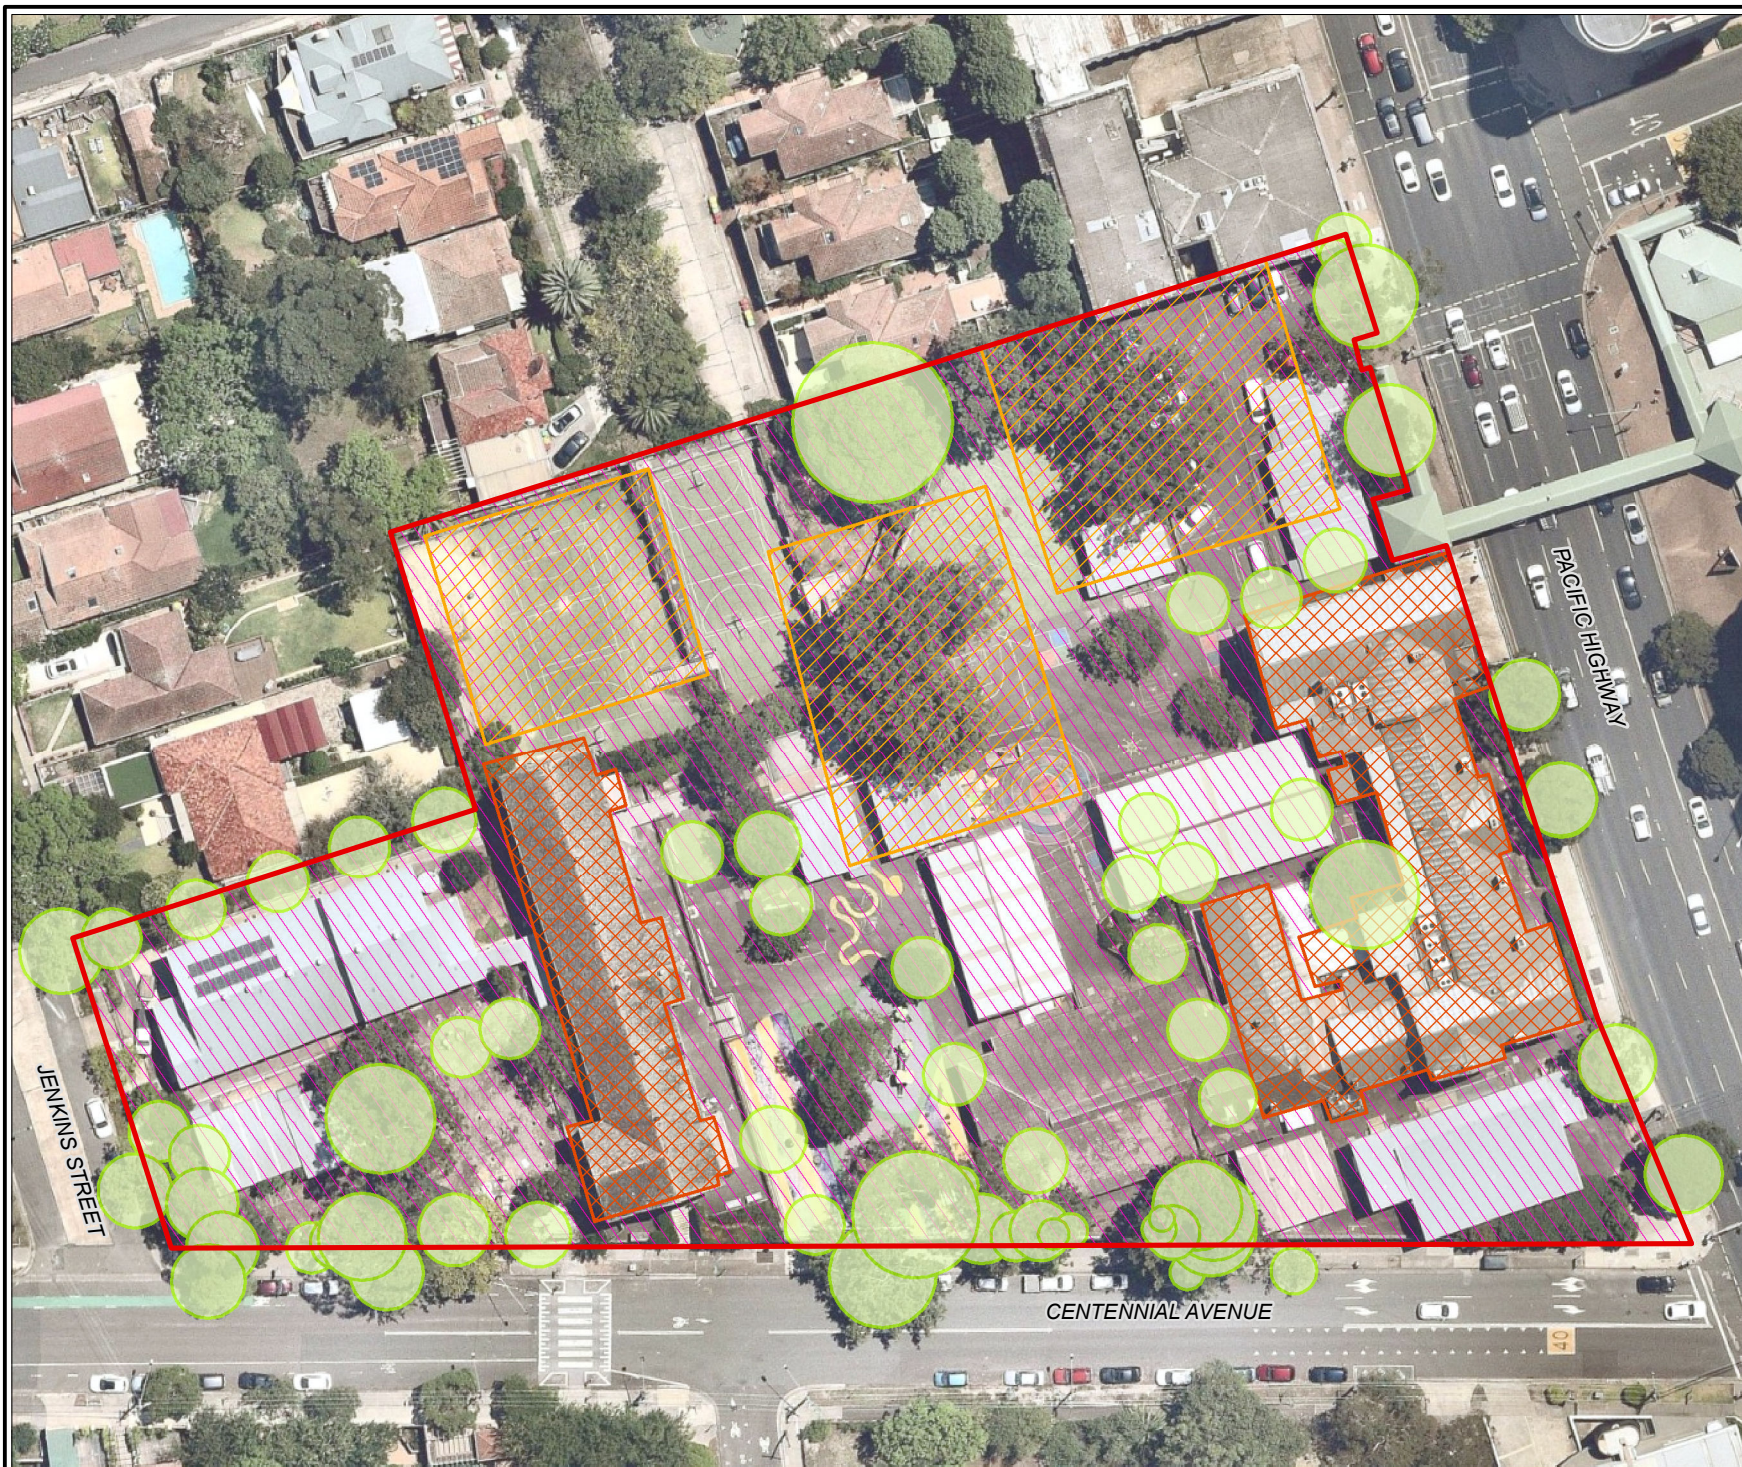
**FIGURE 5**

- ▬ Approximate Site Boundary
- ▬ Proposed Tree Locations
- ▨ Existing Buildings to be retained
- ▨ Proposed Buildings
- ▨ Containment Required

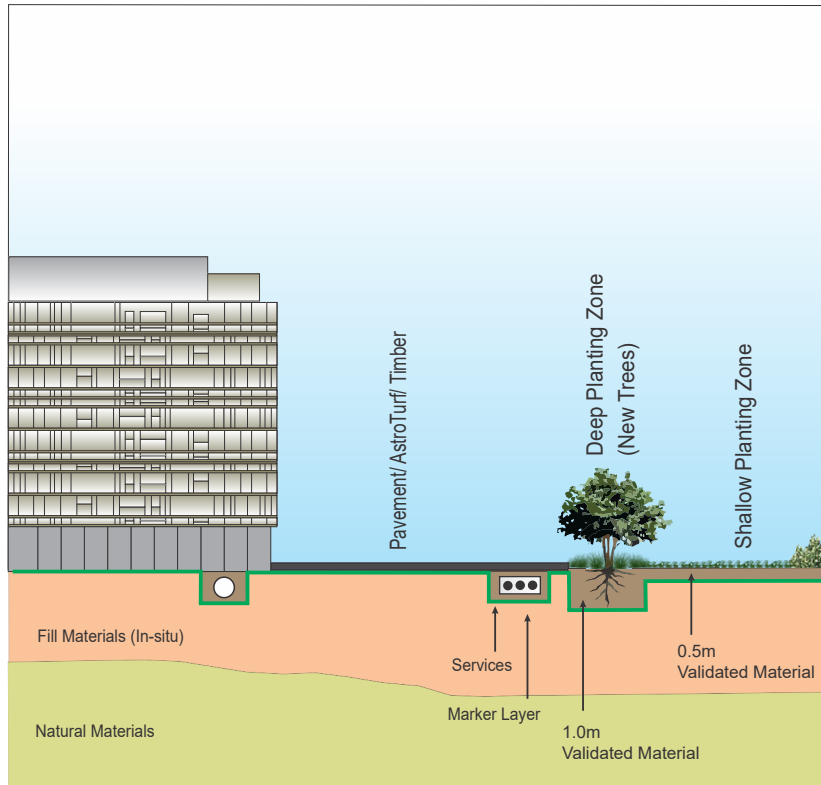
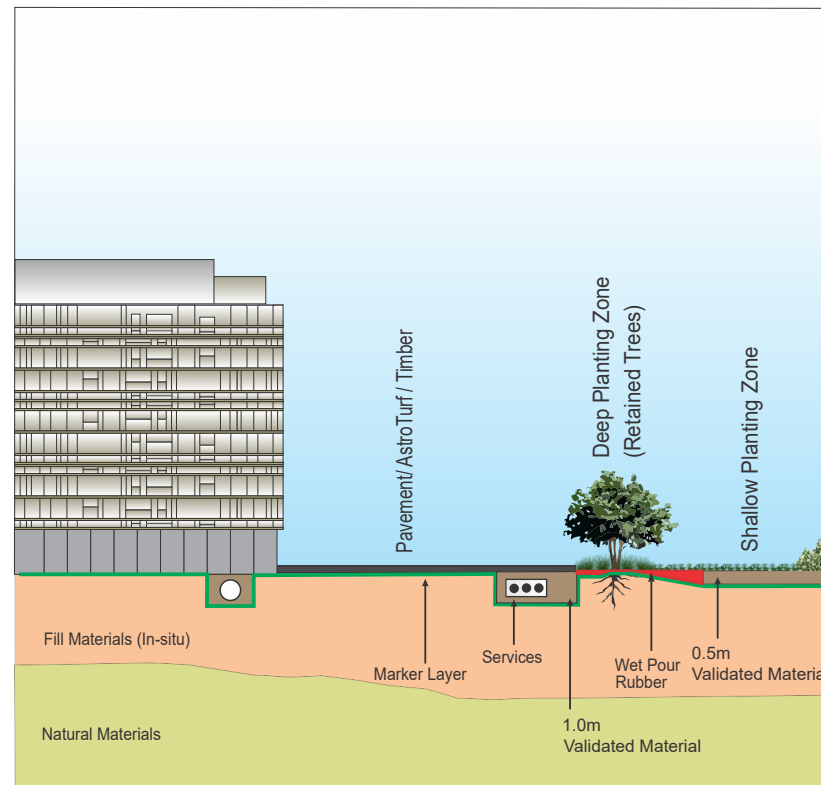
**FIGURE 6**

Capping Layer Layout with New Trees

Capping Layer Layout Retaining Trees

NOTE: Schematic representation of capping requirements only. The diagram is not true to proposed site design features.

- Cover of fill materials by new or replacement permanent paved/sealed areas (includes concrete, asphalt, pavers and synthetic grass areas) – installation of a marker layer underlying the depth of the pavement and overlying potentially contaminated material;

- For new slab on grade buildings, the slab will provide adequate separation without the need for a marker layer, however a marker layer is recommended below building structures that are no slab-on-grade or where there is potential for future penetration of the footprint area (e.g. to facilitate service maintenance, etc);
