## **Preliminary Geotechnical site investigation report**

Proposed public school on Lot 1 DP1253855, Estella Road  
Estella NSW 2650

Ref: R9930g

Date: 14 August 2018

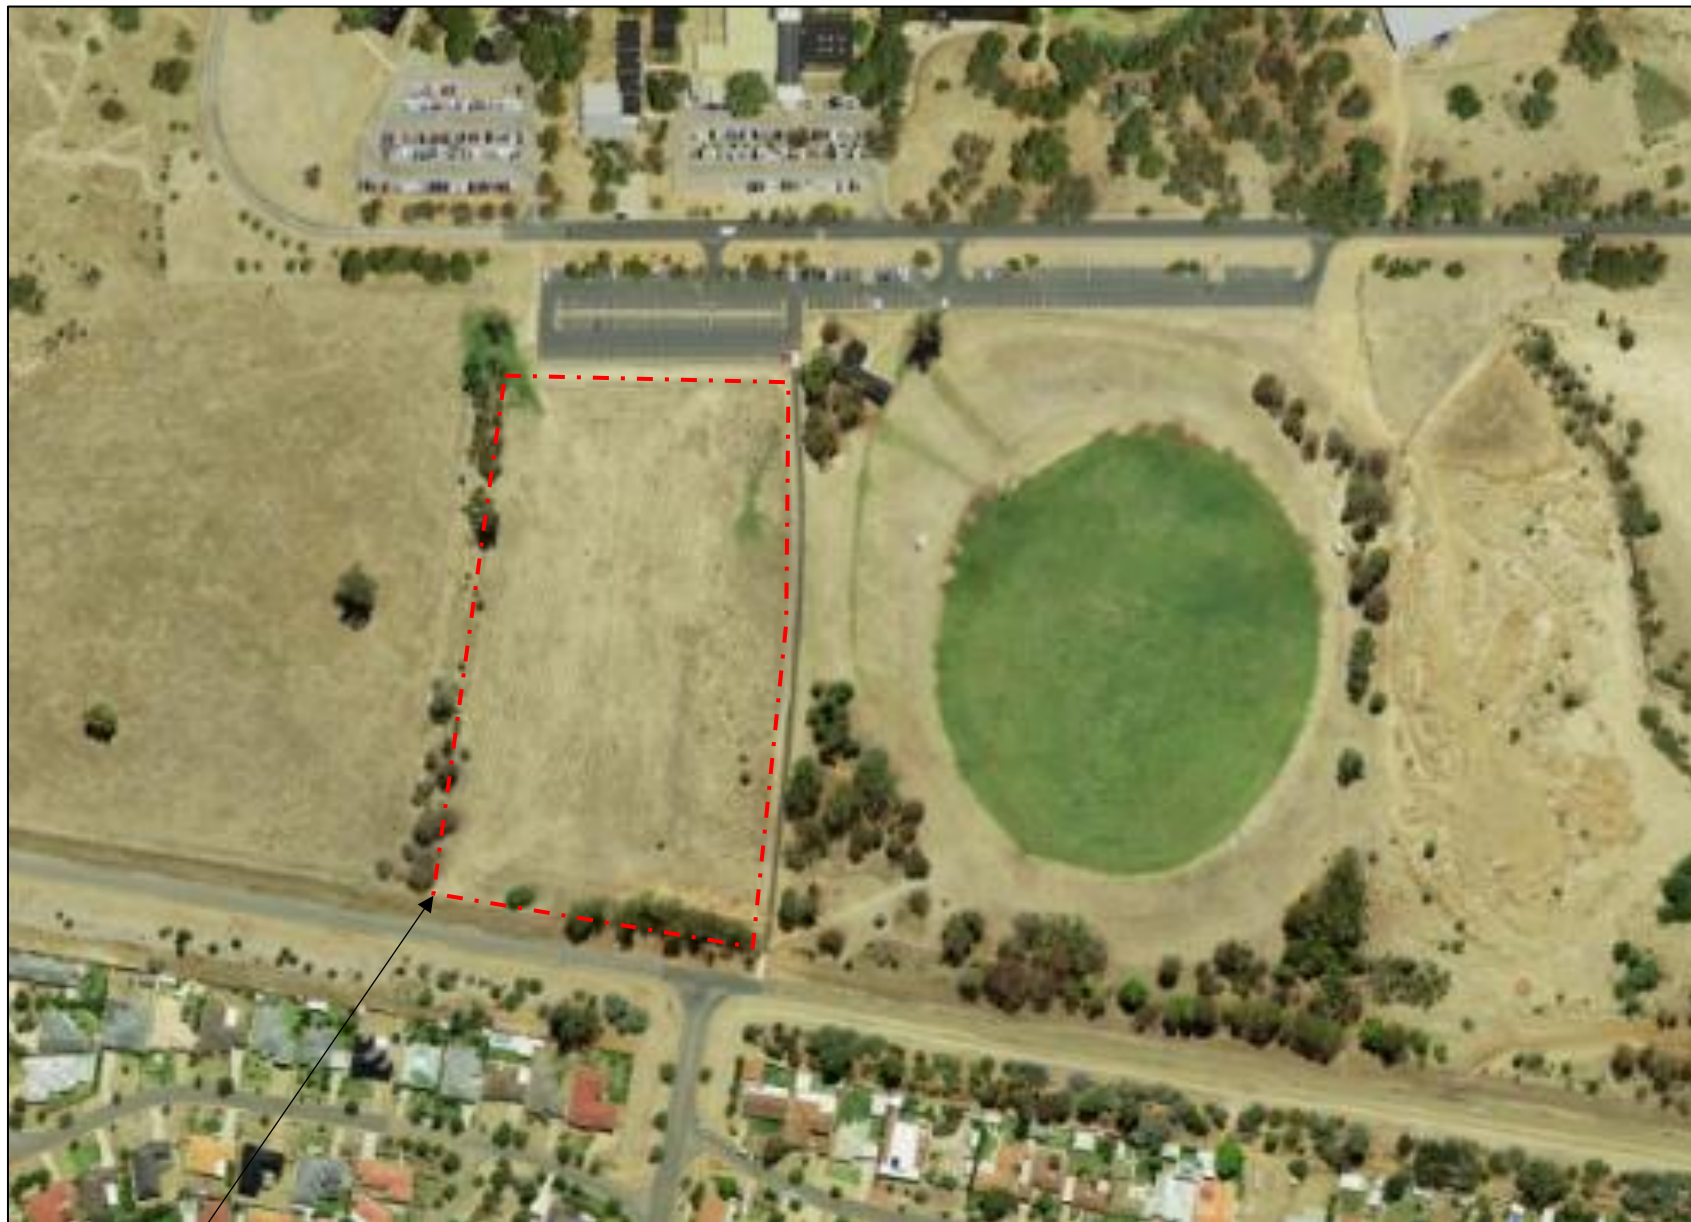
| Figure 3. Aerial photograph | | |

Investigation area
