15 November 2021

Supplementary Site Suitability Assessment – SSD9522 Modification - Symbion Development Site Mamre Road, Kemp's Creek, NSW

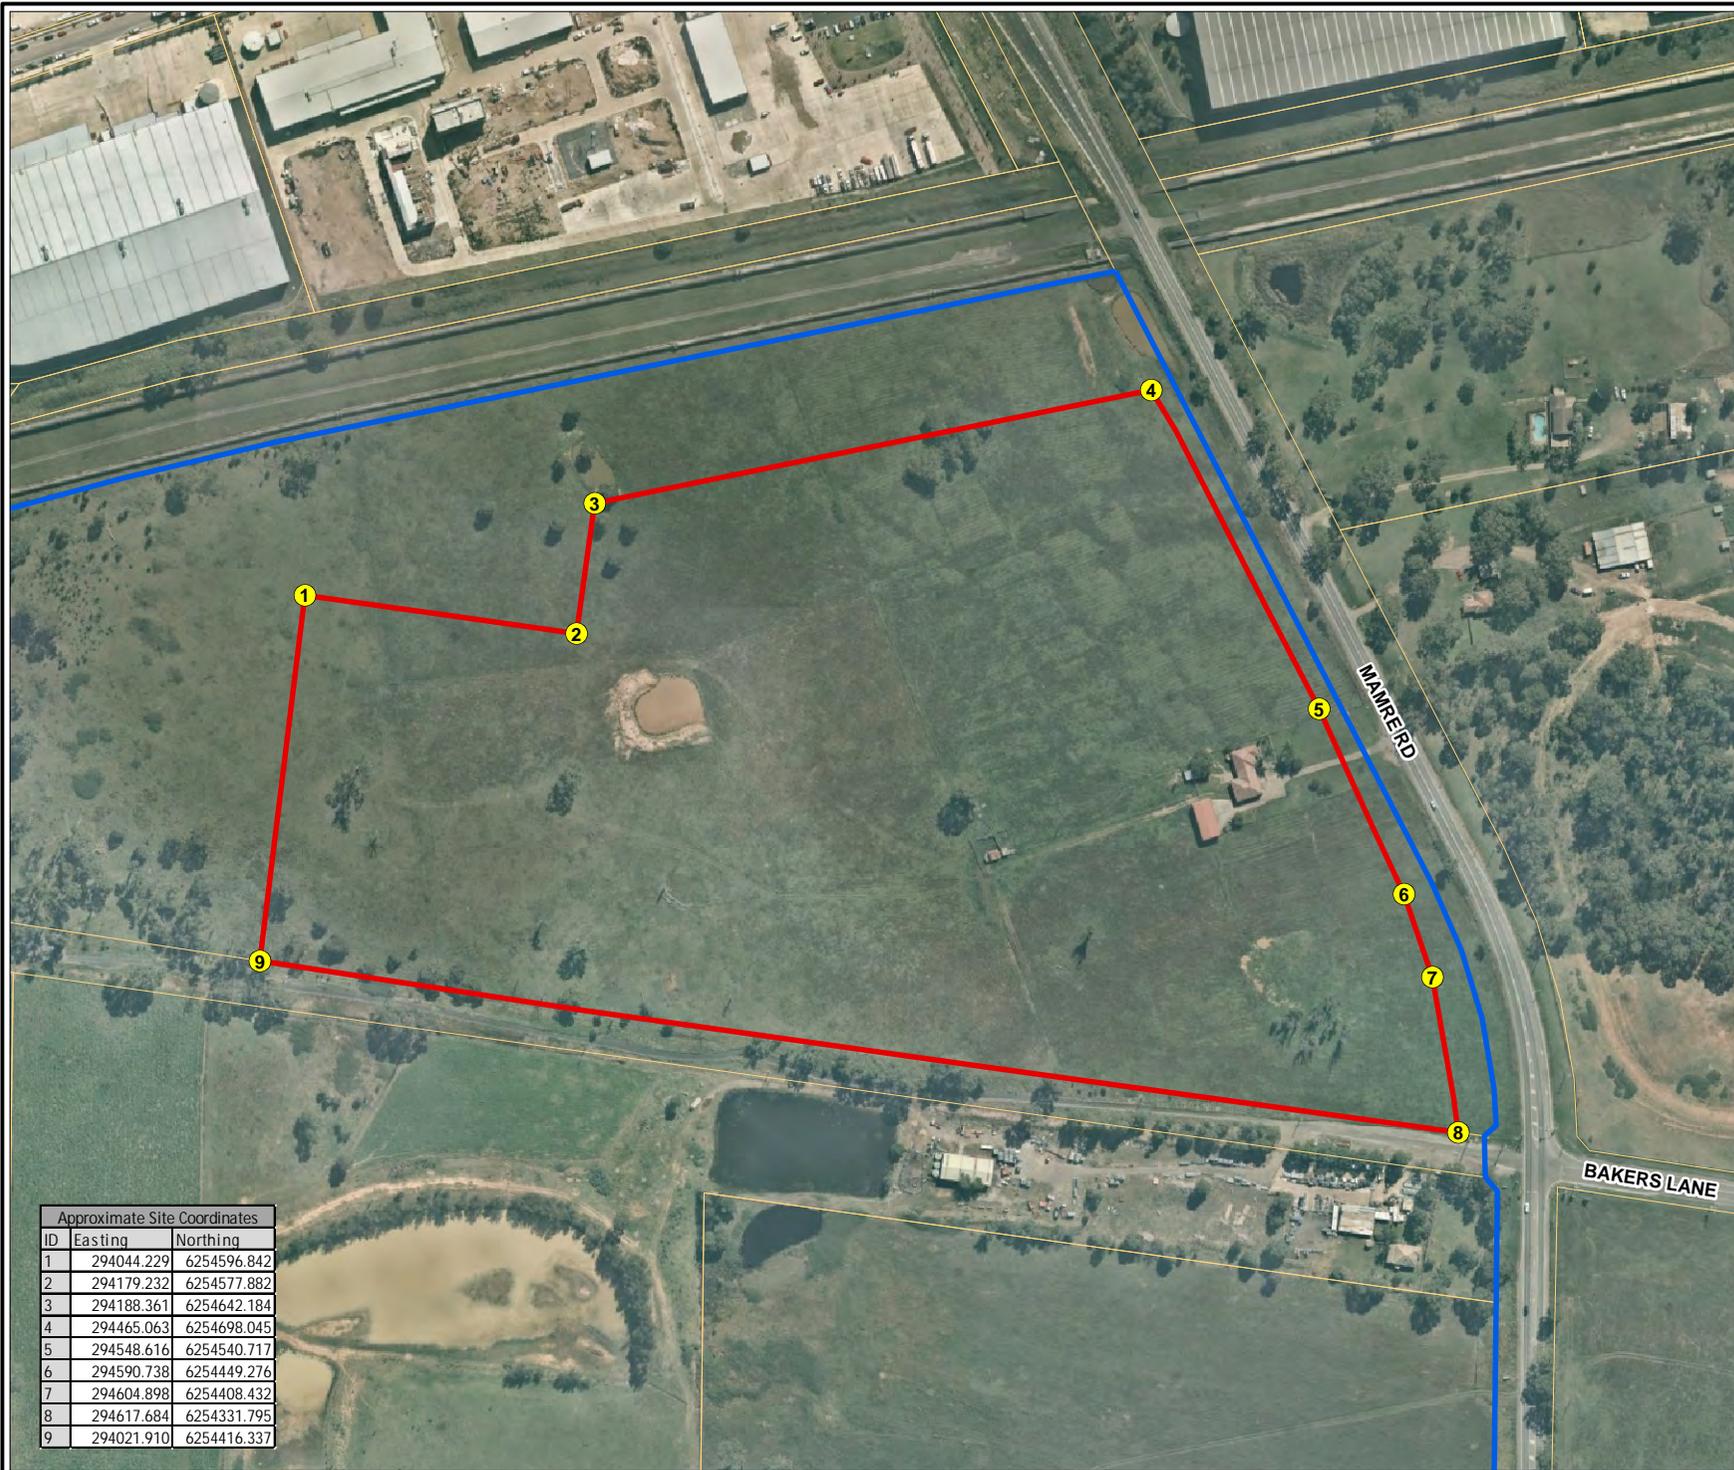
FIGURE 2

- At the time of the DSI, the site was observed to comprise acreage formerly utilised as a rural residence with livestock grazing. The site was surrounded by properties assessed as part of the DSI, which comprised generally vacant agricultural land; and

Coord. Sys. GDA 1994 MGA Zone 56
Industrial Facility
Kemps Creek Industrial Community
Mamre Road,
Kemps Creek NSW
PREVIOUS SITE LAYOUT
(APRIL 2019)

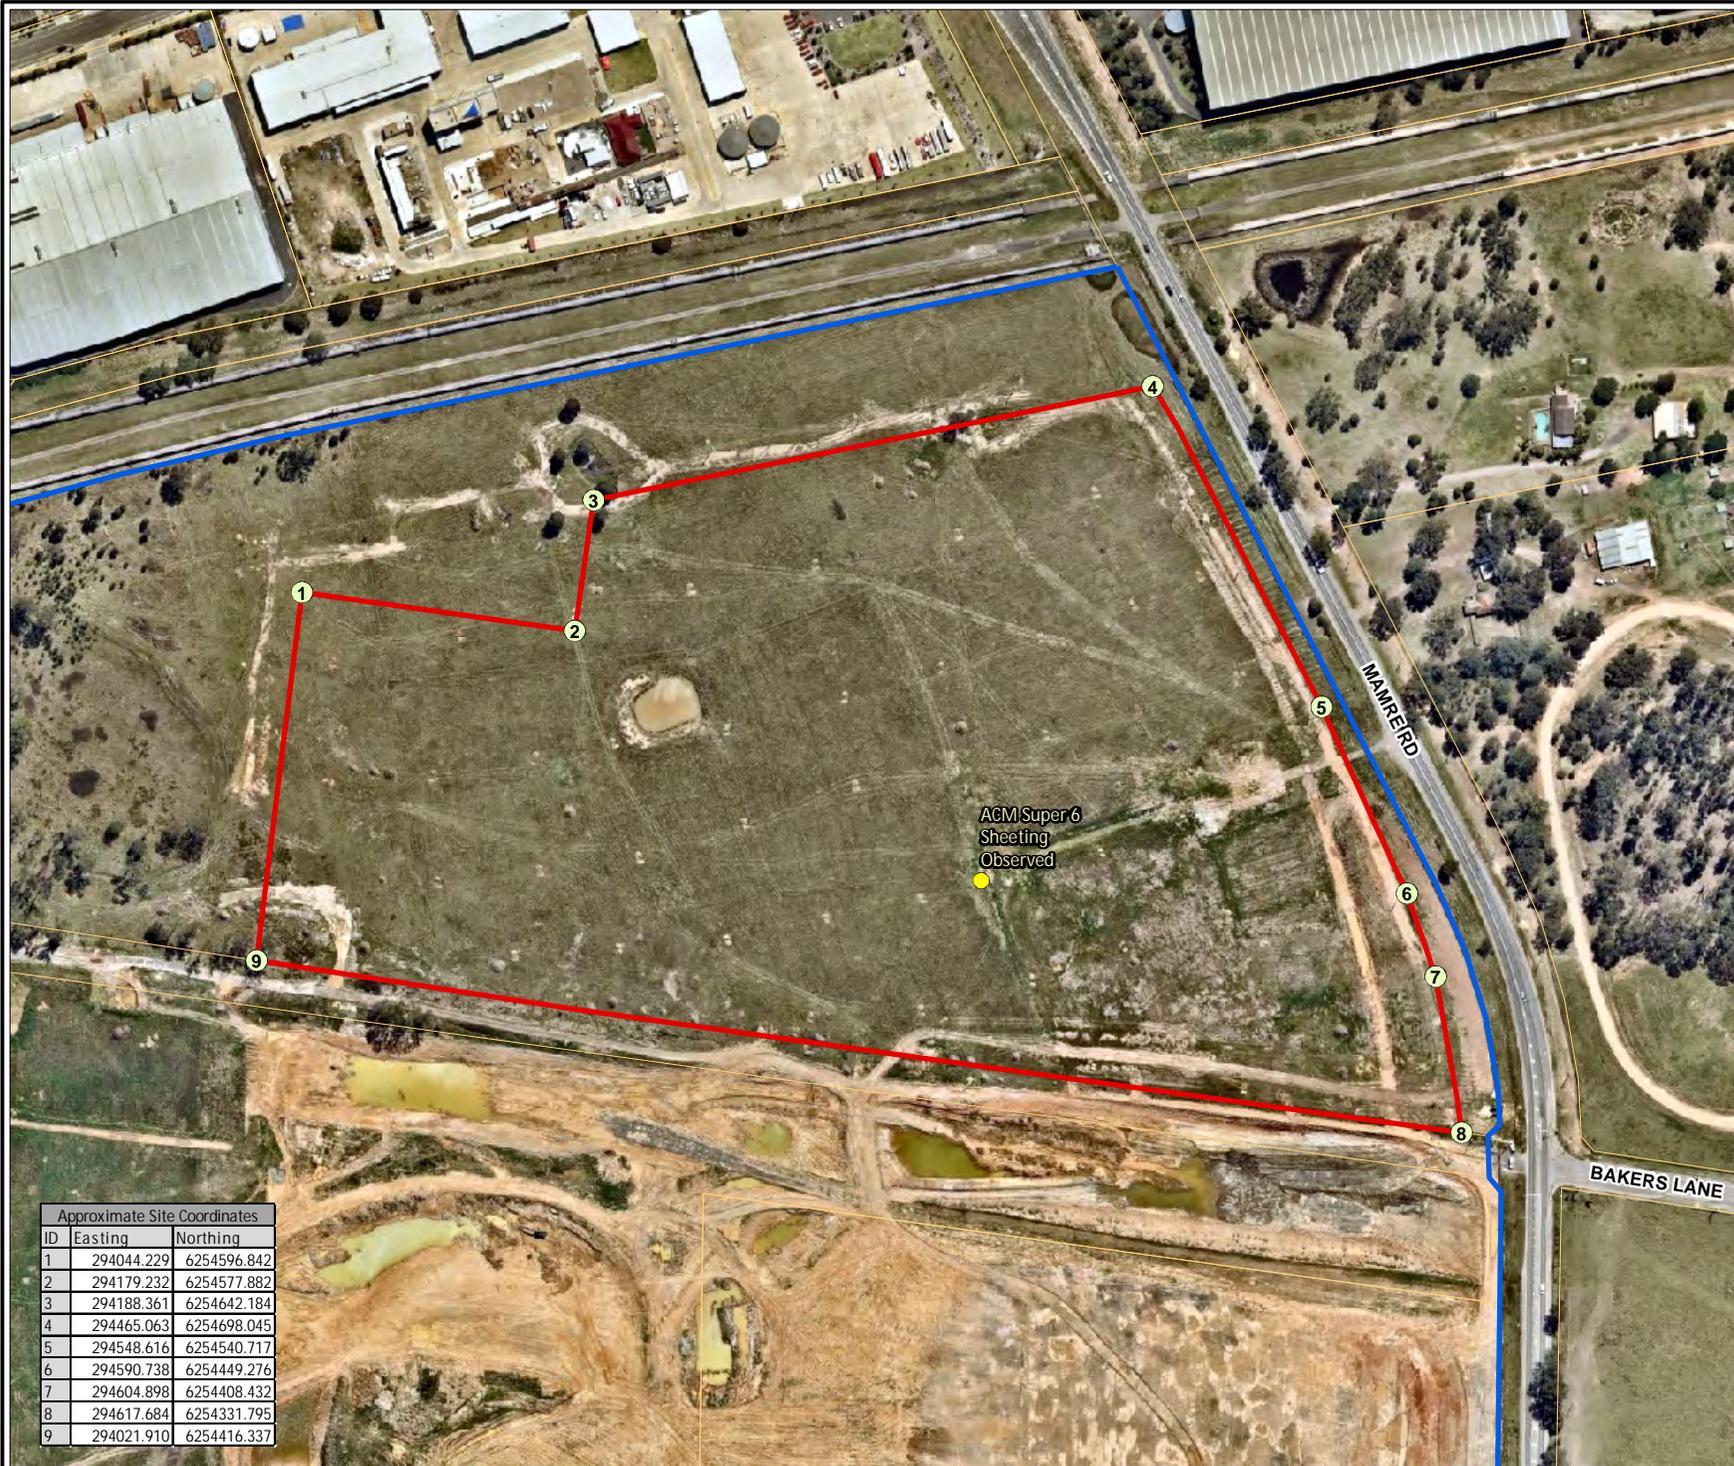
FIGURE 3

- The most recent image (6 October 2021) shows the majority of the site as covered with long grass, and mulch stockpiles (anecdotally understood to have been mulched as part of former tree clearance). Multiple cleared vehicle tracks were observed in the image around the site perimeter, and through the central-eastern portion of the site in an east/west alignment, in the vicinity of the former residence. Smaller vehicle tracks are observable throughout the centre of the site, possibly associated with the mulching of the trees which were recently cleared across the site. The balance of the areas surrounding the site appeared similar to the previous aerial image, noting that demolition of a house and shed structures had occurred. A

small white discolouration in the footprint of the former shed structure was observed in the recent imagery, consistent with the observation of plastic wrapped super six asbestos sheets described in **Section 2.3**. Earthworks and preliminary development were evident external to the site to the south.

CURRENT SITE LAYOUT
(OCTOBER 2021)

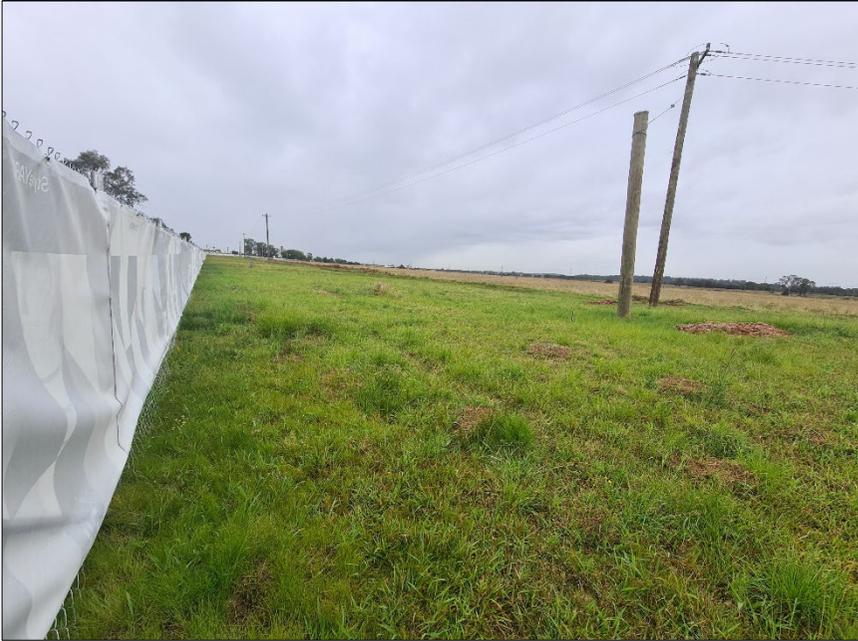
1 – NORTHEASTERN CORNER OF SITE, FACING SOUTHWEST. METAL FENCING & AWJ SCREENING OBSERVED TO THE LEFT

- The property was covered in long grass and sporadic stockpiles of mulch, where trees had recently been cleared;
- The eastern perimeter of the site was now secured by metal fencing with AWJ screening along Mamre Road;

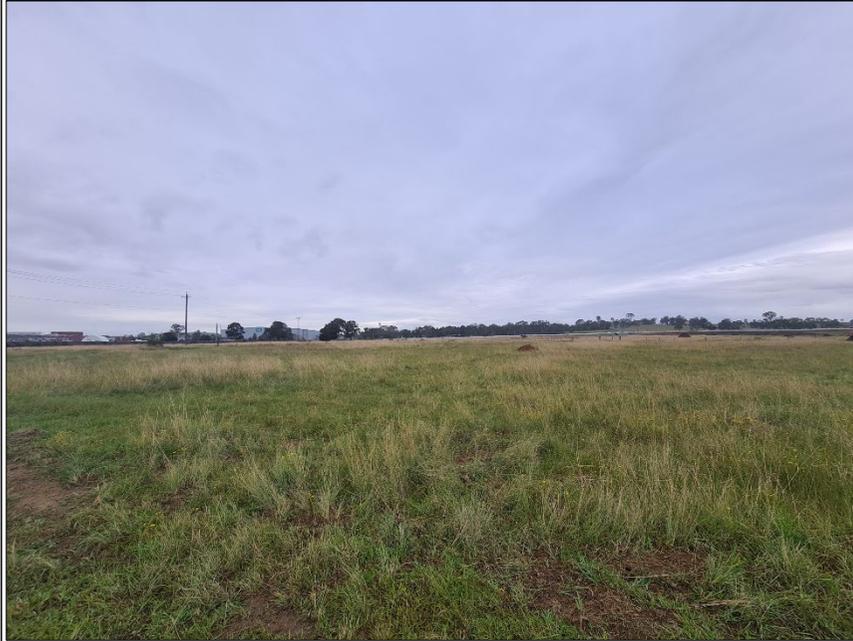
2 – CENTRAL WESTERN BORDER OF SITE, FACING EAST

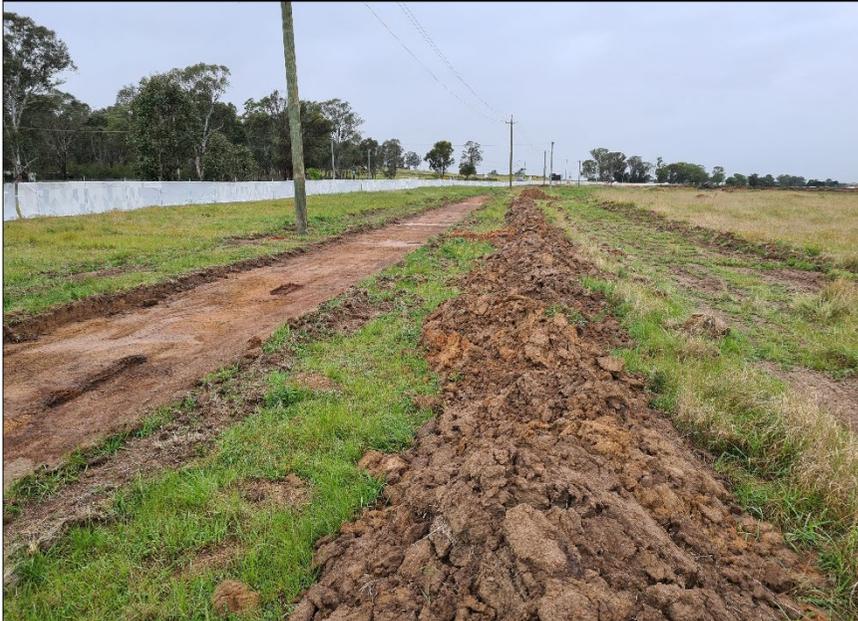
3 – CLEARED VEHICLE ACCESS TRACK TO THE LEFT, WINDROW OF ASSOCIATED SOILS TO THE RIGHT AT THE CENTRAL EAST OF SITE, FACING SOUTH

- Vehicle tracks, were present around the site perimeter, and through the central-eastern portion of the site in an east/west alignment, and in the vicinity of the former residence;

- Windrows of stockpiles lined the vehicle tracks. The material was generated during track construction. Windrow materials generally comprised topsoils and underlying natural orange/red clays. No odours, staining, asbestos or other indicators of contamination were observed;

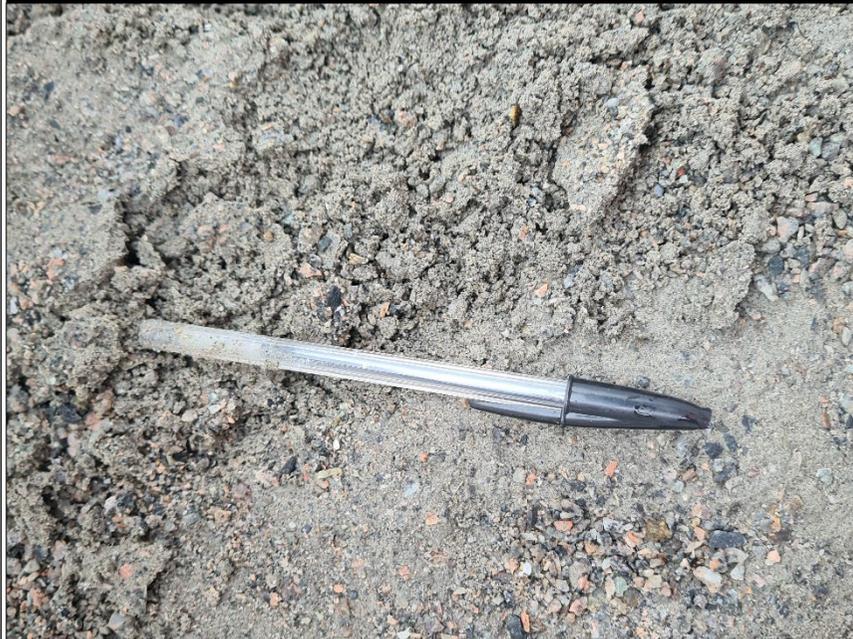
4 – CLOSE-UP OF IMPORTED COARSE SAND OBSERVED NORTHEAST OF THE SITE

- A 1 tonne bag of coarse sand from Nepean Landscape supplies was observed within the north-eastern portion of the site. This was likely unused backfill associated with the recently installed powerlines, as discussed with the site operator (**Section 2.1**). The coarse sand appeared to comprise an imported product and is unlikely to represent a contamination source;

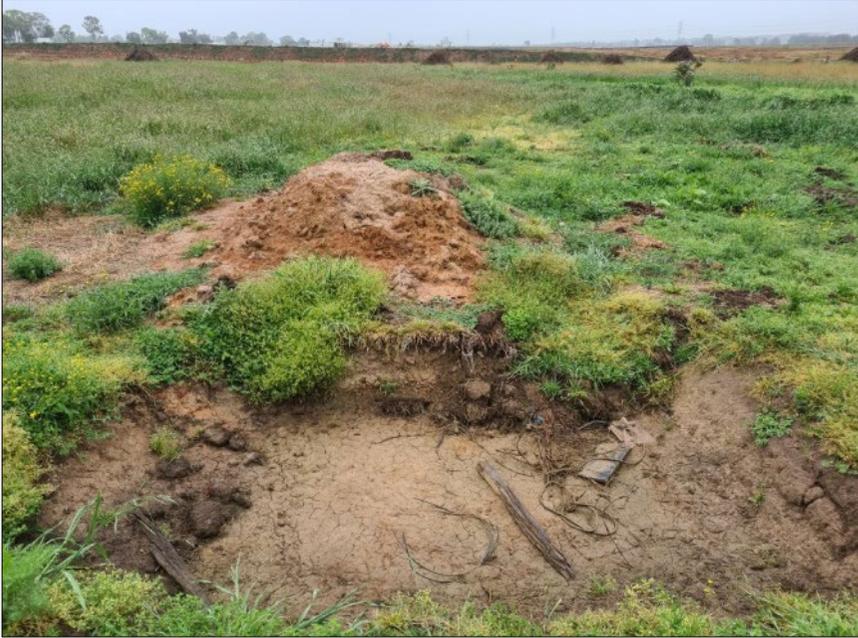
5 – OPEN TEST PIT OBSERVED ONSITE USED TO DETERMINE DEPTH OF FILL

Additionally, soil test pits had been excavated within the extent of the site for the purpose of estimating the depth of soil strata. Estimates ranged between 0.1 to 0.7 m of fill, with an average fill depth of 0.35 m across the site. Test pits that were conducted south of the former residence, near a former retaining wall, was observed to have asbestos sheeting within its construction. This was removed offsite with the asbestos sourced from the demolition of the former residence.

- Test pits were present within the site, as discussed with the site operator (**Section 2.1**). The soil profile was observed to comprise an average of approximately 0.35 m of reworked natural material present on top of residual natural ground;

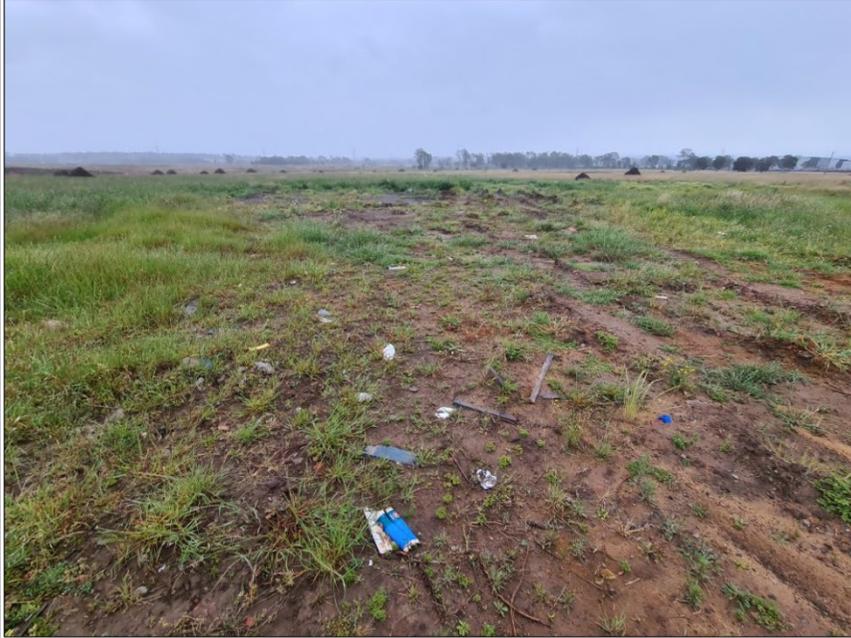
6 – MINOR BUILDING AND DEMOLITION WASTE OBSERVED WITHIN THE FOOTPRINT OF THE FORMER RESIDENCE, FACING WEST

- The footprints of the former residence and the shed were observed to contain minor building and demolition materials of inert nature, including brick, tile, plastic and metal. No odours, staining or asbestos were noted; and

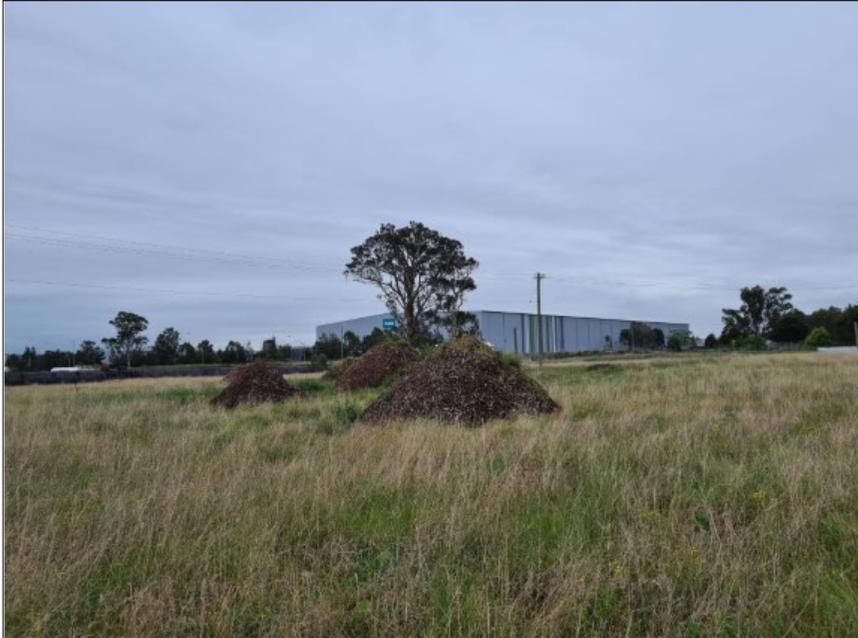
7 – STOCKPILES OF MULCH OBSERVED TO THE NORTH OF SITE, FACING NORTHEAST

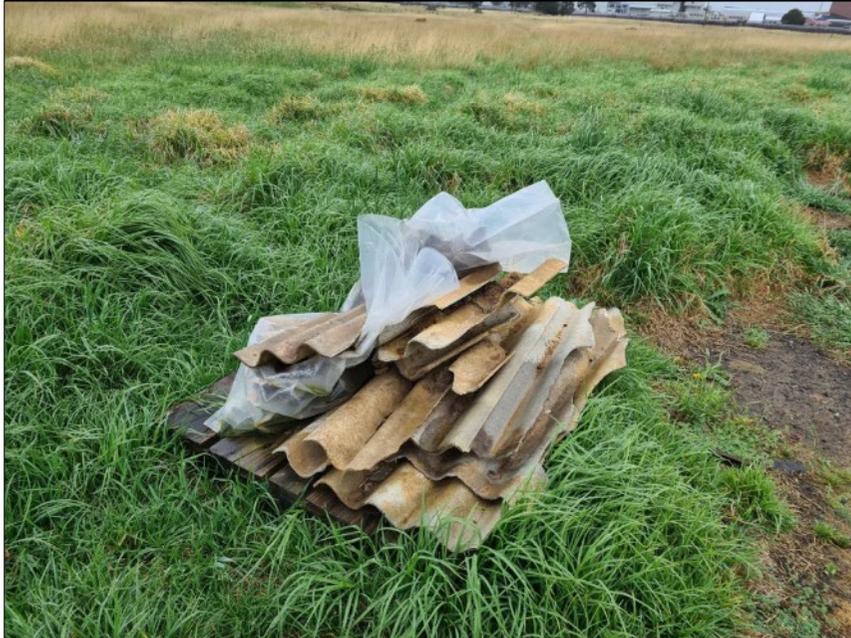
- A wooden pallet with some ACM super six sheeting was observed within the central portion of the site, in the vicinity of a former shed structure. (see **Section 2.2**, a review of Near Map imagery indicates that between April and June of 2021 the shed was disassembled, and the pallet and sheeting was visible from June onwards).

8 – PALLET AND SUPER SIX ASBESTOS SHEETING OBSERVED IN VICINITY OF FORMER SHED

- Based on the recent site condition assessment undertaken (**Section 2.1, 2.2 and 2.3**), no evidence of gross and/or widespread contamination was identified at the site. The pallet and super six asbestos sheeting observed within the central portion of the site appears to be materials not disposed during the demolition works. It is recommended that the sheeting should be protected from disturbance pending finalisation of the removal of demolition materials. The ACM sheeting should be removed by an appropriately licensed removalist and disposed to a facility licensed to receive asbestos;

- The site is considered suitable for the proposed commercial/industrial development, subject to removal of the asbestos sheeting observed onsite; and
- It is recommended that the UFP and IFP are implemented during works to ensure that, upon completion of development works, the site remains suitable for the proposed commercial/industrial development.
