ENVIRONMENTAL REPRESENTATIVE SITE INSPECTION REPORT

From:	Carl Vincent carl.vincent@ersed.com.au	Date:	03/05/21	DATE OF INSPECTION	26/04/21
To:	Naiem Teghlobi Naiem.Teghlobi@frasersproperty.com.au	Construction Activities: <ul style="list-style-type: none"> Initial works to create access plus formation works for the future main site compound Fencing activities along eastern extent Importation of material Demolition of buildings and structures at western extent of bakers lane Investigation and survey (archaeological) at the western extent. Dewatering of existing farm pond 		Weather Conditions	Fine
CC:				Rainfall previous 24hrs	NIL
				Rainfall forecast next 24hrs	NIL
Project	SSD 9522: Kemps Creek Warehouse, Logistics and Industrial Facilities Hub (THE YARDS)			http://www.bom.gov.au/jsp/ncc/cdio/weatherData/av?p_nccObsCode=136&p_display_type=dailyDataFile&p_startYear=&p_c=&p_stn_num=067066	
Attendees	Maria Divis (DPIE) Lachlan Paton – AWJ Tim Culmone – AWJ Naiem Teghlobi – Frasers			Project Status RISK - LOW COMPLIANT

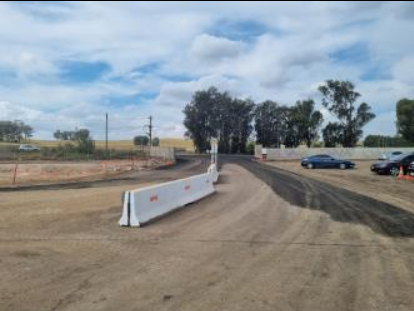
CONTRACT		OWE AWJ	DATE OF INSPECTION		26 APRIL 21	
ITEM	LOCATION	DETAILS OF ISSUE	PRIORITY/ RISK	COMMENT / ACTION	DATE FOR CLOSE OUT	RESPONSE/CLOSE OUT
1.	Temp entrance

OBSERVATION	A chip sealed access and exit is provided at the temporary site entrance. A cattle grid is provided at the exit. It was indicated that this will be maintained for approximately 4-6 weeks	NA	
2.	Construction access control	 	OBSERVATION	A wheel wash is being provided for the trucks importing material. It was indicated the wheel wash will have cattle grids at the approaches and exits of the wash bay.	NA

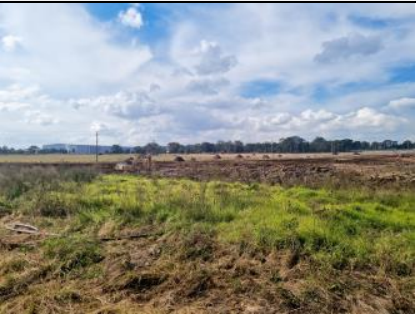
OBSERVATION	<p>A small portion of the northern works area drains to a low point and outside the catchment to the sediment control basin.</p> <p>This low point is itself a significant excavation and suitable to contain and detain water</p>	NA	
4.

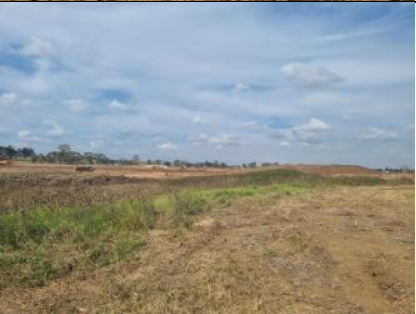
OBSERVATION	Water is directed across the front of the stockpile towards the sediment control basin	NA	
5.

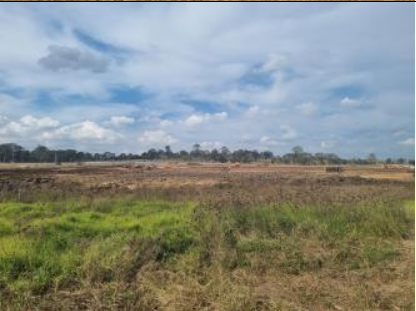
OBSERVATION	The main body of the works drains directly to the sediment control basin per indicated on the ESCP Provided as figure 1	NA

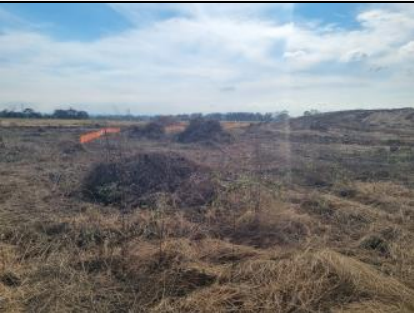
CONTRACT		OWE AWJ	DATE OF INSPECTION		26 APRIL 21	
ITEM	LOCATION	DETAILS OF ISSUE	PRIORITY/ RISK	COMMENT / ACTION	DATE FOR CLOSE OUT	RESPONSE/CLOSE OUT
6.	Rear of topsoil stockpile

OBSERVATION	Sediment fence is installed below the main topsoil stockpile – this is per indicated in figure 1	NA	
7.	Western extent of initial works

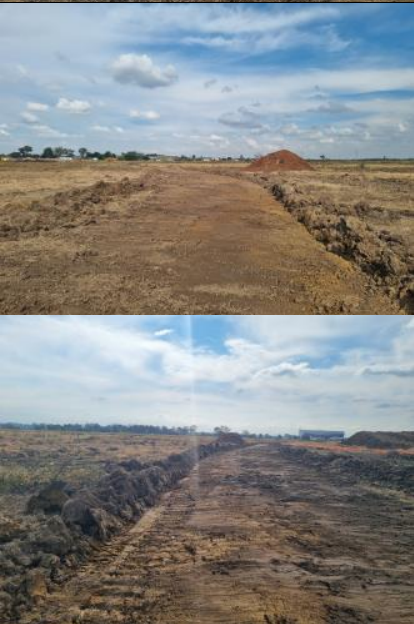
OBSERVATION	A graded diversion has been cut across the lower extent of the work area as indicated in the ESCP. This confirms the lowest extent of the catchment to the temporary basin per the ESCP in figure 1	NA

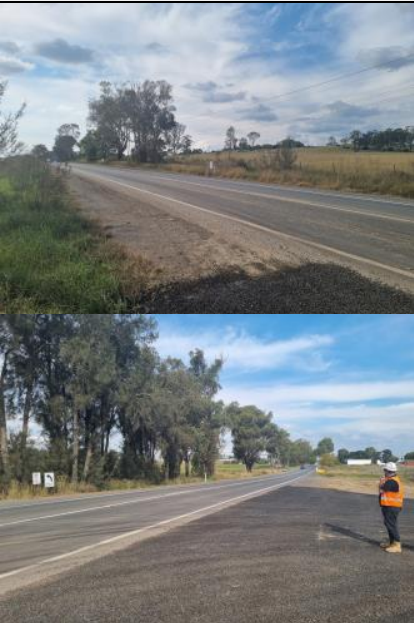
CONTRACT		OWE AWJ	DATE OF INSPECTION		26 APRIL 21	
ITEM	LOCATION	DETAILS OF ISSUE	PRIORITY/ RISK	COMMENT / ACTION	DATE FOR CLOSE OUT	RESPONSE/CLOSE OUT
8.	Mamre Road

OBSERVATION	It is confirmed that the eastern table drain from Mamre road acts to intercept and divert all water from the east of the site.	NA

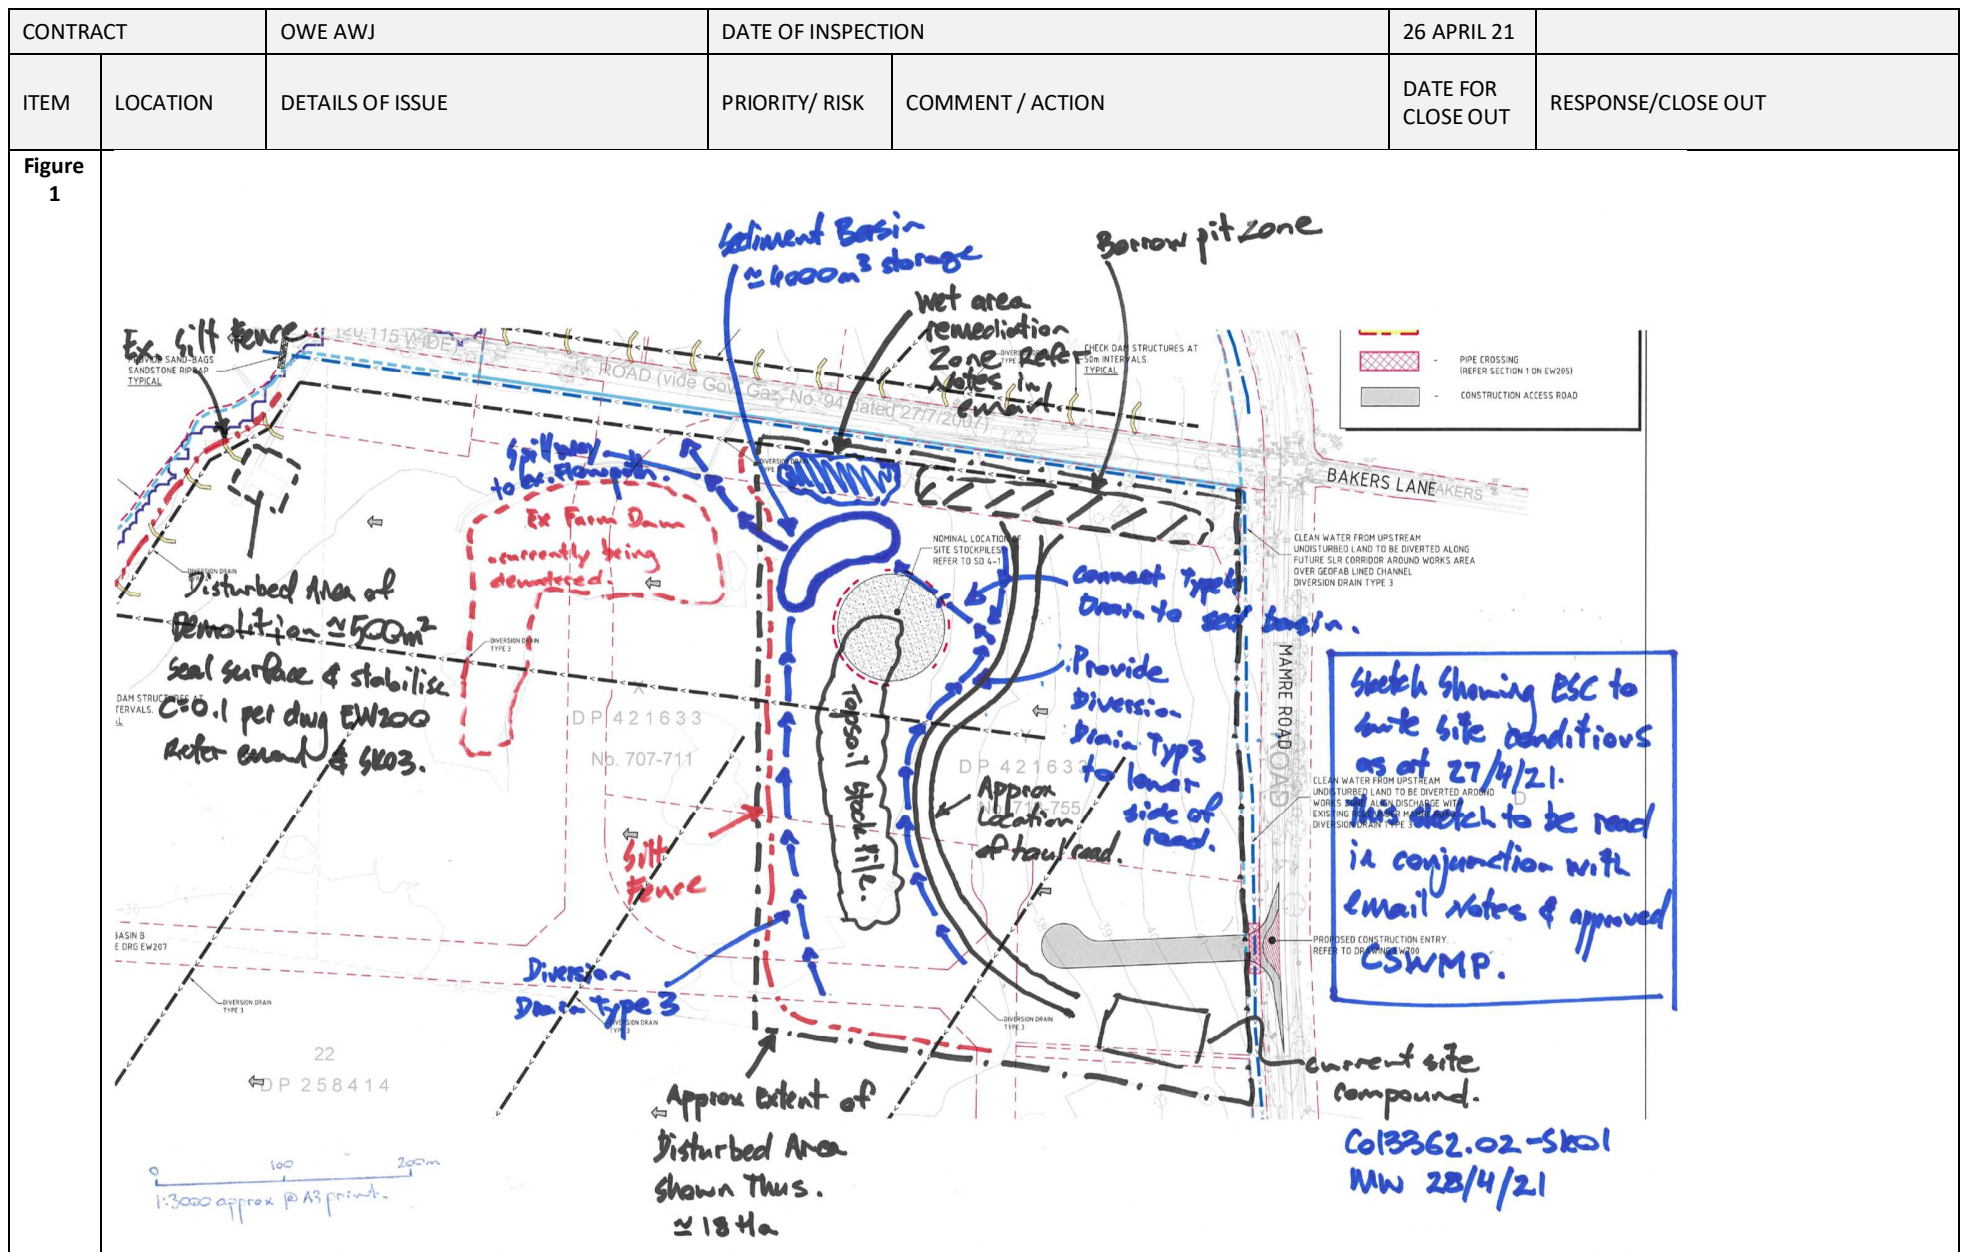
- 1.1 Inspection of site and confirmation of primary features and controls in accordance of the progressive ESCP managing the works to the central area.
- 1.2 The PESCP is in place pending installation of the primary sediment control basins indicated in the approved ESCPs within the CEMP.
- 1.3 The PESCP is provided as included as figure 1.
