ENVIRONMENTAL REPRESENTATIVE SITE INSPECTION REPORT

CONTRACT		THE YARDS (AWJ)	DATE OF INSPECTION		04 MAY 21	
ITEM	LOCATION	DETAILS OF ISSUE	PRIORITY/ RISK	COMMENT / ACTION	DATE FOR CLOSE OUT	RESPONSE/CLOSE OUT

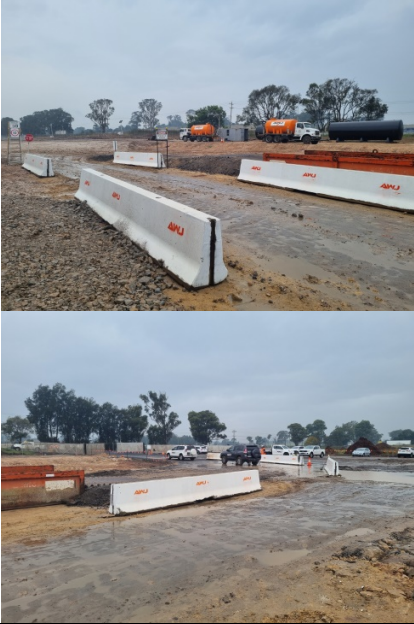
CONTRACT		THE YARDS (AWJ)	DATE OF INSPECTION		04 MAY 21	
ITEM	LOCATION	DETAILS OF ISSUE	PRIORITY/ RISK	COMMENT / ACTION	DATE FOR CLOSE OUT	RESPONSE/CLOSE OUT
3.	Access/ entrance

OBSERVATION	<p>Controls are in place at the entrance in place at entrance.</p> <p>LV wheels are being hosed going out prior to exit.</p>	NA	
4.	Main works

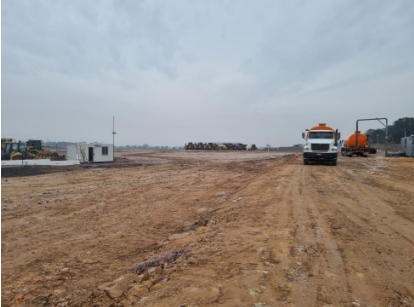
OBSERVATION	<p>Works at the site have been suspended due to wet weather.</p> <p>Items 6-8 below provide drone photos confirming the ESCP for the works.</p>	NA

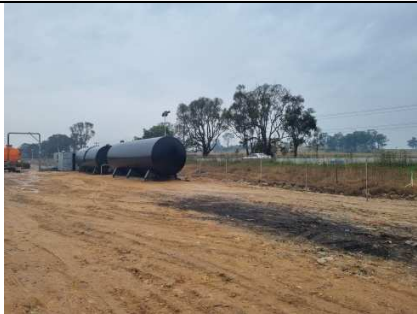
CONTRACT		THE YARDS (AWJ)	DATE OF INSPECTION		04 MAY 21	
ITEM	LOCATION	DETAILS OF ISSUE	PRIORITY/ RISK	COMMENT / ACTION	DATE FOR CLOSE OUT	RESPONSE/CLOSE OUT
5.	Fence line to Mamre Road

OBSERVATION	The fence line at the eastern boundary has been installed. It was indicated that the fence along the northern boundary has been also been installed. This will be confirmed in subsequent inspections.	NA	
6.	DRONE PHOTO

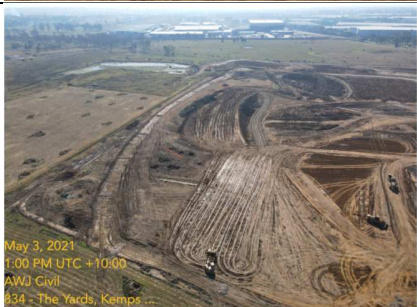
OBSERVATION	Drone photos confirming limit of works and ESC in accordance with the PESCP.	NA	
7.	DRONE PHOTO

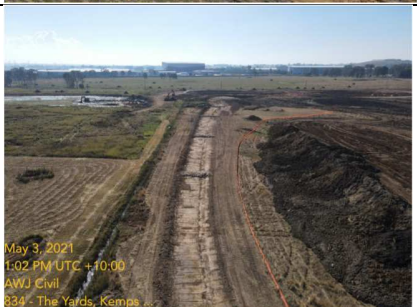
OBSERVATION	Drone photos confirming limit of works and ESC in accordance with the PESCP.	NA

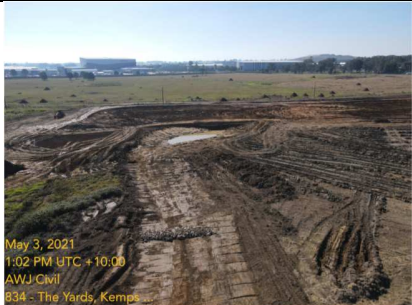
CONTRACT		THE YARDS (AWJ)	DATE OF INSPECTION		04 MAY 21	
ITEM	LOCATION	DETAILS OF ISSUE	PRIORITY/ RISK	COMMENT / ACTION	DATE FOR CLOSE OUT	RESPONSE/CLOSE OUT
8.	DRONE PHOTO

OBSERVATION	Drone photos confirming limit of works and ESC in accordance with the PESCP.	NA
