New Rouse Hill Hospital Laydown Area

Aboriginal Objects Due Diligence Assessment

Prepared for TSA Riley on behalf of Health Infrastructure | 15 May 2025

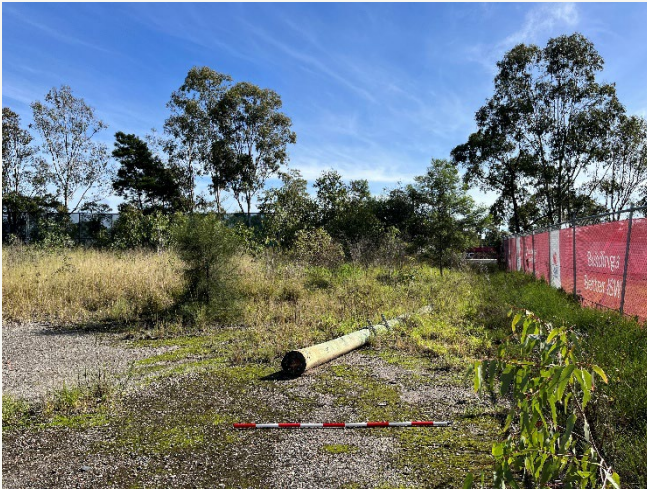
Plate 3: General overview of northern portion of the Activity Area showing the presence of an existing asphalt/gravel hardstand area and telegraph pole; facing north

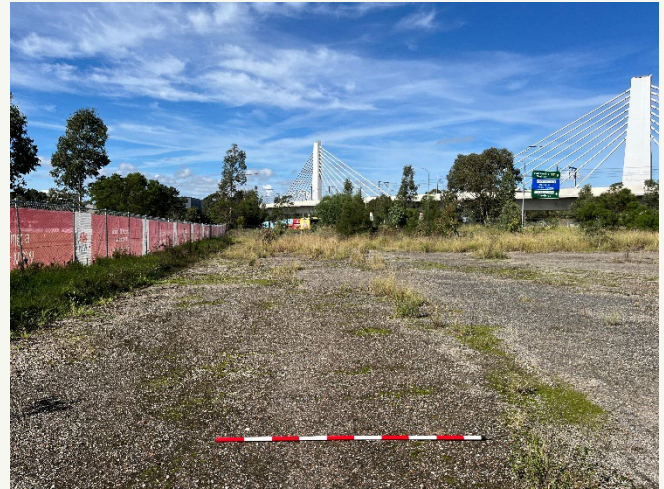
Plate 4: Existing gravel/asphalt hardstand area showing the extent of previous disturbance within the eastern and central portions of the Activity Area; facing south

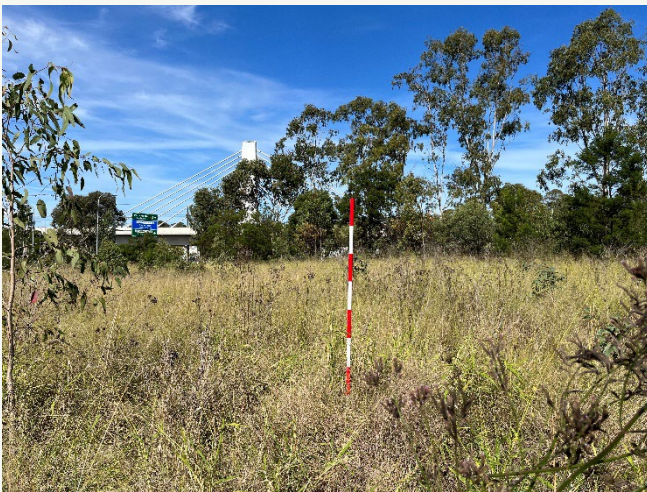
Plate 5: Long grass/weeds and regrowth trees were present in the western portion of the Activity Area; facing southwest

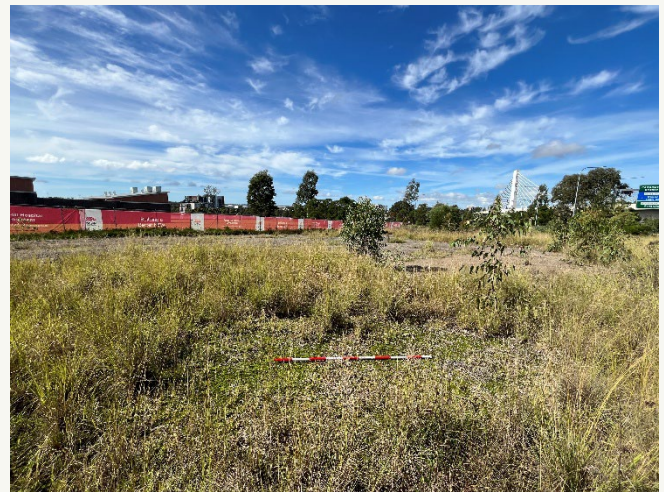
Plate 6: Weeds have grown in recent years over areas of the existing gravel/ asphalt hardstand area; facing south

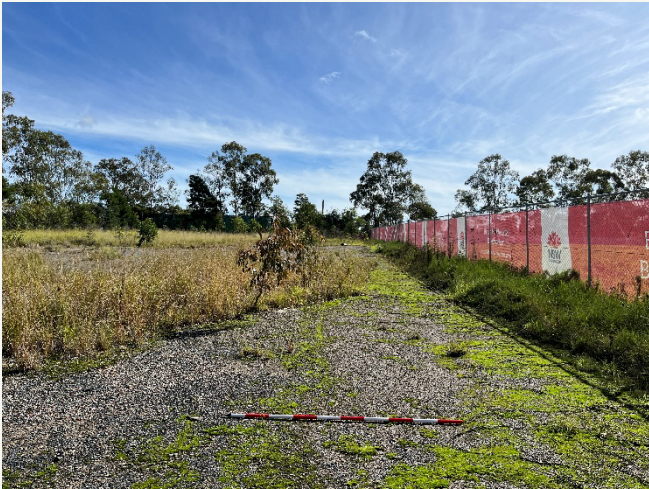
Plate 7: Moss and grass have begun to grow over the asphalt/ gravel hardstand area; facing north

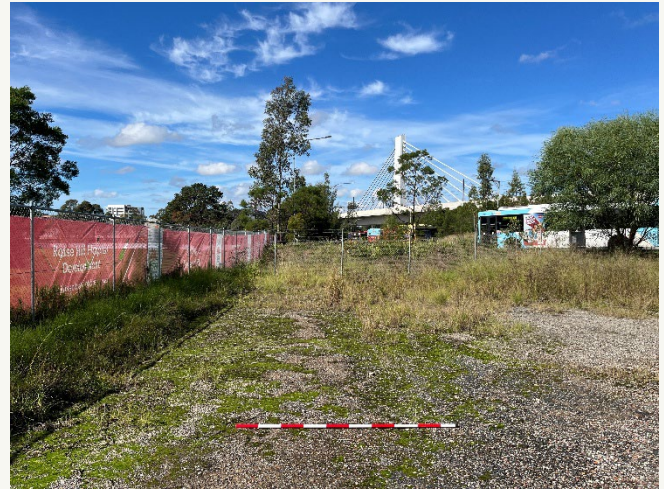
Plate 8: Extensive disturbance was observed in the southern portion of the Activity Area; facing south

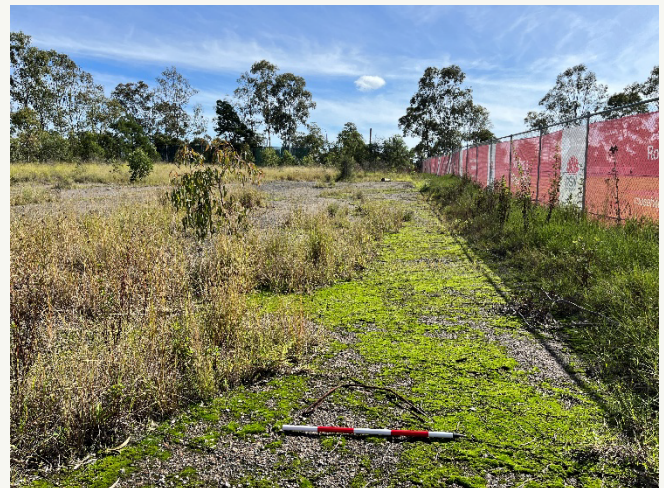
Plate 10: Narrow area of regrowth trees and grass/weeds growing in the background along the northern boundary of the Activity Area; facing north
