REPORT TO
NSW HEALTH INFRASTRUCTURE

ON
**SURFACE AND GROUNDWATER IMPACT
ASSESSMENT (SGIA)**

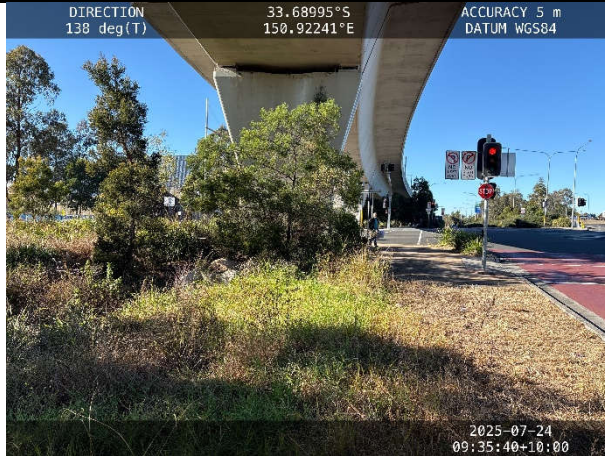
Photograph 4: Overview of the southern portion of the site, depicting the footing of the overhead Sydney Metro bridge and plant dieback noted along the edge of the bus lane to the west of the site.

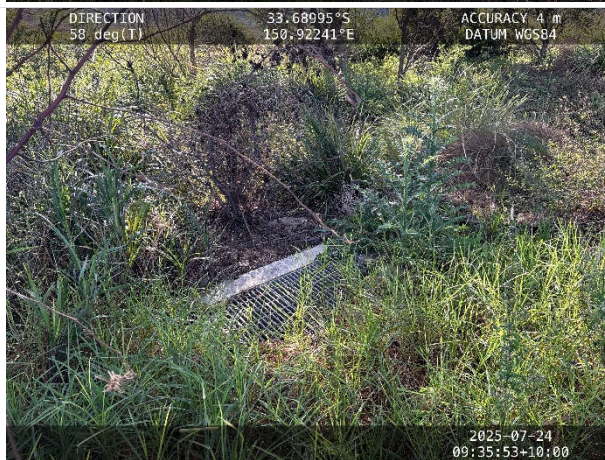
Photograph 5: Stormwater trench man hole observed in the southern portion of the site.

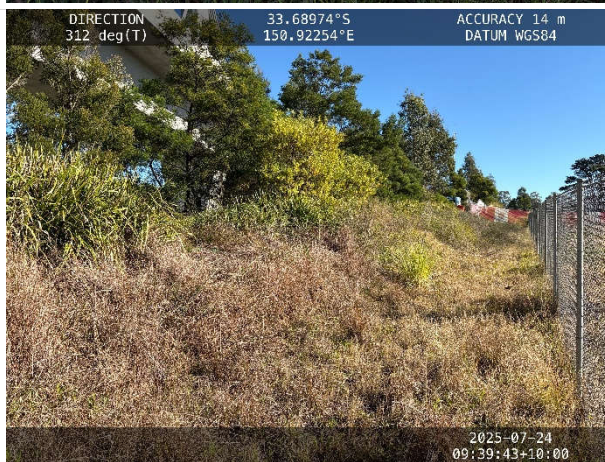
Photograph 6: Overview from the southern boundary along Rouse Hill Drive, depicting the chain link fence along the north-eastern boundary, and the vegetated bank.

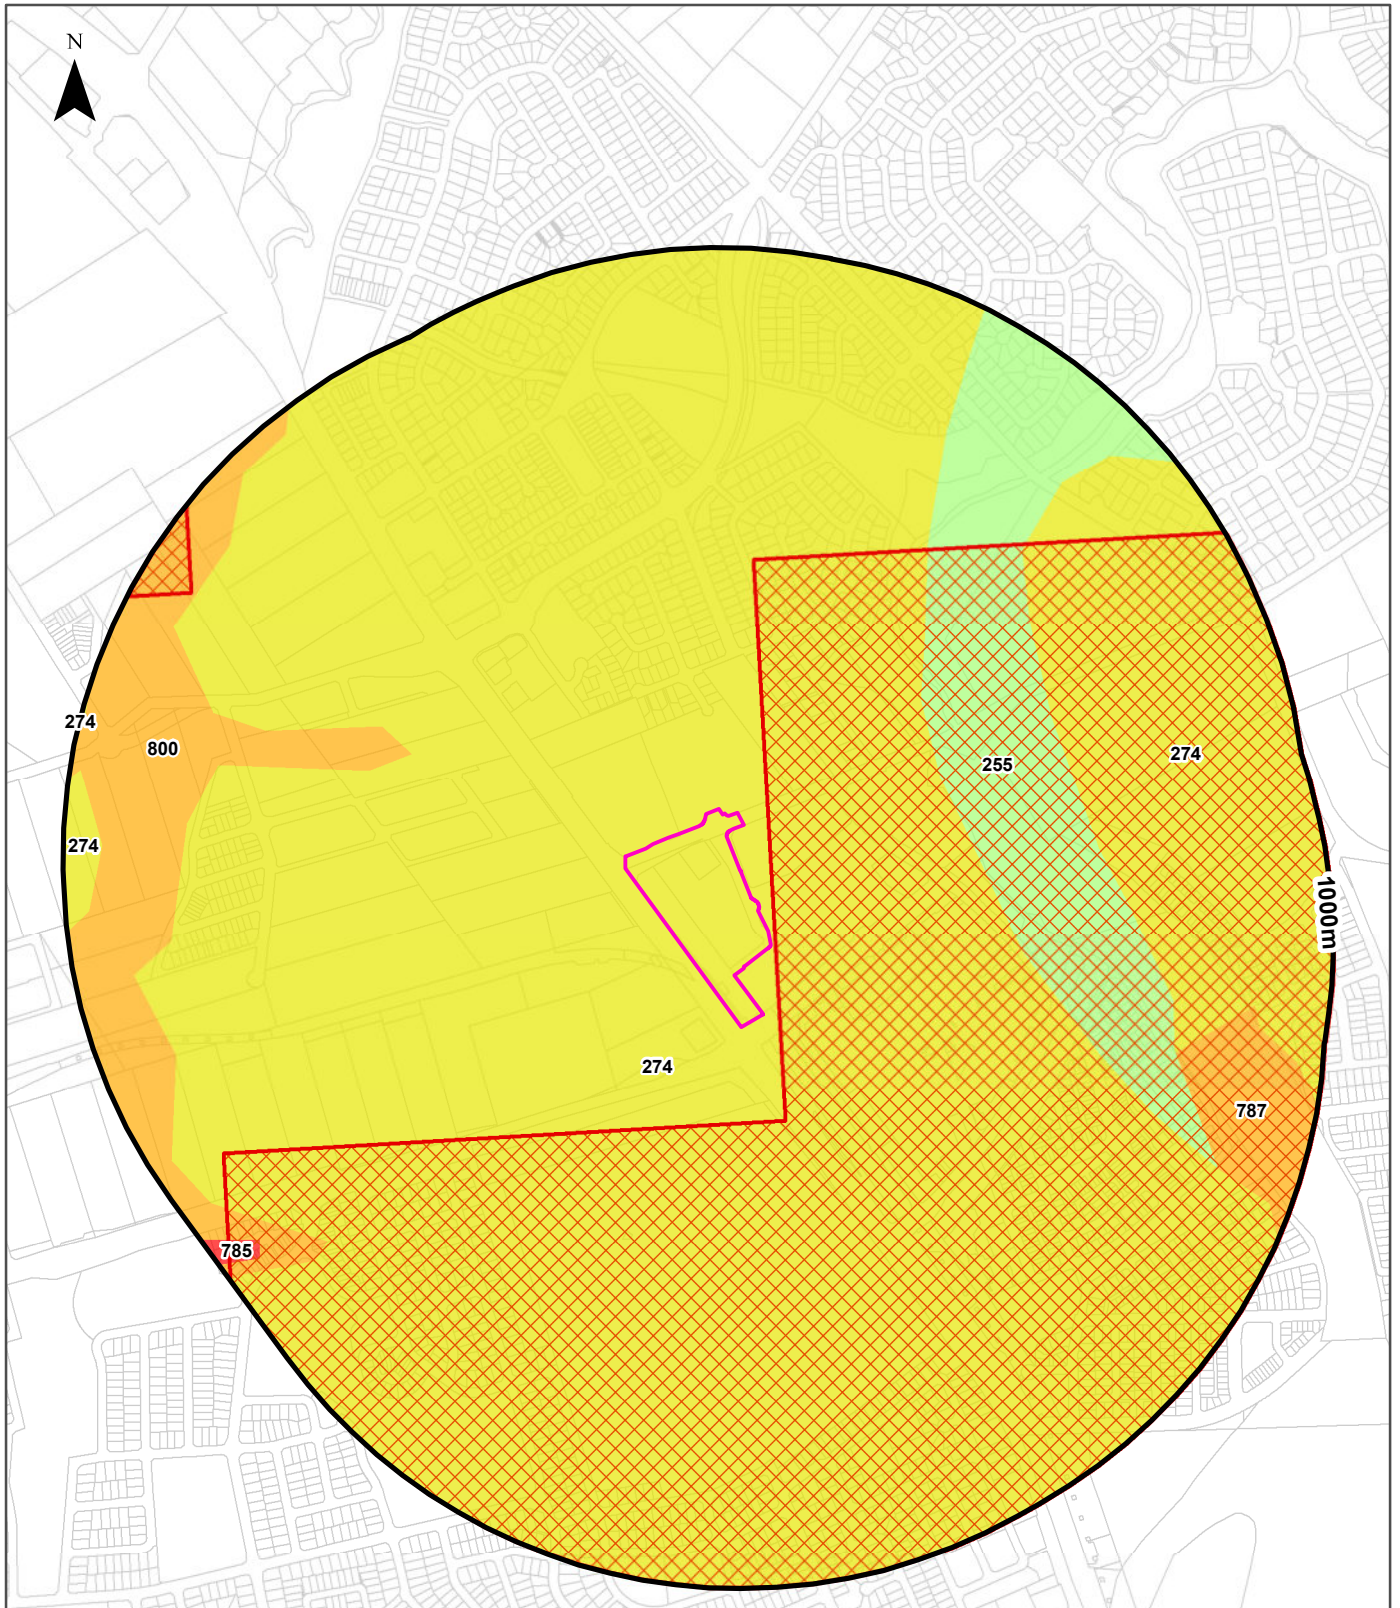
| <ul style="list-style-type: none"> Site Boundary Buffer 1000m Property Boundary | <p>Dryland Salinity - National Assessment</p> <ul style="list-style-type: none"> Delineated risk area but no high hazard or risk rating for either 2000, 2020, 2050 High hazard or risk in 2050 only High hazard or risk defined for 2050, but no assessment made for 2000 or 2020 High hazard or risk in 2020 and 2050 High hazard or risk in 2000 and 2050. 2020 not defined as high hazard High hazard or risk defined for all years: 2000, 2020, 2050 | <p>Salinity Potential of Western Sydney</p> <ul style="list-style-type: none"> Area of Known Salinity Area of High Salinity Potential Area of Moderate Salinity Potential Area of Very Low Salinity Potential Area of Water |
