Groundwater Modelling and  
Dewatering Management Plan

Doncaster Avenue Student Accommodation  
4-18 Doncaster Avenue, Kensington

Project 73965.06  
June 2019

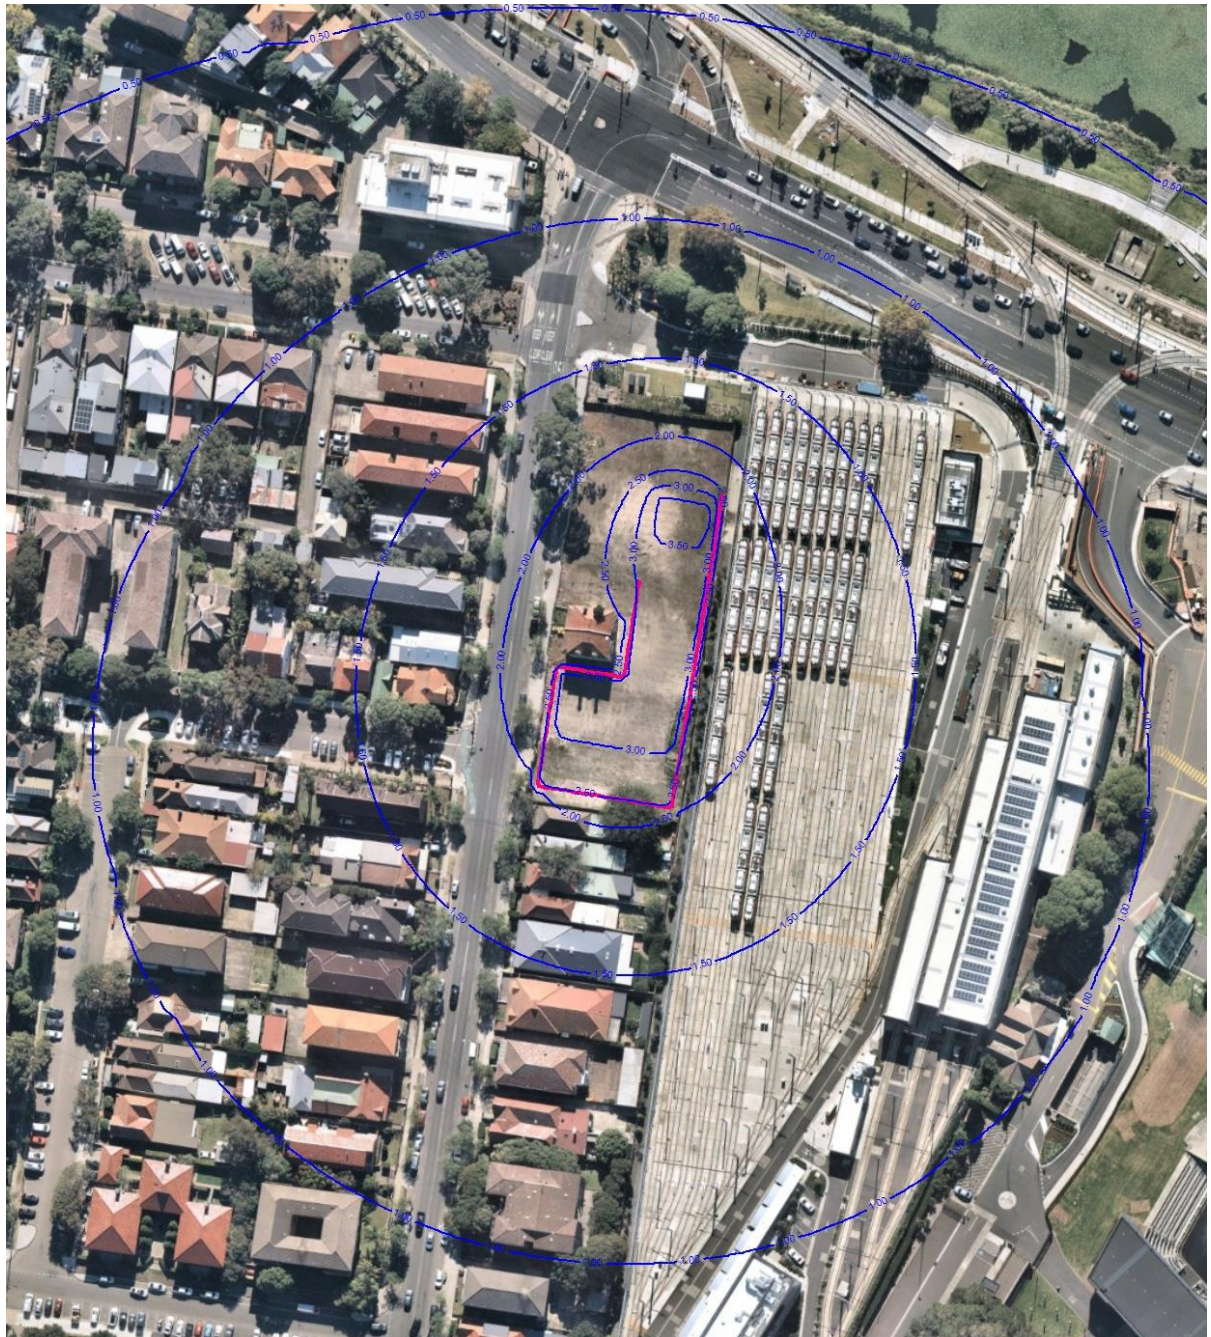
**Figure 3 – Simulated Groundwater Drawdown Levels During Temporary Dewatering**

The actual magnitude and extent of the drawdown will depend upon the integrity of the shoring wall and its ability to 'seal' off the horizontal flow of groundwater through the sand. The modelling has assumed that the wall is of good construction with no gaps and that no major leaks develop through

the shoring walls during construction. The results are also dependent upon the type of dewatering system installed onsite, and particularly the depth of dewatering spears / wells. The modelling has assumed that the wells / spears would be installed to RL 23.75 m, approximately 4 m above the toe of the secant walls.

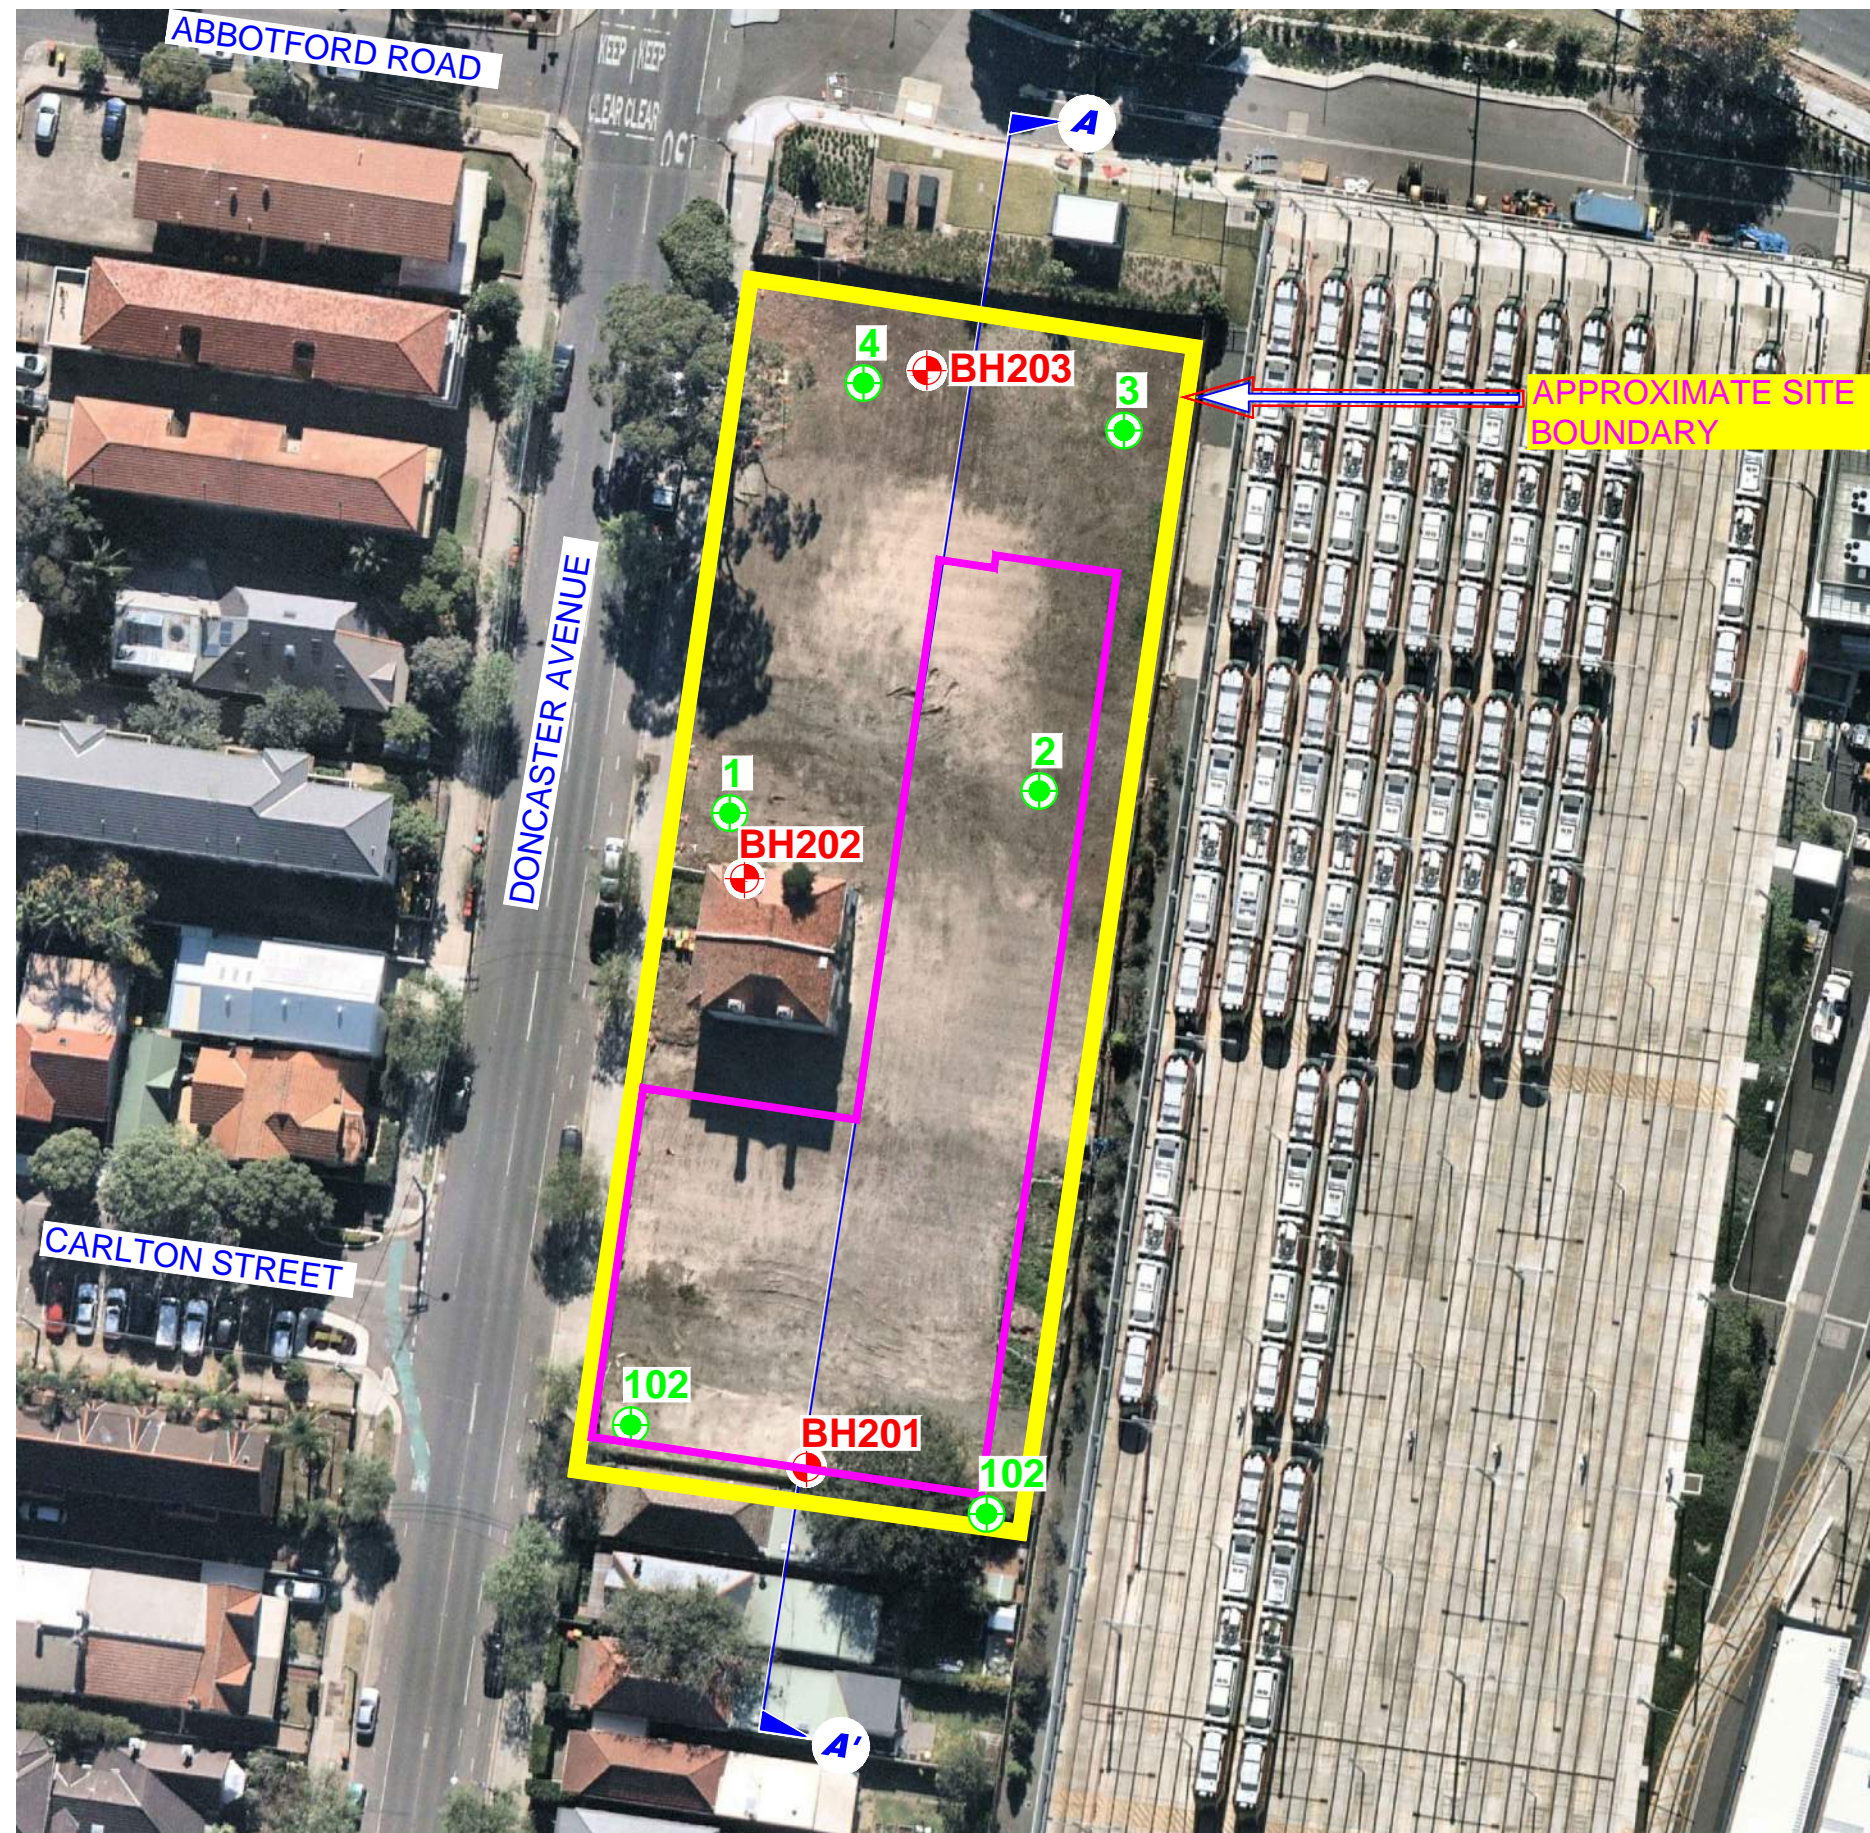
**Locality Plan**

- Previous CPT (1, 2, 3, 4, 101, 102)
- Previous borehole (201, 202, 203)
- Interpreted Geotechnical Cross Section A-A'
