REMEDIATION ACTION PLAN

19-23 Rosalind Street, Cammeray NSW

Perifa Rosalind Development Pty Ltd

January 2026

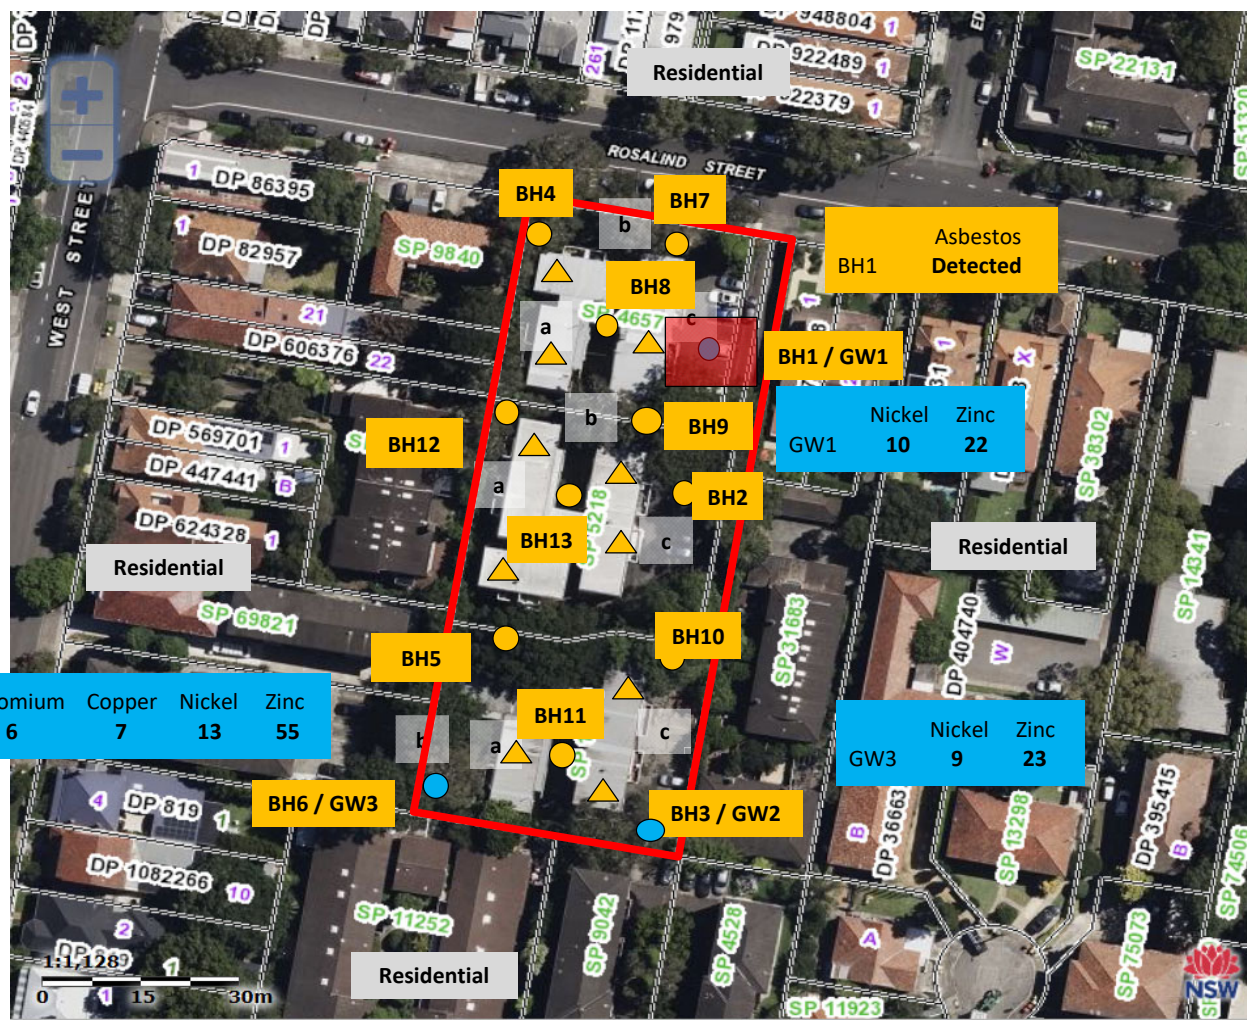
Building Footprint

Chromium	Copper	Nickel	Zinc
GW6	6	7	13	55

BH1 Asbestos Detected

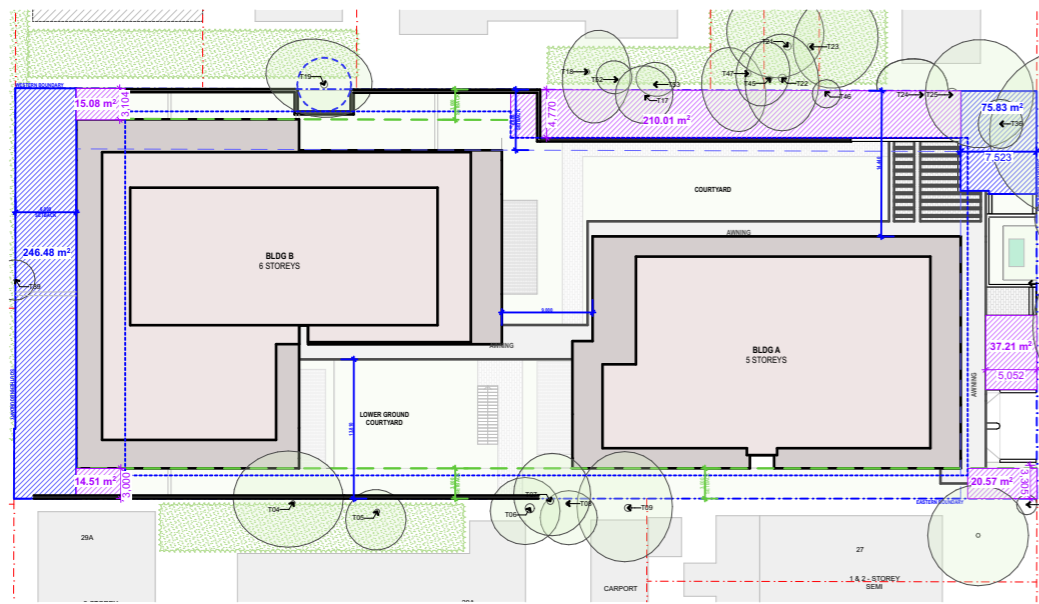
- DEEP SOIL - WIDTH < 6M
- DEEP SOIL - WIDTH > 6M

DEEP SOIL	
DEEP SOIL (M2) * < 6M WIDTH	297.38
DEEP SOIL (M2) * > 6M WIDTH	322.31
TOTAL AREA	619.69 m²
% OF SITE AREA	15%
SITE AREA (M2)	4106
MIN SEPP REQ. (M2)	616M2 (15%)

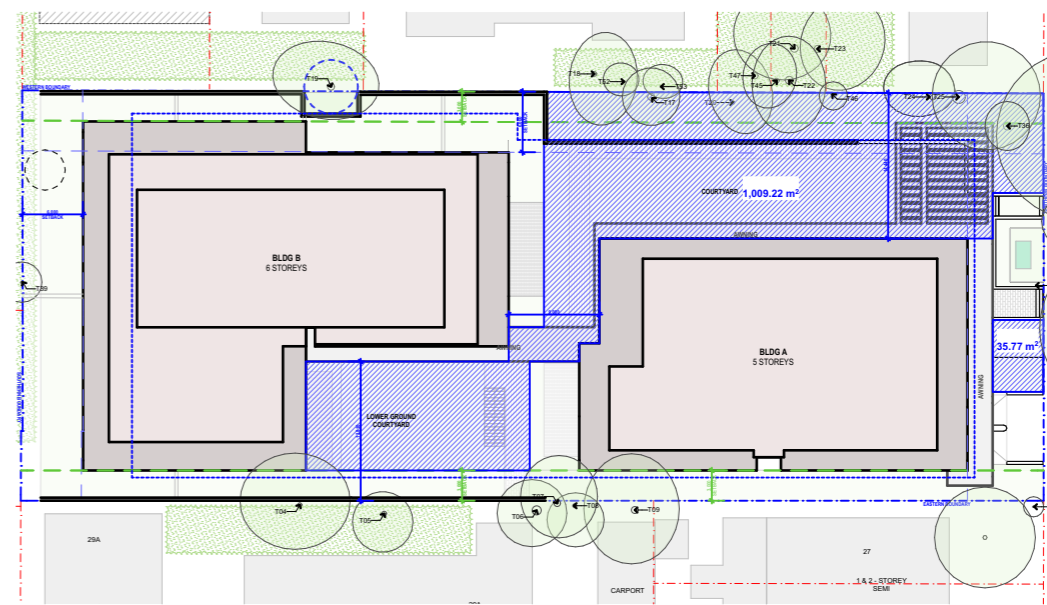
- COMMUNAL OPEN SPACE

COMMUNAL OPEN SPACE	
TOTAL AREA (M2)	1,044.99
% OF SITE AREA	25%
SITE AREA (M2)	4106
MIN ADG REQ. (M2)	1027 (25%)

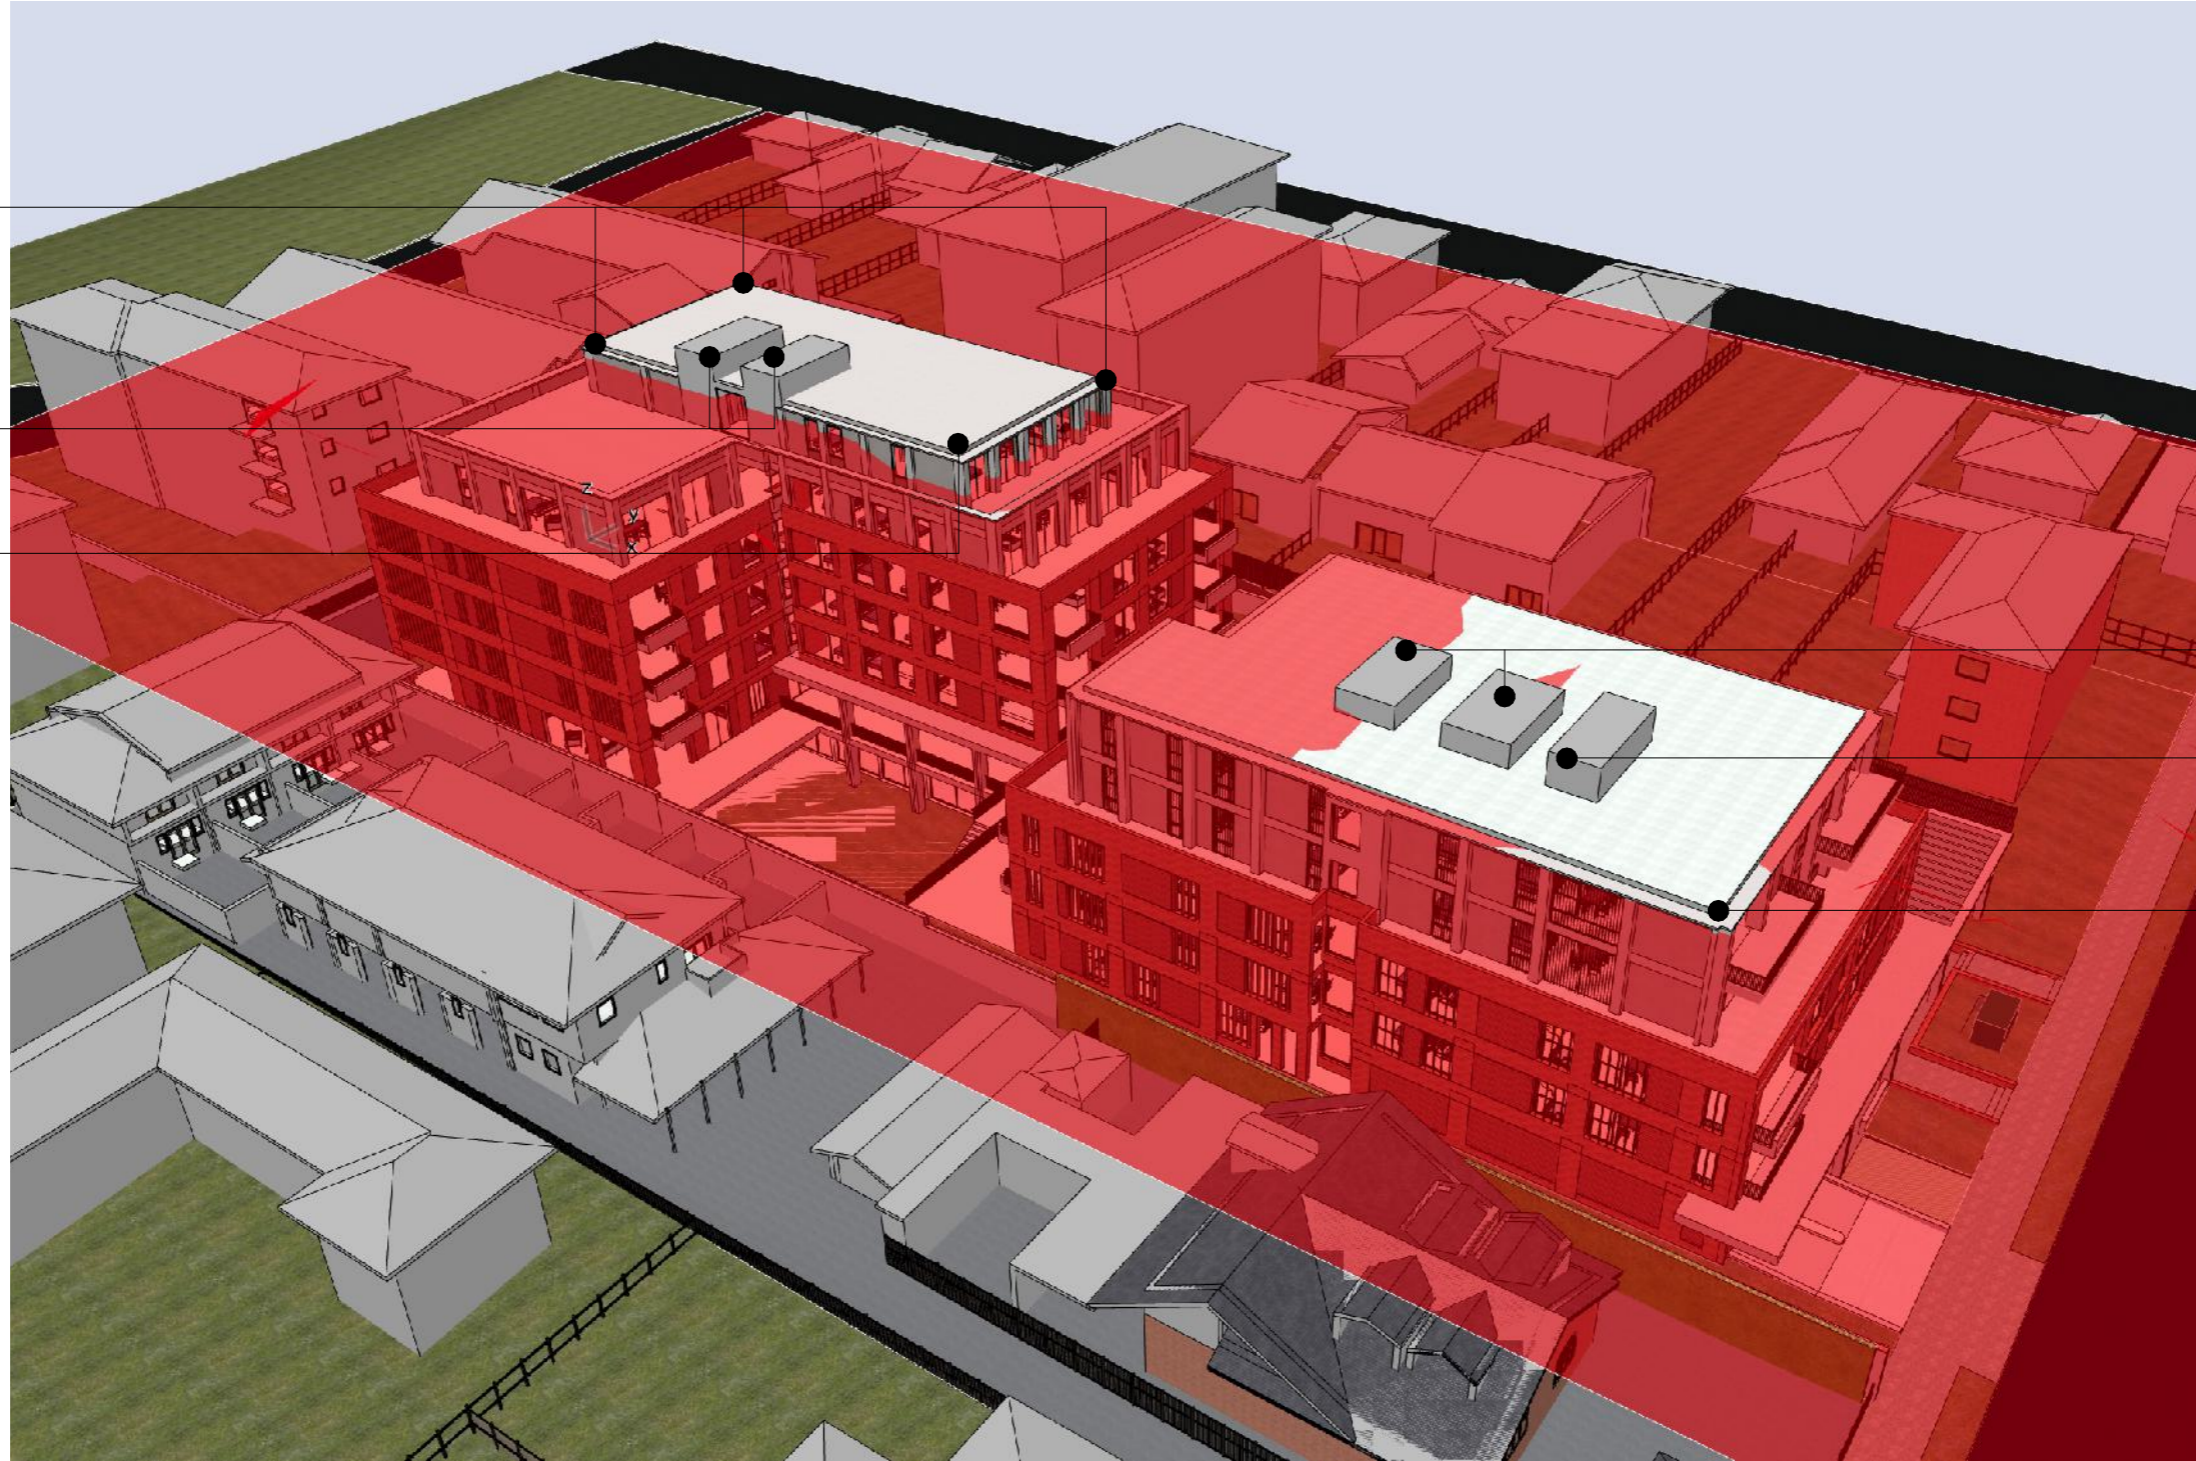
DRAWING TITLE
HEIGHT PLANE DIAGRAM

BLDG B RL
RL 103,540

BLDG B MAX RL
RL 105,040
