Technical Memorandum

To	Perifa Rosalind Development Pty Ltd	From	Terence Huang Director Neal Li Principal Geotechnical Engineer
SSD Ref	SSD-96505456	Date	29/01/2026
Project	Proposed residential redevelopment	Location	19-23 Rosalind St, Cammeray
Subject	Groundwater inflow estimates and impact assessment for the proposed redevelopment		
Report Status	Revision 2	Attachments	Analysis results and groundwater measured records

This report has been prepared to assess the groundwater inflow estimates and surface and groundwater impact assessment for the proposed residential redevelopment at 19-23 Rosalind Street, Cammeray NSW (the Site)

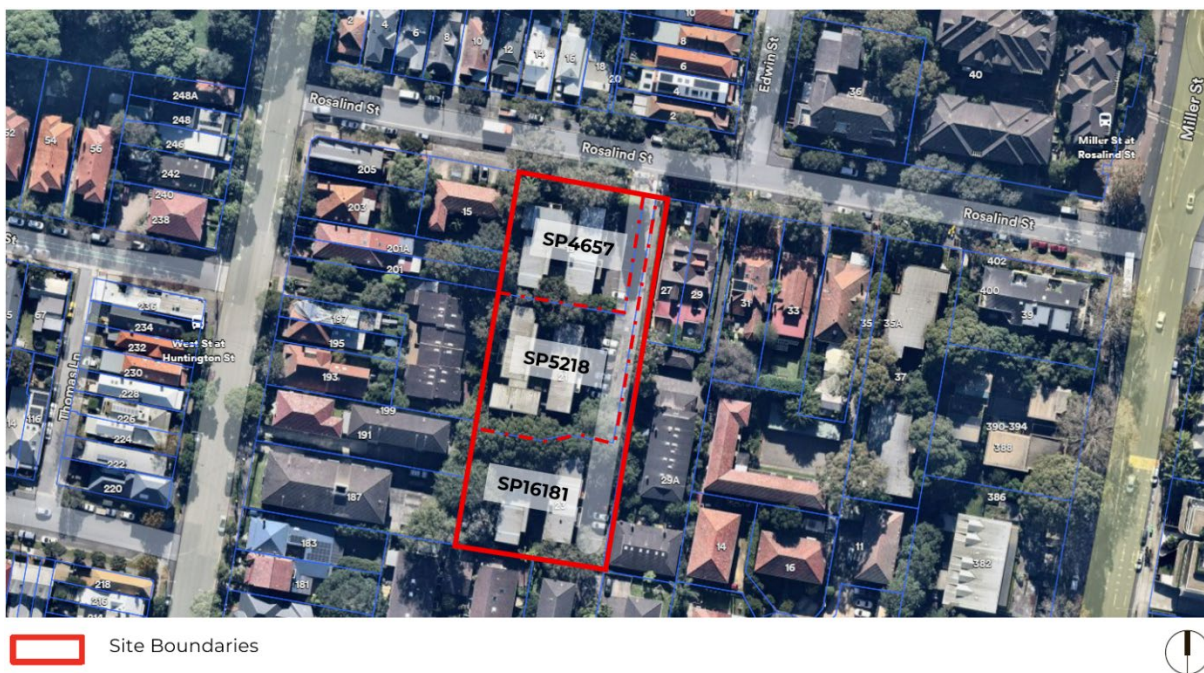
Figure 1 Site Aerial

The site is located at 19–23 Rosalind Street, Cammeray within the North Sydney Local Government Area (LGA). It comprises three (3) allotments legally described as SP4657, SP5218 and SP16181, and occupies a total area of approximately 4,100m². A site aerial showing each allotment is provided at **Figure 1**. Each respective lot currently comprises a three (3) storey residential flat building with the two (2) of the rear buildings situated on battleaxe allotments connected to Rosalind Street.

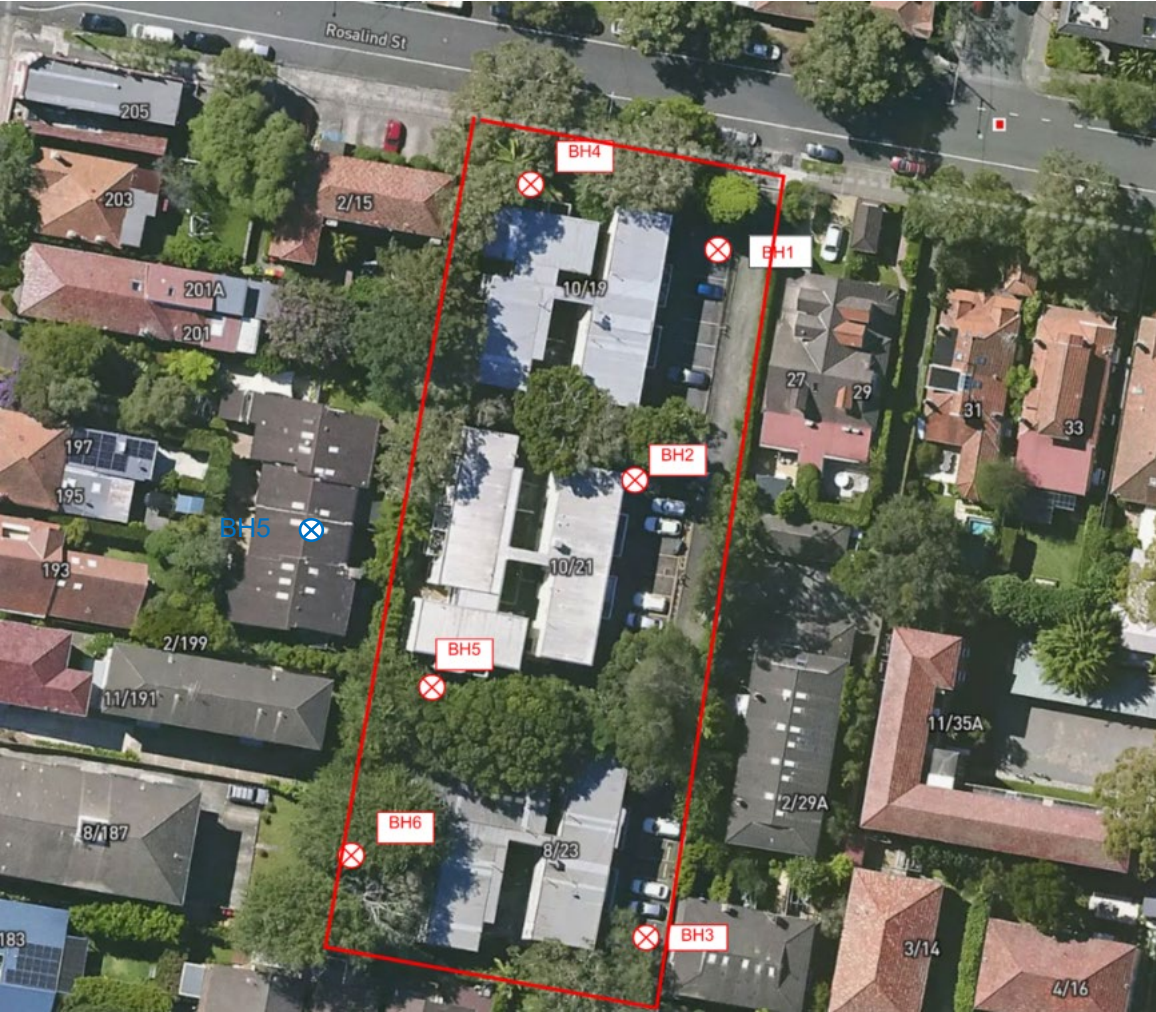
Figure 2 – Testing Plan

Existing geotechnical test locations are illustrated Appendix A. Logs are attached in Appendix B.

These geotechnical investigations form the basis of the subsurface conditions adopted in this assessment. The subsurface conditions are summarized in Table 1. Rocks are classified based on rock strength and defect spacing in accordance with Pells et al. (2019).

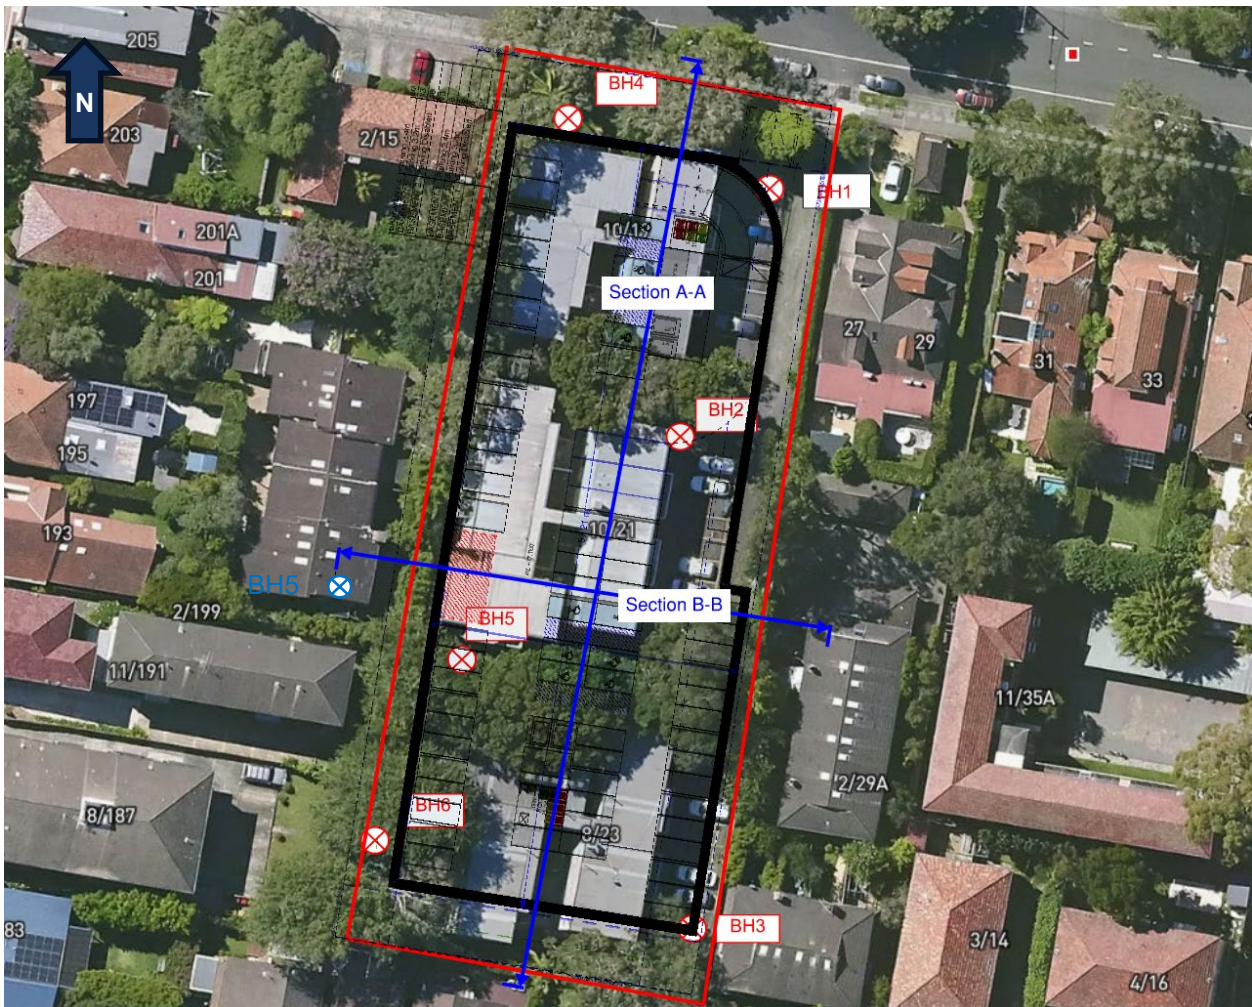
Figure 3 – Analysed Sections

Considering the site landform and subsurface variability across the site, the basement excavation has been modelled using two selected representative cross-sections as shown in Figure 3 to assess the soil variability around the excavation.

components to be simulated more accurately. Details of the layering for analysed sections are provided in Figure 3. The model boundaries were extended approximately 80 m from each excavation boundaries.

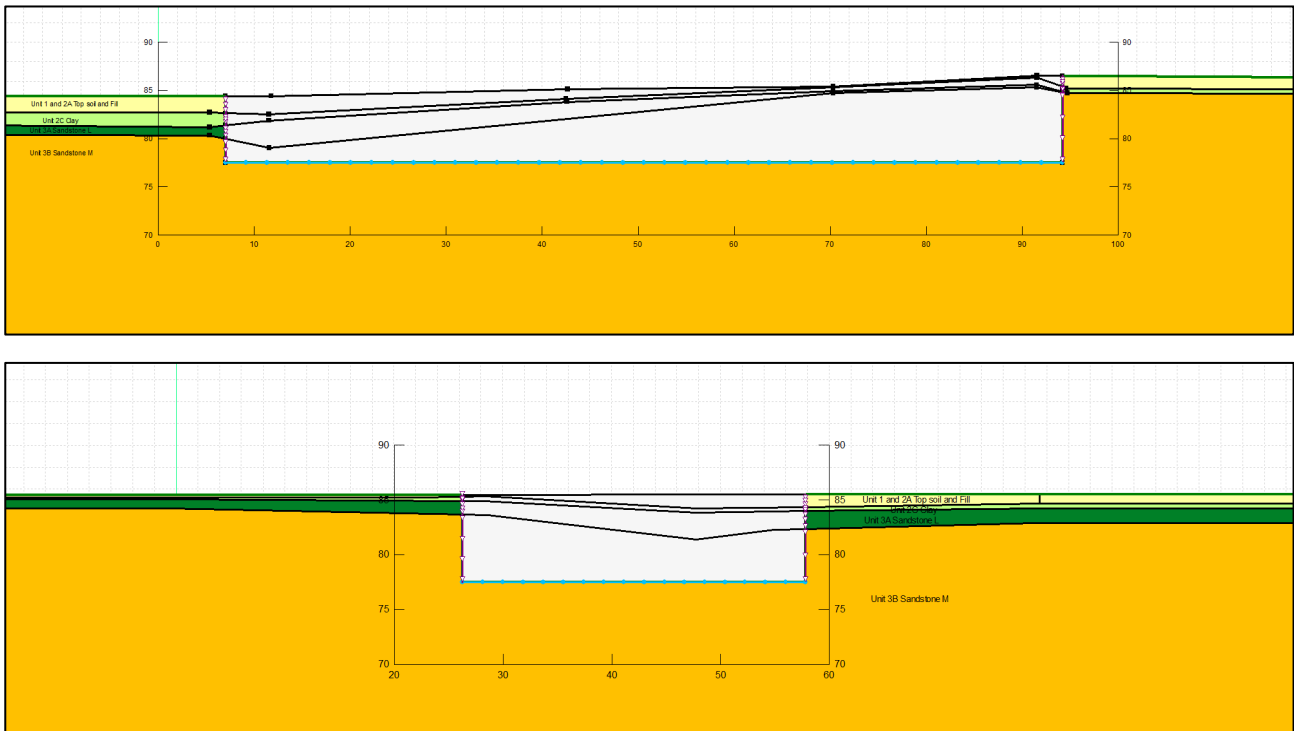
Figure 4 – Model Geometry of Analysed Section A-A (Top) and B-B (Bottom)

The ground surrounding the proposed development was simulated as being a multi-layered numerical model to represent the subsurface conditions surrounding the site and to allow the vertical flow

On the basis that groundwater monitoring data, for section A and B, the design ground water is conservatively adopted at RL 83.5mAHD, 1 m higher than the recorded highest groundwater standing level to model the sudden increase in groundwater flows into the excavation due to variations in rainfall duration. The basement excavation is expected to be crossing the measured groundwater level at both sides of excavation.

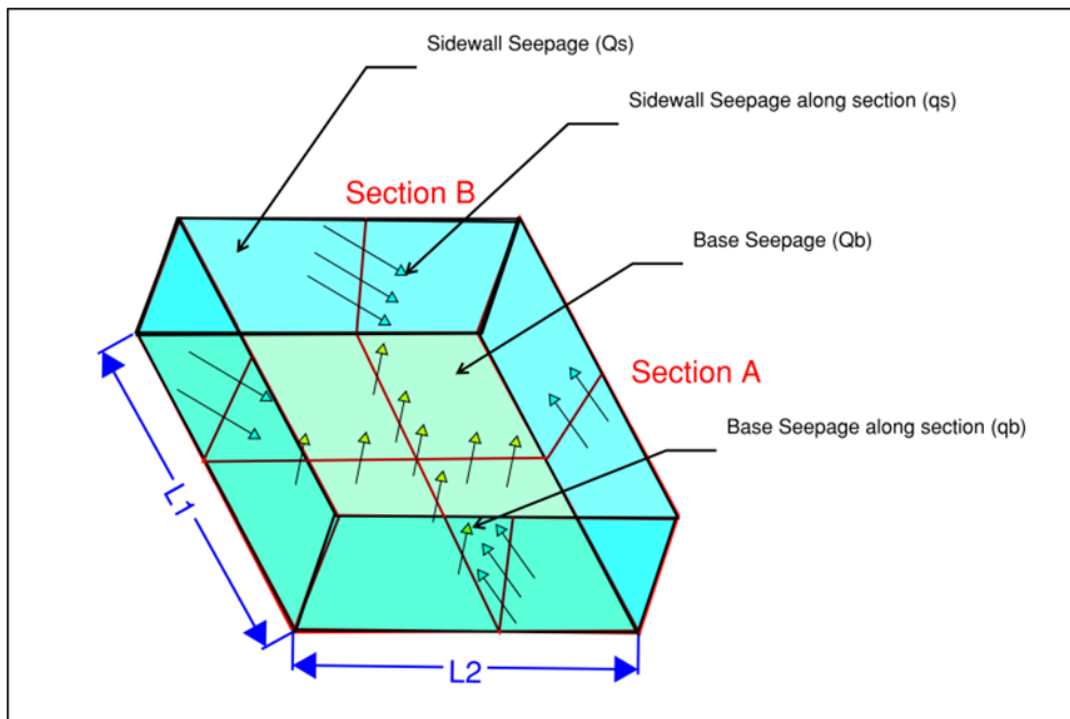
Figure 5 – Flow Rates

$$Q_b = q_{b,section A} * L_1 \text{ or } q_{b,section B} * L_2$$

as illustrated in the figure below.

However, because a impermeable shoring system was adopted, the side wall seepage Q_s is assumed to negligible. The seepage rates is solely depending on the base seepage Q_b and the size of the proposed excavation, the expected seepage to the temporary excavation during construction is modelled to be:

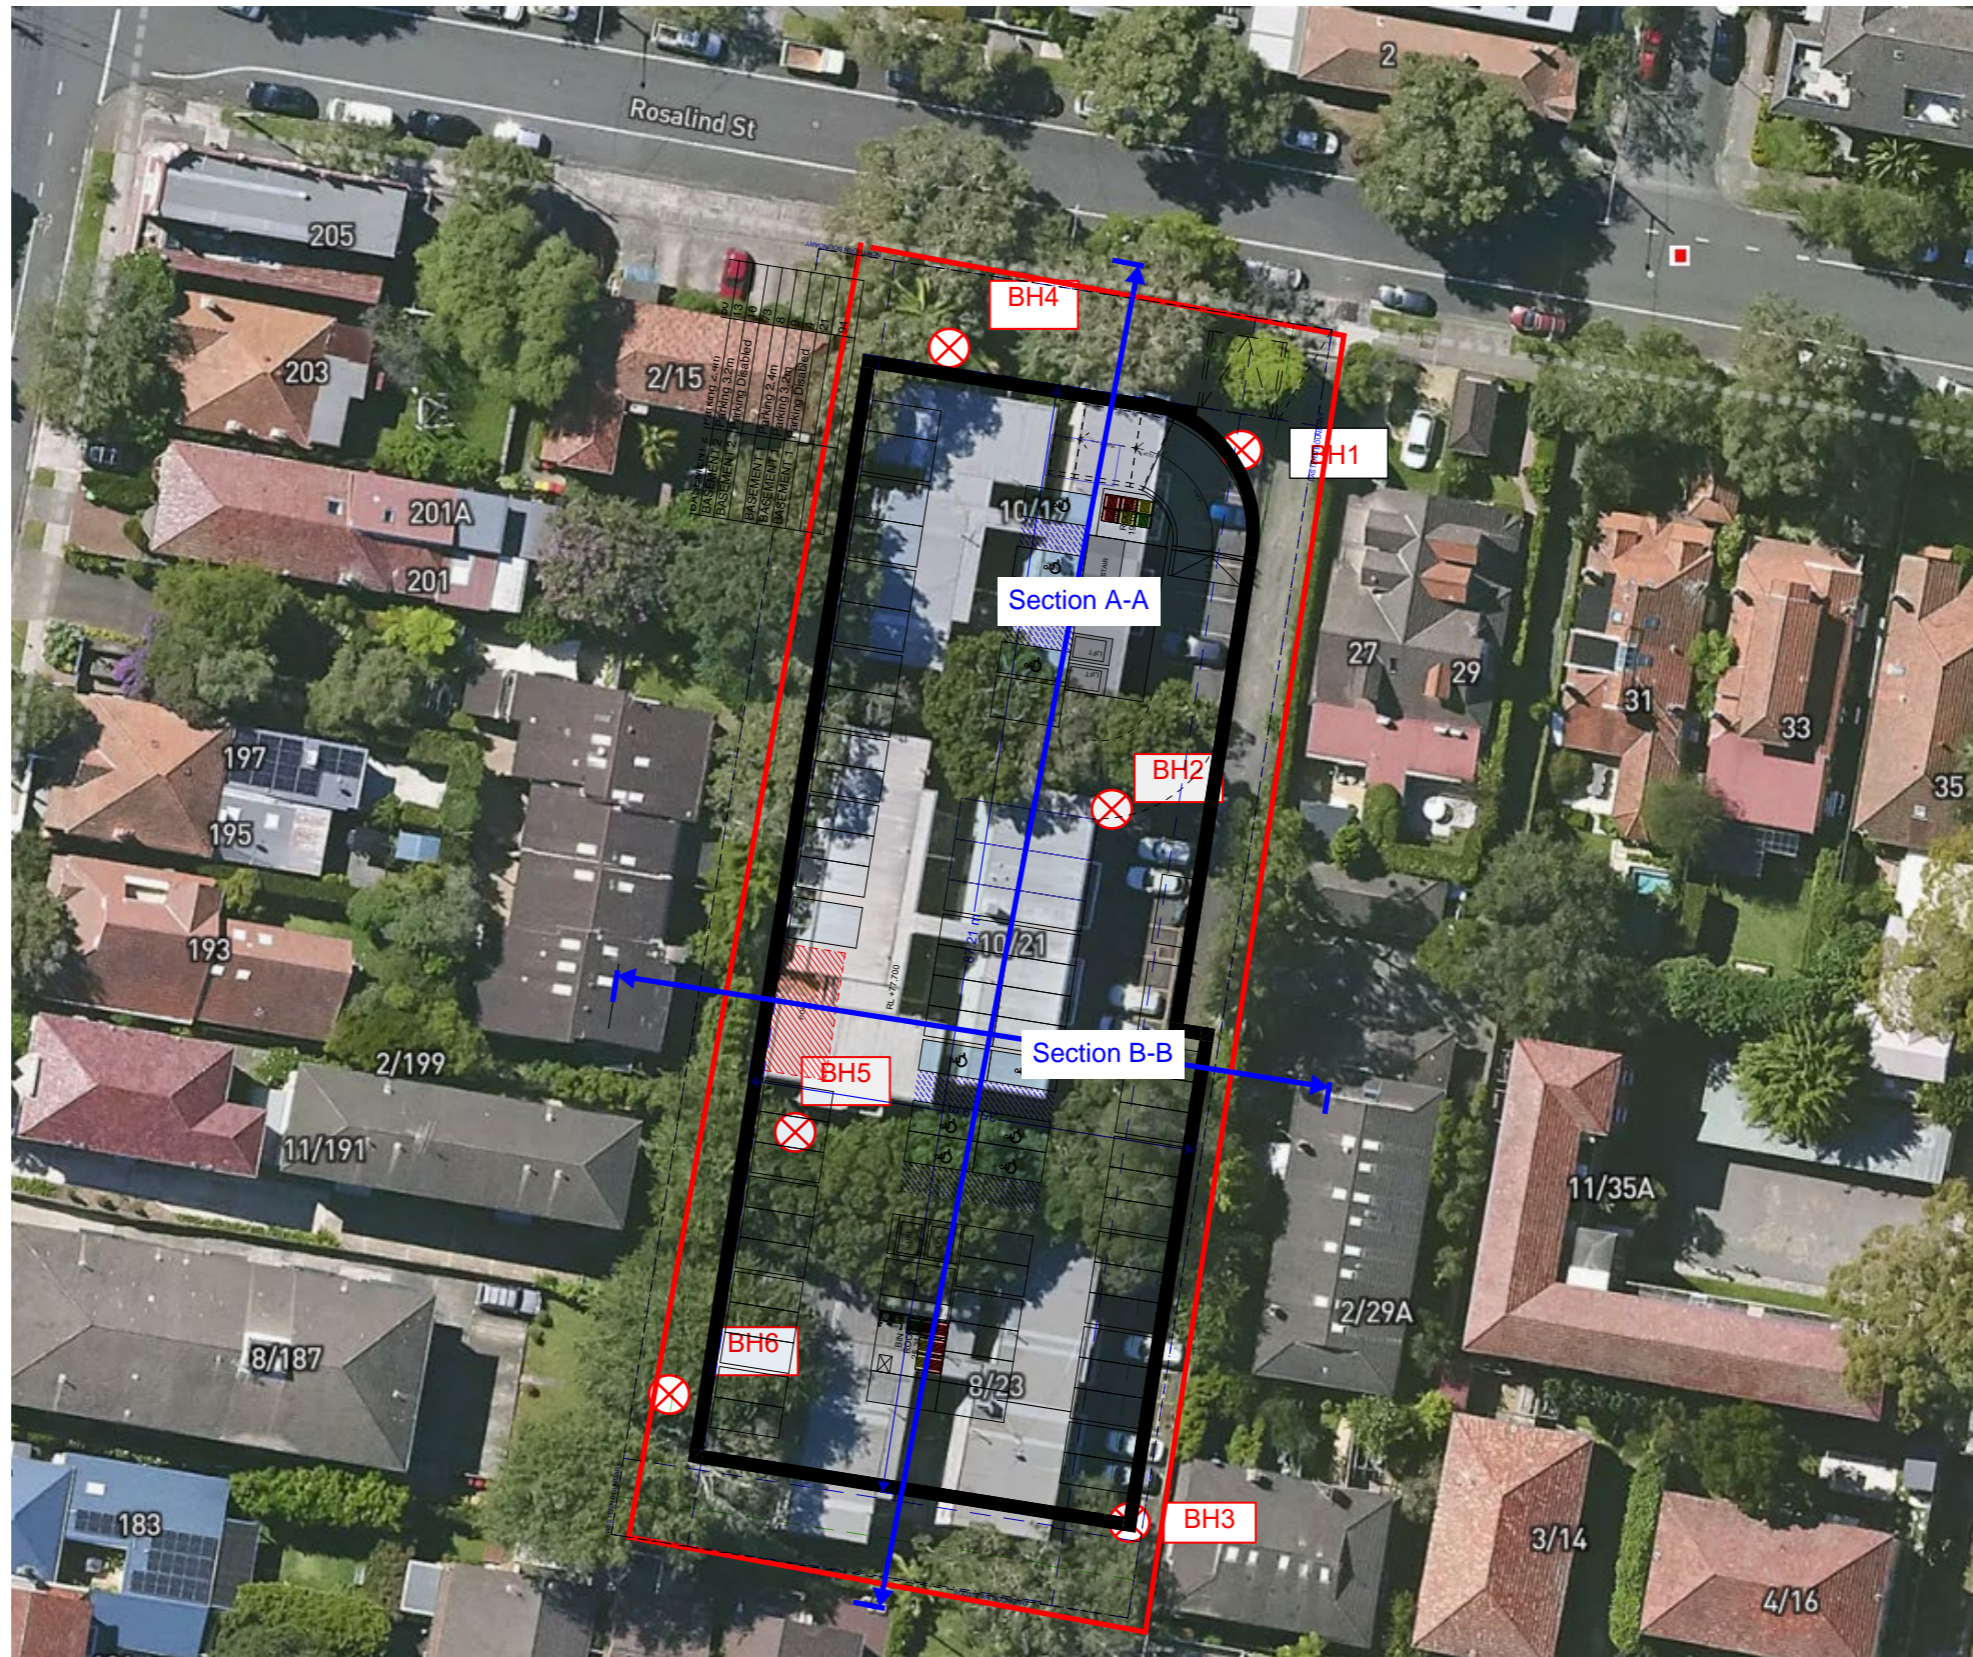
Appendix A – Site Plan

⊗ NEW BOREHOLE AND TEST LOCATION

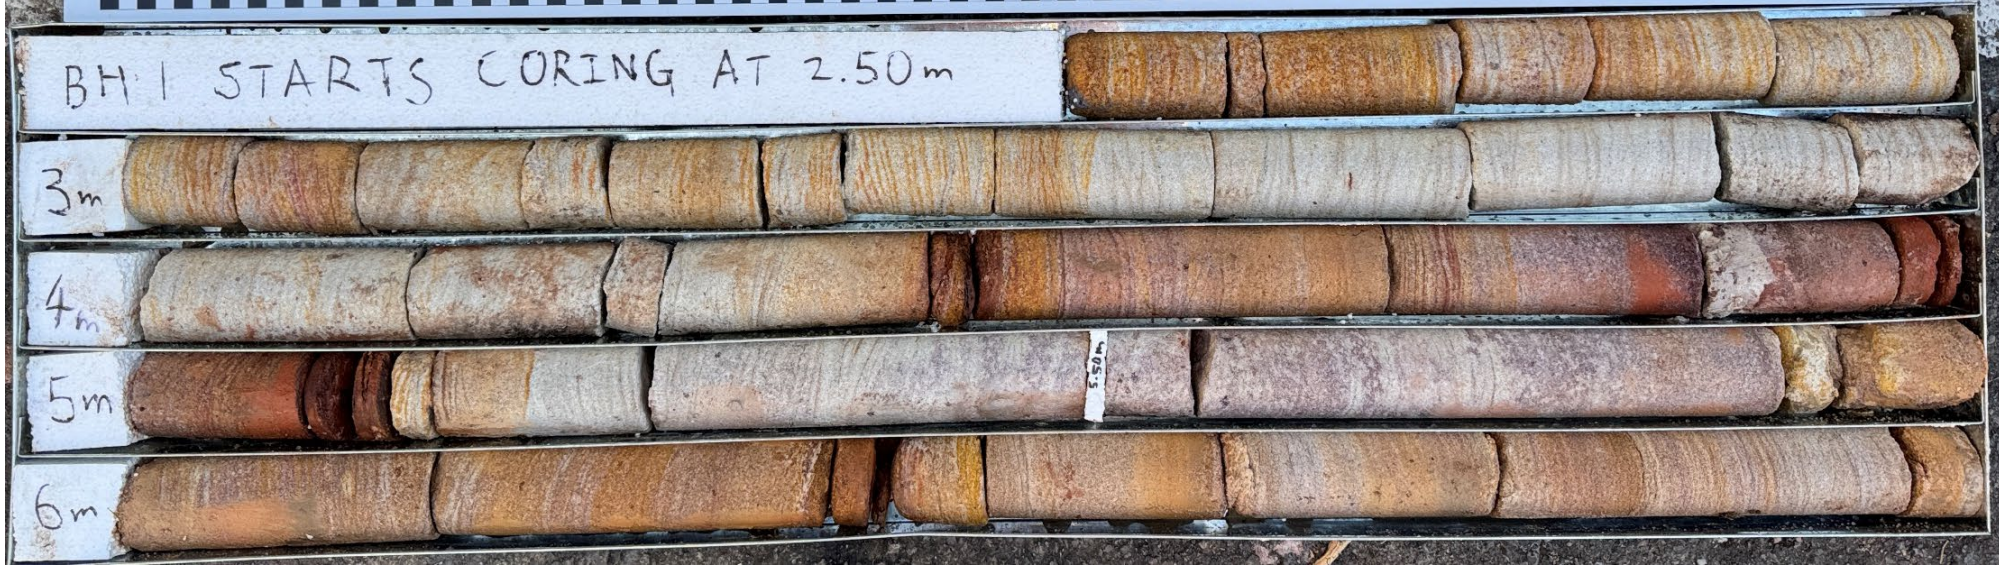
X Chalk marks denote handling or drilling breaks

ELITE GEOSCIENCES	TITLE: Borehole Core Photographs - 19-23 Rosalind Street, Cammeray			
	PROJECT NO: 2025181	TEST DATE: 23/09/2025	INCLINATION: -90 degree	CORE LENGTH: 2.50m to 7.00m
	DRILL RIG: RIG 32	CONTRACTOR: BG Drilling	LOGGED BY: PL	CHECKED BY: TH

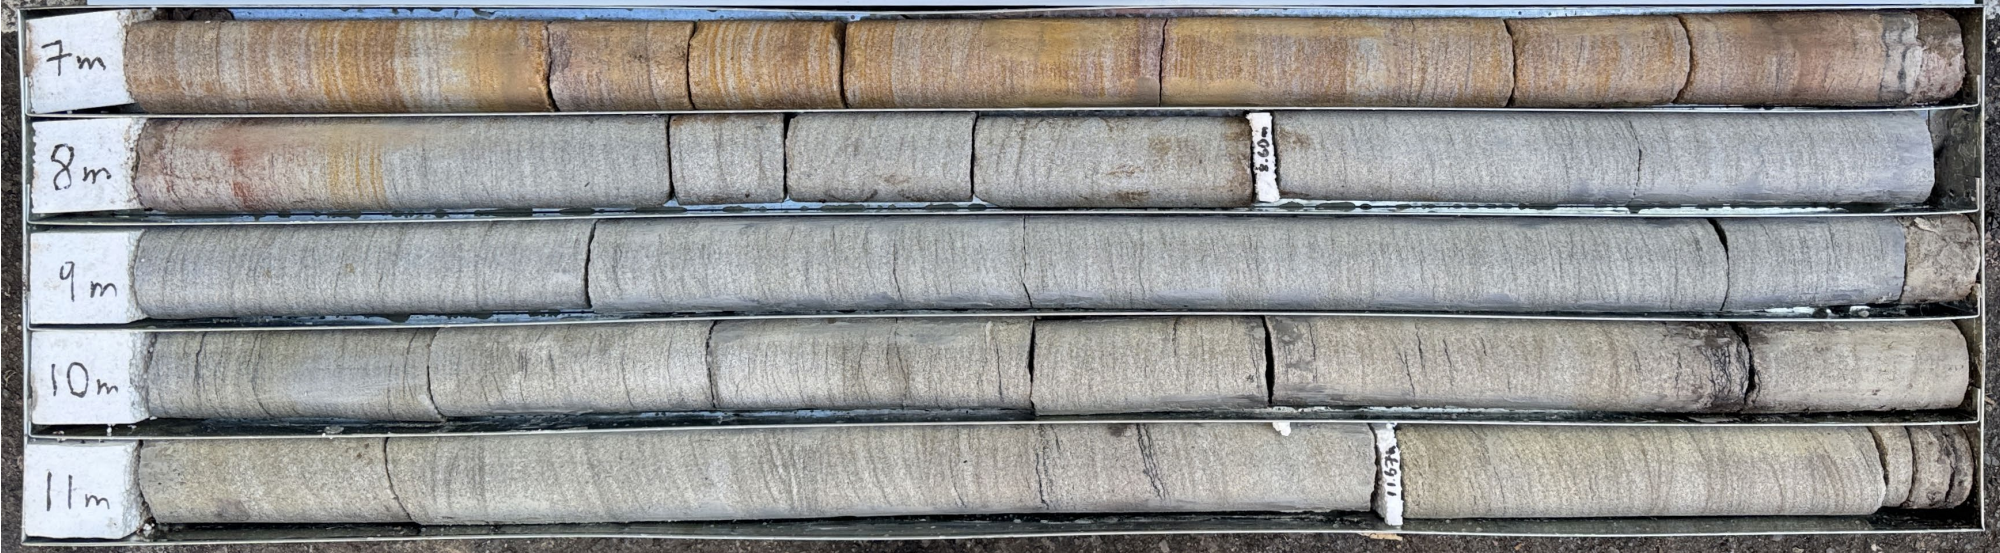
✗ Chalk marks denote handling or drilling breaks

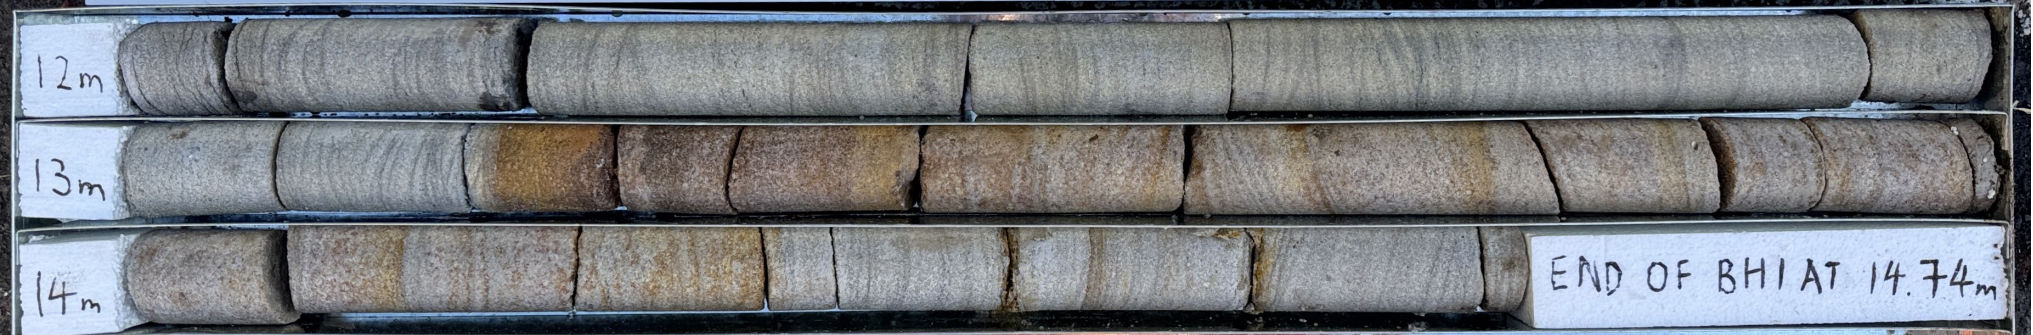
✗ Chalk marks denote handling or drilling breaks

ELITE GEOSCIENCES	TITLE: Borehole Core Photographs - 19-23 Rosalind Street, Cammeray			
	PROJECT NO: 2025181	TEST DATE: 23/09/2025	INCLINATION: -90 degree	CORE LENGTH: 12.00 m to 14.74m
	DRILL RIG: RIG 32	CONTRACTOR: BG Drilling	LOGGED BY: PL	CHECKED BY: TH

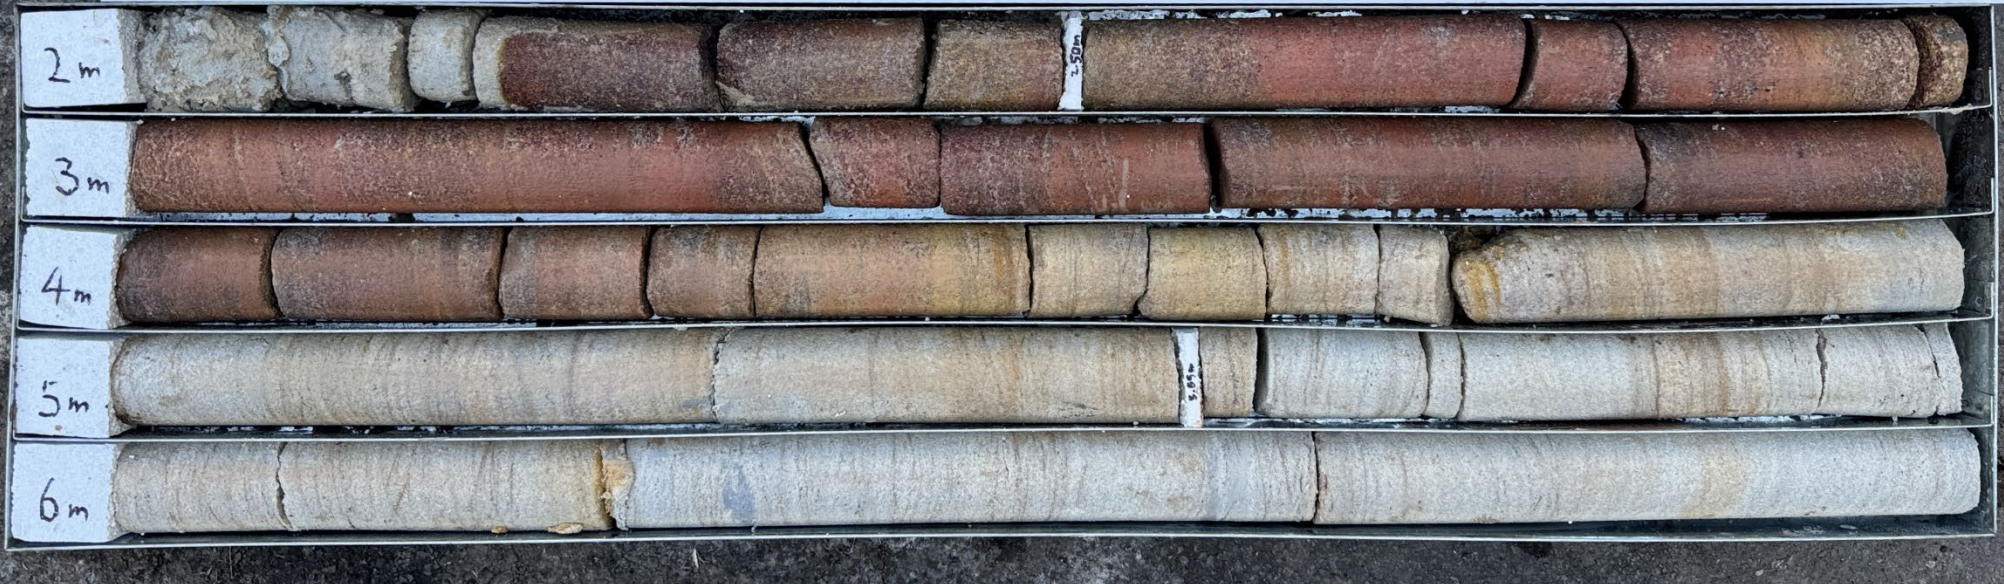
ELITE GEOSCIENCES	TITLE: Borehole Core Photographs - 19-23 Rosalind Street, Cammeray			
	PROJECT NO: 2025181	TEST DATE: 23/09/2025	INCLINATION: -90 degree	CORE LENGTH: 6.00m to 10.23m
	DRILL RIG: RIG 32	CONTRACTOR: BG Drilling	LOGGED BY: PL	CHECKED BY: TH

X Chalk marks denote handling or drilling breaks

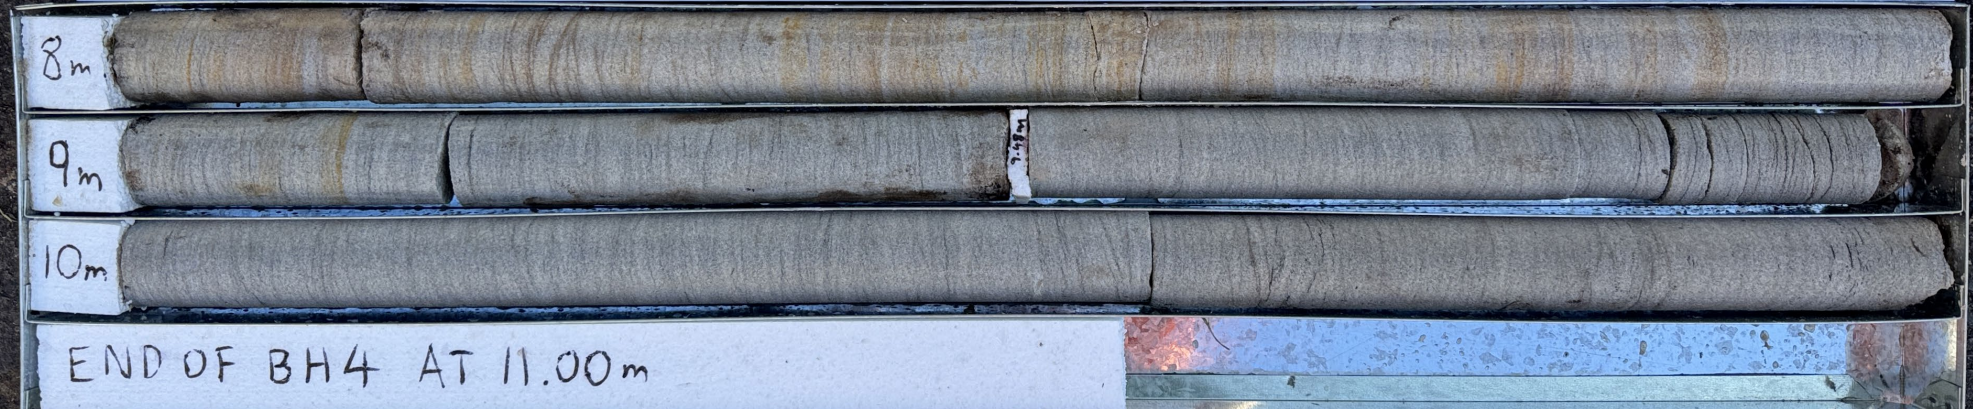
✗ Chalk marks denote handling or drilling breaks

ELITE GEOSCIENCES	TITLE: Borehole Core Photographs – 19-23 Rosalind Street, Cammeray			
	PROJECT NO: 2025181	TEST DATE: 23/09/2025	INCLINATION: -90 degree	CORE LENGTH: 8.00m to 11.00m
	DRILL RIG: RIG 32	CONTRACTOR: BG Drilling	LOGGED BY: PL	CHECKED BY: TH

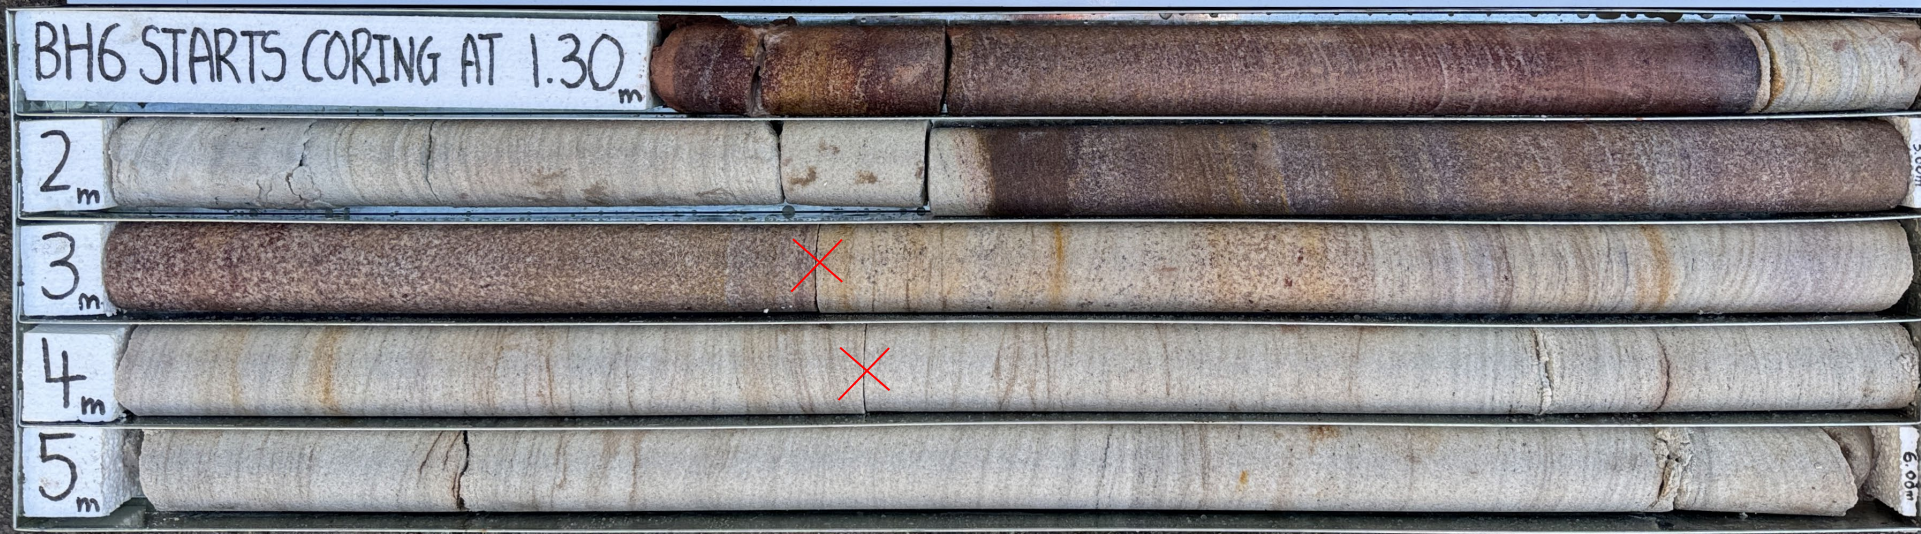
X Chalk marks denote handling or drilling breaks

ELITE GEOSCIENCES	TITLE: Borehole Core Photographs - 19-23 Rosalind Street, Cammeray			
	PROJECT NO: 2025181	TEST DATE: 23/09/2025	INCLINATION: -90 degree	CORE LENGTH: 1.30m to 6.00m
	DRILL RIG: CE 180	CONTRACTOR: BG Drilling	LOGGED BY: PL	CHECKED BY: TH

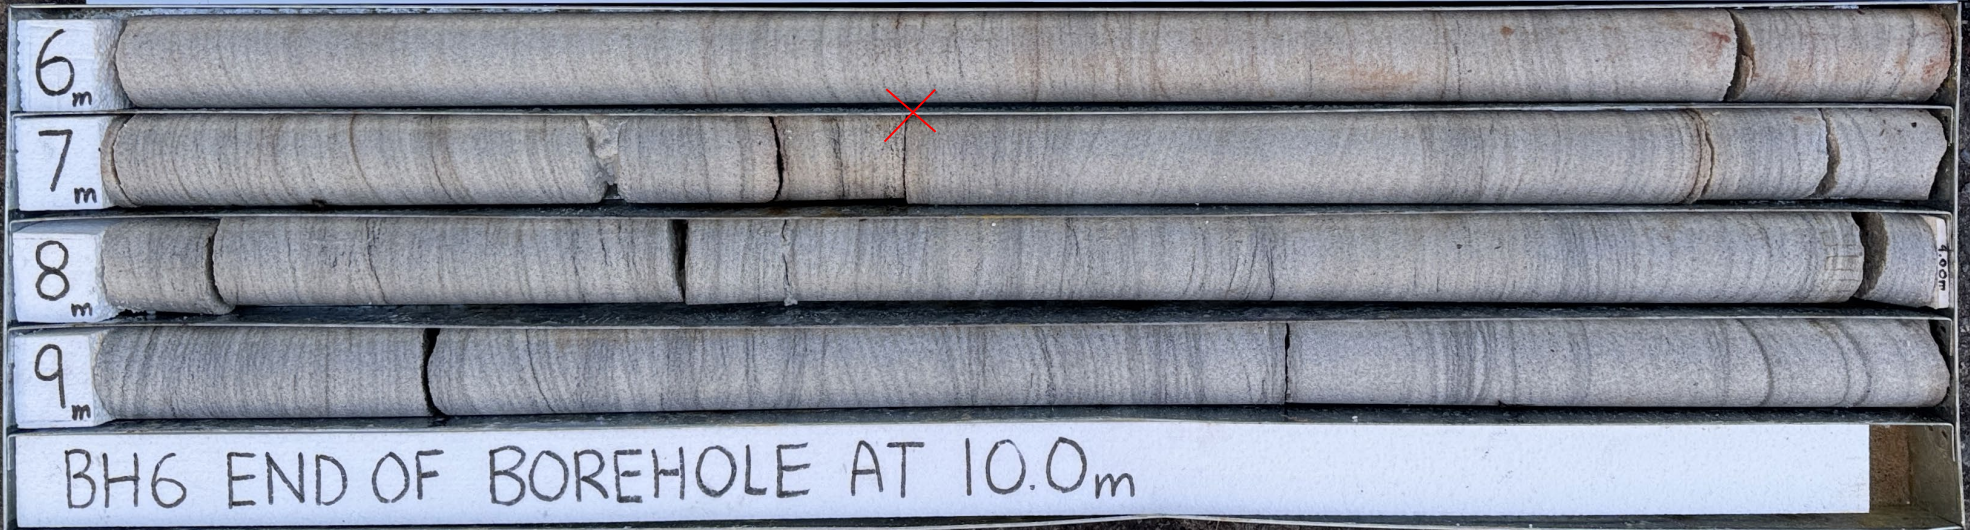
✗ Chalk marks denote handling or drilling breaks

ELITE GEOSCIENCES	TITLE: Borehole Core Photographs – 19-23 Rosalind Street, Cammeray			
	PROJECT NO: 2025181	TEST DATE: 23/09/2025	INCLINATION: -90 degree	CORE LENGTH: 6.00m to 10.00m
	DRILL RIG: RIG 32	CONTRACTOR: BG Drilling	LOGGED BY: PL	CHECKED BY: TH

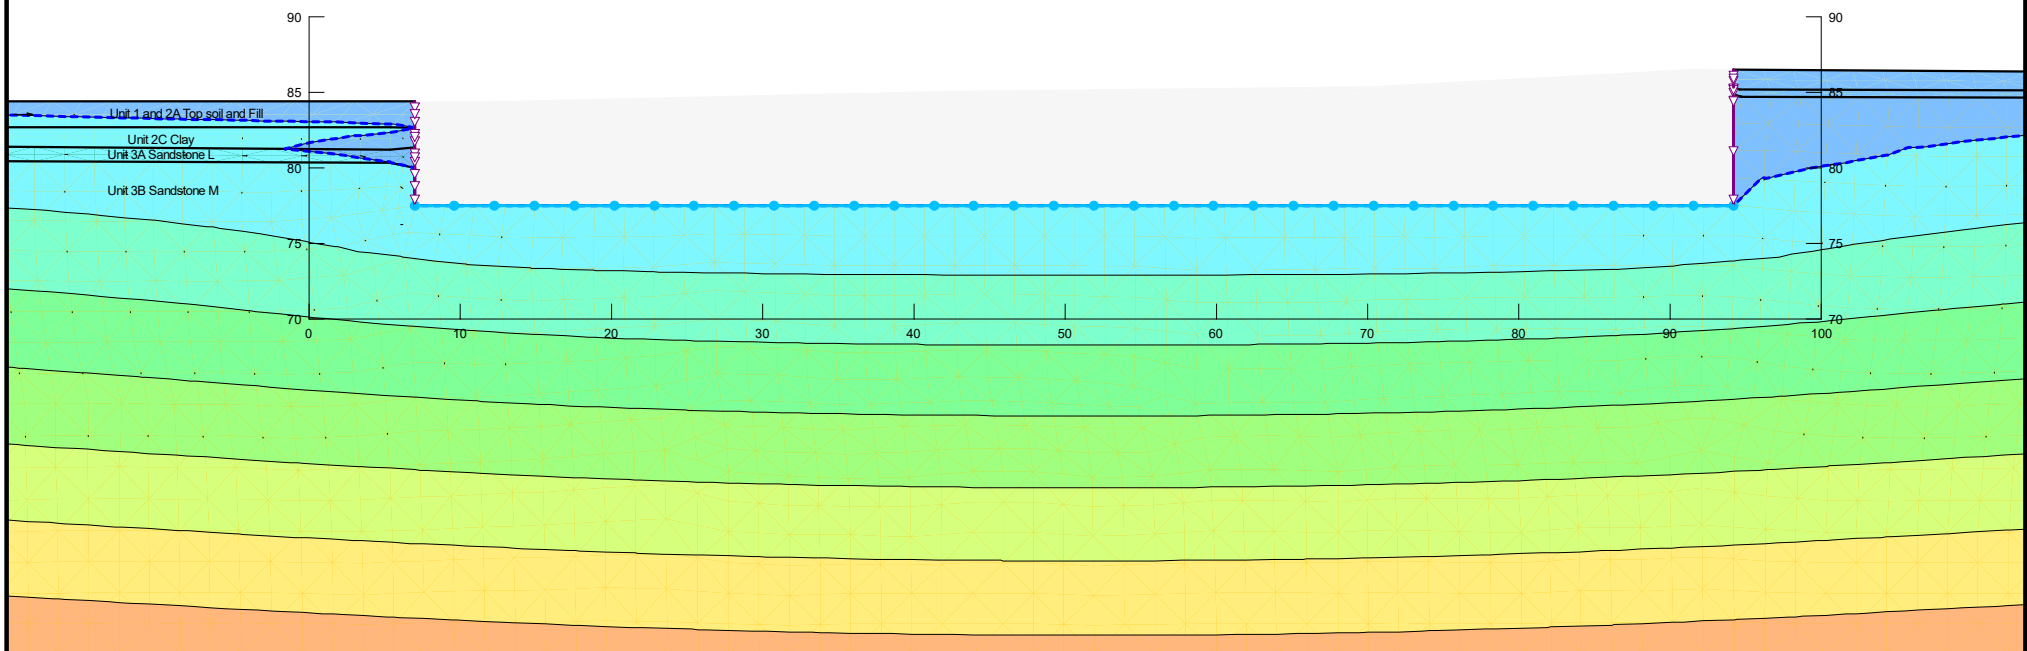
01 Transient (AA)	Time: 180 d
Section A.gsz	
31/10/2025	1:500

Color	Name	Hydraulic Material Model	Vol. WC. Function	K-Function	Ky/Kx' Ratio	Kz/Kx' Ratio	Dip Direction (°)	Dip (°)
Yellow	Unit 1 and 2A Top Soil and Sand	Saturated / Unsaturated	Sand	Sand	0.5	1	90	0
Light Green	Unit 2C Clay	Saturated / Unsaturated	Clay	Clay	0.3	1	90	0
Dark Green	Unit 3A Sandstone VL	Saturated / Unsaturated	3A	3a	0.3	1	90	0
Orange	Unit 3B Sandstone M	Saturated / Unsaturated	3B	3B	0.3	1	90	0

- **Transient condition:** A transient scenario to estimate the volume of water removed by sump-and-pump in phases of dewatering (i.e. 6-month construction period) in the ‘drained’ basement during basement excavation construction.
- **Steady-State condition:** Fully drained basement was adopted to estimate the inflows for a long-term condition.

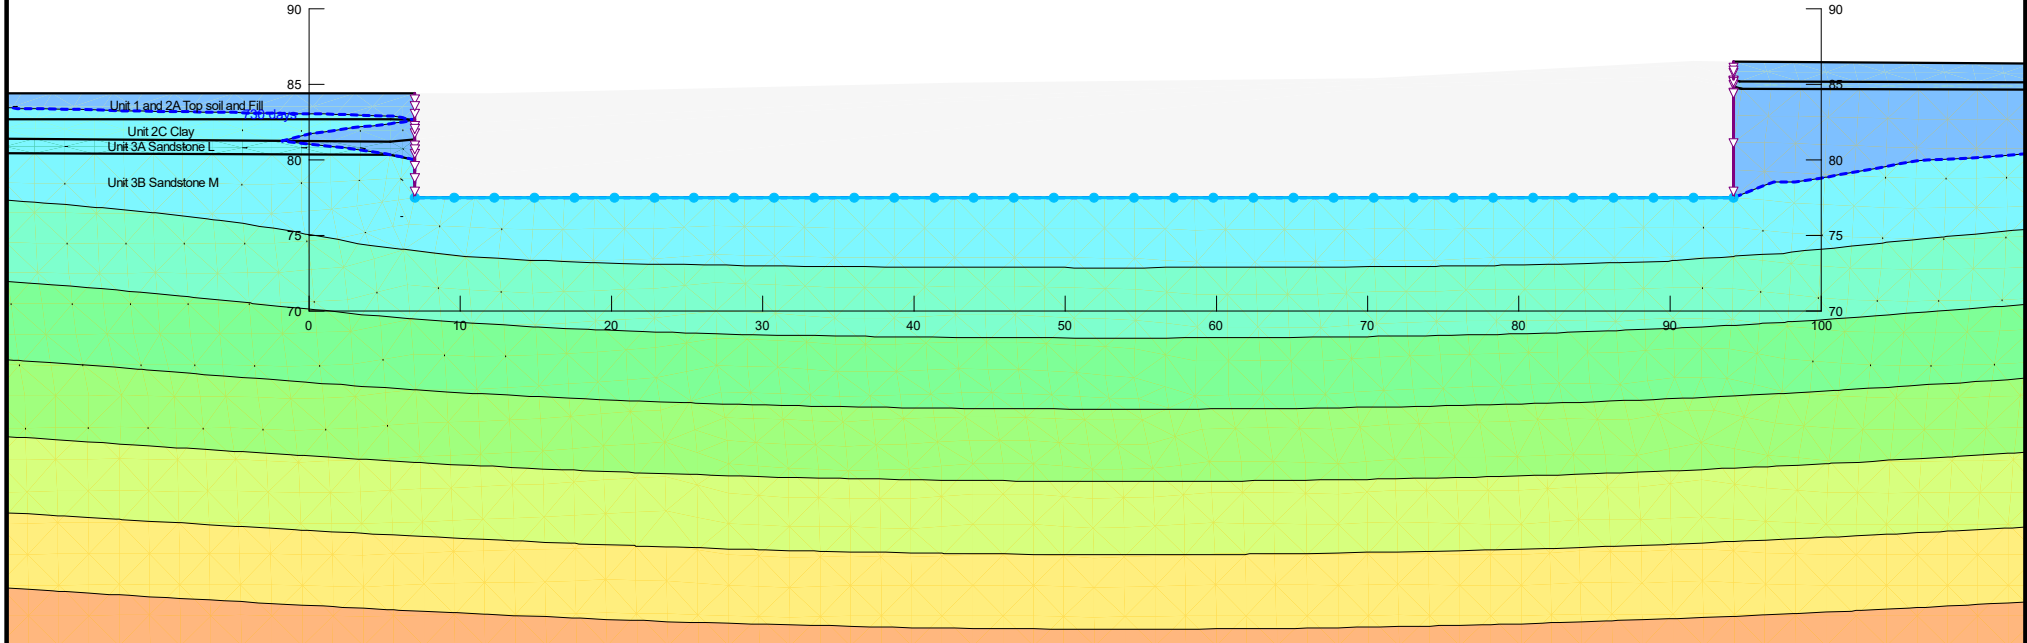
02 Strady State (AA)
Section A.gsz
31/10/2025 1:500

Color	Name	Hydraulic Material Model	Vol. WC. Function	K-Function	Ky/Kx' Ratio	Kz/Kx' Ratio	Dip Direction (°)	Dip (°)
Yellow	Unit 1 and 2A Top Soil and Sand	Saturated / Unsaturated	Sand	Sand	0.5	1	90	0
Light Green	Unit 2C Clay	Saturated / Unsaturated	Clay	Clay	0.3	1	90	0
Dark Green	Unit 3A Sandstone VL	Saturated / Unsaturated	3A	3a	0.3	1	90	0
Orange	Unit 3B Sandstone M	Saturated / Unsaturated	3B	3B	0.3	1	90	0

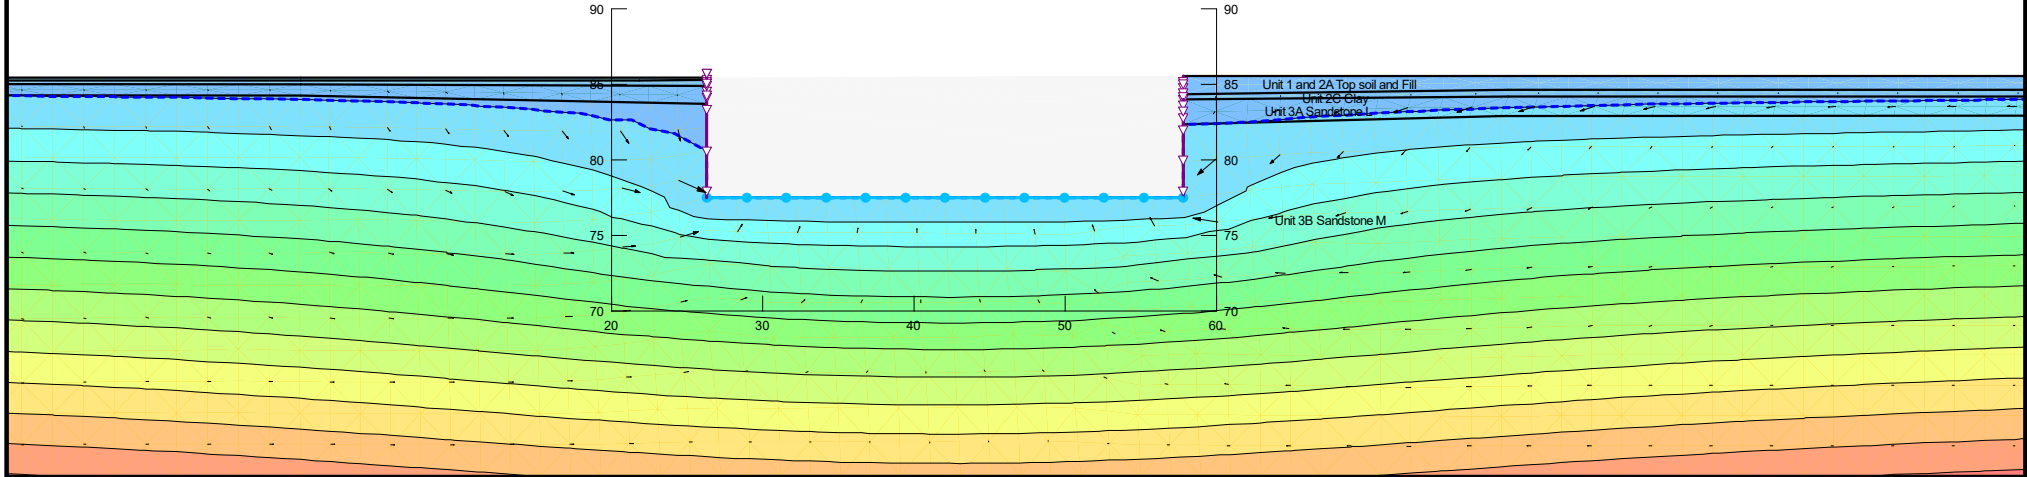
01 Transient (BB)	Time: 180 d
Section A.gsz	
31/10/2025	1:500

Color	Name	Hydraulic Material Model	Vol. WC. Function	K-Function	Ky/Kx' Ratio	Kz/Kx' Ratio	Dip Direction (°)	Dip (°)
Light Yellow	Unit 1 and 2A Top Soil and Sand	Saturated / Unsaturated	Sand	Sand	0.5	1	90	0
Light Green	Unit 2C Clay	Saturated / Unsaturated	Clay	Clay	0.3	1	90	0
Dark Green	Unit 3A Sandstone VL	Saturated / Unsaturated	3A	3a	0.3	1	90	0
Orange	Unit 3B Sandstone M	Saturated / Unsaturated	3B	3B	0.3	1	90	0

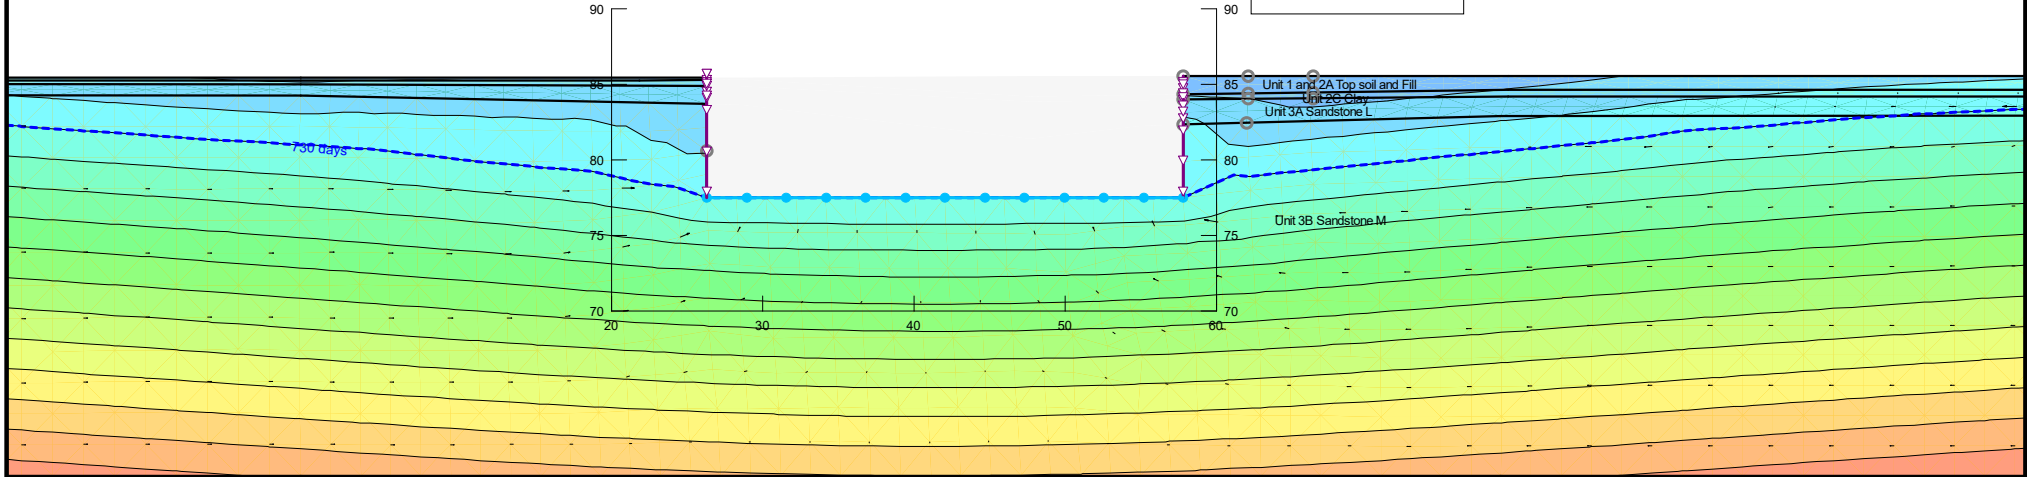
02 Steady State (BB)

Color	Name	Hydraulic Material Model	Vol. WC. Function	K-Function	Ky/Kx' Ratio	Kz/Kx' Ratio	Dip Direction (°)	Dip (°)
Light Yellow	Unit 1 and 2A Top Soil and Sand	Saturated / Unsaturated	Sand	Sand	0.5	1	90	0
Light Green	Unit 2C Clay	Saturated / Unsaturated	Clay	Clay	0.3	1	90	0
Dark Green	Unit 3A Sandstone VL	Saturated / Unsaturated	3A	3a	0.3	1	90	0
Orange	Unit 3B Sandstone M	Saturated / Unsaturated	3B	3B	0.3	1	90	0
