**Re: 9-11 Mawson Avenue, Bella Vista NSW: Aboriginal Objects Due Diligence Assessment**

# 9-11 Mawson Avenue, Bella Vista NSW

## Aboriginal Objects Due Diligence Assessment

Final REV01

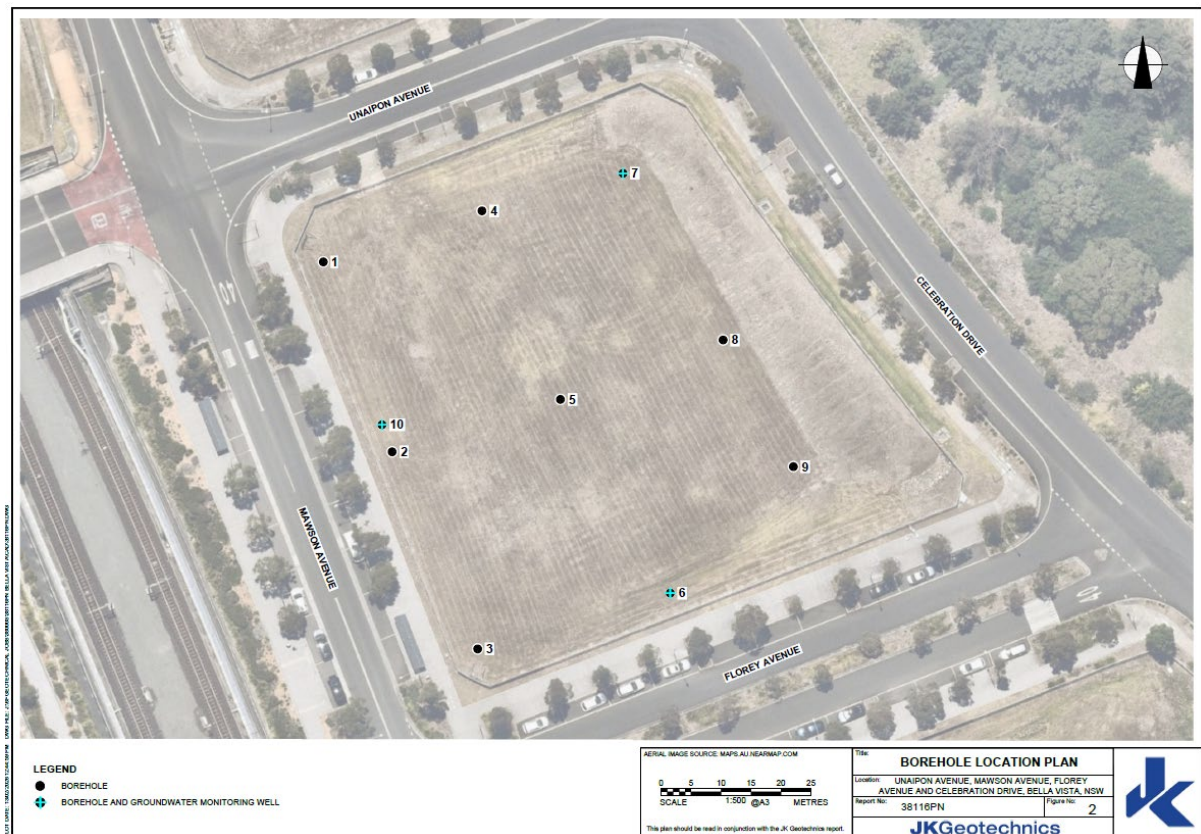
Figure 4: JK Geotechnics Borehole locations within the Activity Area (Source: JK Geotechnics 2026:106).

The potential for in-situ Aboriginal objects is lower on land that has been disturbed by more recent land use. Under the legislation, land is considered disturbed “if it has been the subject of human activity that has changed the land’s surface, being changed that remain clear and visible” (DECCW 2010c:7). Within the Activity Area the soil profile has been modified down to the B-Horizon during previous development within the Activity Area boundaries. This is highlighted in the results of the geotechnical testing that was completed for the Project by JK Geotechnics (2026). During this assessment ten boreholes were excavated that were each cored to a depth of up to 10.07 metres. All of the boreholes completed within the Activity Area contained fill within depths of 3.7 to 5.5 metres that then came on to an archaeologically sterile silty clay layer (Figure 4).

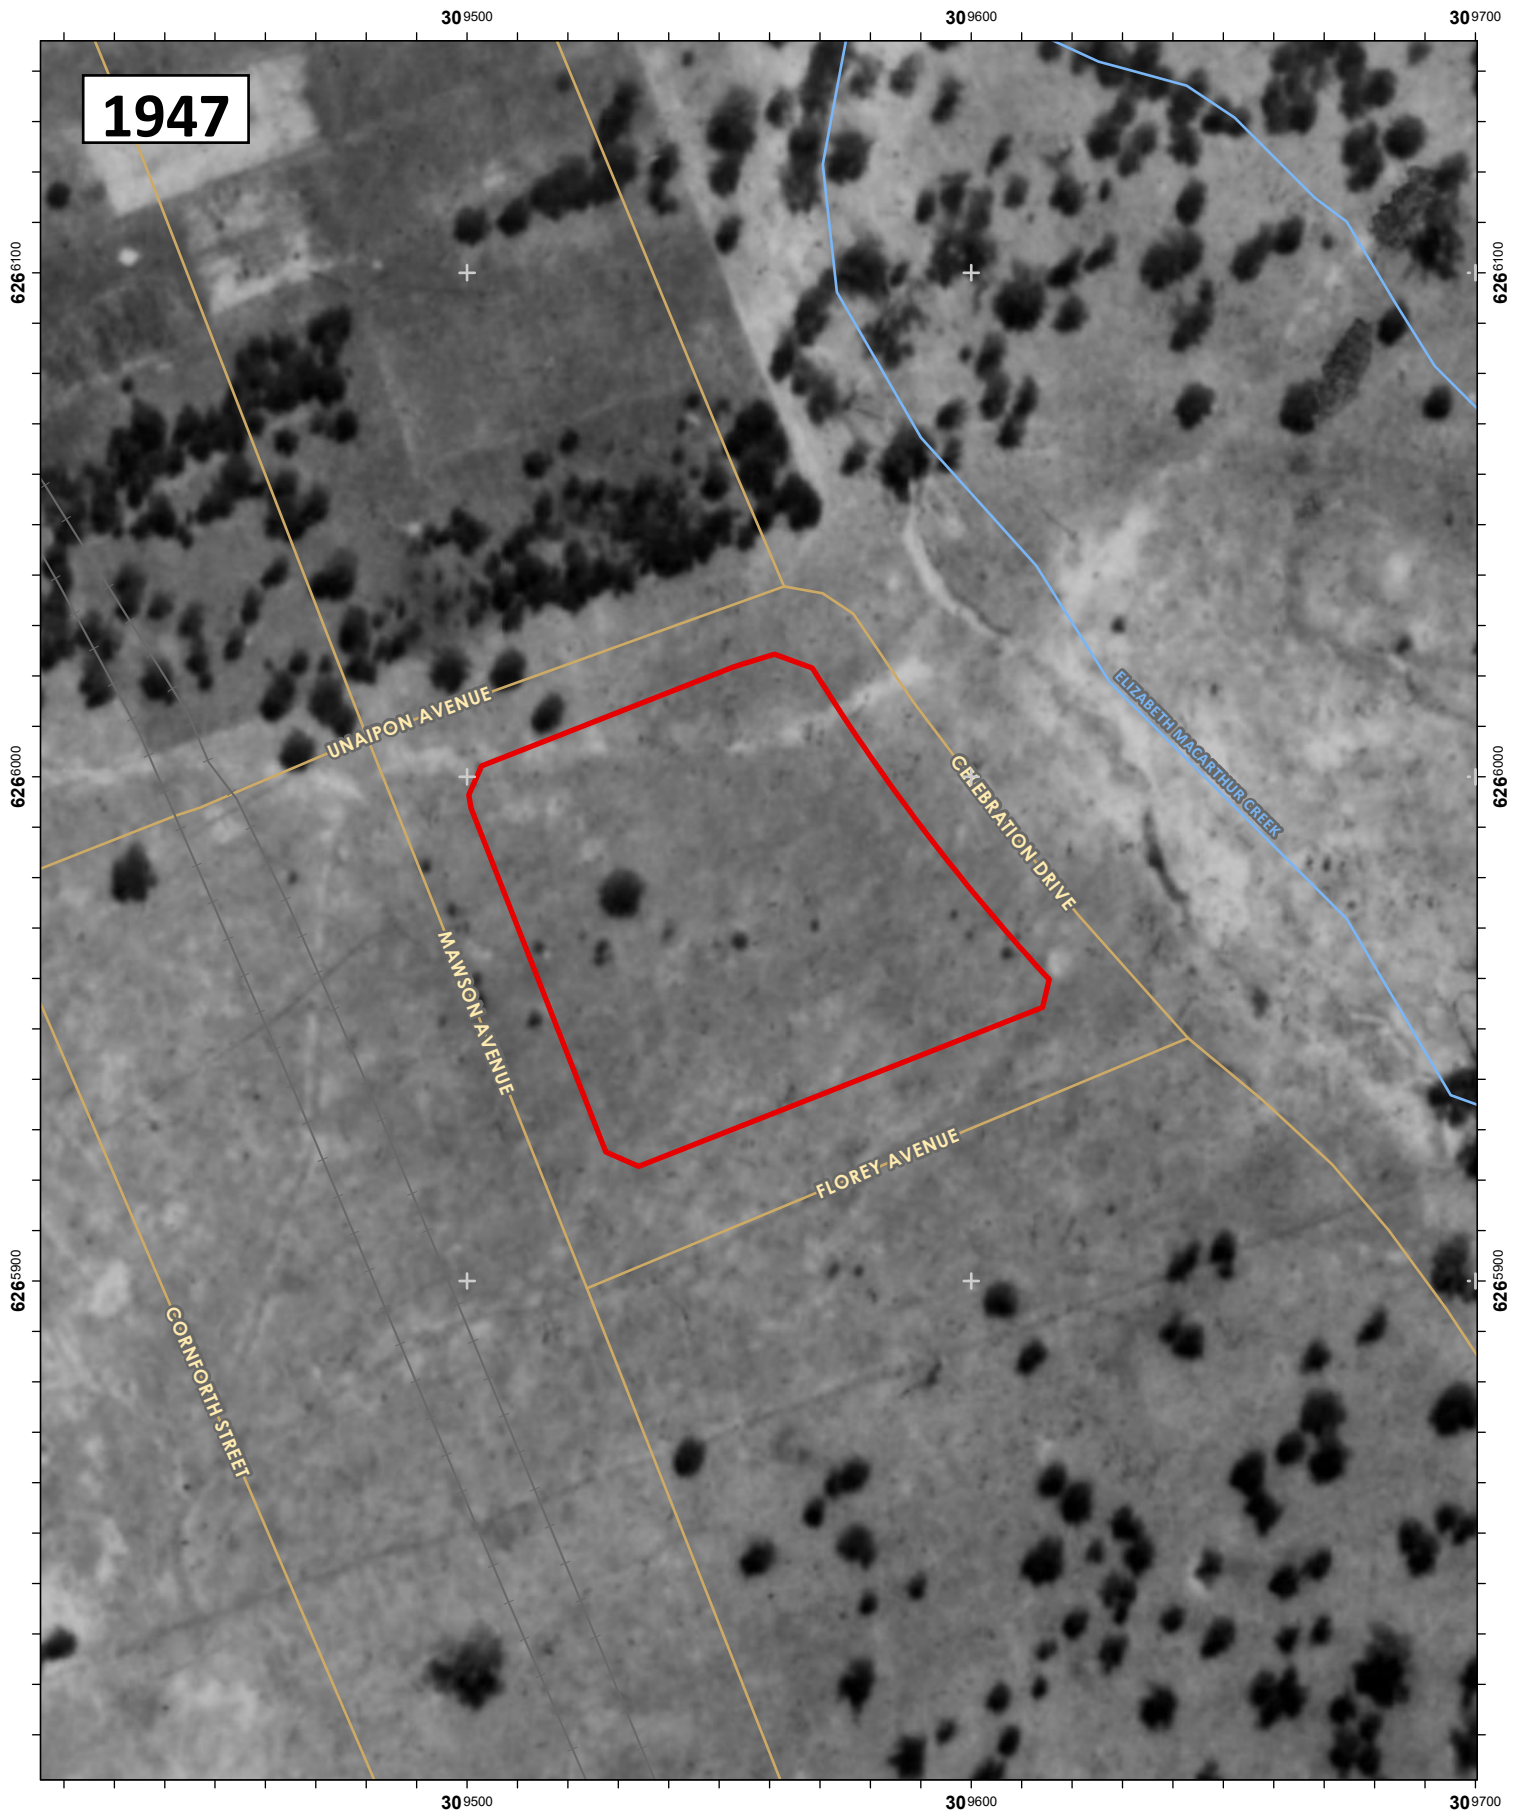
## Figure 4: Historical Aerials and photographs

| Photograph Year | Assessment of impacts to the Activity Area |
|---|---|
| 2014 | The Activity Area has been completely stripped of vegetation and cut for the works associated with the current surrounding roads and the Bella Vista Train Station. |

As highlighted by the historical aerial's above considerable disturbance has occurred across the majority of the site, due to this erosion and clearance there is no potential for subsurface deposit to remain within the Activity Areas boundary.

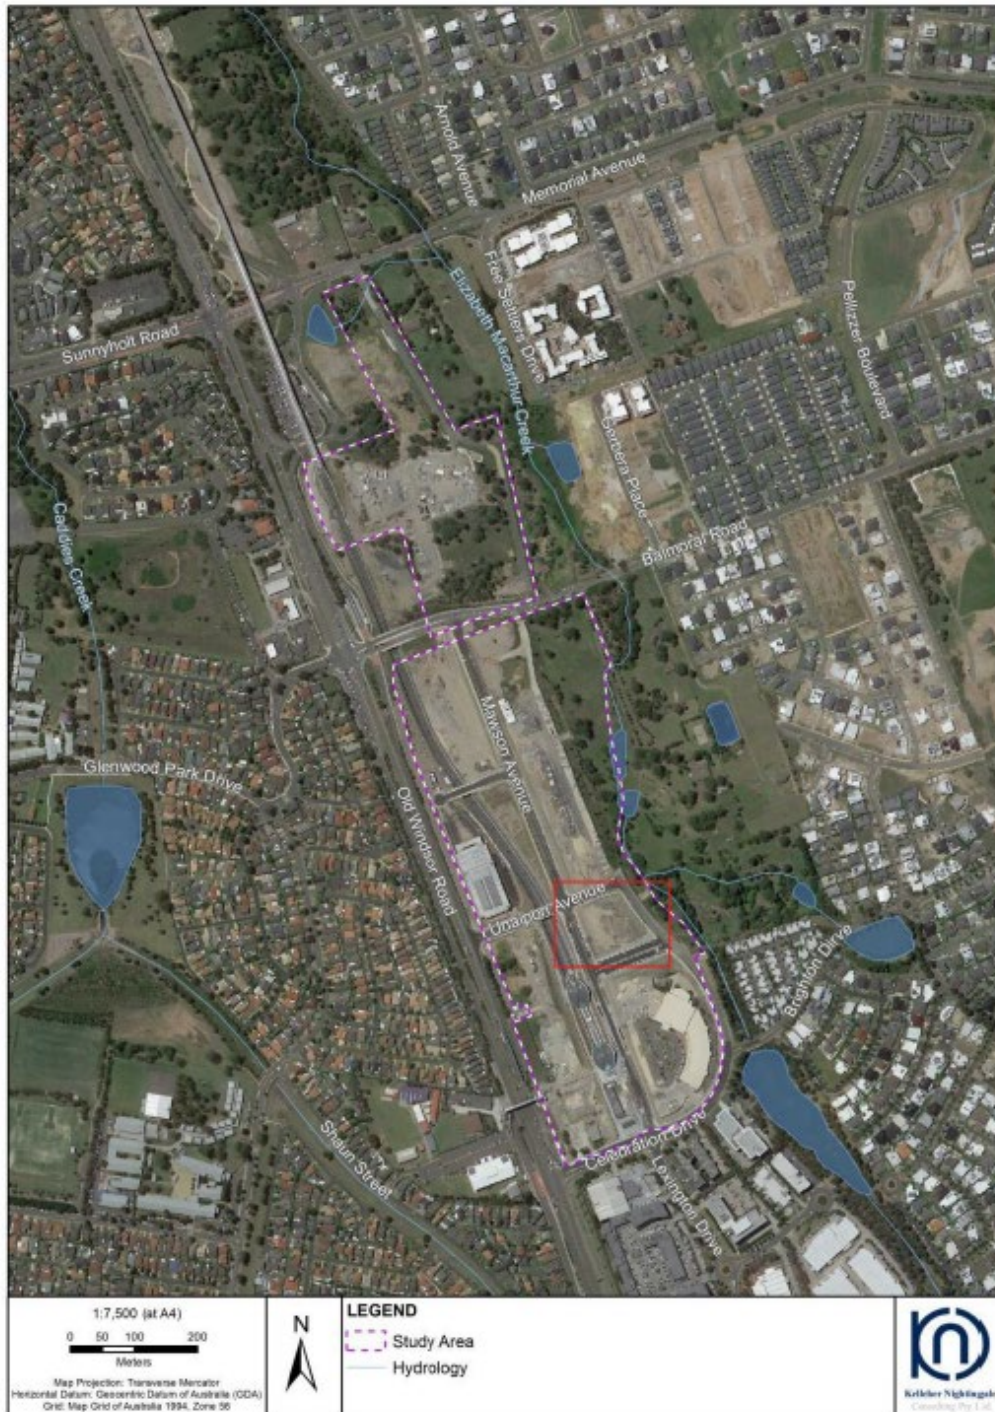
Figure 9: Location of the current Activity Area highlighted in red on the replicated Figure 3 from Kelleher and Knightingale 2019:3.

There has been one previous Aboriginal Heritage Impact Statement completed of the current Activity Area Kelleher and Knightingale Consulting Pty Ltd (KNC) *Bella Vista Station Precinct Aboriginal Heritage Impact Statement* (2019) KNC were engaged by Landcom to complete an assessment to deliver accelerated housing supply and facilitate interim precinct activation relating to the Bella Vista Station Precinct this assessment was completed as a State Significant Assessment with Project SEARs. The Subject Area for this assessment included the current Activity Area (Figure 9, highlighted in red). During this assessment four Aboriginal cultural heritage sites were identified on AHIMS, however these sites have since been destroyed under an Aboriginal Heritage Impact Permit (AHIP) process. The fourth site comprised of a Potential Archaeological Deposit (PAD) that was excavated during this previous assessment and was identified as not being an Aboriginal cultural Heritage site, as it did not contain any Aboriginal objects. There were no Aboriginal objects or areas of PAD identified within the current Activity Area.

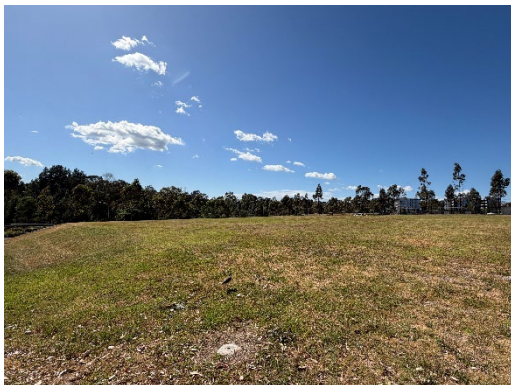
*Plate 2: General photograph of the proposed development location facing south east.*

A visual inspection of the Activity Area was completed by Renée Regal (Director/ Heritage Consultant, Regal Heritage) on the 27 October 2025 this assessment no Aboriginal objects or areas of Potential Archaeological Deposit were identified due to the historical disturbance that has occurred across the site (Plate 2 through to Plate 5).

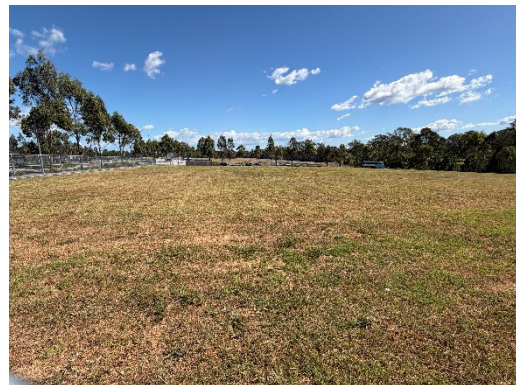
*Plate 3: General photograph of the Activity Area facing north.*

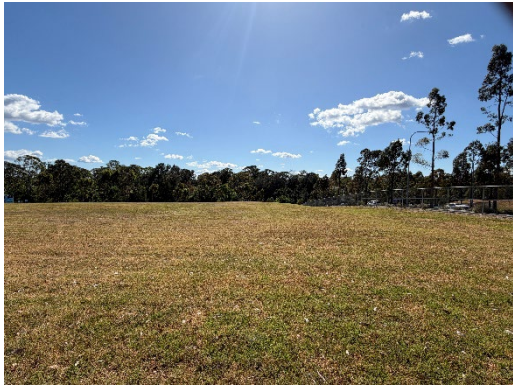
*Plate 4: General photograph of the southern end of the Activity Area.*

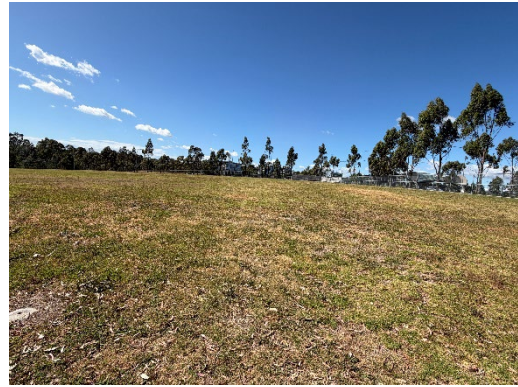
*Plate 5: General photograph of the Activity Area, taken from the northern end.*
