<b>Client</b>	University of New South Wales
<b>Location</b>	Building B22 – Student Academic Administration Building
<b>Document Type</b>	Arboricultural Impact Assessment, Tree Protection Plan & Tree Protection Specification
<b>Date</b>	13 September 2019

Revision 3, 90% Design Review 13/09/2019

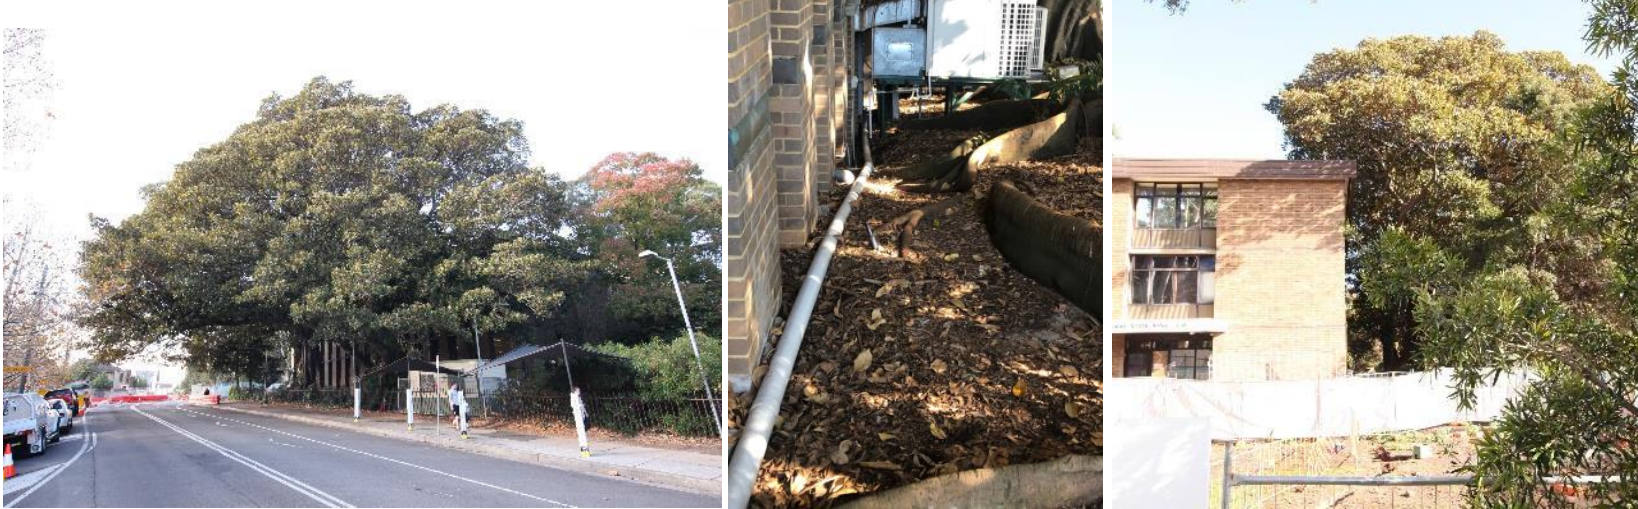
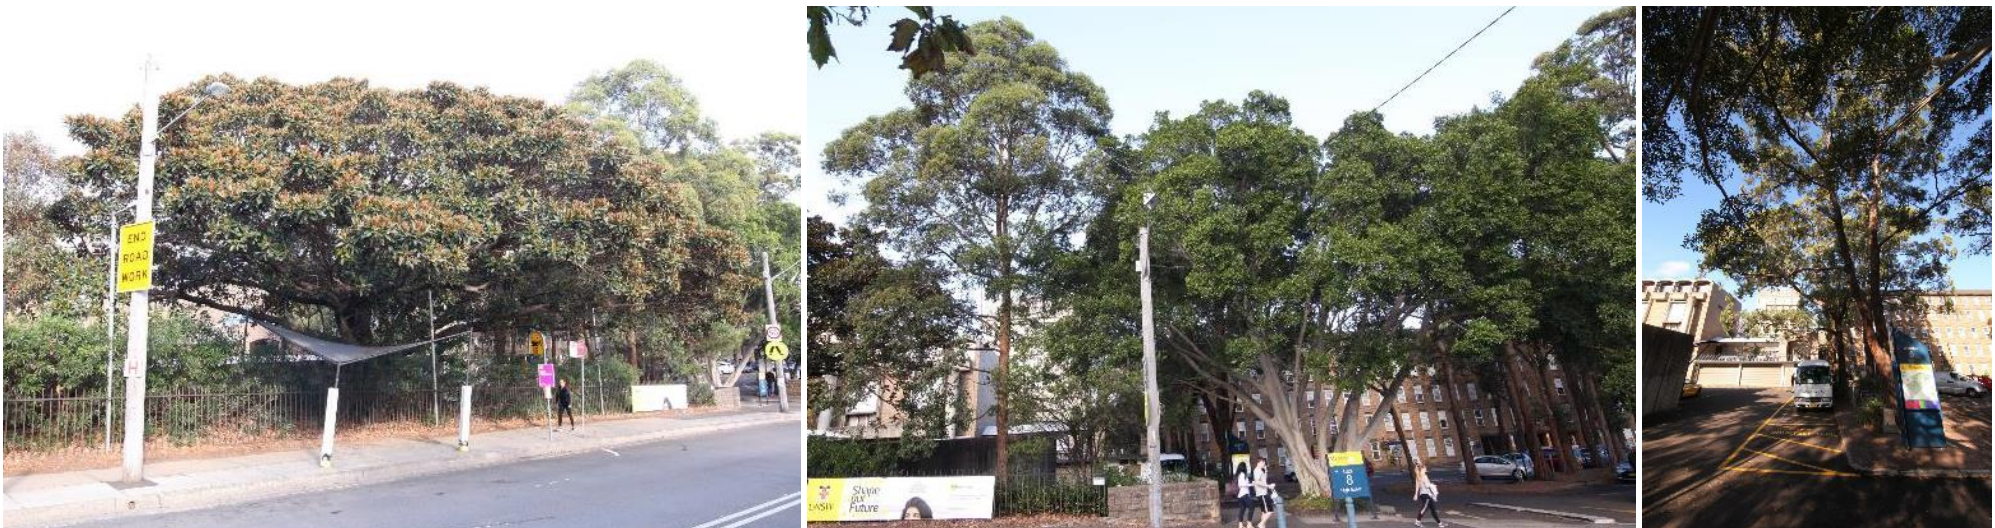
### Appendix 3 Images of Tree

Image 1 shows trees trees 311 & 312 on the High Street Frontage. Image 2 above centre shows an example of trees roots present near tree 311 to the south. Image 3 above right shows tree 311 from the east and the canopy over the building. Image 4 below left shows tree 319 on the High street frontage. Image 5 shows trees 007 & 320 & 321 on the High Street frontage near gate 8. Image 6 below right shows trees 322-326 proposed to be removed.
