Appendix C

Viewpoint Analysis

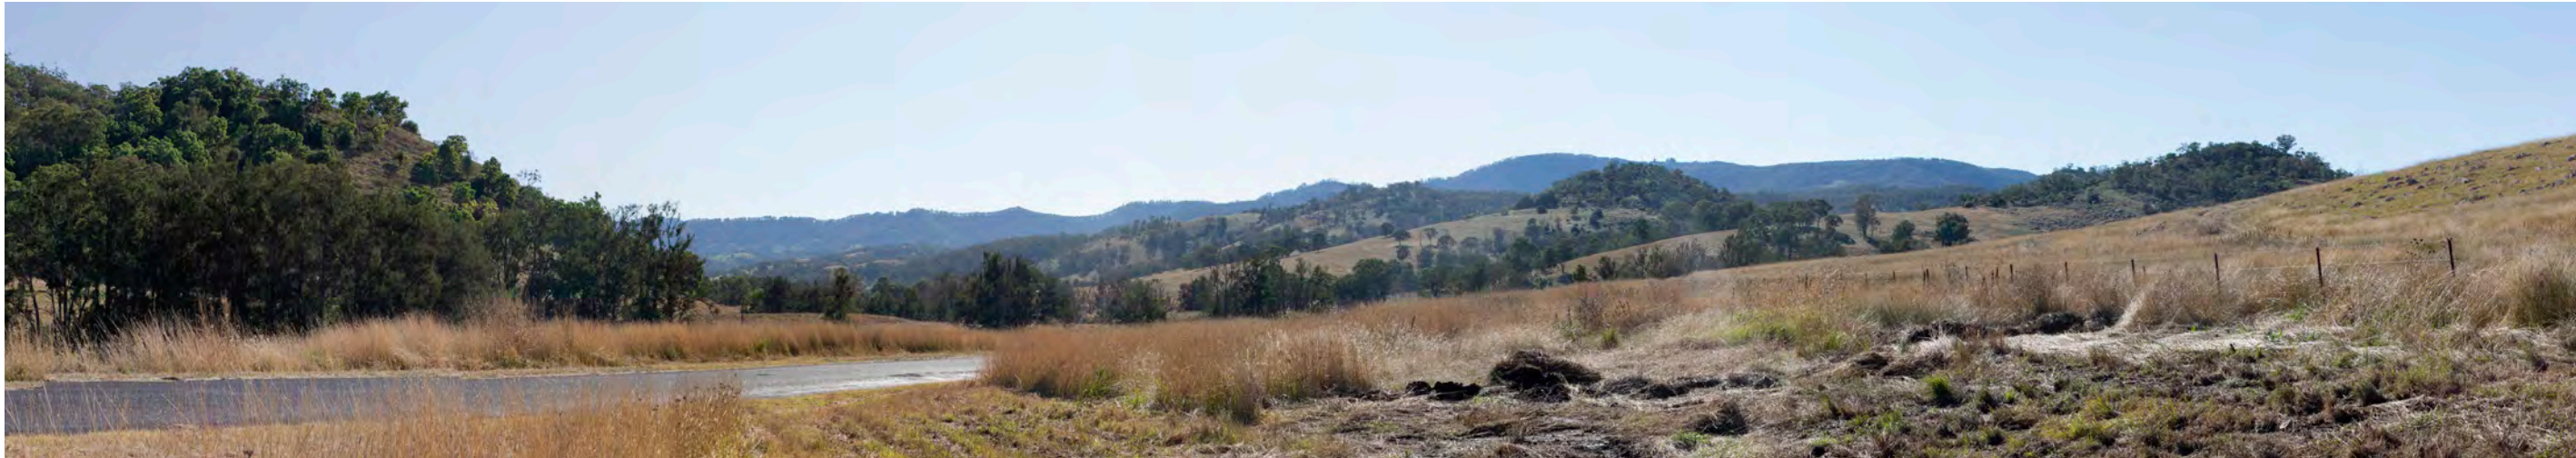
VIEWPOINT HOG01

Viewpoint Summary		Viewpoint Description	Visual Performance Objectives: VIZ3
Location:	Elevation:	<p>Viewpoint taken from Timor Crawney Road, 550m from the intersection of Sargeants Gap Rd. The land is characterised by undulating and mostly cleared land used for grazing in parts. The road is a low use road. Rocky outcrops and vegetation are present in gullies and on ridgelines in the middleground of the viewpoint. The view extends north towards the vegetated ridge associated with the project in the far middleground. Views from this location are largely contained to the east and west by the existing landforms and vegetation in the foreground.</p> <p>Potential Visual Impact</p> <p>A preliminary analysis based on topography alone suggests that 35 WTG's may be visible from this location on the vegetated ridge in the far middleground.</p>	<p>There are no visual performance objectives that apply to this viewpoint due to the Visual Influence Zone Rating (VIZ3).</p> <p>Refer Photomontage 10</p>

Timor Crawney Road	488m		
Coordinates:	Viewing Direction:		
151° 5'57.62"E 31°42'6.37"S	Generally North		
Distance to WTG:	Visibility Distance Zone:		
Approx. 7.2km	Far Middleground (FM)		
Land Use:	Viewer Sensitivity Level:		
Low Use Road	Level 3: Low		
LCU:	Scenic Quality Rating:	Nearby Residences:	
Crawney	Moderate	-	
Visual Influence Zone VIZ3

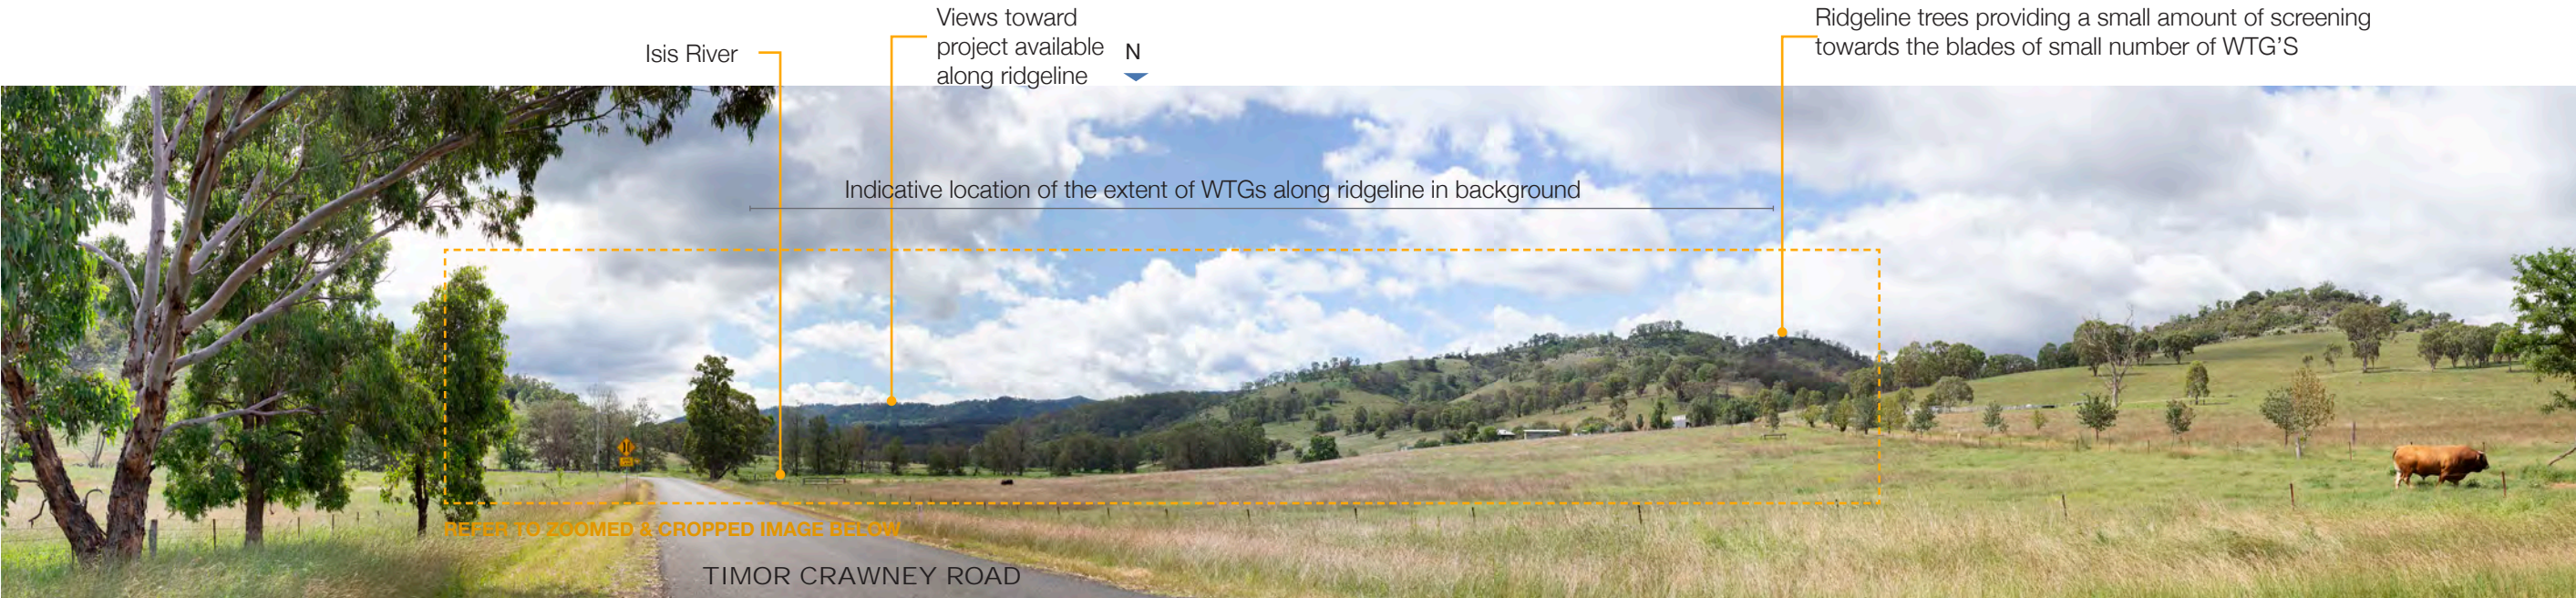
VIEWPOINT HOG02

Viewpoint Summary		Viewpoint Description	Visual Performance Objectives: VIZ3
Location:	Elevation:	Viewpoint taken from along Timor Crawney Rd. Land in the area is undulating and mostly cleared. The road is a low use road and the surrounding land is used mainly for grazing. There are remnant stands of vegetation generally contained to gullies, creek lines, ridgelines, fence lines and surrounding rocky outcrops in the middleground. The views from this location extend towards the ridge associated with the project site with the landform containing the view to the north east. The ridge associated with the project site can be seen in the far middleground to the north. Potential Visual Impact From this location 27 WTG's may be visible to the north along the ridgeline. The existing vegetation in the middleground may fragment views to a small number of WTG's. The landform and associated vegetation in the north east fragments views toward approximately 7 WTG blades, slightly reducing the number of WTG's visible from this location.	There are no visual performance objectives that apply to this viewpoint due to the Visual Influence Zone Rating (VIZ3).

Indicative location of the extent of WTGs behind dense vegetation

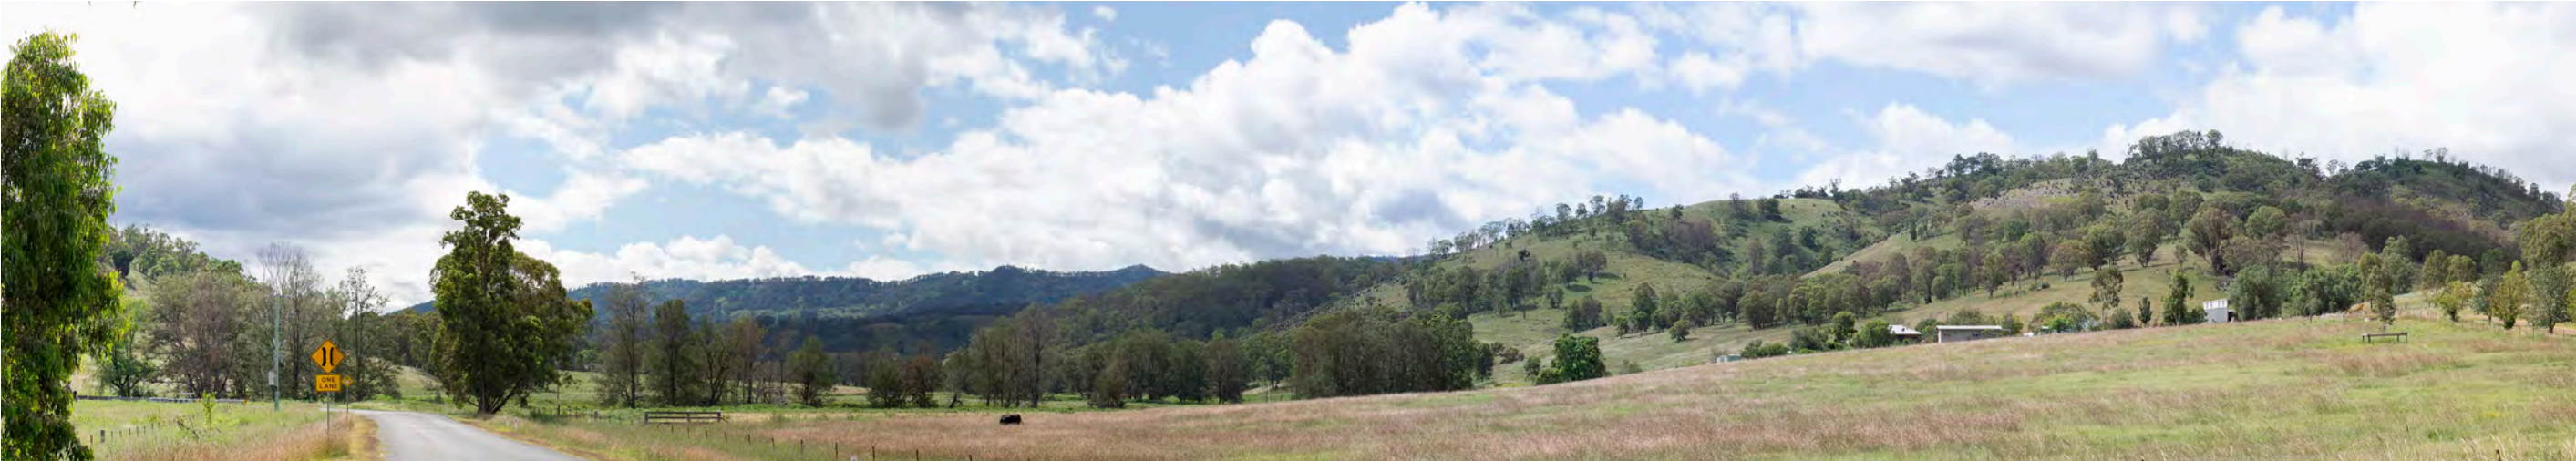
Timor Crawney Road	496m		
Coordinates:	Viewing Direction:		
31°41'23.79"S 151°5'52.29"E	Generally North		
Distance to WTG:	Visibility Distance Zone:		
Approx. 6.2km	Far Middleground (FM)		
Land Use:	Viewer Sensitivity Level:		
Low Use Road	Level 3: Low		
LCU:	Scenic Quality Rating:	Nearby Residences:	
Crawney	Moderate	-	
Visual Influence Zone VIZ3

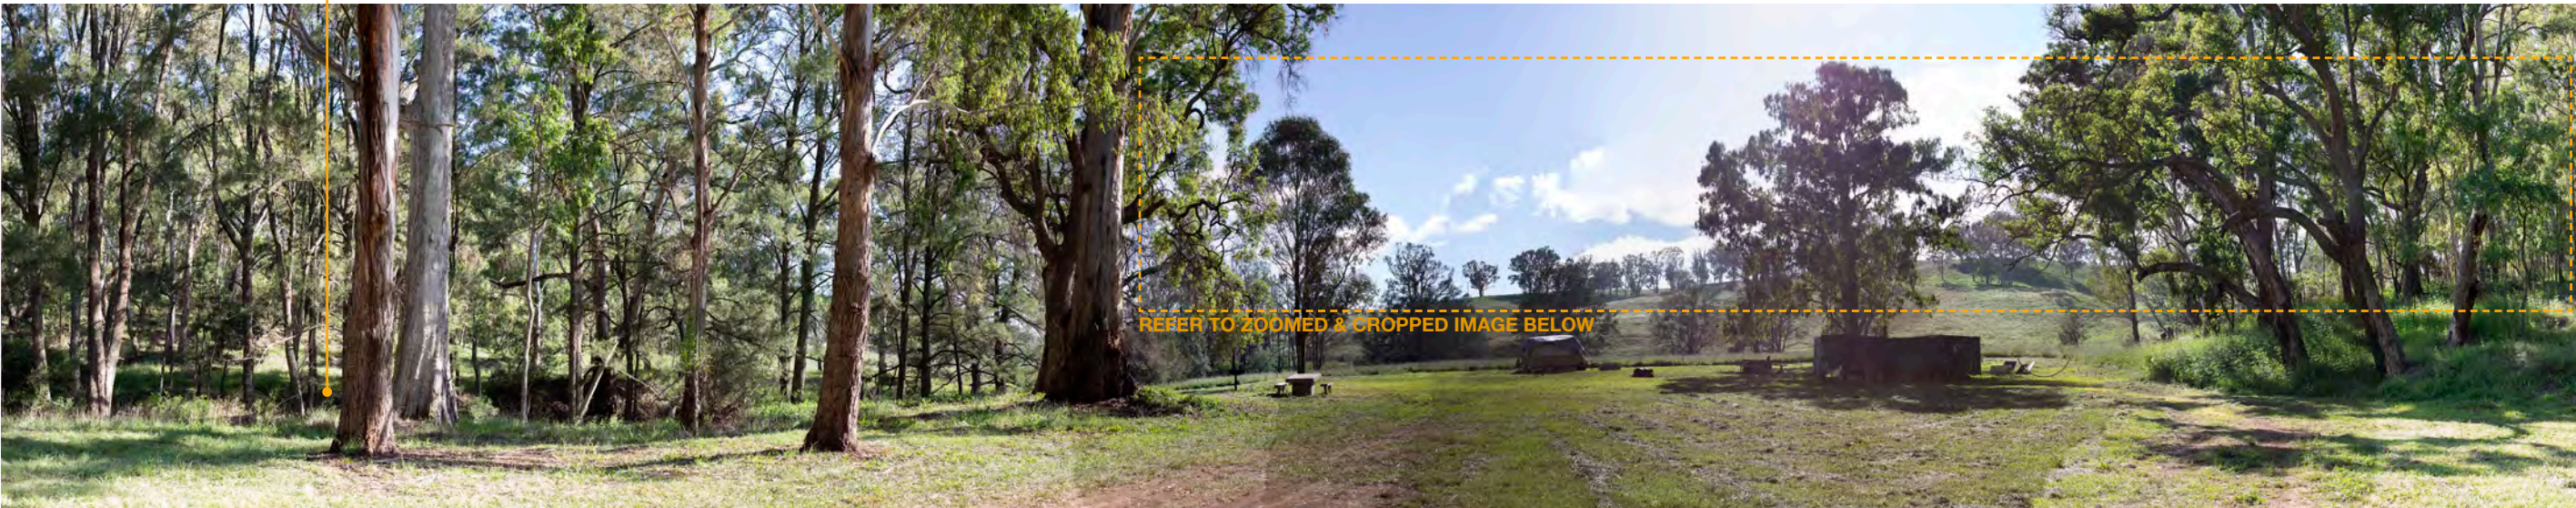
VIEWPOINT HOG03

Viewpoint Summary		Viewpoint Description	Visual Performance Objectives: VIZ2
Location:	Elevation:	<p>This viewpoint is taken from 'Teamsters Rest': a public camp ground near Crawney Pass National Park. It is located approximately 350m from NAD22 and 400m from NAD74. The land use is recreational and is accessed by a low use road. The views are contained by dense native vegetation in the foreground. A small creek can be seen to the NW of the view. The land in the middleground is slightly undulating with scattered vegetation.</p> <p>Potential Visual Impact</p> <p>An assessment based on topograhy alone indicates that 6 WTG's would be visible however, due to the dense vegetation in the foreground it is unlikely that any WTG's will be visible from this viewpoint location.</p> <p>Nearby Residences:</p> <p>AD74 & NAD22</p>	<p>Visual Magnitude:</p> <p>Screening is unlikely to be necessary due to the existing vegetation.</p> <p>Landscape Scenic Integrity:</p> <p>The vegetation in the foreground is likely to contain views toward the wind turbines therefore it is unlikely the WTG's will alter the existing visual landscape from this location.</p> <p>Key Feature Disruption:</p> <p>The forested edges to the viewpoint provide a visual backdrop to the north and east of this viewpoint. The hill in the foreground will remain the most visually prominent feature from this location.</p>

Indicative location of the extent of WTGs along ridgeline behind the vegetation in the foreground

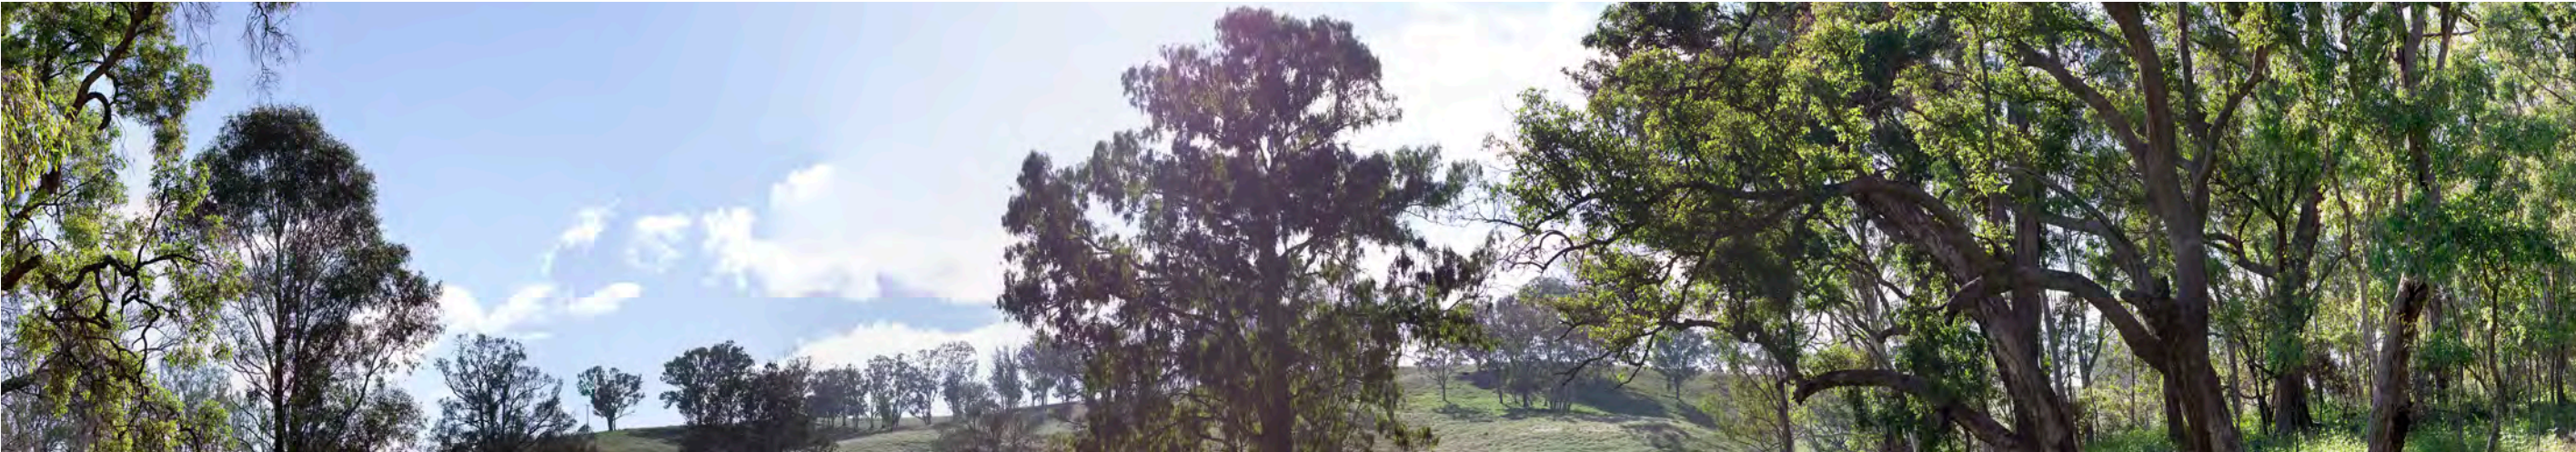
'Teamsters Rest' off Crawney Road	715m		
Coordinates:	Viewing Direction:		
31°33'23.58"S 151°5'23.53"E	Generally North East		
Distance to WTG:	Visibility Distance Zone:

4.1km	Far Middleground (FM)		
Land Use:	Viewer Sensitivity Level:		
Recreation	Level 2: Moderate		
LCU:	Scenic Quality Rating:		
Nundle Rolling Foothills	Moderate		
Visual Influence Zone VIZ2

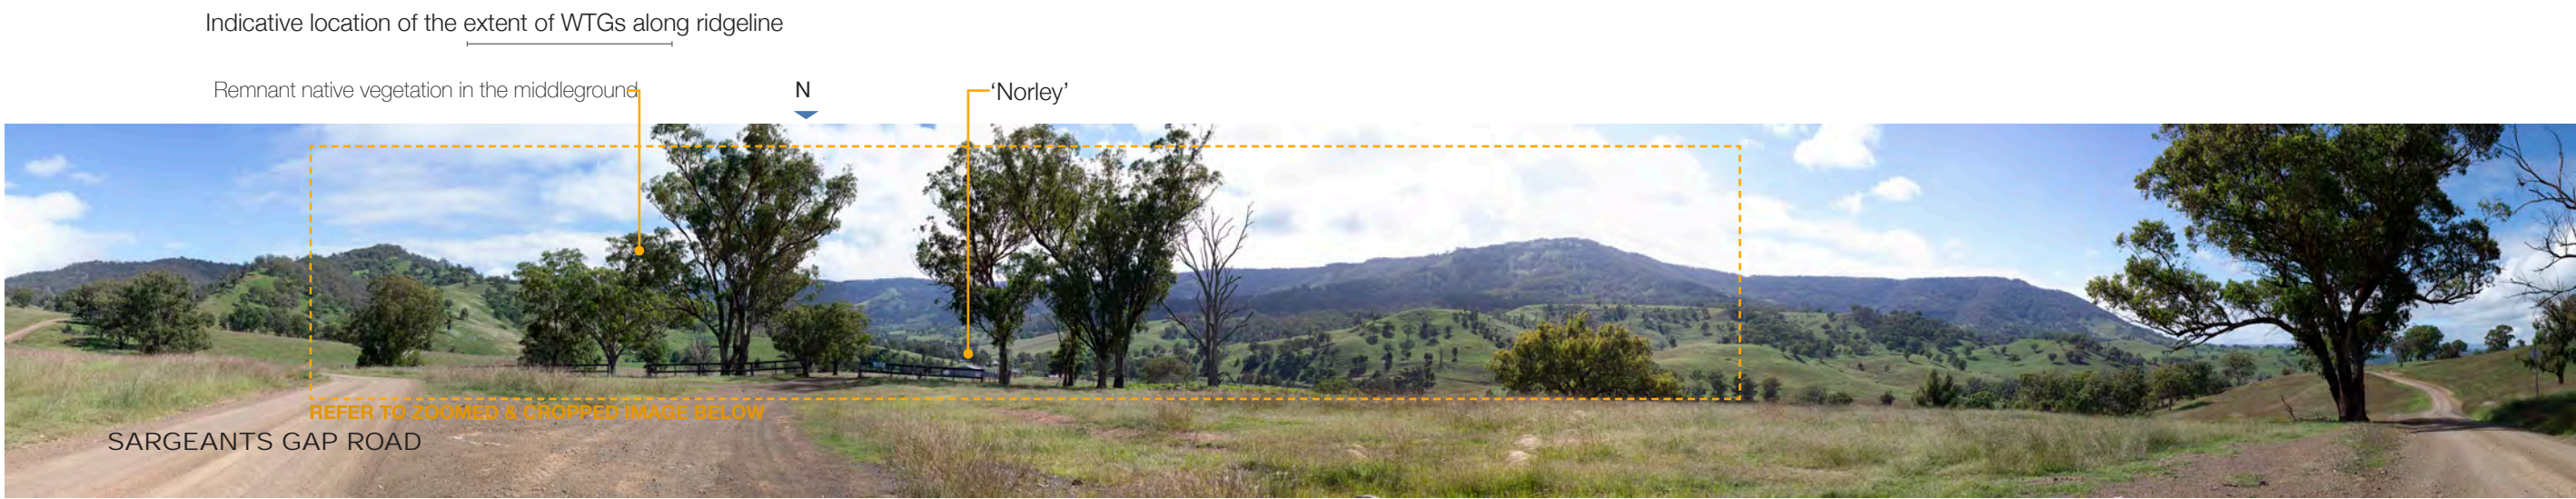
VIEWPOINT HOG05

Viewpoint Summary		Viewpoint Description	Visual Performance Objectives: VIZ3
Location:	Elevation:	This viewpoint is taken from an elevated position at the intersection of Pages Creek Rd and Sargeants Gap Rd, approximately 20m from the entry to 'Norley'. The land is undulating, mostly cleared rural residential and agricultural land mainly used for grazing. The property and associated structures are visible in the background to the NE of the view. There is remnant native vegetation in the middleground at the entry to the property and stands of scattered vegetation in the distance associated with the gullies and ridgelines of the undulating landform. The view is expansive and extends toward the densely vegetated ridge in the distance.	There are no visual performance objectives that apply to this viewpoint due to the Visual Influence Zone Rating (VIZ3).
Sargeants Gap Road	750m		
Coordinates:	Viewing Direction:

151°12'22.22"E 31°41'51.84"S	Generally North		
Distance to WTG:	Visibility Distance Zone:		
Approx. 8.0km	Near Background (NB)	Potential Visual Impact A preliminary assessment based on topography along suggest that views of approximately 3 WTG's to the north may be visible from this location. The vegetation in the middleground is likely to screen these views and when combined with the distance from the Site they will be difficult to discern.	
Land Use:	Viewer Sensitivity Level:		
Low Use Road	Level 3: Low		
LCU:	Scenic Quality Rating:	Nearby Residences:	
Crawney	Moderate	'Norley' is in excess of 8km from Turbines.	
Visual Influence Zone VIZ3

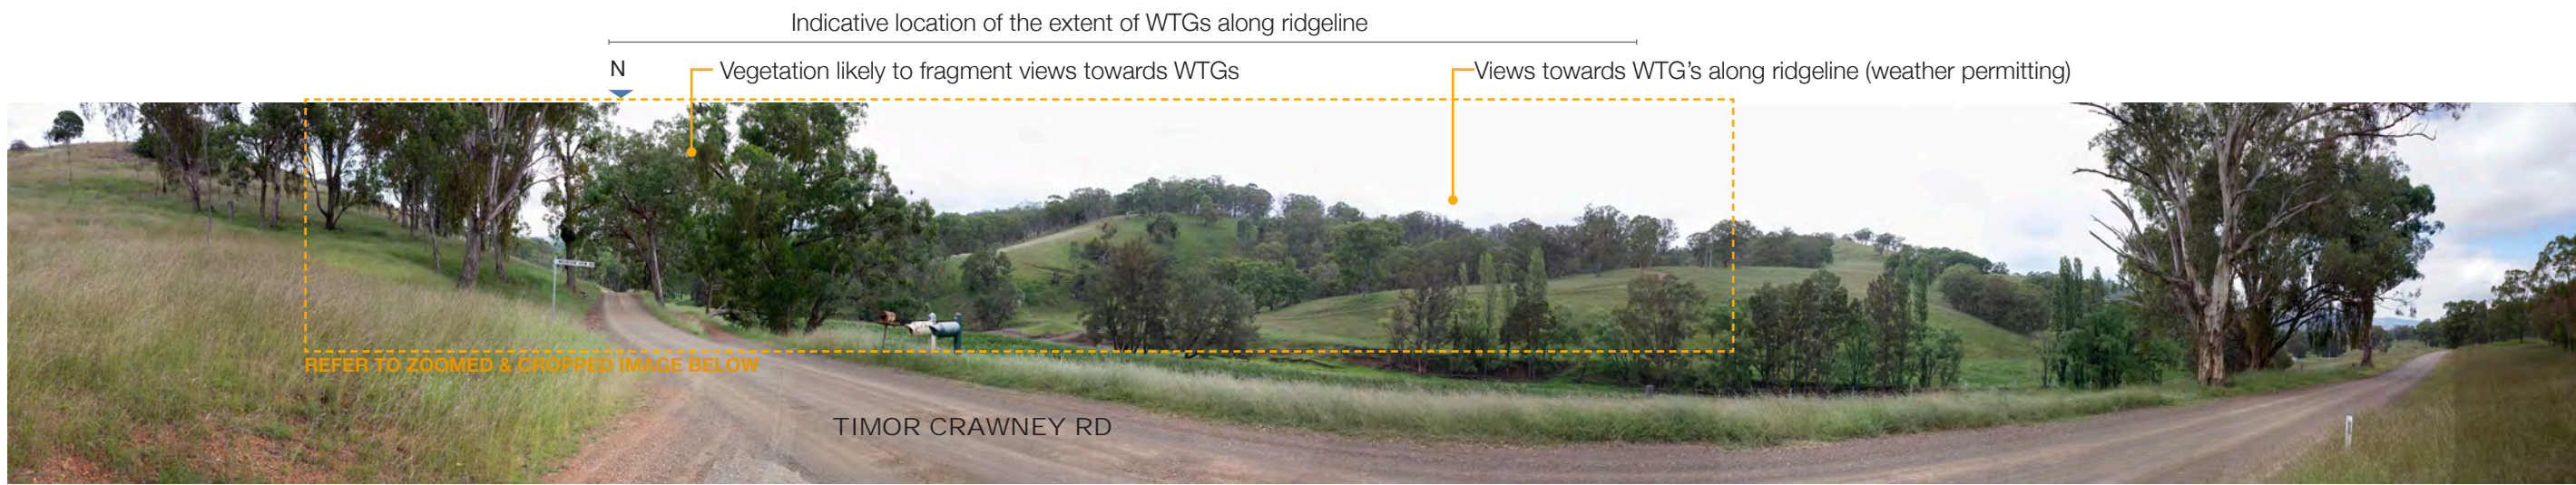
VIEWPOINT HOG06			
Viewpoint Summary		Viewpoint Description	Visual Performance Objectives: VIZ3
Location:	Elevation:	<p>This viewpoint is taken from the corner of Timor Crawney Rd and Mountain View Road, at the entry to residences NAD50,69 & 1 and approximately 600m from residence NAD70. The road is a low use road. The land is characterised by undulating partially cleared rural residential and agricultural land. There are stands of dense vegetation that follow the undulating landform and Isis River which runs generally in a N/S direction, parallel to the road. The view is partially contained by the foreground vegetation. On a clear day, the ridge can be seen in the distance to the east of the view.</p> <p>Potential Visual Impact</p> <p>From this location approximately 30 WTG's may be visible along the ridgeline in a north east direction. It is likely that existing foreground vegetation will fragment this view, reducing the number of visible WTG's in a northerly direction.</p>	<p>There are no visual performance objectives that apply to this viewpoint due to the Visual Influence Zone Rating (VIZ3).</p> <p>Detailed assessment of dwellings associated with Mountain View Road is included in <i>Appendix E. See PM22.</i></p>

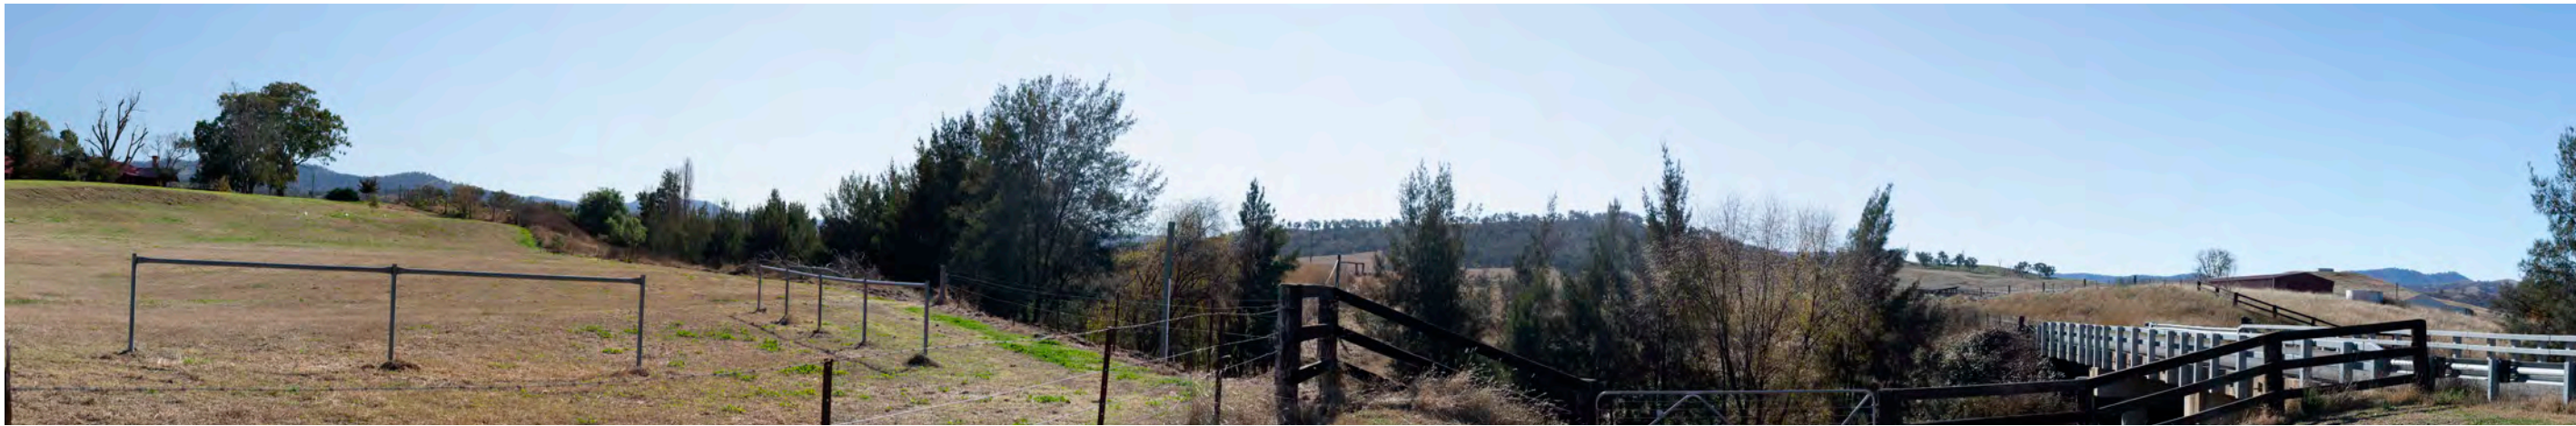
VIEWPOINT HOG07

Viewpoint Summary		Viewpoint Description	Visual Performance Objectives: VIZ3
Location:	Elevation:	<p>View taken from Timor Crawney Road, at the driveway of the Timor Polo Club. The land is cleared and maintained turf field, used to host Polo matches. Timor Creek is visible in the foreground and the scattered vegetation associated with the creek fragmenting views toward the north. The ridgeline associated with the Project is visible in the far distance.</p> <p>Potential Visual Impact</p> <p>From this location approximately 27 WTG's may be visible to the of this viewpoint. However, a combination of vegetation in the foreground and distance to the Turbines are likely to fragment views to toward the majority of the WTG's from this location.</p>	<p>There are no visual performance objectives that apply to this viewpoint due to the Visual Influence Zone Rating (VIZ3).</p>
Timor Crawney Road	420m

Coordinates:	Viewing Direction:		
151° 4'44.21"E 31°45'21.73"S	Generally North		
Distance to WTG:	Visibility Distance Zone:		
13.5km	Mid Background		
Land Use:	Viewer Sensitivity Level:		
Low Use Road	Level 3: Low	<p>Nearby Residences:</p> <p>Timor Polo Club located in excess of 13.5km from Turbines.</p>	
LCU:	Scenic Quality Rating:		
Crawney	Moderate		
Visual Influence Zone VIZ3

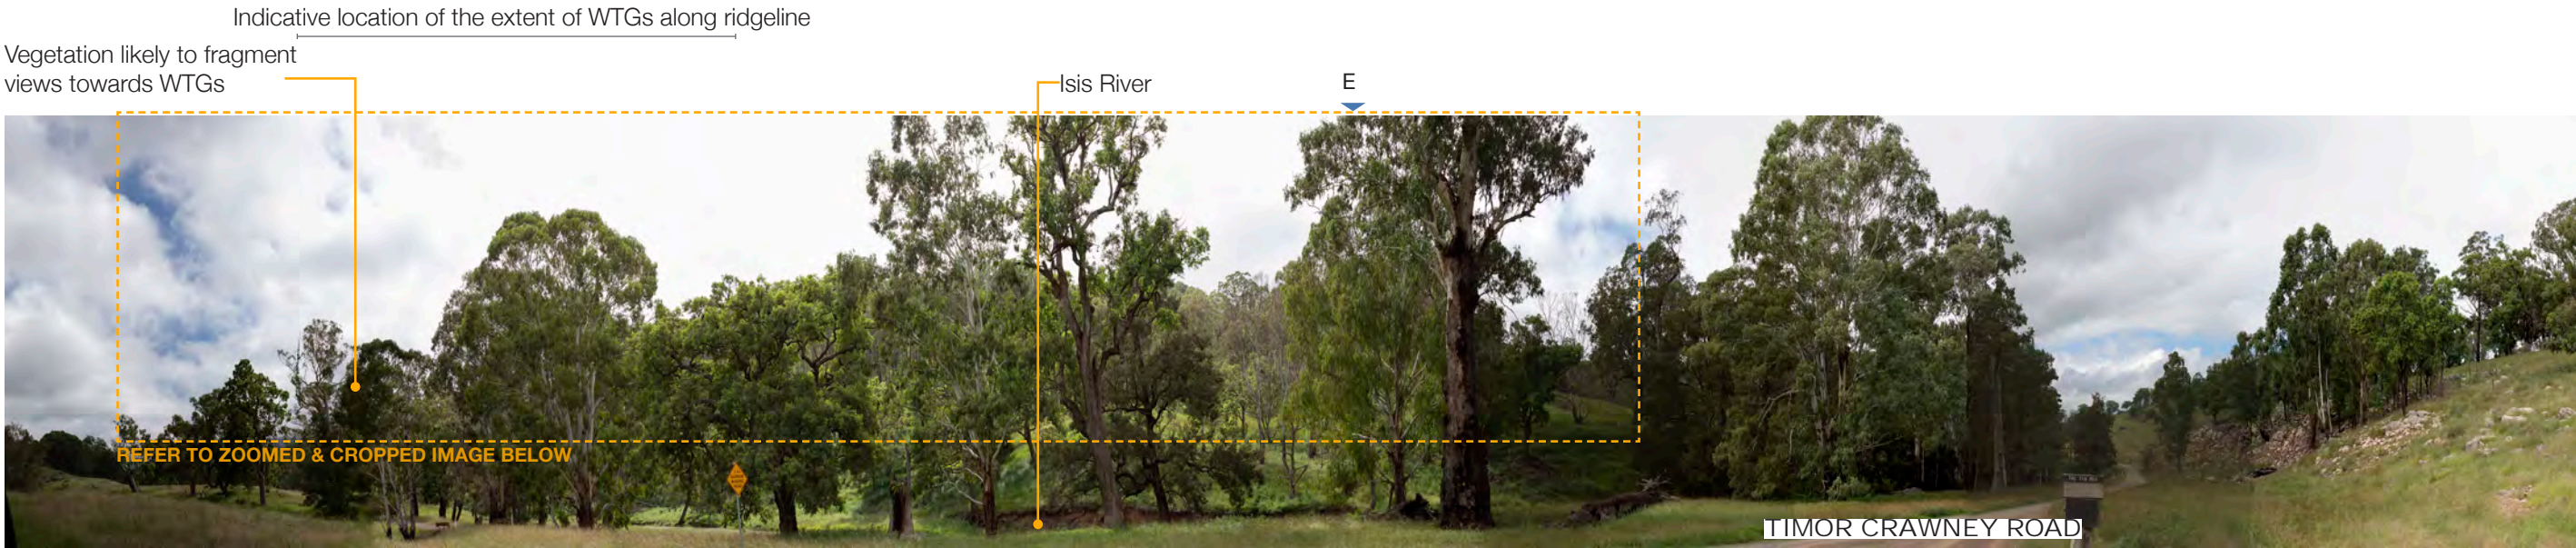
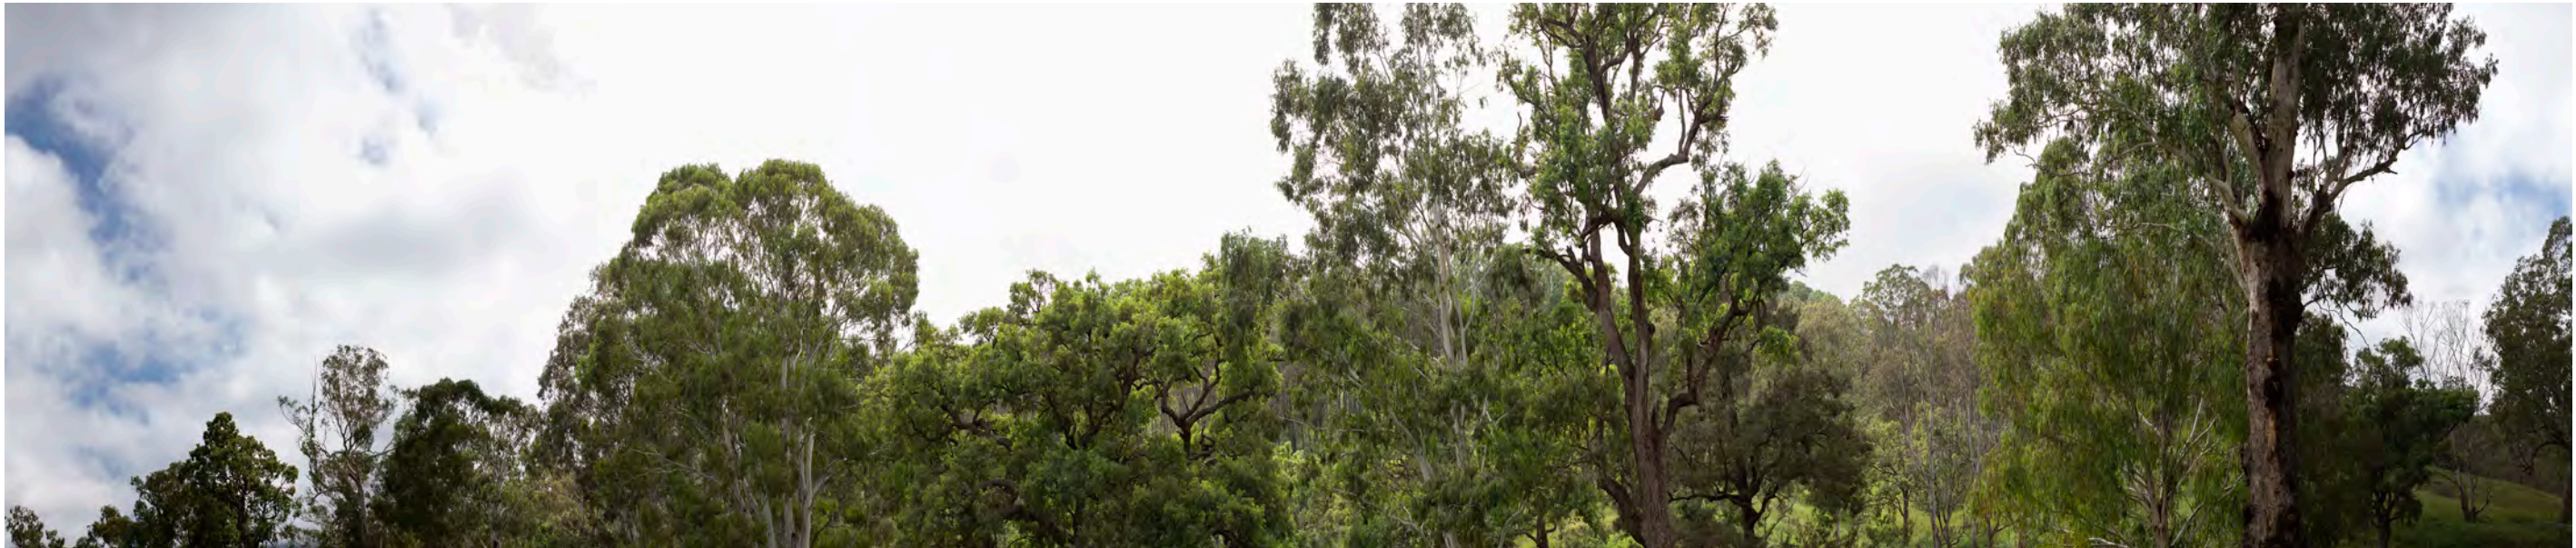
VIEWPOINT HOG08			
Viewpoint Summary		Viewpoint Description	Visual Performance Objectives: VIZ3
Location:	Elevation:	<p>View taken from Timor Crawney Rd near to the entry to residence NAD41, approx. 800m to the residence. The land is characterised by the partially cleared agricultural land and dense vegetation that runs along the Isis River. It is undulating with rocky outcrops and scattered vegetation in the middleground.</p> <p>Potential Visual Impact</p> <p>There are approximately 9 WTG's that may be visible from this location. However, the existing vegetation typical of this area is likely to fragment views toward the project area, reducing the number of WTG's visible from this location.</p> <p>Nearby Residences:</p> <p>NAD41</p>	<p>Visual Magnitude:</p> <p>There are no visual performance objectives that apply to this viewpoint due to the Visual Influence Zone Rating (VIZ3).</p>
Timor Crawney Road	563m

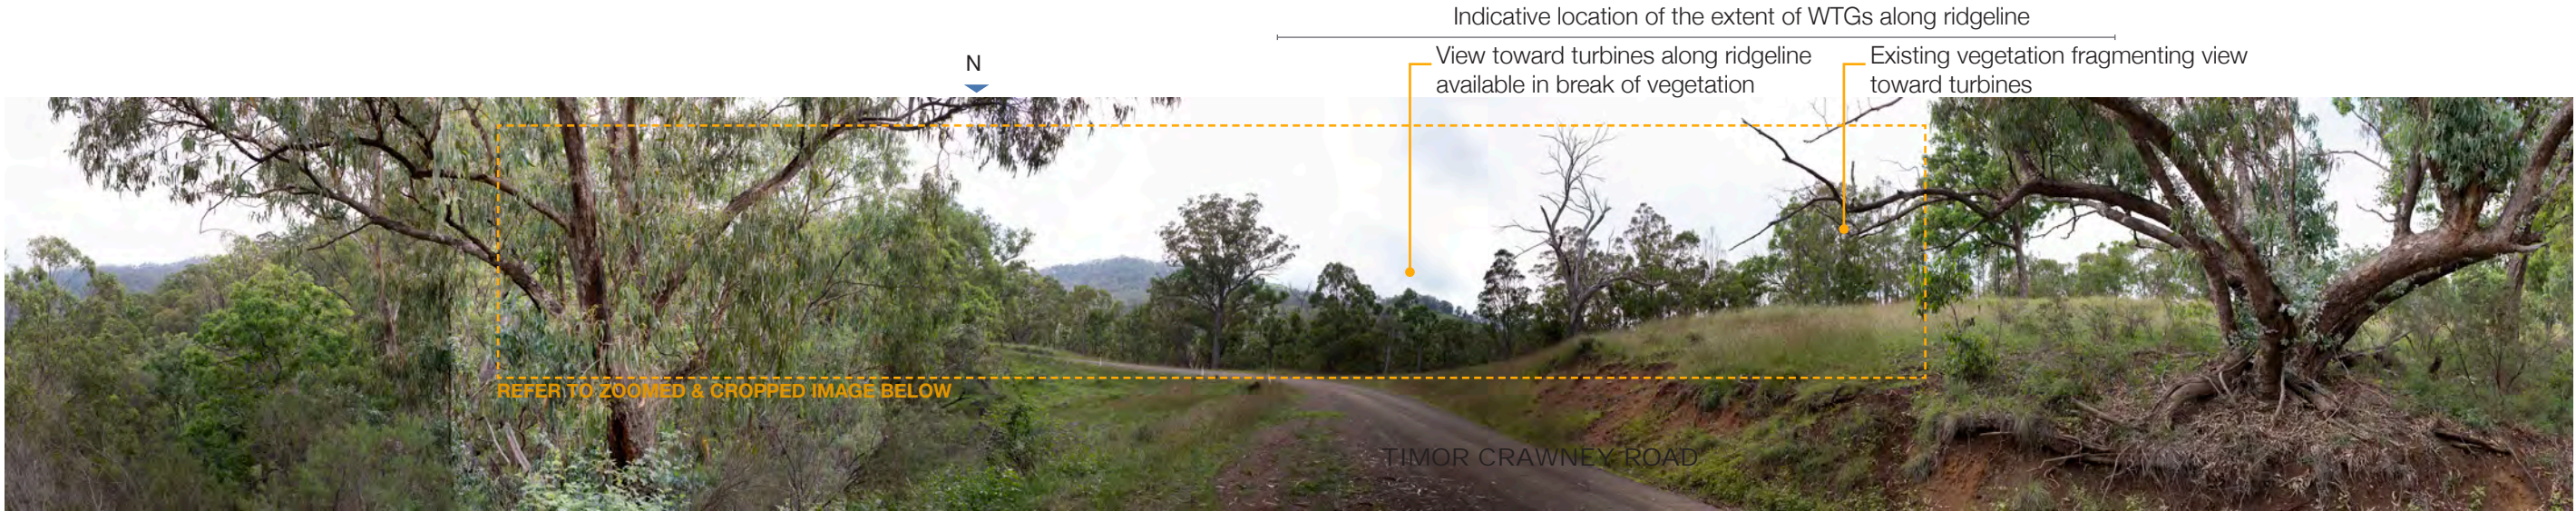
VIEWPOINT HOG09			
Viewpoint Summary		Viewpoint Description	Visual Performance Objectives: VIZ3
Location:	Elevation:	View from Timor Crawney Road, just south of the Crawney Pass National Park. Land in the immediate area is undulating and falls to the west. Land has been cleared to make way for the roadway. Native vegetation has been retained along the roadside edges and is visible in the foreground and middleground and contains views to the north and east. The view extends north east toward the ridge associated with the project in the background.	Visual Magnitude: There are no visual performance objectives that apply to this viewpoint due to the Visual Influence Zone Rating (VIZ3).
Timor Crawney Road	747m		
Coordinates:	Viewing Direction:		
151°2'40.05"E 31°36'51.20"S	Generally North East		
Distance to WTG:	Visibility Distance Zone:		
Approx. 2.5km	Near Middleground (NM)	Potential Visual Impact From this location approximately 27 WTG's may be visible. However, the vegetation in the middleground is likely to partially fragment views to the east of the project area, reducing the amount of WTG's visible from this location. Due to the windy nature of the road and the heavily wooded sections of the roadside vegetation, views toward the turbines would be fleeting and would extend for around 200m when travelling in a northerly direction along the road.

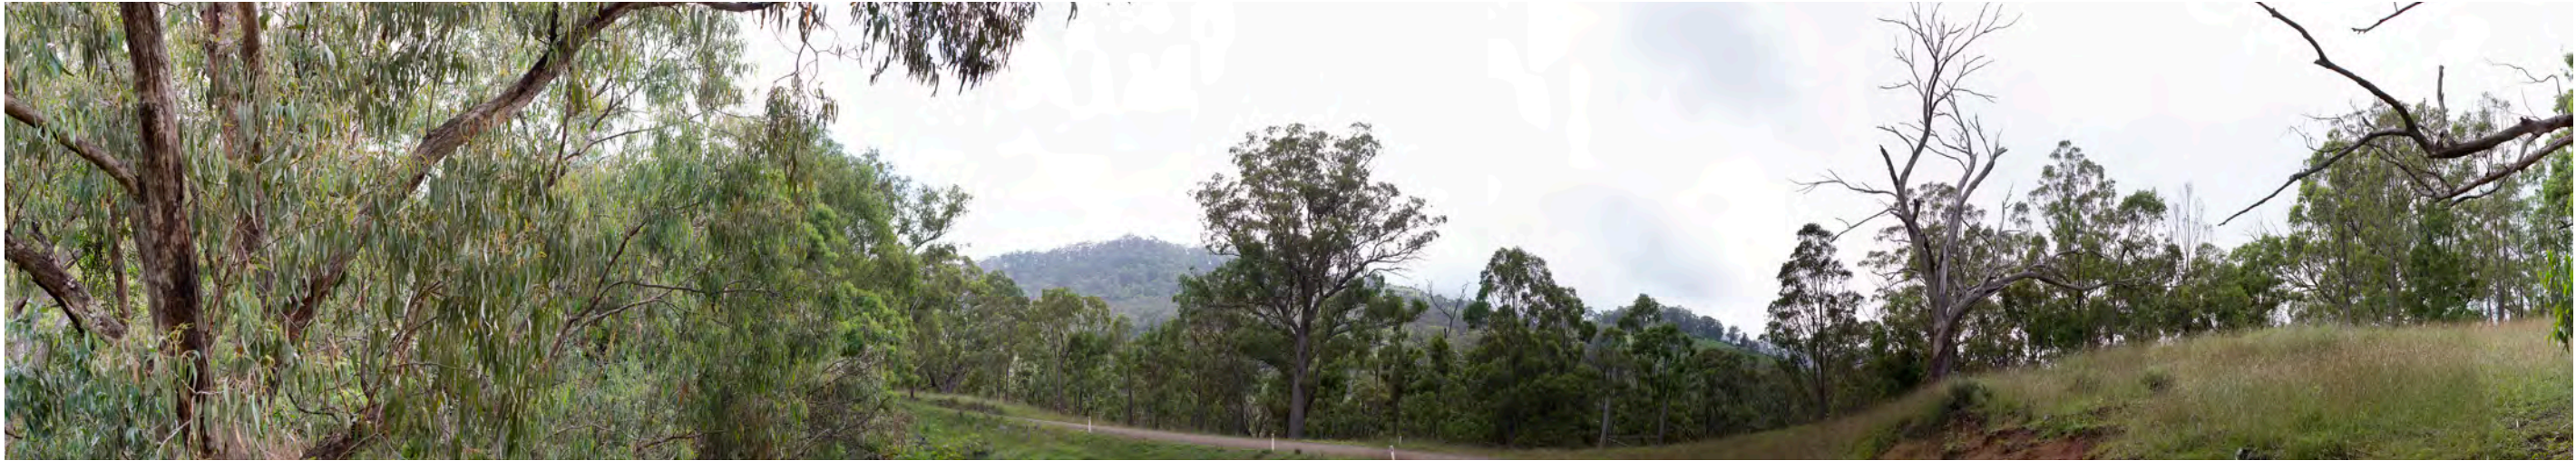
Land Use:	Viewer Sensitivity Level:		
Low Use Road	Level 3: Low		
LCU:	Scenic Quality Rating:	Nearby Residences:	
Crawney	Moderate	-	
Visual Influence Zone VIZ3

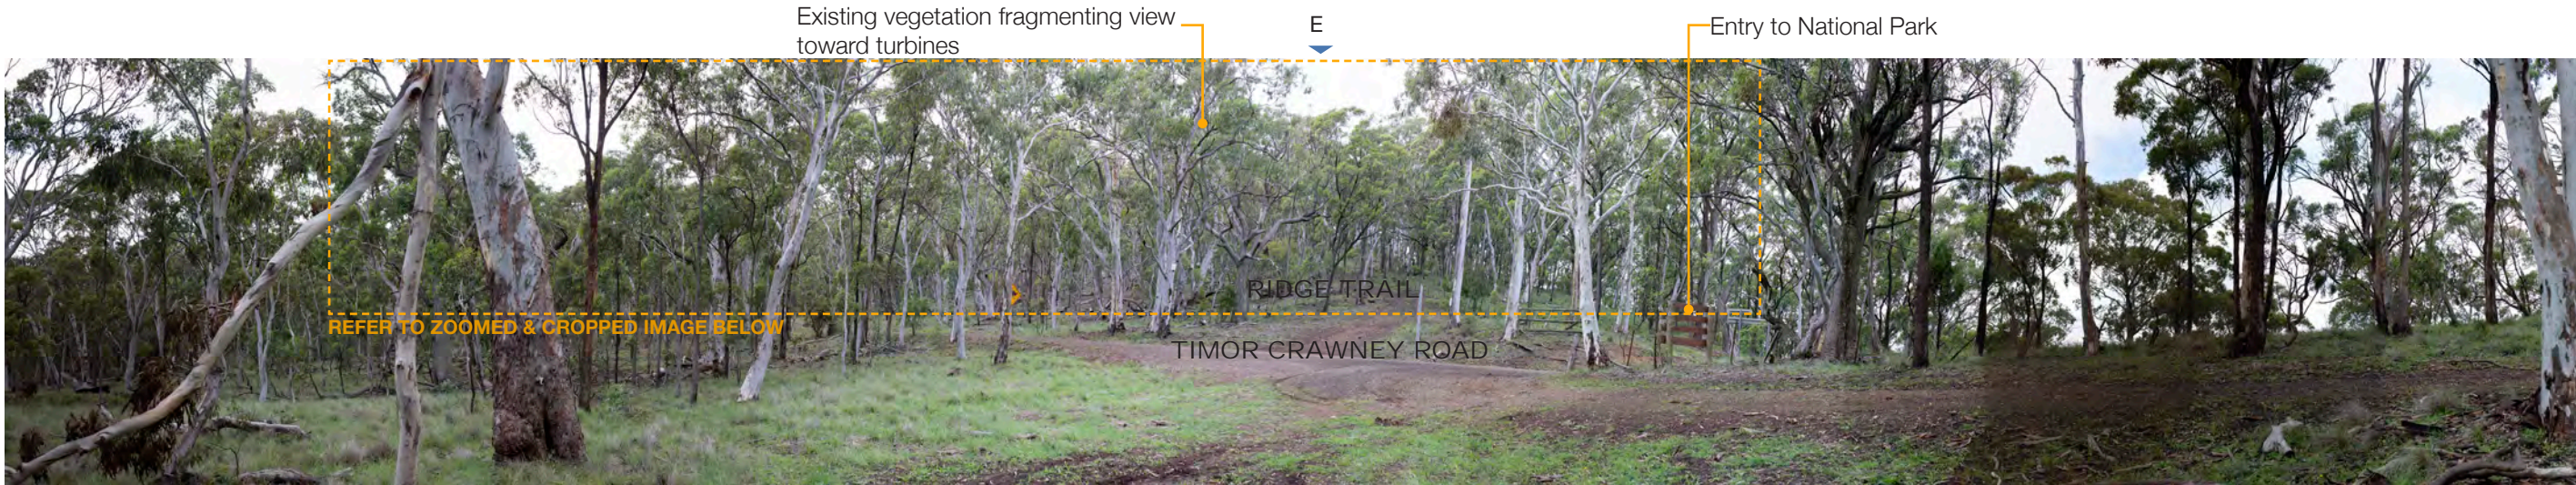
VIEWPOINT HOG10			
Viewpoint Summary		Viewpoint Description	Visual Performance Objectives: VIZ1
Location:	Elevation:	<p>This viewpoint is taken from the corner of Timor Crawney Road and Ridge Trail along the ridge. The view is taken from within the Crawney Pass National Park boundary. Dense native vegetation surrounds the viewpoint, containing the view toward the project site. The land is undulating and slopes to the north.</p> <p>Potential Visual Impact</p> <p>Dense vegetation surrounding the viewpoint is likely to obscure views toward the project site.</p>	<p>Landscape Scenic Integrity:</p> <p>The wind turbines are unlikely to significantly modify the visual catchment from this location. The majority of the Project is likely to be screened by vegetation from this location.</p> <p>Key Feature Disruption:</p> <p>The proposal is unlikely to have any major visual impact on visually significant landform, vegetation or cultural features that have visual prominence or are focal points from this location due to vegetation.</p>

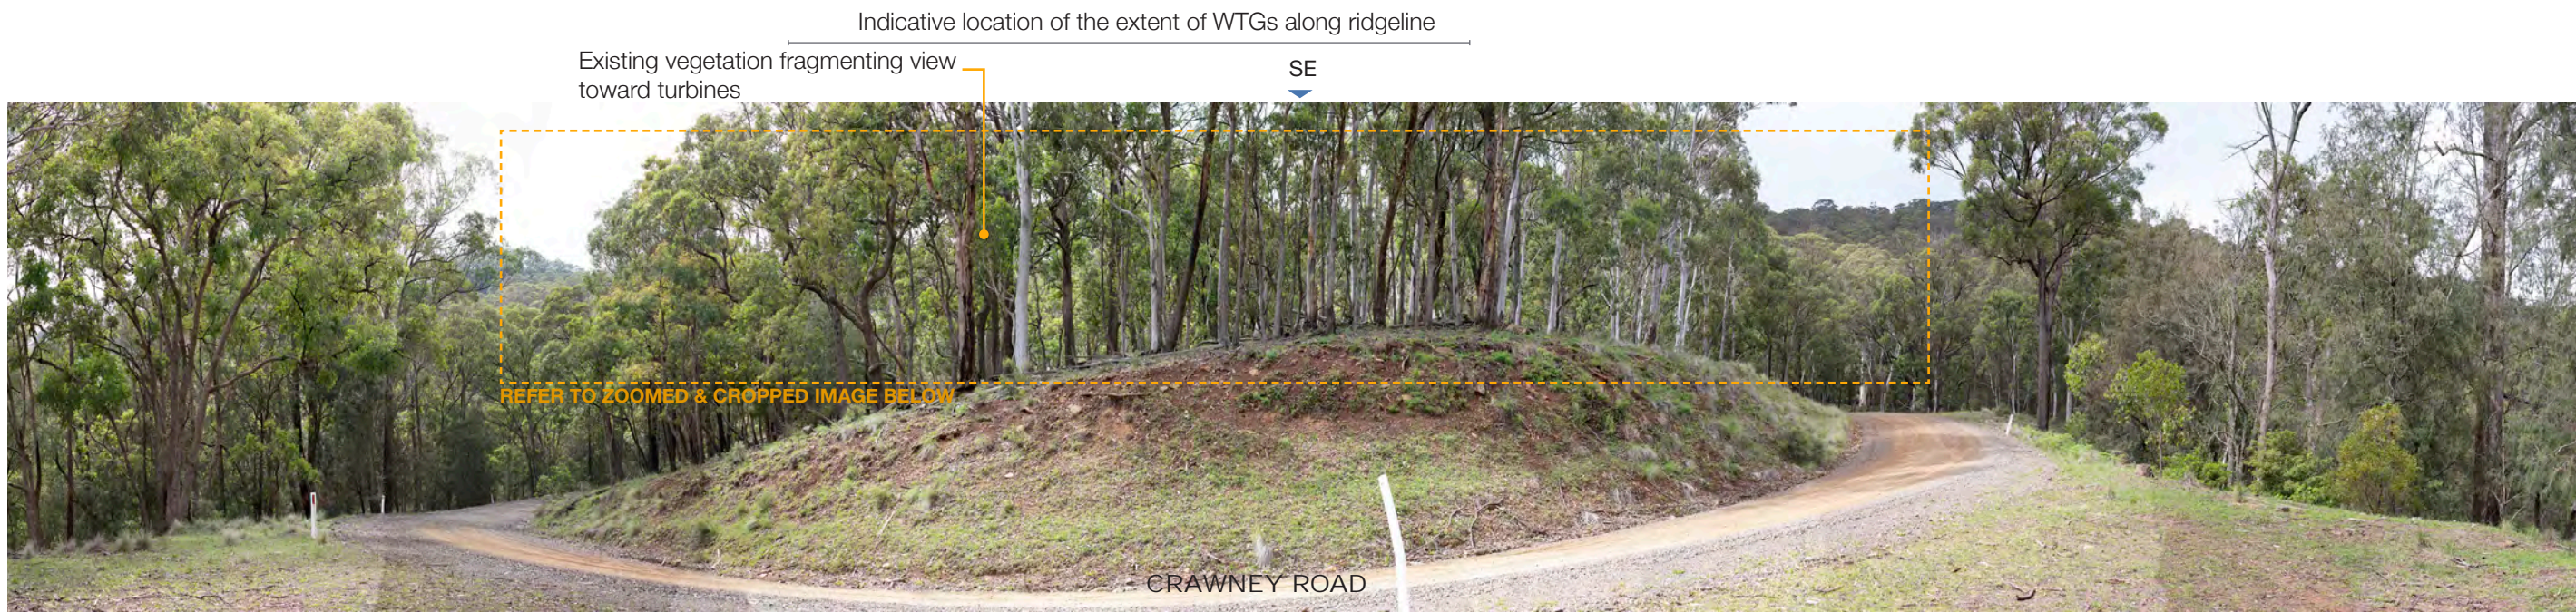
VIEWPOINT HOG11			
Viewpoint Summary		Viewpoint Description	Visual Performance Objectives: VIZ1
Location:	Elevation:	View from Crawney Road within Crawney Pass National Park. Land in this area is steep, falling to the west. Dense, native vegetation typical of the Crawney Pass National Park is visible in the foreground. The ridge is visible in the opening in the vegetation associated with the road. The road itself is windy and steep.	Landscape Scenic Integrity: The wind turbines are unlikely to significantly modify the visual catchment from this location. The majority of the Project is likely to be screened by vegetation from this location. It is possible that there may be brief moments when travelling 200m along Crawney Road whereby the turbines will be a major element in the visual catchment, however this view will fleeting.
Crawney Road	945m		
Coordinates:	Viewing Direction:		
151°3'7.04"E 31°35'33.43"S	Generally South East

Distance to WTG:	Visibility Distance Zone:		
Approx. 1.1m	Far Foreground (FF)	Potential Visual Impact From this location approximately 4 WTG's associated with the project may be seen. The dense vegetation in the foreground fragments the view toward the WTG's. It may be possible to have a fleeting view of the WTG's when travelling along Crawney Road for around 200m.	Key Feature Disruption: The proposal is unlikely to have any major visual impact on visually significant landform, vegetation or cultural features that have visual prominence or are focal points from this location due to vegetation. It is possible that there may be brief moments when the WTG's will be a major feature in the landscape, however this will be fleeting.
Land Use:	Viewer Sensitivity Level:		
Recreational	Level 1: High		
LCU:	Scenic Quality Rating:	Nearby Residences:	
Nundle Rolling Foothills	Moderate	-	
Visual Influence Zone VIZ1
